historic structure report
historical data
november 1978

PICTURED ROCKS
AU SABLE LIGHT STATION

HISTORIC STRUCTURE REPORT
HISTORICAL DATA
AU SABLE LIGHT STATION
PICTURED ROCKS NATIONAL LAKESHORE
MICHIGAN

Prepared by
Louis Torres

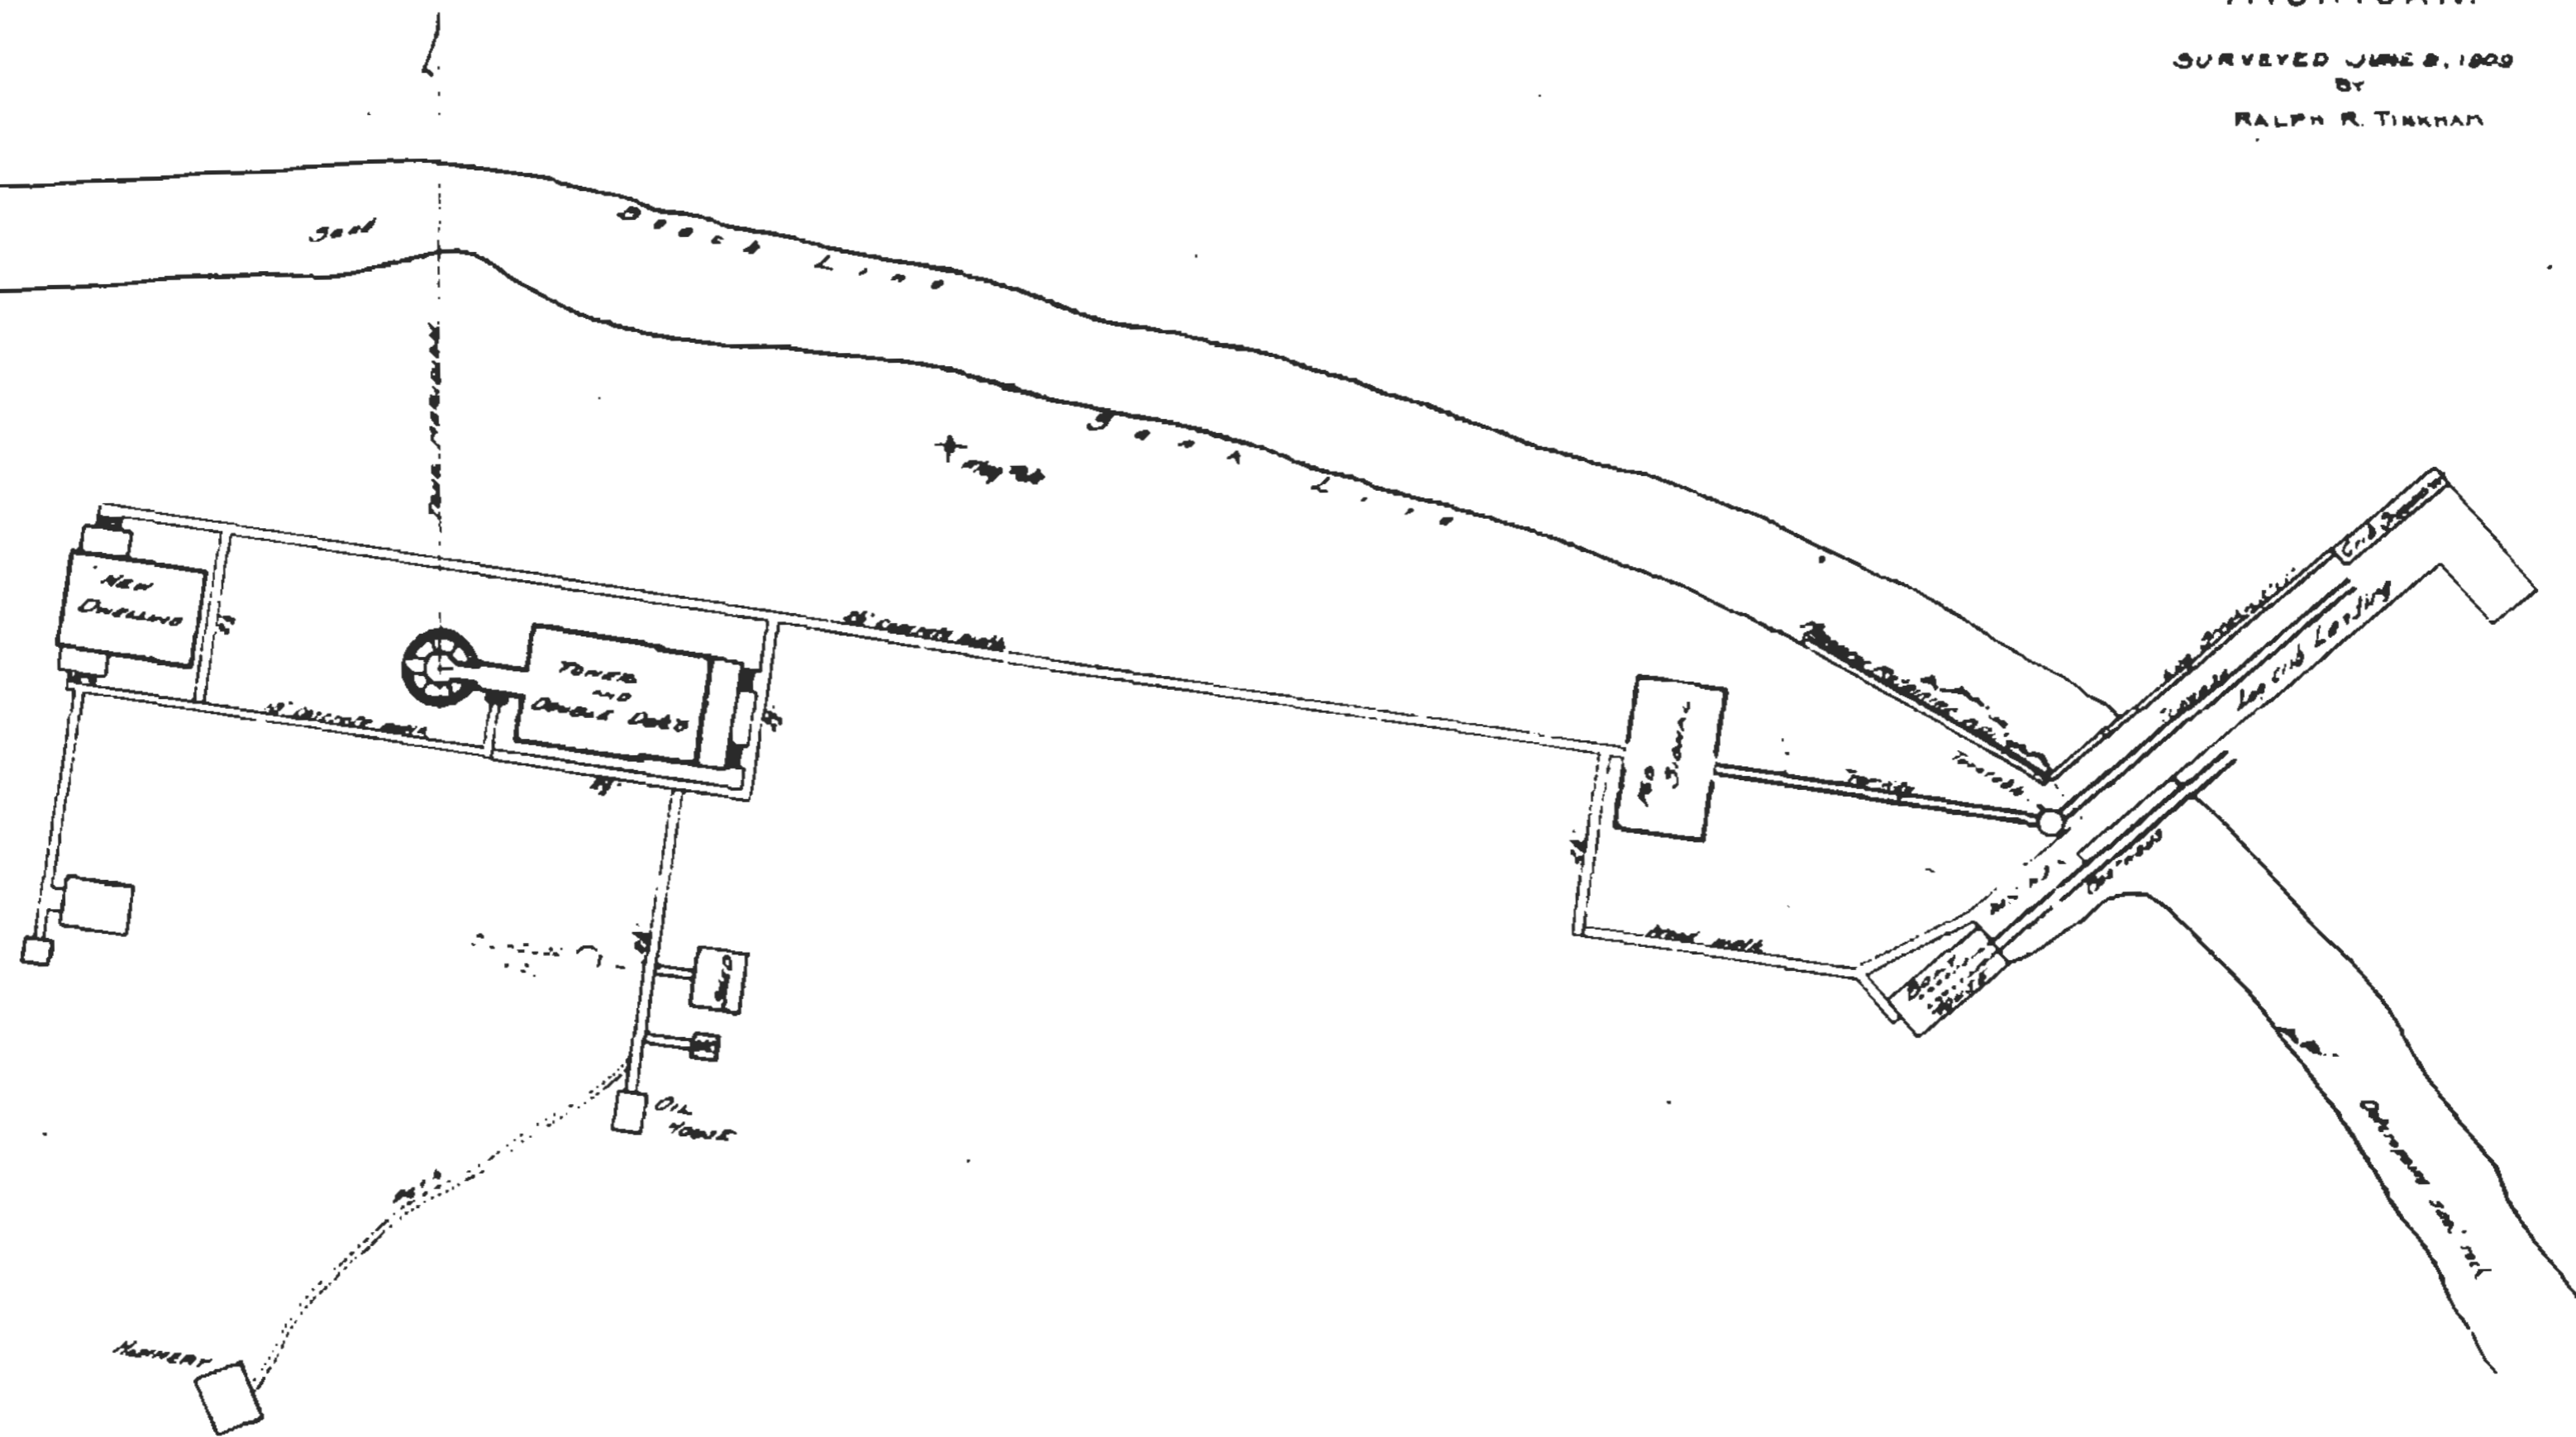
BIG SABLE LT. STA.
MICHIGAN.

SURVEYED JUNE 8, 1900
BY
RALPH R. TINKER

19. Drawing, "Big Sable Lt. Sta., Michigan, surveyed June 9, 1909, by Ralph R. Tinkham," site file, RG 26, NA.

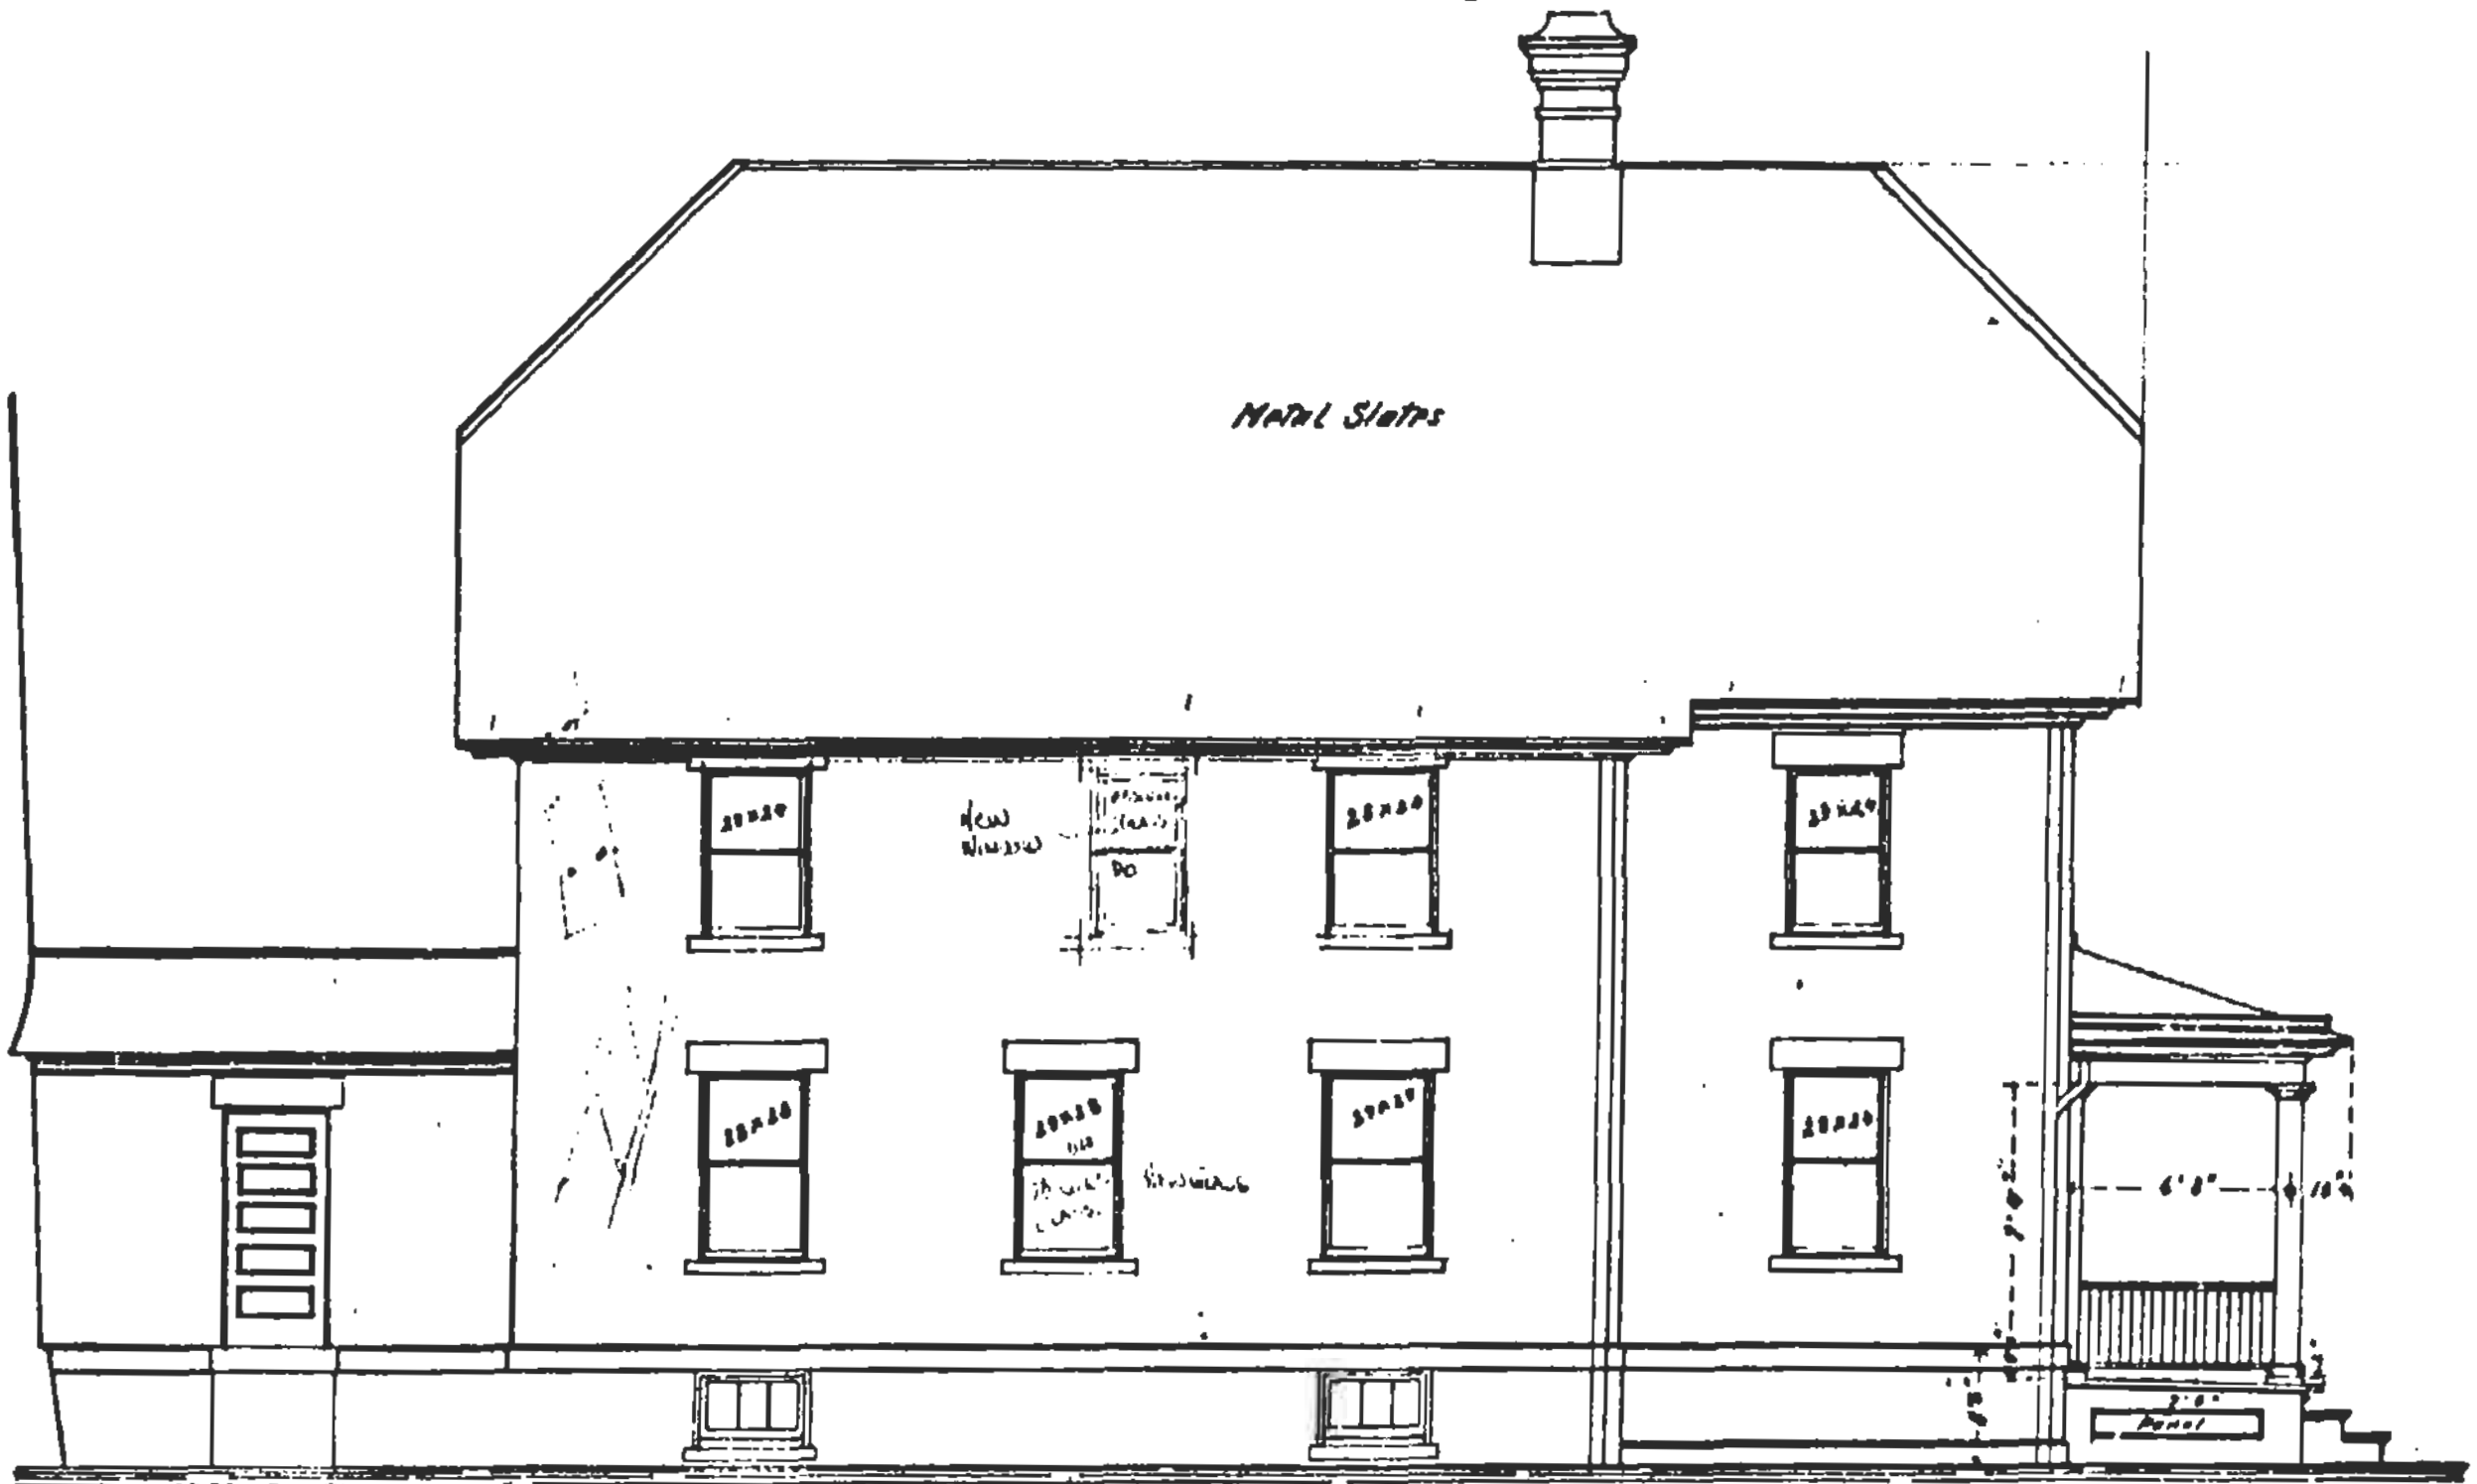
Modified Dwelling

South Side Elevation

Plan of 1st Story

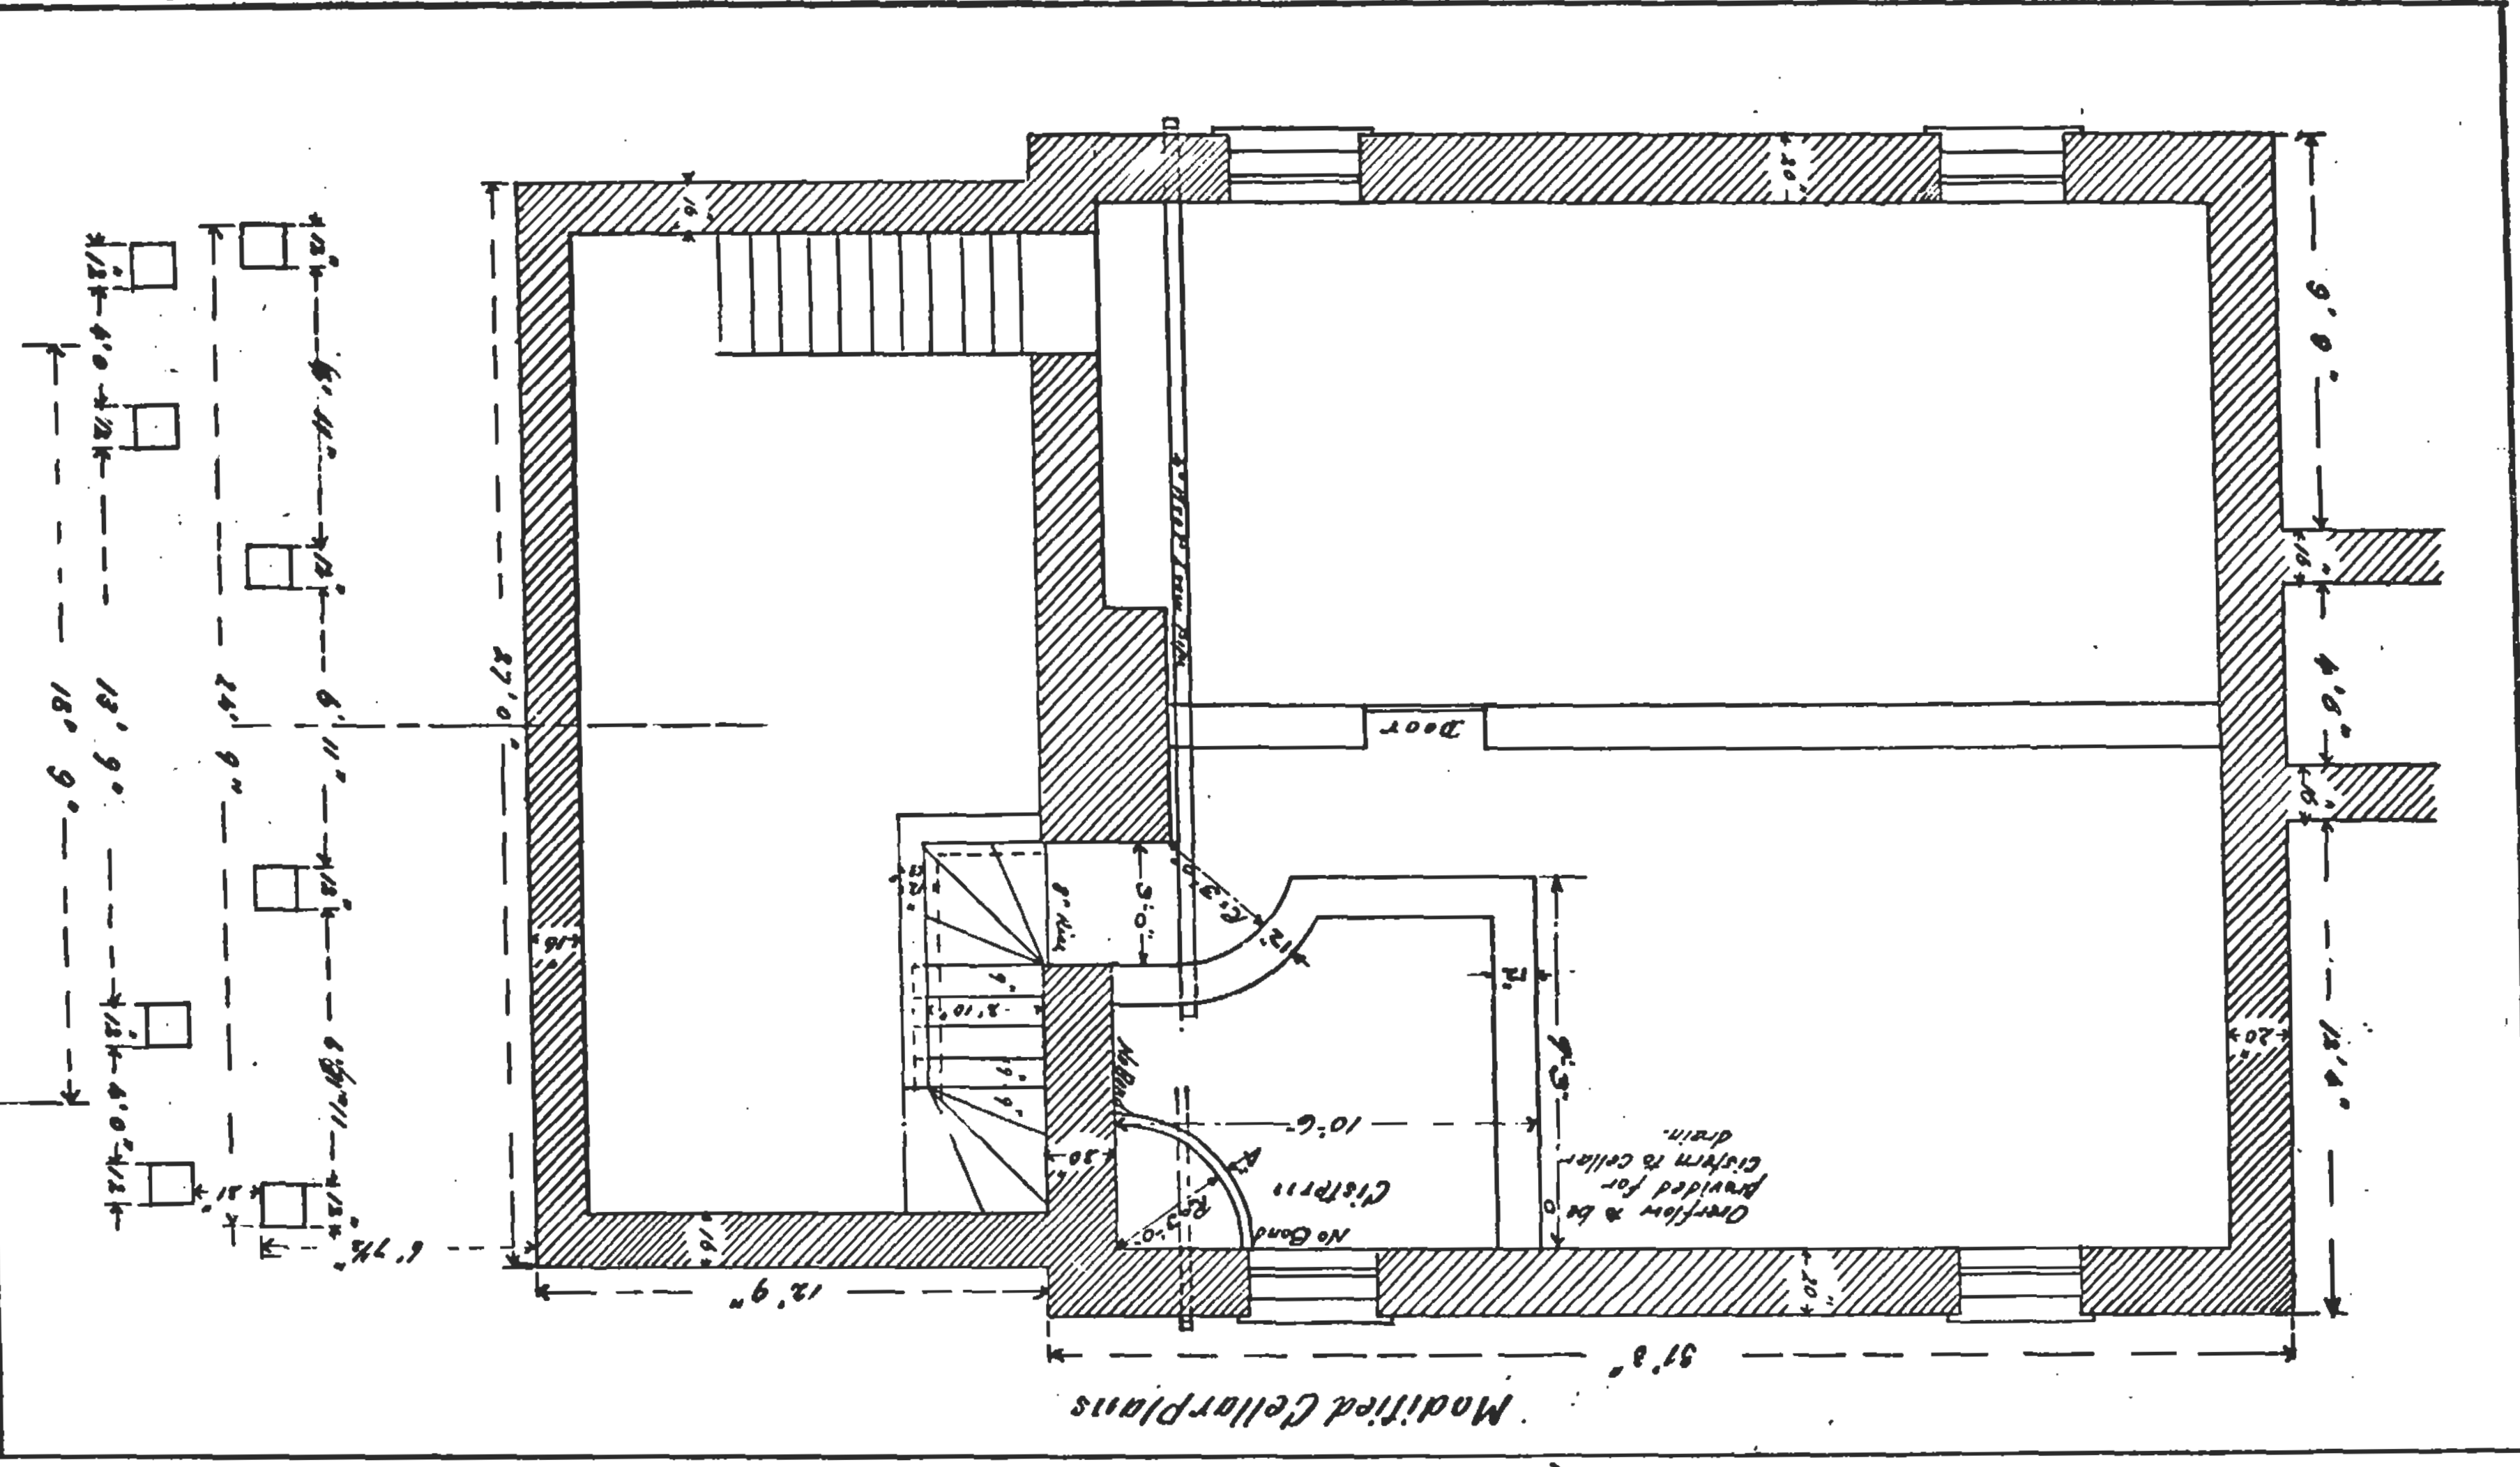
Modified Cellar Plans

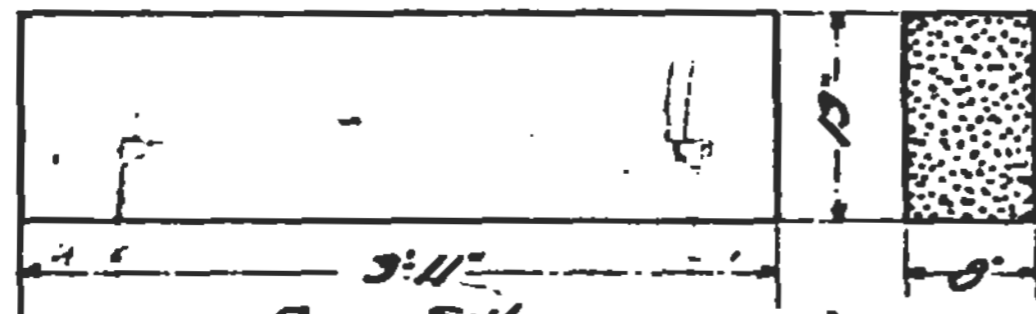
Door Sill
2 Req'd - 3'11"

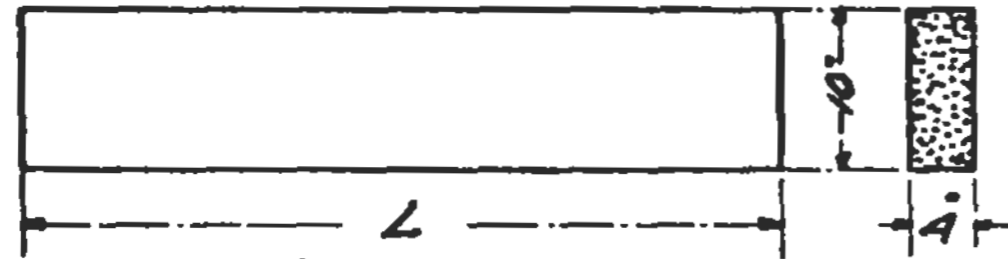
2 Door Lintels, L = 3'11"
23 Window .. L = 3'8"
1 .. L = 3'4"

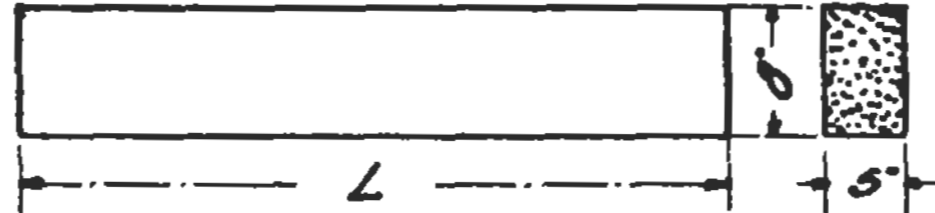
Window Sill
7 Req'd - L = 3'8"
1 .. L = 3'4"

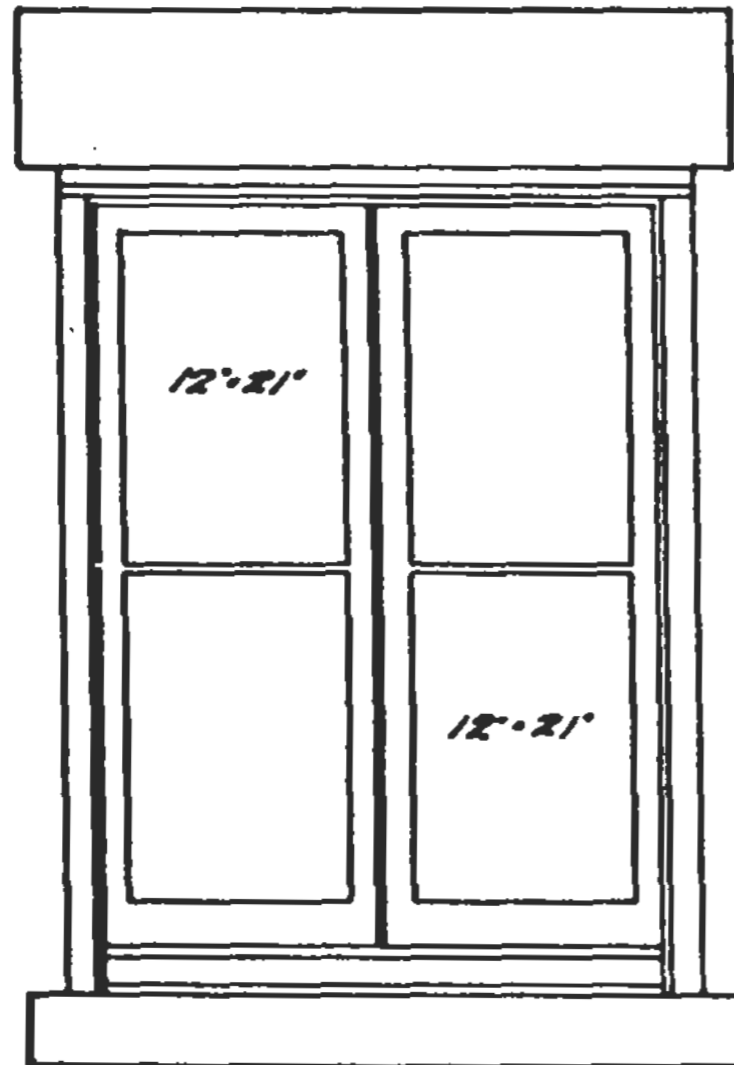
CASEMENT WINDOW
3 REQ'D

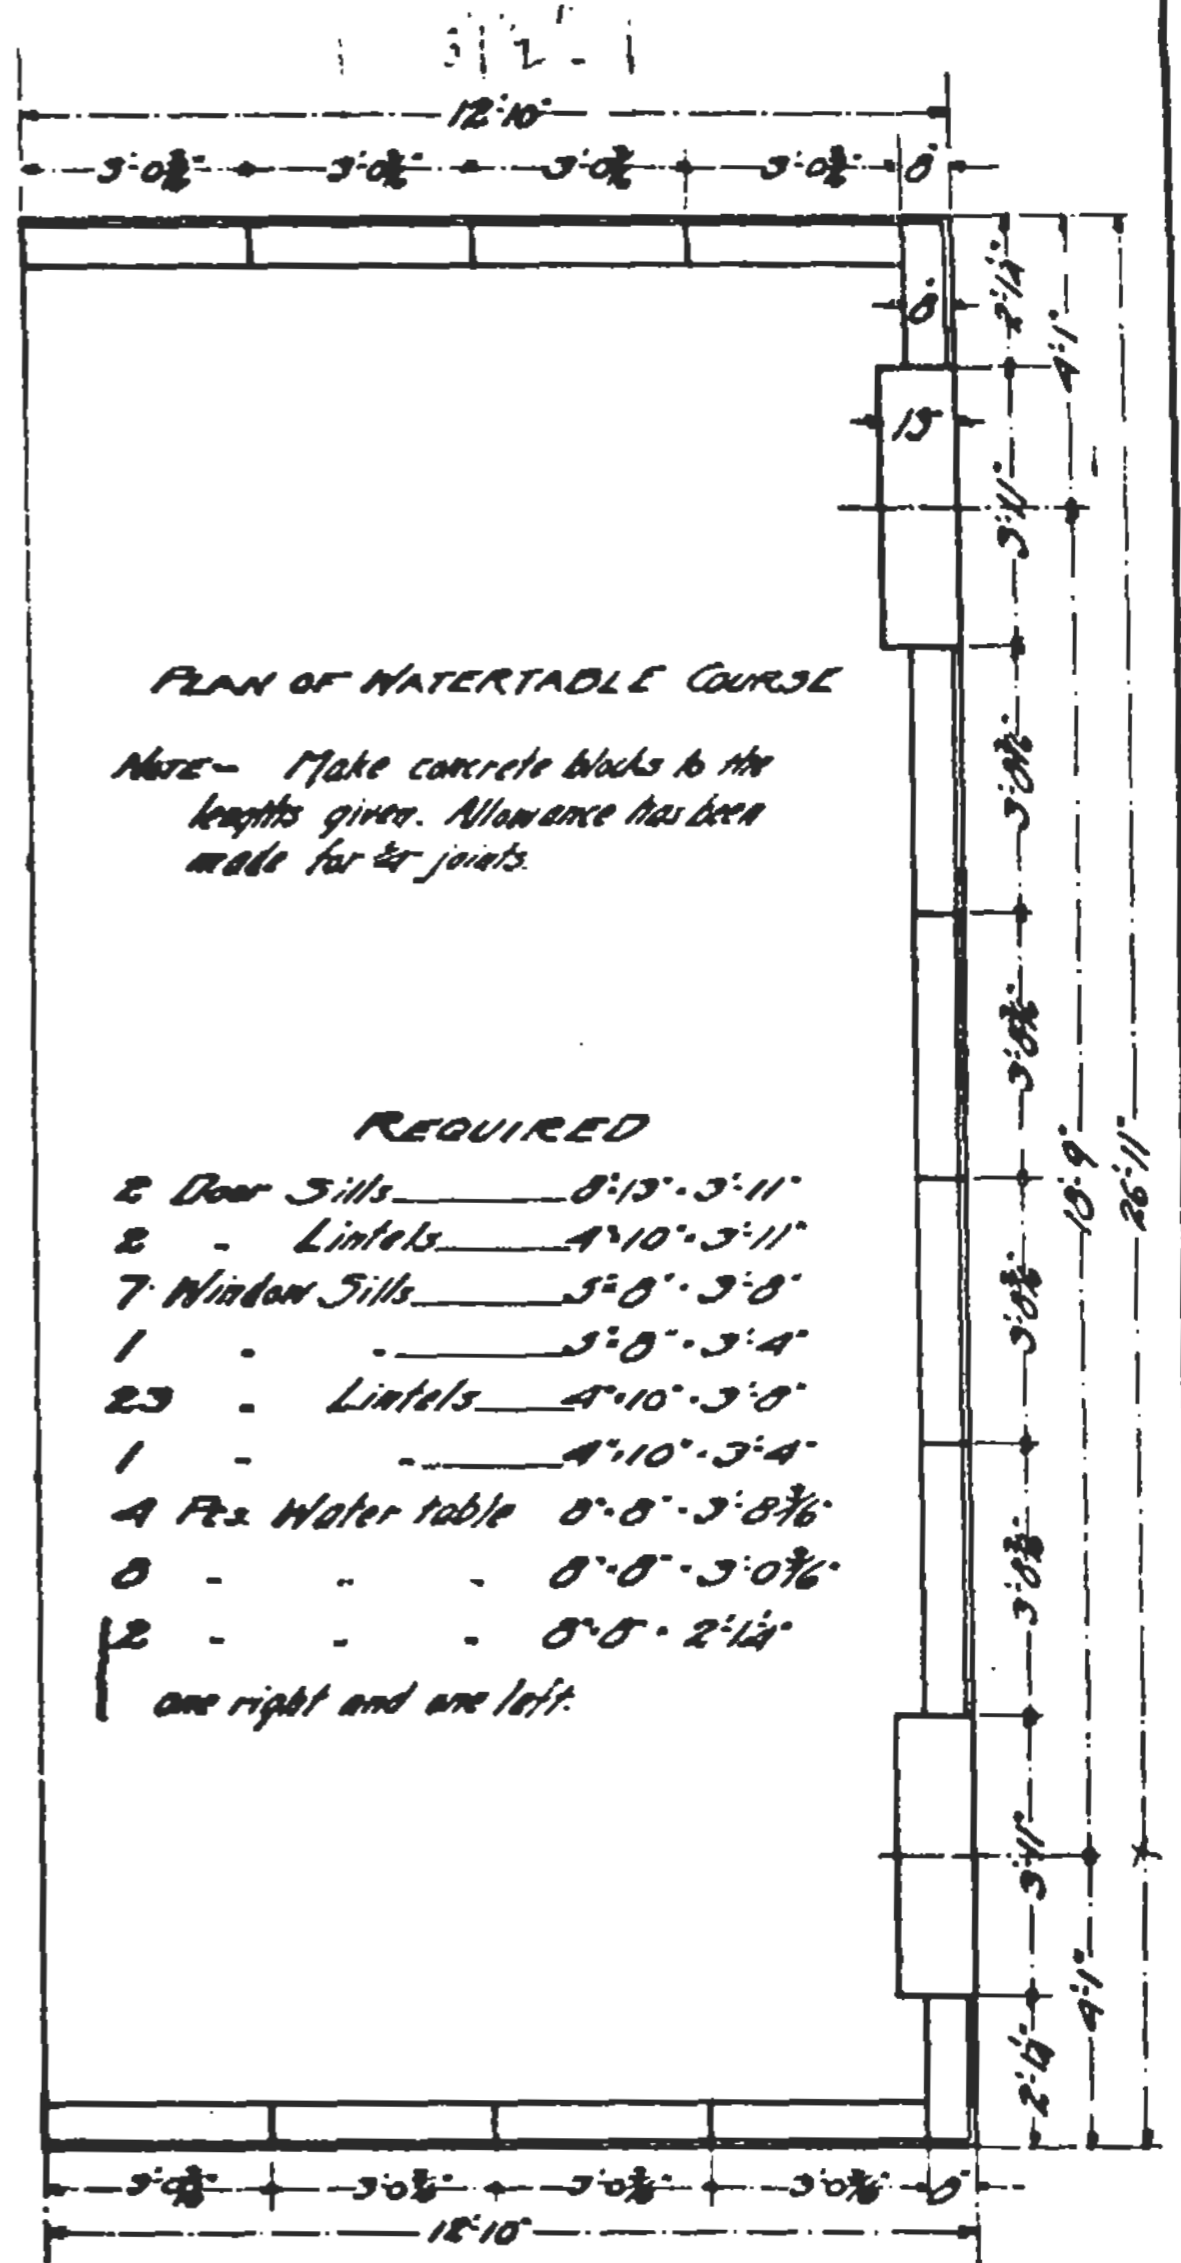
PLAN OF WATERTABLE COURSE

Note - Make concrete blocks to the lengths given. Allowance has been made for joints.

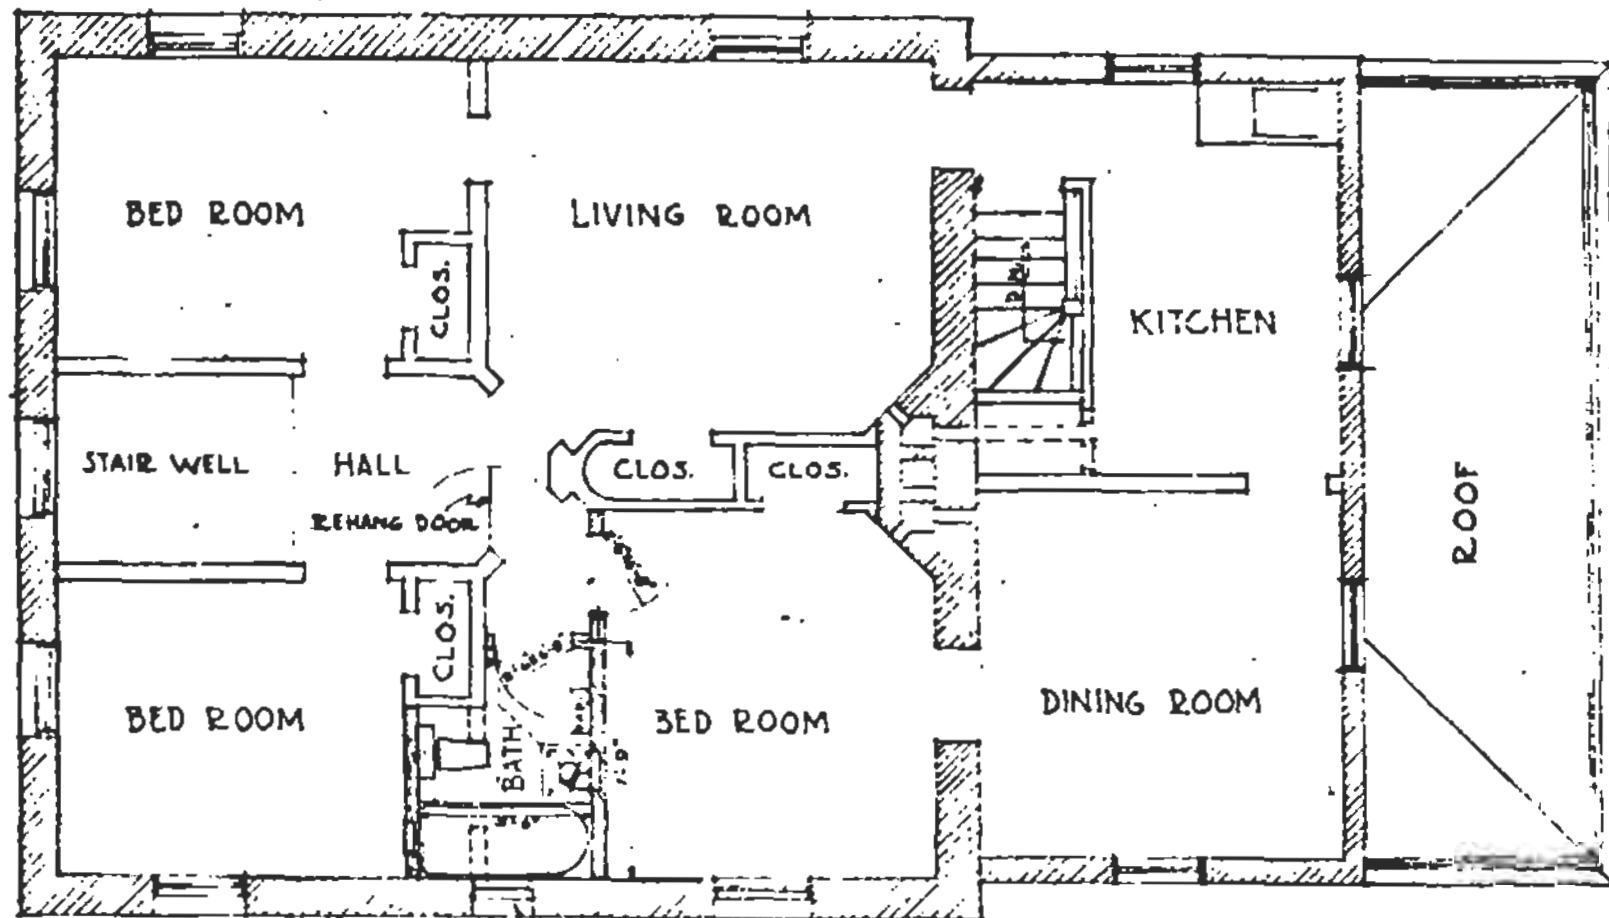
NEW WINDOW
 SECOND FLOOR APARTMENT
 SCALE 3/4" = 1'-0"

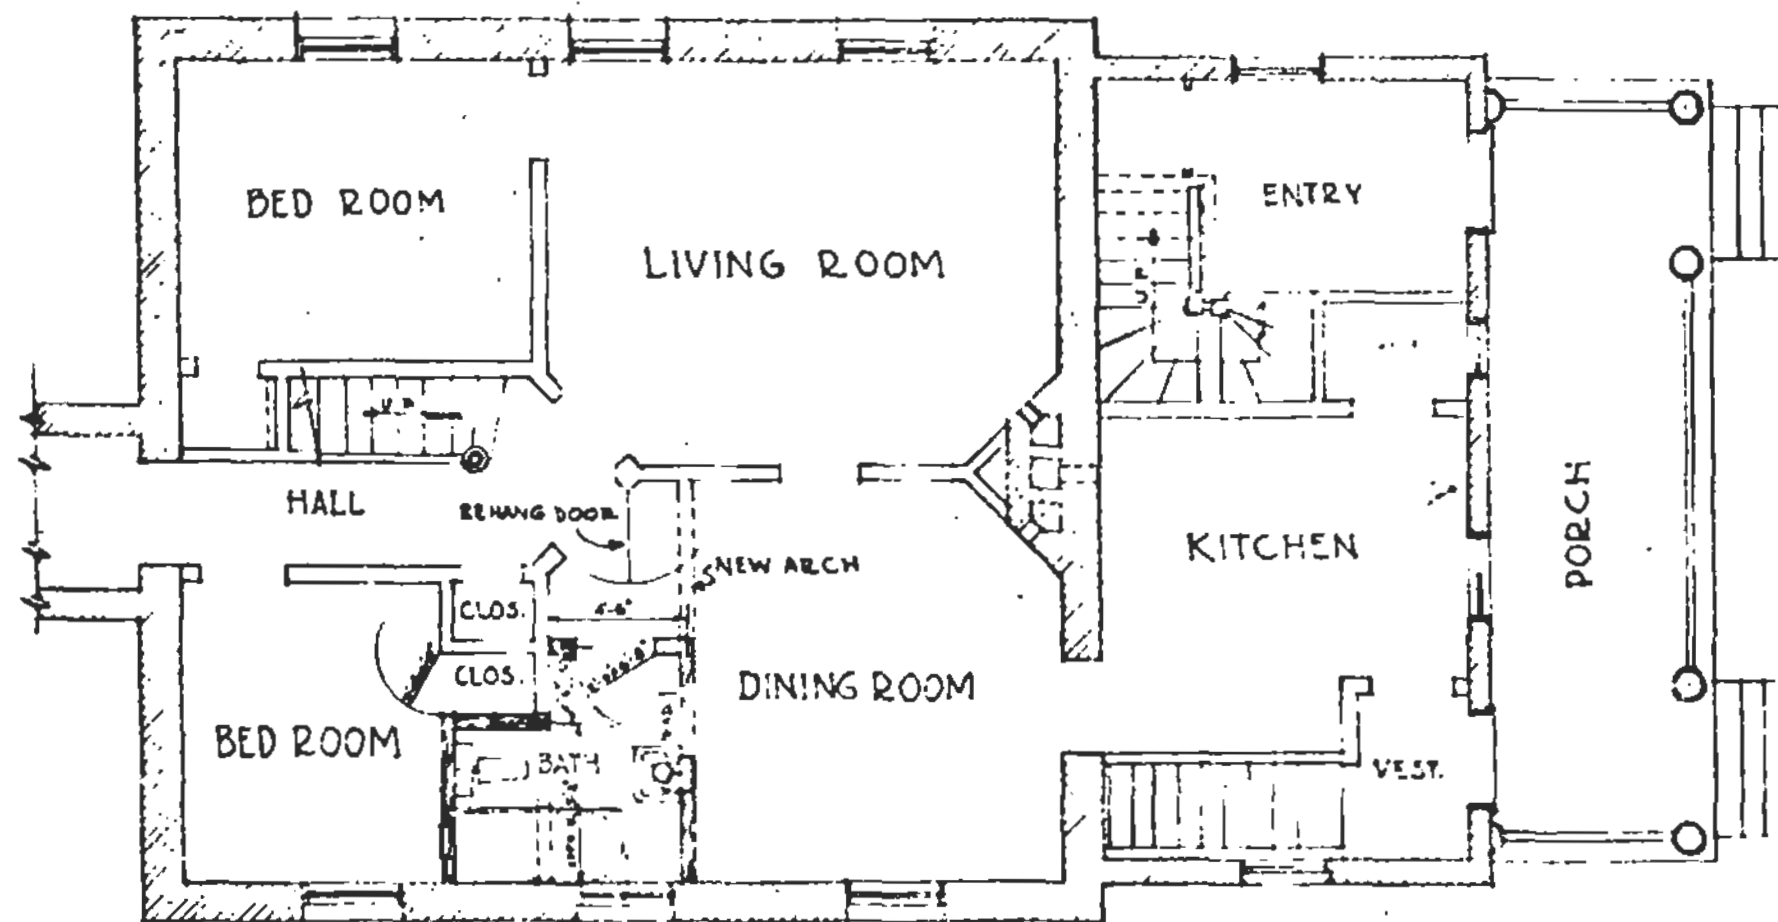
FIRST FLOOR APARTMENT
 SCALE 3/4" = 1'-0"

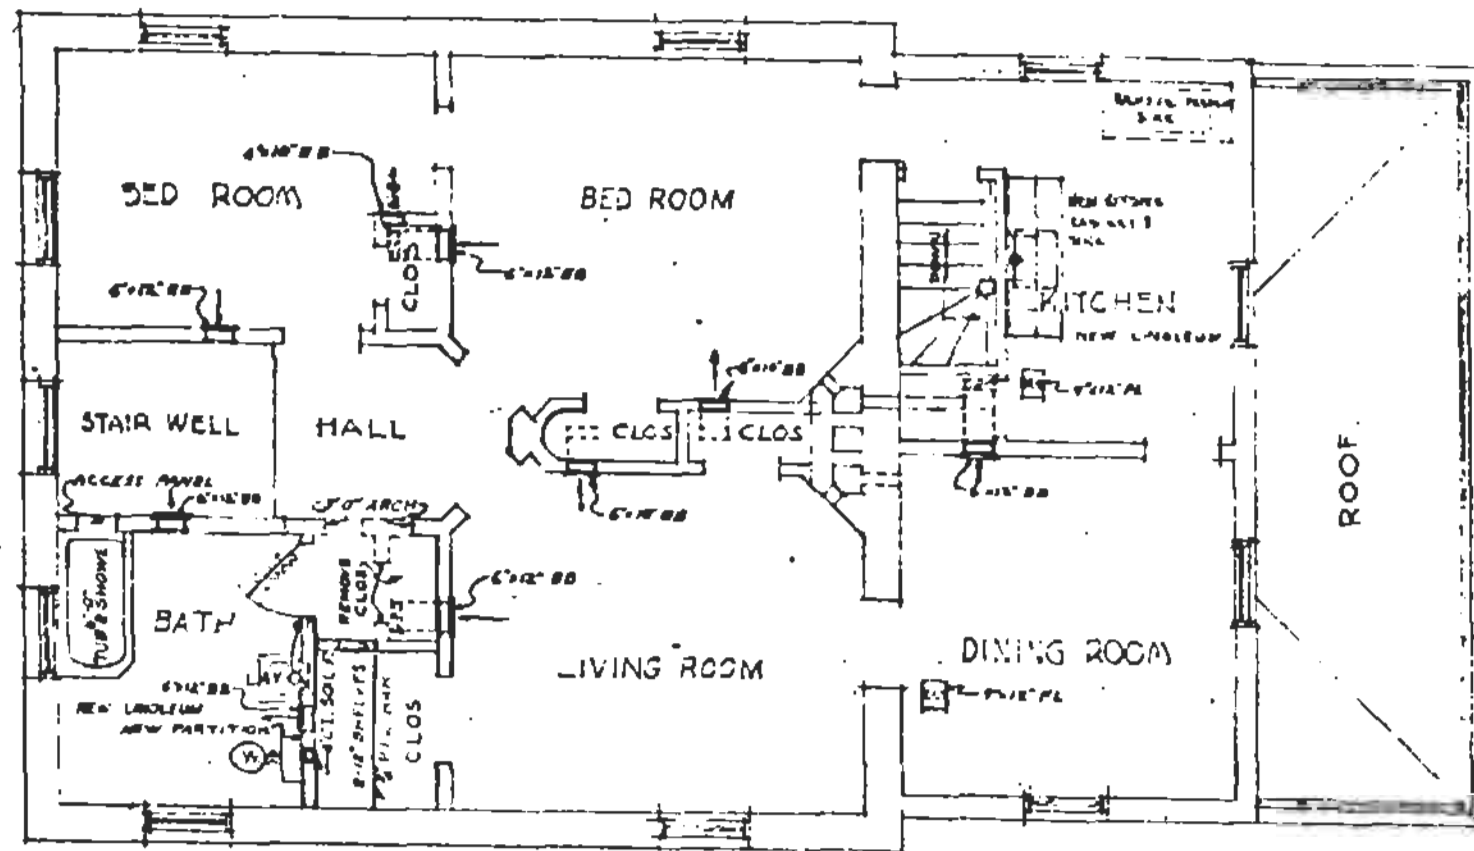
SECOND FLOOR APARTMENT
SCALE 1/4" = 1'-0"

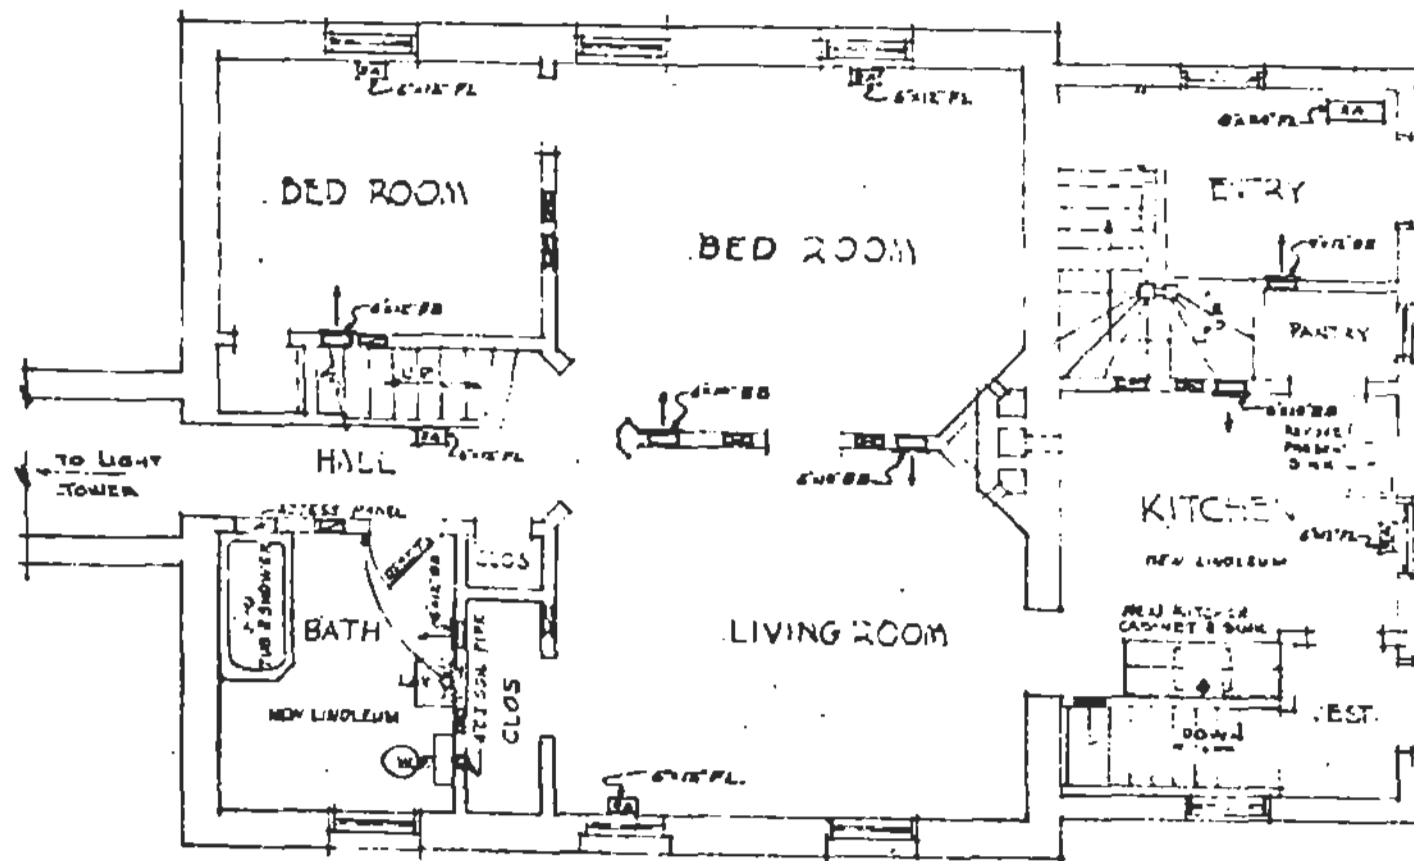
FIRST FLOOR APARTMENT
SCALE 1/4" = 1'-0"

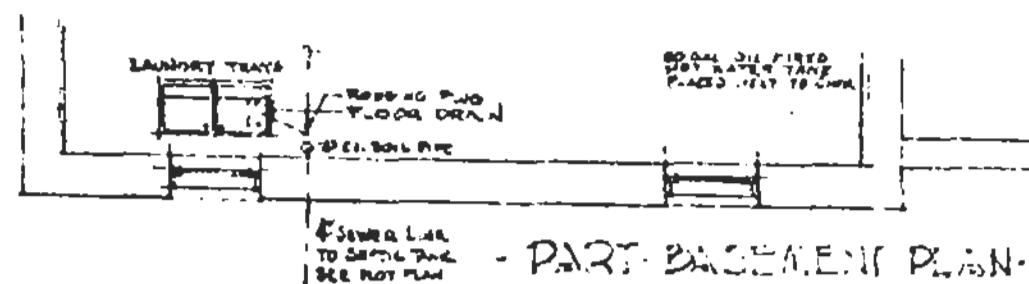
PART BASEMENT PLAN
