historic structure report
historical data
november 1978

PICTURED ROCKS
AU SABLE LIGHT STATION

HISTORIC STRUCTURE REPORT
HISTORICAL DATA
AU SABLE LIGHT STATION
PICTURED ROCKS NATIONAL LAKESHORE
MICHIGAN

Prepared by
Louis Torres

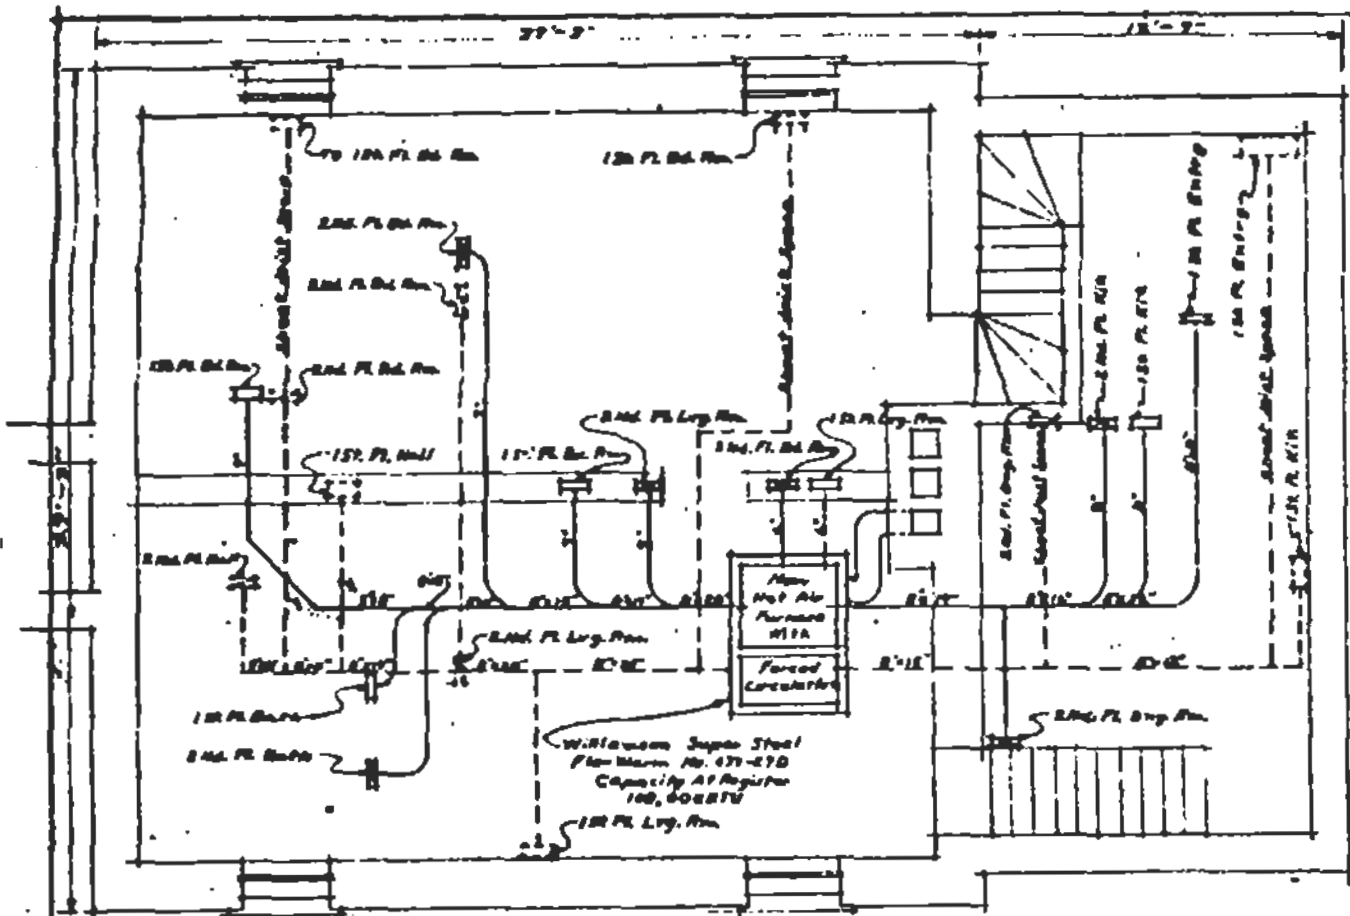
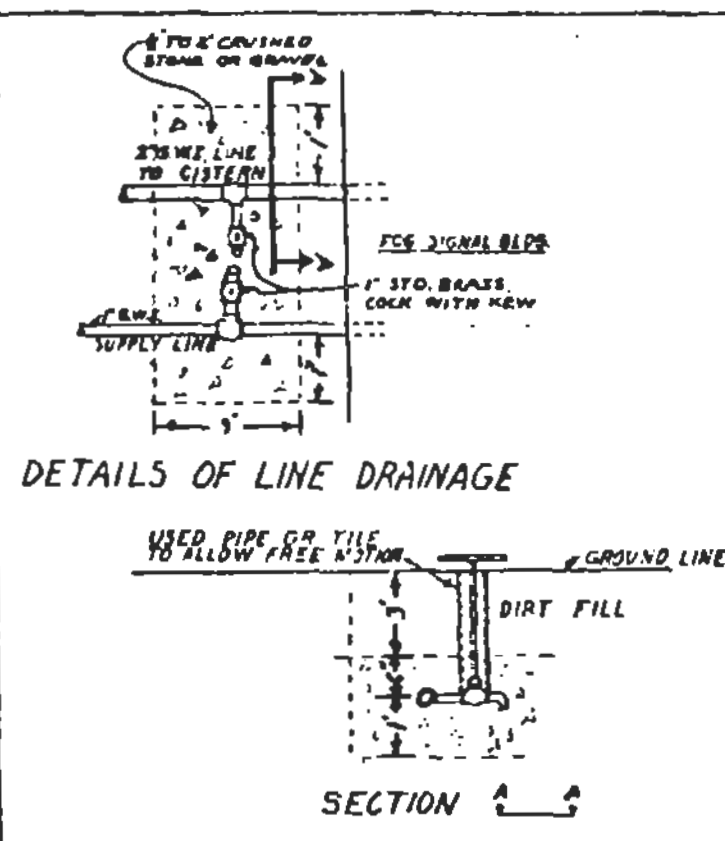
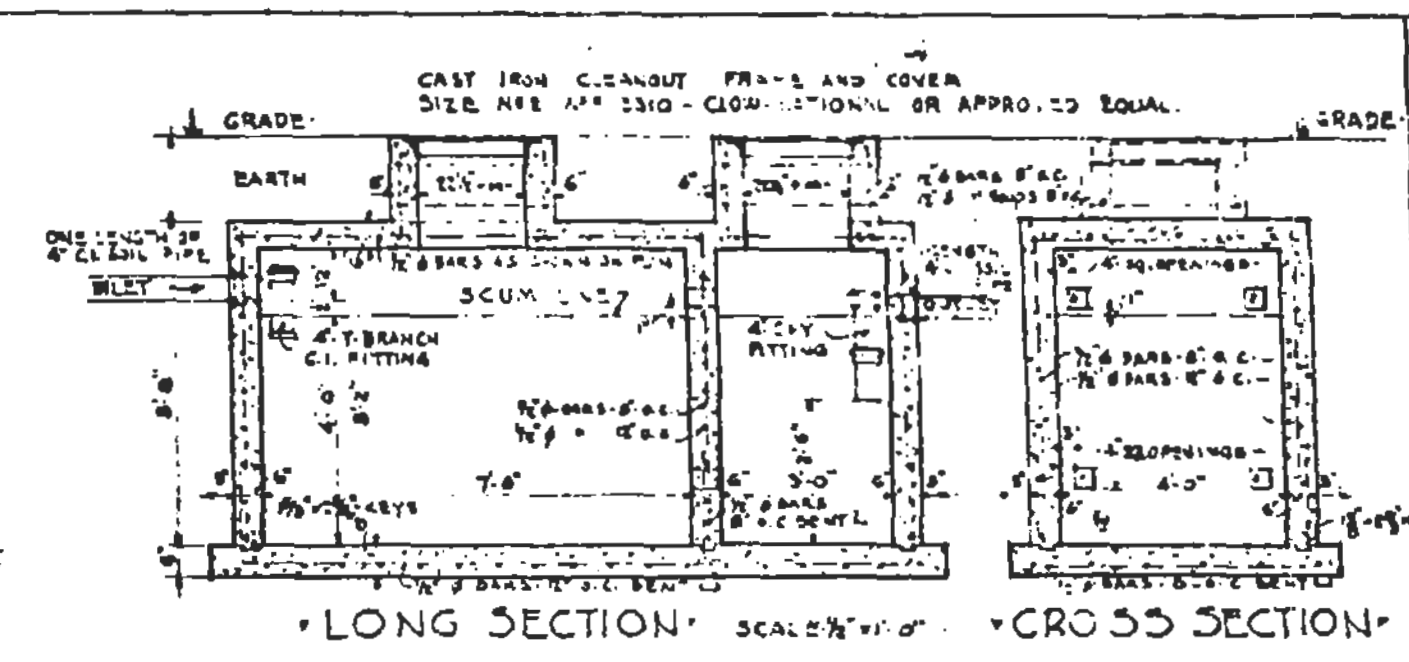
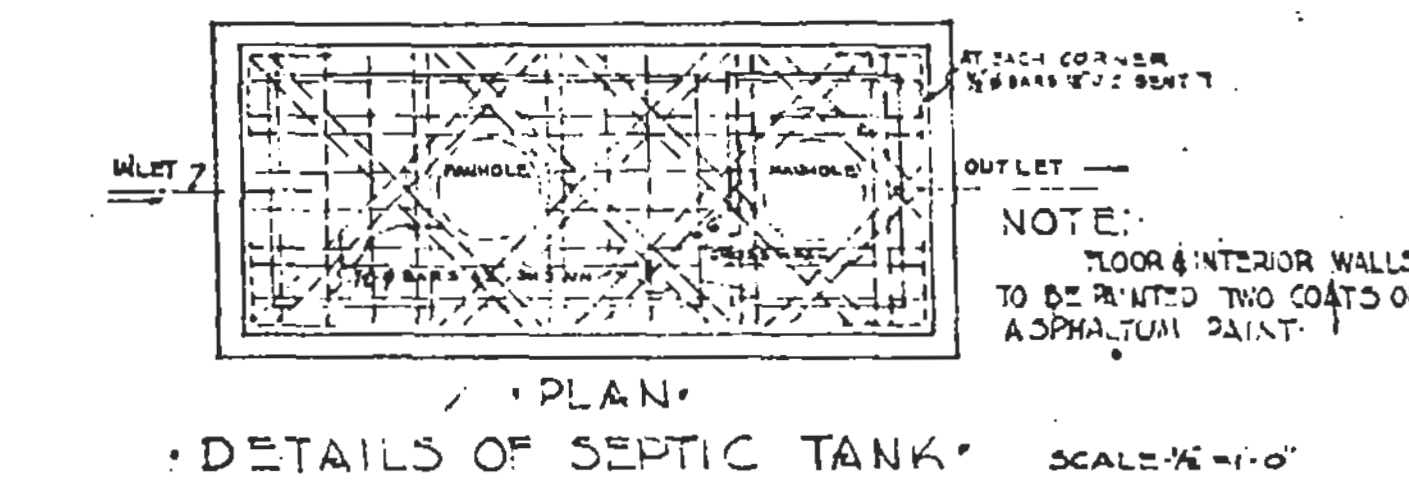
BASEMENT-DOUBLE DWELLING
 SCALE: 1/4"=1'-0"
 NEW HOT AIR HEATING SYSTEM

LEGEND
 Hot Air
 Return Air
 Hot Air Duct Section
 Return Air Duct Section

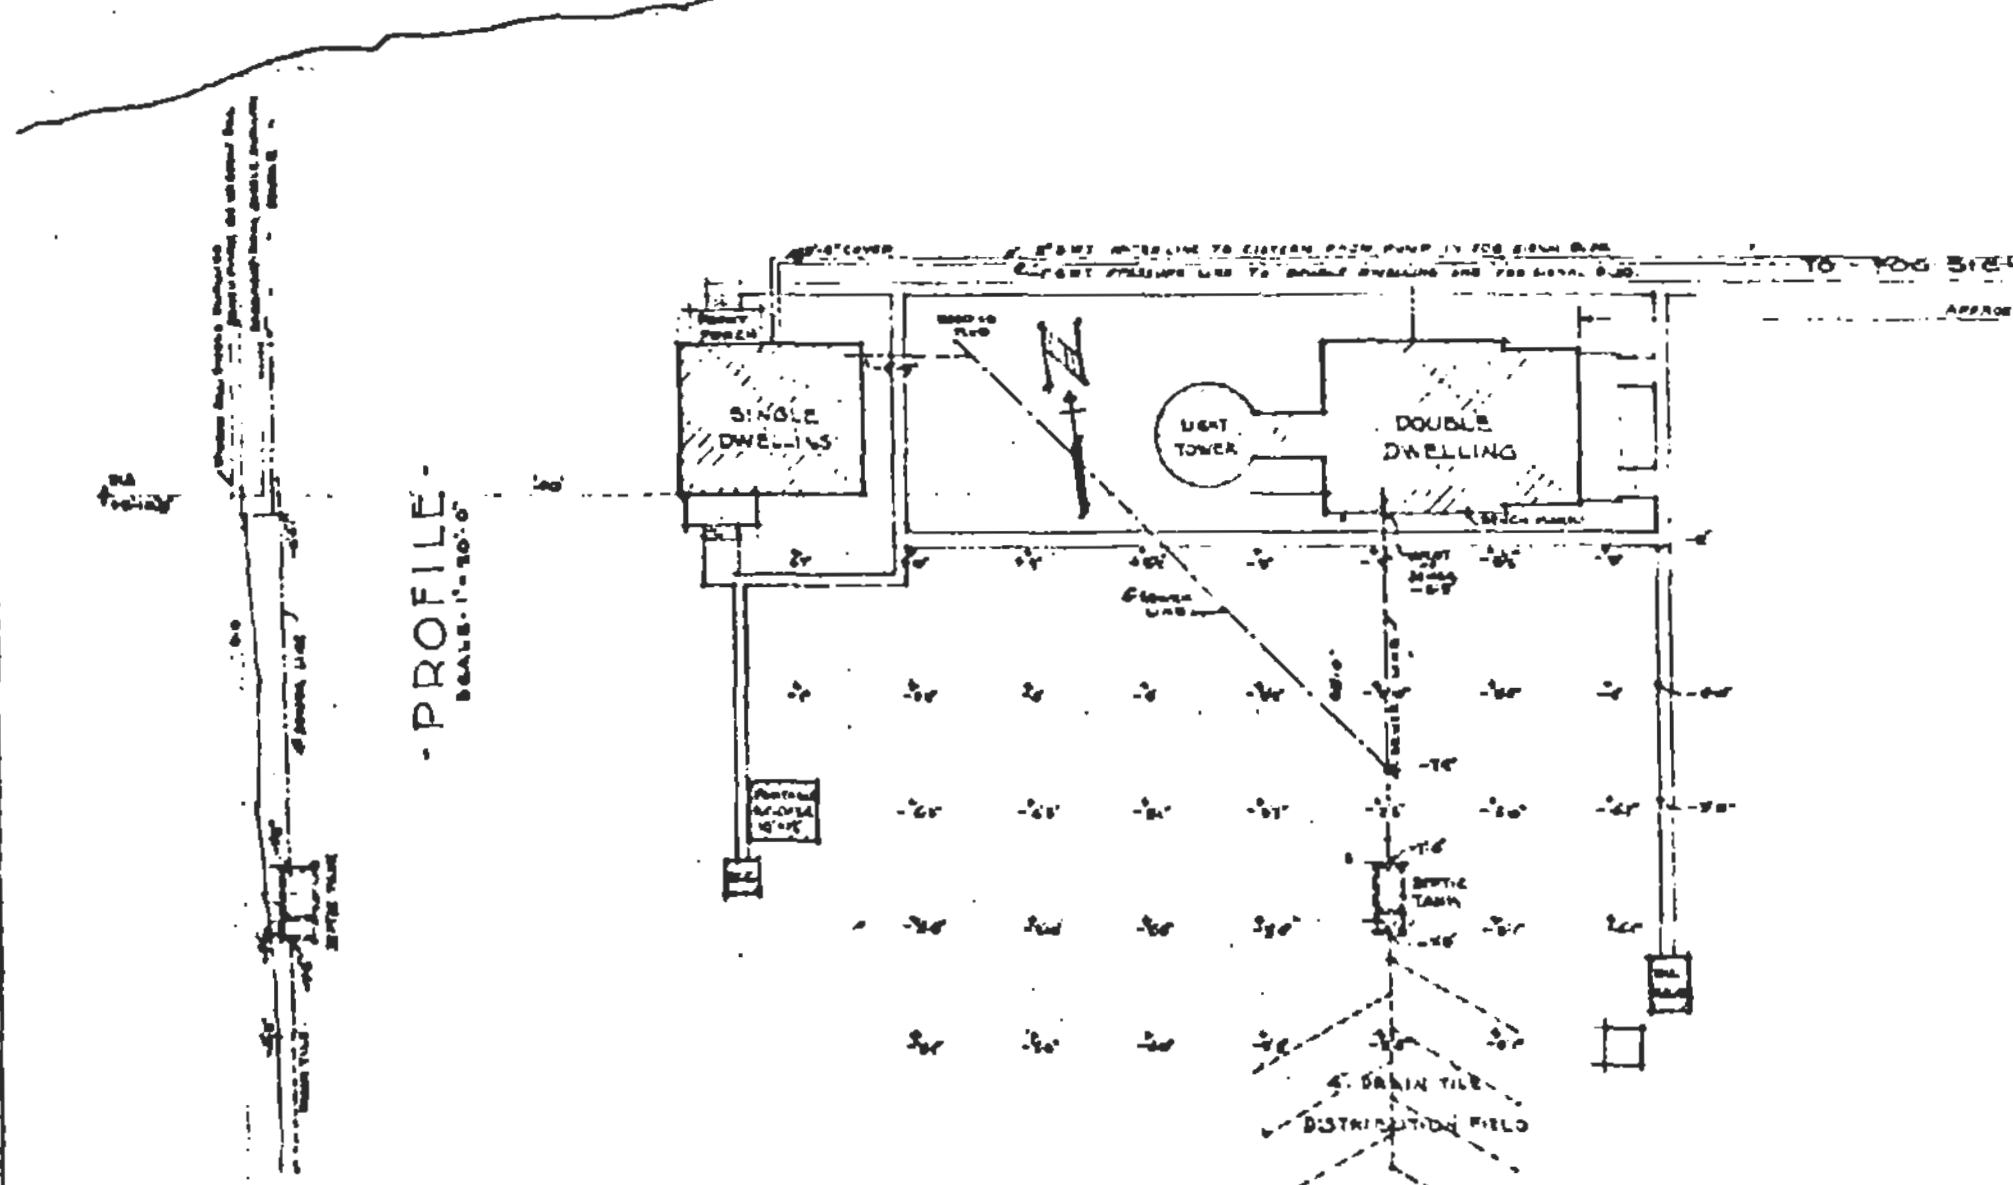
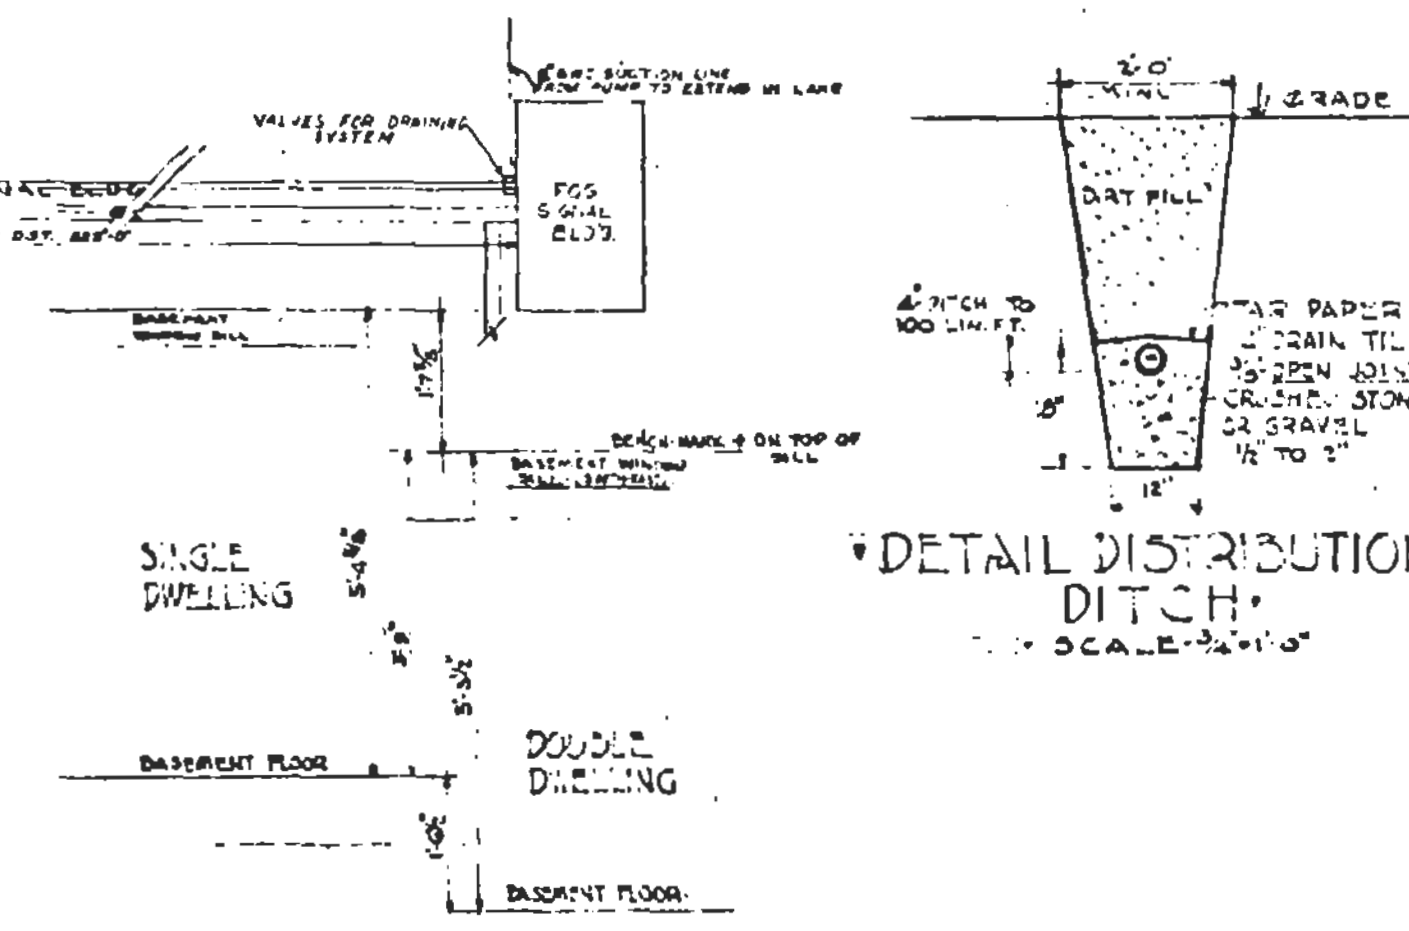
PART OF PLOT PLAN
 SCALE: 1"=20'-0"

PLOT PLAN & DETAILS 825/28701

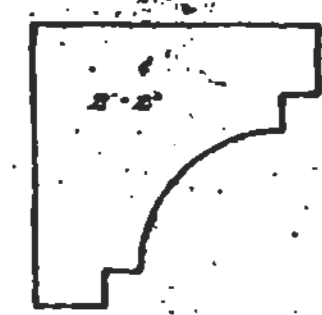
PORCH CORNICE MOULD A

BED MOULD D

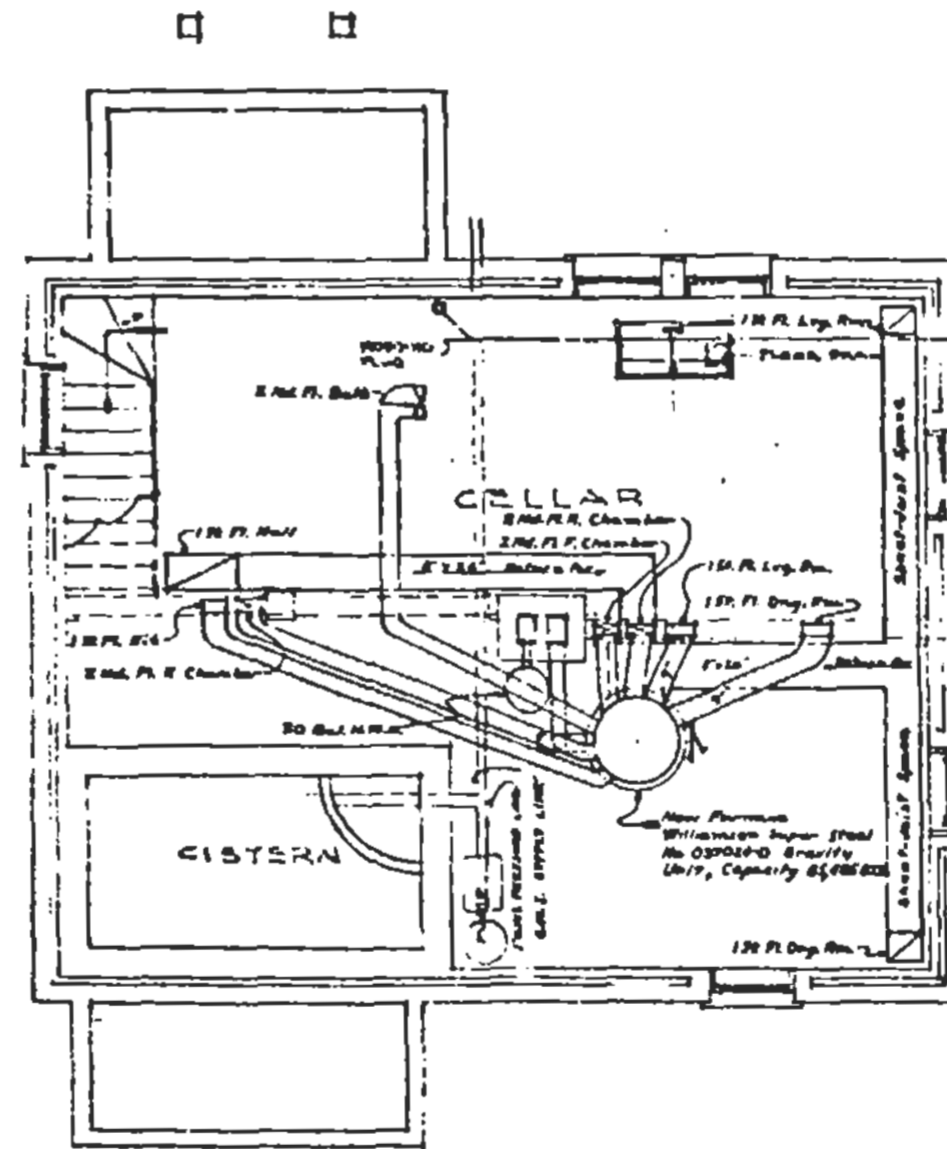
BASEMENT PLAN
SCALE: 1/8"=1'-0"

NOTE:—
ATTIC FLOOR INSULATED.
SEE WORK ORDER NO 437-pressing from 100194
