THE FORTIFICATIONS OF SAN JUAN NATIONAL HISTORIC SITE

HISTORIC STRUCTURE REPORT

Castillo de San Felipe del Morro

Building Conservation Branch
Cultural Resources Center
North Atlantic Region
National Park Service
and the
Center for Preservation Research
Columbia University

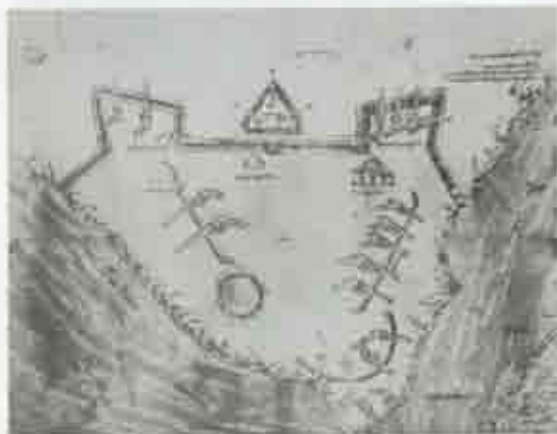
Figure 2. Ca. 1534 sketch of el Morro. (AGI-SD-10, 11, Seville.)

Following the capture of el Morro by Cumberland (1598), the land defenses or, "Hornwork" were rebuilt.¹² Judging from a few early schematic sketches (fig. 2), in addition to the tower at the harbor entrance, there were some cannon located at intermediate levels between the tower and the hornwork. During the intervening years before 1600, recommendations were made regarding improvements to el Morro. Mostly these consisted of strengthening the land defense and raising the elevation of the tower in order to create a larger gun platform. In 1591, a program was proposed under Governor Tejada for rebuilding the fortress.¹³ However, not much of this work was carried out before the attacks of Drake (1595) and Cumberland showed the need for greater defenses. Prior to 1600, the hornwork might best be described as a weak construction of rubble masonry that may have been partly demolished by Cumberland.¹⁴ After the departure of Cumberland, the Spanish began to rebuild their fortification in March of 1602, following the basic plan laid down by Antonelli.¹⁵ It would appear that much of this rebuilding was completed by the 1620s, for the Dutch, under Hendrik, failed to take el Morro in 1624. There is a drawing supposedly from the period of this attack, that shows a relatively complete el Morro (fig. 7). However, it is printed in reverse and may actually be of a later date since. The appearance of the fortress in this drawing is similar in detail to a Dutch drawing of el Morro, from this period, located at Forteleza.

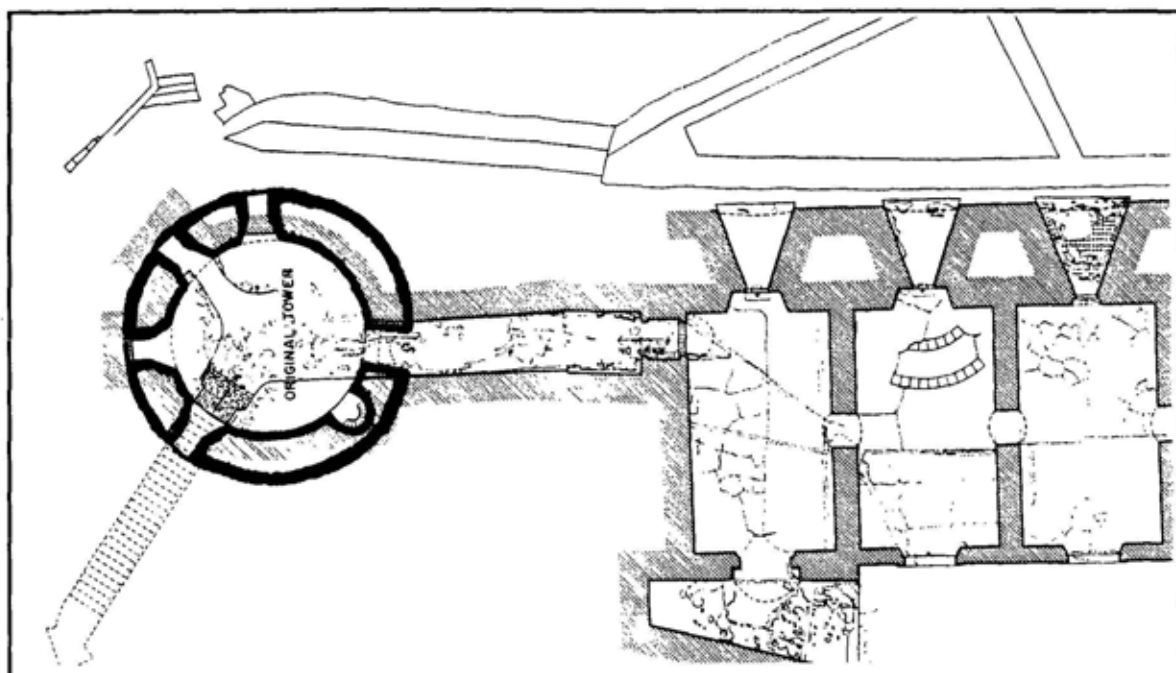
Figure 3. Location of ca. 1540 Tower in plan. (Annotated HABS drawings.)

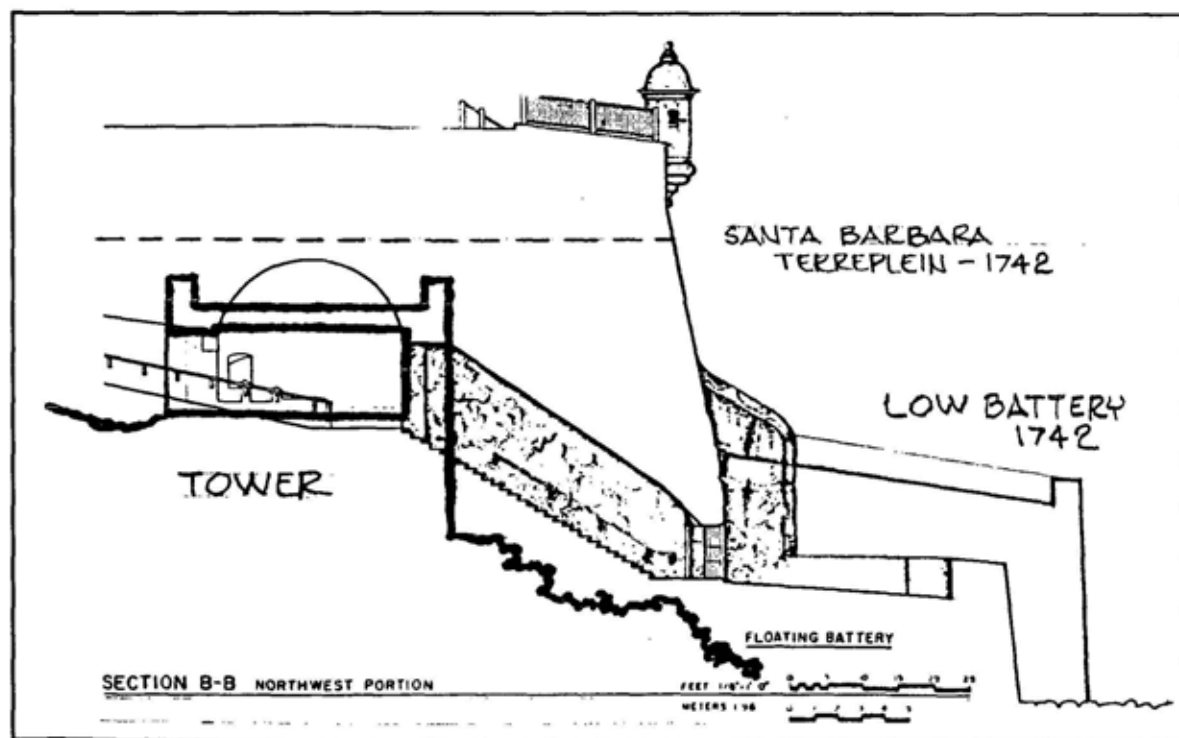
Figure 4. Location of ca. 1540 Tower in section. (Annotated HABS drawings.)

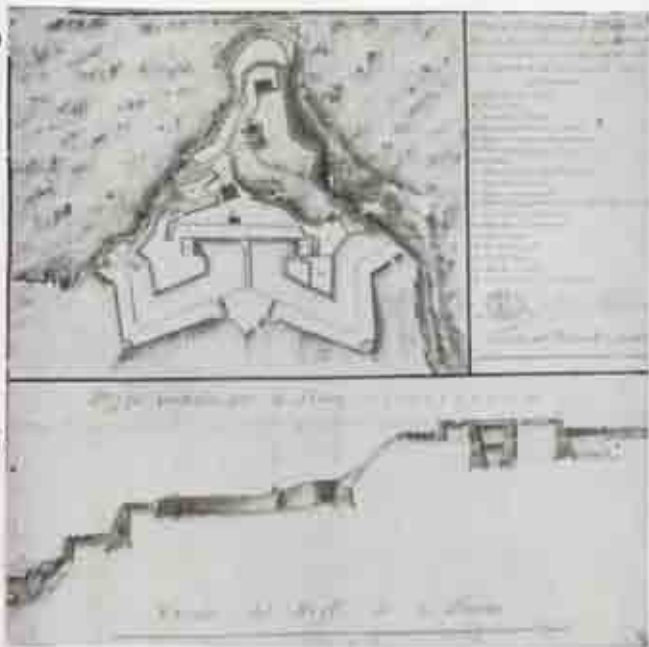
Figure 6. 1742 Drawing of El Morro. (HNM-Madrid; sign. S.750; K-
b-2-5a.)

The early years of the site remain vague and no physical remains, with the exception of the "Tower", have been identified as dating prior to ca. 1600. What is evident from the 1742 drawing, is that the defenses at the site consisted primarily of two separate fortifications; one guarding the harbor entrance and one providing protection from a land attack. It should be noted that at this early date there is little concern, judging from the layout of defenses and lack of cannons with a seaward orientation, for attack from the sea, including naval bombardment. Such considerations were based, on the size of cannon carried by naval vessels and their ability to fire at elevated targets.¹¹ As the capacity of ships to carry larger cannon increased, an increase in

By using the corrected scale to measure on the 1742 section, the pre-1770 elevations above sea level were scaled and compared with the actual heights found today. These comparisons show some surprising correlations and contradictions:

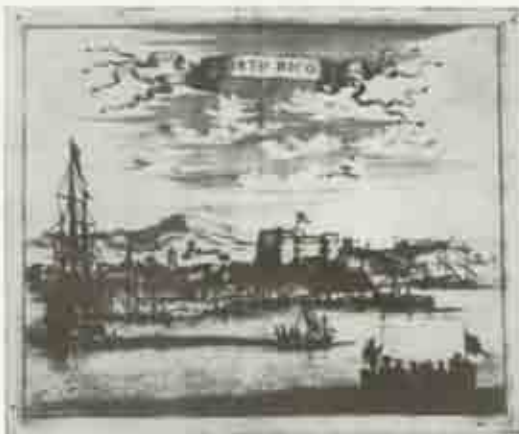
Figure 7. Drawing of San Juan, presumed to have been made at the time of the Dutch attack, 1625. (Collection of La Casa del Libro, San Juan.)

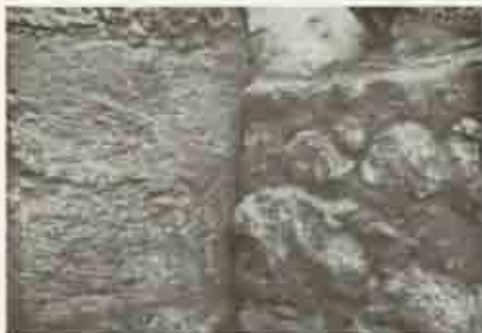
Figure 9. Rubble wall (ca. 1771) meeting seventeenth-century orillon corner. (Photo by E.S. Cliver, 1990.)

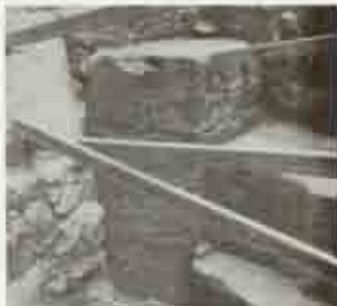
Figure 10. May 1990 excavation showing corner of the 17th c. orillon. (Photo by E.M. Cliver.)

After a week of work during which no construction joint at the orillón fill was found in the below-grade surface of the flanking wall, the archaeological team uncovered the top of the orillón corner approximately 0.8 meter (32 inches) out from the flanking wall's surface, and about 1.25 meters (4 feet) below the ground surface. This discovery was different from what had been expected. As the excavation continued to expose the corner, it became clear that the earlier hornwork wall had not been increased in elevation, but had been demolished down to a level approximately 70 centimeters (28 inches) below the anticipated level of the moat floor (ca. 1773) and now acted as a foundation for the present wall. (See fig. 8, a section through the excavation.) The moat floor was increased about 2.8 meters (9 feet) at the orillón corner during the ca. 1773 construction. The rubble foundation at the orillón corner began and continued to the curtain wall; clearly not pre-1600, but part of the ca. 1773 construction that filled in the orillón (fig. 9). The brick courses at the base of this foundation appeared to be the footing for the rubble foundation wall, and not the beginning of a floor surface; clearly, part of the later construction, owing to the type of mortar in which the brick were bedded. The construction of the earlier wall (presumed to be that constructed in ca. 1602, owing to the lack of any record of major construction in this area between ca. 1600 and ca. 1773) was similar to the later construction (fig. 10). In fact, the ca. 1773 work may have incorporated into its construction some of the demolished material of the earlier wall including the cordon course just below the embrasures. When fully exposed, the orillón corner (inches) in height and roughly dressed. The wall had no batter, or scarp, on was four stone courses high,

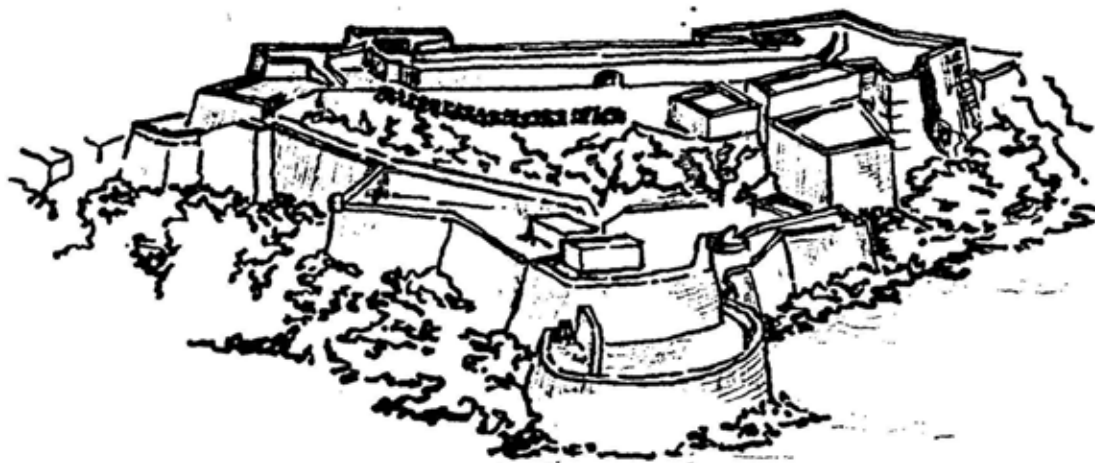
EL MORRO 1742

Figure 11. Conjectured view of el Morro, 1742.

This description indicates why an extensive rebuilding campaign was begun after 1765. (However, it does not explain why the hornwork wall was demolished and rebuilt, since it is the one area of the castle described as being "of good construction.") The description conforms well with the 1742 drawing. A major difference with present conditions is the description of the lower battery at the harbor entrance. Through scaling the elevation of this battery on the 1742 drawing, and from the physical evidence at the toe of Santa Barbara, it is evident that the present configuration is not what is shown on the plan. In 1742, the Low Battery was higher than the present Water Battery, some 11 meters (35.5 feet) above sea level as compared to the existing 6.3 meters

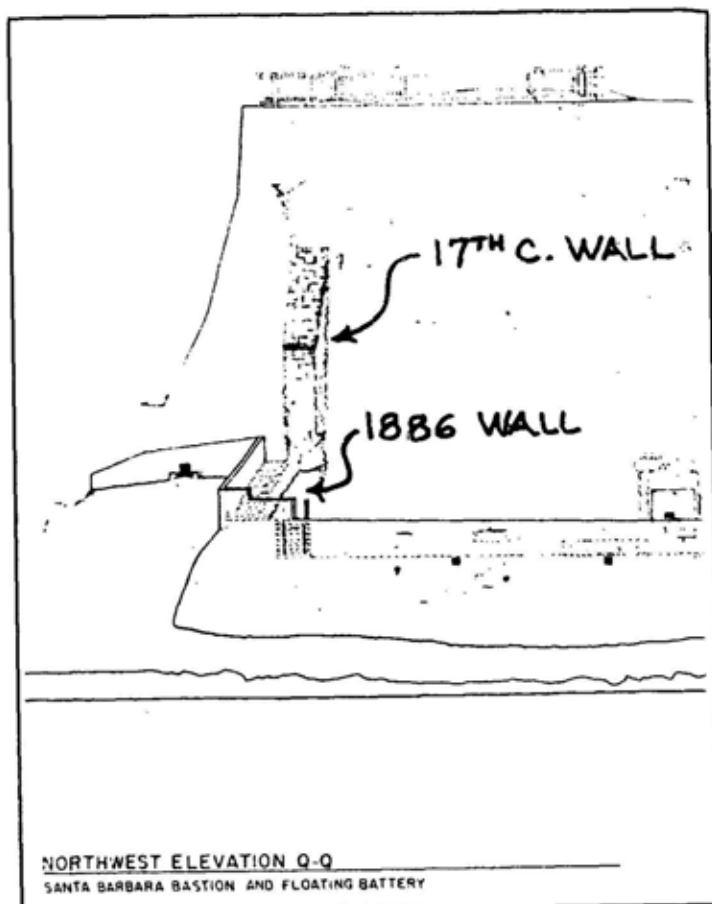
Figure 12. The extension of the old wall is seen going up the scarp; at the base is the 1886 rubble wall.

Battery (see the 1776 plan). On the 1742 plan there is a curved wall within the battery that extends out from the scarp wall of the higher battery screening the passage entrance from the harbor. It is the remnant of this wall that extends up the exterior of the Santa Barbara wall (see HABS drawing 33, and figs. 5 and 12). Presumably, the earlier height of the Santa Barbara Bastion, or high platform, cannot have been lower than the top of this wall remnant; that is approximately 3 meters (10 feet) below the present terreplein. There also is a change in angle of the wall slope, and in the character of the stucco at this point. These changes place the height of the earlier level of the Santa Barbara terreplein at about 20.3 meters (66 feet) above sea level; higher than the dimension found by scaling off the 1742 section using the 4:3 correction (see chart above). A reason for this difference would seem to be an inaccuracy in the 1742 section. The elevation of 16 meters (51 feet), scaled off the 1742 section using the 4:3 correction, cannot be correct; it would place the terreplein height below the elevation of the door lintel leading into the tower chamber, which is 16.3 meters (53 feet). Since the tower chamber, and the Santa Barbara terreplein existed together, the terreplein could not have been at that low a level and still allowed entrance to the chamber. If the height is scaled without using the 4:3 correction, an elevation of 20.8 meters (67.5 feet) above sea level is achieved, approximating the height of the wall fragment; it also appears that the height of the Low Battery is accurately scaled without the 4:3 correction. The elevation of the Santa Barbara terreplein, scaled from the 1742 plan, is close to the figure based on the height of the curved wall remnant found above. Without further documents, or partial demolition of the wall, it is difficult to be certain of the exact seventeenth, or late-sixteenth century elevation of this level.

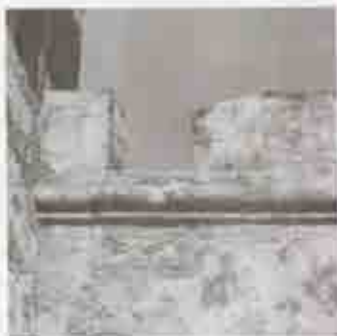
Figure 14. Only remaining seventeenth c. embrasure - Mercado N. (Photo by E.S. Cliver, 1970.)

is the Mercado demi-bastion (referred to as "Medio Baluarte de Texada" on the 1742 plan). Constructed in ca. 1602,²⁶ it served as a battery to enfilade the seaward side of the hornwork as well as the northern curtain wall. This bastion retains the only remaining, pre-1770, embrasure in its western wall (fig. 14). The north and west walls may be part of the original construction (these have a cordon just below the embrasure line, typical of the seventeenth-century construction as seen at el Cañuelo; the cordon on the hornwork may be reused from the earlier works) but the east wall was rebuilt during the post-1770 construction.

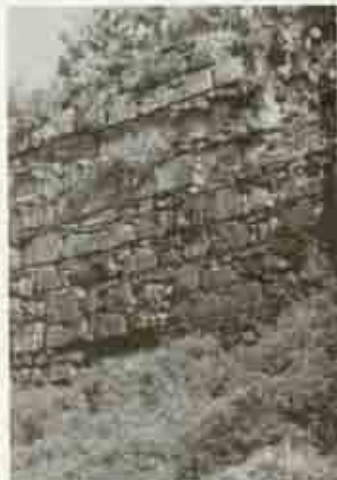
Figure 15. Remains of seventeenth c. retaining wall at the sea end of the counterscarp. (E.S. Cliver, 1990.)

Other areas that appear to date from the pre-1770 period are the outer bay of the entrance portal (not the vaulting), possibly the west facing wall of the Austria Bastion, and the lower portion of the tunnel to the tower room. In addition, walls by the sea that formed part of the land defense on the 1742 plan and seem to have been abandoned in the late-eighteenth century, still have sections remaining, albeit in poor condition (Fig. 15). These walls are found on the far side of the moat outside Ochoa and Carmen bastions.

A portion of a retaining wall remains seaward of the moat. Based on construction and the early plans, it is believed that these walls are from the first quarter of the seventeenth century with some rebuilding during the twentieth century using rubble, and limestone slabs.

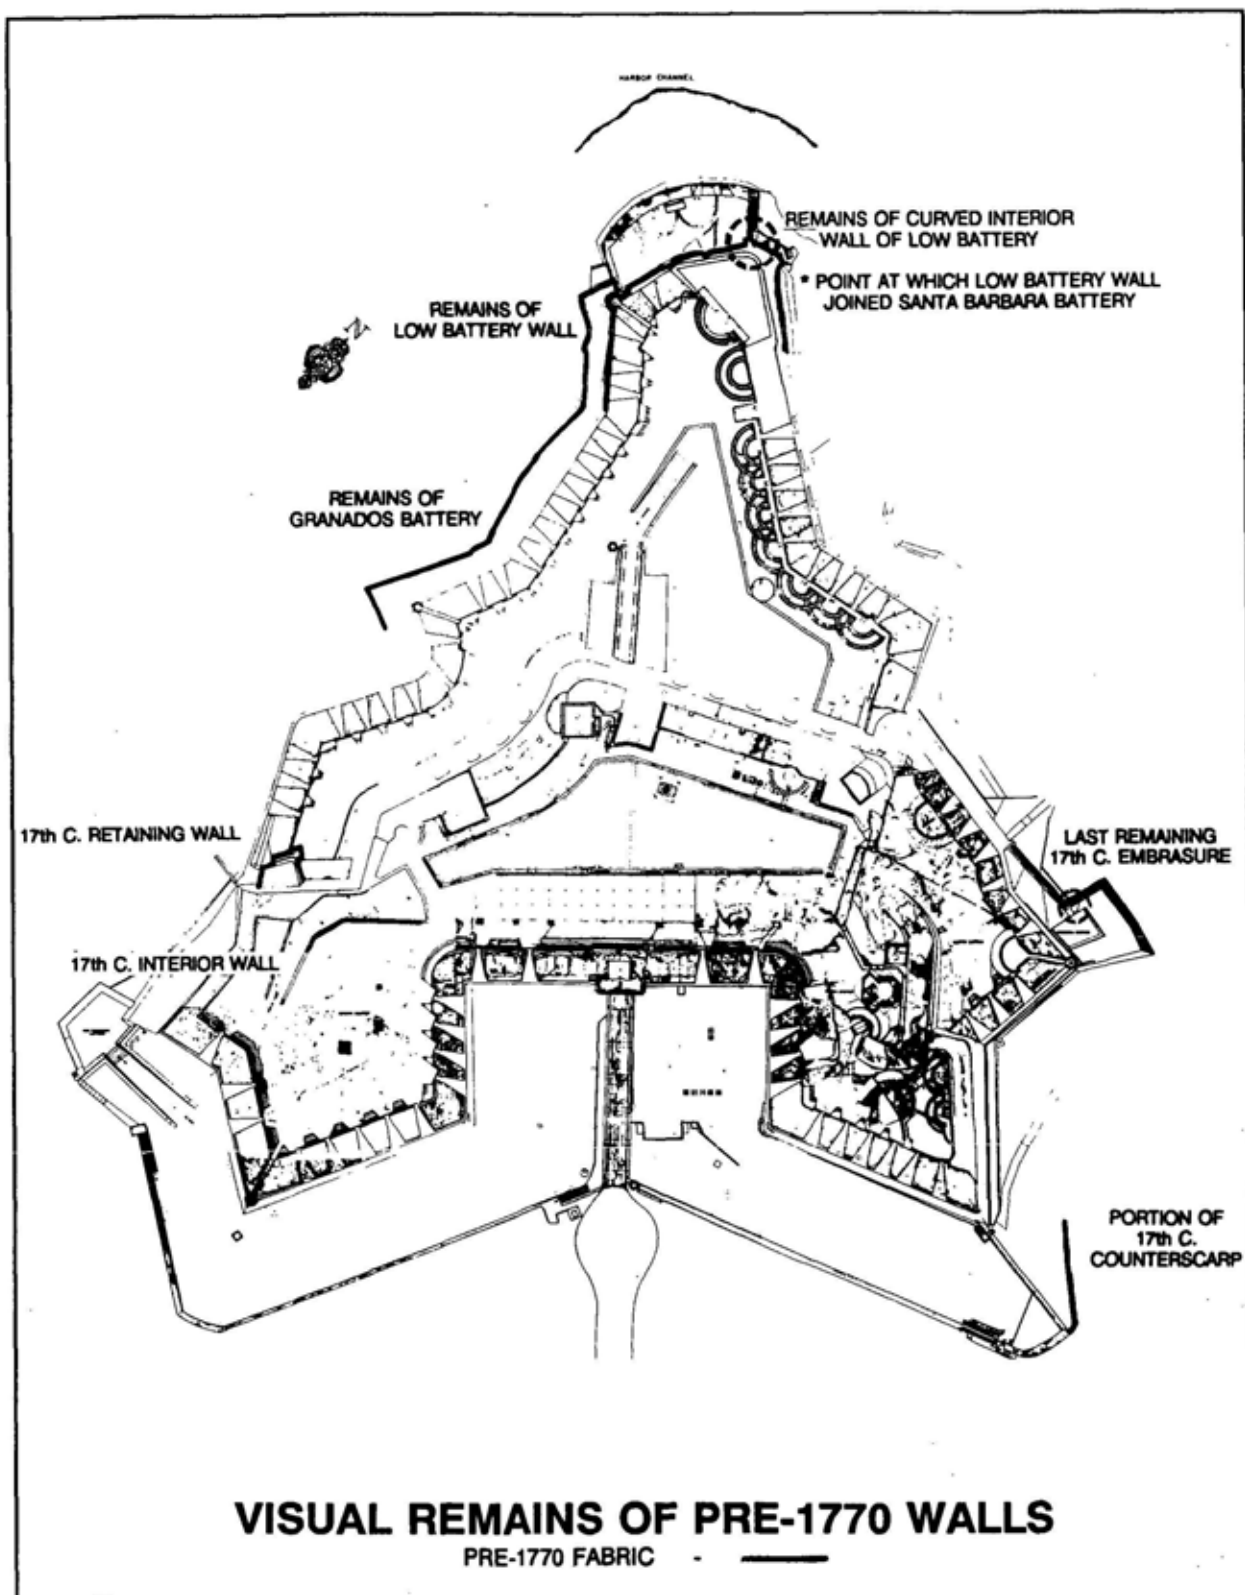
Figure 17. Plan showing the location of the remaining pre-1765 historic fabric at the fortress. (HABS, ca. 1960.)

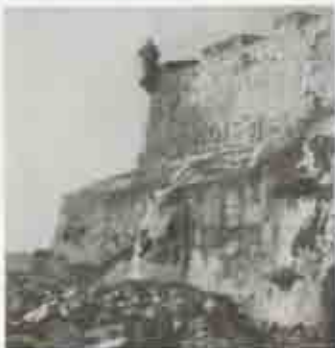
Figure 18. Harbor side of Santa Barbara B. showing the line of Granados B., the triangular sentry post and the fragment that was the beginning of the Low Battery. (Photo by E.S. Cliver, 1990.)

As part of the construction of the wall, a large cistern was built, filling the void under the main plaza. On the surface of the plaza was a cistern head (similar to that of a well) from which water could be drawn. (The present cistern head is a reconstruction by the NHC after 1860.) For the great wall to have been built by 1774,¹⁴ the terreplein of Santa Barbara already would have to have been raised, or its elevation determined, so the ramp could end at the correct level. In raising the elevation of the Santa Barbara terreplein, the old Granados Battery, of which O'Reilly was critical in his 1765 description, was filled and used as a foundation for the harbor side of the extended Santa Barbara terreplein.¹⁵ Evidence for this can be seen on the 1743 plan. A small triangular projection (a guard post) exists at the transition point to the Low Battery, just below the wall of the then smaller Santa Barbara Bastion. The configuration of the present foundation wall supporting the Santa Barbara harbor wall, follows that of Granados Battery as depicted on the 1743 plan, including the small triangular projection (fig. 5). If one follows the outer wall of the foundation (the old Granados Battery) westward, the height drops down, as the Granados wall does on the 1743 plan, to the remaining fragment of the Low Battery (fig. 18) leaving no doubt that the Granados Battery exists under the later fill that

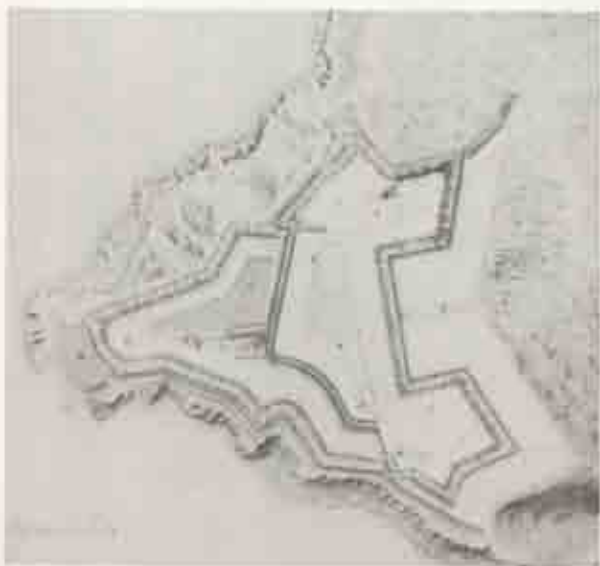
Figure 19. Detail of 1784, Mestre plan. (Servicio Histórico Militar No. 3795, Madrid.)

Ochoa Bastion was raised in height beginning in 1773, as was Austria Bastion,⁴⁵ but not as recommended by D'Assilly. Prior to 1765, Ochoa Bastion was of two tiers, with an upper and a lower level (see the 1747 plan). The reason for the two levels was the rapid drop in elevation toward the sea from the level of the hornwork wall. In order to avoid the construction of massive foundations and a high retaining wall on the sea side, the Spanish, in raising the levels of Ochoa Bastion during the 1770s, maintained the two tier configuration. Later, a 1784 Mestre Drawing (Fig.

19) proposed the increase in elevation of the seaward side of Ochoa Bastion. In 1786, before a 1787 earthquake that caused some damage to this bastion, the seaward side of Ochoa was raised to the existing elevation, and the Ochoa terreplein became one continuous level, equal in height to Austria Bastion and the curtain wall terreplein.⁴¹ It is curious that prior to the seaward level being raised, the upper level is shown in the 1784 drawing with three embrasures on the southeast wall facing the moat (fig. 19). This same drawing proposes three embrasures on the northeast (seaward) side of the raised wall. A May 12, 1787, Mestre drawing, after the terreplein elevation has been increased, shows three embrasures on the northeast side, and five embrasures on the southeast wall (see historic drawing 21 in Volume I). From this document, it would appear that after the increase in elevation, the southeast wall had five embrasures. However, today there are six embrasures. Either the drawing is incorrect, or when the two en barbette guns were installed on Ochoa in the 1850s (discussed below), an additional embrasure was added at the corner; this seems unlikely if the Spanish were going to a different gun arrangement, one that did not require embrasures. It is possible that the wall was rebuilt after being damaged in the earthquake. However, a 1793 drawing (Historic Drawing 24, Volume I) proposing a ravelin, shows four embrasures on the southeast wall. This seems impossible. The simplest assumption is that after the terreplein was raised, the southeast wall had six embrasures, as it does now, and that what we see in the drawings are inaccuracies that may be attributed to focus, due to the fact that the drawings are either a plan of the city as a whole, or one depicting a proposed ravelin; the number of embrasures may have been irrelevant.

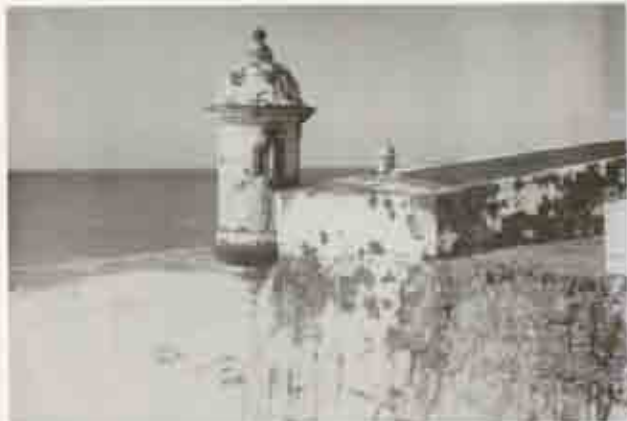
Figure 21. Only remaining unaltered *al Morro* seventeenth c. sentry box, on Santa Barbara St. J. Bowsher, WASH, 1960.1

Another feature that is typical of the post-1770 work is the sentry boxes (these have become a symbol of San Juan, and are found on automobile license plates). Almost decorative in character (fig. 21), they are located at the corners of walls (city and fortress) where the most opportune views for detecting intrusion existed. The present type of sentry boxes, from the post-1770 period, are characterized by their open curved domes with finials, and the corbelled rings, resting on a ball, supporting the boxes at the bastion corners. The earlier sentry boxes from the seventeenth century were simple in appearance, having only a semi-spherical dome over the cylinder of the guard space. Rather than being corbelled out from the corner, as are the later sentry boxes, they merely sat on a circular slab built into the curved corner of the wall. Only two of these seventeenth-century sentry boxes remain; one at *el Cañonc* (ca. 1665)⁴² seen in fig. 22, and the other on *el Túpido* (mid-seventeenth century), below San Cristóbal. Evidence remains of the circular supporting slab for the earlier sentry box of the North Bastion at San Cristóbal; this is now part

(1) The sentry boxes (one on Carson and one on Santa Barbara), that had the upper portions removed by the Spanish in the nineteenth century, were restored to their present appearance (fig. 34); a second sentry box on Santa Barbara Bastion at the salient, was intended to be reconstructed, but was eliminated from the work. (The sentry box on Austria Bastion had been reconstructed as part of an earlier project, but is not listed by Hearns.) The restoration used a cast-stone block for the wall and cap (the drawings for the solids are found in the park archives) that was set in place with mortar but left without stucco. The original post-1765 sentry boxes were made of brick with stuccoed surfaces. One of these eighteenth-century sentry boxes remains, unaltered, on the harbor side of Santa Barbara Bastion (Fig. 21).

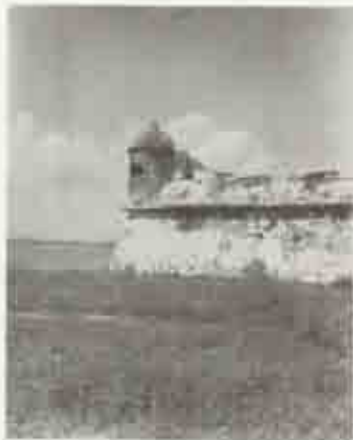
Figure 22. A seventeenth c. sentry box on el Cañuelo, 1937. (SAND HRH Archives.)

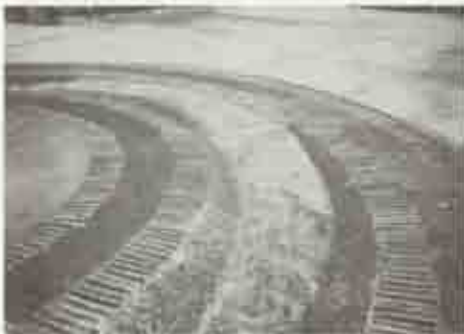
Figure 34. Tracks for an 1815's gun emplacement; note groove in dark stone from the iron rail. (Photo by S.R. Cliver, 1988.)

Primarily, the nineteenth century saw alterations for incorporating new types of gun emplacements, and included the addition of a lighthouse and signal tower. The addition of the first type of modern gun emplacement can be seen in Santa Barbara Bastion at its western end. Between 1831 and 1835,⁴⁴ four embrasures were eliminated (filled in) and positions for two newer guns (possibly mortars, or columbs) on banquettes were built. This work is characterized by an iron pintle with three arcs (the inner arc is missing on what remains) of dark basalt on the

tarraplein surface, to which iron tracks once were fastened (fig. 34). A raised wooden platform, on which the gun was placed to fire above the sea level, pivoted around the pintle supported by wheels running on the tracks. (Eventually the U.S. Army built a large emplacement in this area covering most of the left-hand

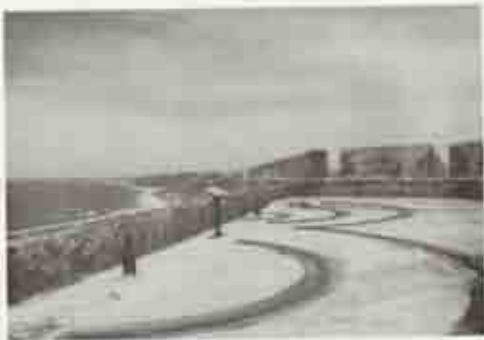
Figure 25. Two 1850's gun emplacements on Ochon Bastion. (Photo by E.B. Oliver, 1986.)

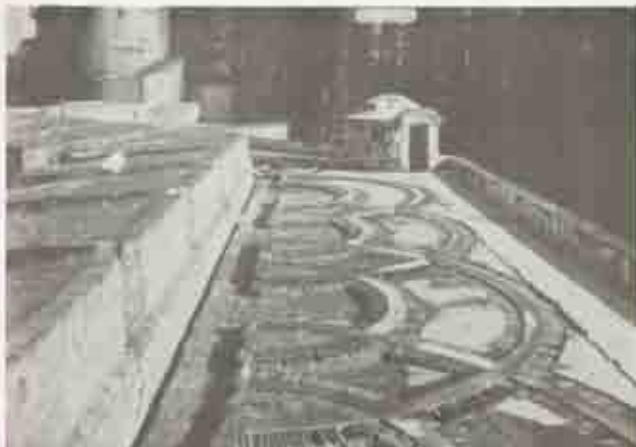
Figure 27. Tracks for 1860's gun emplacements on Santa Barbara Bastion. (J. Soucher, 2532, 1960.)

The 1860's emplacements (fig. 27) are characterized by having two tracks of a lighter colored limestone without evidence of iron rails and with a different type of plinth using four wooden posts as part of the support (not sure remains of this material). Although not much evidence remains, it appears that four emplacements in the Water Battery were installed as part of this work since they also exhibit the four wooden post plinth support.

(3) In its efforts to restore el Morro the Americans opened the embrasures that had been filled by the Spanish as part of the 22 Baskette artillery modernization of the 1860's (fig. 27). This was part of the restoration of nine embrasures as well as the rebuilding of two embrasures on the north side of the Santa Barbara terreplain, and the restoration of all the embrasures and firing steps (banquettes) along the west side of Santa Barbara. Other embrasures also were restored or repaired on Carson Battery, where the incinerator had been, and in the casemates off the plaza, judging by the number of embrasures cited on this level.

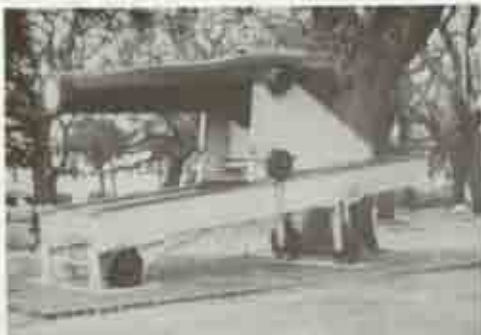
Figure 28. Iron carriage for an 80-barbette gun emplacement, Battery Park, Charleston, S.C. (Photo by E.H. Cliver, 1988.)

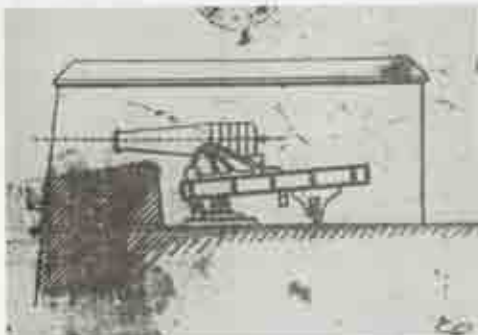
Figure 29. An 1878 drawing for a gun emplacement in Havana, Cuba. (Servicio Histórico Militar-España, Madrid, Drawing # 031-098.)

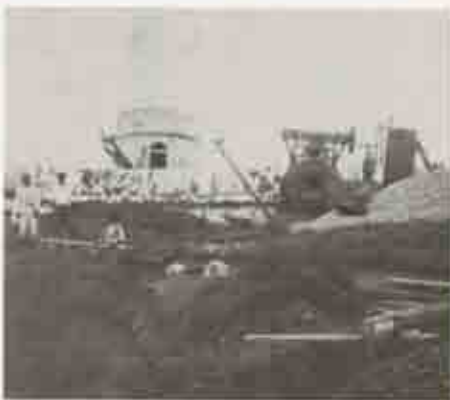
Figure 31. Semaphore tower on Austria Bastion, after the 1902 alteration. Ca. 1917. (SAJU NMS files.)

tower into a position and range-finding station. This involved the removal of the roof and siding of the upper portion of the walls for lighting purposes.²⁸ (Figure 31 shows the tower in 1931 after the upper portion had been removed in 1902.) During these early years of American occupation, the water supply for el Morro was from the large cistern under the main plaza, and was pumped to a 2,327 gallon water tank by a windmill. It was decided that the garrison required about

semaphore tower demolished by the U. S. Army in 1940 and shown in figure 31. The foot print of this structure remains on the Austria terreplein as a patch on the surface.¹⁰¹ One side of this patch projects beyond the circular shape on the base, indicating the location of the stairs that went up on the outside of the structure to the level of the tower base. A similar base was duplicated, with the exterior stair, on the Ochoa terreplein.

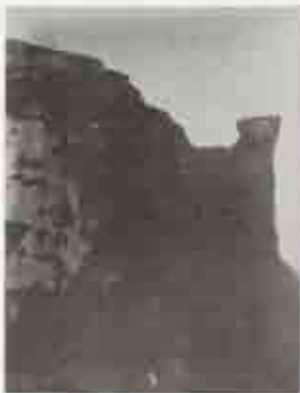
Figure 33. Santa Barbara salient damaged during the 1898 bombardment. 1975. (SAJU WMS files.)

had received the worst damage, with much of the corner and wall toward the postern gate missing (Fig. 33). Here, the void was filled with a poured concrete. (In the process of doing this work the sentry-box, that had been in the salient corner, was not replaced.) This type of insensitive approach by the U.S. Army was severely criticized in the local newspaper, El Mundo. The district engineer agreed with the local preservationists that it was desirable for the new work to "harmonize" with the old, and that this could be achieved by inserting stone into the repair, so as to "harmonize with existing walls."⁴⁹ However, when the wall near the angle was repaired in 1929, the work was not done to harmonize with the old, judging by what remains; such attempts at harmony would come later. (Records indicate that this wall was poured concrete faced with stone; our investigation found it to be exposed concrete showing only marks from the forming.)

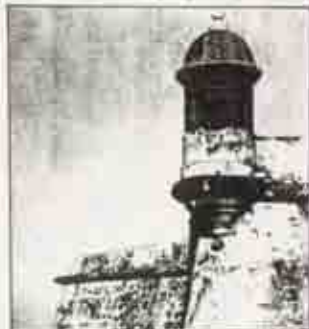
Figure 34. Rebuilt sentry box on Austria Bastion. (J. Boucher, NARS, 1940.)

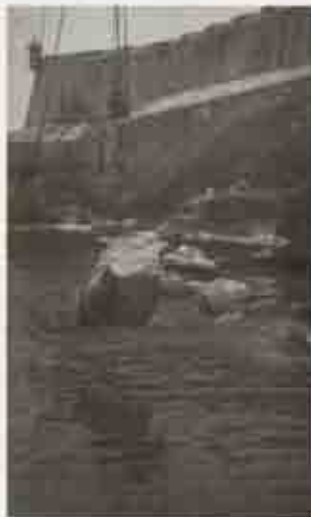
Figure 35. Sea wall work, ca. 1940. (U.S. Army Corps of Engineers, SAJU NMS files.)

(5) The erosion caused by the wave and current action at the harbor entrance, that has been implicated in the demise of the Low Battery below Santa Barbara Bastion, again had taken its toll. Work was required to plug the holes and rebuild portions of the wall, including the resapplication of facing stone (fig. 35). In this same area, the northwest corner of Santa Barbara Bastion, the wall that had been damaged earlier in the bombardment was rebuilt.

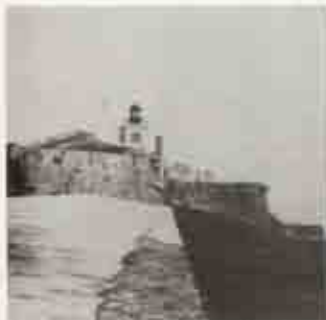
Figure 16. Osboe and Carmen Bastions with stack from incinerator at center. (SAJU NMS files).

(6) The effort to preserve fortifications of "historical interest", resulted in the Army removing an incinerator that had been constructed earlier by the Americans, on the exterior wall at the junction of Ochoa and Carmen bastions (fig. 36). Also removed from the terreplein of Austria Bastion in this year of restoration were: the water tower, built by the Army earlier in the century; the before stated 1890's mortar emplacement on the Austria terreplein, built by the Spanish; and the signal tower, constructed by the Spanish on the base of an earlier lighthouse when that lighthouse was relocated to Ochoa Bastion in 1878. (See fig. 32 for the location of these structures.) In addition, a small eighteenth-century magazine structure (fig. 37, called a storeroom by the Army) located at the toe of Santa Barbara Bastion was demolished. The footprints of these structures still remain visible in the terreplein paving. As part of the removal work, the ventilators for the magazine below were rebuilt on Austria Bastion, as well as other

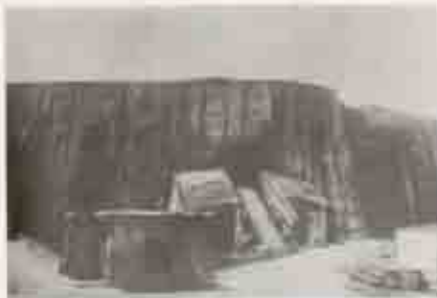
Figure 17. Small eighteenth c. building at the toe of Santa Barbara Bastion, demolished in 1940. (Col. F.J. Farris, SAJU NMS files.)

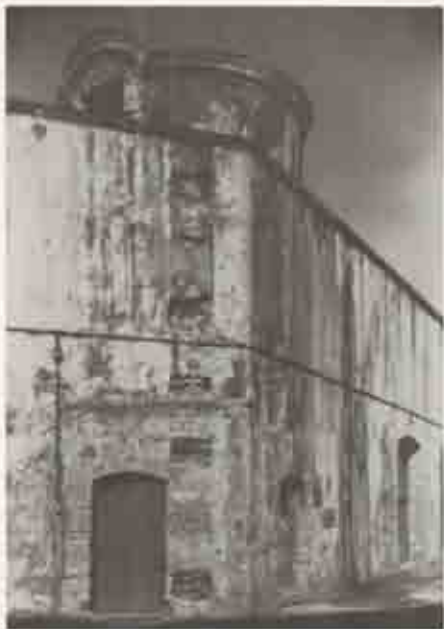
Figure 38. Inside corner of the Santa Barbara terraplain where earlier masonry wall had been. (J. Soucher, MADS, 1960.)

ventilators on the curtain terreplein. Also, during this period, a wall located in the lower plaza, running north to south, was removed leaving evidence of its existence as patches in the corner of the Santa Barbara crenate wall (Fig. 18).

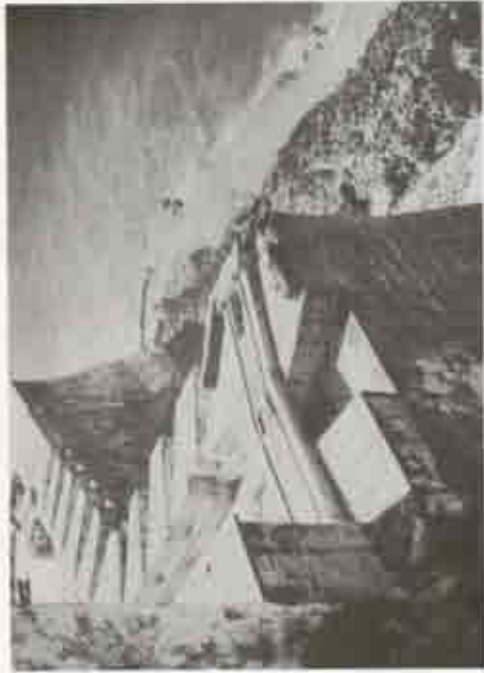
Figure 19. World War II search light trunk at the east end of Santa Barbara Station; demolished. (P.C. Ojessing, 1957, pack files.)

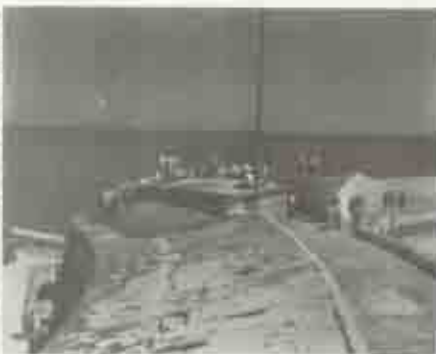
Figure 40. World War II concrete signal platform on top of the high wall, existing. (S&W HNS files.)

addition, a visual signal station was constructed at the same time on top of the high wall of el Morro over the center 1297 gun emplacement (Fig. 40). This consisted of a single deck concrete landing or platform.

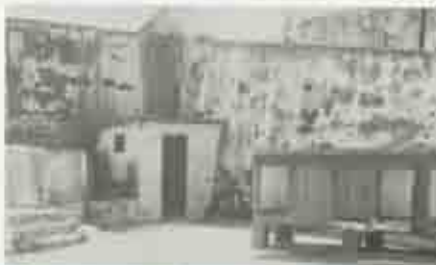
Figure 41. World War II latrine, demolished. (J. Boucher, HNS, 1960.)

This structure was built on the C a r a e n t e r r e p l a n between the ramp and the parapet wall (Fig. 41) and has since been demolished. The erosion of the rock cliffs on the channel side of Santa Barbara Bastion continued to p r e s e n t problems.⁴⁵ Work again was done in this area by

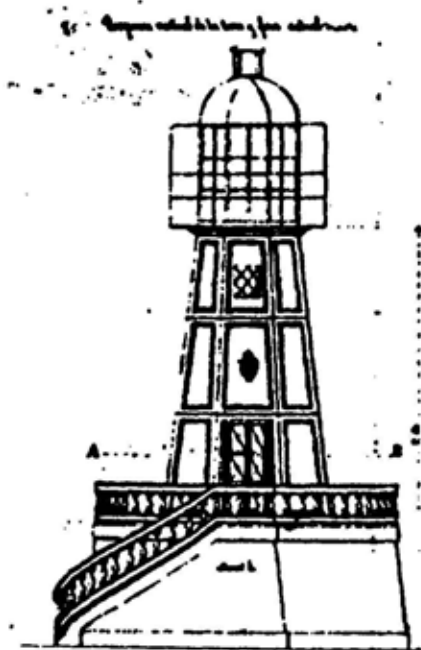
Figure 44. 1868 - Drawing of the lighthouse on its first base located on the Austria terreplein. (AHN)

The earliest view of the lighthouse is in the elevations of the Castro drawings of 1861. These drawings show little detail. However, a drawing of September 10, 1867, shows the lighthouse, in detail, on its Austria terreplein base (fig. 44).⁹² The British Sailing Directions for 1859, give the elevation of the light as 174 feet above sea level.⁹³ Considering that the terreplein has an

elevation of 140 feet and that the tower was to be 18 feet high and, scaling from the drawing in figure 44, the height of the stone base was approximately 7 feet and the focal plane of the light was about 4 feet above the tower top, the light would have been 29 feet above the terreplein or, 169 feet in elevation.*

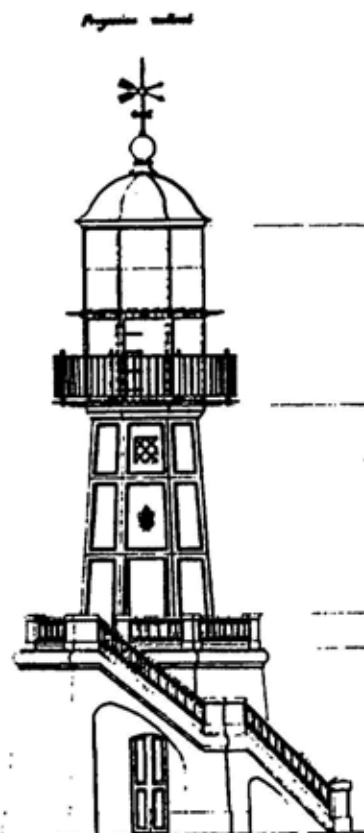
Figure 45. 1877 - Drawing of the lighthouse on its Ochoa terreplein base. (AHN)

In 1876, the lighthouse was relocated to the terreplein of Ochoa Bastion⁹⁴ where the present lighthouse now stands. Plans for this move were begun in 1868. A drawing dated July 27, 1868 shows the proposed base for the lighthouse as it was to be relocated on Ochoa Bastion.⁹⁵ Another drawing, dated March 22, 1878, shows the lighthouse in its new location (fig. 45). Here, the tower appears very much as it does in the photo in figure 43. By scaling the height of the tower in figure 45 a dimension of 18 feet is obtained, the same as that found in figure 44. The U. S. Hydrographic Office's Sailing

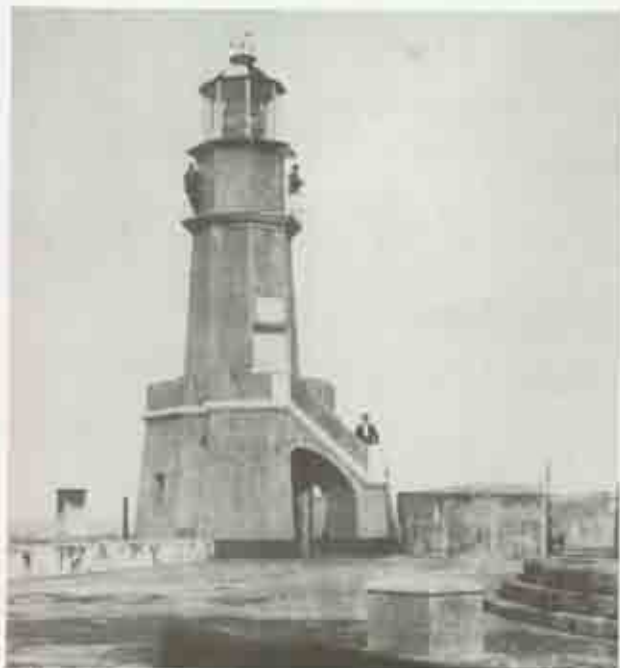
Figure 46. First American lighthouse, built on the base of the damaged Spanish lighthouse. (National Archives, 24-10-42-13B.)

A photograph of this tower exists (fig. 46). A 56-foot high tower, if built directly on the terreplein (140-foot elevation), placed the light at least 196 feet above sea level; even higher considering the light would be positioned 4 to 6 feet above the top of the tower. The lighthouse in figure 46 looks very similar, in height and detail, to the lighthouse in figure 43.

The difference between the lighthouses is in the width of the platform at the top of the octagonal tower and in the solid crenelated parapet replacing the balustrade on the stairs and at top of the base. The structural pattern seen on the tower of the older lighthouse is gone from the tower of the American structure. A drawing prepared by the U.S. Army in 1905, shows this 1899 lighthouse on a sheet with the proposed new lighthouse.¹⁰⁴ A note on the earlier lighthouse states, "Present Tower as rebuilt [emphases added] in 1899 by the Navy Dept." The drawing shows the old tower having a crack just below the lower platform with the notation, "cracked entirely through and around tower." The height of the focal plane of the light, as measured on this drawing, is 42.5 feet above the terreplein (182.5 feet in elevation).

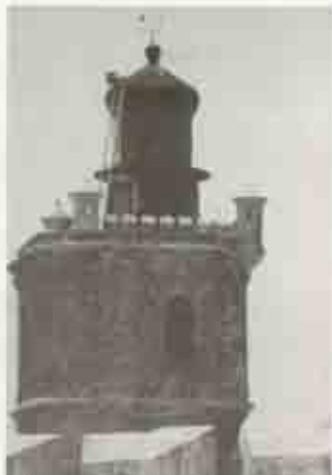
Figure 48. Present el Morro Lighthouse. (Photo by F.S. Cliver, 1990.)

Today, the deterioration of the brick is extensive. In addition, rust jacking occurs where steel beams are inserted into the masonry. This jacking is exhibited by horizontal cracks that run along the joints below the parapet and near the bottom cordon of the square portion of the tower. This type of deterioration will occur at an accelerated rate because the cracks allow the entry of salts. As the width of the cracks increases, more salt-moisture can enter, resulting in an increase in oxidation. When oxidation occurs, the rust expands with great force (similar to ice formation or salt crystallization), causing stress cracking in the brick masonry unit. The alternatives for correcting these problems are dealt with in the section on RECOMMENDATIONS found in Volume I of this HSR.

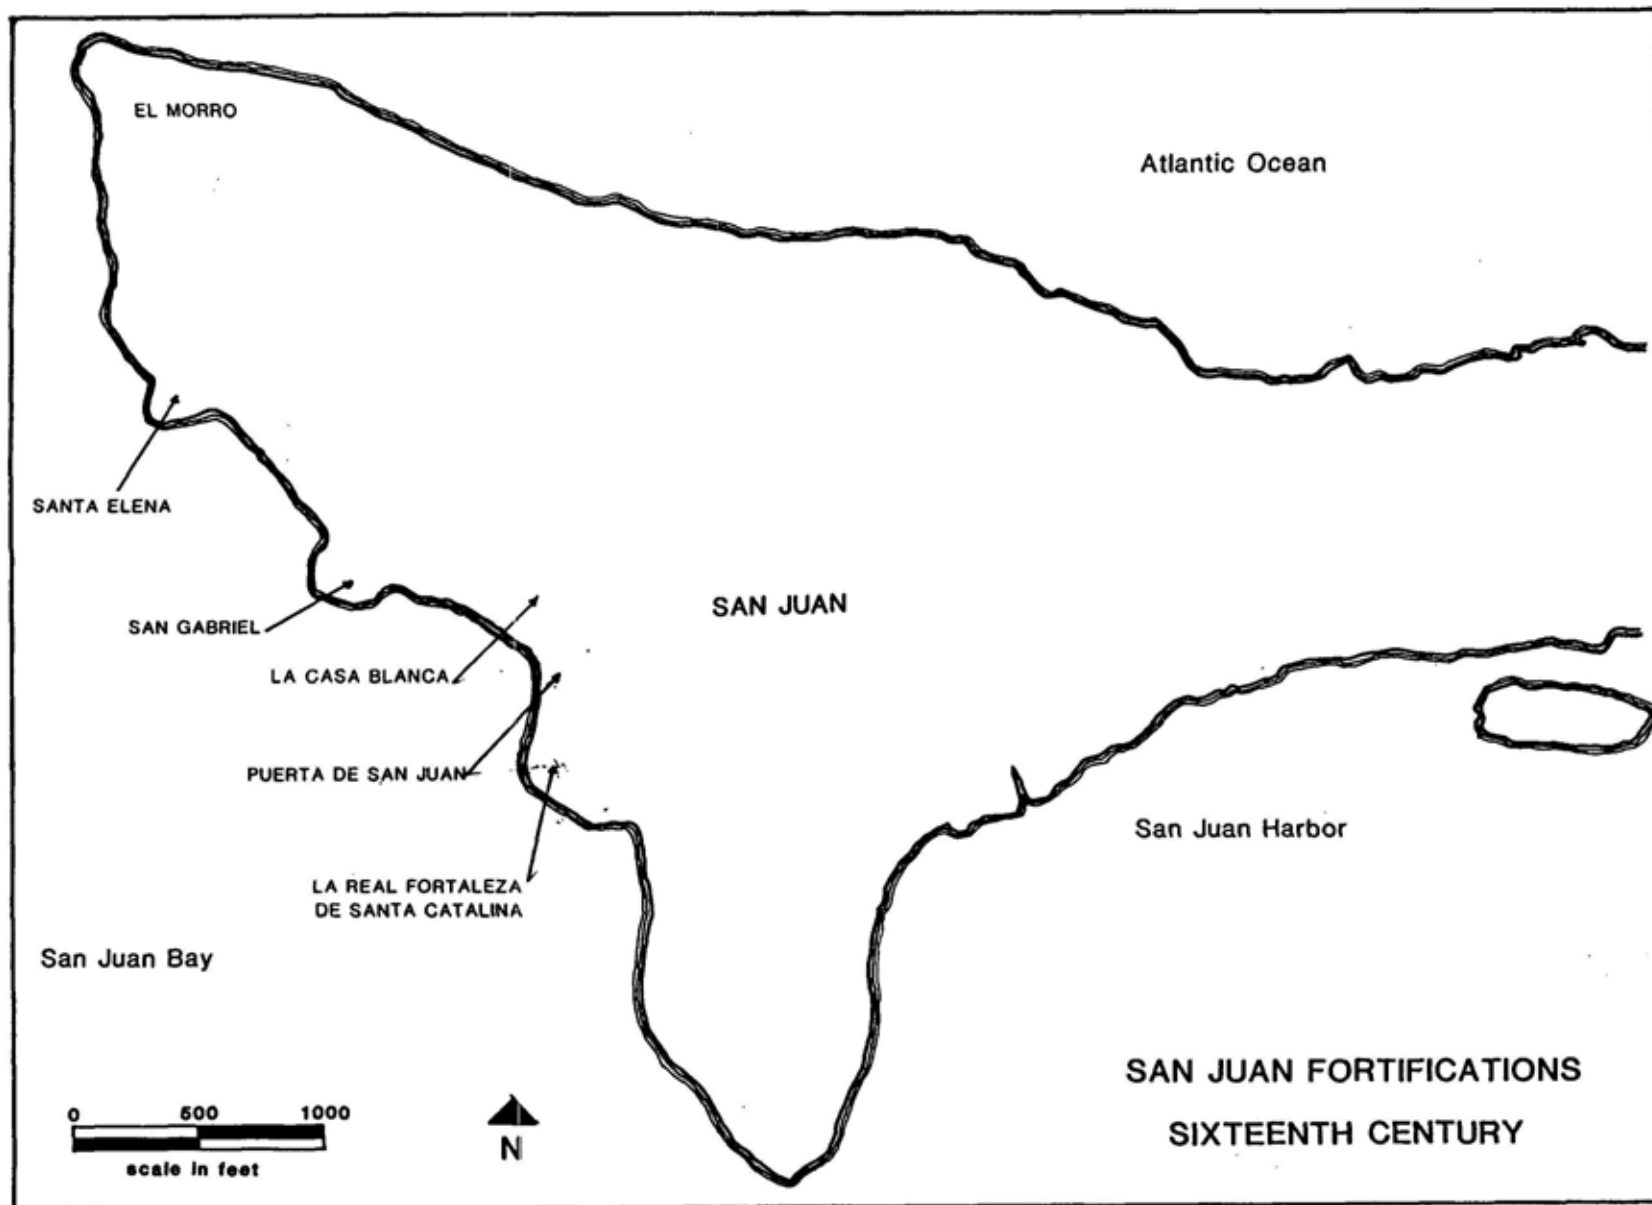
Figure 1. San Juan Fortifications in the sixteenth century. (Plan drawn by K. Faust and annotated by R. Crisson, 1991.)

The earliest fortifications in Puerto Rico were those defensive buildings constructed as casa fuerte (fortified houses) for the early colonizers. The best surviving example in San Juan is la Casa Blanca (the White House), built by the family of Juan Ponce de Leon shortly after the founding of San Juan in ca. 1520.* When constructed, the main defensive purpose of Casa Blanca was to protect its inhabitants from Carib Indian raids.³ Casa Blanca was conveniently situated on a bluff that was eventually integrated with the city wall defensive system (the building today overlooks the curtain wall of San Agustín). More importantly, Casa Blanca overlooked the entrance to the harbor. San Juan harbor, measuring 3 miles long by less than 2 miles wide, was always considered a "safe harbor," because many ships could be anchored and protected from the rough seas. It was the only harbor on the north coast of Puerto Rico that afforded protection in all weather, since it was shielded on the north by the relatively high land mass of the Islet of San Juan, and on the south, east, and west by the mainland of Puerto Rico. (See figures 1, 2 and 3.)
