THE FORTIFICATIONS OF SAN JUAN NATIONAL HISTORIC SITE

HISTORIC STRUCTURE REPORT

Castillo de San Felipe del Morro

Building Conservation Branch
Cultural Resources Center
North Atlantic Region
National Park Service
and the
Center for Preservation Research
Columbia University

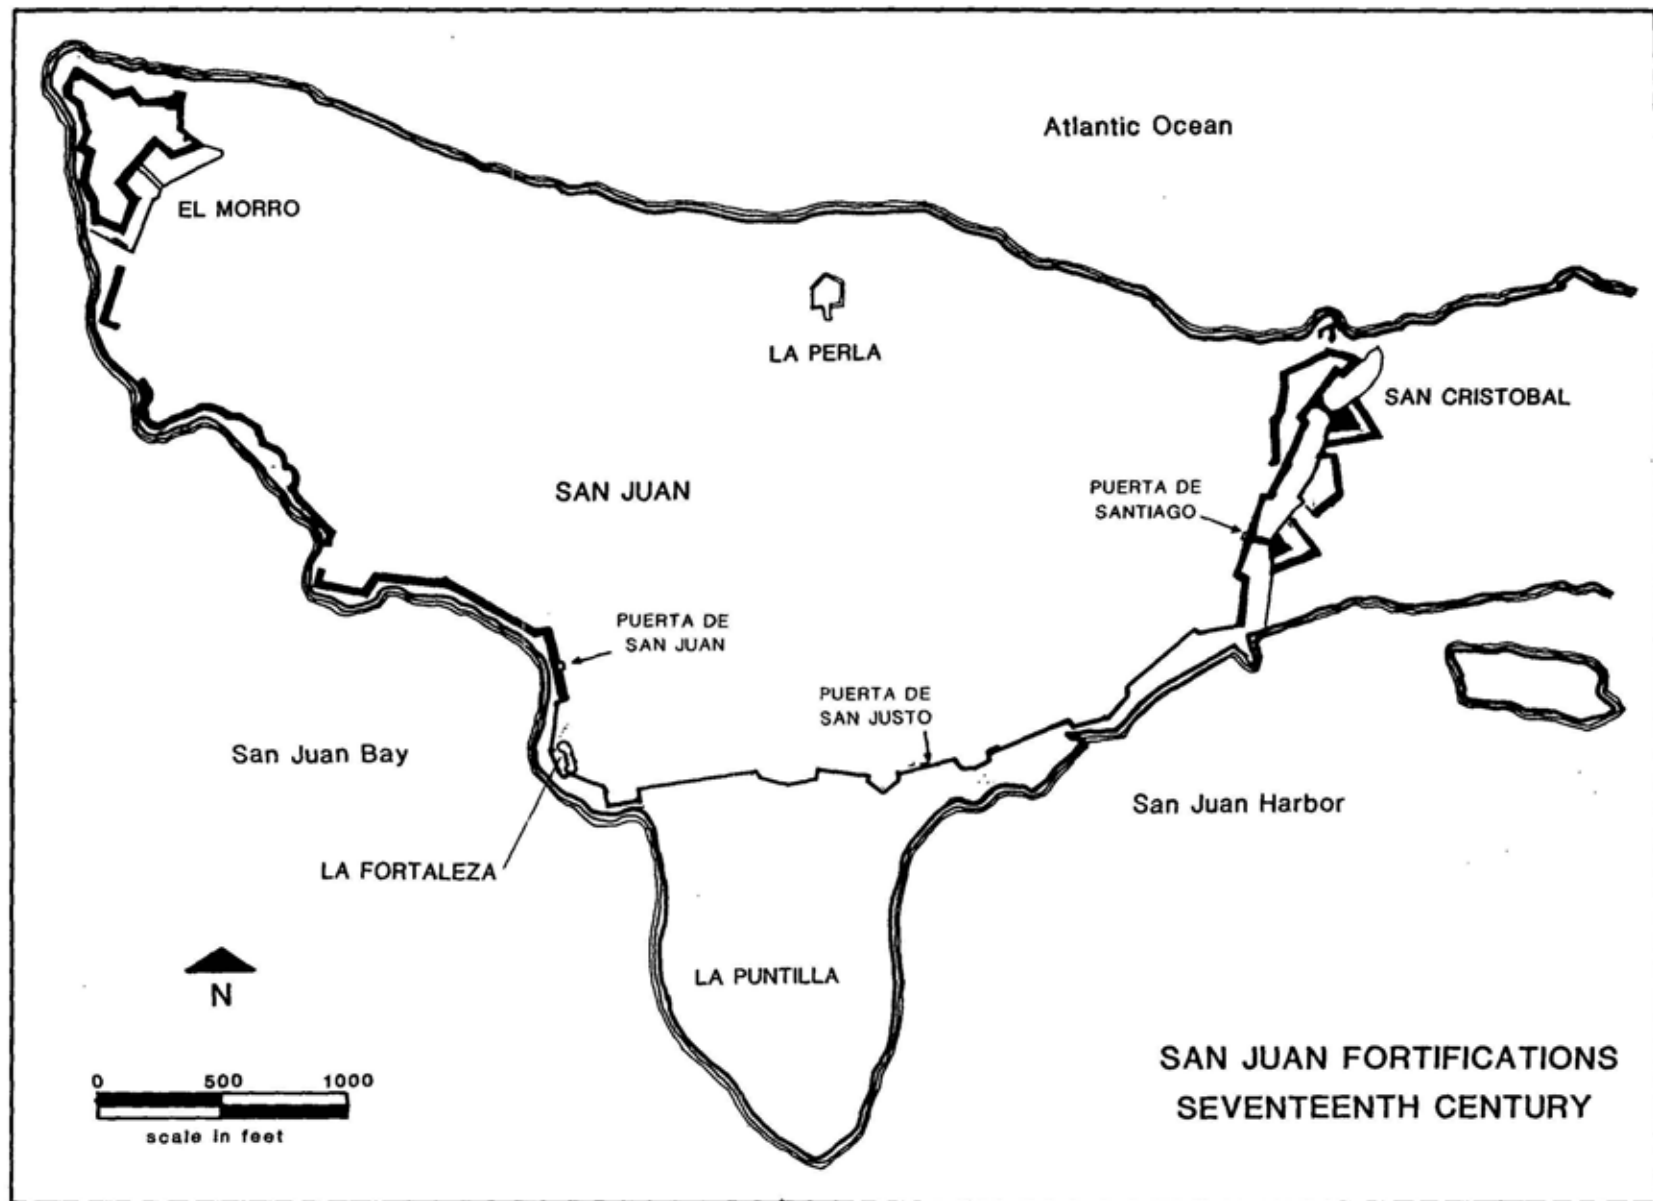
Figure 5. San Juan Fortifications in the seventeenth century. (Plan drawn by K. Faust and annotated by R. Crisson, NPS, NARO, 1991.)

Between 1630-60, the Spanish builders continued executing extensive repairs, reconstructions, and new construction (fig. 5). Both la Fortaleza and el Morro were rebuilt; city walls facing west, south, and east were either built or reconstructed; and el Cañuelo was rebuilt in its present square form as a masonry redoubt. San Cristóbal was begun in 1634 to serve as the bulwark of the easterly defenses.

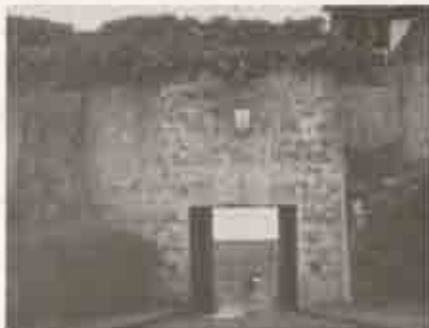
Figure 6. San Juan Gate, east elevation from Sancto Ochoa. (Photo by E. Criscon, 1996.)

The symbolic entrance to the city was for many years San Juan Gate. The gate was probably constructed in 1618, under the leadership of Governor Enrique de Sotomayor. Symbolism qui yunit in homini Domini (Blessed are they who come in the name of God) is the L E T I N inscription over the gate (fig. 6 and 7).

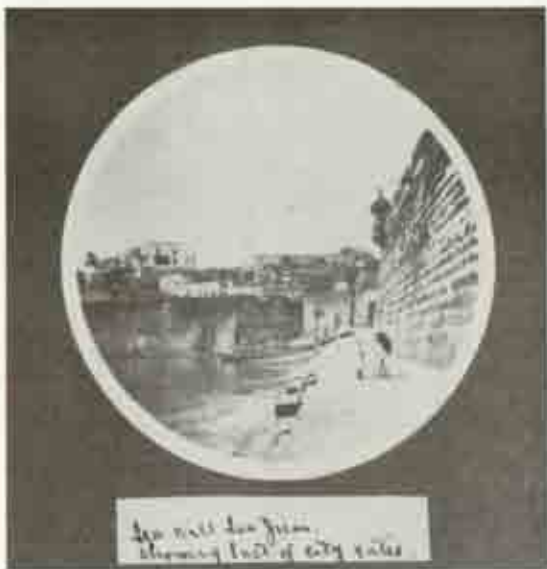
San Juan Gate
showing end of city gates

Figure 7. San Juan Gate, ca. 1904. (Capt. R.E. Seshell Collection, SAJU NHM Archives.)

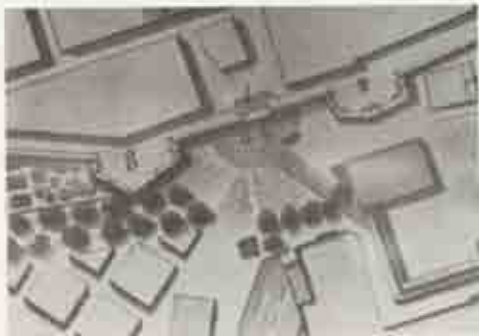
Figure 8. Area of Fuerte de San Justo in 1842, detail of plan by M.J. Castro and J. López Baño. (Servicio Geográfico del Ejército, no. 40, Madrid)

The remaining features of the south wall included la Puerta de San Justo (the Gate of Saint Just), ca. 1630-39. Based on nineteenth-century photographs, this was an imposing gate with a pedimented gable supported by large engaged columns (figs. 8 and 9). It stood at the foot of the present-day Calle San Justo. Like the other two original gates, it also was embellished with a motto above the doors. Here it said in Latin: Dominus mihi adjutor quem timebo? (If God is my helper, who should I fear?).¹⁵ Farther east was the other bastion that defended this gate, el Baluarte del Muelle (the Bastion of the Wharf), dating from the same period. The final portion of the south wall was a curtain wall of ca. 1630-39, extending eastward; it may have been called la Cortina de San Rafael (the Curtain Wall of Saint Raphael). At the southeast corner of the south wall was el Baluarte de San Pedro Martir (the Bastion of Saint Peter the Martyr), but most often called San Pedro; it was constructed between 1634-50.

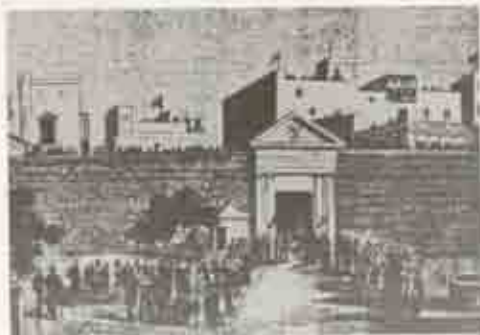
Figure 9. Fuerte de San Justo in 1884. Engraving in *La Ilustración Española y Americana*. (Repro. in A.S. Rivera's *SAN JUSTO*, 1969.)

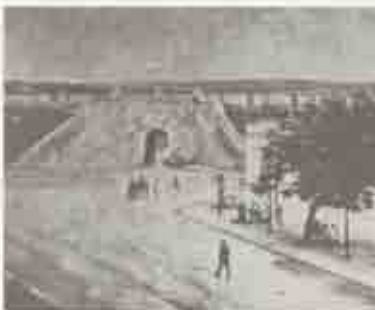
Figure 10. West elevation of Puerta de Santiago, ca. 1490. Photo by Feliciano Alonso. (Repro. in A. S. Rivera, 1929.)

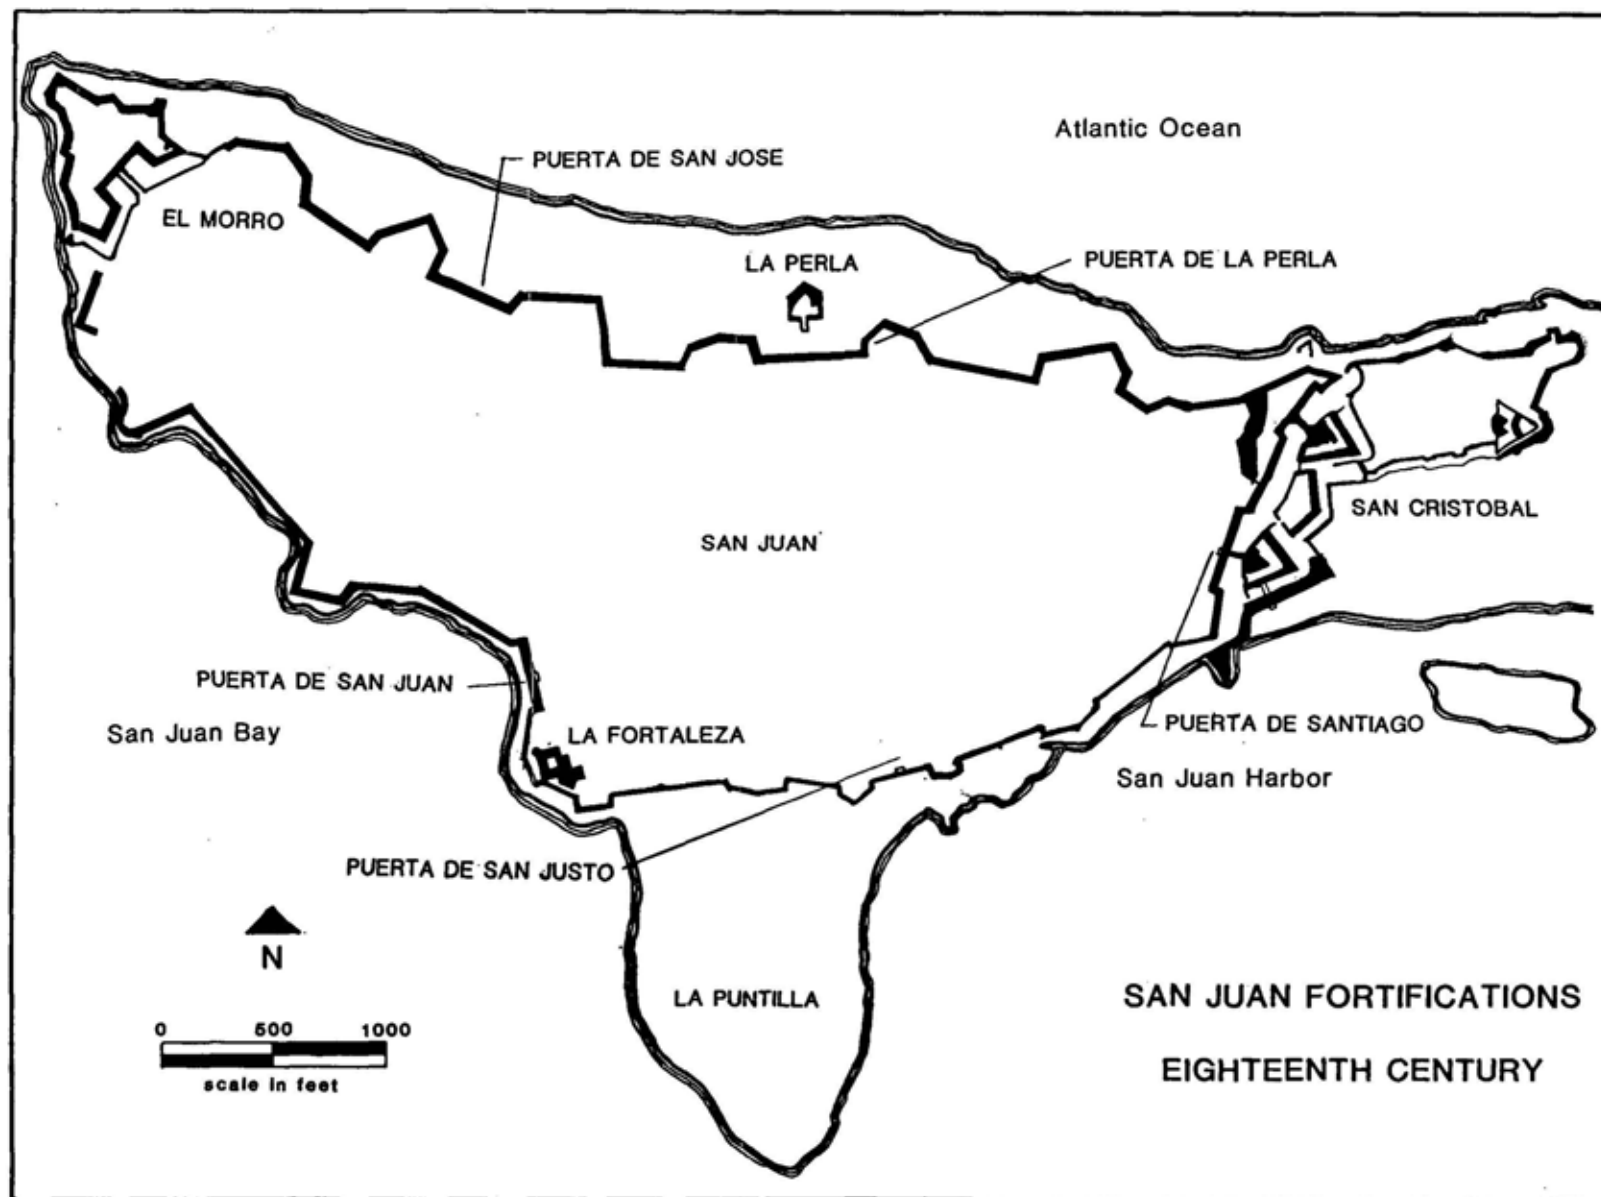
Figure 11. San Juan Fortifications in the eighteenth century. (Plan drawn by K. Faust and annotated by R. Crisson, NPS, NARO, 1991.)

The first half of the eighteenth century was politically calm for San Juan, particularly from 1701 on when the French Bourbons and the Spanish kings were politically aligned. Puerto Rico remained an almost forgotten colony. Correspondingly, little work except for a few improvements made around 1740, can be documented for this period. Complacency ended, however, with the conclusion in 1763 of the Seven Years' War and the reforms inaugurated by Charles III in 1759 when he became King of Spain. Impending conflict between Spain and England signaled that improvements had to be made to the fortifications of San Juan. (See figure 11.)

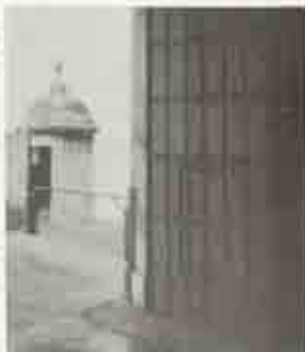
Figure 12. San Juan Gate looking west. (Photo by W. Crissien, 1996.)

The gateway probably acquired its present form during this period. Of the same period may be the pair of heavy, wood and bronze-studded doors, each 14 feet high by 6 feet wide (fig. 12). The doors are inscribed with the year 1749. The doorway (as it appears today), is of masonry with painted stucco, and is elaborately decorated with neoclassical moldings, square pilasters, and an arched recessed niche above. A depression in the center of the paved road provided drainage from Caleta

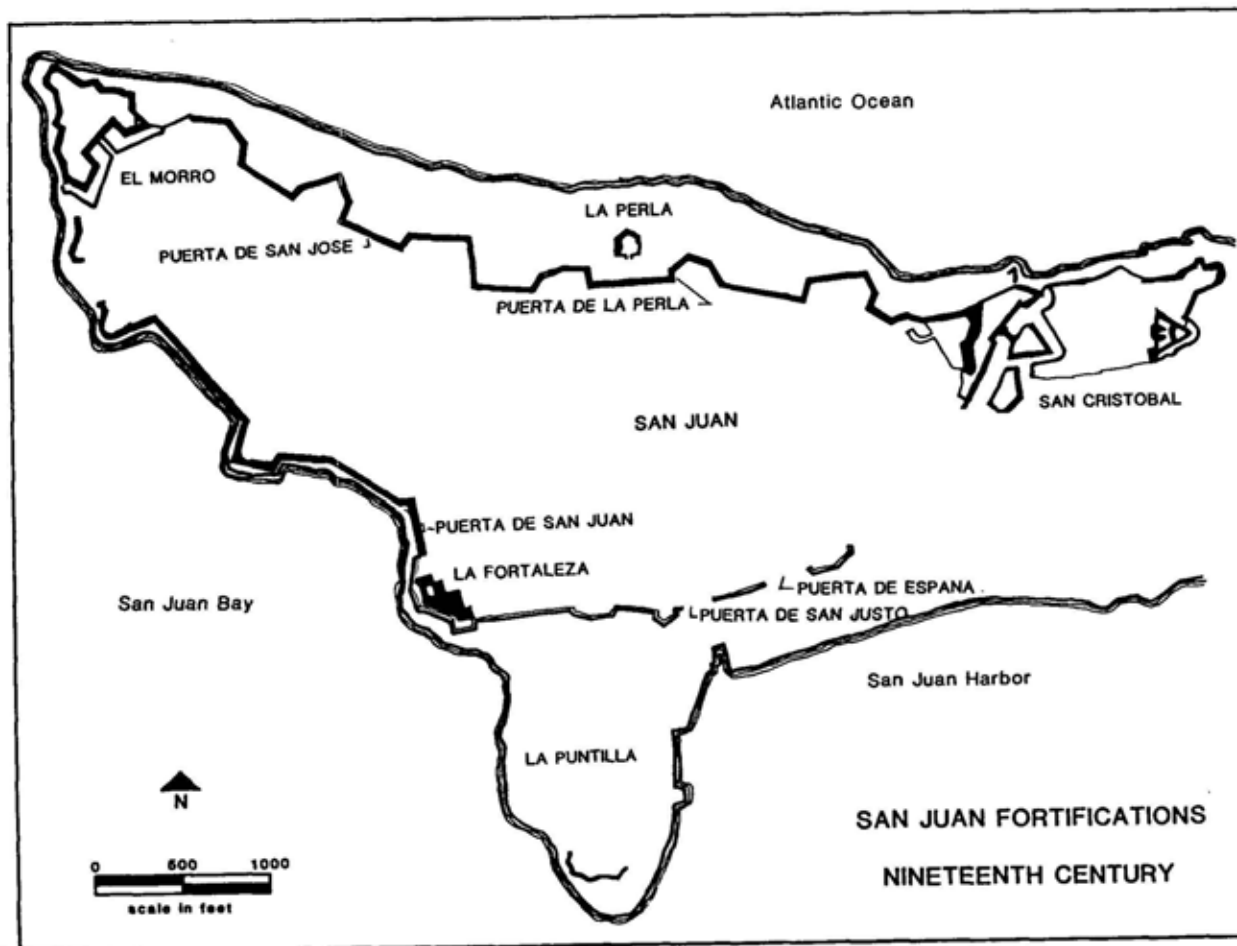
Figure 13. San Juan Fortifications in the nineteenth century. (Plan drawn by K. Faust and annotated by R. Crisson, 1991.)

Even though warfare and political forces changed considerably during the nineteenth century, neither of these changes affected the fortifications of San Juan as much as the socio-economic forces (fig. 13). The threat of war had diminished, and by 1830 only Cuba and Puerto Rico remained under Spanish dominion in the Caribbean. This century is best described as a period of repair and maintenance at the fortifications; many of these repairs may have been needed as part of regular maintenance, but others may have been to correct damage caused by the 1797 British attack. Records allude to repairs and replastering of many fortification walls in the period 1824-35. Artillery and gun emplacements were routinely upgraded during the century. Military engineers continued to depict the city and its defensive features in overall city plans from mid-century onward. (See Historical Drawings, Volume I.)

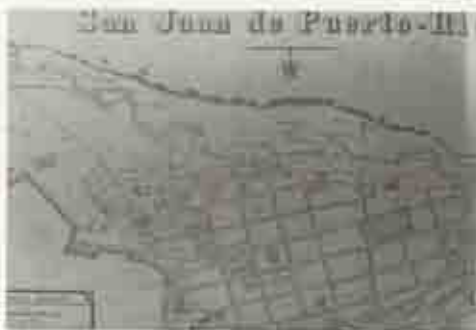
Figure 14. "Plano de la Plaza de San Juan de Puerto Rico," by S. Koldán y Navarro, 1887. (AGN, cart. ultr. cat. 61, Madrid.)

The west wall was discussed in a number of documents beginning in 1808 and was portrayed in general city plans dating to mid-century (fig. 14). A report written by Ignacio Mascaró for the years 1808-11, made reference to many overall repairs. The report stated, in reference to the curtain wall of Santa Elena, that "part of the wall was undermined due to the onslaught of the sea, and hewn and rubble stone were being stored until repairs could be made."³⁷ The report also stated that the San Juan Gate was rehabilitated in ca. 1809. A ca. 1887 plan³⁸ titled "Plano de la Plaza de San Juan de Puerto Rico" labeled all of the features of the west wall (fig. 15). It also documented the wall failure and the poor conditions of the west wall. Some of these failures continued throughout the nineteenth and twentieth centuries.

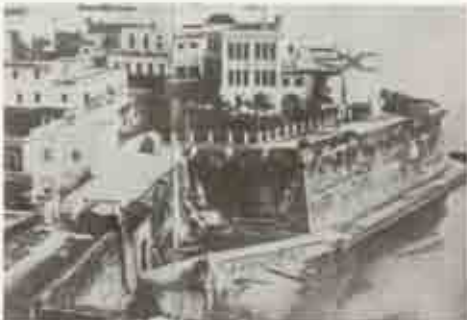
Figure 16. La Fortaleza and Santa Catalina Bastion, ca. 1898. (Repro. in A. Sepúlveda Rivers, 1989.)

Goethals and Crosby indicated in 1898 that the Spanish had modernized "la Fortaleza Battery" with a 19-cm Ordóñez rifle and the parapet had been reinforced by constructing a parallel wall 10 or 15 feet away and [by] filling the space in between with earth.⁴¹ It is clear that the west wall had taken a renewed defensive role in preparation for the war with the United States; however, none of these positions were used during the 1898 conflict. (See Figure 16.)

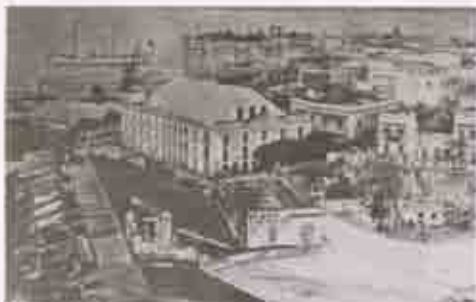
Figure 19. View prior to demolition of East Wall, 1897. Puerta de Santiago on left. (Repro. in A. Sepúlveda Rivera, 1989.)

The most significant easterly defenses were those comprising San Cristóbal and its outworks. Unfortunately, every structure south of la Trinidad (at San Cristóbal) was demolished in 1897, including el Revellín del Principe and la Puerta de Tierra, the curtain wall of Santiago and Santiago Gate and Santiago Bastion.⁵⁰ (See figures 19 and 20.)

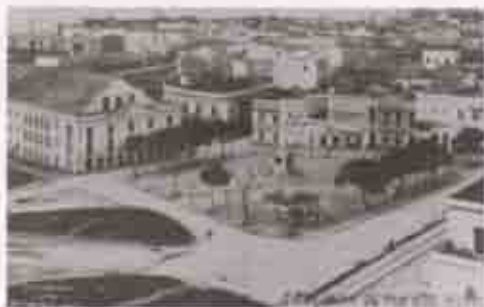
Figure 20. View soon after demolition of East Wall, ca. 1900. (Photo archives, UPQ, Rio Piedras.)

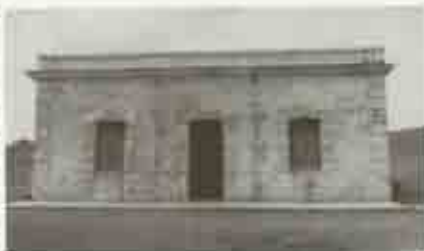
Figure 23. San Antonio Guardhouse at San Antonio Bastion. (Photo by R. Crisson, 1980.)

As part of the various changes and improvements made by the
 Spanish just prior to the Spanish-American War in 1898 was the
 construction of the San Antonio Guardhouse ca. 1897 in the
 Bastion of San Antonio, and adjoining el Morro (fig. 23).⁴⁴
 Evidently, the defensive role of the north wall was reduced in
 the nineteenth century, while el Morro and San Cristóbal were
 strengthened with far-reaching artillery. This was confirmed
 in the description of 1898 by Goethals and Crosby in which San
 Antonio bastion was the only reinforced element of the north
 wall. This battery, immediately east of el Morro, was close
 enough to the fort to be considered a defensive extension of
 el Morro. The 1898 report described it as having:

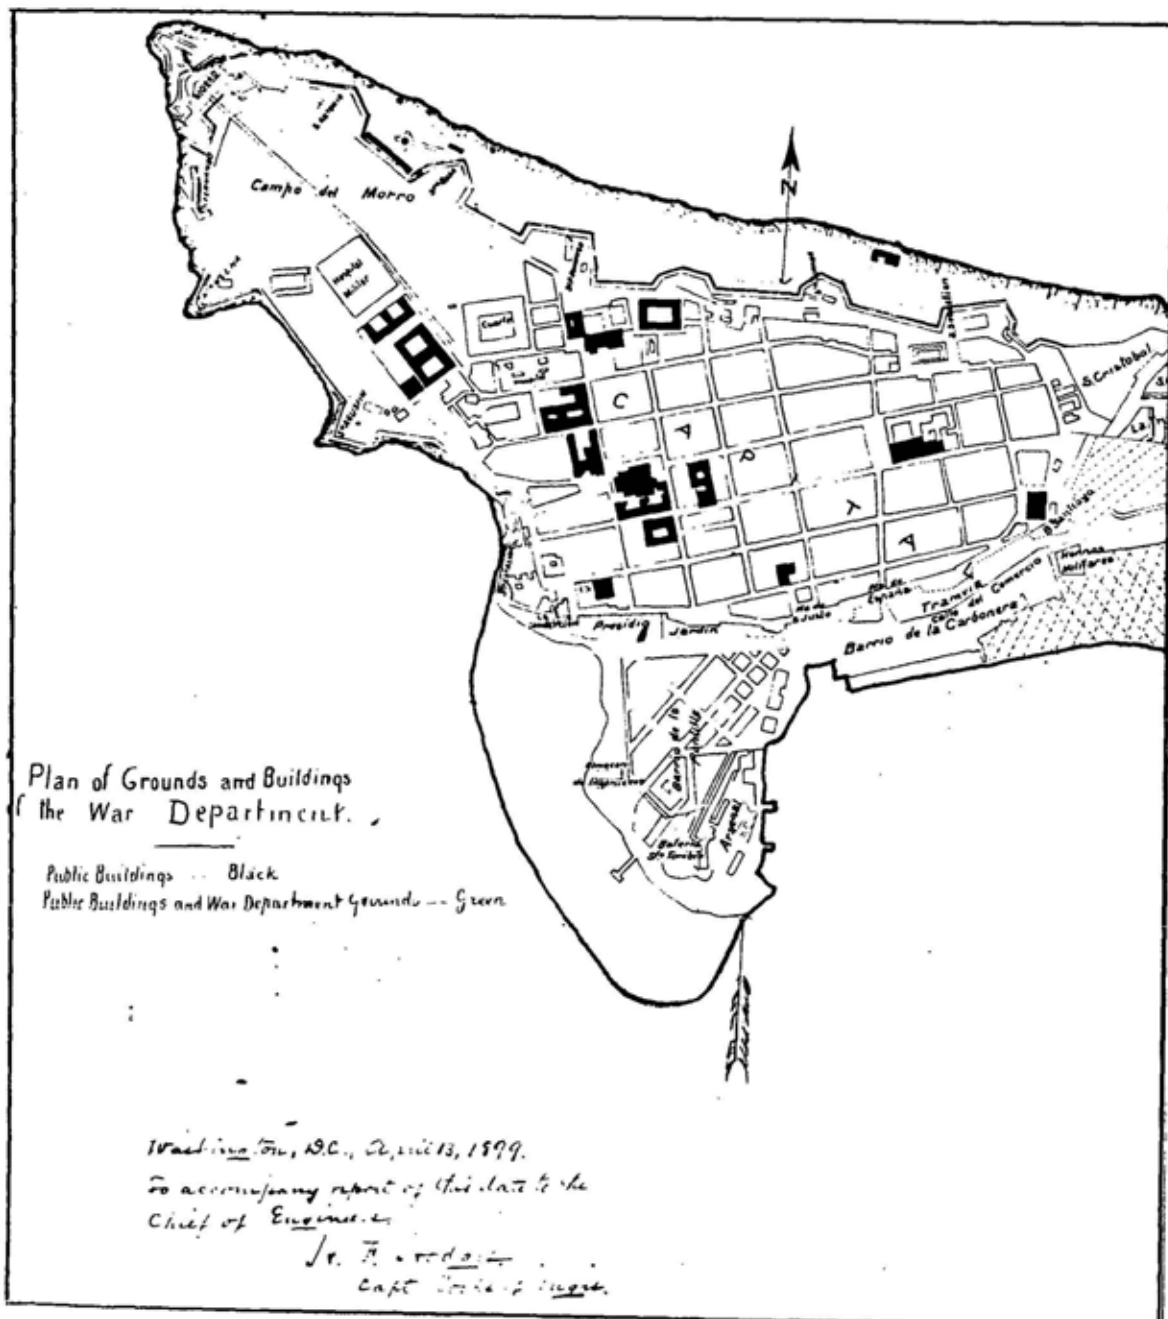
Figure 24. Plan of grounds and buildings of the War Department, 1899. (SAJU NHS 0543-1864.)

In preparation for the work that would be needed in the twentieth century, U.S. Army engineers soon began to document the extent and conditions of the defensive walls. The first of many plans prepared in the twentieth century was dated 1900 (fig. 24).⁶⁰ In five short months the aggressor became the

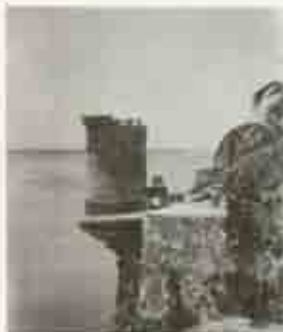
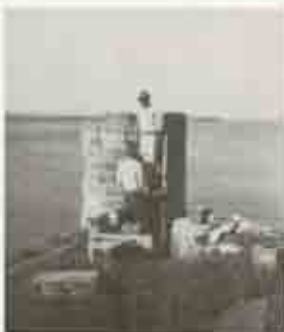
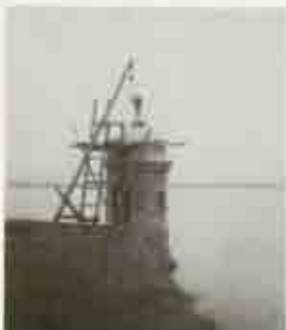
Figure 24. San Agustin sentry box, August 1933. (SAJU MMS Archives.)

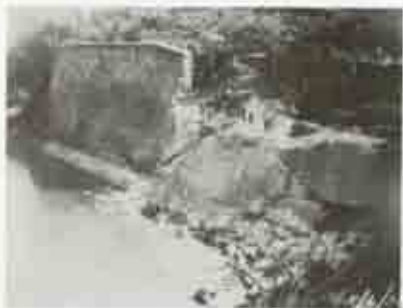
Figure 27. Workers beginning to work on the collapsed curtain wall between Santa Elena and San Agustín. [West Wall]. 1938. (SAJU NNS Archives.)

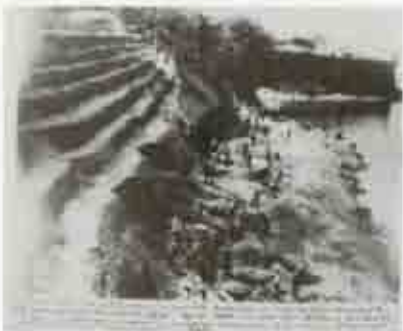
Figure 28. Demolished curtain wall between Santa Elena and San Agustín. [West Wall]. 1938. (SAJU NNS Archives.)

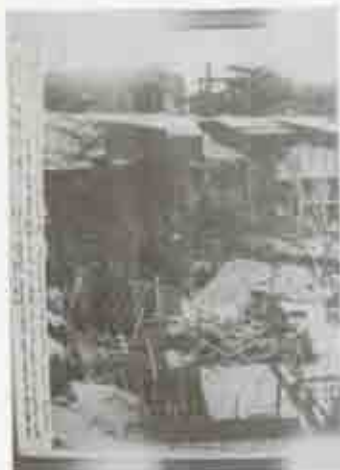
Figure 29. New concrete foundation at NW corner of San Agustín Station. [West Wall], 1938. (SAJN HNS Archives.)

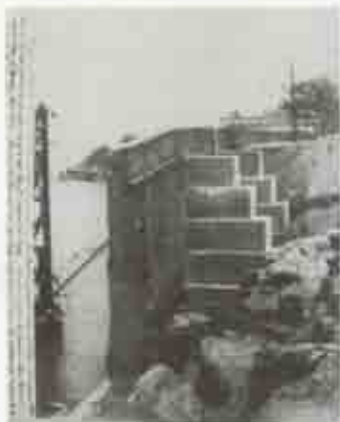
Figure 31. New concrete counterforts for the curtain wall between Santa Elena and San Agustín Bastions, 1938. (SAJU NMS Archives.)

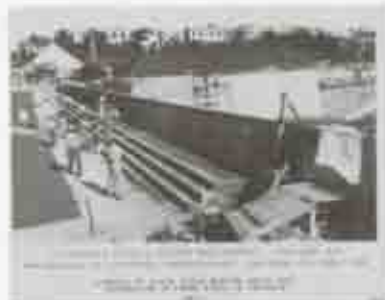
Figure 34. Santa Elena Bastion, reconstruction of firing steps, 1839. (Completion Report, SAJU NMS Archives.)

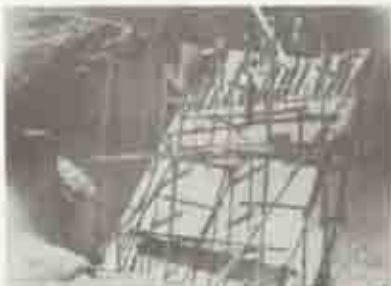
Figure 35. Reconstructed scarp wall, Santo Domingo Bastion, May 1938. (NARS NPS Archives.)

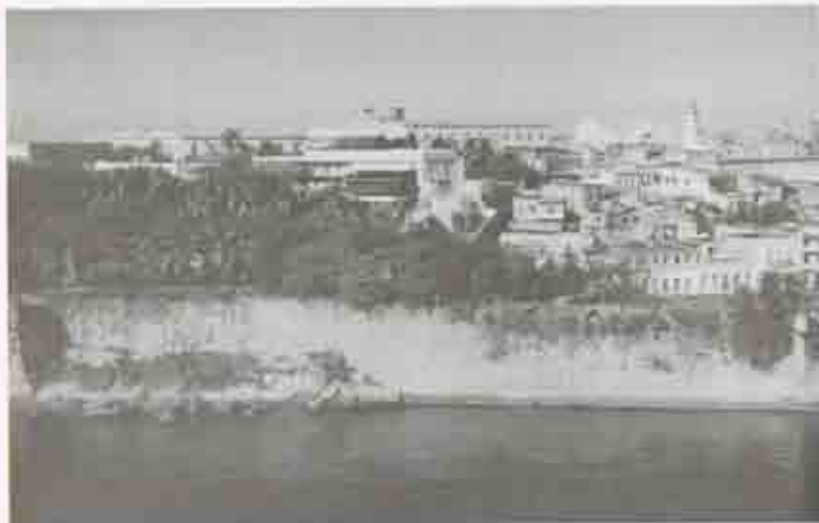
Figure 18. Conditions prevalent between Casa Rosa curtain wall with San Agustín at left and Casa Blanca at center, ca. 1940. (IAJU BHS Archives.)

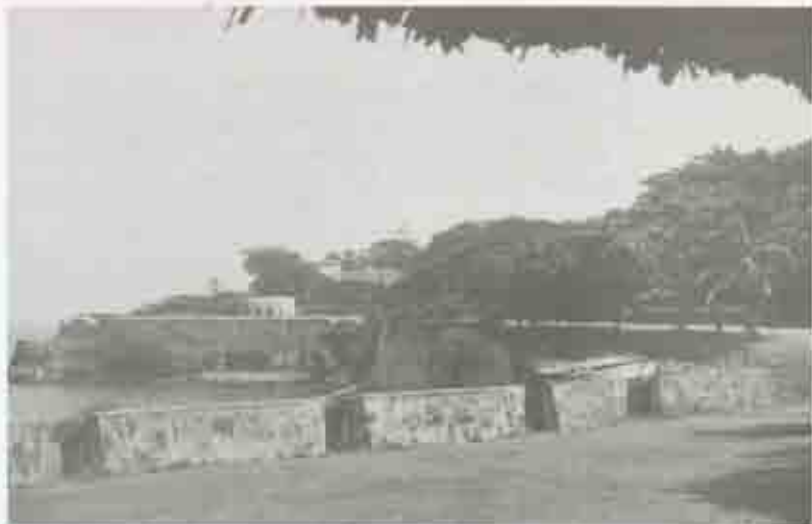
Figure 27. Condition of the west city wall in vicinity of the San Agustín (foreground) and Santa Elena (background) bastions, ca. 1960. (K&JH VHS Archives.)

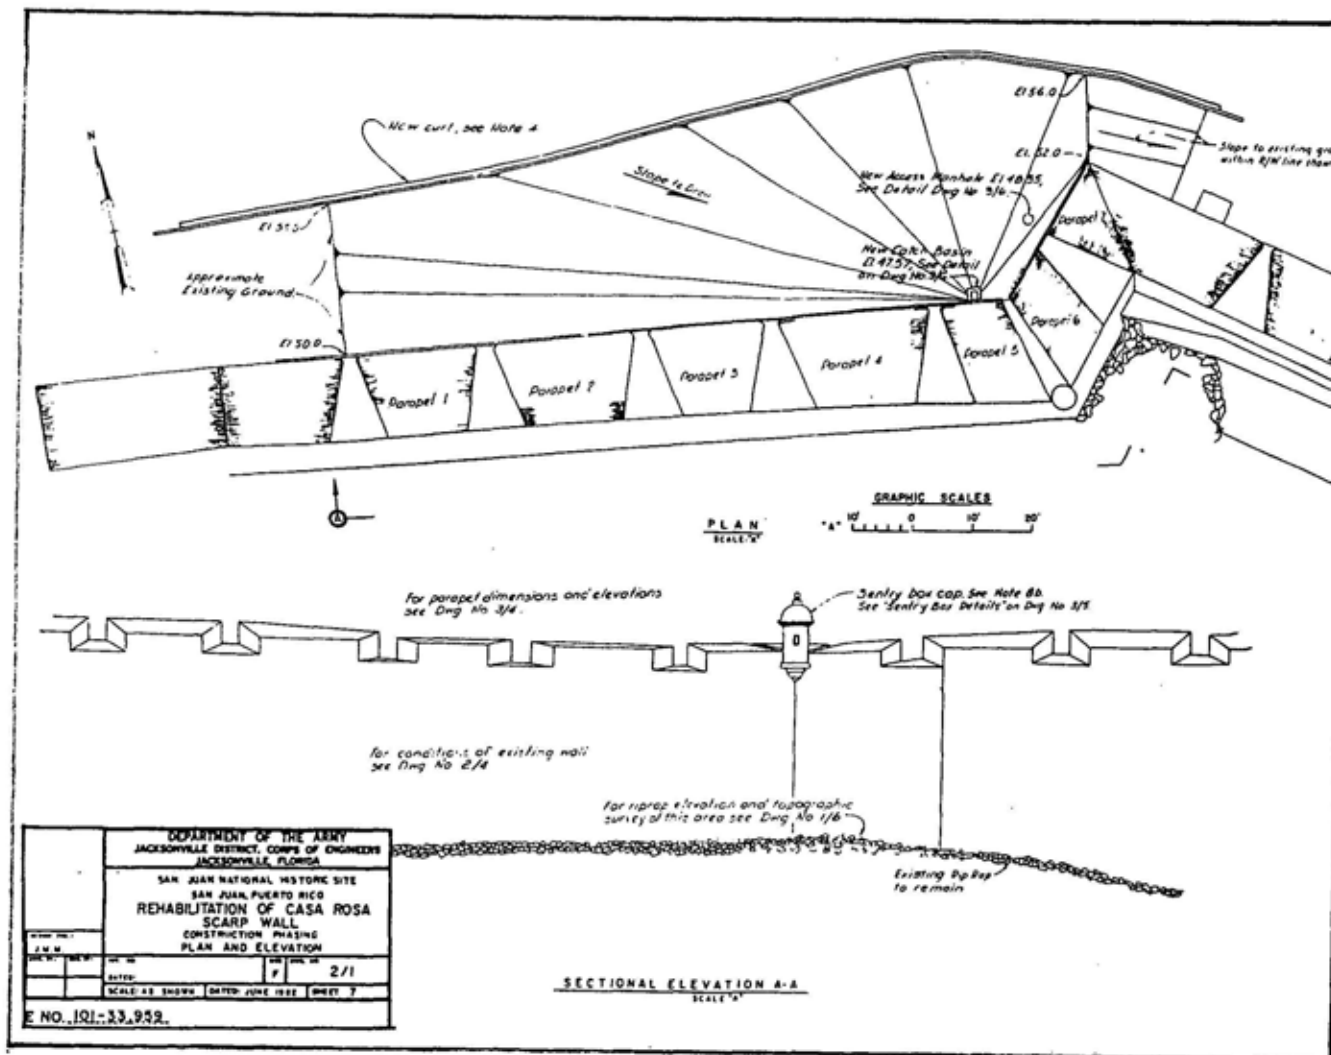
Figure 39. Elevation and plan of reconstructed wall, 1982, at San Agustín Bastion, U.S. Army Corps of Engineers. (Copies of drawing at SAJU NHS Archives.)

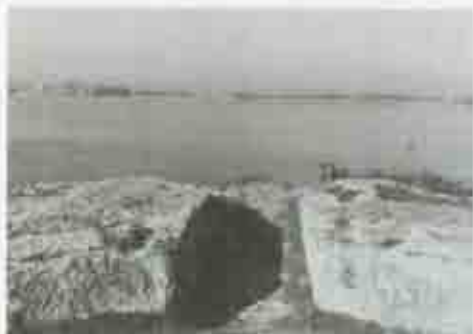
Figure 43. Embrasure at San Fernando Bastion.
(Photo by E. Crisson, 1990.)

San Fernando Bastion is situated south of el Morro (fig. 42). It has been greatly modified over the years and contains neither a sentry box, however, what may survive from a former embrasure is still evident (fig. 43). A modern chain-link fence separates San Fernando from the edge of the cliff. Further south is Santa Elena Bastion. Santa Elena is the only rounded bastion. It has no sentry box but contains 11 embrasures. The exterior walls are constructed of coursed, face-dressed sandstone rubble; the openings of the embrasures are of chamfered dressed stone. Horizontal surfaces of the merlons are brick-edged concrete, probably installed as part of the 1977 Corps of Engineers project. The embrasures exhibit various conditions of deterioration, including differential weathering and biological growth. Most of the flat wall surfaces are patched and have a number of surface cracks. All of the embrasures have iron fences placed approximately one foot away from the exterior face. Santa Elena is identified with a bronze marker on the wall.

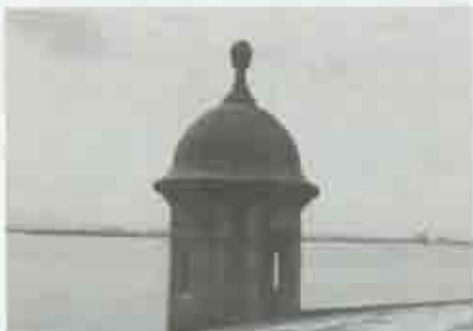
Figure 45. Reconstructed sentry box of San Agustin curtain wall. (Photo by R. Crismon, 1990.)

The adjoining Curtain Wall of San Agustín has 10 embrasures and one sentry box that was reconstructed in 1938. The embrasures have severe biological growth, patches, and numerous cracks. The next feature is San Juan Gate and its original sentry box (Fig. 46). Although not examined as part of the 1988 conditions survey, a cursory visual inspection confirmed that many of the wall surfaces have biological growth, cracks, patching, staining, and differential weathering. Adjoining San Juan Gate is Santa Catalina Bastion with la Fortaleza. Though this bastion is not part of this study, it is noteworthy for having three embrasures, a ca. 1932 sentry box, and an original eighteenth-century sentry box.

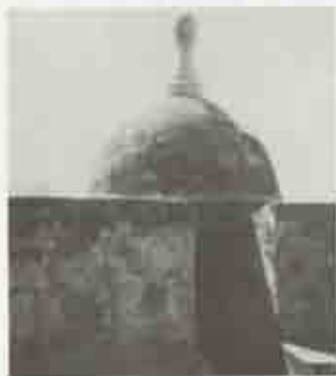
Figure 31. Gentry box at las Palmas Bastion, north elevation. (Photo by K. Crismon.)

Las Palmas bastion is at the eastern end of the curtain wall (figs 50 and 51). It has two embrasures and an original eighteenth-century sentry box.¹⁴ Part of the terreplein of las Palmas bastion has been converted into a pedestrian park with trees, pavement, lighting, and fixed benches. A bronze plaque on the wall denotes the bastion of las Palmas.¹⁵ The remainder of the terreplein of las Palmas is occupied by a modern masonry structure known as the Chamber of Commerce Building. A modern utility pole has been located on the easternmost merlon. The embrasures fronting the Chamber of Commerce building have been closed off with a metal railing and the terreplein has been paved with ceramic tile. The coursed, face-dressed sandstone rubble wall has been patched in many places, but appears neglected today. The parapet wall has three sealed, vaulted tunnels at the base of the surmounted wall. The conditions include severe biological growth, differential weathering, patching, and staining.¹⁶ Farther east is the severely deteriorated bastion of San Justo with its eighteenth-century sentry box.

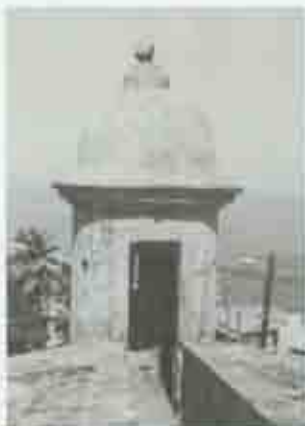
Figure 54. San Sebastián, original sentry box. (Photo by S. Crissan, 1990.)

brick rubble, covered with stucco. This sentry box has severe cavity erosion below the cornice and at the dome, and has exposed brick and stucco patches (fig. 54).

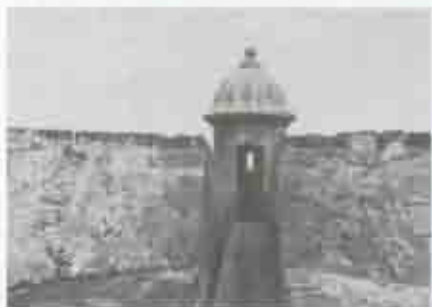
Figure 59. Santa Rosa sentry box. (Photo by W. Crissan, 1990.)

Santa Rosa bastion lies farther west, with one sentry box at the salient angle that was reconstructed ca. 1939 on its original sandstone base (fig. 59). The bastion has 18 embrasures. The bastion is constructed of coursed, face-dressed sandstone rubble, with rubble joints, dressed stone corners, and brick-edged embrasures (fig. 60). Merlons are of brick rubble and concrete. The cemetery wall sits the west flank of the bastion and various tombs are set into the base of the scarped wall. The embrasures are in generally poor condition, with many patches, differential weathering, surface cracks, and loss of mortar. A few embrasures have biological growth and cavity erosions. Santa Rosa bastion is identified with a bronze marker on the wall.

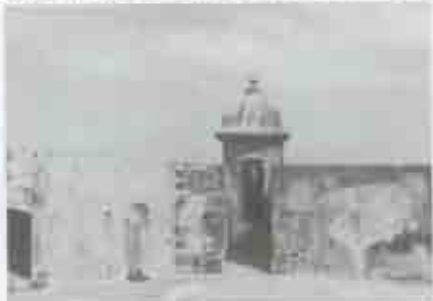
Figure 61. Sentry Box at San Antonio Bastion. (Photo by R. Crisson, 1990.)

(Fig. 61). The bastion consists of coursed, face-dressed sandstone rubble with rubble joints, dressed stone corners, and brick-edged embrasures. A large stone scupper is located near the salient angle and has a large cast iron pipe leading down to the base of the scarp wall. The embrasures have cavity erosion and differential weathering. Most have been patched and have areas of mortar loss, while others have cracks and biological growth. San Antonio is identified with a bronze marker on the wall.

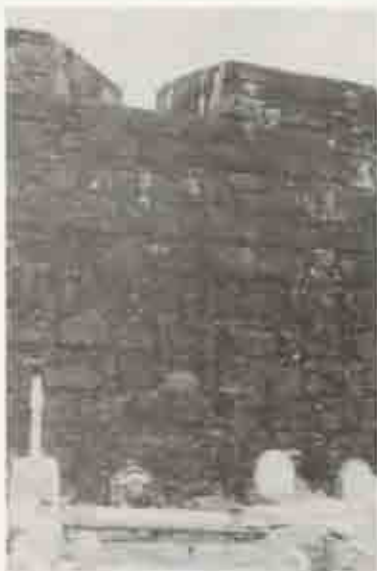
Figure 1. North wall of San Juan, backing
sanctuary. Note use of ashlar with stone
chinking (this wall has more chinking than
other walls); brick chinking and brick of
merlons may be repairs. Photo by J. Jacob,
1949.

Identifying size, tooling, and bedding patterns of stone blocks is difficult and often impossible to determine due to the stucco covering. However, much of the deteriorated stucco has weathered and formed to the contour of the blocks beneath (especially at el Morro), revealing these characteristics. (See figures 1 and 2.) Almost all of the fortified walls are constructed with a slight batter. Rock-face blocks are generally 18 inches to 24 inches in height and 30 to 36 inches in length, with length varying more than height. Their depth cannot be determined without further investigation.

Black and white marble pavers are found in the chapel at el Morro, in the vestry of the chapel at San Cristóbal, and outside the northern-most casemate of the Officers' Quarters under the arcade. These are 11 inches square and laid in a checker-board fashion. Marble grave stones are embedded at the base of the north wall adjacent to the San Juan Cemetery (fig. 1).

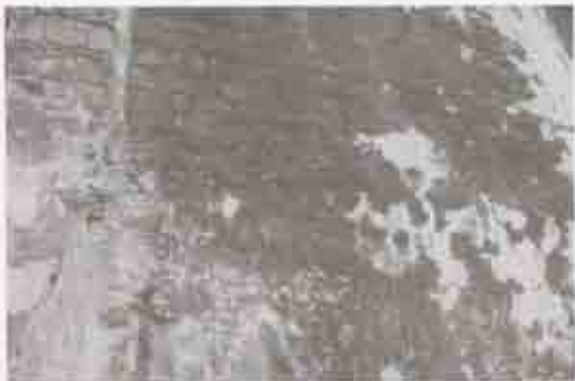
Figure 2. Santa Barbara Battery scarp wall above Water Battery. Lower wall is of rubble stone, upper wall is of ashlar. Both stone and brick chinking are present. Photo by J. Jacob. 1989.

Rubble stone construction is found throughout the fortifications and seems to be predominantly used for non-fortified walls. Casemate walls and counterscarps are generally of rubble stone. The scarped wall at the toe of Santa Barbara Battery is of both ashlar and rubble, with the former surmounting the latter (fig. 2).⁹ Rubble stone was combined with earth in filling the interstices of walls. Rubble stone was most likely obtained from stone cutting and finishing locations, excavations, and demolished structures.

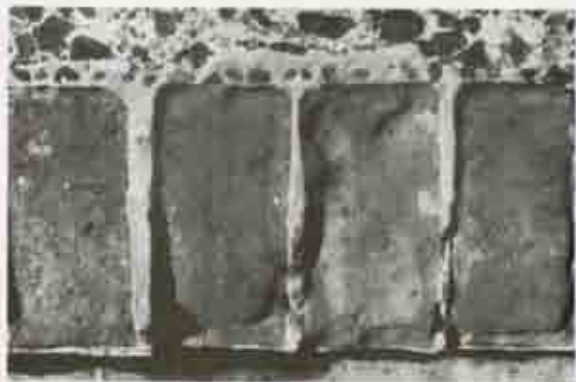
Figure 4. Northwest edge of ramp connecting the Plaza de Armas and Santa Barbara Battery. Brick galling is located between brick and concrete. Photo by J. Jacob, 1989.

Small gravel-sized chunks of brick are used in galleting.²⁷ The very edge of the ramp leading from the Plaza des Armas to Santa Barbara Battery is faced with paving brick. Imbedded in the strip of mortar running between the inside edge of these brick and the adjacent hormigón of the ramp are small brick chunks set 1 to 2 inches apart (fig. 4).

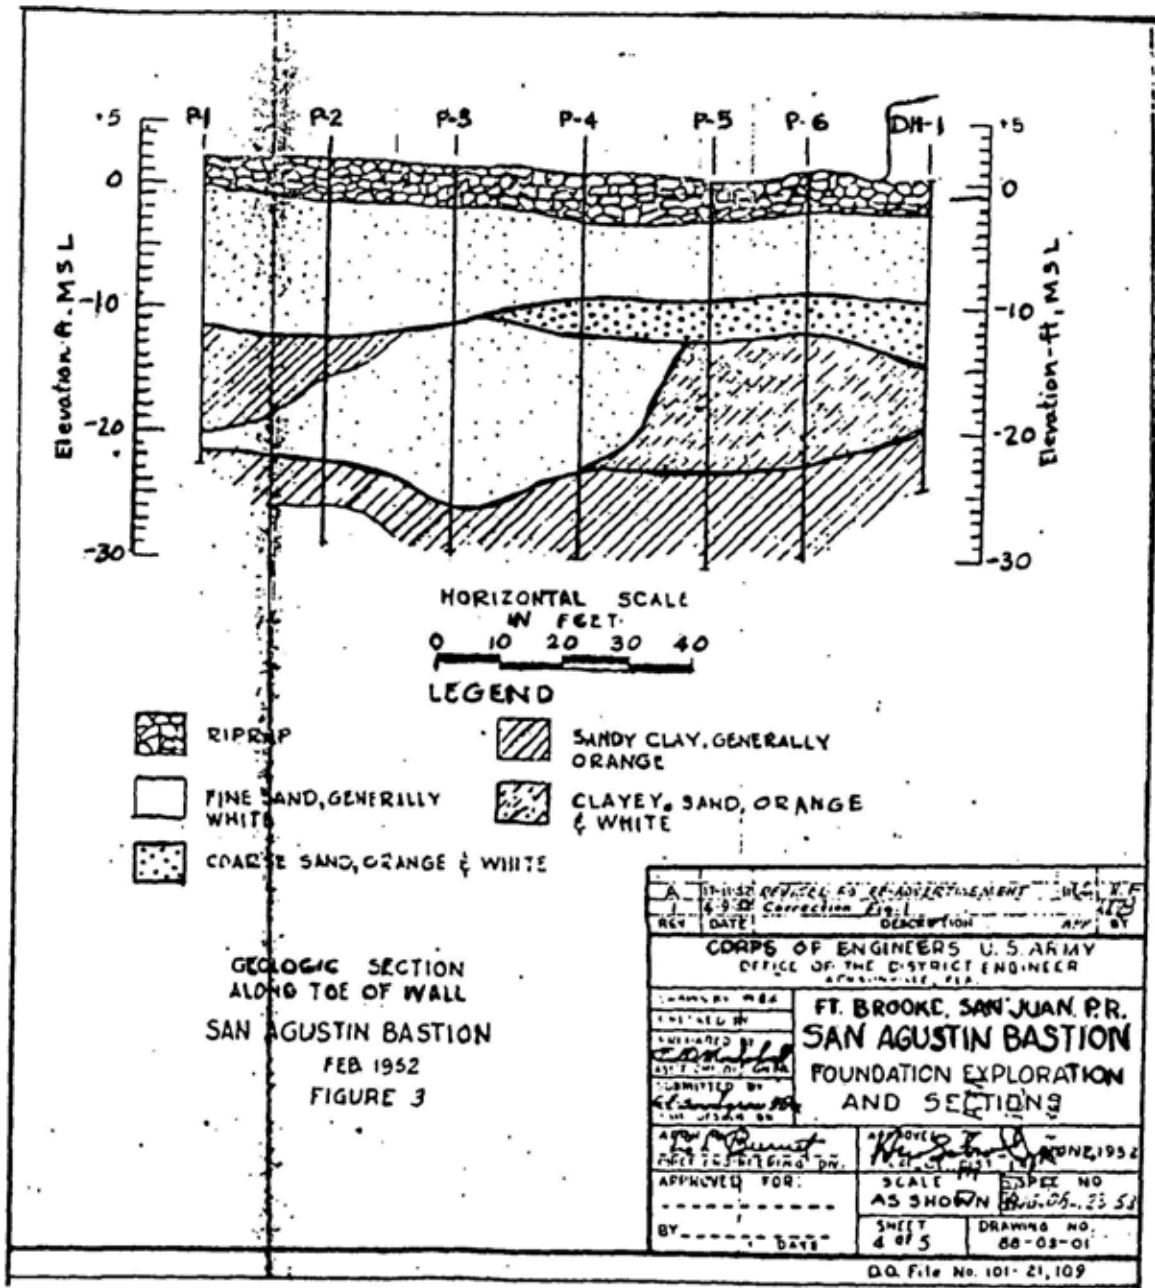
Figure 5. U.S. Army Corps of Engineers drawing, 1952. Wall section along toe of San Agustín Bastion. (San Juan NHS Archives.)

A U.S. Army drawing from 1952 shows a wall section along the toe of San Agustín Bastion depicting different layers of sand and soil (fig. 5). The layers are labeled: "fine sand, generally white"; "coarse sand, orange and white"; "sandy clay, generally orange"; and "clayey sand, orange and white." These descriptions are not unlike sands found in mortar samples collected on the site.

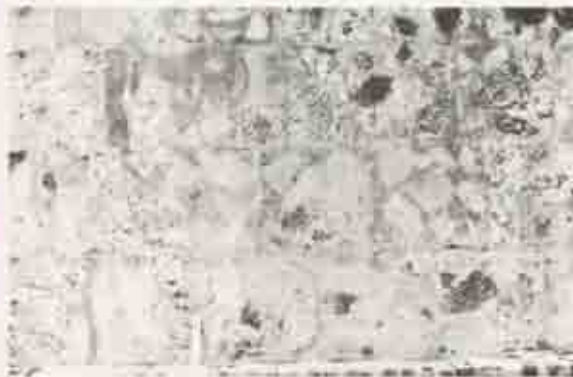
Figure 6. Cast composite stone of merlon on north wall of Santa Barbara Battery. Photo by J. Jacob, 1988.

Cast composite stone is found throughout the fortifications and was installed by the U.S. Army for patching and repair work in the late 1930s, and by the NPS from the 1960s through the 1980s (fig. 6). These "stones" (or blocks) are 12 inches square by 2 inches thick and were produced as follows: a long trough or box was constructed, measuring 12 x 12 inches by an indeterminate length. Pieces of stone were packed into this box and then filled with mortar. When the mortar had set, the

formwork was removed and the mass sawn into slabs (circular saw marks are visible on some of the slabs). The principal binding ingredient of the mortar appears to be lime, although there may be a small percentage of cement mixed in. Cast composite stones are set with cement or cement-lime mortars. All blocks are mounted into the walls in a square position except on a small retaining wall by San Agustín Bastion where they are mounted on the diagonal.

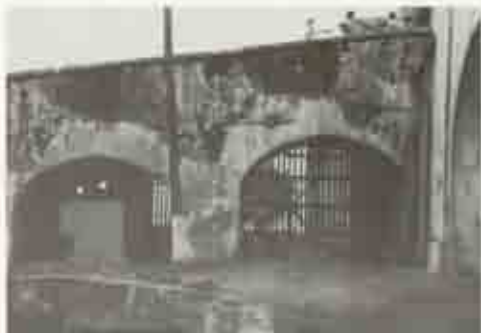
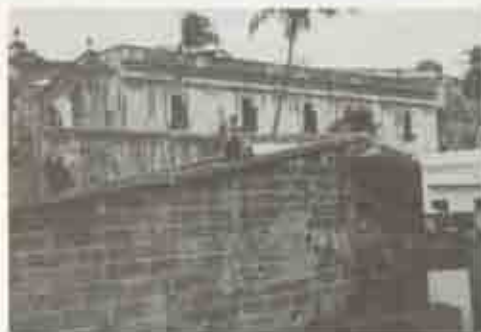
Figure 8. South face of ramp wall leading to the Main Gate of San Cristóbal. Photos by J. Berkowitz, 1987.

result of the yellow from the blocks streaking down the wall face.) A scribed line pencilled black outlines each faux block (fig. 7). Above the segmental arches of the ramp, faux voussoirs are depicted in a like manner (fig. 8).

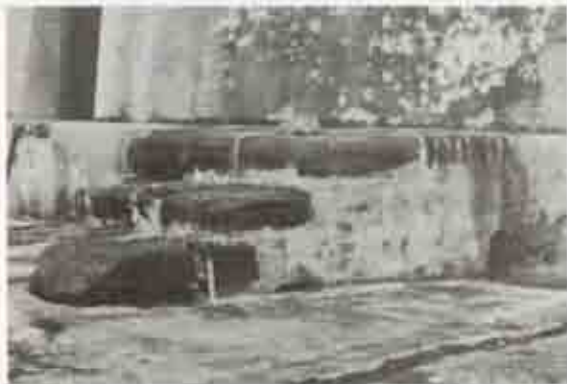
Figure 9. Banquette on top level of la Trinidad. Photo by J. Jacob, 1969.

All four levels of la Trinidad have a similar finish treatment with the top level of the battery exhibiting the most intact condition. The east scarped wall is entirely finished with a coursed ashlar pattern; on the north scarped wall, faux quoins embellish the east end. The exterior ends of merlons have faux quoins facing their embrasures; they are rough in texture while the faux joints are smooth with scribed lines pencilled black on either side. As on San Carlos, diagonal black lines bisect the outside corners of the faux joints. Banquettes are finished with faux quoins on their vertical surfaces; the horizontal surfaces are too deteriorated to determine an original appearance (fig. 9.) The three south walls have a coursed ashlar pattern covering both faces, similar to the exterior surfaces of the structure. The ramp of the lower level has a similar pattern on its south side.

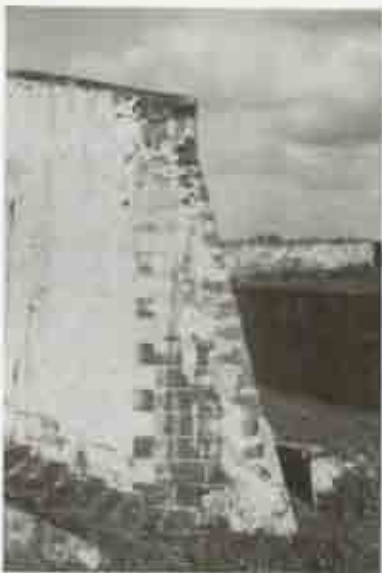
Figure 10. South salient angle of el Ahanico. Photo by J. Jacob, 1969.

Faux quoins are located on the north and south salient angles of el Abanico (fig. 10). These are yellow in color and have a rough surface texture. Faux joints are painted black.
