THE FORTIFICATIONS OF SAN JUAN NATIONAL HISTORIC SITE

HISTORIC STRUCTURE REPORT

Castillo de San Felipe del Morro

Building Conservation Branch
Cultural Resources Center
North Atlantic Region
National Park Service
and the
Center for Preservation Research
Columbia University

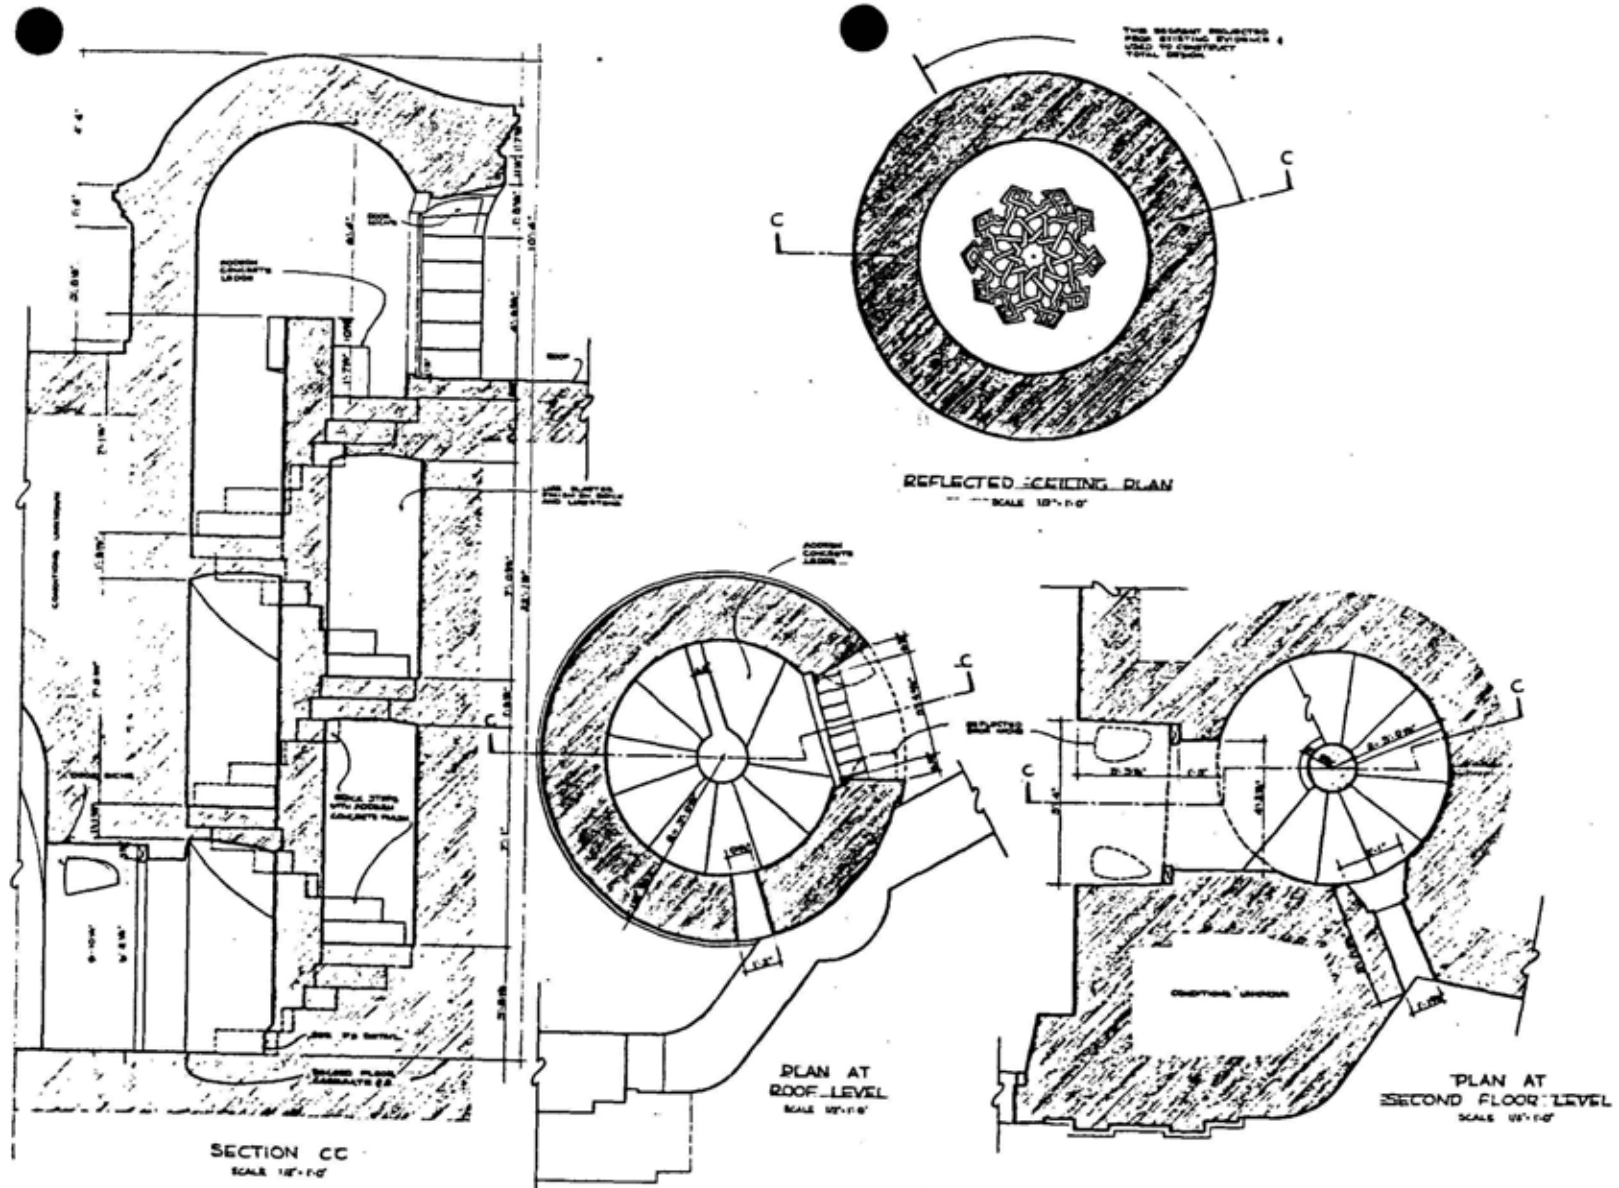
Figure 13. El Caballero, detail of spiral stairs. Drawing by HABS, 1962.

On the interior side of the dome of the stair tower at San Cristóbal are the remains of a decorative finish scheme. A geometric design is outlined in scribed lines pencilled black. A hypothetical view of the dome and its finish as it appeared in the nineteenth century is illustrated in a HABS drawing (fig. 13).

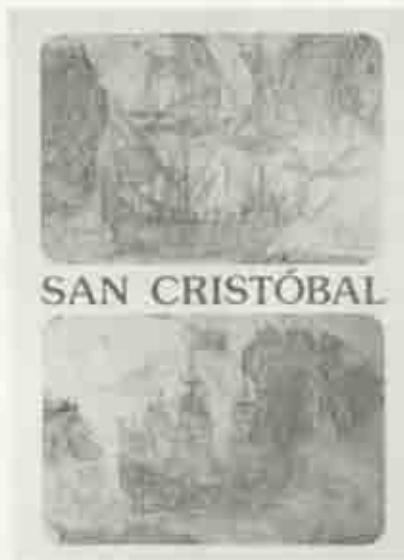
Figure 14. Drawings of ships found in the "dungeon" at San Cristóbal. Date unknown. (Postcard, San Juan HNS.)

Sailing ships are a common image on the walls of the fortifications. Those documented by HABS are carefully executed in black and found in the tower at el Morro and the dungeon at San Cristóbal (fig. 14). Black ships are also found in Tunnel 6 and on a merlon (facing the embrasure) on Santo Domingo Bastion. Other black line drawings are found in el Morro. In addition to the drawing of the ship in the tower is the remains of a drawing of a pediment. A drawing of a serpent is on the wall in the circular stair.

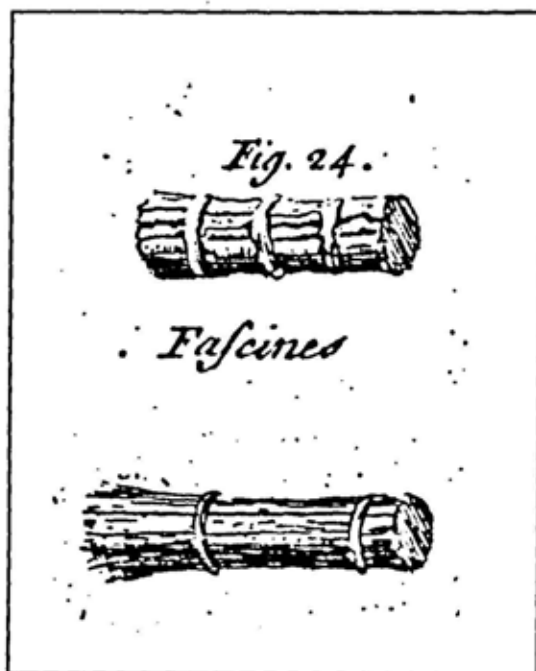
Figure 16. Fascines. Illustrated in E. Chambers, Cyclopedia of Arts and Sciences, 1752.

In E. Chambers Cyclopedia of Arts and Sciences (London, 1752), an illustration of fascines is given.⁸⁴ Two bundles of sticks are depicted: one with both ends cut off evenly, one with one end cut off evenly and the other left uncut with its tapered ends protruding (fig. 16). George Ripley and Charles A. Dana also mention fascines in The American Cyclopaedia (1874): "The interior slope [of a ditch in temporary works] is revetted by sods, or some material hastily gathered for the purpose, as logs, boards, fascines, gabions, &c."⁸⁵ Although the exact configurations of fagina described in the Spanish definitions are unclear, the illustration provided by Chambers appears to be a close match. It may be that fagina were used for facing earthworks, both to prevent (or retard) erosion from weathering and enemy access.

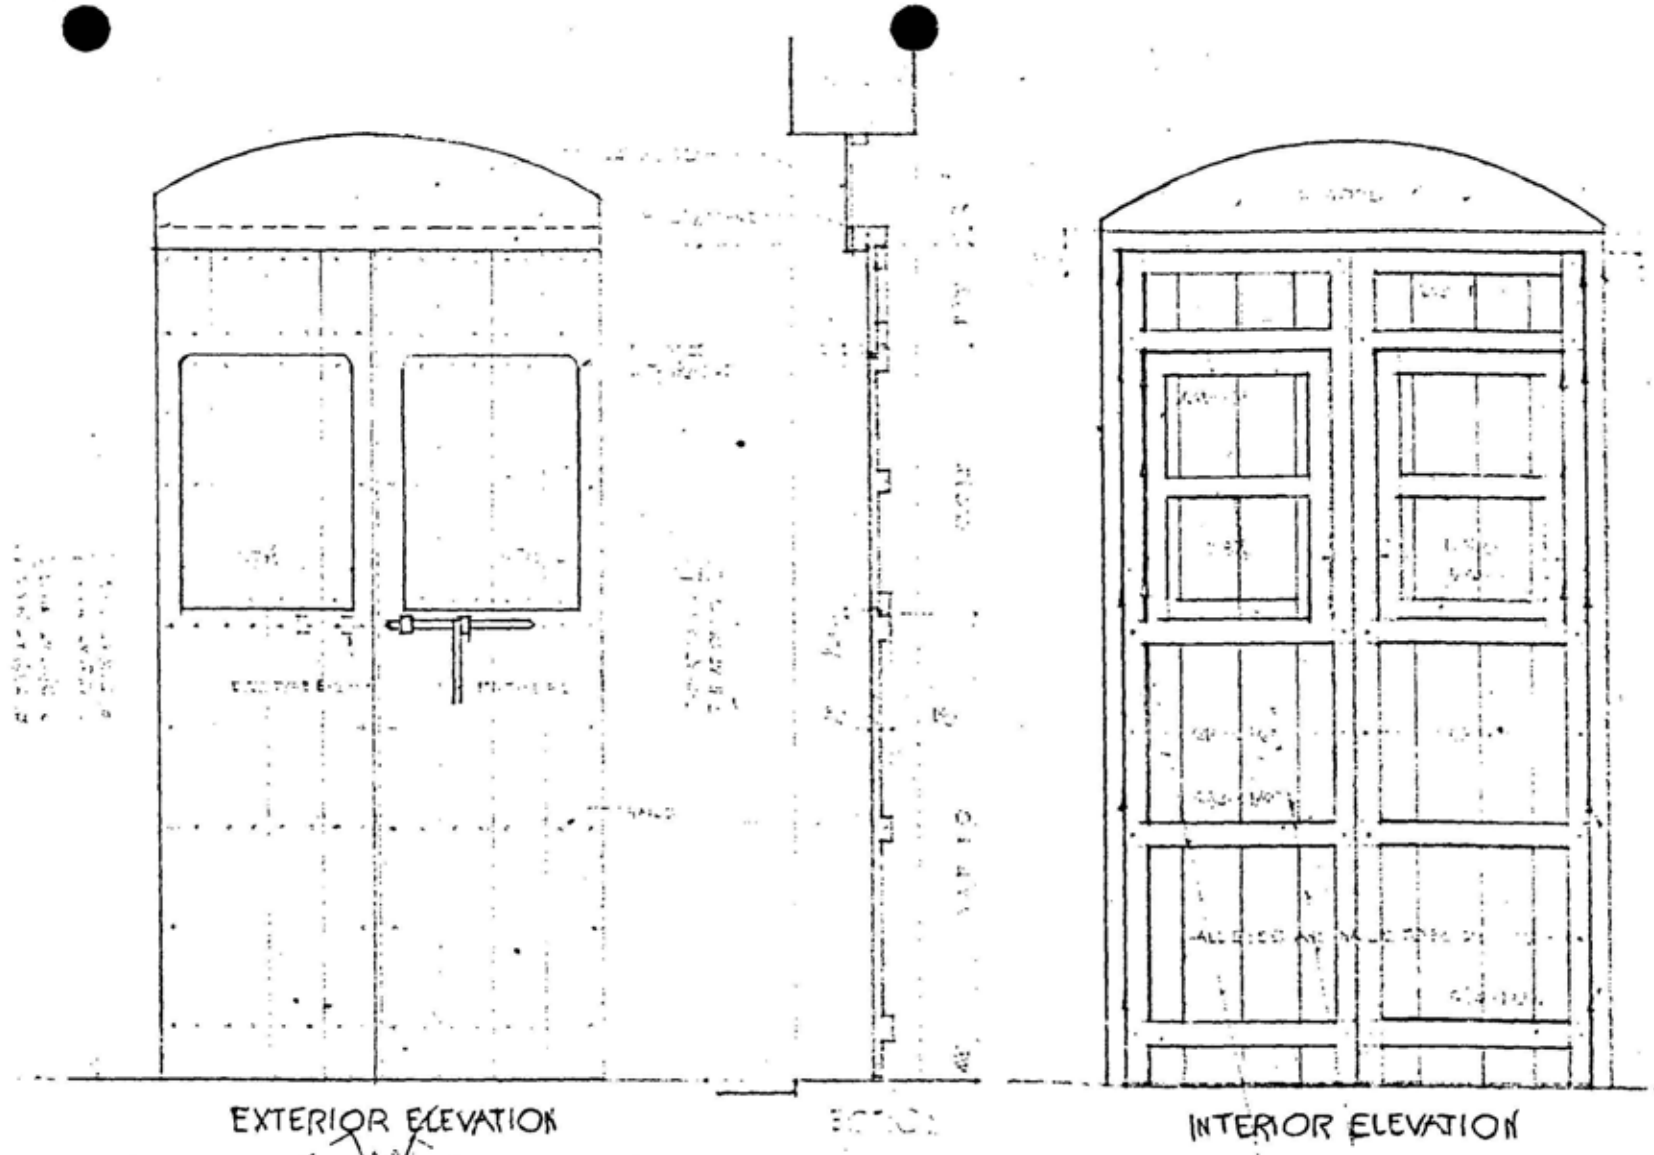
Figure 17a. Door type "A", San Cristóbal. (Dept. of Interior, Division of Design and Construction. Drawing no. NHS: SJ/3062, 1962.)

In the early 1960s, HABS documented extant doors, gates and shutters in the fortifications (figs. 17-22 and 28); some of these may date to the late-eighteenth century, others to the early-twentieth century. It is presumed that an attempt was made to replicate these accurately (from what was either being replaced or what was extant), and that the HABS illustrations can be considered to portray doors, gates and shutters as they appeared in the late-eighteenth century.

Doors are typically of vertical planks braced on the back (interior side) by both vertical and horizontal members. Doors to casemates are double, hinged on either side with both sides opening to the exterior. Some doors have a small opening in the top third; this opening has a hinged cover opening to the interior with a grille on the exterior side.

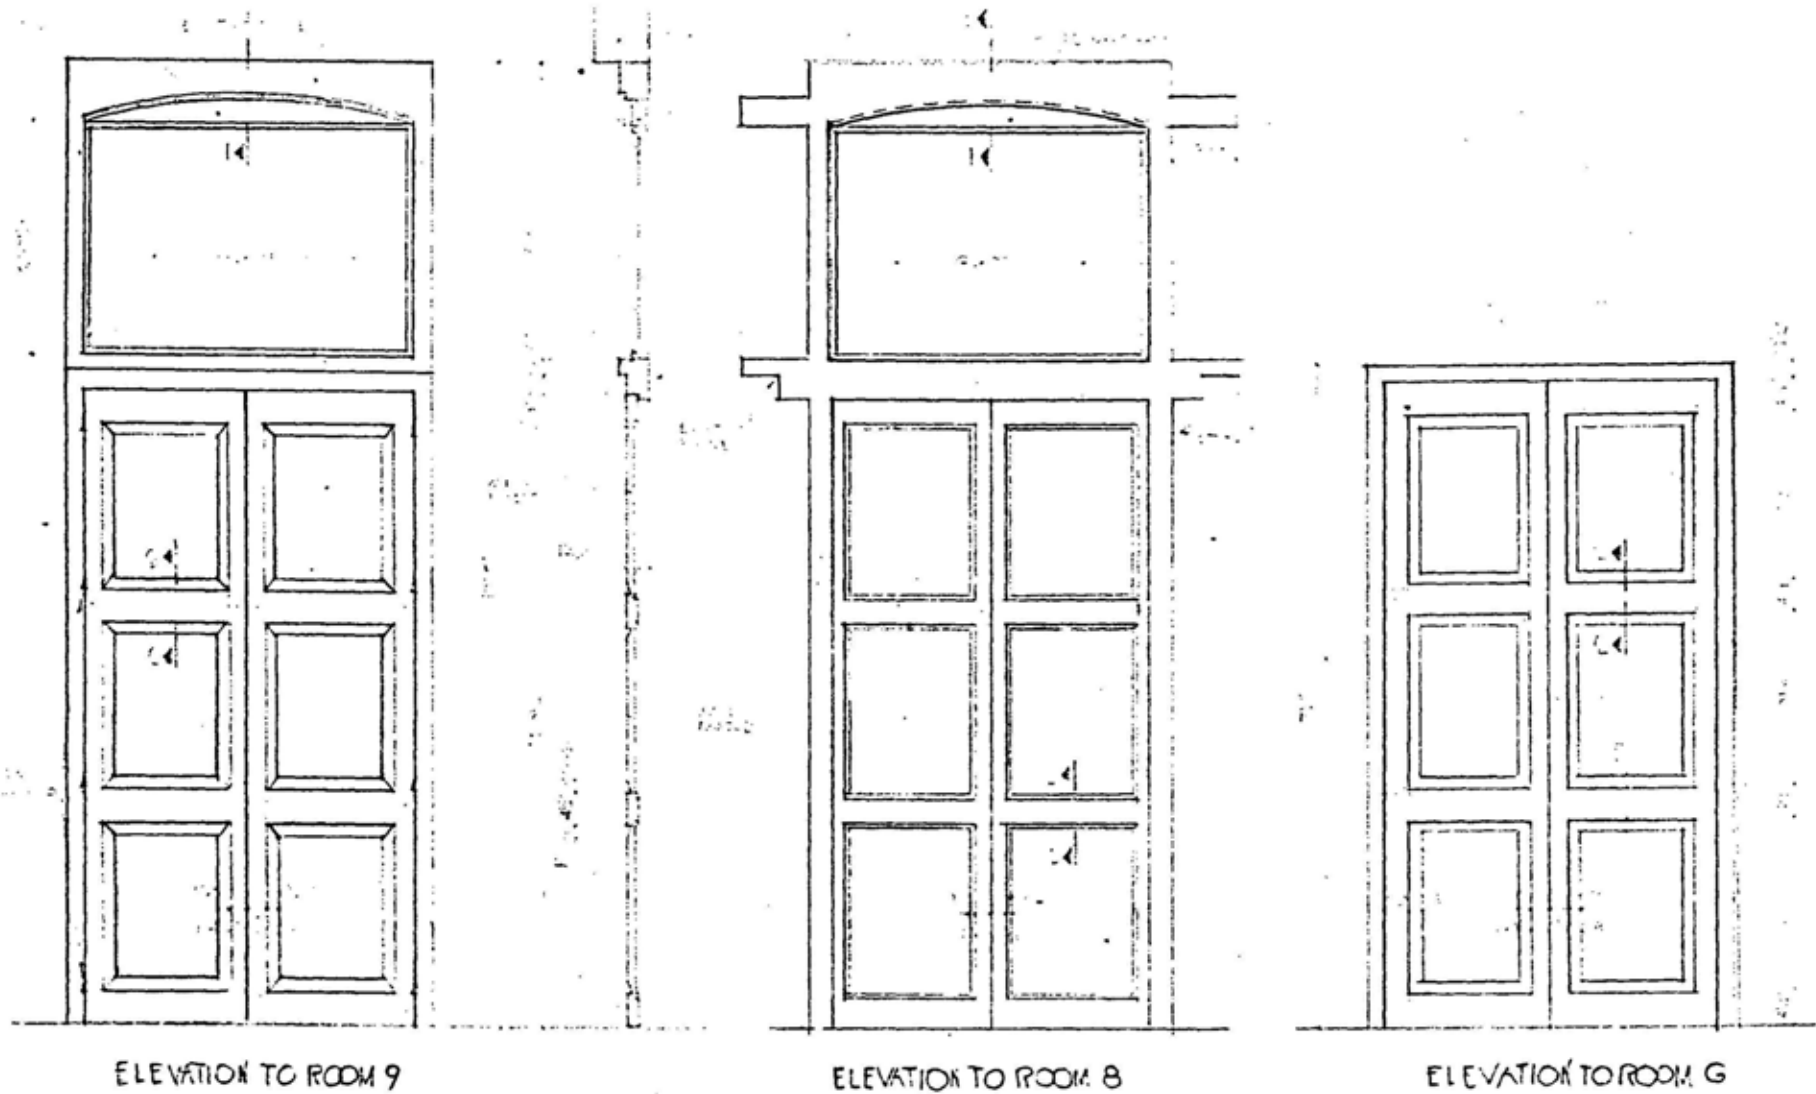
Figure 17b. Door type "D", San Cristóbal. (Dept. of Interior, Division of Design and Construction. Drawing no. NHS: SJ/3062, 1962.)

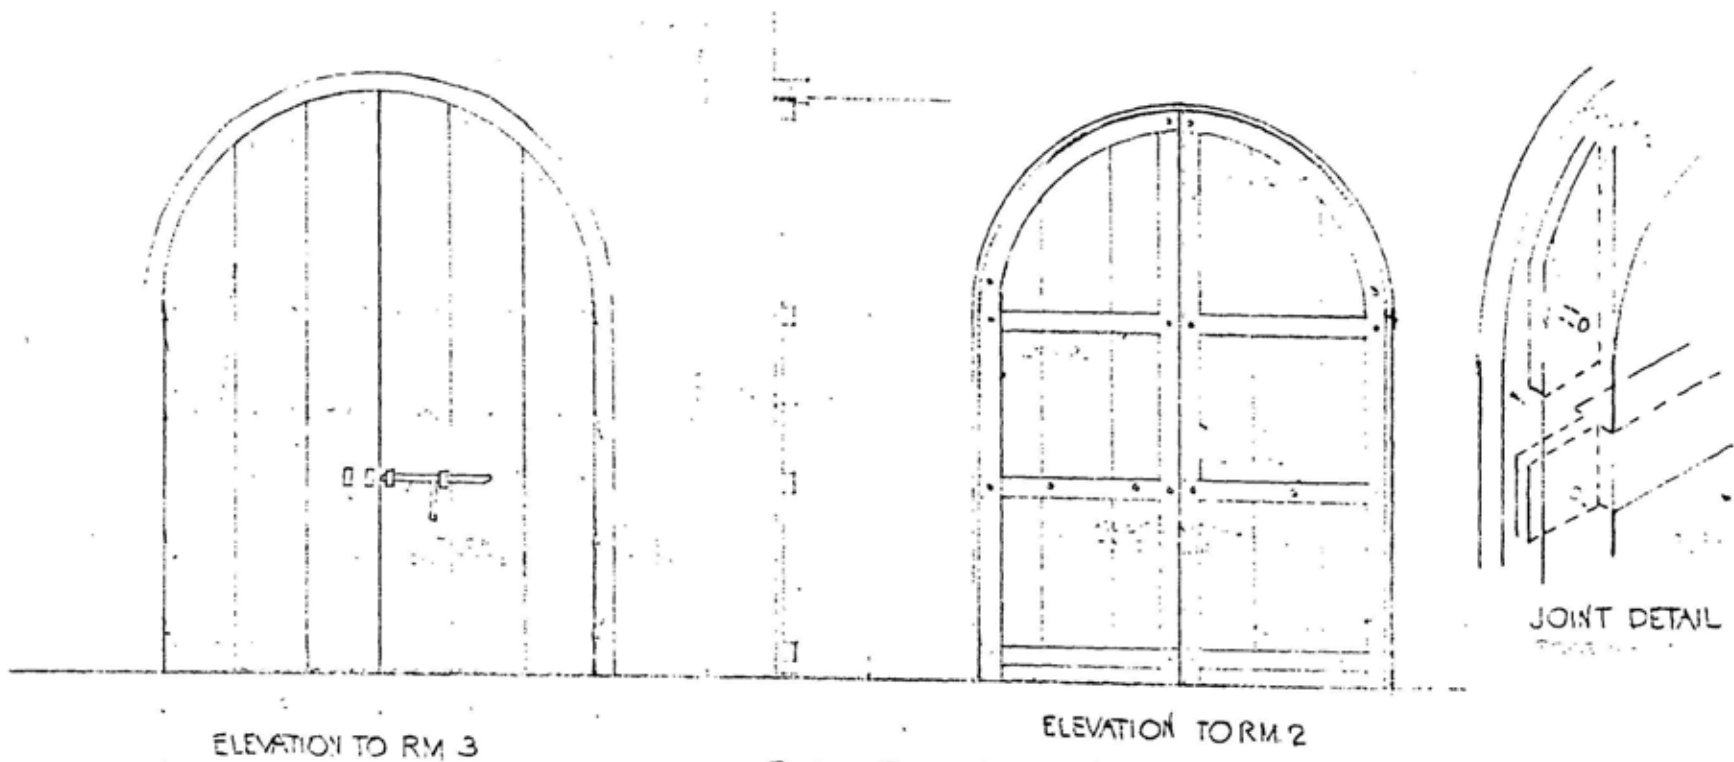
Figure 17c. Door type "E", San Cristóbal. (Dept. of Interior, Division of Design and Construction. Drawing no. NHS:SJ/3062, 1962.)

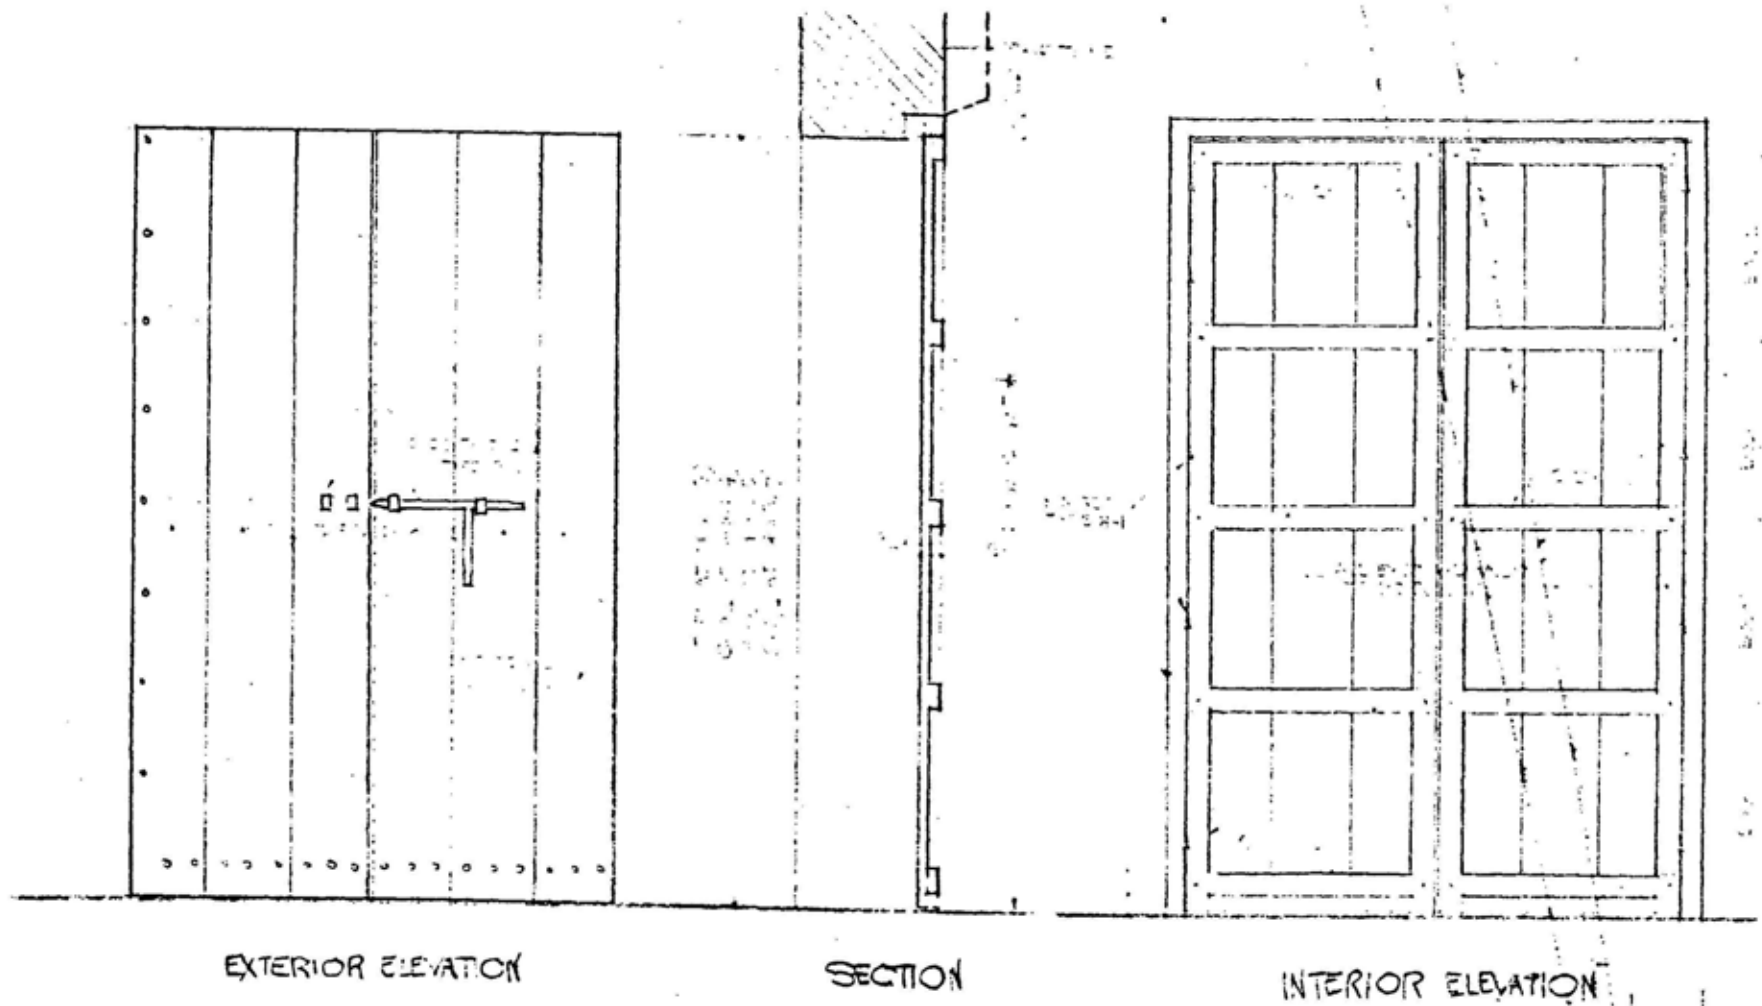
Figure 17d. Door type "F", San Cristóbal. (Dept. of Interior, Division of Design and Construction. Drawing no. NHS:SJ/3062, 1962.)

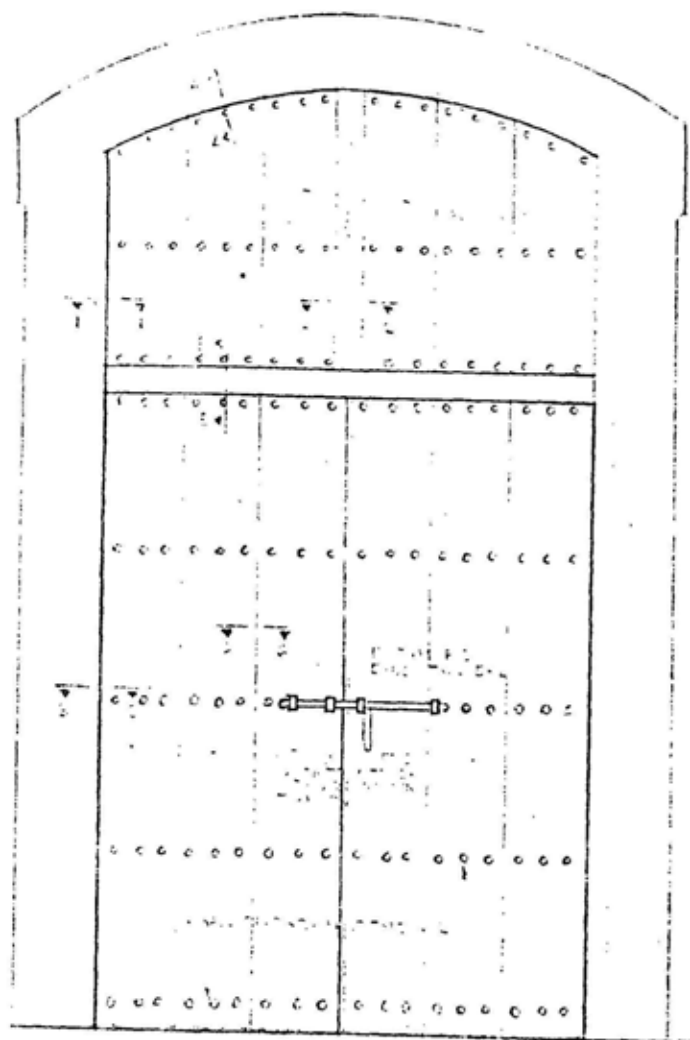
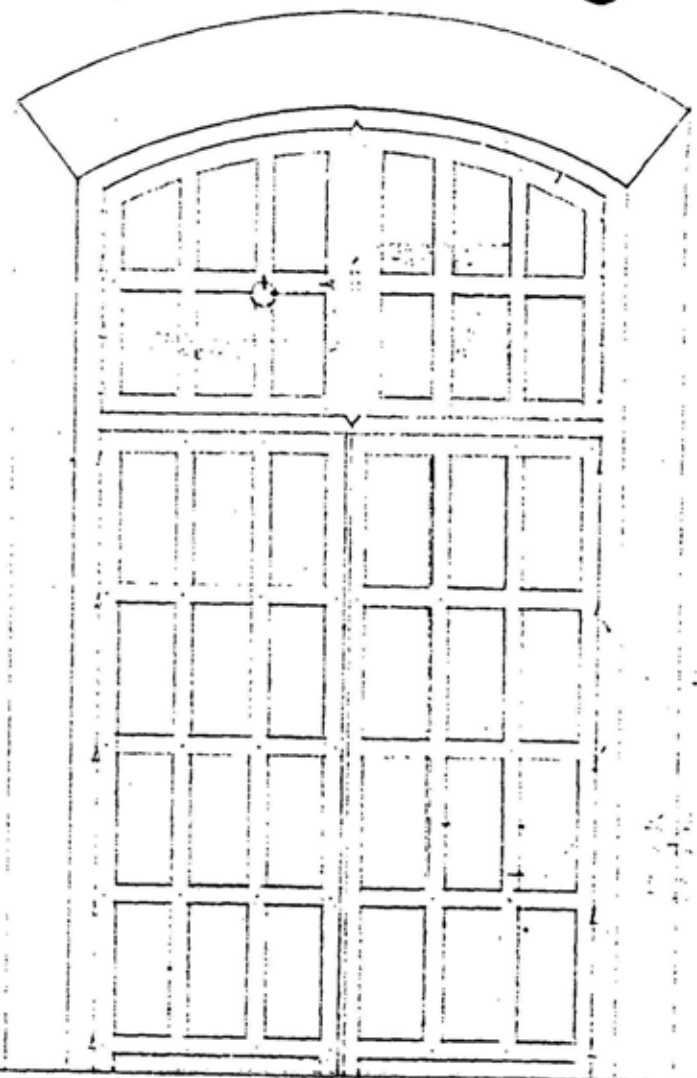
Figure 18a. Door type "A", San Cristóbal. (Dept. of Interior, Division of Design and Construction. Drawing no. NHS:8J/3062, 1962.)

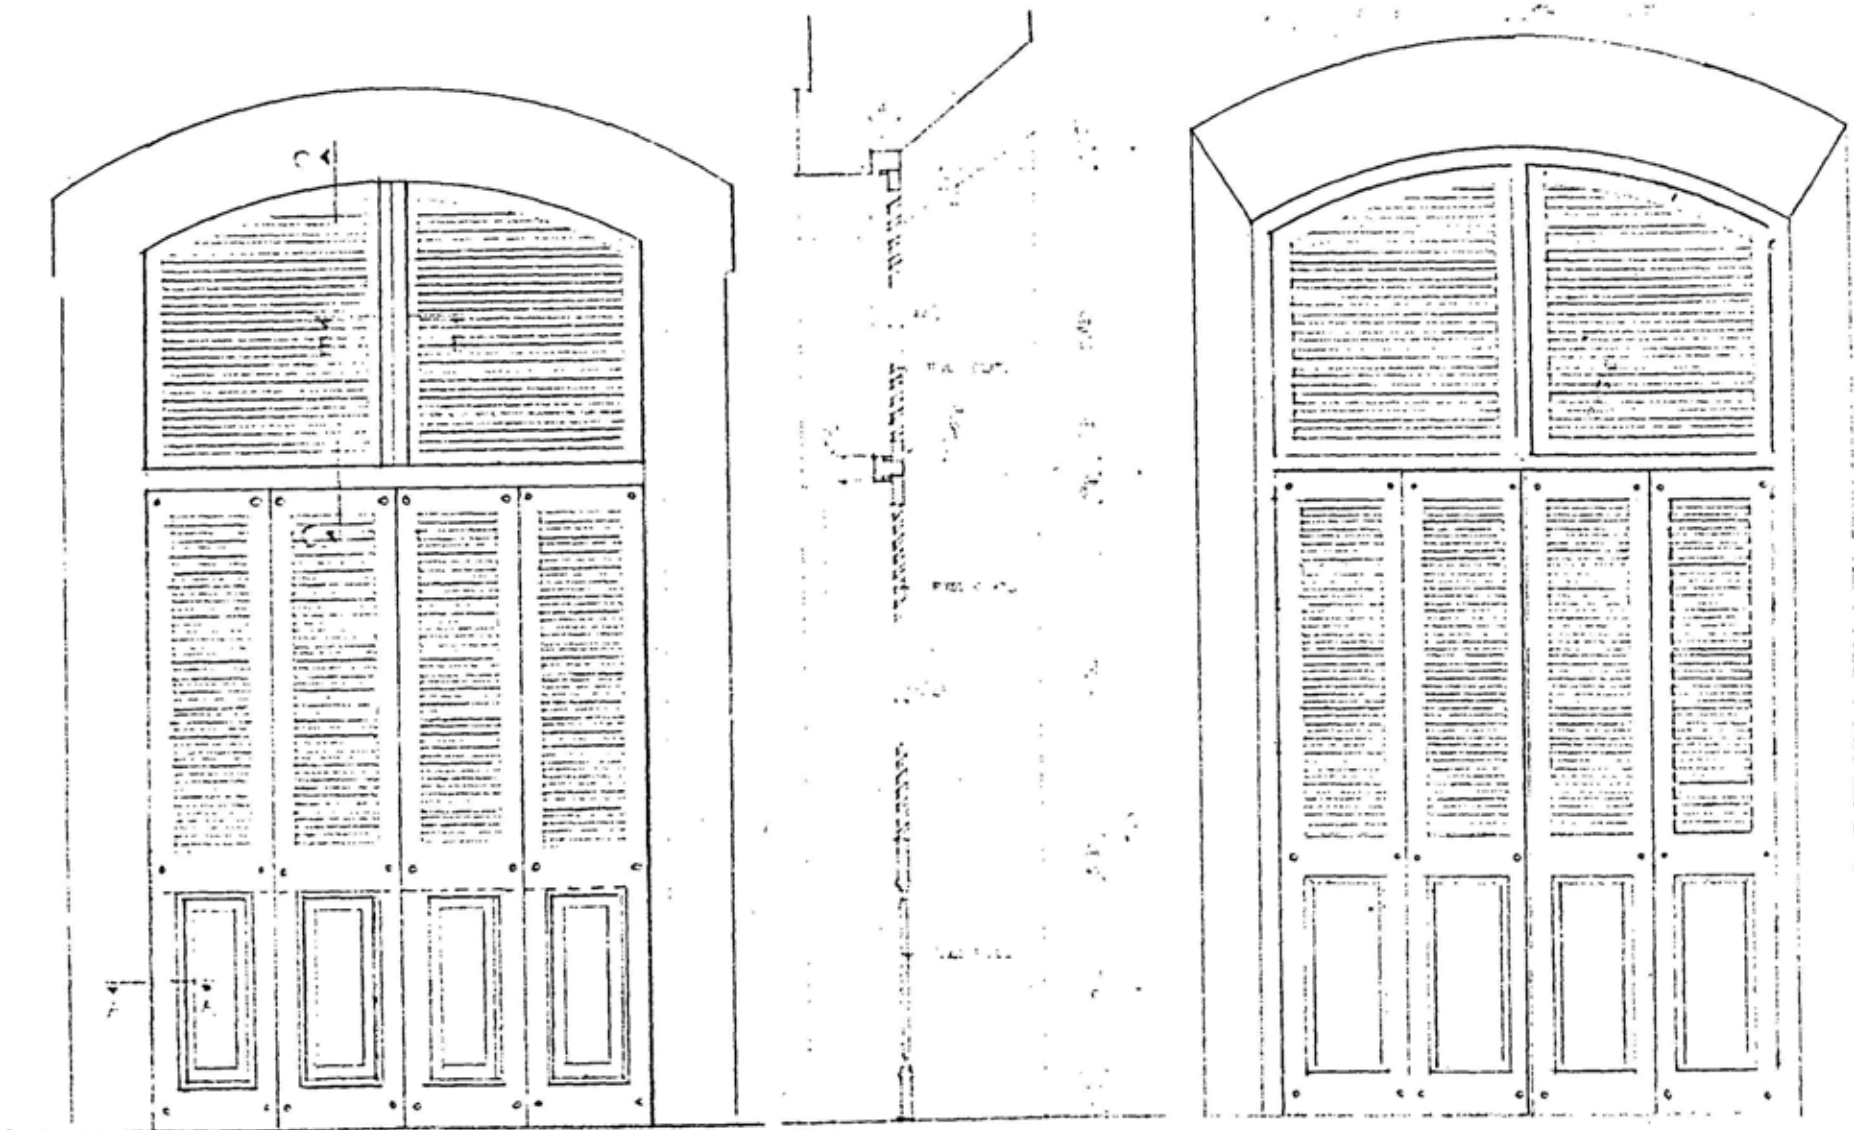
Figure 18b. Door type "B", San Cristóbal. (Dept. of Interior, Division of Design and Construction. Drawing no. NHS:SJ/3062, 1962.)

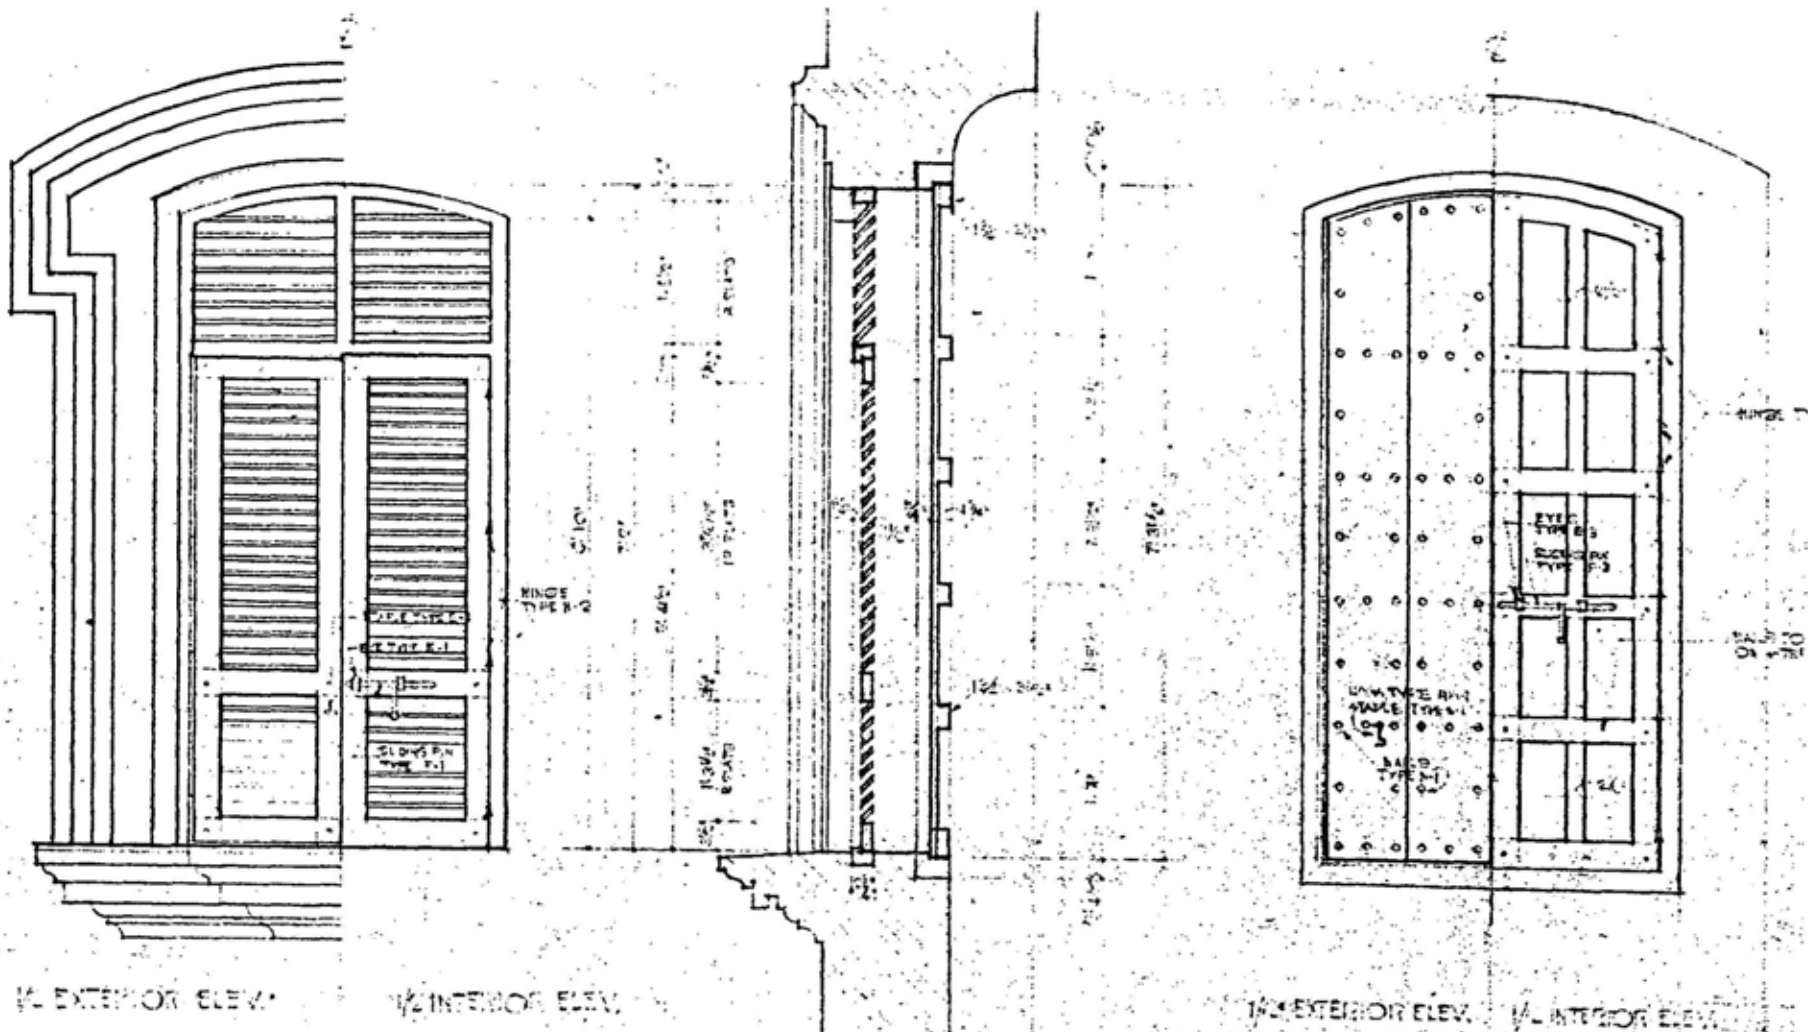
Figure 19. Shutter types, San Cristóbal. (Dept. of Interior, Division of Design and Construction. Drawing no. NHS:8J/3062, 1962.)

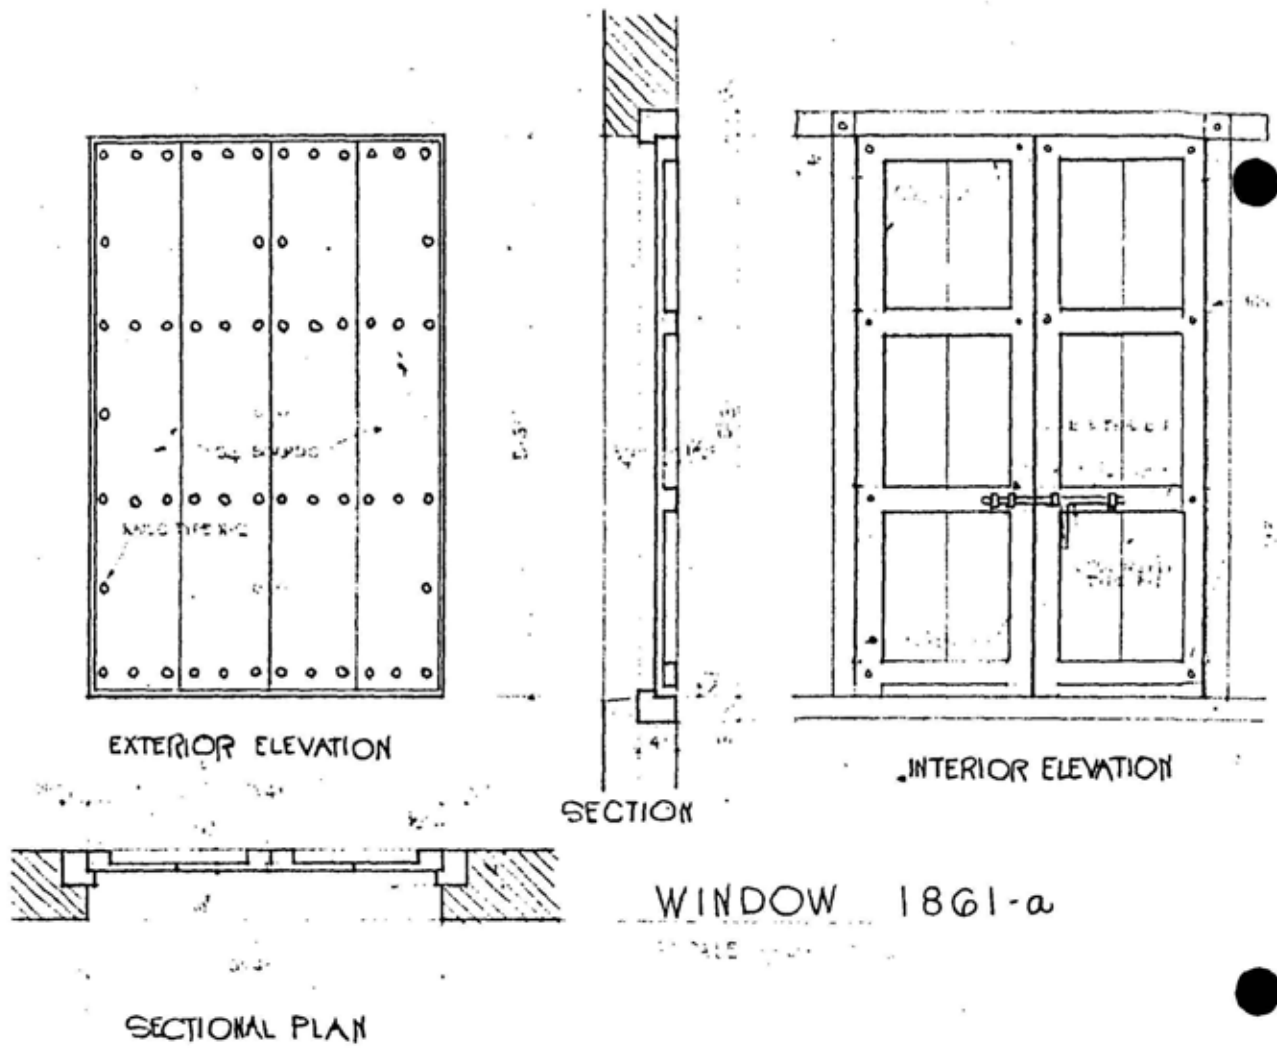
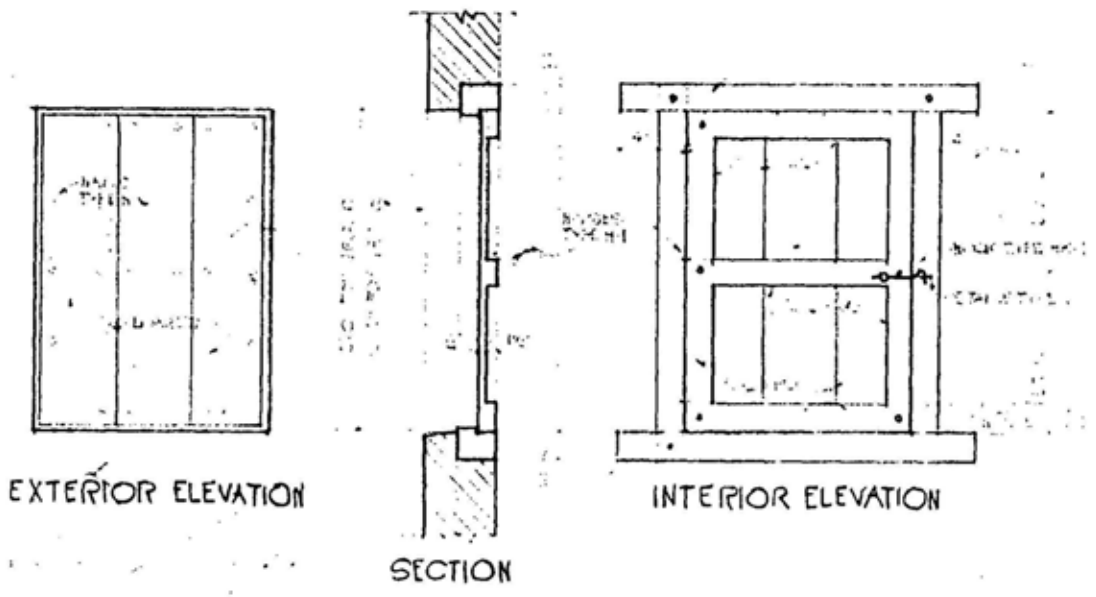
WINDOW 1861-a

Figure 20a. Shutter types, San Cristóbal. (Dept. of Interior, Division of Design and Construction. Drawing no. NBS:SJ/3062, 1962.)

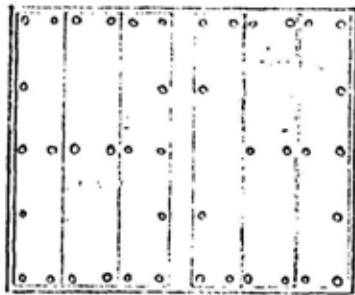
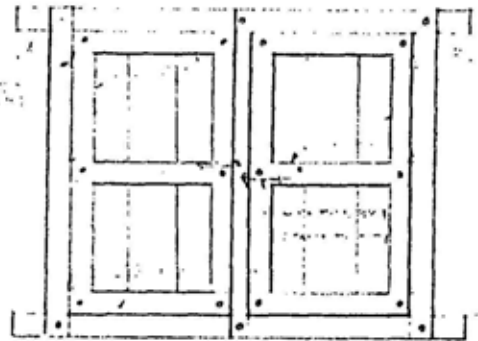
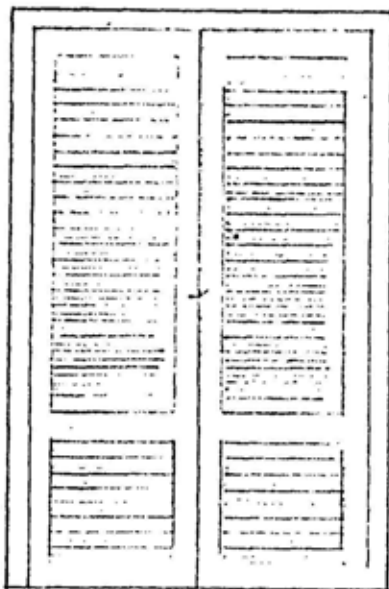
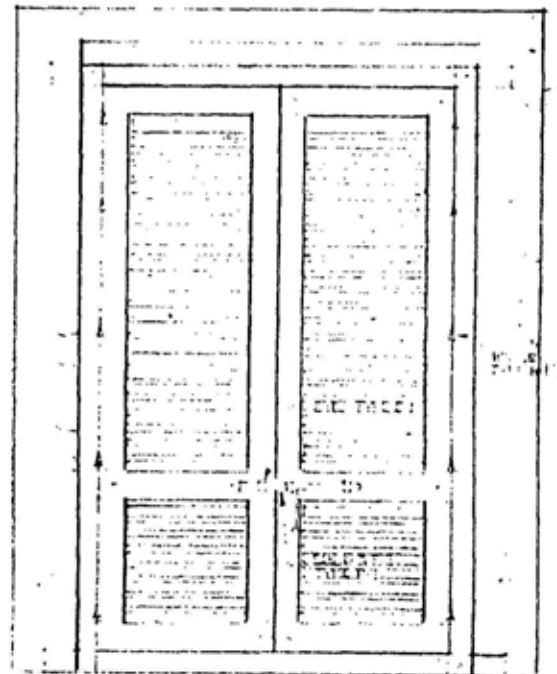
WINDOW 18G1 b

Figure 20b. Shutter types, San Cristóbal. (Dept. of Interior, Division of Design and Construction. Drawing no. NHS:SJ/3062, 1962.)

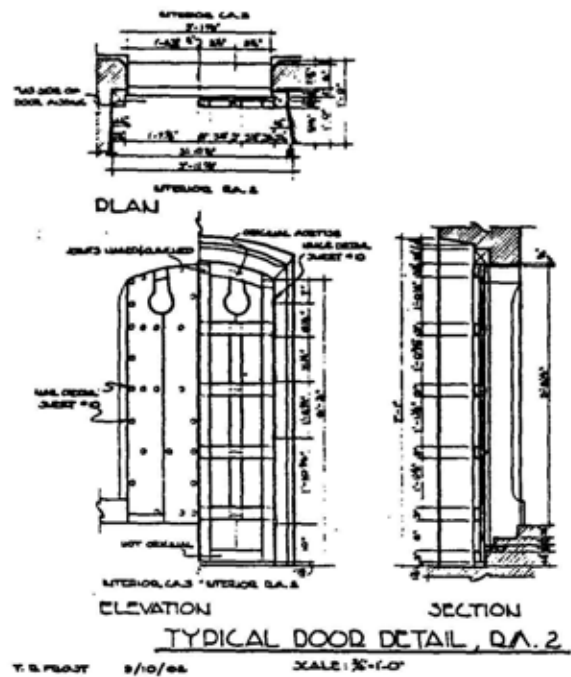
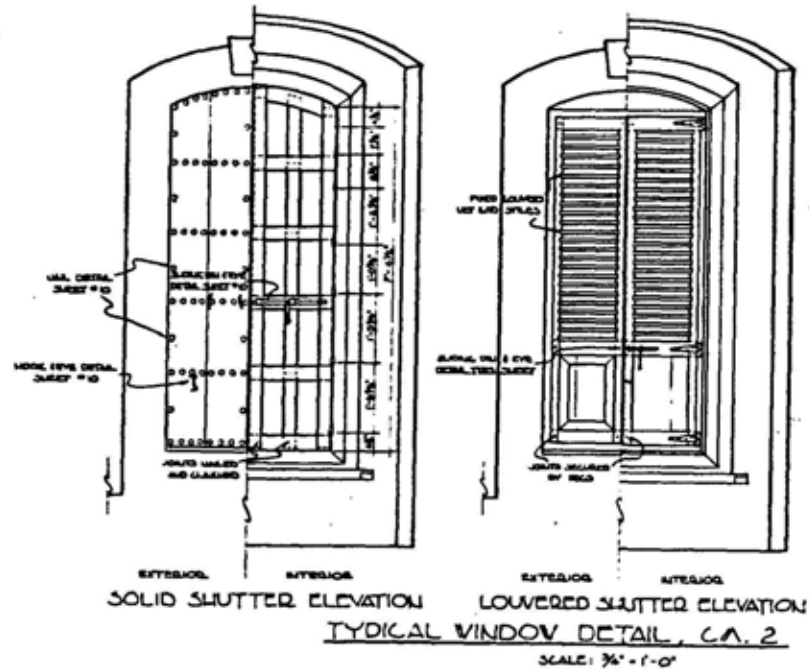
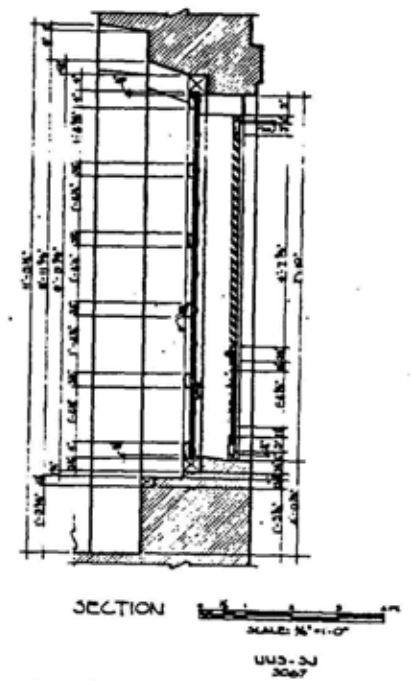
Figure 21. Door and shutter types, San Cristóbal. (Drawing by HABS, 1962.)

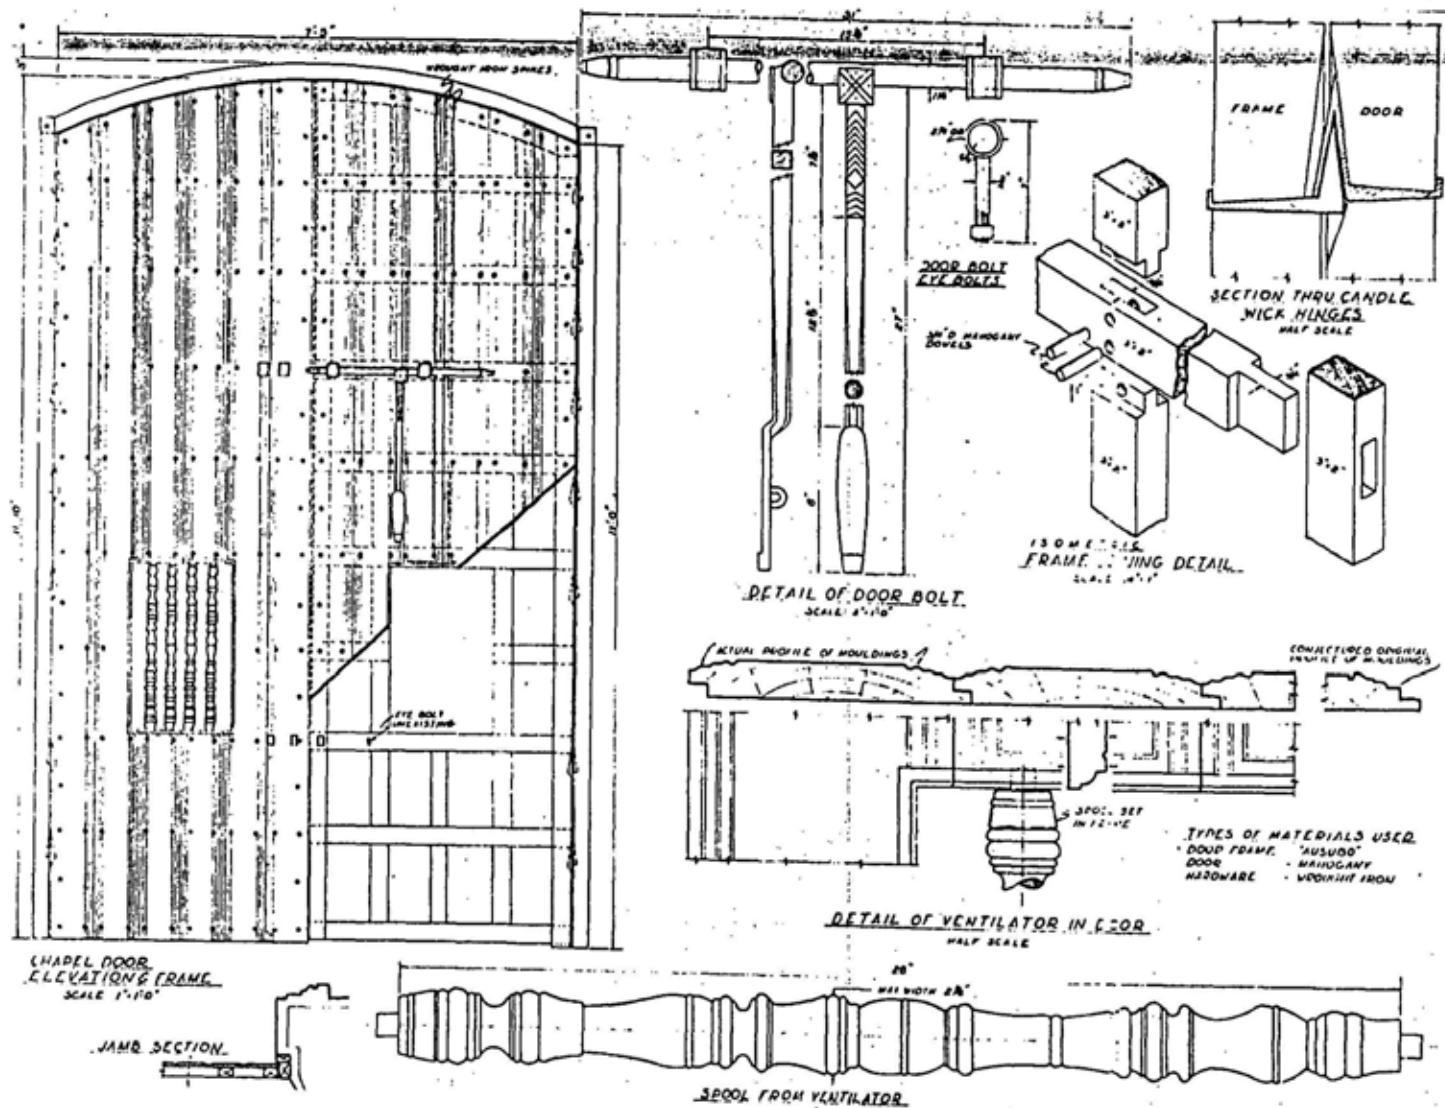
Figure 22. Chapel door and details in el Morro. (Drawing by HABS, 1955.)

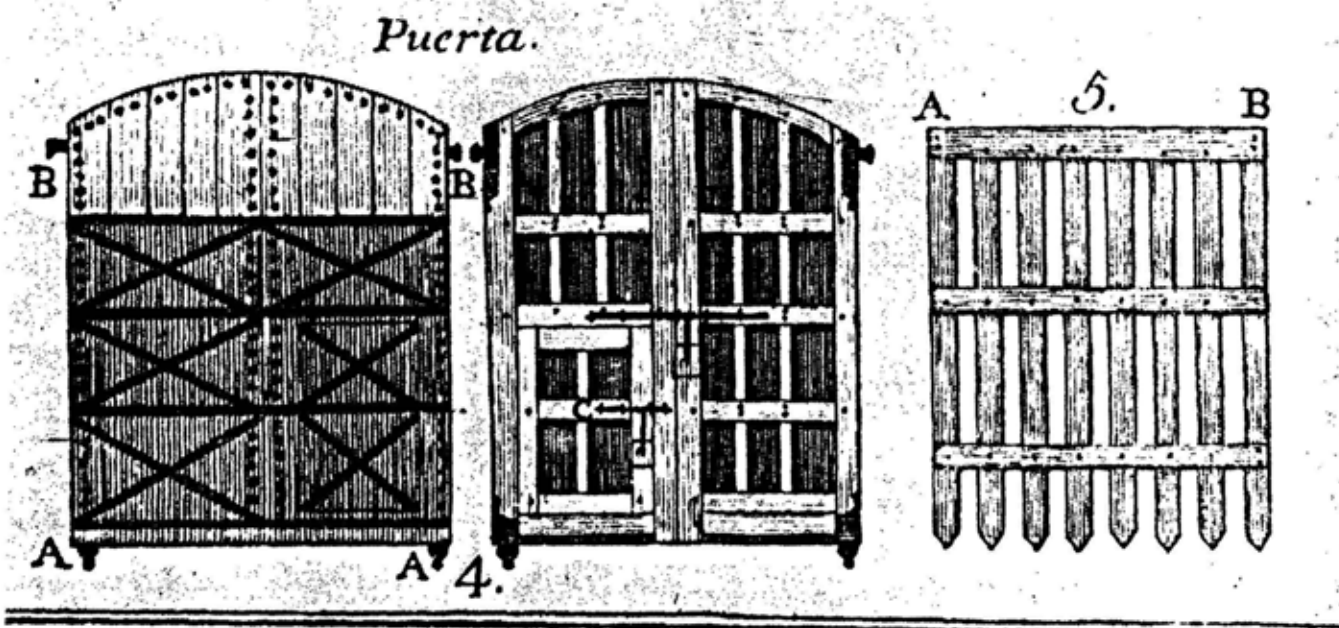
Figure 23. A harrow gate is illustrated on the right. The gates currently found at the fortifications are similar to that illustrated in the center. (From Richard Torres-Reyes "San Cristóbal Gates," 1964.)

The main gates of el Morro and San Cristóbal, and those at el Morro's chapel, the Troops' Quarters, and the San Juan Gate are constructed of vertical boards braced on the back by horizontal and vertical members. Wickets (a small hinged door in the lower part of a larger door) were placed in these gates to enable easy pedestrian access (fig. 23).

The harrow gates referred to in 1770-1771 are described by Torres-Reyes as "made of timbers whose dimensions were commonly 6 by 4 inches, and 6 inches distant from each other, well fastened to three or four crossed bars, and secured with iron."⁹⁵ A harrow gate is illustrated in a late-eighteenth-century document (fig. 23) and appears just outside of the Main Gate of San Cristóbal in Castro's drawing. This type of gate is no longer extant in the fortifications.
