THE FORTIFICATIONS OF SAN JUAN NATIONAL HISTORIC SITE

HISTORIC STRUCTURE REPORT

Castillo de San Felipe del Morro

Building Conservation Branch
Cultural Resources Center
North Atlantic Region
National Park Service
and the
Center for Preservation Research
Columbia University

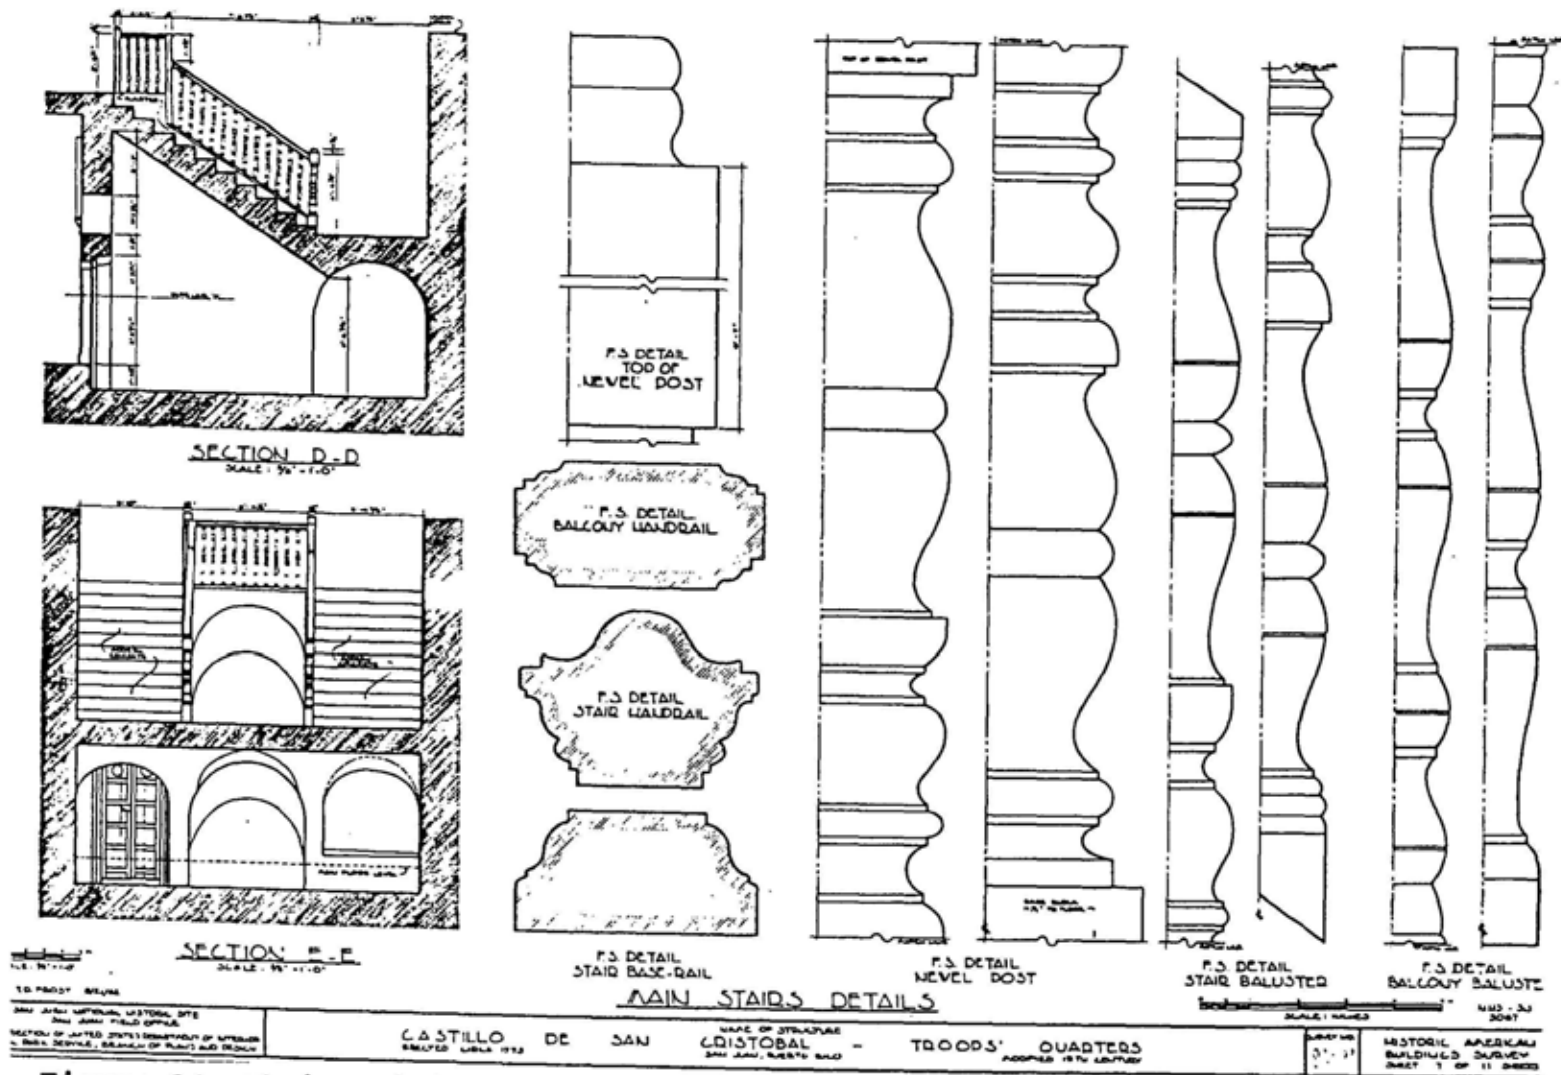
Figure 24. Stair railing details from the Troops' Quarters, San Cristóbal. (Drawing by HABS, 1962.)

The balustrade of the main stairway in the Troops' Quarters is presumed to be original to the building's construction in 1771. The newel posts and balusters are turned. There are two types of balusters: one on the stair and one on the balcony; the balcony and stair handrail have different profiles as well (fig. 24). The balustrade is now painted a dark green.

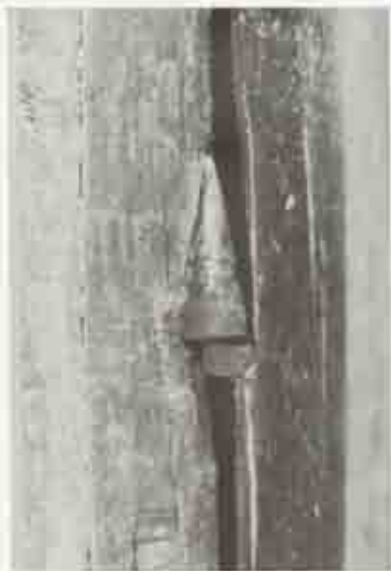
Figure 19. Capachico hinge from shutter on Troops' Quarters, San Cristóbal. Photo by J. Jacob, 1987.

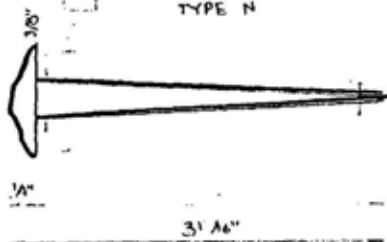
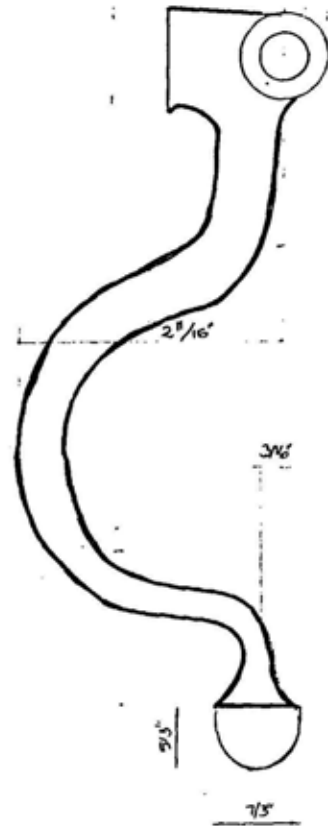
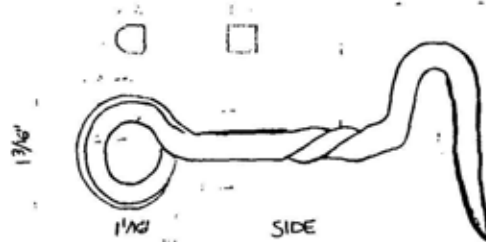
Figure 26a. Hardware details from the Troops' Quarters, San Cristóbal. (Dept. of Interior, Division of Design and Construction. Drawing no. NHS: SJ/3062.)

Many metal elements are twentieth-century replacements, both reproduction and new design. It is not known how closely the designs for the replacement elements followed the originals. HABS drawings from the 1950s and 1960s illustrate hardware that was to be reproduced: all fasteners, sliding bolt latches, and small grilles (figs. 21, 22 and 26). Many elements that were originally iron were refabricated in bronze to prevent rapid corrosion. There are two basic sizes of grilles. Small grilles cover the small openings in doors and large grilles function as gates to tunnels or casemates. They all appear to date to this century. Numerous iron fasteners are situated on tops of merlons, parapets, and on walls. The dates of their installation are not known, nor were their functions researched for this report.

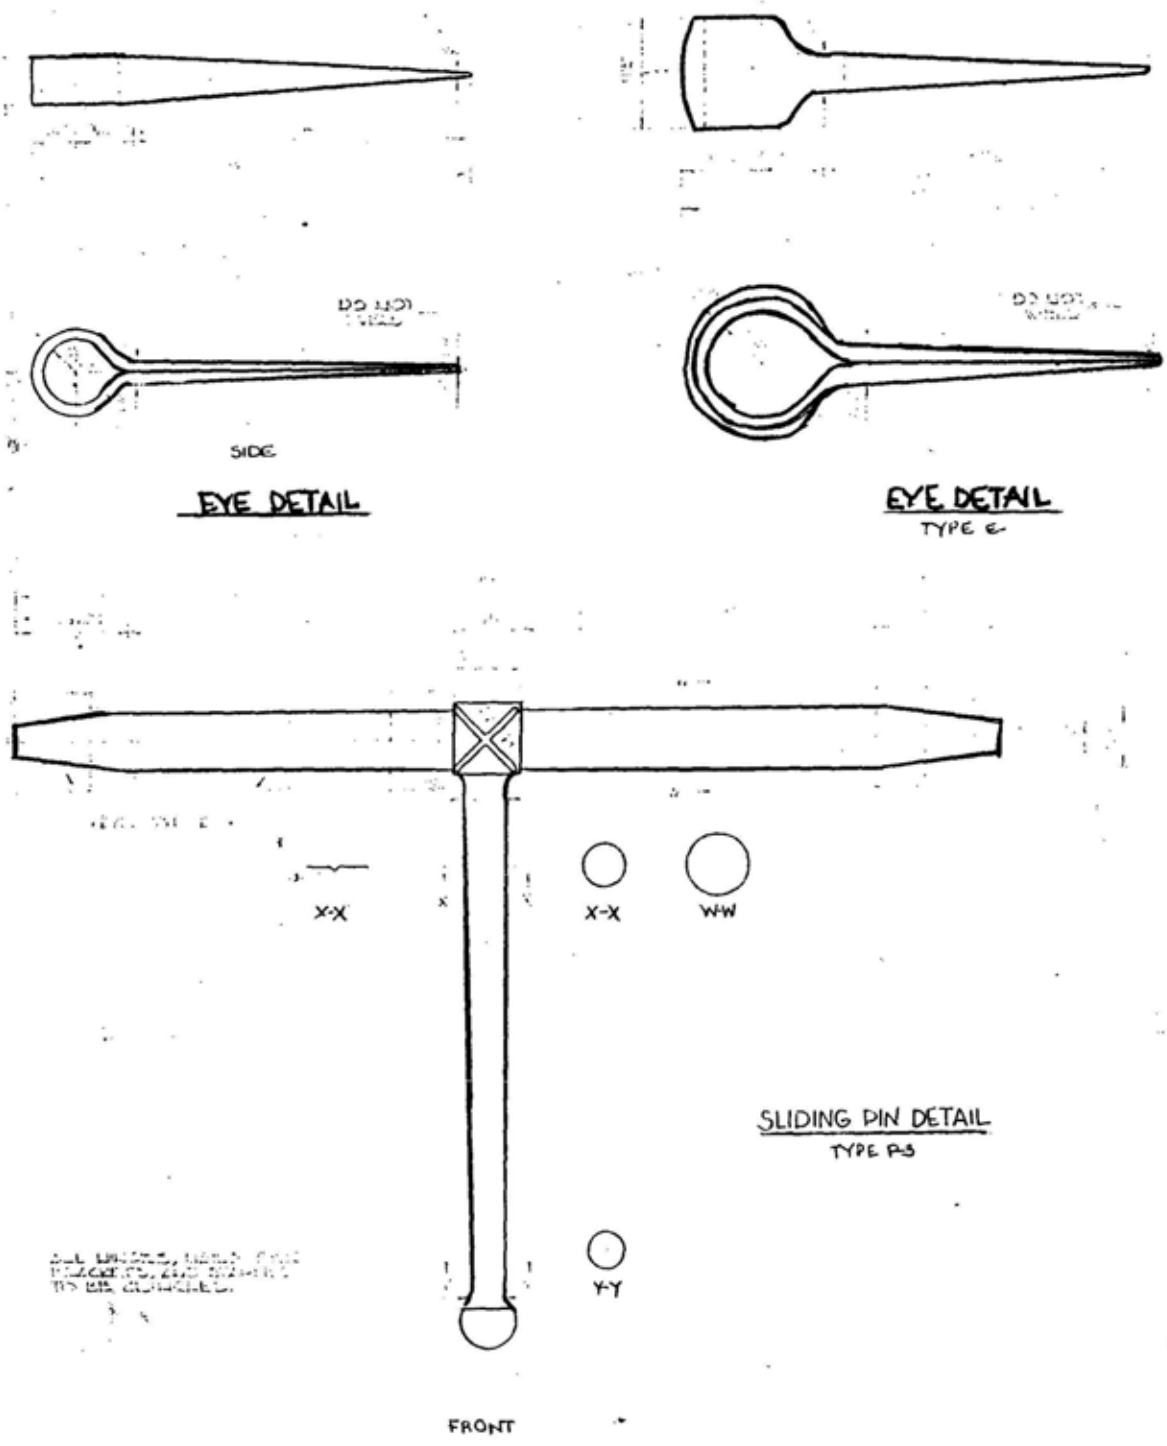
Figure 26b. Hardware details from the Troops' Quarters, San Cristóbal. (Dept. of Interior, Division of Design and Construction. Drawing no. NHS:SJ/3062, 1962.)

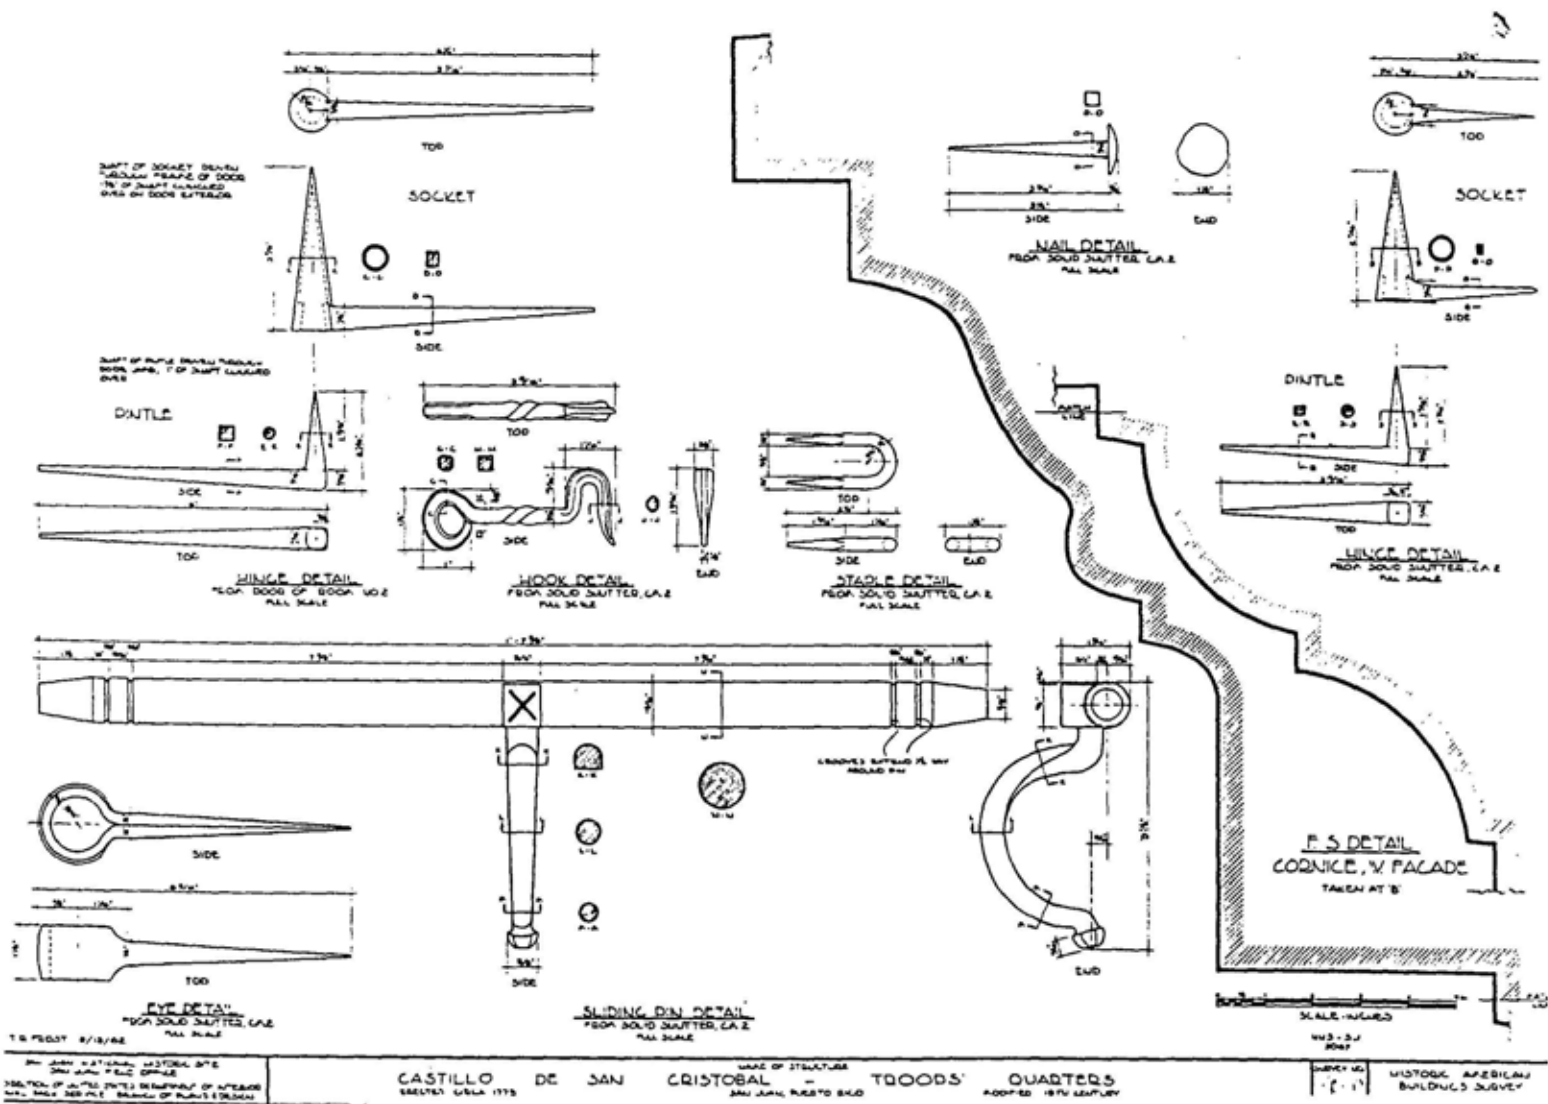
Figure 27. Hardware details from San Cristóbal. (Drawing by HABS, 1962.)

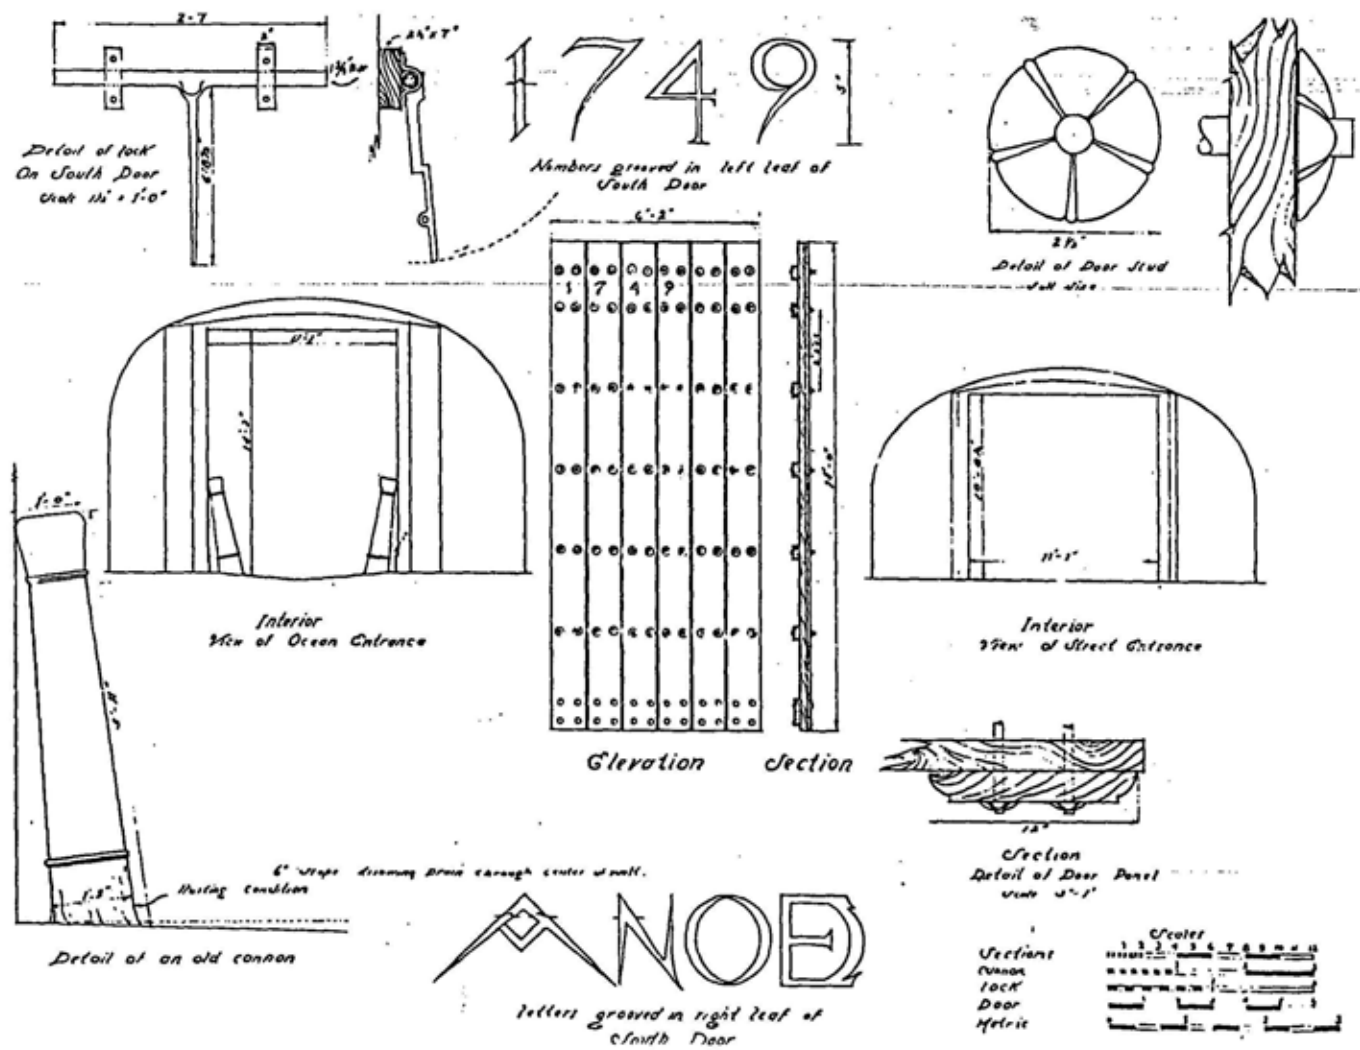
Figure 28. Old cannon and hardware details of Old San Juan Door. (Drawing by HABS, ca. 1960.)

In the early 1960s, HABS documented extant doors, gates and shutters in the fortifications (figs. 17-22 and 28); some of these may date to the late-eighteenth century, others to the early-twentieth century. It is presumed that an attempt was made to replicate these accurately (from what was either being replaced or what was extant), and that the HABS illustrations can be considered to portray doors, gates and shutters as they appeared in the late-eighteenth century.

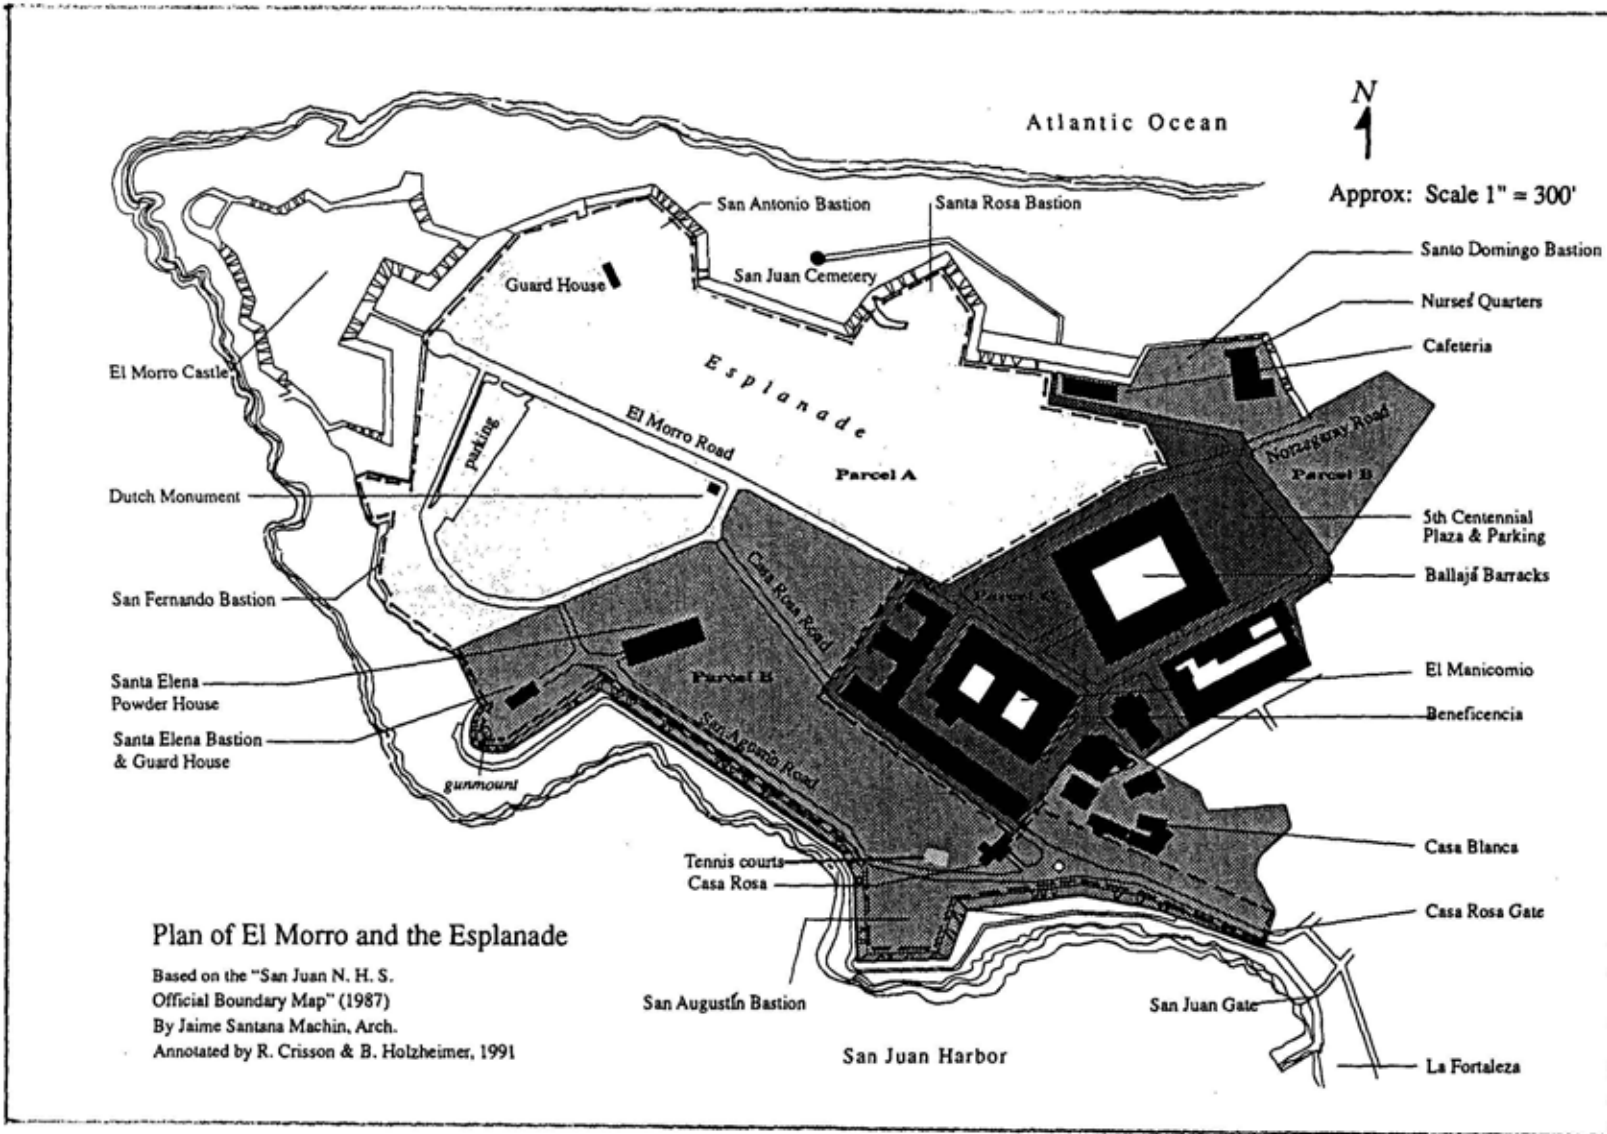
Figure 1. Study area. This site plan indicates the study area for this report and Parcels A, B, and C. The study area is shown within the dashed line and the Parcels are differentiated by varying textures.

The focus of the CLR is to study the area referred to as the Esplanade of el Morro, as indicated on fig. 1. The rocky promontory containing the Esplanade lies at the extreme northwest point of the islet of San Juan. It began as a fortified site ca. 1540, when it was referred to by the Spanish as el Morro, meaning the bluff or headland. The geographic advantages of this site may have been apparent even earlier to the native Indian population.³ The fortified site soon became known as el Castillo de San Felipe del Morro.

The eastern edge of the Esplanade is defined by various elements that are on Parcel B and C: the Fifth Centennial Plaza and Parking Garage (both presently under construction); Bastión de Santo Domingo, containing the Neurological Institute, but often referred to by its former name, the "Nurses' Quarters"; and terminating with another large masonry structure, known by its former name, the "Cafeteria," located between the Road to the Cemetery and the north city wall.⁴ The Esplanade is enclosed on the north by the defensive north city wall, defined east to west by the two bastions of Santa Rosa and San Antonio. San Juan Cemetery is directly below this wall, and extends northward to the edge of the shore. The limits of the CLR study area and the parcel locations are shown on fig. 1.

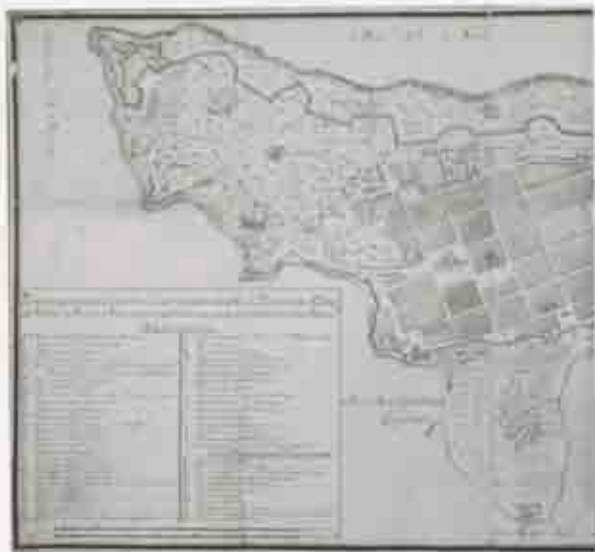
Figure 2. 1776 Map, San Juan, Juan de Villalonga, under the direction of Thomas O'Daly, Museo Naval, XXIII-A-9, Madrid. Reproduced in Anibal Sepúlveda Rivera, *SAN JUAN. Historia Ilustrada de su Desarrollo Urbano, 1800-1898*.

Maps from 1776 (fig. 2) and 1792¹⁷ show not only the three older routes but also a network of paths on the Esplanade. Both maps suggest that the southern route was the major means of accessing el Morro from 1540 to 1860. It would have been used to transport supplies and artillery from the harbor to the fort. This old route is approximated by the present-day Casa Rosa Road and the portion of el Morro Road leading from Casa Rosa Road to the fort.

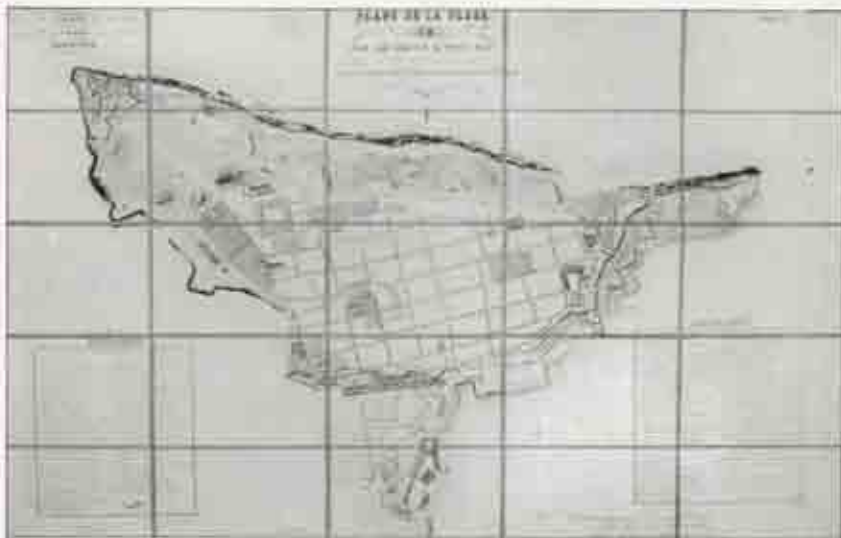
Figure 3. 1841 Map, Plano de la Plaza de San Juan Bautista de Puerto Rico. Rafael Clavijo y Piá, 1841, S.G.E. Cart. X (CAT. 40). Reproduced in Anibal Sepúlveda Rivera, *San Juan. Historia Ilustrada de su Desarrollo Urbano, 1808-1898*.

A map from 1861 (fig. 3) suggests that the route from the center of the city became the more prominent means of accessing el Morro at about this time.¹⁸ The section of the road known as Norzagaray and at the eastern end of the Esplanade was

The original purpose of the old northern route is unclear. It resembled a road on the 1625 map, and did in fact connect the city with el Morro. However, its out-of-the-way location suggests that it was not a major route to the fort. It later gained in importance. After San Cristóbal was built, the northern route was extended to form a link between it and el Morro. In the late eighteenth century it provided access to defensive bastions built along the north shore. After the north bastions became obsolete due to improvements in artillery during the nineteenth century, the segment of the path connecting to the main route to the fort disappeared (see fig. 3).

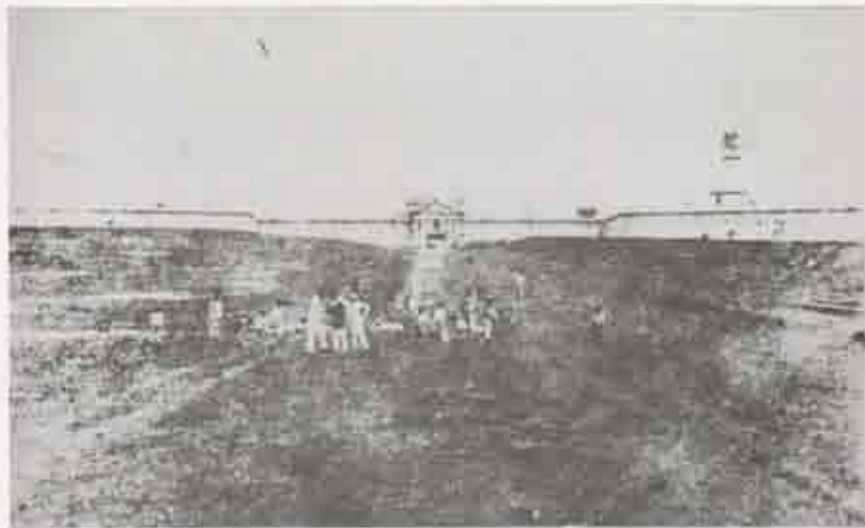
Figure 4. The Esplanada; ca. 1890. This view of the Fort from el Morro Road illustrates the open character of the Esplanada, its lansform and the road treatment. SAJN Archives, San Juan, PR.

Between 1873 and 1887, then, the present configuration of the Esplanade was established. The condition of the relatively smooth-surfaced Esplanade was shown in a ca.-1890 photograph (fig. 4). The 1898 bombardment left numerous holes in the Esplanade, however. "The dark hillside was dotted with the geyser-like earth clouds of exploding shells, most of them rising around el Morro and the barracks."⁴⁵ In 1899, work was approved to regrade and fill in the holes on the Esplanade.⁴⁶

The lack of vegetation on the Esplanade was also confirmed by a Dutch map of 1625 showing the Esplanade barren of trees, while other areas of the islet were heavily vegetated.⁴⁹ The lack of vegetation was also apparent in the previously cited sketch map by A. Vingboons of the same year.⁵⁰ The sketch map of el Morro and San Cristóbal by Luis Venegas Ossorio in 1678 did not show trees on the Esplanade, but did indicate vegetation in other outlying areas of the city.⁵¹ By 1797, French naturalist Andrée Pierre Ledrú reported that vegetation was limited on the entire islet. He explained that "it was necessary to travel three miles from the city to find habitat in which to gather specimens."⁵² An 1821 sketch of the Esplanade by another French naturalist, Auguste Plée, illustrated one single palm tree growing near the moat and sallyport of el Morro.⁵³ Figure 4 shows the Esplanade still barren of trees ca. 1890.⁵⁴

The views across the Esplanade were largely unobstructed throughout Period I, as illustrated in fig. 4. The San Antonio Bastion, Casa Rosa, the Insane Asylum, Ballajá Barracks, and Santo Domingo Bastion were all clearly visible from el Morro. During the early part of Period I (ca. 1540-1780), views from the fort also would have included Calvary Hill, the adjacent ravine, and the road to the San Juan Gate. Juan de Villalonga's plan of 1776 (fig. 2), documented in plan the features discussed above. The open views were maintained during the quarrying of the hill and the filling of the ravine, and they persisted up to the end of Period I.

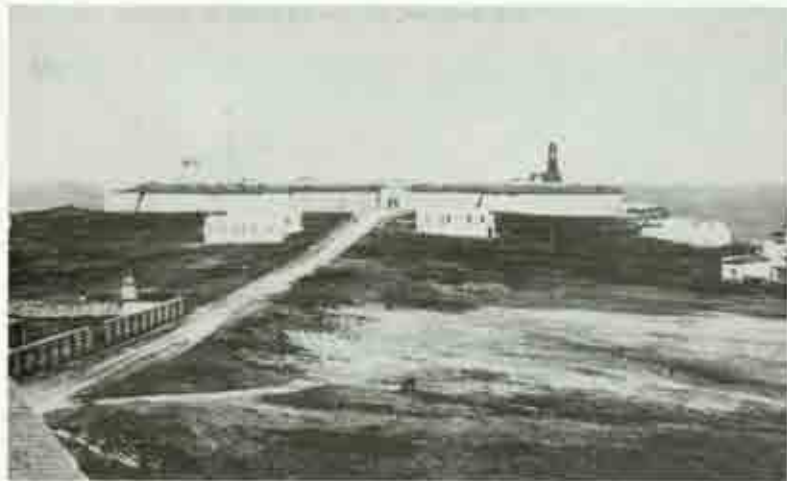
Figure 3. The Esplanade: ca. 1903. This view of el Morro from the east shows three Officers' Quarters, masonry wall of the Yellow Fever Hospital, and the Dutch Monument. The open character of the Esplanade, areas denuded of grass due to intensive use, projectiles along road, early utilities and road treatment are illustrated. Captain Ralph E. Gambell Collection, SAJU Archives, San Juan, PR.

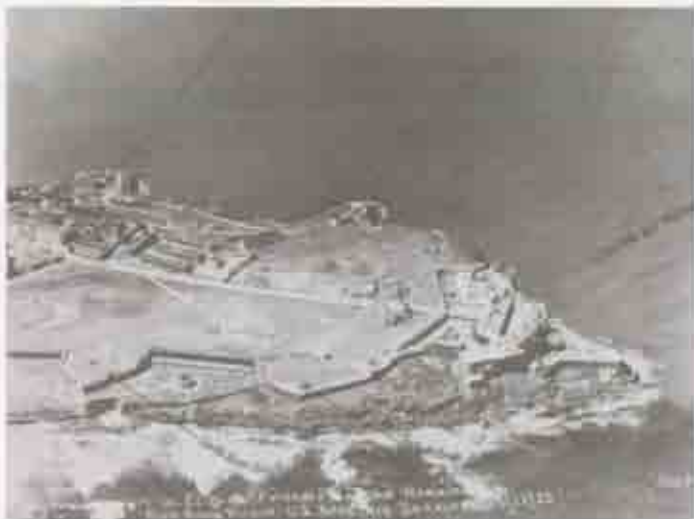
Figure 8. South view of Napianado, 1922. Aerial view showing areas denuded of grass, soldiers marching in drill formations, the Baseball Diamond, 9-hole golf course, three Officers' Quarters and Yellow Fever Hospital. Vegetation is very limited with a few trees clustered near the Quarters and Casa Rosa. SAJG Archives, San Juan, PR.

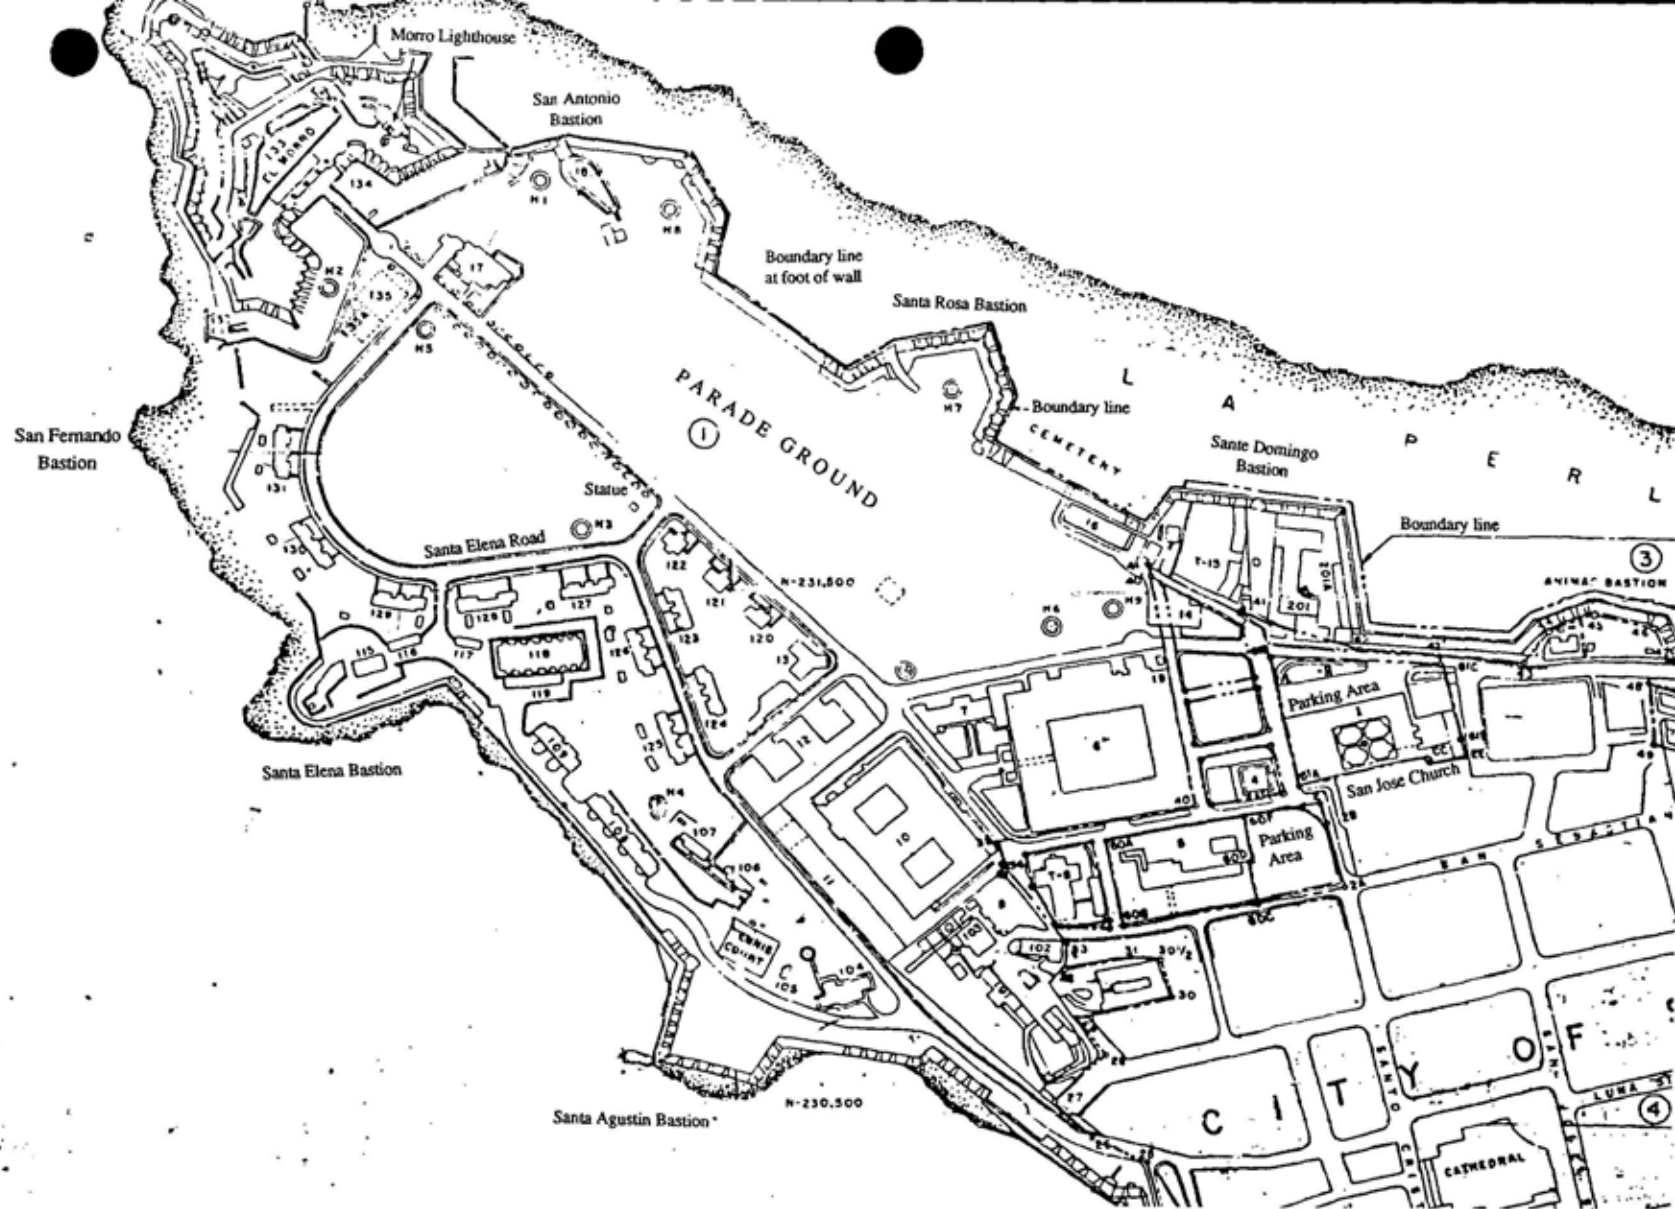
Figure 7. Map of ca. 1960, el Morro and surroundings. Based on 1886 survey showing U.S. Army development, ca. 1930-1961. Sheet 1 of 1, SAJU 0550. SAJU Archives.

Plumbing and sewer systems were first installed during the spring of 1899.⁸² The area north of el Morro Road was regraded, and obstructions in the sewer line were removed to alleviate the drainage problem.⁸³ A square feature is shown with dotted lines in the same area, on the ca.-1960 plan (fig. 7). This may have been associated with site drainage. However, field investigation has not verified its function, present condition, or even its existence. The ca.-1960 plan also shows the existence of a cistern in the area south of el Morro Road, near the sallyport. The construction date of the cistern is unknown. The ca.-1960 plan is the first to show it, but cisterns at el Morro generally date to Period I. The cistern survives today, but its condition was not verified.

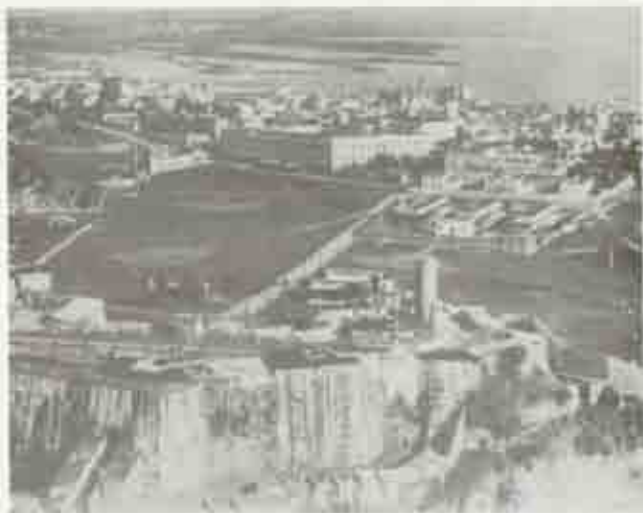
Figure 8. East view of Esplanade, 1933. Aerial view showing the open character of the site, the condition of the Esplanade, city in background, and the three Officers' Quarters and the Yellow Fever Hospital in the foreground. Projectiles and utility poles are seen along the paved El Morro Road. USIU Archives, San Juan, PR.

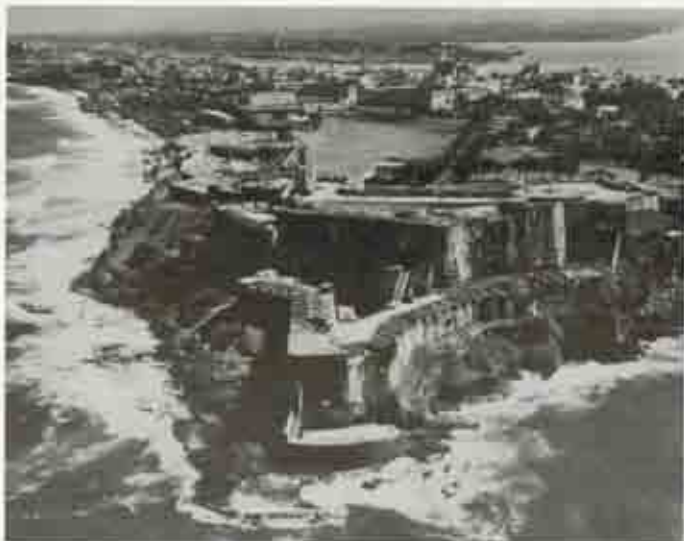
Figure 9. East view ca. 1937. Aerial view from el Morro towards the city shows mature trees lining the roads, in Parcel N, and along the north city wall. The Officers' Mess and military housing south of el Morro Road can be seen. The Esplanade appears well maintained. SAJU Archives, San Juan, PR.

During Period II, the views previously associated with the Esplanade became obstructed as buildings were constructed, and as trees were planted and matured. The northern half of the Esplanade remained relatively open and was visible from the fort. From el Morro, one could see across the northern half of the Esplanade toward the Ballajá Barracks and toward Santo Domingo Bastion. However, the views of el Morro Road, el Manicomio Road, Casa Rosa Road, and to the Santa Elena and San Agustín Bastions were largely obstructed by the two-story concrete buildings constructed by the U.S. Army and by the mature trees lining these roads. In summary, by 1957, views between the south half of the Esplanade and the fort were substantially obscured (see fig. 9).

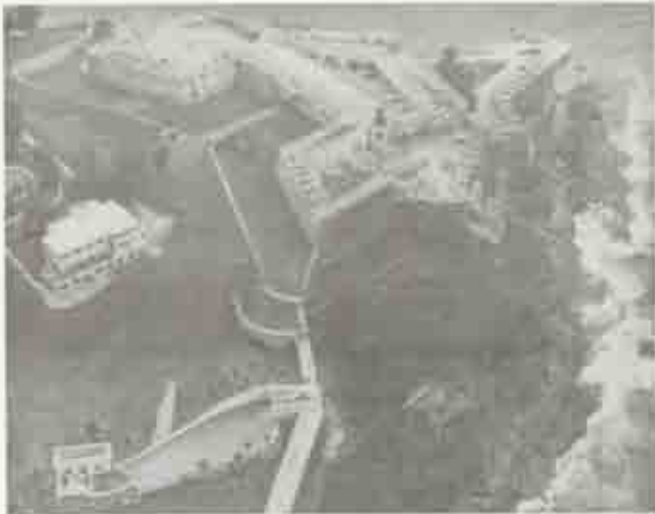
Figure 10. East view, ca. 1917. Aerial view of El Morro showing gally port, Officers' Mess, San Antonio Guardhouse, swimming pool and golf greens. Mature palm trees are clustered near the pool and the Officers' Mess. The Esplanade appears well maintained. HAJU Archives, San Juan, PR.

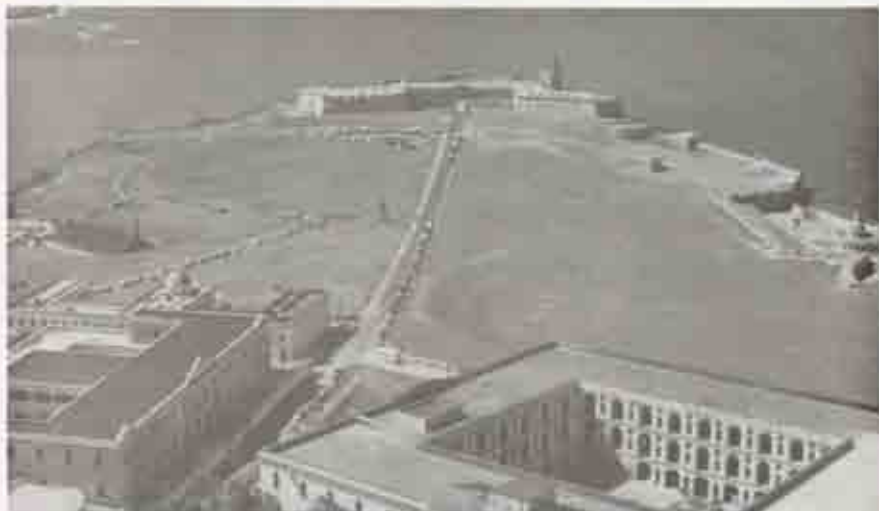
Figure 11. West view, 1966. Aerial view towards el Morro showing paved road system, 40-car parking lot, parallel parking, and the Dutch Monument. URSRP, San Juan, PR.

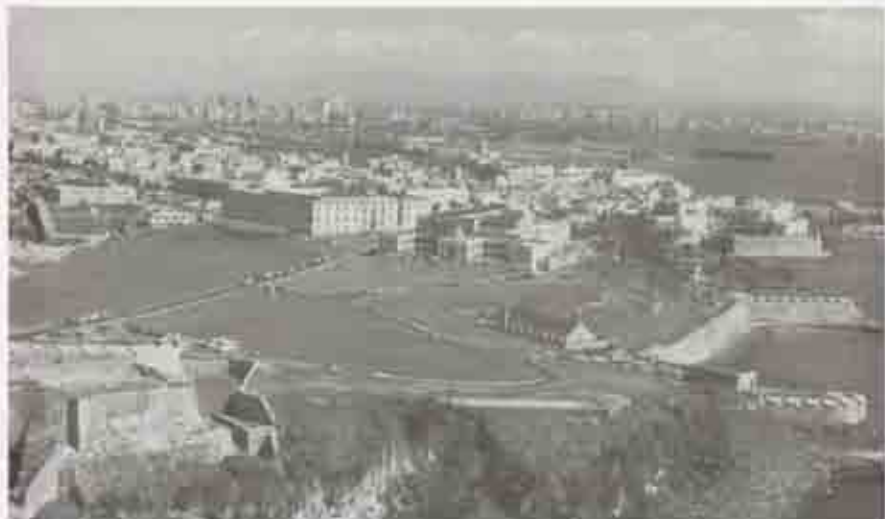
Figure 12. East view, 1988. Aerial view from el Morro toward the city showing the paved road system, 40-car parking lot; parallel parking, the Dutch Monument, tennis courts, the chain-link fence, and the play area in Parcel 9. PRMPO, San Juan, PR.

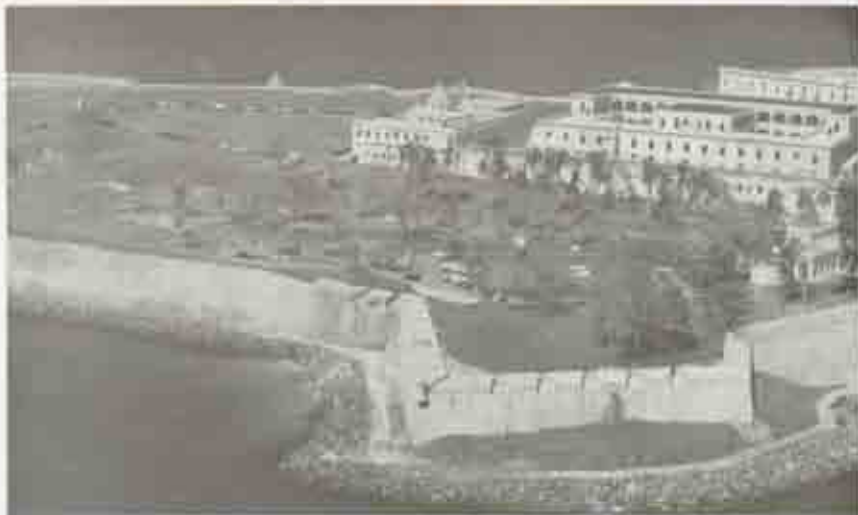
Figure 11. North view of Parcel B, 1989. Aerial view of Parcel B shows the Casa Rosa, the tennis courts, and the play area, the San Agustín Road and Bastion. The condition of Parcel B trees was indicative of damage caused by Hurricane Hugo, September 1983. PCHMCO, San Juan, PR.

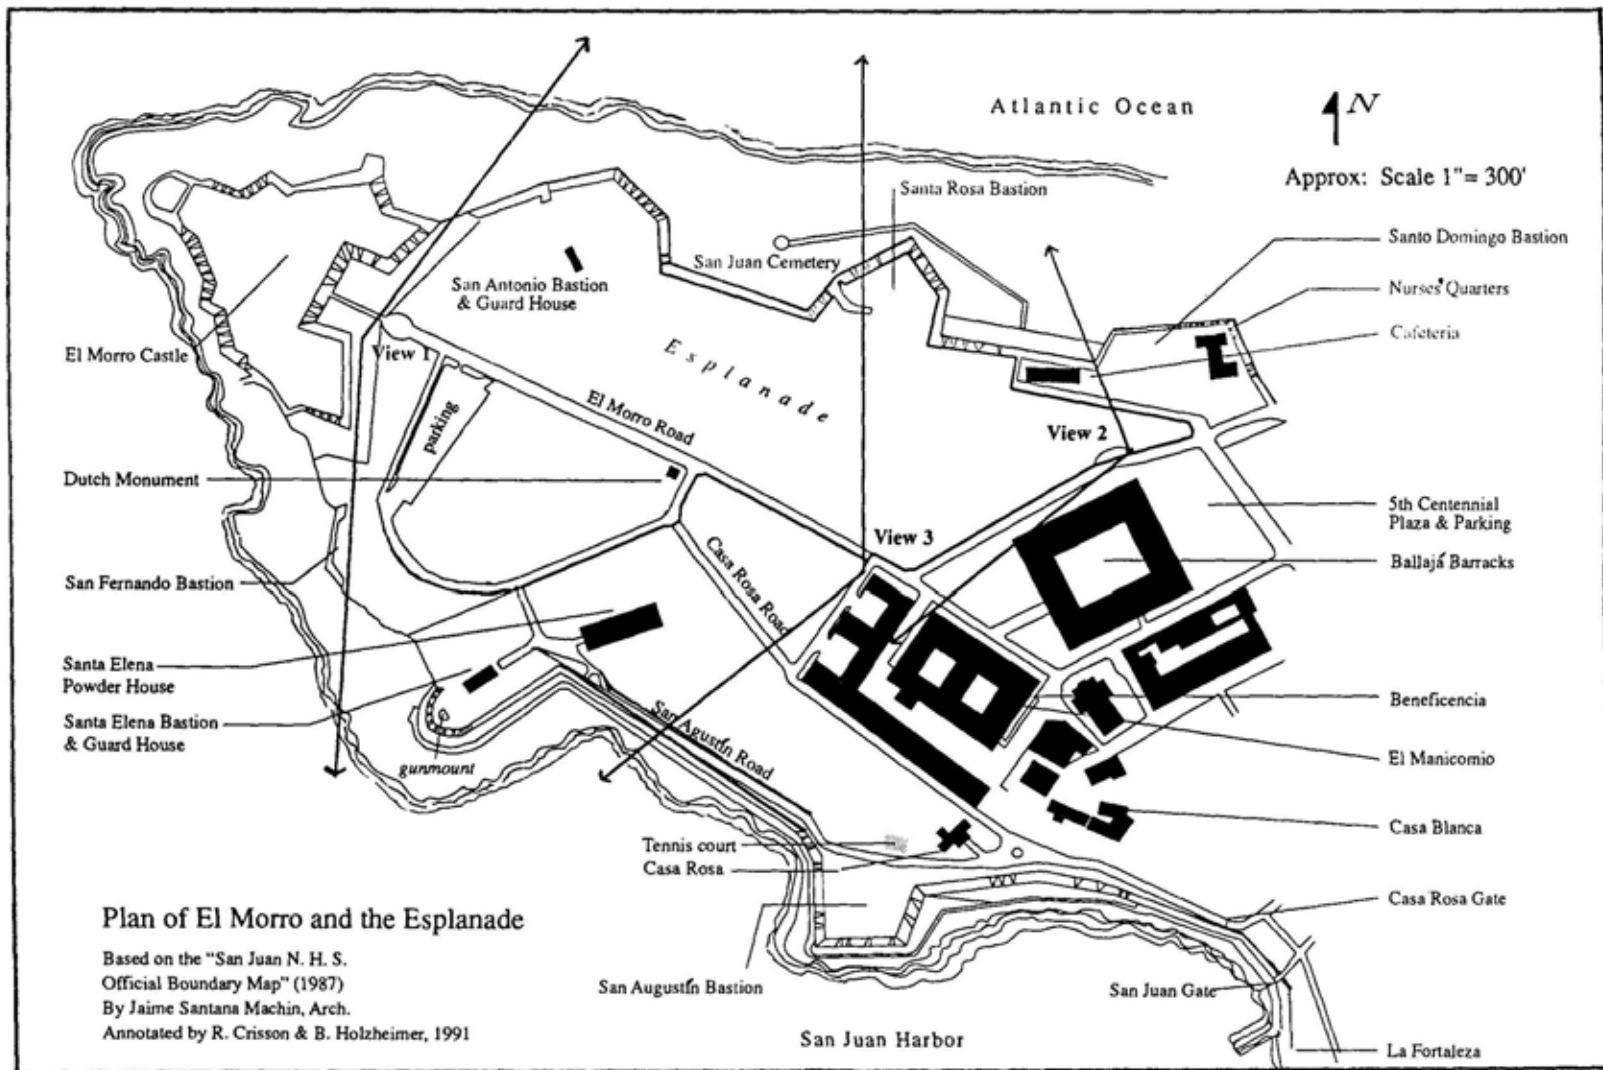
Figure 14. Existing Conditions. Site plan indicates locations of existing buildings, roads, vegetation, and primary views. The primary views (Views 1, 2, and 3) are keyed to composite photographs depicted in Figures 15, 16, and 17.

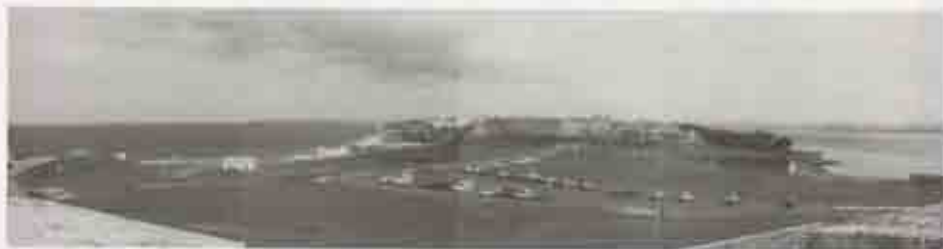
Figure 15. Composite photograph, East View, 1971 (View 1). Vista from el Morro showing parking lot, parallel parking along the roads, trees in Parcel B, and the general open character of the site. Photography by Richard C. Crismon.

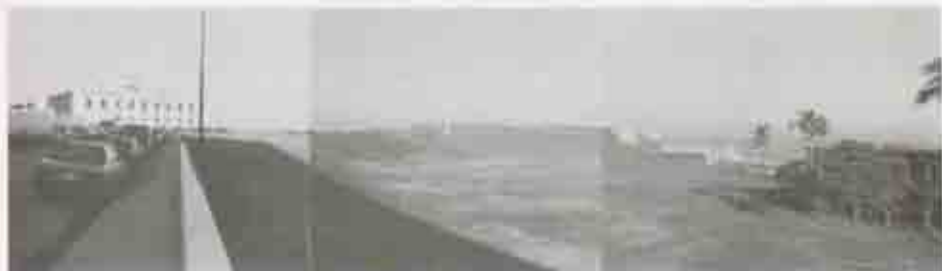
Figure 18. Composite photograph, West View, 1991 (View 2). Vista from Ballajá Barracks shows el Morro, Dutch Monument, parallel parking along roads and sloped area in front of Ballajá Barracks. View is limited to the south by el Manicomio (School of Plastic Arts). Photography by Richard C. Grissen.

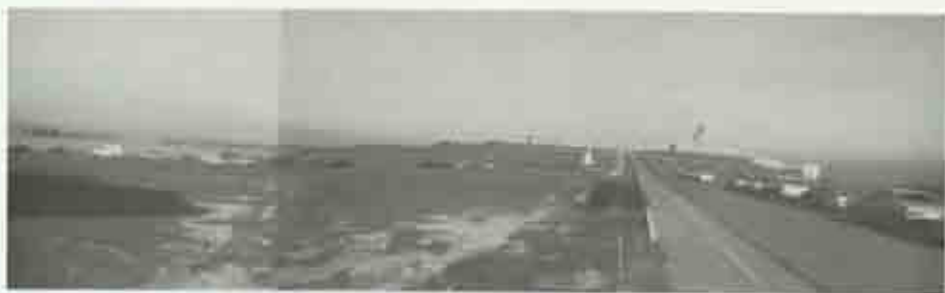
Figure 17. Composite photograph, West View, 1991 (View 2). Vista from intersection of Mahiconic and el Morro Roads shows el Morro, Dutch Monument, parking, and Powder Magazine area. Photography by Richard C. Crismon.

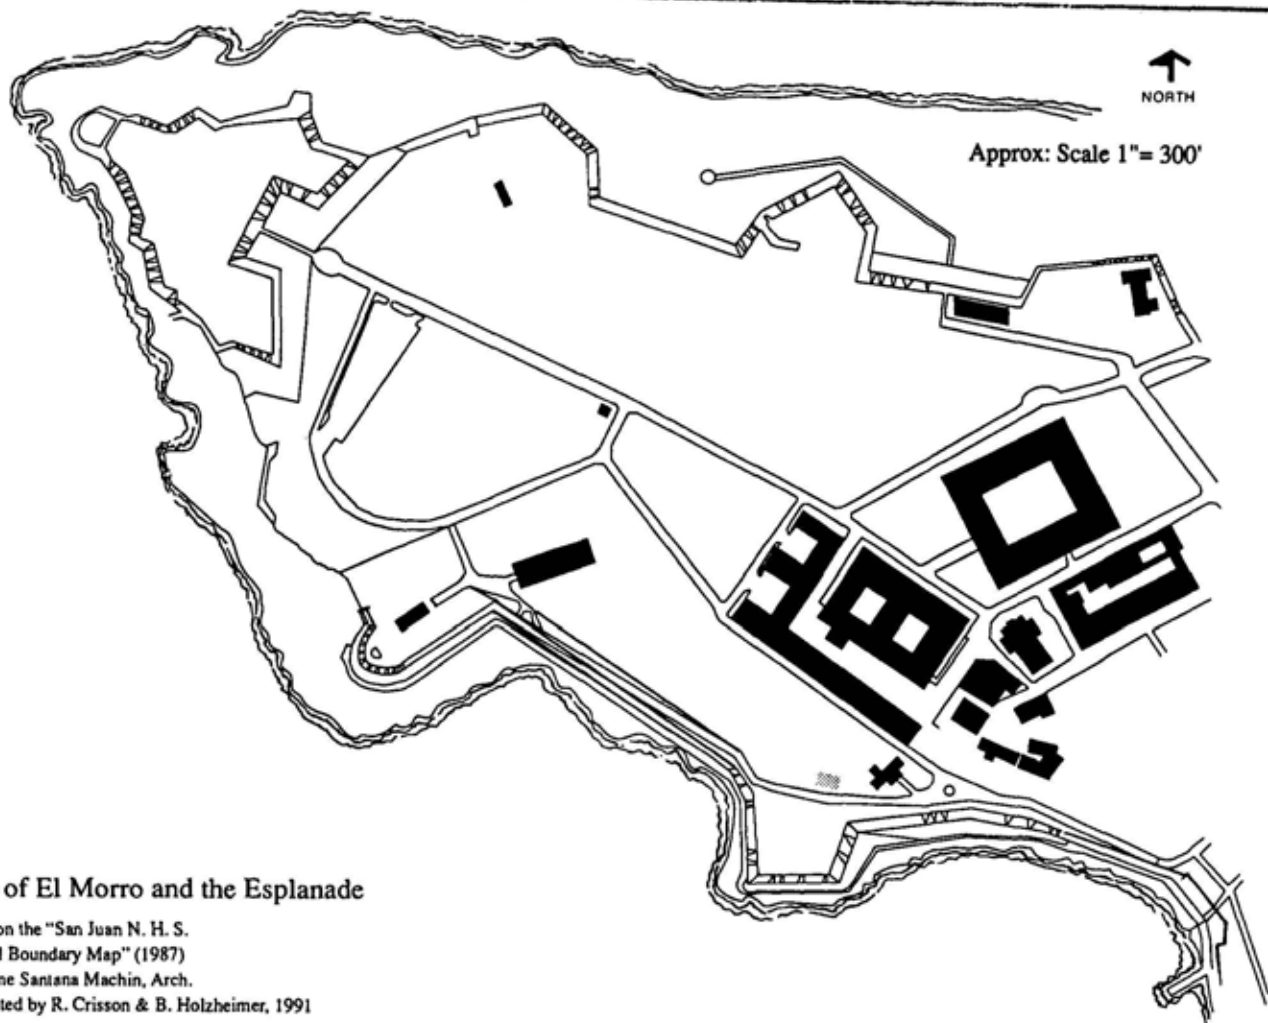
Plan of El Morro and the Esplanade

Based on the "San Juan N. H. S.
Official Boundary Map" (1987)
