HISTORICAL OVERVIEW AND ASSESSMENT OF CIVILIAN
CONSERVATION CORPS ROCK WORK ALONG GENERALS HIGHWAY FROM
ASH MOUNTAIN TO GIANT FOREST IN SEQUOIA NATIONAL PARK

HARLAN D. UNRAU
HISTORIAN
WESTERN TEAM
DENVER SERVICE CENTER

AUGUST 1988

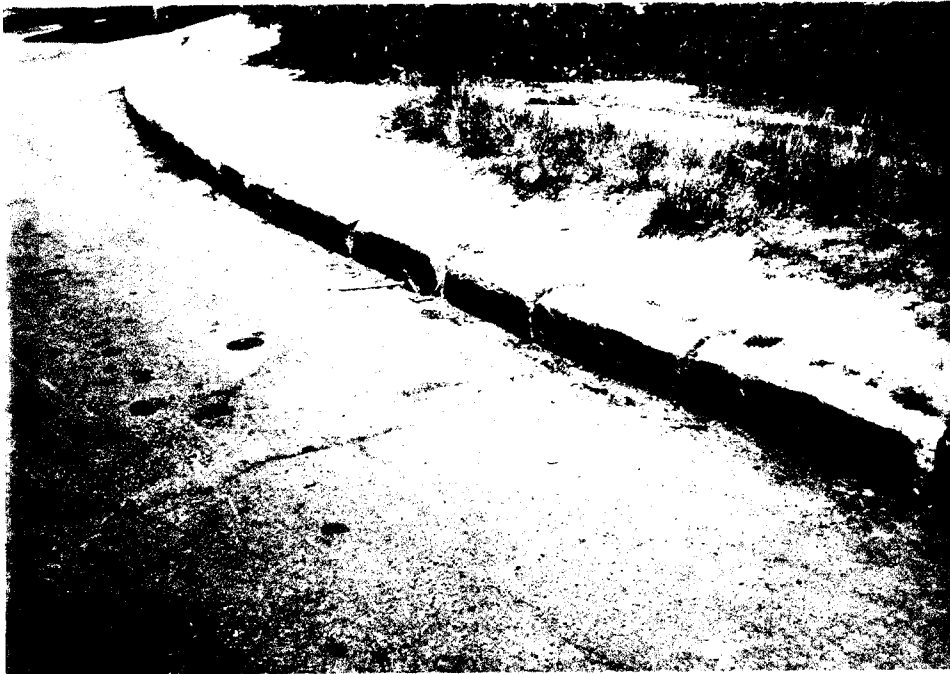
Photograph No. 1 -- Cut stone curbing around parking lot at Grant Forest Market Plaza

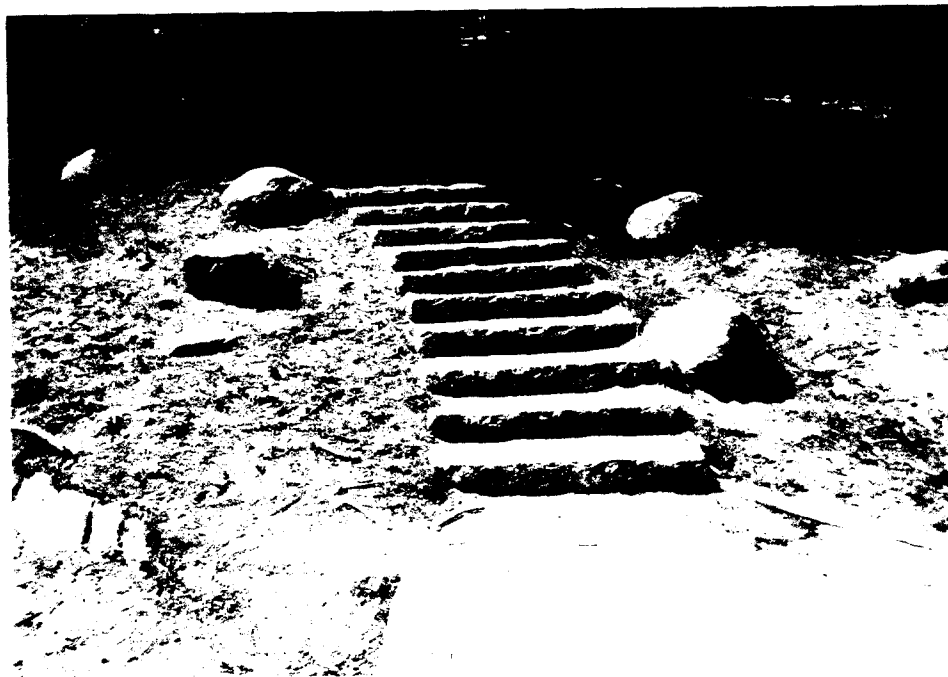
Photograph No. 4 -- Cut stone steps leading from
highway toward Camp Kaweah Motel area

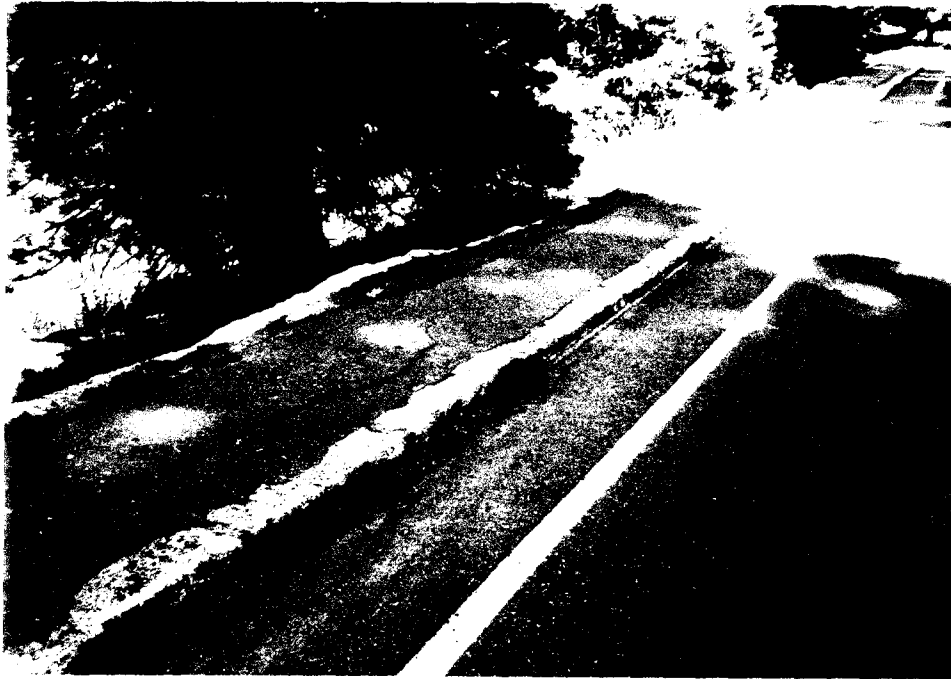
Photograph No. 5 -- Blacktop walk between cut stone curbing along highway just above Giant Forest Market Plaza

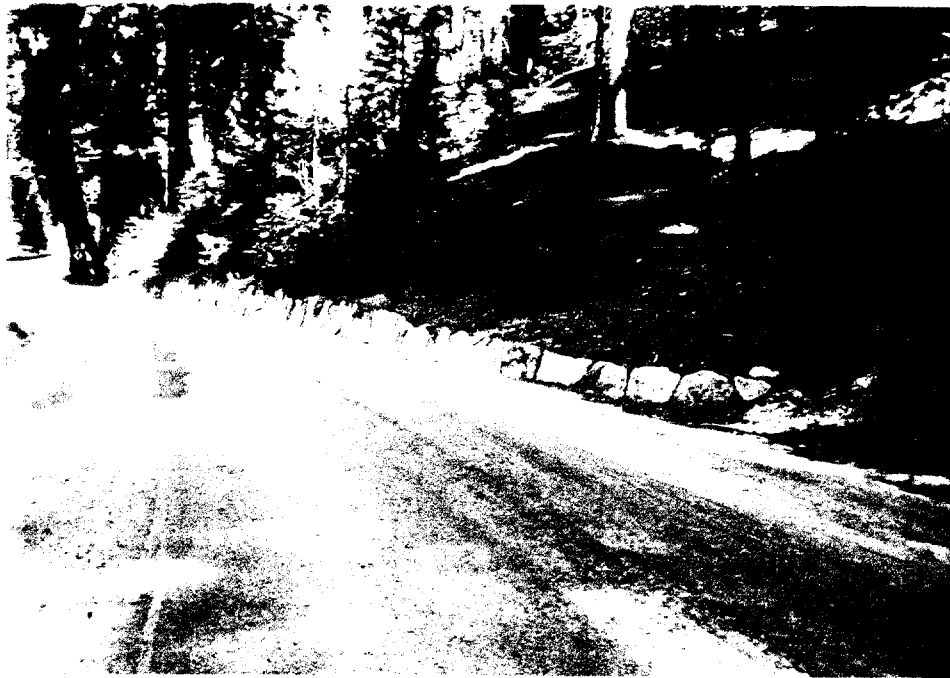
Photograph No. 7 -- Stone retaining wall along highway
just above Giant Forest Market Plaza

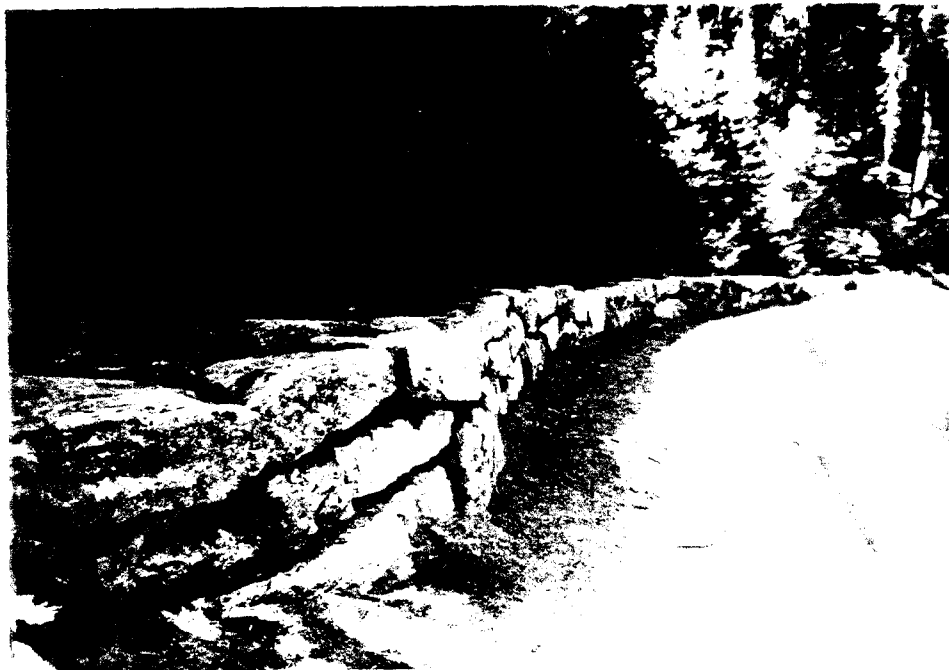
Photograph No. 10 -- Longest example of low granite retaining wall along highway; on upslope side just below Wall Spring (0.9 mile below Giant Forest Market)

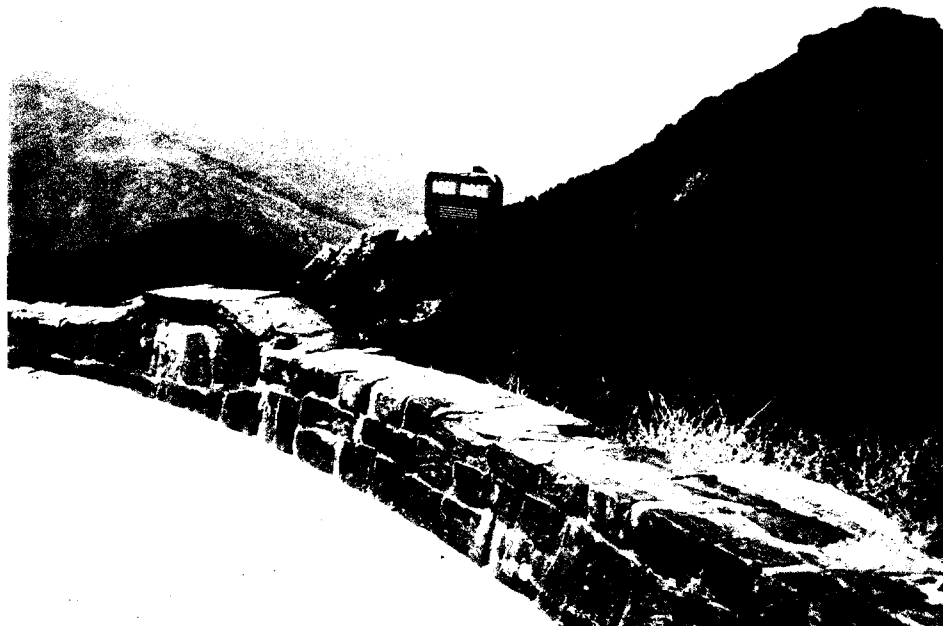
Photograph No. 14 -- Deer Ridge overlook parapet rock wall on downslope side of highway; uppermost turnout of rustic design (4.0 miles below Giant Forest Market)

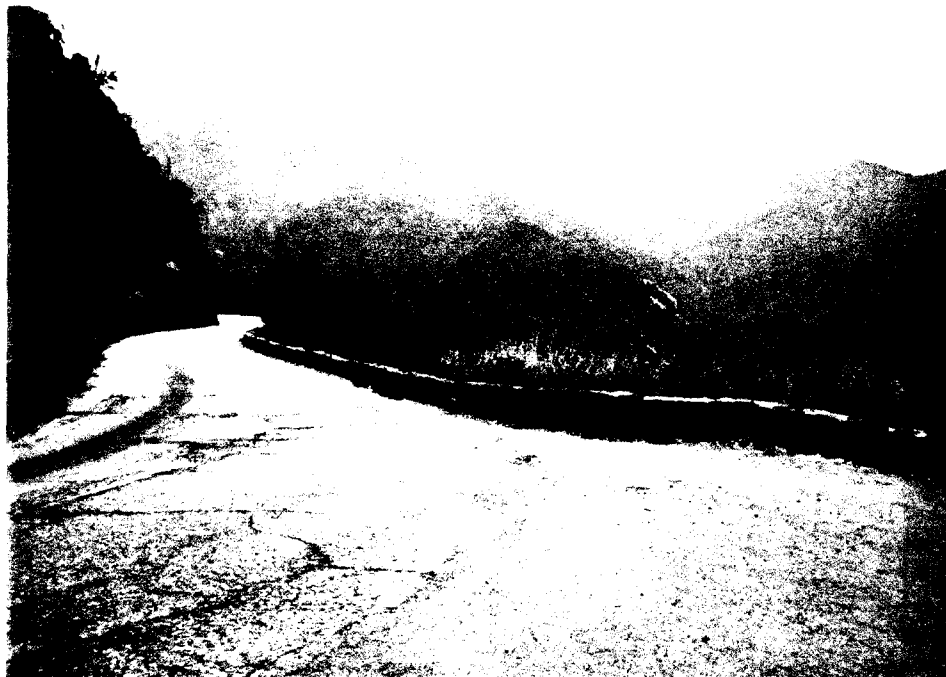
Photograph No. 15 -- Parapet rock wall at Deer Ridge overlook and along downslope side of highway below turnout (4.0 miles below Giant Forest Market)

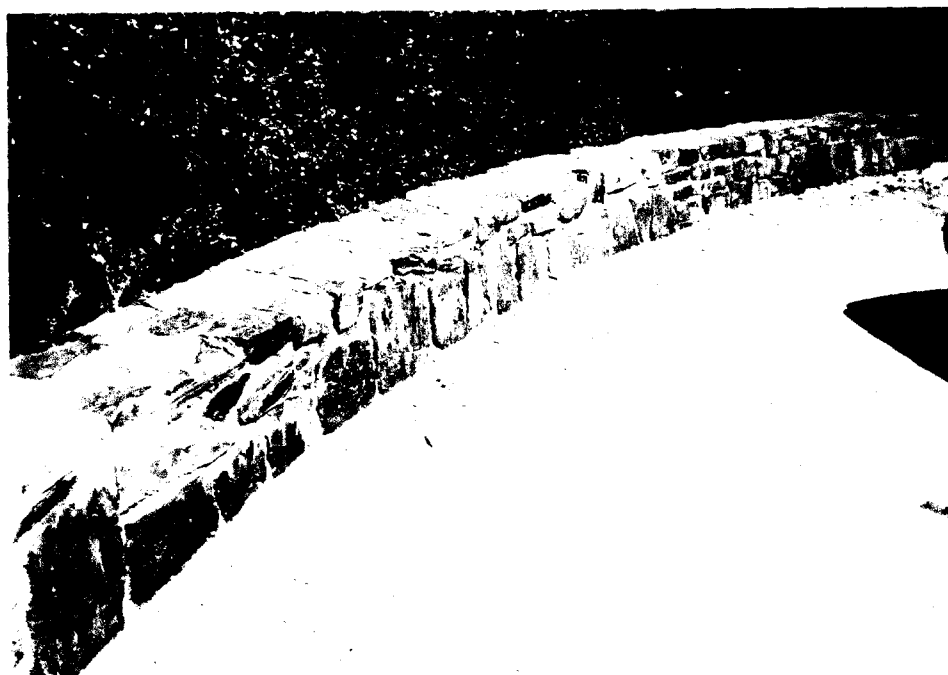
Photograph No. 16 -- Parapet rock wall at Deer Ridge overlook on downslope side of highway (4.0 miles below Giant Forest Market)

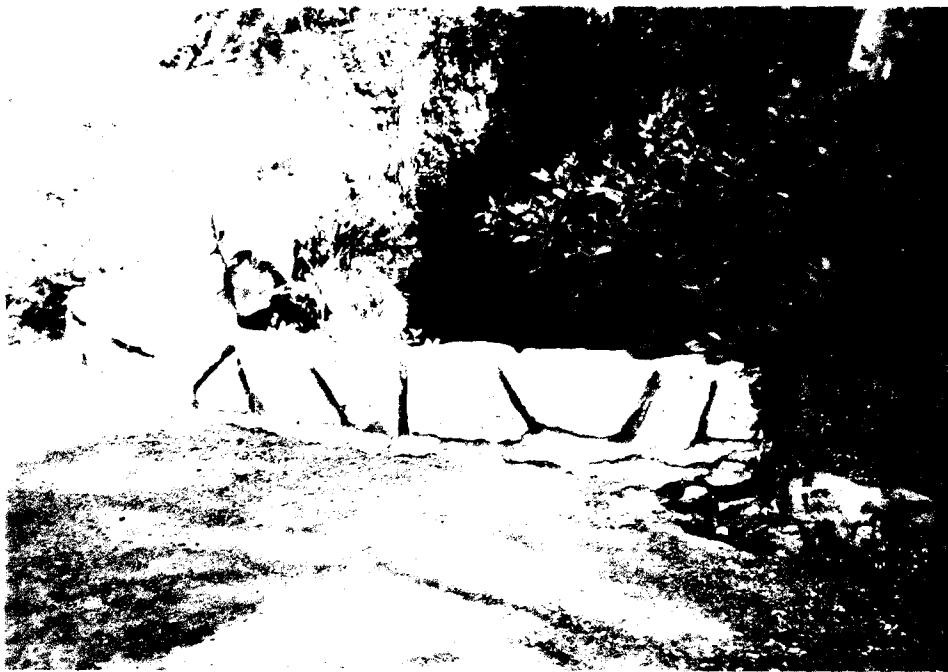
Photograph No. 17 -- Granite Spring rock work on
upslope side of highway; water fall ring
(4.7 miles below Giant Forest Market)

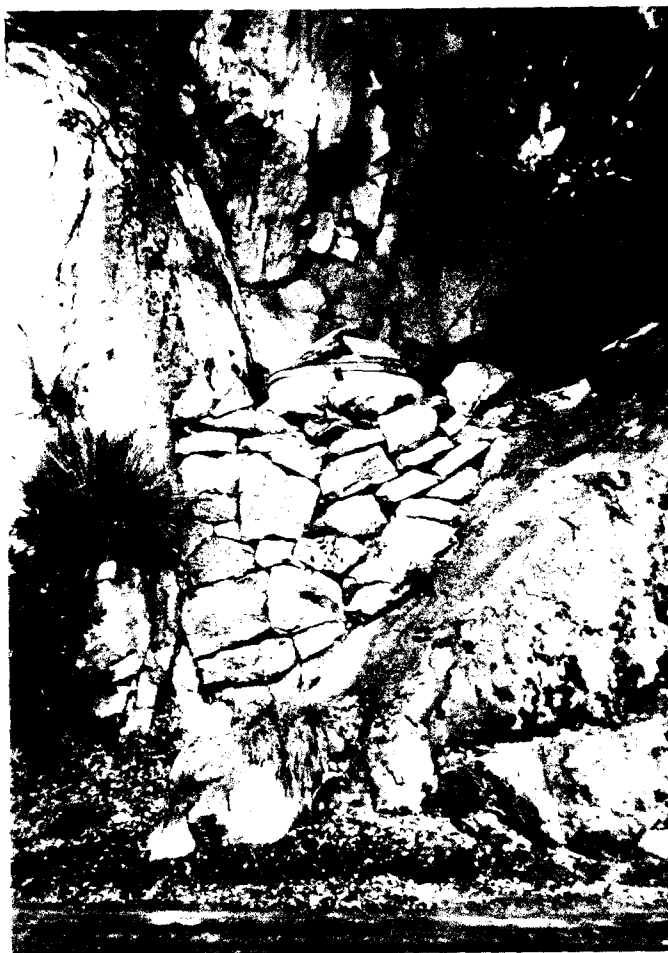
Photograph No. 18 -- Granite Spring water tower and stone retaining wall on upslope side of highway (4.7 miles below Giant Forest Market)

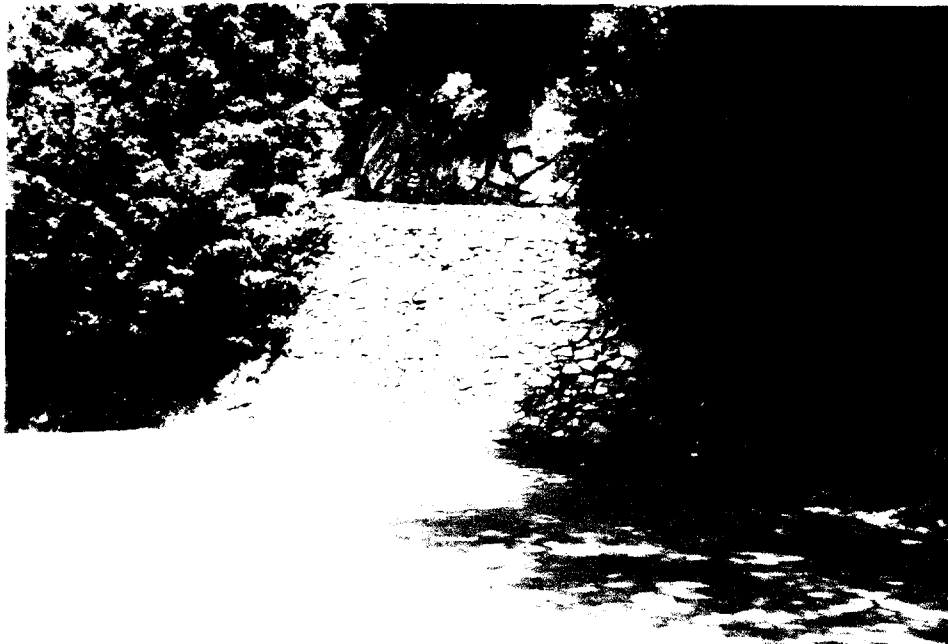
Photograph No. 20 -- Stone retaining wall on S-curve just above
Granite Spring; parapet wall in Photograph No. 19 forms
top of this retaining wall

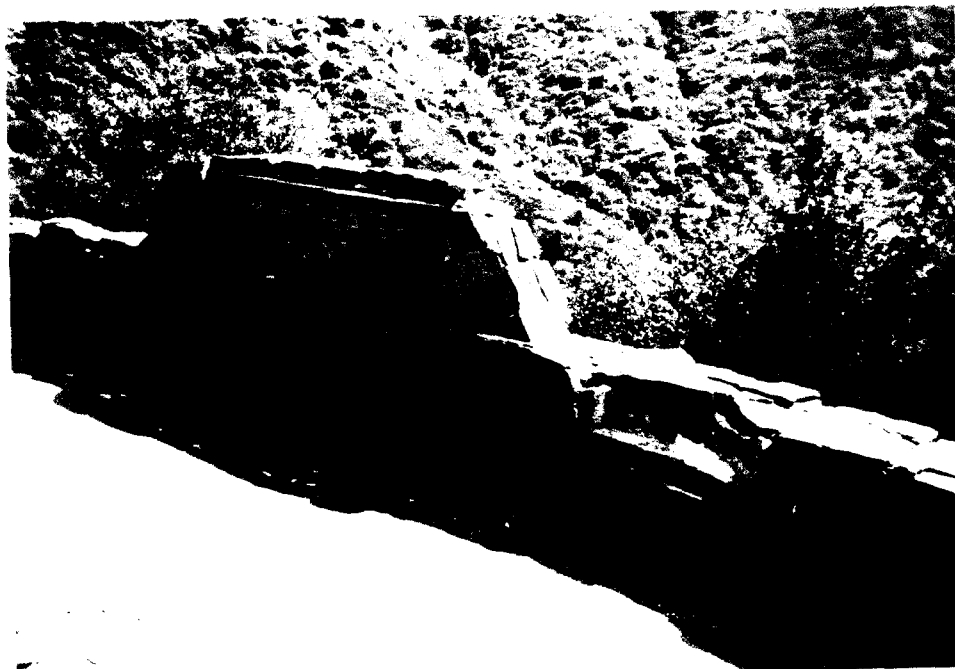
Photograph No. 22 -- Amphitheater Point overlook parapet wall along downslope side of highway; only place where signing, exhibit and visitor view platform is located along highway (5.55 miles below Giant Forest Market)

During 1938-39 improvements were made to the Amphitheater Point parking area, which had become one of the favorite tourist stops on the highway. The point offered one of the most prominent panoramic views along the road, and thus encouraged many automobiles to stop. Prior to this improvement project, the area had been "rather ragged and unsightly." The improvements included development "of a systematic parking area and observation point," construction of some "300 lineal feet of schist rock wall and curb," oiling of the parking area and walks, and planting. A characteristic rustic sign ("Amphitheater Point") was incorporated in the parking area parapet rock wall, and a rounded rock wall lookout point with an interpretive marker on a stone foundation were among the items constructed to accommodate tourists.

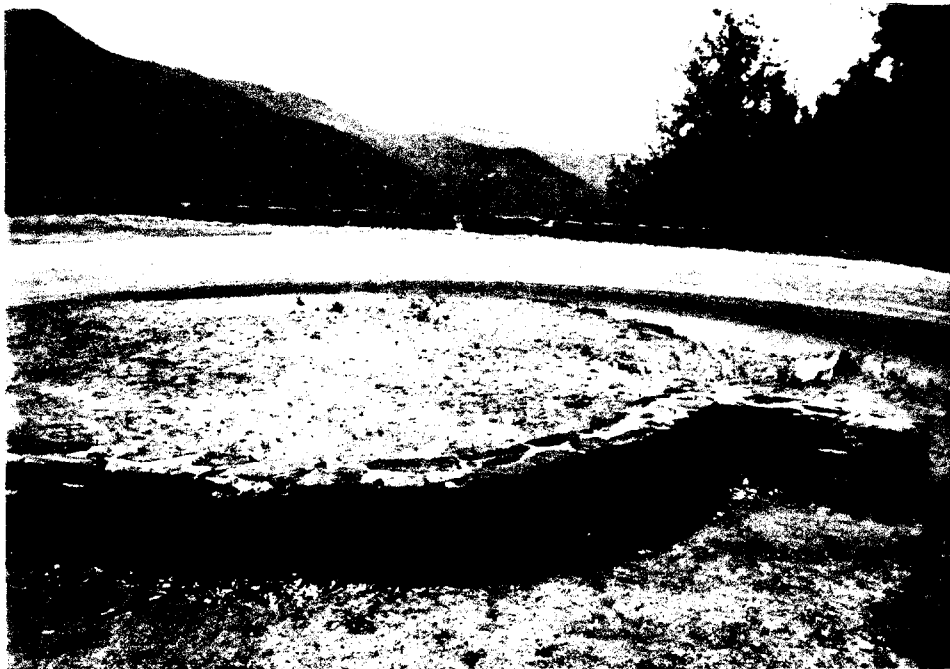
Photograph No. 23 -- Amphitheater Point parapet wall on downslope
side of highway in background and circular platform parapet
wall on upslope side of highway in foreground
(5.55 miles below Giant Forest Market)

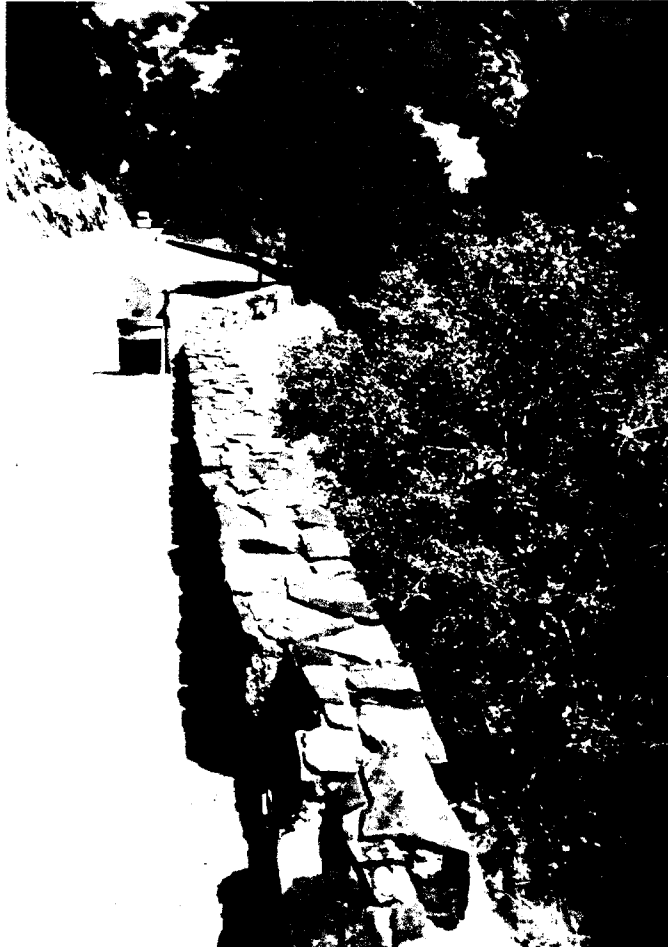
Photograph No. 24 -- Amphitheater Point overlook
parapet wall along downslope side of highway
(5.55 miles below Giant Forest Market)

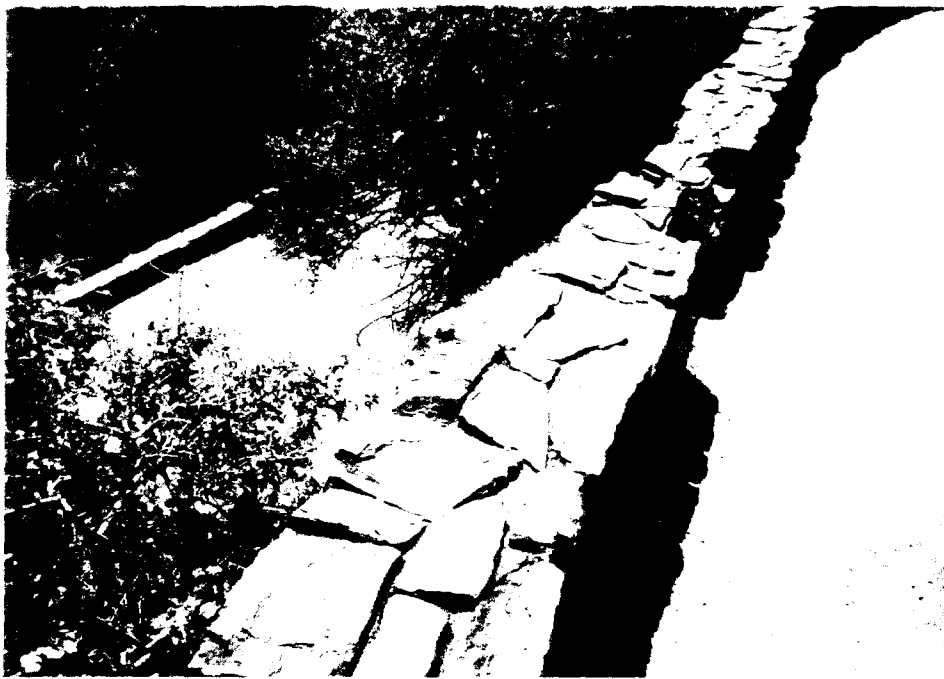
Photograph No. 25 -- Amphitheater Point overlook parapet wall in foreground with parapet wall along downslope side of highway below (5.55 miles below Giant Forest Market)

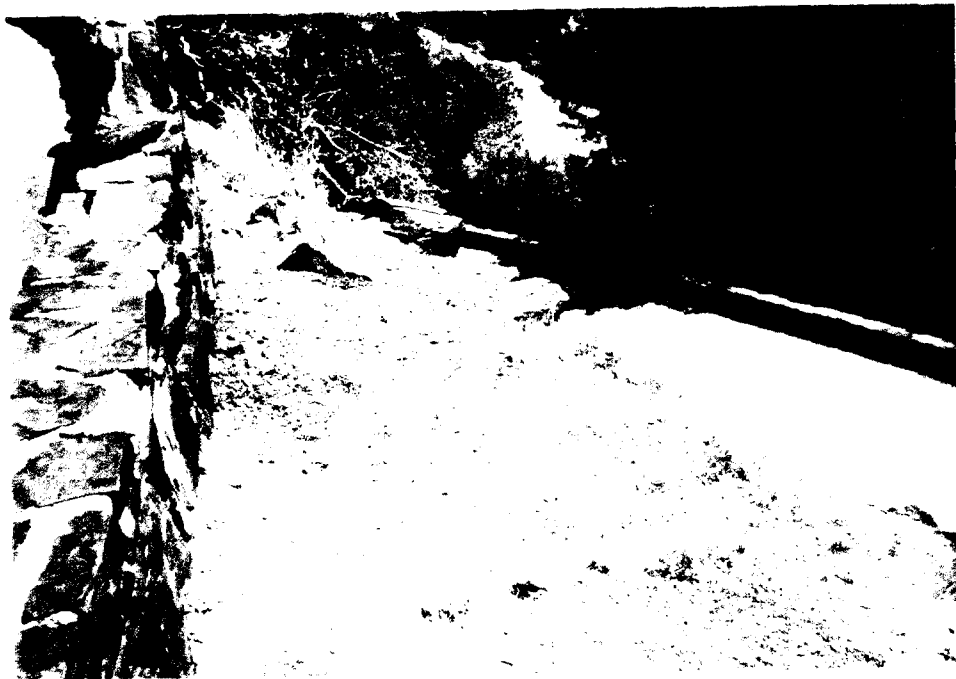
Photograph No. 26 -- Amphitheater Point overlook parapet wall at left; parapet forms top of stone retaining wall on upslope side of highway below; parapet wall along downslope side of highway below at right (5.55 miles below Giant Forest Market)

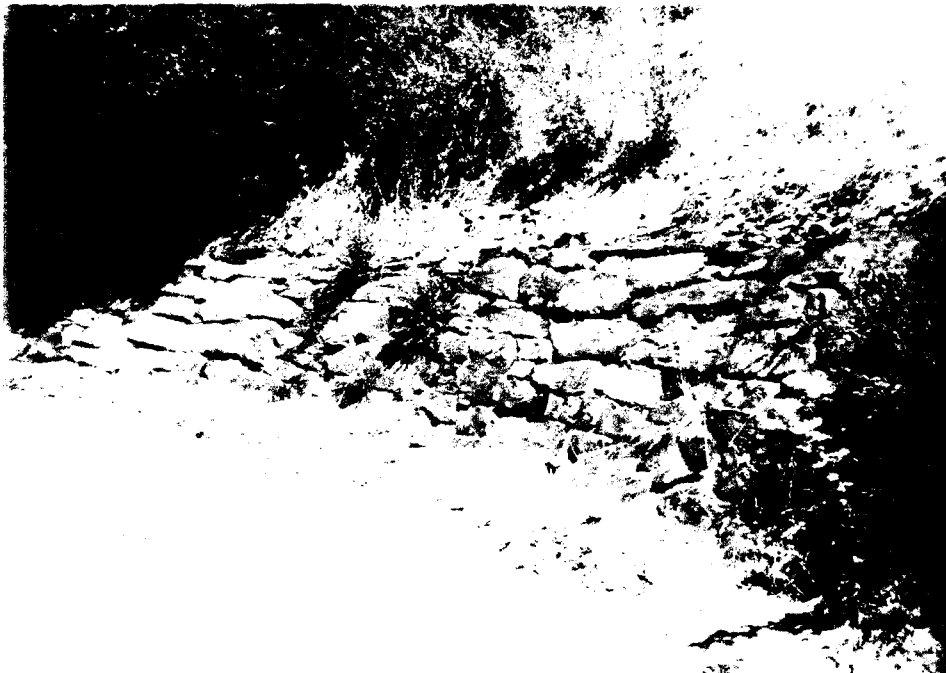
Photograph No. 27 -- Sloping retaining wall along upslope side of highway just above Black Oak Corner (6.5 miles below Giant Forest Market)

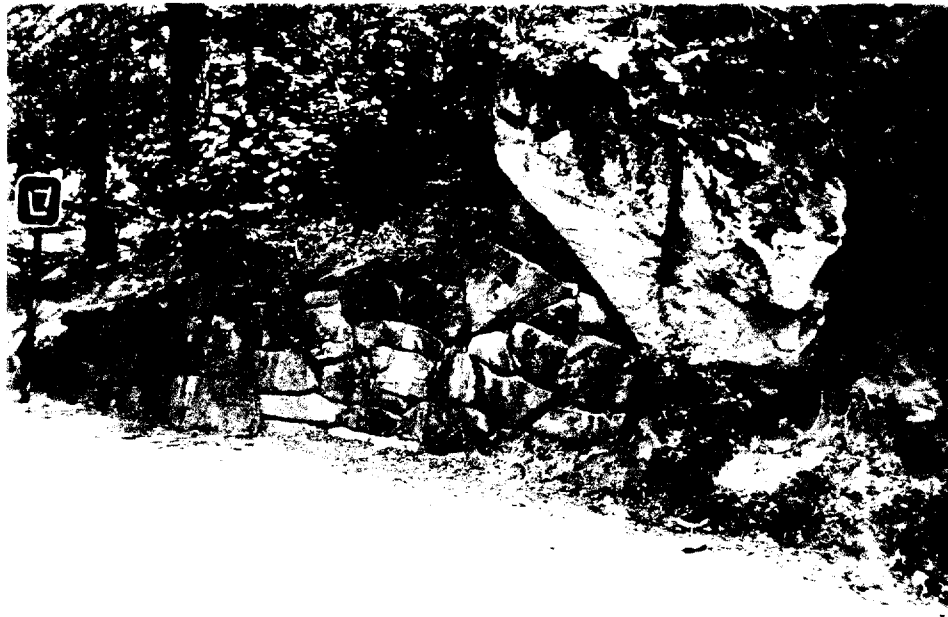
Photograph No. 29 -- Big Fern Spring rock work along upslope side of highway; watering station at left (6.95 miles below Giant Forest Market)

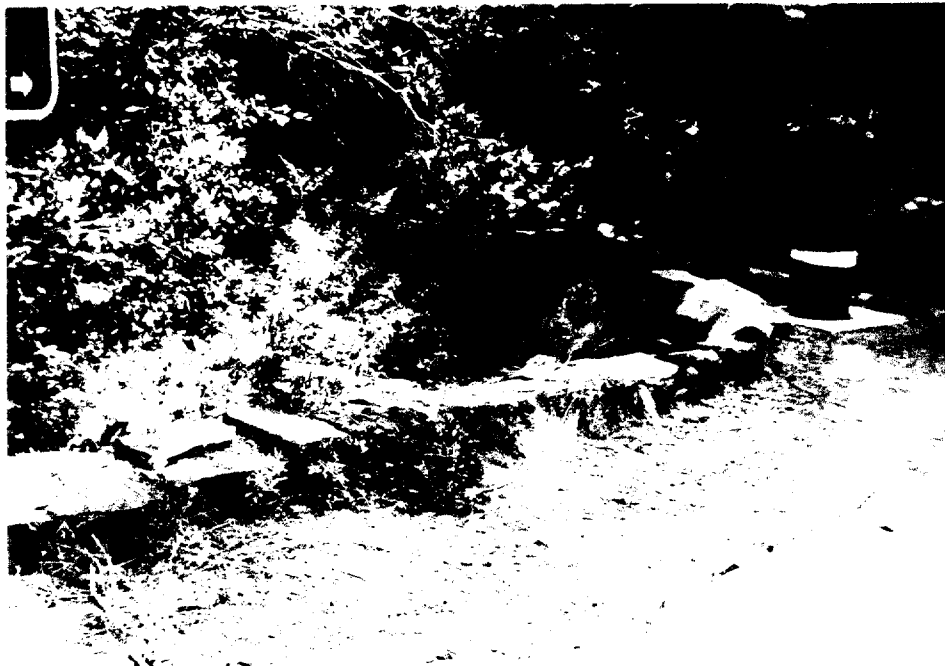
Photograph No. 30 -- Big Fern Spring rock work along upslope side of highway with short trail to spring in background (6.95 miles below Giant Forest Market)

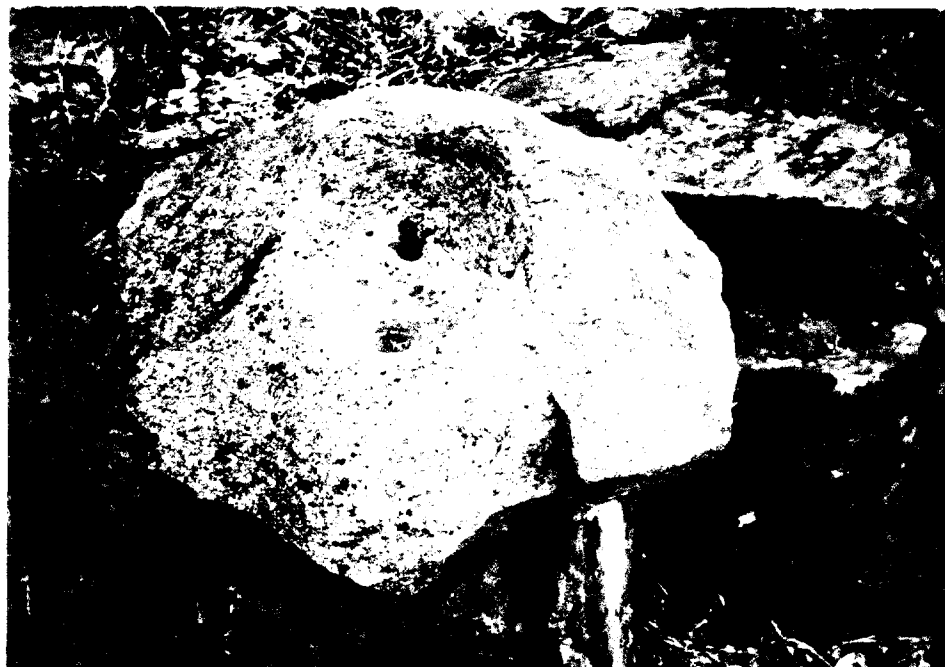
Photograph No.32 -- Big Fern Spring stone water fountain on upslope side of highway (6.95 miles below Giant Forest Market)

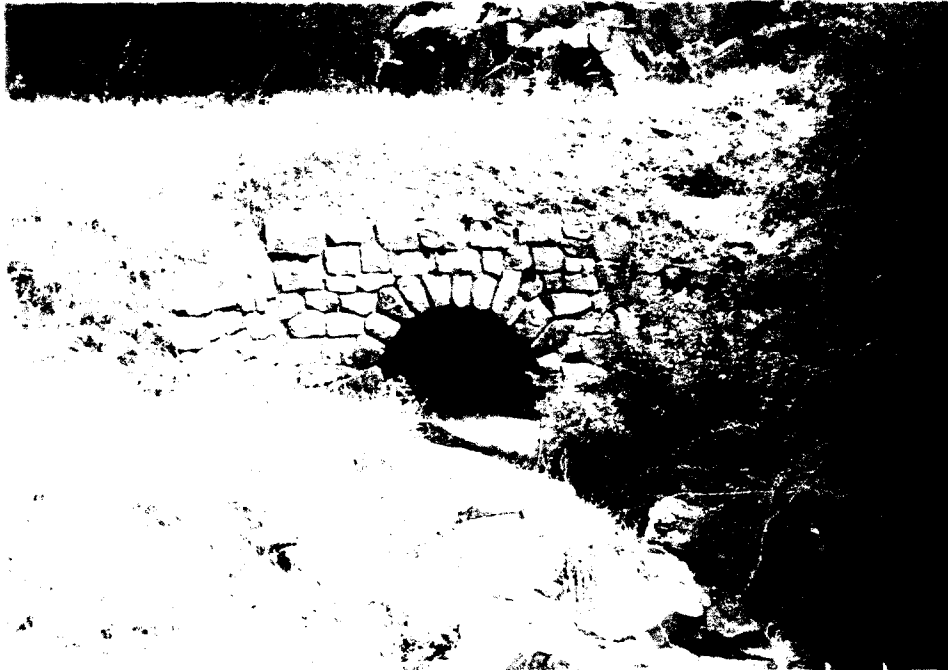
Photograph No. 33 -- Double stone culvert
headwalls on S-curve along highway
(7.95 miles below Giant Forest Market)

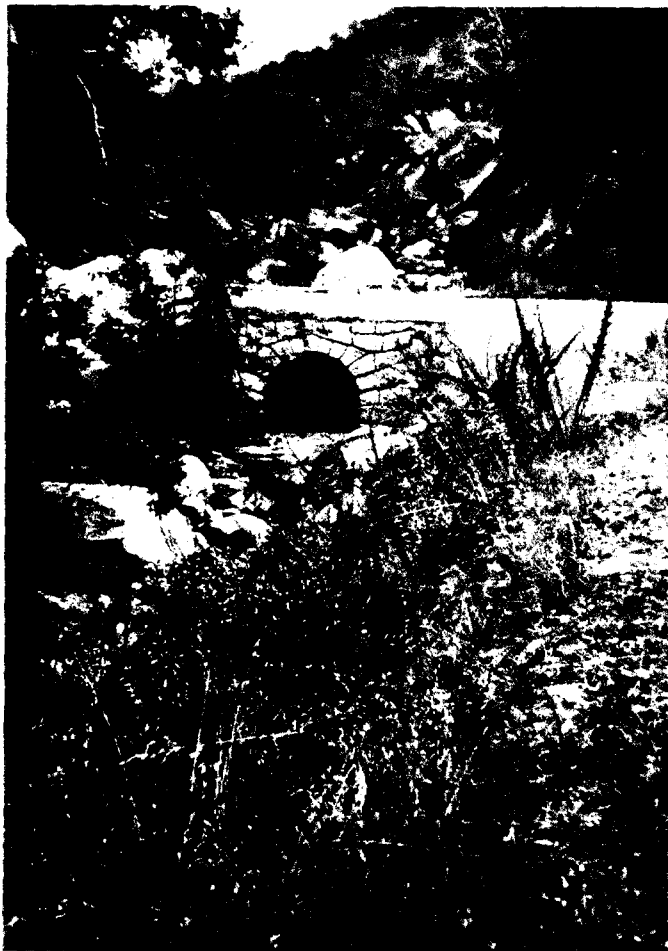
Photograph No. 38 -- Double stone culvert headwalls
on S-curve along highway
(10.15 miles below Giant Forest Market)

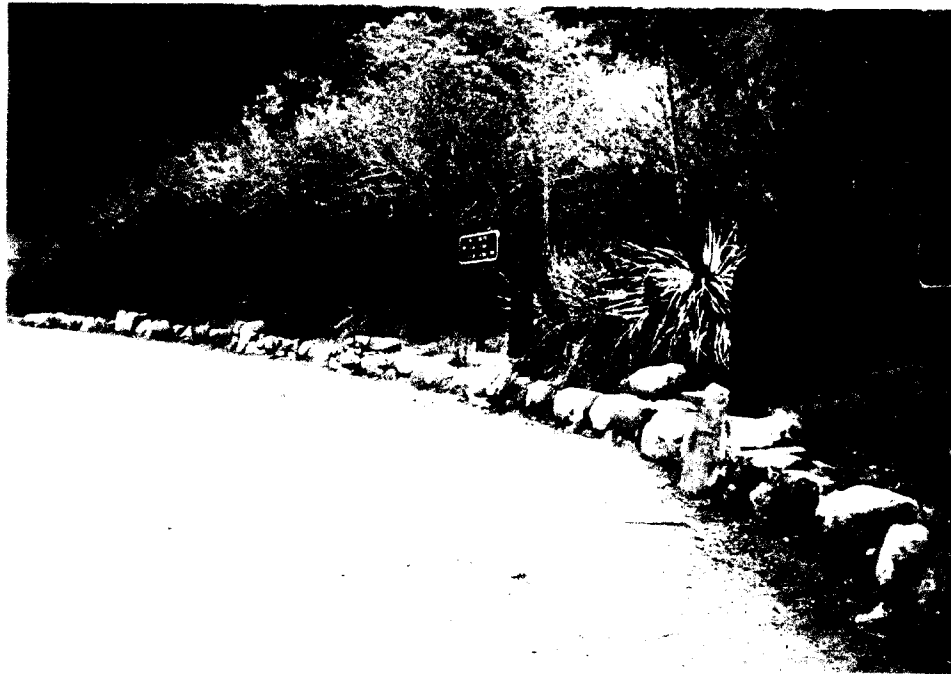
Photograph No. 39 -- Hospital Rock stone curbing and
five-post watering station along upslope side of highway
(10.25 miles below Giant Forest Market)

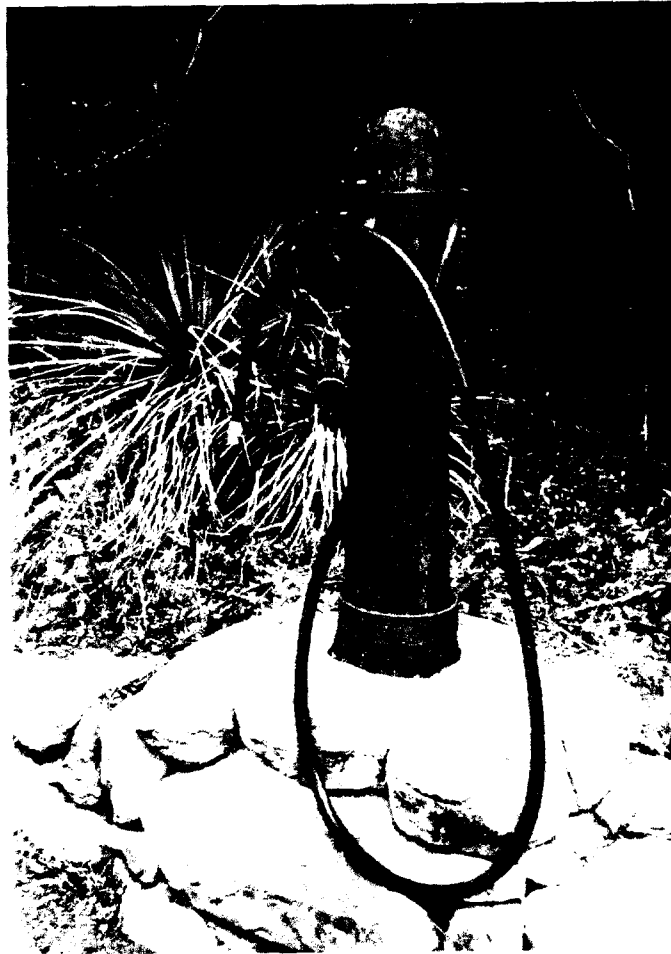
Photograph No. 40 -- Close-up of Hospital Rock watering station
post and curbing along upslope side of highway
(10.25 miles below Giant Forest Market)

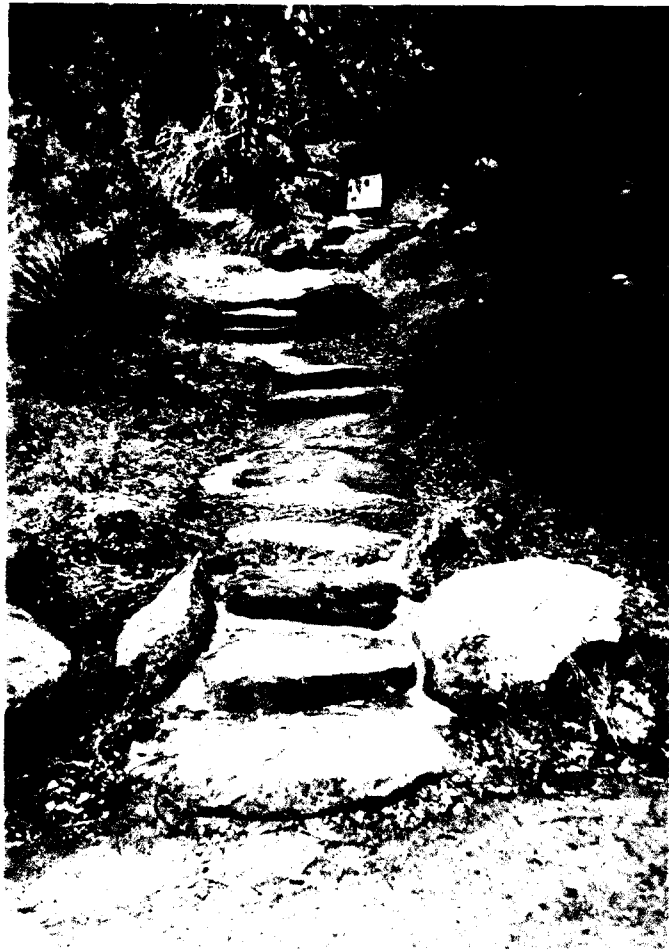
Photograph No. 41 - Hospital Rock stone drinking
fountain along upslope side of highway
(10.25 miles below Giant Forest Market)

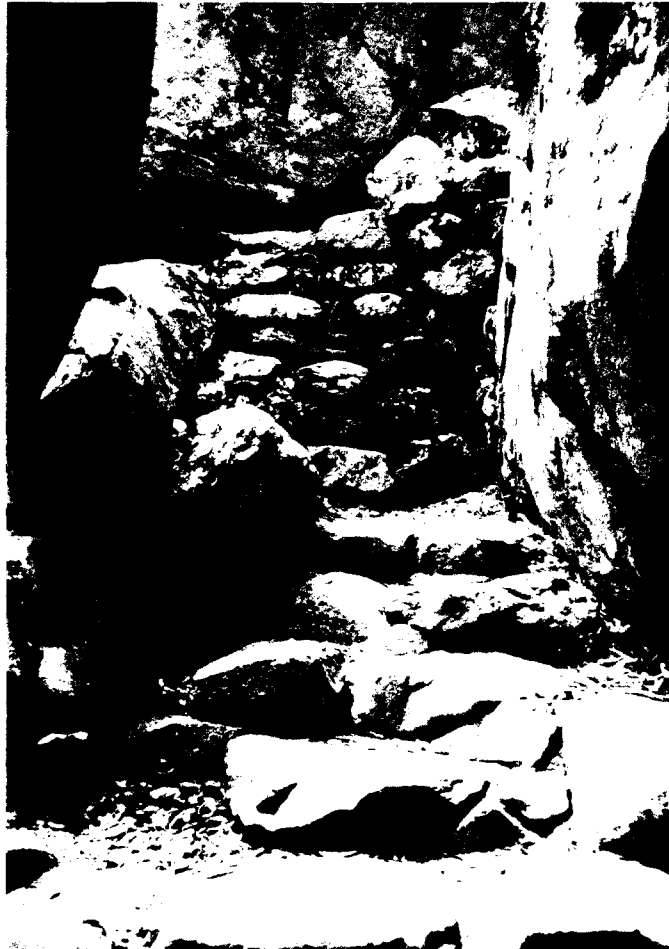
Photograph No. 43 -- Cut stone steps leading to exhibits
along upslope side of highway at Hospital Rock
(10.25 miles below Giant Forest Market)

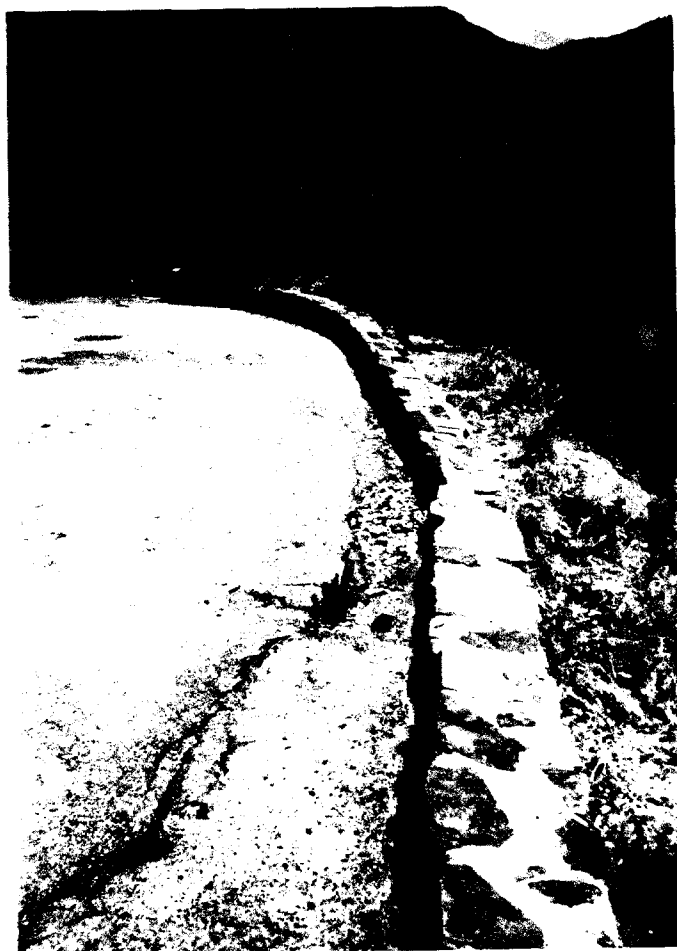
Photograph No. 45 -- Buckeye Flat Camp Road stone retaining wall and parapet wall curbing near Hospital Rock (10.25 miles below Giant Forest Market)

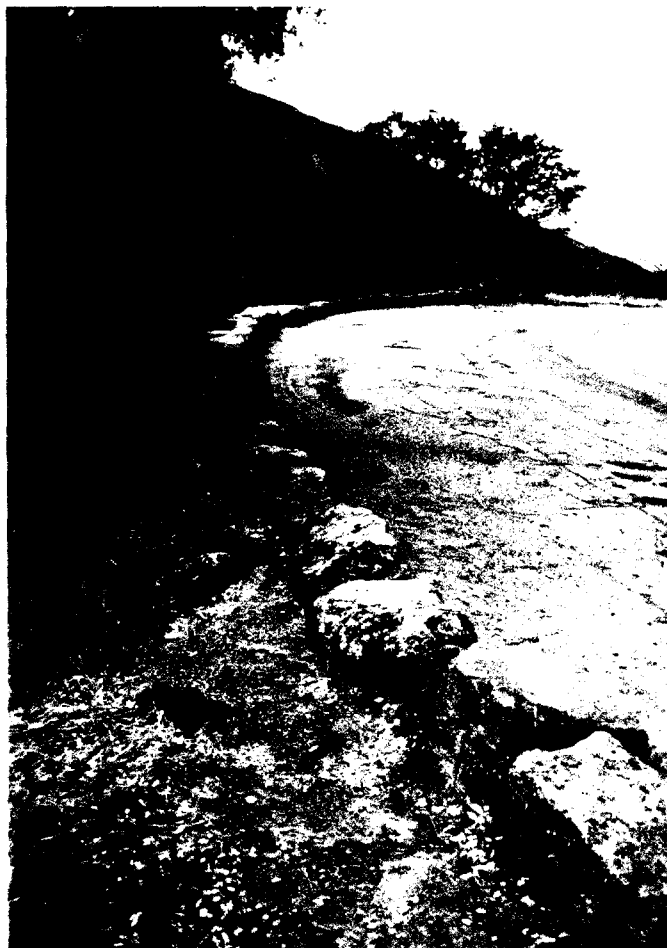
Photograph No. 46 -- Mt. Stewart turnout parapet
wall along downslope side of highway
(11.0 miles below Giant Forest Market)

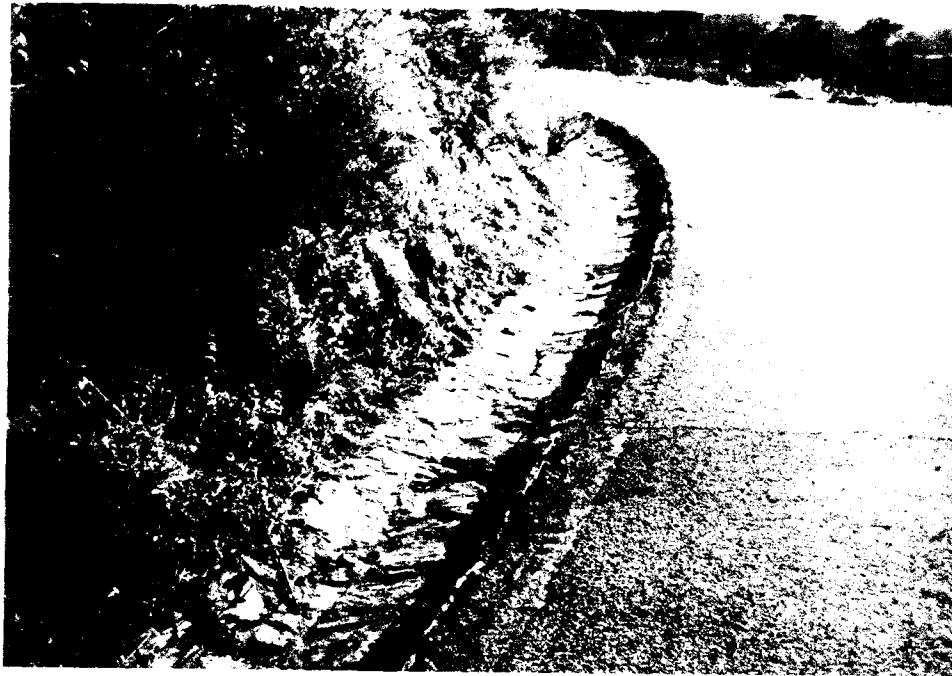
Photograph No. 51 -- Stone steps
leading to top of Tunnel Rock
(13.9 miles below Giant Forest Market)

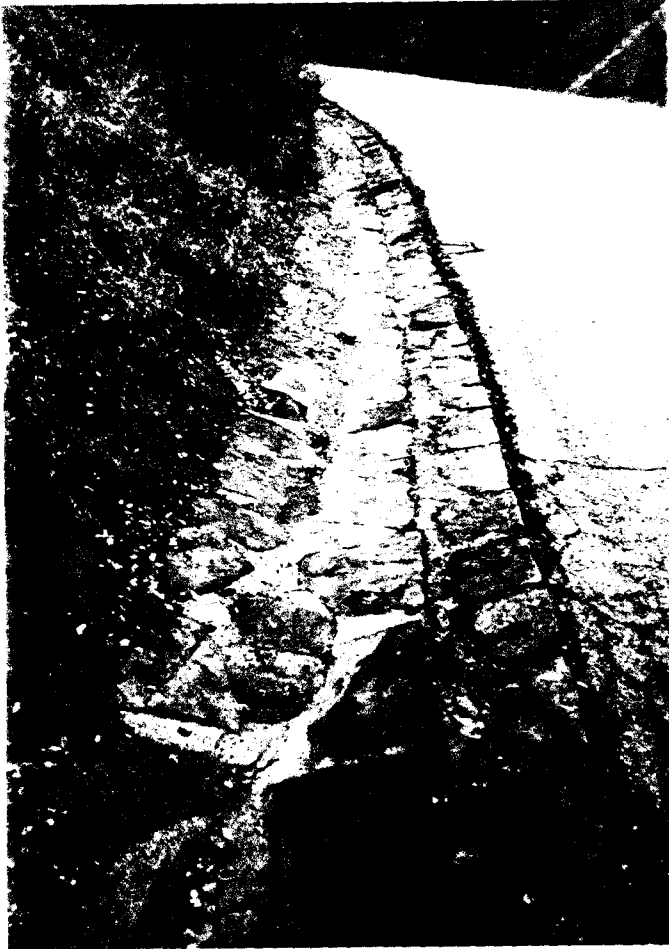
Photograph No. 52 -- Stone-lined gutter on upslope
side of highway near Ash Mountain
(15.1 miles below Giant Forest Market)

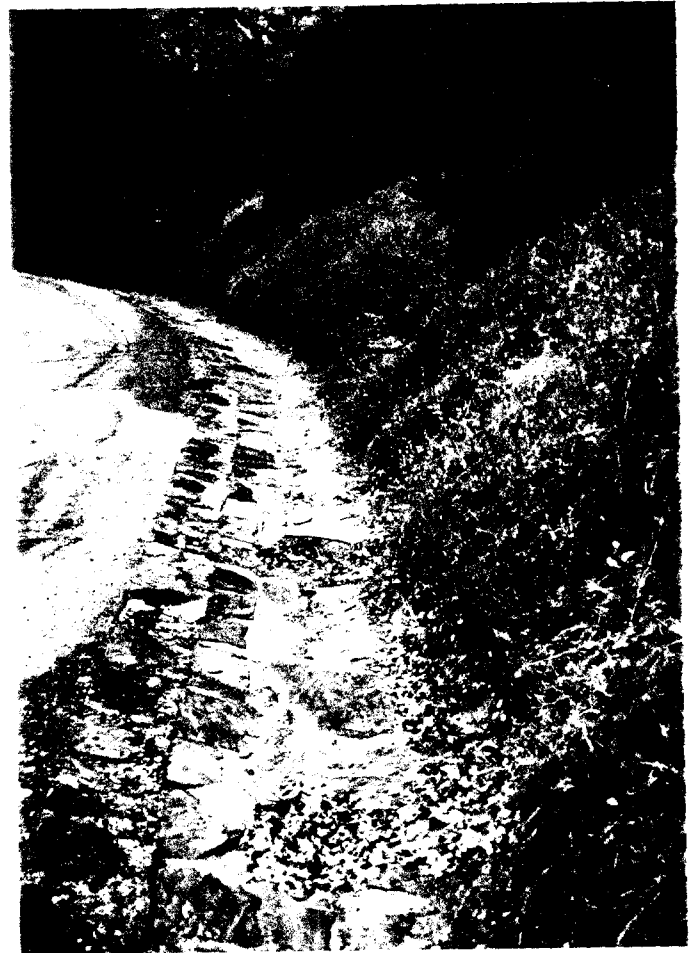
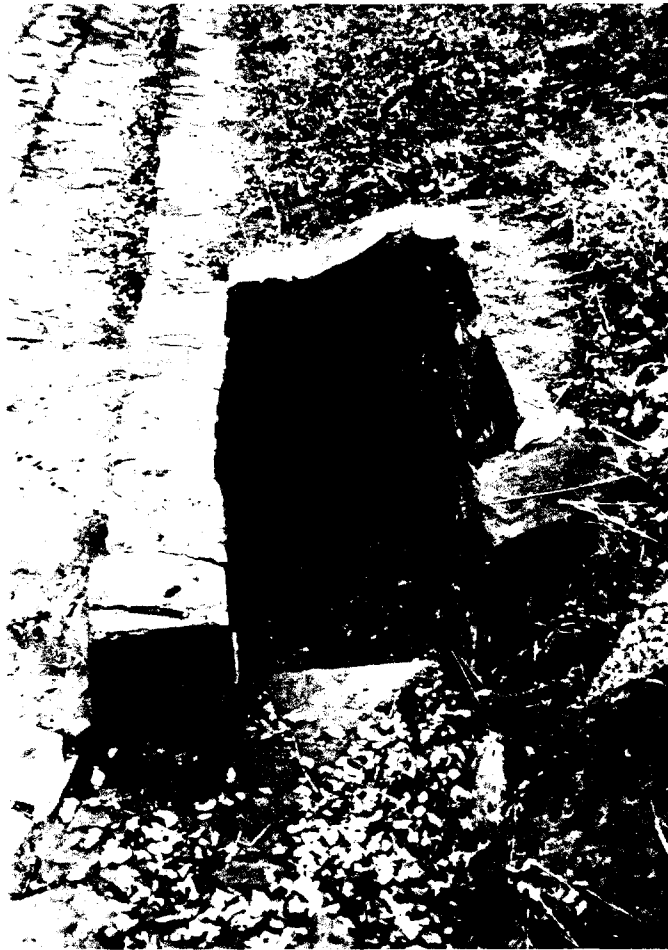
Photograph Nos. 53 and 54 -- Stone-lined gutter on upslope
side of highway near Ash Mountain
(15.1 miles below Giant Forest Market)

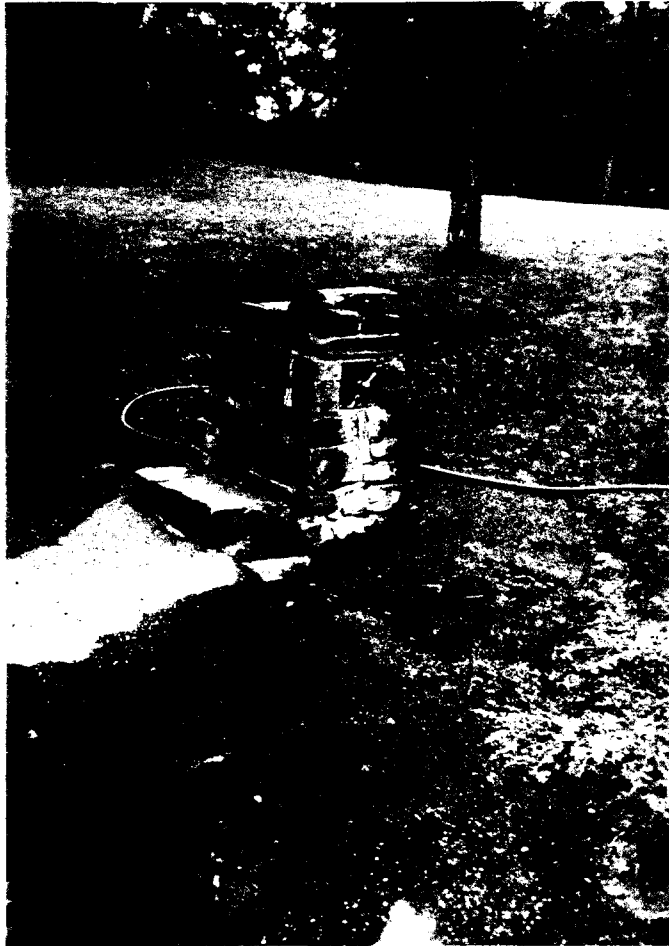
Photograph No. 55 -- Culvert and drain across
highway from Ash Mountain Visitor Center
(15.1 miles below Giant Forest Market)

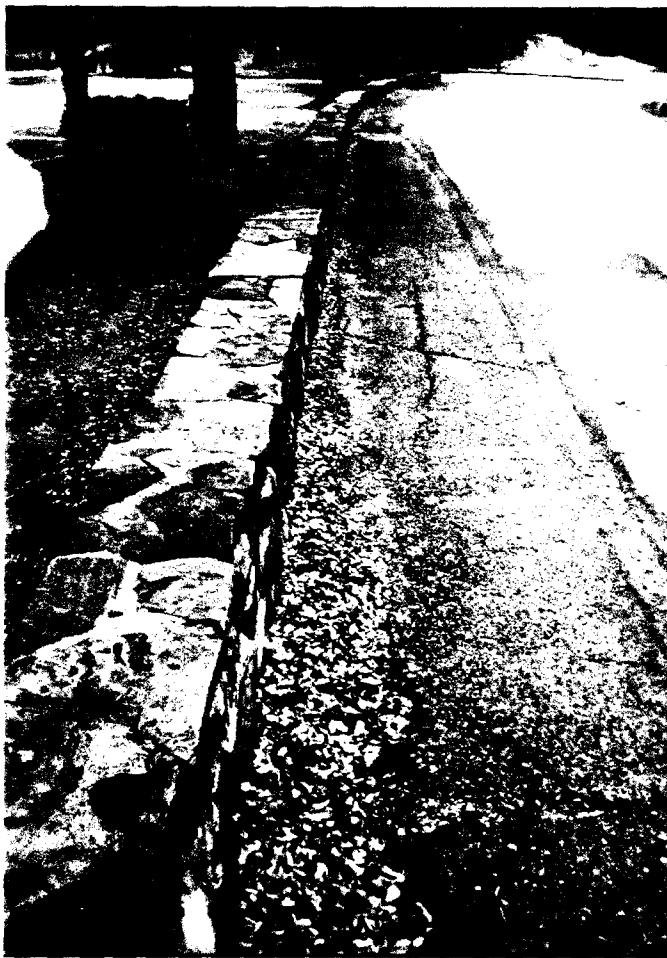
Photograph No. 57 -- Cut stone parapet wall in
front of Ash Mountain Visitor Center
(15.1 miles below Giant Forest Market)
