HISTORICAL OVERVIEW AND ASSESSMENT OF CIVILIAN
CONSERVATION CORPS ROCK WORK ALONG GENERALS HIGHWAY FROM
ASH MOUNTAIN TO GIANT FOREST IN SEQUOIA NATIONAL PARK

HARLAN D. UNRAU
HISTORIAN
WESTERN TEAM
DENVER SERVICE CENTER

AUGUST 1988

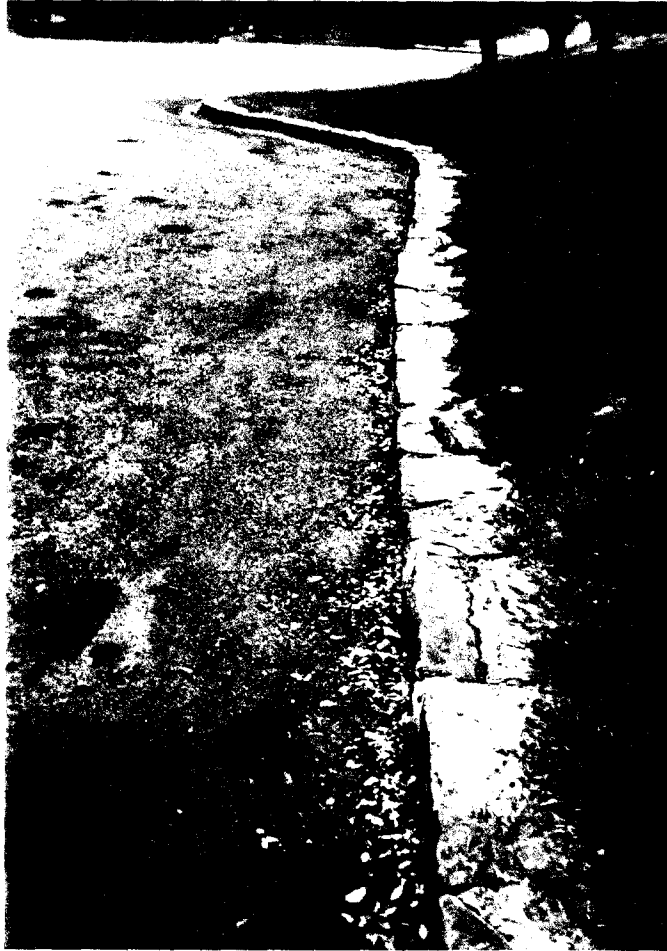
Photograph No. 58 -- Stone parapet wall along highway with
Ash Mountain Visitor Center parking lot in upper left
(15.1 miles below Giant Forest Market)

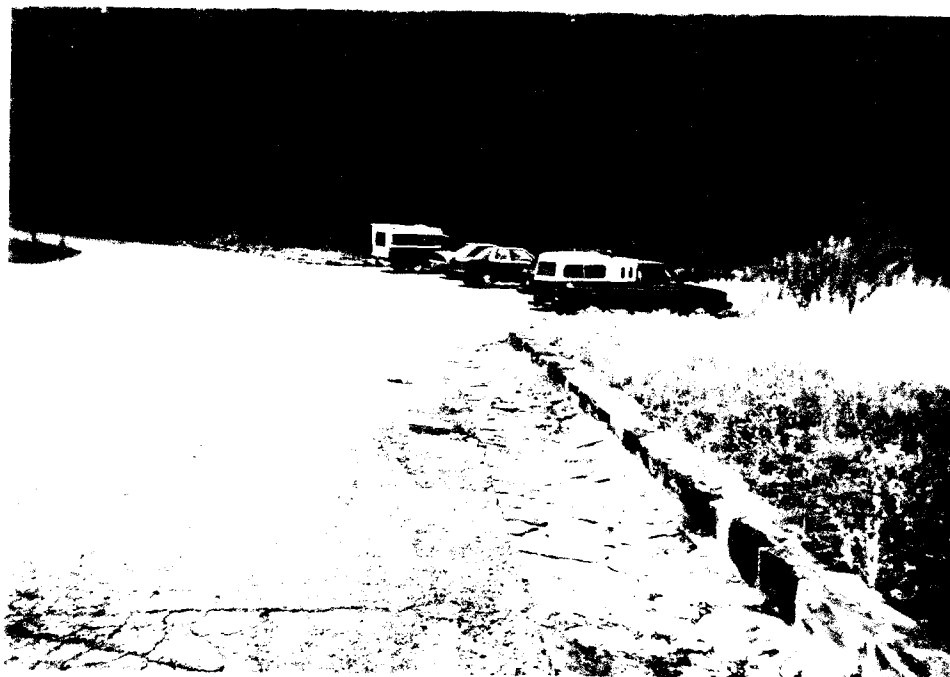
Photograph No. 59 -- Stone curbing on turnout along highway
across from Ash Mountain Visitor Center
(15.1 miles below Giant Forest Market)

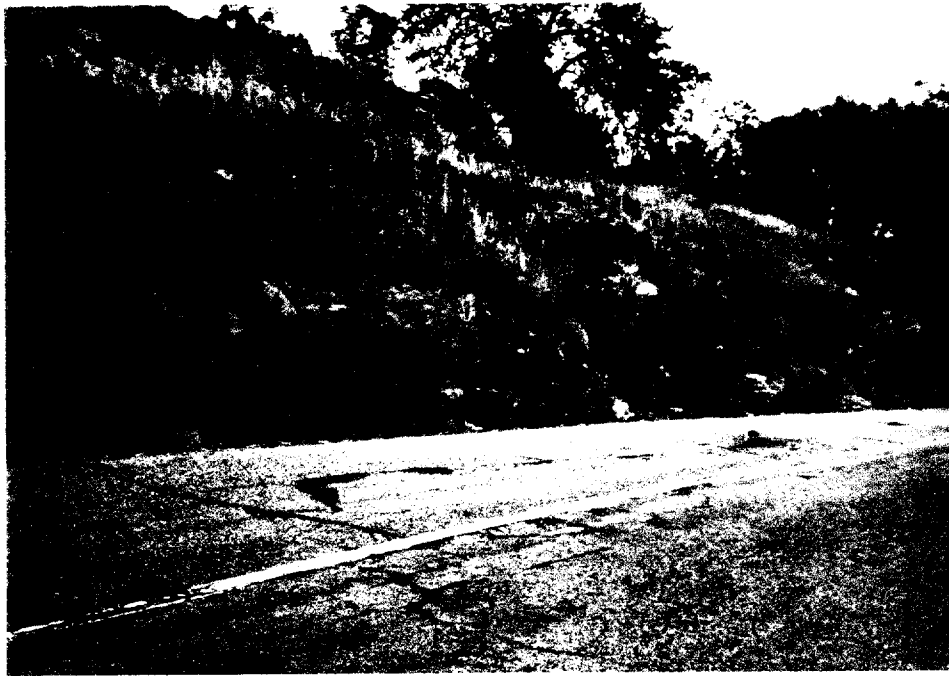
Photograph Nos. 62 and 63 -- Stone culvert and drain along upslope side
of highway between Ash Mountain and south park entrance
(15.75 miles below Giant Forest Market)

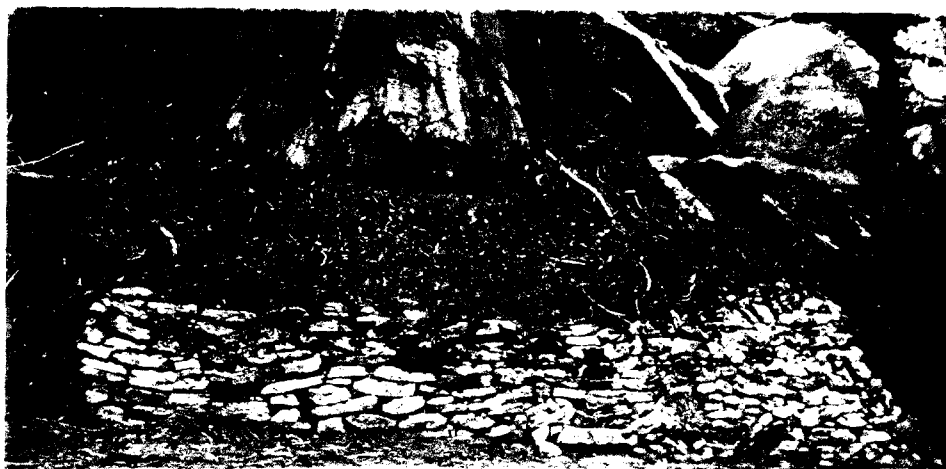
Photograph No. 58 -- Stone retaining wall along upslope side of highway to protect Sequoia tree (1.8 miles above Giant Forest Market)

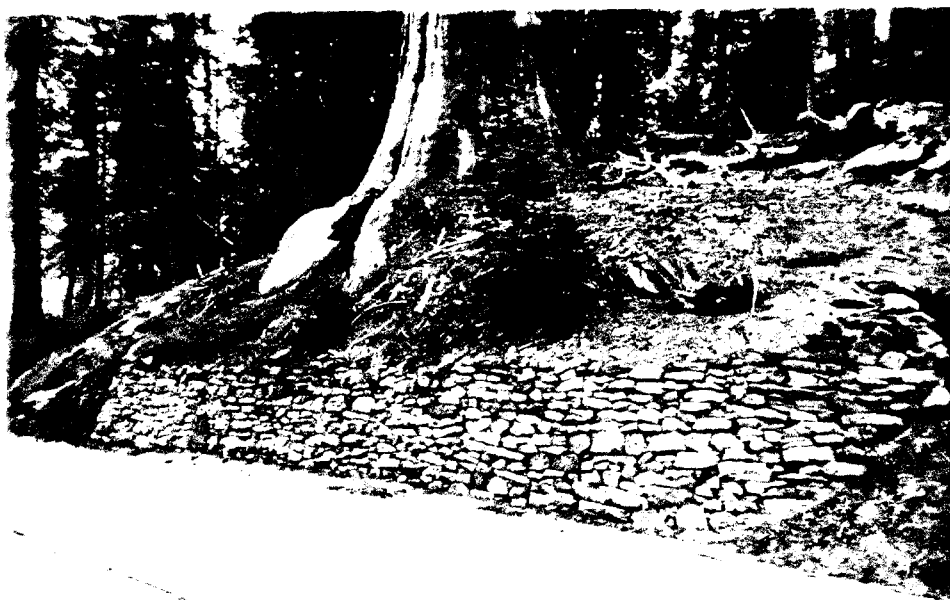
Photograph No. 69 -- Loose rock retaining wall along upslope side of highway to protect Sequoia tree (1.85 miles above Giant Forest Market)

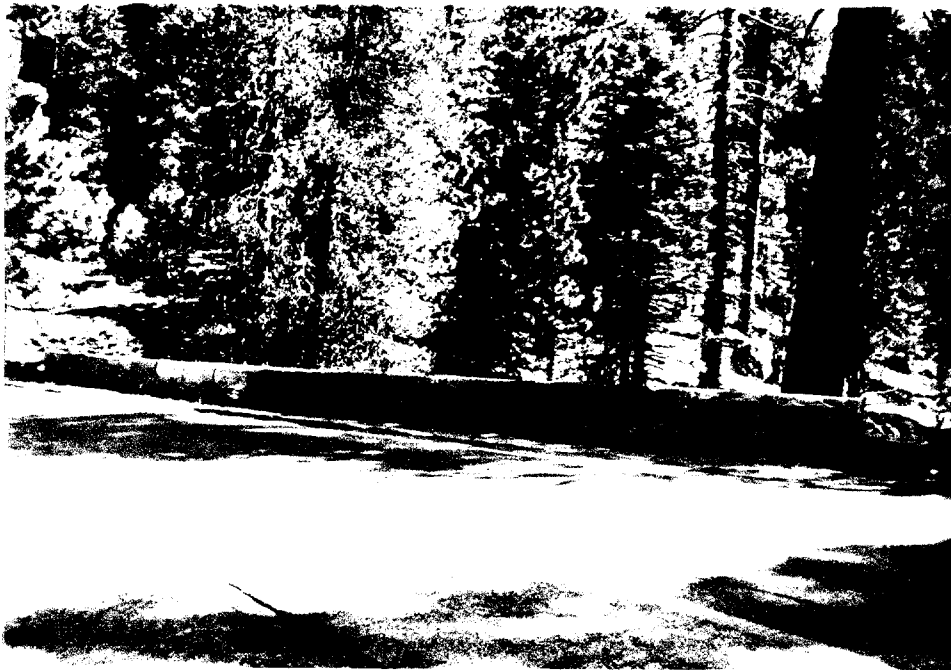
Photograph No. 72 -- Wolverton Creek culvert
along upslope side of highway

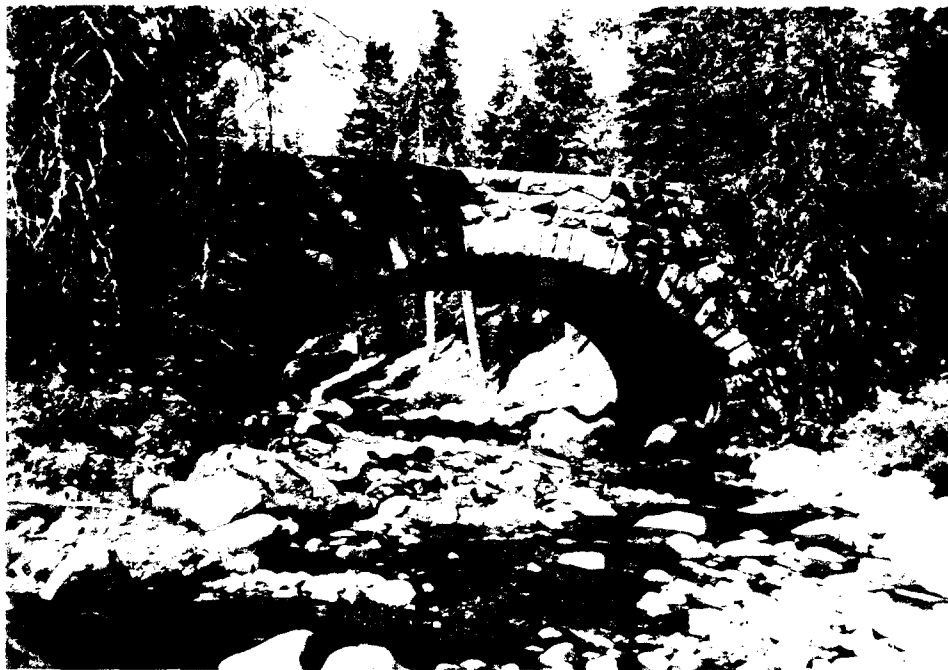
Photograph No. 74 -- Masonry rock parapet wall on bridge over
Marble Fork of Kaweah River on upslope side of highway

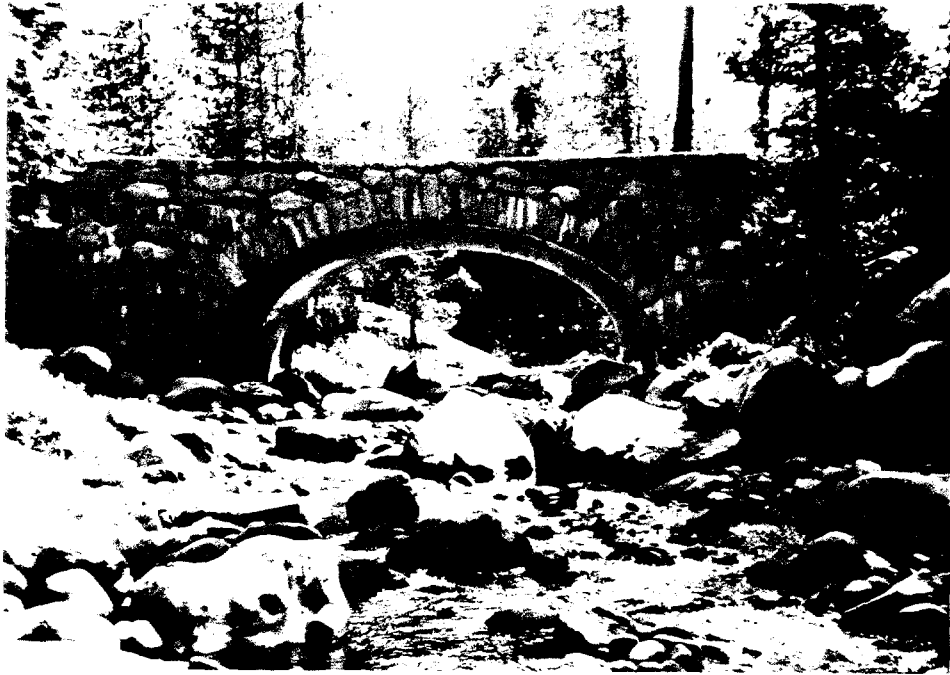
Photograph No. 75 -- Stone bridge over Marble Fork
of Kaweah River looking upstream

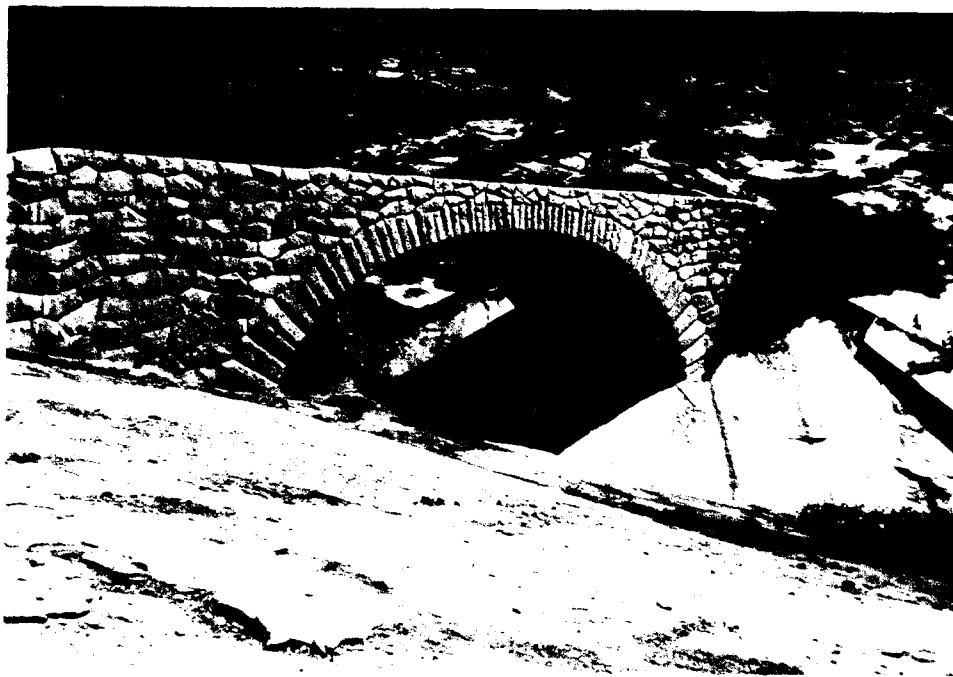
Photograph No. 78 -- Stone masonry culvert; upstream side
(4.55 miles above Giant Forest Market)

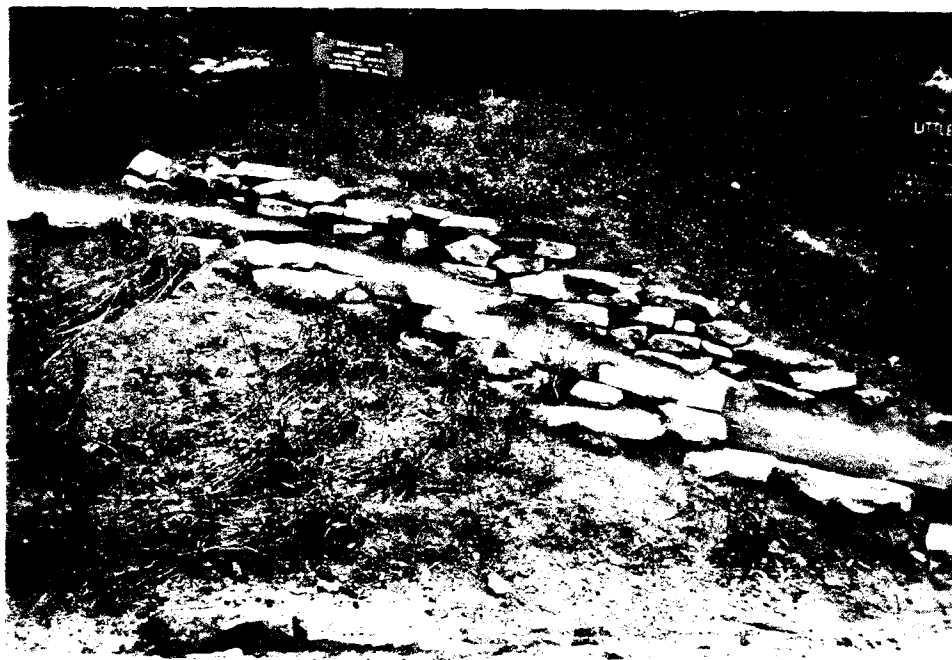
Photograph No. 85 -- Rock-lined Little Baldy trail
head along upslope side of highway

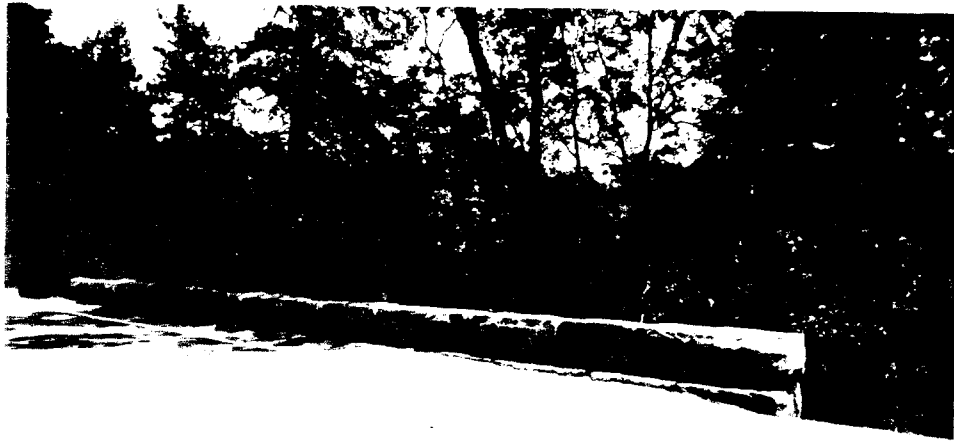
Photograph No. 88 -- Sierra View Overlook
exhibit on stone work foundation

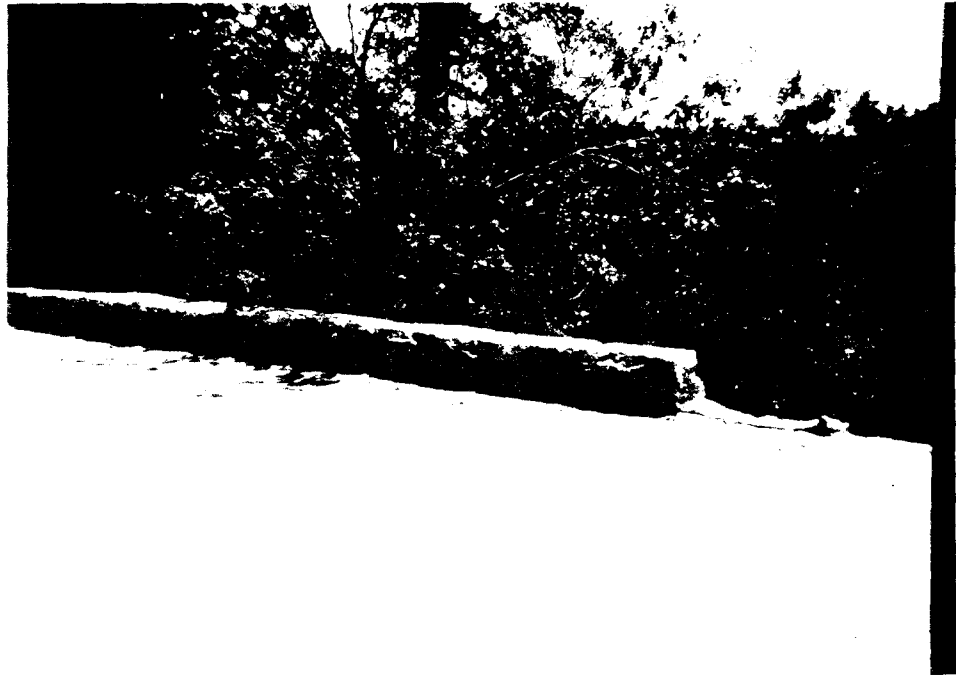
Photograph No. 90 -- Masonry retaining wall which is topped by Photograph No. 89

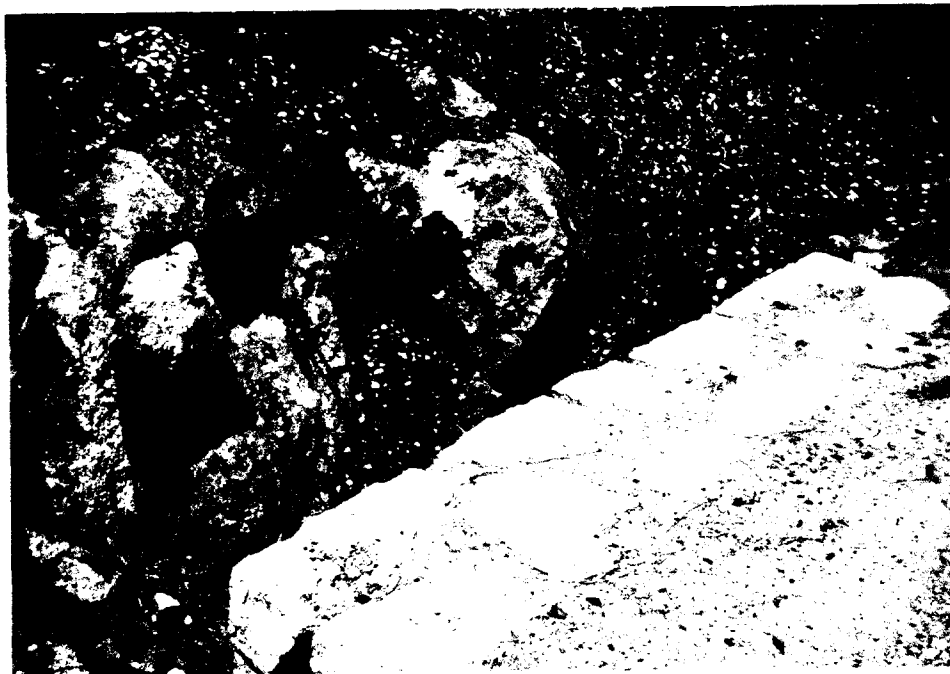
Photographs Nos. 95 and 96 -- Stone culvert and drain along upslope side of highway just above Redwood Mountain Grove turnout
