Cable Insulation Resistance Measurements Made During Cable Fire Tests

**U.S. Nuclear Regulatory Commission
Office of Nuclear Regulatory Research
Washington, DC 20555-0001**

Manuscript Completed: April 2002
Date Published: June 2002

Prepared by
F. J. Wyant, S. P. Nowlen

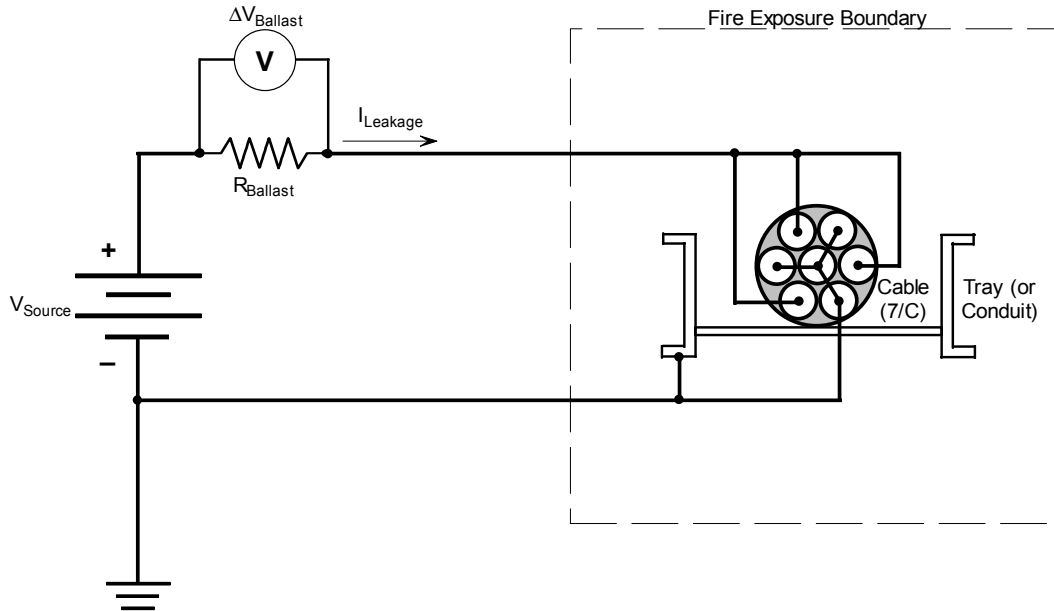
Figure 2-3. A single voltage source system applied to a multiconductor cable without a switching system. Note that the individual conductors are ganged into two groups, one energized and the second grounded. IR is determined for the energized conductors only, and then only as a group.

A slight variation on this general approach is to energize a subset of conductors while grounding the rest. That is, in a seven-conductor cable, one might choose to energize three conductors while grounding the other four. In this case, the leakage current path would be from any of the conductors in the energized set directly to ground or to any one of the grounded conductors. Typically, the selection of the energized conductors would be based on the physical configuration of conductors within the cable. The energized conductors would be selected so that, to the extent possible, each physically adjacent conductor pair would involve one energized and one grounded conductor. This approach was used in a number of past cable fire testing programs and is illustrated in Figure 2-3 for a seven-conductor cable.

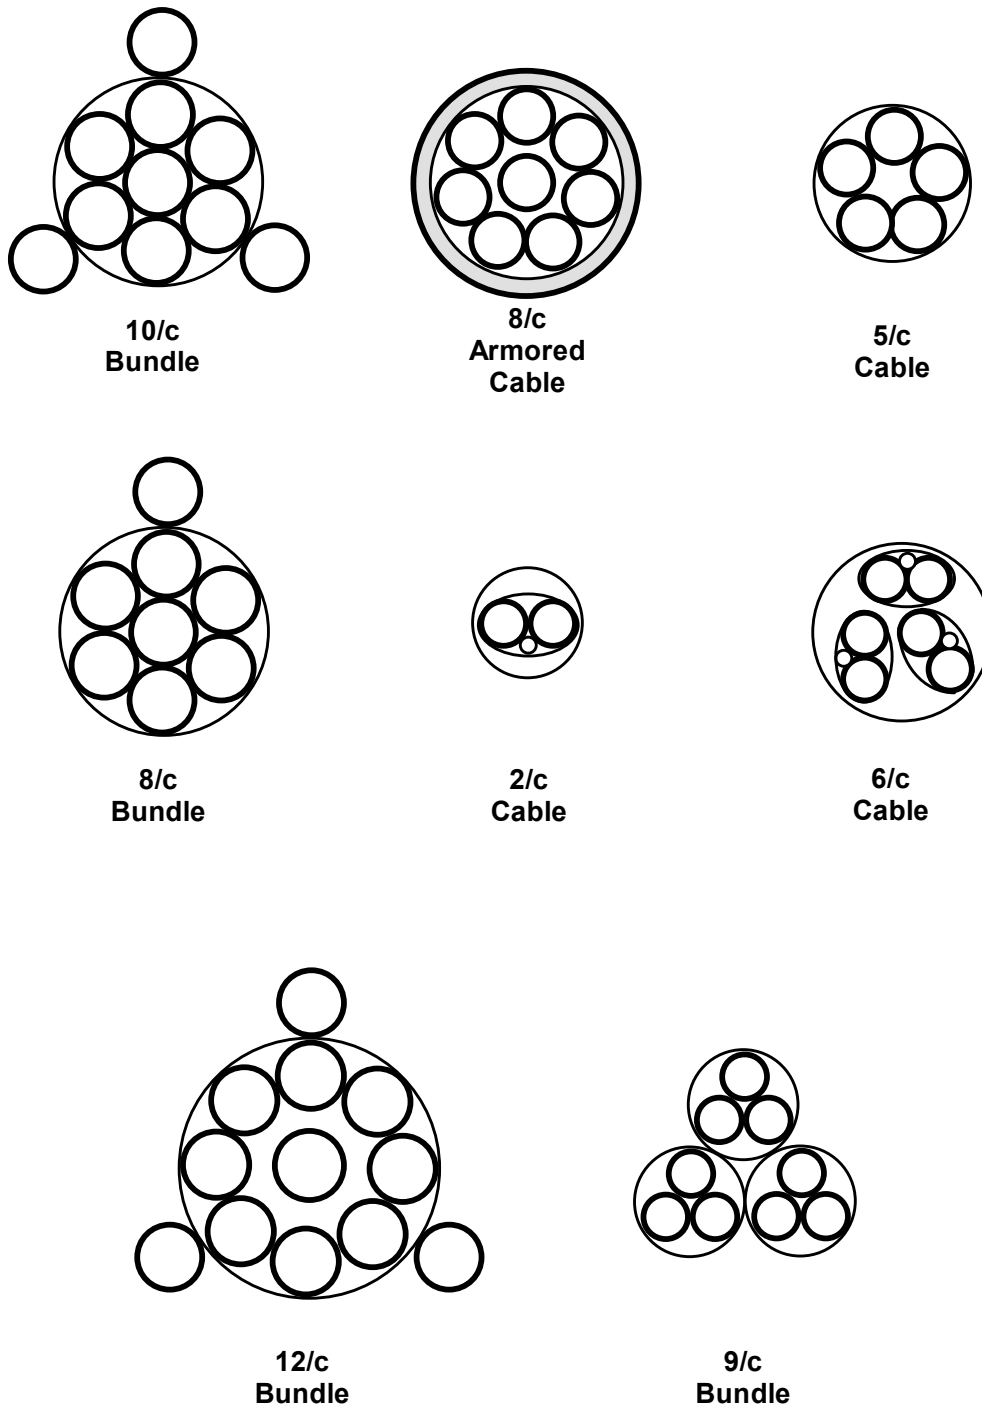
Figure 3-8. Cross-sectional views of the various cable bundle configurations tested using the IR measurement system.

For nine of the 18 tests conducted, the IR measurement system was connected to a 10-conductor test bundle, as described above (see also Figure 3-8). For the other tests, the test cable consisted of one of the following cable designs: two tests monitored a single eight-conductor armored cable, one test monitored two five-conductor cables (not collocated in the same raceway), one test monitored an eight-conductor cable, one test monitored IR for two separate instrument cables (one two-conductor cable and one six-conductor), two tests monitored a 12-conductor bundle, and two tests monitored a bundle of three three-conductor cables (a 9/C bundle).

Figure 5-2 shows the IR occurring between Conductor 1 and each of the other conductors in the IR cable. Conductor 1 was the center conductor in the cable and the other seven conductors surrounded Conductor 1 (see Figure 3-8 for an illustration of the cable configuration). Conductor 9 shown in the plot is the armor shield that surrounded all of the conductors (a spiral-wound metal band much like a flexible metal conduit).

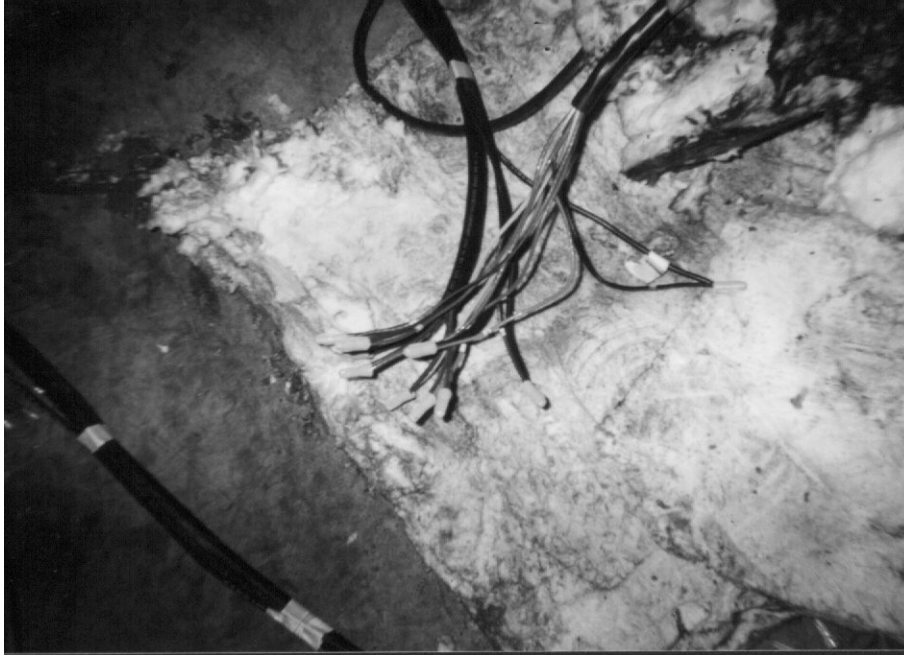
Figure 3-11. IR measurement system “in” wiring harness connection to the test cable bundle.

Connection of the wiring harnesses to the test cable was accomplished using commercially-available wire nuts (see Figure 3-11). It is important that each end of a specific conductor in the test cable be connected to the corresponding conductors in both wiring harnesses. For example, the conductors marked “1” in each wiring harness needed to be connected to the ends of the same conductor in the test cable. This also applied to the conductors marked “2” through “10” in the harnesses. Proper connections are checked by performing a continuity check of the pairs of harness conductors at the patch panel ends of the wiring harnesses.

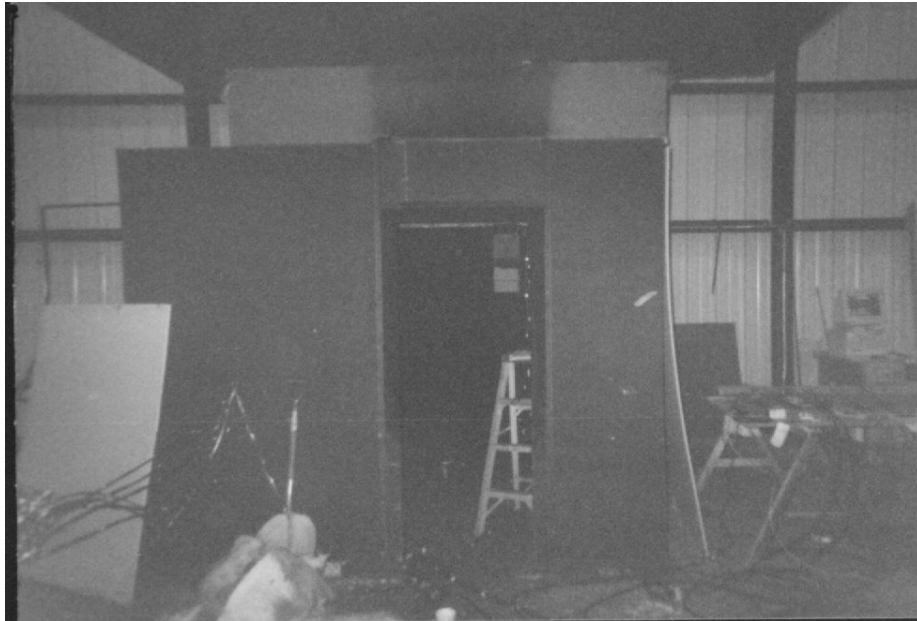
Figure 4-1. Fire test cell.

All of the 18 fire tests described here were conducted in a steel chamber measuring 3 m (10 ft) wide, 3 m (10 ft) deep, and 2.4 m (8 ft) high, shown in Figure 4-1. The chamber has an opening (door) ~76 cm (30 in.) wide by 2.1 m (7 ft) high in the center of one wall. The exposure fire was generated by flowing propane gas through a 30 cm (12 in.) × 30 cm (12 in.) diffusion burner (a “sand burner,” see Figure 4-2). The fire intensity was controlled by the flow rate of the propane through the burner and ranged from 70 to 350 kW.

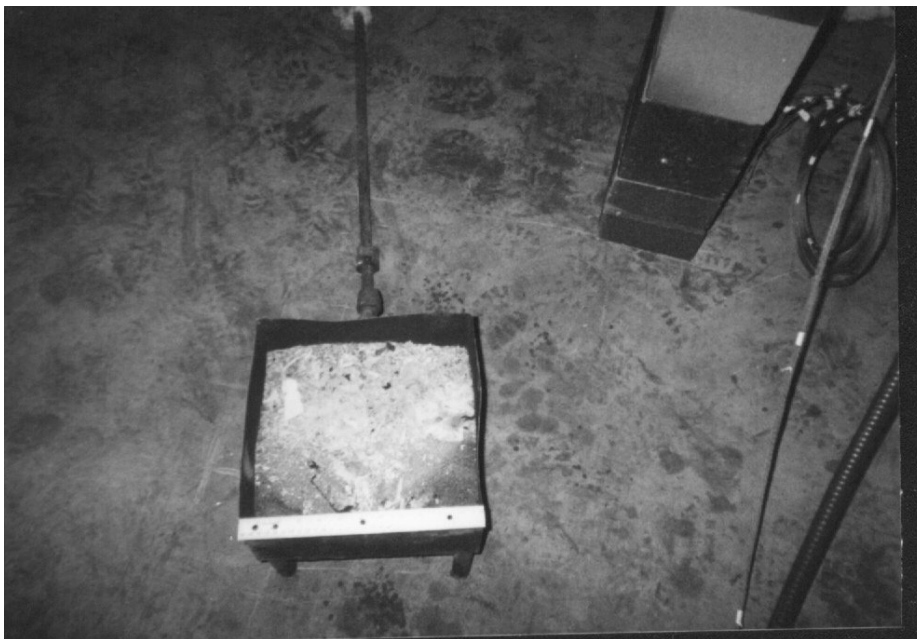
Figure 4-2. Diffusion burner—30 cm × 30 cm (12 in. × 12 in.).

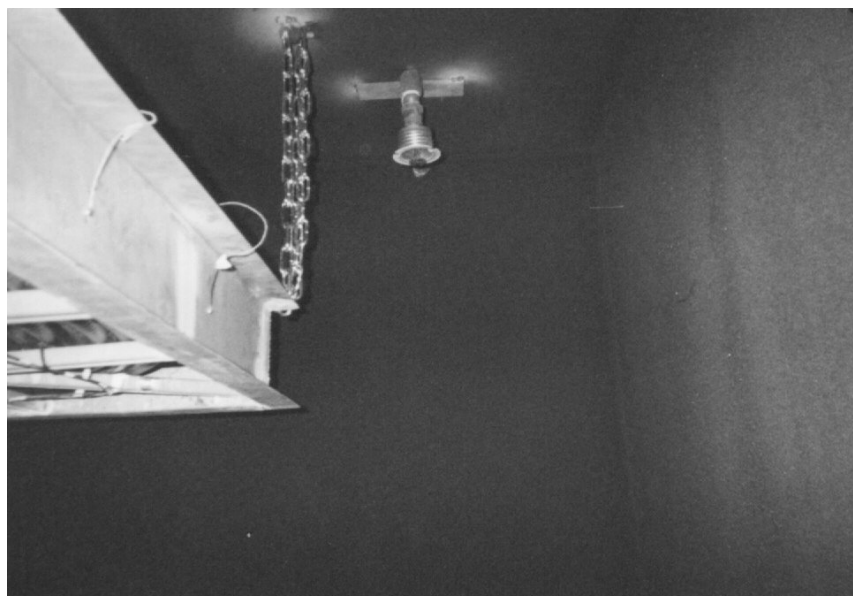
Figure 4-7. Water sprinkler head inside fire test cell.

A water sprinkler head (Figure 4-7) was located in the top of the test cell to provide water spray at the corner of the tray after the flame had been extinguished. The water spray was conducted for one minute at the end of most tests.

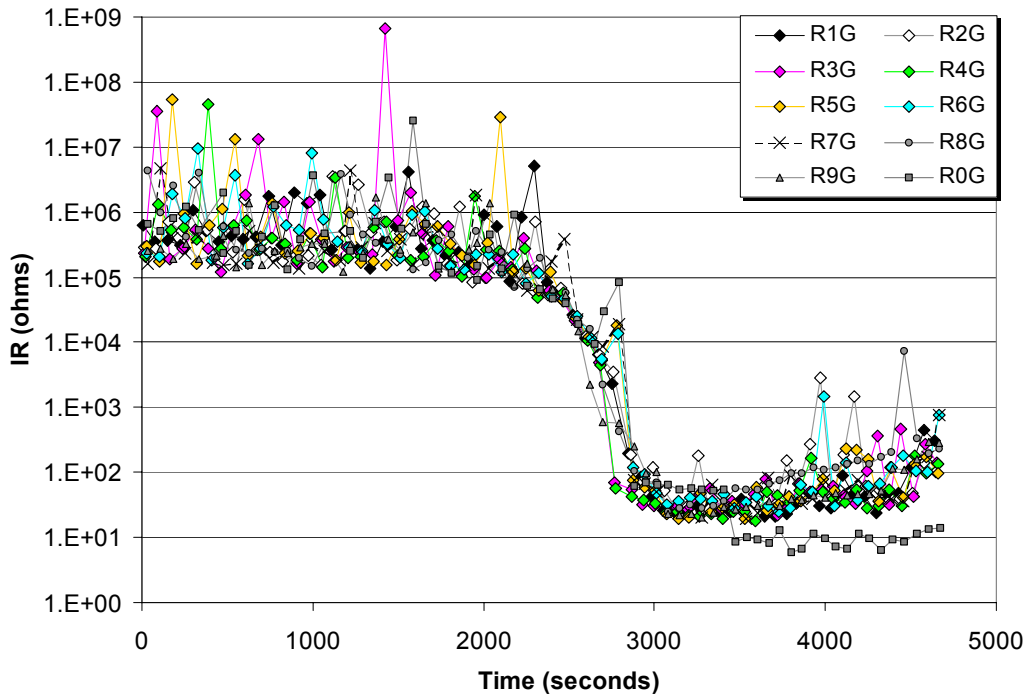
Figure 5-11. Conductor-to-ground IRs obtained during Test 3.

The IR change over time of the individual conductors to ground is shown in Figure 5-11. Here it appears that the effect of the 145 kW fire causes a very smooth transition to a lower IR to ground during the time between 1700 and 3000 seconds. It also appears that a very limited amount of IR recovery occurs at the very end of the test run, possibly due to the cooling effect of the water spray.

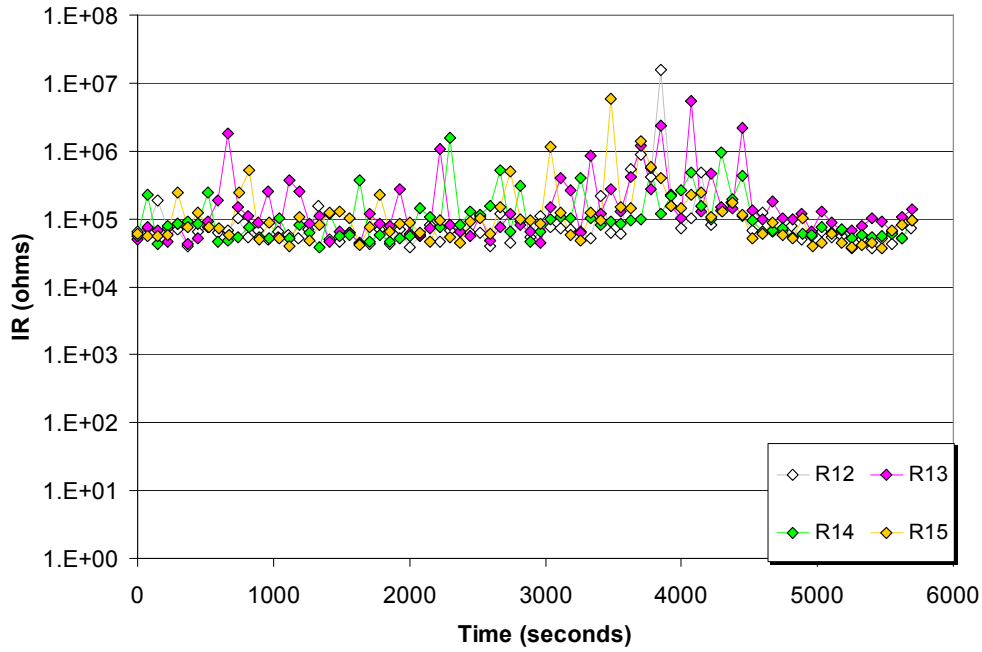
As Figure 5-31 shows, none of the conductors for the IR cable located in the tray appear to suffer significant degradation. The IR between Conductor 1 and the other conductors in the cable (2–5) remained at about $10^5 \Omega$ throughout the test.

Figure 5-31. Representative conductor-to-conductor IRs for cable IR1 in the cable tray during Test 8. This plot shows the IR between Conductor 1 to the other four conductors in the cable located in the tray during the test.
