**Controlled Flight Into Terrain  
Era Aviation  
Sikorsky S-76A++, N579EH  
Gulf of Mexico, About 70 Nautical Miles  
South-Southeast of  
Scholes International Airport, Galveston, Texas  
March 23, 2004**

**Aircraft Accident Report**

**NTSB/AAR-06/02**

The National Transportation Safety Board determines that the probable cause of this accident was the flight crew's failure to identify and arrest the helicopter's descent for undetermined reasons, which resulted in controlled flight into terrain.

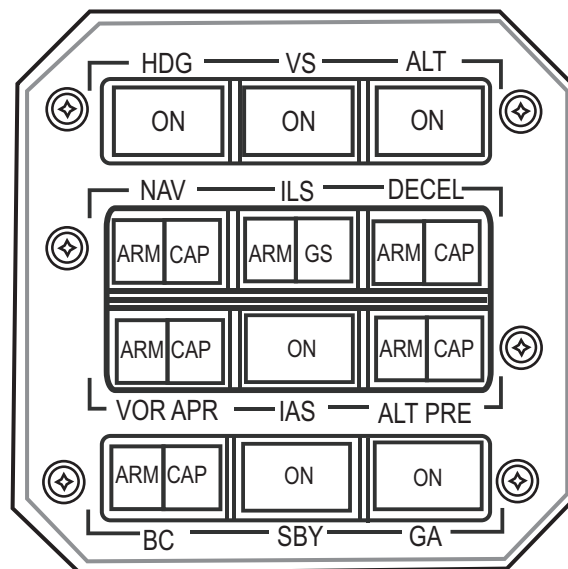
**Figure 3.** Flight Director Mode Selector

The command cues that are presented on the ADIs generally correspond to the selected flight director modes, which include heading (HDG), vertical speed (VS), altitude (ALT), navigation (NAV), altitude preselect (ALT PRE), and standby (SBY). Figure 3 shows the flight director mode selector, which is located on the front instrument panel (as shown by numbers 4 and 6 in figure 1).

Note: Other buttons on the flight director mode selector are ILS, instrument landing system mode; DECEL, deceleration mode; VOR APR, very high frequency omnidirectional range approach mode; IAS, indicated airspeed mode; BC, instrument landing system backcourse; and GA, go-around mode.

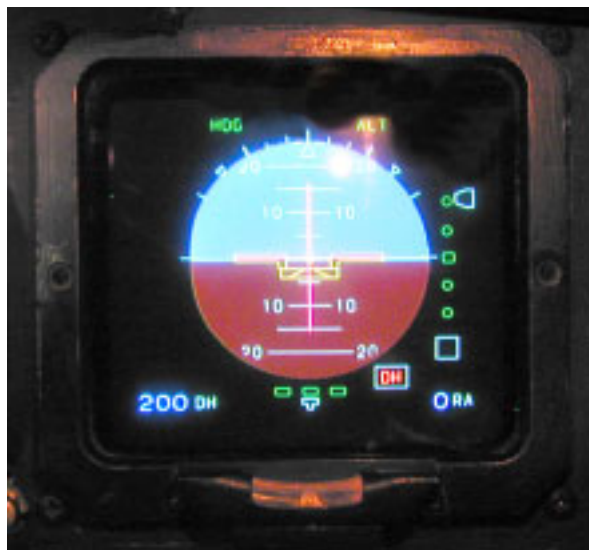
**Figure 5.** Indications of Descent on the Attitude Direction Indicator

flight crew. As shown in figure 5, the following indications of descent were seen on the pilots' ADIs during the scenarios:

- The radar altitude appeared in blue at the bottom right of the ADIs followed by an "RA" indication in white.
- The decision height was displayed in blue at the bottom left of the ADIs followed by a DH indication in white. A white square box appeared above the radar altitude (at the bottom right of the ADIs) when the helicopter was 100 feet above the decision height (based on the radar altimeter). When the decision height was reached, an amber DH indication appeared inside the box and remained there as the helicopter continued to descend.
- A yellow rising runway symbol appeared at the bottom center of the ADIs at 180 feet (based on the radar altimeter). As the helicopter's altitude decreased, this symbol ascended until it met the aircraft symbol at 0 feet.

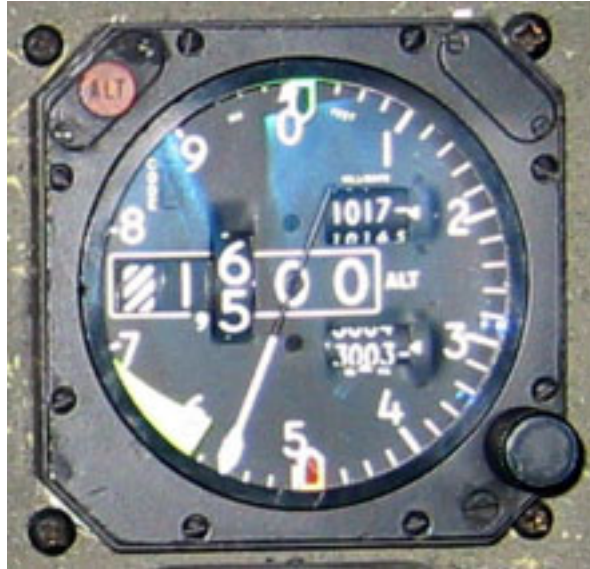
**Figure 6.** Altitude Alert Light

In addition, for one scenario, an altitude of 900 feet was selected on the air data command display (the AL-300).<sup>74</sup> At an altitude of 600 feet (300 feet below the preselected altitude), an amber altitude alert light at the top left of the barometric altimeters illuminated,<sup>75</sup> and a 1-second aural tone sounded over the pilots' headsets. The light remained illuminated for the rest of this simulation.<sup>76</sup> Figure 6 shows the amber altitude alert light on one of the simulator's barometric altimeters.

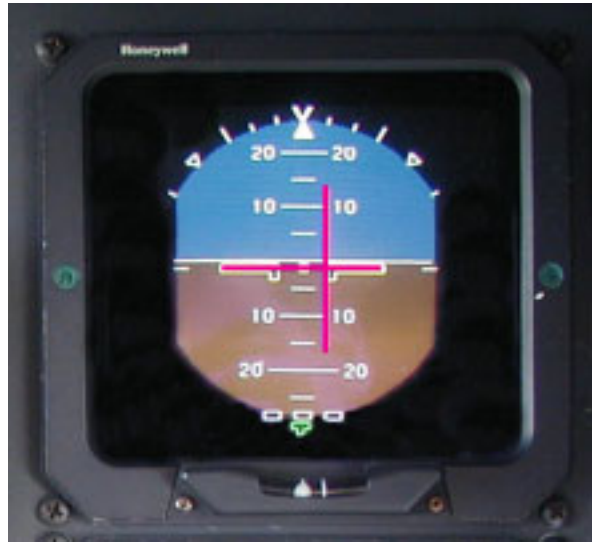
**Figure 7.** SPZ-7000 Dual-Cue Format

Both the SPZ-7000 and the SPZ-7600 have the capability to display pitch and roll command cues in either a dual- or a single-cue format. With the dual-cue format, pitch attitude is represented by a horizontal line, and roll attitude is represented by a vertical line, as shown in figure 7. With the single-cue format, angular bars integrate pitch and roll guidance, as shown in figure 8. When both pitch and roll commands are selected in either mode, the guidance provided by the command cues is intuitive and well understood by pilots who have been trained on either flight control system.

Also, both the SPZ-7000 and the SPZ-7600 have the capability for the pilot to select a command cue for only one axis, either pitch or roll, at a time. The displayed cue for the selected axis is functionally the same as when command cues for both axes are selected. However, depending on the system and the command cue format, the command cue for the unselected axis may or may not be displayed. In addition, no annunciation appears on the ADIs regarding the source of guidance for the unselected command cue presented in the SPZ-7000 dual- and single-cue formats and the SPZ-7600 single-cue format.
