High Lakes Stabilization Brown Duck and Island Lakes Technical Memorandum

Uinta Basin Replacement Project

January 2008

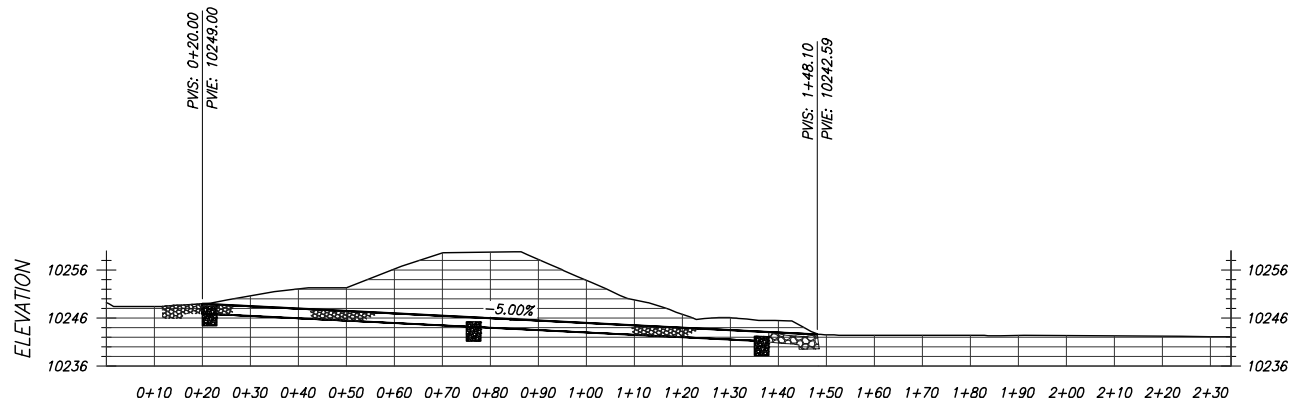
HORIZONTAL GEOMETRY	92.30	0.67	26.49	47.98
	PI STA: 1+20.79	PI STA: 1+52.68	PI STA: 1+84.58	
	DELTA: 28.28	DELTA: 32.65	DELTA: 14.78	
	R: 113.05	R: 13.31	R: 13.31	
	L: 55.80	L: 7.58	L: 3.43

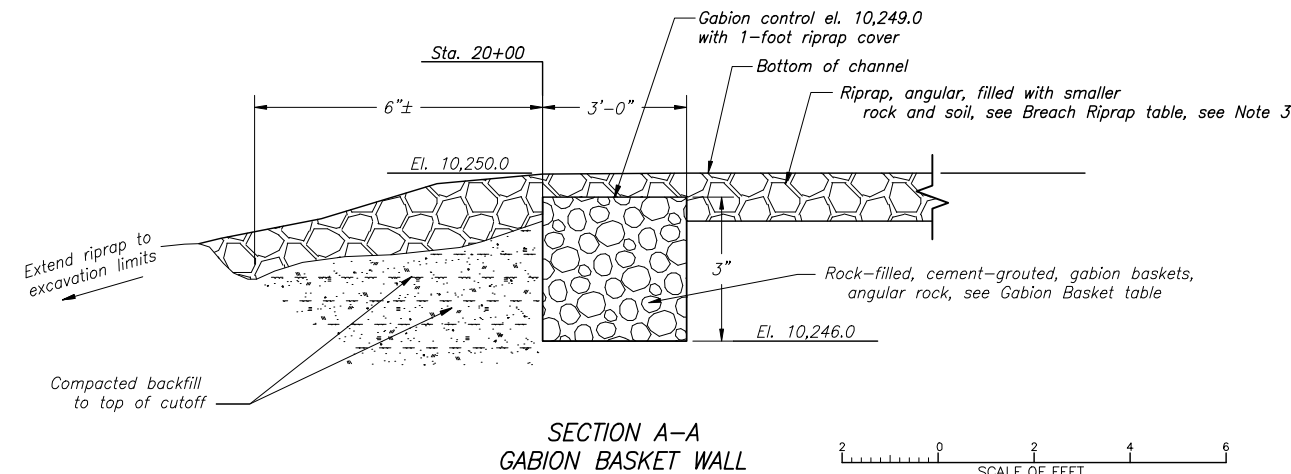
SECTION A-A GABION BASKET WALL

GABION BASKET			
GABION BASKET	PREDOMINATE ROCK SIZE (INCHES)	MINIMUM ROCK SIZE (INCHES)	MAXIMUM ROCK SIZE (INCHES)
36	6 to 10	4	12

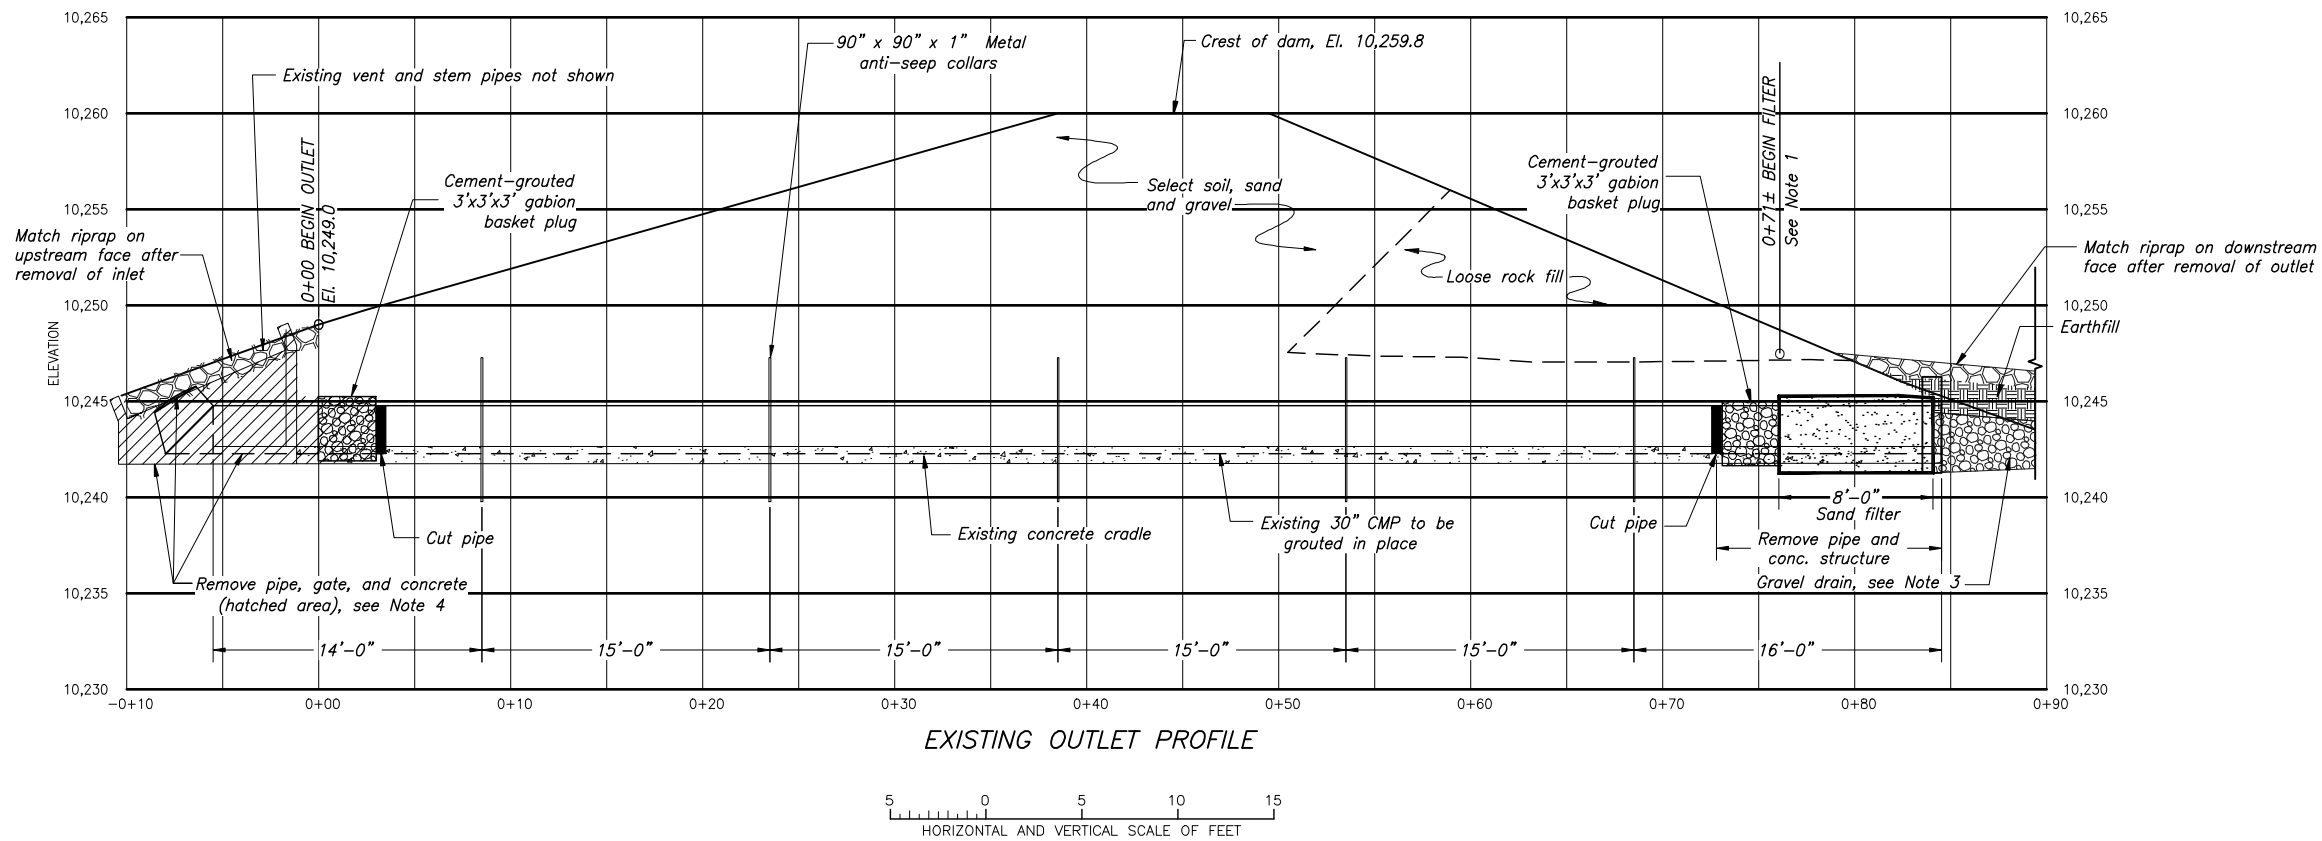
SAND FILTER MATERIAL GRADATION REQUIREMENTS

SIEVE SIZE	% PASSING BY WEIGHT
1/2 inch	100
3/8 inch	100
No. 4	95-100
No. 8	80-100
No. 16	50-85
No. 30	25-60
No. 50	10-30
No. 100	2-10
No. 200	0-3

screen will be utilized to remove any oversized material. The filter will be placed in the last 8 feet of the outlet works excavation trench resulting in an approximate volume of 5 to 6 cubic yards of material required. In the unlikely event that adequate sand is not available from onsite excavations, contingency plans would be required. This would include either locating an adequate source within the proximity of the work or flying in bagged sand by helicopter. Geotextile fabrics are not recommended due to the potential of plugging over time.

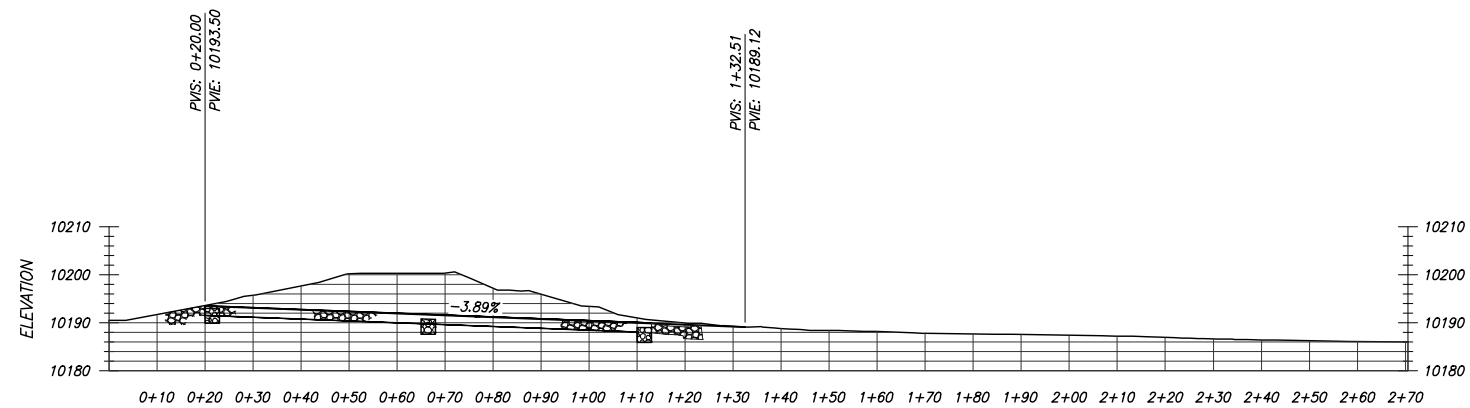
PROFILE: RIGHT ABUTMENT BREACH

Breach - 20 inch riprap depth
 15 ft. bottom width
 1.667 ft. riprap thickness
 2.5:1 Cut slopes

1. Contour interval is 1 foot.
2. Vary centerline alignment along ramp to create resting pools.
3. Breach El. 10,193.50
4. Cut vol. = 945 c.y.
5. Contours shown through the breach and outlet channel represent excavated grade below final riprap placement.
6. Grid factor = 0.99949466

To enable a no hazard classification, the maximum height of the outlet channel elevation could be set at approximately 10,198 feet. However, it was decided to restore Brown Duck to close to the original natural lake level which results in a **recommended outlet channel elevation of 10,193.5 feet**. The amount of material to be excavated for the outlet channel is estimated at 945cubic yards. The grade will be established and maintained by three grout- or concrete-filled rock gabion cutoffs – one at the inlet of the outlet channel, one mid-way through the outlet channel, and one at the downstream end of the outlet channel. The gabions will rise 1 foot above the excavated floor of the outlet channel notch, with a minimum of 2 feet of the gabion buried. Riprap will cover the top of the gabions. The design elevation of 10,193.5 will be measured at the top of the gabion basket in the channel. The outlet channel will be

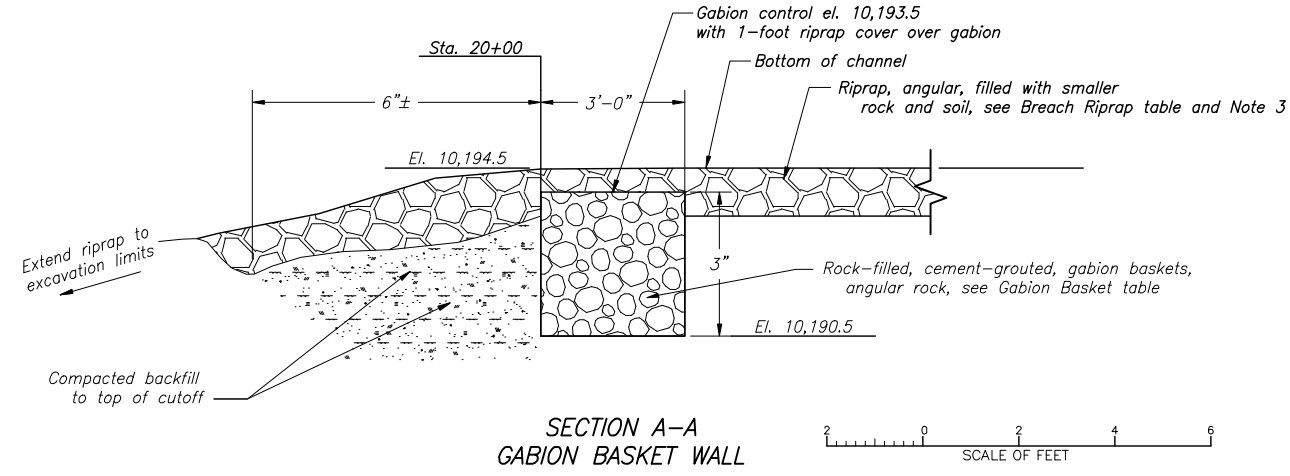
SECTION A-A GABION BASKET WALL

GABION BASKET			
GABION BASKET	PREDOMINATE ROCK SIZE (INCHES)	MINIMUM ROCK SIZE (INCHES)	MAXIMUM ROCK SIZE (INCHES)
36	6 to 10	4	12

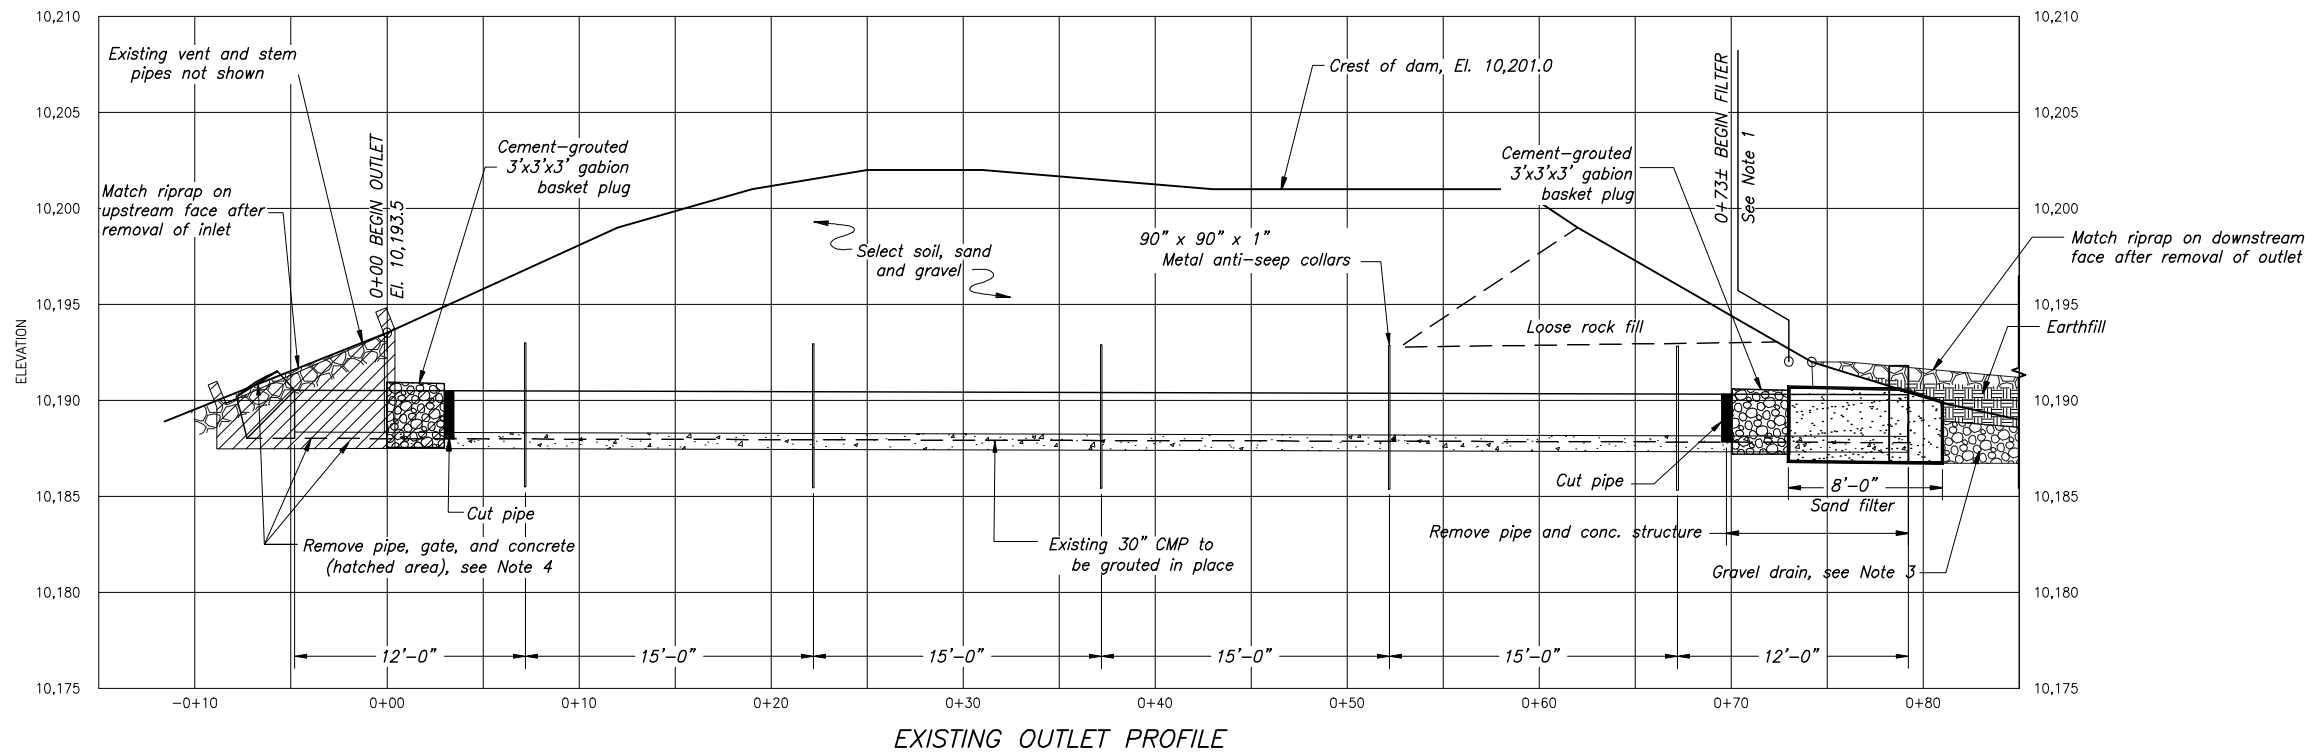
SAND FILTER MATERIAL GRADATION REQUIREMENTS	
SIEVE SIZE	% PASSING BY WEIGHT
1/2 inch	100
3/8 inch	100
No. 4	95-100
No. 8	80-100
No. 16	50-85
No. 30	25-60
No. 50	10-30
No. 100	2-10
No. 200	0-3

GRAVEL DRAIN MATERIAL GRADATION REQUIREMENTS	
SIZE	% PASSING BY WEIGHT
1 1/2 inch	90-100
3/4 inch	55-100
3/8 inch	19-75
No. 4	0-40
No. 8	0-10
No. 16	0

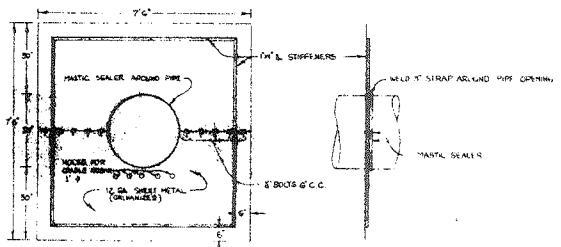
LOW ANTI-SEEP COLLARS WITH QUAL TIE ENAMEL
METAL ANTI-SEEP COLLAR DETAIL 2
Scale 1" = 2'

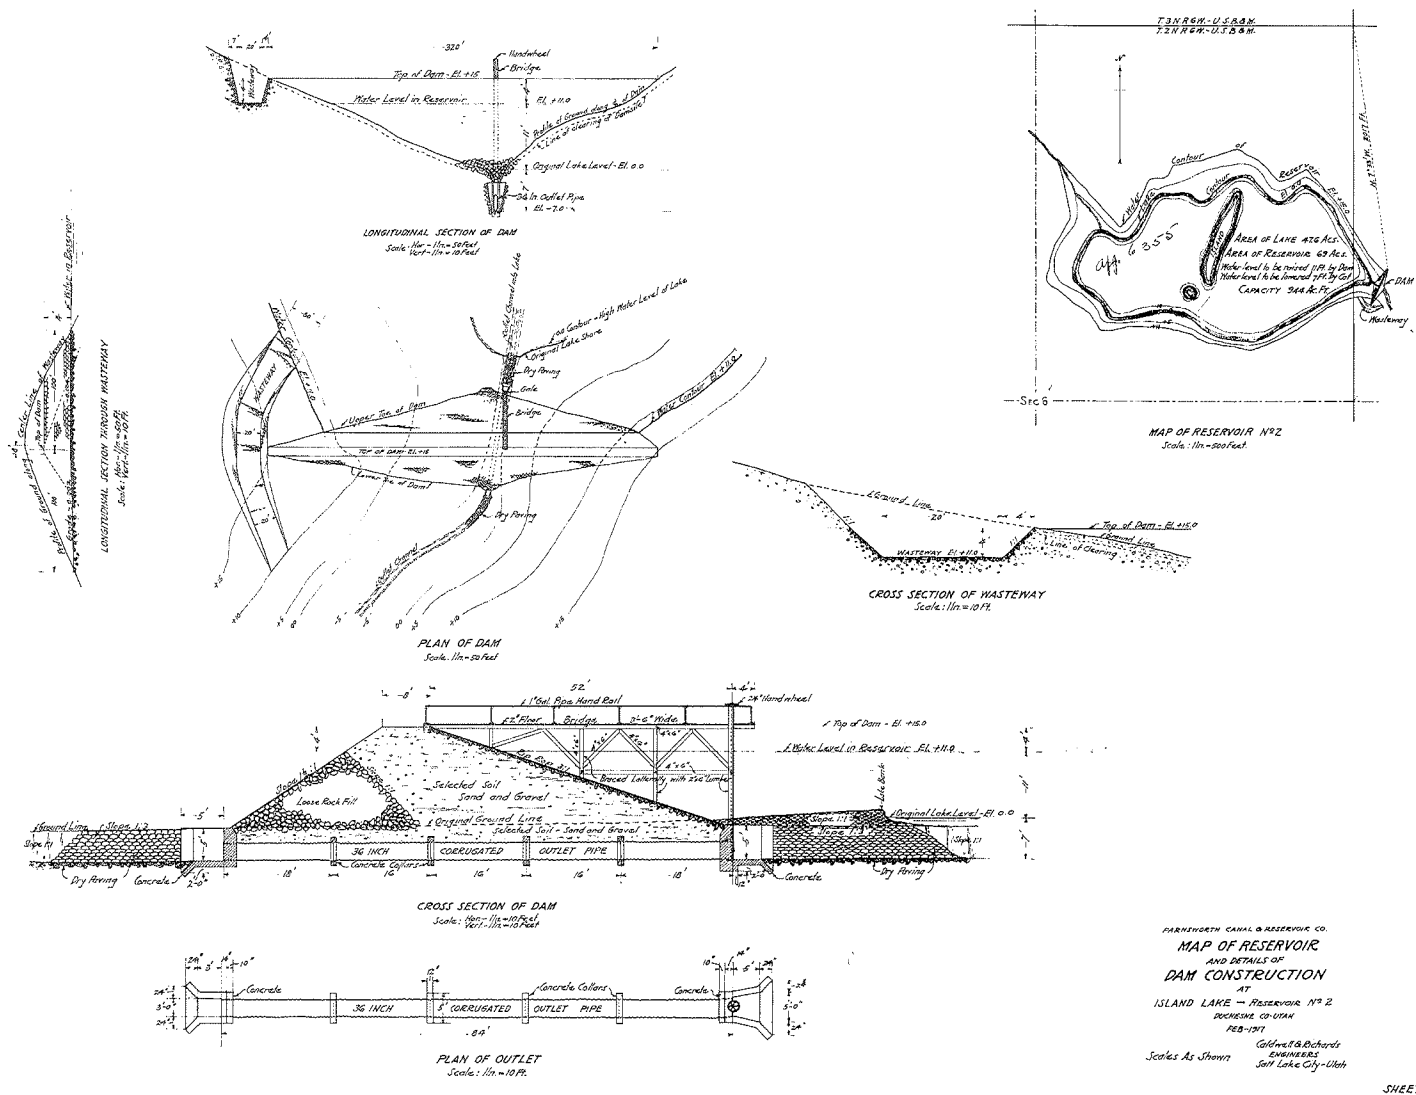
FARNHORTH CANAL & RESERVOIR CO.
**MAP OF RESERVOIR
 AND DETAILS OF
 DAM CONSTRUCTION**
 AT
 ISLAND LAKE - RESERVOIR NO. 2
 DOUGHERT CO. IOWA
 FEB-1911
 Colwell & Richards
 ENGINEERS
 Salt Lake City - Utah
 Scales As Shown

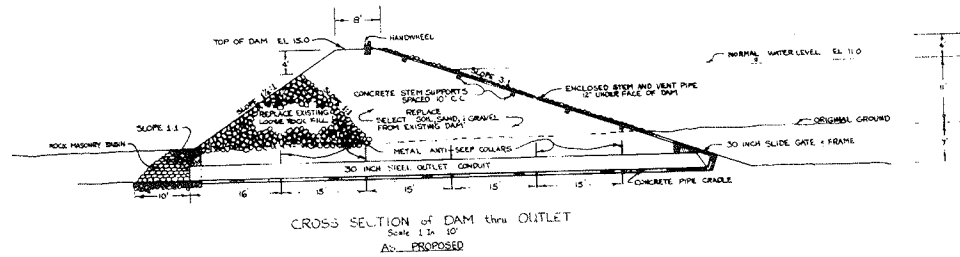
CROSS SECTION OF DAM thru OUTLET
Scale: 1 in = 10'
As PROPOSED

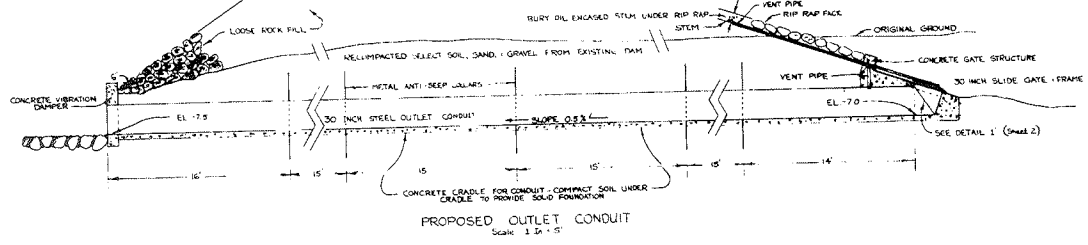
PROPOSED OUTLET CONDUIT
Scale: 1 in = 5'
