**Erosion and Deposition of
Channel-side Alluvial Deposits
in Degrading and Stable
Channel Segments
Downstream from Large Dams**

Paul Grams, Jack Schmidt, and Dave Topping

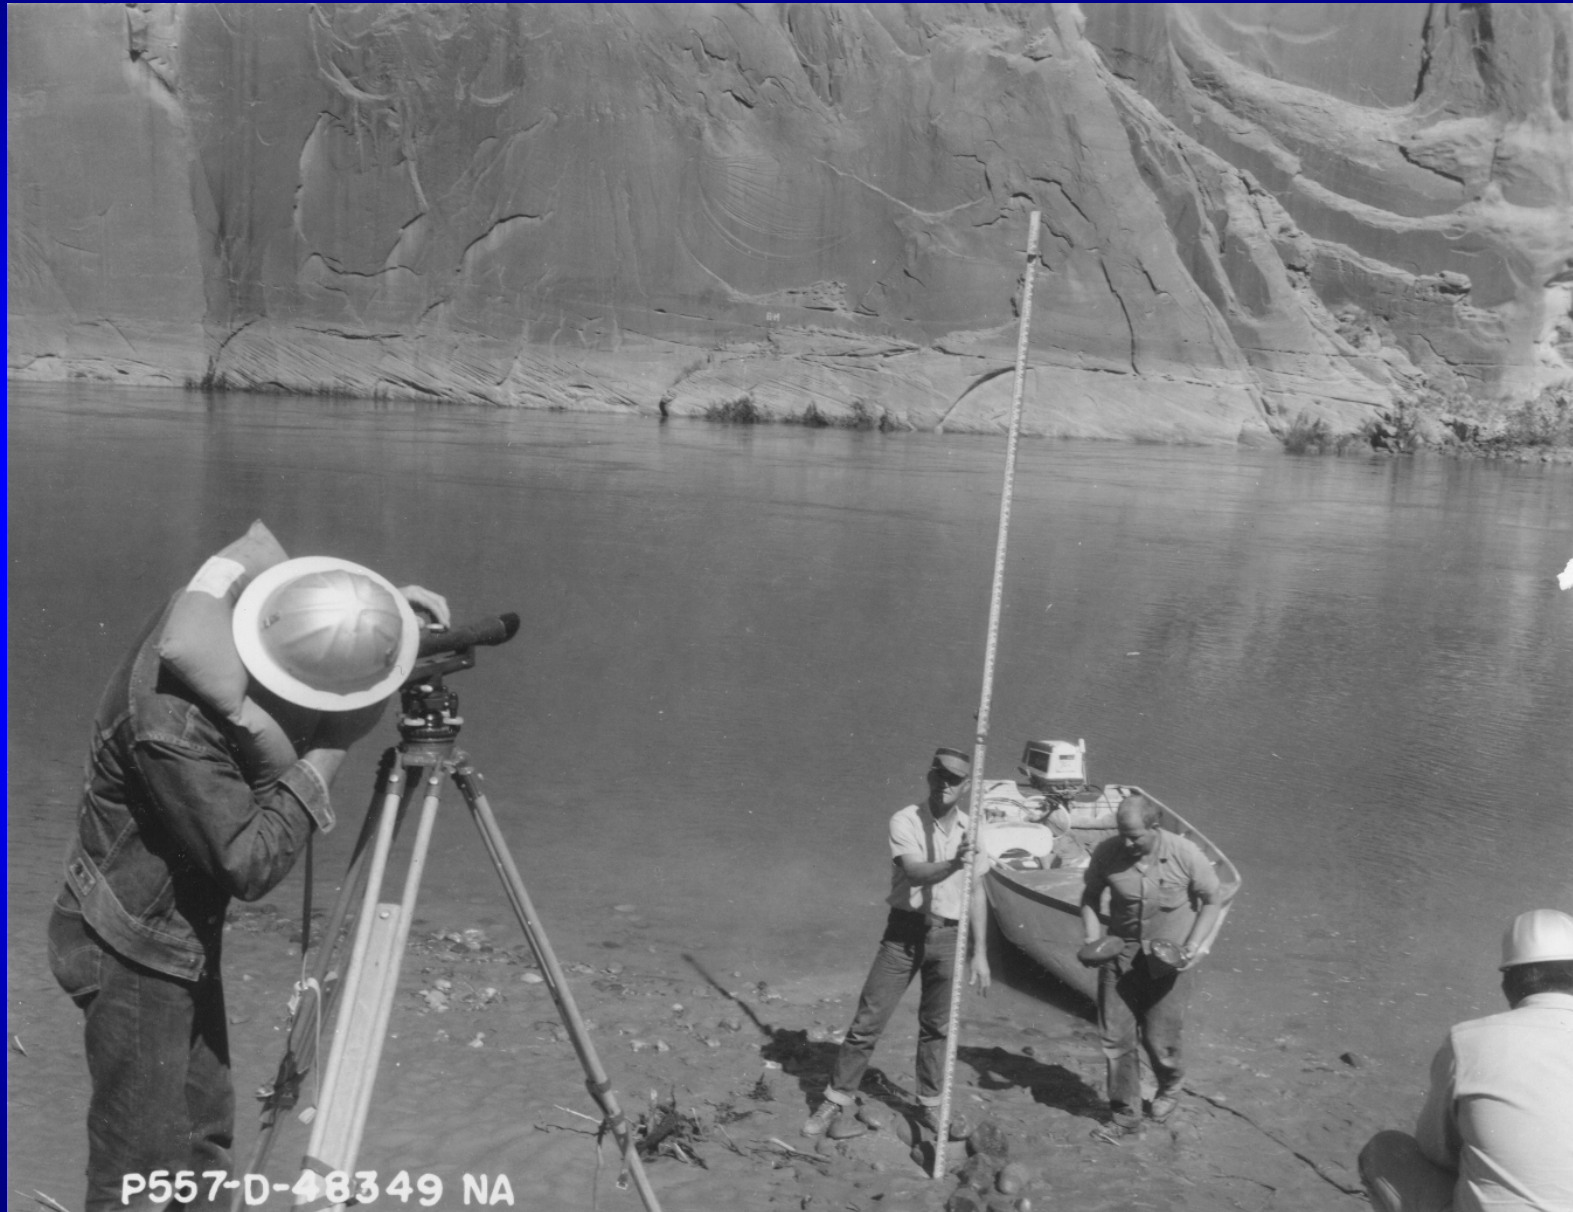
The Reclamation monitoring “Ranges”

- 20 sections established in 1956
- 11 measured in 1959, 1963, 1965, 1975, 1983, and 1990
- 18 measured in 2000

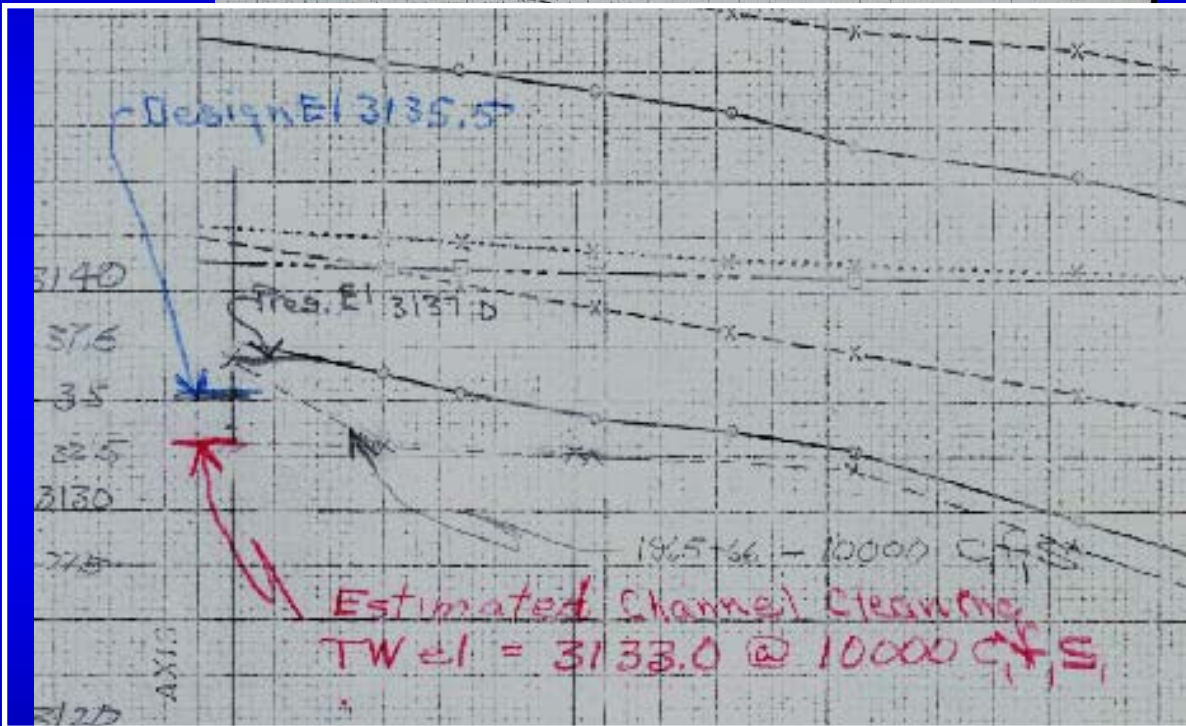
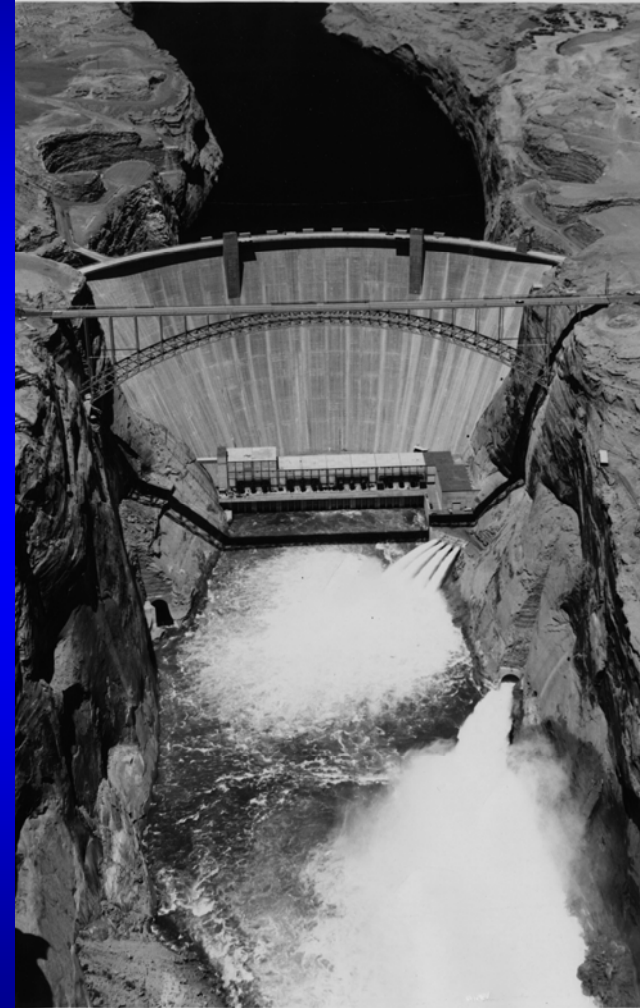
“Channel Cleaning” Flows

- Most degradation resulted from 1965 channel-cleaning flows
- Pool and riffle segments have emerged in the process of bed degradation
 - Degradation of riffles decreases in downstream direction, has decreased with time, and has probably stopped.
 - Degradation of pools does NOT decrease with distance below dam and continues during post-dam high flows.
- Degradation of channel controls has caused corresponding changes in stage-discharge relations.

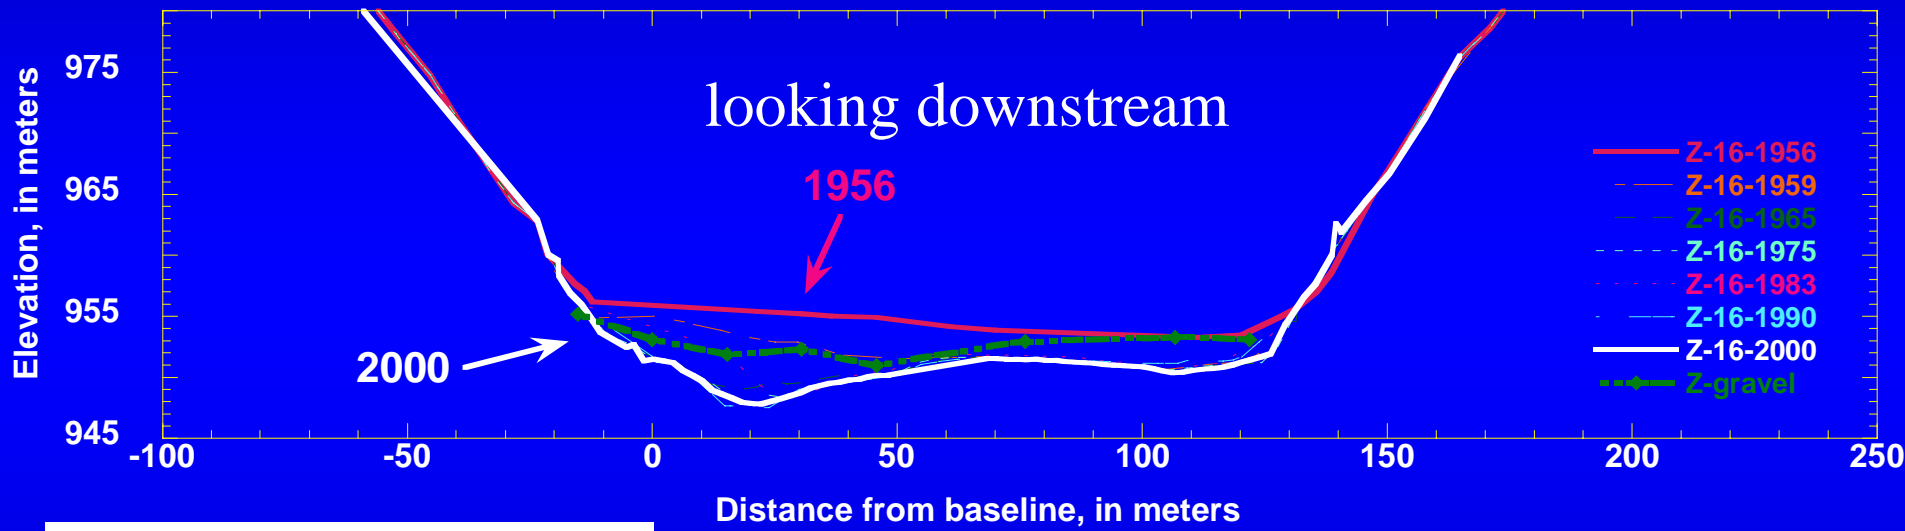
Range 16, 4.3 km downstream from Glen Canyon Dam

Cross section showing bed degradation, 1956-2000

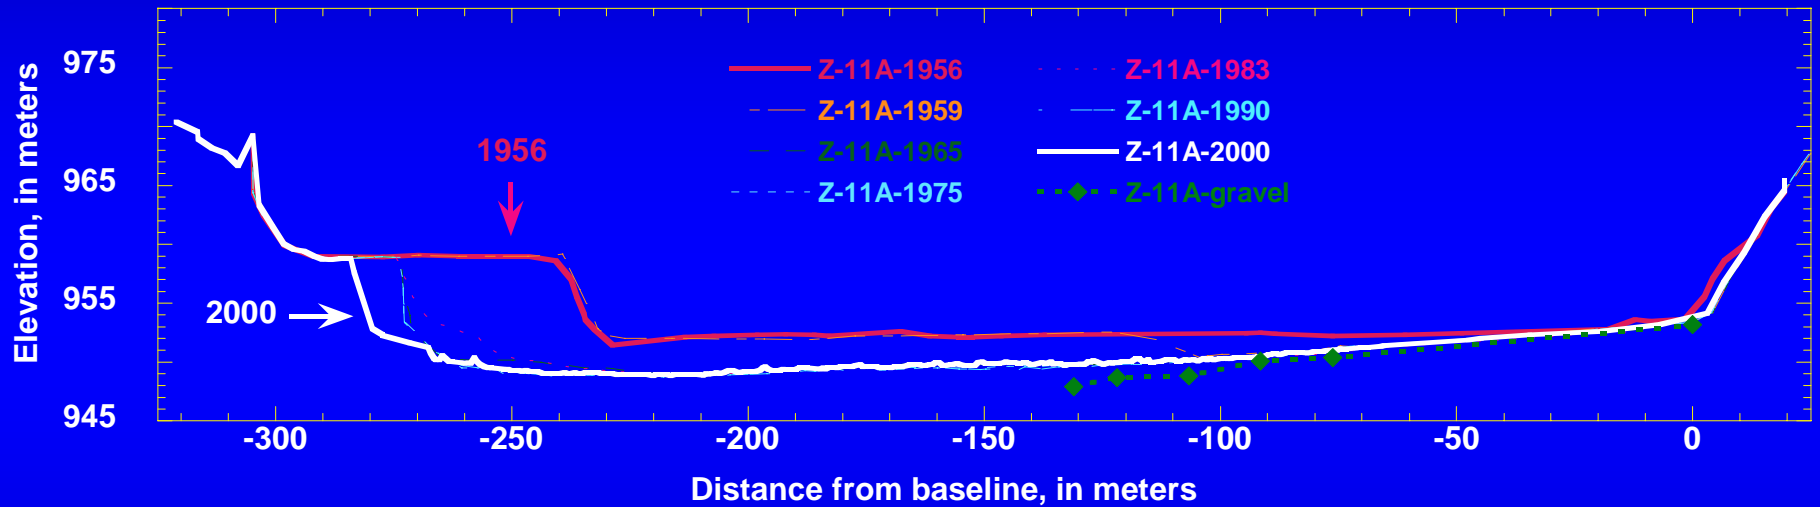
Range 11a, 10.3 km downstream from Glen Canyon Dam

Cross section showing bed degradation, 1956-2000

looking downstream

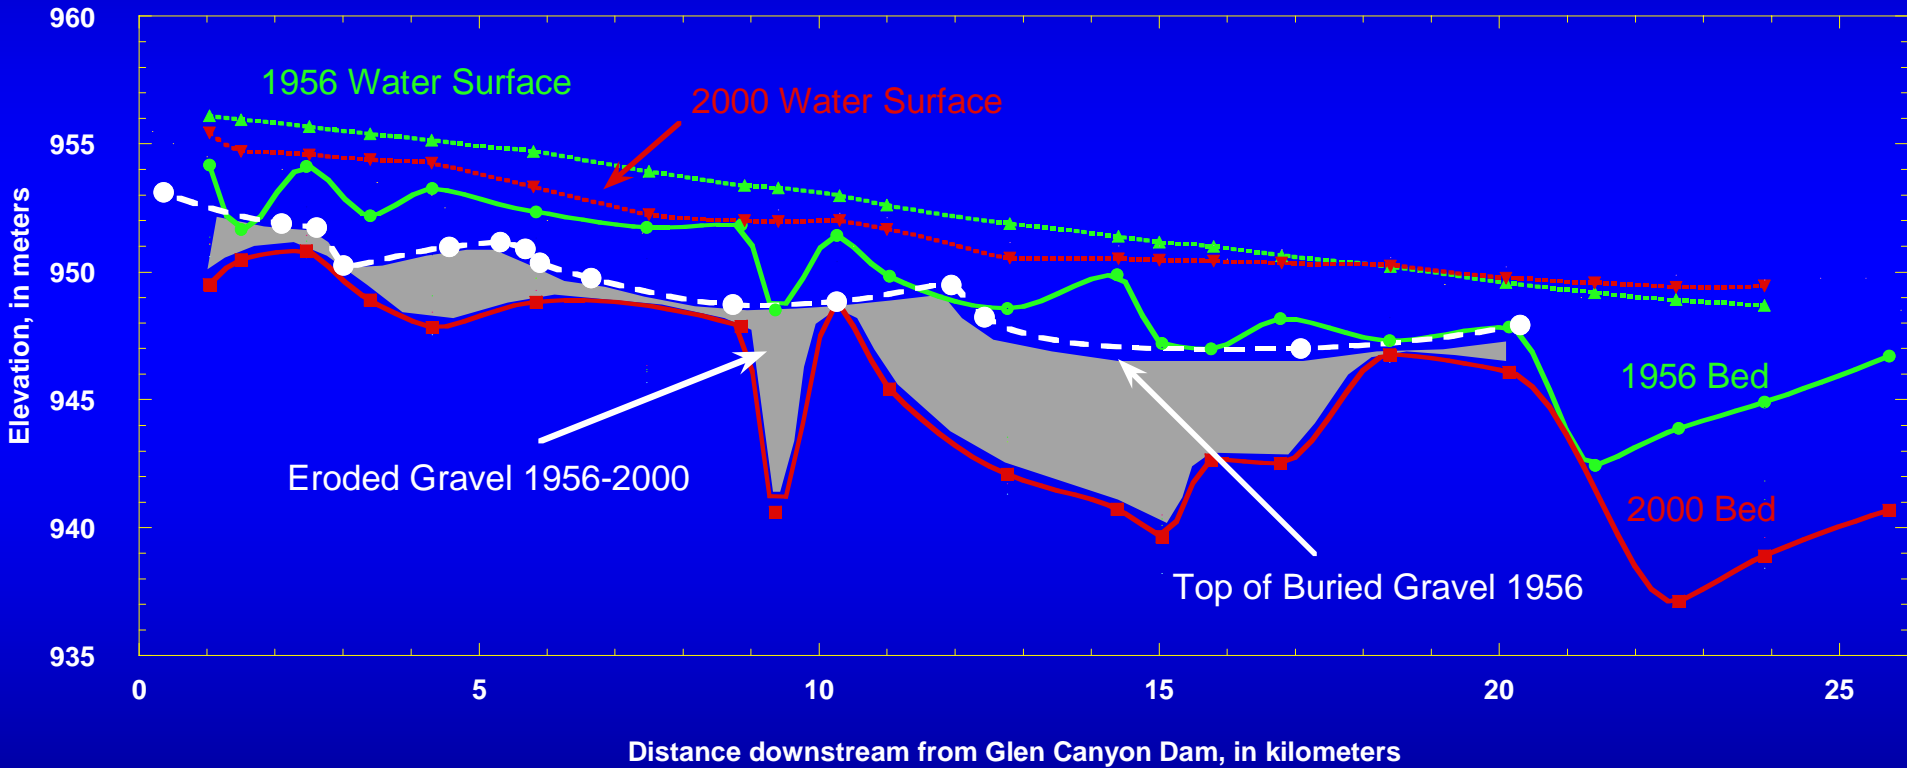
Longitudinal Profile of Bed Degradation: 1956 - 2000

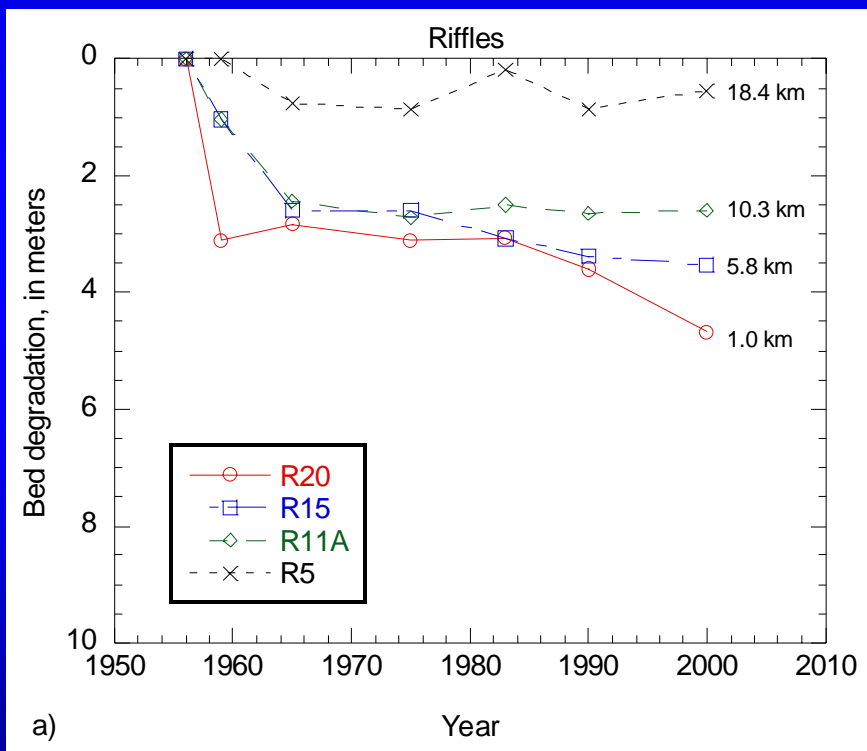
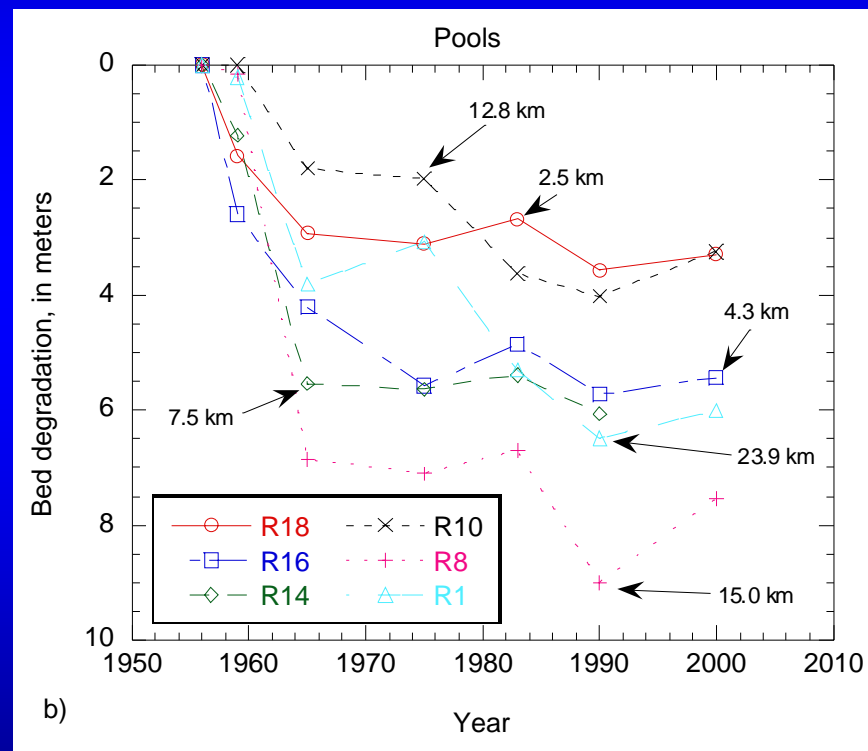
Minimum bed elevation from 1956 to 2000 for cross-sections located in riffles and pools

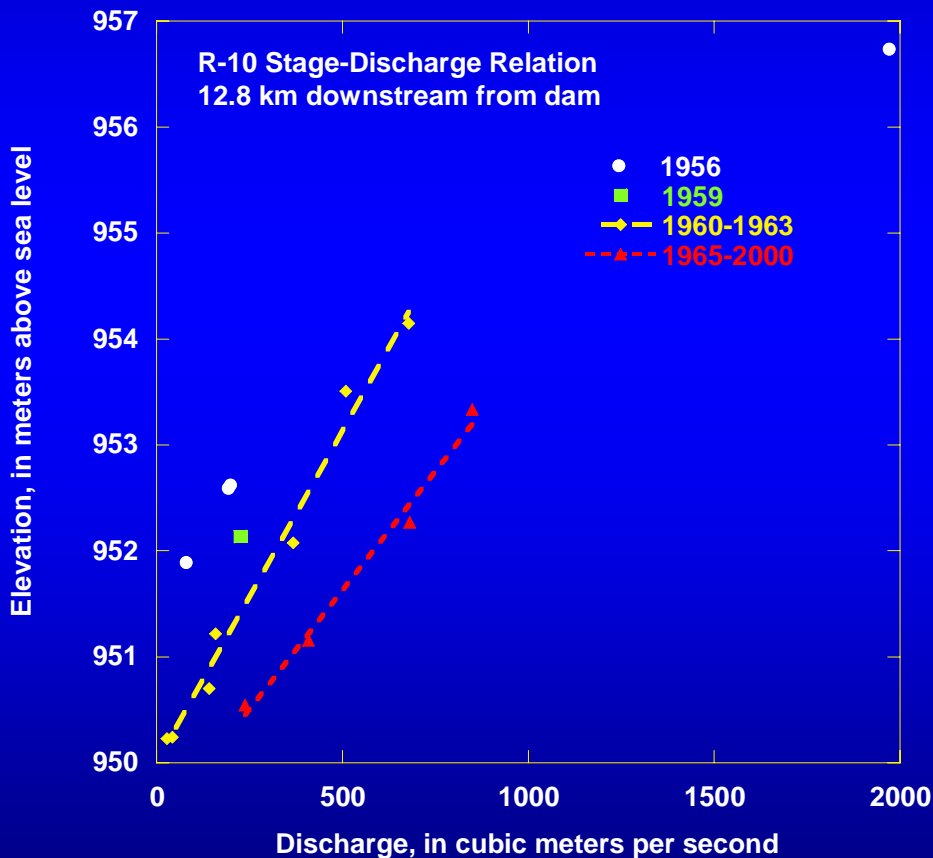
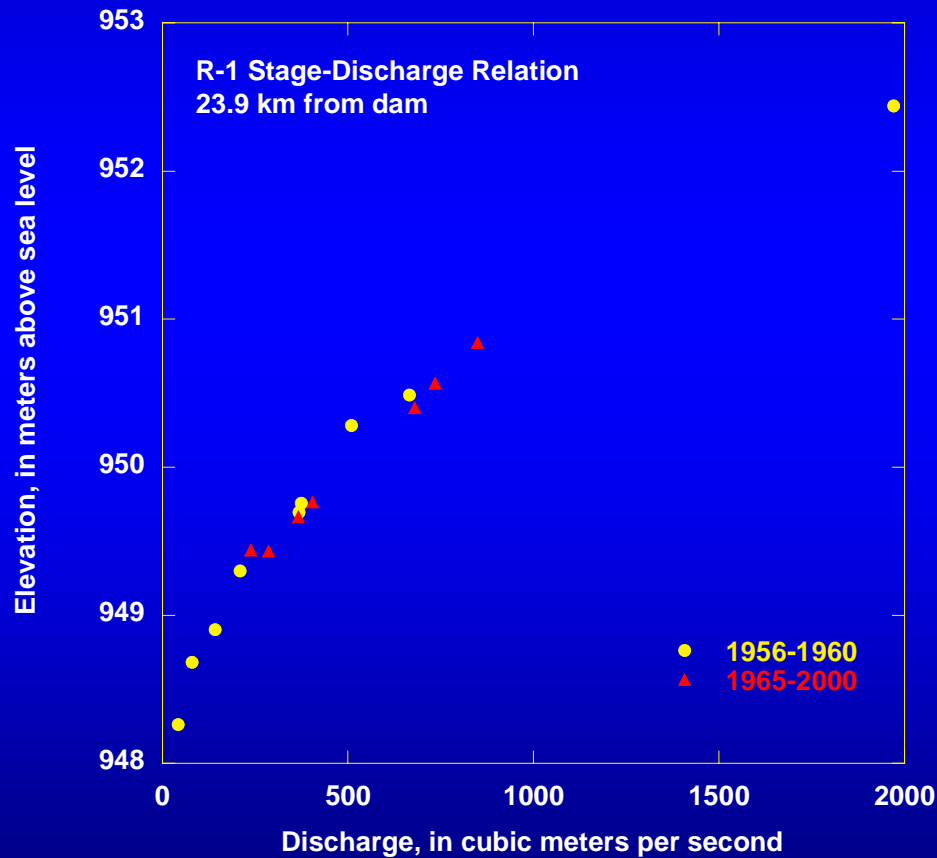
Adjustment of Stage-Discharge Relations: Greatest at upstream end of Reach

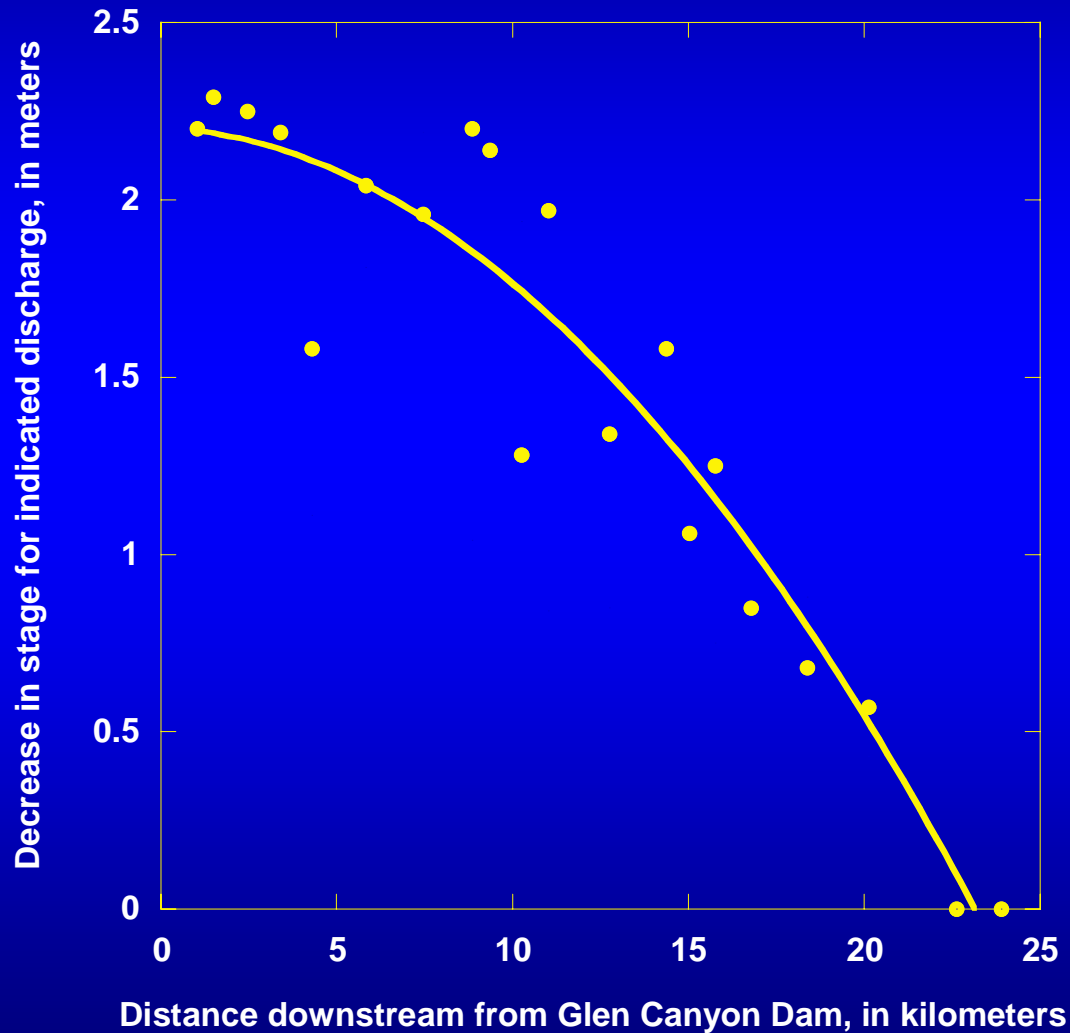
Drop in Stage-Discharge Relation Decreases with Distance Downstream

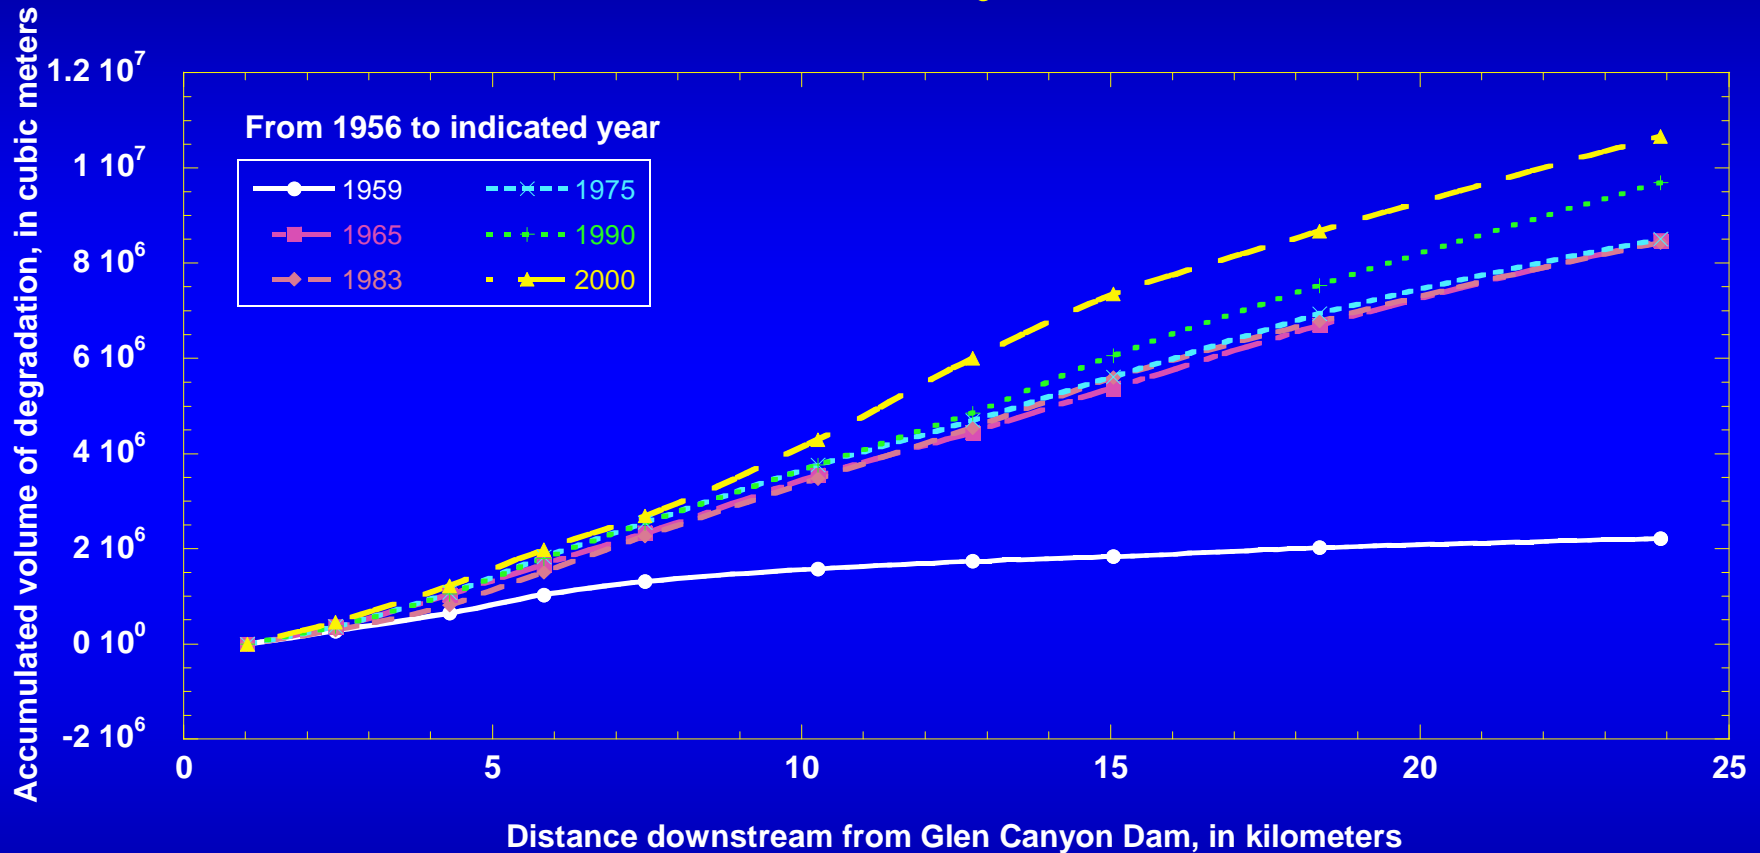
Accumulated sediment evacuation from Glen Canyon

8.3 million m³ sediment evacuation predicted in 1957

9.9 million m³ measured in 1975

10.7 million m³ measured in 2000 – exceeds predicted by ~ 30%

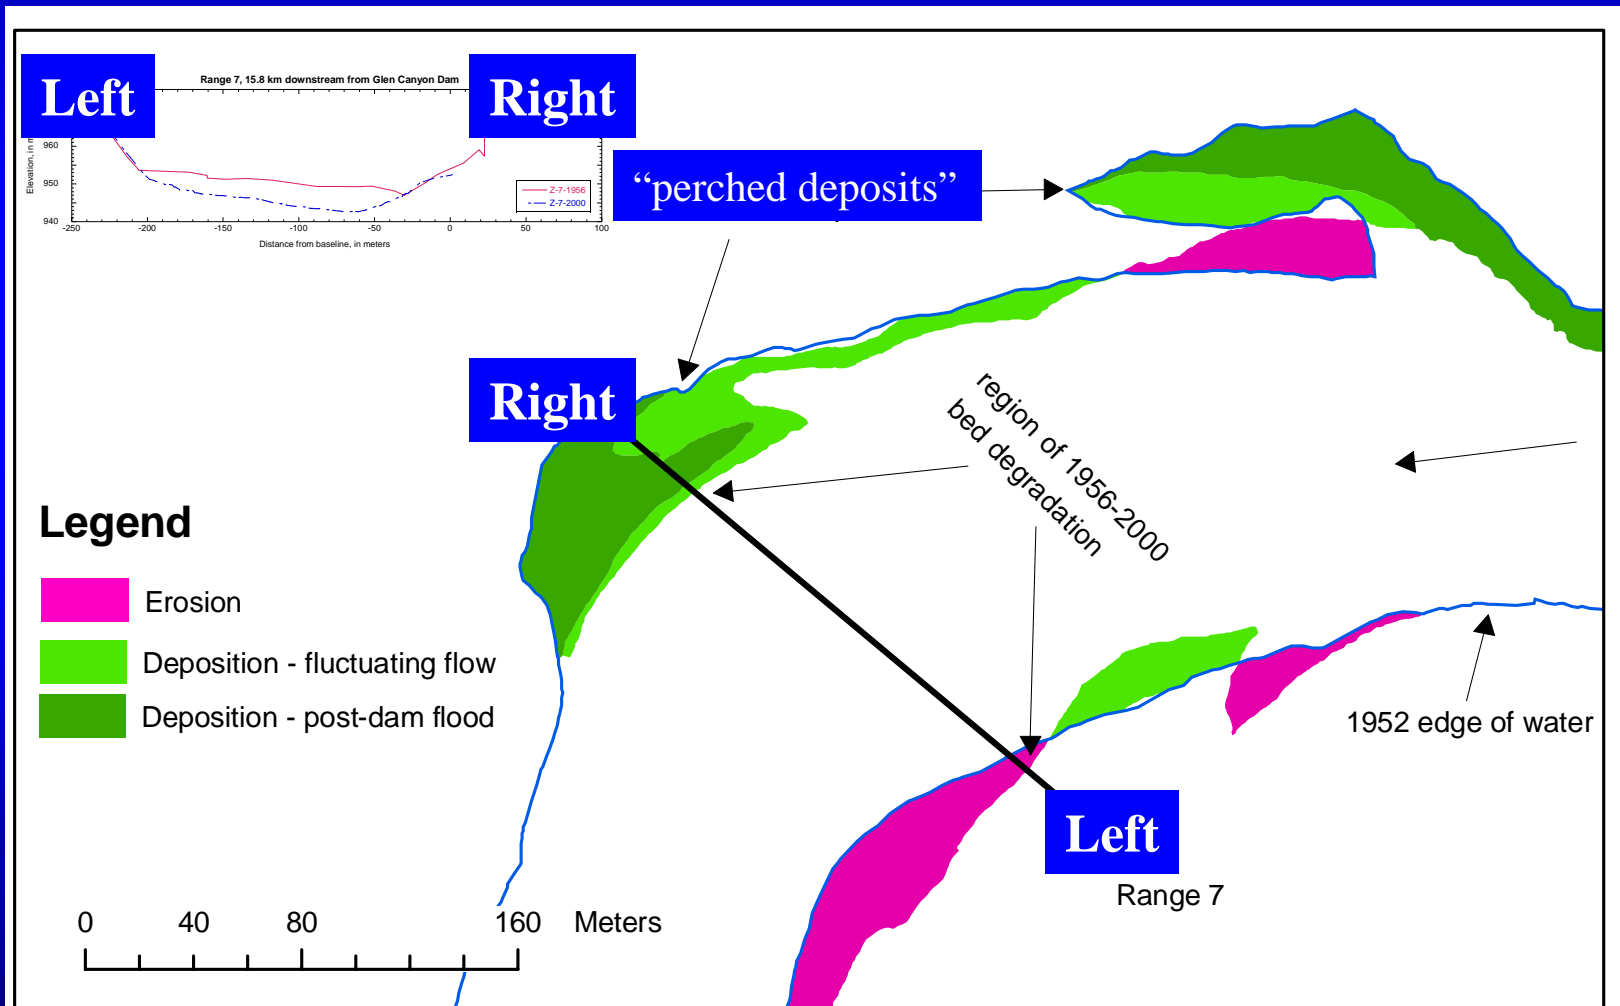
Styles of channel adjustment in segments with degrading bed and **decreasing** stage-discharge relation: Eroded and “perched” channel-side deposits

- Segments with degrading bed and decreasing stage-discharge relation
 - Sand and gravel deposits “perched” above active channel and stabilized by vegetation
 - Massive terrace erosion at localized sites during the channel cleaning flows, not widespread throughout reach and current rates of erosion are very low
- Segments with degrading bed and stable stage-discharge relation
 - Pre- and post-dam deposition on channel margins and stabilization by riparian vegetation, resulting in channel narrowing

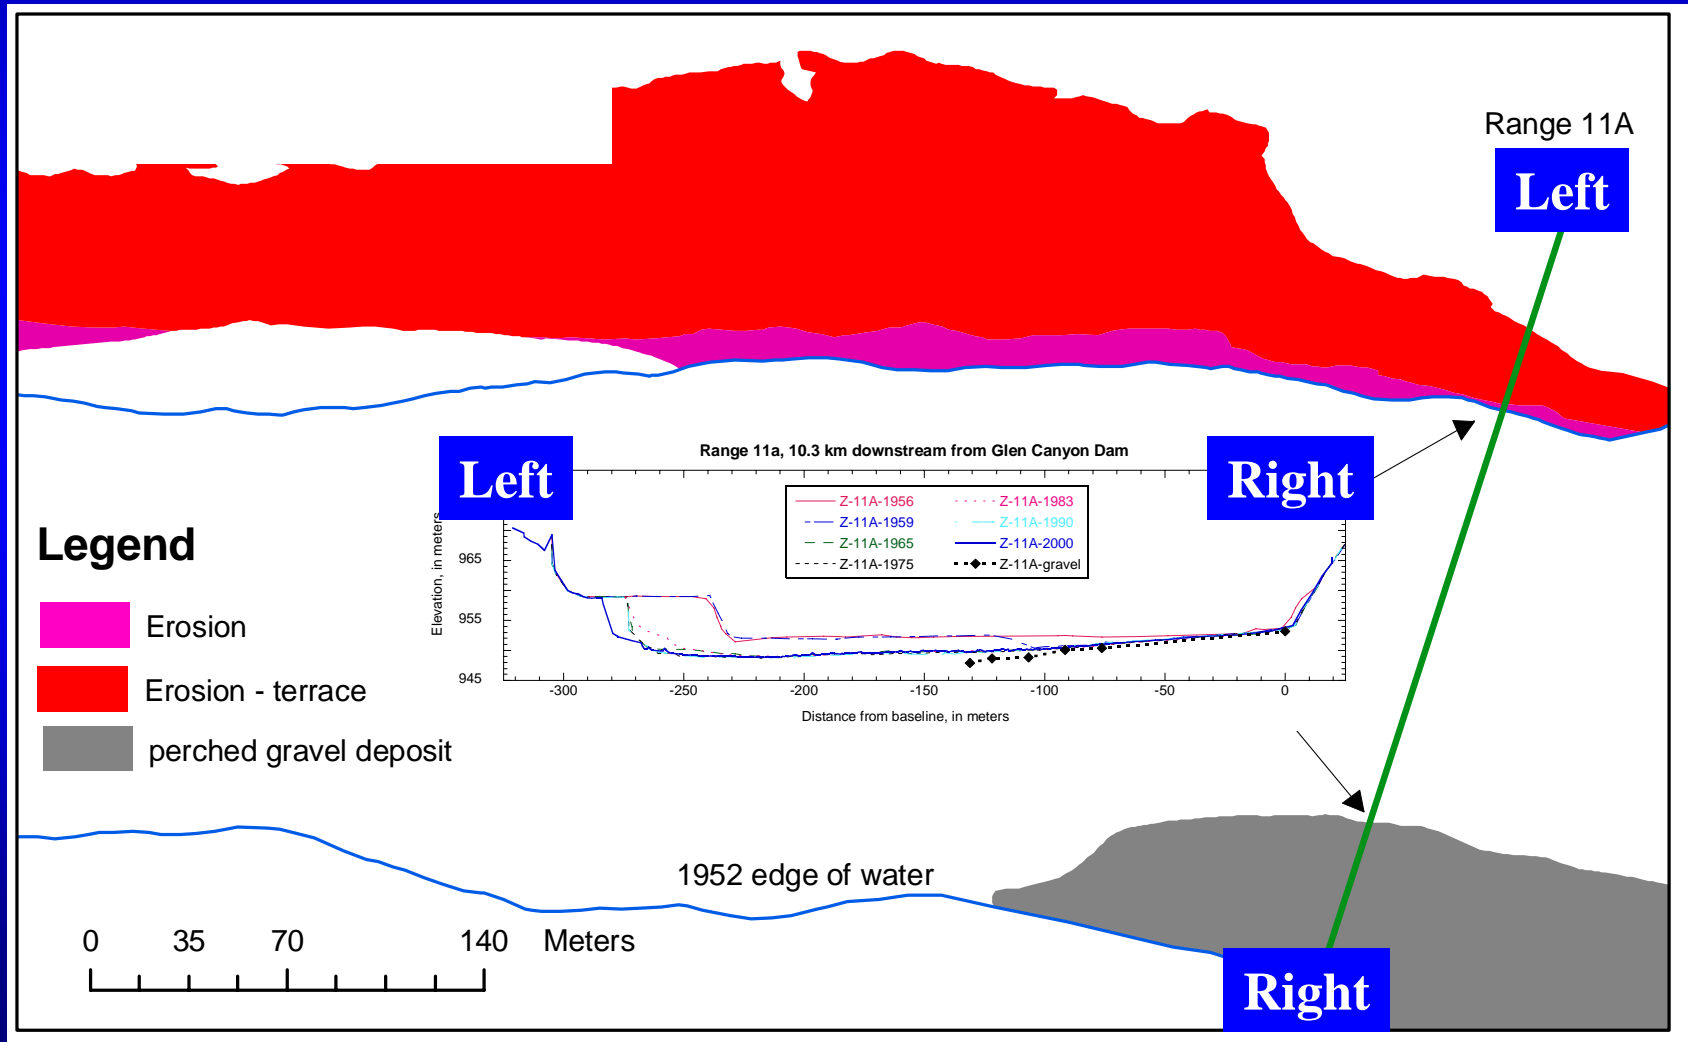
Styles of channel adjustment in segments with degrading bed and **decreasing** stage-discharge relation: Eroded pre-dam terrace and perched gravel bar

- Because of the degrading channel, many of the pre-dam deposits are perched above the range of power plant operations and most post-dam floods
- Erosion of pre-dam terraces:

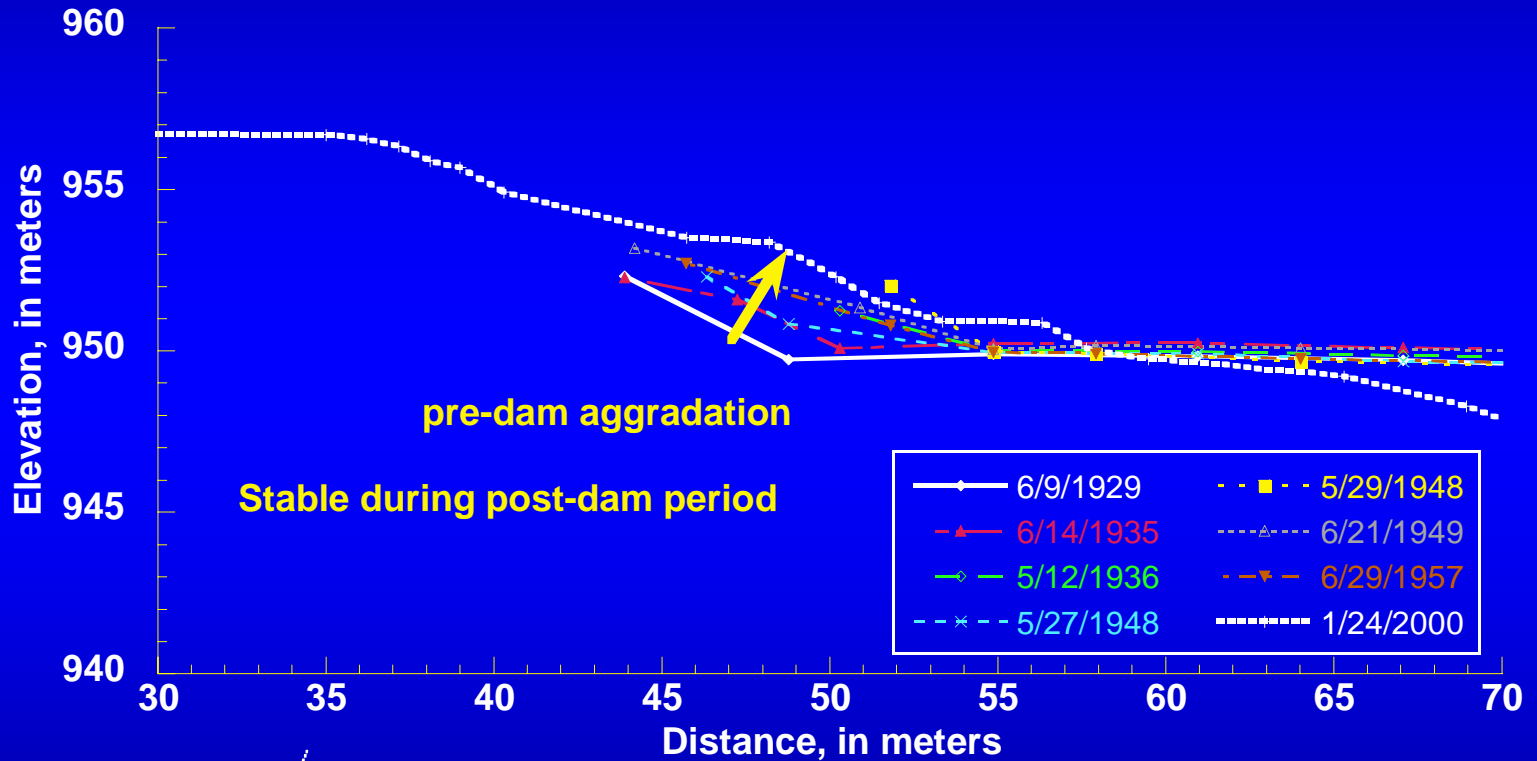
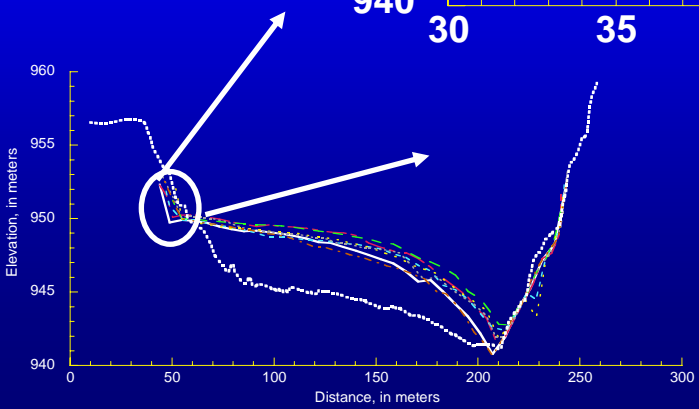
Styles of channel adjustment in segments with degrading bed and **stable** stage-discharge relation: Bed Scour and bank deposition

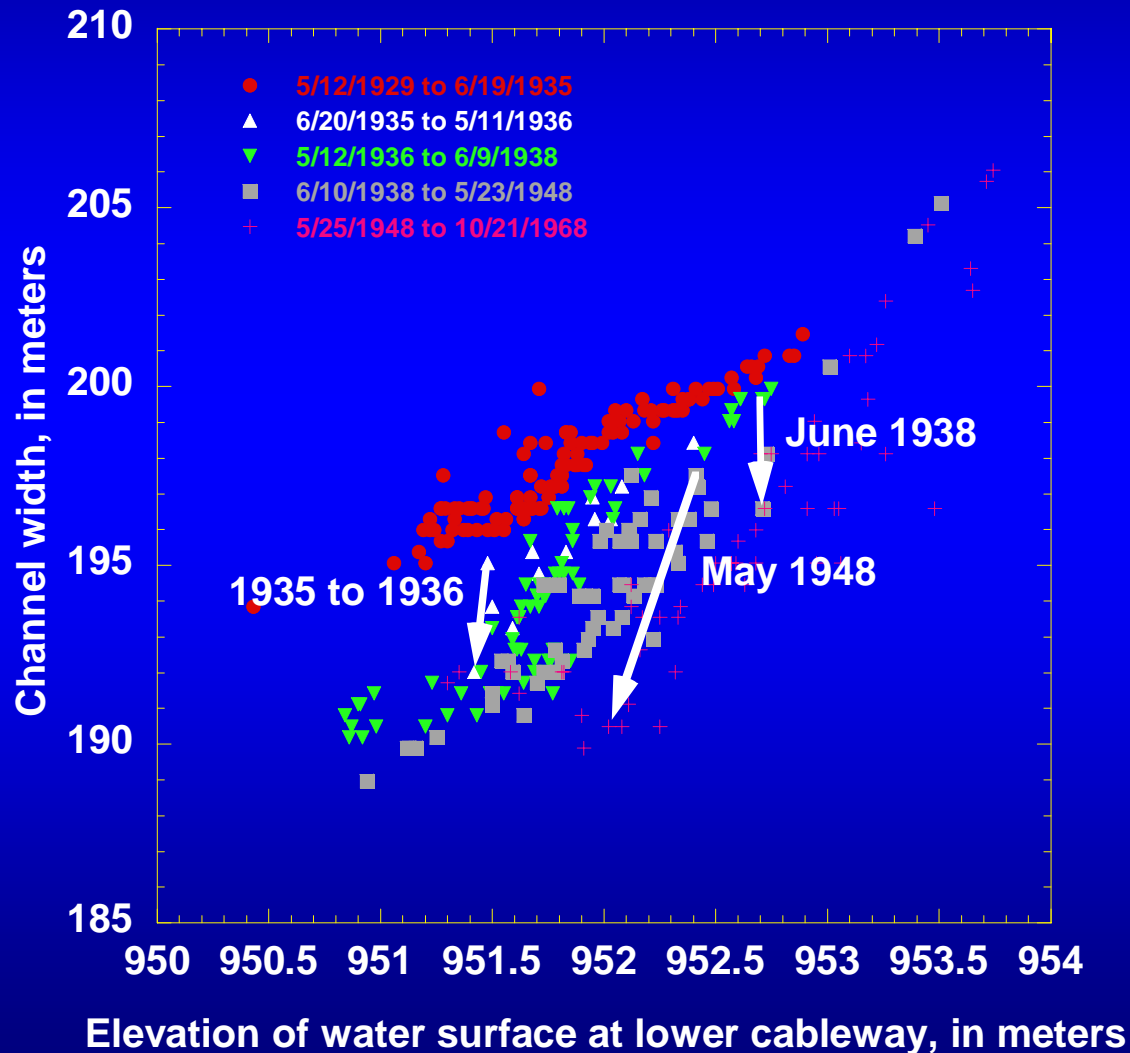
Lees Ferry, Lower Cableway

Progressive decrease in channel width at Lower Cableway

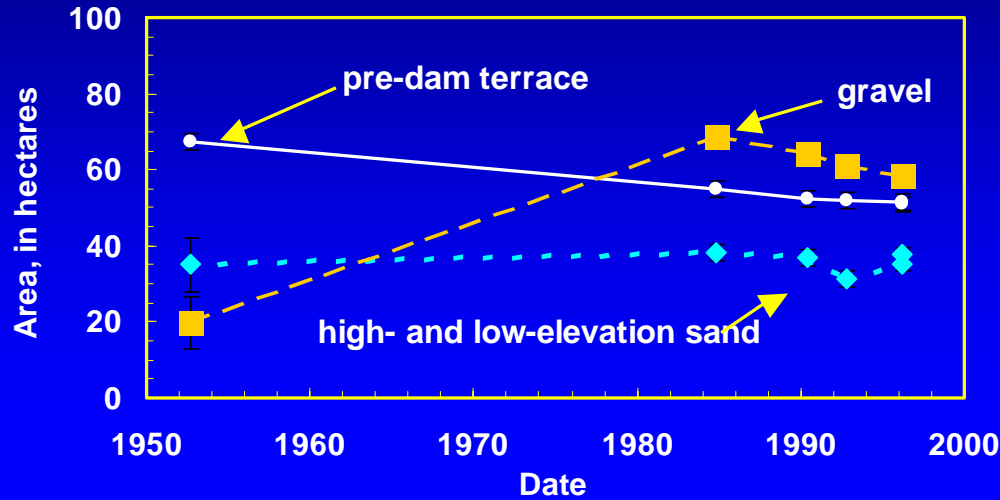
Post-dam distribution of alluvial deposits

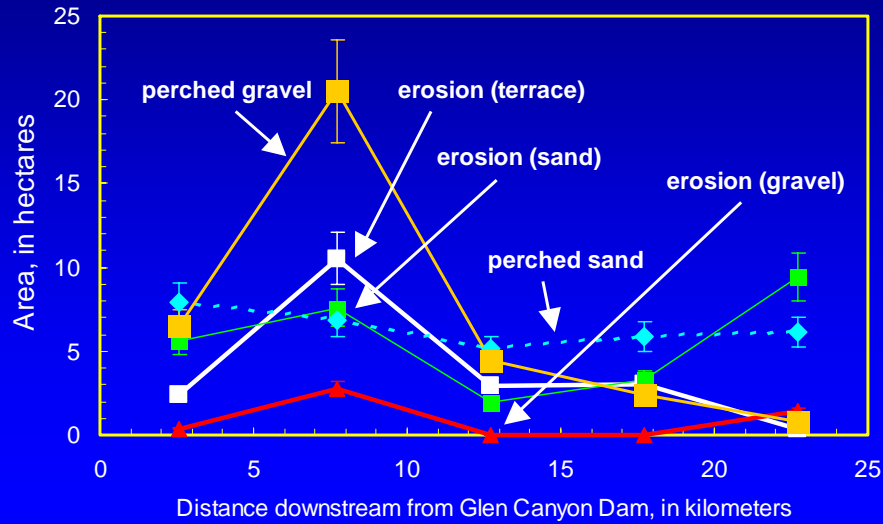
Post-dam distribution of alluvial deposits

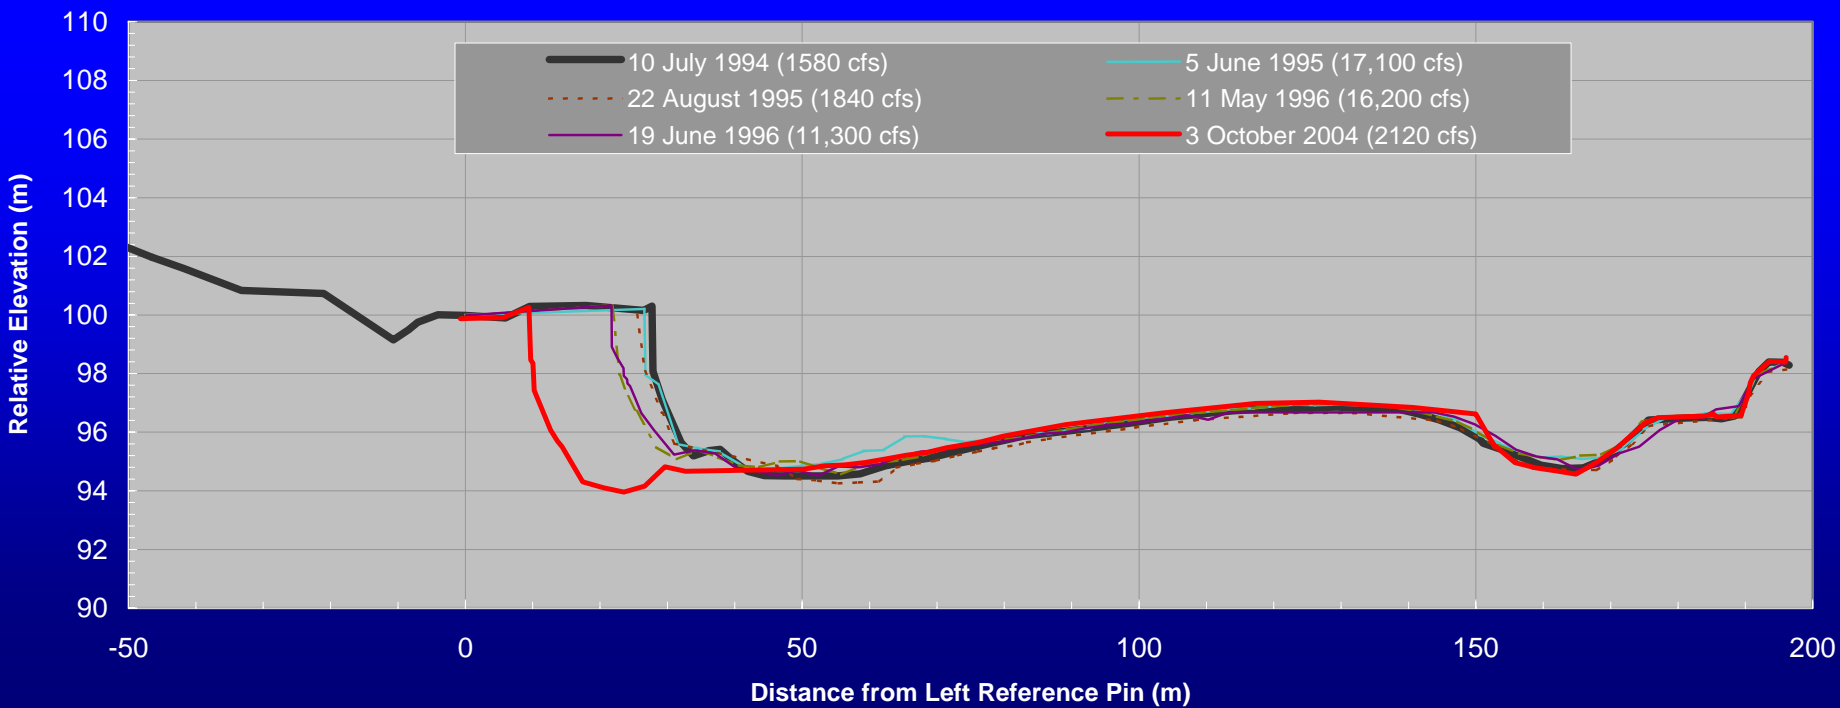
Green River in Echo Park

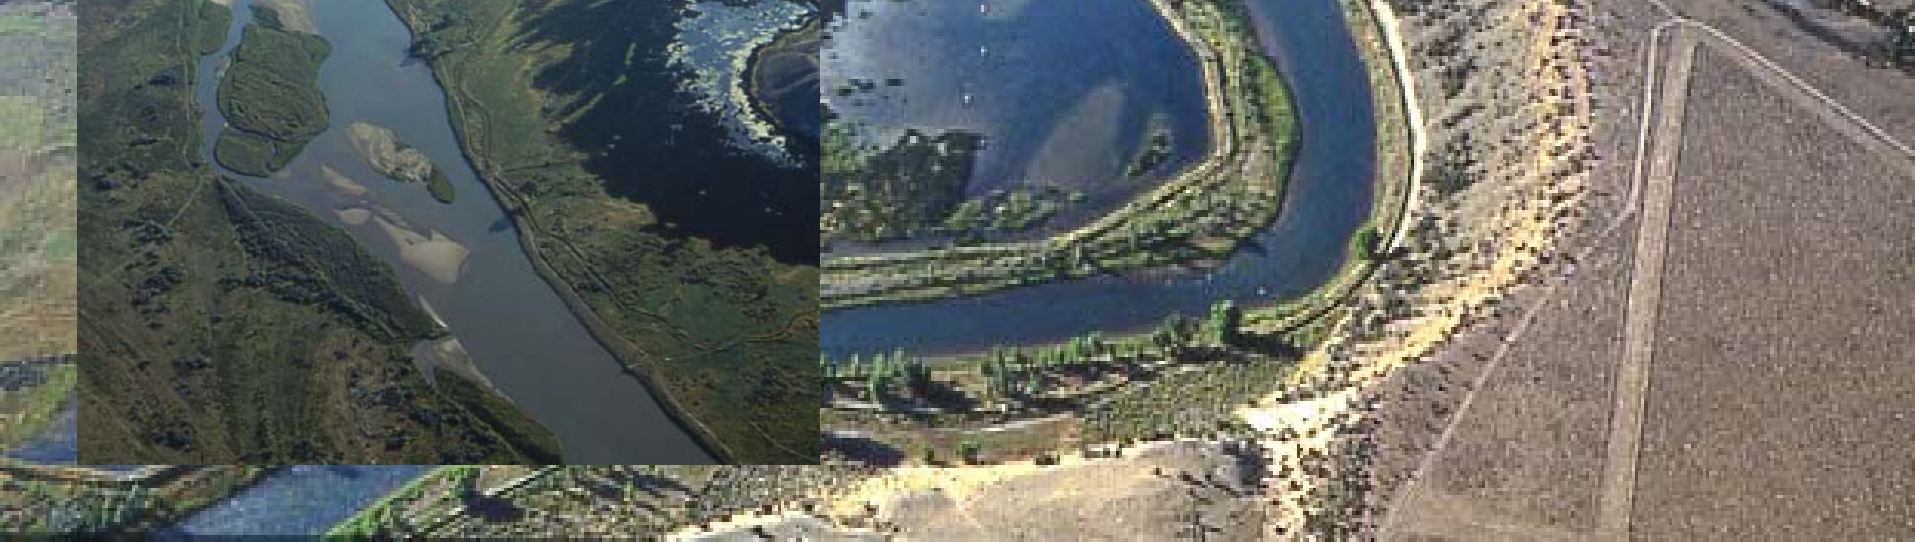
Green River in Browns Park
