Many Glacier Hotel
Historic Structure Report

Glacier National Park
Montana

July 2002

Prepared by
National Park Service

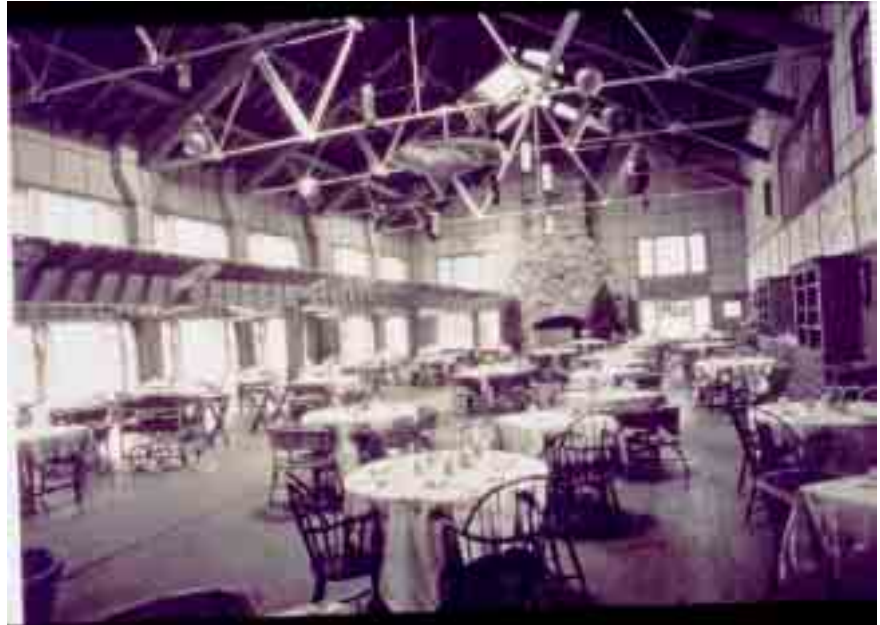
Above left: Original dining hall with exposed roof trusses. Note pergola and decorative Oriental umbrellas left, Blackfeet pictographs right, and evergreen trees at stone fireplace. Furniture included 36 hardwood chairs, 122 Japanese wicker chairs, square homemade tables, round tables, homemade sideboards, tray stands, Japanese lanterns, blue willow ware china and one tea tray wagon. *Left:* Following 50's remodel, dining hall after ceiling was dropped below bottom of trusses, wood floor covered with linoleum.

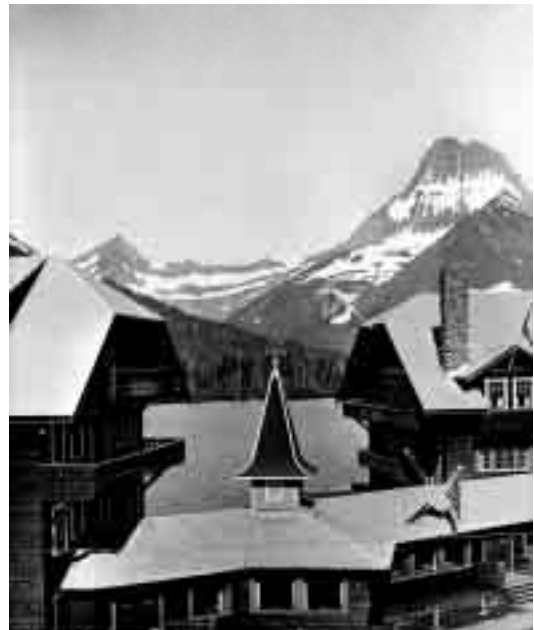
Annex 2, left, and connecting south bridge with spired cupola constructed in 1917. The spire was likely inspired by the first set of drawings submitted by Kirtland Cutter but rejected by Louis Hill. *Courtesy Glacier National Park Archives*

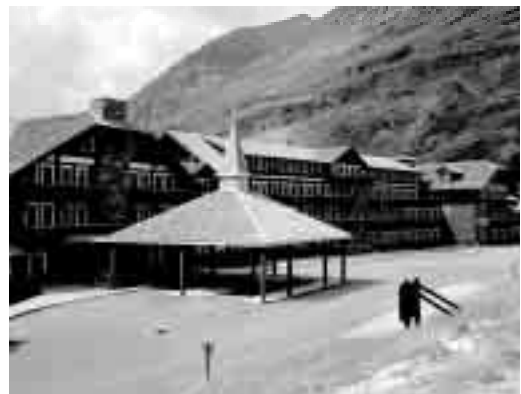
Porte Cochere added in 1957 to protect arriving and departing guests from the weather. *Courtesy of Glacier National Park Archives*

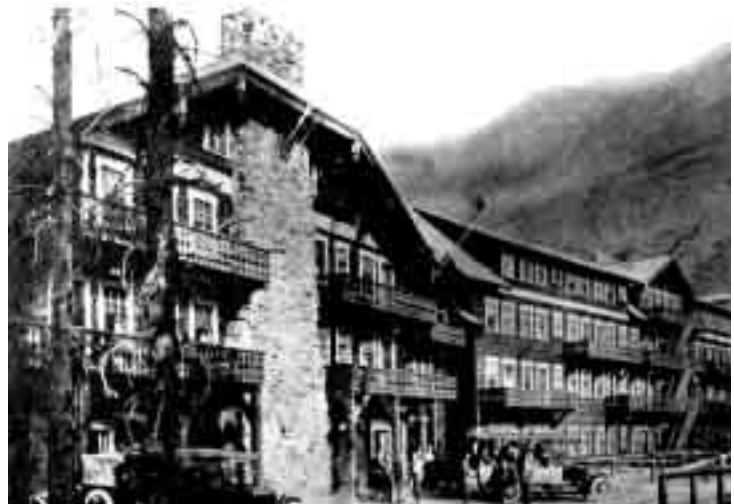
East side of hotel with tourists waiting to board the "Old White" touring buses. 1920 Note stone chimney at entry, flag pole supports, and balconies without extensive "add-on" supports (steel angles, cables, wood posts). *Courtesy Glacier National Park Archives*

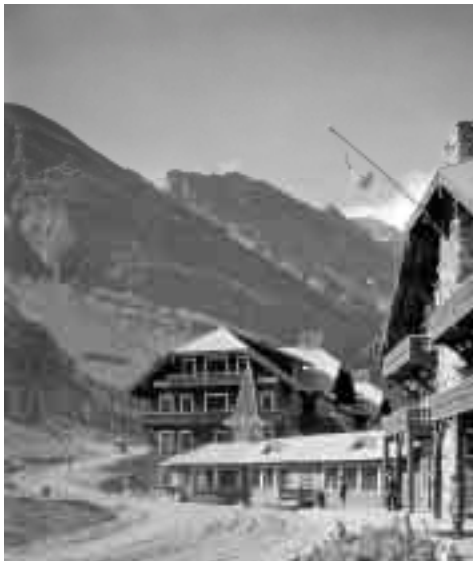
South end of Many Glacier Hotel. Annex 2 in background with spired South Bridge in middle of photo connecting the annex and main lobby building to right. Note flagpole supports. *Courtesy Glacier National Park Archives*

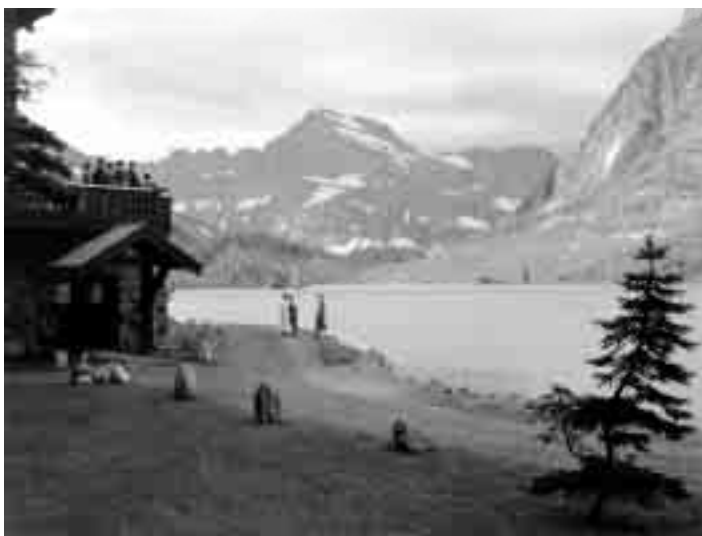
Visitors on front veranda off of lobby, 1933. Mt. Gould in distance. Note original gable-covered entry (no longer exists) to lower level Grill Room (original Soda Fountain was next to this entryway). *Courtesy Glacier National Park Archives*

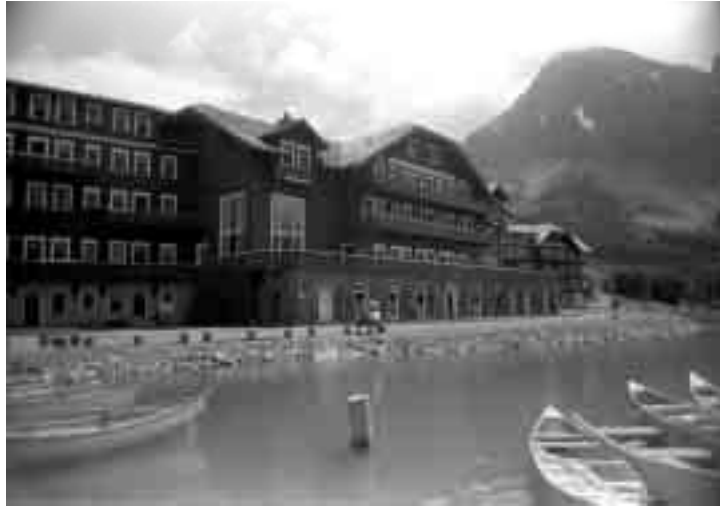
South end of main building. Note arched window and door heads composed of segments of locally quarried stone. *Courtesy Glacier National Park Archives*

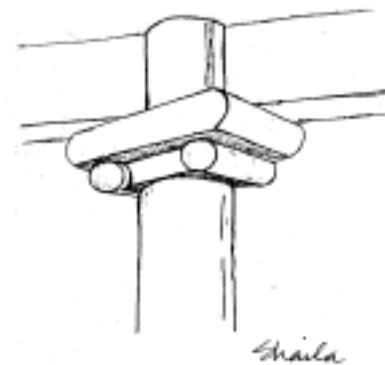
Below: Log column capital typical in lobby

Doric-like columns and capitals are found in the lobby of the main building and the Interlaken Lounge. These columns are full heights high, unfluted, and without bases, giving them an unbroken verticality. They are constructed of natural bark-off log with a stain varnish or shellac finish. The wooden components that form the echinus and abacus blocks are curve-edged and mitered square blocks of increasing size laid on top of the columns with a neck transition. The larger upper blocks support the round log beams that surround the atrium-like space of the lobby.

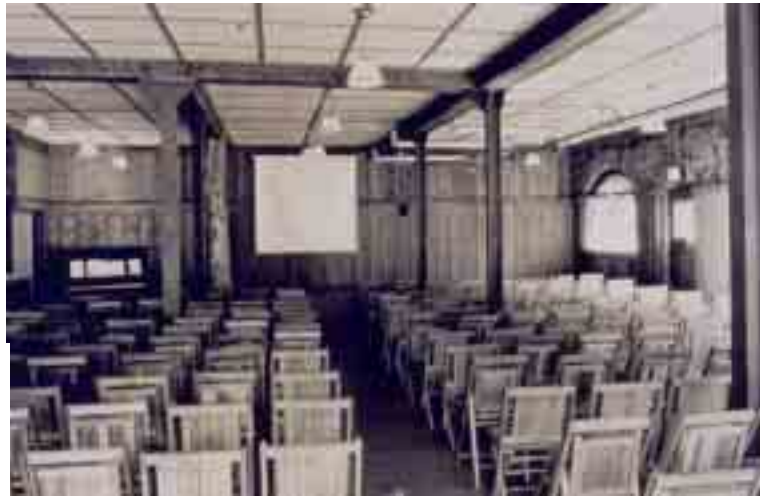
Original Lucerne Room conference center, lake level of main lobby building. Note arched windows, beams, light fixtures, and furnishings. *Courtesy Minnesota Historical Society*

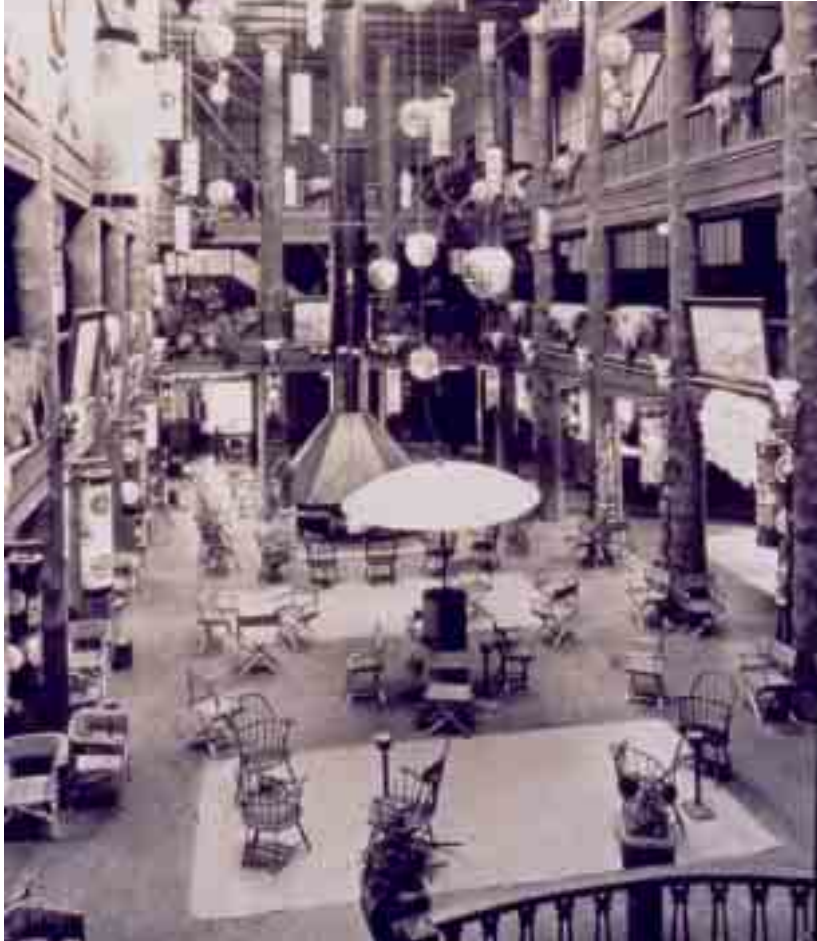
The fireplace hood was designed after the Sibley hood that the U.S. Army used in tents. It was made out of cast iron and was raised and lowered with counterweights. *Courtesy Minnesota Historical Society*

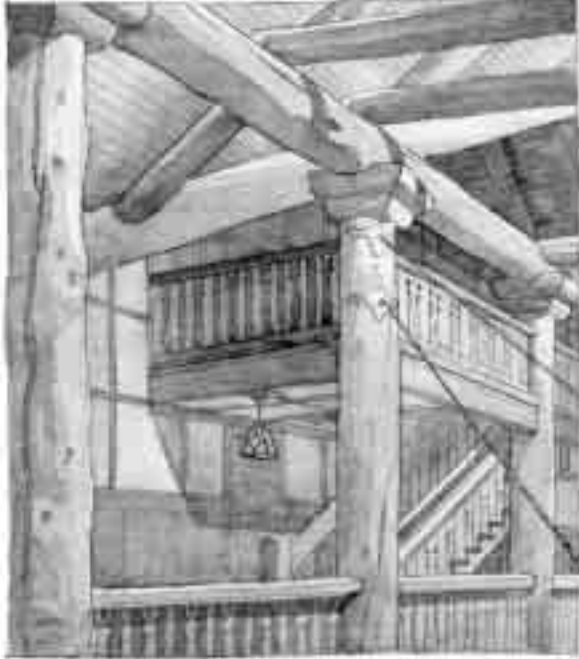
Painting of interior log structure: log columns with capitals, log beams and trusses. Original crafted balustrades. Patterned batten boards over Sackett board above wood wainscoting. *Artwork Henry Sorensen 1999*

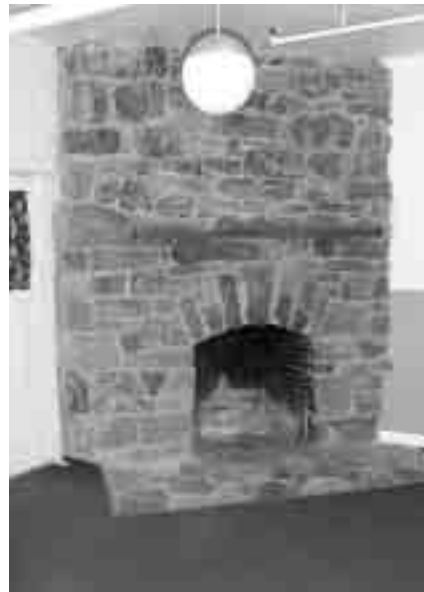
Corner fireplace in Deluxe Guestrooms. Note obtrusive contemporary light fixture. 2001 *Courtesy Glacier National Park*

Lesser fireplaces and chimneys are found in the lounges, the hallway openings, and the luxury guestrooms. However, many of the smaller fireplaces and their chimneys have been removed over time. A comparison of the historic photos of the east façade with that façade today reveals the regrettable decrease of a feature that was not only functional but an essential part of the designer's palette for using native materials and old world masons' craftsmanship.
