Mark B. Geiger, M.S., M.S.E., CIH, CSP

# Application of Human Systems Engineering Guidelines to Improve Safety, Access and Maintainability in Aircraft Carrier Storage Tanks

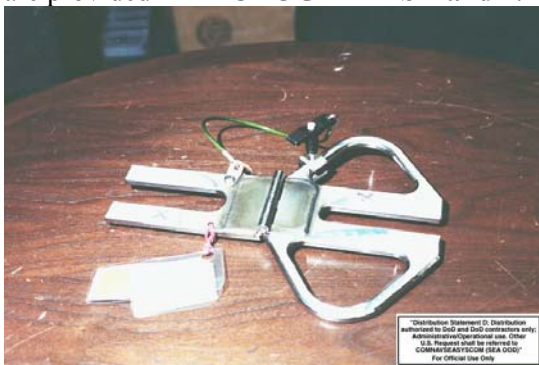
**PHOTOGRAPH 1. Anchor Point Assembly**

ring hole footholds in the transverse bulkheads, used for access into the hull's infrastructure (in wing deep tanks and voids), did not qualify as either safe or acceptable ladders since they did not provide for any fall protection. (Vertical ladders more than 15 feet high are required to provide fall protection, typically through a climbers safety rails or ladder cages). PSNS initiated measures to provide assured fall protection that include; development of an anchorage assembling that fits into D-Ring holes and provides an assured anchorage; erection of scaffolding inside many tanks undergoing repair or maintenance; and requirement for fall protection to be used in all jobs conducted at elevation, with the potential exception of the "first man up" in certain situations. PSNS also provides worker training that includes practice inside a mock-up of a carrier deep tank. Photographs of the anchorage device and deployment in a "D-ring" in a training "mock-up" of a shipboard confined spaces are provided in **PHOTOGRAPHS 1 and 2**.

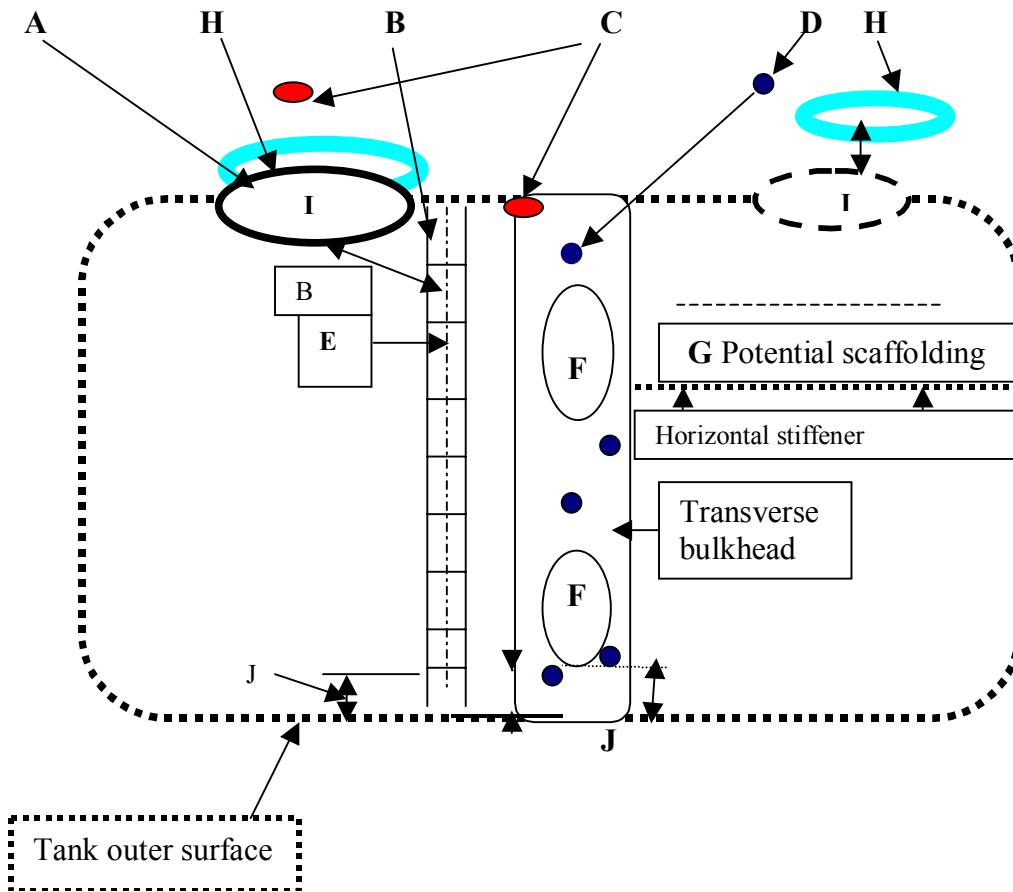
**FIGURE 2 (Key). Summary of Parameters for Confined Space Access**

There are many pace configurations and issues that increased the difficulty and risk of access. Initial access can be complicated by the distance between manholes or other entry points and secure ladders; limited anchor points above the entry point (manhole); and lack of anchor points at the top level of the climbing location to support the use fall protection. Movement within the tank can be made more difficult by location of the lowest lightening holes (often reportedly 4 to 6 feet above the deck) and position of the lowest climbing D-ring hole (sometimes reportedly greater than three feet above the lowest level). **FIGURE 2** illustrates the locations and access points of potential concern.

Item	Description
A	Access manhole (or hatch) dimensions
B	Space between entry and secure foothold
C	Location and capacity of anchorage points
D	Size, spacing and configuration of footholds
E	Ladder type, configuration and associated fall protection safeguards
F	Size and orientation of swash (lightening) holes
G	Hardware and anchorage points supporting scaffolding
H	Perimeter protection for deck opening
I	Number and location of hatches/manholes
J	Maximum distance from innerbottom (base of tank) to swash hole and first ladder tread or other foothold.

Refer to **FIGURE 2** for diagram summarizing parameters

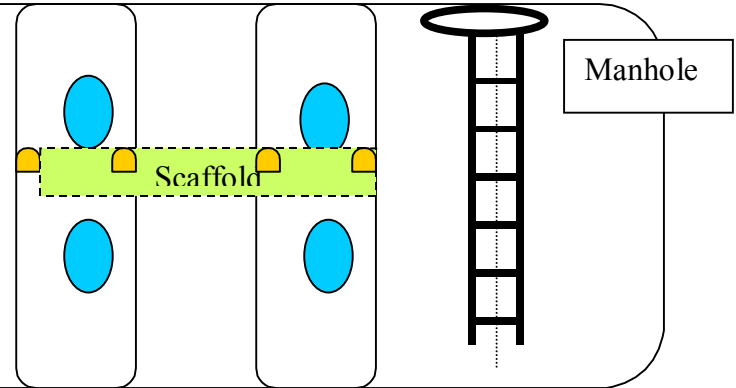
Swash (lightening) holes in transverse bulkheads

Detail: Two (2) D ring holes within 1-2 feet below swash hole and in same plane. One (1) D ring 1-2 feet above sash hole (providing fall protection anchorage)

**Annex B Figure 4 (Item F) Dimensions of Swash (Lightening) Holes**

Swash (lightening hole dimension)	Width (inches) (x)	Height (inches) (y)
Minimum	18	23
Preferred	29	32
