DRAFT ENVIRONMENTAL ASSESSMENT

**REBUILDING THE TAUM SAUK PUMPED STORAGE PROJECT'S
UPPER RESERVOIR**

**Taum Sauk Pumped Storage Project
FERC No. 2277
Missouri**

June 2007

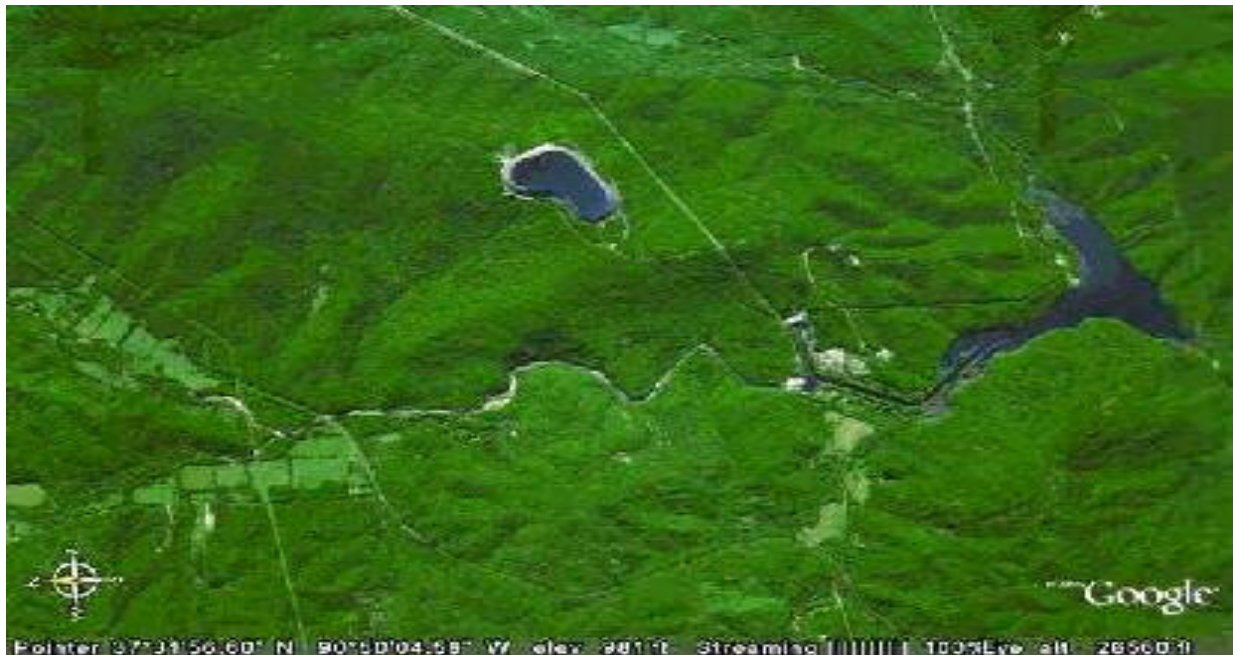
Figure 1-2. Pre-event satellite photograph showing the upper and lower reservoir, the powerhouse and the East Fork Black River along the Johnson Shut-Ins State Park. (Source: Google Earth, 2005)

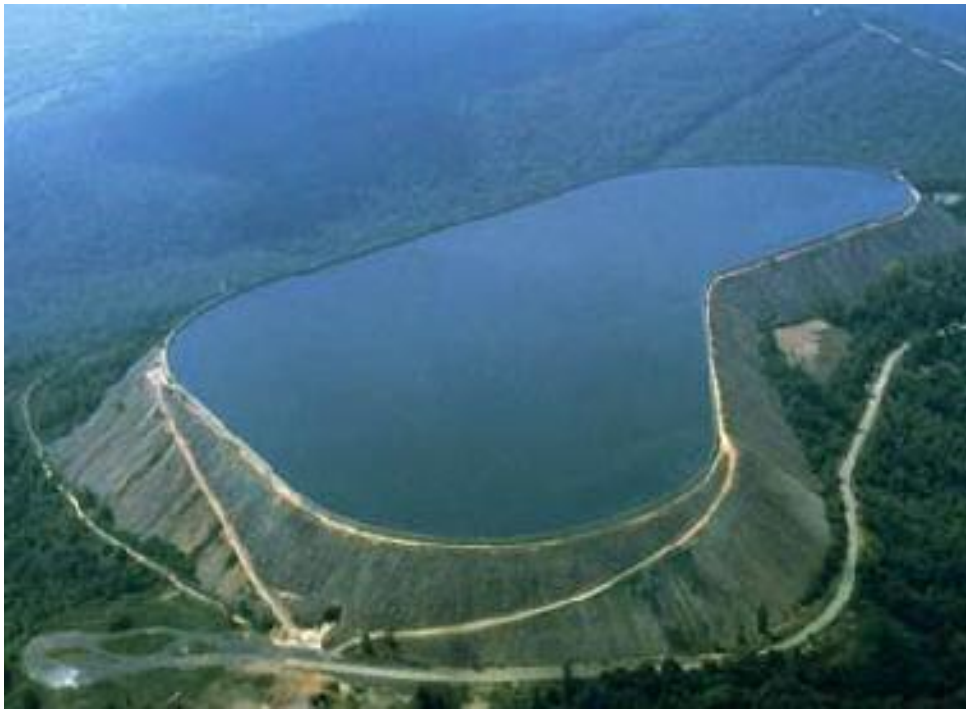
Figure 5-3. View of upper Reservoir, prior to the breach.
(Source: Wikipedia)

The top of Proffit Mountain was leveled and the excavated rock was used to construct the dike that forms the Upper Reservoir (Figure 5-3). The foundation area was stripped to bedrock during the dam failure. The bedrock is hard rhyolite porphyry with areas of closely spaced vertical joints (Figures 5-4 and 5-5). This rock is volcanic and formed by relatively quiet lava flows on the earth's surface. These rocks are fine grained but contain mineral crystals that formed before the rock was erupted. Even though they are 1.4+ billion years old, these rocks still exhibit flow patterns from the original lava flow.

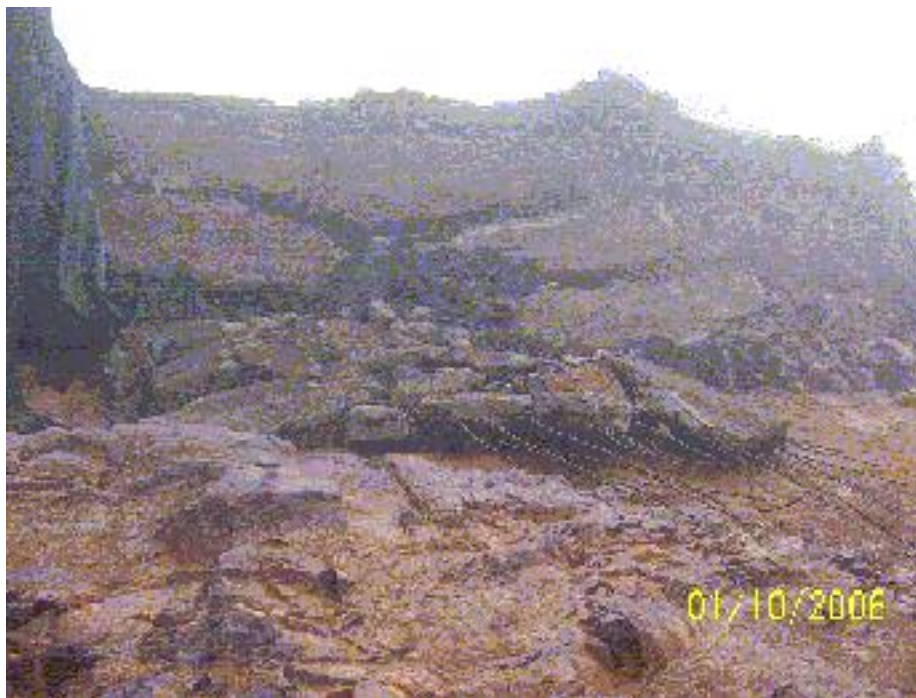
Figure 5-4. View of bedrock immediately below failed embankment section. Note weathered clay in lower portions of the exposure. (Source: FERC Staff)

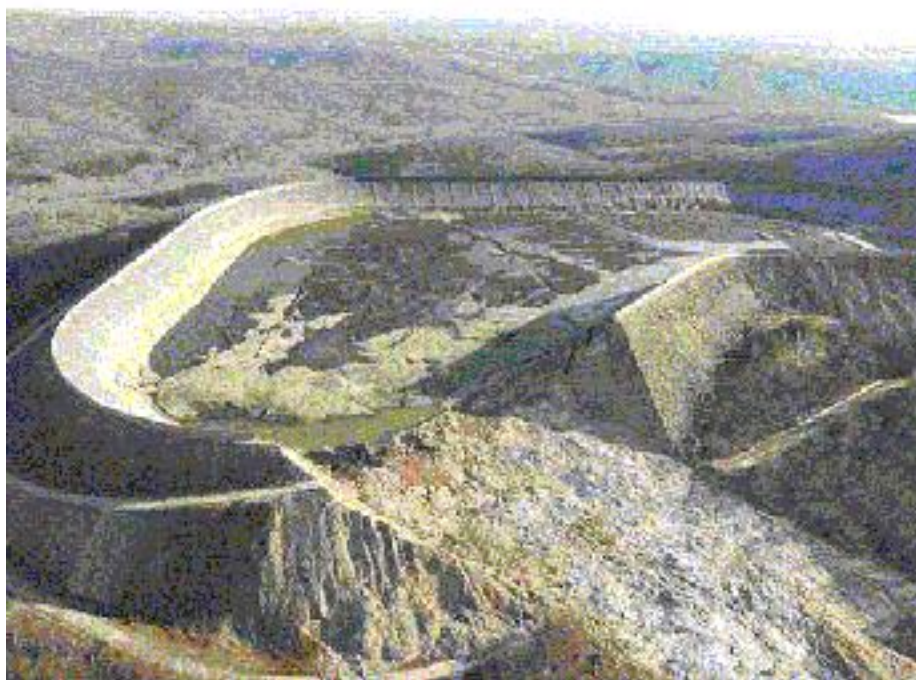
Figure 5-5. View of bedrock within, and immediately below failed embankment section. Note distribution of weathered rock (red-brown color) and topsoil (green-brown color). (Source: MDNR)

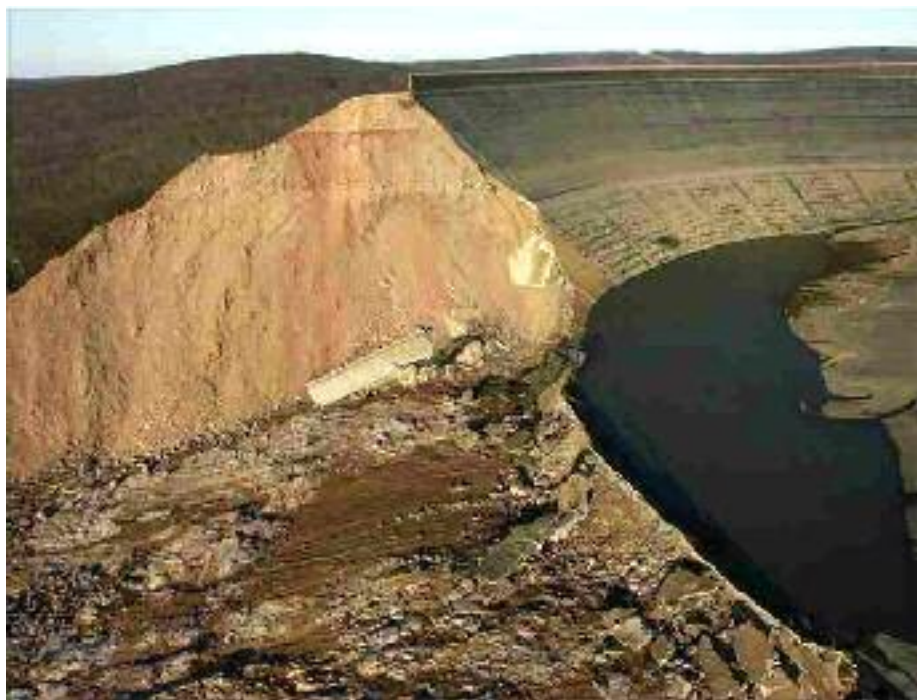
Figure 5-6. Weathered rock and discontinuous clay seam foundation just downstream of fish-pond area. (Source: FERC Staff)

An area of the foundation in the breach section contained clay with low to moderate plasticity and weathered rock in the area just beneath the breach. The clay appears to be a residual weathering product of the bedrock and in areas, relict bedrock structure can be observed in partially and completely decomposed clay remnants. No records were made available that indicate the extent of clay that was left in the breach area. The clay appeared saturated and contained groove marks from debris. This area was over-excavated in the footprint of the reservoir due to the clay foundation conditions, forming the “fish-pond” area of the reservoir floor. There was also some remnant soils found in the breach area (Figure 5-6).

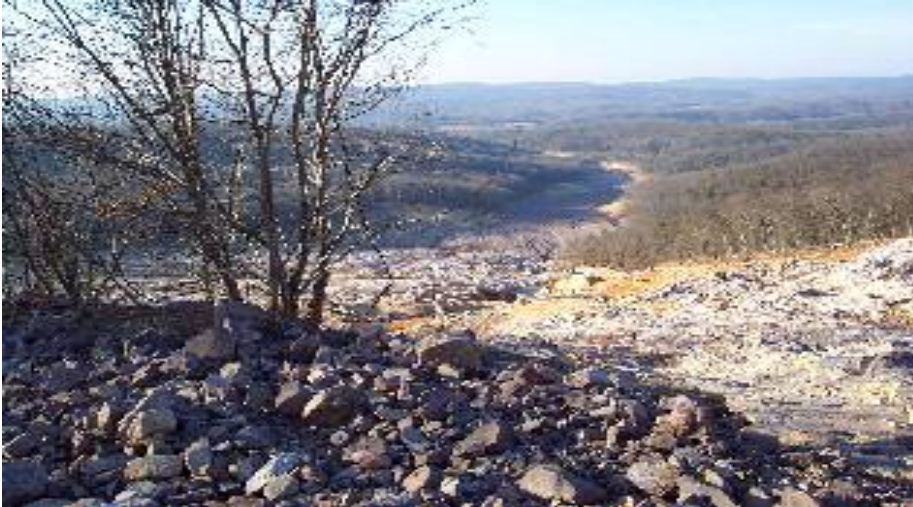
Figure 5-7. Downstream view from breach. (Source: FERC Staff)

The erosive force of the water from the breach removed all topsoil to bedrock in an approximate 200-yard swath, down the face of the Proffit Mountain (Figure 5-7) along the course of an intermittent unnamed tributary. Also, seen in Figure 5-7 is the shallowness of the topsoil along the tree line.

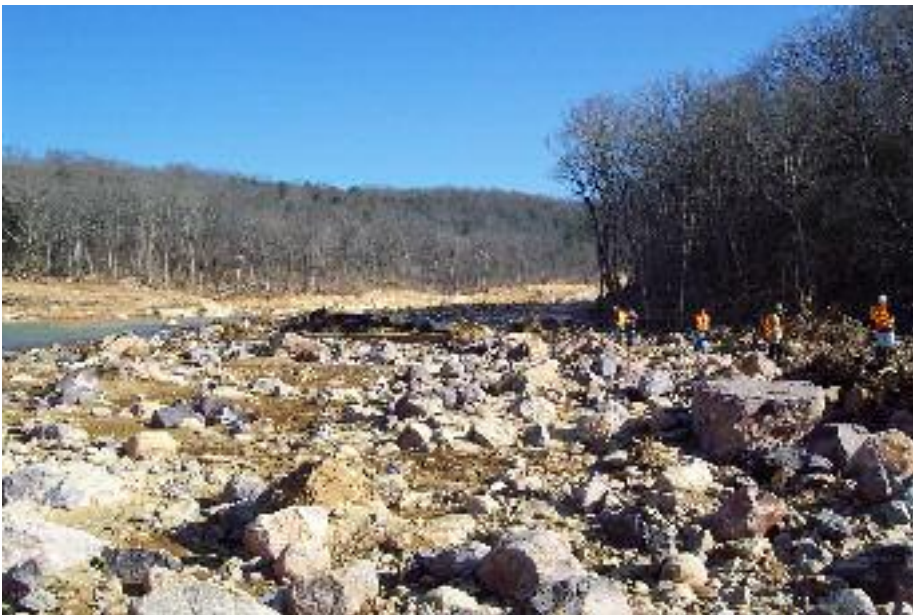
Figure 5-8. Looking upstream from debris dam.
(Source: FERC Staff)

A break in the slope of the terrain is located where the unnamed tributary joins the East Fork Black River at the lower portion of the mountain. Most of the deposition of eroded sediments and rock fill from the dam embankment occurred at this point, forming a debris dam (Figure 5-8) and pond at the approximate location of U.S. Geological Survey gage station (No. 070661270) which was severely damaged during the event. The material deposited at this point ranged from boulders several feet in diameter to sand and fine silts. Concrete, rebar, and sections of the geomembrane lining from the Upper reservoir were also present in the debris field, thus creating a new soil deposit in this area.

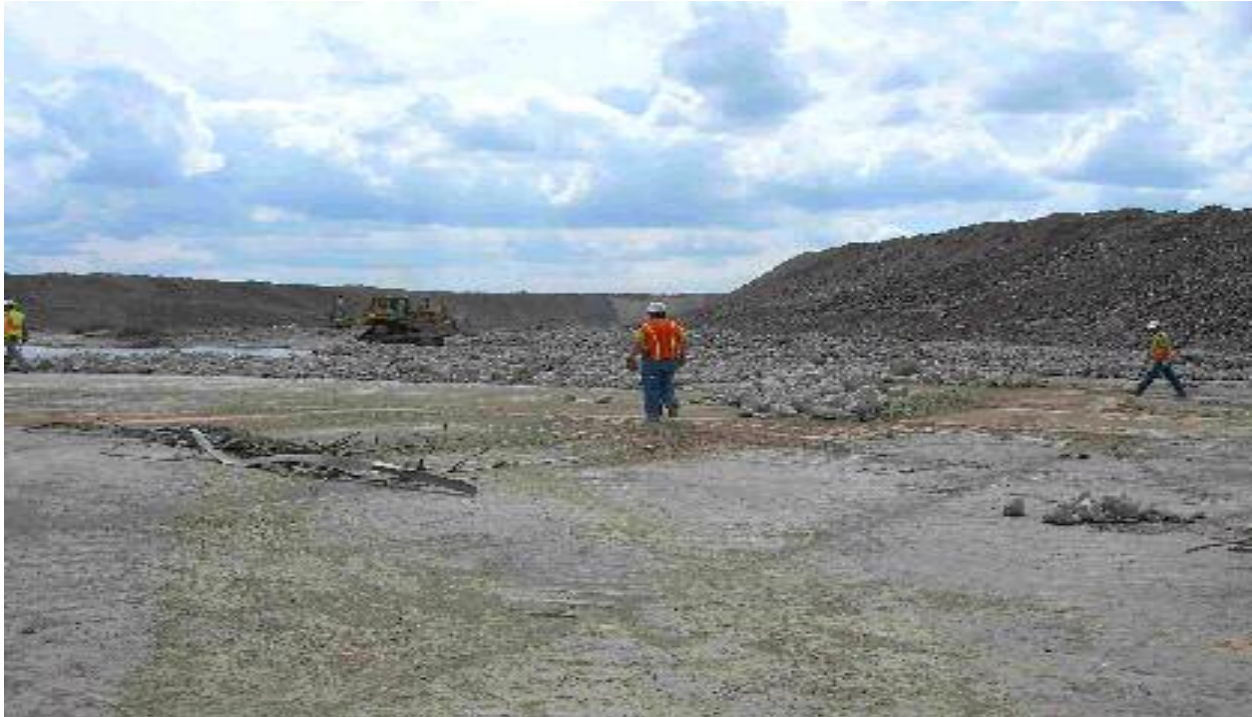
Figure 5-9. Drained upper reservoir basin showing the rockfill materials after removal of the concrete face panels. (Source: FERC Staff)

The licensee's proposal to reuse the material comprising the existing rockfill dam by processing the material through a crushing plant. This processed material would comprise the aggregate utilized in a RCC hardfill dam (Figure 5-9).

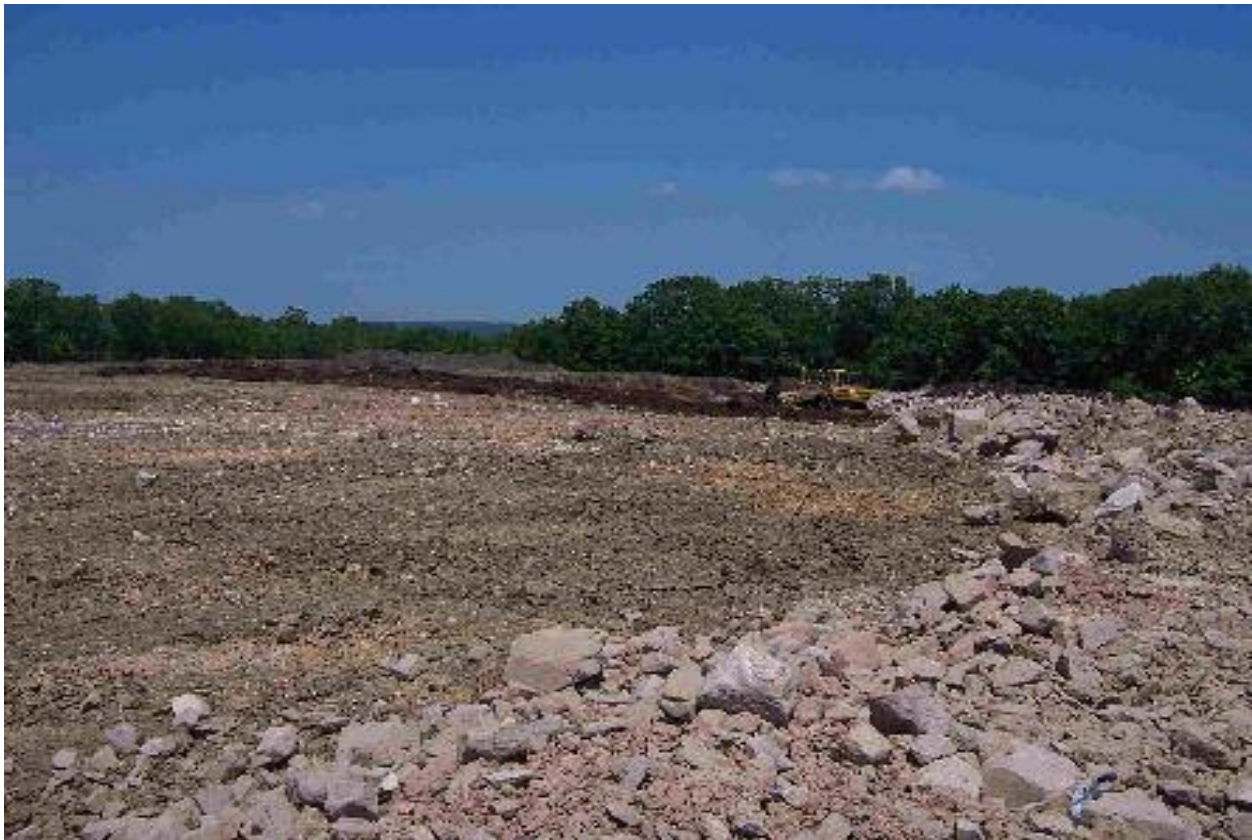
Figure 5-10. Preparation of Laydown Area 1. The fill material from the upper reservoir (sediment and concrete debris) was used to level the site. A hardfill cap will be placed over the top of the area. (Source: FERC Staff)

- Area 1 – North end of upper reservoir – 5.14 acres (Figure 5-10)
- Area 2 – South west side of the upper reservoir – 15.2 acres
- Area 3 – adjacent to Area 2 and Staging Area – 13.2 acres
- Staging Area – South side of upper reservoir – 3.7 acres
- Parking Area (existing) - Boat Landing - 2.5 acres
