The New Orleans and Southeast Louisiana Hurricane Protection System was conceived as a way to buffer the area from hurricane flooding. The system is a network of levees, floodwalls, reinforced bridges, and dikes spanning five parishes. The system was designed to protect southeastern Louisiana from catastrophic flooding in the event of a Standard Project Hurricane, a model of severe meteorological conditions considered reasonably characteristic for the region in 1965.

The U.S. Army Corps of Engineers established the Interagency Performance Evaluation Task Force (IPET) in fall 2005 to provide scientific and engineering answers to questions about the hurricane protection system's performance during Hurricane Katrina on August 29, 2005. This summary of Volume III of the nine-volume IPET Draft Final Report, released on June 1, 2006,

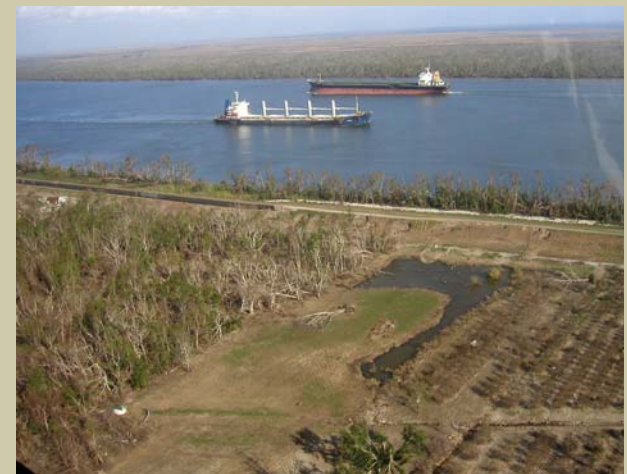
Figure 3-1: Aerial view of the New Orleans and Southeast Louisiana Hurricane Protection System, showing the network of levees, floodwalls, reinforced bridges, and dikes spanning five parishes.
