RE: 17TH STREET CANAL PARALLEL FLOOD PROTECTION
PHASE 1B - HAMMOND HIGHWAY TO SOUTHERN RAILWAY
OLB PROJECT NO. 2043-0207

In your letter of October 21, 1988, you listed comments on our preliminary plans for the above referenced project. In our review of those comments, we discovered that the slope stability calculations for the first six reaches of this project do not properly reflect the actual factors of safety.

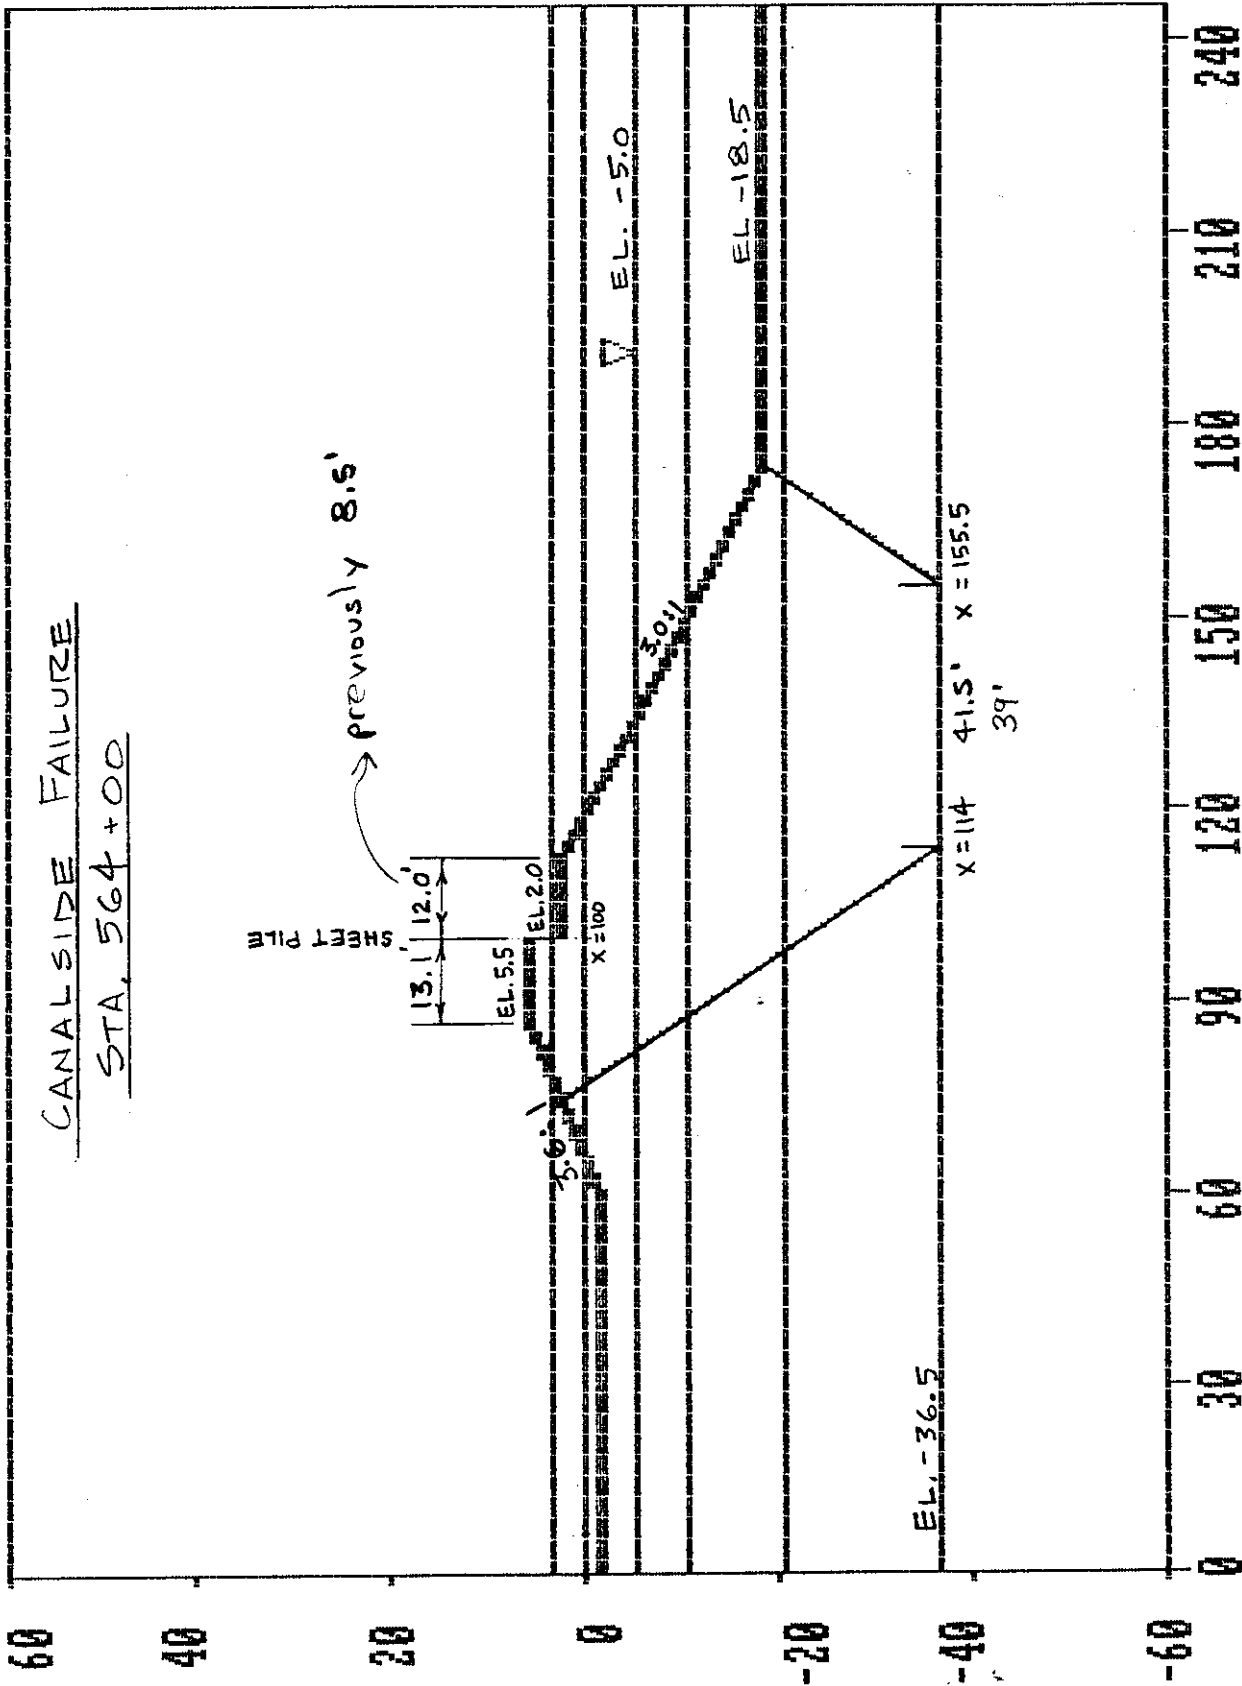
STA. 564+00

CANALSIDE FAILURE

$$F.S. = \frac{R_A + R_B + R_P}{D_A - D_P} = \frac{27,827 + 15,770 + 13,480}{51,901 - 8,381} = \frac{57,077}{43,520} = 1.30$$

$$= \frac{26,922 + 15,770 + 13,834}{83,567 - 39,626} = \frac{56,526}{43,941} = 1.30$$

Canalside Failure - 562+00, 564+00 and 566+00. The section at Sta. 564+00 governs.
*** Minimum Factor of Safety = 1.30 ***

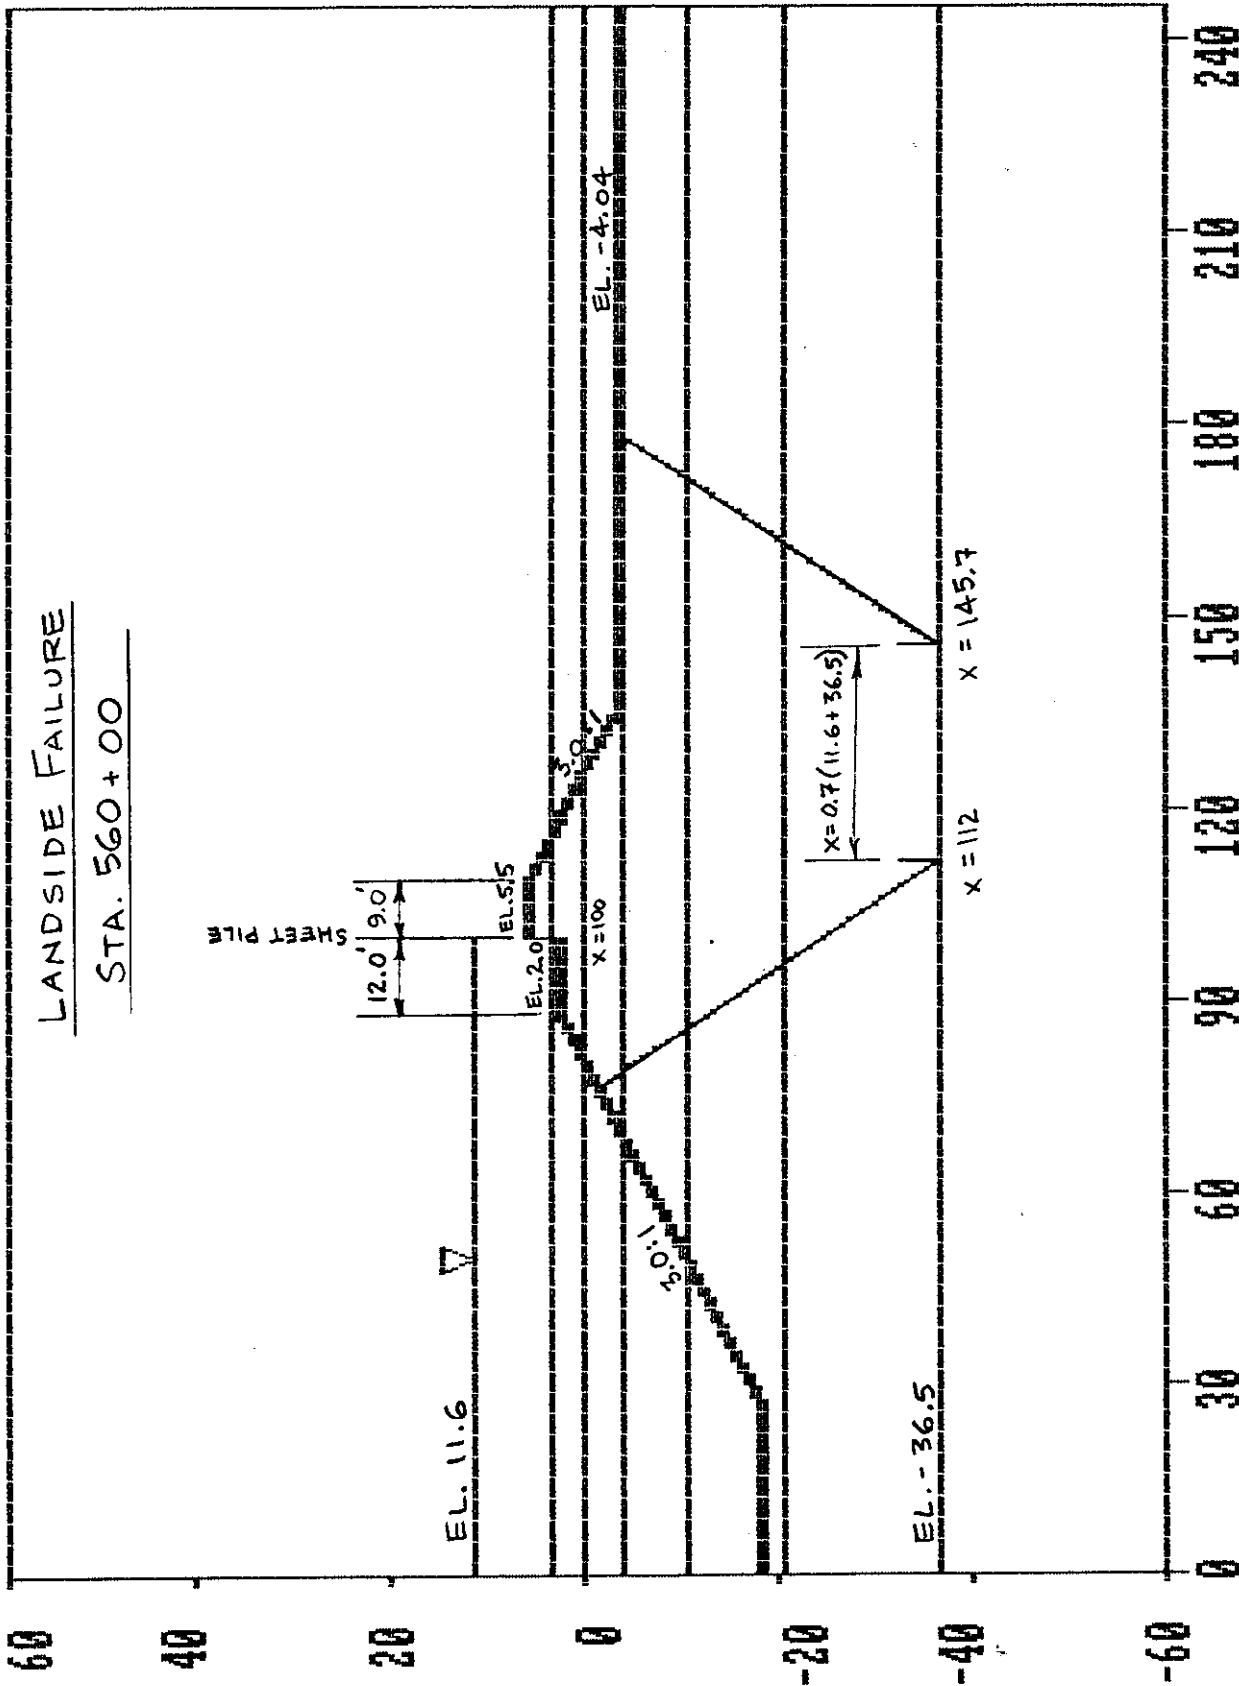
STA. 560+00

LANDSIDE FAILURE

$$\begin{aligned}
 \text{F.S.} &= \frac{R_A + R_B + R_P}{D_A - D_P} = \frac{23,452 + 12,736 + 22,400}{98,703 - 54,283} = \frac{58,588}{44,420} = 1.33
 \end{aligned}$$

Landside Failure - 554+00, 556+00, 560+00 and 562+00. The section at Sta. 560+00 governs.
*** Minimum Factor of Safety = 1.33 ***

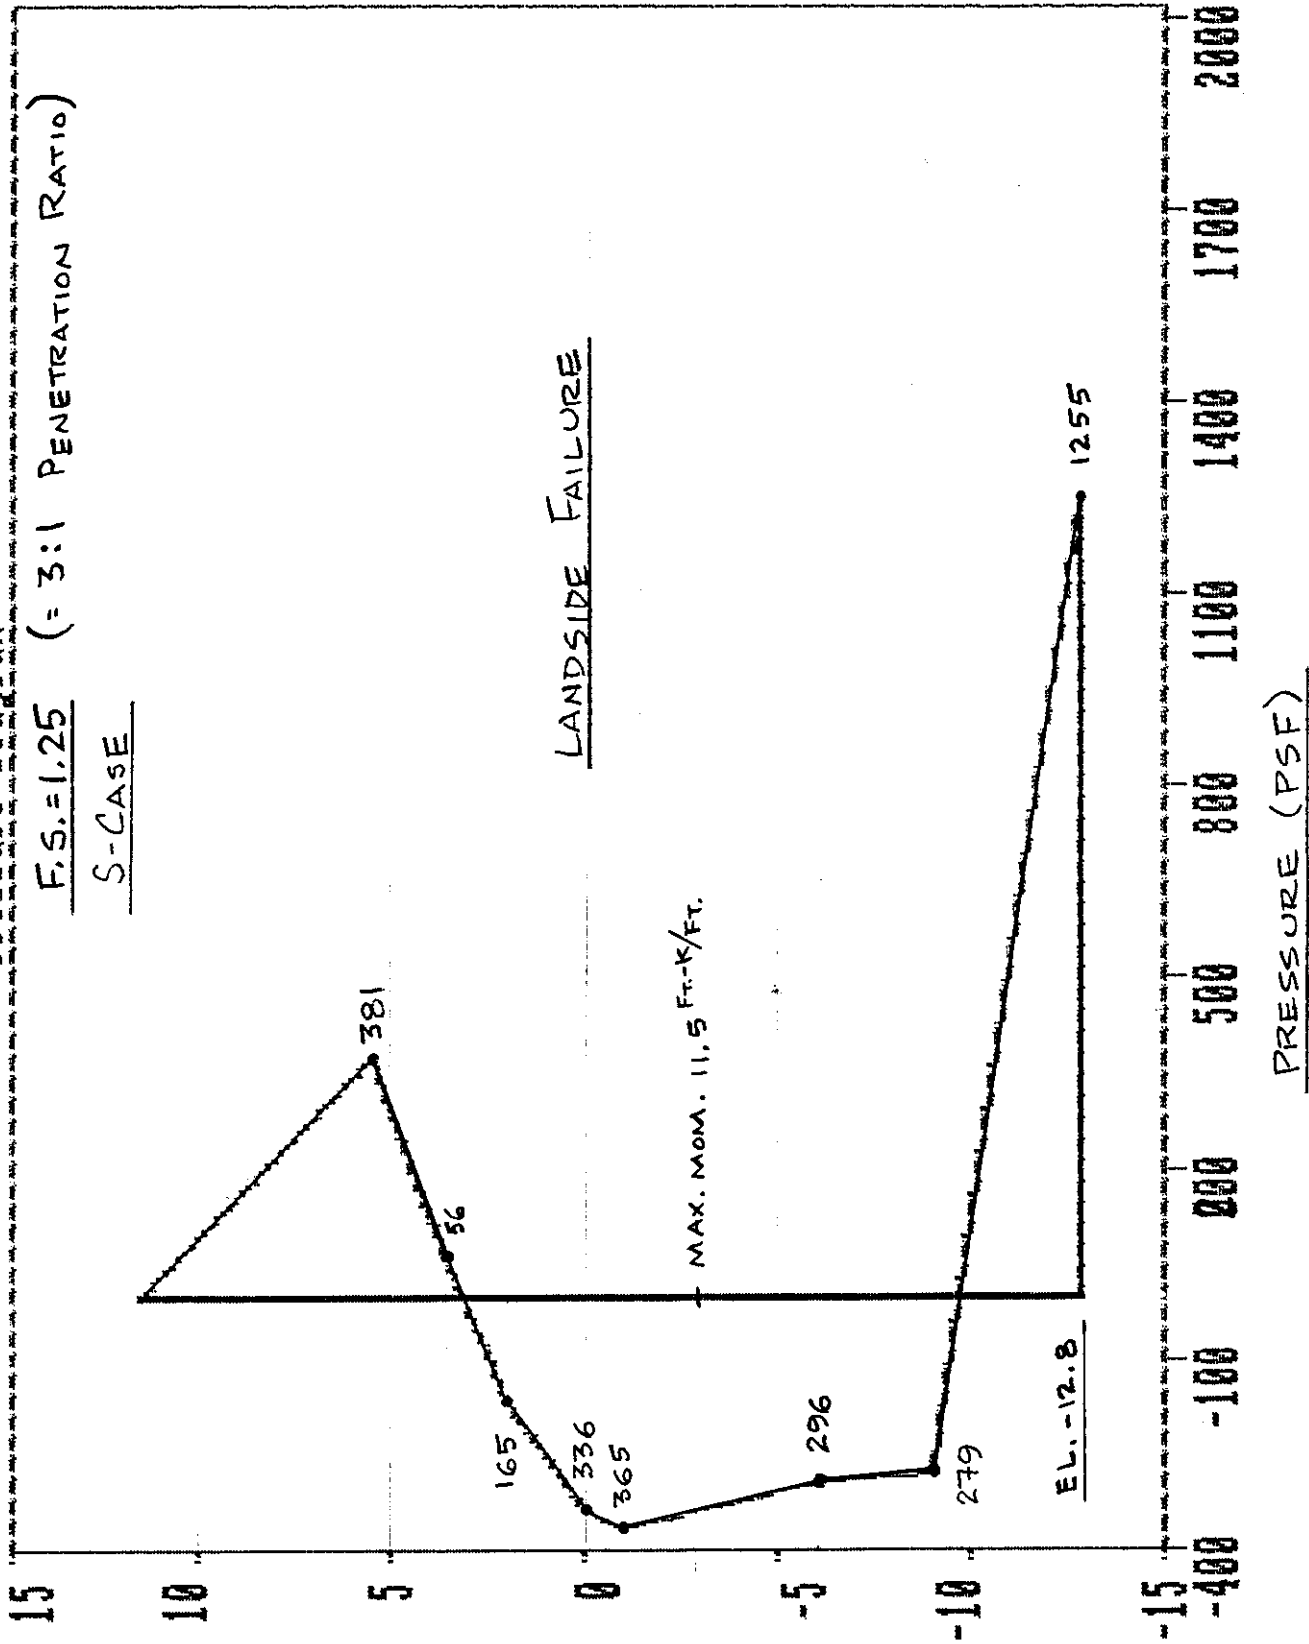
Pressure Diagram

F.S. = 1.25 (= 3:1 PENETRATION RATIO)

S-CASE

Required Penetration : -12.8 (Landside Failure 3:1 Ratio; S-Case F.S. = 1.25)
Design Bending Moment : 11.5 Ft-K/Ft @ EL. -2.8 (Landside Failure 3:1 Ratio; S-Case F.S. = 1.25)
Maximum Deflection : In.

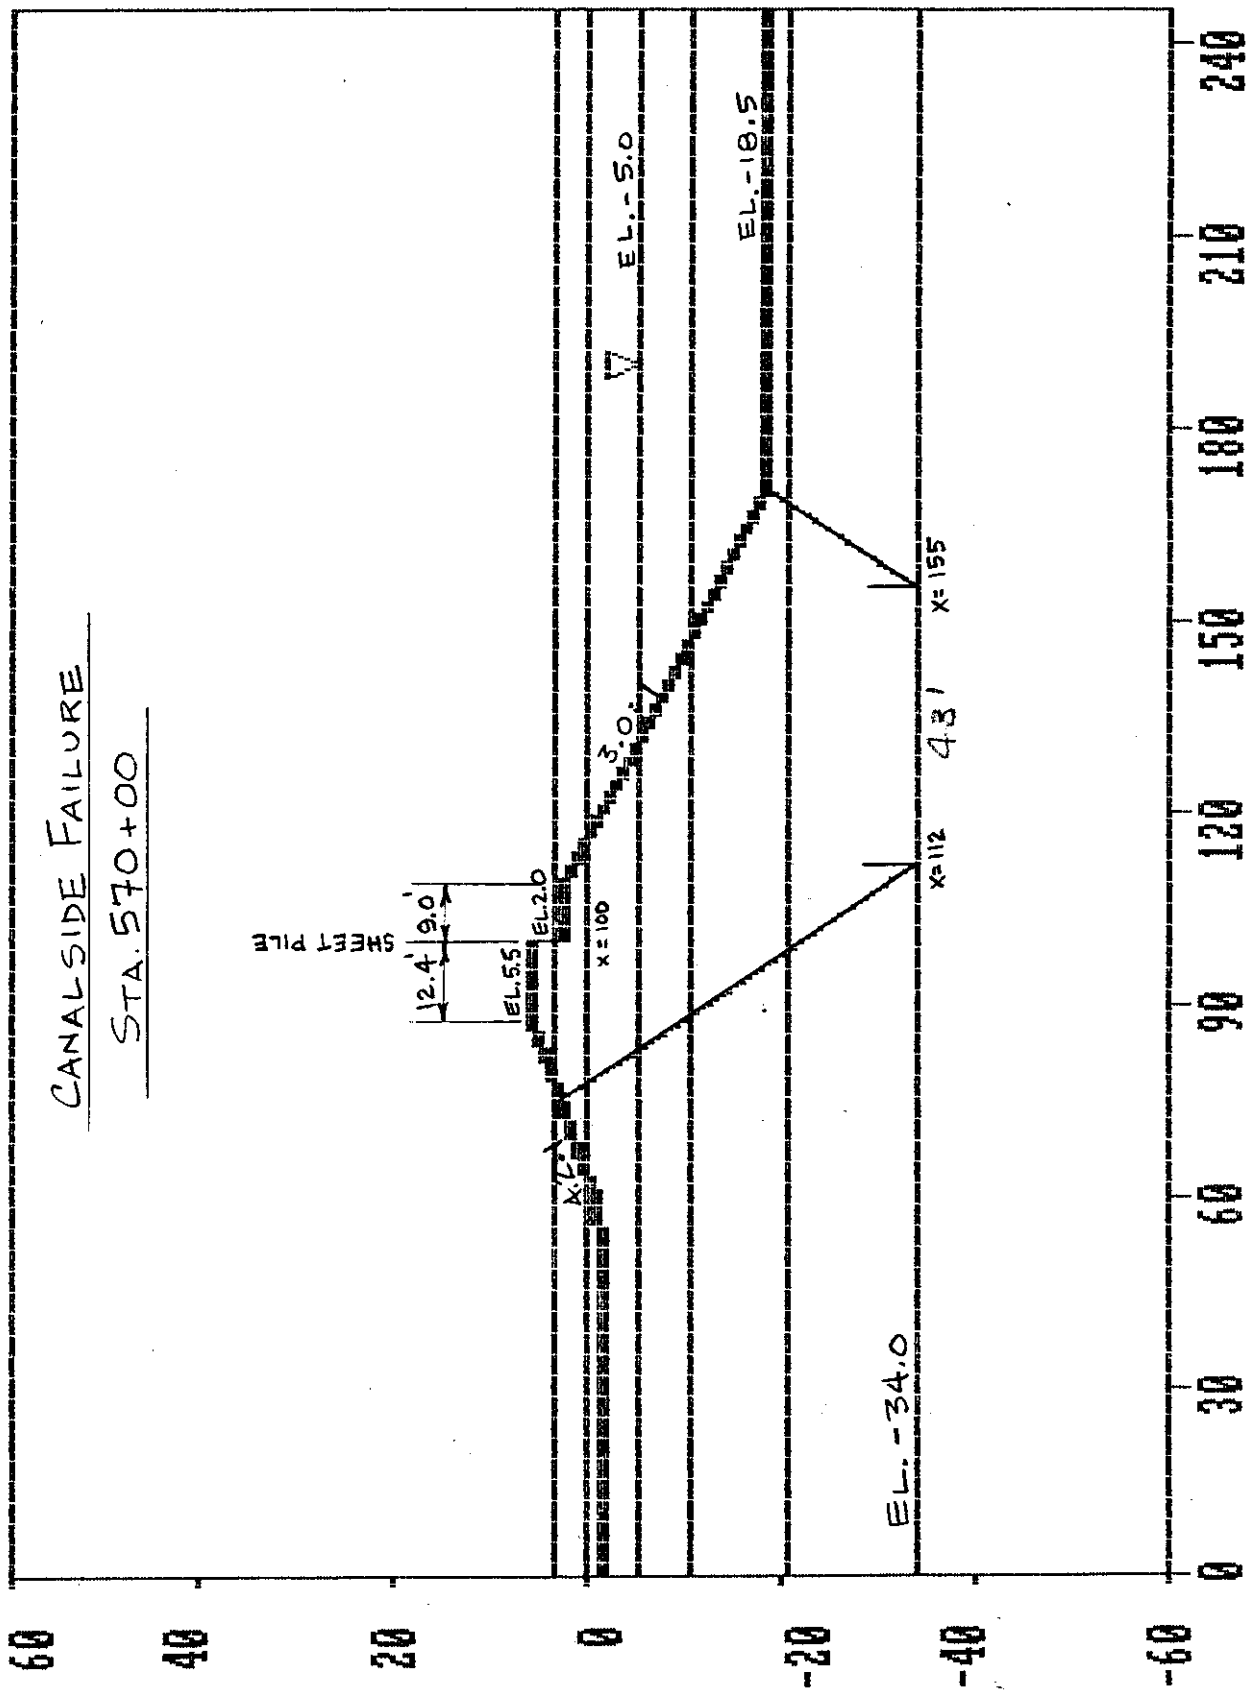
$$F.S. = \frac{R_A + R_B + R_P}{D_A - D_P} = \frac{26,029 \quad 16,340 \quad 12,075}{25,357 + 16,340 + 11,934} = 1.31$$

$$47,101 - 6225 = 40,876$$

$$73,589 - 33,318 = 40,271 = 1.34$$

Canalside Failure - 570+00.
*** Minimum Factor of Safety = 1.31 ***

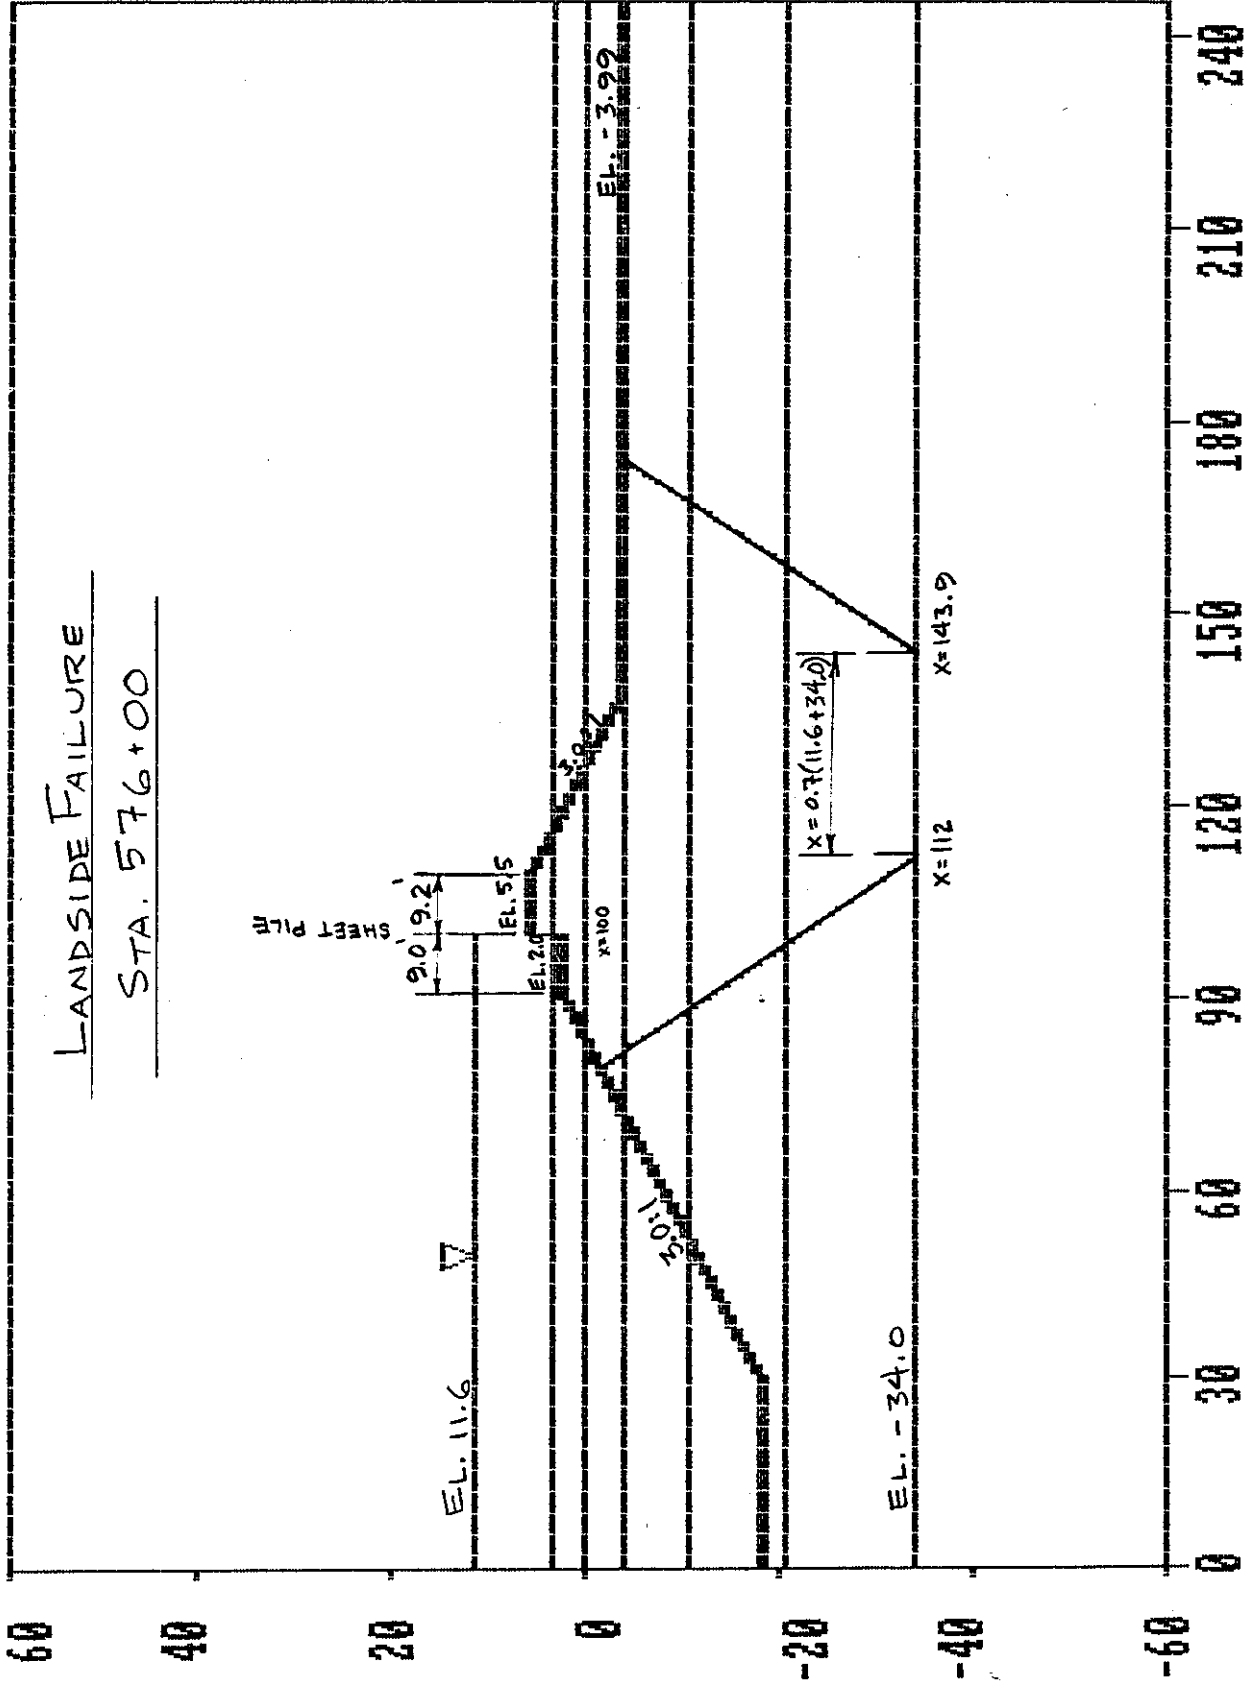
$$F.S. = \frac{R_A + R_B + R_P}{D_A - D_P} = \frac{21,482 + 11,970 + 20,500}{21,781 + 12,130 + 20,527} = \frac{53,952}{54,438} = 1.30$$

$$= \frac{59,036 - 18,005}{87,640 - 46,282} = 1.33$$

Landside Failure - 576+00, 578+00, 584+00 and 588+00. The section at Sta. 576+00 governs.
*** Minimum Factor of Safety = 1.33 ***

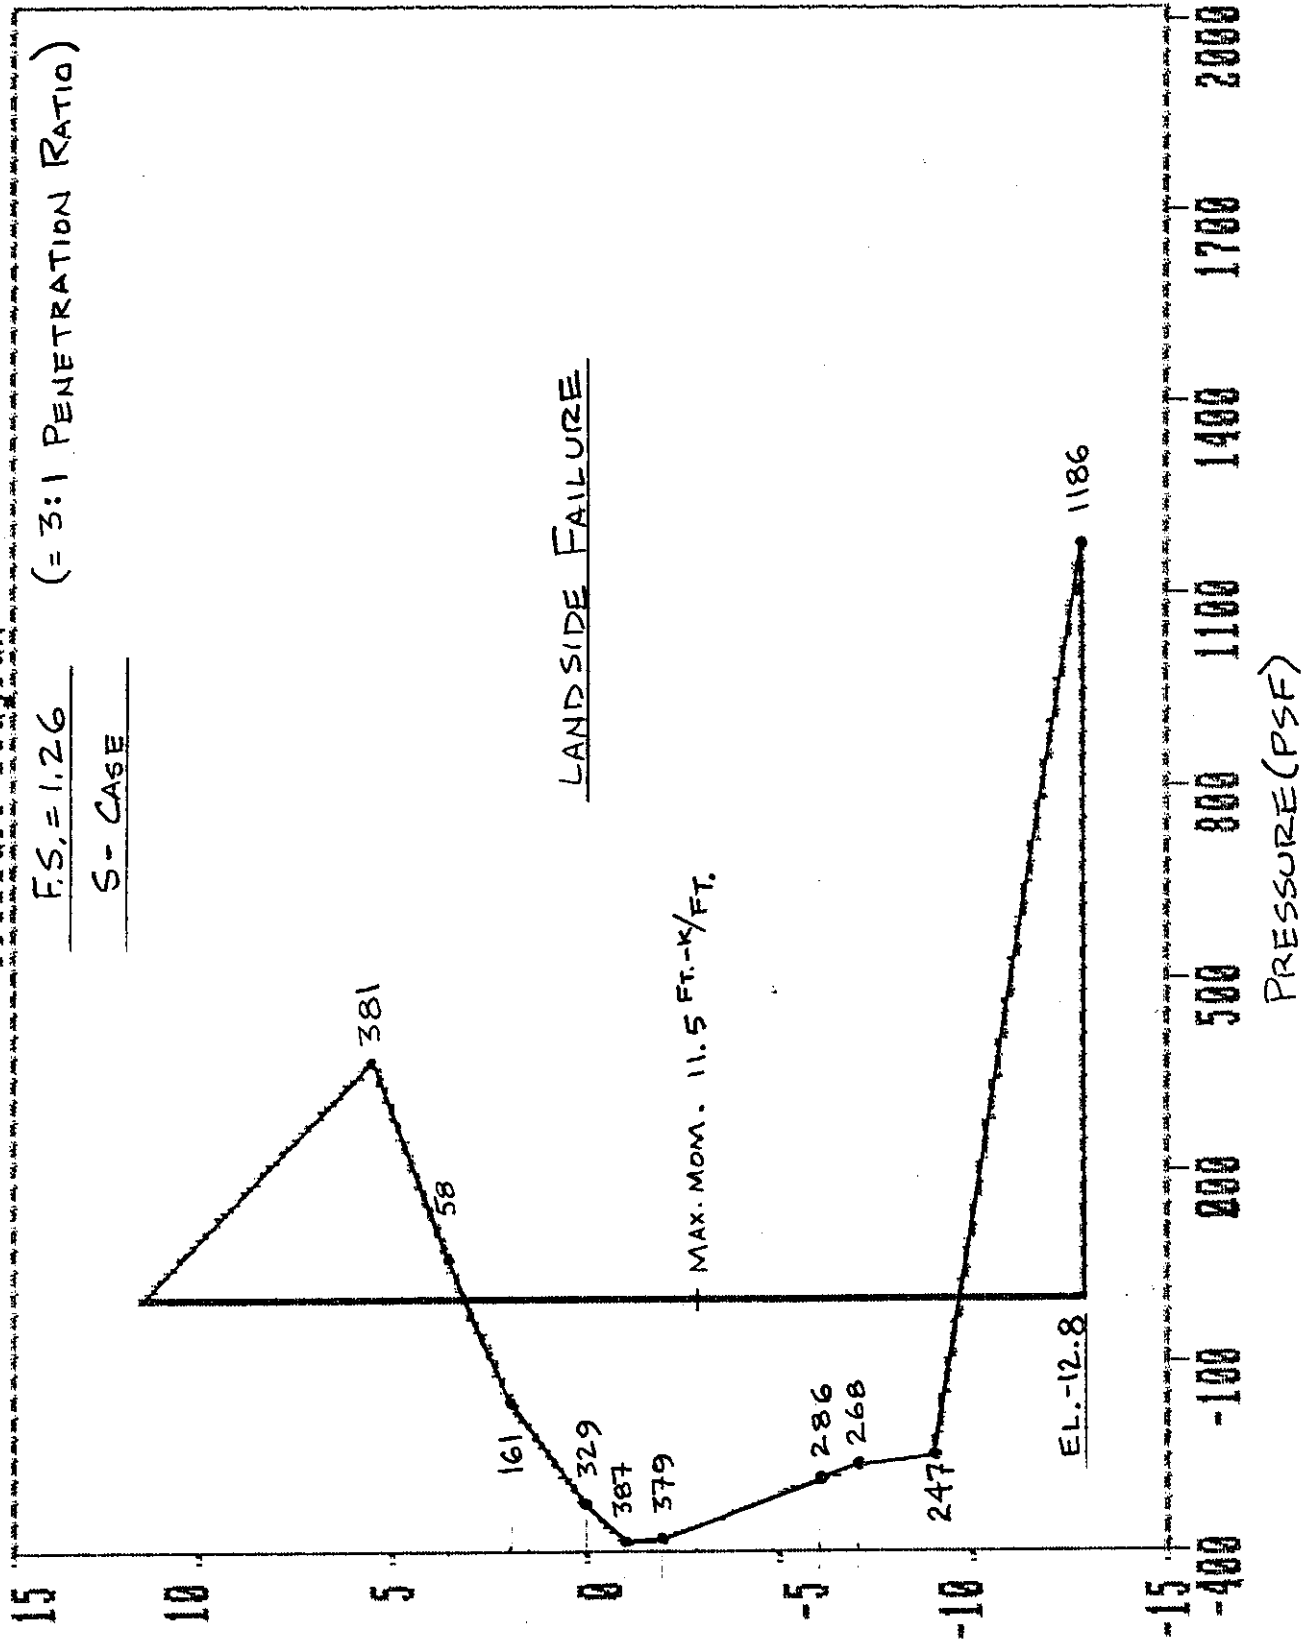
Pressure Diagram

(= 3:1 PENETRATION RATIO)

F.S. = 1.26

S - CASE

Required Penetration : -12.8 (Landside Failure 3:1 Ratio; S-Case F.S. = 1.26)
Design Bending Moment : 11.5 Ft-K/Ft @ El. -2.7 (Landside Failure 3:1 Ratio; S-Case F.S. = 1.26)
Maximum Deflection : In.

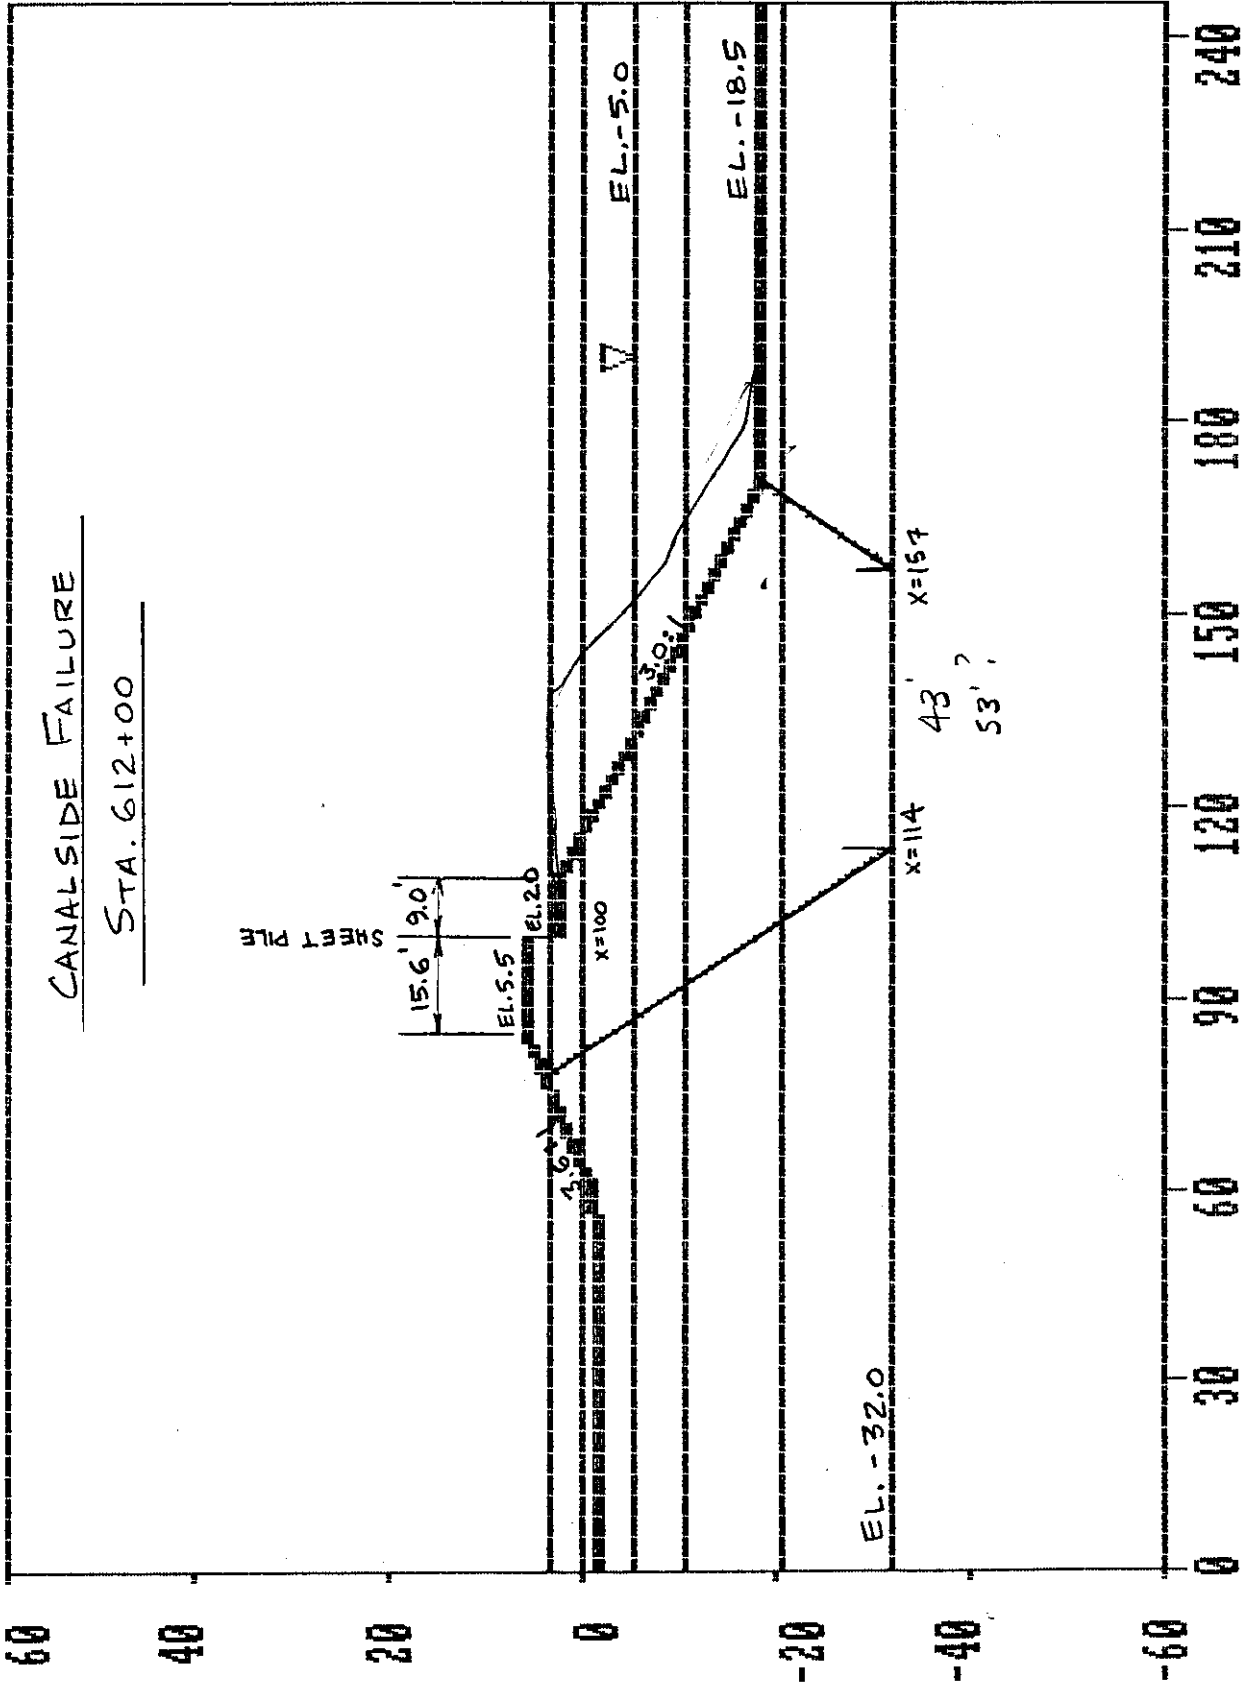
STA. 612+00

CANALSIDE FAILURE

$$F.S. = \frac{R_A + R_B + R_P}{D_A - D_P} = \frac{25,603 \quad 19,799 \quad 10,060}{43,917 - 4,731} = \frac{25,024 + 16,340 + 10,414}{39,186} = 1.32$$

Canalside Failure - 612+00. ***** Minimum Factor of Safety = 1.32 *****

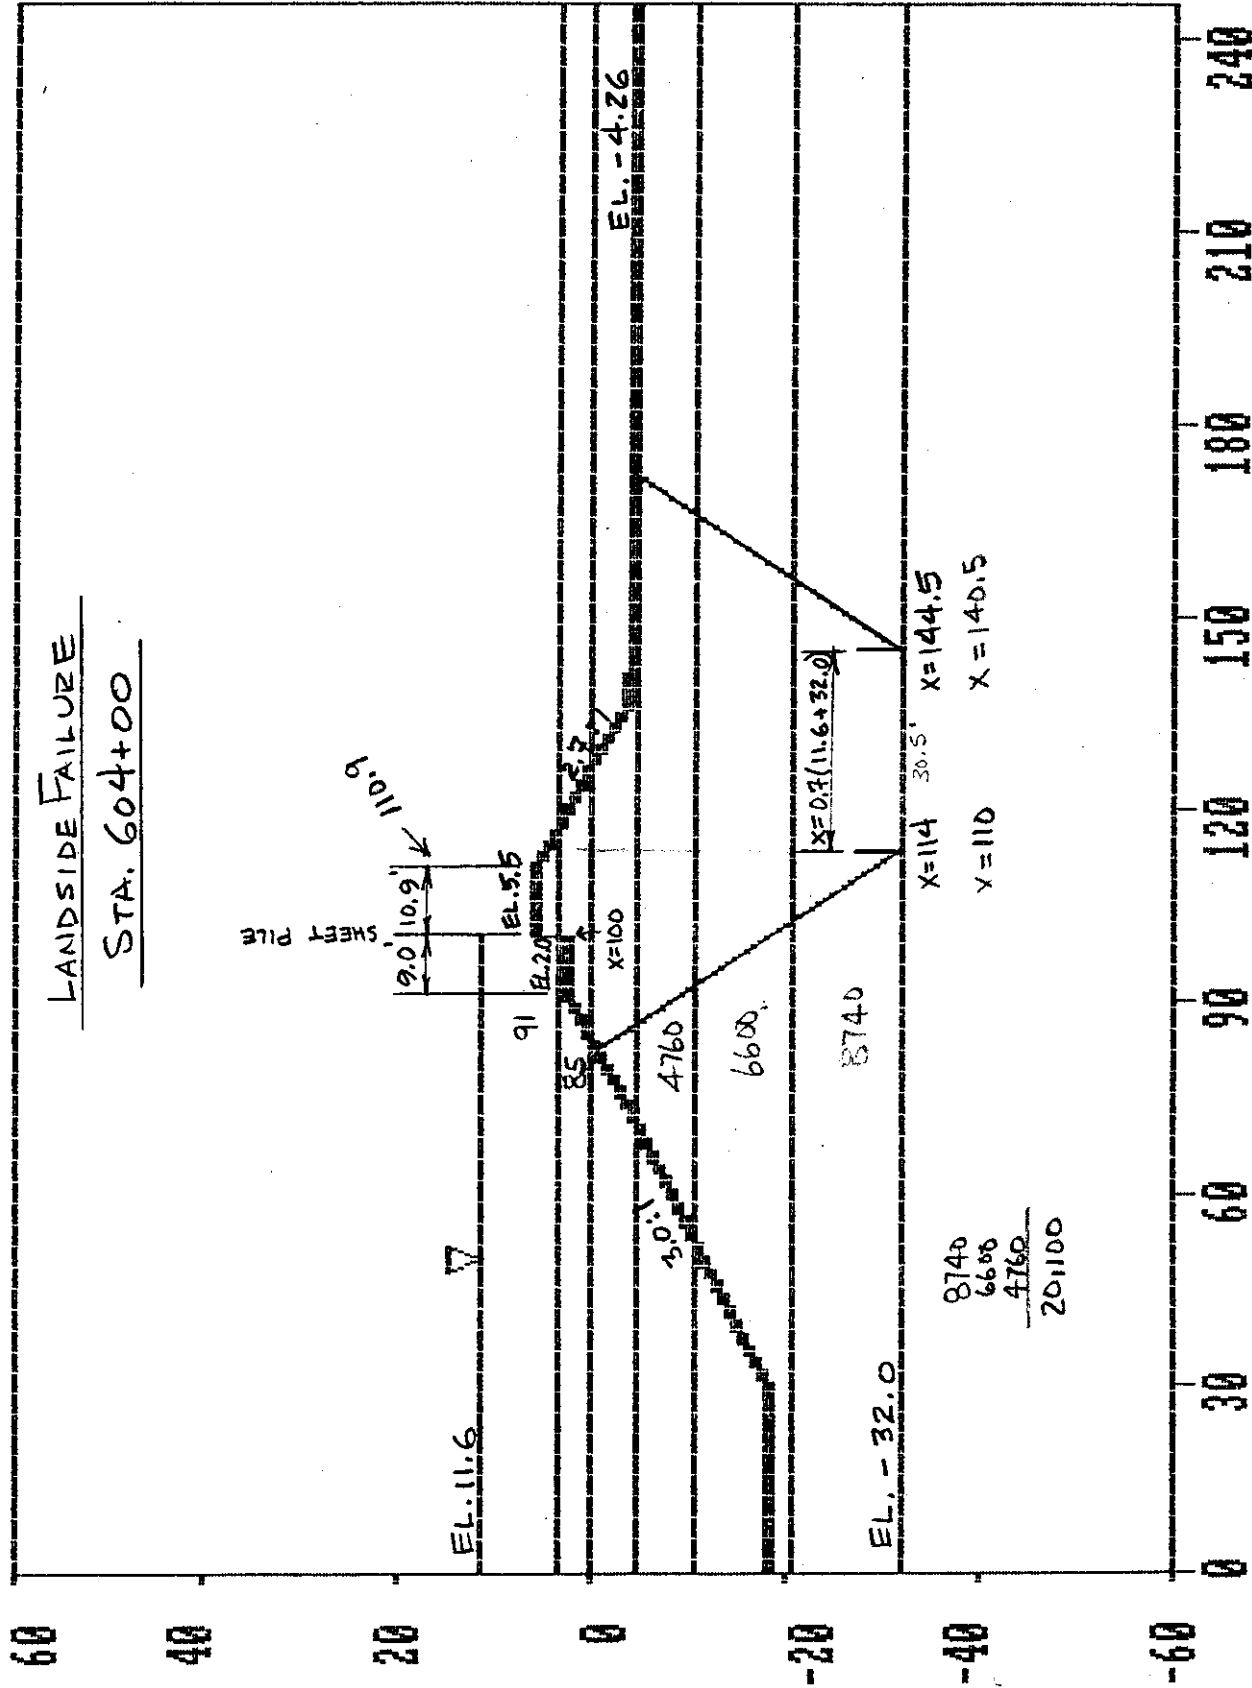
STA. 604+00

LANDSIDE FAILURE

$$\begin{aligned}
 &20,352 \quad 11,590 \quad 18,812 \quad 1.27 \\
 &20,821 + 11,598 + 18,855 = 1.30 \quad (M+M \text{ If use}) \\
 &54,853 - 15,425 = 39,428 \rightarrow \text{same wedge} = 39,602 \\
 &79,437 - 39,373 = 40,064 \quad \text{Active } \phi_{DA-DP}
 \end{aligned}$$

$$\text{F.S.} = \frac{R_A + R_B + R_P}{D_A - D_P} =$$

Landside Failure - 590+00, 592+00, 594+00, 596+00, 600+00, 604+00 and 606+00.
 The section at Sta. 604+00 governs. ***** Minimum Factor of Safety = 1.30 *****

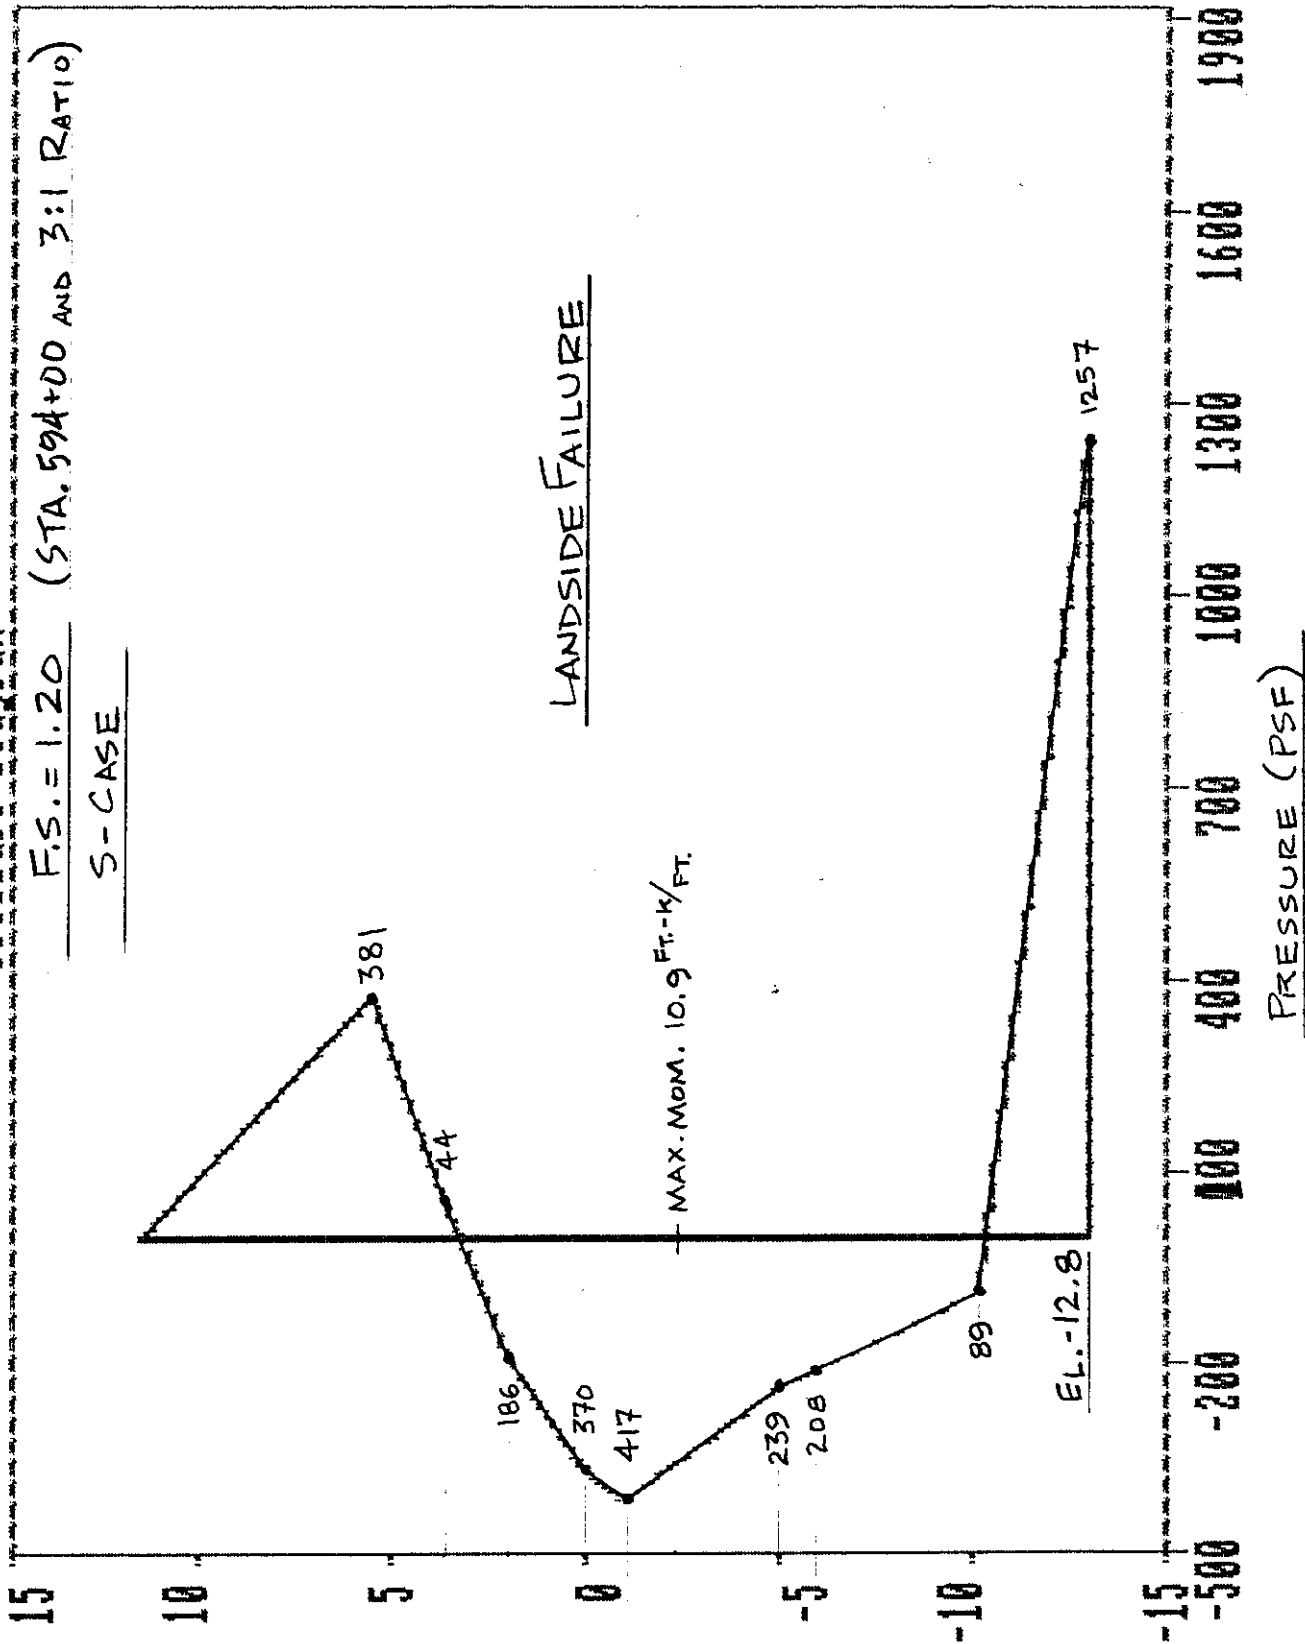
Pressure Diagram

F.S. = 1.20 (STA. 594+00 AND 3:1 RATIO)

S-CASE

Required Penetration : -12.8 (Landside Failure Sta. 594+00 and 3:1 Ratio; S-Case F.S.=1.2)
 Design Bending Moment : 10.9 Ft-K/Ft @ El. -2.3 (Landside Failure Sta. 594+00 and 3:1 Ratio; S-Case F.S.=1.2)
 Maximum Deflection : In.

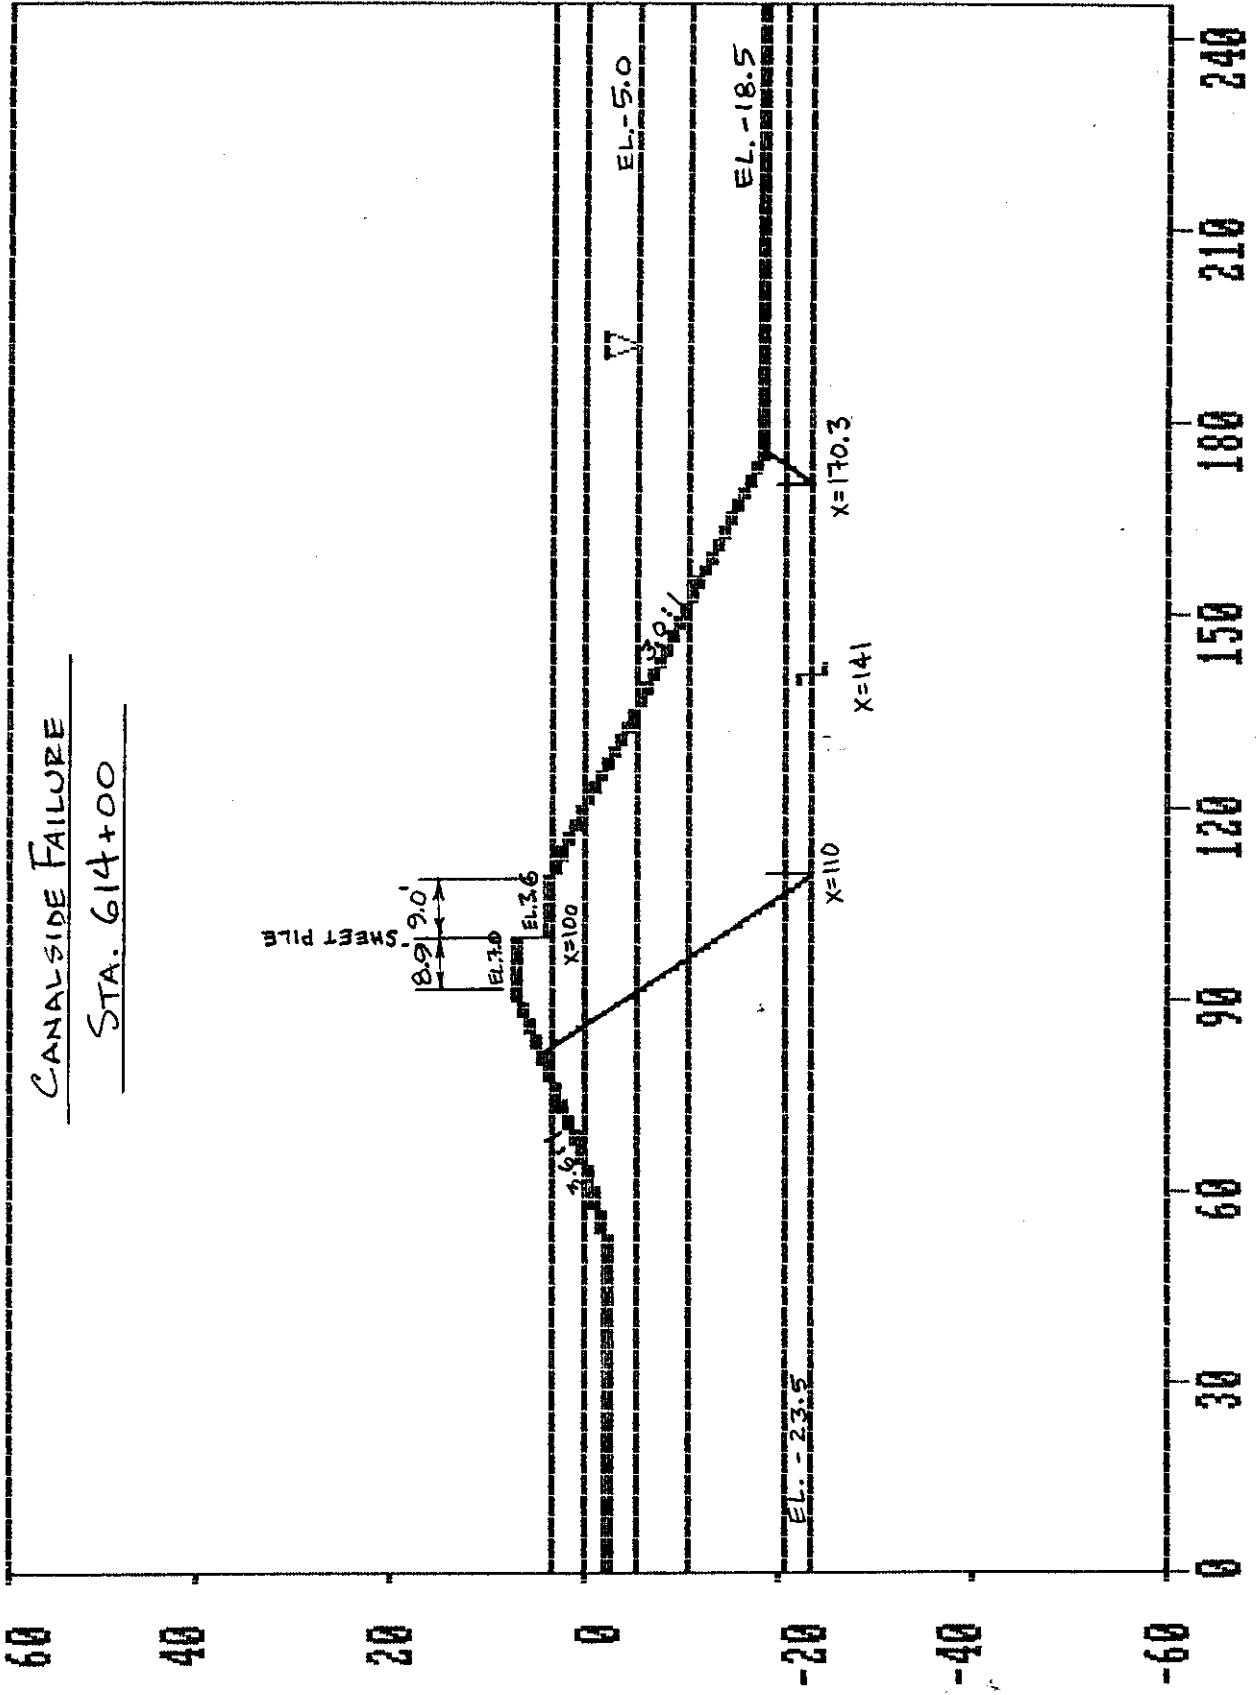
CANALSIDE FAILURE
STA. 614+00

$$\begin{aligned}
 FS. &= \frac{RA + RB + RP}{DA - DP} = \frac{19,685 + 17,251 + 3600}{43,979 - 11,230} = \frac{38,536}{32,749} = 1.174 \\
 &= \frac{19,259 + 19,555 + 3,764}{33,030 - 662} = \frac{42,578}{32,368} = 1.314
 \end{aligned}$$

Canalside Failure - 614+00 and 616+00. The section at Sta. 614+00 governs.
*** Minimum Factor of Safety = 1.32 ***
