RE: 17TH STREET CANAL PARALLEL FLOOD PROTECTION
PHASE 1B - HAMMOND HIGHWAY TO SOUTHERN RAILWAY
OLB PROJECT NO. 2043-0207

In your letter of October 21, 1988, you listed comments on our preliminary plans for the above referenced project. In our review of those comments, we discovered that the slope stability calculations for the first six reaches of this project do not properly reflect the actual factors of safety.

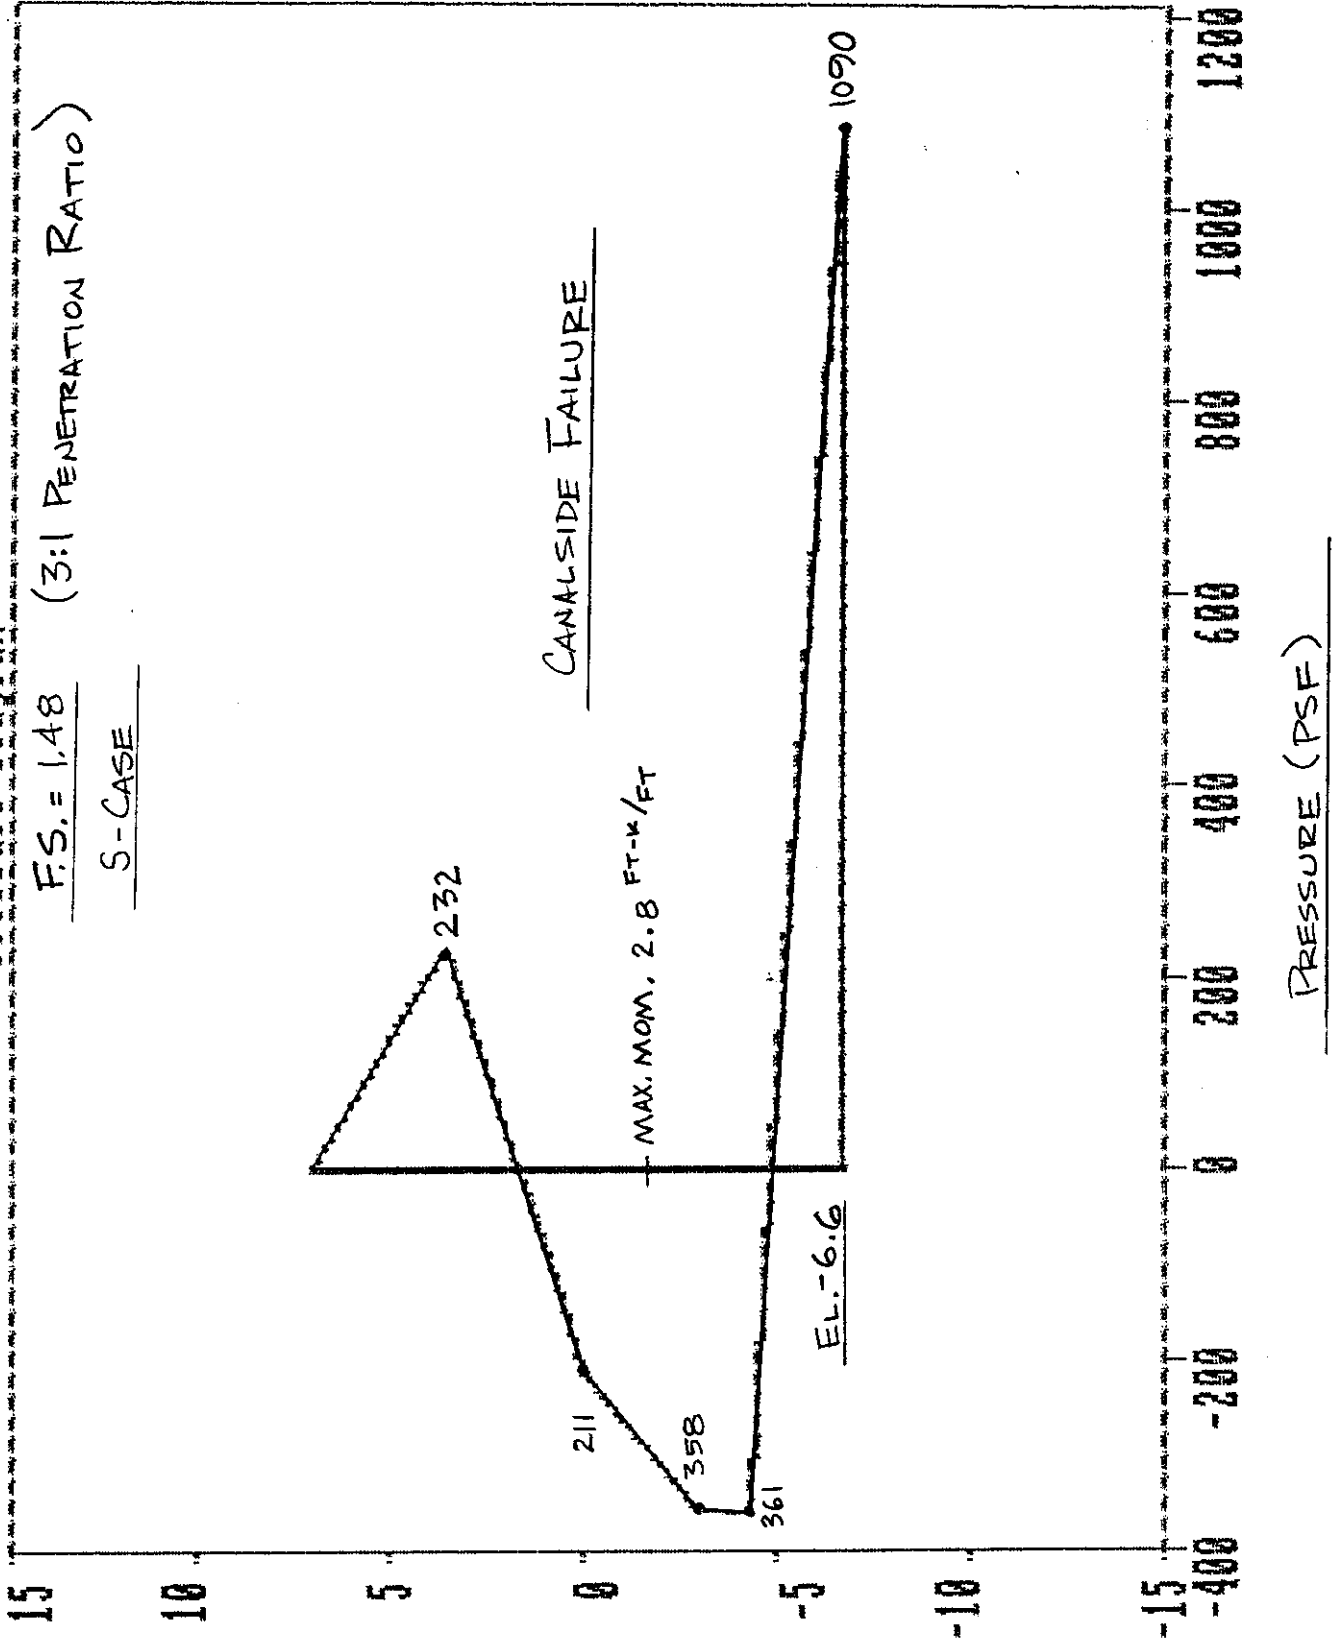
Pressure Diagram

F.S. = 1.48 (3:1 PENETRATION RATIO)

S-CASE

Required Penetration : -6.6 (Canalside Failure 3:1 Ratio; S-Case F.S.=1.48)
Design Bending Moment : 2.8 Ft-K/Ft @ EL. -1.7 (Canalside Failure 3:1 Ratio; S-Case F.S.=1.48)
Maximum Deflection : In.

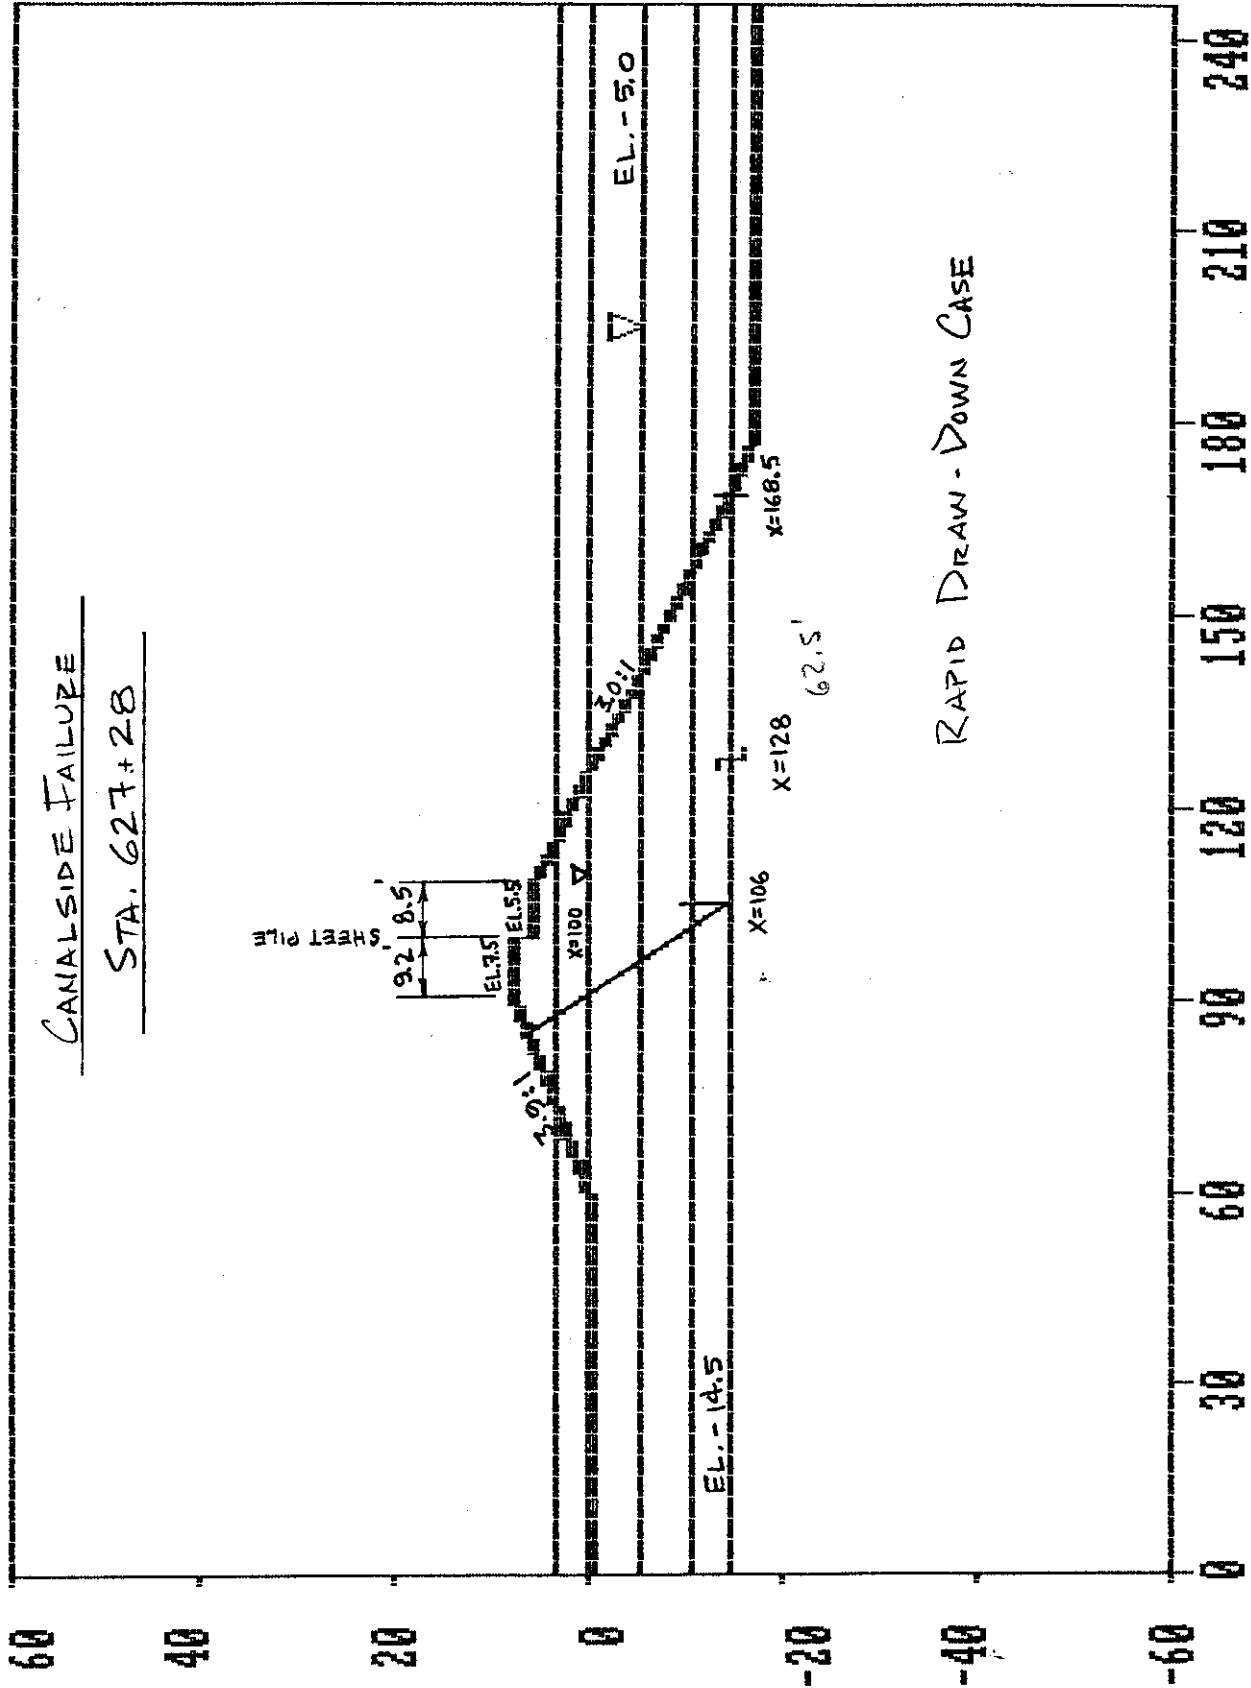
STA. 627+28

CANALSIDE FAILURE

RAPID DRAW-DOWN CASE

- Canalside Failure - 627+28.
*** Minimum Factor of Safety = 1.30 *** (Rapid Draw-Down Case)
- Landside Failure - 632+00 and 634+00. The section at Sta. 632+00 governs.
*** Minimum Factor of Safety = 1.31 ***

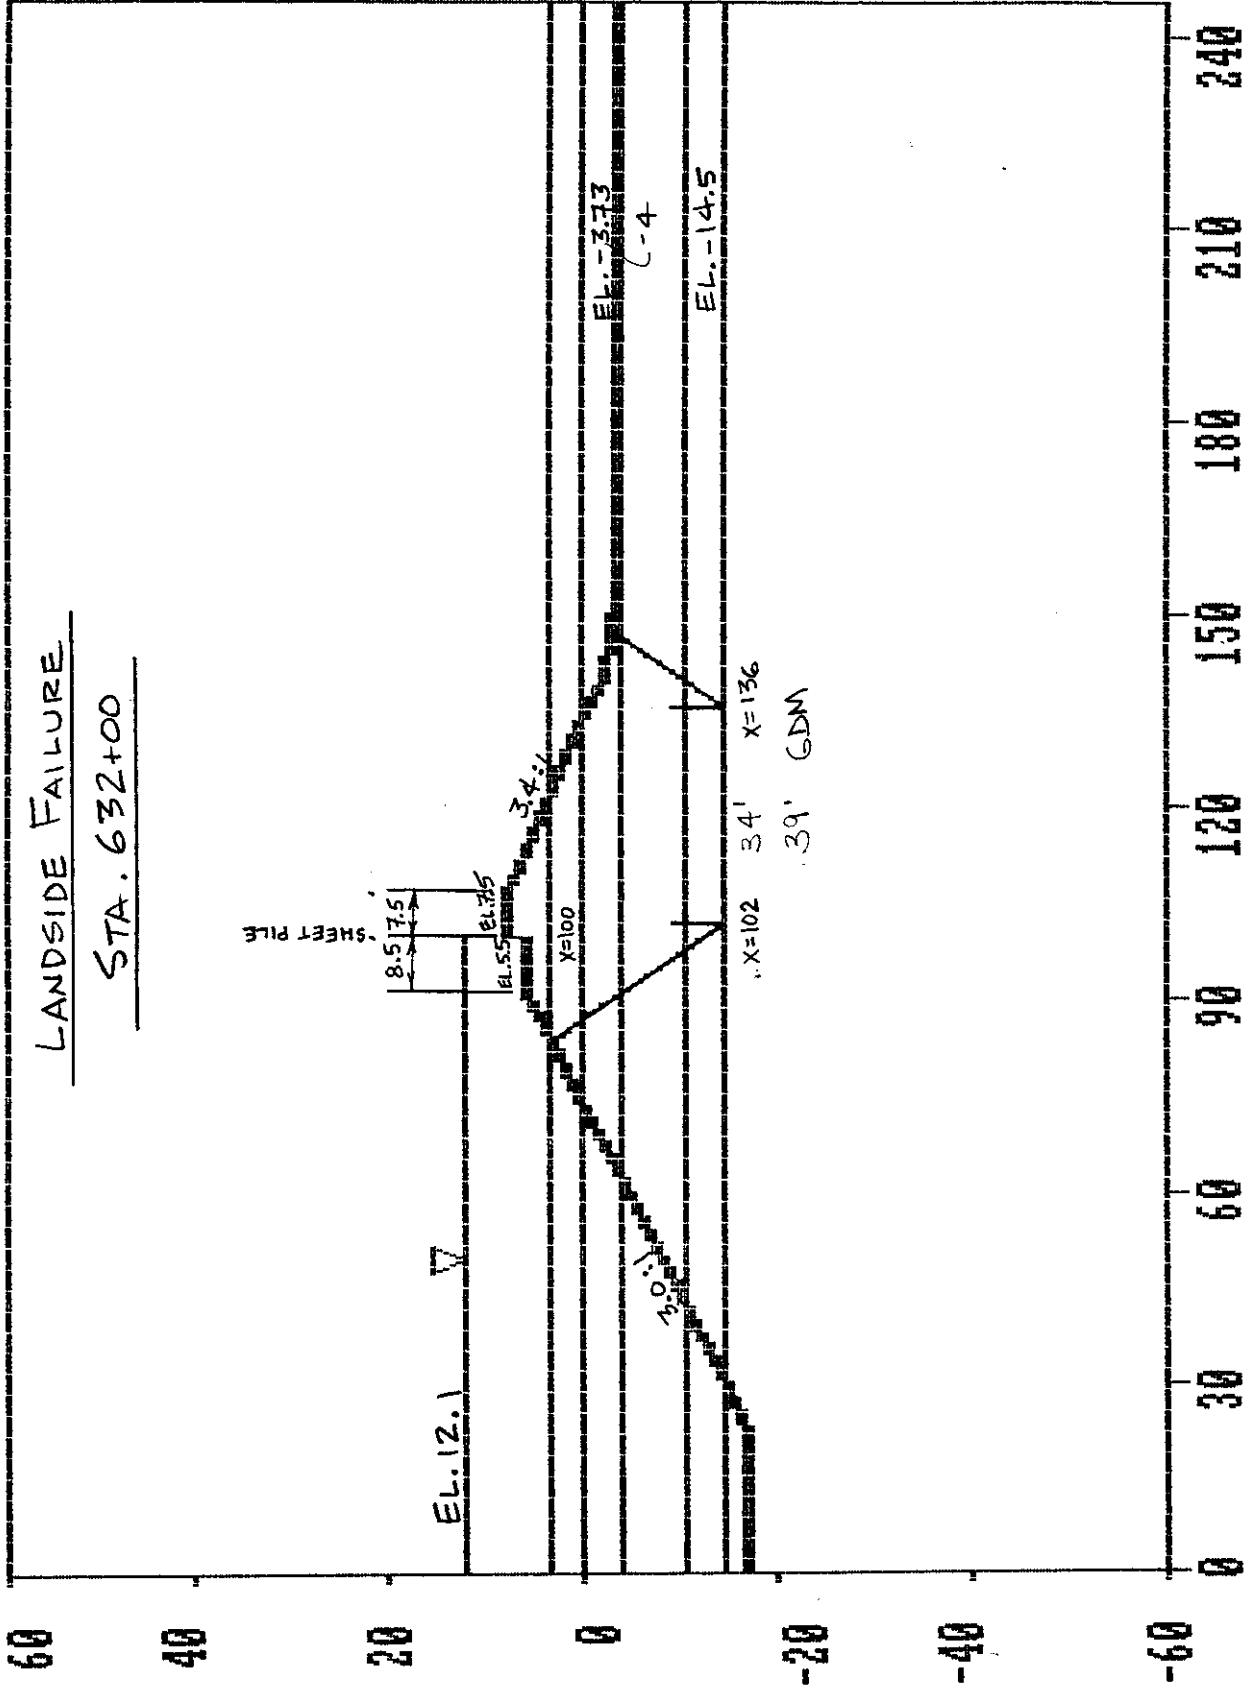
STA. 632+00

LANDSIDE FAILURE

Strength Line
 Eustis Report
 Shows 500 PSF
 to EL -2.0 NOT
 EL 0.0

$$F.S. = \frac{R_A + R_B + R_P}{D_A - D_P} = \frac{12,502 + 12,480 + 6349}{26,207 - 4,171} = \frac{31,331}{22,036} = 1.31$$

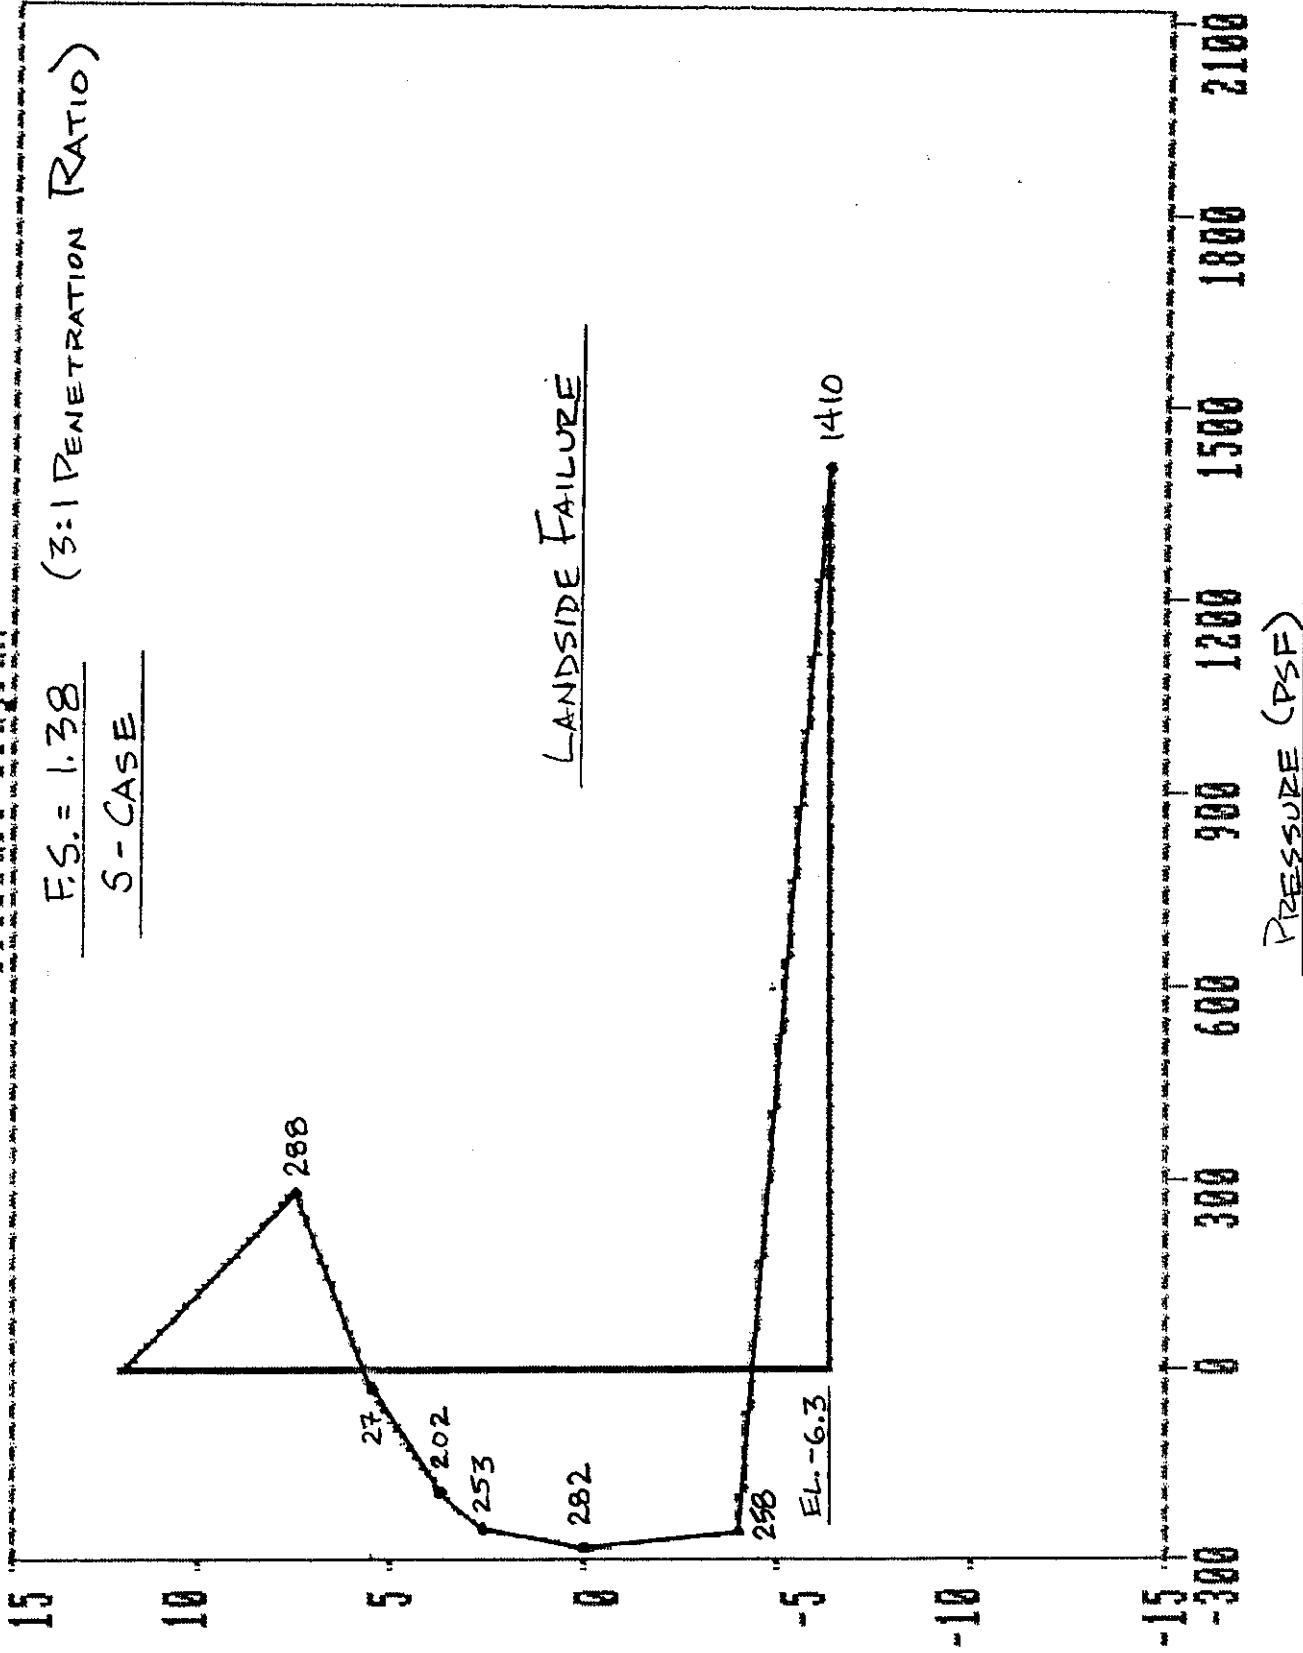
F.S. = 1.38 (3:1 PENETRATION RATIO)

S-CASE

Required Penetration : -6.3 (Landside Failure 3:1 Ratio; S-Case F.S.=1.38)
Design Bending Moment : 5.3 Ft-K/Ft @ El. 0.8 (Landside Failure 3:1 Ratio; S-Case F.S.=1.38)
Maximum Deflection : In.

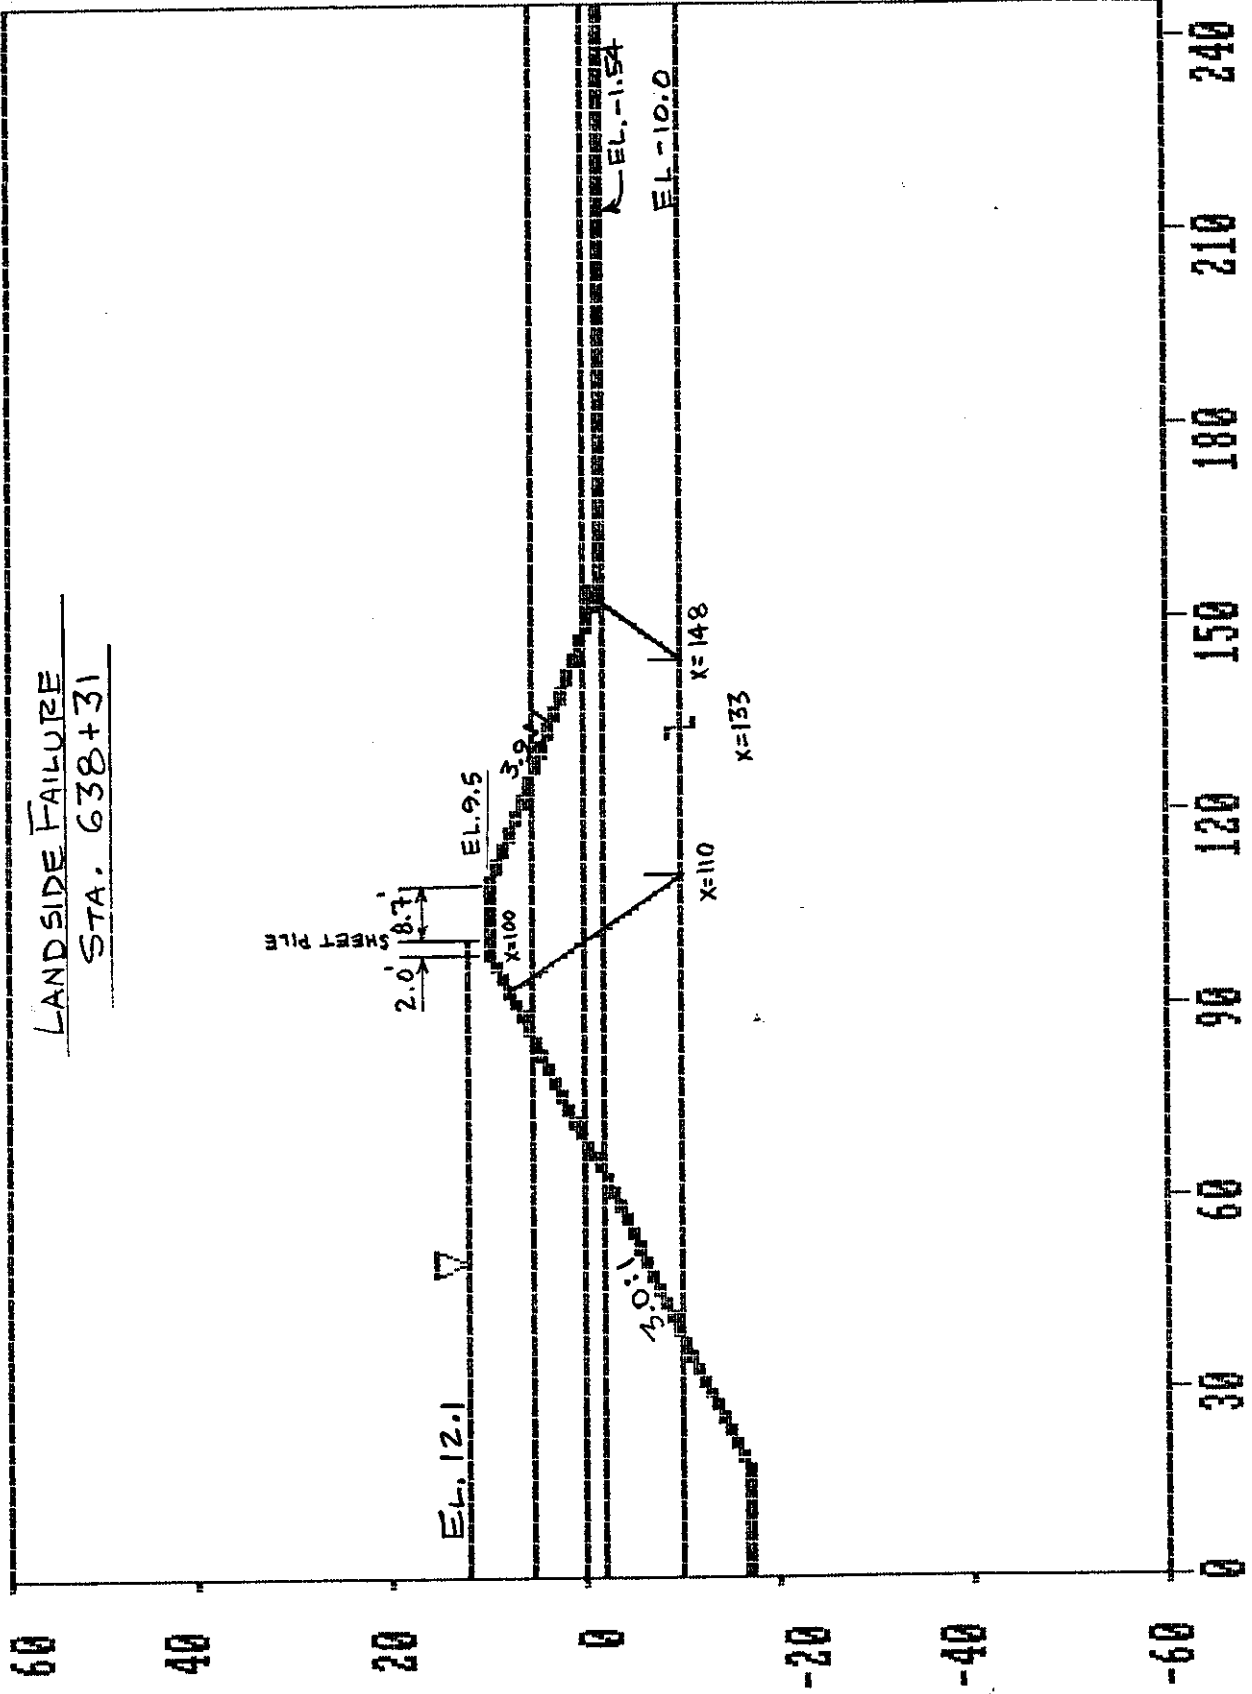
LANDSIDE FAILURE
STA. 638+31

$$F.S. = \frac{R_A + R_B + R_P}{D_A - D_P} = \frac{14,230 + 15,699 + 7,110}{20,138 - 2,110} = 2.05$$

Landside Failure - The section at Sta. 638+31 governs.
*** Minimum Factor of Safety = 2.05 ***

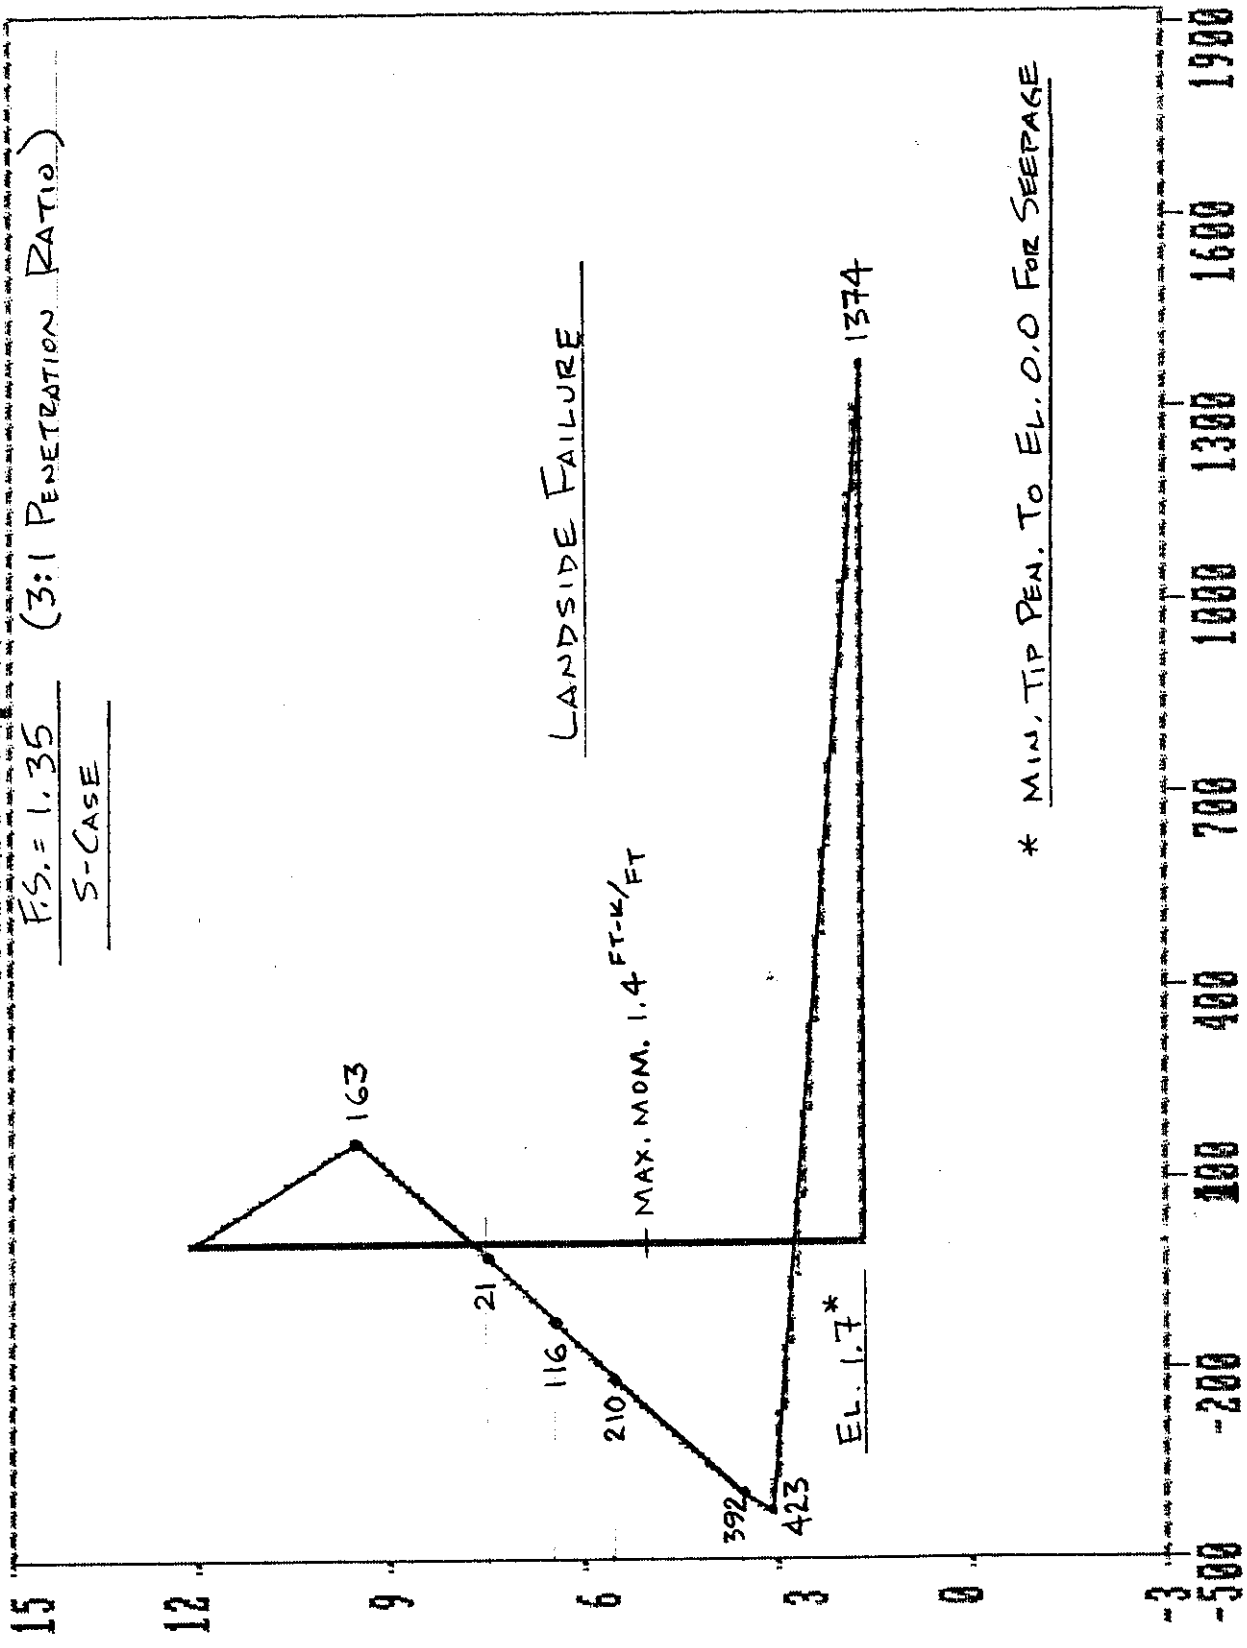
Pressure Diagram

F.S. = 1.35 (3:1 PENETRATION RATIO)

S-CASE

* MIN. TIP PEN. TO EL. 0.0 FOR SEEPAGE

Required Penetration : 0.0 (Governed by Seepage)
Design Bending Moment : 1.4 Ft-K/Ft @ El. 5.0 (Landside Failure 3:1 Ratio; S-Case F.S.=1.35)
Maximum Deflection :

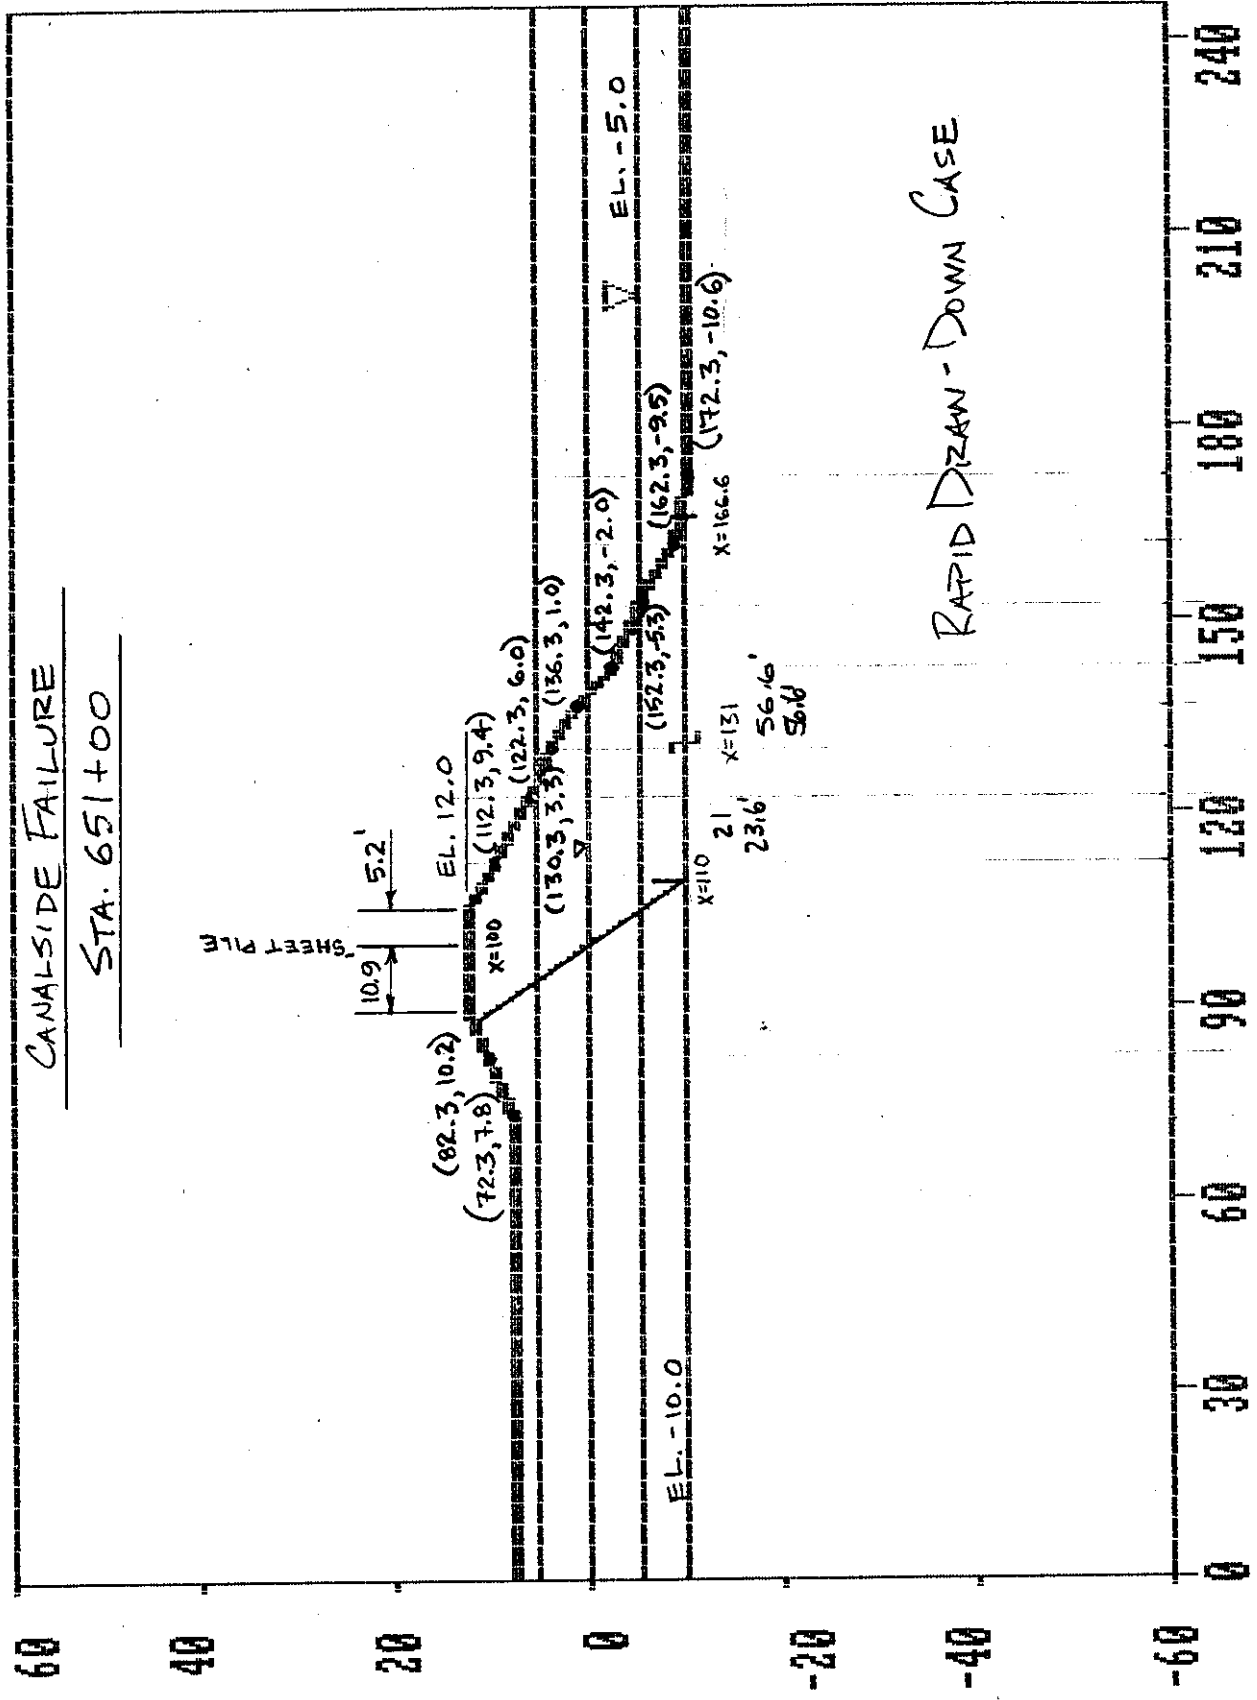
CANALSIDE FAILURE
STA. 651+00

$$F.S. = \frac{R_A + R_B + R_P}{D_A - D_P} = \frac{18,084 + 15,152 + 19,202 + 15,386 + 0}{25,808 - 0} = \frac{67,824}{25,808} = 1.31$$

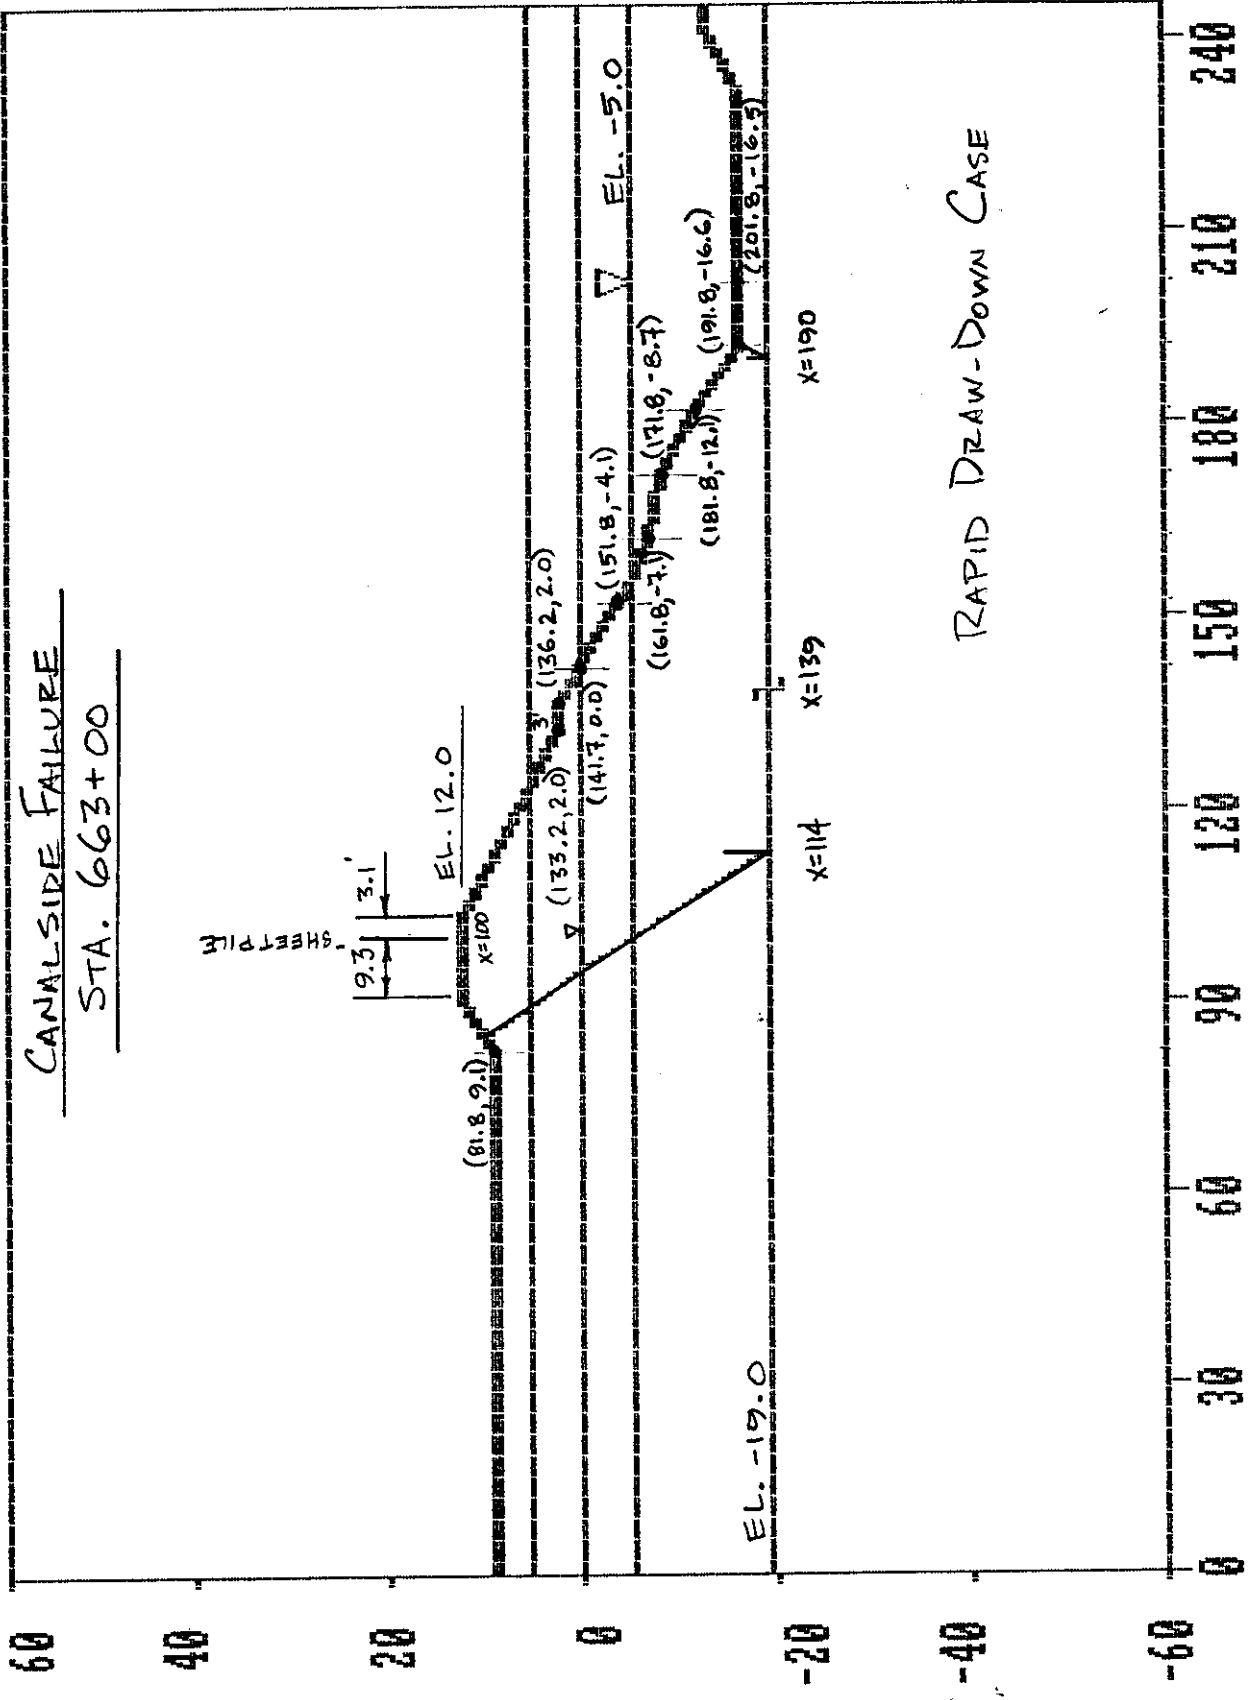
CANALSIDE FAILURE
STA. 663+00

RAPID DRAW-DOWN CASE

$$F.S. = \frac{D_A + D_B + D_P}{D_A - D_P} = \frac{26,282 + 29,018 + 2,263}{44,048 - 158} = 1.31$$

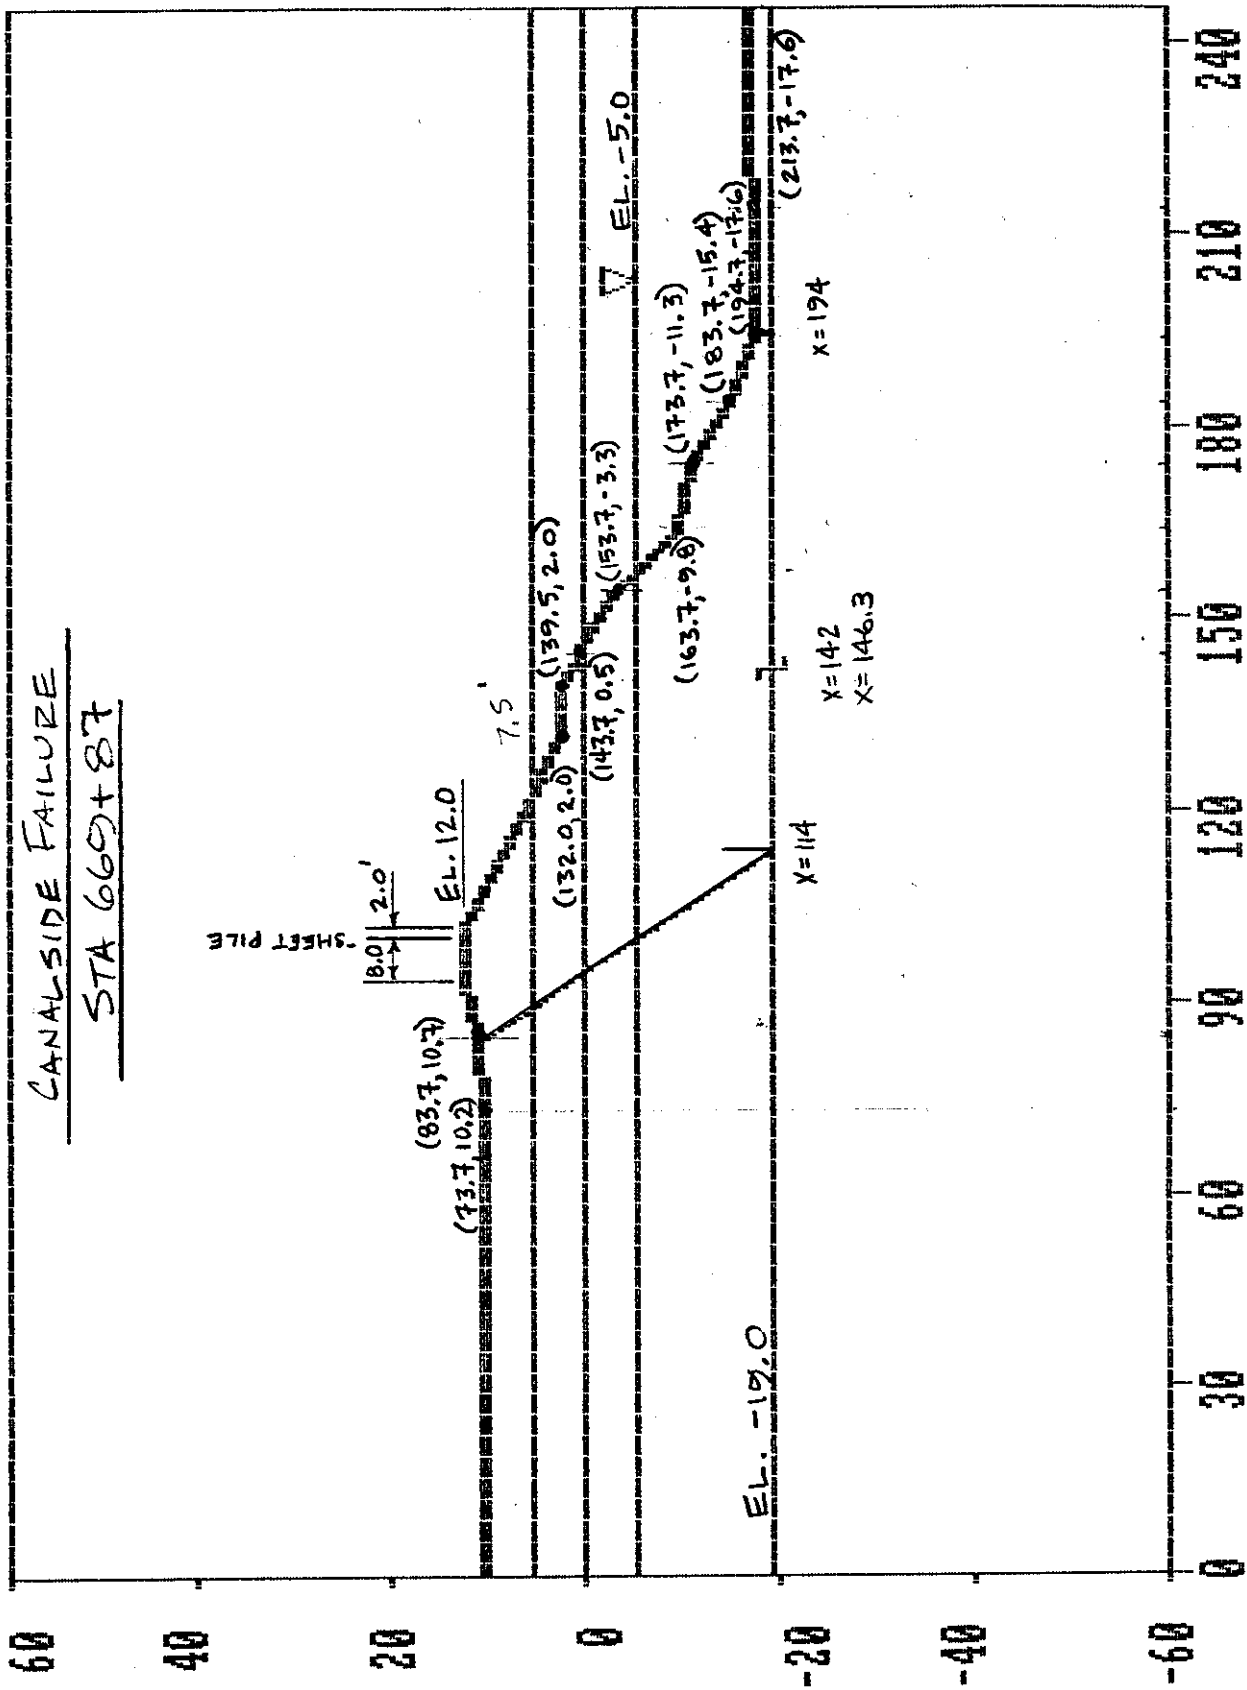
CANALSIDE FAILURE
STA 669+87

$$F.S. = \frac{R_A + R_B + R_P}{D_A - D_P} = \frac{26,980 + 28,224 + 1,306}{43,499 - 44} = \frac{56,510}{43,455} = 1.30$$
