EMERGENCY RESTORATION PLAN AND ENVIRONMENTAL ASSESSMENT

**Pago Pago Harbor
American Samoa**

September 1, 1999

Prepared By:
The Government of American Samoa,
The U.S. Department of the Interior, and
The National Oceanic and Atmospheric Administration

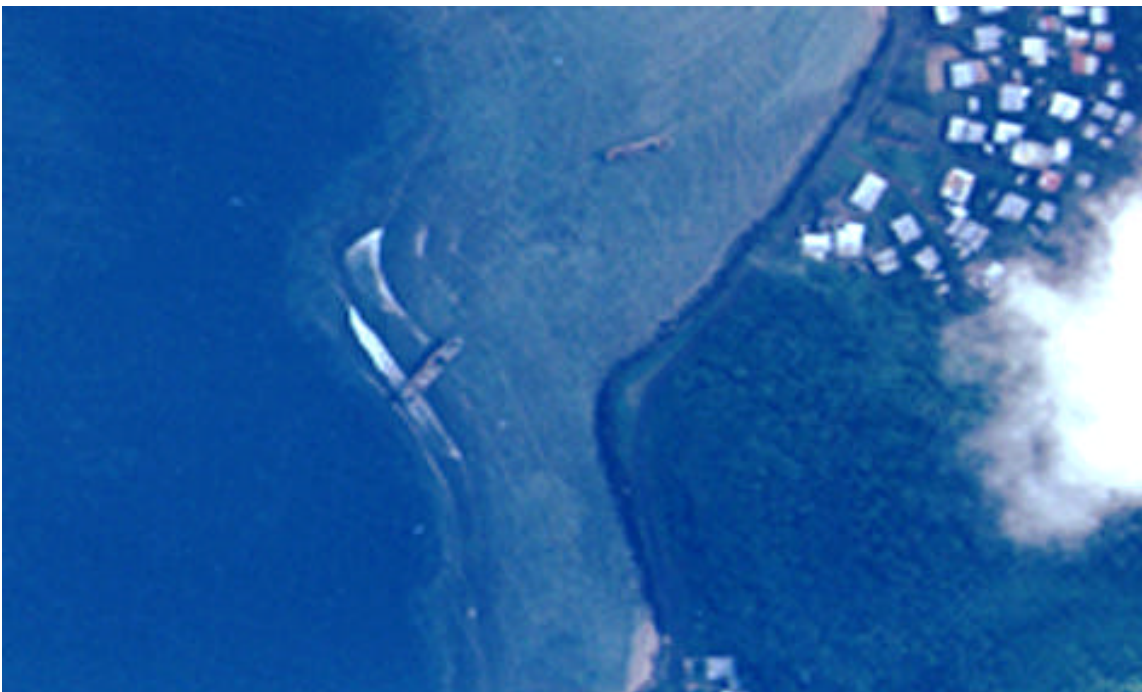
EXHIBIT 5. Vessels 4, 5 and 6 (at Leloaloe Causeway) (taken in 1994). The middle of the three vessels (vessel number 5) is featured prominently in the center of the photograph. A portion of vessel number 4 is visible at the right edge of the photograph. The bow of vessel number 6 is visible at the left edge of the photograph.

4. Aerial Photograph of Two Outer Harbor Vessels
5. Vessels 4, 5 and 6 (at Leloaloa Causeway)
6. Vessel 8
7. Community Type Descriptors Used for Habitat Mapping
