**Internal Review of MSHA's  
Actions at the Sago Mine  
Wolf Run Mining Company  
Sago, Upshur County, West Virginia**

U.S. Department of Labor  
Mine Safety and Health Administration  
Program Evaluation and Information Resources

June 28, 2007

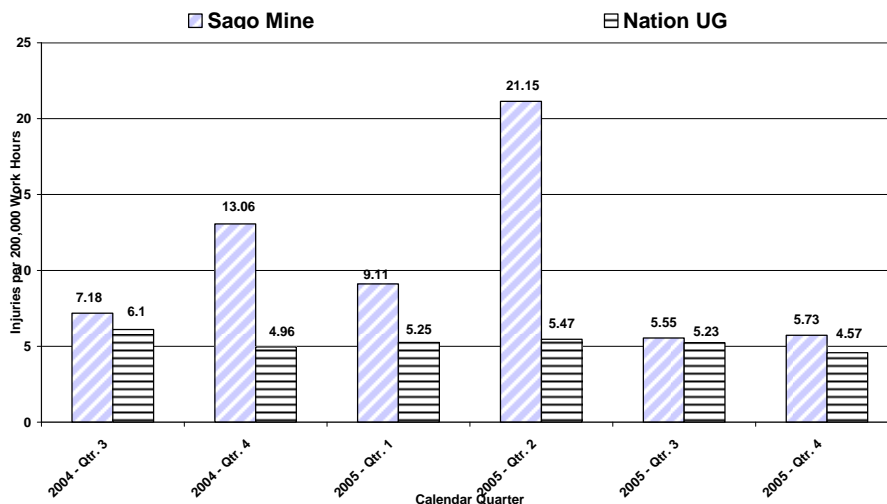
**NFDL Incidence Rate Comparisons  
Sago Mine vs. Underground Coal National Average**

MSHA records indicate that while the operator Wolf Run Mining Company has owned the Sago Mine since January 2002, it actually started producing coal in 2004. Due to the Sago Mine’s production status, the internal review team examined the nonfatal, days-lost (NFDL) injury incidence rates from the 3<sup>rd</sup> quarter of 2004 through the 4<sup>th</sup> quarter of 2005. The NFDL injury incidence rate was significantly above the national average for underground mines between the 4<sup>th</sup> quarter of 2004 and the 2<sup>nd</sup> quarter of 2005. Because of the Sago Mine’s increasing incidence rate, mine management, District 3 personnel, and Technical Support’s Applied Engineering Division began an Incident Rate Reduction (IR) Effort. The program was directed at identifying accident trends, improving the mine’s safety culture, and lowering incidence rates. Miners were interviewed, accident data were analyzed, miners’ work habits and practices were observed, and the operator’s training materials were reviewed. As a result of this effort significant improvement was made in the incidence rate after the 2<sup>nd</sup> quarter of 2005 through the 1<sup>st</sup> quarter of 2006. (See Appendix E for a list of the recommendations from MSHA’s Accident Prevention team.)

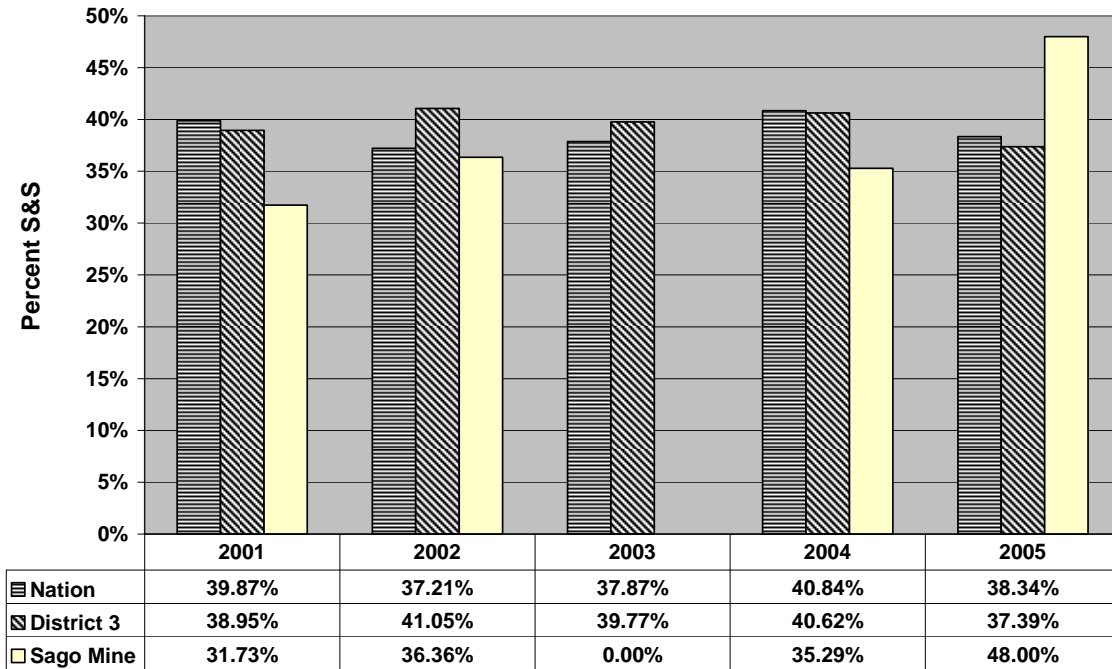
**Comparison of S&S Percentages**  
Nation, District 3, and Sago Mine

District 3 personnel stated in their interviews that they believed a condition had to be an imminent danger to evaluate a citation or order as highly likely (for an injury or illness to occur). A review of the citations and orders at the Sago Mine in 2005 revealed that none were evaluated as highly likely. Section 3(j) of the Mine Act defines an imminent danger as, “the existence of any condition or practice in a coal or other mine which could reasonably be expected to cause death or serious physical harm before such condition or practice can be abated.”

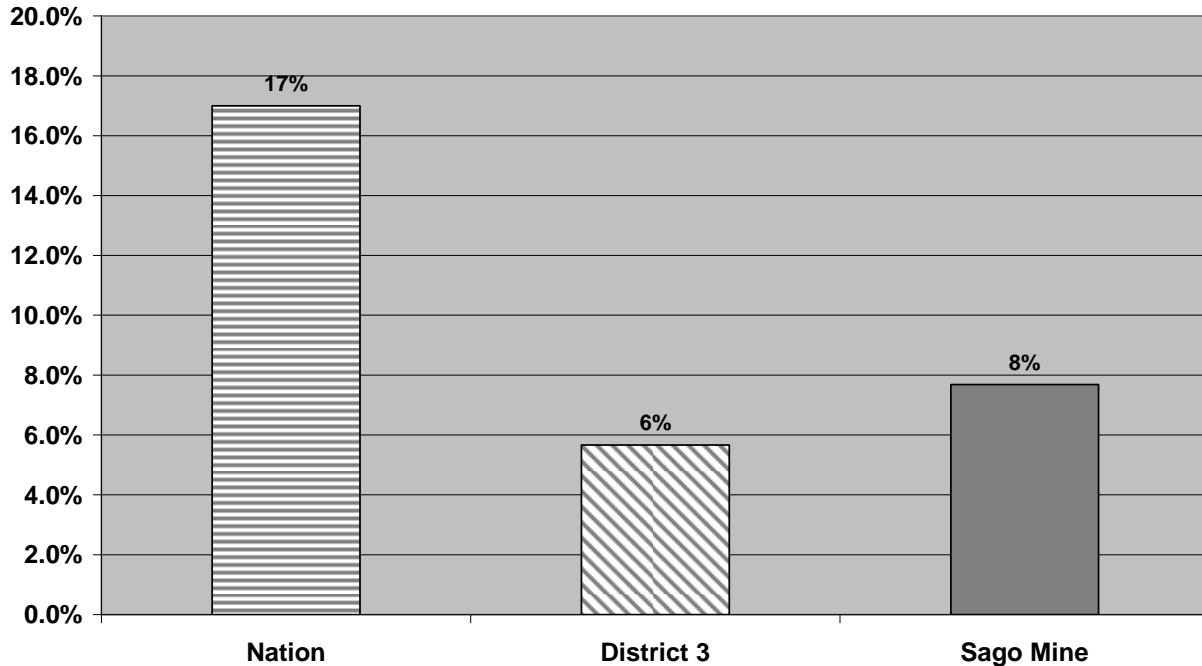
### 2005 - Percent of Citations and Orders Where the Number of Persons Affected Was Evaluated As Greater Than One

during calendar year 2005 indicated more than one person affected. See the following chart.

After reviewing all enforcement actions for the Sago Mine, the internal review team determined enforcement personnel frequently evaluated one person affected on citations and orders when the notes and conditions indicated more persons were affected. Three examples follow.

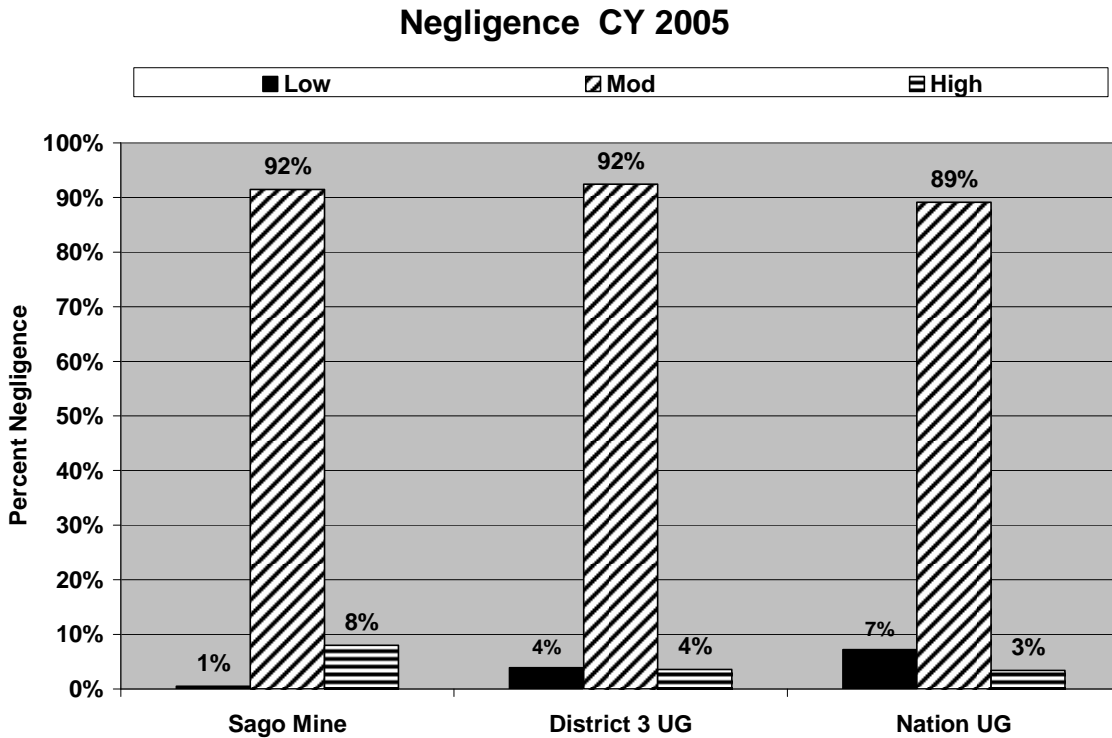
The following chart shows a comparison of negligence determinations at the Sago Mine, District 3 underground mines, and underground mines nationwide during the review period.

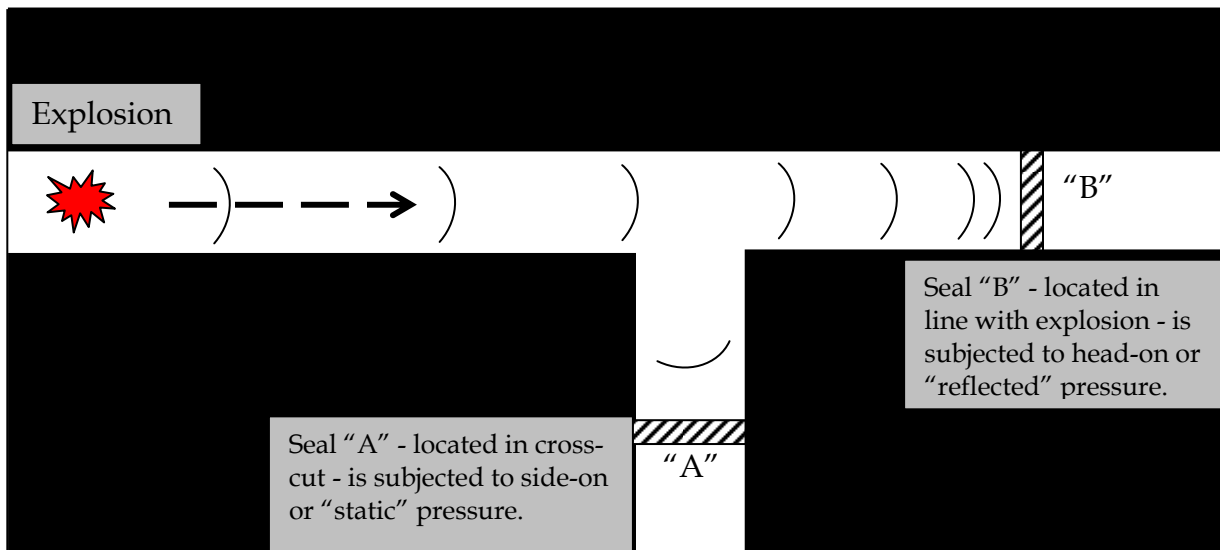
The test seals were constructed in cross-cuts off of the entry in which the methane explosion was initiated (see Seal “A” in Figure 1). As a result, the seals were subjected to a “side on” or “static” pressure. This test set up was based on a recommendation in RI 7581 that a seal be considered explosion proof if it could withstand a “static” pressure of 20-psi. The seal would be subjected to a head-on or “reflected” pressure if it was constructed across the entry in which the explosion was initiated (see Seal “B” in Figure 1). After being subjected to the “side on” pressure from an explosion, the seals were then examined, and if they had survived structurally, were tested for air leakage. The acceptable air leakage rates were established by MSHA. For pressure differentials up to 1-inch of water gauge, air leakage through the seal could not exceed 100 cubic feet per minute; for pressure differentials greater than 3 inches of water gauge, air leakage could not exceed 250 cubic feet per minute.

Figure 1 – Simplified illustration of “side-on” or “static” pressure versus “head-on” or reflected pressure.

While Lake Lynn is a limestone mine, the seal tests were conducted in mine entries configured similar in size to coal mine entries. The tests involved constructing seals and subjecting them to a pressure pulse generated from a methane explosion. The purpose was to determine whether the seals would withstand an explosion pressure of at least 20-psi; there was no attempt to determine the ultimate strength of the seals.

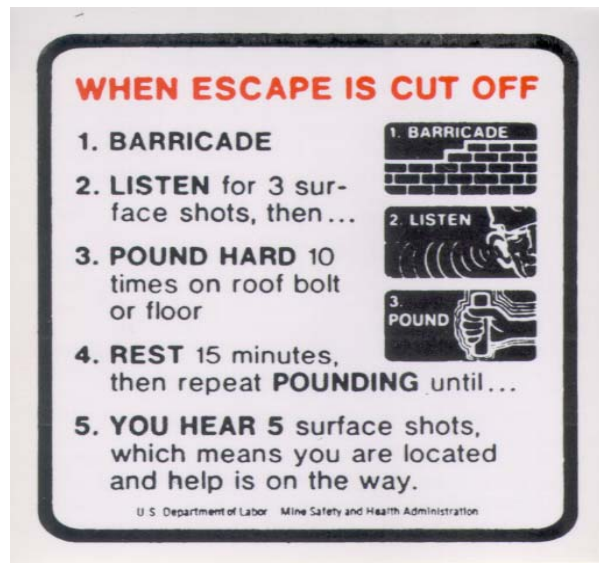
For years, MSHA distributed the following informational sticker to the mining industry to be placed inside the miners' hard hats that described procedures to be followed when escape is cut off.
