Report on Emergency Incidents at Hazardous Waste Combustion Facilities and Other Treatment, Storage, and Disposal Facilities (TSDFs)

SUBJECT: Final Report on Emergency Incidents at Hazardous Waste Combustion Facilities and Other Treatment, Storage and Disposal Facilities (TSDFs)

April 1999

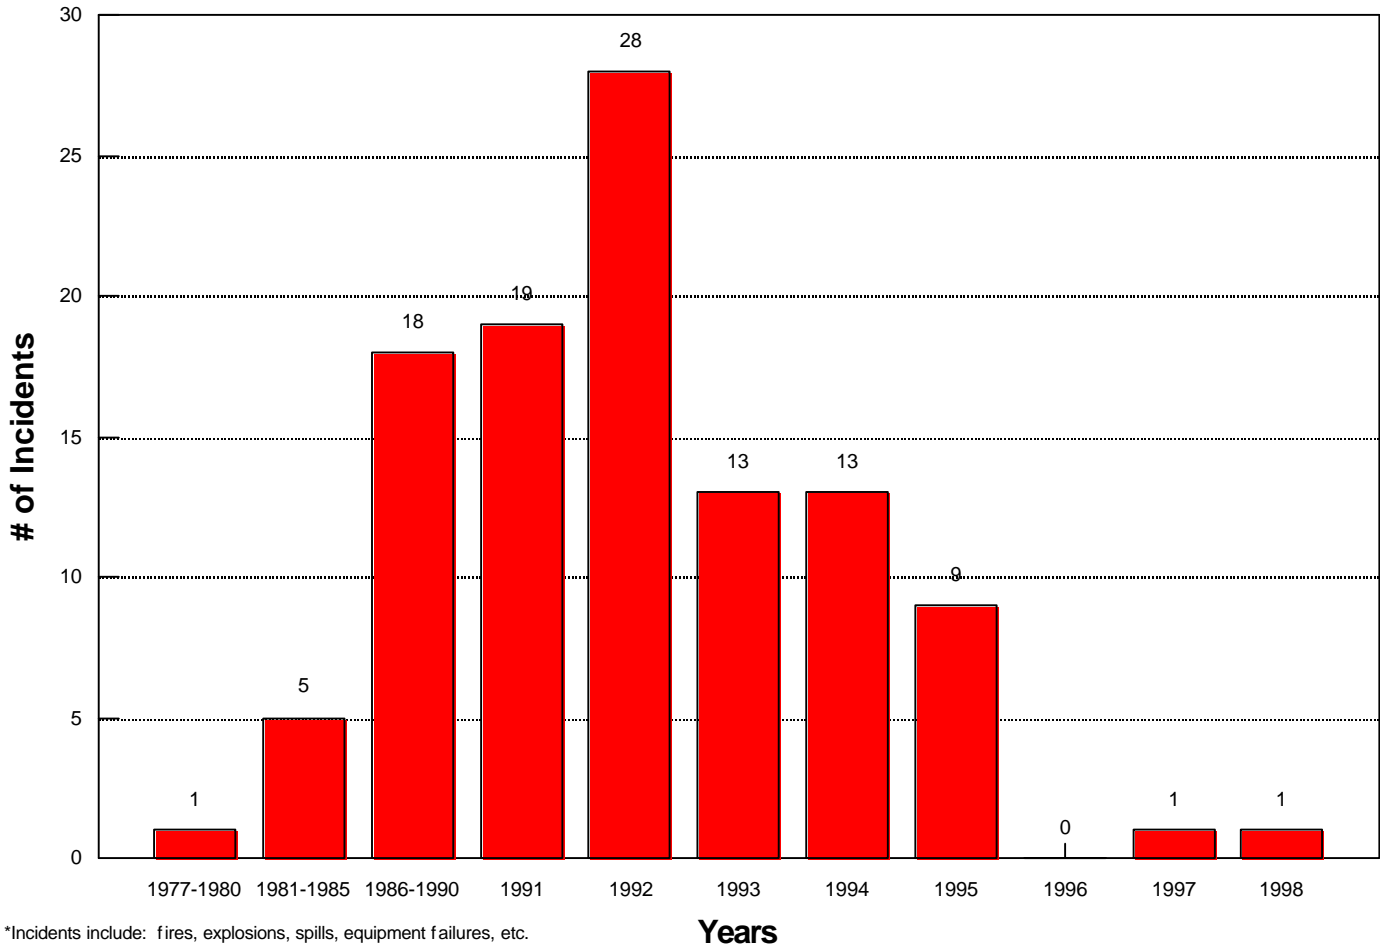
**CHART 1. Number of Incidents at Combustion Facilities and TSDFs
1977-1998**

Hazardous Waste Combustion Facilities			Other TSDFs	
Region	# Facilities Under Interim Status with Incidents	# Facilities Under Permit Status with Incidents	# Facilities with Incidents due to Actual Combustion of Hazardous Waste	# Facilities Under Interim Status or Not Permitted with Incidents	# Facilities Under Permit Status with Incidents
I	0	0	0	0	0
II	0	2	0	1	0
III	0	0	0	2	0
IV	4	2	1 ⁴	7	4 ³
V	2	5	3 ⁵	0	0
VI	0	3	2 ⁶	0	0
VII	1	4	3 ⁷	0	1
VIII	0	0	0	0	1
IX	0	1	0	0	4
X	0	0	0	4	2
Total	7	17	9	14	12
