# *Alternative Cover Assessment Program 2002 Annual Report*

October 2002

Publication No. 41182

U.S. Environmental Protection Agency

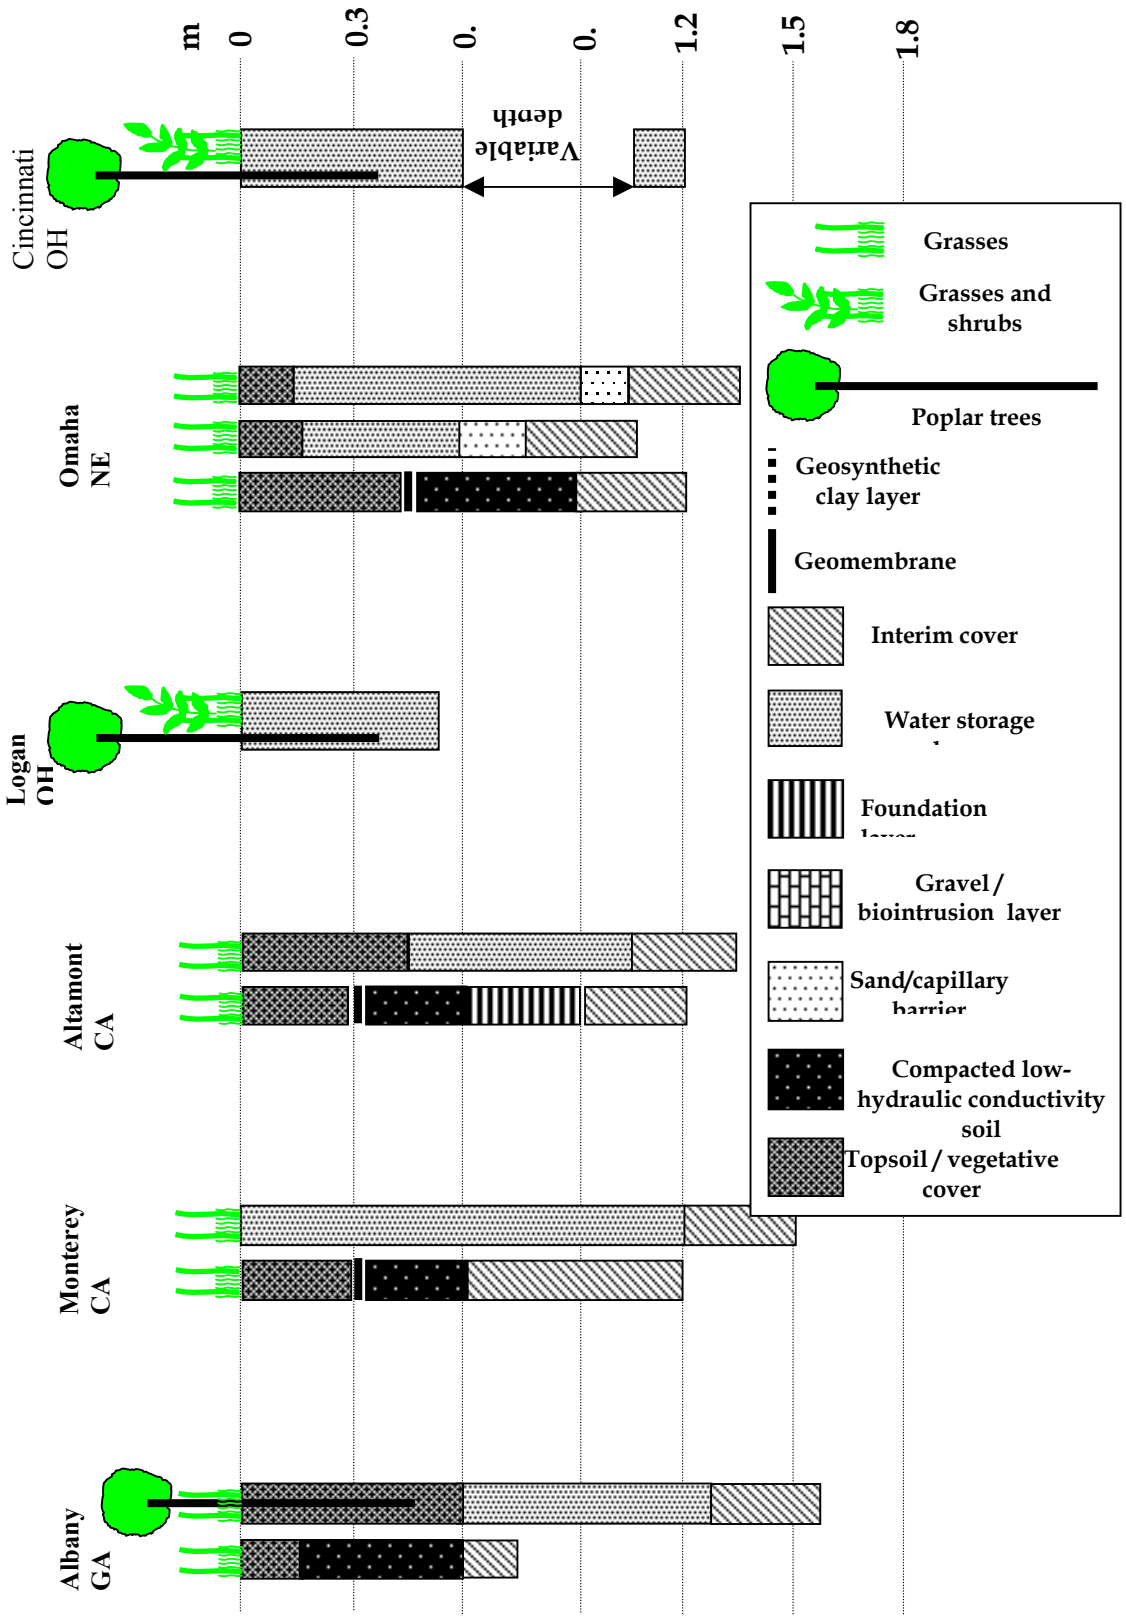
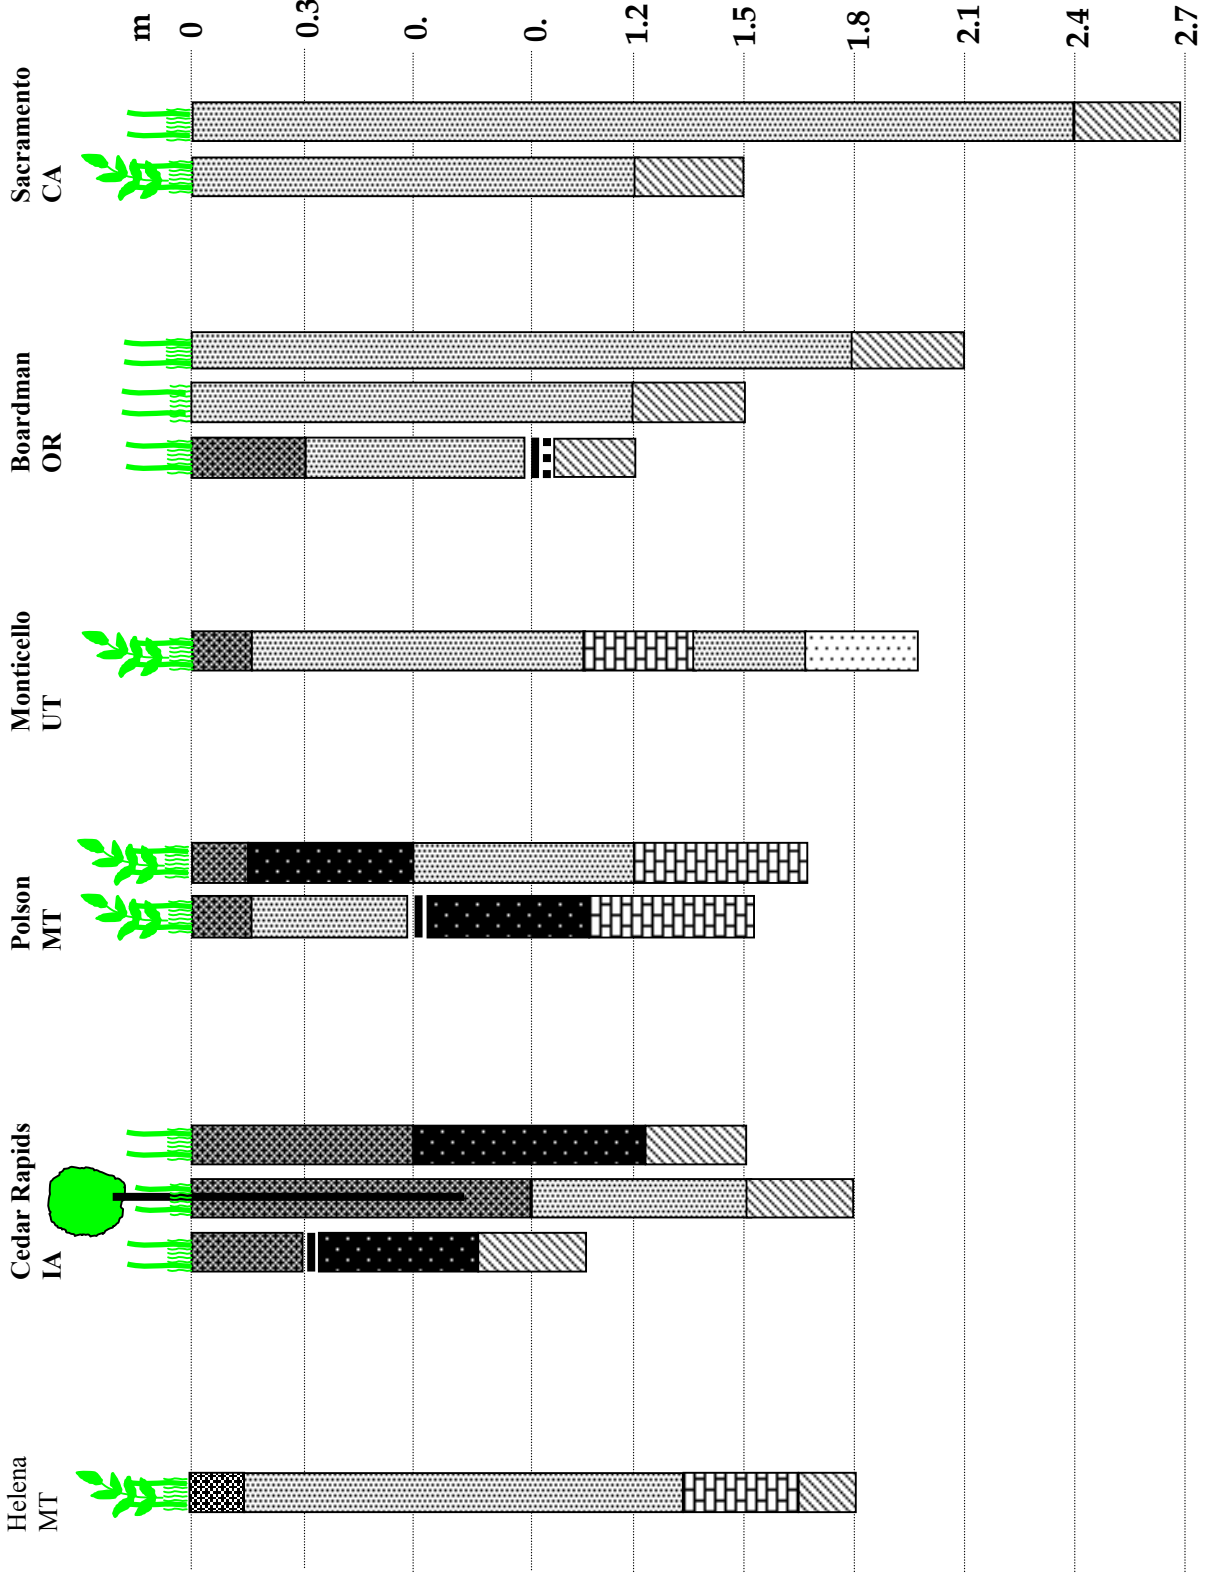
Figure 2. ACAP cover design profiles.

Figure 2 (continued). ACAP cover design profiles.

Soil hydrologic parameters most influential in the performance of alternative earthen final covers (AEFCs) are water holding capacity and hydraulic conductivity. Soils with higher water holding capacity are generally favored for their ability to store precipitation within reach of the surface processes of evaporation and transpiration. An exception to this is the use of coarse-grained soils in a fine-over-coarse arrangement to create a capillary break. Cost favors the use of locally available soils (often from the landfill site itself) in the design of AEFCs while conventional designs may require importation of fine-grained soils to meet the minimum hydraulic conductivity requirement inherent in RCRA conventional designs. Soils used in the ACAP program for construction of AEFCs range from the clay-rich soil used in an evapotranspiration-type design to sand for a capillary break. Fine-grained soils used for construction of conventional covers were available on site at some locations; at others sites the soil was imported. Figure 2 indicates the profiles of the cover designs.

The ideal plant community for an AEFC is one that takes up water for transpiration throughout the soil profile and throughout the year. Site characteristics limit this function primarily by temperature and seasonality of precipitation. Plant community characteristics vary widely across the study sites. While most of the sites have (or have proposed) revegetation efforts consisting primarily of annual and perennial grass mixtures, other sites have employed trees and shrubs to provide transpiration. Two sites (Albany and Cedar Rapids) have planted hybrid poplar trees with an understory of grasses. One test plot at Sacramento has been planted with oleander shrubs in addition to a grass and annual seed mixture. General plant community characteristics are shown in Figure 2 and summarized in Table 4.

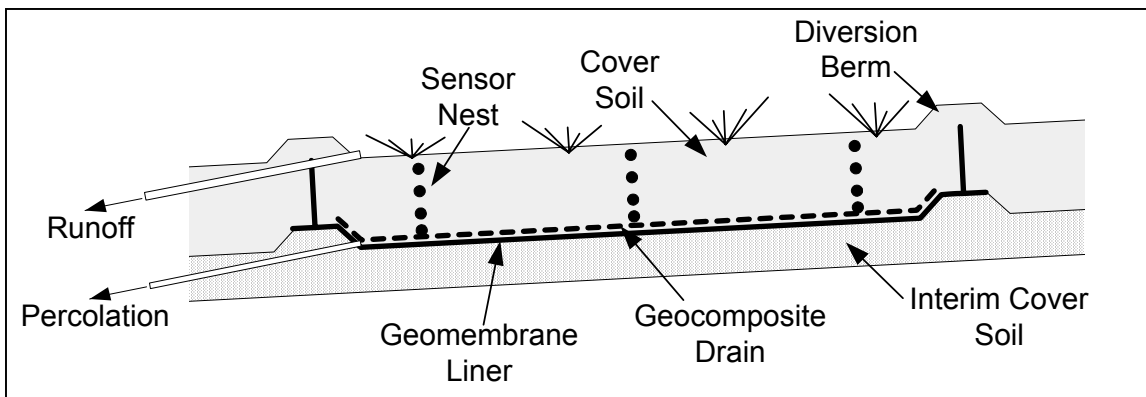
Figure 3. Schematic of ACAP drainage lysimeter.

The primary features of the ACAP program are the large pan-type lysimeters (Benson et al. 1999) located at 10 of the sites (Figure 3). These 10 m x 20 m geomembrane basins allow direct measurement of most variables in the near-surface water budget. The geomembrane is low-density linear polyethylene (LLDPE) and forms the bottom and sides of the lysimeter. Full-scale (in depth) models of the tested cover designs were constructed in the lysimeters. A geocomposite drainage layer was placed between the geomembrane and the cover soils to protect the membrane and allow rapid lateral transmission of intercepted water through the drainage collection system. Surface berms surround the lysimeter to prevent run-on and collect run-off. Collection systems made of PVC pipe carry drainage and surface run-off water to measurement systems. Soils within the lysimeters are instrumented at multiple depths for measurement of soil moisture content and matric potential.

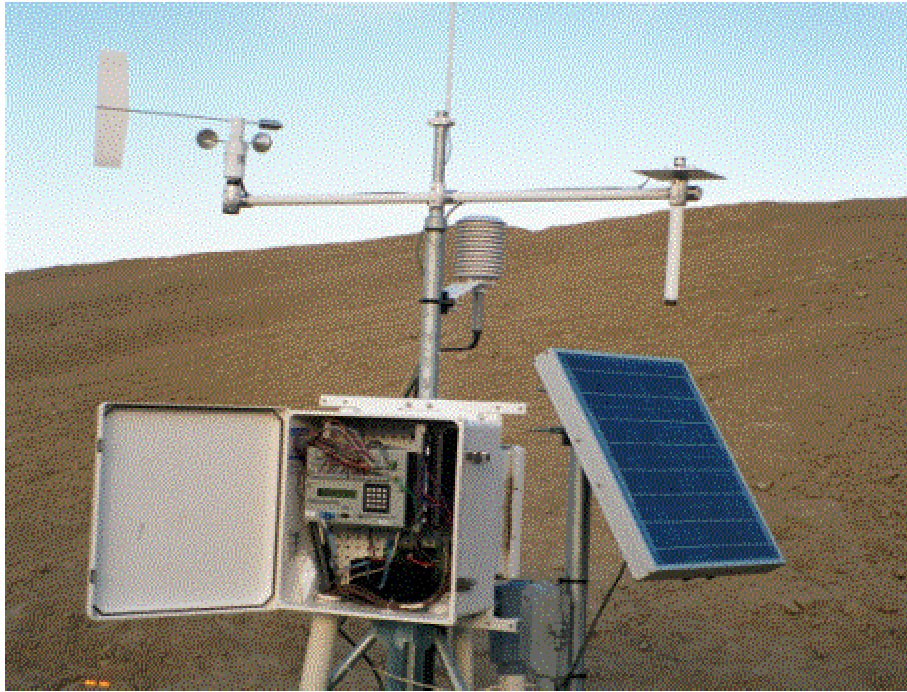
Figure 4. Typical instrument installation.ACAP

Measured meteorological parameters include precipitation, air temperature, relative humidity, solar radiation, wind speed, and wind direction. Potential evapotranspiration is calculated. A central instrument station includes the meteorological instruments, data logger, multiplexers, solar panel (at most sites), along with a cellular phone that allows daily remote access to the data (Figure 4).

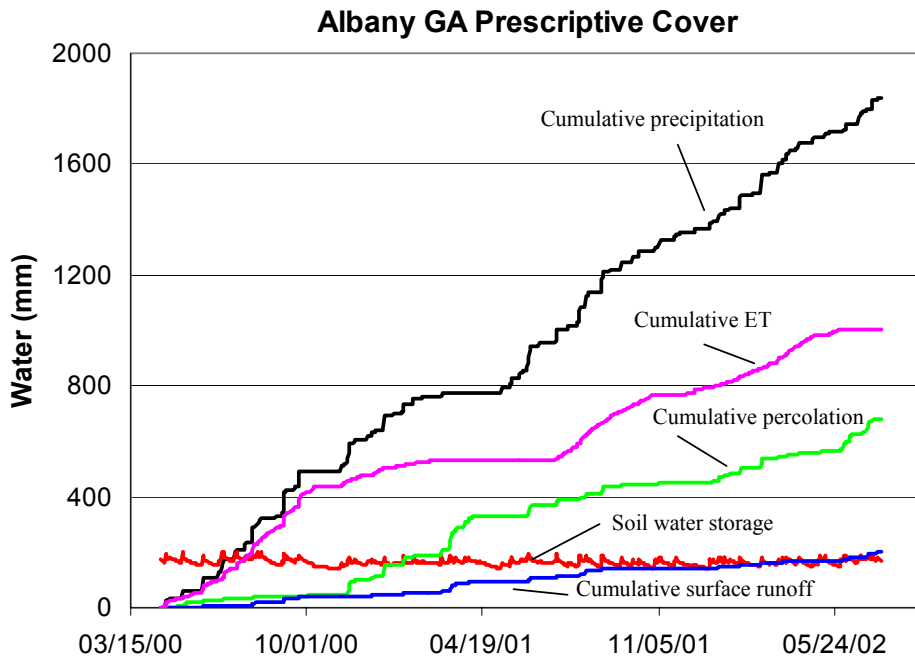
Figure 5. Water balance summary for the prescriptive cover at the Albany GA ACAP site.

Data collection at the Albany, GA site began April 19, 2000. Irrigation was applied to the alternative (E-Cap) cover to maintain the poplar trees. A small quantity of irrigation water was applied to the RCRA cover as well. The water balance summaries for the two test sections at the Albany are shown in Figures 5, 6 and 7. Total applied water (precipitation plus irrigation) during the 28-month data collection period for the alternative cover was 2160 mm resulting in 185 mm of total percolation. Total applied water for the RCRA cover was 1835 mm resulting in 683 mm of percolation. Mean annual precipitation at the site is 1280 mm.

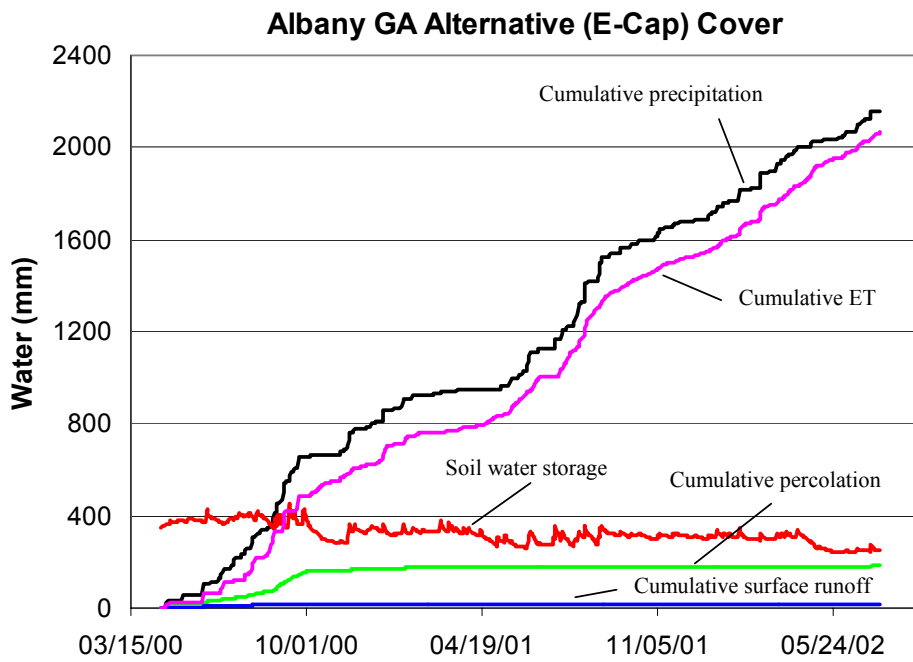
Figure 6. Water balance summary for the alternative cover at the Albany GA ACAP site.

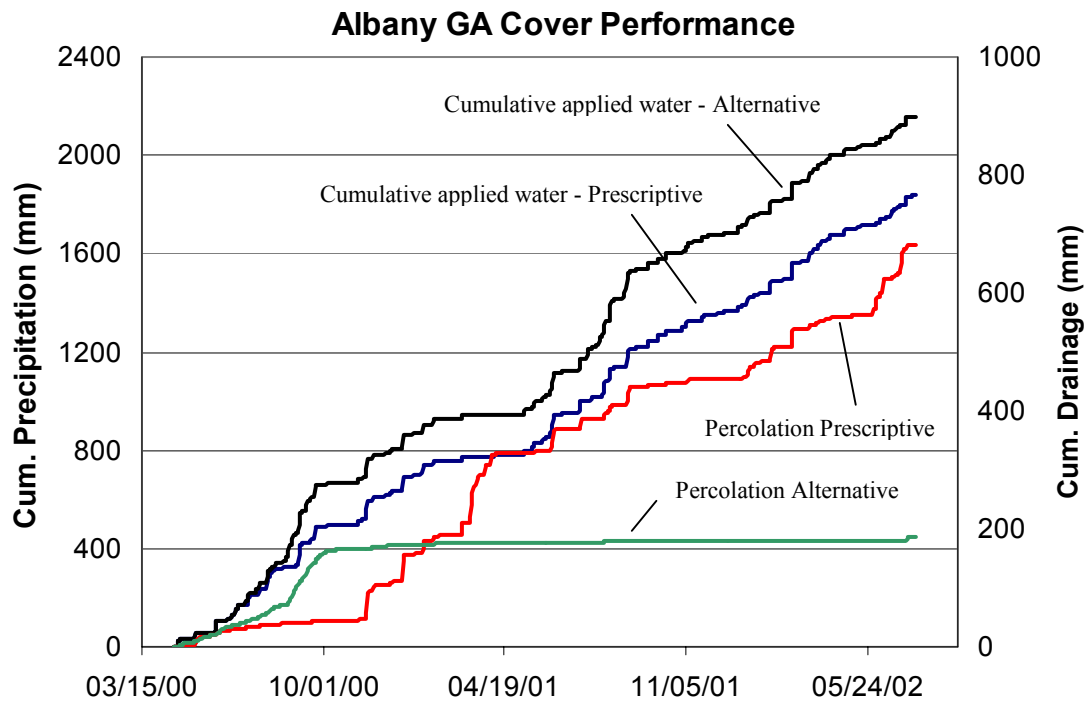
Figure 7. Cover performance at Albany GA.

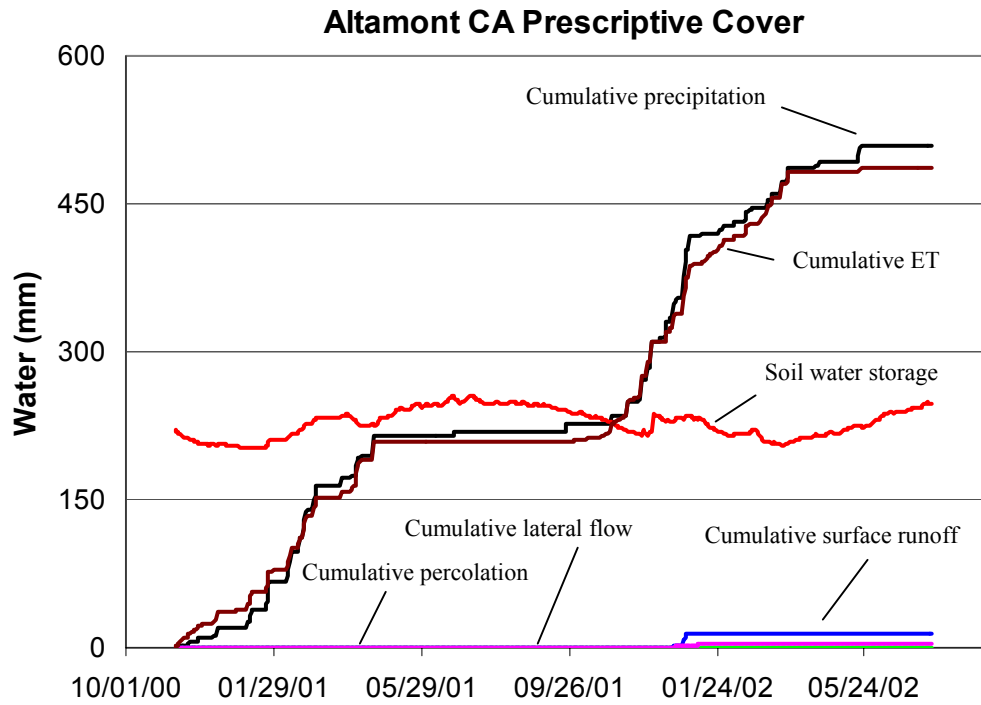
Figure 8. Water balance summary for the prescriptive cover at the Altamont CA ACAP site.

Data collection at the Altamont CA site began November 10, 2000. Water balance summaries for the test sections at the Altamont site are shown in Figures 8, 9 and 10. Total precipitation during the 18-month data collection period was 509 mm. Mean annual precipitation for the site is about 340 mm.

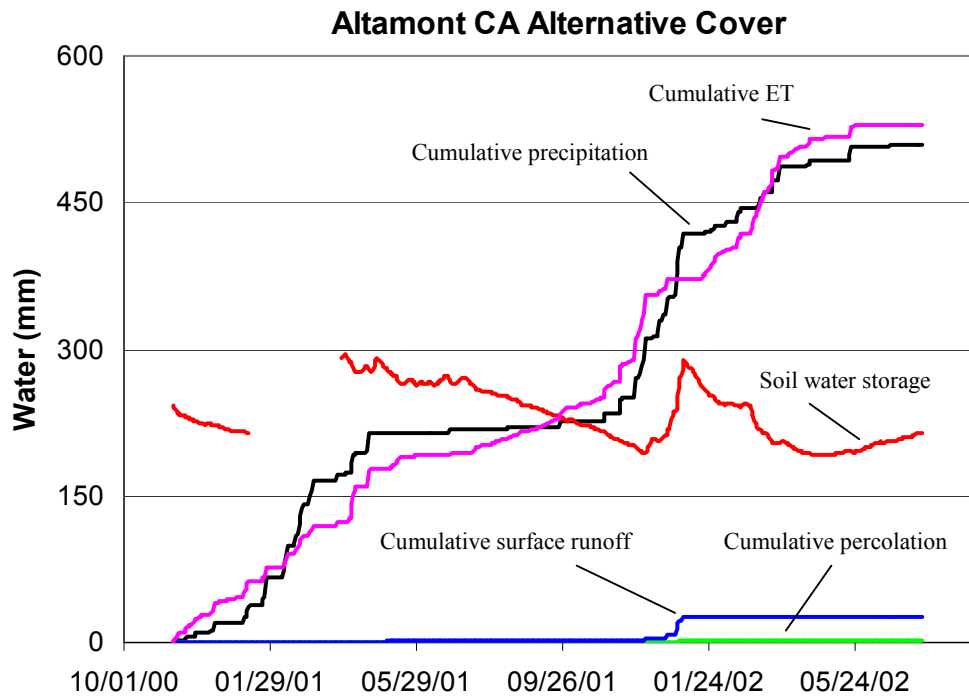
Figure 9. Water balance summary for the alternative cover at the Altamont CA ACAP site.

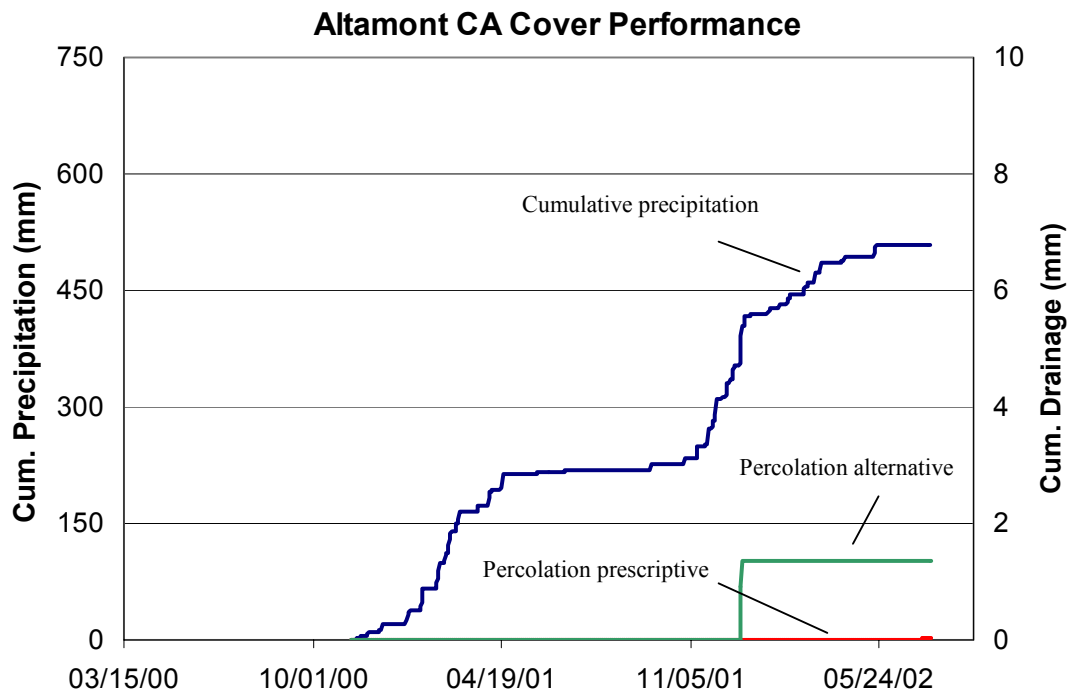
Figure 10. Cover performance at Altamont CA.

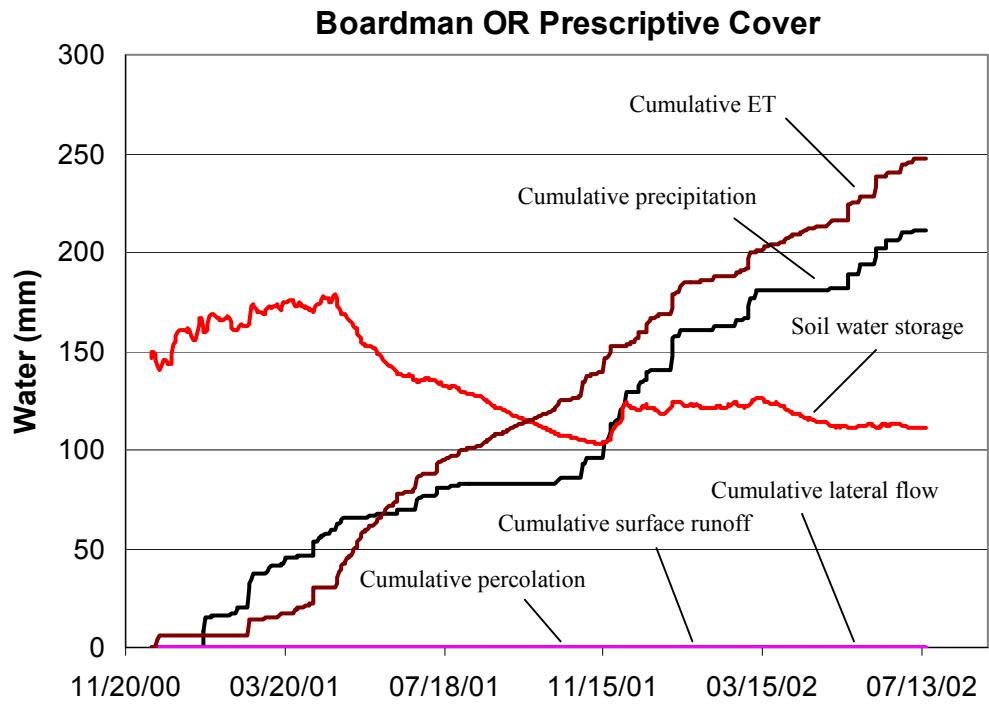
Figure 11. Water balance summary for the prescriptive cover design at the Boardman OR ACAP site.

Data collection at the Boardman site began December 9, 2000. Water balance summaries for the test sections at the Boardman site are shown in Figures 11, 12, 13 and 14. Total recorded precipitation during the 19-month data collection period was 211 mm. Mean annual precipitation for the site is about 220 mm. Trace amounts of percolation (< 1mm) were recorded for all three test sections.

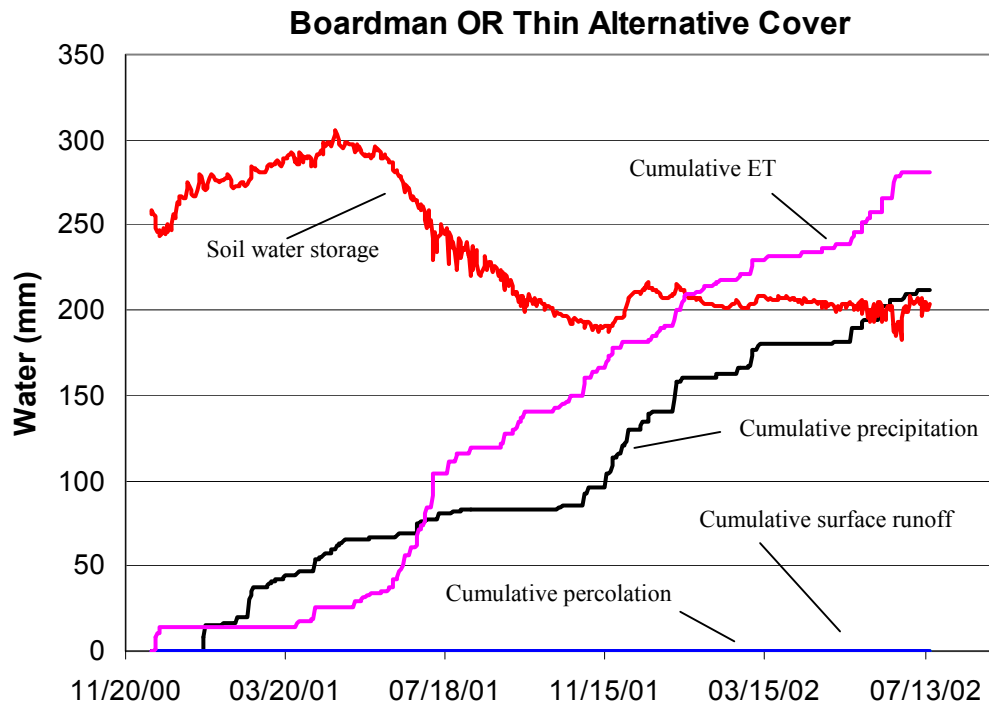
Figure 12. Water balance summary for the thin alternative cover design at the Boardman OR ACAP site.

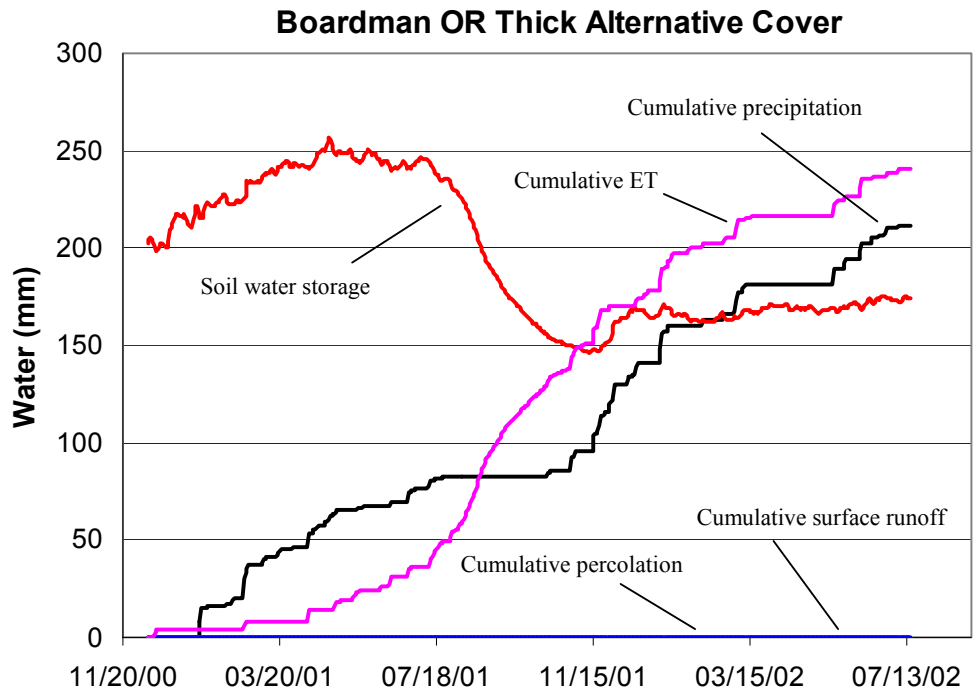
Figure 13. Water balance summary for the thick alternative cover design at the Boardman OR ACAP site.

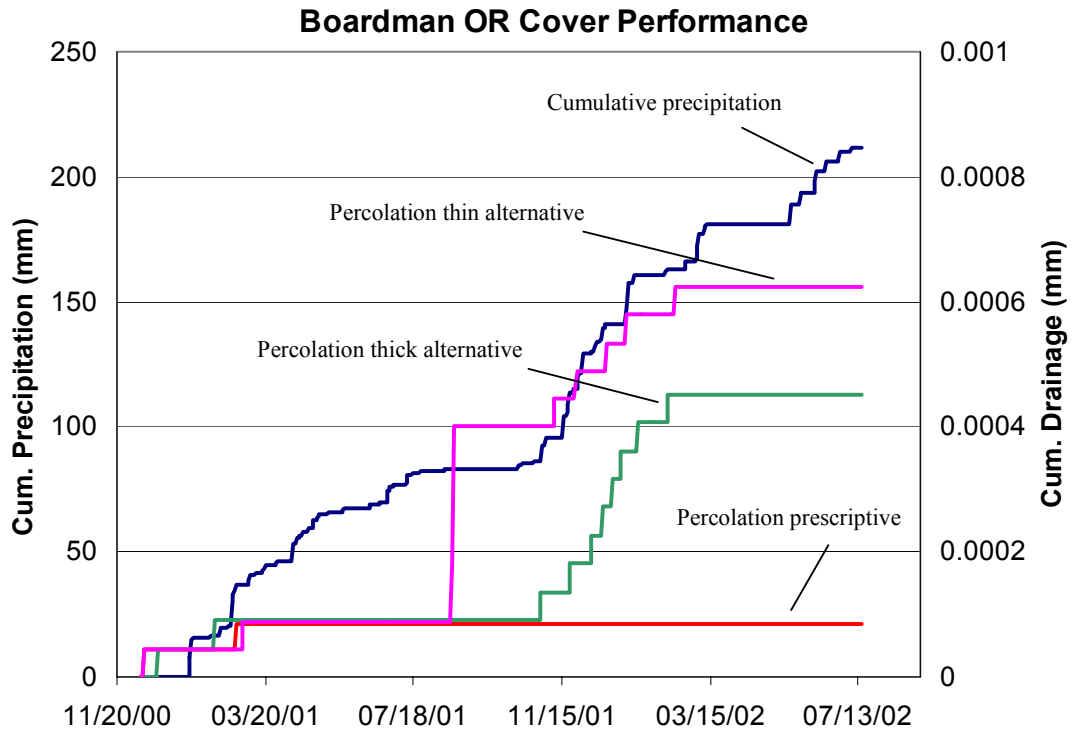
Figure 14 Cover performance at Boardman OR.

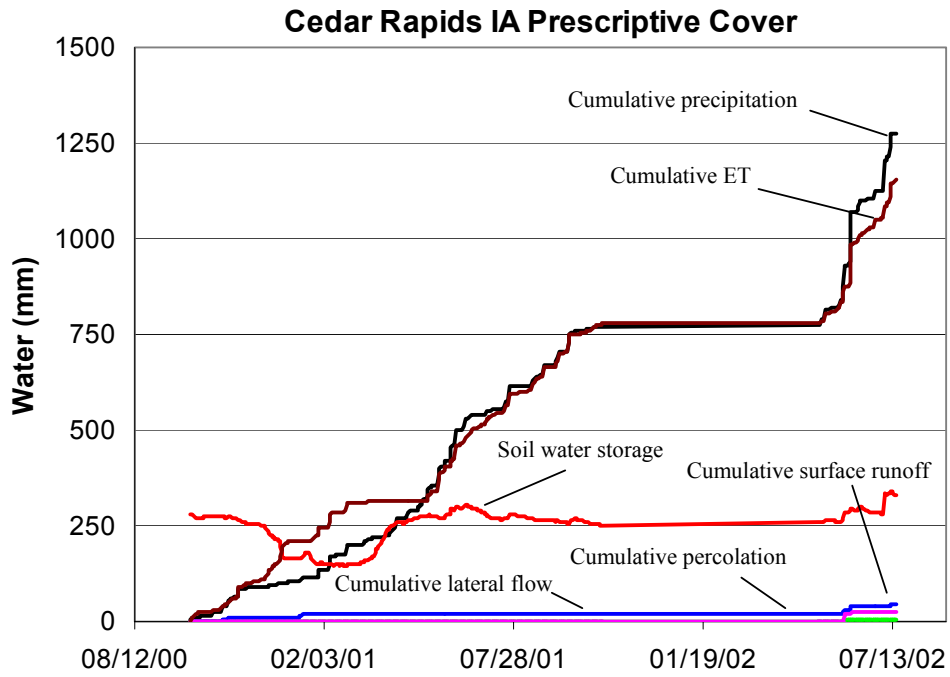
Figure 15. Water balance summary for the prescriptive cover design at the Cedar Rapids IA ACAP site.

Data collection at the Cedar Rapids site began October 3, 2000. Data were lost for a six-month period from mid-October 2001 to early May 2002 due to a variety of instrument and communication problems. Water balance summaries for the test sections at the Cedar Rapids site are shown in Figures 15, 16, 17 and 18. Total recorded precipitation during the 21-month data collection period was 1277 mm. Mean annual precipitation for the site is about 925 mm.

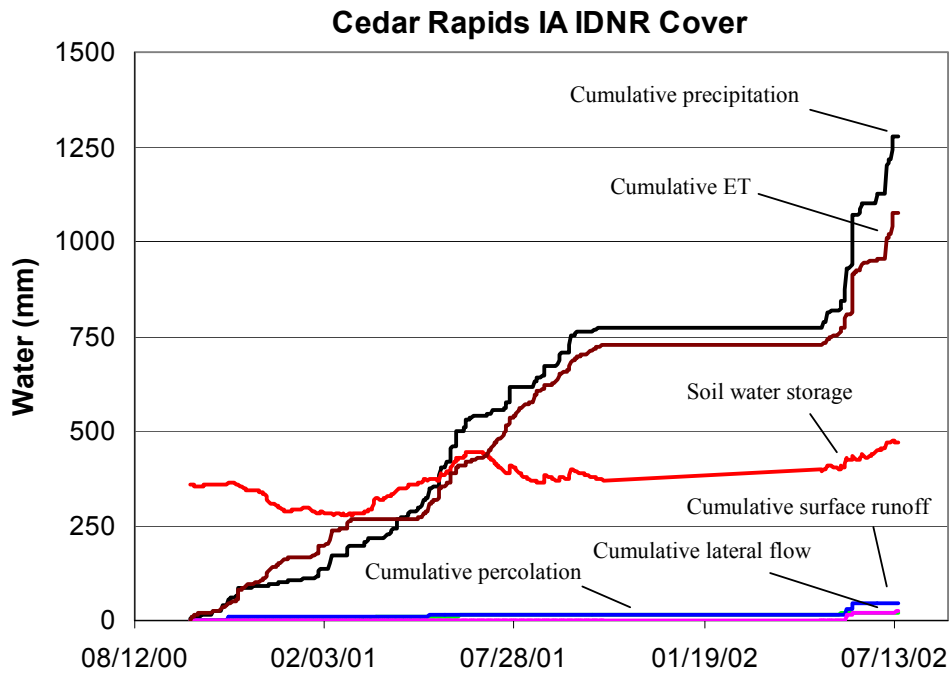
Figure 16. Water balance summary for the IDNR cover design at the Cedar Rapids IA ACAP site.

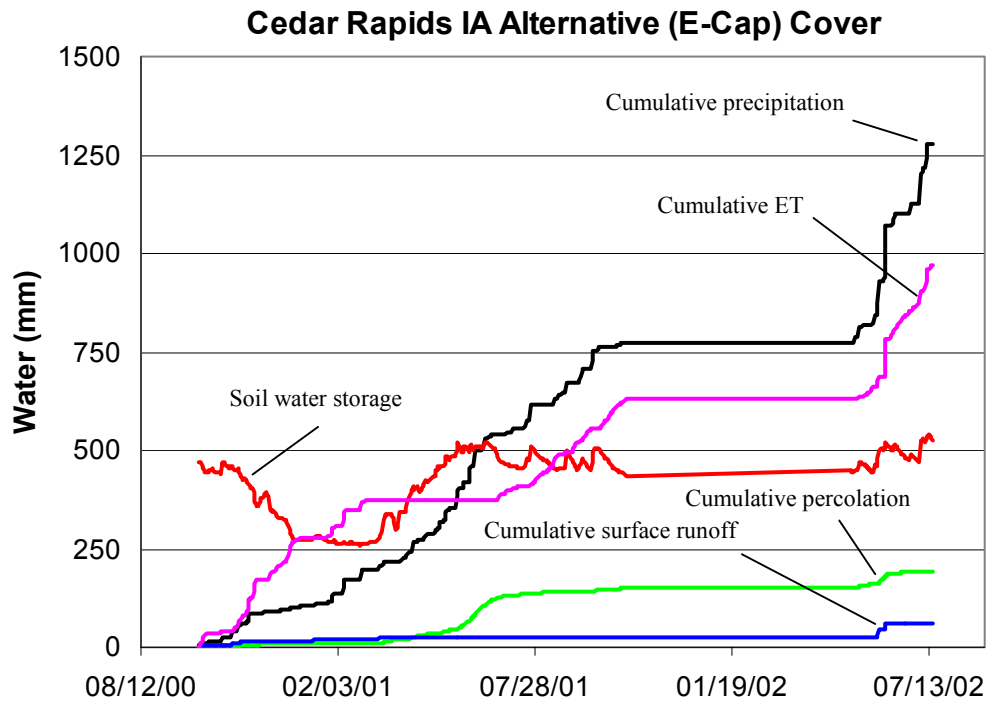
Figure 17. Water balance summary for the alternative (E-Cap) cover design at the Cedar Rapids IA ACAP site.

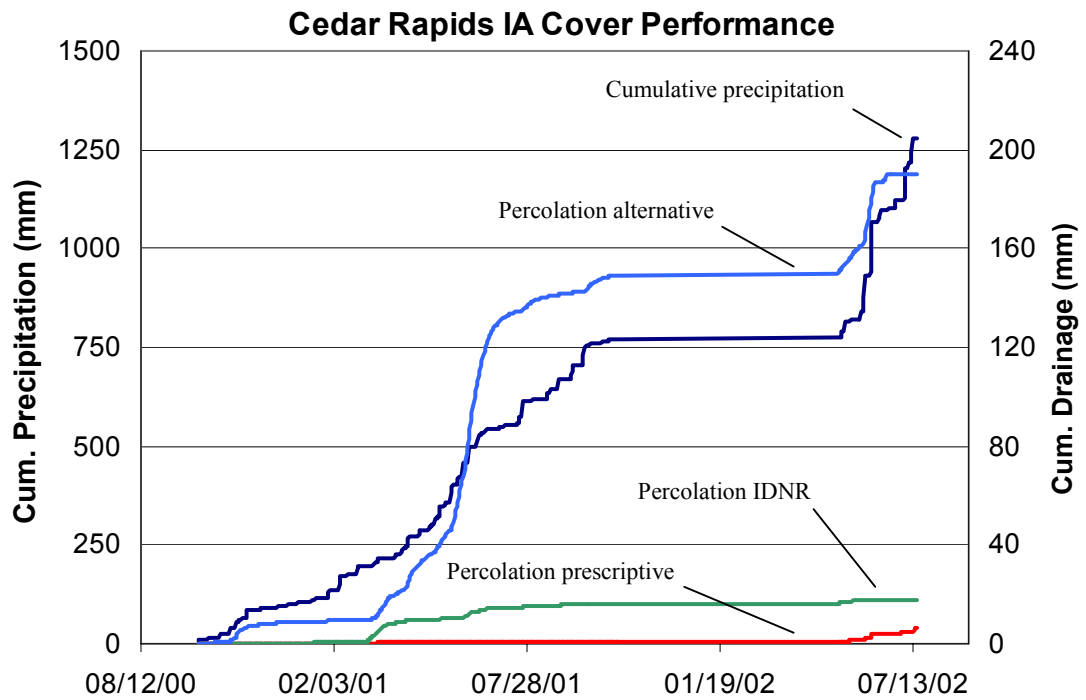
Figure 18. Cover performance at Cedar Rapids IA.

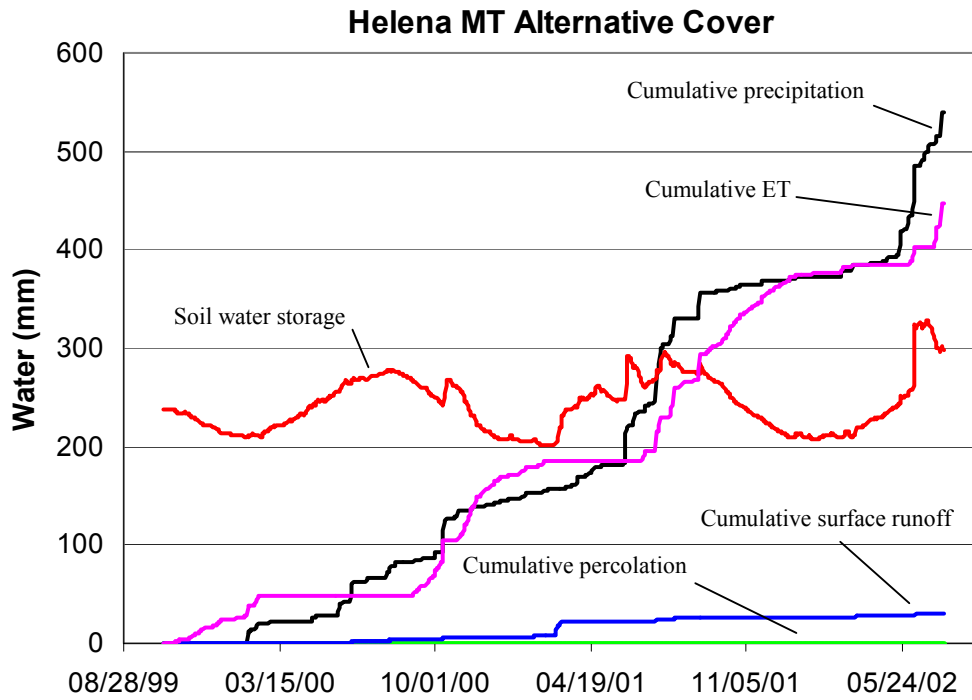
Figure 19. Water balance summary for the alternative cover design at the Helena MT ACAP site.

Data collection at the Helena site began October 10, 1999. Water balance summaries for the test section at the Helena site are shown in Figures 19 and 20. Total recorded precipitation during the 33-month data collection period was 540 mm. Mean annual precipitation for the site is about 305 mm. No percolation has been recorded from the alternative cover at the Helena site.

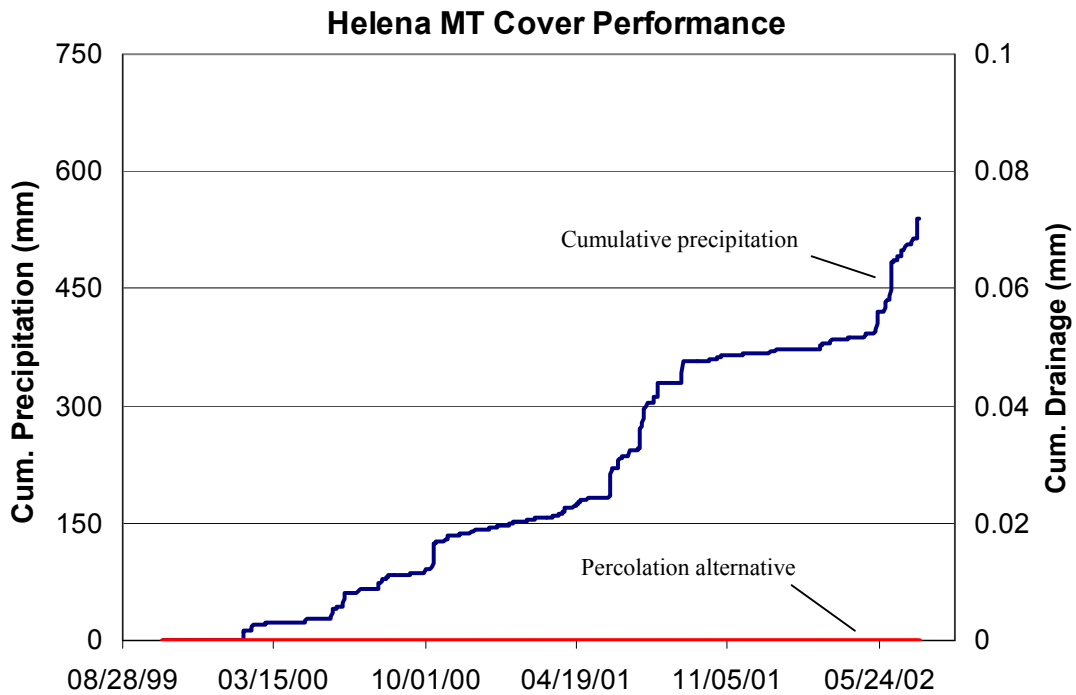
Figure 20. Cover performance at Helena MT.

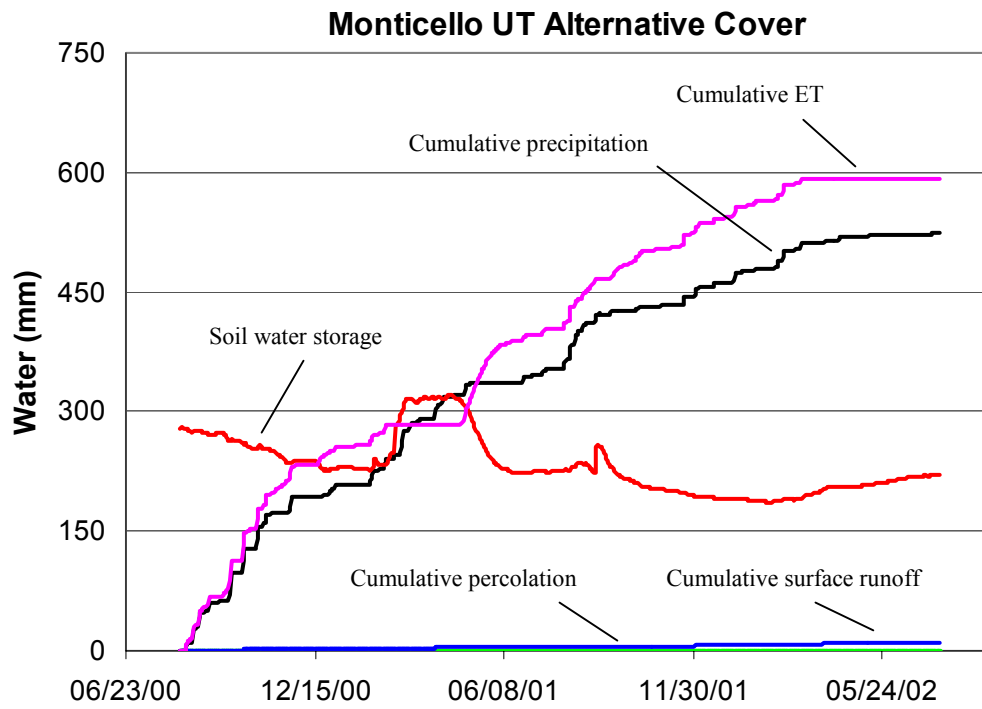
Figure 21. Water balance summary for the alternative cover design at the Monticello UT ACAP site.

Data collection at the Monticello site began August 2, 2000. Water balance summaries for the test section at the Monticello site are shown in Figures 21 and 22. Total recorded precipitation during the 23-month data collection period was 525 mm. Mean annual precipitation for the site is about 384 mm. Cumulative percolation through the Monticello cover is less than 0.1 mm.

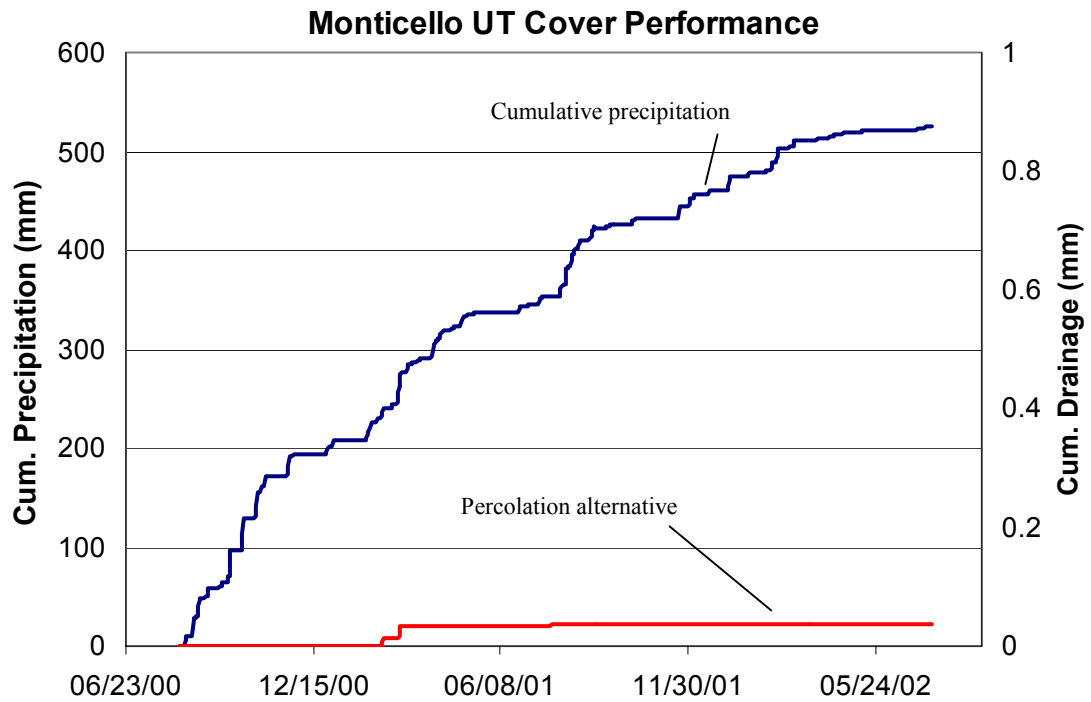
Figure 22. Cover performance at Monticello UT.

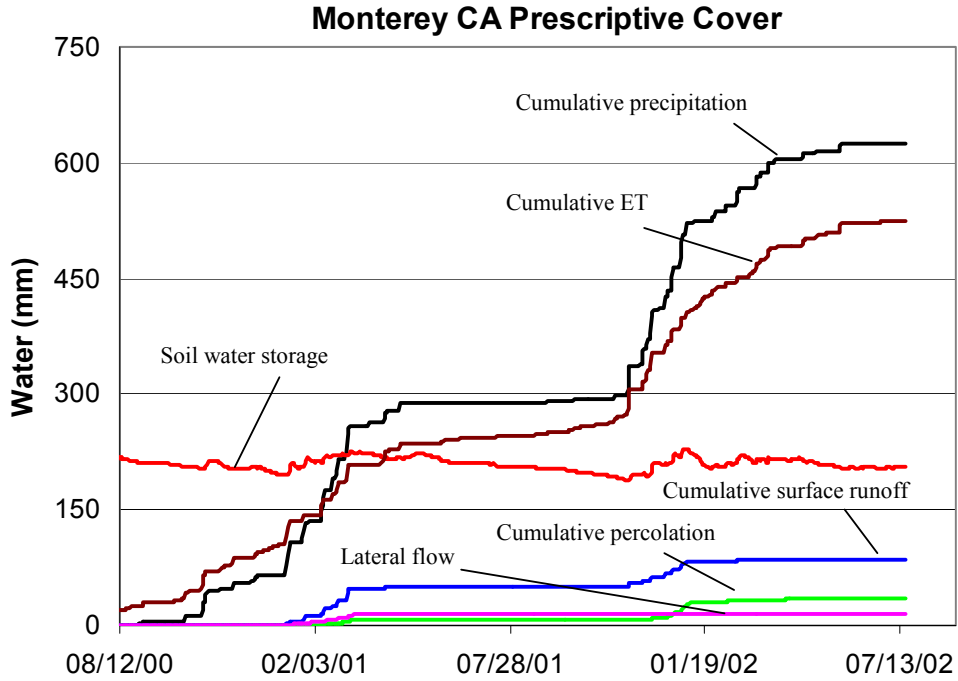
Figure 23. Water balance summary for the prescriptive cover design at the Monterey CA ACAP site.

Data collection at the Monterey site began May 27, 2000. Water balance summaries for the test sections at the Monterey site are shown in Figures 23, 24 and 25. Total recorded precipitation during the 25-month data collection period was 624 mm. Mean annual precipitation for the site is about 412 mm.

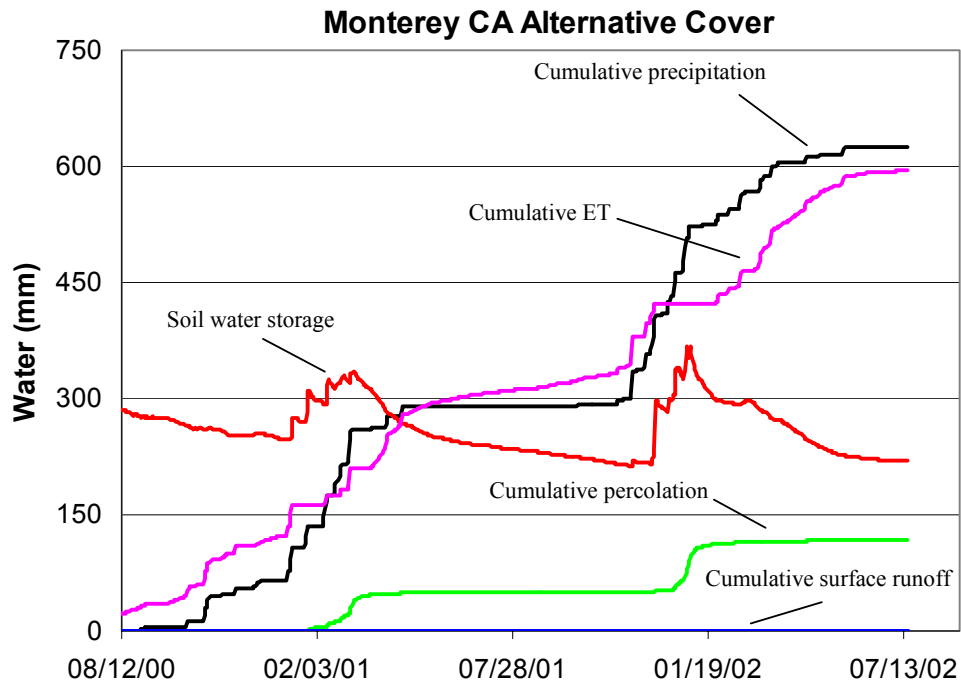
Figure 24. Water balance summary for the alternative cover design at the Monterey CA ACAP site.

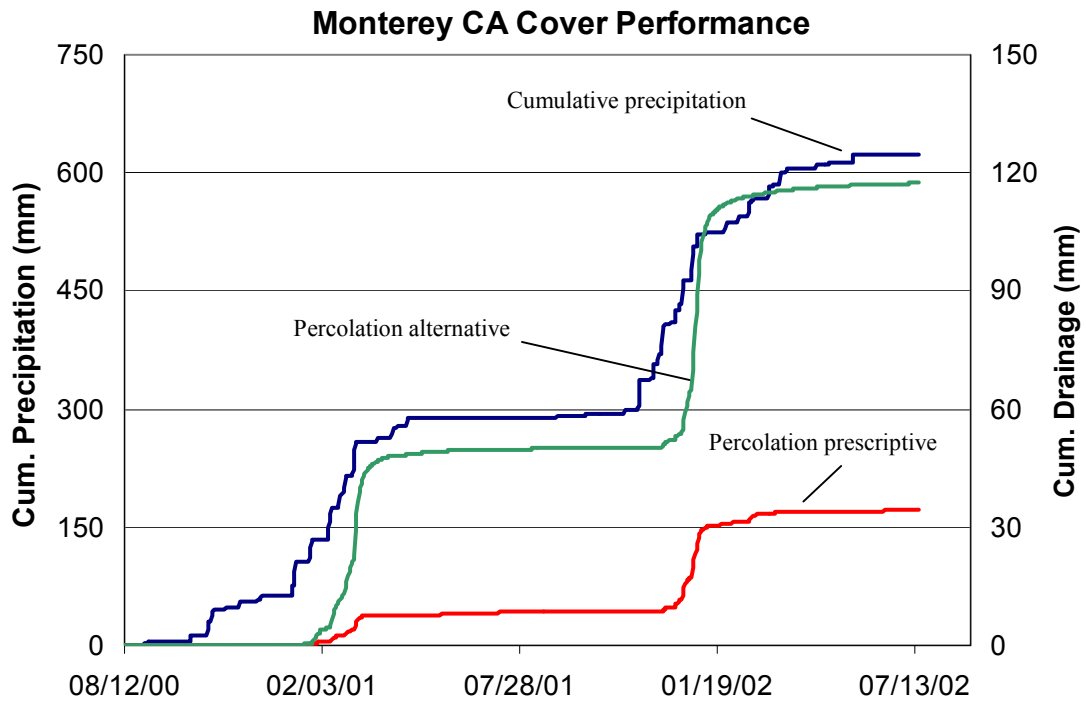
Figure 25. Cover performance at Monterey CA.

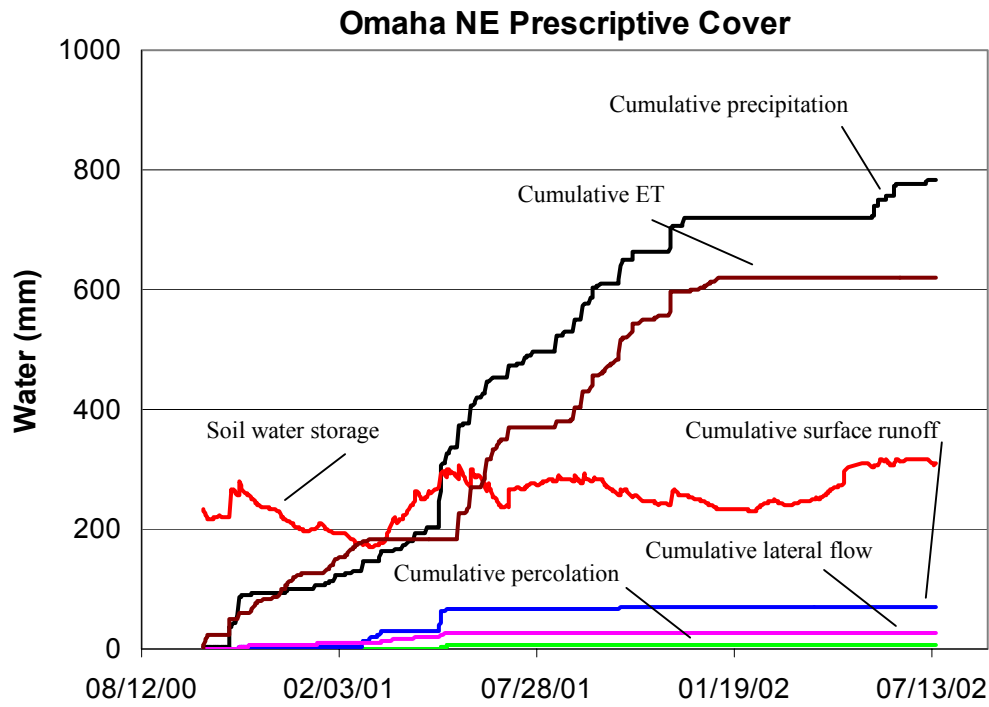
Figure 26. Water balance summary for the prescriptive cover design at the Omaha NE ACAP site.

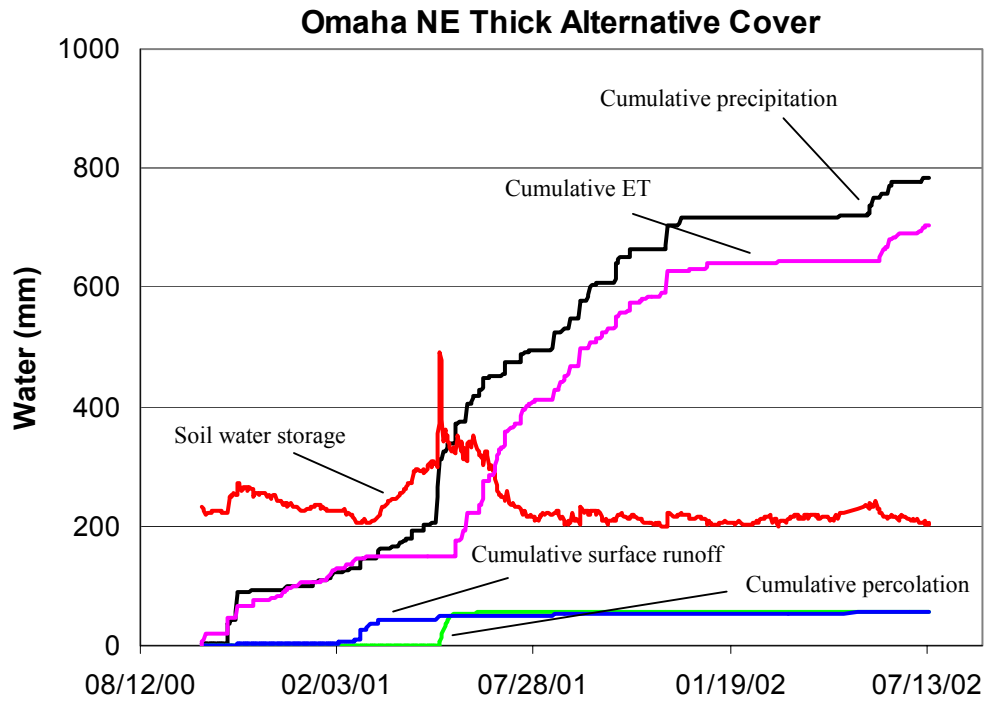
Figure 27. Water balance summary for the thick alternative cover design at the Omaha NE ACAP site.
