# *Alternative Cover Assessment Program 2002 Annual Report*

October 2002

Publication No. 41182

U.S. Environmental Protection Agency

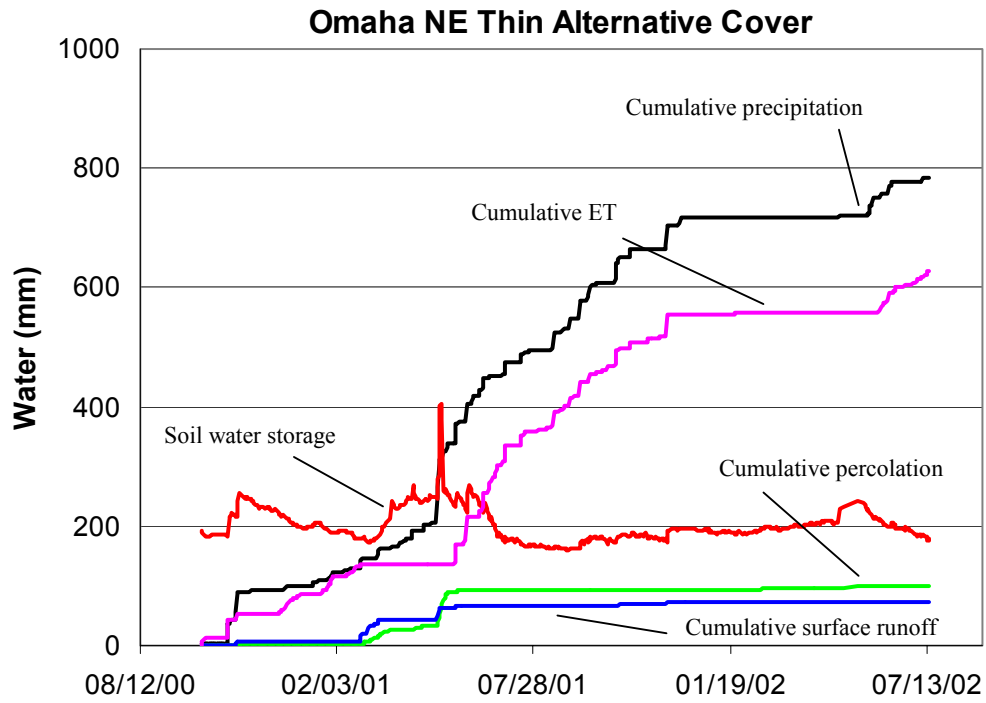
Figure 28. Water balance summary for the thin alternative cover design at the Omaha NE ACAP site.

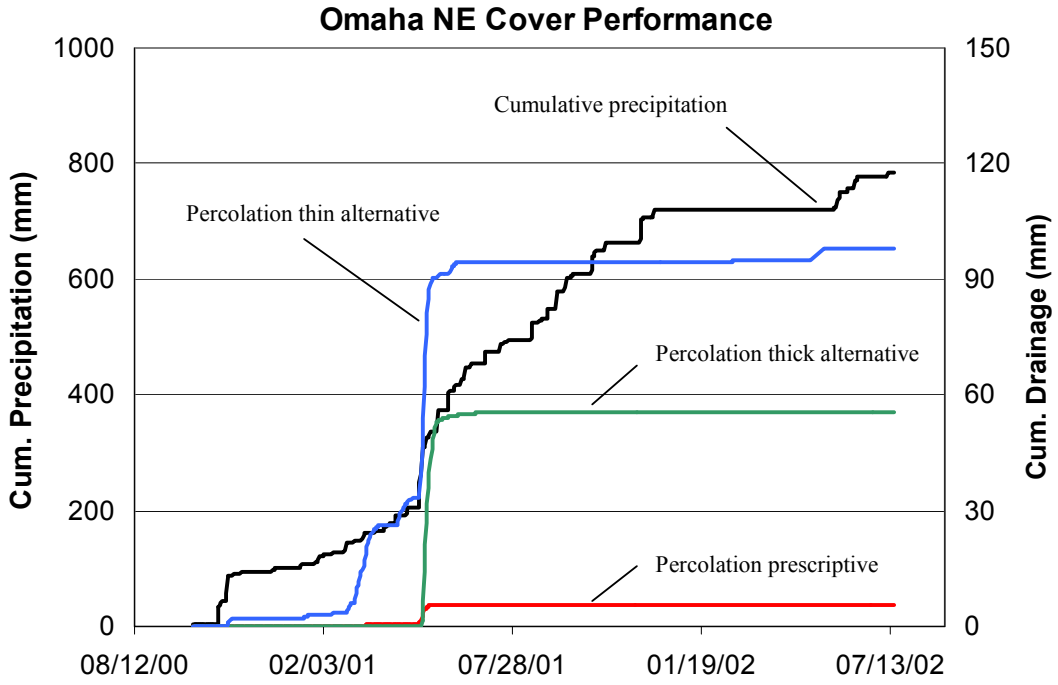
Figure 29. Cover performance at Omaha NE.

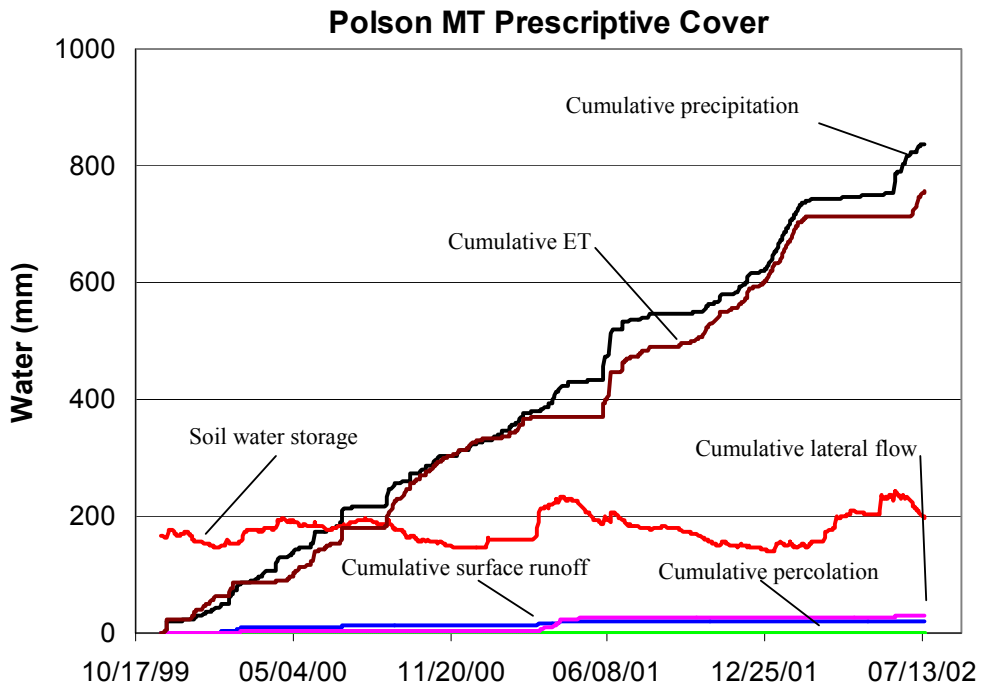
Figure 30. Water balance summary for the prescriptive cover design at the Polson MT ACAP site.

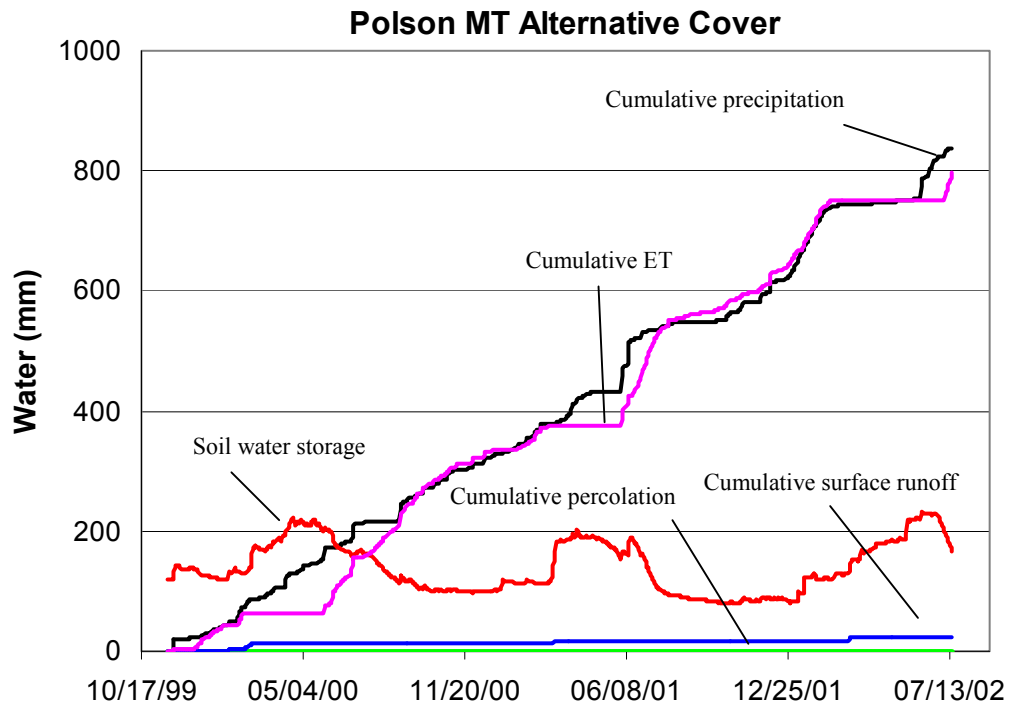
Figure 31. Water balance summary for the alternative cover design at the Polson MT ACAP site.

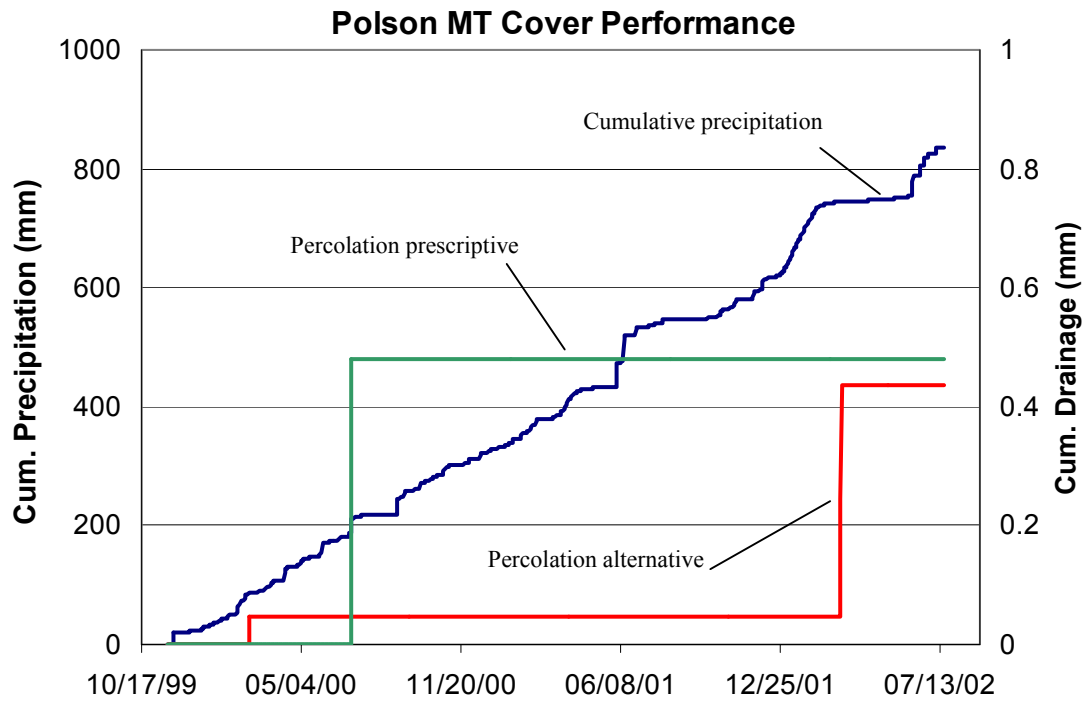
Figure 32. Cover performance at Polson MT.

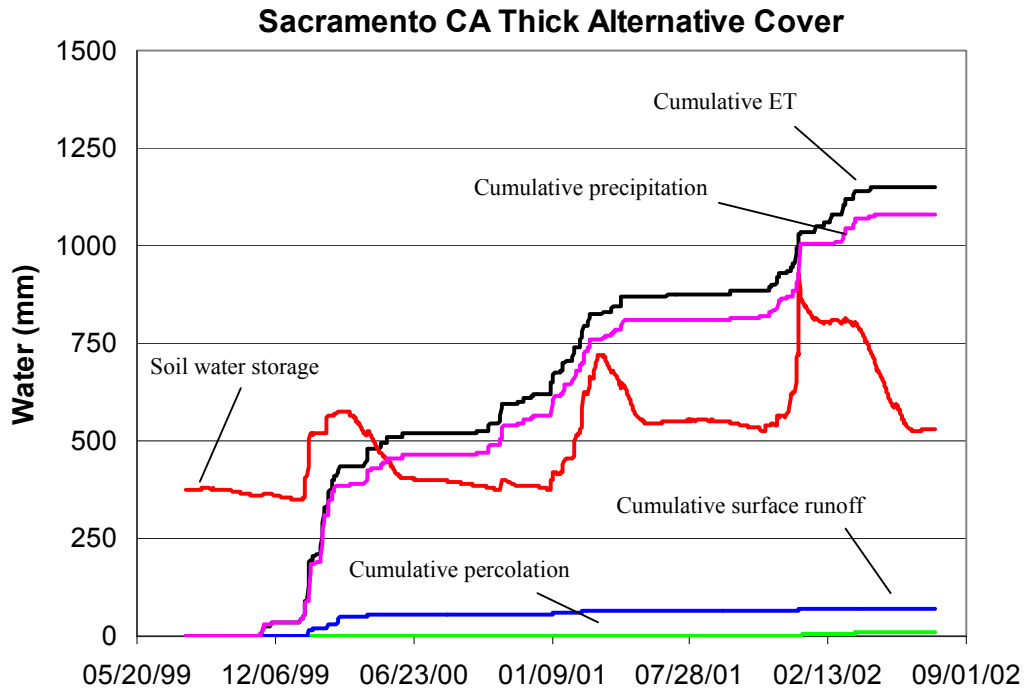
Figure 33. Water balance summary for the thick alternative cover design at the Sacramento CA ACAP site.

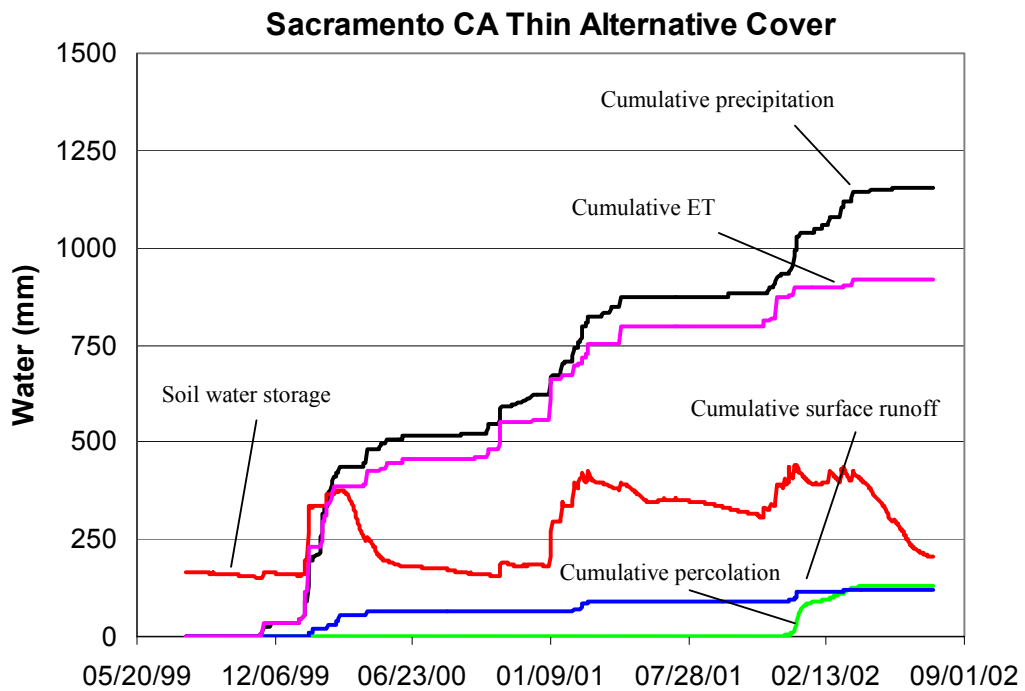
Figure 34. Water balance summary for the thin alternative cover design at the Sacramento CA ACAP site.

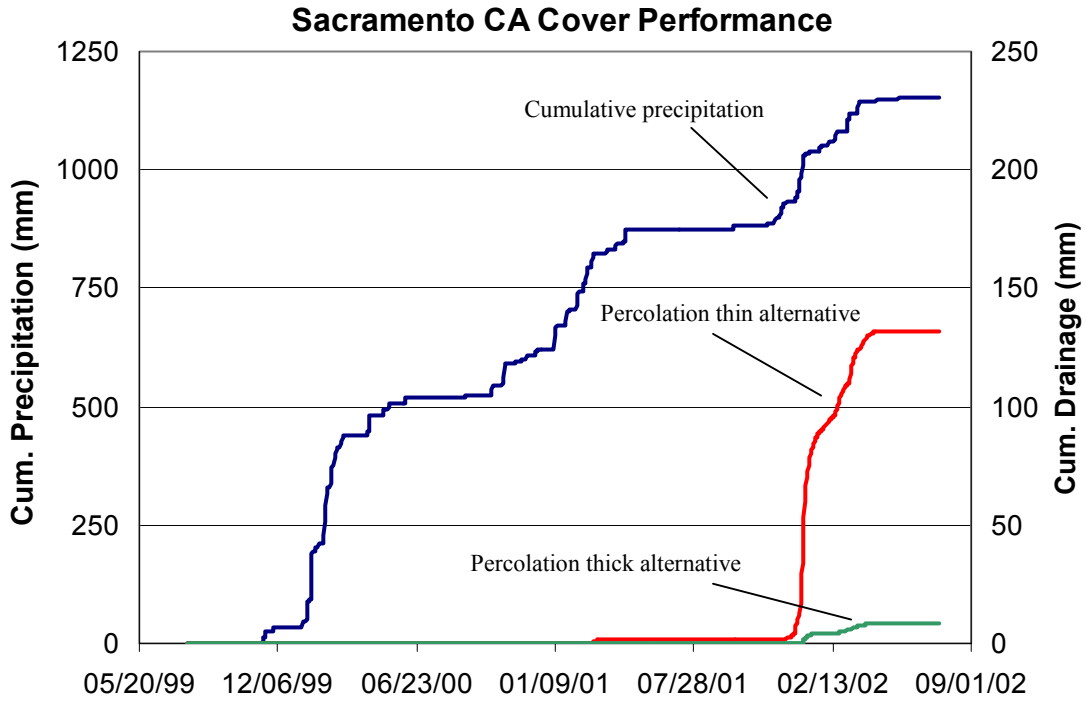
Figure 35. Cover performance at Sacramento CA.

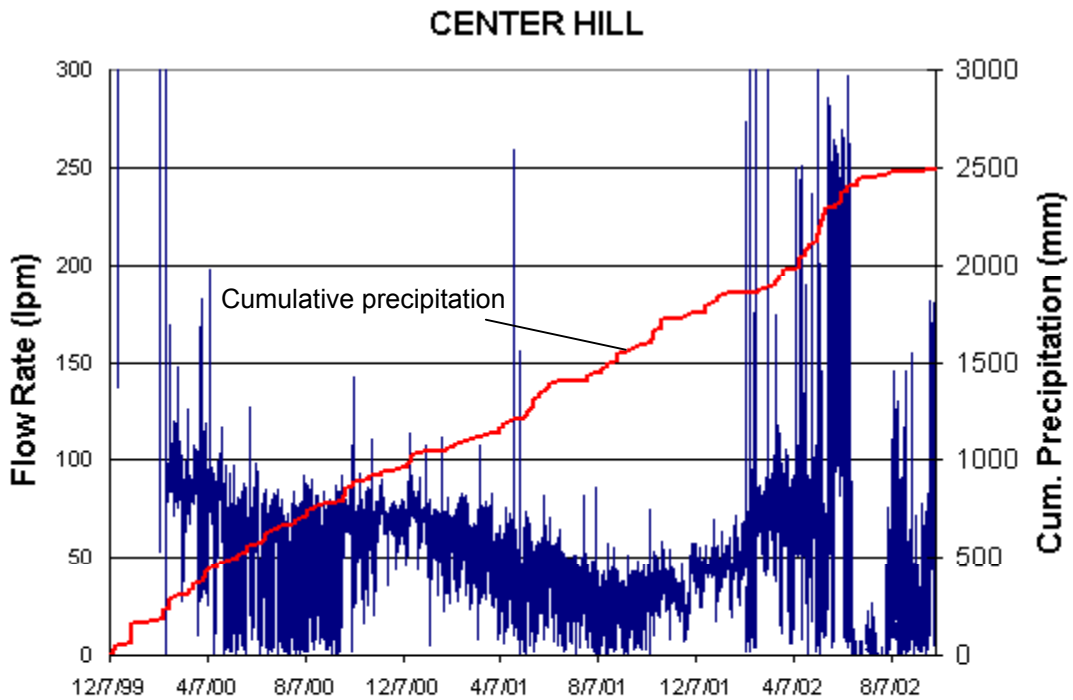
Figure 36. Summary of leachate flow measurements at the Center Hill Landfill ACAP site.

pumped to a storage tank. Measurement of leachate is accomplished by monitoring the fluid level in the storage tank. The landfill at Center Hill is also closed with a final cover and does not include a liner. Leachate collected by two collection trenches is monitored with a flow meter.

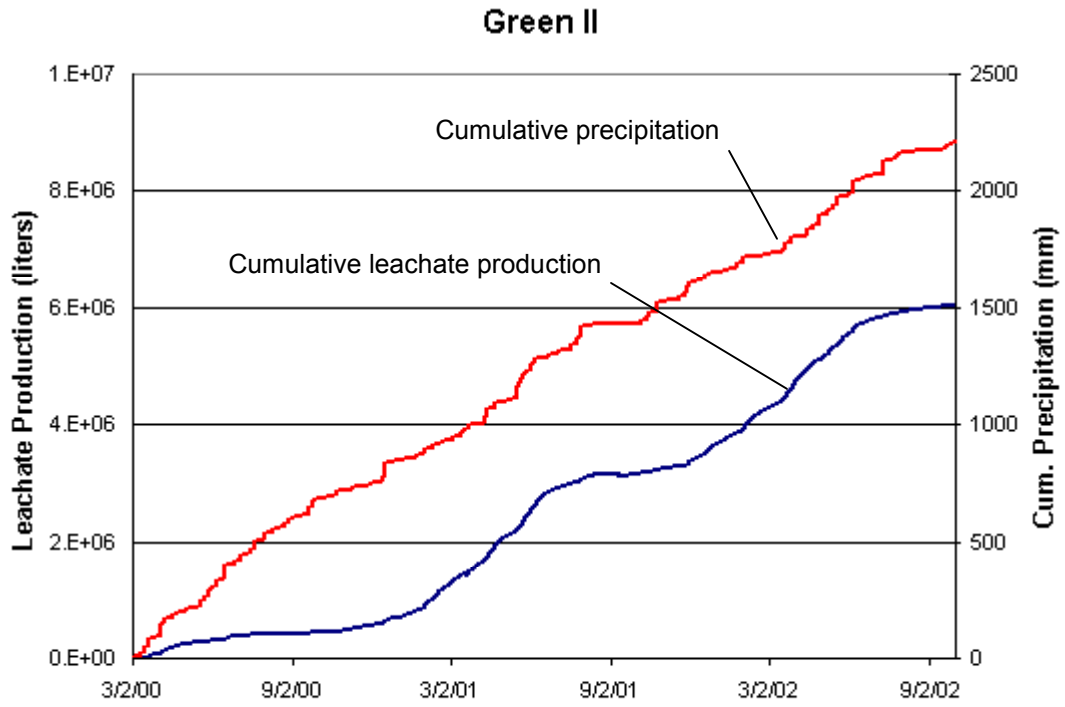
Figure 37. Summary of leachate flow measurements at the Green II Landfill ACAP site.

The ACAP sites at Center Hill (Cincinnati OH) and Green II (Logan OH) do not include drainage lysimeters as the basis for performance monitoring. Both sites are closed with final covers in place and offered alternative methods for estimating the performance of the covers. The landfill at Green II was located in an abandoned clay mine and, as such, rests atop a natural base of low-permeability soil. Leachate from the site is collected in two collection trenches and
