November 2008 Electrical Safety Occurrences

Electrical Occurrences by Month & Secretarial Office

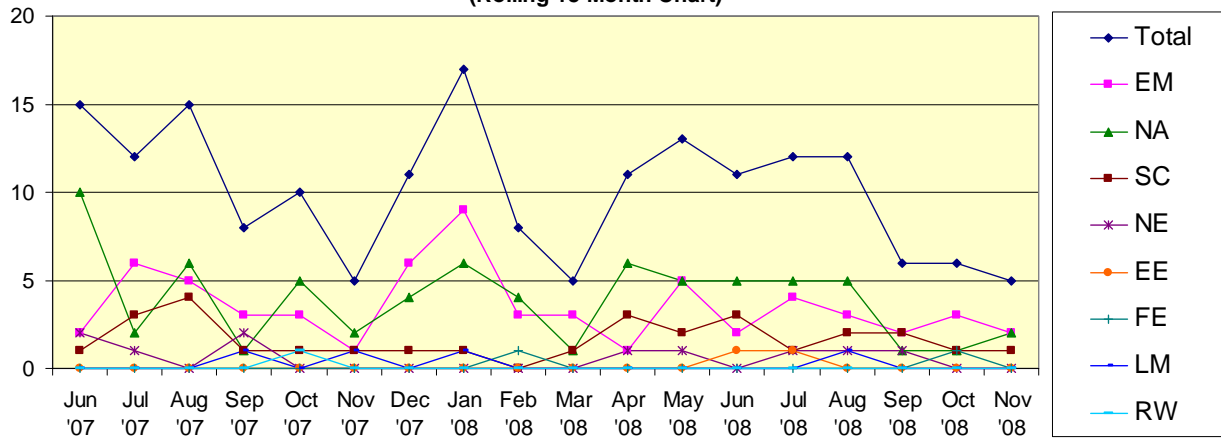
(Rolling 18-Month Chart)

EE - Energy Efficiency and Renewable Energy, EM - Environmental Management, FE - Fossil Energy, LM - Legacy Management, NA - National Nuclear Security Administration, NE - Nuclear Energy, RW - Civilian Radioactive Waste Management, SC - Science
