January 2009 Electrical Safety Occurrences

Electrical Occurrences by Month & Secretarial Office

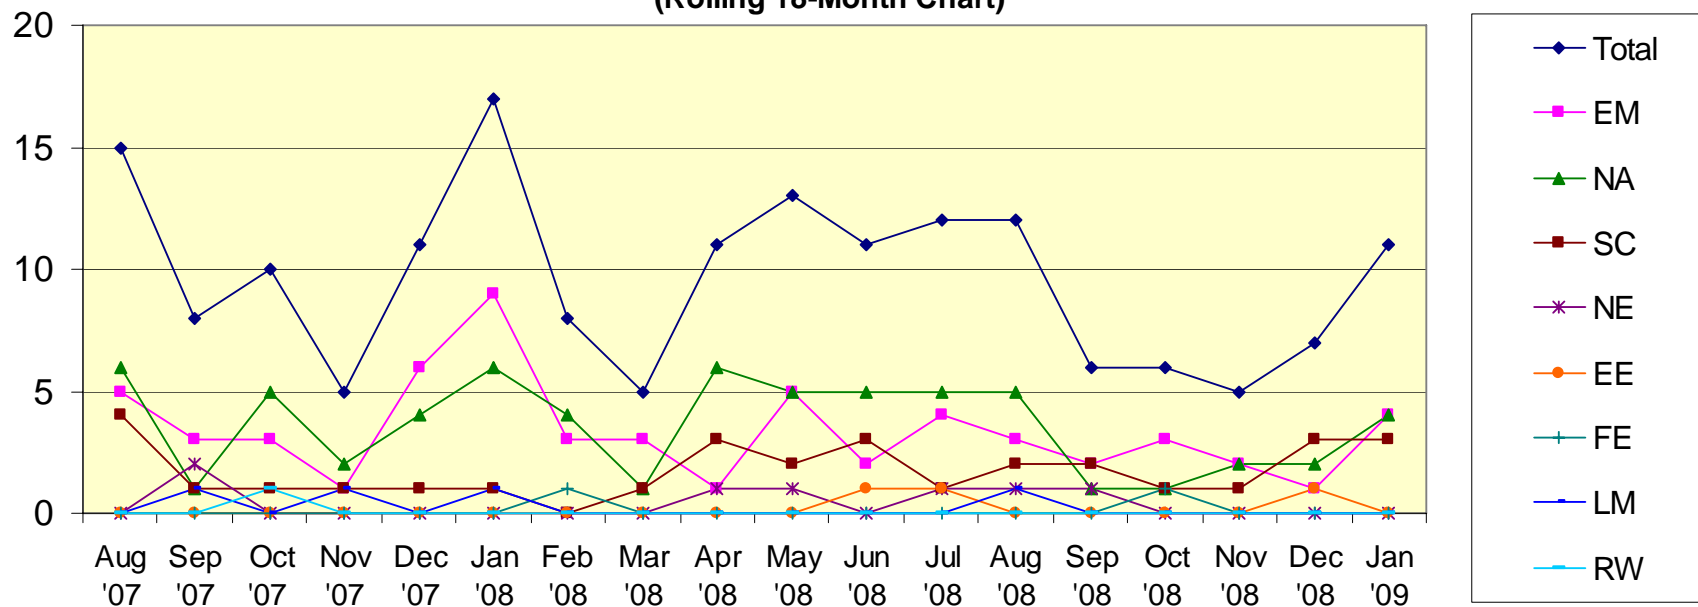
(Rolling 18-Month Chart)

EE - Energy Efficiency and Renewable Energy, EM - Environmental Management, FE - Fossil Energy, LM - Legacy Management, NA - National Nuclear Security Administration, NE - Nuclear Energy, RW - Civilian Radioactive Waste Management, SC - Science
