Department of the Interior
Bureau of Reclamation

OPERATION AND MAINTENANCE EQUIPMENT AND PROCEDURES

RELEASE NO. 46

VERTICAL PLASTIC CUTOFF

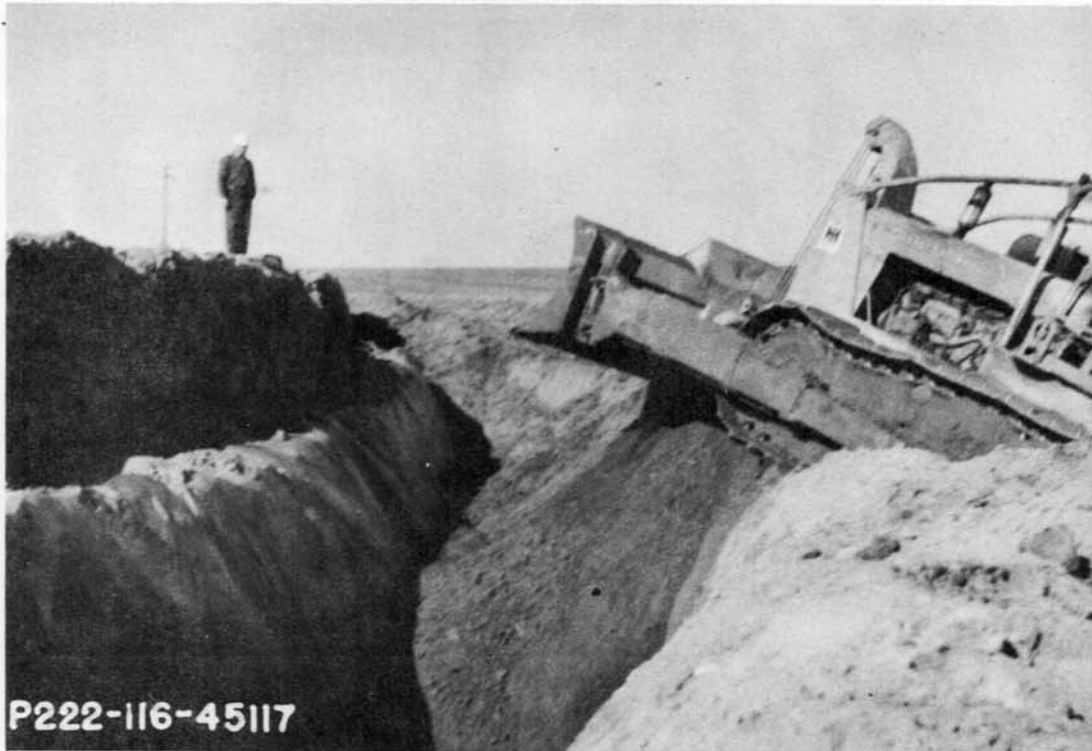
Cover page. Backfilling against a plastic curtain cutoff provided
for the East Low Canal, Columbia Basin Project, Washington.
P222-116-45117

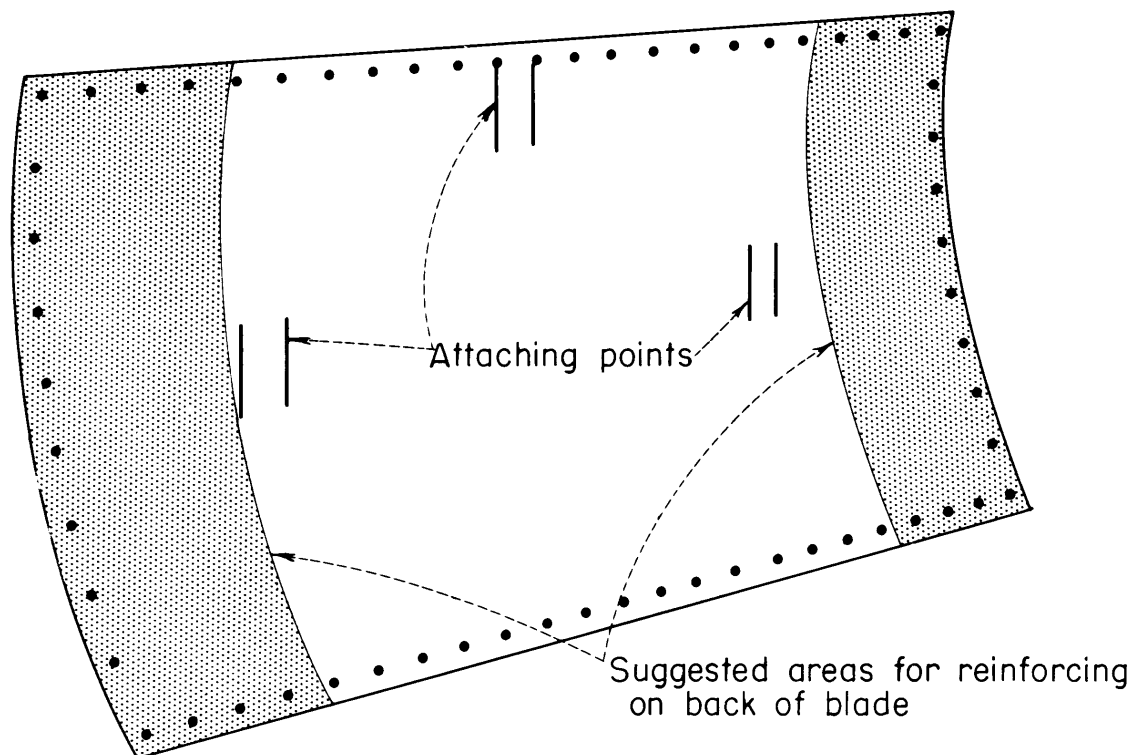
Needing a pusher snow plow blade but not having the more than \$100 required to purchase one, personnel at Warren Dunes State Park, Michigan, cut a piece out of a discarded 550-gallon water tank and mounted that on a front-end loading tractor. The tank had just the right curve so that the blade lets snow roll off easily.

The welder who handled the job cut a piece 20 inches high and 4-1/2 feet long, in such a way as to have the riveted double edges from the tank reinforce the blade edges. He then fitted brackets to the back of the blade.

Lyle McDonald, Park Manager, says the blade probably would last longer if reinforced with an extra thickness of metal plate for a foot or so at each end. Such reinforcing pieces could also be cut from the salvaged tank.

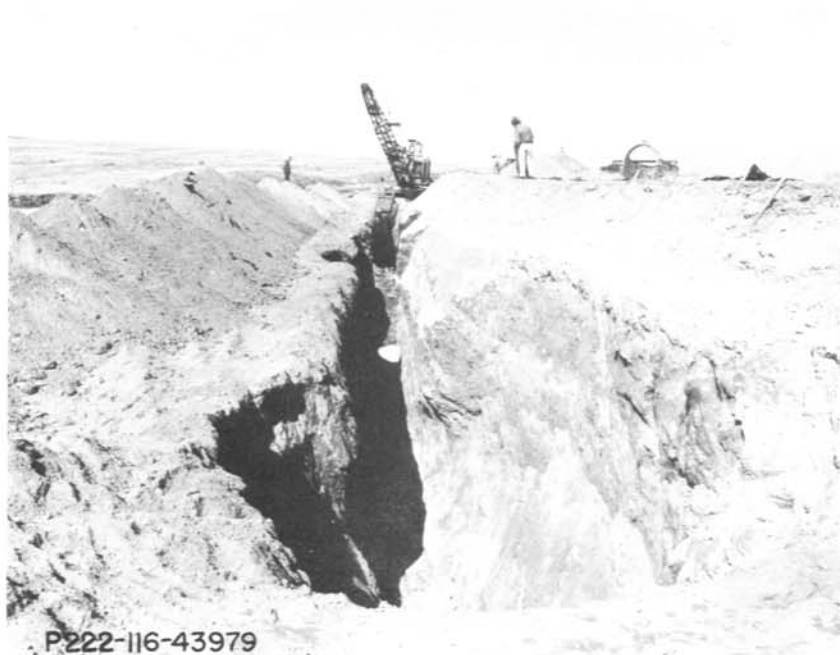
Figure 1 on the preceding page is a view of the cutoff trench. In general, the trench was standing in a nearly vertical position, although excavation was complete.

Figures 1, 2, 3, 4, 5, and 6 illustrate various stages of this installation.

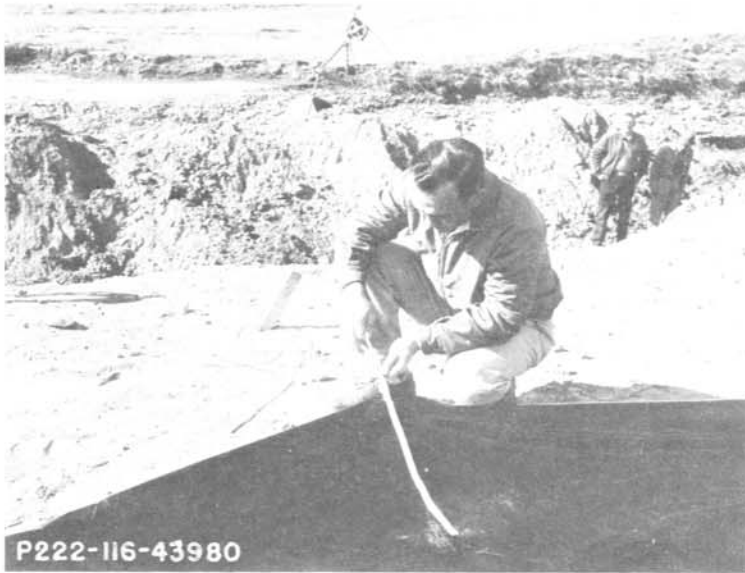
Figure 2 shows the method of tying the anchor ropes to a loop formed by a piece of filament tape to anchor the top edge of the plastic. This tape works very well on clean plastic.

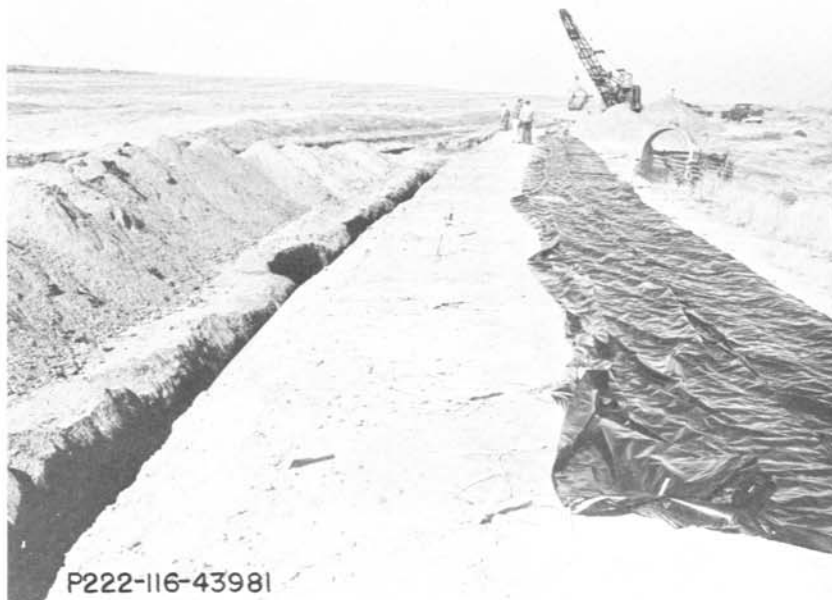
Figure 3 below is a view looking downstream showing the plastic sheet lying on the operating road preparatory to placing it in the trench. This sheet extends approximately 118 feet and the decision was made to install this piece of plastic before additional caving could occur.

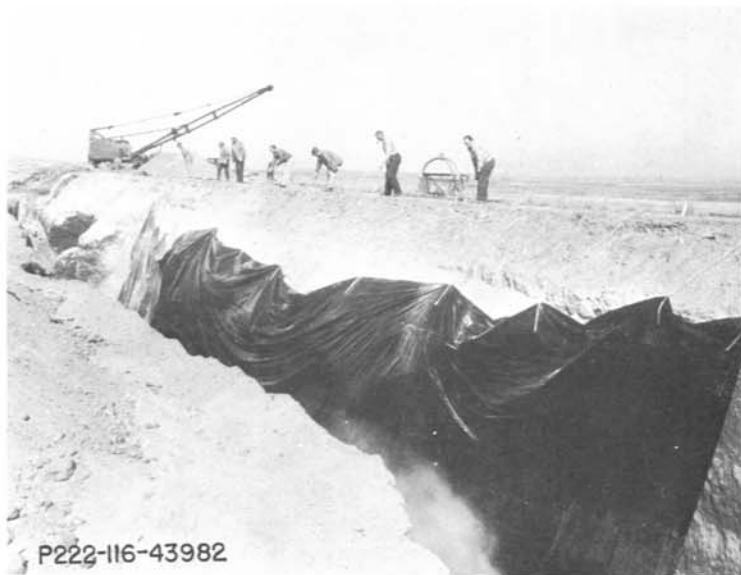
Figure 4 shows workmen placing the plastic sheet in the reach shown previously. Although the filament tape anchored to the upper edge of the plastic was spaced 10 to 12 feet apart, it appeared to be quite secure. Additional anchors were placed to strengthen the hold on the plastic after it was determined the plastic was being subjected to considerable stress during subsequent backfilling operations.

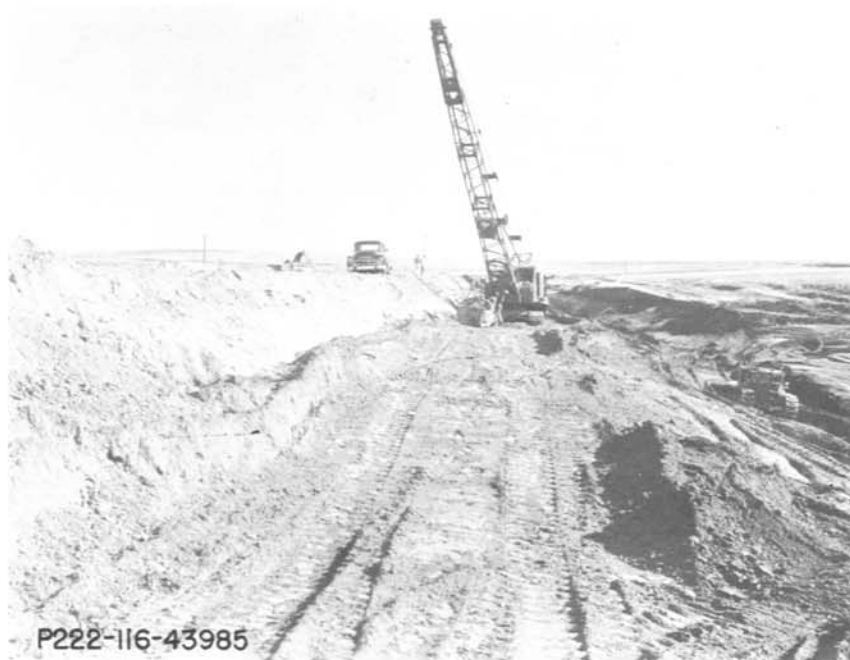
Figure 5 is a view looking upstream showing backfilling operations. The backfill corresponds closely to the top of the plastic sheet. Figure 6 at the top of the next page is a view of the canal looking downstream along the right bank showing conditions after completion of

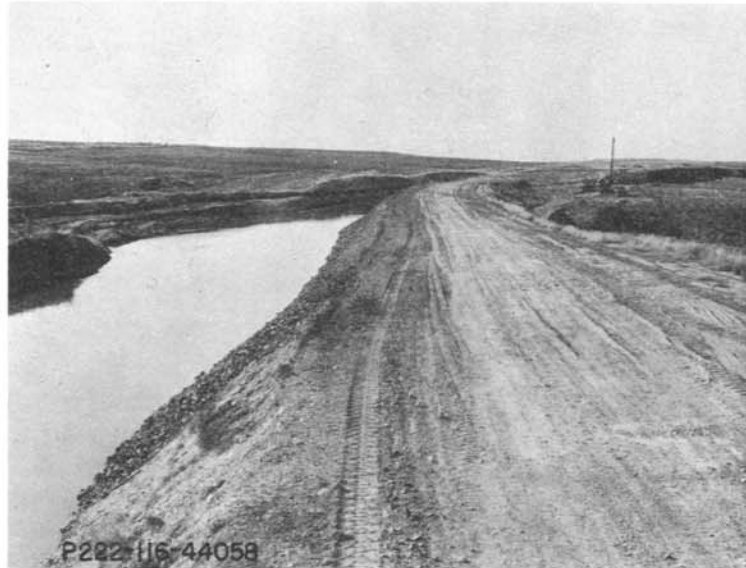
Figure 6

the test installation. Gravel has been placed on the inside sideslope to provide erosion protection. The drill at the right embankment toe is installing an additional ground-water observation well to be used to evaluate the effectiveness of the cutoff.

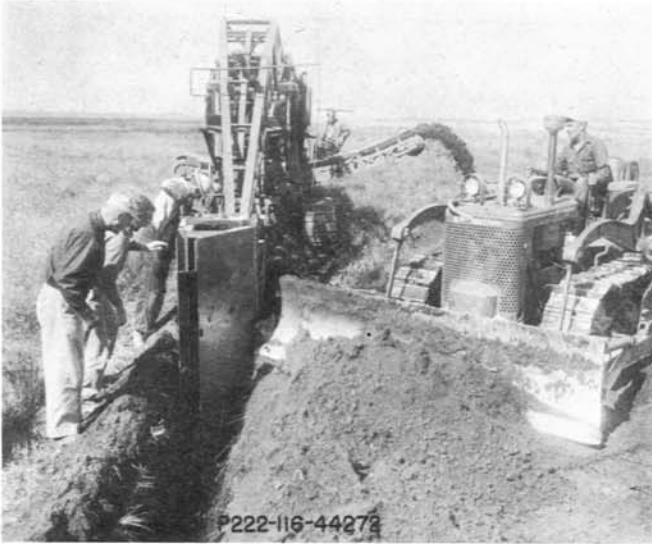
Figure 7

The trial run is shown in Photographs 7 and 8. Photograph 7 is a closeup of the plastic cutoff curtain being installed during early trials. A trencher was used to excavate to a depth of approximately 10 feet in preparation for the commencement of the trial. One man is inside the project-

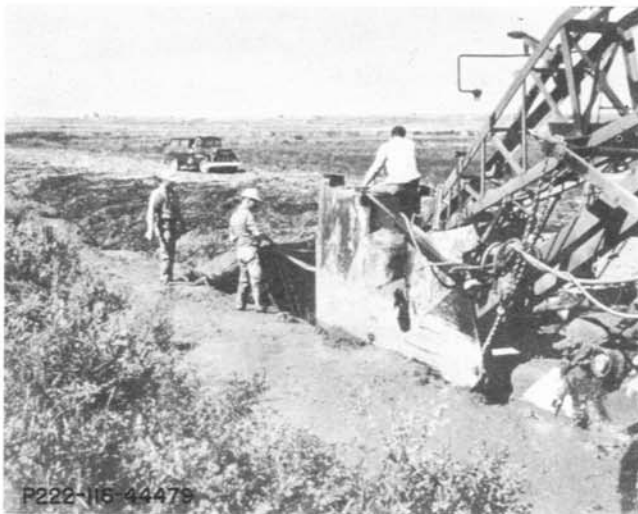
Figure 8

Photograph 8 shows more detail of the actual operation along the wasteway. An auxiliary shield attached to the trencher for protection against sloughing ahead of the shield is visible. The trencher is a special model built for drain-tile installation.

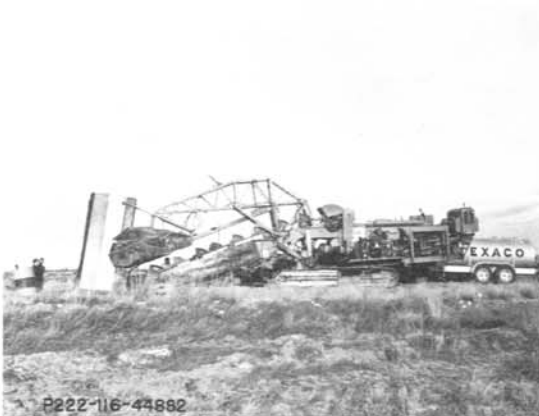
Photo 9

Photograph 9 is a view of the trenching equipment and attached Government-owned shield containing a 400-foot roll of 10-mil polyvinyl chloride plastic to be installed to a depth to 12 feet below the toe of the left bank of the West Canal.

Details of the work are shown in Photographs 9, 10, 11, 12, and 13.

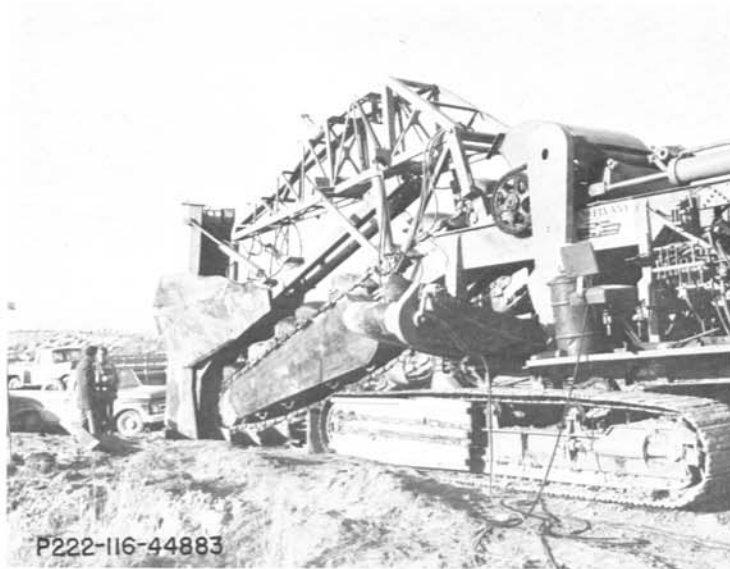
Figure 10 is another view of the trenching equipment and attached shield containing a 400-foot roll of the plastic. Figure 11 below is a view from the left slope of the canal showing backfilling operations in badly caving sand areas. Workman in the center is holding the plastic curtain as dozers are filling around it. An air hose directly under the workman on top of the plastic dispenser shield leads to an air pump located in the bottom of the shield which in turn is used to pump out water and silt and make sure the plastic rolls are turning freely.

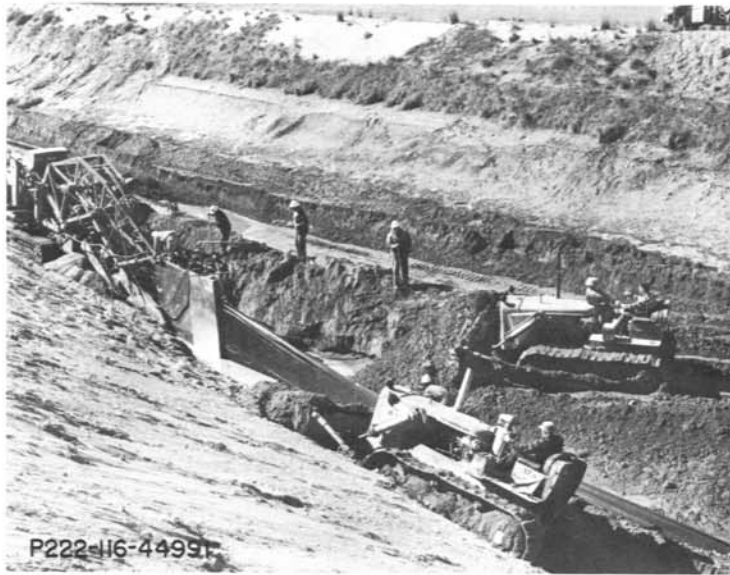
Figure 12 shows backfilling operations of the plastic cutoff curtain. Note the caving area in front of the two workmen in center of the figure. Water is visible on the left side of the plastic curtain and directly in front of the dozer in the foreground. Figure 13 is another view of the backfill operations for the plastic curtain. Workman in the center holds the plastic as dozers are filling on each side of it.

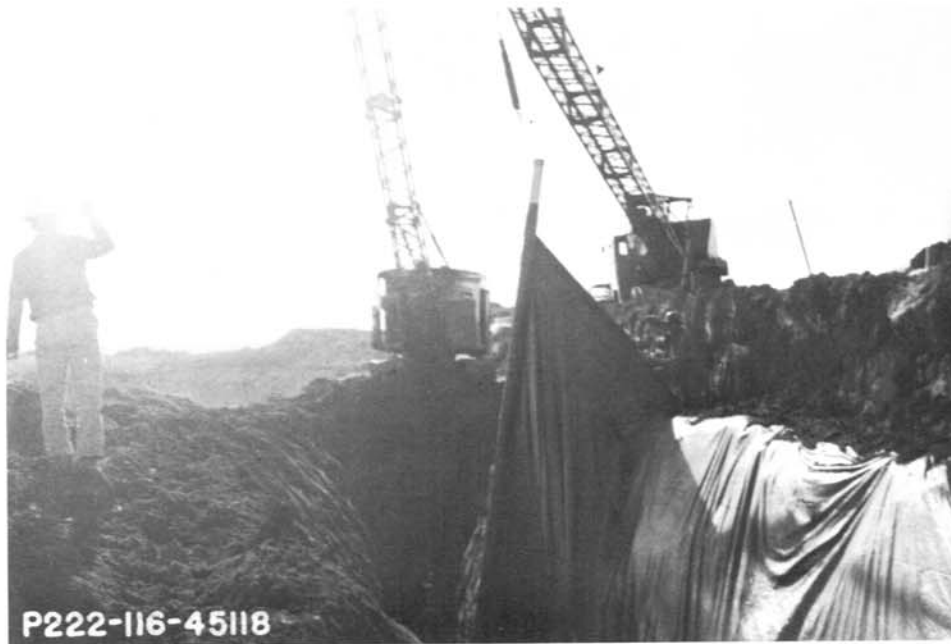
Construction details are shown on Figures 14 through 18. Figure 14 on the following page is a view of the plastic lining in the excavated trench showing the spindle around which the plastic was rolled.

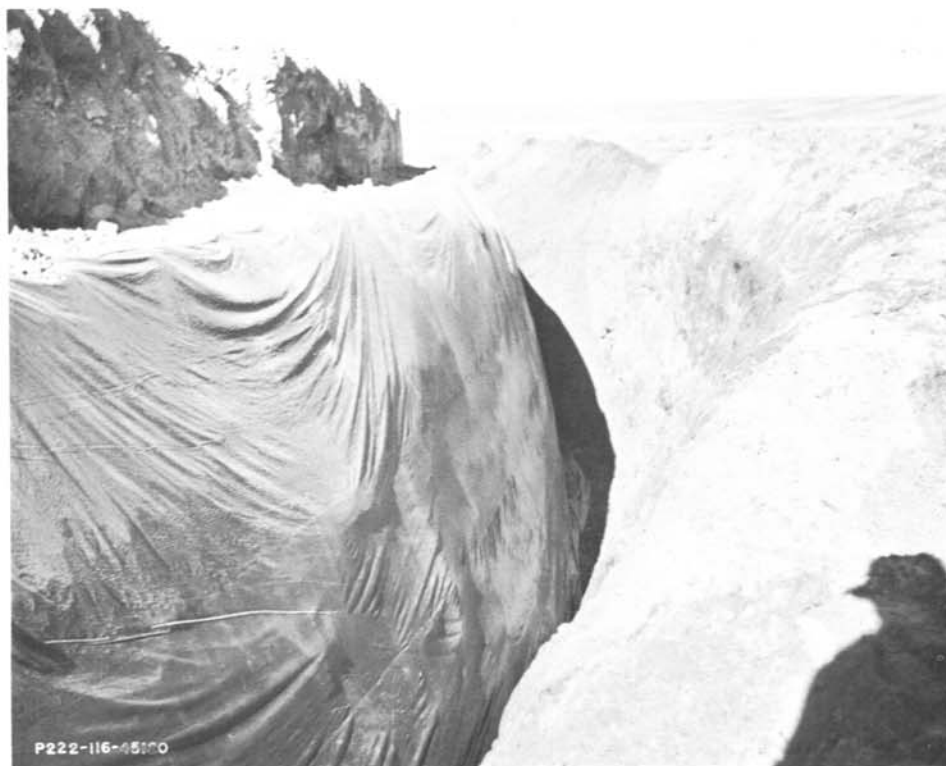
Figure 15 also on the next page is a view of the plastic curtain in place.

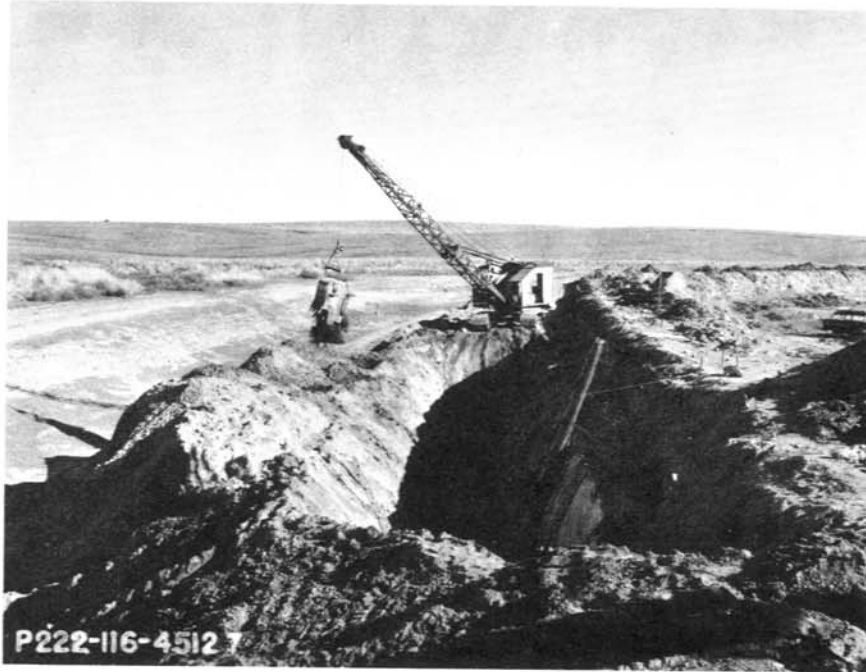
Figure 16 is a view of the trench being excavated and the plastic cutoff material in place. Figure 17 shows the completed work and the beach belt protection provided to control erosion.

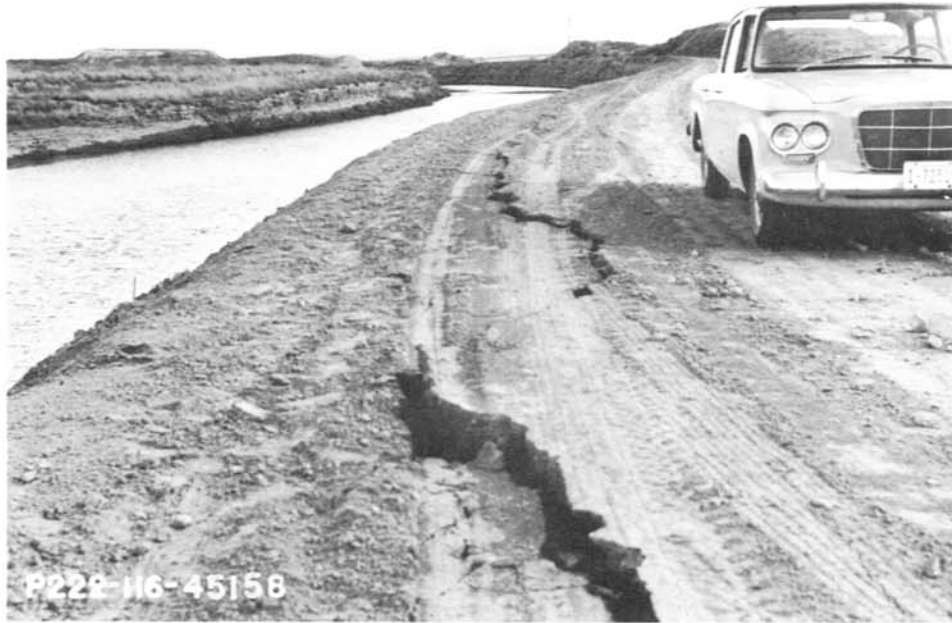
Typical of this settlement is that shown in Figure 18 above. The bank will be dressed up by project forces when settlement is complete.

Except for some minor sloughing when too much trench was opened up on too steep a slope, work was completed on this reach of cutoff without incident. The contractor reported some holes or voids were encountered in or below the bank during excavation. When the canal was primed at the beginning of the 1963 irrigation season there was some settlement over the work area but this had been expected.
