Appendix B2

ESEM/EDS Data for Test #4, Day-15 Fiberglass in High-Flow Zones

Appendix C1

ESEM/EDS Data for Test #4, Day-30 Fiberglass in Low-Flow Zones

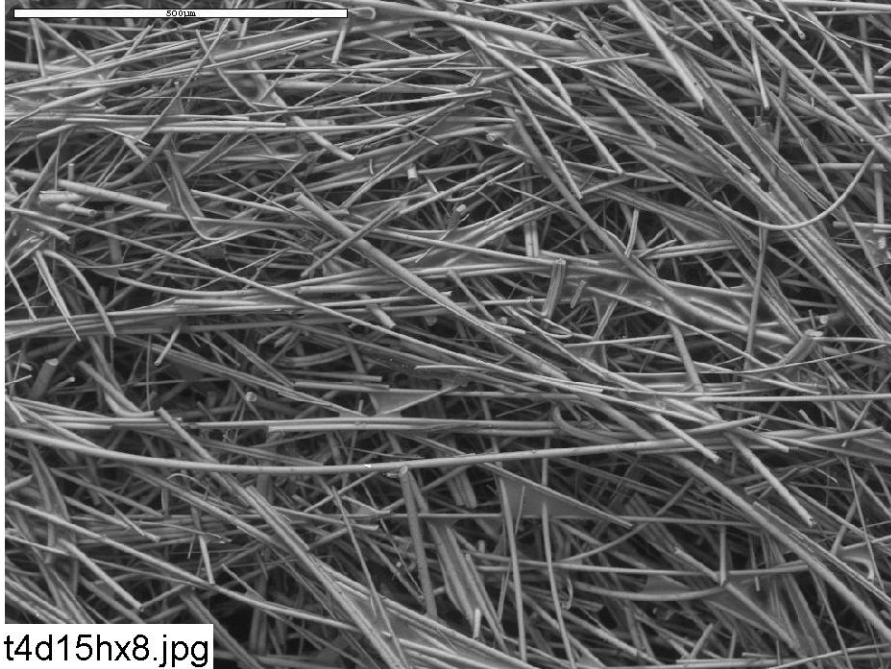
Figure B2-1. Environmental SEM image magnified 100 times for a Test #4, Day-15 exterior high-flow fiberglass sample. (t4d15hx8.jpg)

Image:	t4d15hx8	100 ×	ESEM image	Figure B2-1
	t4d15hx9	400 ×		Figure B2-2
	t4d15hx7	750 ×	ESEM Annotated Image	Figure B2-3
EDS:	t4d15hx6		EDS on web material for t4d15hx7	Figure B2-4

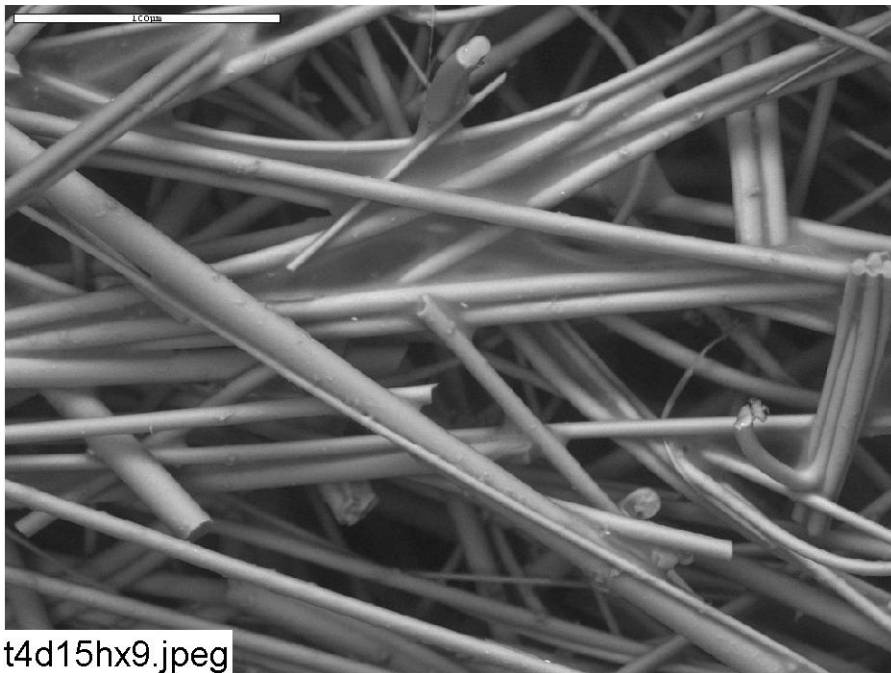
Figure B2-2. Environmental SEM image magnified 400 times for a Test #4, Day-15 exterior high-flow fiberglass sample. (t4d15hx9.jpg)

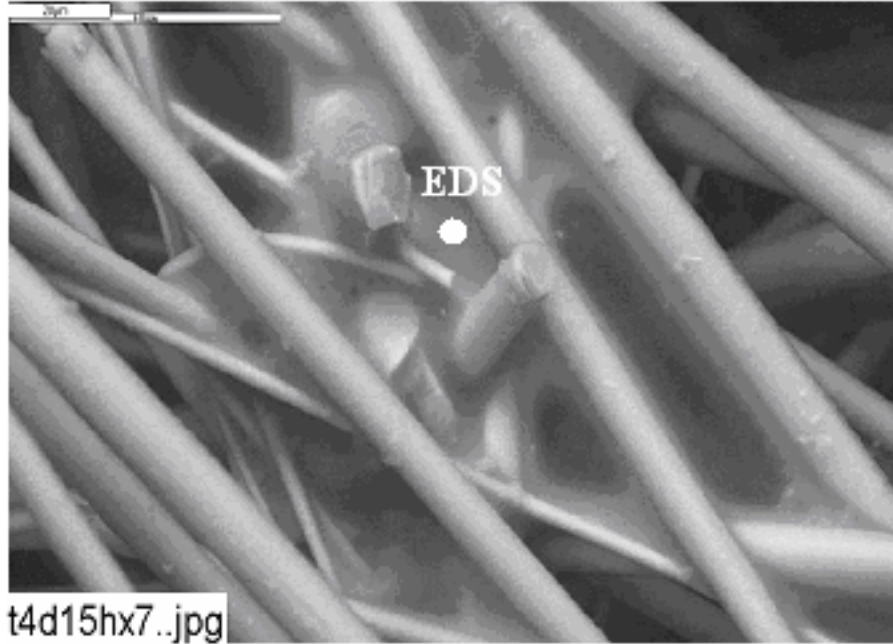
Figure B2-3. Annotated environmental SEM image magnified 750 times for a Test #4, Day-15 exterior high-flow fiberglass sample. The white spot shows the area for EDS analysis. (t4d15hx7.jpg)

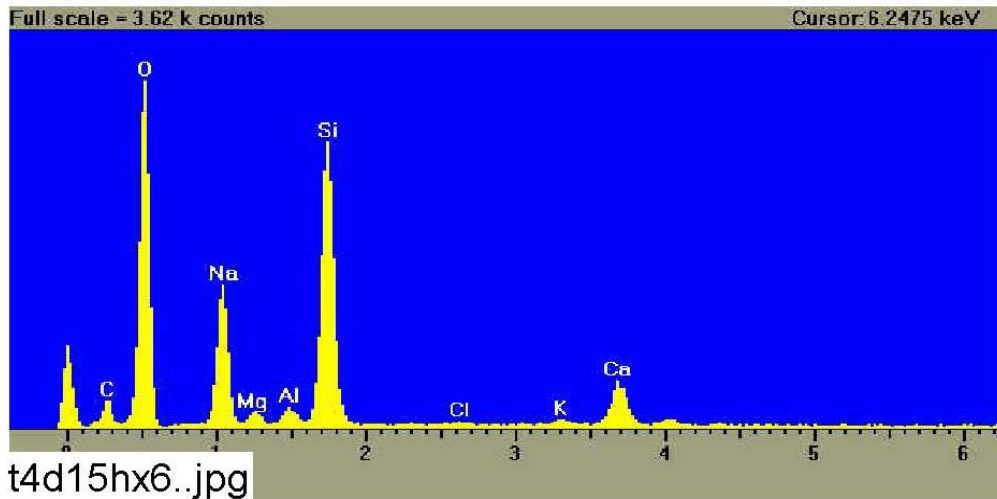
Figure B2-4. EDS counting spectrum for the spot of the film between the fibers shown in Figure B2-3. (t4d15hx6.jpg)

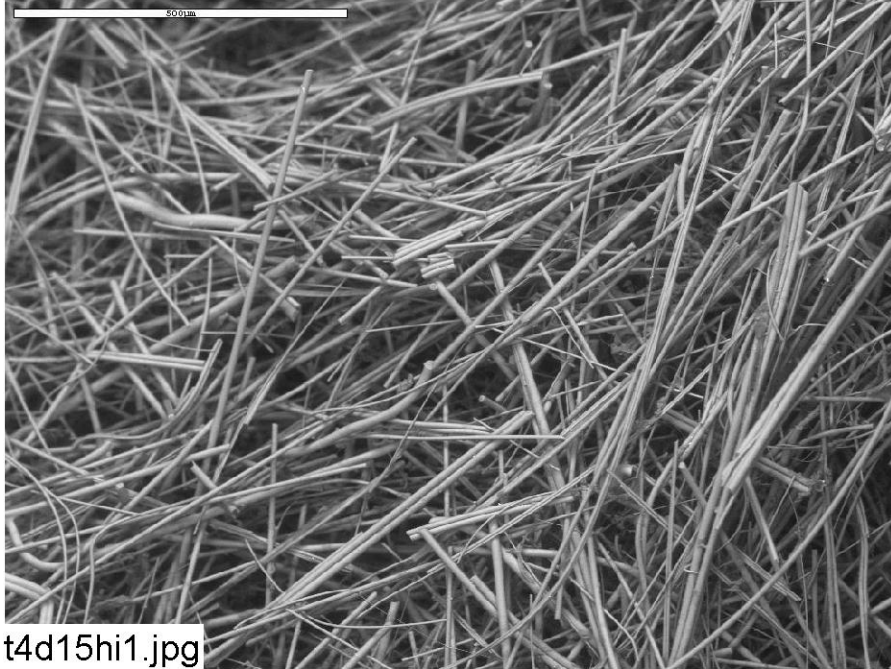
Figure B2-5. Environmental SEM image magnified 100 times for a Test #4, Day-15 interior high-flow fiberglass sample. (t4d15hi1.jpg)

Image:	t4d15hi1	100 ×	ESEM image	Figure B2-5
	t4d15hi3	100 ×		Figure B2-6
	t4d15hi2	800 ×		Figure B2-7

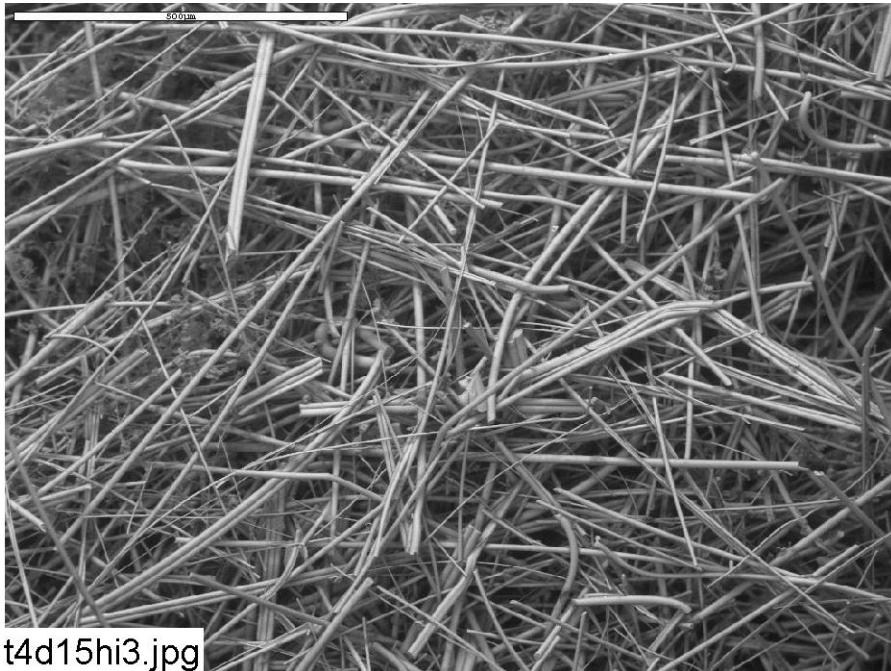
Figure B2-6. Environmental SEM image magnified 100 times for a Test #4, Day-15 interior high-flow fiberglass sample. (t4d15hi3.jpg)

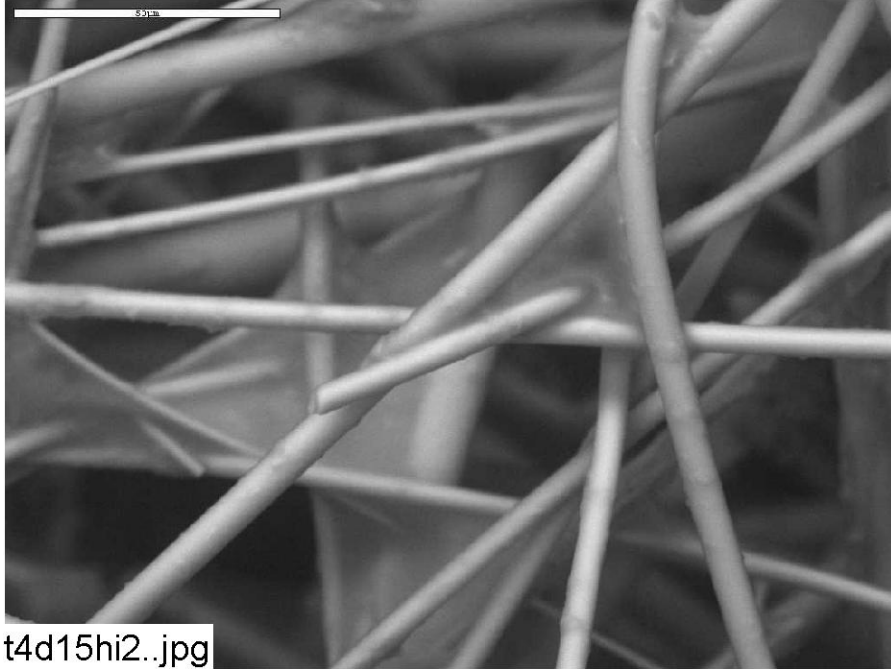
Figure B2-7. Environmental SEM image magnified 800 times for a Test #4, Day-15 interior high-flow fiberglass sample. (t4d15hi2.jpg)

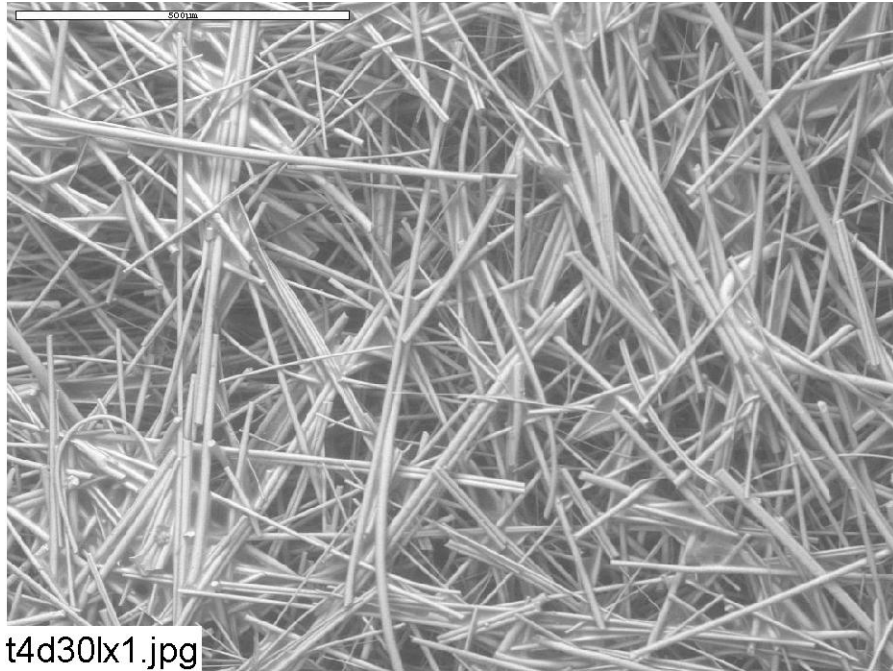
Figure C1-1. Environmental SEM image magnified 100 times for a Test #4, Day-30 exterior low-flow fiberglass sample. (t4d30lx1.jpg)

Image:	t4d30lx1	100 ×	ESEM image	Figure C1-1
	t4d30lx2	500 ×	ESEM image higher magnification	Figure C1-2
	t4d30lx5	1000 ×	ESEM annotated image	Figure C1-3
EDS:	t4d30lx4		Spot of coating substance for t4d30lx5	Figure C1-4

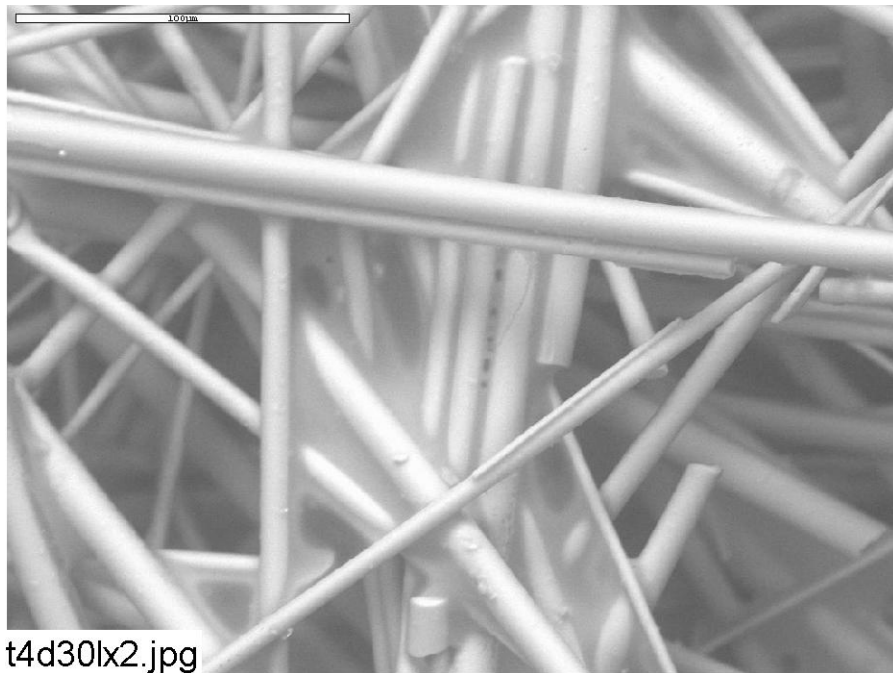
Figure C1-2. Environmental SEM image magnified 500 times for a Test #4, Day-30 exterior low-flow fiberglass sample. (t4d30lx2.jpg)

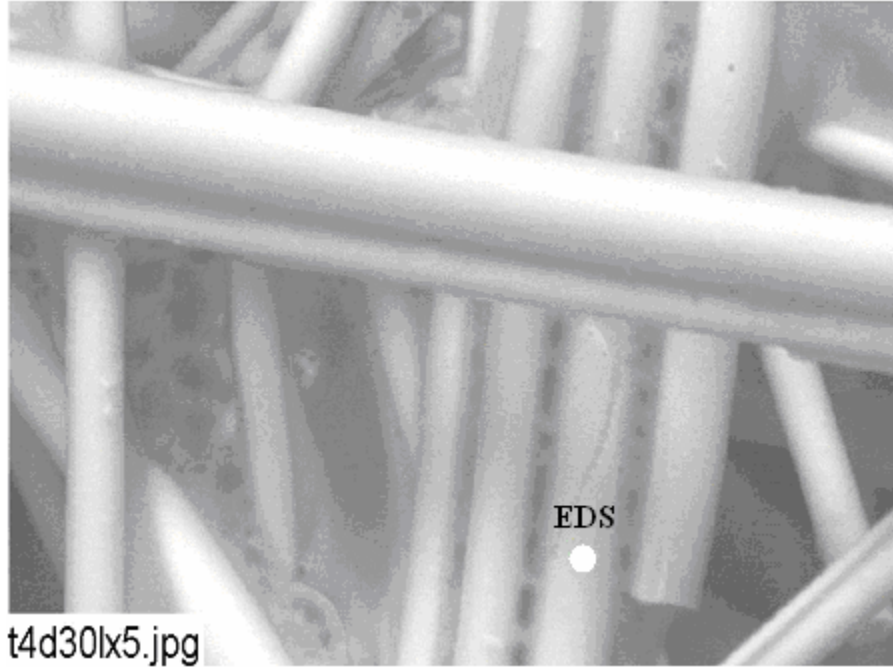
Figure C1-3. Annotated environmental SEM image magnified 1000 times for a Test #4, Day-30 exterior low-flow fiberglass sample. (t4d30lx5.jpg)

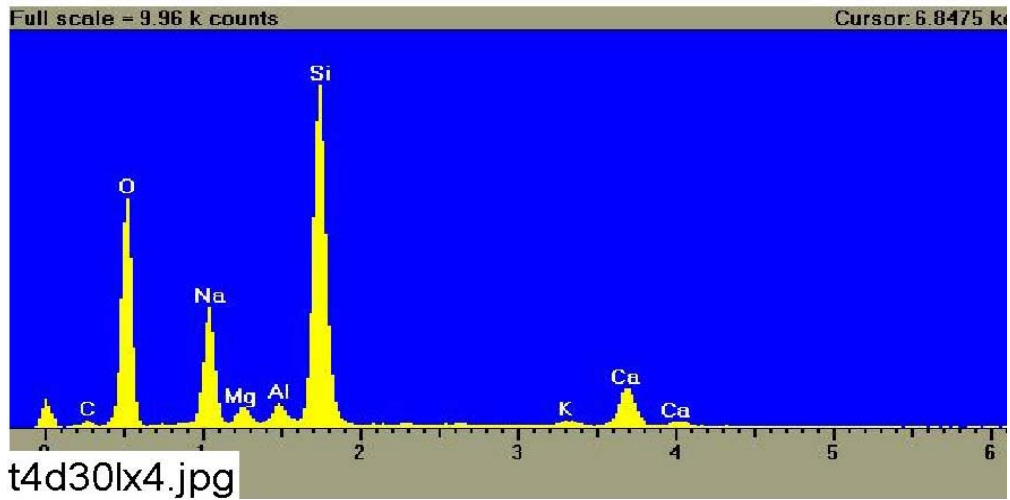
Figure C1-4. EDS counting spectrum for the spot of coating substance on fiberglass shown in Figure C1-3. (t4d30lx4.jpg)

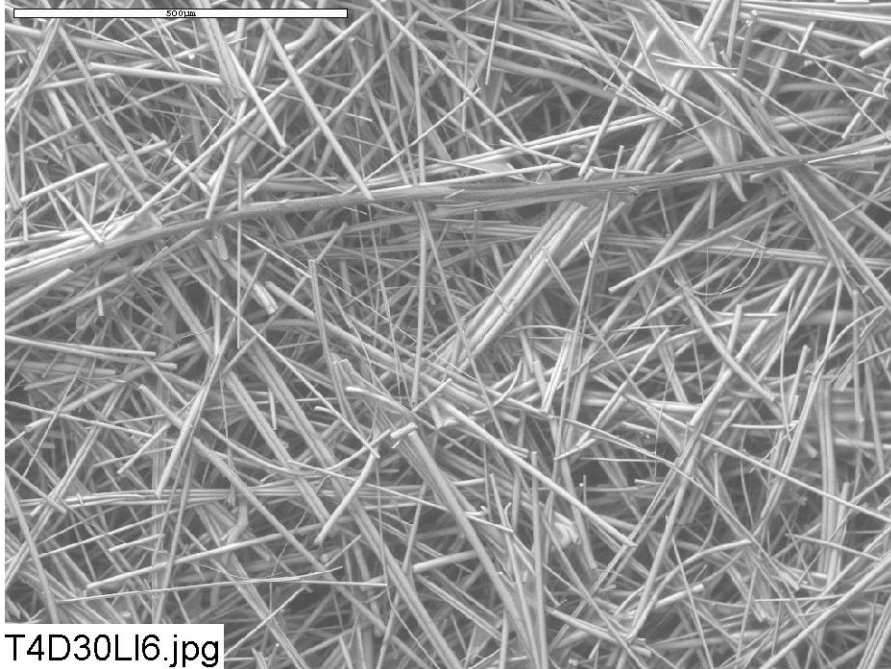
Figure C1-5. Environmental SEM image magnified 100 times for a Test #4, Day-30 interior low-flow fiberglass sample. (T4D30LI6.jpg)

Image:	T4D30LI6	100 ×	ESEM image of fiberglass	Figure C1-5
	t4d30li9	500 ×	ESEM annotated image	Figure C1-6
EDS:	t4d30li8		Film on fiberglass for t4d30li9	Figure C1-7

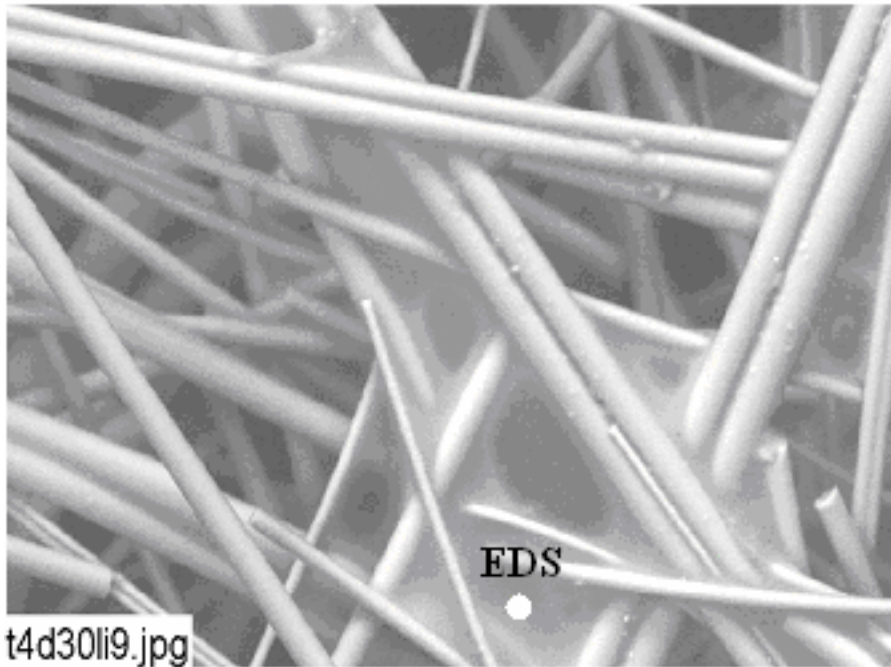
Figure C1-6. Annotated environmental SEM image magnified 500 times for a Test #4, Day-30 interior low-flow fiberglass sample. EDS spot is shown in the picture (t4d30li9.jpg)

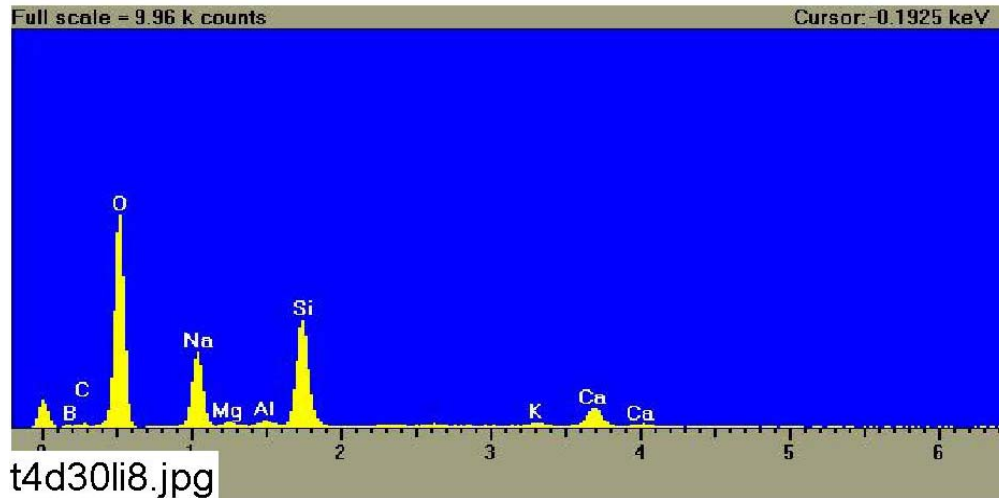
Figure C1-7. EDS counting spectrum for the film between fibers shown in Figure C1-6. (t4d30li8.jpg)
