Appendix C4

ESEM/EDS Data for Test #4, Day-30 Fiberglass in High-Flow Zones

Appendix C5

ESEM/EDS Data for Test #4, Day-30 Fiberglass Inserted in Front of Header in a High-Flow Zone

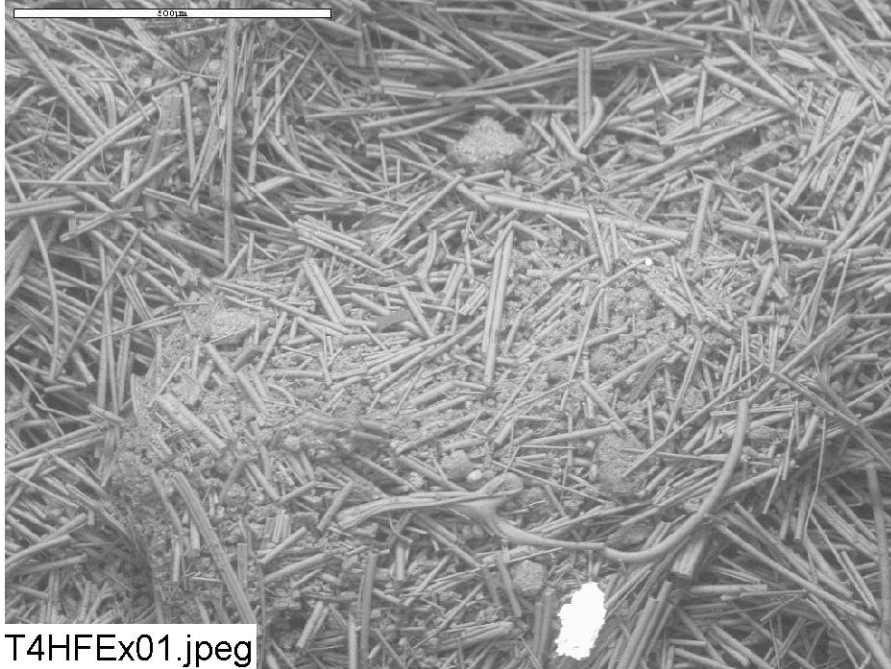
Figure C4-1. Environmental SEM image magnified 100 times for a Test #4, Day-30 exterior high-flow fiberglass sample. (T4HFEx01.jpg)

Image:	T4HFEx01	100 ×	ESEM image	Figure C4-1
	t4hfex02	100 ×	ESEM image	Figure C4-2
	t4hfex07	500 ×	ESEM image	Figure C4-3
	t4hfex06	800 ×	ESEM annotated image	Figure C4-4
EDS:	t4hfex05		Spot of film for t4hfex06	Figure C4-5

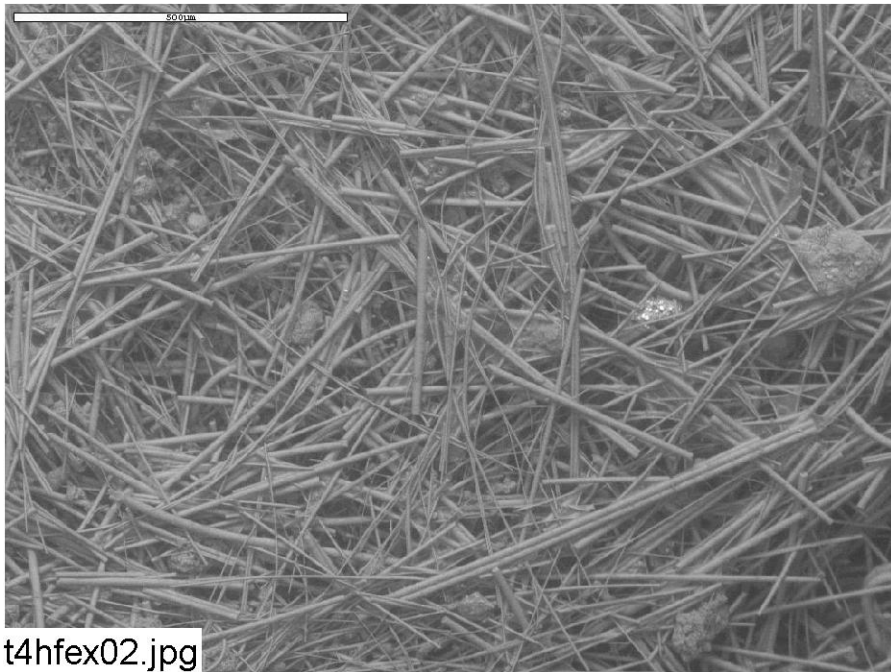
Figure C4-2. Environmental SEM image magnified 100 times for a Test #4, Day-30 exterior high-flow fiberglass sample. (t4hfex02.jpg)

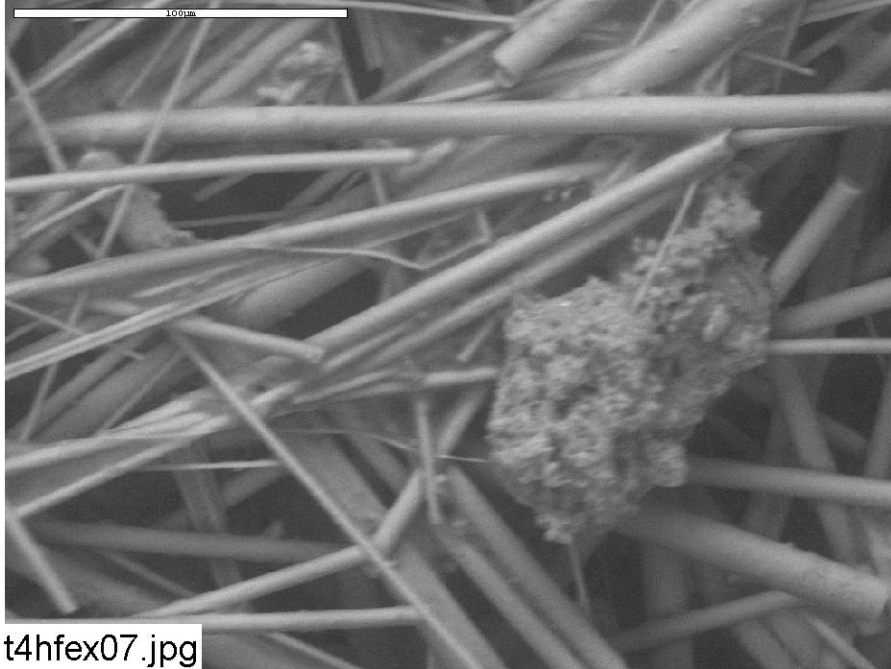
Figure C4-3. Environmental SEM image magnified 500 times for a Test #4, Day-30 exterior high-flow fiberglass sample. (t4hfex07.jpg)

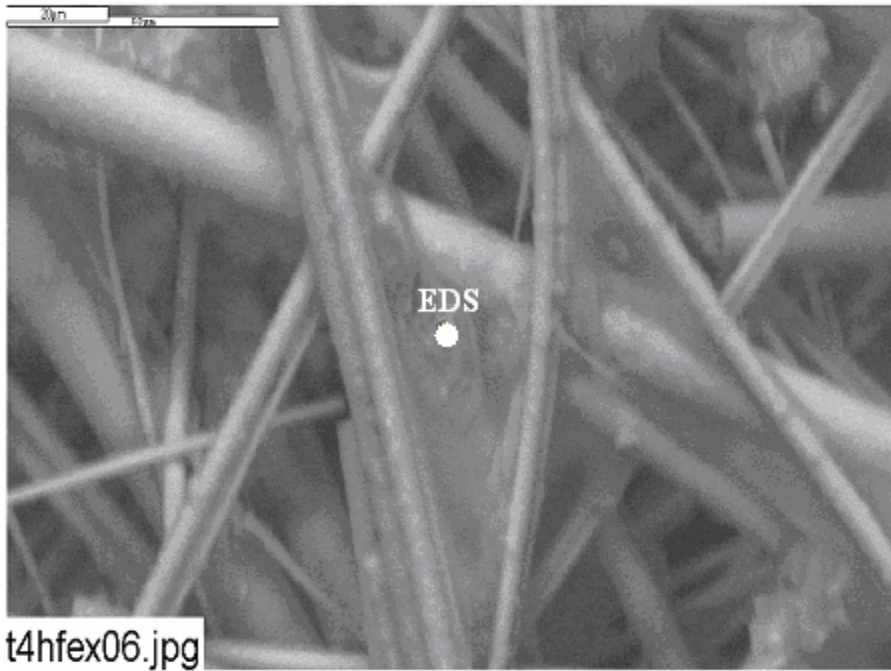
Figure C4-4. Annotated environmental SEM image magnified 800 times for a Test #4, Day-30 exterior high-flow fiberglass sample. EDS spot is shown in the picture. (t4hfex06.jpg)

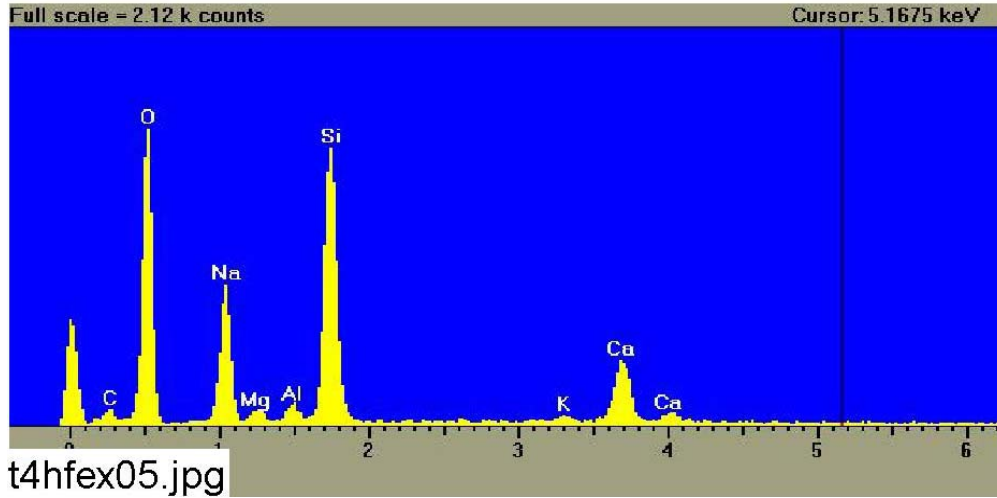
Figure C4-5. EDS counting spectrum for the spot of film between fibers shown in Figure C4-4. (t4hfex05.jpg)

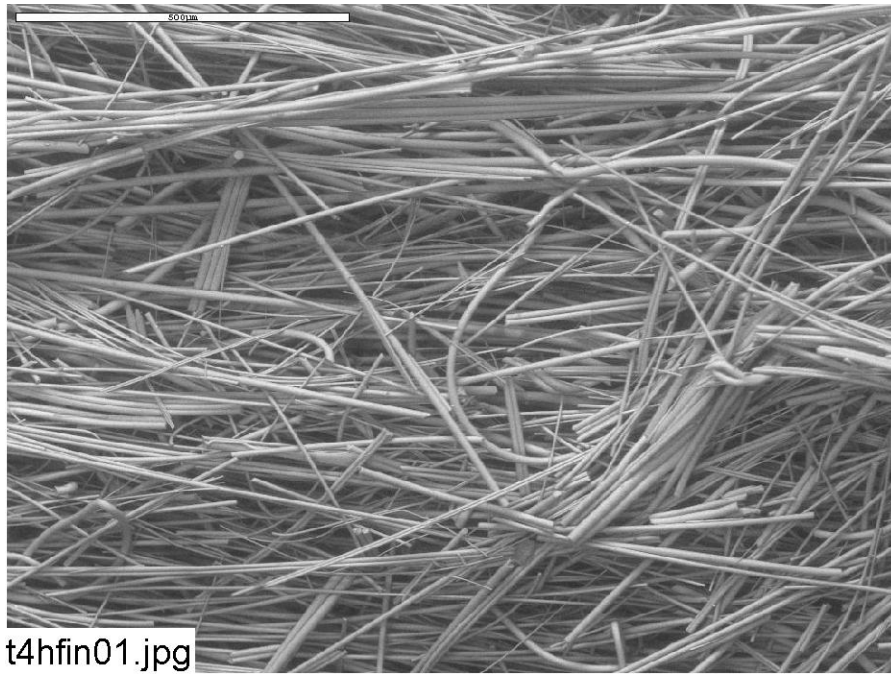
Figure C4-6. Environmental SEM image magnified 100 times for a Test #4, Day-30 interior high-flow fiberglass sample. (t4hfin01.jpg)

Image:	t4hfin01	100 ×	ESEM image of fiberglass	Figure C4-6
	t4hfin02	100 ×	ESEM image	Figure C4-7
	t4hfin03	500 ×	ESEM image high magnification	Figure C4-8
	t4hfin04	500 ×	ESEM image high magnification	Figure C4-9

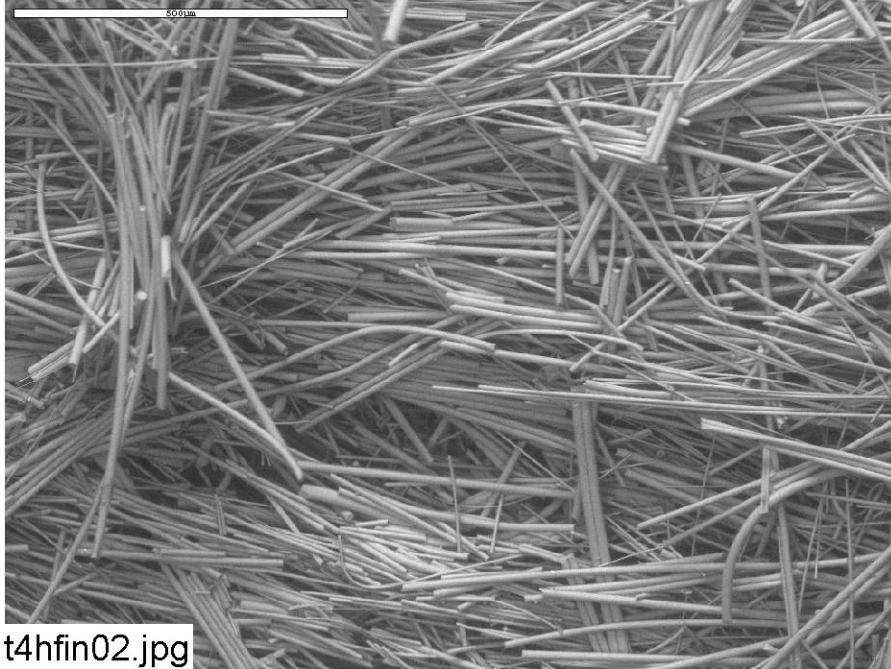
Figure C4-7. Environmental SEM image magnified 100 times for a Test #4, Day-30 interior high-flow fiberglass sample. (t4hfin02.jpg)

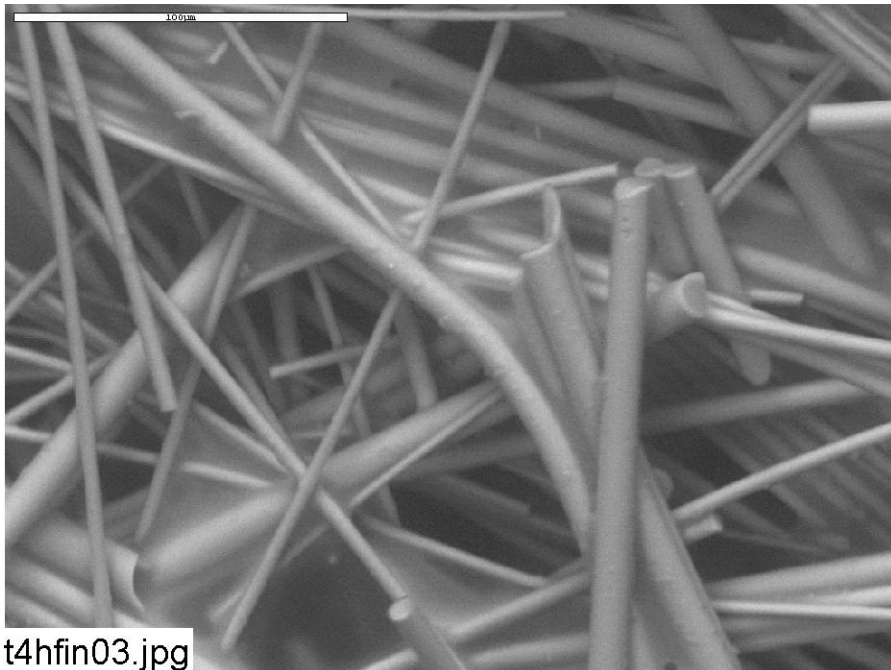
Figure C4-8. Environmental SEM image magnified 500 times for a Test #4, Day-30 interior high-flow fiberglass sample. (t4hfin03.jpg)

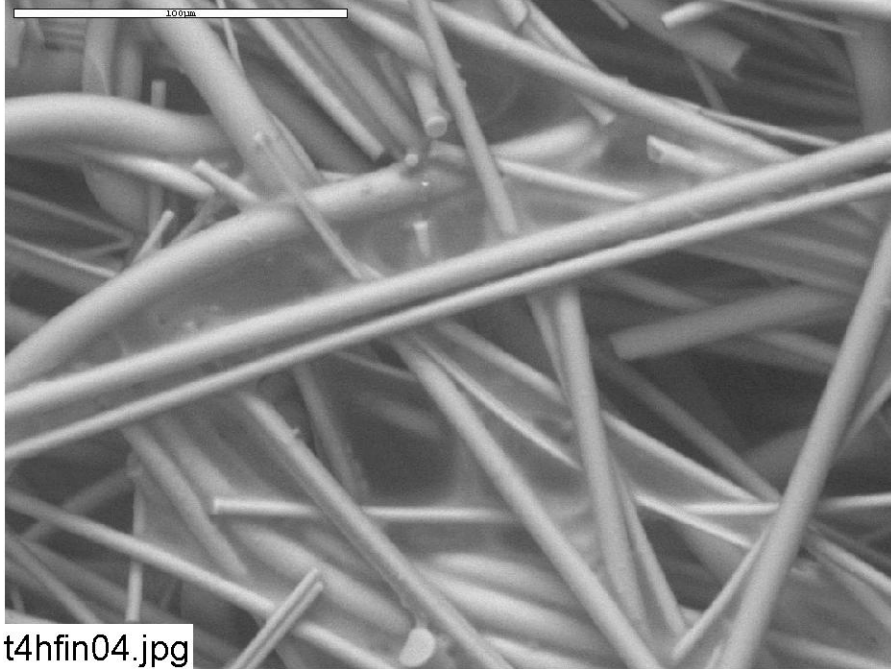
Figure C4-9. Environmental SEM image magnified 500 times for a Test #4, Day-30 interior high-flow fiberglass sample. (t4hfin04.jpg)

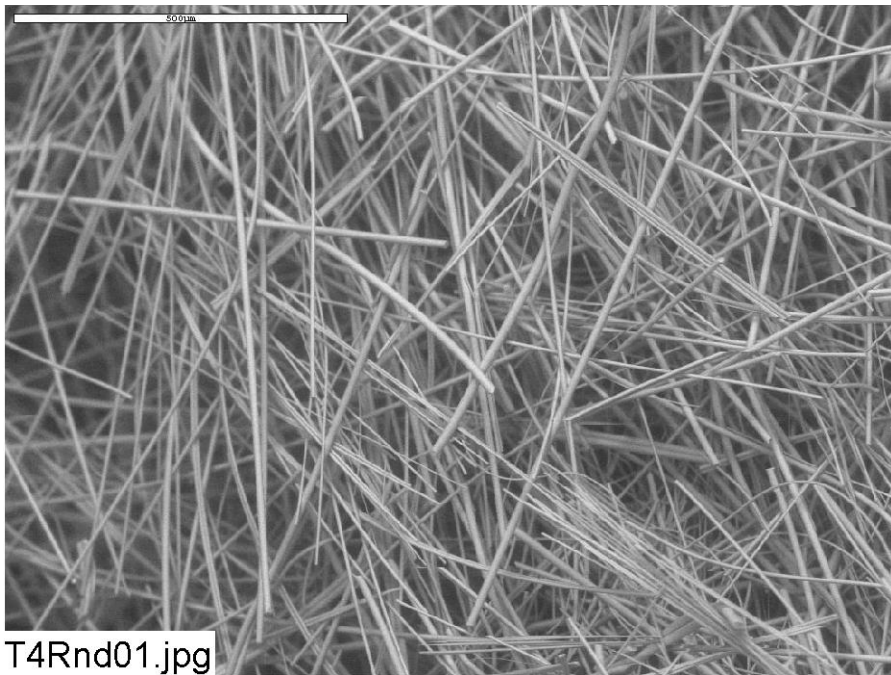
Figure C4-10. Environmental SEM image magnified 100 times for a Test #4, Day-30 interior high-flow fiberglass sample. The sample was gently prerinsed with RO water. (T4Rnd01.jpg)

Image:	T4Rnd01	100 ×	ESEM image	Figure C4-10
	t4rnd02	100 ×	ESEM image	Figure C4-11
	t4rnd03	500 ×	ESEM image	Figure C4-12
	t4rnd04	500 ×	ESEM image	Figure C4-13
	t4rnd05	500 ×	ESEM image	Figure C4-14
	t4rnd06	500 ×	ESEM image	Figure C4-15

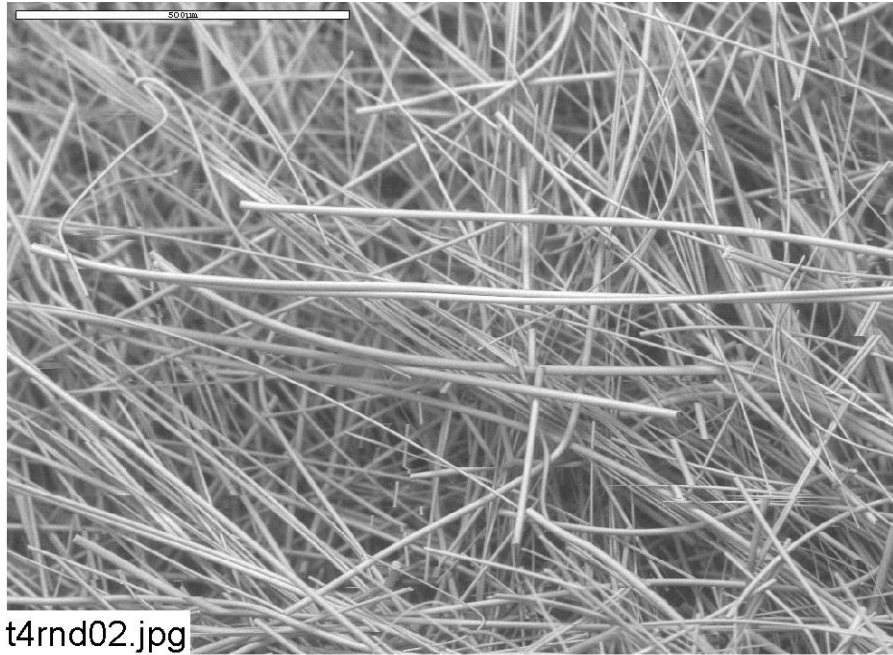
Figure C4-11. Environmental SEM image magnified 100 times for a Test #4, Day-30 interior high-flow fiberglass sample. The sample was gently prerinsed with RO water. (t4rnd02.jpg)

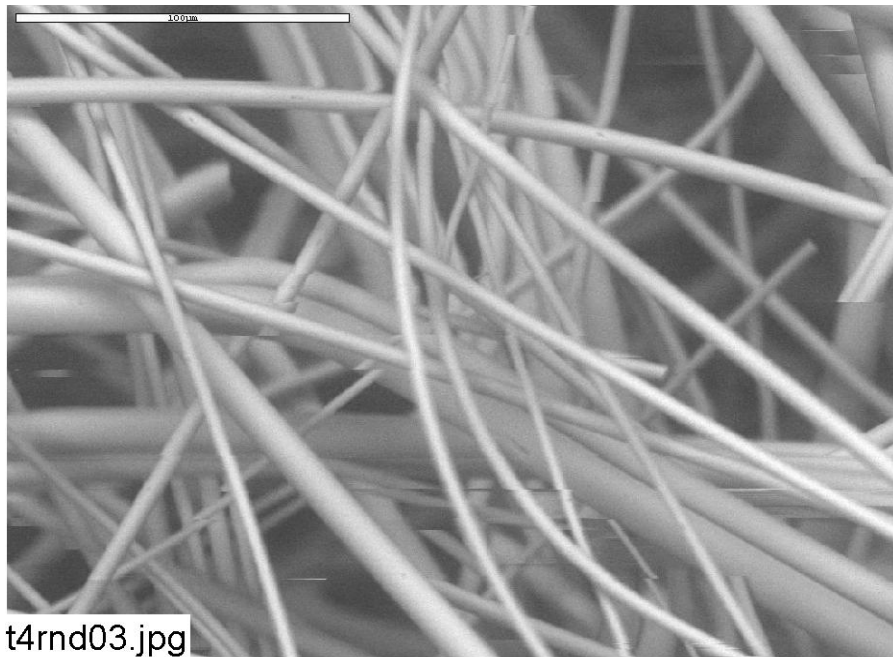
Figure C4-12. Environmental SEM image magnified 500 times for a Test #4, Day-30 interior high-flow fiberglass sample. The sample was gently prerinsed with RO water. (t4rnd03.jpg)

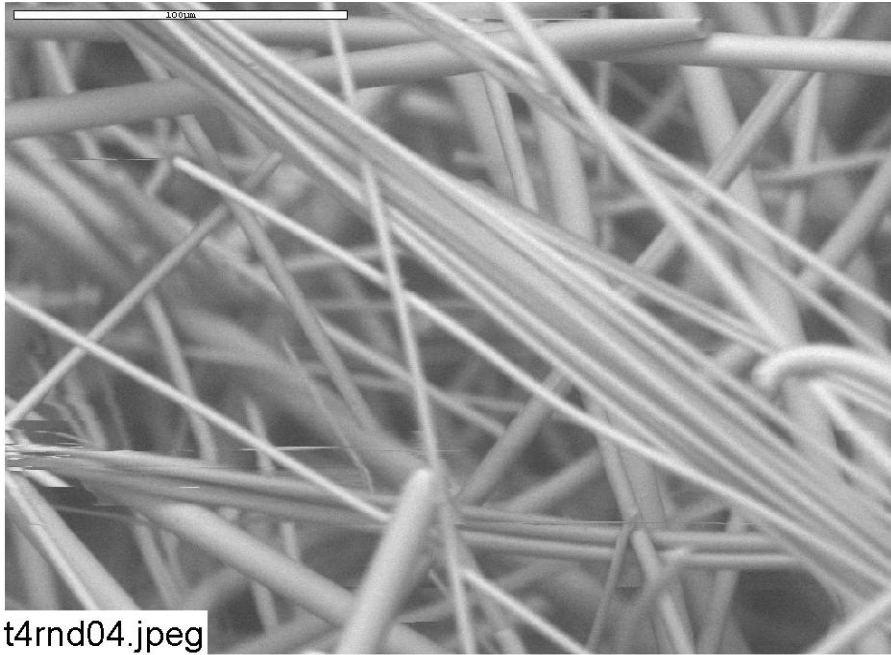
Figure C4-13. Environmental SEM image magnified 500 times for a Test #4, Day-30 interior high-flow fiberglass sample. The sample was gently prerinsed with RO water. (t4rnd04.jpg)

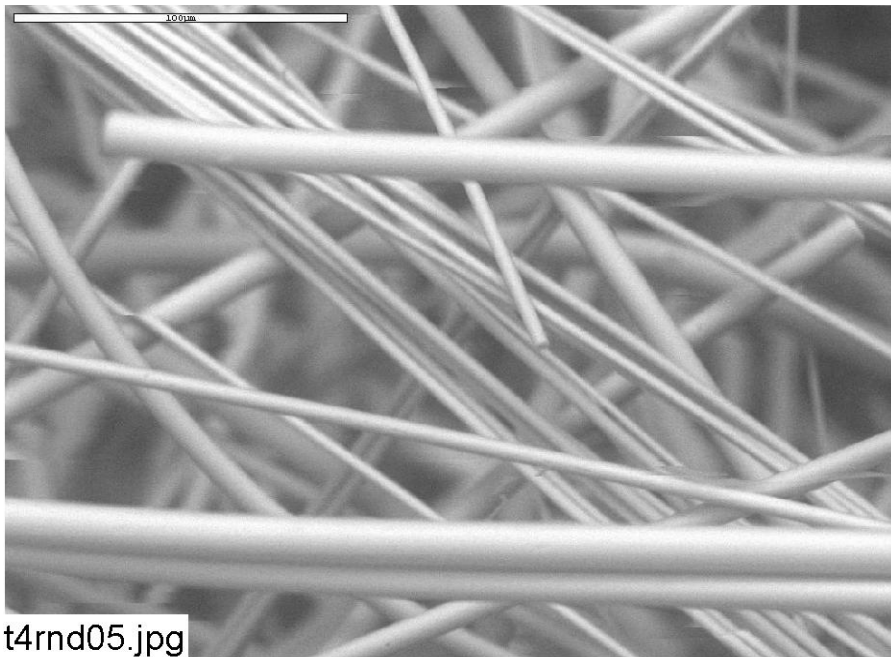
Figure C4-14. Environmental SEM image magnified 500 times for a Test #4, Day-30 interior high-flow fiberglass sample. The sample was gently prerinsed with RO water. (t4rnd05.jpg)

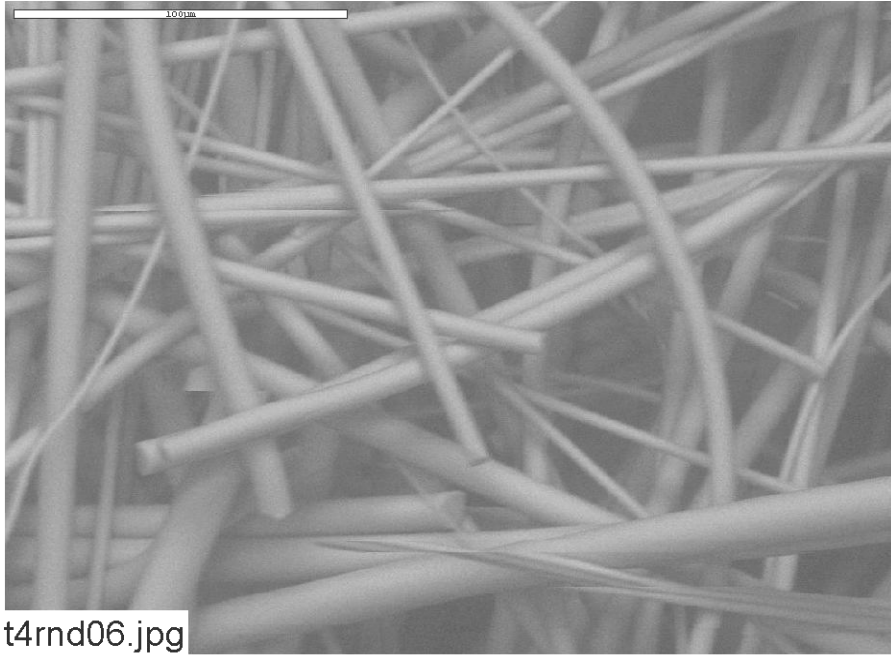
Figure C4-15. Environmental SEM image magnified 500 times for a Test #4, Day-30 interior high-flow fiberglass sample. The sample was gently prerinsed with RO water. (t4rnd06.jpg)

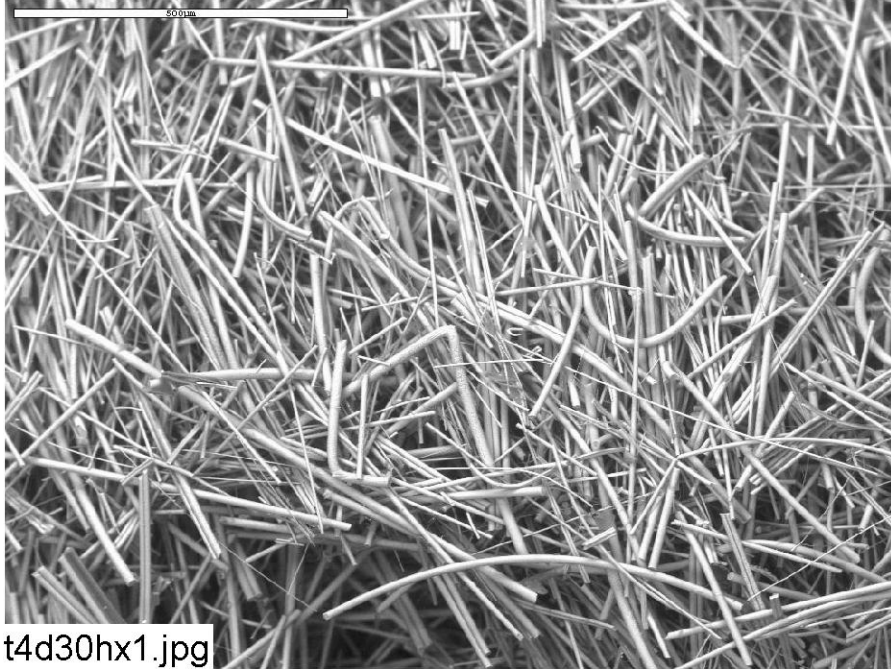
Figure C5-1. Environmental SEM image magnified 100 times for a Test #4, Day-30 exterior high-flow fiberglass sample in front of the header (inserted on Day 4). (t4d30hx1.jpg)

Image:	t4d30hx1	100 ×	ESEM image	Figure C5-1
	t4d30hx2	500 ×	ESEM image	Figure C5-2
	t4d30hx5	1000 ×	ESEM annotated image	Figure C5-3
EDS:	t4d30hx4		EDS on coating of fiberglass shown in t4d30hx5	Figure C5-4

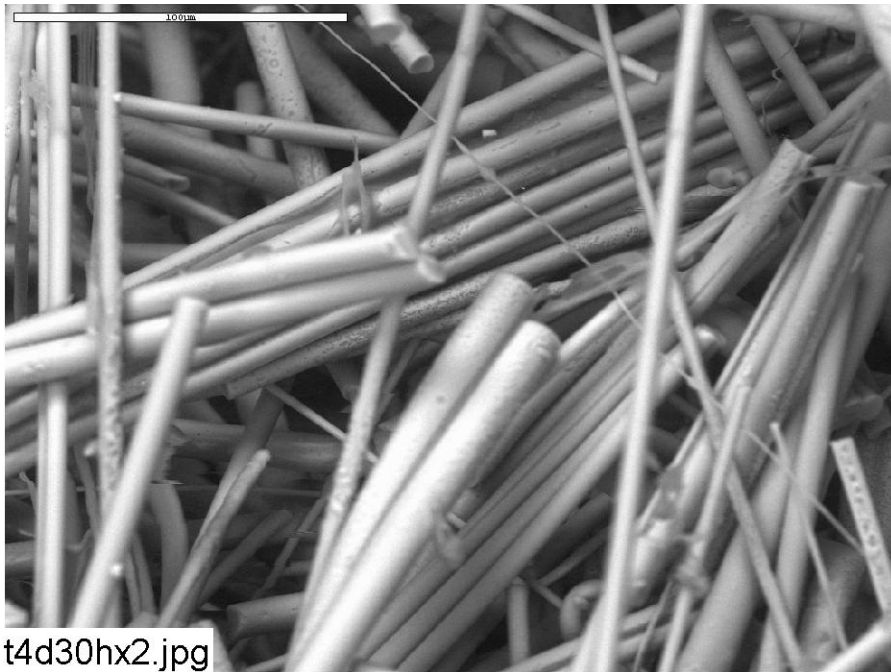
Figure C5-2. Environmental SEM image magnified 500 times for a Test #4, Day-30 exterior high-flow fiberglass sample in front of the header (inserted on Day 4). (t4d30hx2.jpg)

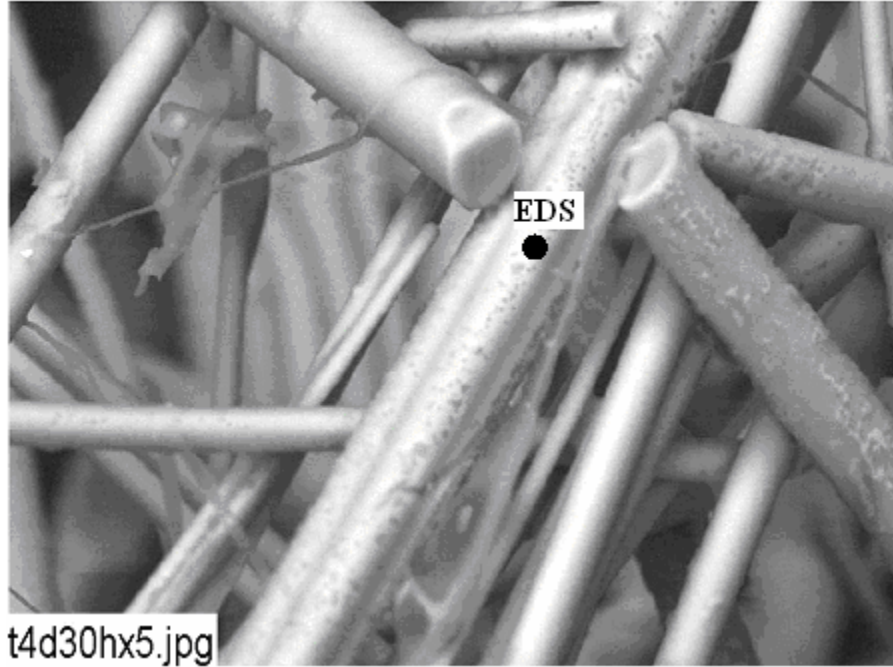
Figure C5-3. Annotated environmental SEM image magnified 1000 times for a Test #4, Day-30 exterior high-flow fiberglass sample in front of the header (inserted on Day 4). The EDS spot is shown in the picture. (t4d30hx5.jpg)

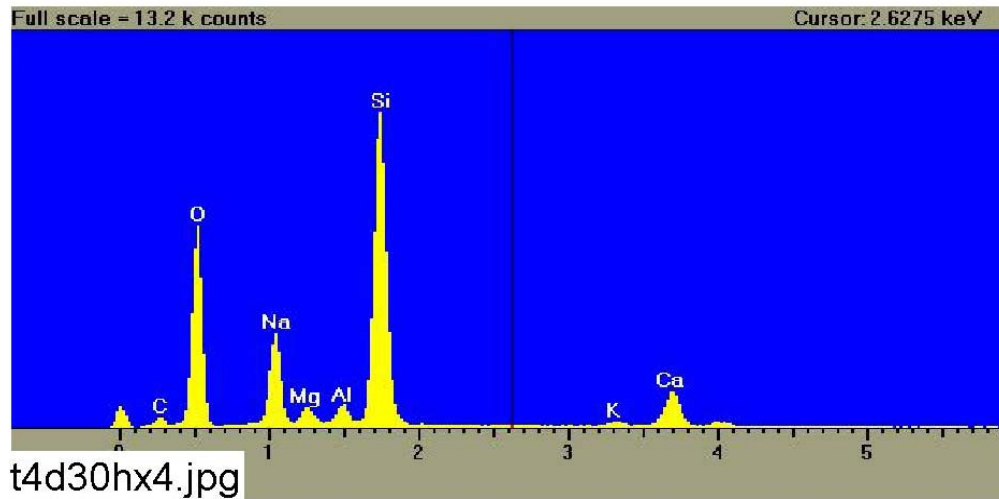
Figure C5-4. EDS counting spectrum for the spot of coating substance on fiberglass shown in Figure C5-3. (t4d30hx4.jpg)

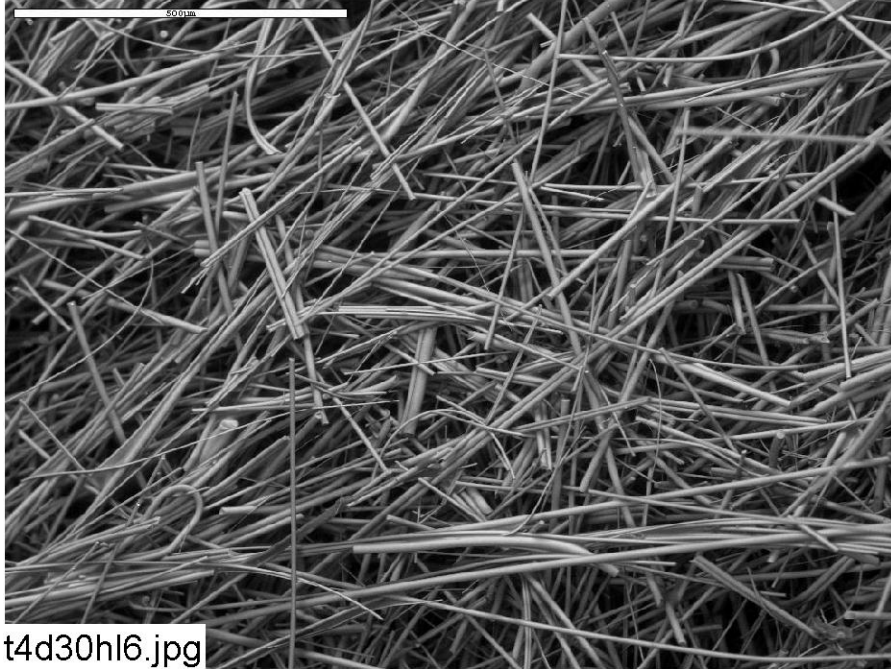
Figure C5-5. Environmental SEM image magnified 100 times for a Test #4, Day-30 interior high-flow fiberglass sample in front of the header (inserted on Day 4). (t4d30hI6.jpg)

Image:	t4d30hi6	100 ×	ESEM image of fiberglass	Figure C5-5
	t4d30hi9	500 ×	ESEM annotated image	Figure C5-6
EDS	t4d30hi8		EDS on web in t4d30hi9	Figure C5-7
Image	t4d30hi	1000 ×	ESEM annotated image	Figure C5-8
EDS	t4d30hi0		EDS on spot in t4d30hi	Figure C5-9

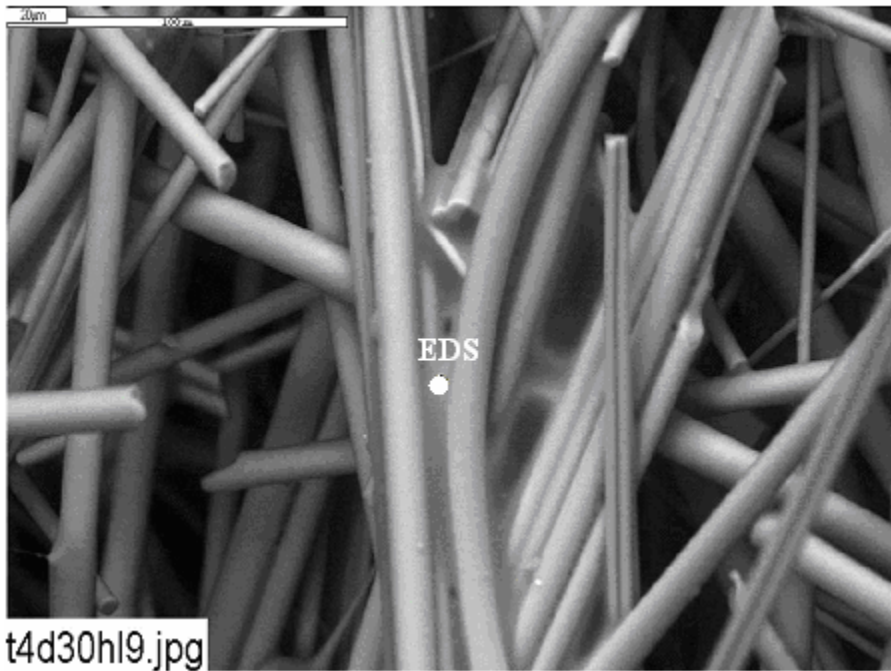
Figure C5-6. Annotated environmental SEM image magnified 500 times for a Test #4, Day-30 interior high-flow fiberglass sample in front of the header (inserted on Day 4). The EDS spot is shown in the picture. (t4d30hI9.jpg)

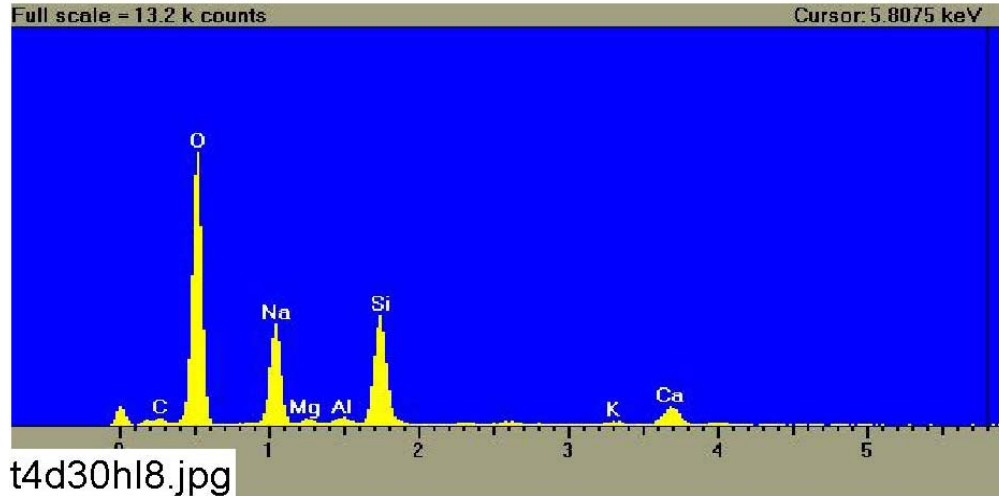
Figure C5-7. EDS counting spectrum for the spot of substance attached on fiberglass shown in Figure C5-6. (t4d30hi8.jpg)

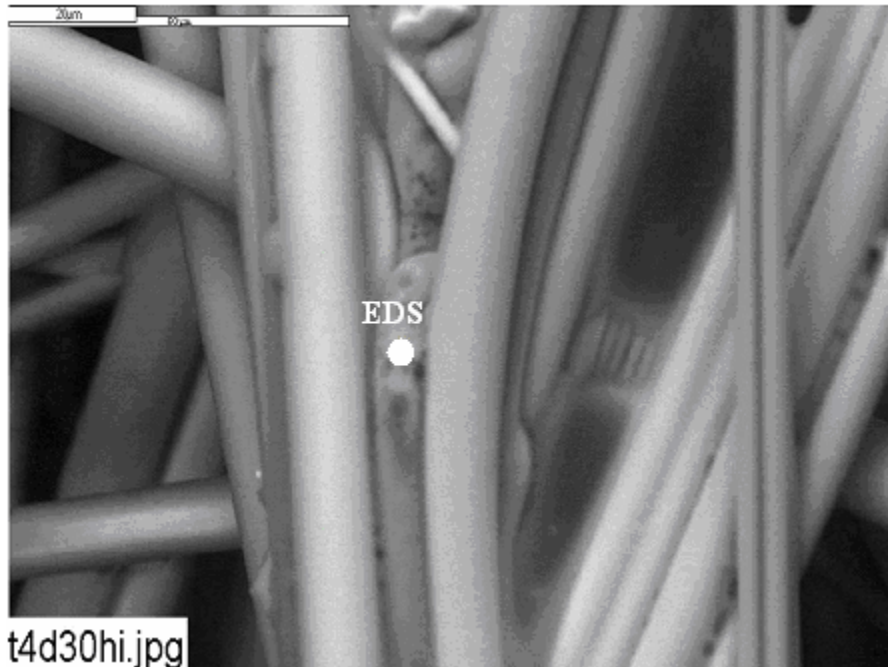
Figure C5-8. Annotated environmental SEM image magnified 1000 times for a Test #4, Day-30 interior high-flow fiberglass sample in front of the header (inserted on Day 4). The EDS spot is shown in the picture. (t4d30hi.jpg)

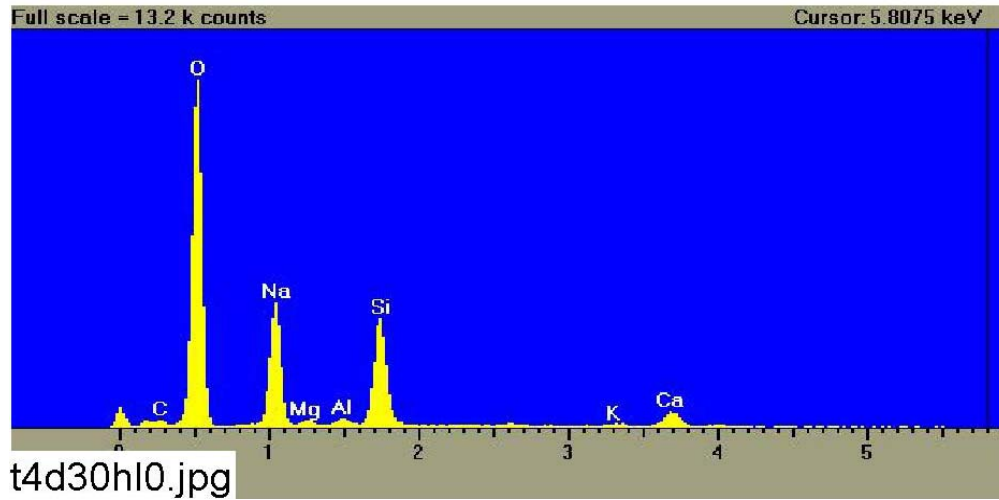
Figure C5-9. EDS counting spectrum for the spot of substance attached on fiberglass shown in Figure C5-8. (t4d30h10.jpg)
