## Appendix C3

### ESEM Data for Test #5, Day-30 Fiberglass in High-Flow Zones

### ESEM Data for Test #5, Day-30 Fiberglass Inserted in Front of a Header in a High-Flow Zone

### ESEM/EDS Data for Test #5, Day-30 Fiberglass Inserted in Nylon Mesh in Low-Flow Zones

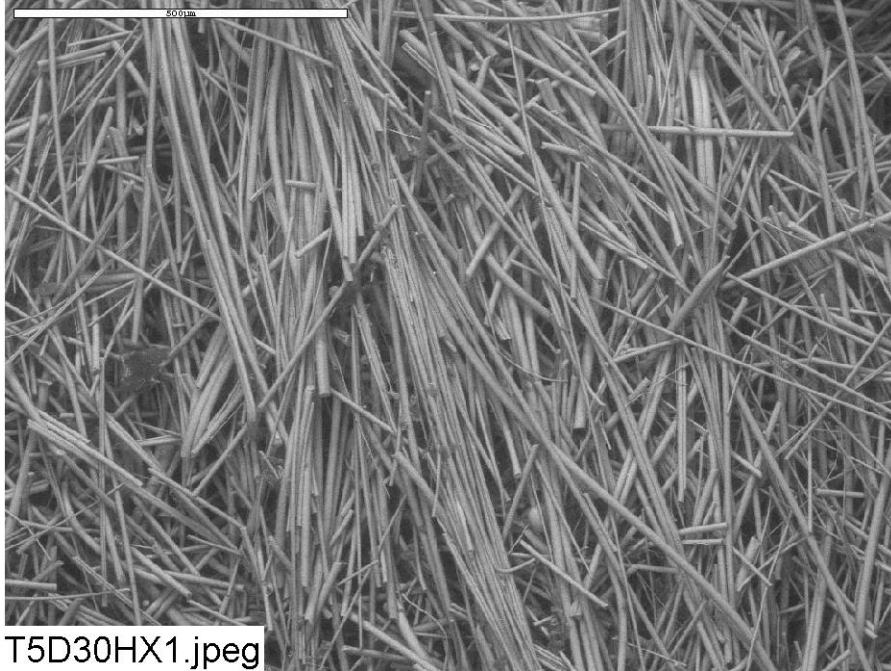
**Figure C3-1.** ESEM image magnified 100 times for a Test #5, Day-30 high-flow exterior fiberglass sample. (T5D30HX1.jpeg)

Image: T5D30HX1	100 ×	ESEM image	Figure C3-1
t5d30hx2	100 ×	ESEM image	Figure C3-2
t5d30hx3	500 ×	ESEM image higher magnification	Figure C3-3

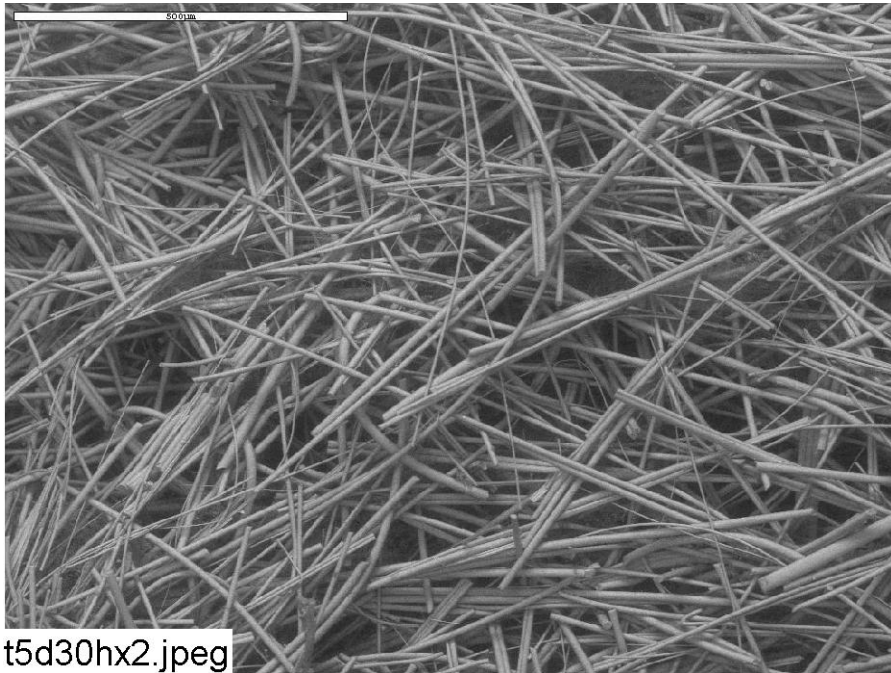
**Figure C3-2.** ESEM image magnified 100 times for a Test #5, Day-30 high-flow exterior fiberglass sample. (t5d30hx2.jpeg)

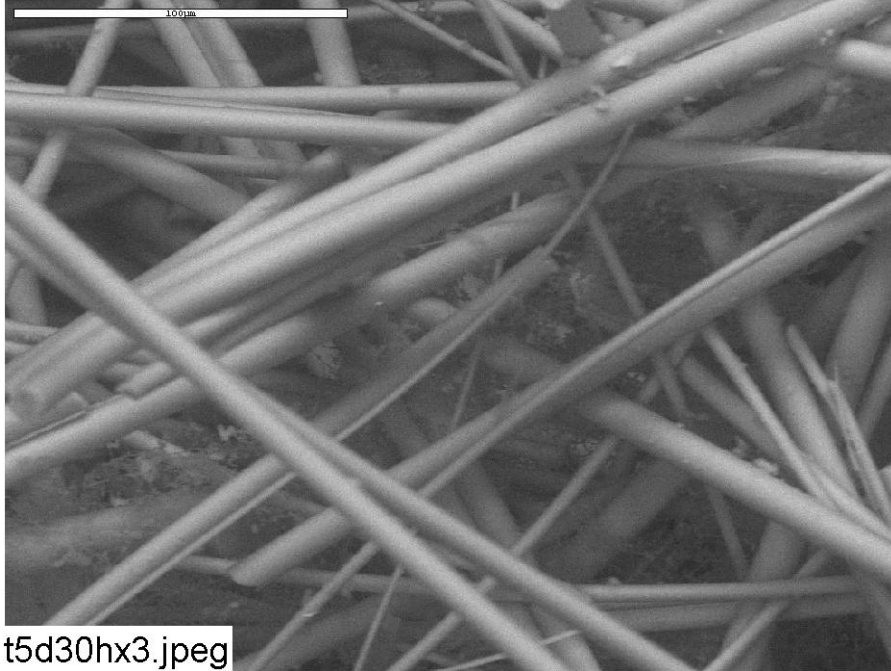
**Figure C3-3.** ESEM image magnified 500 times for a Test #5, Day-30 high-flow exterior fiberglass sample. (t5d30hx3.jpeg)

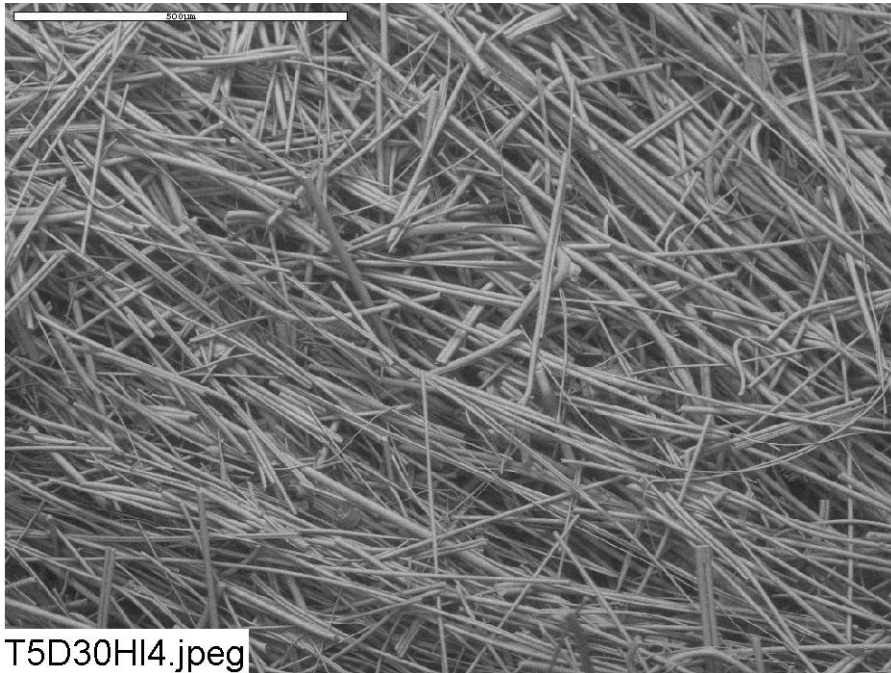
**Figure C3-4.** ESEM image magnified 100 times for a Test #5, Day-30 high-flow interior fiberglass sample. (T5D30HI4.jpeg)

Image: T5D30HI4	100 ×	ESEM image	Figure C3-4
t5d30hi5	100 ×	ESEM image	Figure C3-5
t5d30hi6	500 ×	ESEM image higher magnification	Figure C3-6

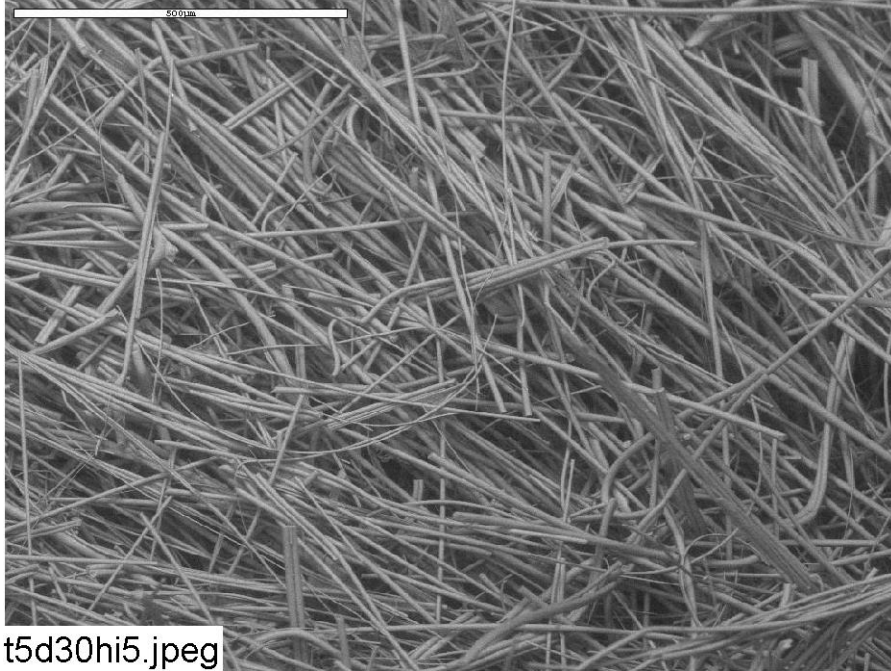
**Figure C3-5. ESEM image magnified 100 times for a Test #5, Day-30 high-flow interior fiberglass sample. (t5d30hi5.jpeg)**

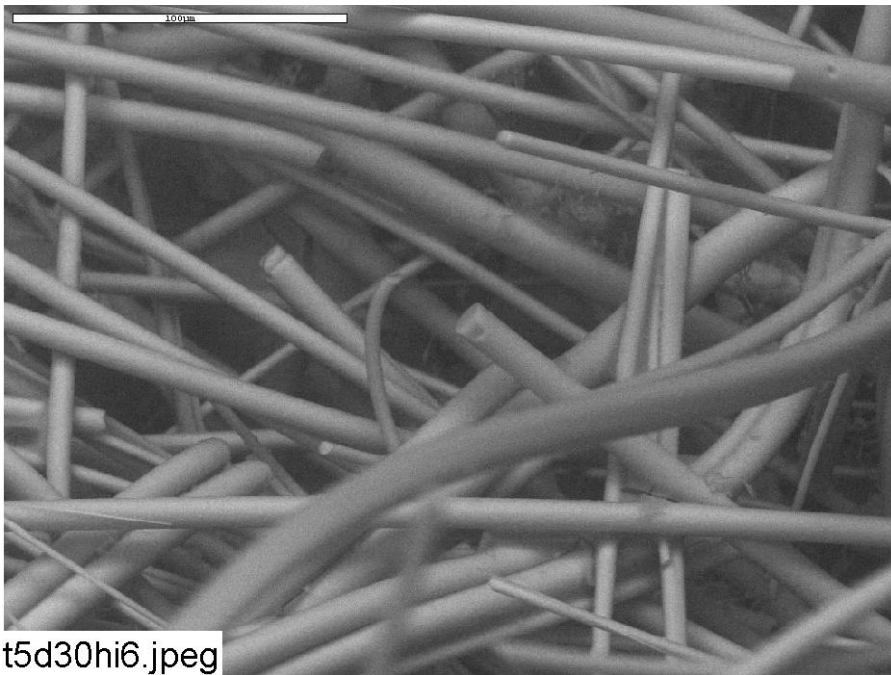
**Figure C3-6. ESEM image magnified 500 times for a Test #5, Day-30 high-flow interior fiberglass sample. (t5d30hi6.jpeg)**

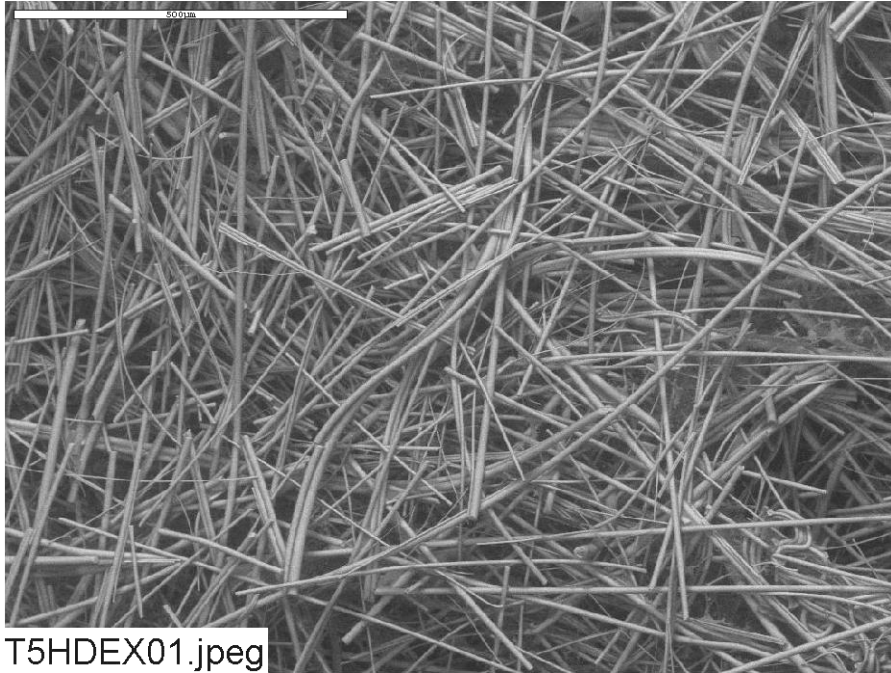
**Figure C4-1.** ESEM image magnified 100 times for a Test #5, Day-30 high-flow exterior fiberglass sample in front of the header. The sample was put in the tank on Day 6. (T5HDEX01.jpeg)

Image: T5HDEX01	100 ×	ESEM image	Figure C4-1
t5hdex02	100 ×	ESEM image	Figure C4-2
t5hdex03	500 ×	ESEM image higher magnification	Figure C4-3

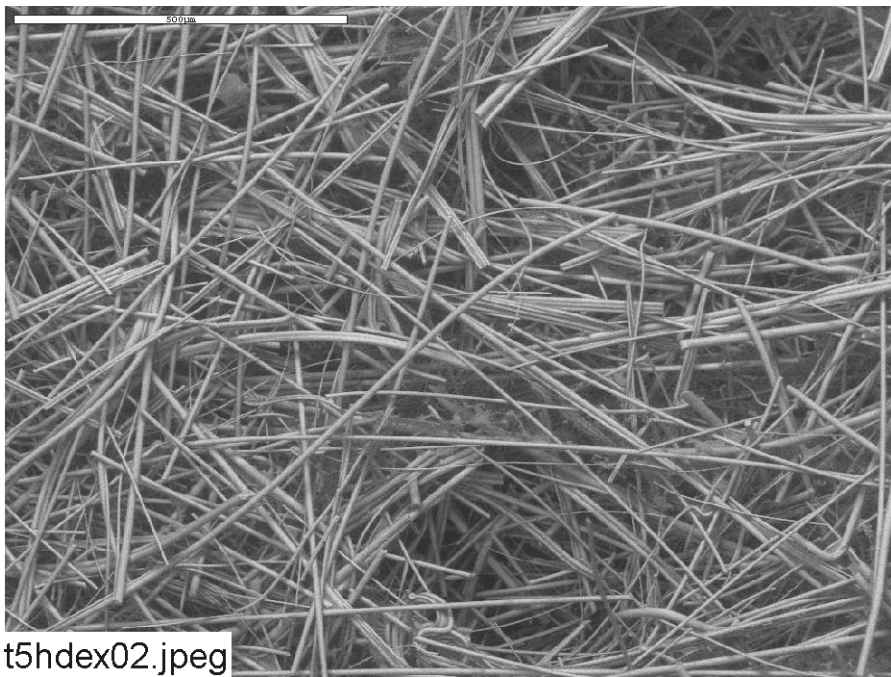
**Figure C4-2.** ESEM image magnified 100 times for a Test #5, Day-30 high-flow exterior fiberglass sample in front of the header. The sample was put in the tank on Day 6. (t5hdex02.jpeg)

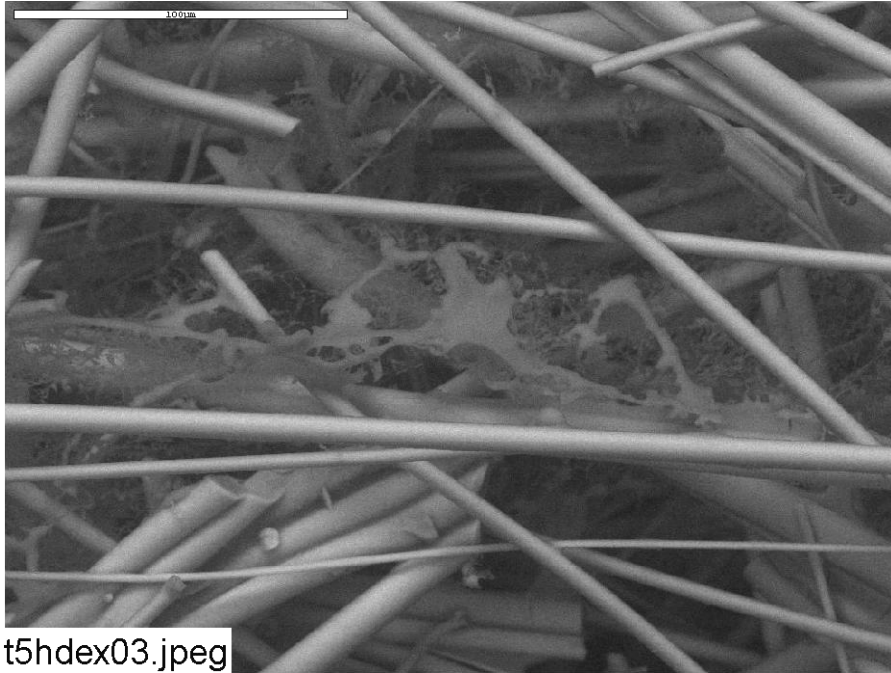
**Figure C4-3.** ESEM image magnified 500 times for a Test #5, Day-30 high-flow exterior fiberglass sample in front of the header. The sample was put in the tank on Day 6. (t5hdex03.jpeg)

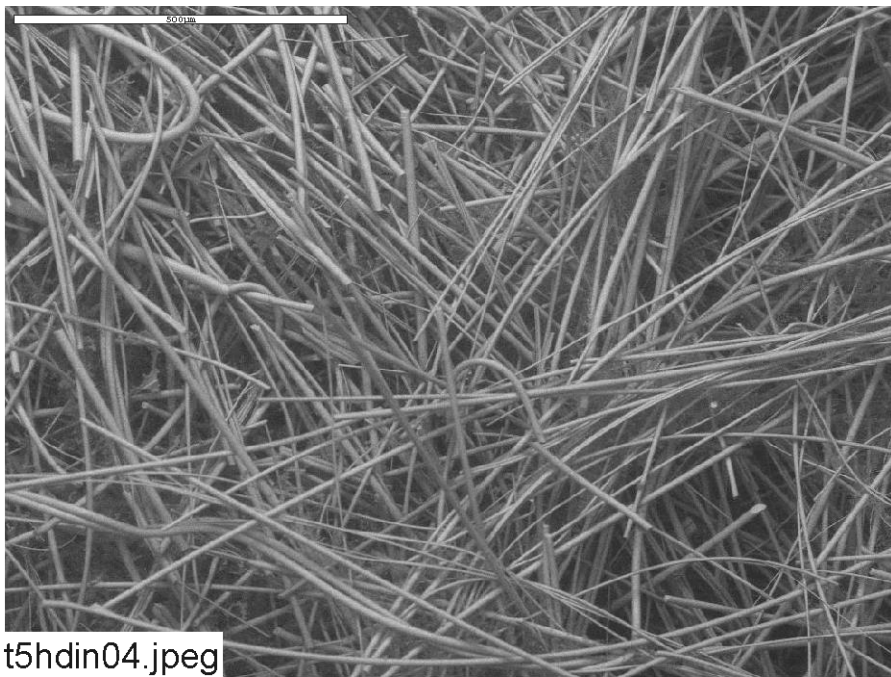
**Figure C4-4.** ESEM image magnified 100 times for a Test #5, Day-30 high-flow interior fiberglass sample in front of the header. The sample was put in the tank on Day 6. (t5hdin04.jpeg)

Image: t5hdin04	100 ×	ESEM image of fiberglass	Figure C4-4
t5hdin05	500 ×	ESEM image higher magnification	Figure C4-5

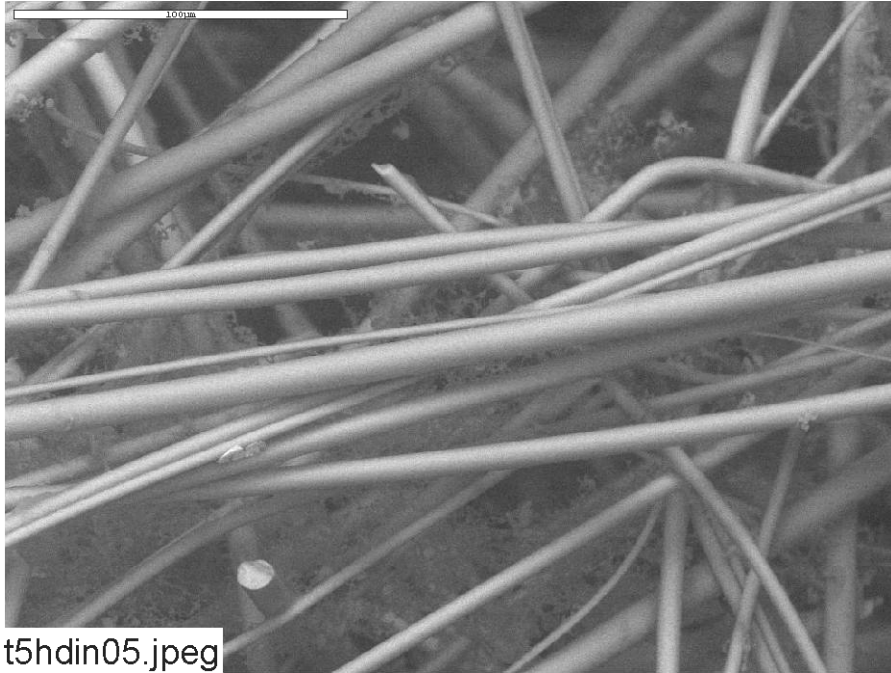
**Figure C4-5.** ESEM image magnified 500 times for a Test #5, Day-30 high-flow interior fiberglass sample in front of the header. The sample was put in the tank on Day 6. (t5hdin05.jpeg)

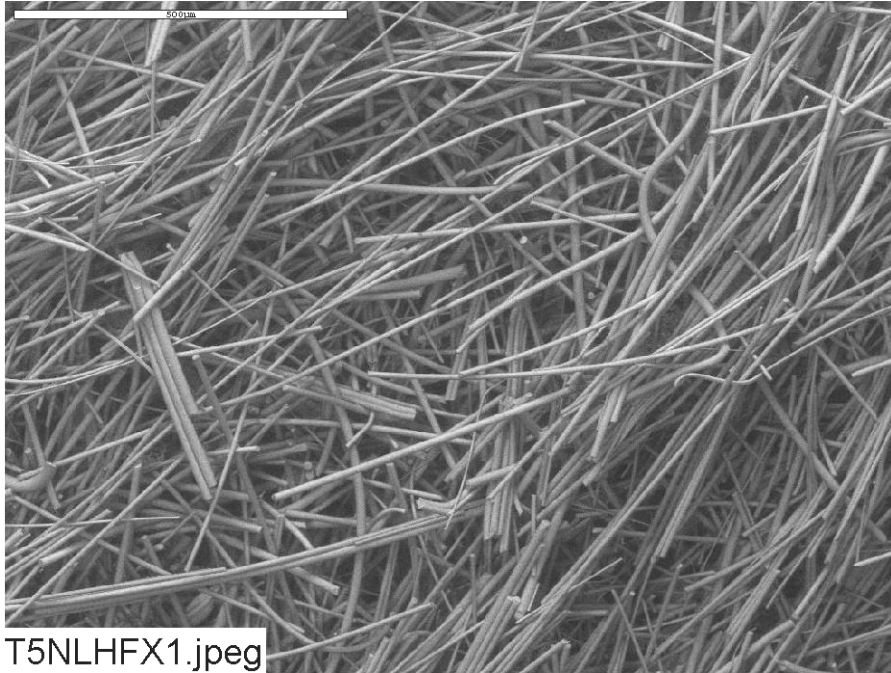
**Figure C5-1.** ESEM image magnified 100 times for a Test #5, Day-30 low-flow exterior fiberglass sample in a nylon mesh. The sample was put in the tank on Day 6. (T5NLHFX1.jpeg)

Image: T5NLHFX1      100 ×      ESEM image  
t5nlhfx1      500 ×      ESEM image

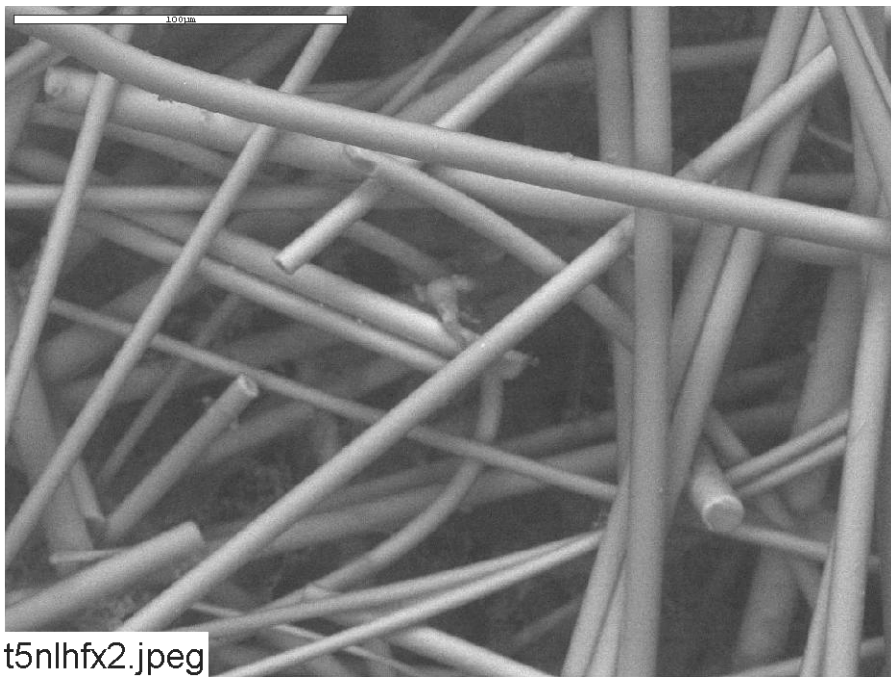
**Figure C5-2.** ESEM image magnified 500 times for a Test #5, Day-30 low-flow exterior fiberglass sample in a nylon mesh. The sample was put in the tank on Day 6. (t5nlhfx2.jpeg)

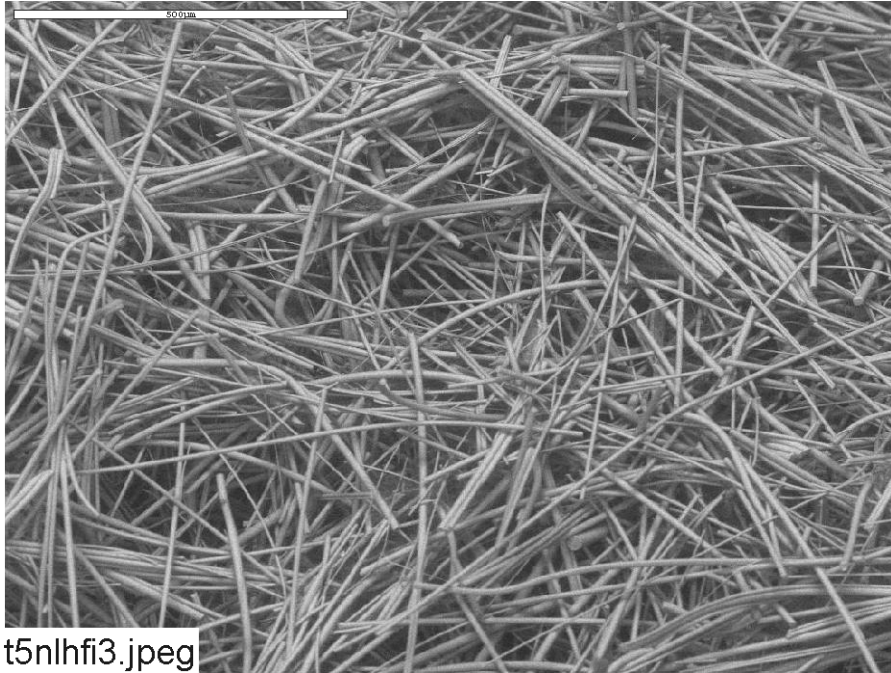
t5nlhfi3.jpeg

**Figure C5-3.** ESEM image magnified 100 times for a Test #5, Day-30 low-flow interior fiberglass sample in a nylon mesh. The sample was put in the tank on Day 6. (t5nlhfi3.jpeg)

Image:	t5nlhfi3	100 ×	ESEM image of fiberglass	Figure C5-3
	t5nlhfi4	500 ×	ESEM image higher magnification	Figure C5-4
EDS	t5nlhfi5		EDS on floc in image t5nlhfi4	Figure C5-5

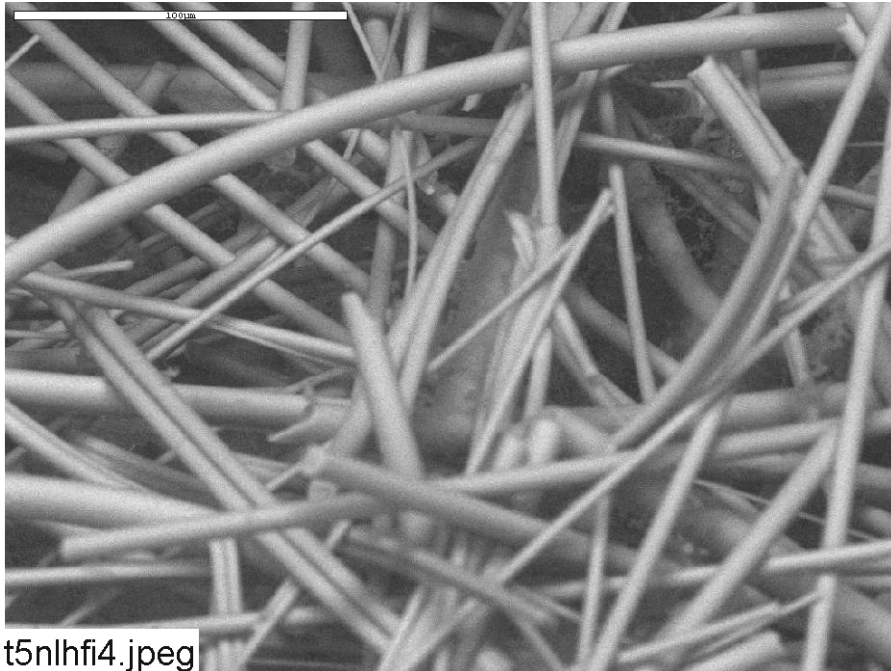
t5nlhfi4.jpeg

**Figure C5-4.** ESEM image magnified 500 times for a Test #5, Day-30 low-flow interior fiberglass sample in a nylon mesh. The sample was put in the tank on Day 6. (t5nlhfi4.jpeg)

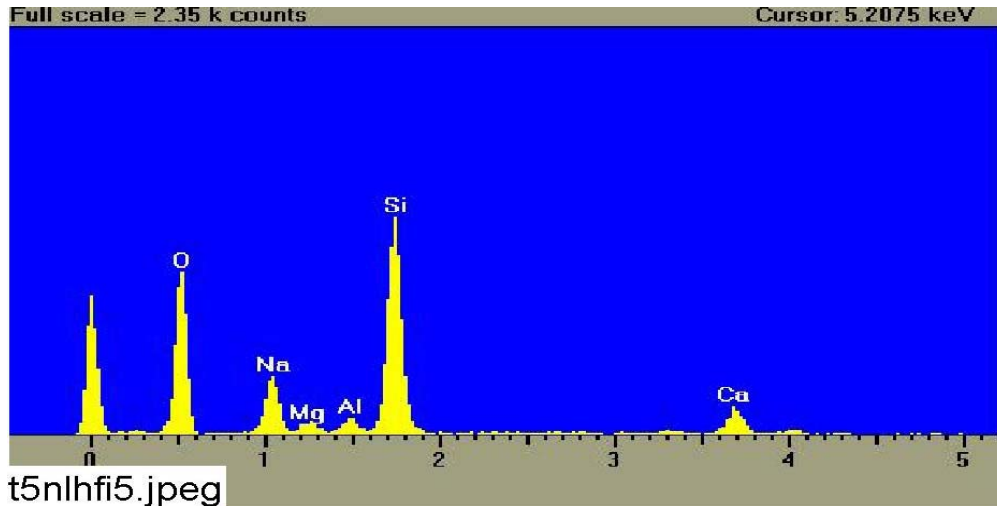
Figure C5-5. EDS counting spectrum for the deposits between the fibers shown in Figure C5-4. (t5nlhfi5.jpeg)

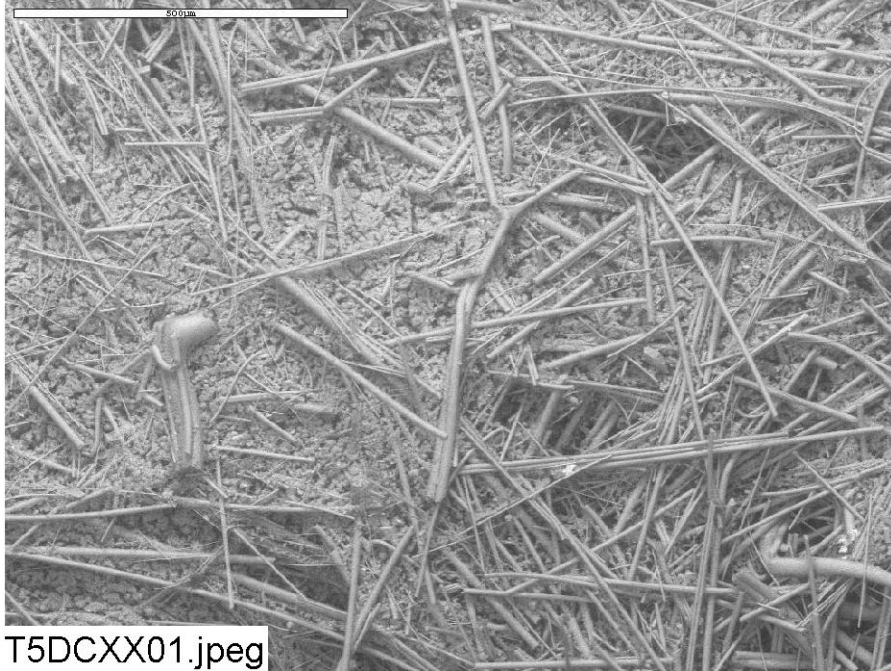
**Figure C6-1. ESEM image magnified 100 times for a Test #5, Day-30 exterior drain collar fiberglass sample farthest from the drain screen. (T5DCXX01.jpeg)**

Image:	T5DCXX01	100 ×	ESEM image	Figure C6-1
	t5dcxx02	100 ×	ESEM image	Figure C6-2
	t5dcxx03	500 ×	Annotated ESEM image	Figure C6-3
EDS:	t5dcxx04		EDS on particles in t5dcxx03	Figure C6-4
	t5dcxx05		EDS on particles in t5dcxx03	Figure C6-5
	T5D30Draincollar Particle16		EDS on particles on exterior of drain collar	Figure C6-6

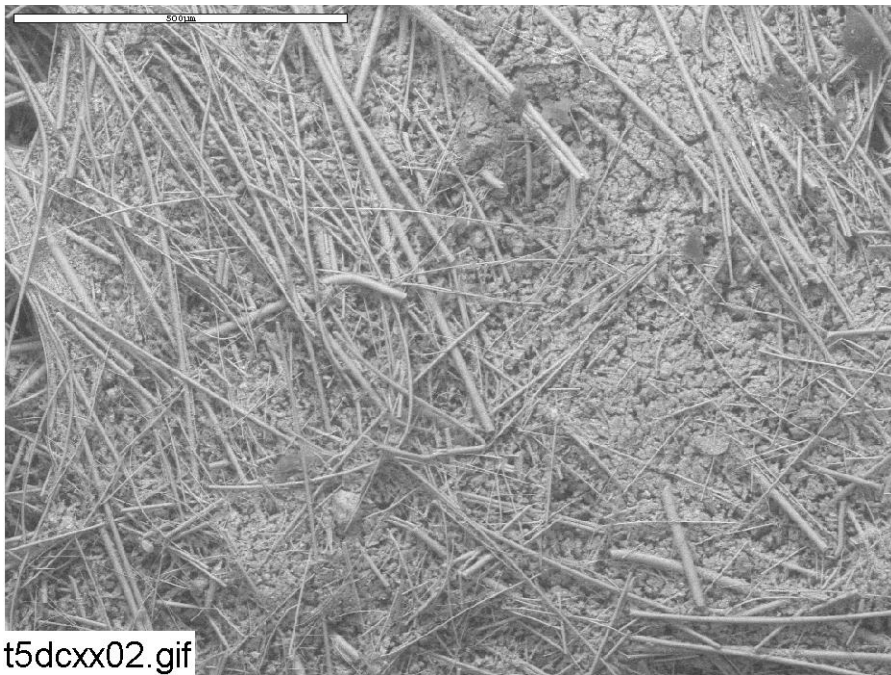
**Figure C6-2. ESEM image magnified 100 times for a Test #5, Day-30 exterior drain collar fiberglass sample farthest from the drain screen. (t5dcxx02.gif)**

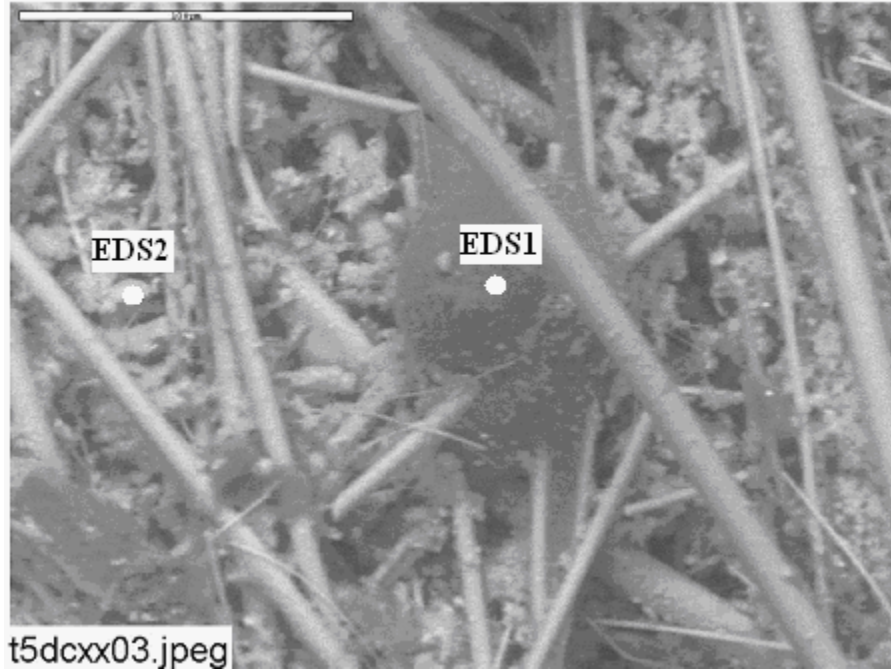
Figure C6-3. Annotated ESEM image magnified 500 times for a Test #5, Day-30 exterior drain collar fiberglass sample farthest from the drain screen. (t5dcxx03.jpeg)

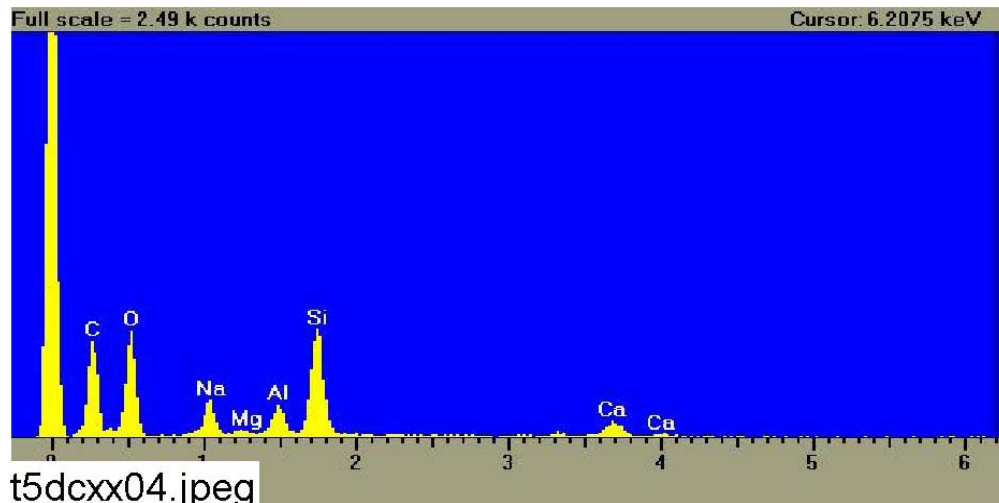
Figure C6-4. EDS counting spectrum for the dark deposits (EDS1) between fibers shown in Figure C6-3. (t5dcxx04.jpeg)

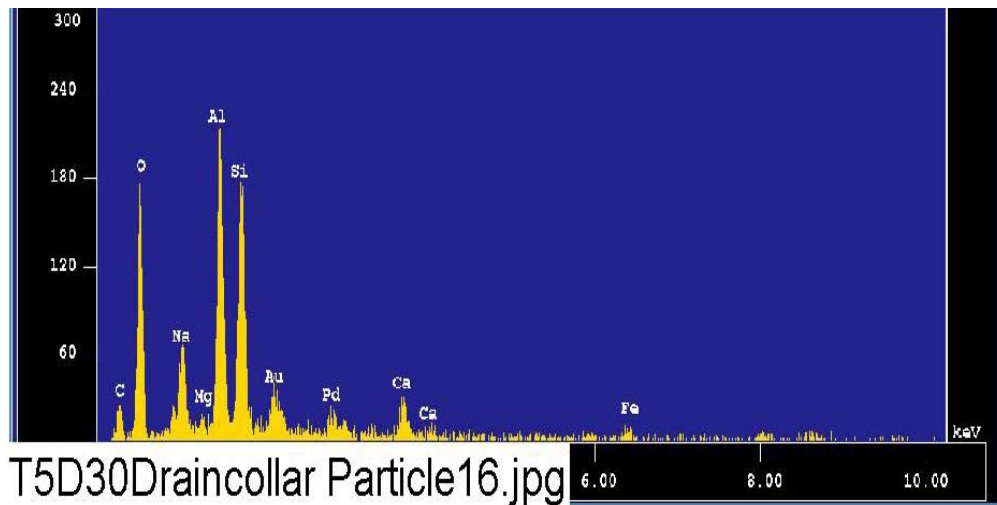
Figure C6-6. EDS counting spectrum by probe SEM for the small particulate deposits (EDS2) between fibers shown in Figure C6-3. (T5D30Draincollar Particle16.jpg)

The results from the chemical composition analysis for T5D30Draincollar Particle16.jpg are given in Table C6-1.

Group	: NRC						
Sample	: T5D30 ID# : 22						
Comment	: Particles on Drain collar out exterior						
Condition	: Full Scale : 20KeV(10eV/ch, 2Kch)						
	Live Time	: 72.190 sec		Aperture #	: 1		
	Acc. Volt	: 15.0 KV		Probe Current	: 1.003E-09 A		
	Stage Point	: X=76.455 Y=54.980 Z=11.000					
	Acq. Date	: Tue Aug 30 18:08:20 2005					
Element	Mode	ROI(KeV)	K-ratio(%)	+/-	Net/Background		
Na K	Normal	0.83- 1.28	0.3947	0.0041	351 /	16	
Al K	Normal	1.26- 1.78	1.2712	0.0008	1702 /	55	
Si K	Normal	1.50- 2.07	1.0873	0.0004	1598 /	110	
Ca K	Normal	3.40- 4.30	0.4688	0.0034	332 /	4	
Mg K	Normal	1.00- 1.53	0.1133	0.0002	85 /	66	
O K	Normal	0.31- 0.74	4.4301	0.0055	5013 /	7	
C K	Normal	0.11- 0.47	14.5489	0.0068	176 /	25	
Fe K	Normal	6.04- 7.40	0.4946	0.0012	158 /	2	
-----							
Chi_square = 2.8684							
Element	Mass%	Atomic%	ZAF	Z	A	F	
Na	2.761	1.9859	1.0916	0.9815	1.1113	1.0007	
Al	8.876	5.4401	1.0897	0.9899	1.1034	0.9977

Si	8.579	5.0513	1.2314	0.9822	1.2538	0.9999	
Ca	2.914	1.2022	0.9700	0.9929	0.9778	0.9991	
Mg	1.039	0.7068	1.4318	0.9712	1.4778	0.9976	
O	42.666	44.1002	1.5030	0.9888	1.5200	1.0000	
C	29.326	40.3765	0.3146	0.9920	0.3171	1.0000	
Fe	3.840	1.1369	1.2115	1.2176	0.9950	1.0000	
-----							
Total	100.000	100.0000					
Normalization factor = 6.4077

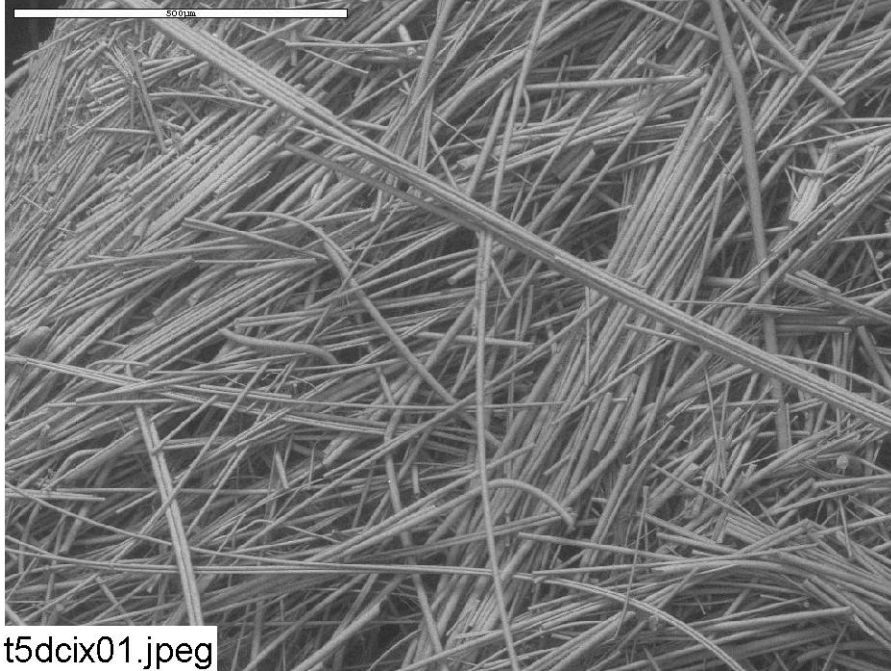
**Figure C6-7. ESEM image magnified 100 times for a Test #5, Day-30 exterior drain collar fiberglass sample next to the drain screen. (t5dcix01.jpeg)**

Image:	t5dcix01	100 ×	ESEM image	Figure C6-7
	t5dcix05	100 ×	ESEM image	Figure C6-8
	t5dcix02	100 ×	ESEM image higher magnification	Figure C6-9
	t5dcix03	500 ×	ESEM image high magnification	Figure C6-10
EDS:	t5dcix04		EDS on particles image t5dcix03	Figure C6-11

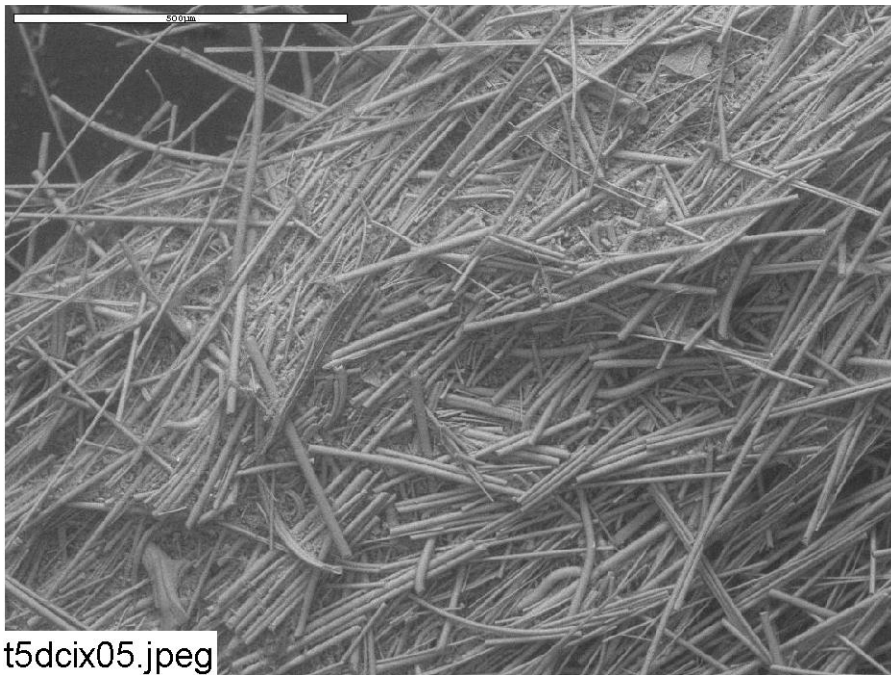
**Figure C6-8. ESEM image magnified 100 times for a Test #5, Day-30 exterior drain collar fiberglass sample next to the drain screen. (t5dcix05.jpeg)**

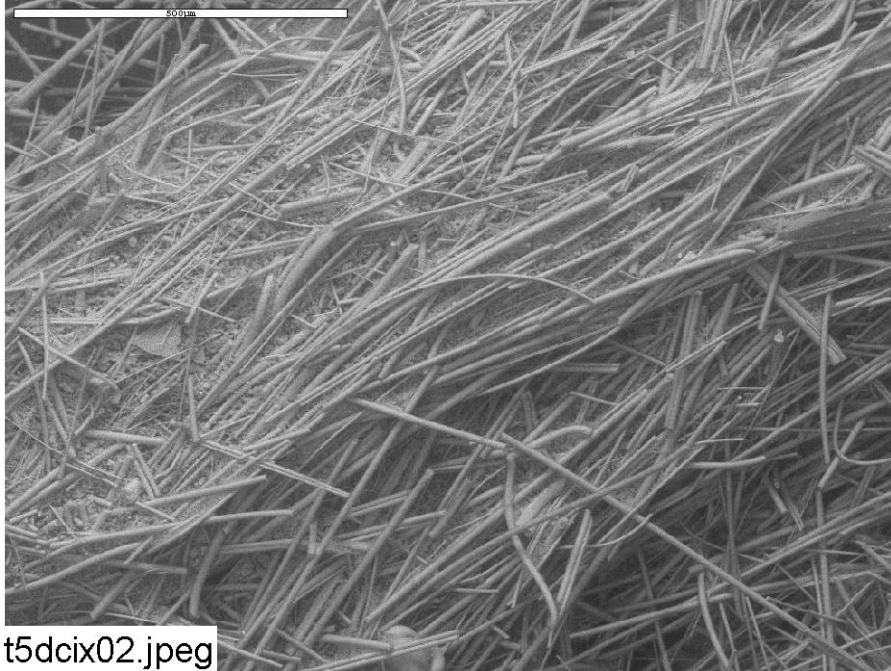
t5dcix02.jpeg

**Figure C6-9.** ESEM image magnified 100 times for a Test #5, Day-30 exterior drain collar fiberglass sample next to the drain screen. (t5dcix02.jpeg)

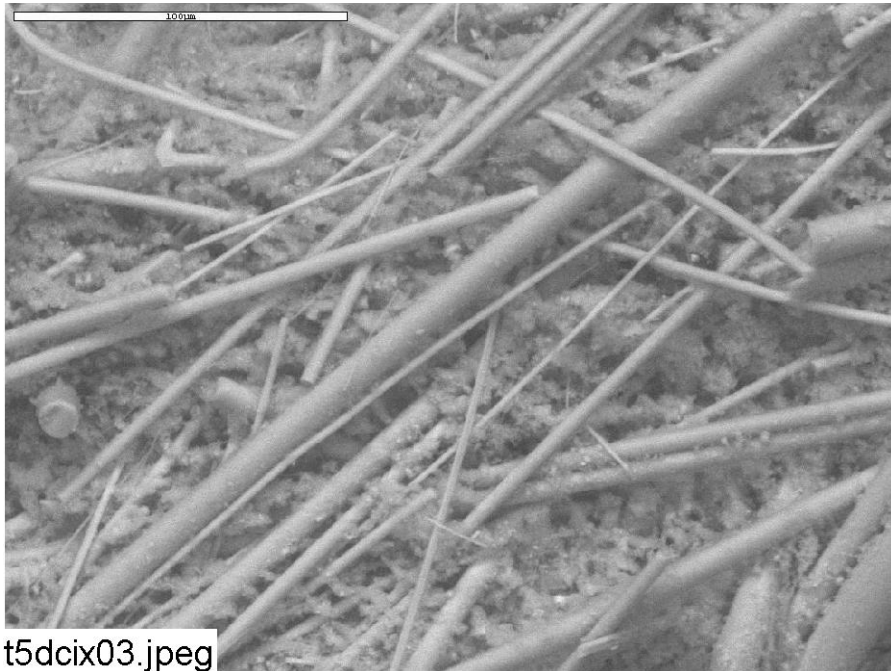
t5dcix03.jpeg

**Figure C6-10.** ESEM image magnified 500 times for a Test #5, Day-30 exterior drain collar fiberglass sample next to the drain screen. (t5dcix03.jpeg)

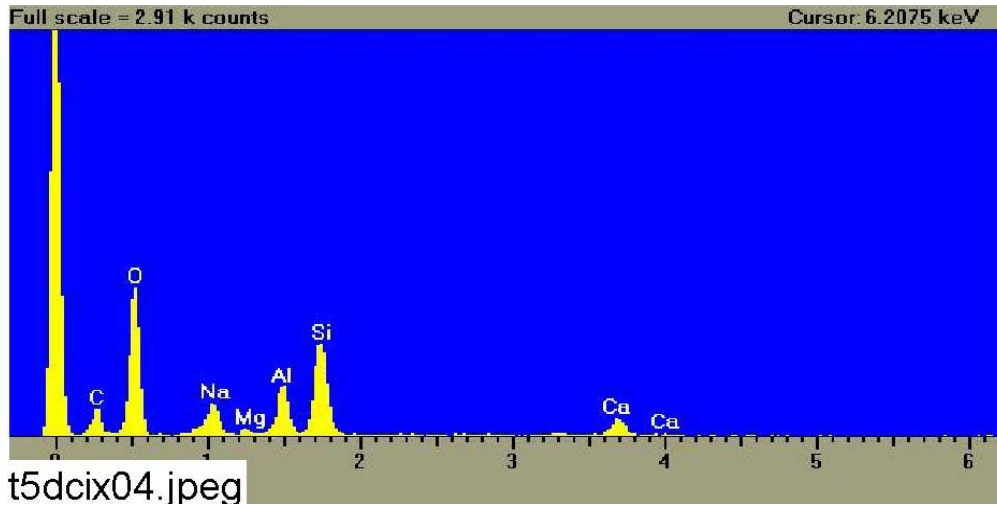
Figure C6-11. EDS counting spectrum for the particulate deposits between fibers shown in Figure C6-10. (t5dcix04.jpeg)

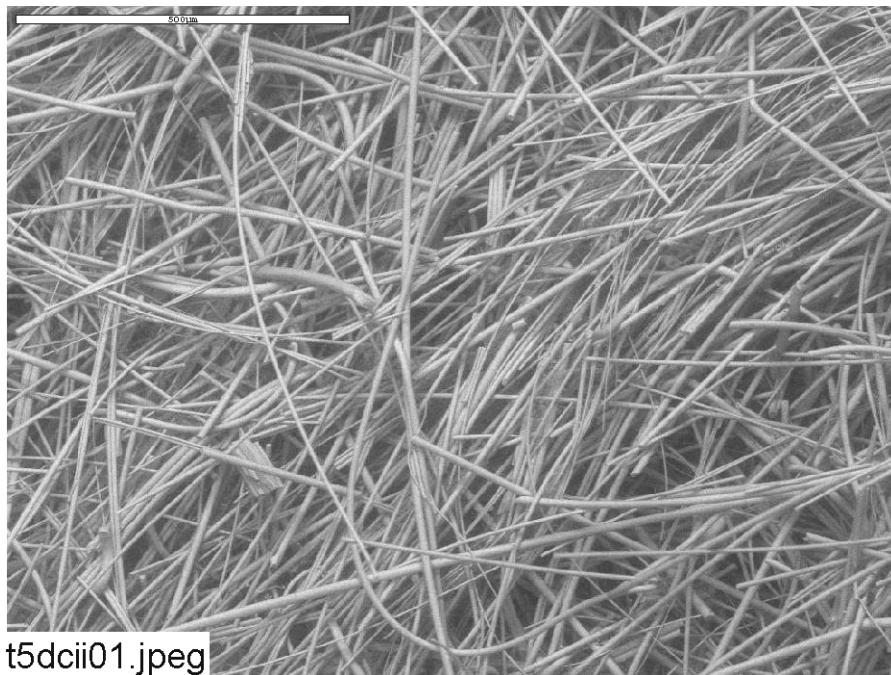
Figure C6-12. ESEM image magnified 100 times for a Test #5, Day-30 interior drain collar fiberglass sample. (t5dcii01.jpeg)

Image:	t5dcii01	100 ×	ESEM image	Figure C6-12
	T5D30DraincollarInt027	200 ×	Probe SEM image	Figure C6-13
	t5dcii02	500 ×	ESEM image	Figure C6-14
	T5D30DraincollarInt026	1000 ×	Probe SEM image higher	Figure C6-15
EDS:	T5D30fiber flocc17		EDS on particles in t4dcix08	Figure C6-16

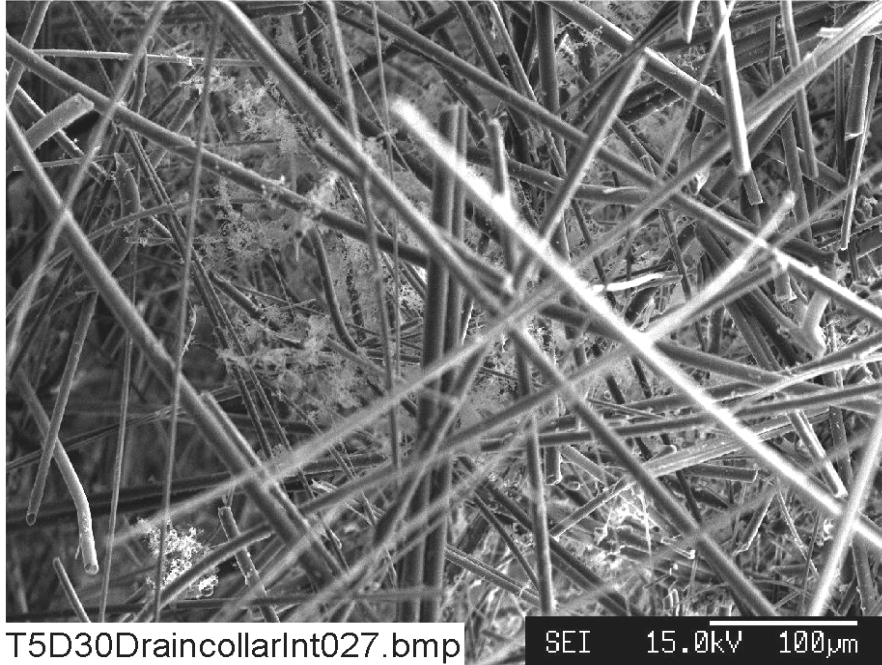
**Figure C6-13. Probe SEM image magnified 200 times for a Test #5, Day-30 interior drain collar fiberglass sample. (T5D30DraincollarInt027.bmp)**

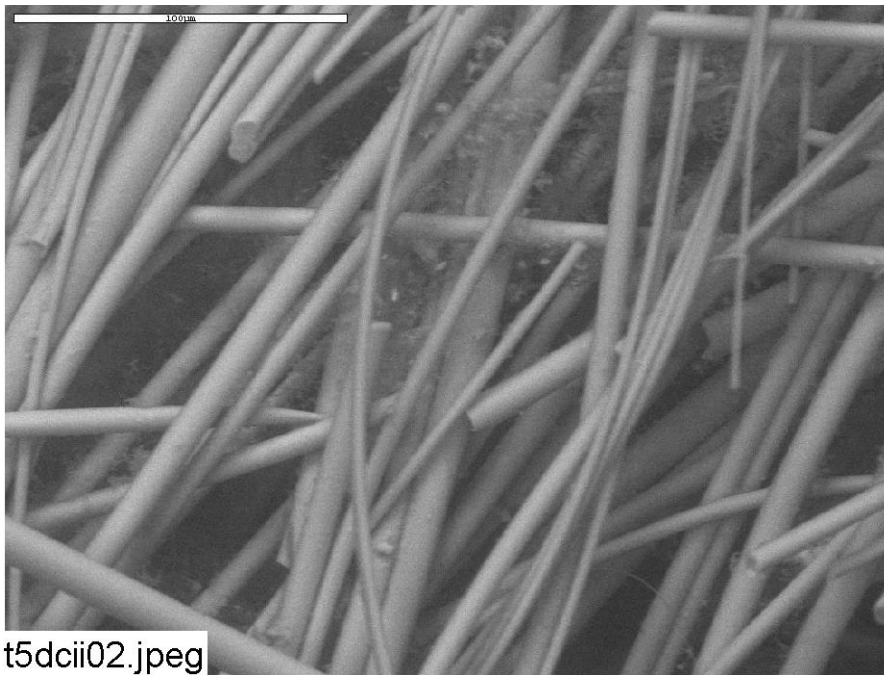
**Figure C6-14. ESEM image magnified 500 times for a Test #5, Day-30 interior drain collar fiberglass sample. (t5dcii02.jpeg)**

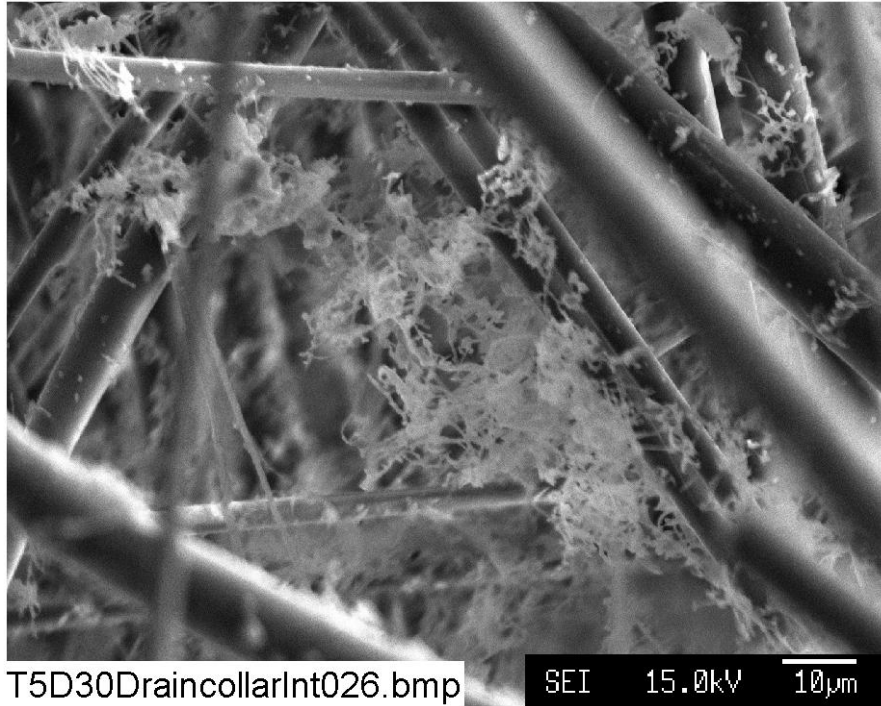
Figure C6-15. Probe SEM image magnified 1000 times for a Test #5, Day-30 interior drain collar fiberglass sample. (T5D30DraincollarInt026.bmp)

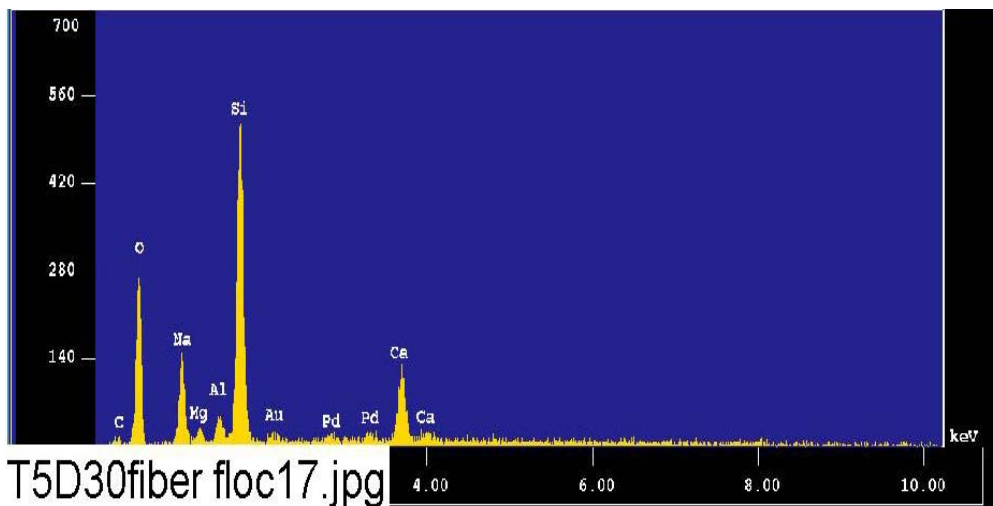
Figure C6-16. EDS counting spectrum by probe SEM for the flocculence deposits between fibers shown in Figure C6-15. (T5D30fiber flocc17.jpg)

The results from the chemical composition analysis for T5D30fiber floc17.jpg are given in Table C6-2.

Group      : NRC
Sample     : T5D30 ID# : 23
Comment    : Floculence on draincollar interior
Condition  : Full Scale : 20KeV(10eV/ch,2Kch)
            Live Time  : 96.780 sec Aperture # : 1
            Acc. Volt  : 15.0 KV Probe Current : 1.003E-09 A
            Stage Point : X=76.455 Y=54.980 Z=11.000
            Acq. Date  : Tue Aug 30 18:19:56 2005
