**Submission and Appendix of BUSCO to the
National Transportation Safety Board**

**Mexican Hat, UT
HWY-08-MH-012**

Alternative Crash Theory – Mexican Hat, UT.

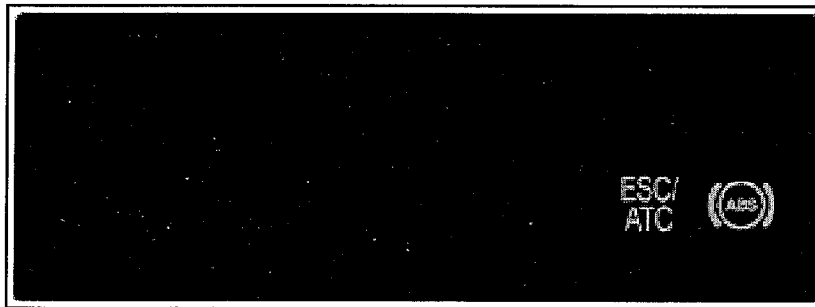
The ESC and Automatic Traction Control (ATC) functions share the same tell-tale lamp in the RH tell-tale cluster (refer to Figure 1). At system start-up, tell-tales illuminate briefly for self-test. If the coach is equipped with ESC, the ESC / ATC tell-tale will remain illuminated approximately one second after the ABS tell-tale lamp extinguishes.

Figure 1. RH tell-tale cluster.

During a traction control or stability control event, with the Mud/Snow switch in the OFF position, the ESC / ATC tell-tale will illuminate solid. The tell-tale will extinguish when normal driving conditions are resumed.

During a traction control event, with the Mud/Snow switch in the ON position, the ESC / ATC tell-tale will blink continuously. The tell-tale will extinguish when normal driving conditions are resumed.

If the ESC / ATC tell-tale remains illuminated solid during normal driving conditions, there is an existing fault in the ESC system. If the ABS tell-tale remains illuminated solid during normal driving conditions, there is an existing fault in the ABS or ATC system. If there is a fault, perform diagnostics using the latest version of TOOLBOX™ Software to identify fault and have coach serviced as soon as possible.
