# Mech

Summer 2009

**The Navy & Marine Corps  
Aviation Maintenance Safety Magazine**  
Summer 2009, Volume 48 No. 3

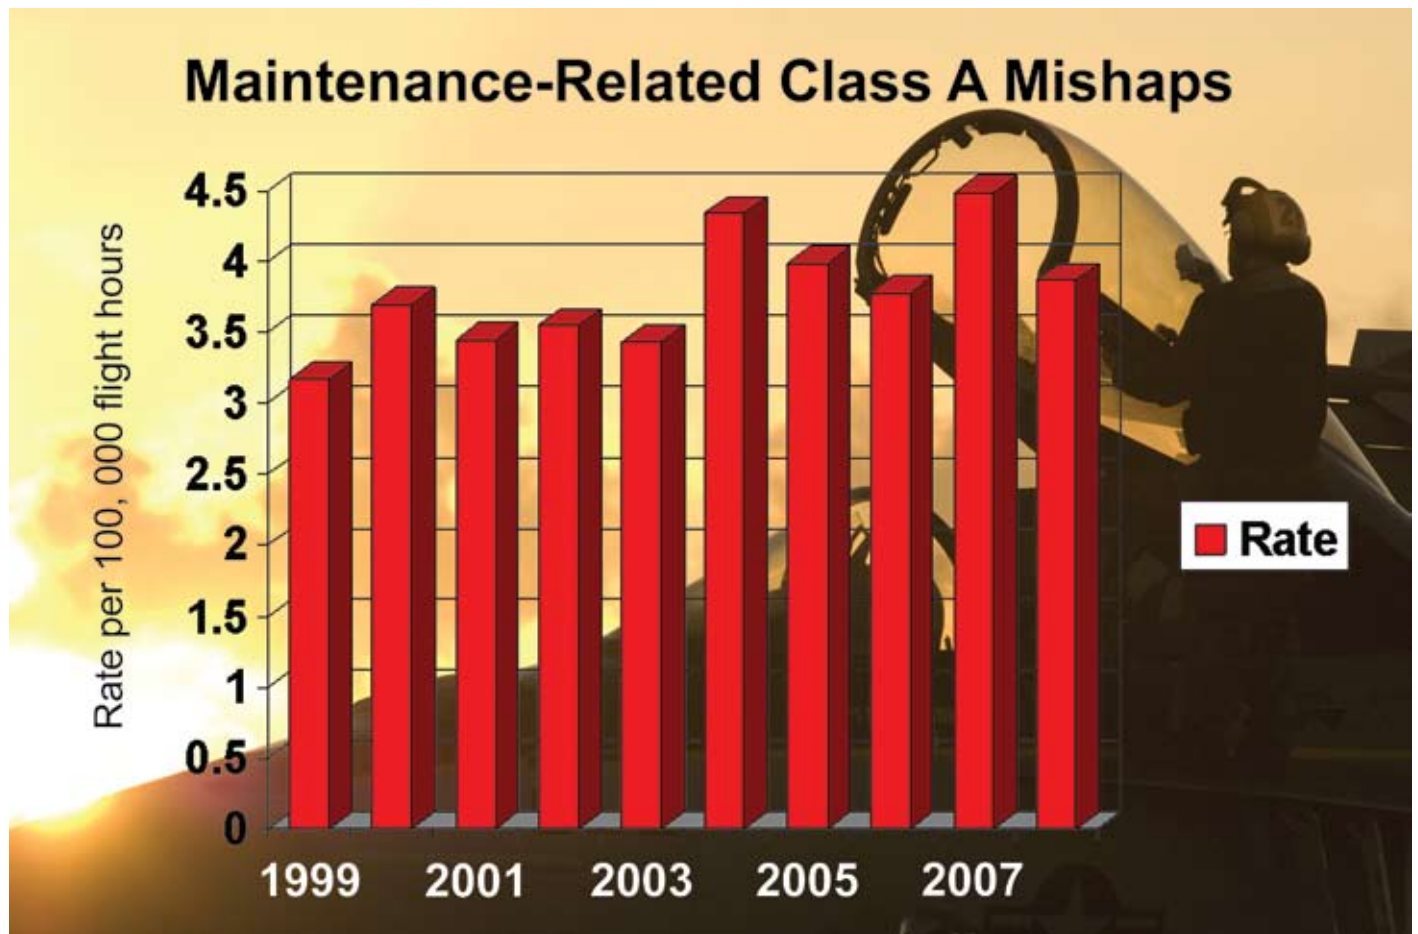
Figure 1

Maintenance error slightly increased from FY04 to FY08 when compared to FY99 to FY03 (Fig. 1).

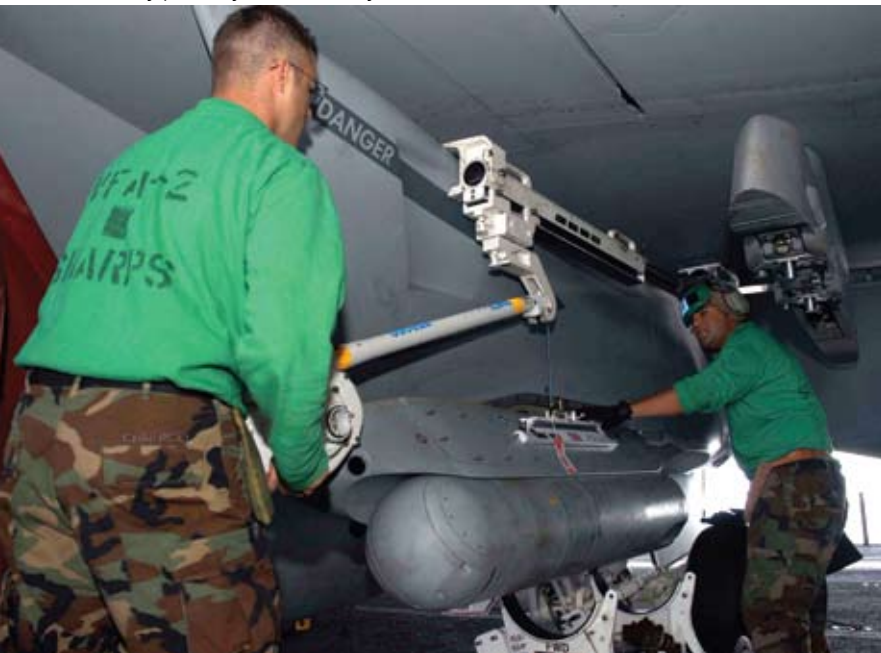
The Sailors in this photo are installing an advanced targeting forward looking infrared (ATFLIR) pod on an FA-18C Super Hornet. The author is in a different squadron than the Sailors pictured here.

The electro optical servo unit (EOSU) of the ATFLIR pod has 24 screws that have to be inspected as part of the daily inspection. These screws should not be loose and are held in place by thread-locking compound. To help us inspect the screws more effectively, the avionics shop had started a practice of painting a torque-inspection stripe on the screws around the entire

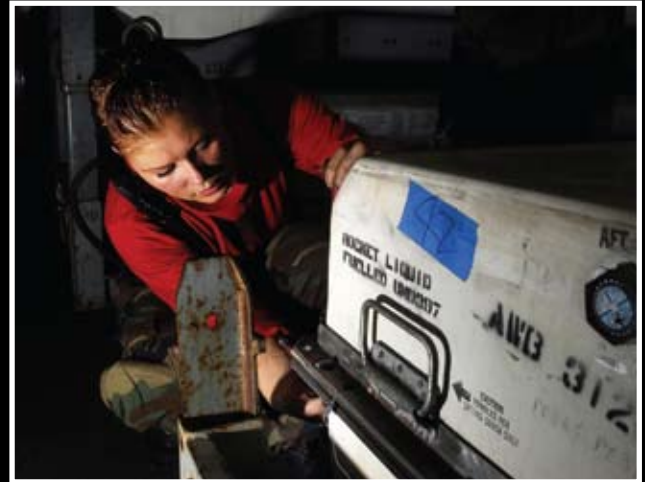
AOAN Shantee Lancour tightens bolts on a missile container in the hangar bay of the aircraft carrier USS *John C. Stennis* (CVN-74) in preparation for an ammunition offload. Navy photo by MC3 Josue Escobosa

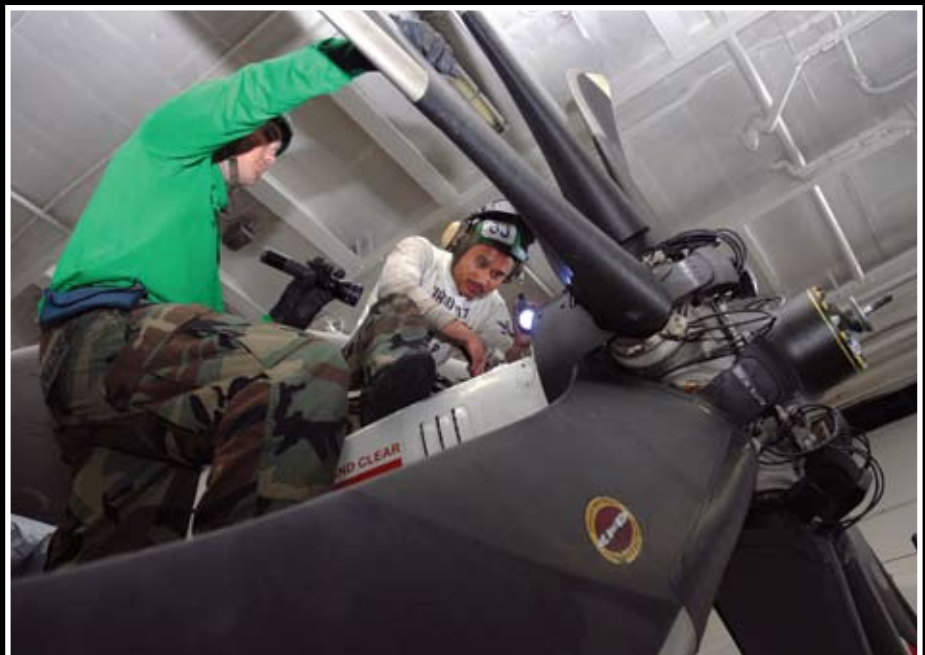
AE1 Josh Deitrick and AD2 Mikhos Maneru, both assigned to the "Wall-bangers" of VAW-117, perform propeller maintenance on an E-2C Hawkeye aboard the aircraft carrier USS *Nimitz* (CVN-68). Navy photo by MC3 J. D. Levite

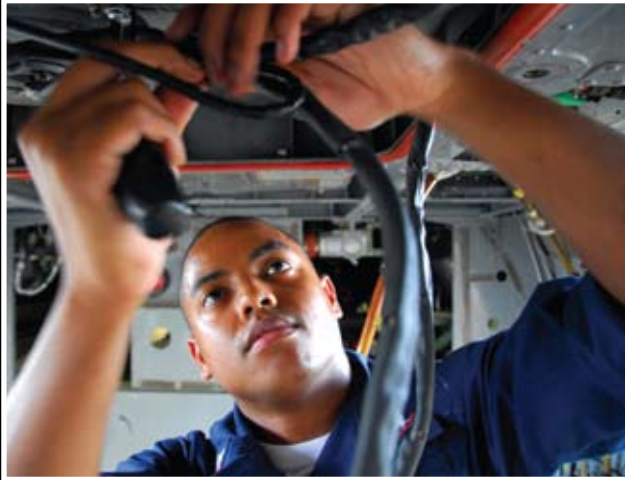
AE3 Christopher Houston, assigned to the "Blackjacks" of HSC-21, reattaches a distributor harness to the environmental-control system of an MH-60S Sea Hawk helicopter at Naval Air Station North Island. Navy photo by MC3 Joshua Valcarcel

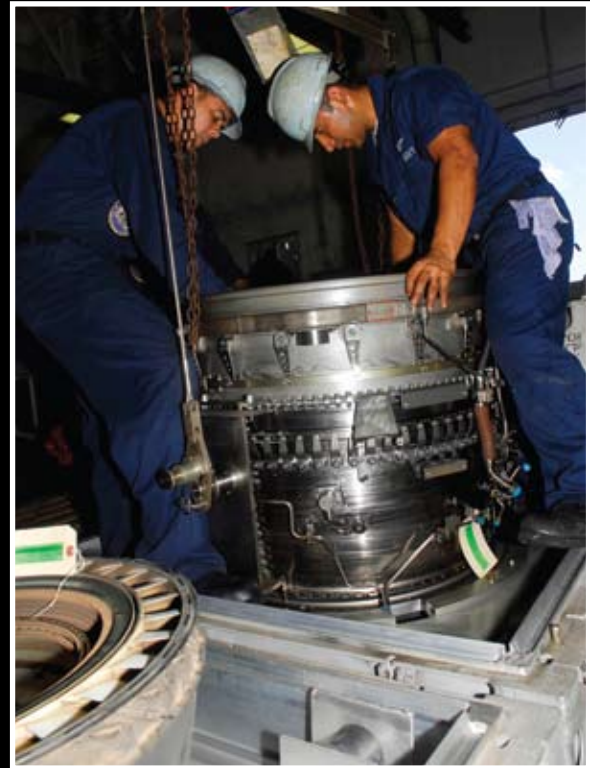
ADAN Joan Medina, left, and AD3 Elman Pena perform a level III preservation on the NRFI F-414 fan module of a turbo-fan engine from an FA-18F Super Hornet aboard the aircraft carrier *USS John C. Stennis* (CVN-74). Navy photo by MC3 Kenneth Abbate

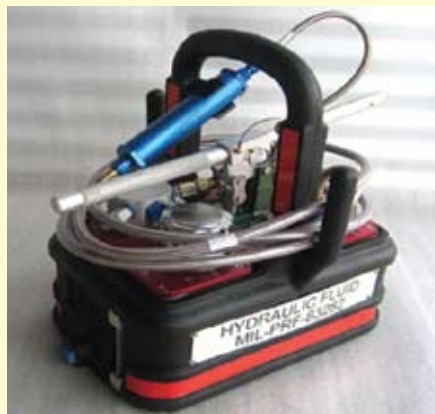
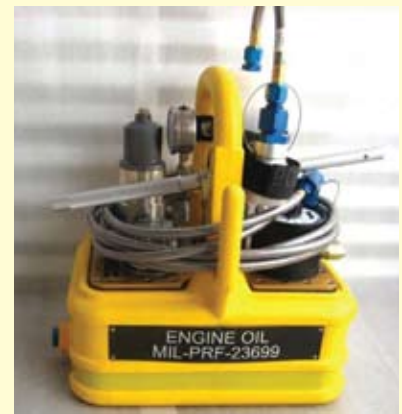
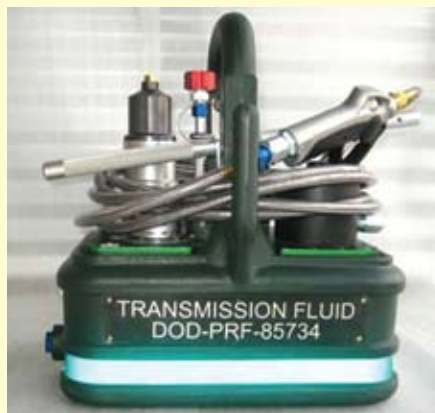
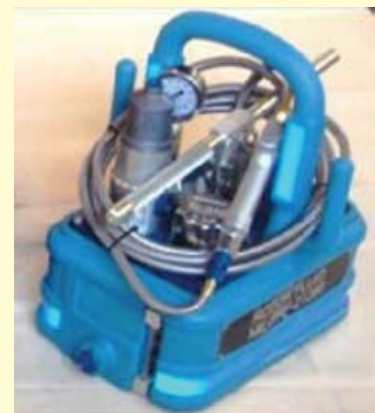
NAVAIR developed the new AFSUs to address this problem. The new design of these units will make them easier to see and use, helping prevent servicing errors. As Bill Englehart of NAVAIR explained, "It's very difficult, if not impossible, to cross-contaminate systems. We've gone to great lengths to do away with those problems."

Other benefits of the new units include filter-replacement indicators, wear-pads on the bottom, and sight-level gauges. The 15-foot braided lines with clear outer plastic covers make it easier to reach certain areas. The AFSUs also are more efficient (3 ounces dispensed per stroke), compared to the HSU-1 (1.5 ounces per stroke) and the PON-6 (0.7 ounces per stroke).

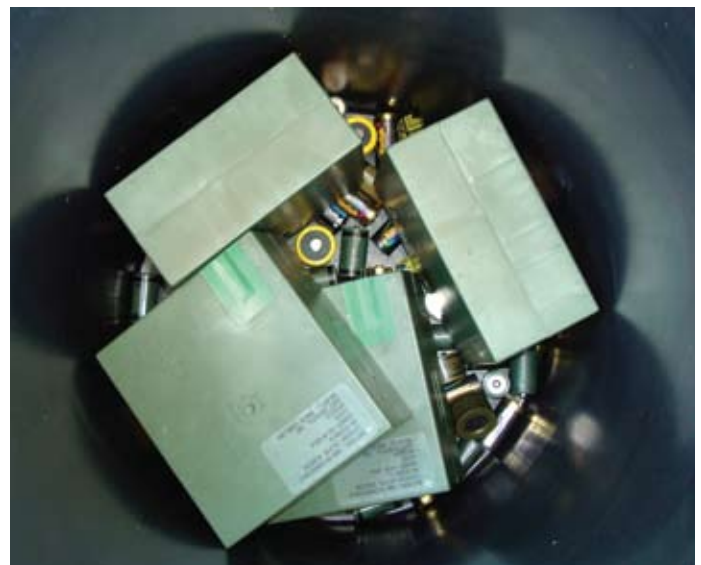
**The wrong way:** Lithium batteries stored alongside other types of batteries.
