# NIST Technical Note 1618

## Fire Fighting Tactics Under Wind Driven Conditions: Laboratory Experiments

Daniel Madrzykowski  
Stephen Kerber

U.S. Department of Commerce  
Building and Fire Research Laboratory  
National Institute of Standards and Technology  
Gaithersburg, MD 20899

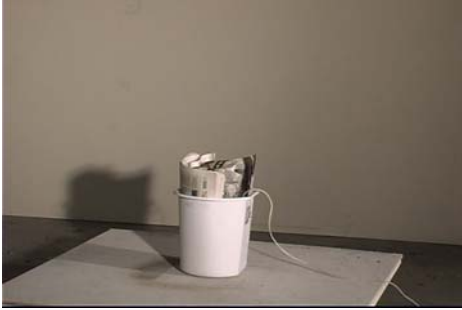
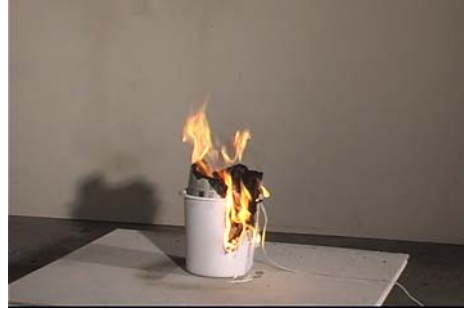
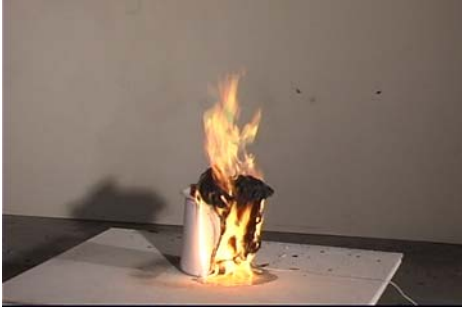
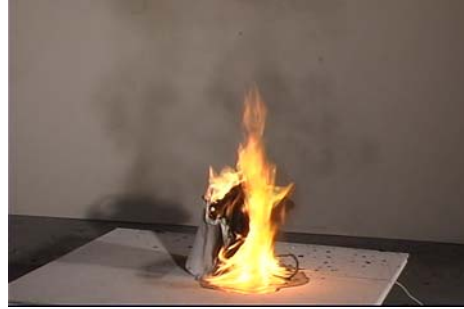
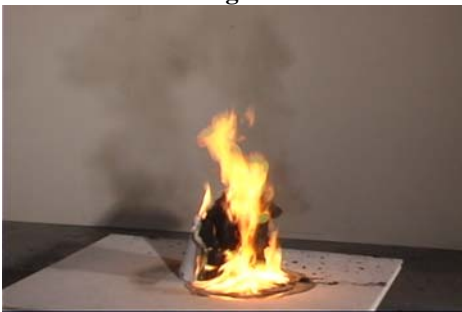
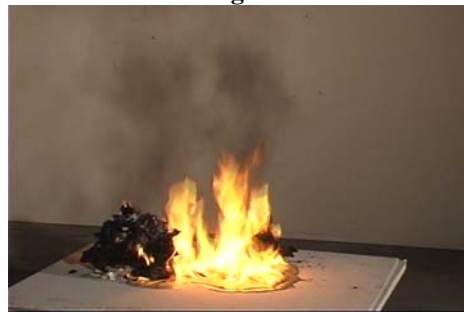
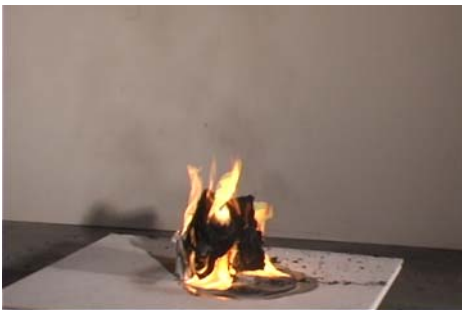
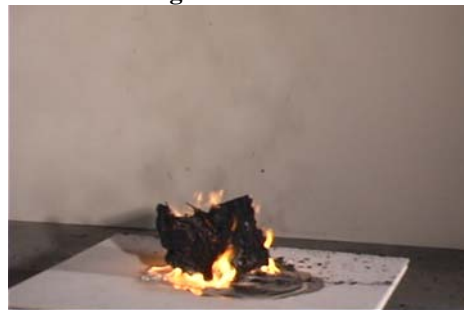
**Figure 3.2-1. Trash container 1, ignition**

**Figure 3.2-2. Trash container 1, 100 s after ignition**

**Figure 3.2-3. Trash container 1, 200 s after ignition**

**Figure 3.2-4. Trash container 1, 300 s after ignition**

**Figure 3.2-5. Trash container 1, 400 s after ignition**

**Figure 3.2-6. Trash container 1, at peak heat release rate, 406 s after ignition**

**Figure 3.2-7. Trash container 1, 500 s after ignition**

**Figure 3.2-8. Trash container 1, 600 s after ignition**

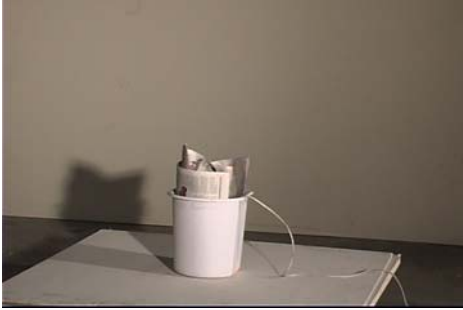
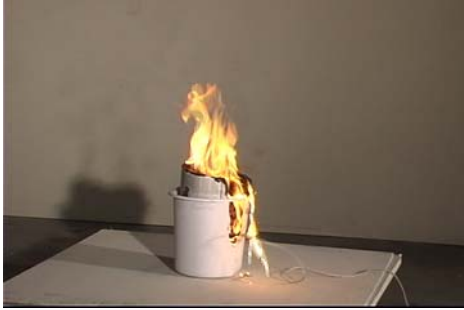
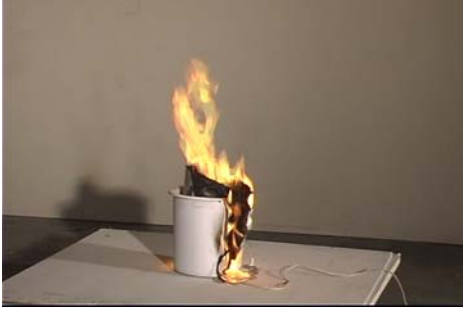
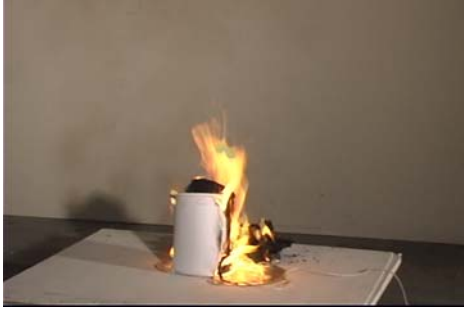
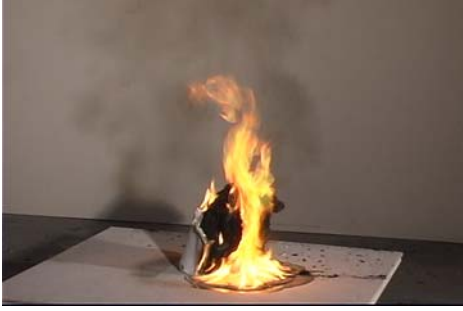
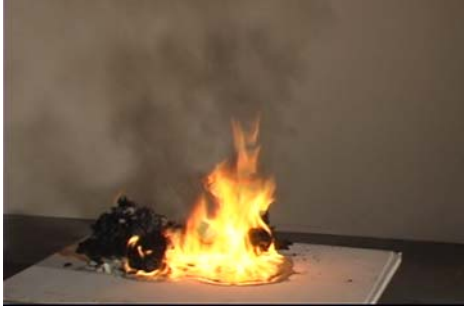
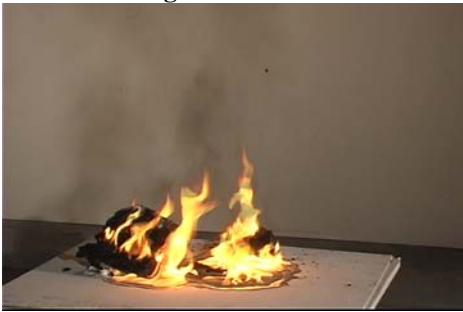
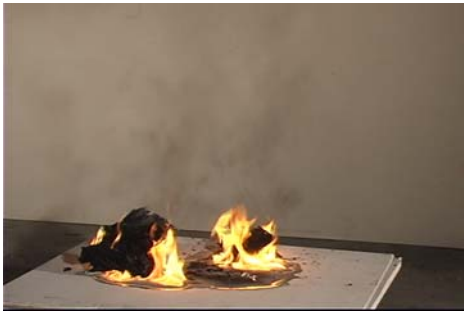
Figure 3.2-9. Trash container 2, ignition

Figure 3.2-10. Trash container 2, 100 s after ignition

Figure 3.2-11. Trash container 2, 200 s after ignition

Figure 3.2-12. Trash container 2, 300 s after ignition

Figure 3.2-13. Trash container 2, at peak heat release rate, 363 s after ignition

Figure 3.2-14. Trash container 2, 400 s after ignition

Figure 3.2-15. Trash container 2, 500 s after ignition

Figure 3.2-16. Trash container 2, 600 s after ignition

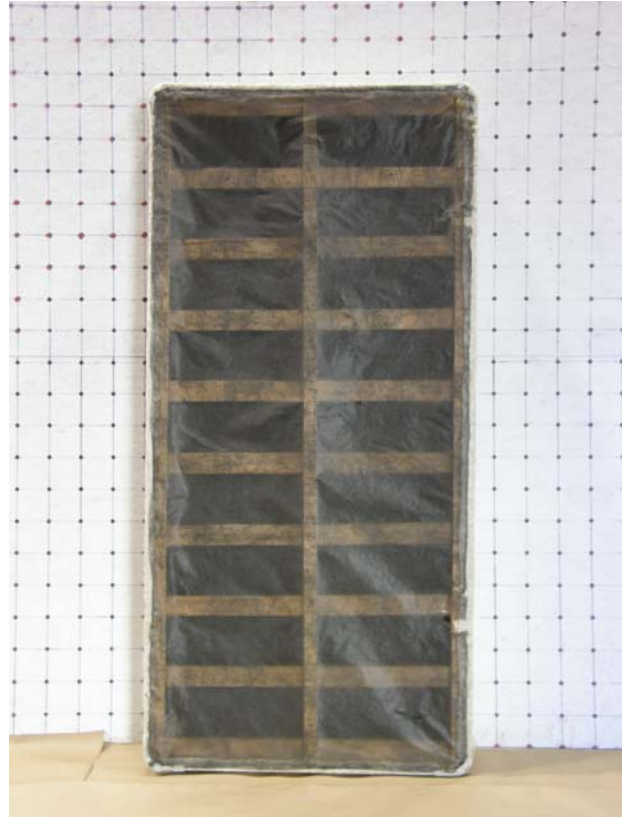
**Figure 3.3-2. Bottom side of box spring.**

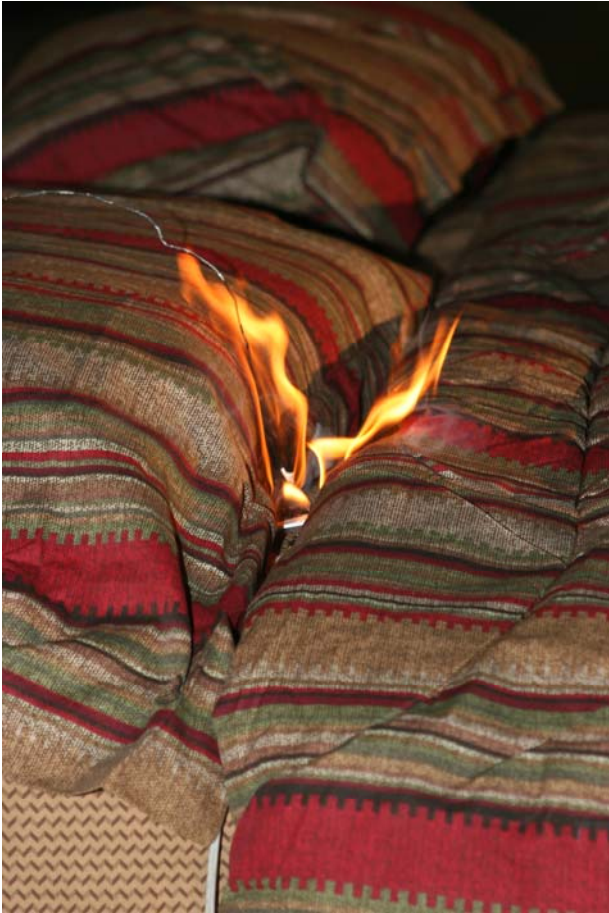
Two heat release rate experiments were conducted. In the first experiment, a bed fuel package was ignited by an electric match positioned on the top surface of the mattress, in a fold formed by the comforter and underside of the covered pillow as shown in Figure 3.3-3. The second experiment was ignited with a trash container fuel package positioned next to the bed as shown in Figure 3.3-4.

Figure 3.3-3. Electric match ignition of bed fuel package.

Bed fuel package 1 was ignited with an electric match as shown in Figure 3.3-3. Figure 3.3.2-1 through Figure 3.3.1-10 are a series of photographs showing the fire development in the first bed fuel package. The photographs document the period from ignition to 800 s after ignition at which point the fuel package has been reduced to burning debris in and under the springs of the mattress. The photographs are at intervals of 100 s with the exception of Figure 3.3.2-5, which shows the bed fuel package at the time of peak heat release rate, 484 s.

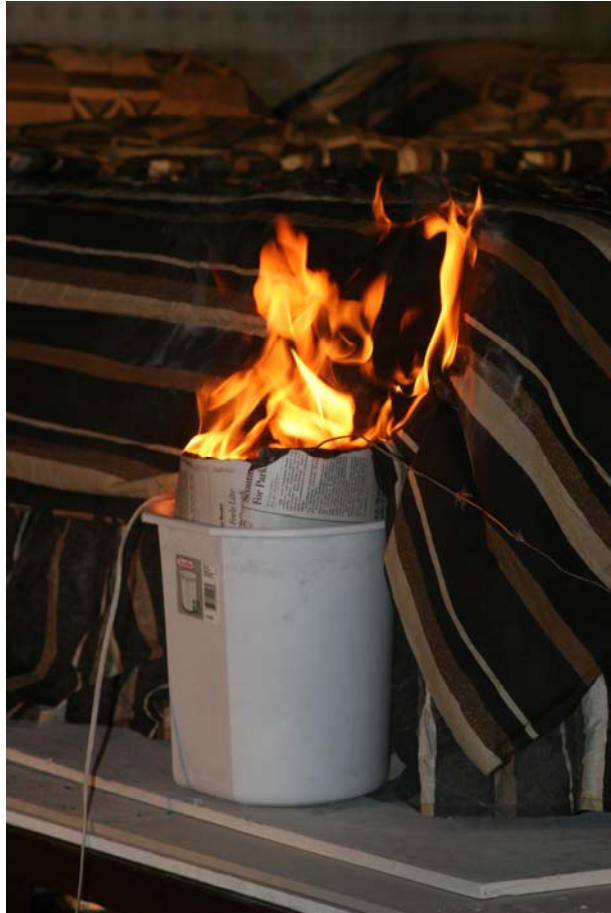
Figure 3.3-4. Trash container ignition of bed fuel package.

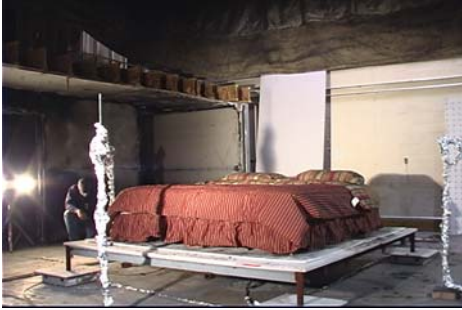
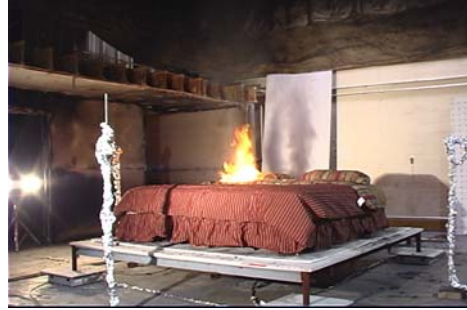
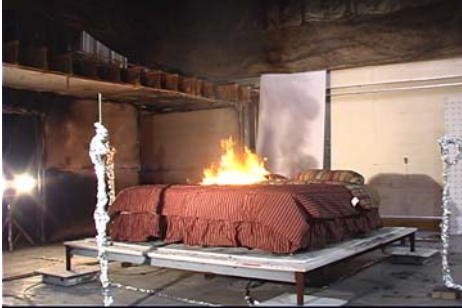
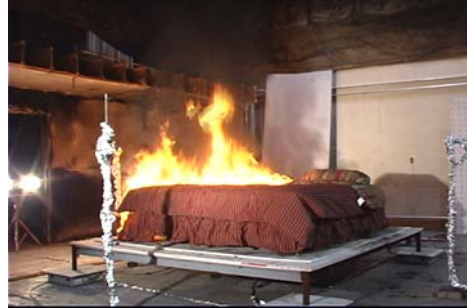
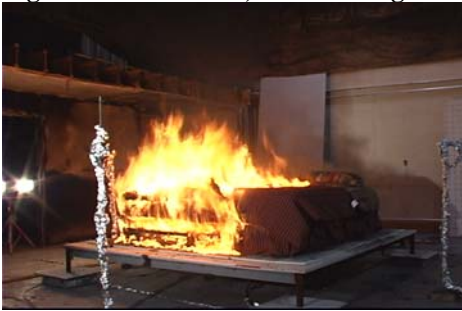
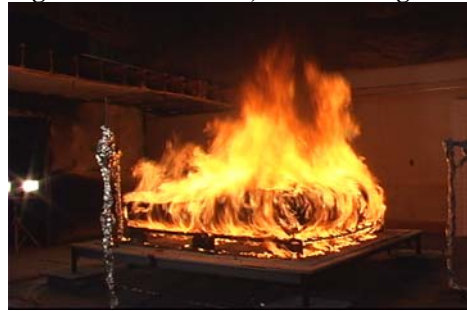
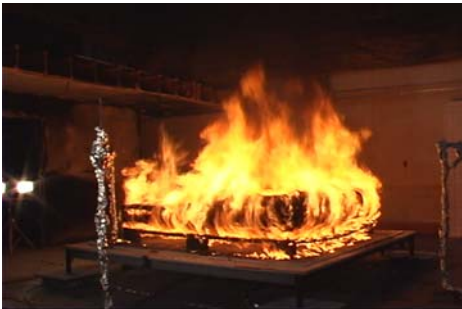
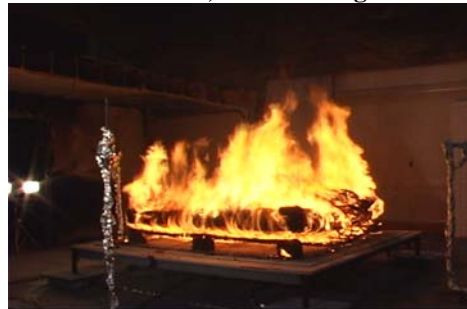
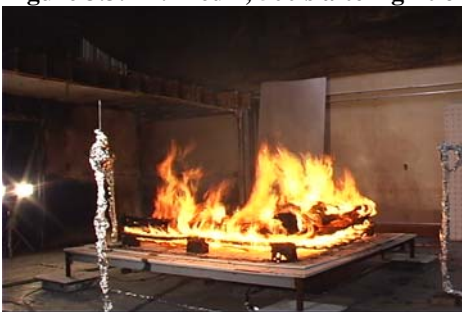
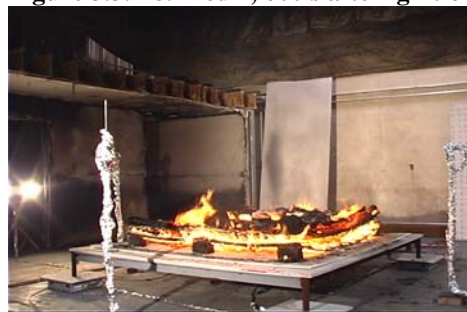
Figure 3.3.1-1. Bed 1, ignition

Figure 3.3.1-2. Bed 1, 100 s after ignition

Figure 3.3.1-3. Bed 1, 200 s after ignition

Figure 3.3.1-4. Bed 1, 300 s after ignition

Figure 3.3.1-5. Bed 1, 400 s after ignition

Figure 3.3.1-6. Bed 1, at peak heat release rate, 484 s after ignition

Figure 3.3.1-7. Bed 1, 500 s after ignition

Figure 3.3.1-8. Bed 1, 600 s after ignition

Figure 3.3.1-9. Bed 1, 700 s after ignition

Figure 3.3.1-10. Bed 1, 800 s after ignition

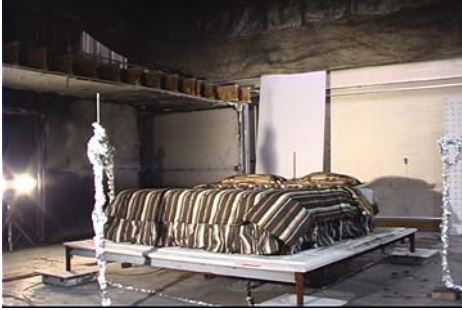
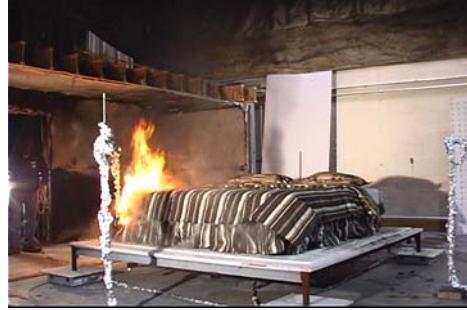
Figure 3.3.2-1. Bed 2, ignition

Figure 3.3.2-2. Bed 2, 100 s after ignition

Bed fuel package 2 was ignited with a trash container fuel package as shown in Figure 3.3-3. Figure 3.3.2-1 through Figure 3.3.2-8 are a series of photographs showing the fire development in bed fuel package 2. The photographs document the period from ignition to 600 s after ignition at which point the fuel package had been reduced to burning debris in and under the springs of the mattress. The photographs are at intervals of 100 s with the exception of Figure 3.3.2-5, which shows the bed fuel package near the time of peak heat release rate, 380 s. Given the larger ignition source, and ignition placement that involved the mattress sooner, the total burn time was reduced by more than 6 minutes.

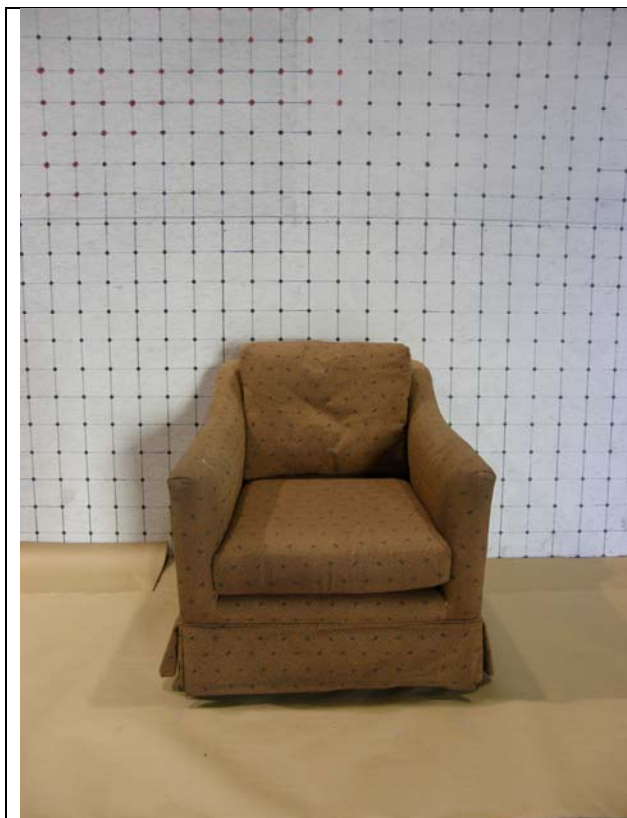
**Figure 3.4-1. Upholstered chair, front view.**

The upholstered chair was 0.72 m (2.4 ft) wide, 0.76 m (2.5 ft) deep and 0.73 m (2.4 ft) high. Based on the manufacturer’s information, the chairs had a hard wood frame which was wrapped in the arms and back portions with 10 % blended cotton and 90 % polyurethane foam. The seat cushion, which measured 0.53 m (1.75 ft) wide, 0.66 m (2.2 ft) deep and 0.15 m (0.5 ft) thick, was composed of 90 % polyurethane foam and 10 % polyester fiber. The back pillow measured approximately 0.48 m (1.6 ft) wide, 0.37 m (1.2 ft) high and 0.15 m (0.5 ft) thick. It was made up of polyester fiber 90 % and polyurethane foam 10 %. Six upholstered chairs and sets of cushions were weighed. The chairs had an average mass of 23.7 kg (52 lbs) with a range from 23.3 kg (51.4 lbs) to 24.0 kg (52.9 lbs). The seat cushion had an average mass of 2.12 kg (4.7 lbs) with a range from 2.05 kg (4.52 lbs) to 2.25 kg (4.96 lbs). The back cushions had an average mass of 1.18 kg (2.6 lbs) with a range of 1.17 kg (2.58 lbs) to 1.19 kg (2.62 lbs). Photographs of the chair and cushions are shown in Figure 3.4-1 through Figure 3.4-4.

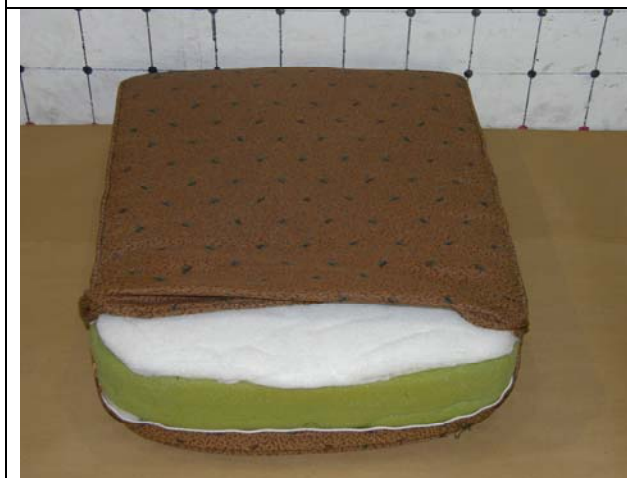
**Figure 3.4-3. Seat cushion, showing layers of upholstery fabric, polyester batting and polyurethane foam.**

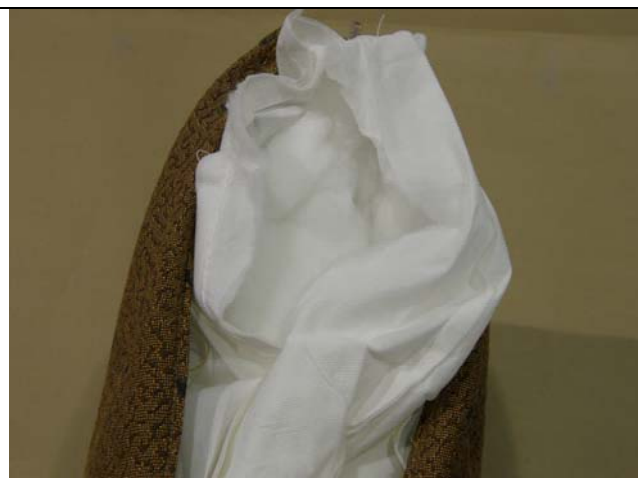
**Figure 3.4-4. Back cushion, showing the upholstery fabric, inner liner, and polyurethane foam.**

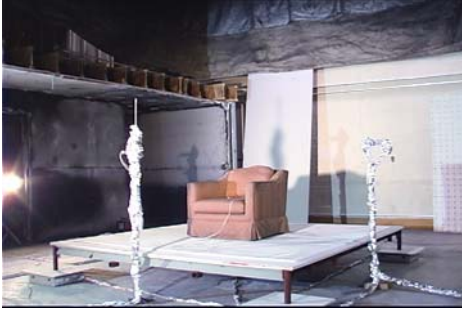
**Figure 3.4.1-1. Chair 1, ignition**

The first upholstered chair was ignited with the electric match positioned at the intersection of the rear corner of the seat cushion, a lower corner of the back cushion and an arm of the chair. Figure 3.4.1-1 through Figure 3.4.1-10 make up a series of photographs starting at the time of ignition through 800 s after ignition. The photographs are shown at intervals of 100 s, with the exception of Figure 3.4.1-6.

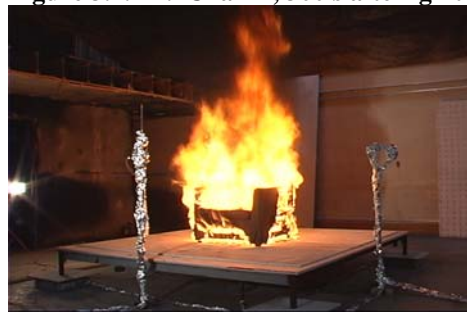
**Figure 3.4.1-6. Chair 1, at peak heat release rate, 417 s after ignition**

Figure 3.4.1-6 shows the chair fire at the time of peak heat release rate, 417 s after ignition. As shown in the Figures Figure 3.4.1-2 through Figure 3.4.1-4, the fire spread from a small ignition area to an area that involved a portion of both cushions and both interior surfaces of the arms of the chair. Shortly after this, the fire began to spread through the body of the chair as shown in Figure 3.4.1-5. This was due to flame contact and burning foam from the seat cushion dropping fire down to lower sections of the chair and the floor below the chair.

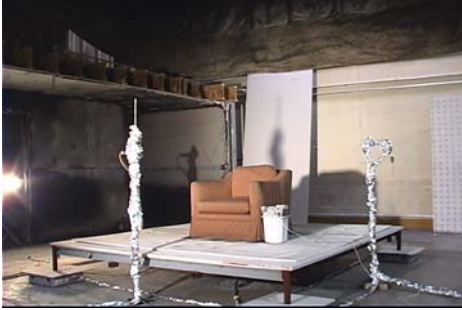
**Figure 3.4.2-1. Chair 2, ignition**

Upholstered chair 2 was ignited with a trash container fuel package positioned adjacent to one side of the chair as shown in Figure 3.4.2-1. Figure 3.4.2-1 through Figure 3.4.2-10 each have a photograph taken between 100 s and 800 s after ignition. Most of the photographs are taken at intervals of 100 s with the exception of Figure 3.4.2-6. The image in Figure 3.4.2-6 was recorded at the time of peak heat release rate, 437 s after ignition. Even though upholstered chair 2 had a significantly different ignition source from upholstered chair 1, the images recorded at 400 s after ignition in both cases provide similar levels of fire development within each chair.

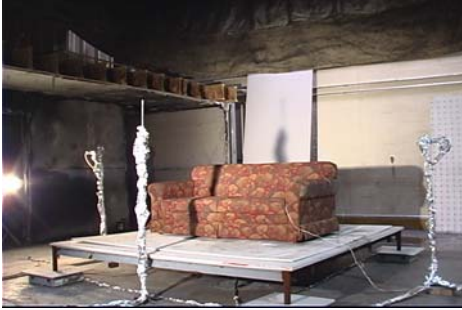
**Figure 3.5-1. Sofa 1, ignition**

Both of the sofa experiments used the same ignition scenario; an electric match located at the intersection of a rear corner of a seat cushion, an arm of the sofa, and a lower corner of a back cushion.

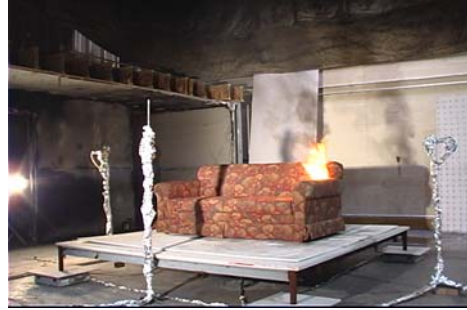
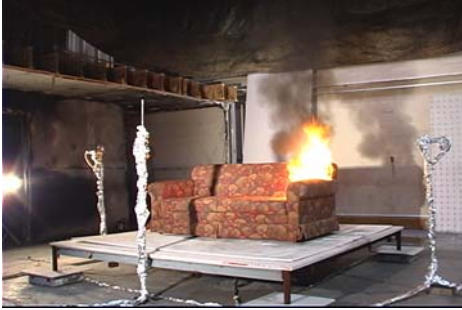
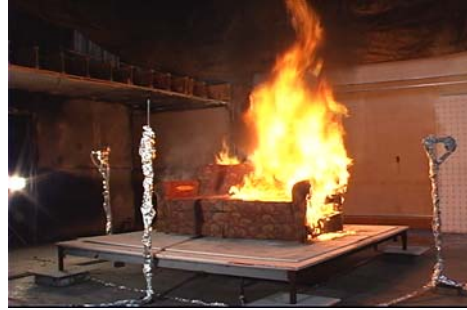
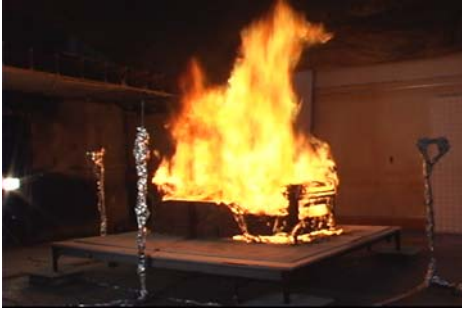
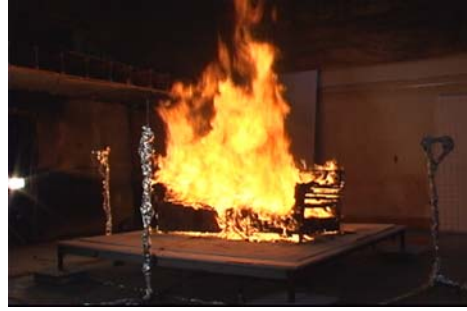
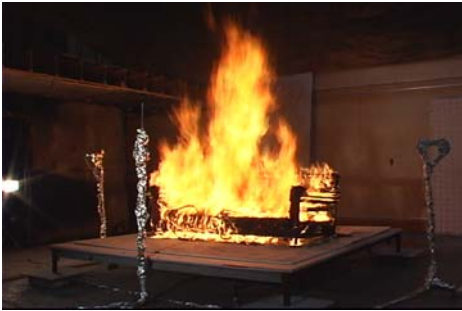
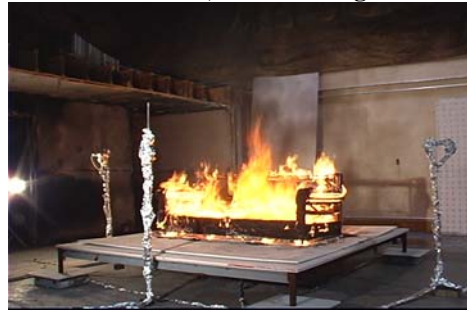
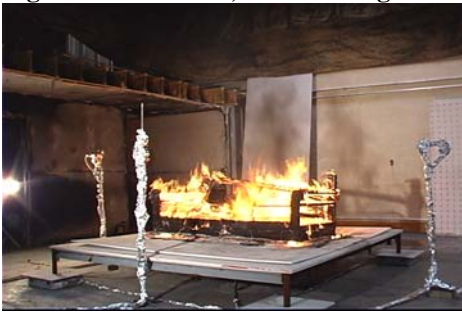
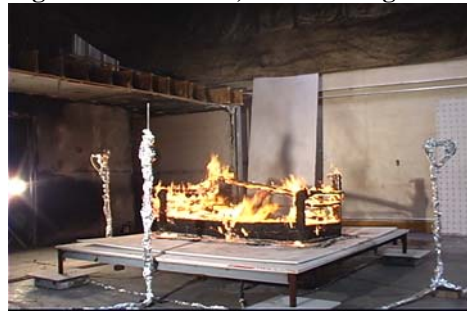
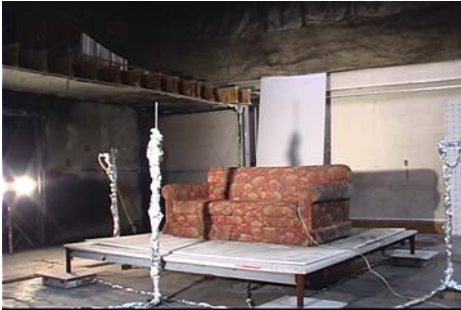
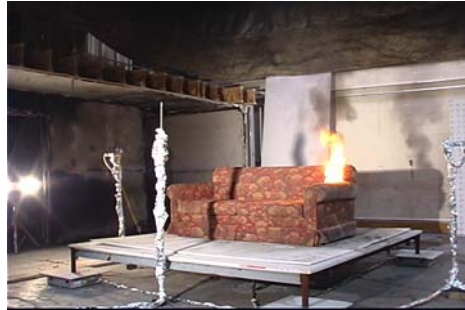
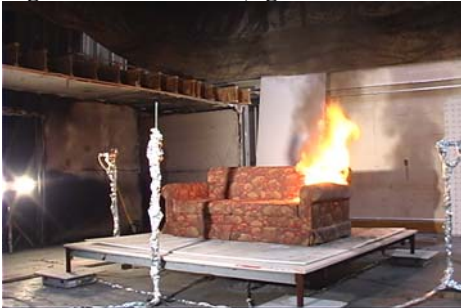
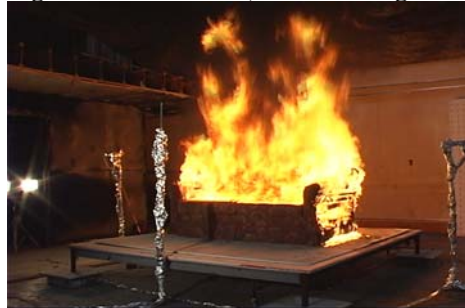
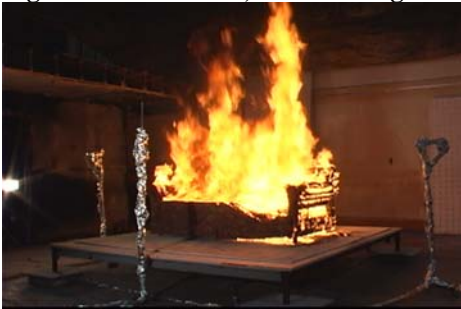
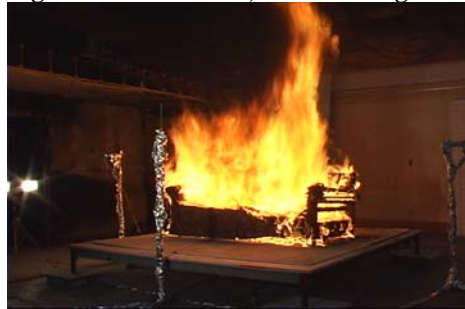
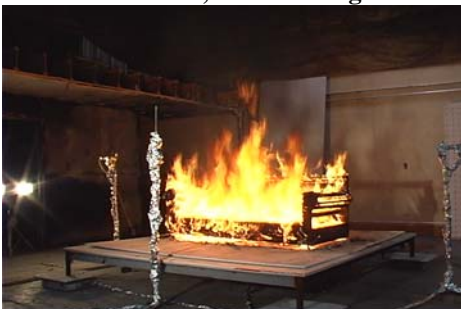
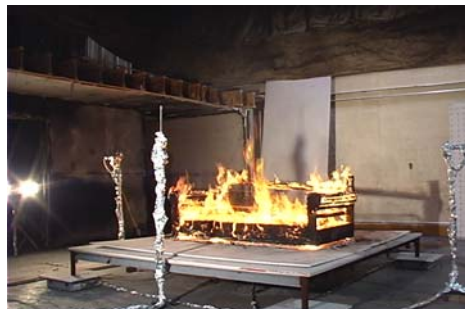
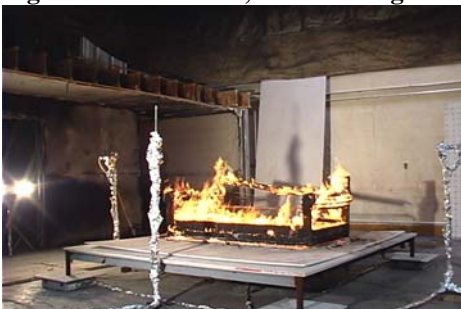
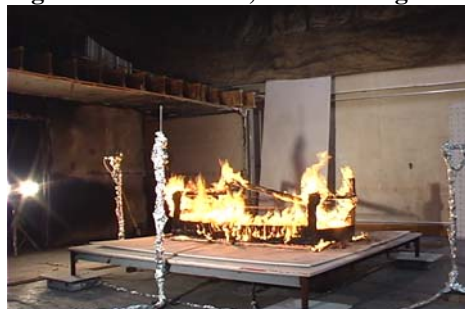
Figure 3.5-1 through Figure 3.5-10 and Figure 3.5-11 through Figure 3.5-20 present images recorded between ignition and 800 s after ignition for both of the sofa experiments. Each set contains images taken every 100 s after ignition during that period. In addition, Figure 3.5-6 for sofa 1 and Figure 3.5-15 for sofa 2 show the fires at the time of peak heat release rate, 455 s and 389 s after ignition respectively. The times to peak heat release rate were more than 60 s apart. The fire spread for both of the sofas was very similar for the first 200 s. During the interval from 200 s to 300 s, sofa 1 had flames moving across the back side of the sofa, while sofa 2 contained the flames to the seat cushion area resulting in flames from one end of the sofa to the other. By 400 s after ignition sofa 1 and sofa 2 had similar levels of flame throughout. At 800 s after ignition, the wood frames of both sofas were still burning along with debris in and below the pullout mattress mechanism.

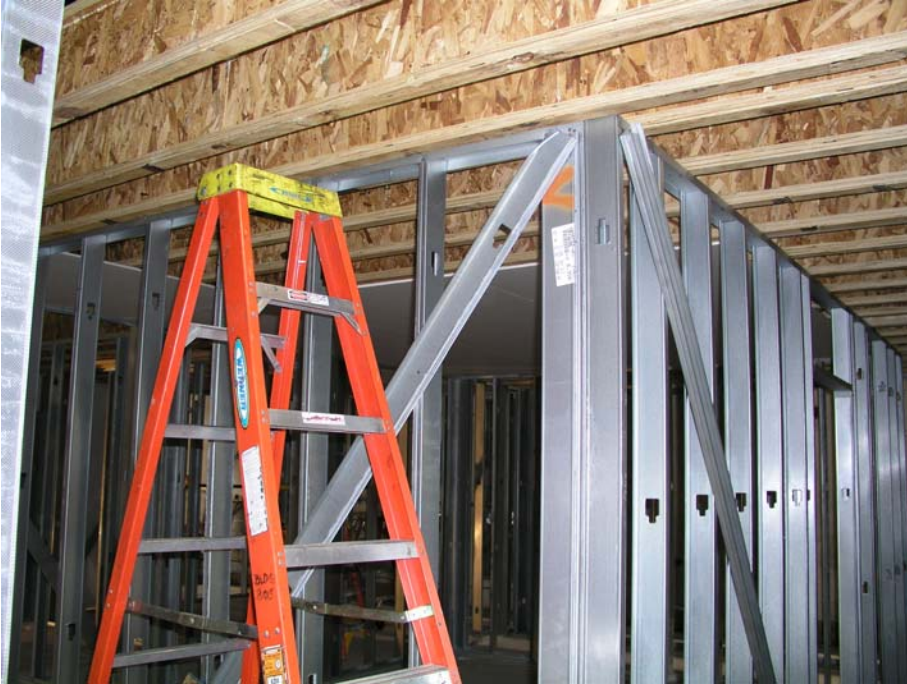
**Figure 4.1.1-3. Ceiling supports for experimental structure.**

One layer of 13 mm (0.5 in) thick cement board panels was laid on the concrete floor of the facility to form a protective foundation for the structure. This layer was covered with 13 mm (0.5 in thick) gypsum board. The structure was framed with steel studs and track as shown in Figure 4.1.1-2. The studs were set to 0.40 m (16 in) centers. The ceiling support was composed of wood truss joist I-beams (TJIs) with a 299 mm (11.88 in) depth. The TJI was composed of laminated veneer lumber flanges with a cross section of 38 mm (1.5 in) x 57 mm (2.25 in) and an 11 mm (0.43 in) thick oriented strand board web as shown in Figure 4.1.1-3.

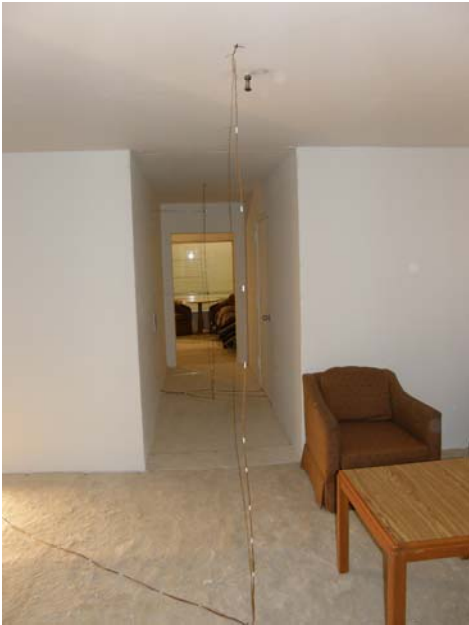
**Figure 4.1.3-2. Thermocouple arrays along center line of structure looking from east to west.**

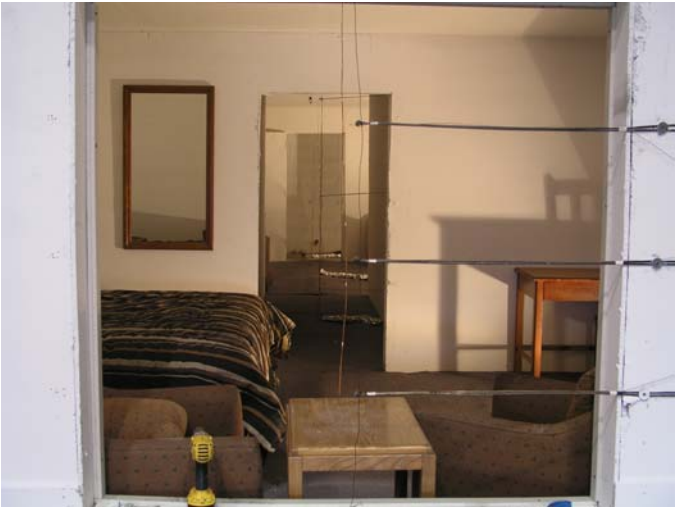
**Figure 4.1.3-3. Bi-directional probe array in west window.**

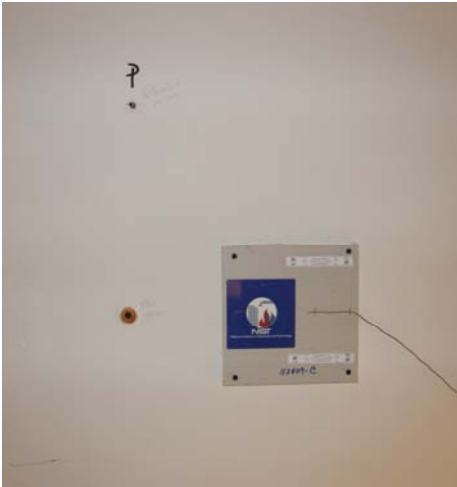
**Figure 4.1.3-4. Wall mounted thermocouples, heat flux sensor, and differential pressure sampling port.**

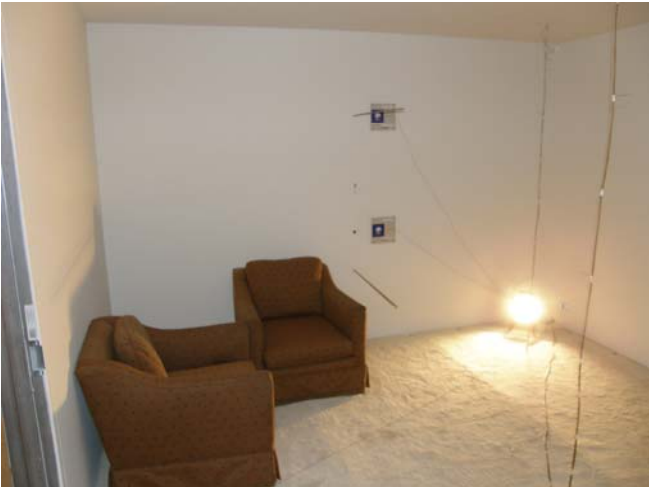
**Figure 4.1.3-5. Gas sampling probe installation on south wall of living room.**

The sampling tubes were connected to a calibrated pump which pulled the gas samples through a sample conditioning system to eliminate moisture in the gas sample. The dry gas sample was then piped to a series of gas analyzers. In all of the experiments, oxygen was measured using paramagnetic analyzers and carbon monoxide and carbon dioxide were measured using non-dispersive infrared (NDIR) analyzers for all four locations. In the latter experiments, total unburned hydrocarbons were measured from the two upper layer positions 0.61 m (2 ft) below the ceiling using flame ionization detectors (FID). Details of this gas sampling and measurement system can be found in [44, 45]. Single thermocouples were also co-located with the gas sample inlet ports. Figure 4.1.3-5 is a photograph of the south wall of the living room, which shows the gas sampling ports.

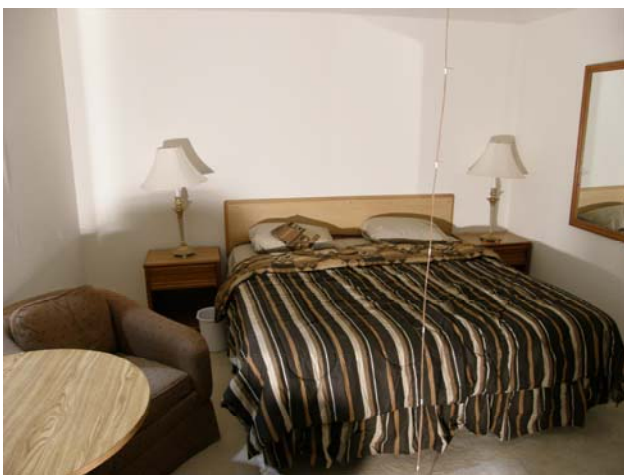
Figure 4.2-2. Bedroom furnishings, looking north.

The bedroom fuel load and its arrangement are shown in Figure 4.2-1 through Figure 4.2-3. Descriptions of the furnishing dimensions, materials, and mass are given in Table 4.2-1. The total mass of the furnishings, carpeting and carpet padding in the bedroom fuel package was 406 kg (894 lbs). Based on metal removed after the experiments, the combustible mass of the bedroom fuel package was 350 kg (769 lbs). Taking those totals and dividing by the floor area of the bedroom yielded total and combustible fuel loadings of 22.8 kg/m<sup>2</sup> (4.7 lb/ft<sup>2</sup>) and 19.6 kg/m<sup>2</sup> (4.0 lb/ft<sup>2</sup>), respectively. This did not take the subfloor or the painted gypsum board walls and ceilings into account.

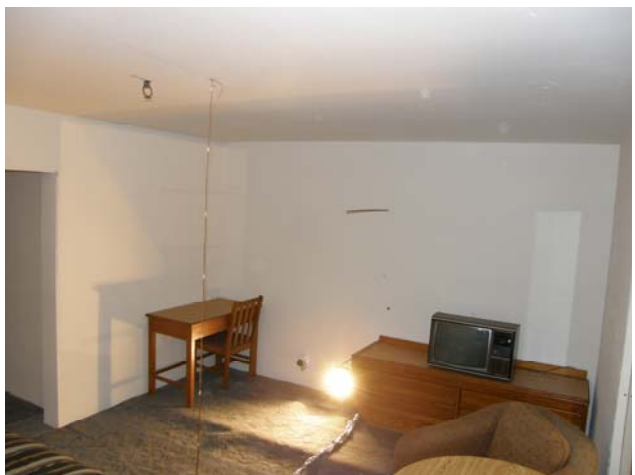
Figure 4.2-3. Bedroom furnishings, looking south.

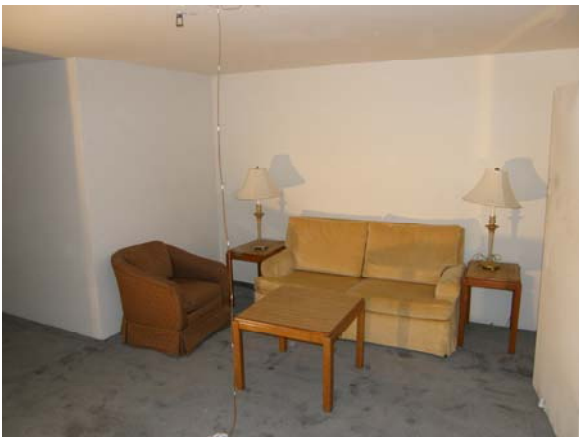
Figure 4.2-5. Living room furniture, looking north.

The living room fuel load and its arrangement are shown in Figure 4.2-4 through Figure 4.2-6. Descriptions of the furnishing dimensions, materials and mass are given in Table 4.2-2. The mass of the fuel load in the living room was less than the bedroom. The total mass of the furnishings, carpeting and carpet padding in the living room was 254 kg (558 lbs). Based on metal removed after the experiments, the approximate combustible mass of the living room fuel package was 218 kg (479 lbs). Taking those totals and dividing by the floor area of the living room yielded total and combustible fuel loadings of 14.2 kg/m<sup>2</sup> (2.9 lb/ft<sup>2</sup>) and 12.2 kg/m<sup>2</sup> (2.5 lb/ft<sup>2</sup>), respectively. Again, this did not take the subfloor or the painted gypsum board walls and ceilings into account.

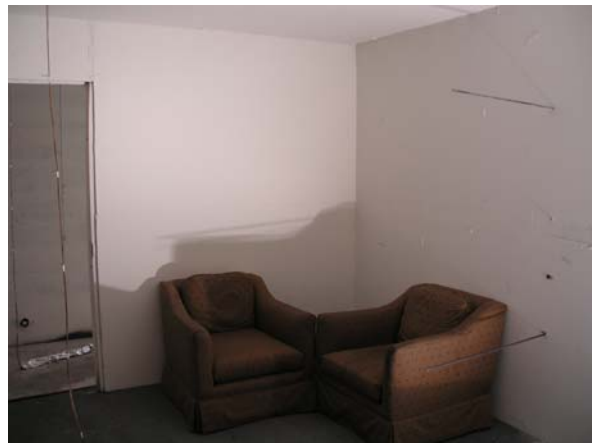
Figure 4.2-6. Living room furnishings, looking east.

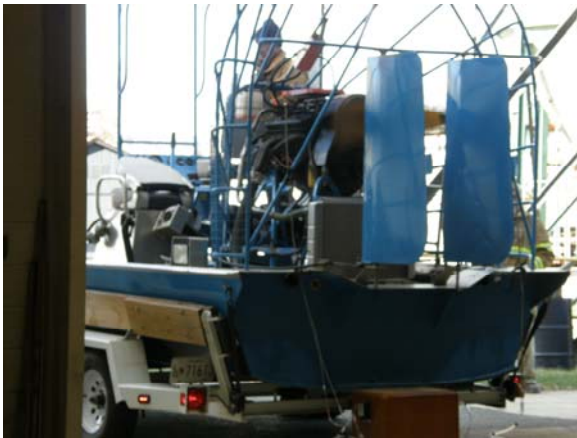
Figure 4.3-1. Air boat from inside of fire lab looking west.

The boat was positioned 9.6 m (31.5 ft) from the west exterior of the structure, the fan was centered on the window and the steering vanes were locked down in the "straight" position as shown in Figure 4.3-1. The roll-up door was raised to create an opening, 4.05 m (13.3 ft) high and 4.88 m (16.0 ft). The boat was leveled so that the centerline of the propeller hub was parallel to the floor of the large fire facility. The centerline of the propeller was 2.13 m (7.0 ft) above ground level. The fan was operated at speeds between 800 rpm and 3000 rpm. Based on hand-held anemometer readings this range provided air speeds of 2.2 m/s (5 mph) to 11.4 m/s (25 mph) at the window opening of the structure.

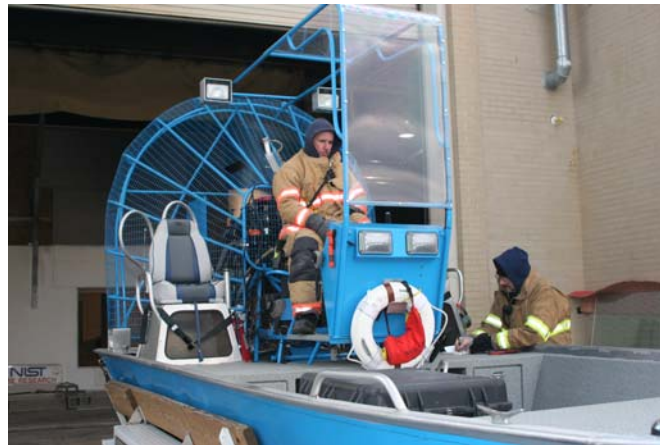
Figure 4.3-2. Air boat from outside of the fire lab looking east.

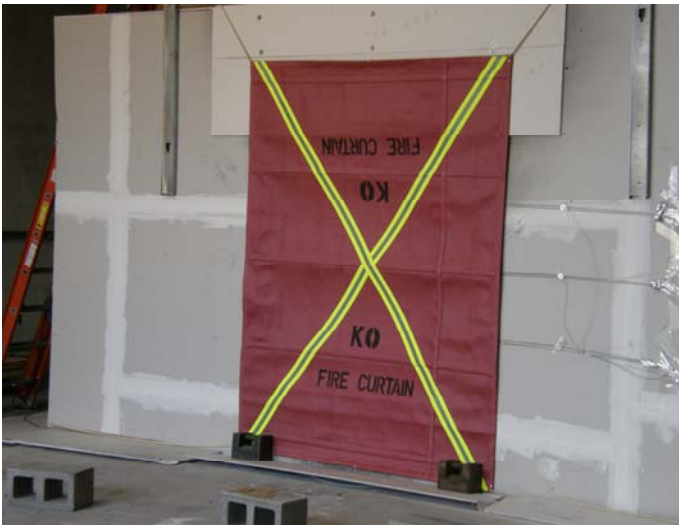
Figure 4.3.2-1. Small WCD deployed over window opening.

The main differences between the two devices are size, weight and stiffness. The smaller WCD measured 1.8 m (6.0 ft) by 2.4 m (8.0 ft) and weighed approximately 12.3 kg (27.1 lbs). It was reinforced with metal rods and had a rope fastened at each corner to secure it. This device, given the size and shape, could be deployed by one firefighter from the floor above the fire. Figure 4.3.2-1 shows the small WCD deployed over the 1.52 m (5.00 ft) by 1.52 m (5.00 ft) window opening under approximately 20 mph wind conditions as generated by the fan. The metal rods hold the fabric flush to the face of the structure. The upper corners were tied off to the structure and the lower corners were secured with weights.

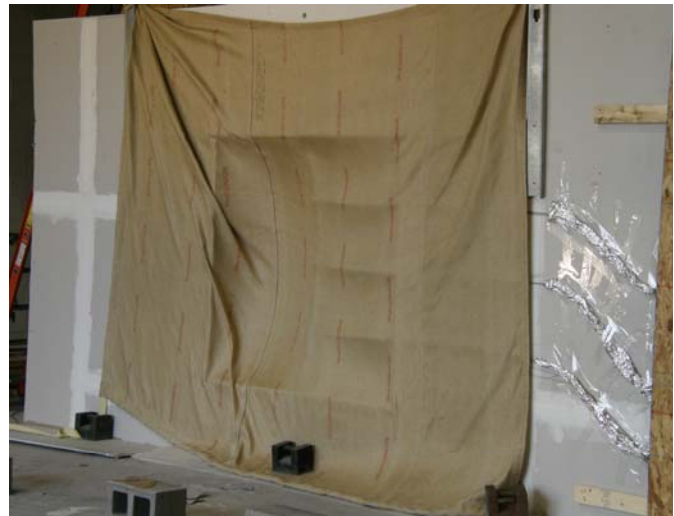
Figure 4.3.2-2. Large WCD deployed over window opening.

The second WCD measured 2.95 m (9.66 ft) by 3.66 m (12.0 ft) and weighed approximately 20.5 kg (45.2 lbs). This WCD had a chain sewn into the bottom of the curtain to assist with deployment. It also had tether straps attached at each corner. This device would typically require two or more firefighters to deploy and secure in place. Figure 4.3.2-2 shows the large WCD deployed over the same window opening under similar wind conditions as the small WCD. In this case the fabric was blown into the window opening. The upper corners were secured to the structure and the lower edge was secured with weights. The right side of the WCD may have been pushed further into the window opening but it is being held by the three bi-directional probes in the window opening.

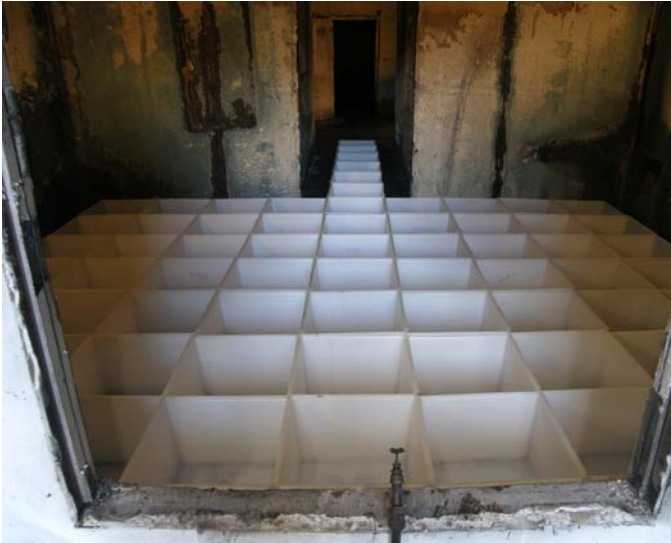
**Figure 4.3.3-1. Water spray distribution experiment arrangement.**

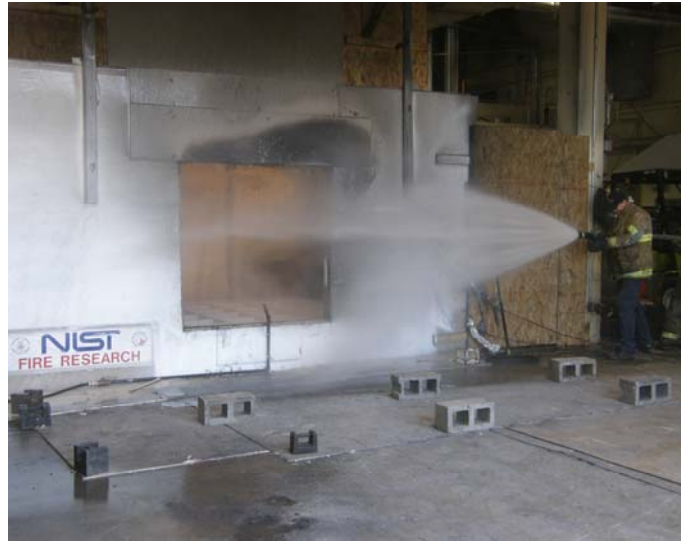
**Figure 4.3.3-2. Fog stream discharged across window opening.**

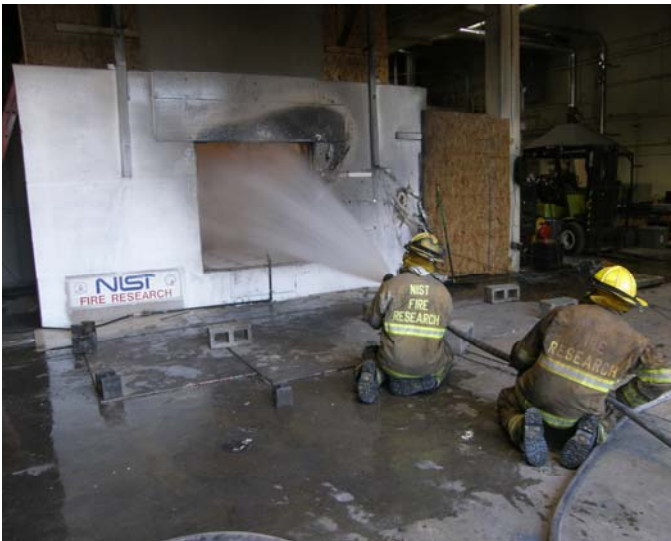
**Figure 4.3.3-3. Fog stream discharged into window opening.**

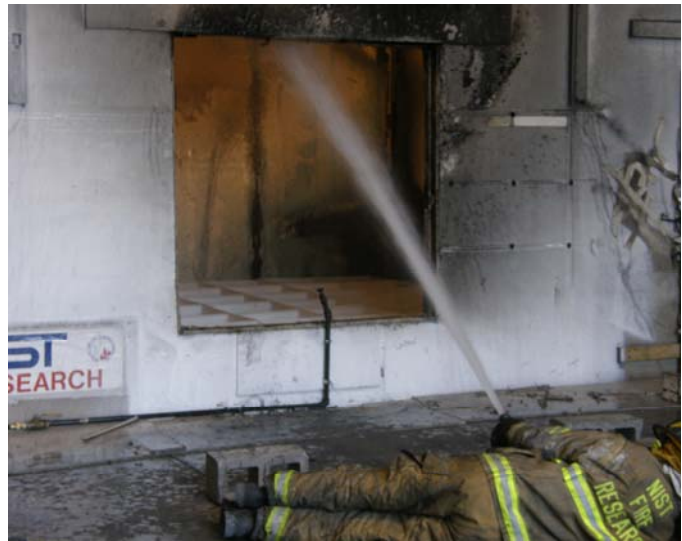
**Figure 4.3.3-4. Solid stream discharged into window opening.**

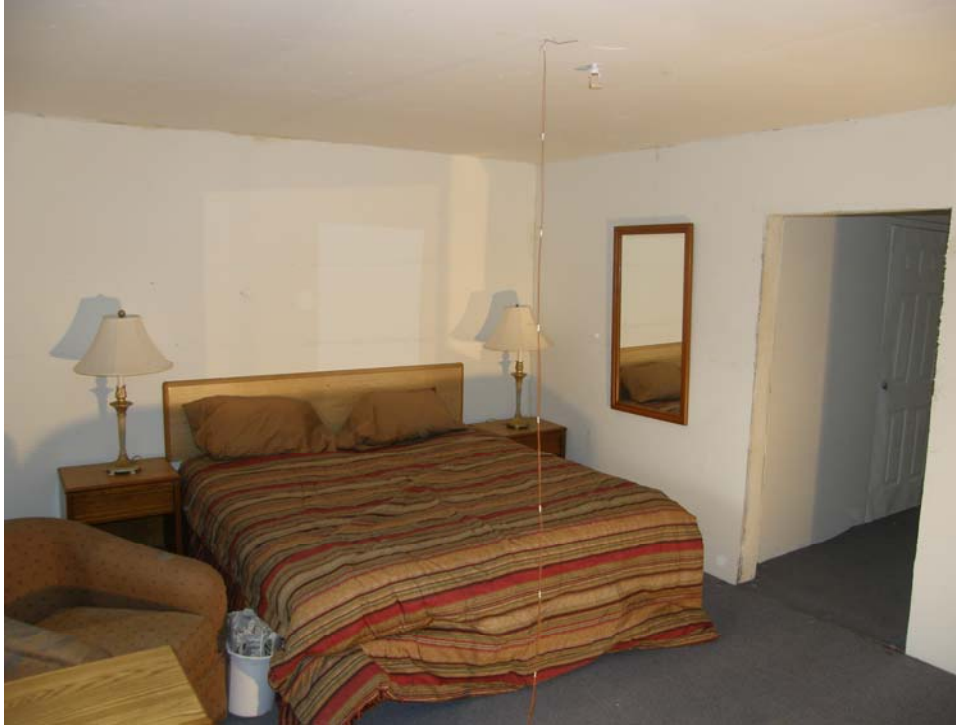
**Figure 5-1. Photograph of the placement of the trash container fuel package ignition source.**

After ignition, the fires grew unaided. The fires continued to grow and eventually transferred enough energy to the 6 mm (0.25 in) thick window glass to cause it to fail, either a crack or an opening created by cracking glass. After window failure, a researcher in a firefighter personal protective ensemble (PPE), would clear out the remaining pieces of glass so that the effective window opening size would be consistent for each experiment. Then the fire was observed until it appeared that it had spread through the structure and untenable conditions, even for a fully protected firefighter, existed in the corridor portion of the structure. Then, the mitigation tactics were employed, and ultimately the fire was suppressed.

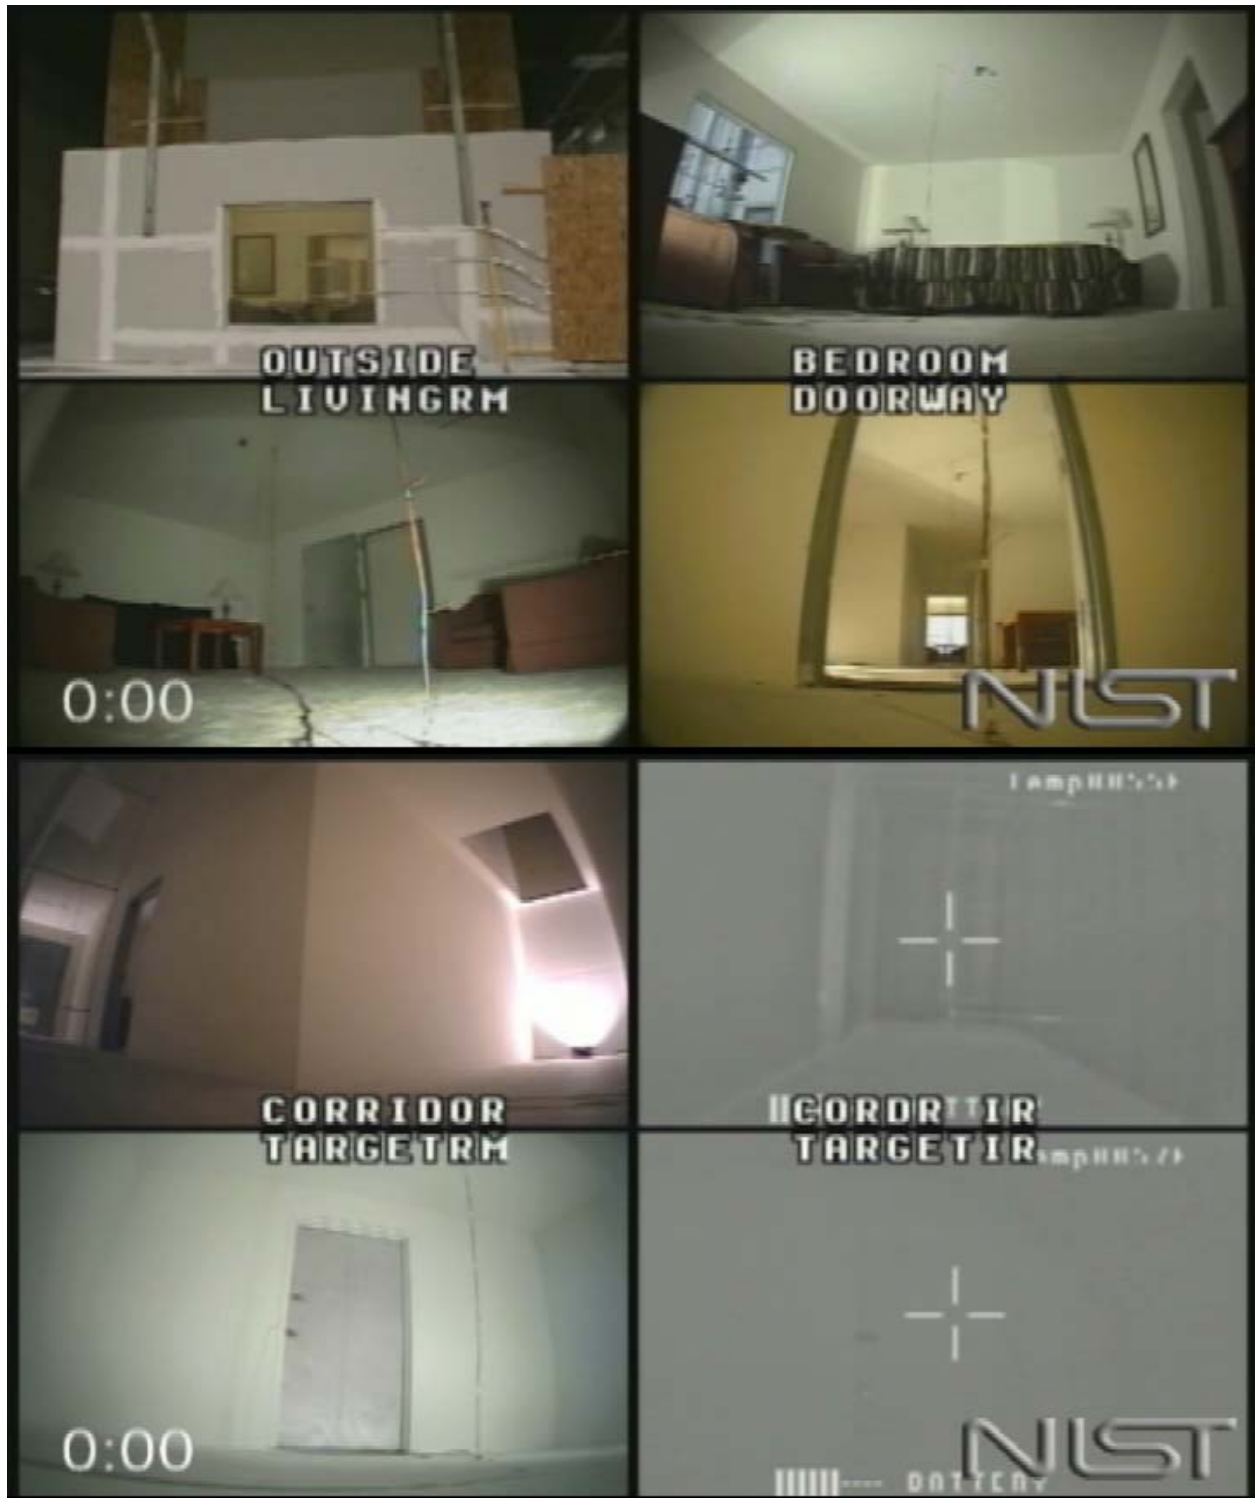
Figure 5.1.1-1. Experiment 1, ignition.

Figure 5.1.1-1 shows the conditions at the time of ignition. At this point, the six video views are clear and unobstructed. However, the thermal images provide limited thermal contrast, because the surfaces in the view were at nearly equal temperature.
