# NIST Technical Note 1618

## Fire Fighting Tactics Under Wind Driven Conditions: Laboratory Experiments

Daniel Madrzykowski  
Stephen Kerber

U.S. Department of Commerce  
Building and Fire Research Laboratory  
National Institute of Standards and Technology  
Gaithersburg, MD 20899

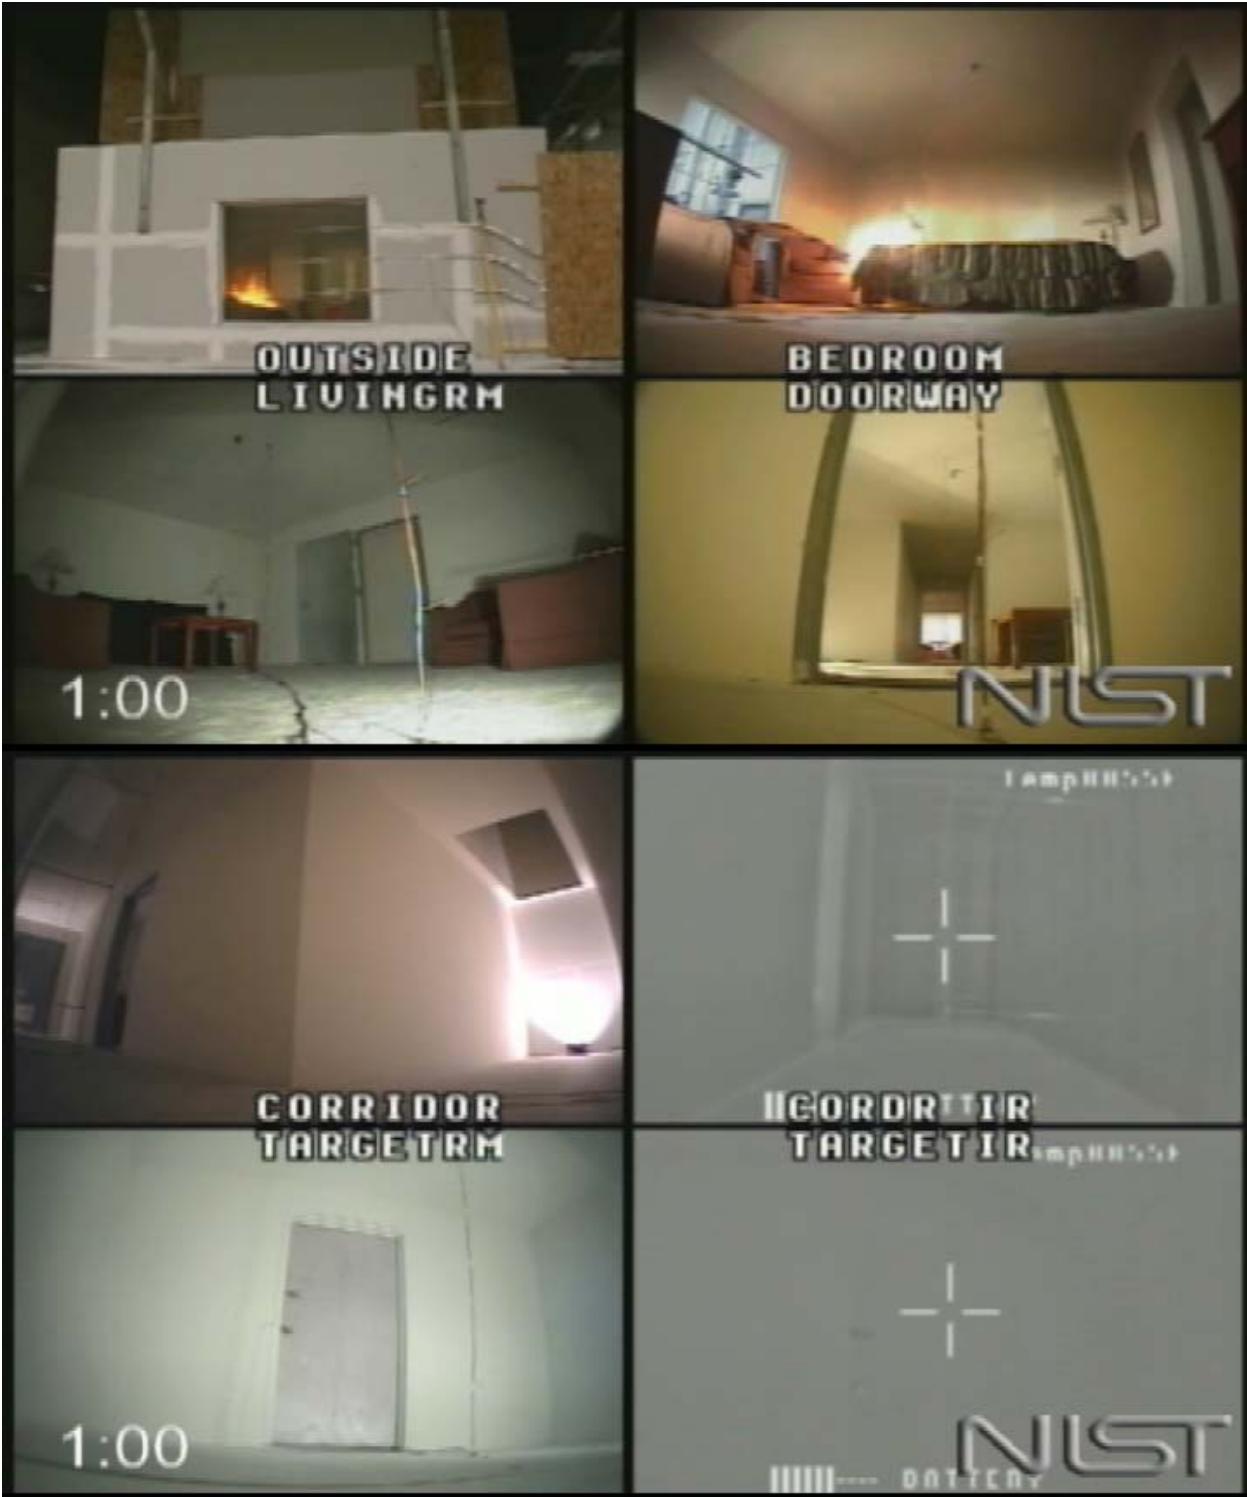
Figure 5.1.1-2. Experiment 1, 60 s after ignition.

The images in Figure 5.1.1-2 were captured 60 s after ignition. The fire from the trash container spread to both the bed and the upholstered chair. A smoke layer formed in the bedroom, and the ceiling jet started to move down the hall. There was no smoke or change in thermal condition in the living room, target room or corridor at this time.

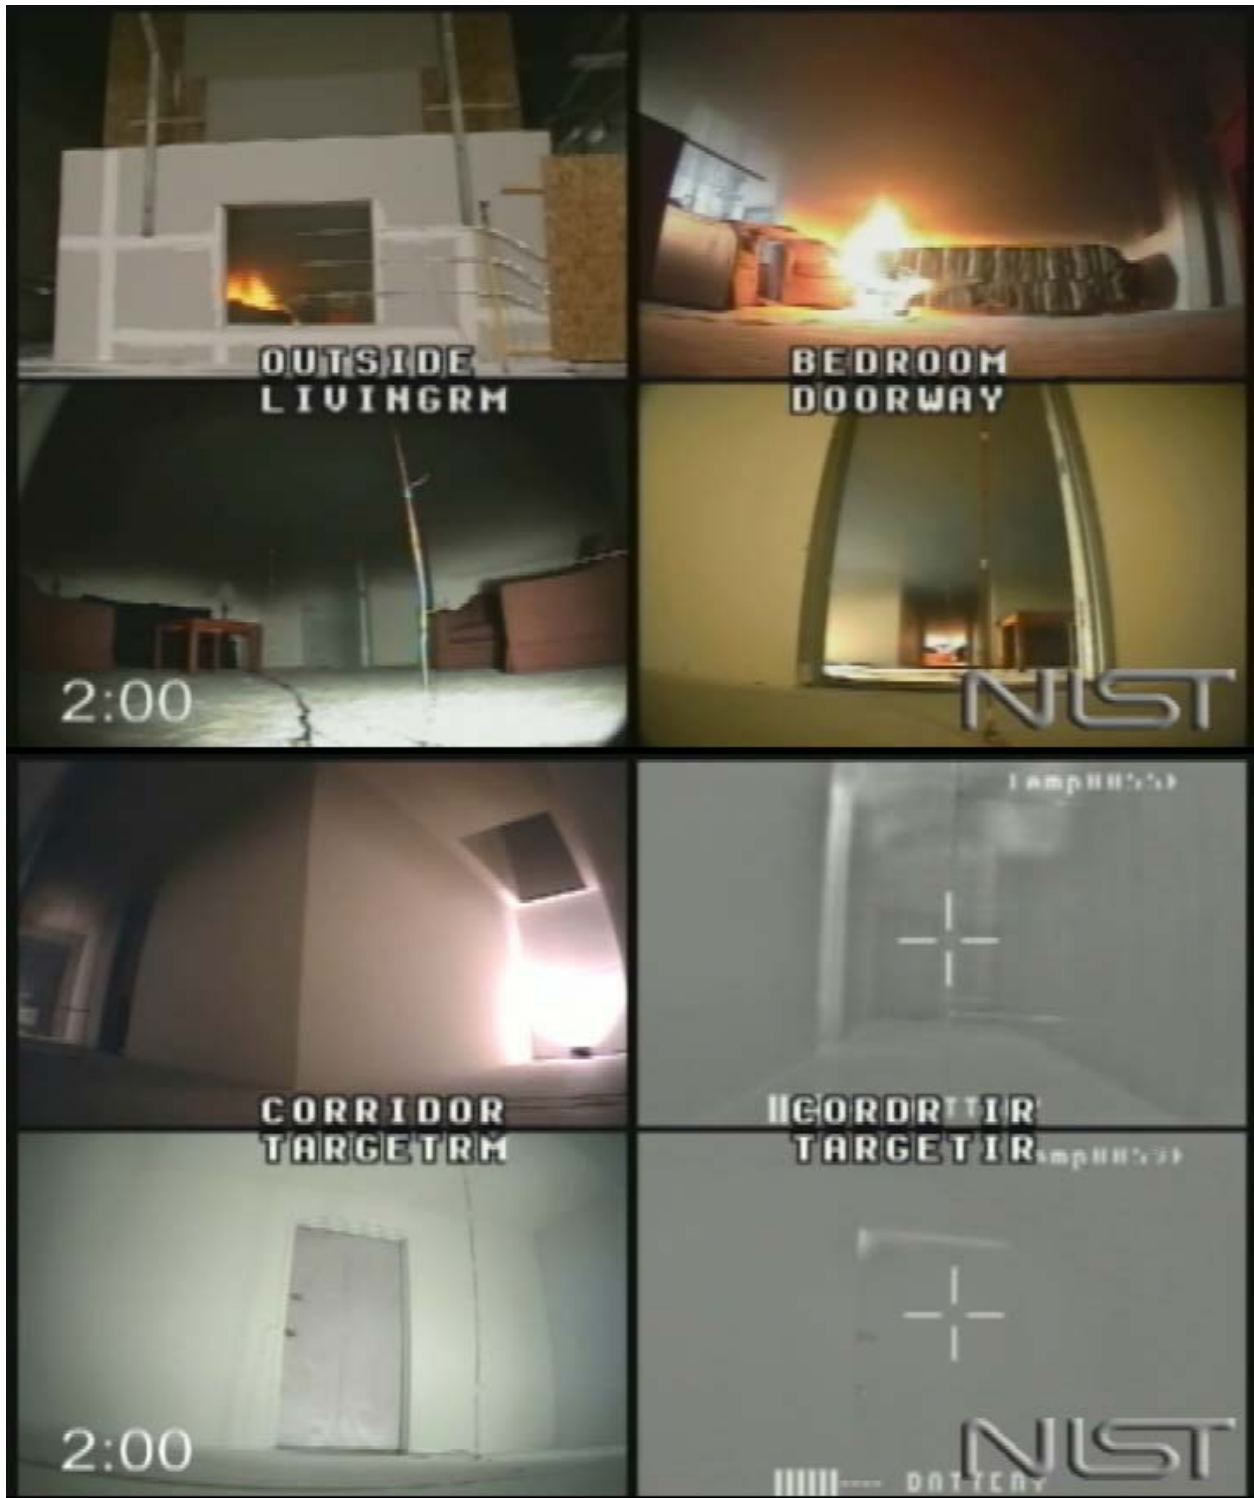
Figure 5.1.1-3. Experiment 1, 120 s after ignition.

The images in Figure 5.1.1-3 were recorded at 120 s after ignition. The area involved in fire between the bed and the chair increased in size. The smoke layer was approximately 1.2 m (4 ft) thick throughout the bedroom, hall and living room. Smoke and heat had just started to flow into the corridor. The target room appears clear of smoke; however the target room IR view shows some heat infiltration along the top edge of the door between the hall and the target room.

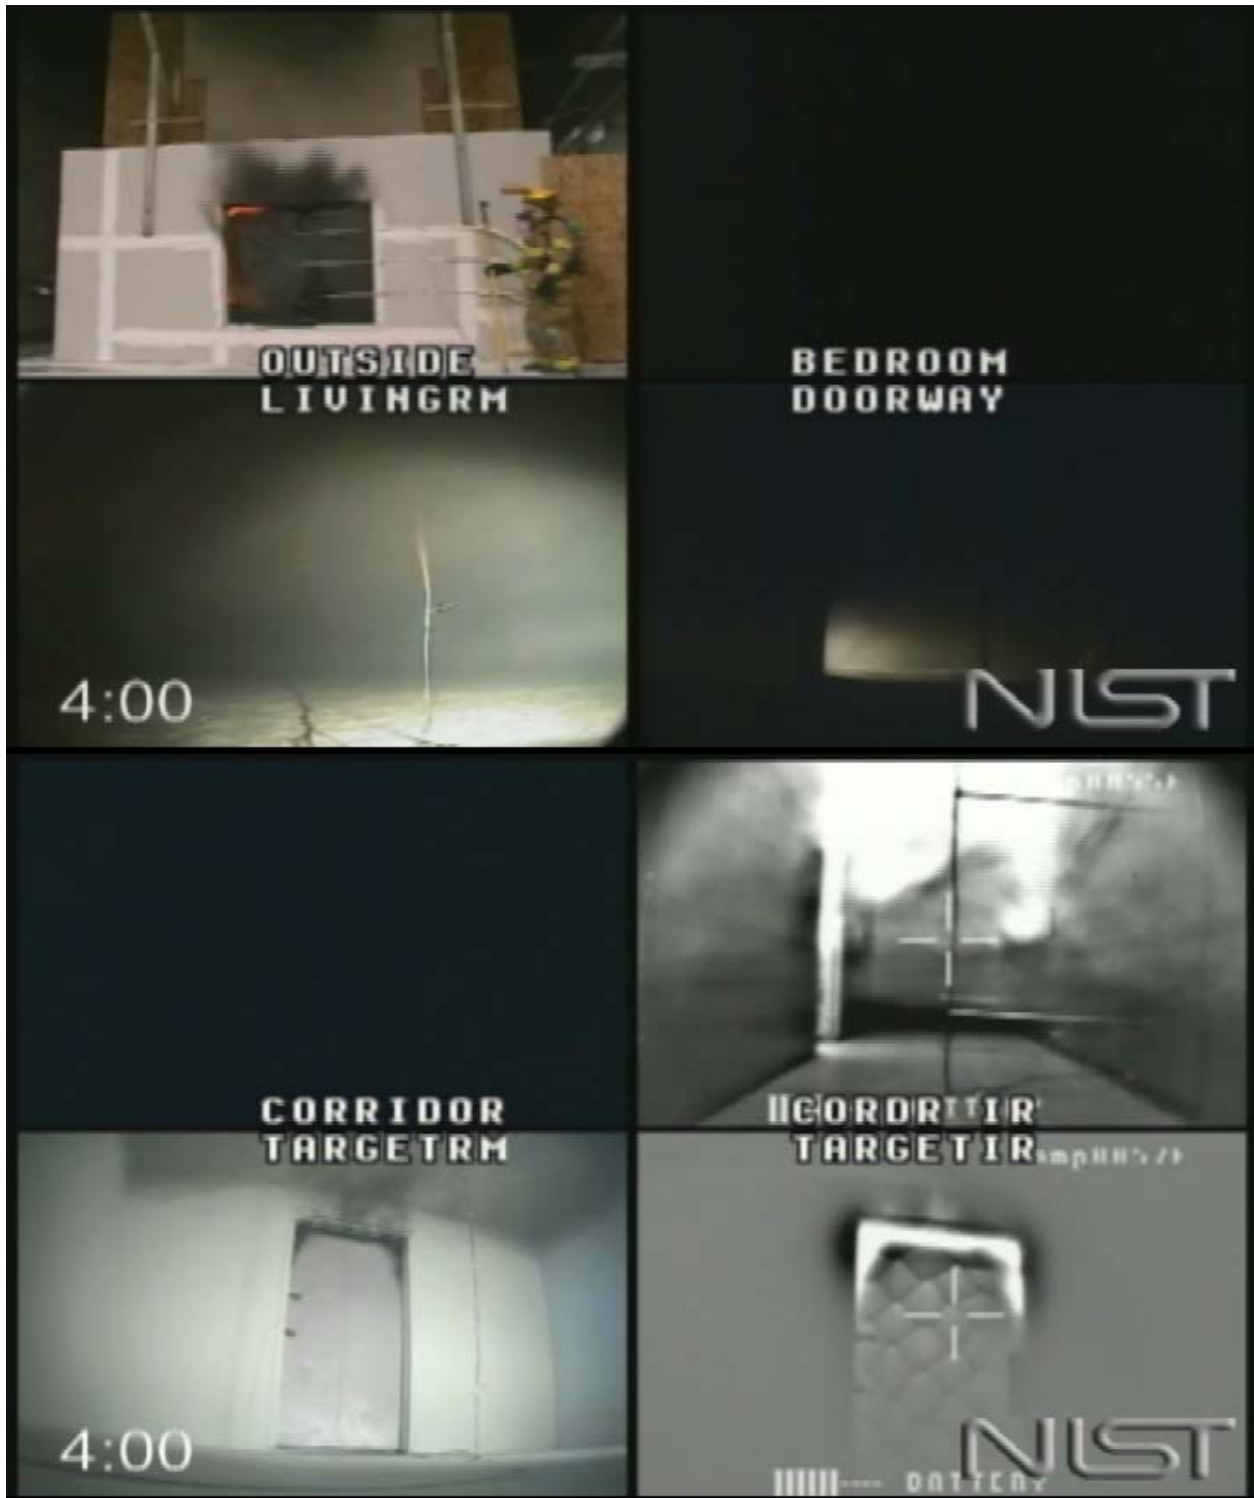
Figure 5.1.1-5. Experiment 1, 240 s after ignition.

Figure 5.1.1-5 shows the conditions at 240 s after ignition. After flames had impinged directly on the upper north side corner of the window, a section of glass had broken out along the top edge of the window, which allowed smoke to vent out. The smoke layer had descended to the floor in the bedroom. This coated the lens of the bedroom camera, which obscured the view for the remainder of the experiment. The smoke layer was down to within 0.3 m of the floor in the living room and in the corridor. The heat in the corridor was still stratified. The video view of the door to the target room showed increased smoke flow into the target room. The thermal image of the target room door showed that the door was transferring heat.

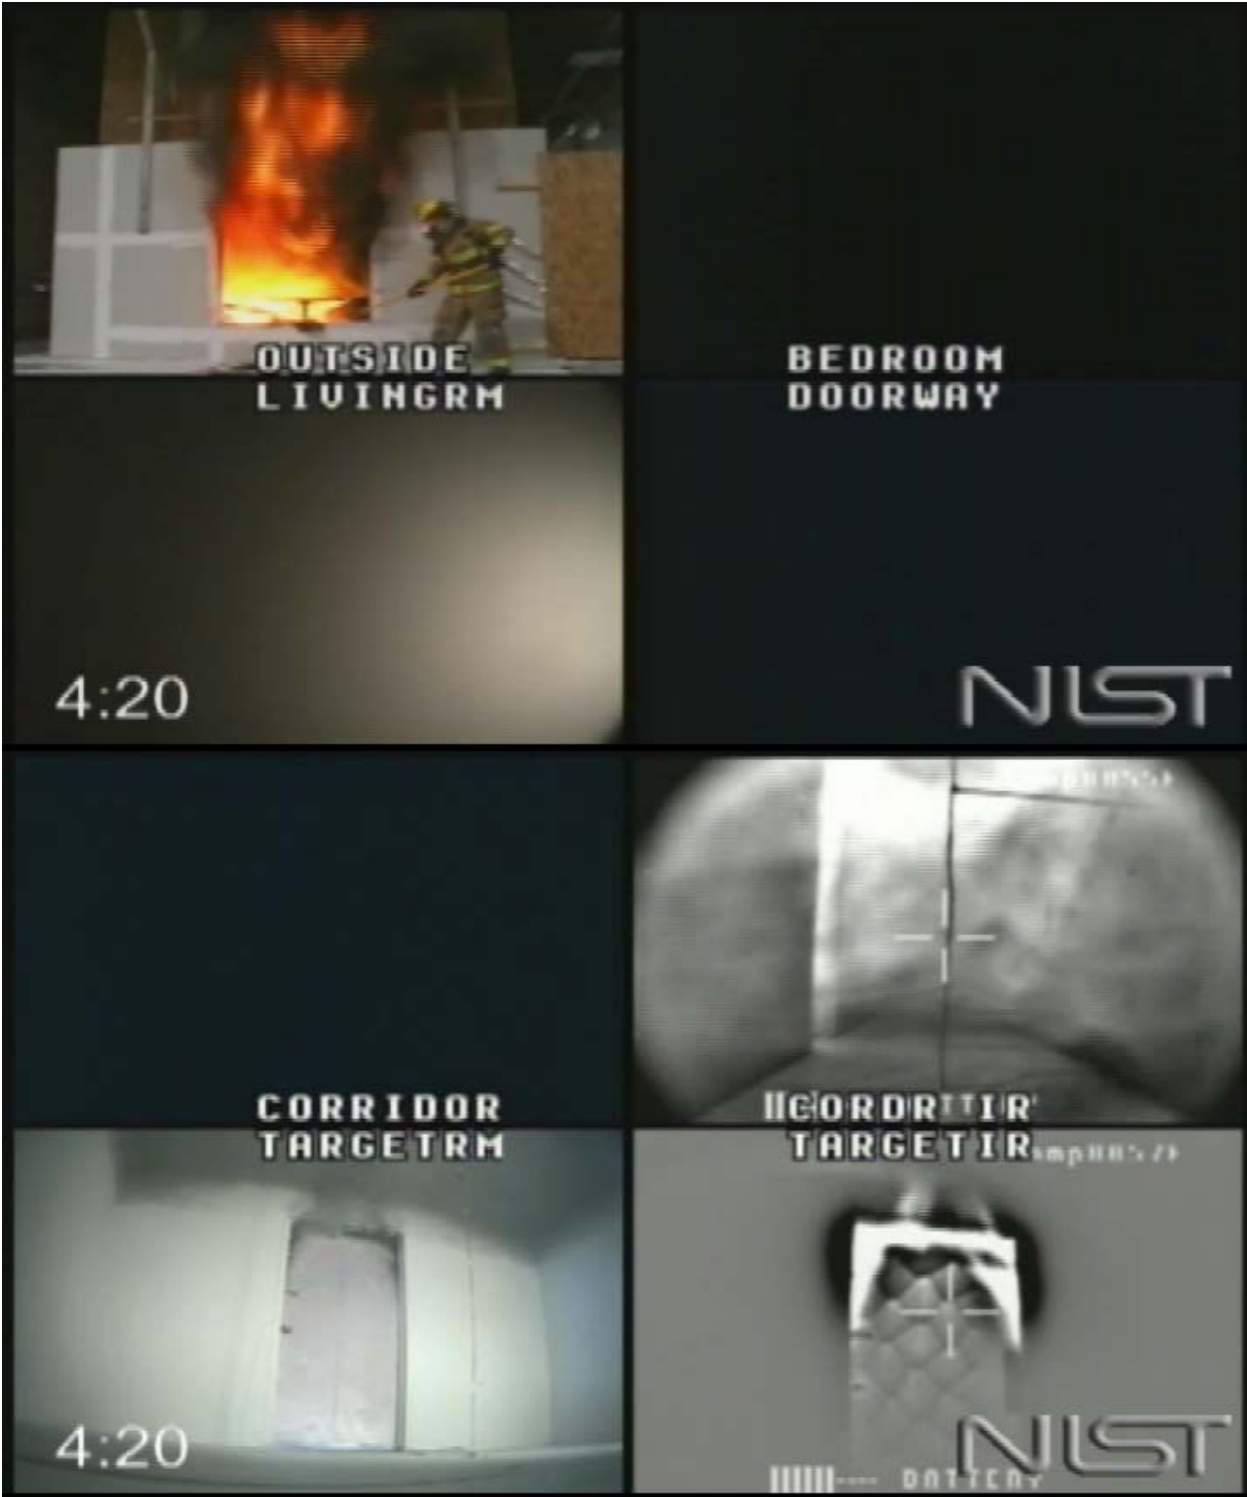
Figure 5.1.1-6. Experiment 1, window fully vented, 260 s after ignition.

As the flames continued to contact the north edge of the window, more glass along the north edge failed, however, the majority of the window glass remained intact. The window was manually vented beginning at 248 s after ignition and completed at 260 s after. Figure 5.1.1-6 shows the images recorded as the clearing of the glass was completed. The fire exiting the bedroom window increased in size as the glass was removed. The views in the bedroom, living room and corridor were obscured by smoke. The thermal image of the corridor shows that the heat flow out of the doorway had the most energy flow out of the top of the door, gradually becoming less intense nearer to the floor. A thin smoke layer, less than 0.3 m thick, had developed across the ceiling of the target room. More heat was flowing into the target room.

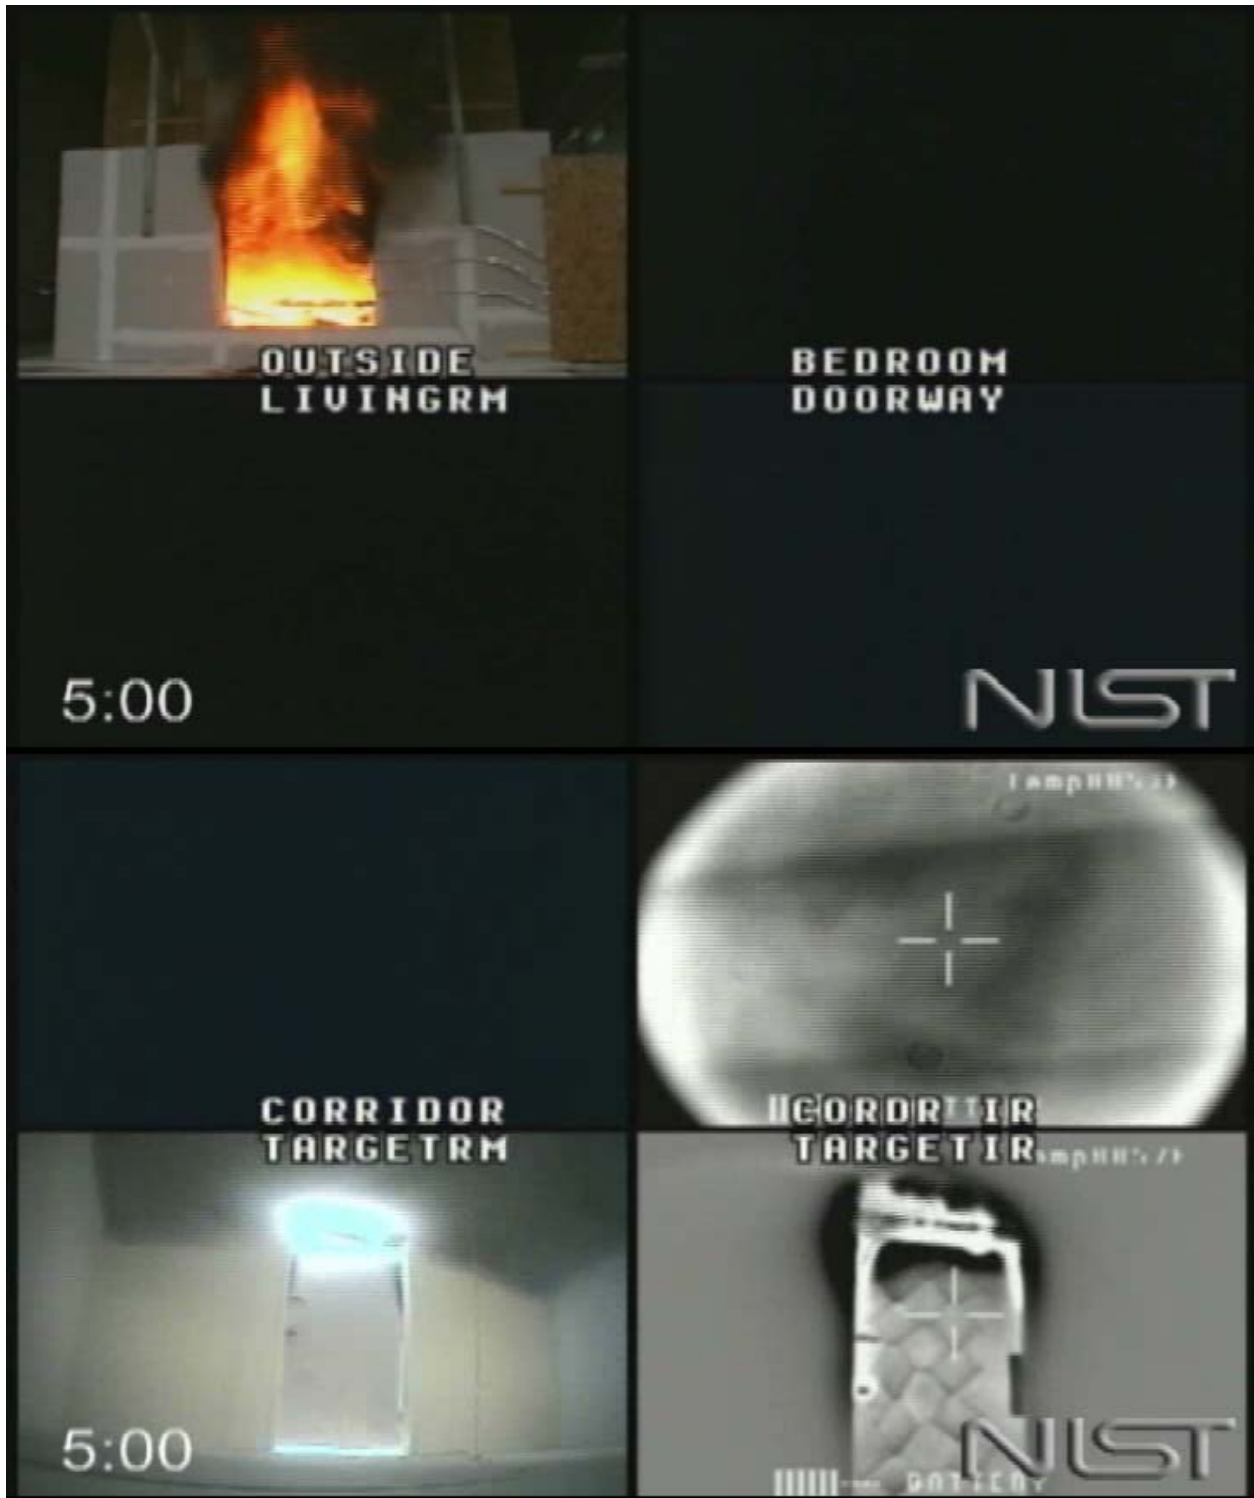
Figure 5.1.1-7. Experiment 1, 300 s after ignition.

Figure 5.1.1-7 shows the images recorded at 300 s after ignition. Flames continued to flow out of the window opening. All of the images in the flow path from the window to the corridor vent were obscured by smoke or heat. Flames had started to burn through the top of the target room door and flames can be seen at the bottom of the door as well.

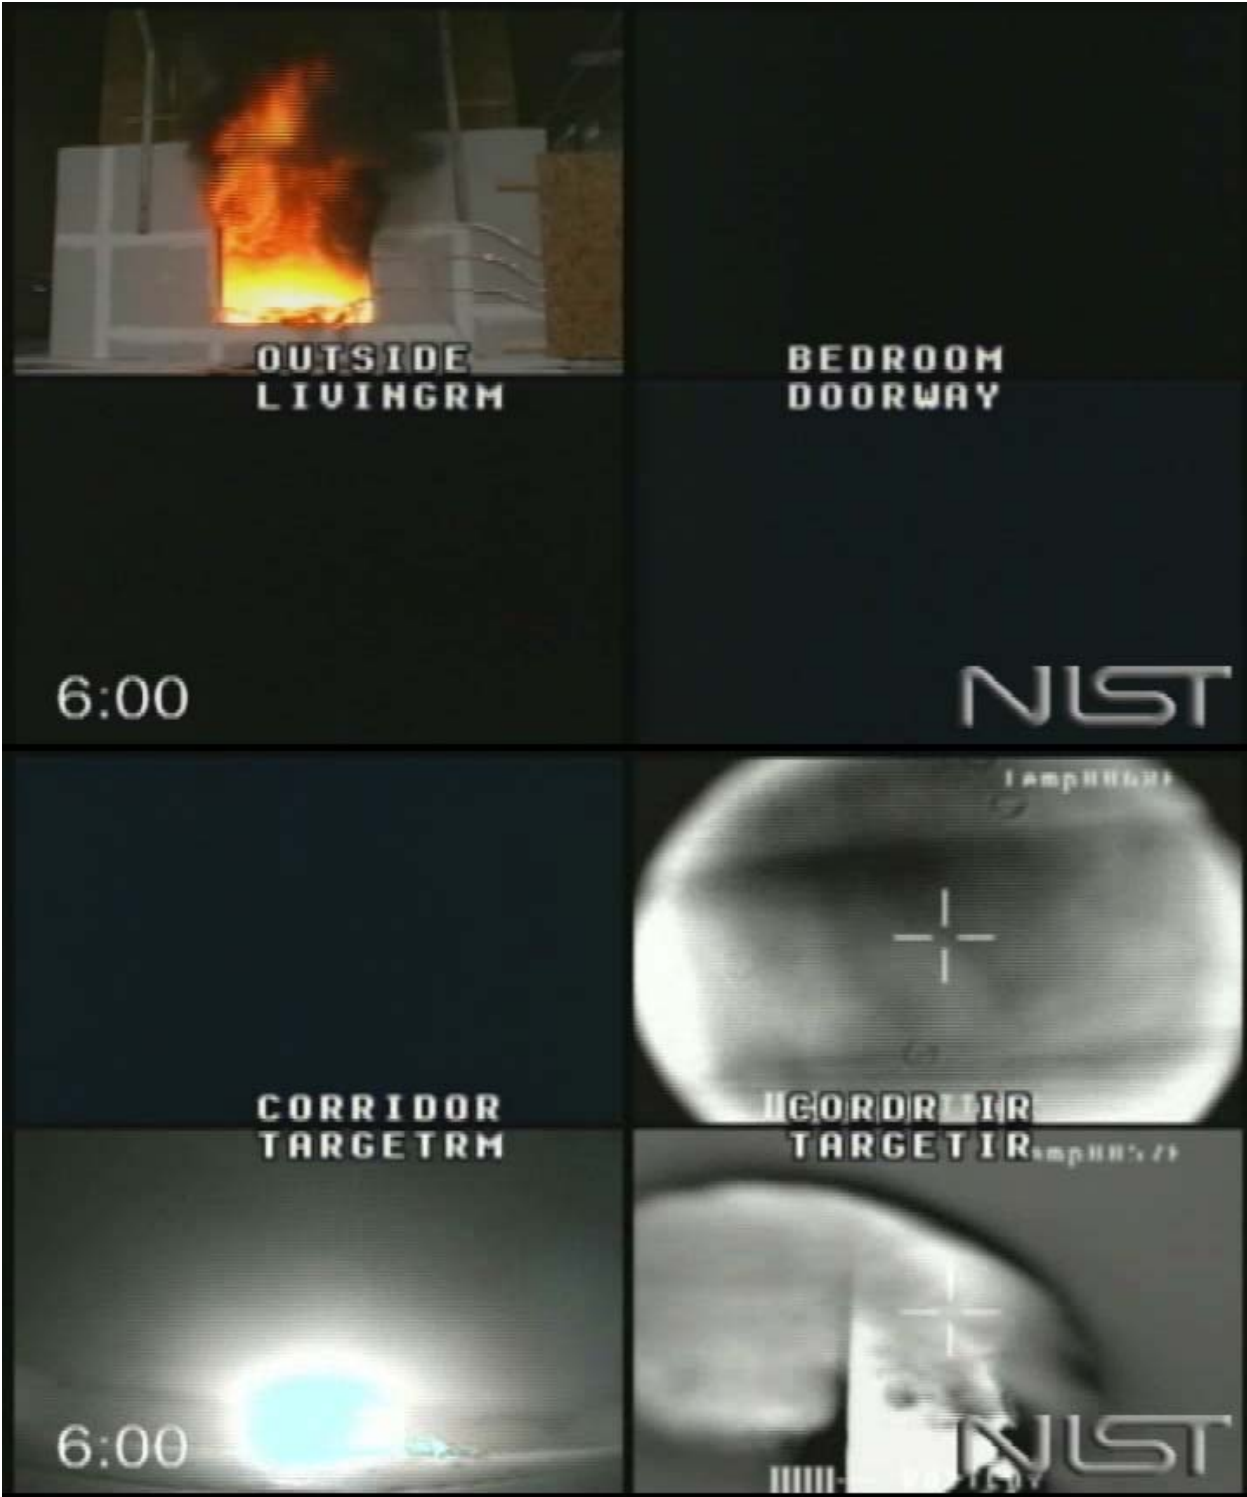
Figure 5.1.1-8. Experiment 1, 360 s after ignition.

At 360 s after ignition, Figure 5.1.1-8 conditions in the bedroom appeared to have reached a steady-state, post-flashover, condition. All of the images in the flow path from the window opening to the

corridor continued to be obscured. The target room showed the biggest change in conditions, as the wood hollow core door burned through and heat and smoke filled the target room.

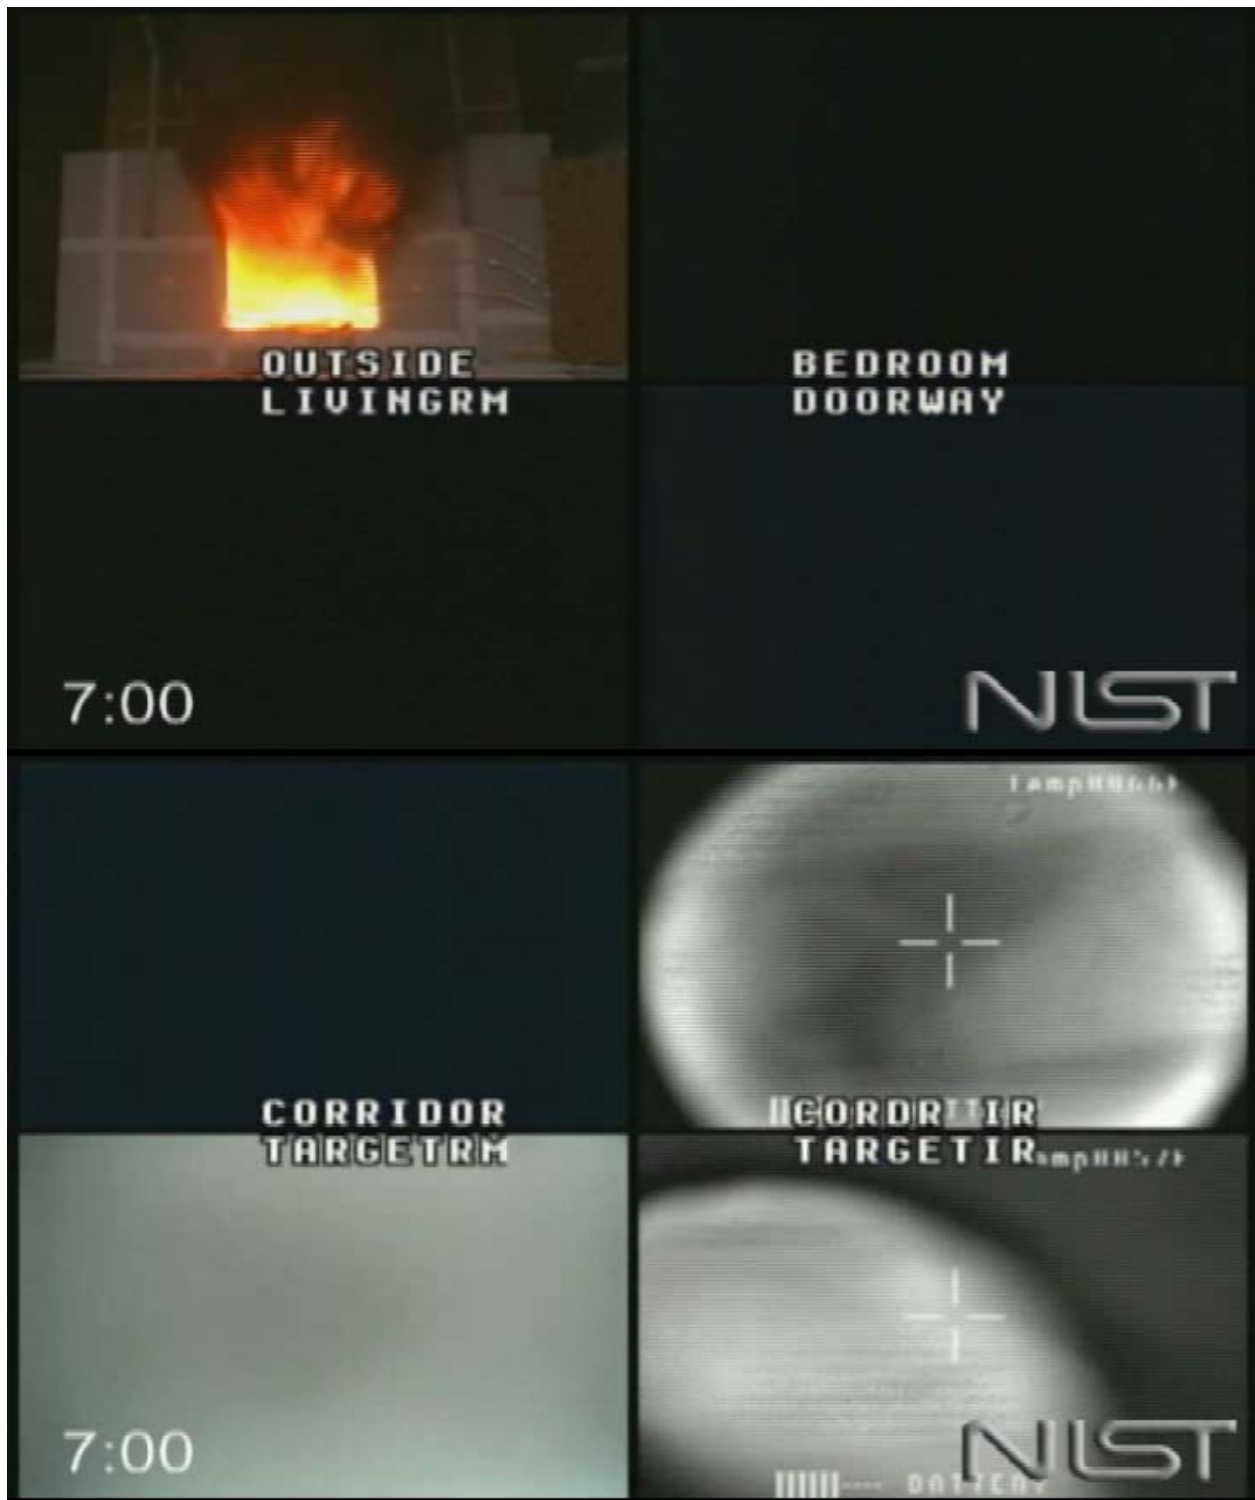
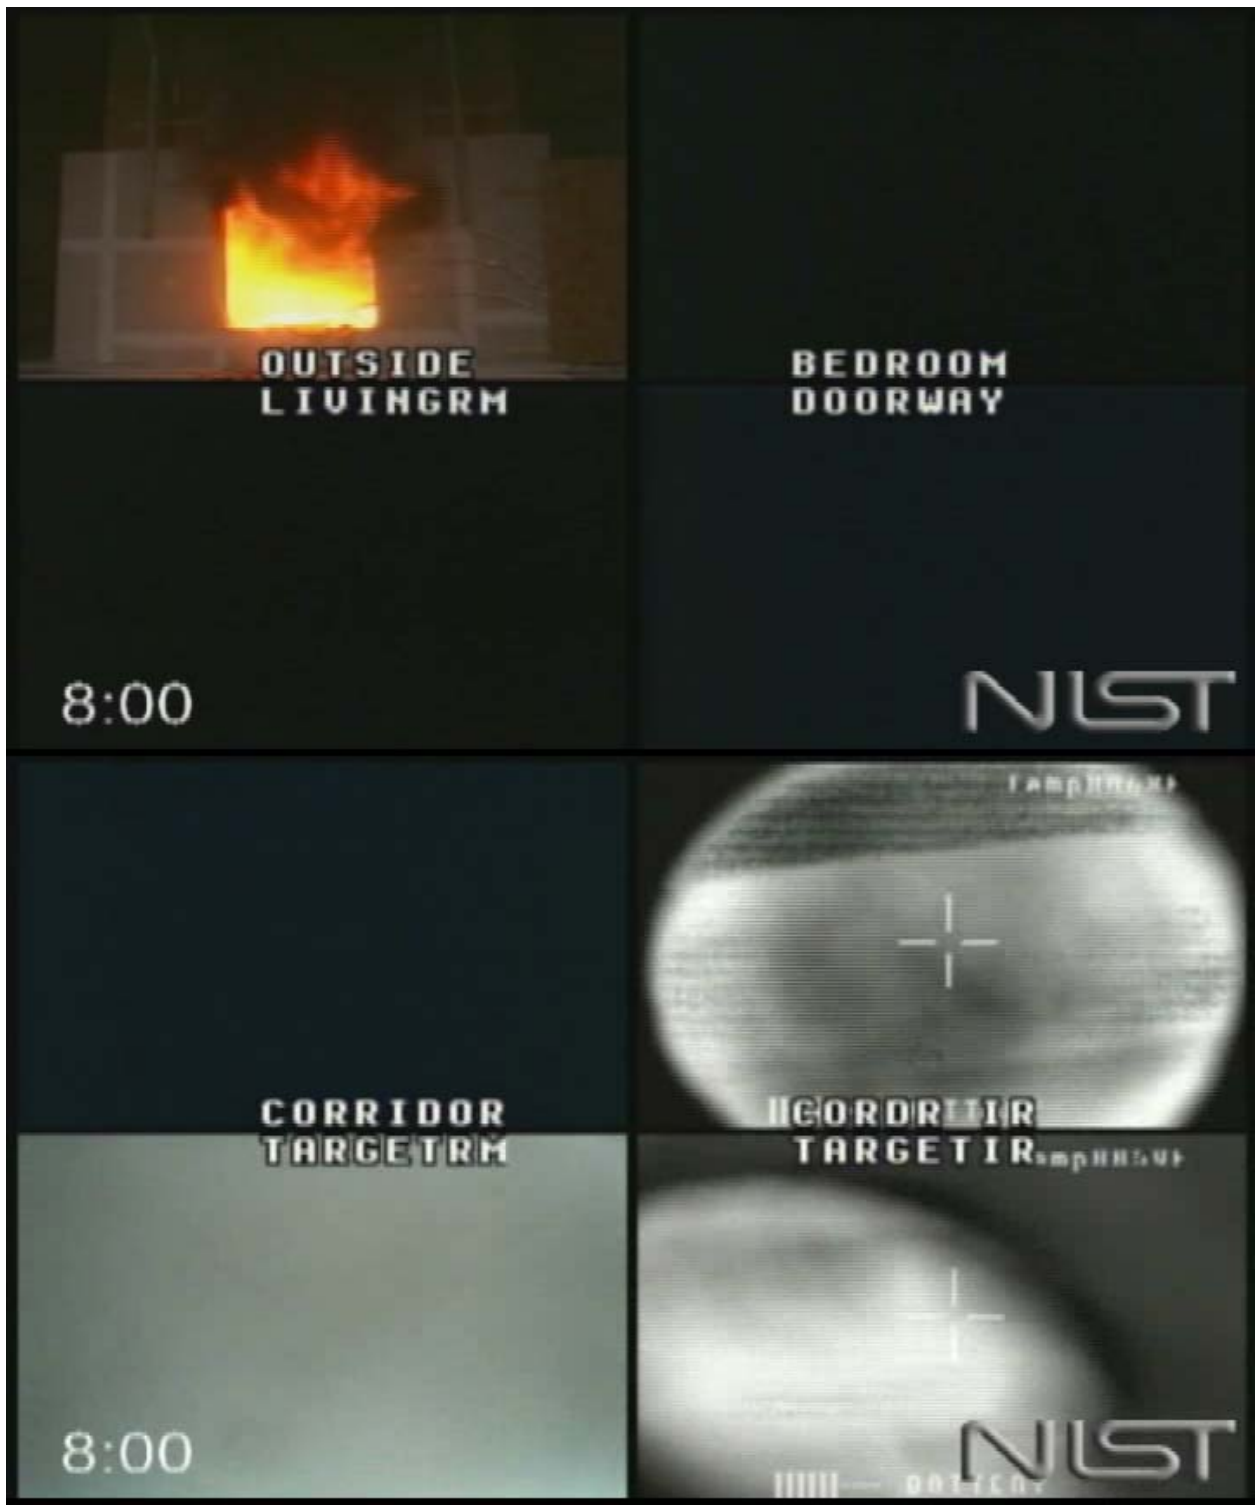
Figure 5.1.1-9. Experiment 1, 420 s after ignition.

Figure 5.1.1-10. Experiment 1, 480 s after ignition.

Figure 5.1.1-9 and Figure 5.1.1-10 show conditions very similar to those recorded at 360 s after ignition. The fire in the bedroom continued as a post-flashover compartment fire as the flames pulsed out of the window opening. This continued until the safety sprinklers were activated at approximately 490 s after ignition. Suppression continued with a hose stream being applied through the window opening at 525 s after ignition.

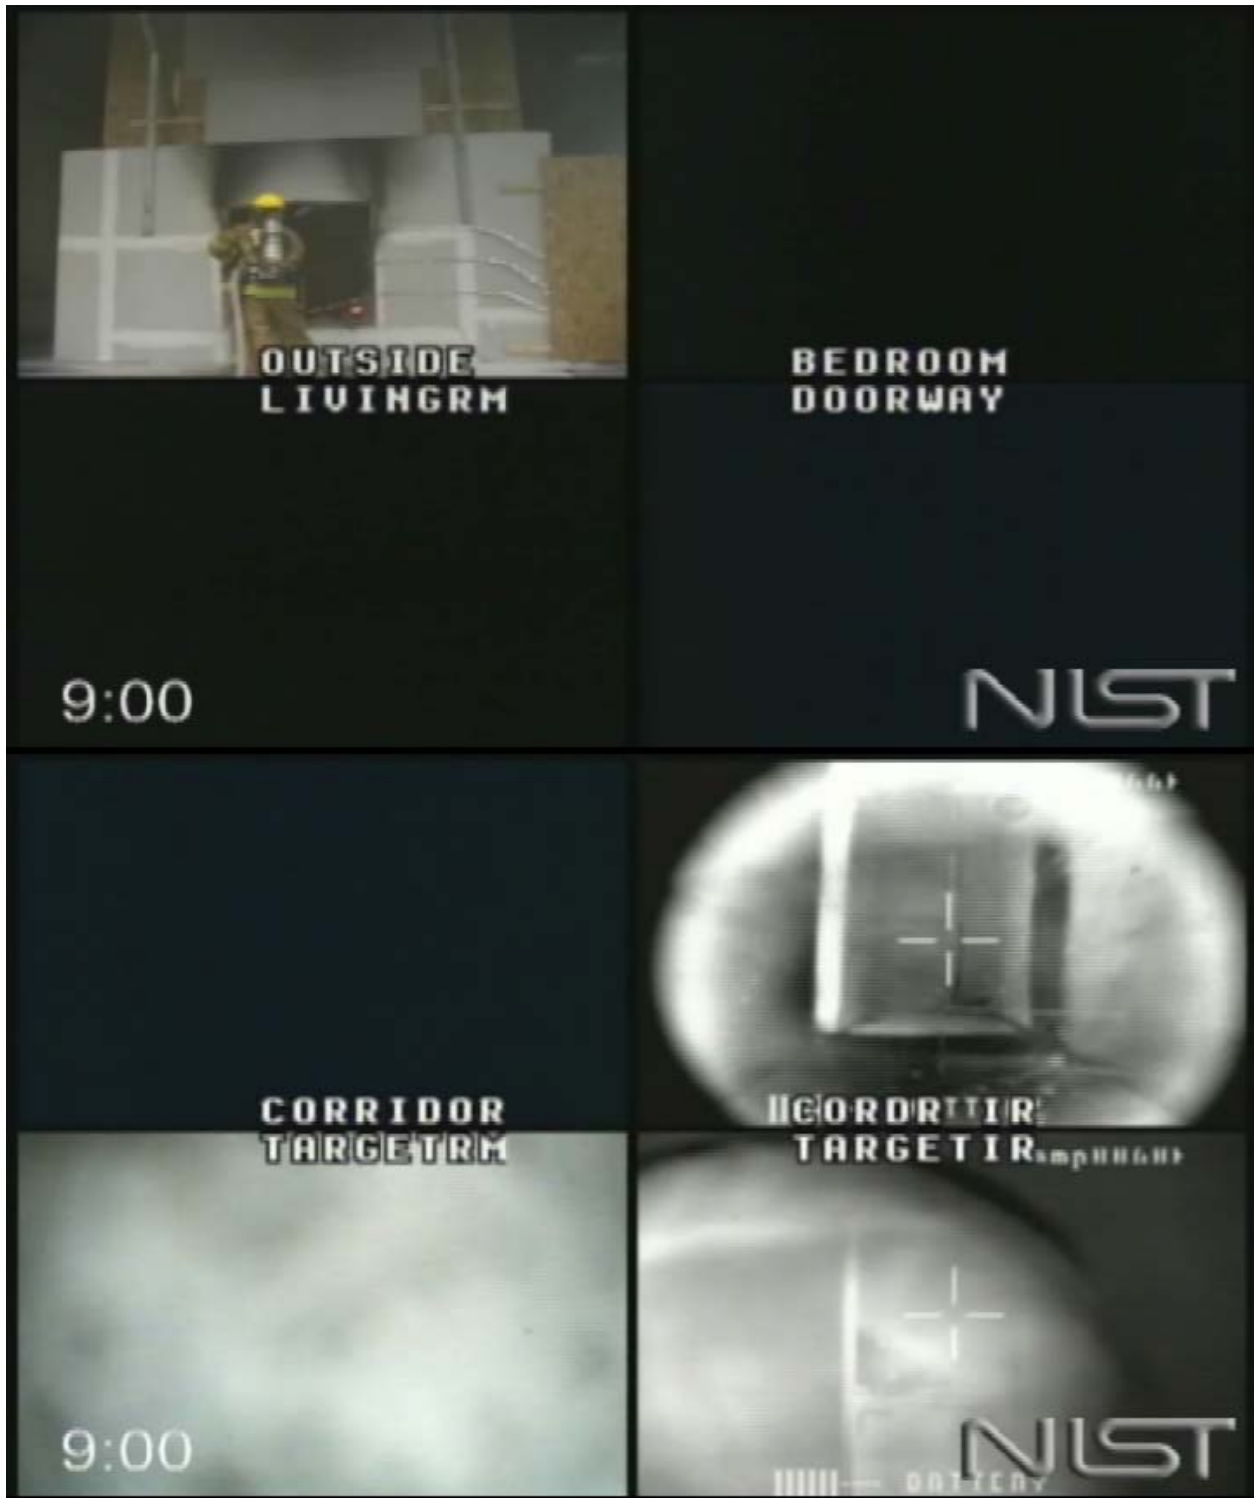
Figure 5.1.1-11. Experiment 1, 540 s after ignition.

The last set of images, Figure 5.1.1-11, was recorded at 540 s after ignition. At this point, the majority of the fire in the bedroom was suppressed. The dark areas, on the floor and the east wall of the corridor, in the corridor IR view are areas that were cooled by water from the hose streams that came through the living room doorway to the corridor.

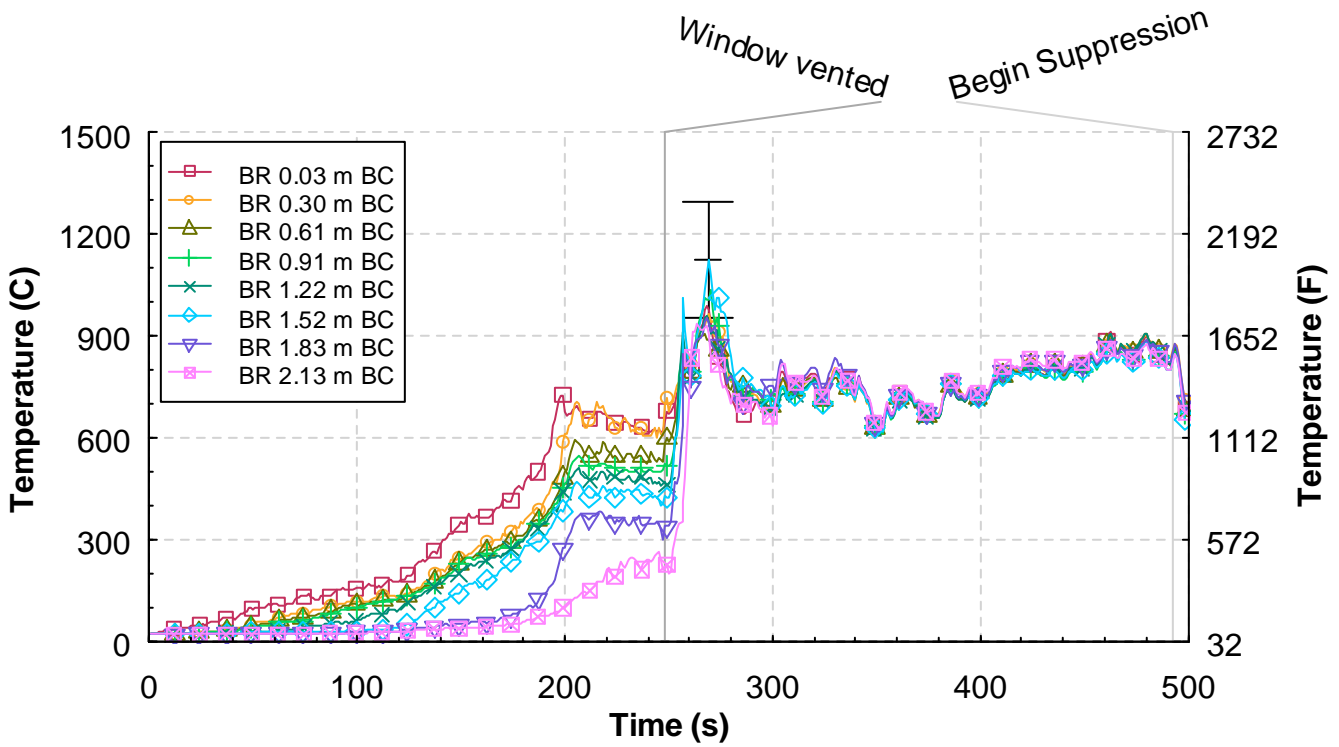
Figure 5.1.3-2. Temperature versus time from the bedroom (BR) thermocouple array, Experiment 1.

Figure 5.1.3-2 shows the measurements from the thermocouple array located in the center of the bed room. A thermocouple was located 0.03 m (1 in) below the ceiling followed by thermocouples that were installed at approximately 0.3 m (1 ft) intervals until they were 2.13 m (7 ft) below the ceiling or 0.3 m (1 ft) above the floor. During the first 200 s, the data shows a temperature gradient in the bedroom ranging from 700 °C (1290 °F) near the ceiling to 100 °C (212 °F) at 0.3 m above the floor. As the window began to fail, the temperatures near the ceiling cooled by almost 100 °C (212 °F), while the rest of the thermal layer increased in temperature. Within seconds of the manual venting of the window at 248 s, the room went from a thermally stratified environment to a post-flashover (thermally well mixed) environment where temperatures at all elevations in the room were similar and in excess of 600 °C (1100 °F). This post-flashover condition continued until the fire was suppressed.

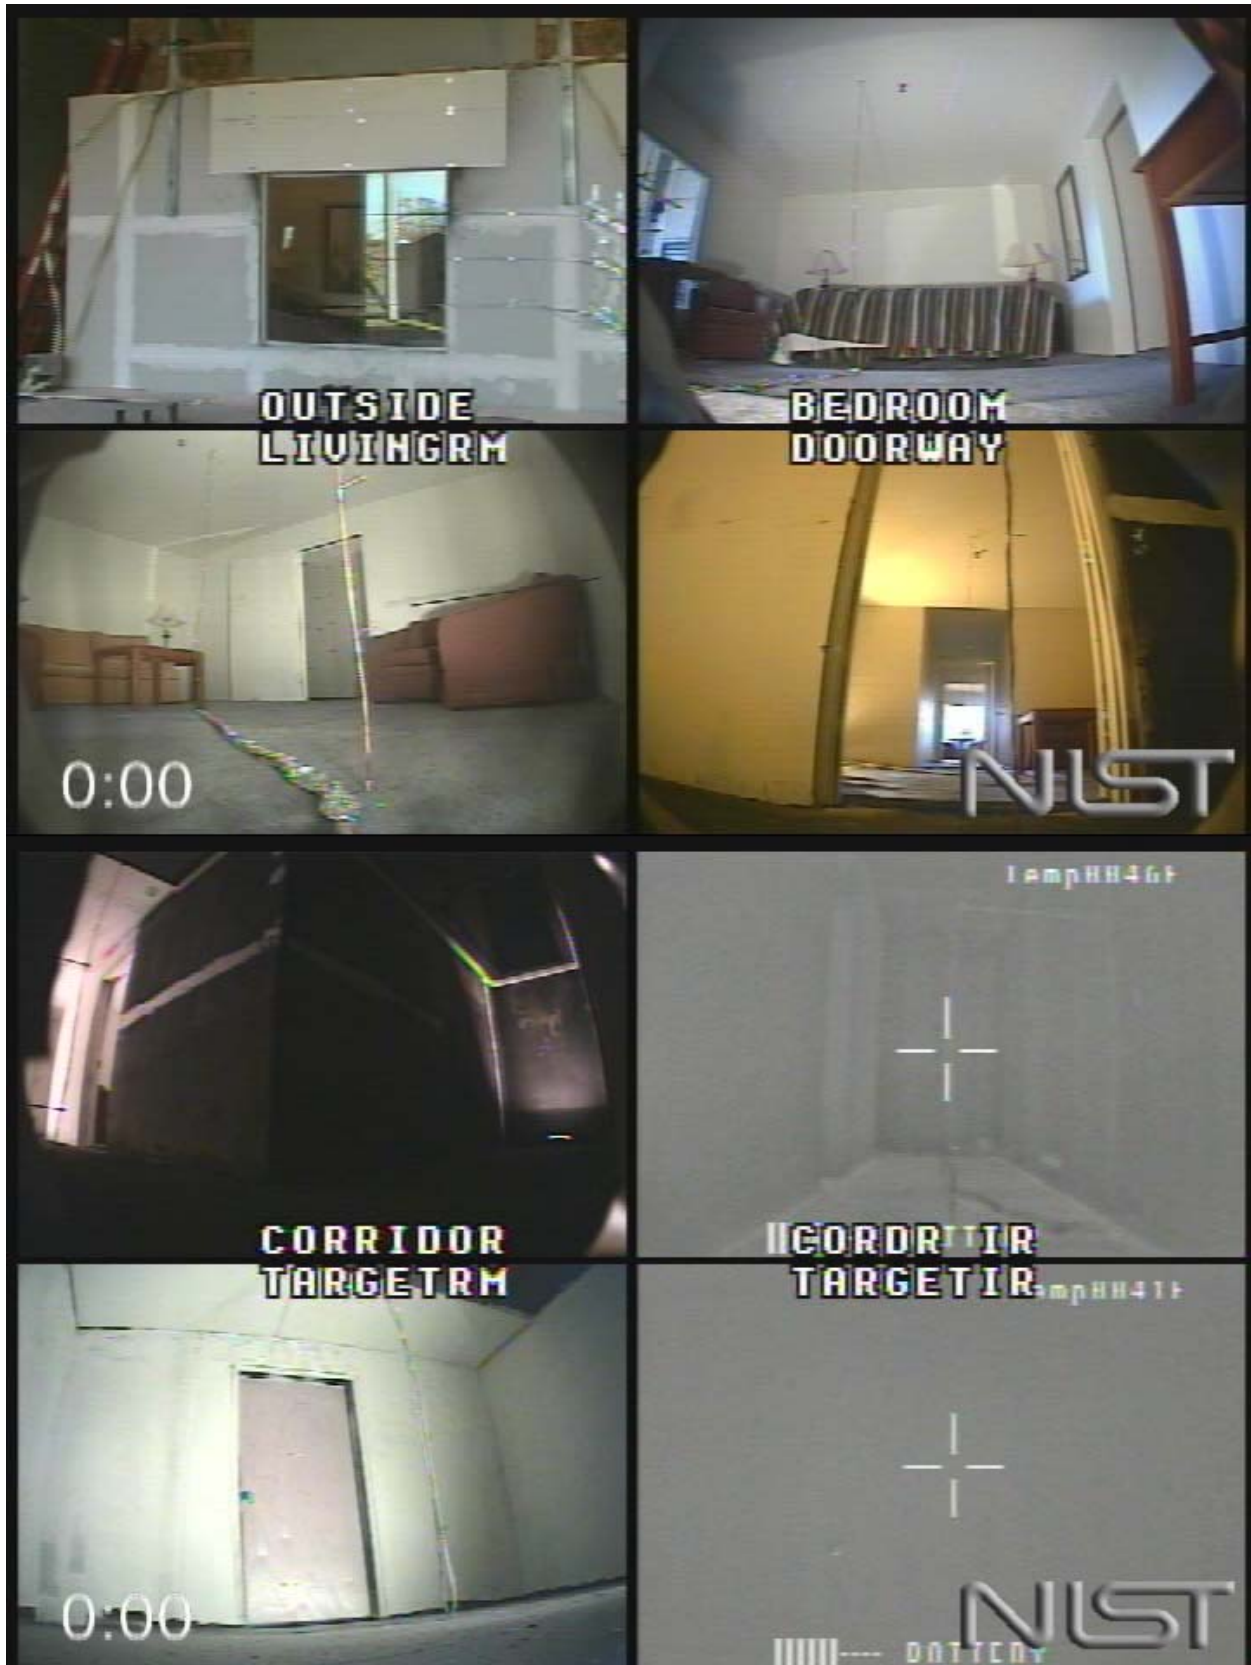
Figure 5.2.1-1. Experiment 2 ignition.

Figure 5.2.1-1 shows the conditions at the time of ignition. At this point, the six video views are clear and unobstructed. However, the thermal images provide limited thermal contrast because the surfaces in the view were at nearly equal temperature.
