# NIST Technical Note 1618

## Fire Fighting Tactics Under Wind Driven Conditions: Laboratory Experiments

Daniel Madrzykowski  
Stephen Kerber

U.S. Department of Commerce  
Building and Fire Research Laboratory  
National Institute of Standards and Technology  
Gaithersburg, MD 20899

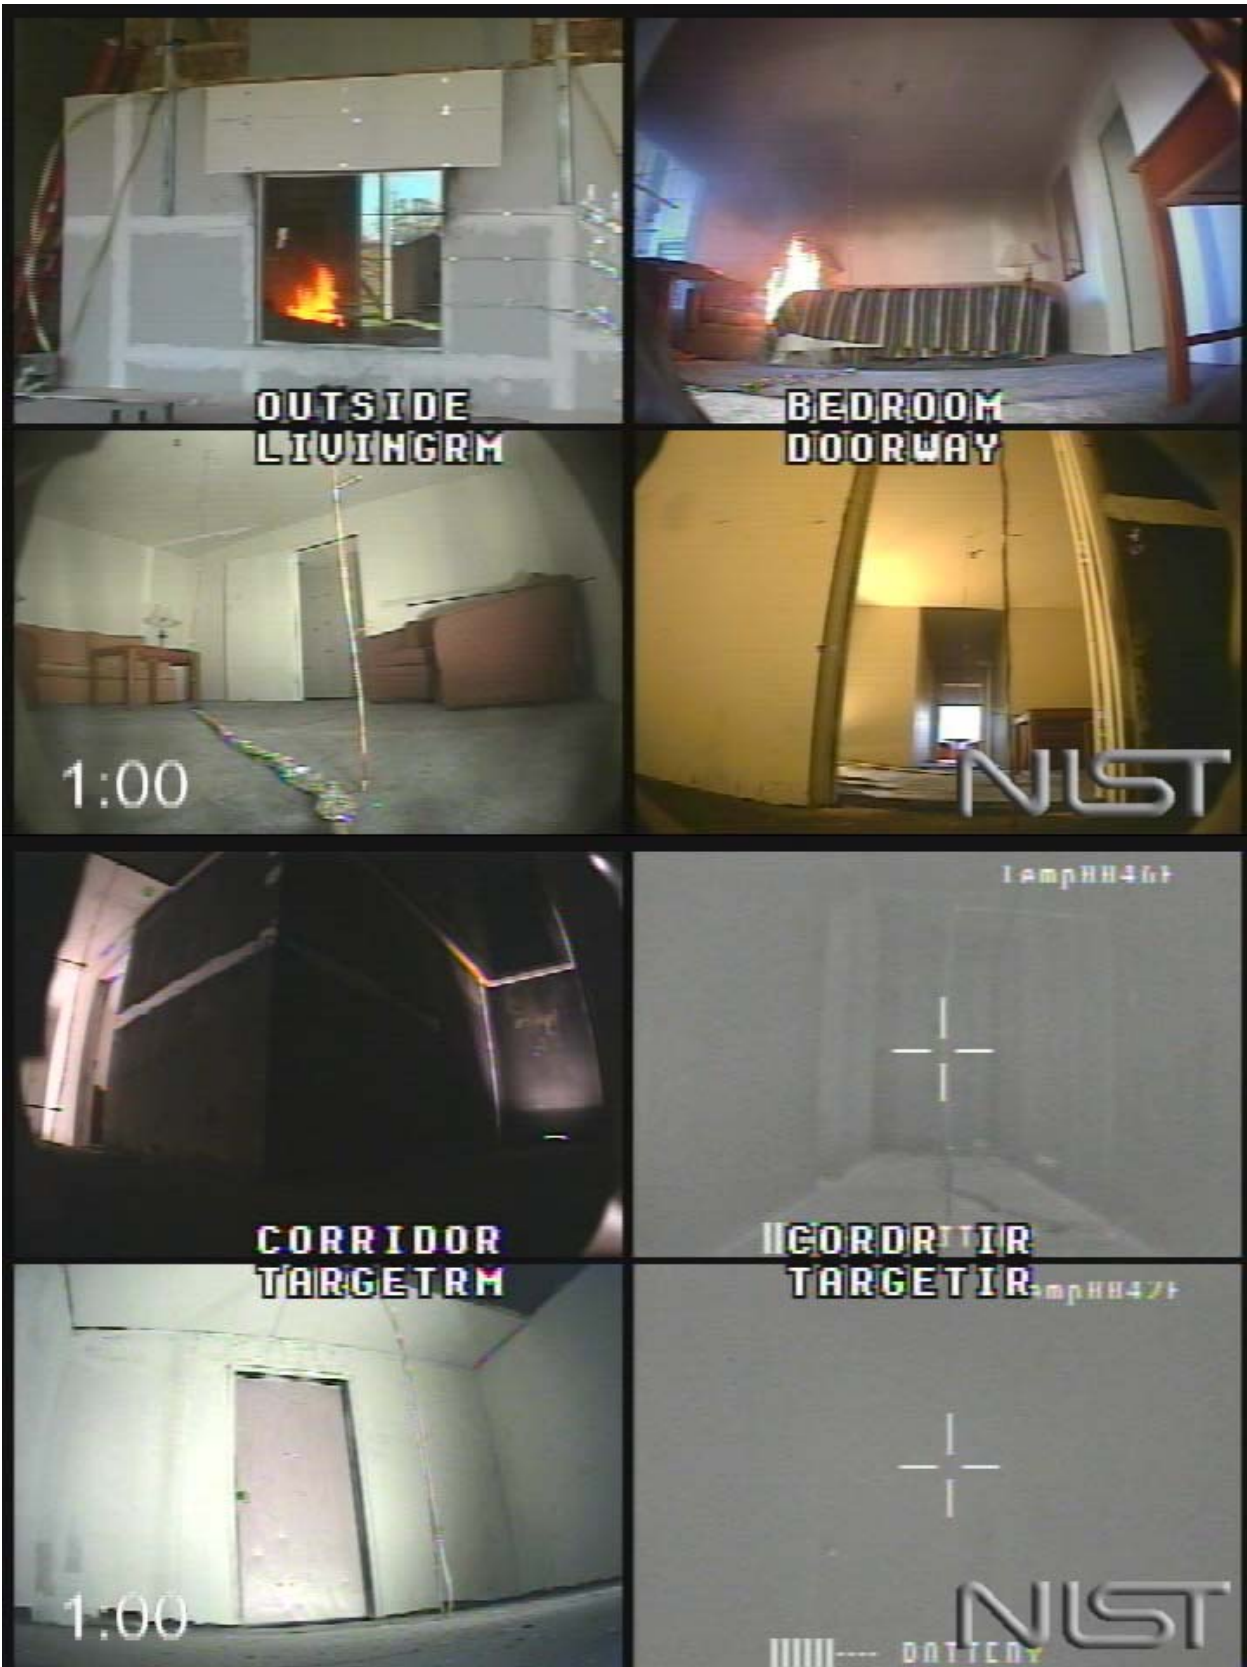
Figure 5.2.1-2. Experiment 2, 60 s after ignition.

The images in Figure 5.2.1-2 were captured 60 s after ignition. The fire from the trash container spread to both the bed and the upholstered chair. A smoke layer formed in the bedroom, and the ceiling jet started to move down the hall. There was no smoke or change in thermal condition in the living room, target room or corridor at this time.

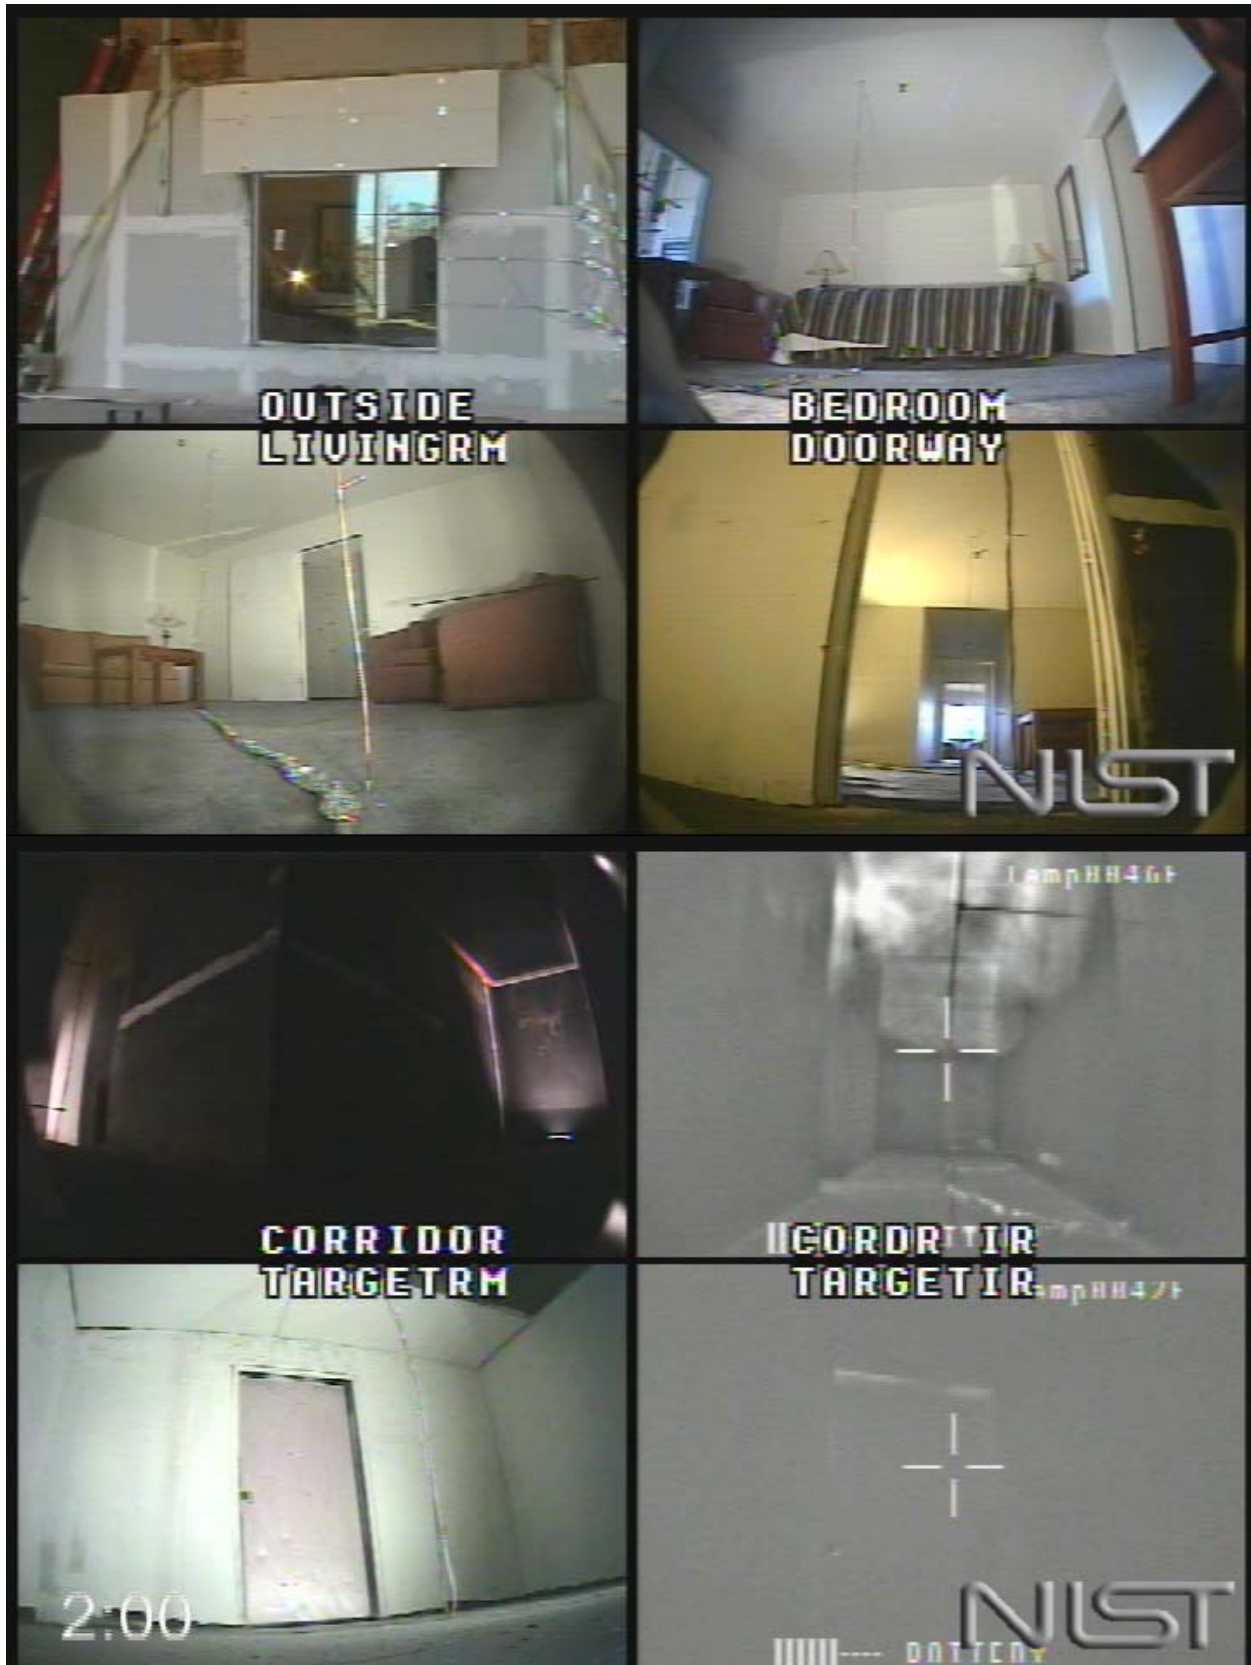
Figure 5.2.1-3. Experiment 2, 120 s after ignition.

The images in Figure 5.2.1-3 were recorded at 120 s after ignition. The area involved in fire between the bed and the chair increased in size. The smoke layer was approximately 1.2 m (4 ft) thick throughout the bedroom, hall and living room. Smoke and heat had just started to flow into the corridor. The target room appears clear of smoke; however the target room IR view shows some limited heat infiltration along the top edge of the door between the hall and the target room.

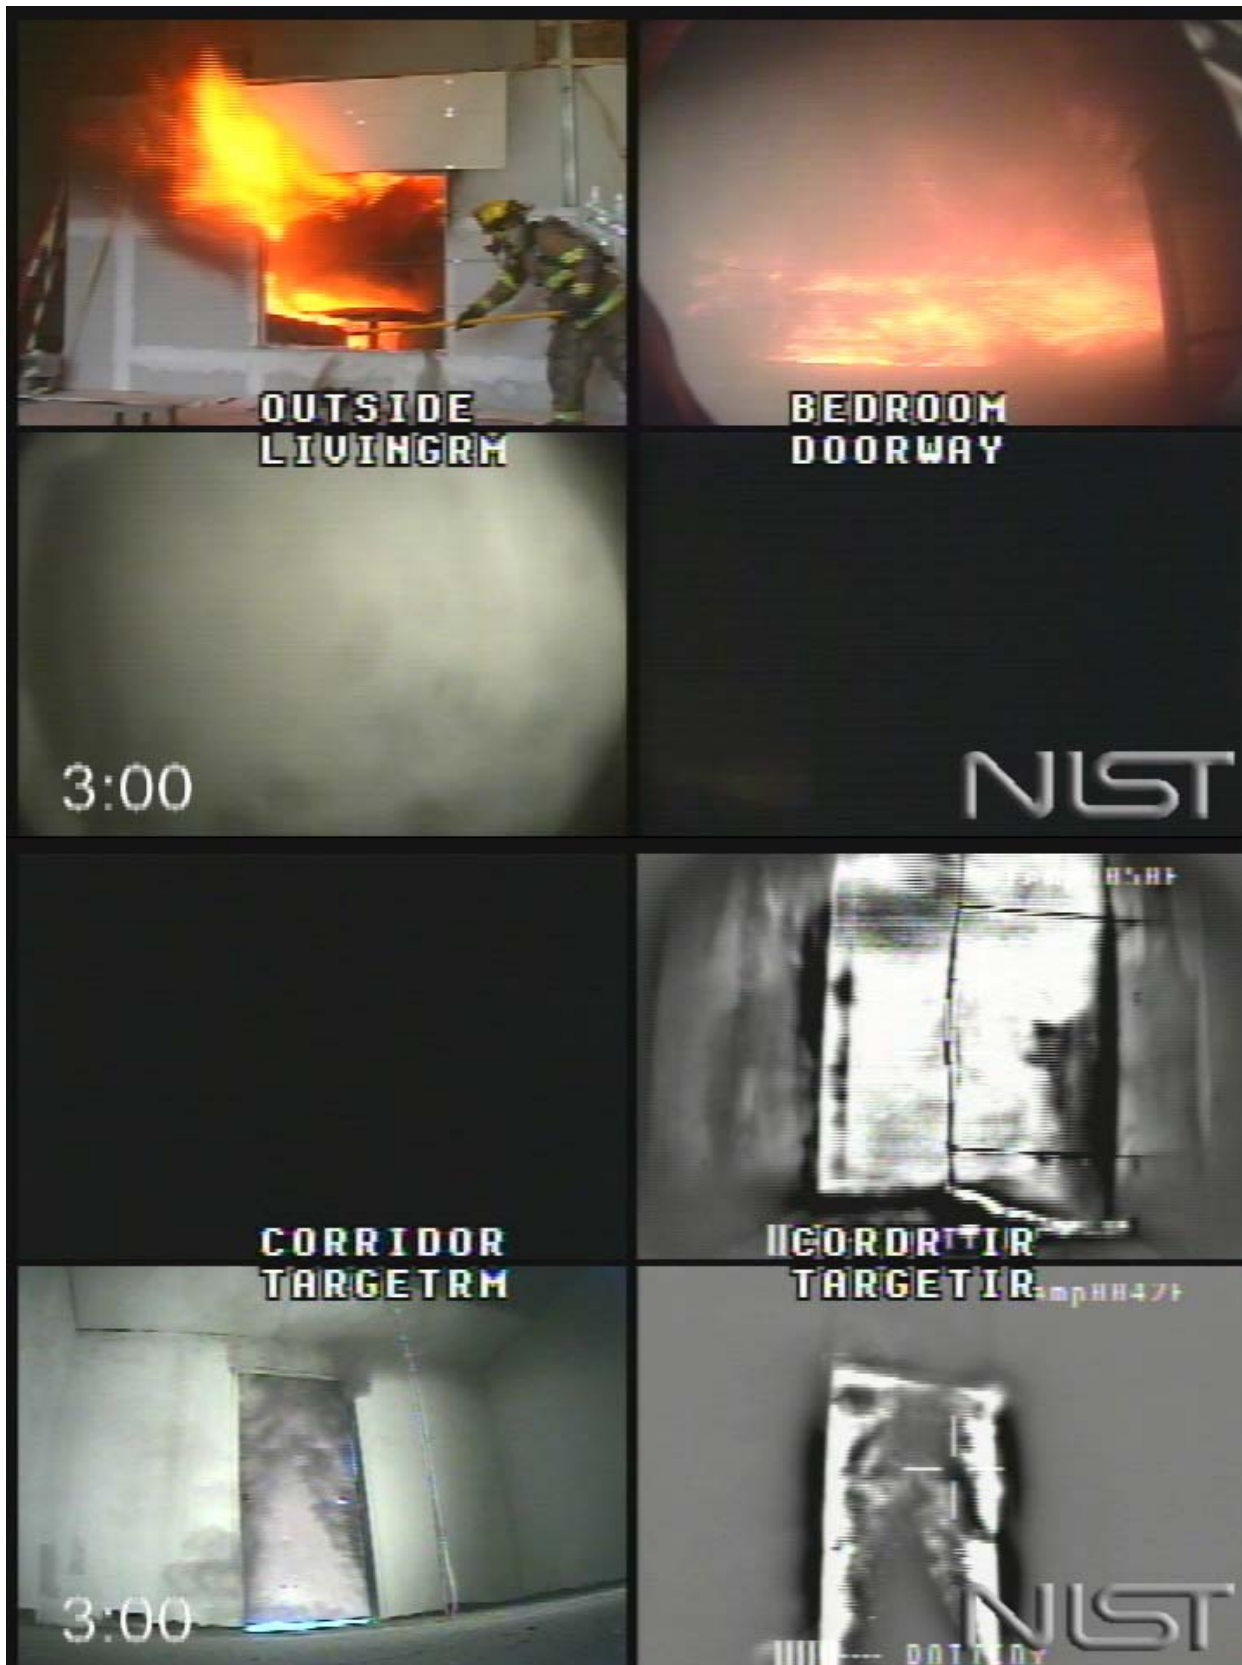
Figure 5.2.1-4. Experiment 2, 180 s after ignition.

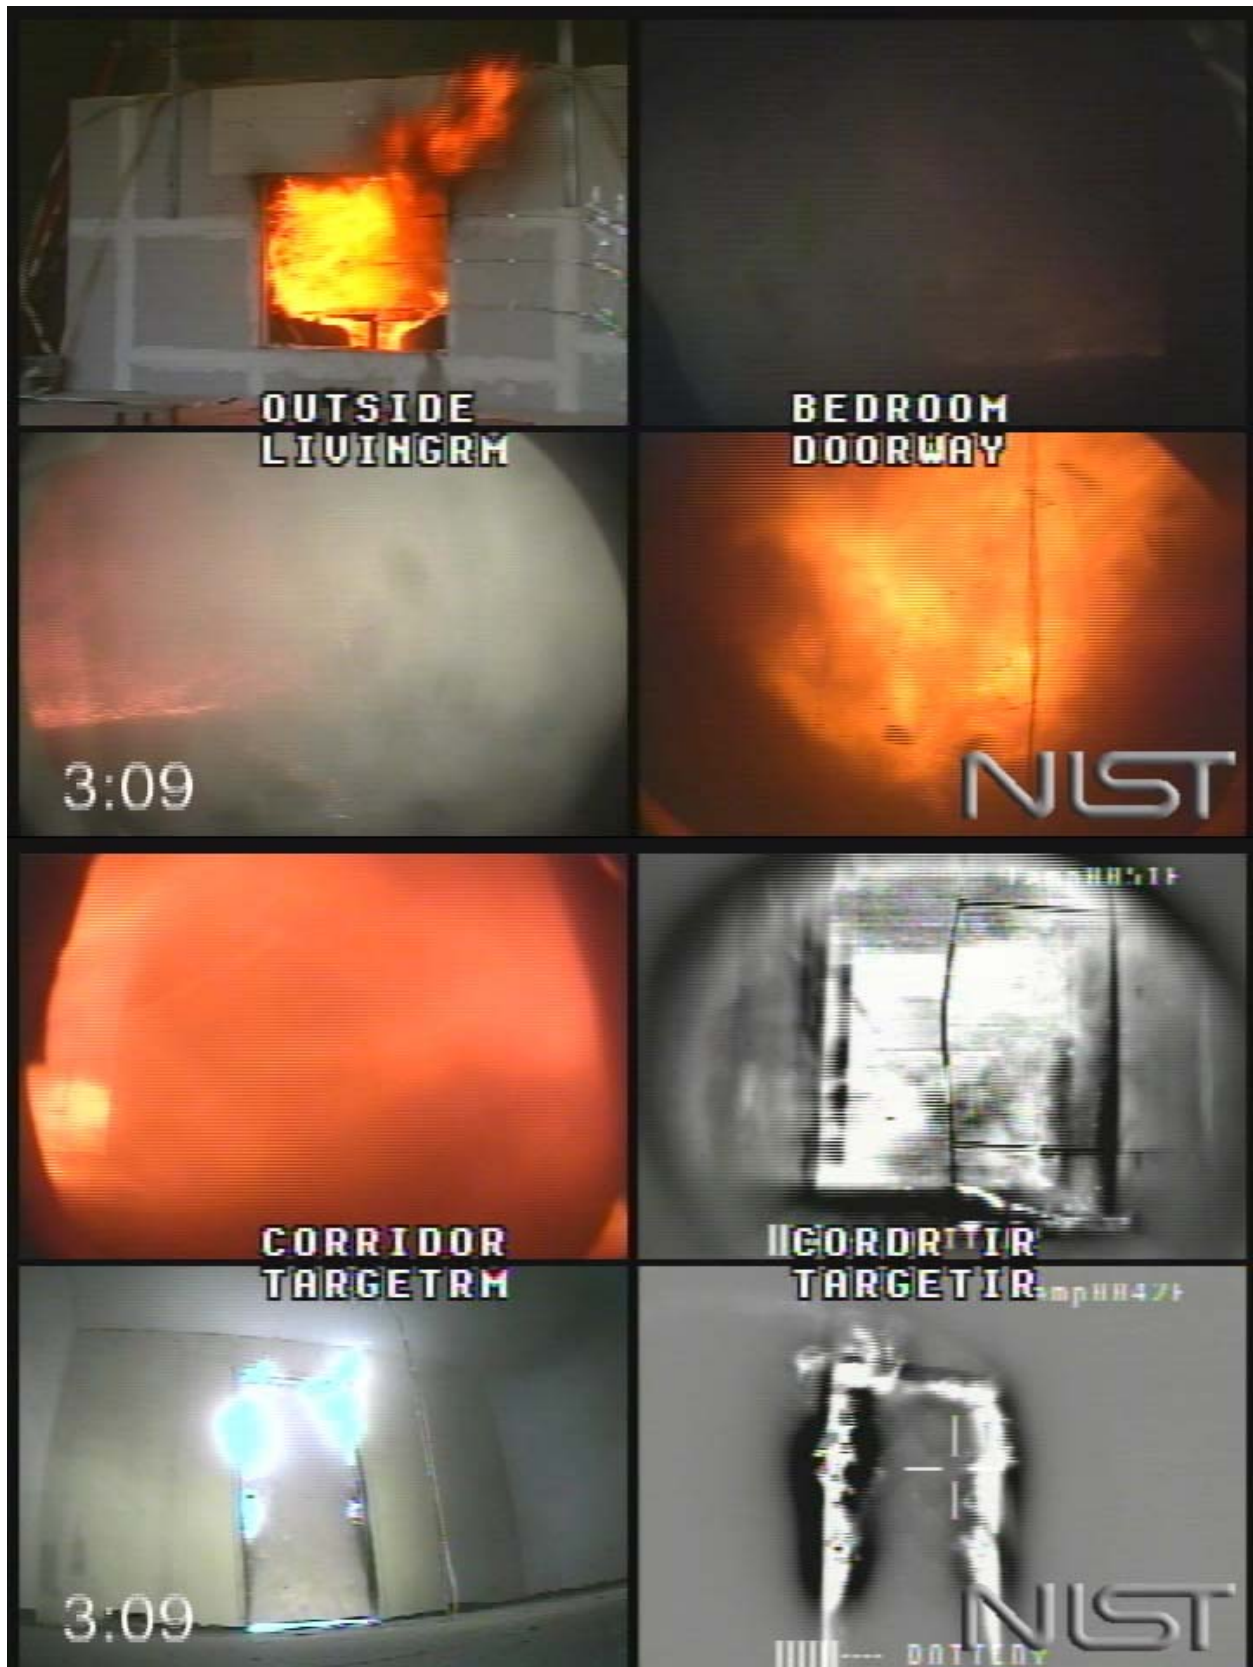
Figure 5.2.1-5. Experiment 2, corridor flames, 189 s after ignition.

Figure 5.2.1-5 shows the conditions at 189 s after ignition. Flames are still flowing out of the top of the window opening. Only a glow could be seen in the bedroom. Horizontal flames are shown extending through the living room and out through the doorway into the corridor. Flames are shown around the top portion of the door and at the bottom edge of the door.

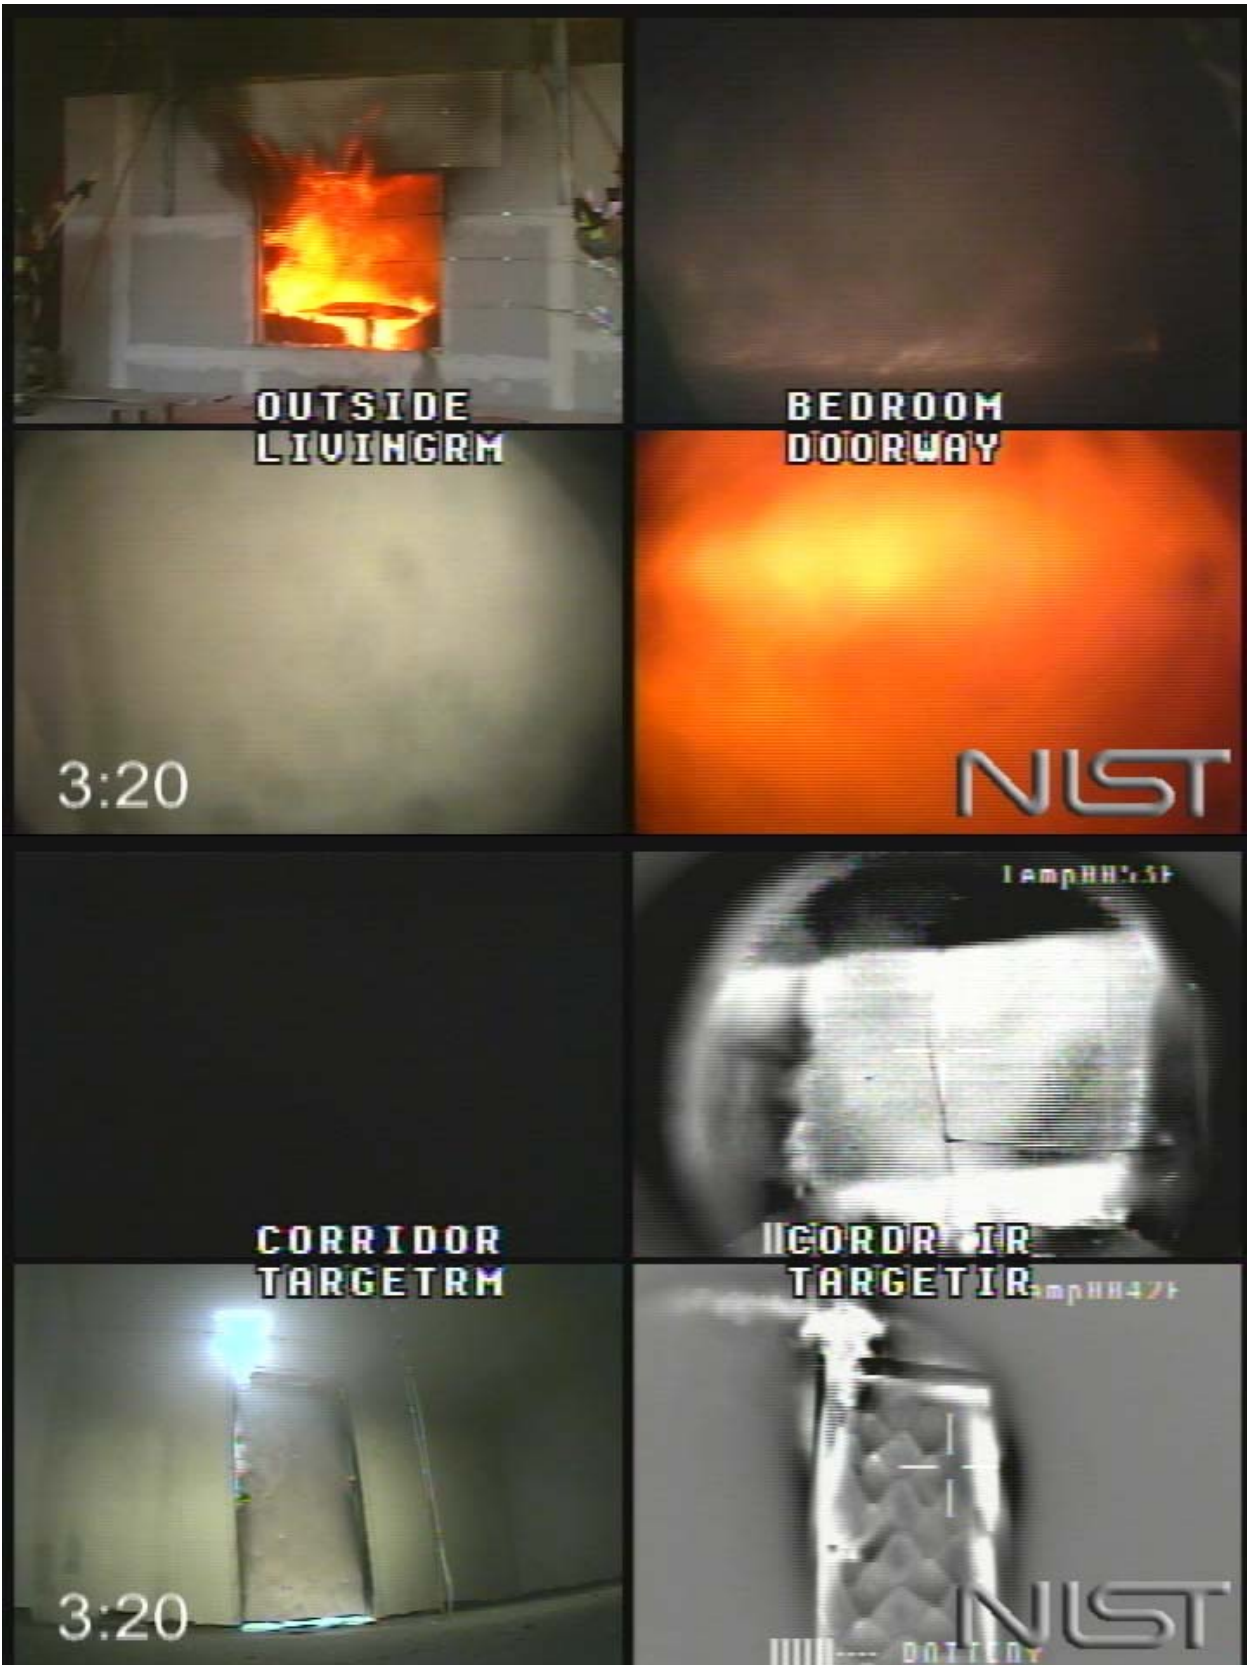
Figure 5.2.1-6. Experiment 2, WCD deployed; 200 s after ignition.

The images in Figure 5.2.1-6 were recorded at 200 s after ignition, just prior to the deployment of the large wind control device. The bedroom was fully involved with a post-flashover fire with some flames extending into the corridor. The thermal view of the corridor continued to show heat exiting the living room, filling the doorway from top to bottom, and at a high velocity. The thermal image was deteriorating due to the high thermal exposure. The target room video view showed less flame around the target room door, than the image from 11 s earlier. The thermal view shows the outlines of the reinforcing material inside the hollow core door, as the door had increased in temperature.

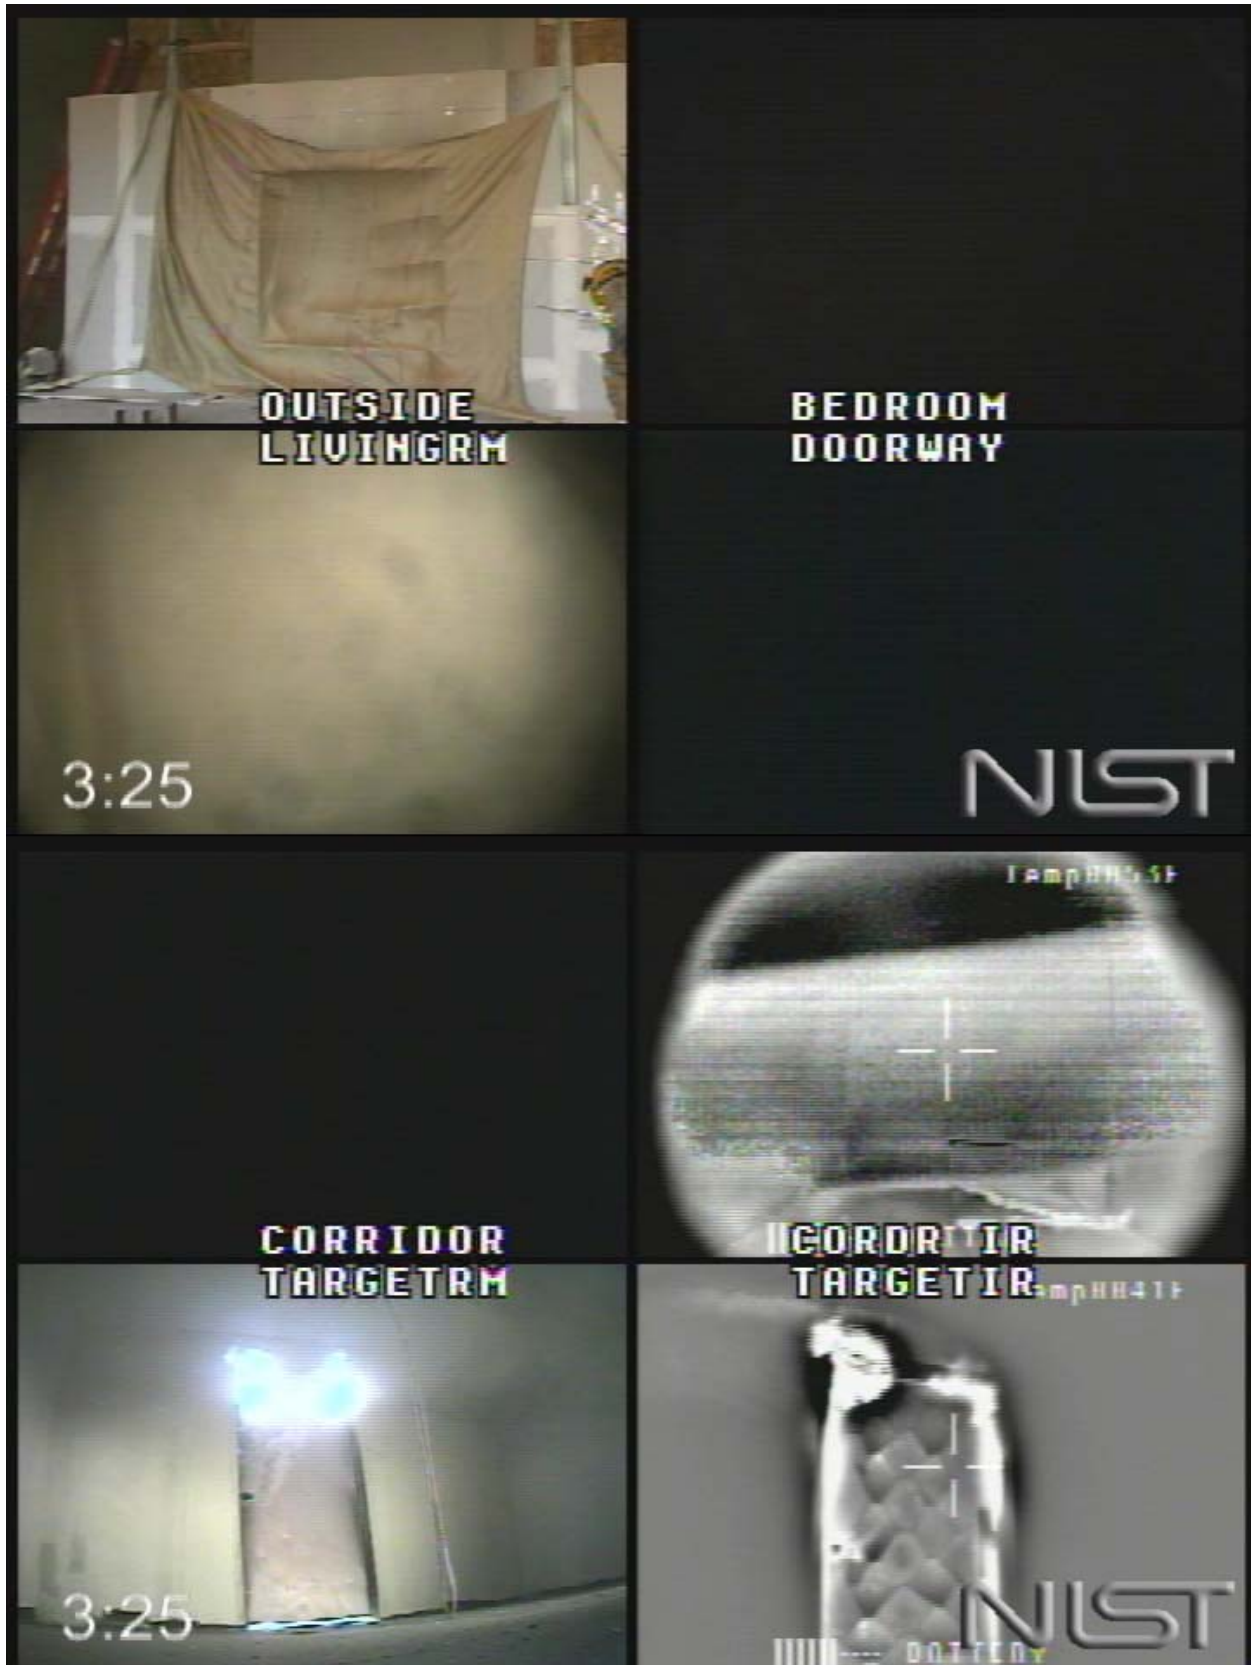
Figure 5.2.1-7. Experiment 2, WCD in place, 205 s after ignition.

At 205 s after ignition, the wind control device was deployed and in place as shown in the outside view of Figure 5.2.1-7. The interior video views were obscured by soot. The thermal view of the corridor no longer showed any hot gas flows, only a hot gas layer. Conditions in the target room did not appear to have changed significantly in the 5 s since the images in Figure 5.2.1-6.

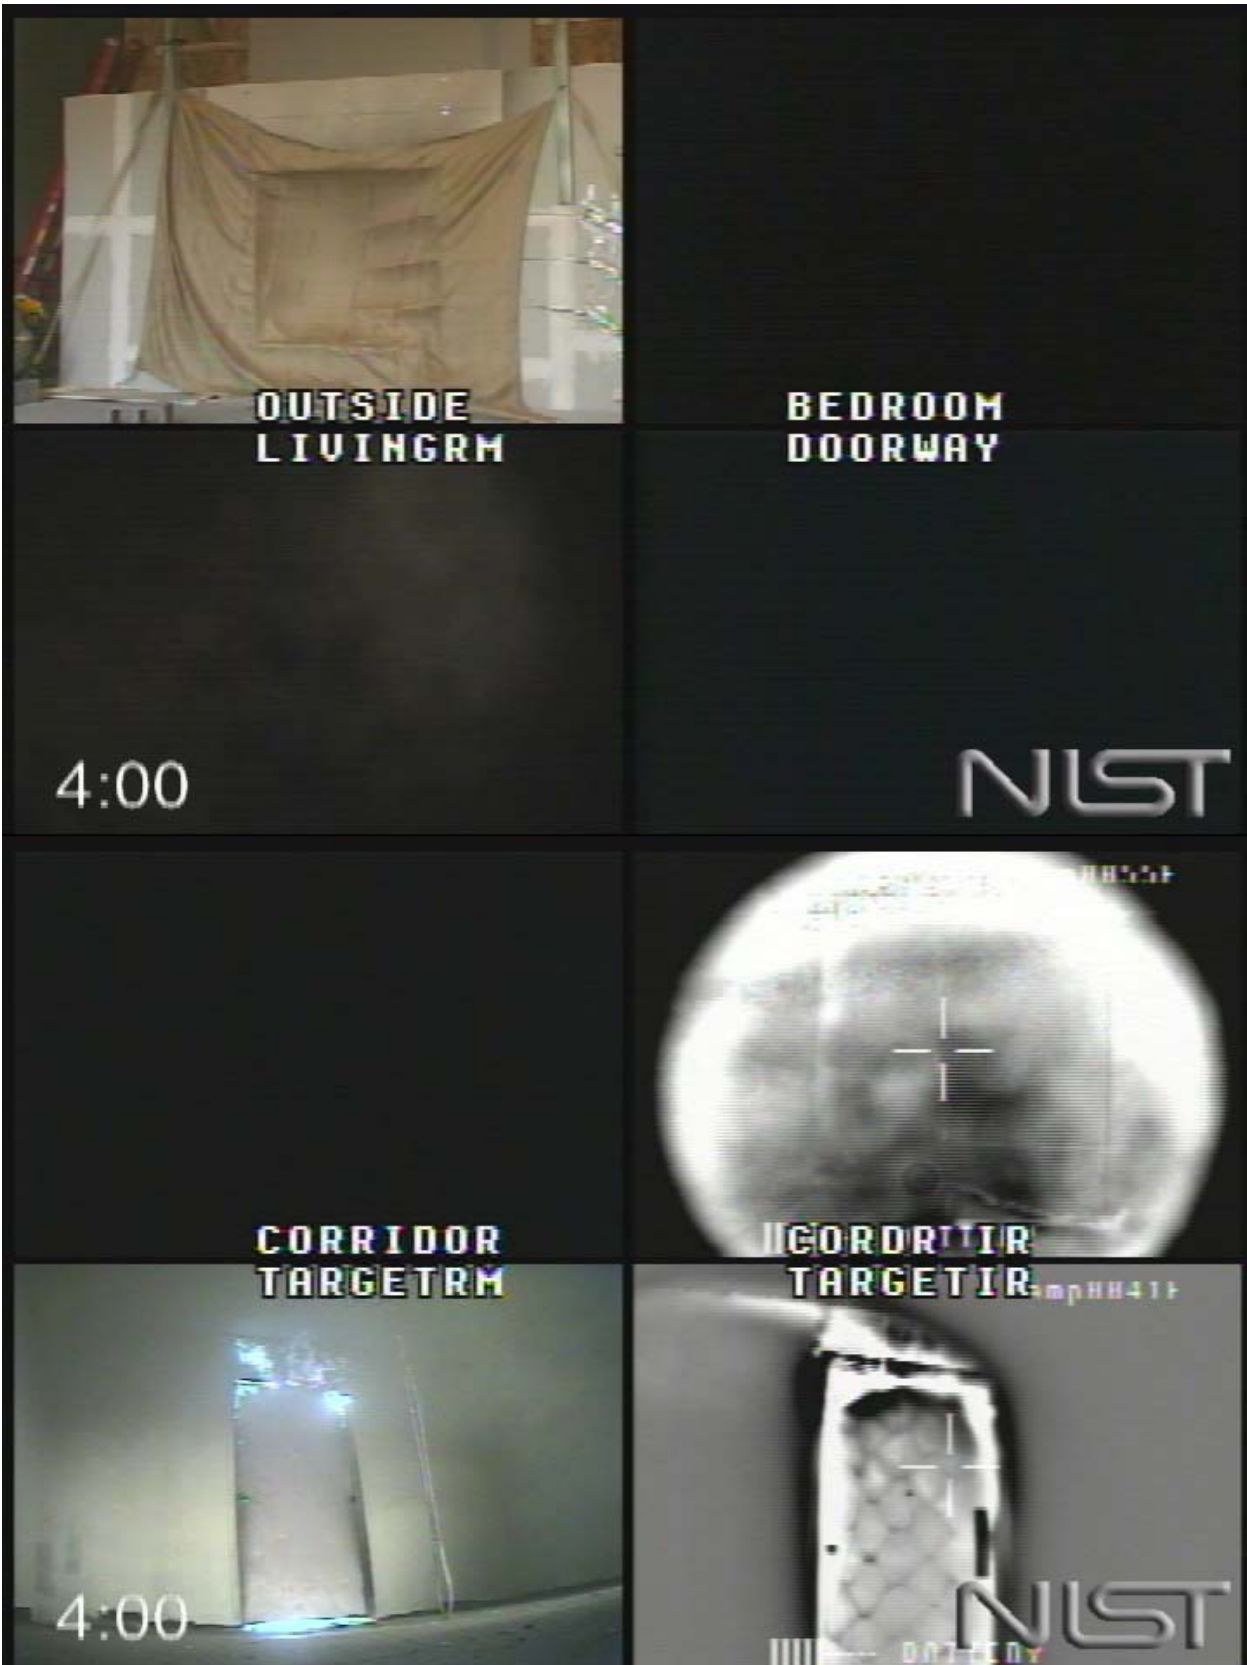
Figure 5.2.1-8. Experiment 2, 240 s after ignition.

Figure 5.2.1-8 shows the conditions at 240 s after ignition, or approximately 75 s since deployment of the wind control device. The interior video views were still obscured by soot. The thermal image from the corridor was still saturated with heat but started to improve in clarity. In the target room the top of the door continued to burn and the thermal image captured the increased heat level of the door.

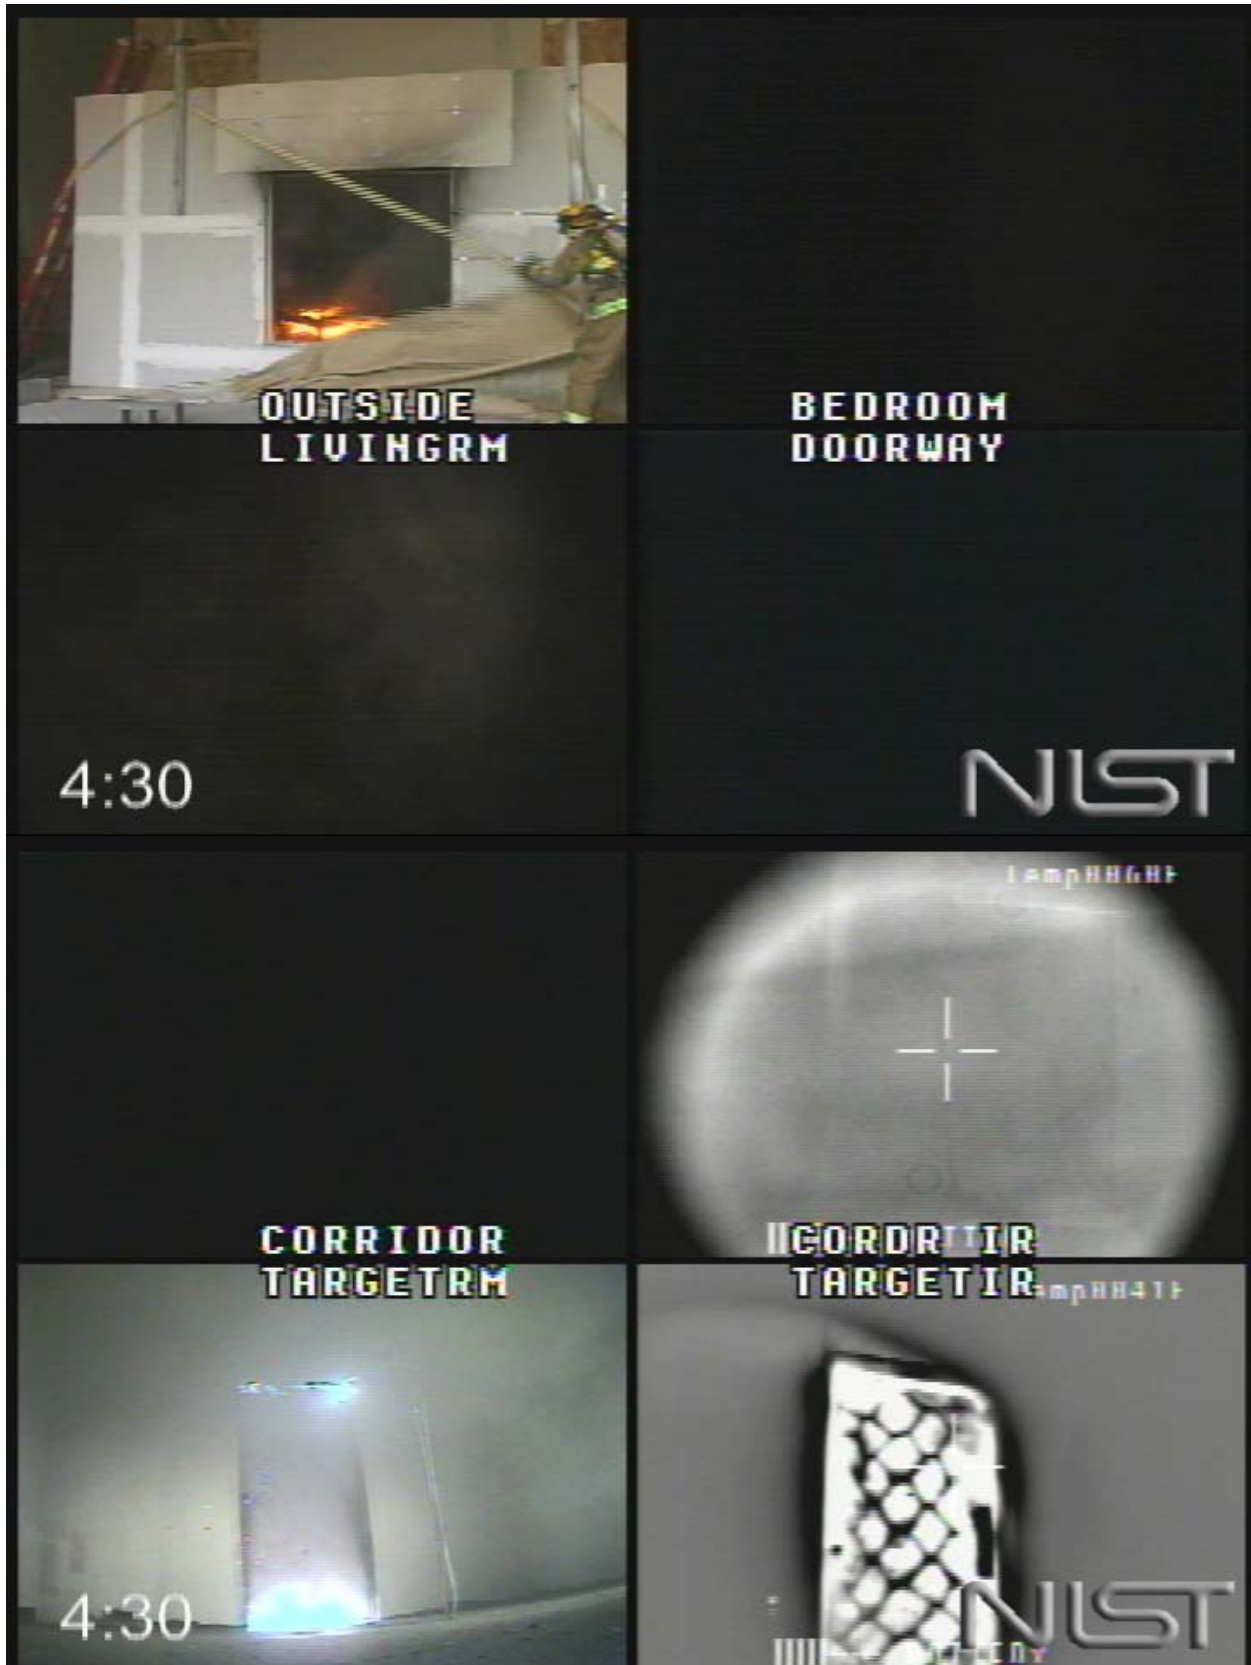
Figure 5.2.1-9. Experiment 2, WCD removed; 270 s after ignition.

Figure 5.2.1-9 shows the conditions at 270 s after ignition, which was about one second after the curtain was removed from the window opening.

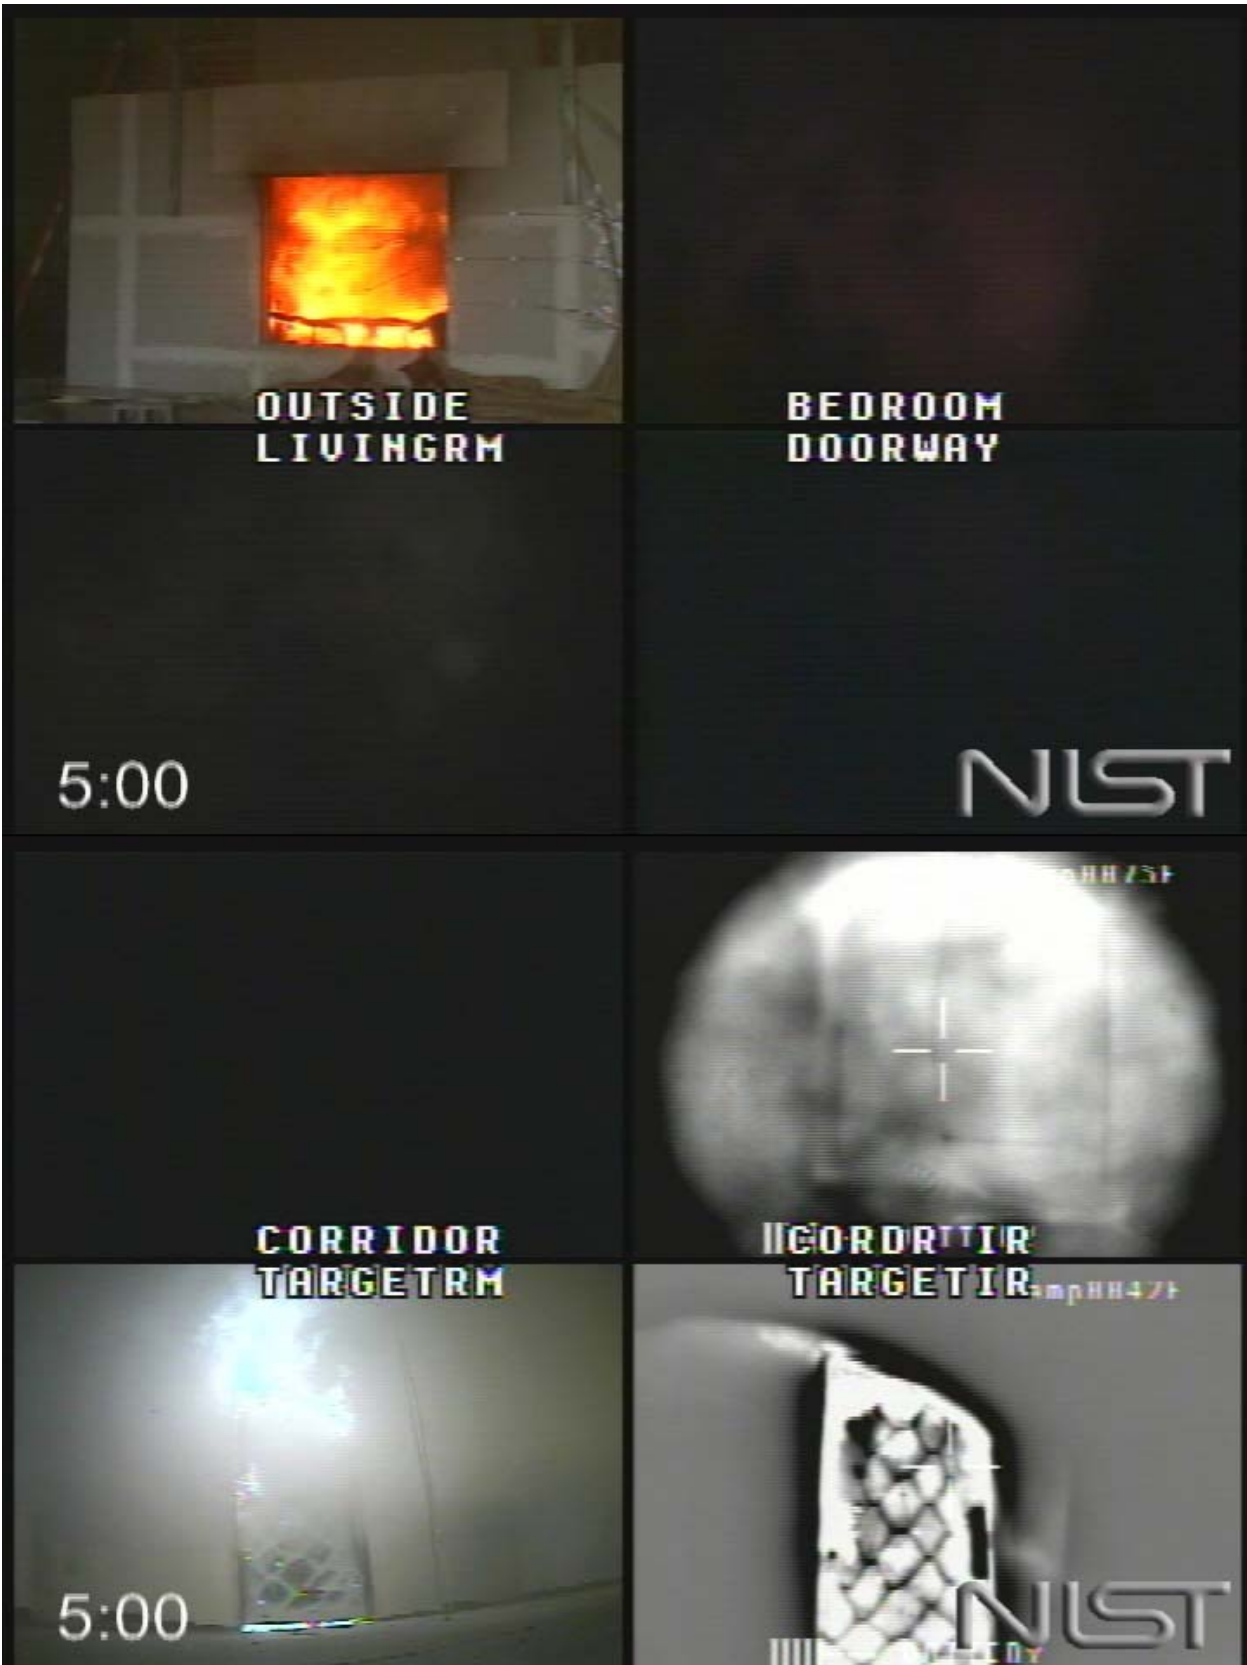
Figure 5.2.1-10. Experiment 2, 300 s after ignition.

The measurements from the thermocouple array in the center of the target room are given in Figure 5.2.3-12. A hot gas layer, 0.61 m (2.00 ft) thick, has formed within 200 s after ignition. During the time the WCD was in place, only the temperatures close to the ceiling increased as smoke and flames burned around the top edge of the door. After the WCD was removed, cool air pushed in through the gap at the top of the door, which caused the upper thermocouples to cool. This was followed by increased flames coming from the door and the opening as it burned away, visible in Figure 5.2.1-10, which resulted in increased temperatures.

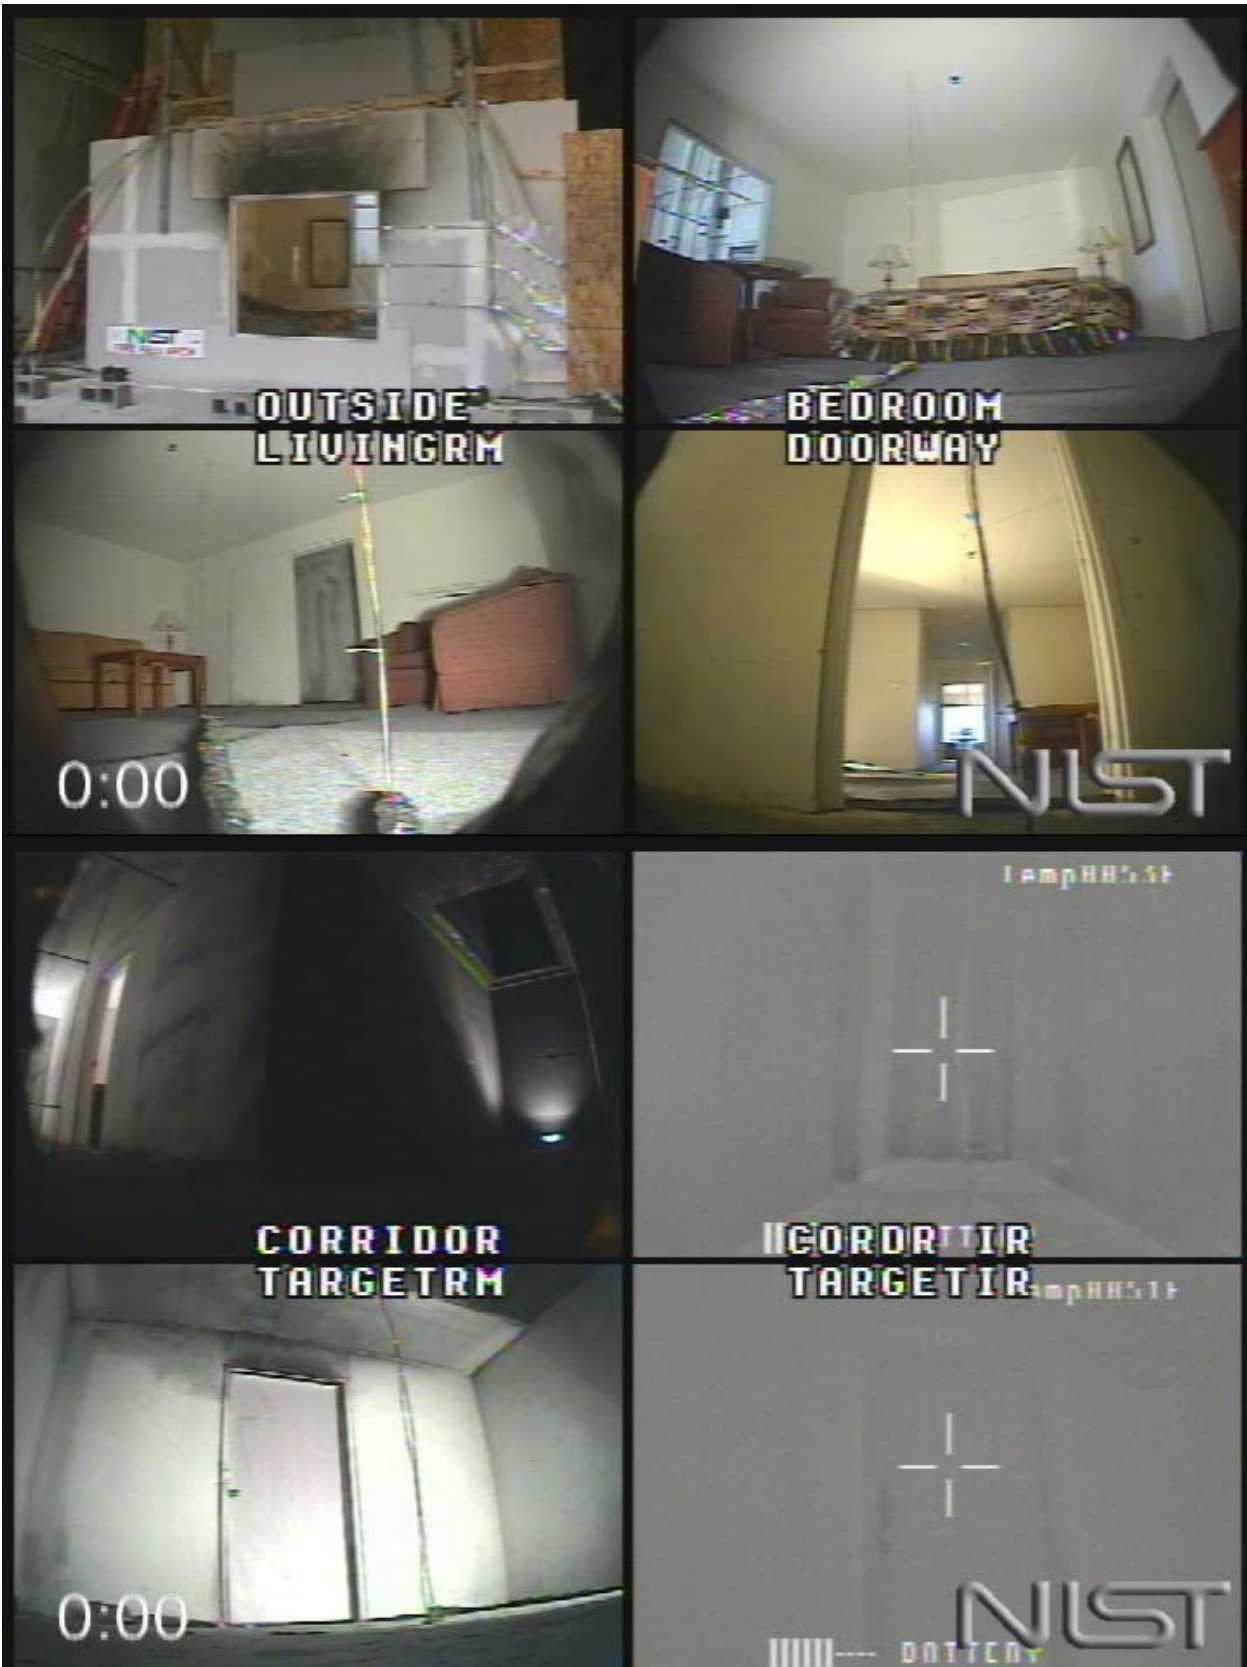
Figure 5.3.1-1. Experiment 3, ignition.

Figure 5.3.1-1 shows the conditions at the time of ignition. At this point, the six video views are clear and unobstructed. However, the thermal images provide limited thermal contrast because the surfaces in the view were at nearly equal temperature.
