# NIST Technical Note 1618

## Fire Fighting Tactics Under Wind Driven Conditions: Laboratory Experiments

Daniel Madrzykowski  
Stephen Kerber

U.S. Department of Commerce  
Building and Fire Research Laboratory  
National Institute of Standards and Technology  
Gaithersburg, MD 20899

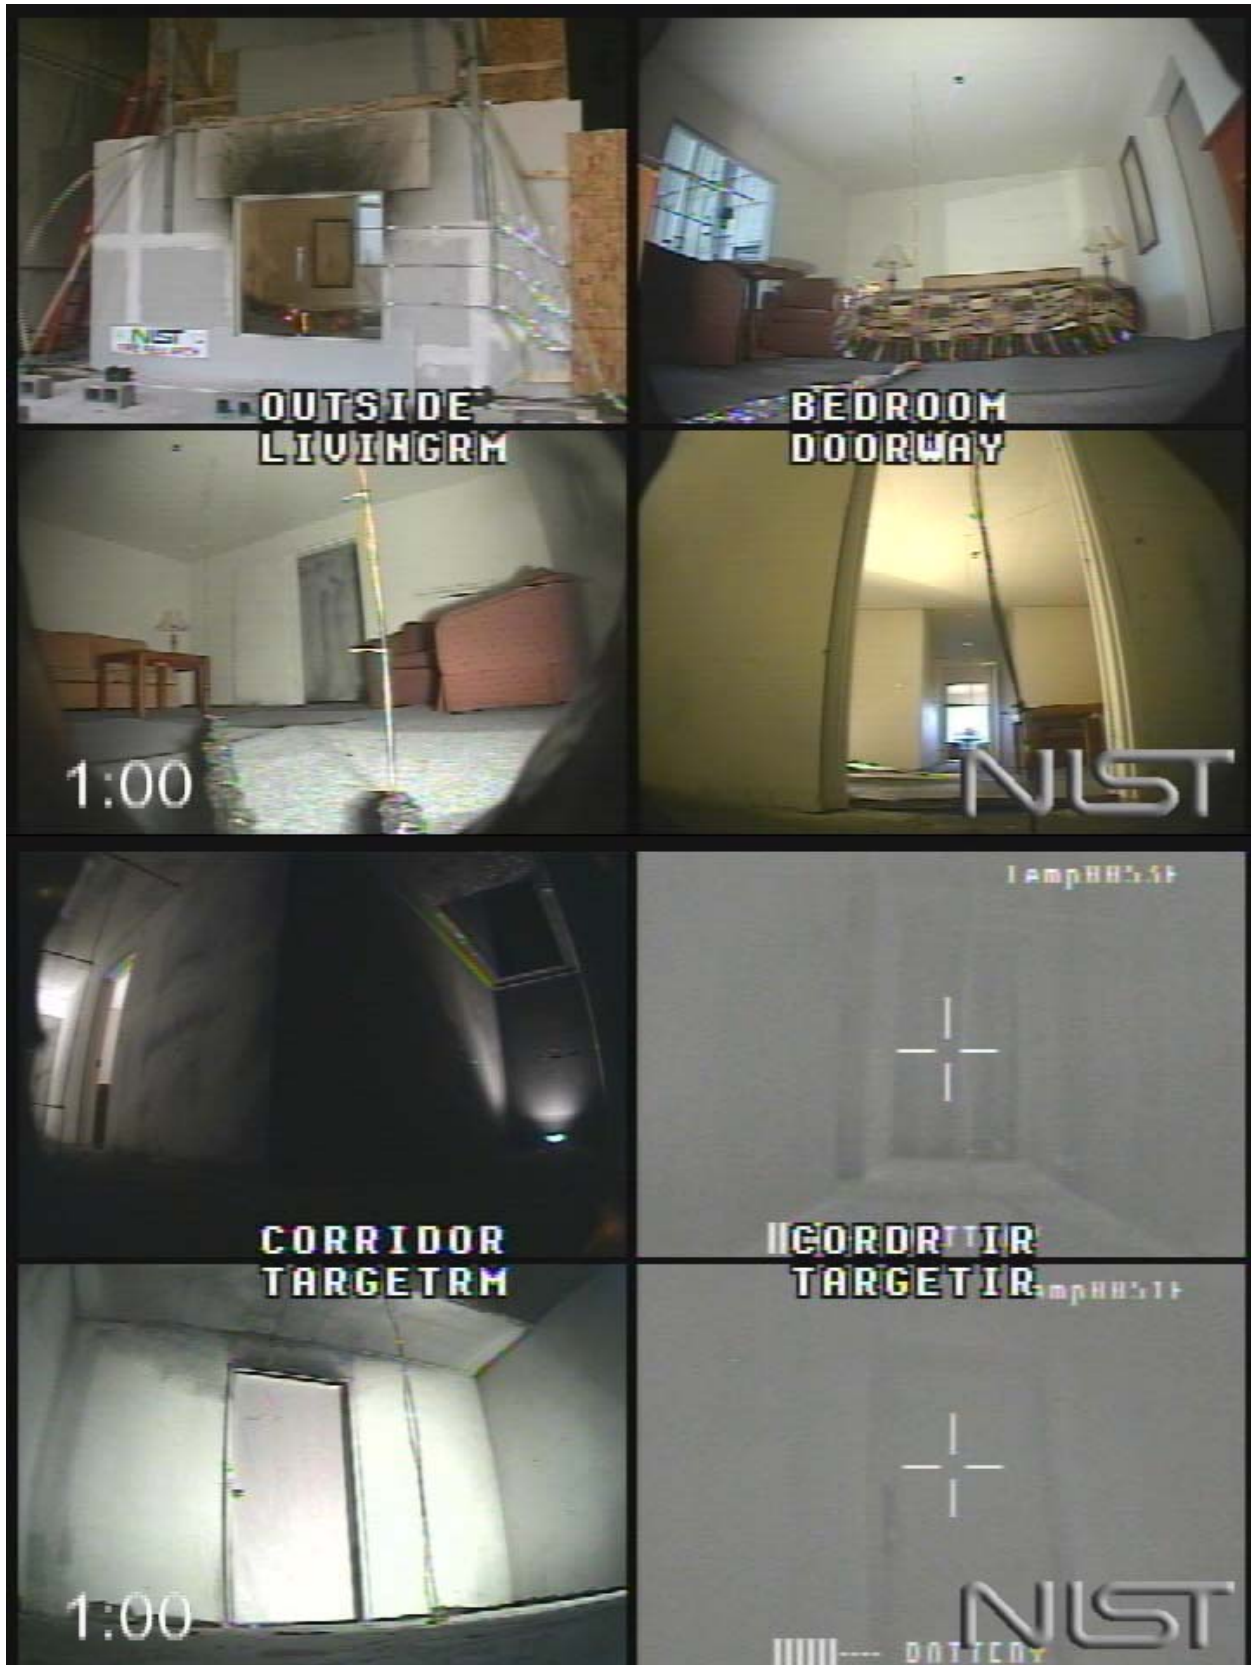
Figure 5.3.1-2. Experiment 3, 60 s after ignition.

The images in Figure 5.3.1-2 were captured 60 s after ignition. The fire from the trash container began to spread to the bed. There was very little smoke being produced and a layer has yet to develop. There was also no smoke or change in thermal condition in the living room, target room or corridor at this time.

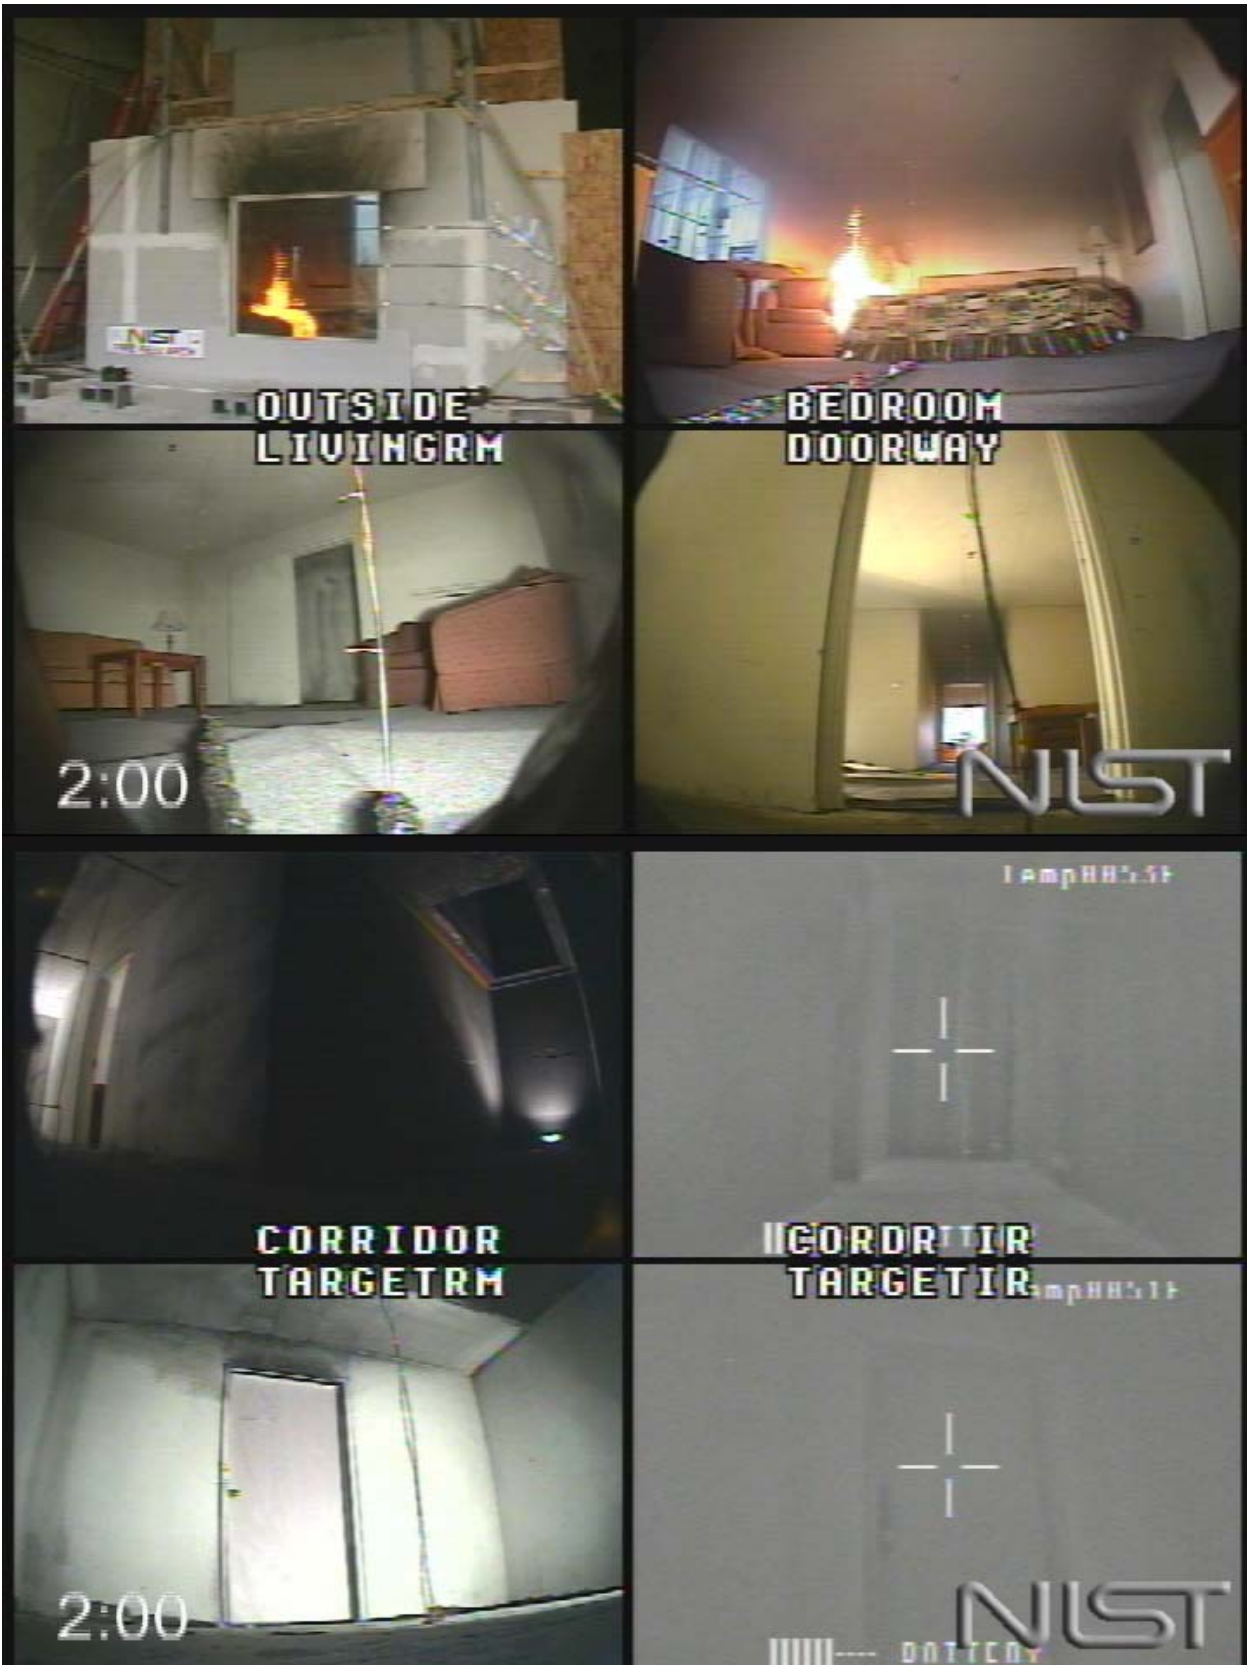
Figure 5.3.1-3. Experiment 3, 120 s after ignition.

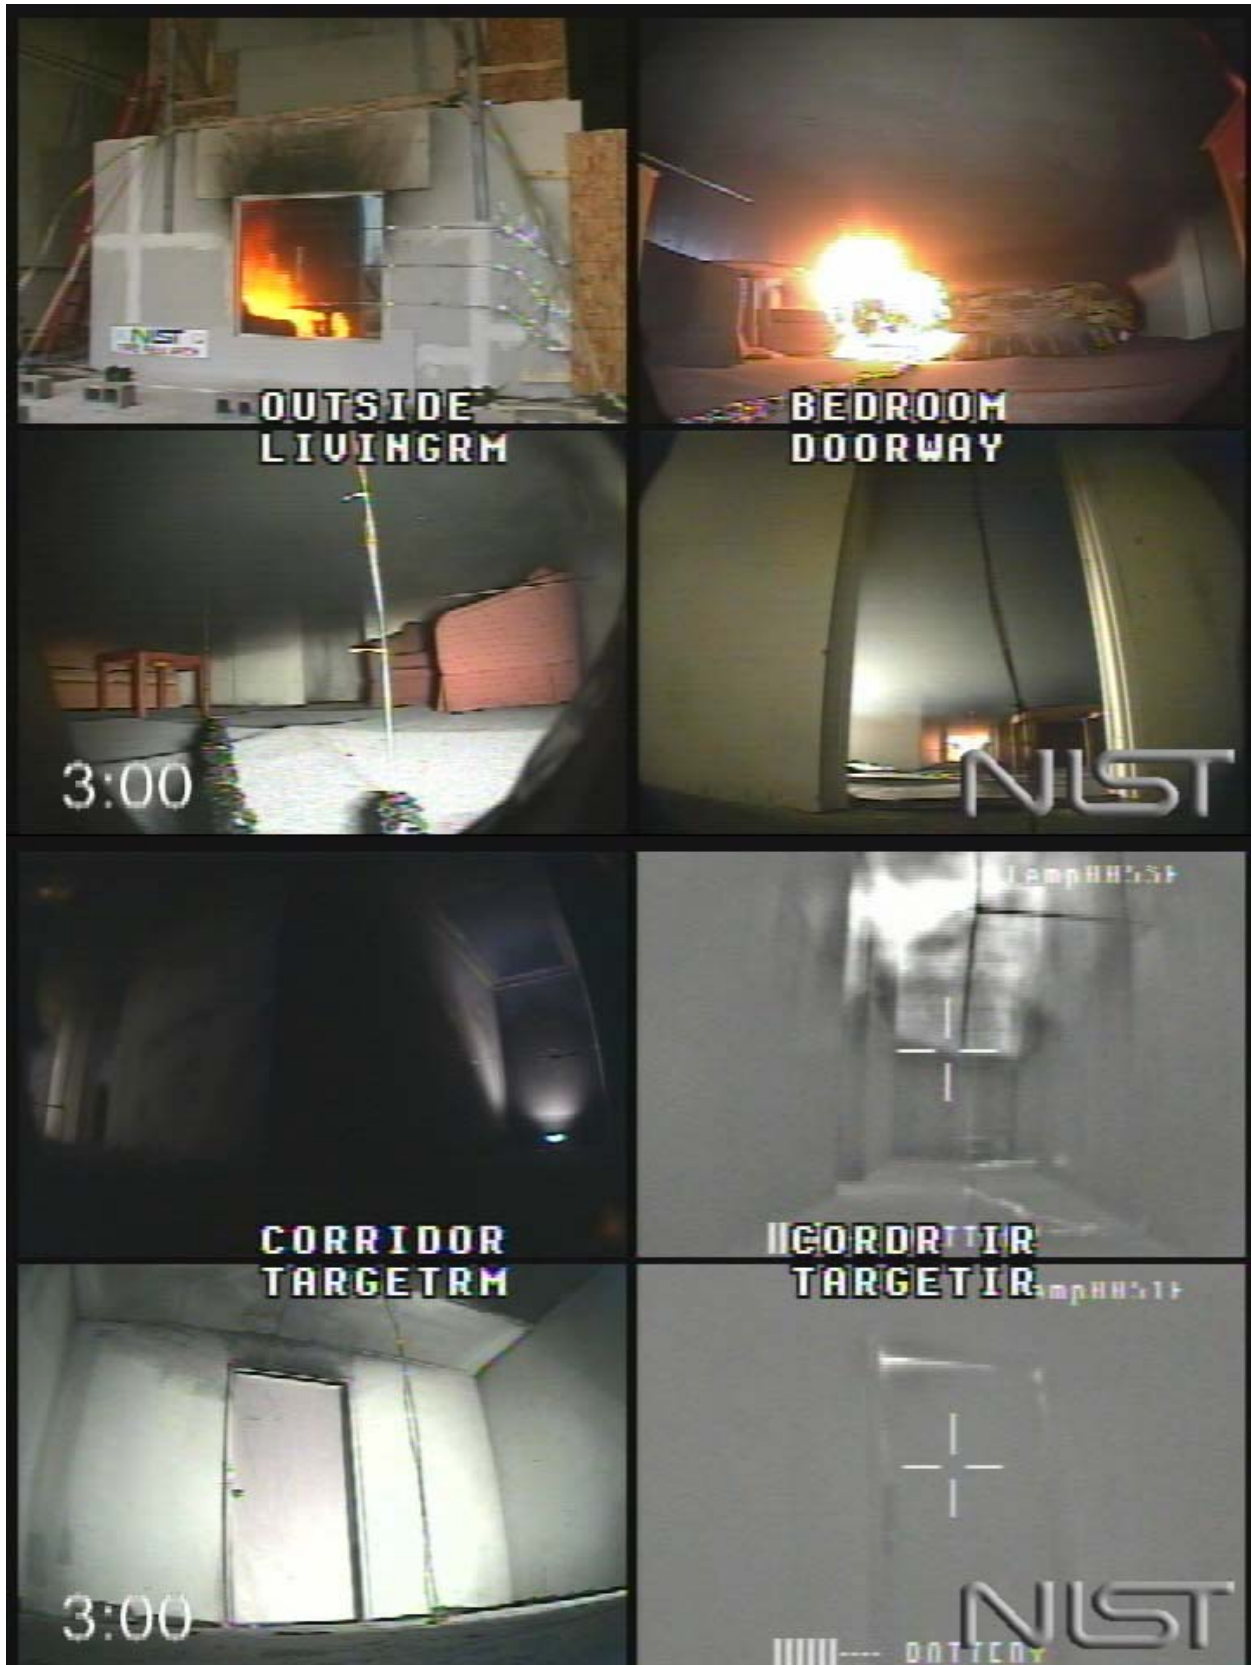
Figure 5.3.1-4. Experiment 3, 180 s after ignition.

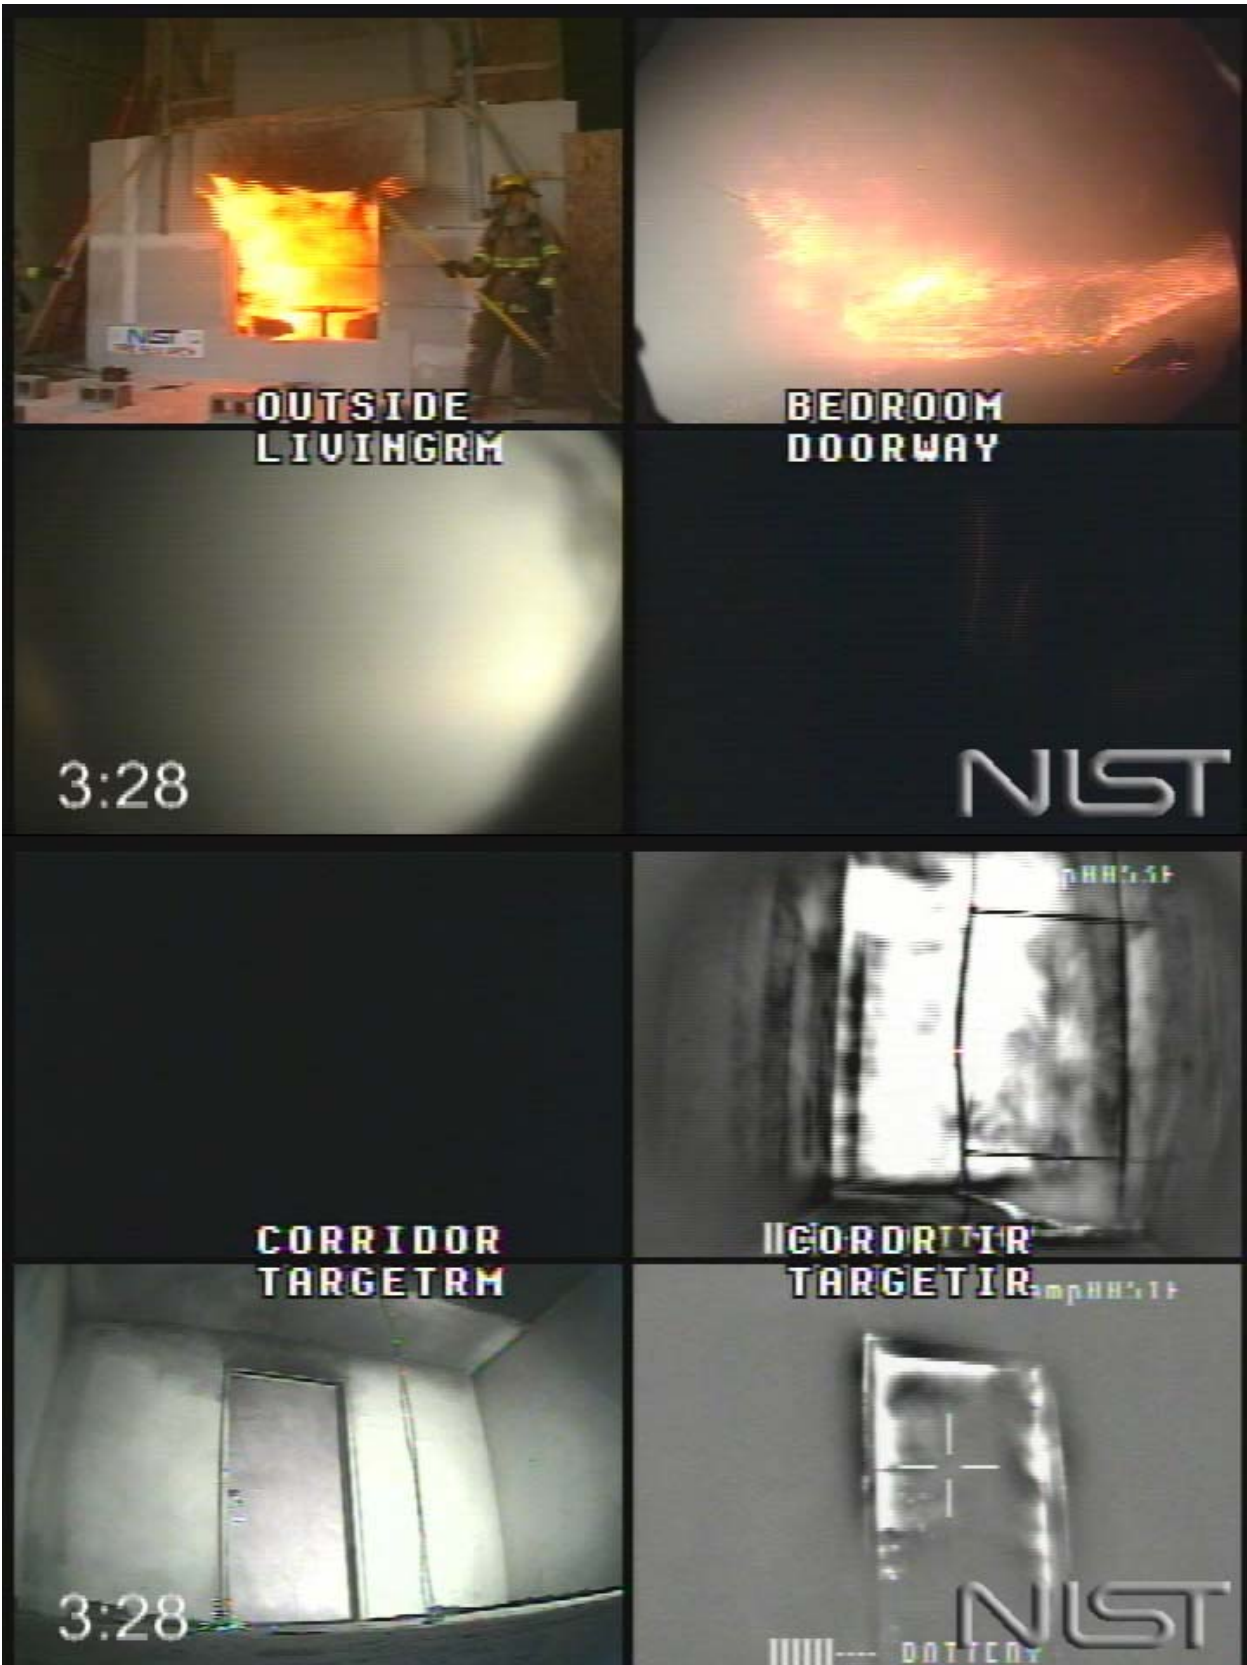
Figure 5.3.1-5. Experiment 3, window fully vented, 208 s after ignition.

Figure 5.3.1-5 shows the conditions at 208 s after ignition. The flames had touched the window at 200 s and a majority of the glass fell out of the frame. The image shows the conditions just after the window was manually cleared. Flames are seen moving across the floor level in the bedroom and the camera views in the living room, hallway and corridor are obscured by smoke. The image from the corridor IR camera shows hot gases exiting the living room, filling the doorway top to bottom and impinging on the east wall of the corridor. Heat was flowing around the entire perimeter of the hall door into the target room, as shown in the thermal image of the target room.

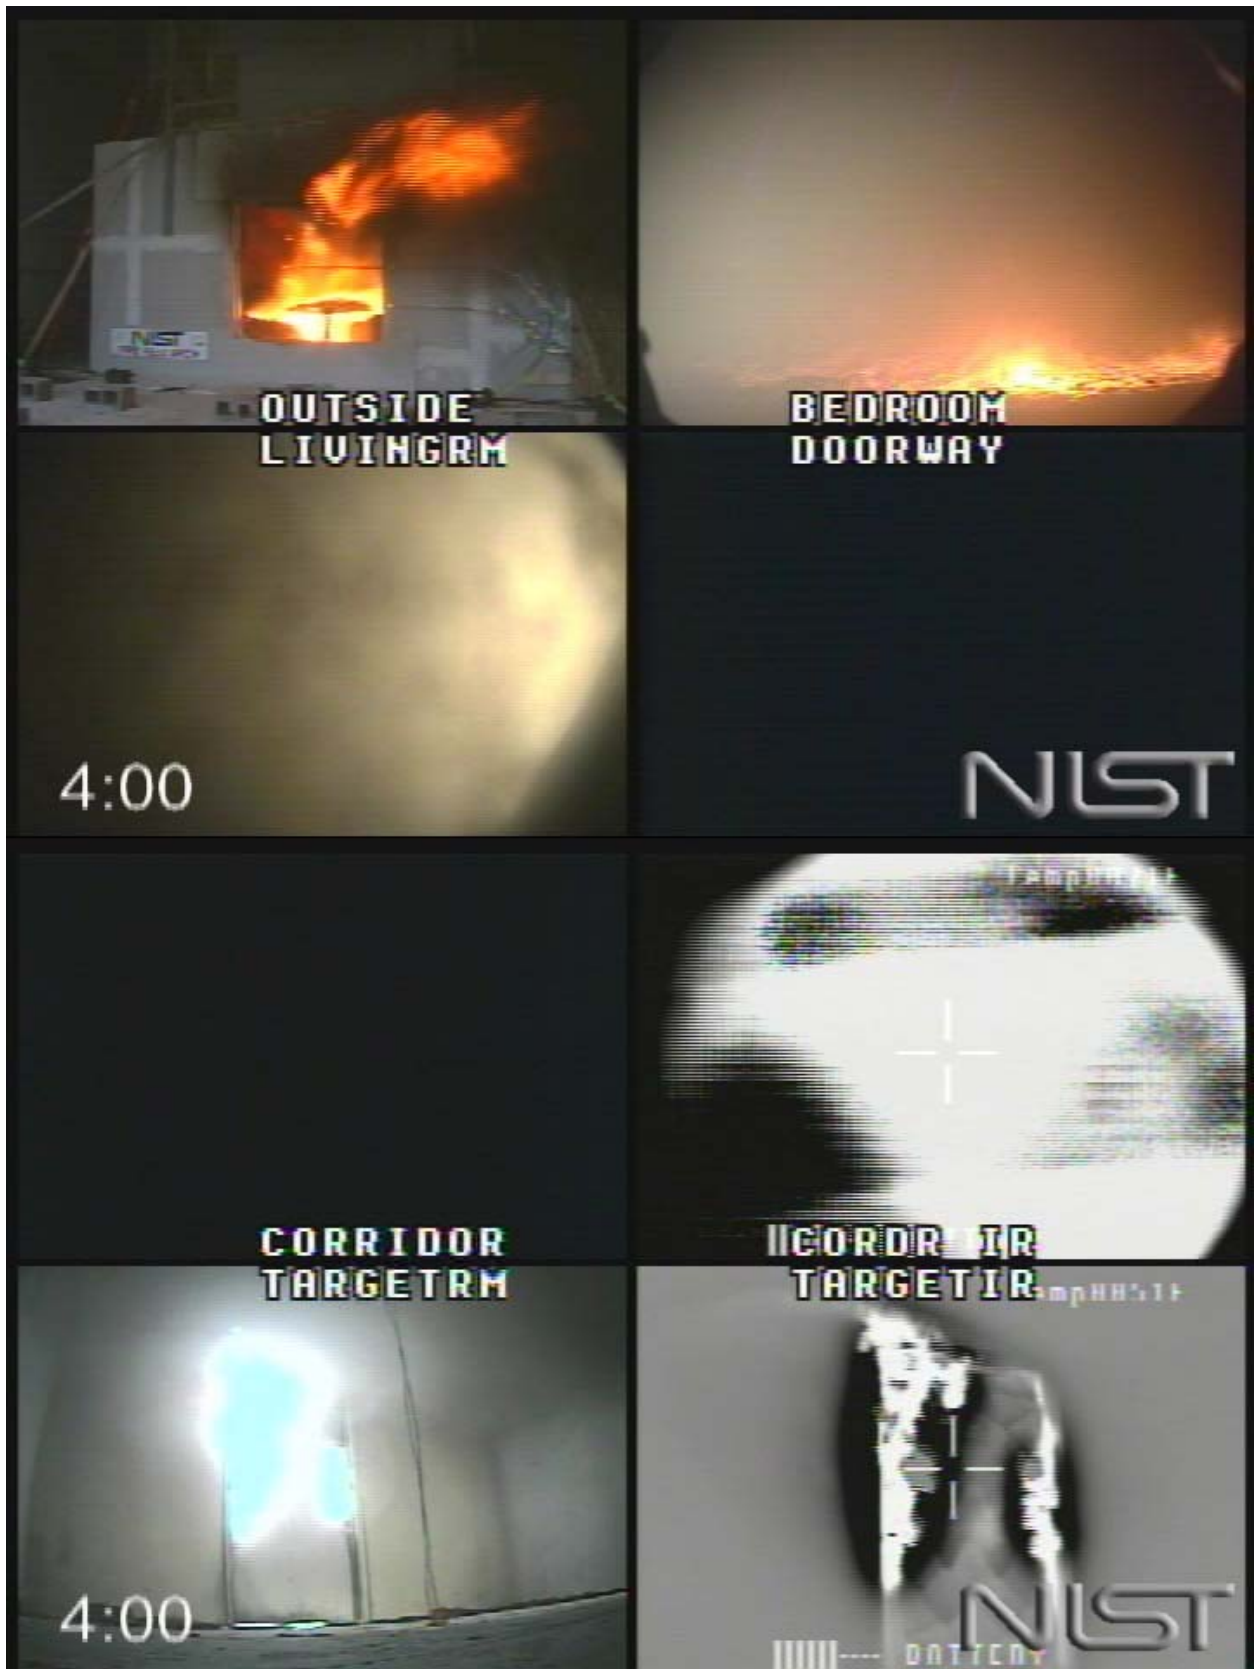
Figure 5.3.1-7. Experiment 3, 240 s after ignition.

Figure 5.3.1-7 shows the conditions at 240 s after ignition. Flames were pulsing out of the top right corner of the window opening. Flames were still visible at the floor level in the bedroom but smoke was obscuring the views in the living room and corridor. The amount of heat entering the hallway has caused the image from the corridor IR camera to deteriorate substantially. The visual image in the target room showed flames consuming both sides of the door and beginning to come under the door. The visibility at the lower layer in the target room remained good.

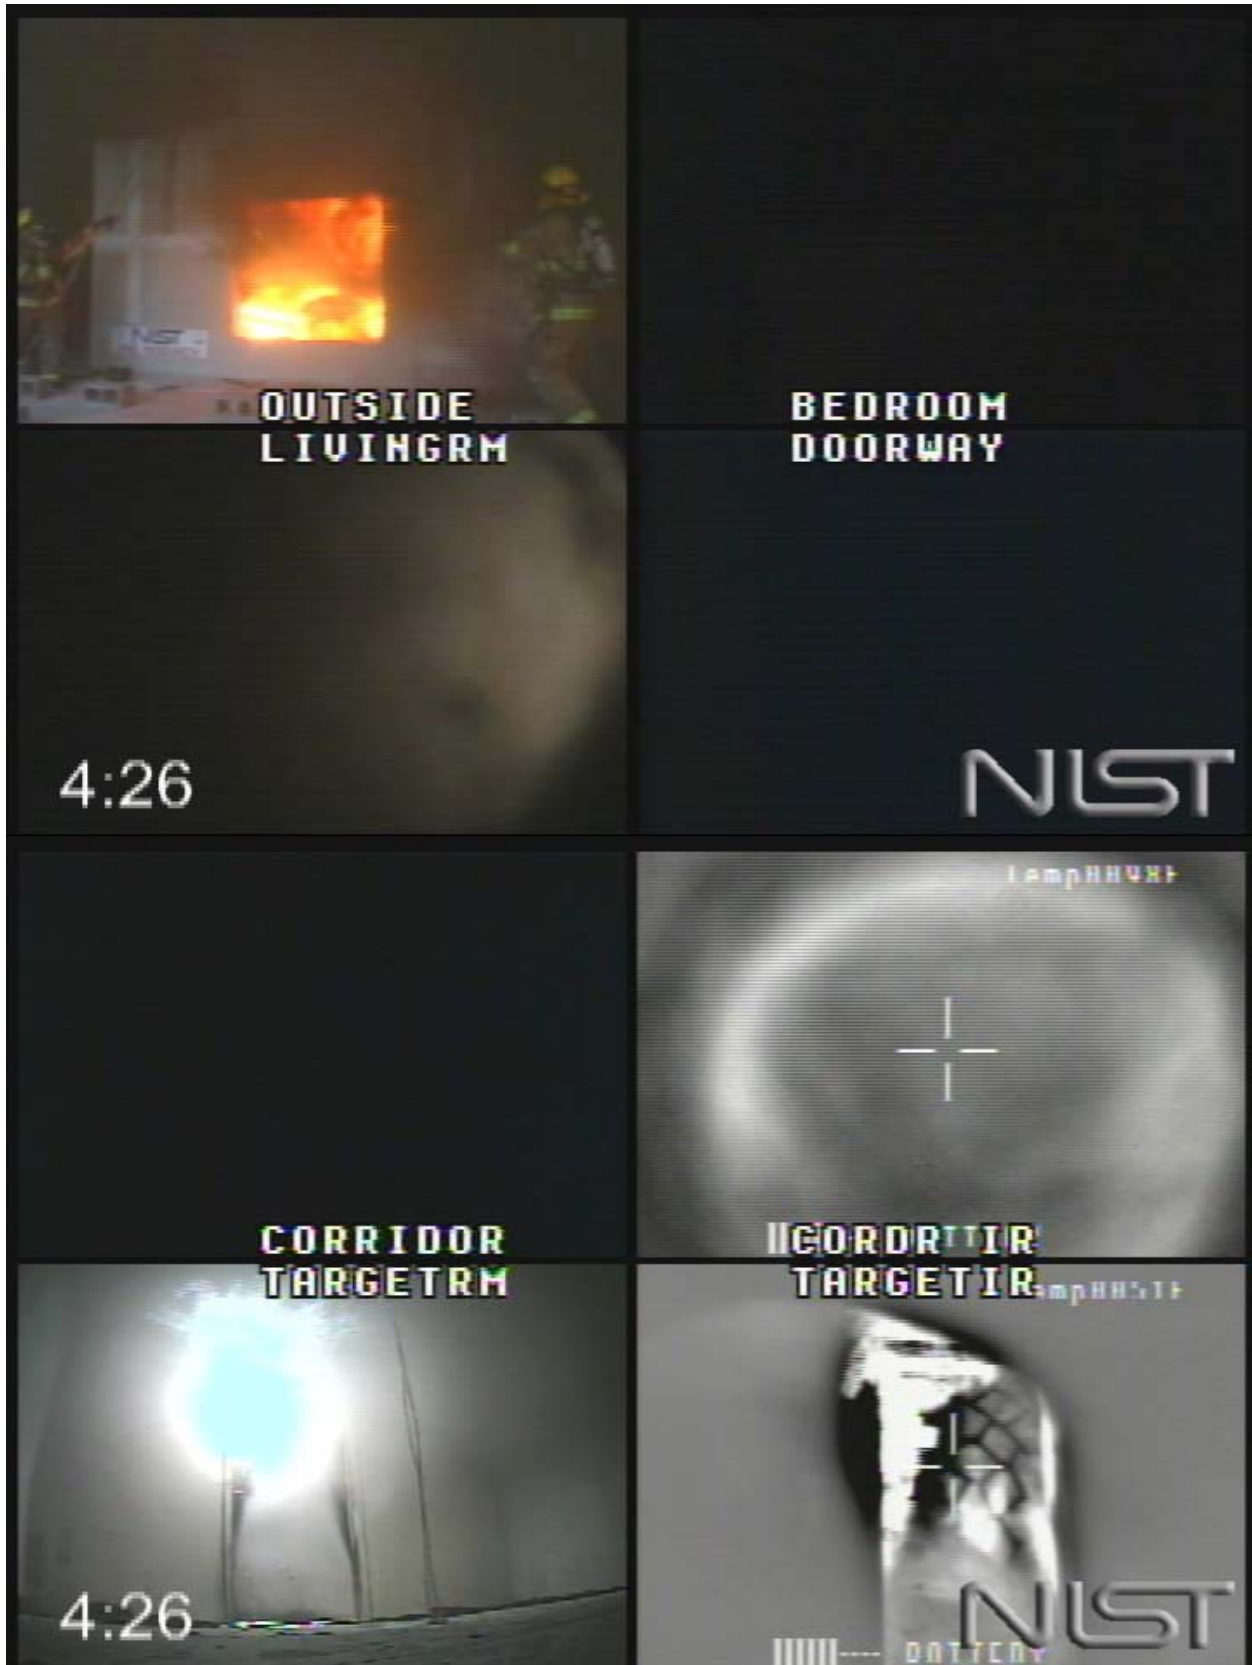
Figure 5.3.1-8. Experiment 3, WCD deployed; 266 s after ignition.

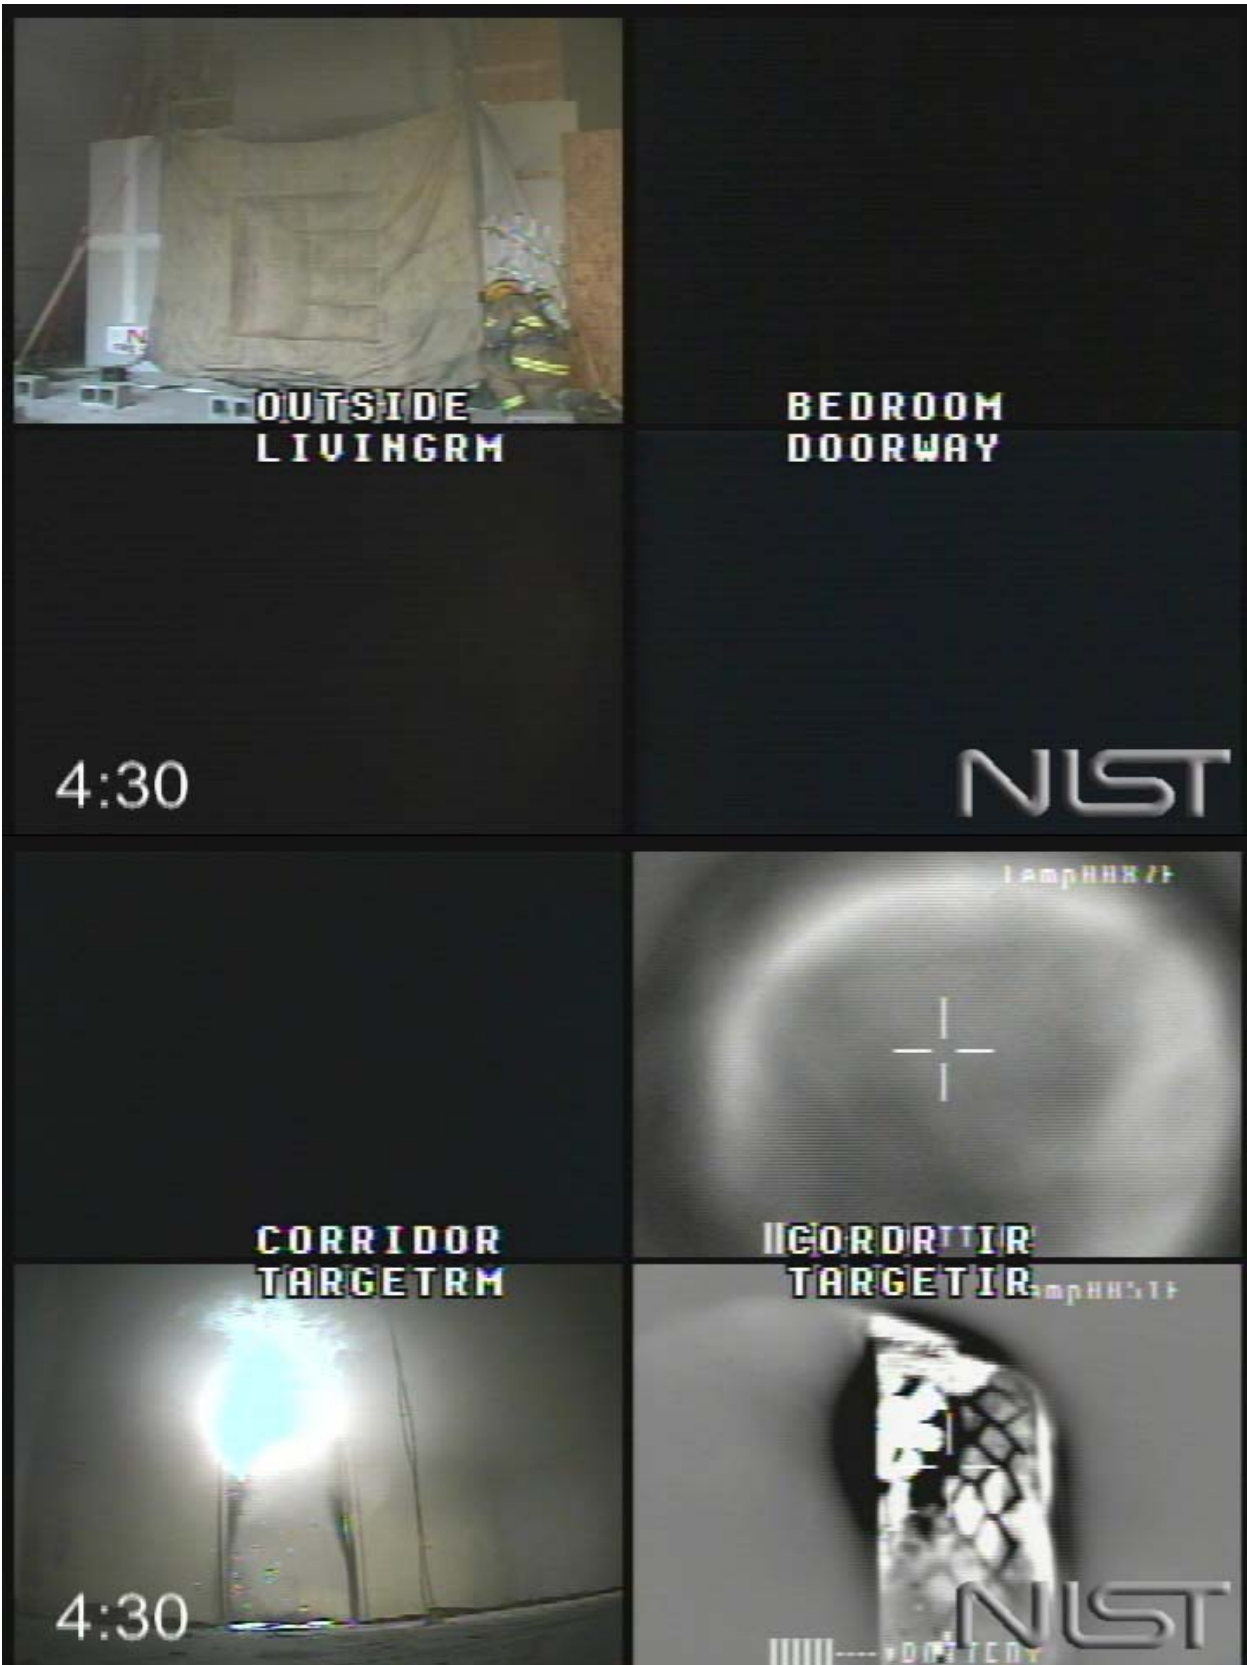
Figure 5.3.1-9. Experiment 3, WCD in place, 270 s after ignition.

At 270 s after ignition, the wind control device was deployed and in place as shown in the outside view of Figure 5.3.1-9. The interior video views were obscured by soot. The thermal view of the corridor no longer showed any hot gas flows, only a hot gas atmosphere. Conditions in the target room did not appear to have changed significantly in the 4 s since the images in Figure 5.3.1-8.

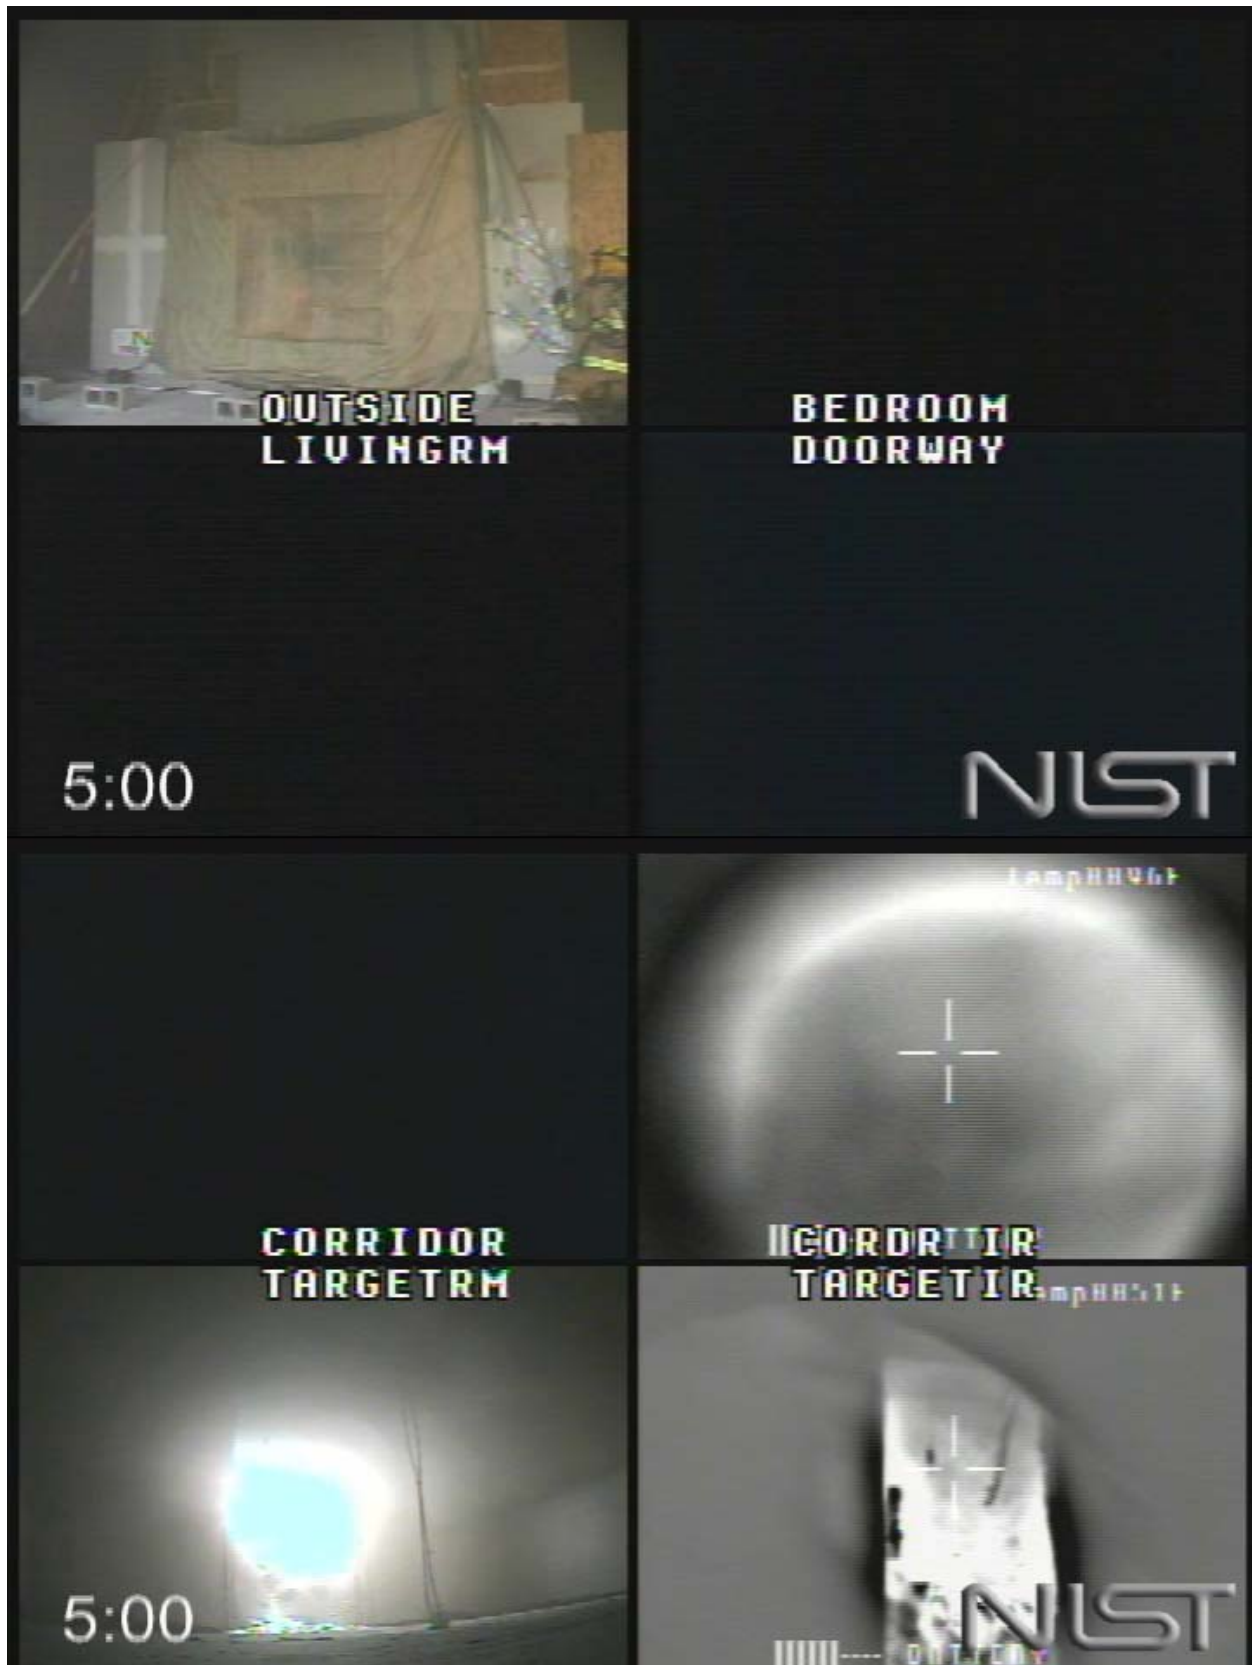
Figure 5.3.1-10. Experiment 3, 300 s after ignition.

Figure 5.3.1-10 shows the conditions at 300 s after ignition, or approximately 30 s since deployment of the wind control device. The interior video views were still obscured by soot. The thermal image from the corridor was still saturated with heat but started to improve in clarity. In the target room the top of the door continued to burn and the thermal image captured the increased heat and the absence of the top half of the door. Although the top half of the door was missing a two layer environment still remained in the target room.

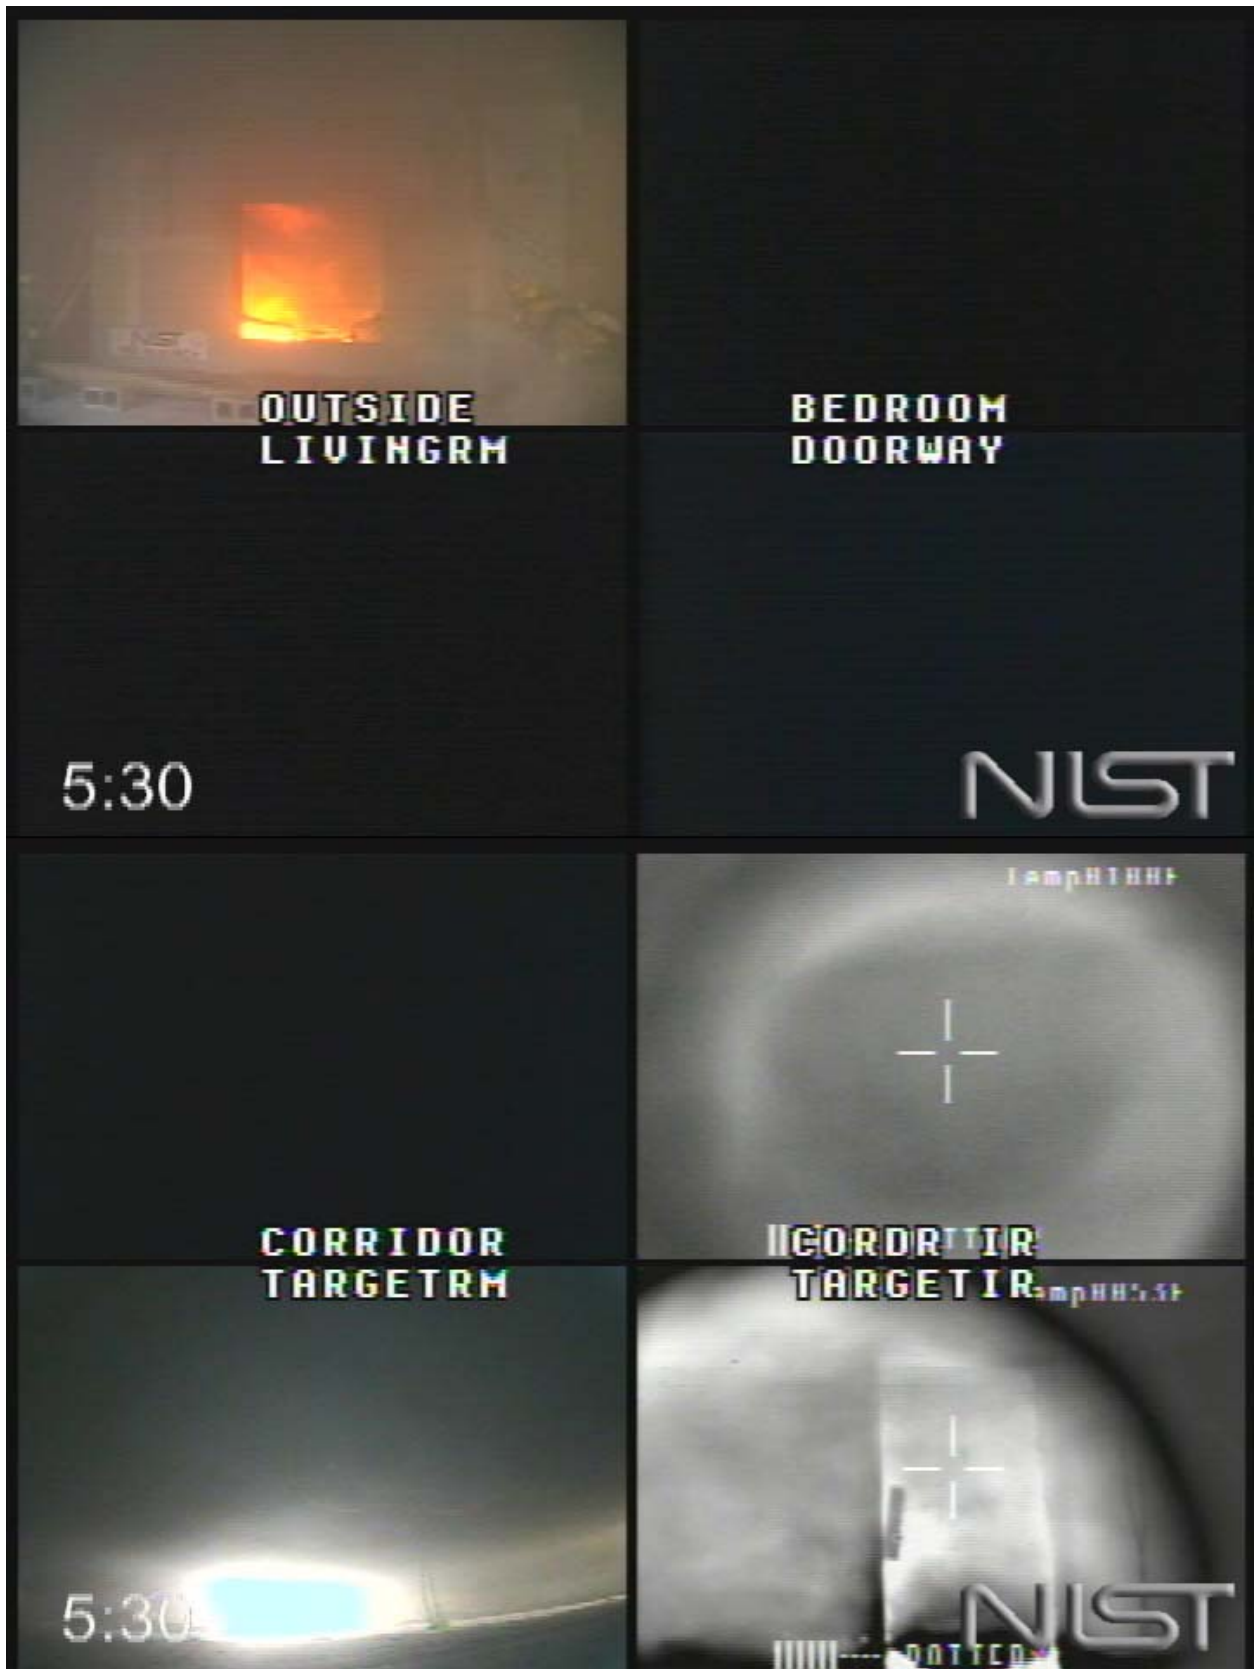
Figure 5.3.1-11. Experiment 3, WCD removed; 330 s after ignition.

Figure 5.3.1-11 shows the conditions at 330 s after ignition, which was about 4 s after the curtain was removed from the window opening. There were flames visible in the bedroom from the outside camera view. The interior video views were still obscured by soot. The target room visual camera shows the smoke layer has descended toward the floor and thermal image shows the heat is mixing throughout the room.

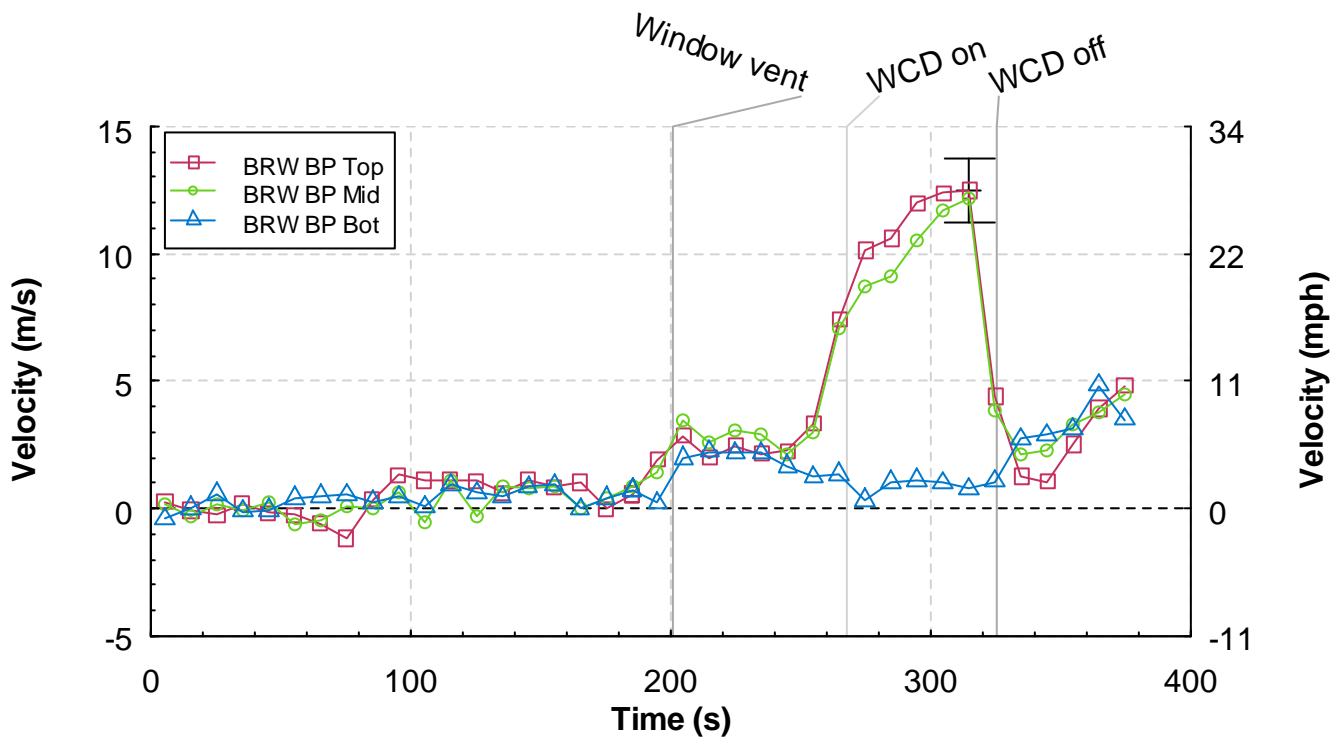
Figure 5.3.6-1. Velocity versus time from the bedroom window (BRW) bi-directional probe array, Experiment 3.

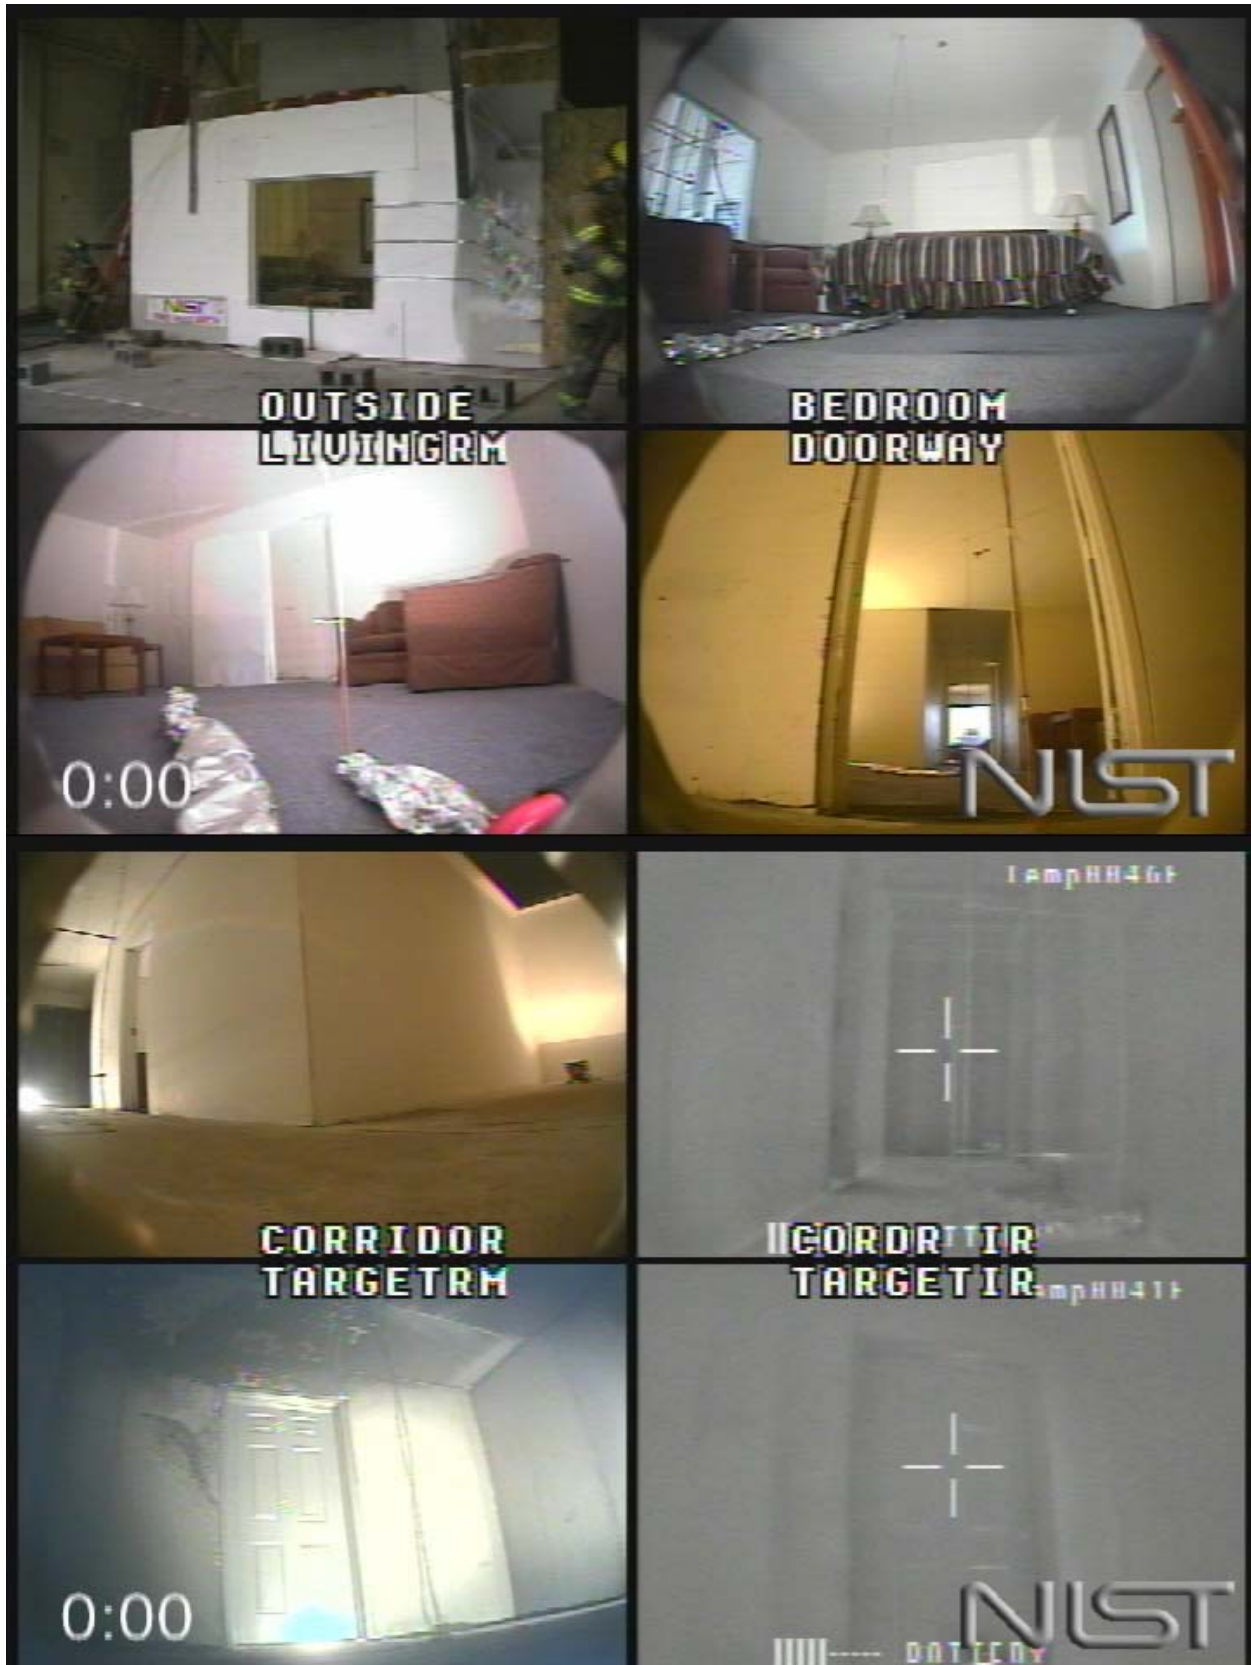
Figure 5.4.1-1. Experiment 4, ignition.

Figure 5.4.1-1 shows the conditions at the time of ignition. At this point, the six video views are clear and unobstructed. The thermal images provide limited thermal contrast because the surfaces in the view are at similar temperatures.
