# NIST Technical Note 1618

## Fire Fighting Tactics Under Wind Driven Conditions: Laboratory Experiments

Daniel Madrzykowski  
Stephen Kerber

U.S. Department of Commerce  
Building and Fire Research Laboratory  
National Institute of Standards and Technology  
Gaithersburg, MD 20899

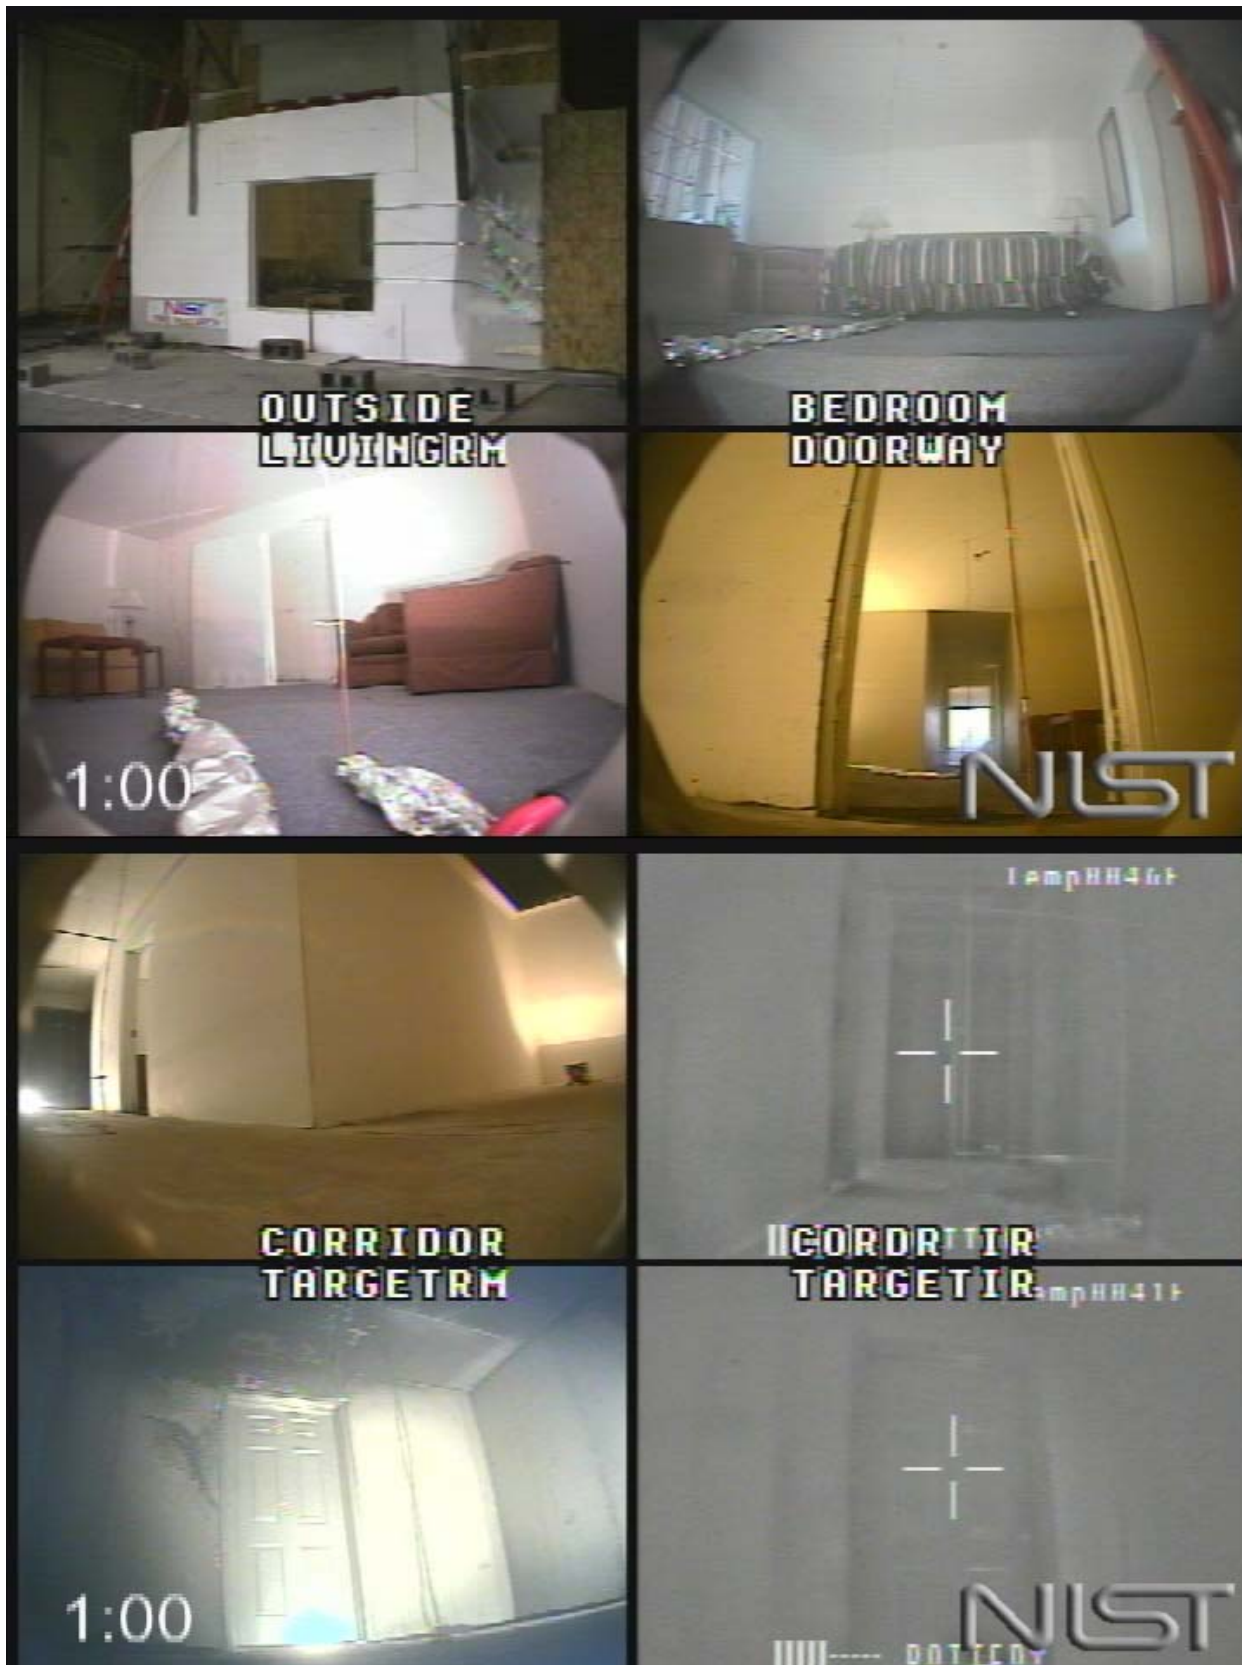
Figure 5.4.1-2. Experiment 4, 60 s after ignition.

The images in Figure 5.4.1-2 were captured 60 s after ignition. At this point the fire is still limited to the trash container fuel package. The fire development in this experiment was slower than in the previous experiments. There is a thin, light smoke layer formed in the bedroom. There was no smoke or change in thermal condition in the living room, target room or corridor at this time.

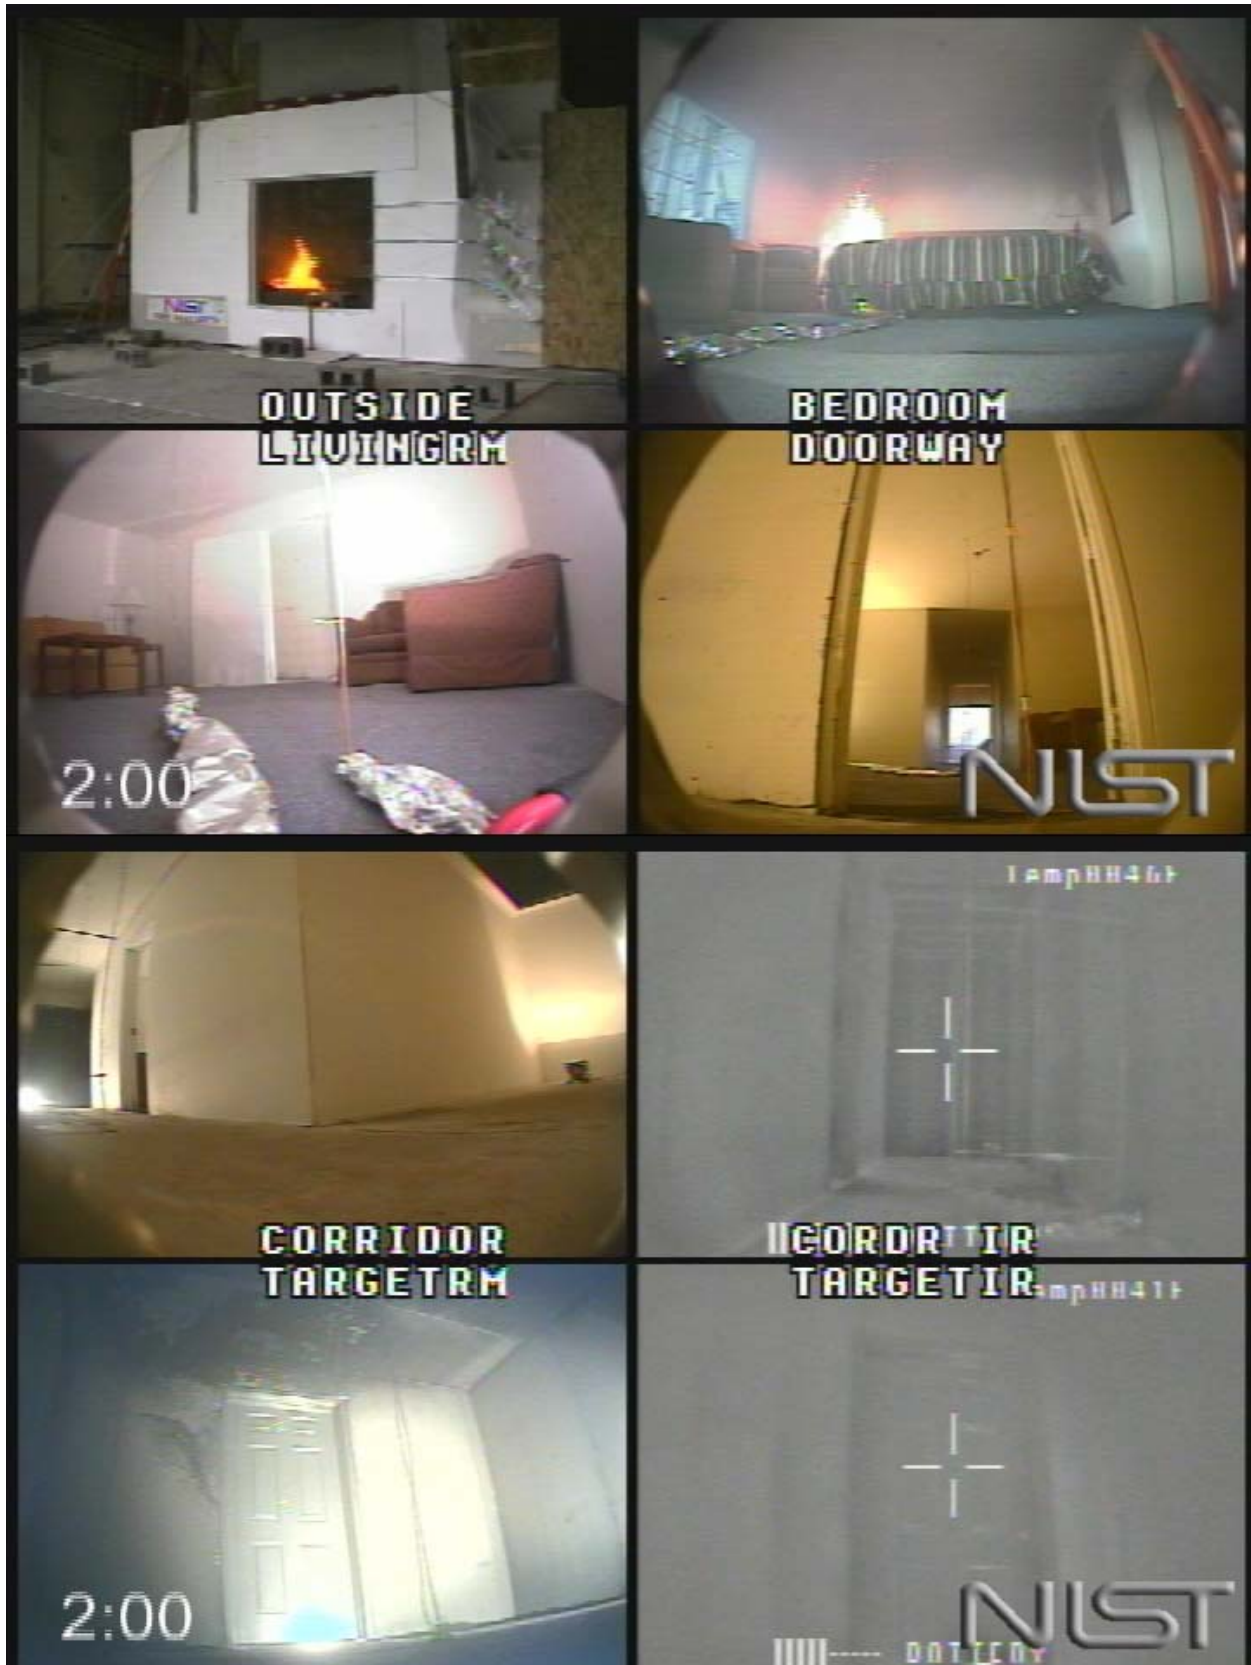
Figure 5.4.1-3. Experiment 4, 120 s after ignition.

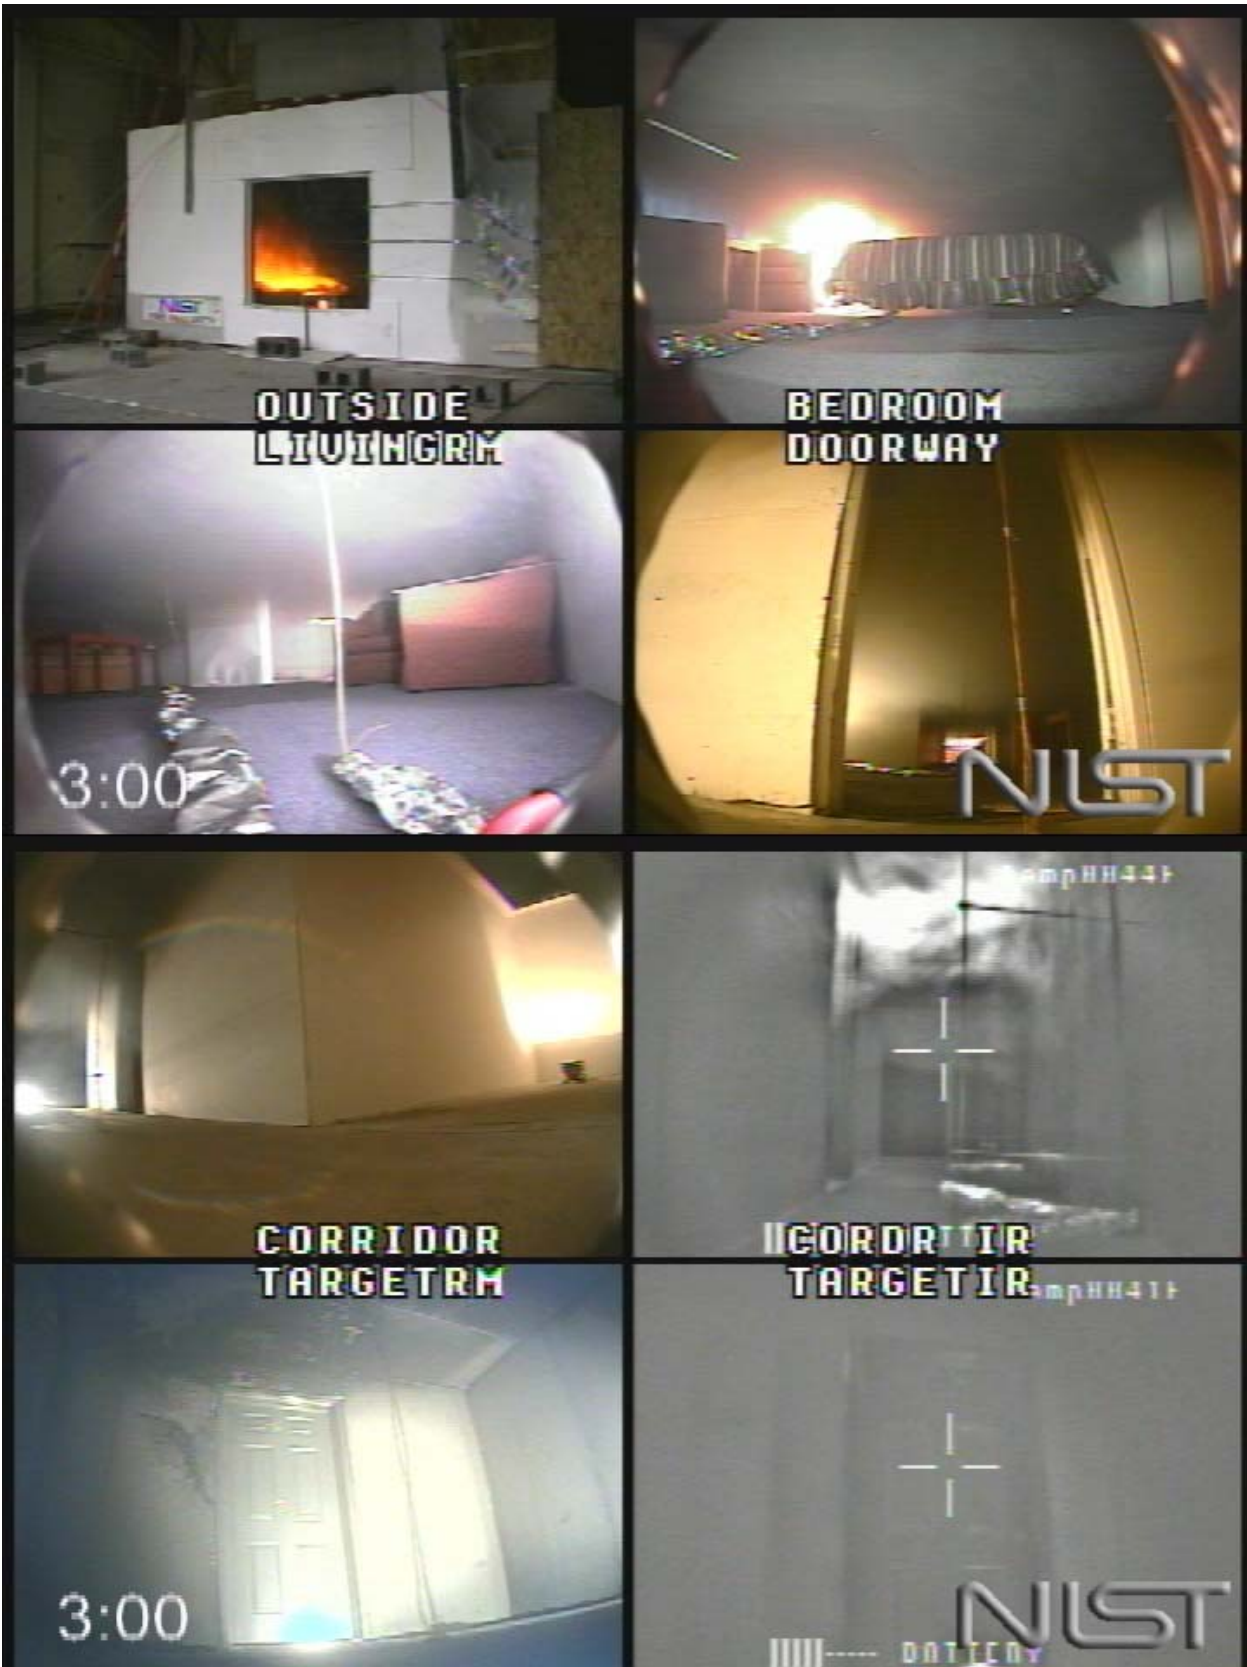
Figure 5.4.1-4. Experiment 4, 180 s after ignition.

Figure 5.4.1-4 shows the images recorded 60 s later at 180 s after ignition. The volume involved in fire has increased. The hot gas layer in the bedroom has become thicker, extending down 1.52 m (5.00 ft) from the ceiling. A hot gas layer has also formed in the living room. It is also approximately 1.52 m (5.00 ft) thick. Smoke and heat are shown flowing into the corridor. The target room appears clear of smoke and thermal view of target room does not show any noticeable heat infiltration.

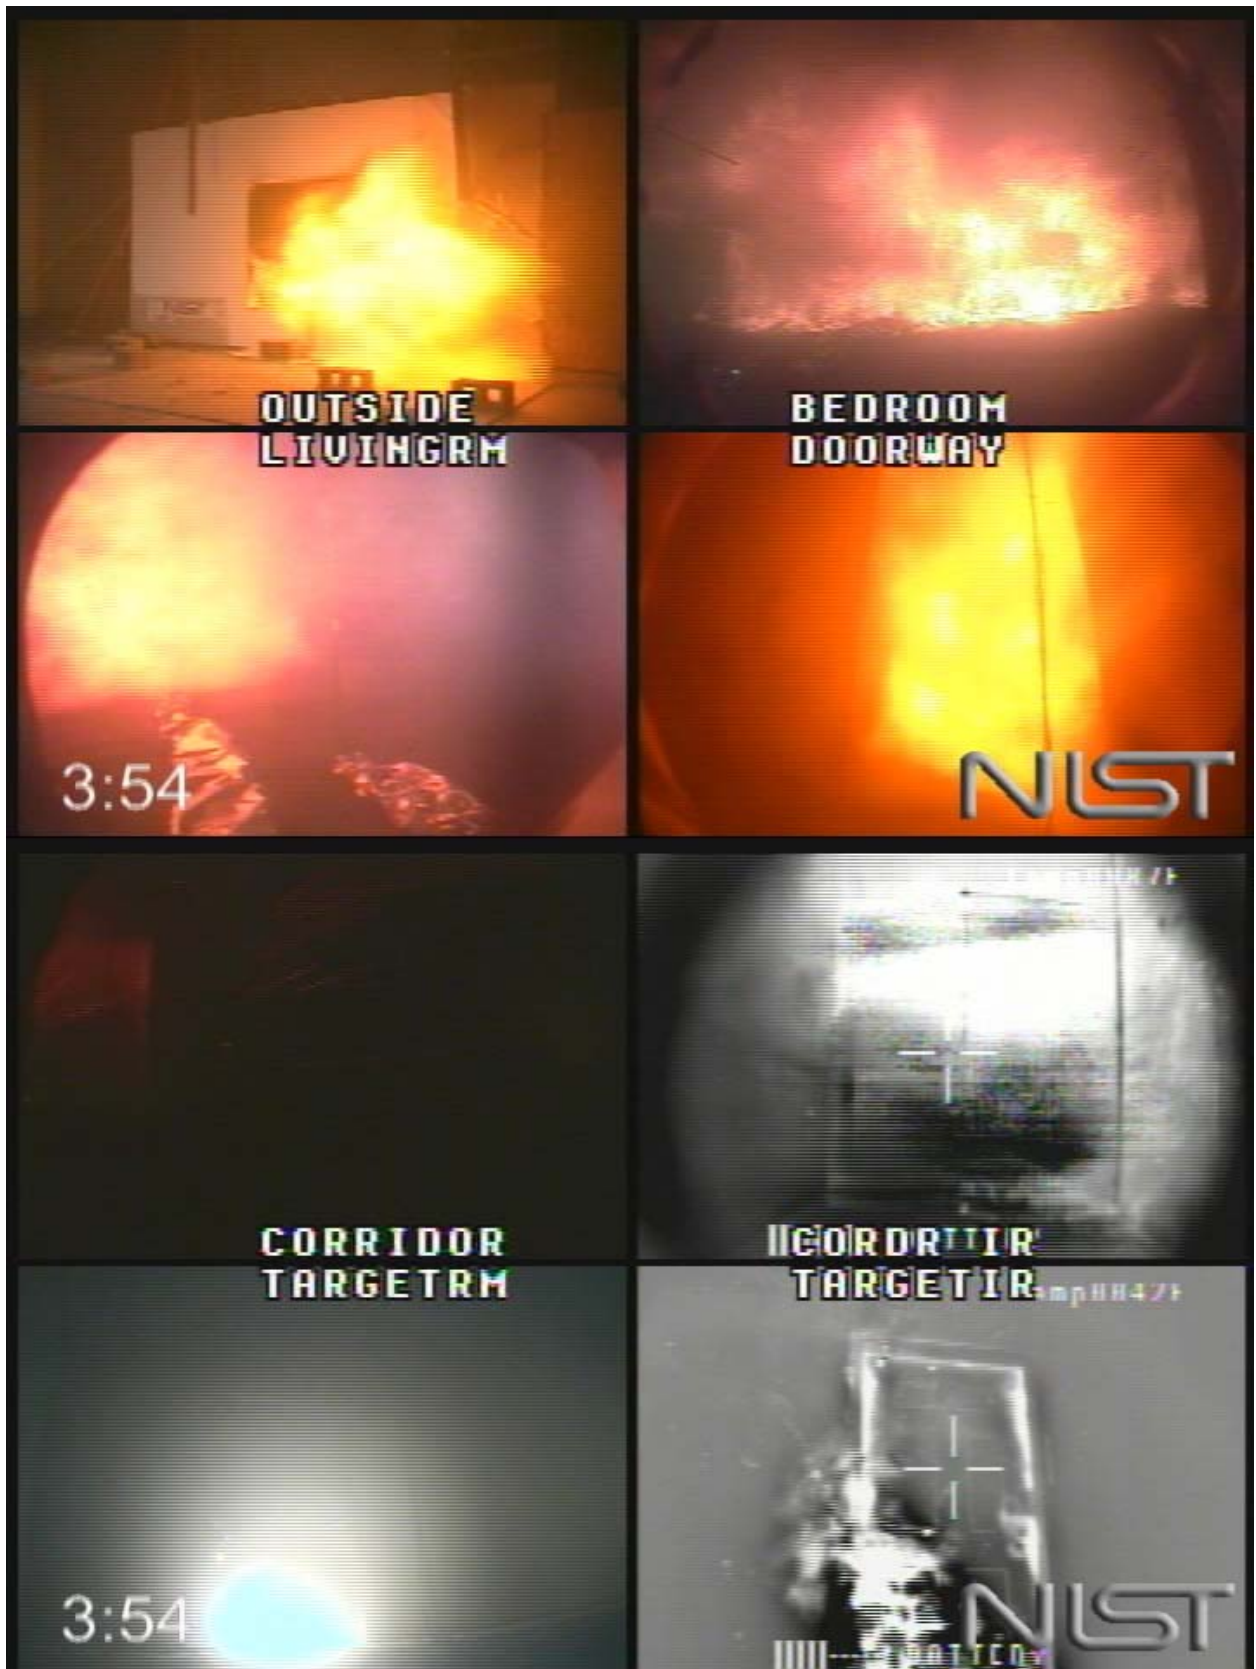
Figure 5.4.1-6. Experiment 4, corridor flames, 234 s after ignition.

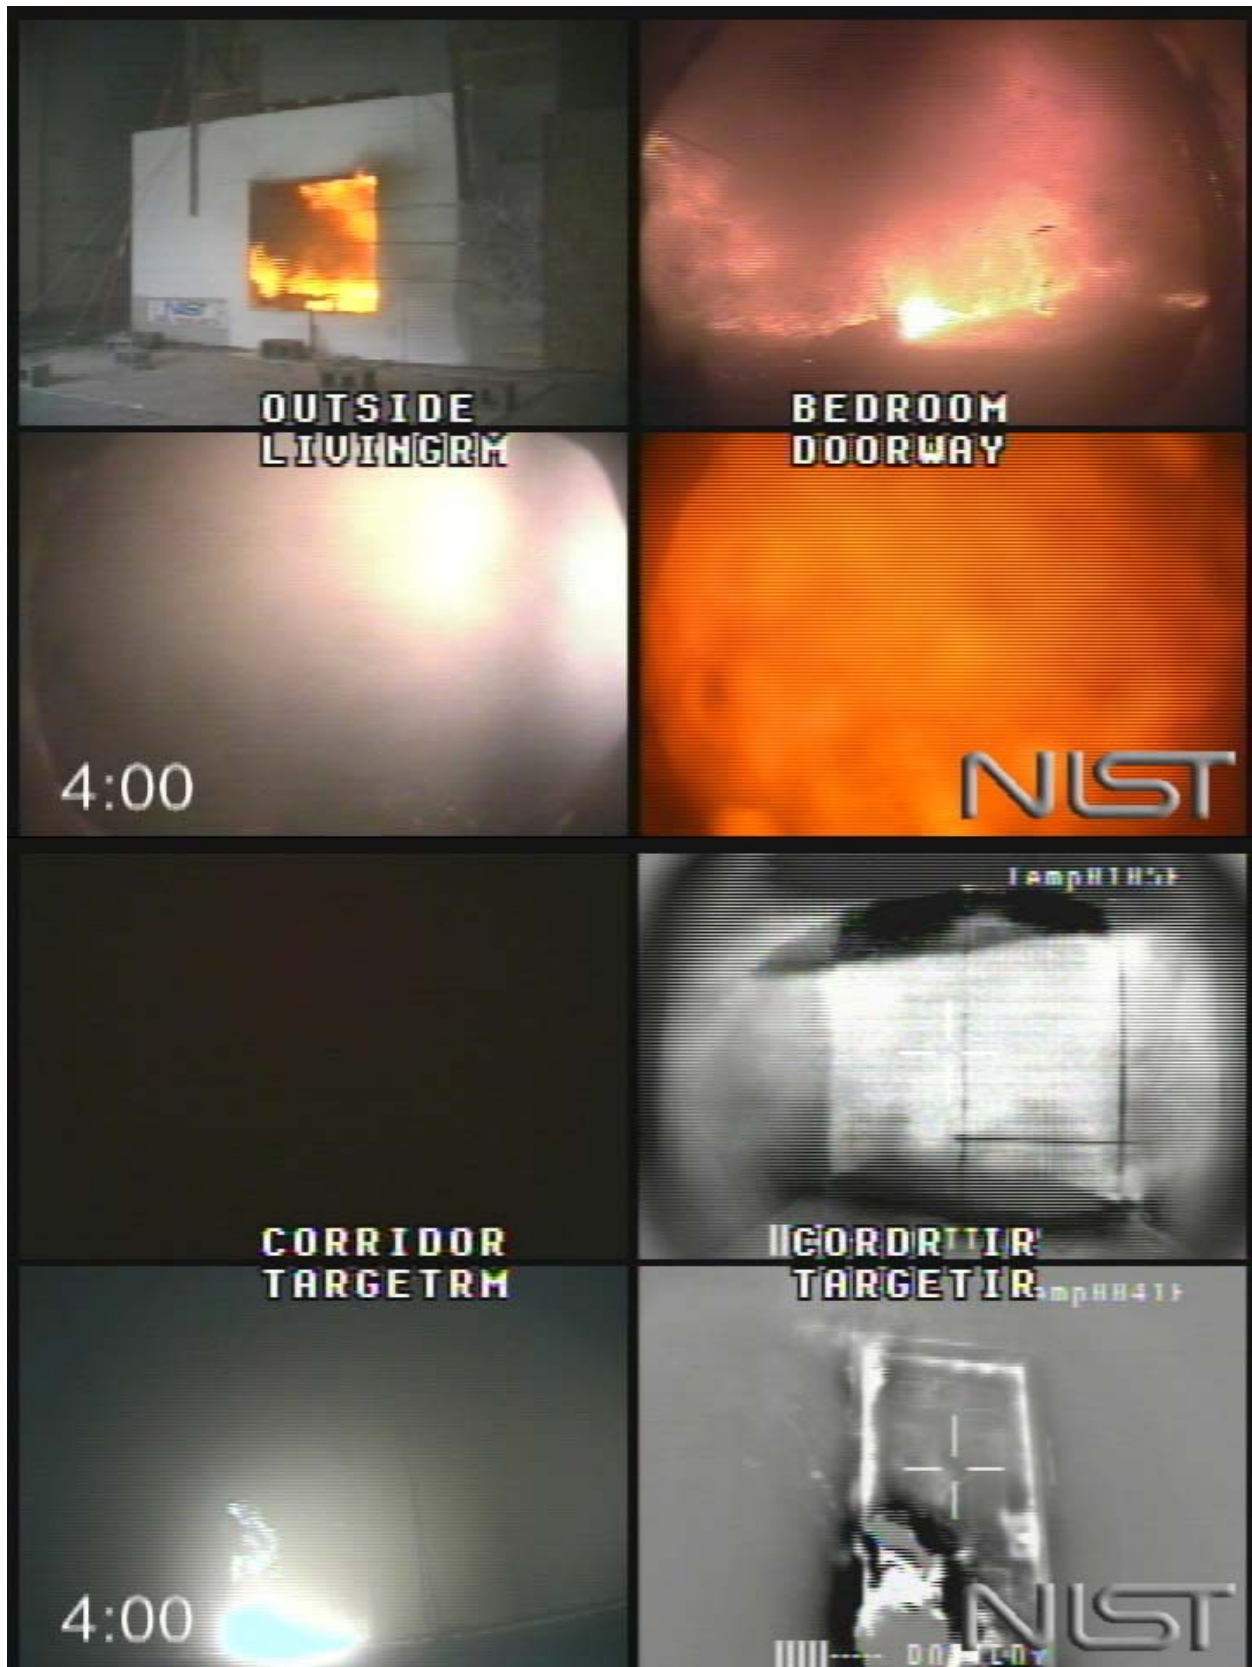
Figure 5.4.1-7. Experiment 4, 240 s after ignition.

The images in Figure 5.4.1-7 were recorded at 240 s after ignition. The image from the bedroom window was captured between pulses of flame coming out of the opening. Based on the video images, the conditions throughout the rest of the test structure are very similar to those described in the previous figure. The thermal image from the corridor shows that the heat had moved down closer to the floor.

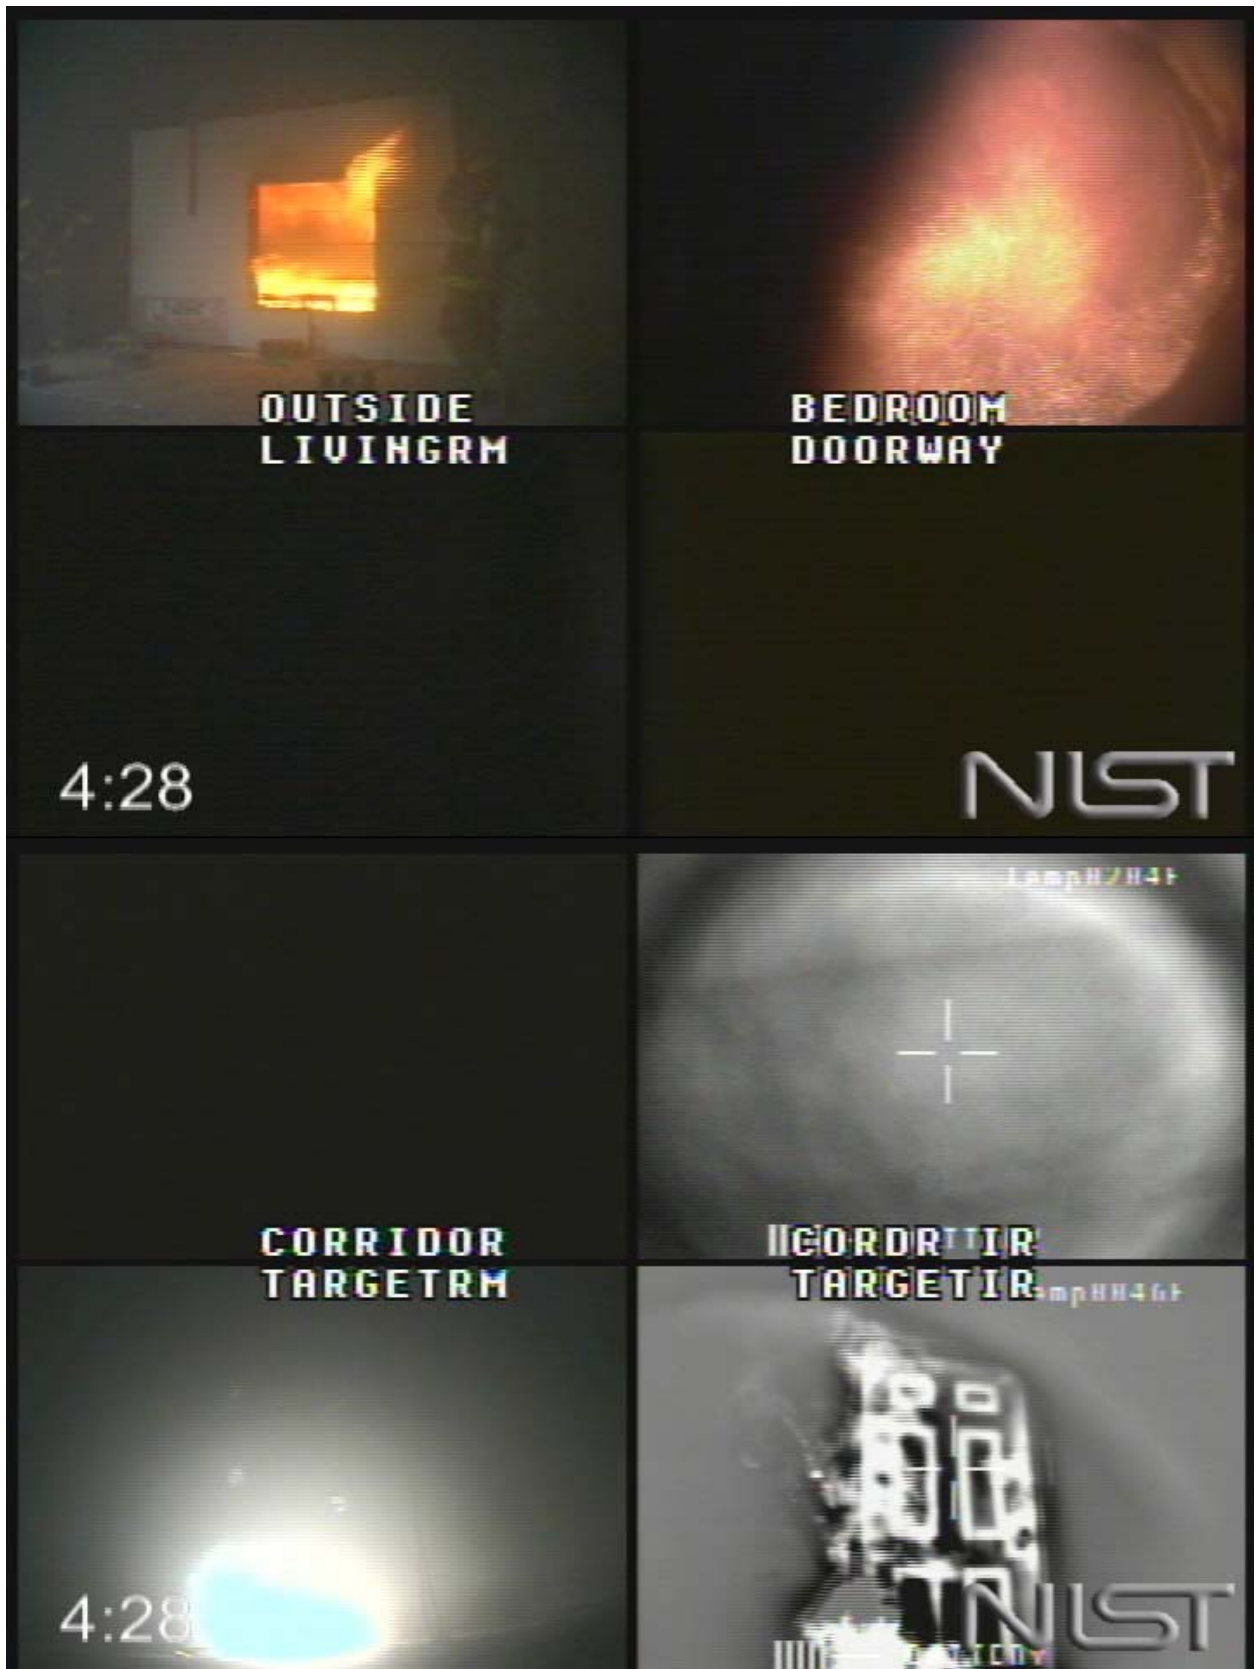
Figure 5.4.1-8. Experiment 4, 268 s after ignition, just prior to WCD deployment.

The images in Figure 5.4.1-8 were taken just prior to the deployment of the small wind control device. The bedroom was still in a post-flashover fire condition with some flames extending out of the window opening. The thermal view of the corridor was obscured from the heat. The thermal image was deteriorated due to the high thermal exposure. The target room video view continued to show the flames at the bottom of the target room door. The thermal view from the target room shows the outlines of the thin sections of the door, as the door had increased in temperature.

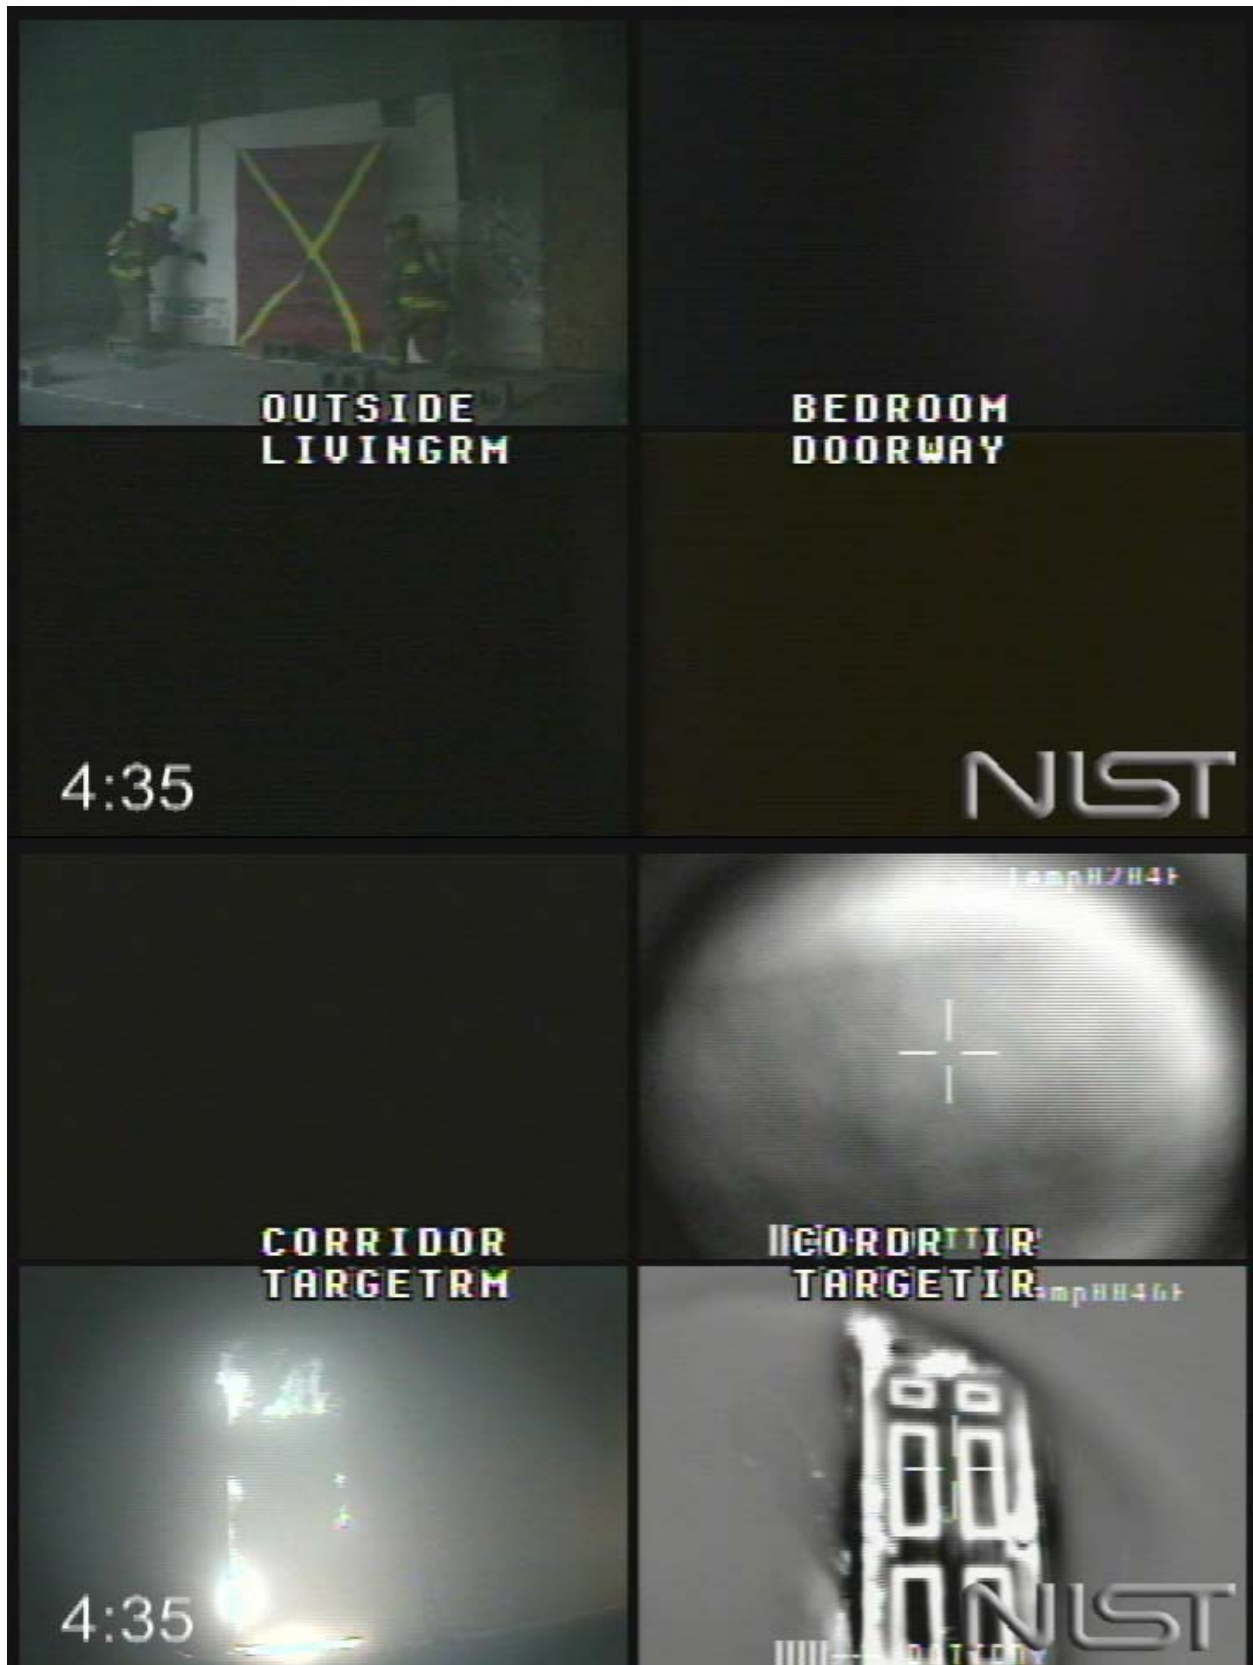
Figure 5.4.1-9. Experiment 4, WCD in place, 275 s after ignition.

The WCD was deployed at 271 s after ignition. Figure 5.4.1-9 has images that were recorded at 275 s after ignition. The wind control device was in place over the window opening as shown in the outside view. The interior video views were obscured. The thermal view of the corridor was still obscured due to high heat conditions. Flames had come through most of the door perimeter as shown in the video image from the target room, although the fire at the base of the door had gotten smaller. The thermal image from the target room, compliments that video image, in that most of the thermal plume from the bottom of the door was no longer visible.

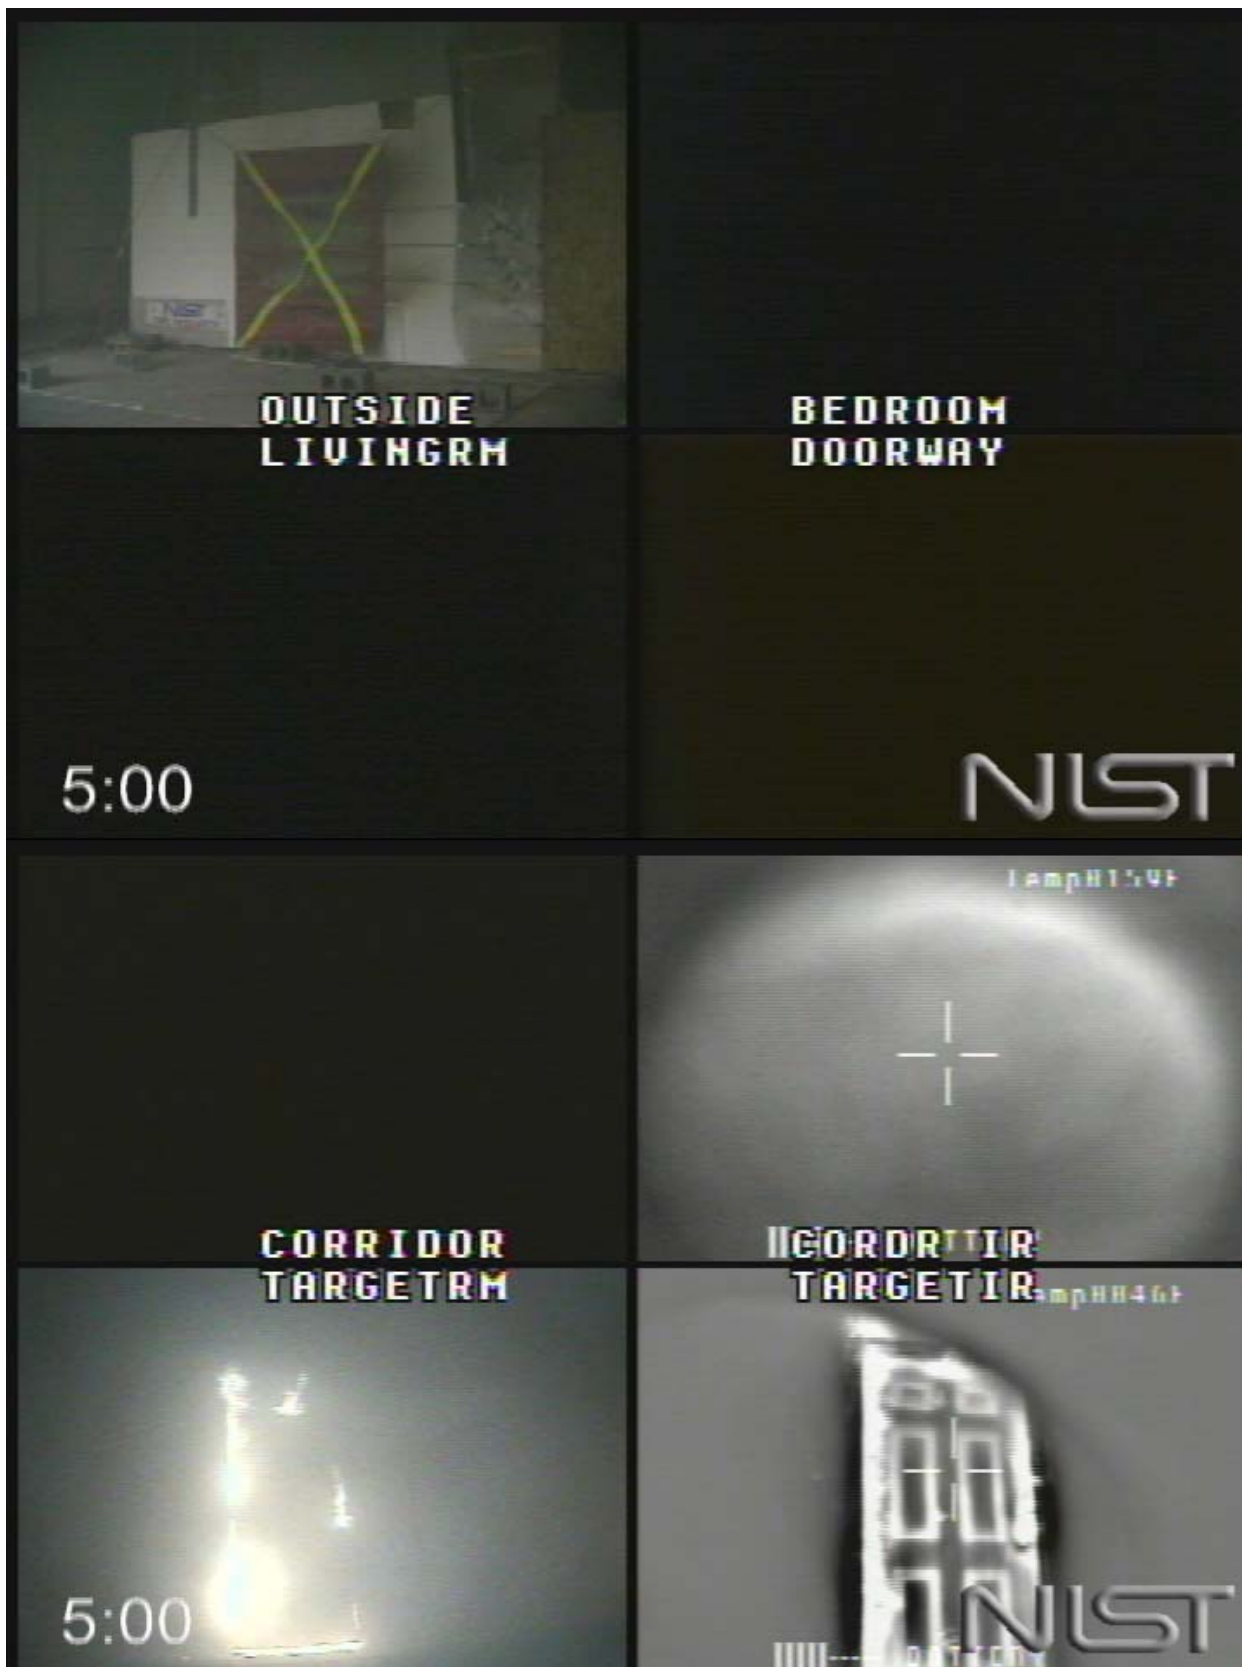
Figure 5.4.1-10. Experiment 4, 300 s after ignition.

Figure 5.4.1-10 shows the conditions at 300 s after ignition, or approximately 30 s since deployment of the wind control device. The interior video views were still obscured by soot. The thermal image from the corridor was still saturated with heat. In the target room the flames were still burning along portions of the edges and the bottom of the door. The thermal image of the target room door had not changed significantly since the previous image.

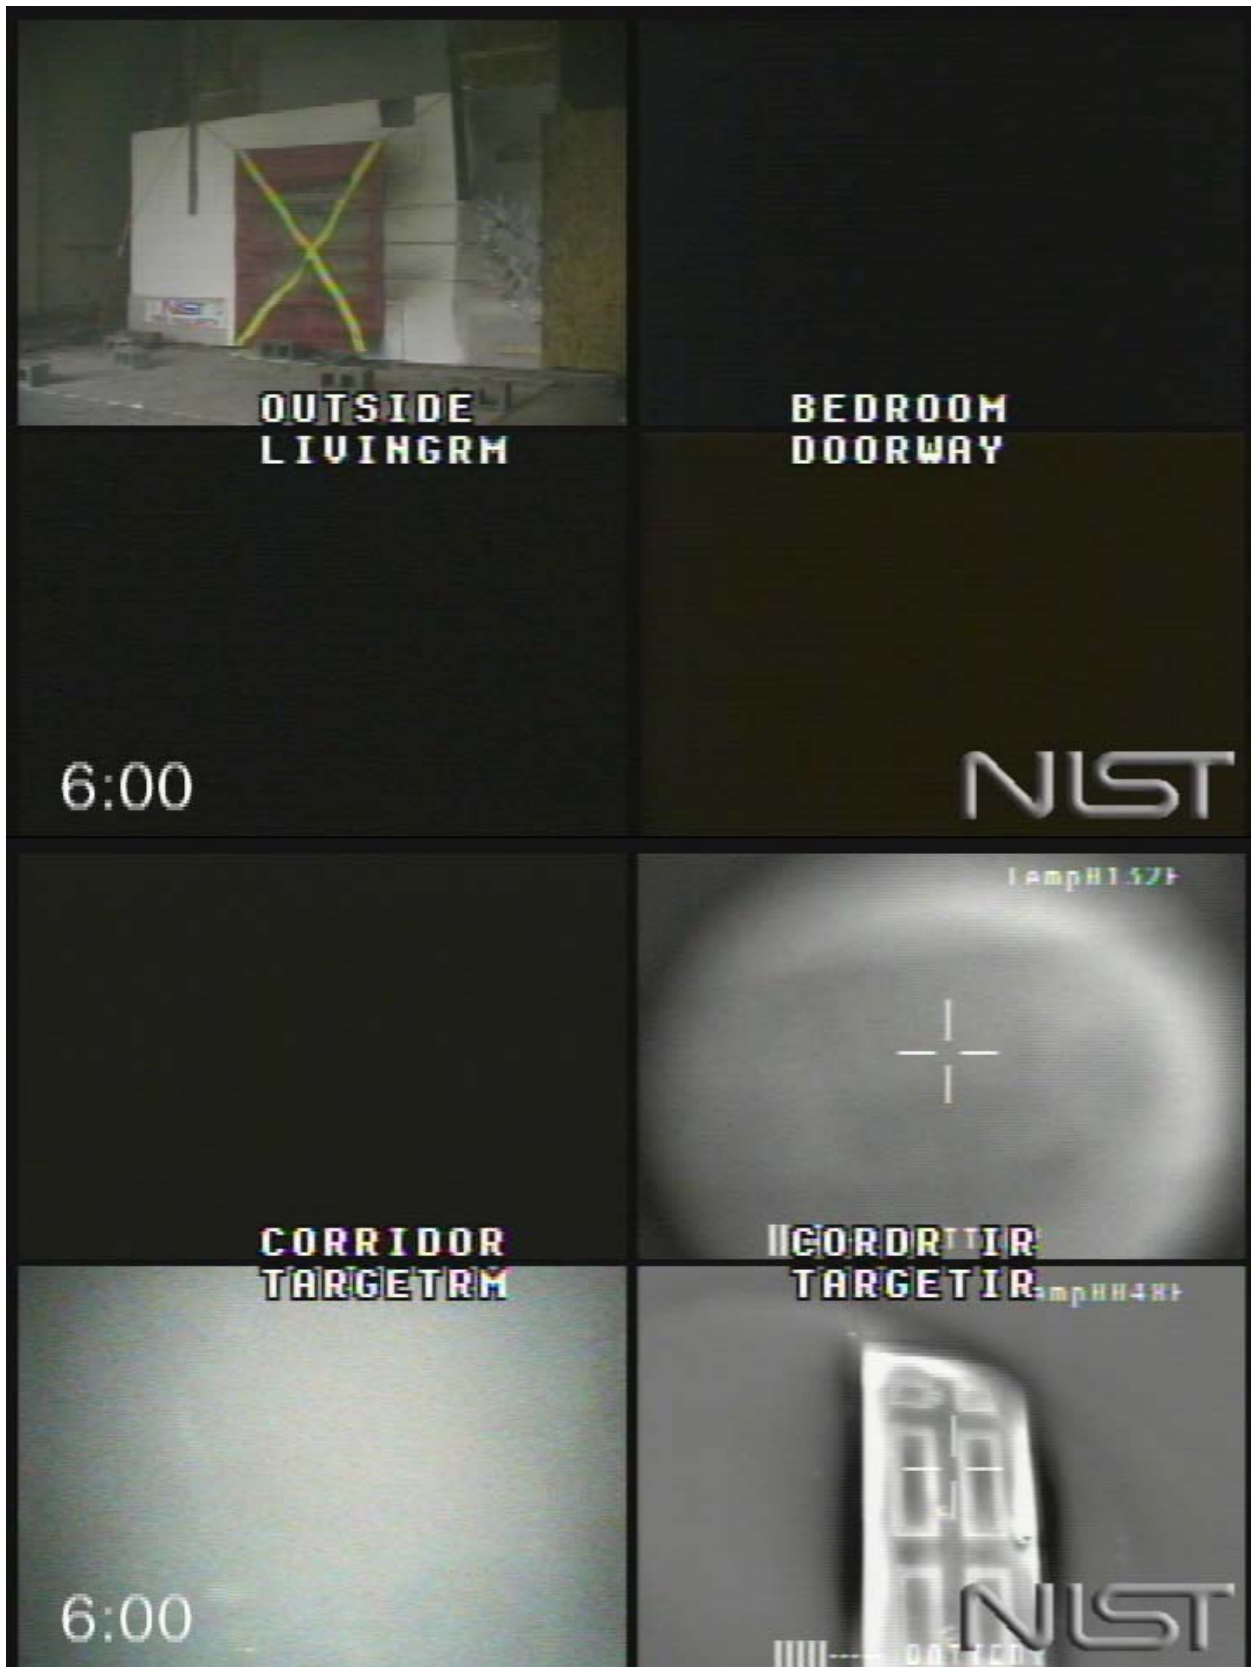
Figure 5.4.1-11. Experiment 4, 360 s after ignition.

Figure 5.4.1-11 shows the conditions at 360 s after ignition. At this point the water spray sprinkler in the window opening had been flowing for almost 30 s. The only noticeable changes between this set of images and Figure 5.4.1-10, occurred in the target room images. The flames are no longer visible in the video view and the thermal view of the door shows that more heat had transferred through and around the door.

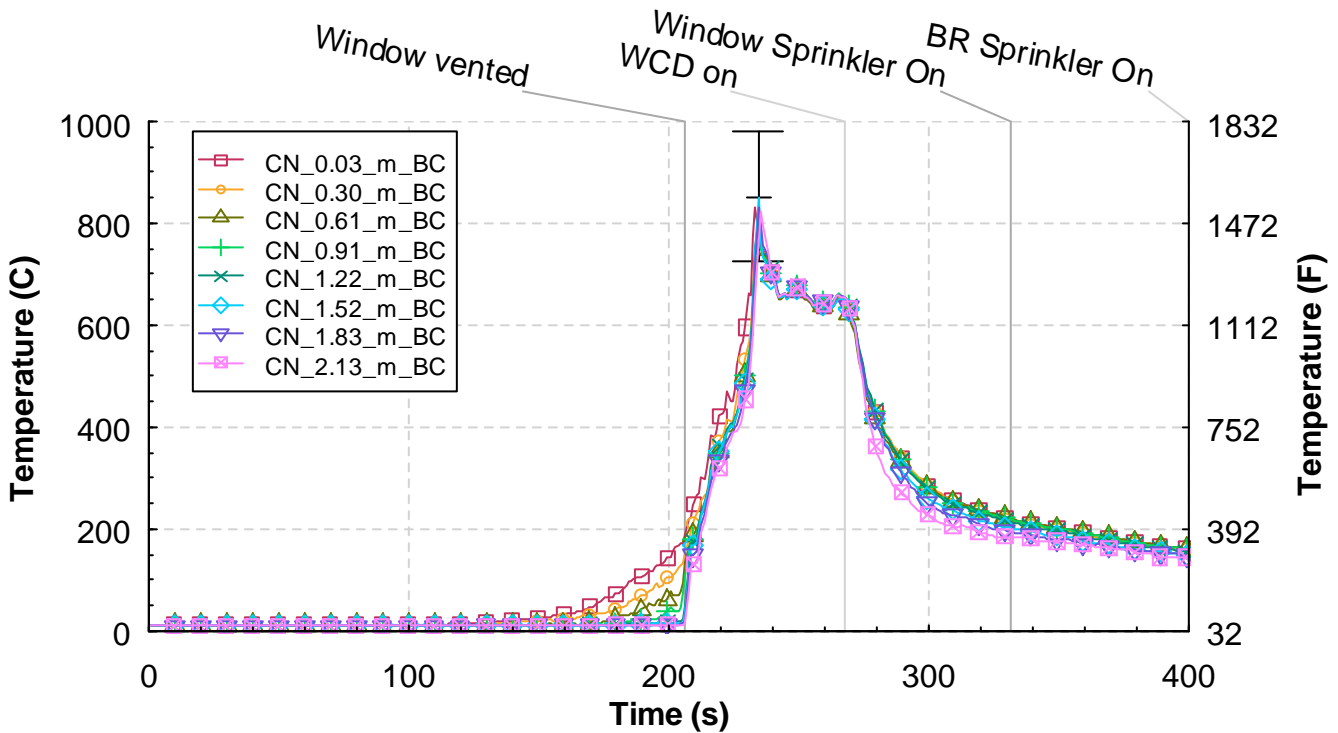
Figure 5.4.3-9. Temperature versus time from the corridor north (CN) thermocouple array, Experiment 4.

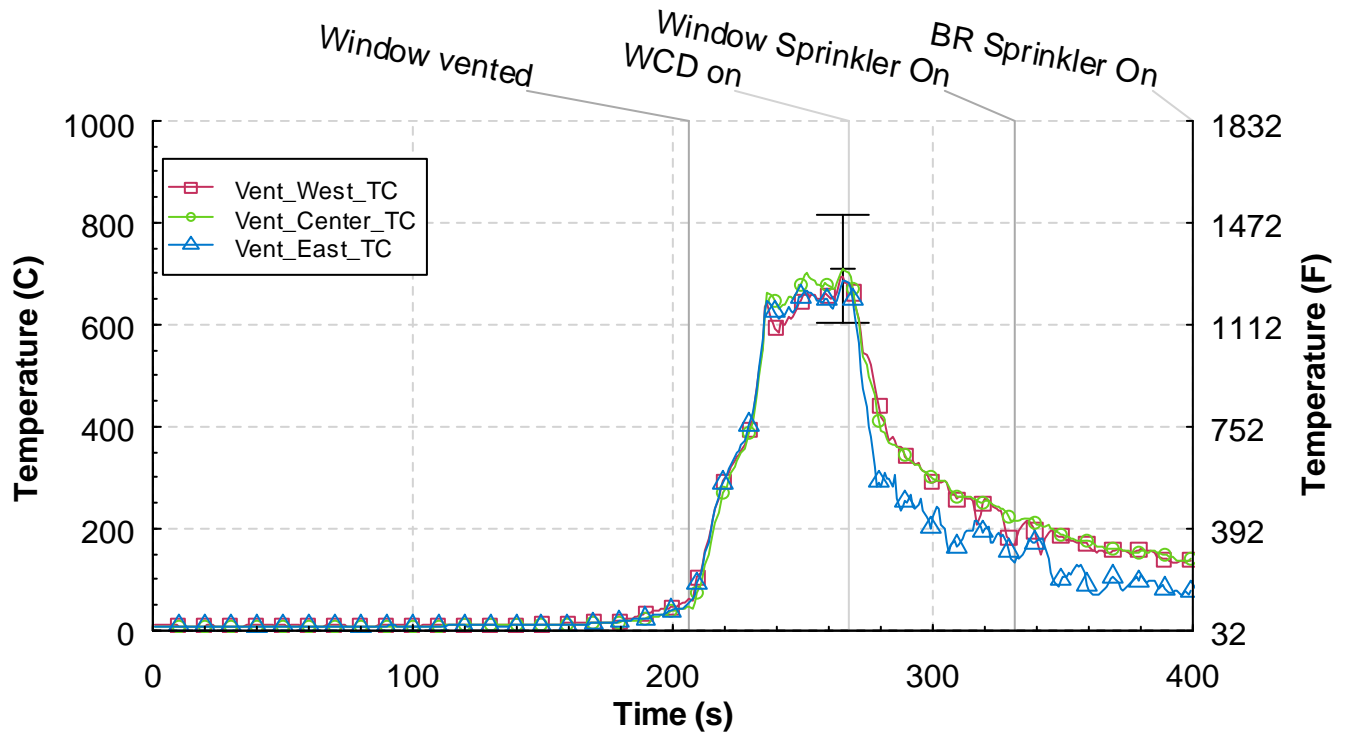
Figure 5.4.3-10. Temperature versus time from the ceiling vent thermocouple array, Experiment 4.

The temperatures at the exhaust vent are given in Figure 5.4.3-10. All of the temperatures are consistent with the trend of the temperatures from the north corridor position.
