# NIST Technical Note 1618

## Fire Fighting Tactics Under Wind Driven Conditions: Laboratory Experiments

Daniel Madrzykowski  
Stephen Kerber

U.S. Department of Commerce  
Building and Fire Research Laboratory  
National Institute of Standards and Technology  
Gaithersburg, MD 20899

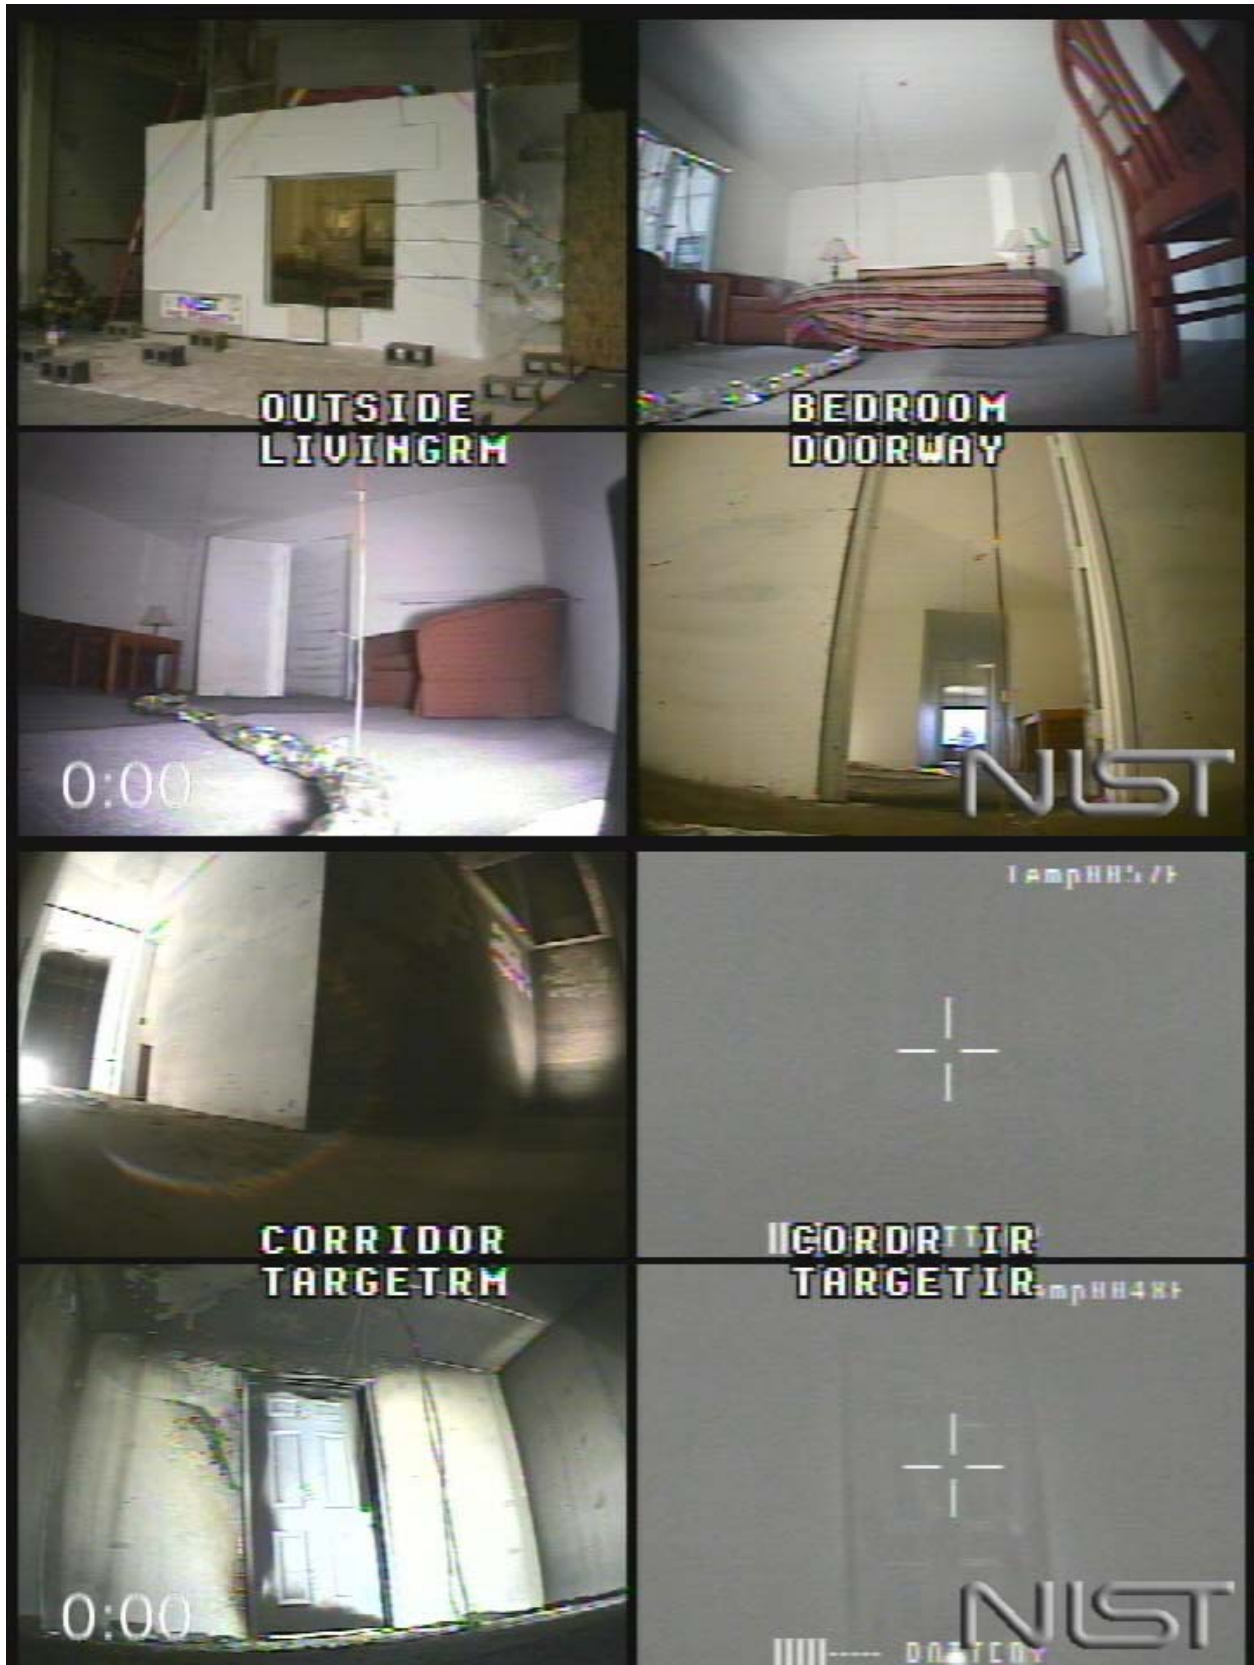
Figure 5.5.1-1. Experiment 5, ignition.

Figure 5.5.1-1 shows the conditions at the time of ignition. At this point, the six video views are clear and unobstructed. However, the thermal images provide limited thermal contrast because the surfaces in the view were at nearly equal temperature.

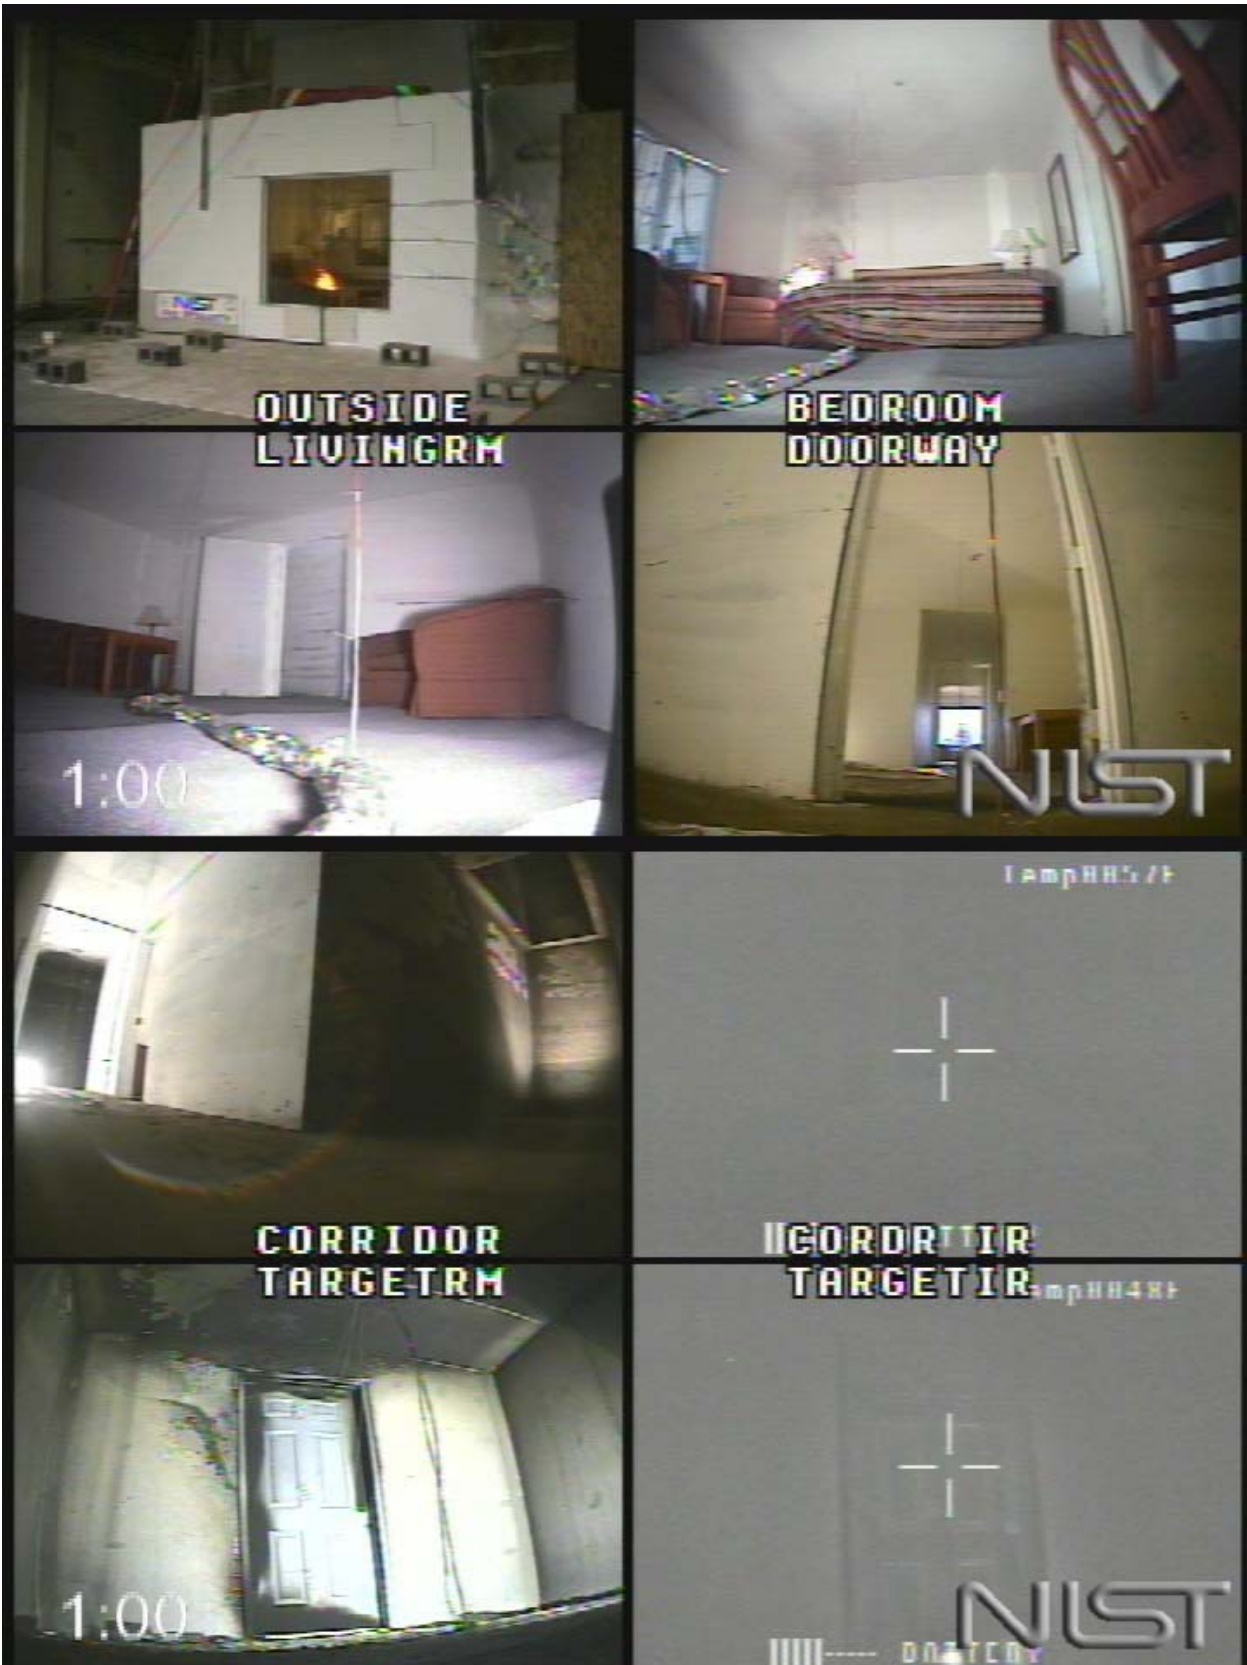
Figure 5.5.1-2. Experiment 5, 60 s after ignition.

The images in Figure 5.5.1-2 were captured 60 s after ignition. The fire from the trash container began to spread to the bed. There was very little smoke being produced and a layer has yet to develop. There was also no smoke or change in thermal condition in the living room, target room or corridor at this time.

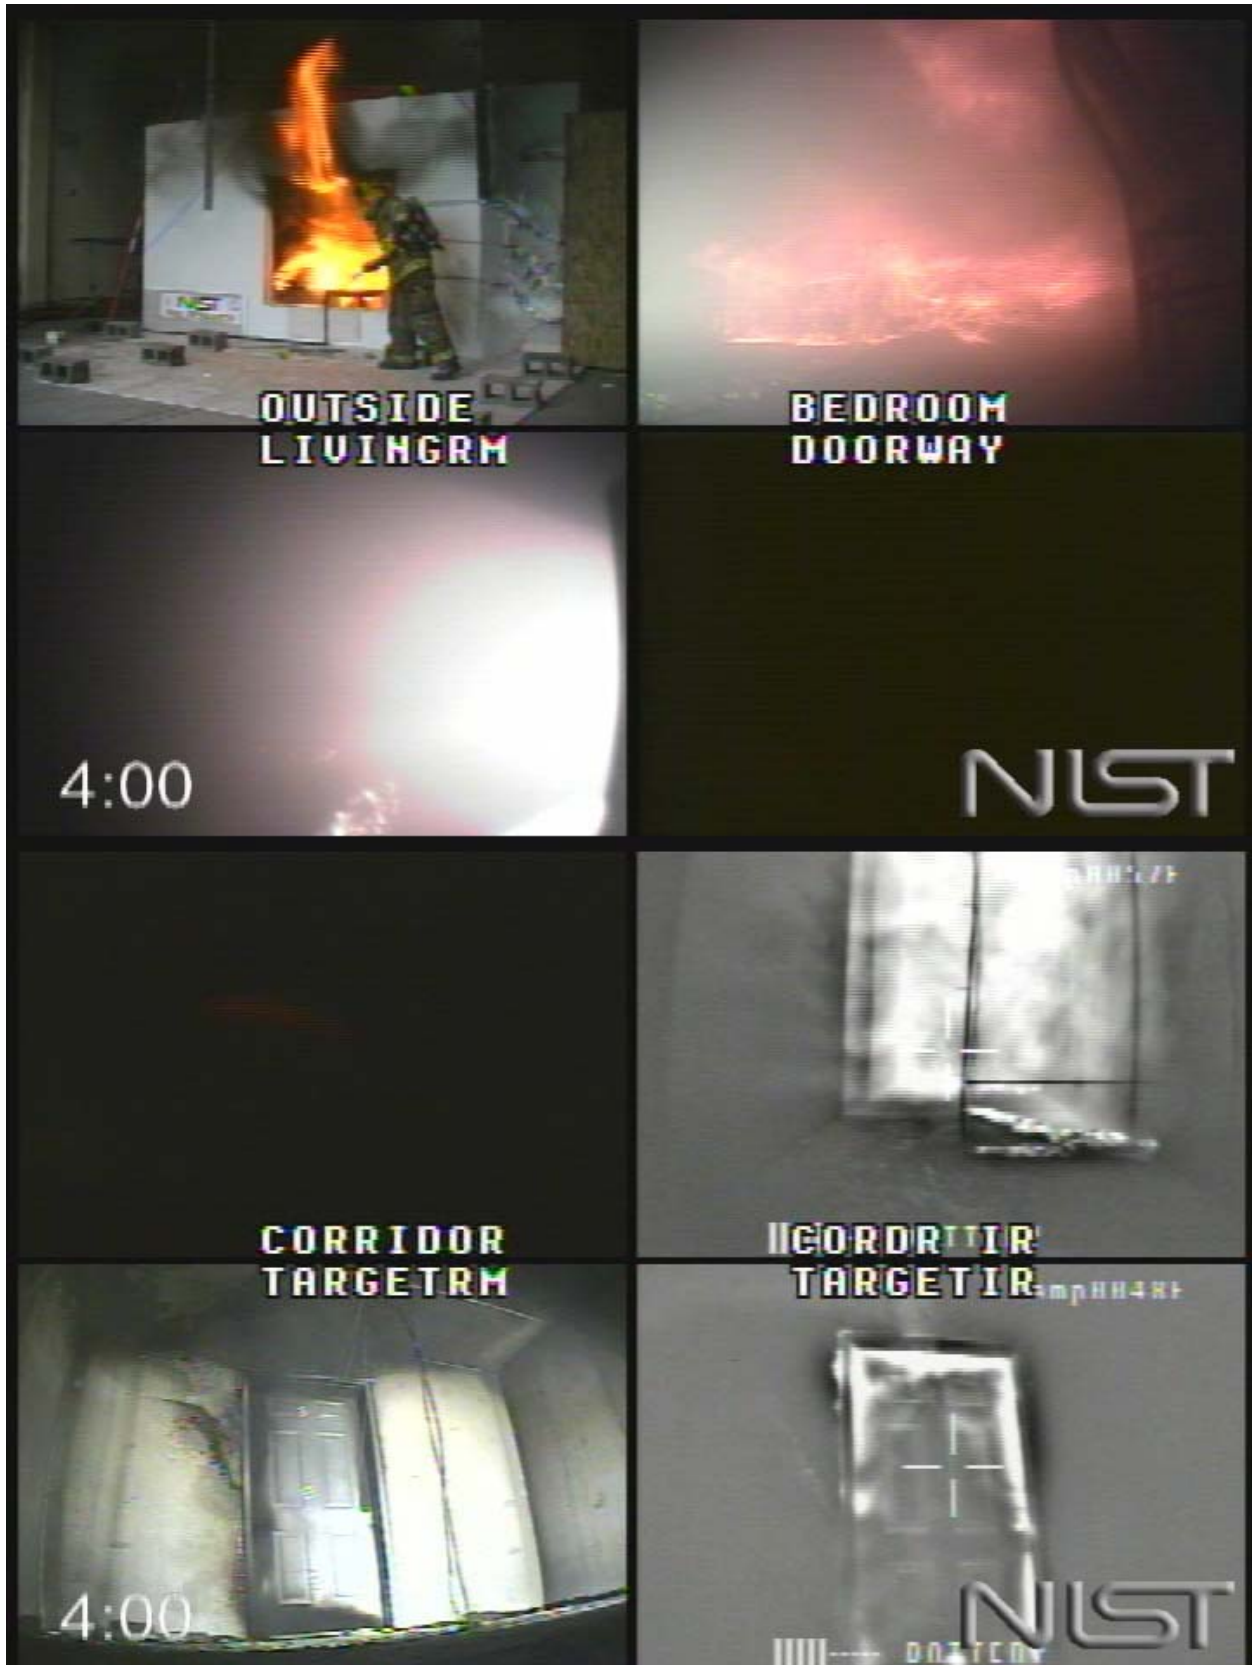
Figure 5.5.1-5. Experiment 5, 240 s after ignition.

Figure 5.5.1-5 shows the conditions at 240 s after ignition. The image shows the conditions just after the window was manually cleared. Flames are seen moving across the floor level in the bedroom and the camera views in the living room, hallway and corridor are obscured by smoke. The image from the corridor IR camera shows hot gases exiting the living room, filling the doorway top to bottom and impinging on the east wall of the corridor. Heat was flowing around the entire perimeter of the hall door into the target room, as shown in the thermal image of the target room.

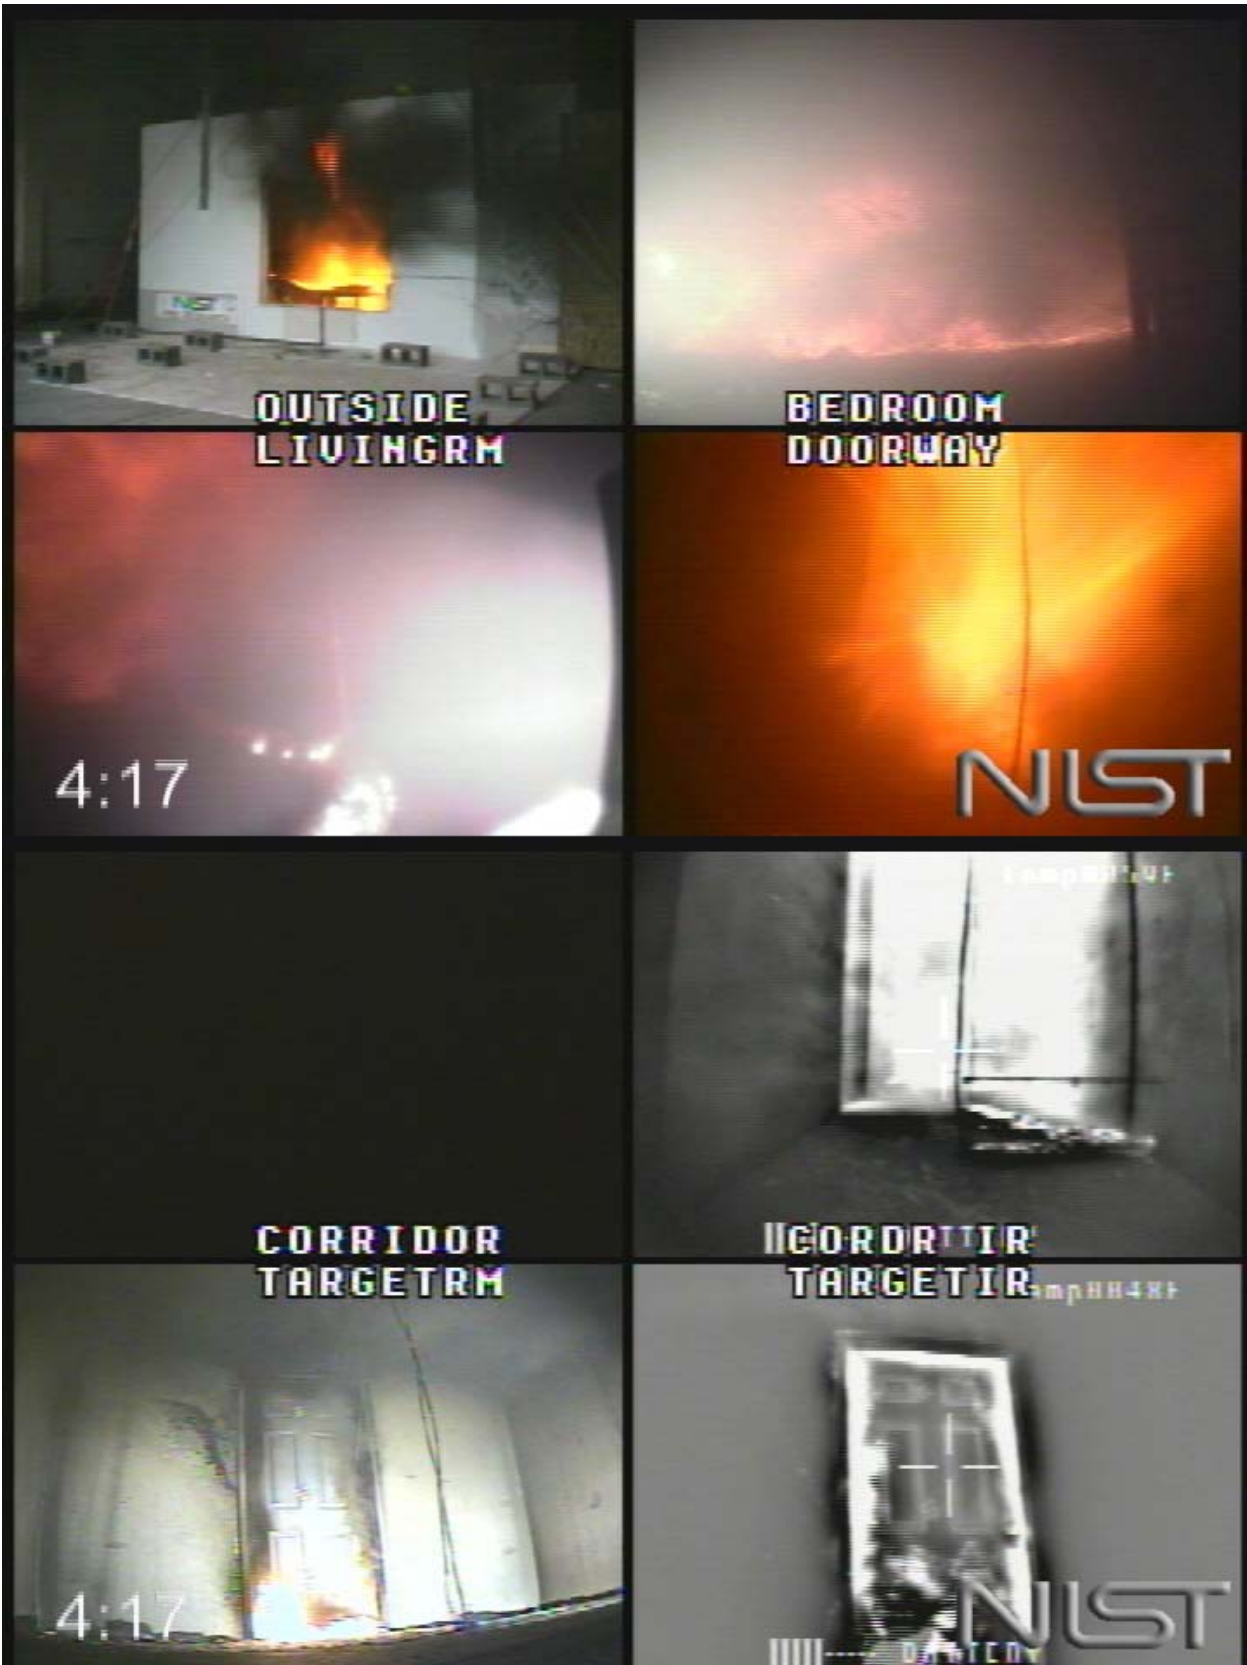
Figure 5.5.1-6. Experiment 5, corridor flames, 257 s after ignition.

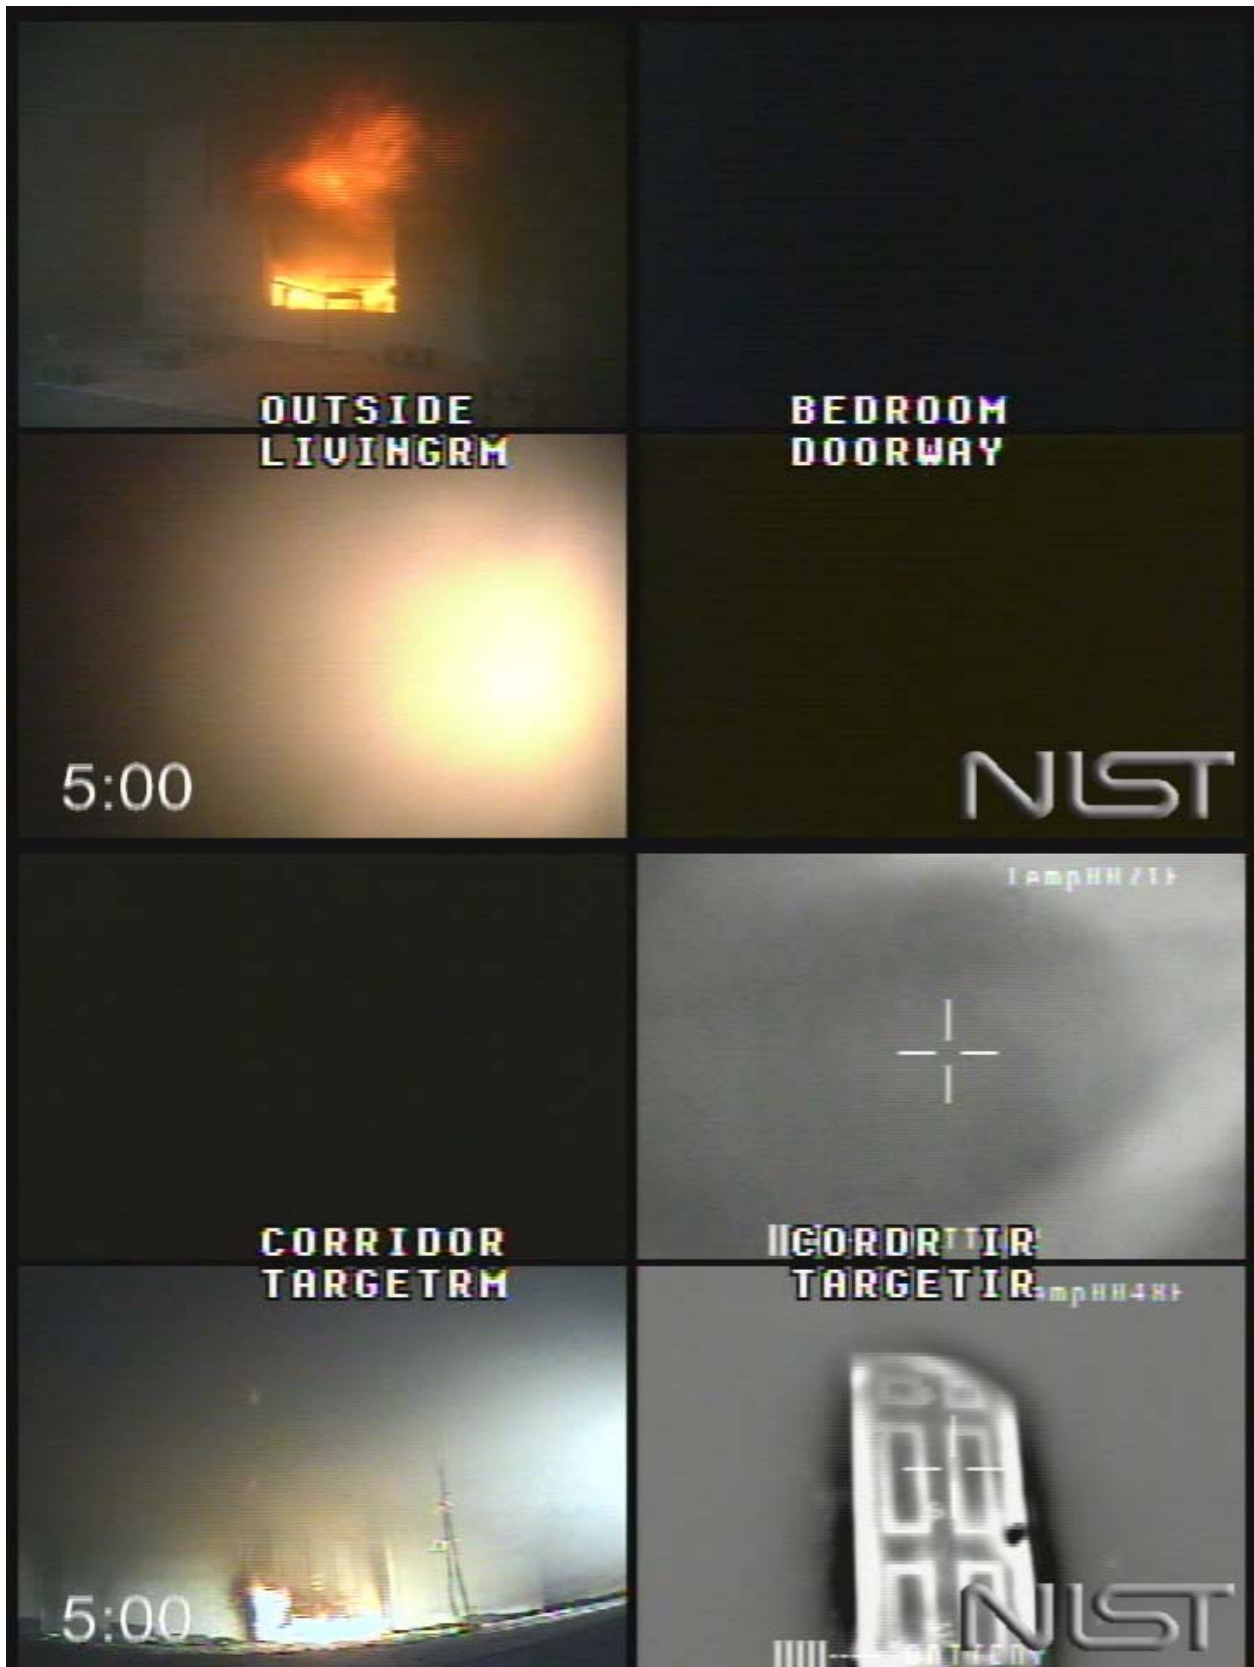
Figure 5.5.1-7. Experiment 5, 300 s after ignition.

Figure 5.5.1-7 shows the conditions at 300 s after ignition. Flames were pulsing out of the top of the window opening. Smoke was obscuring the views in the bedroom, living room and corridor. The amount of heat entering the hallway has caused the image from the corridor IR camera to deteriorate substantially. The visual image in the target room showed flames continuing to burn under the door. The visibility at the lower layer in the target room remained good.

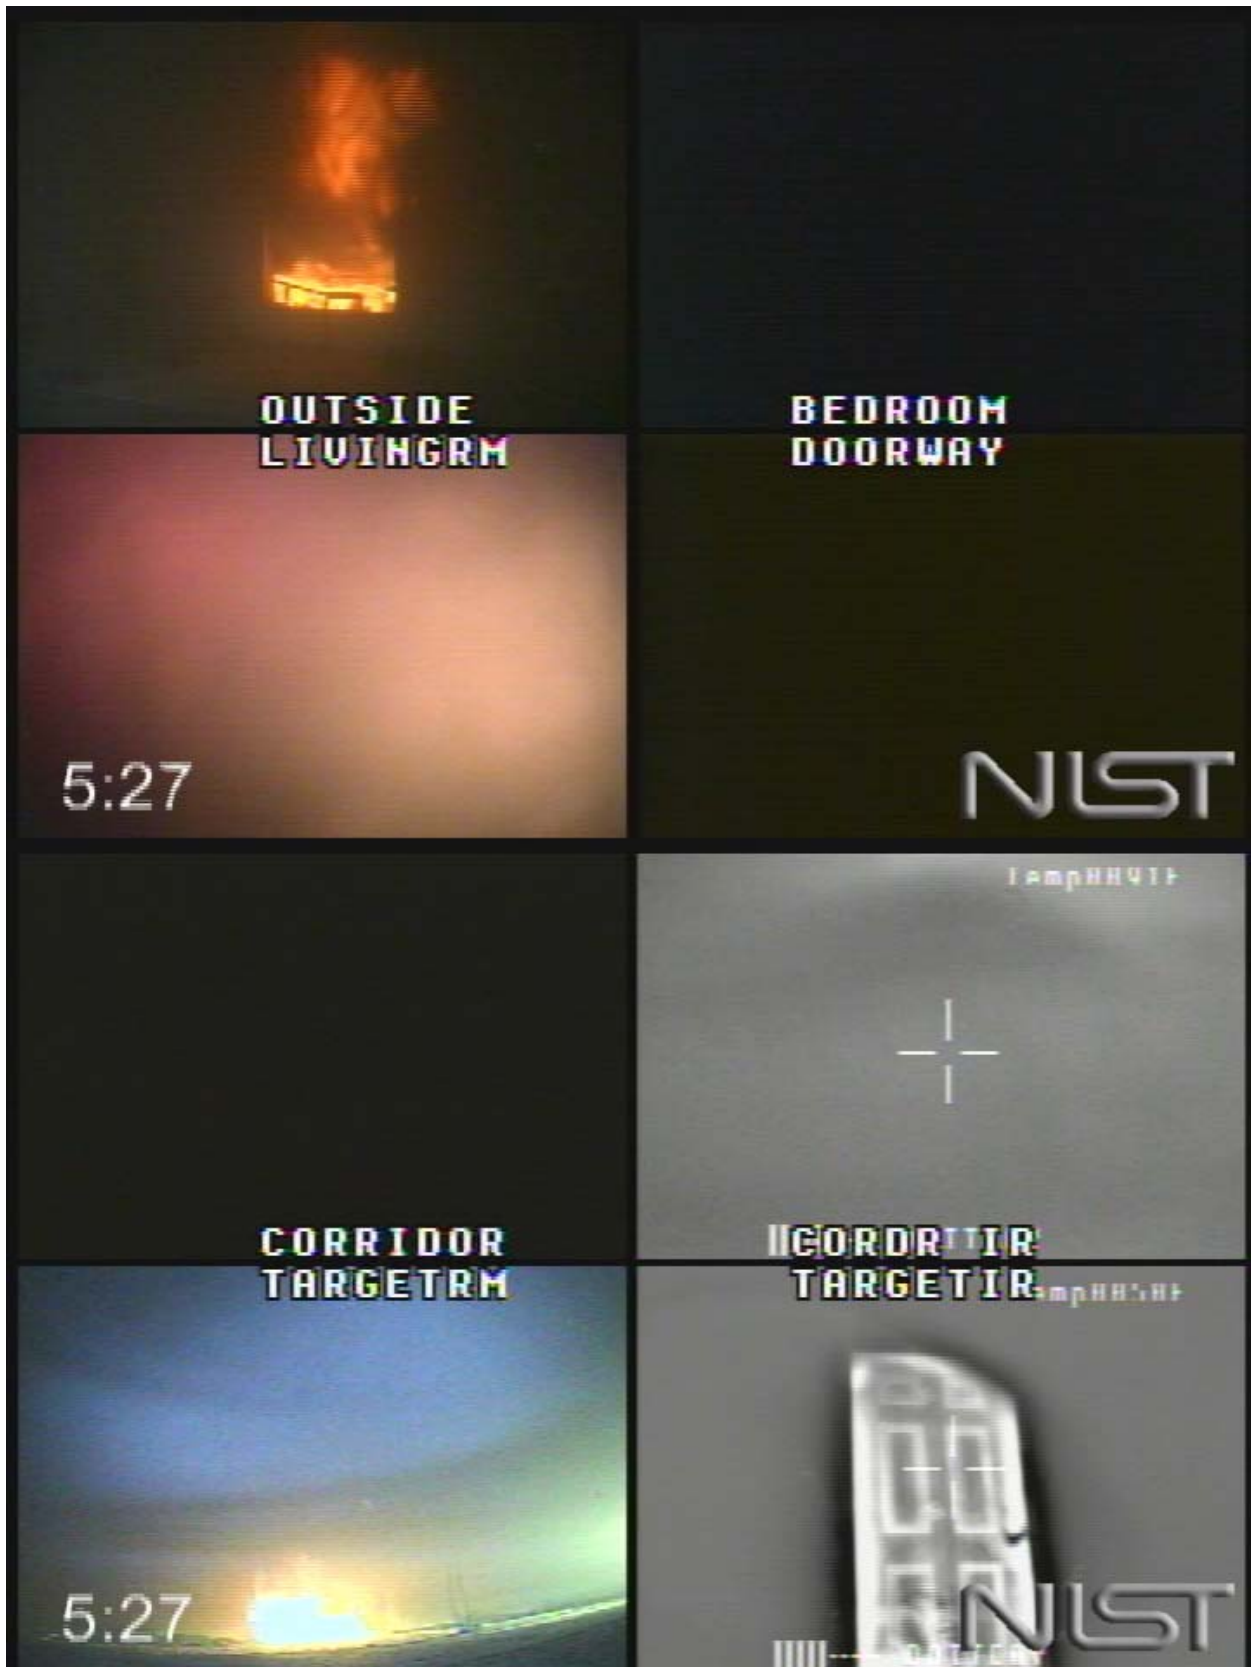
Figure 5.5.1-8. Experiment 5, WCD deployed; 327 s after ignition.

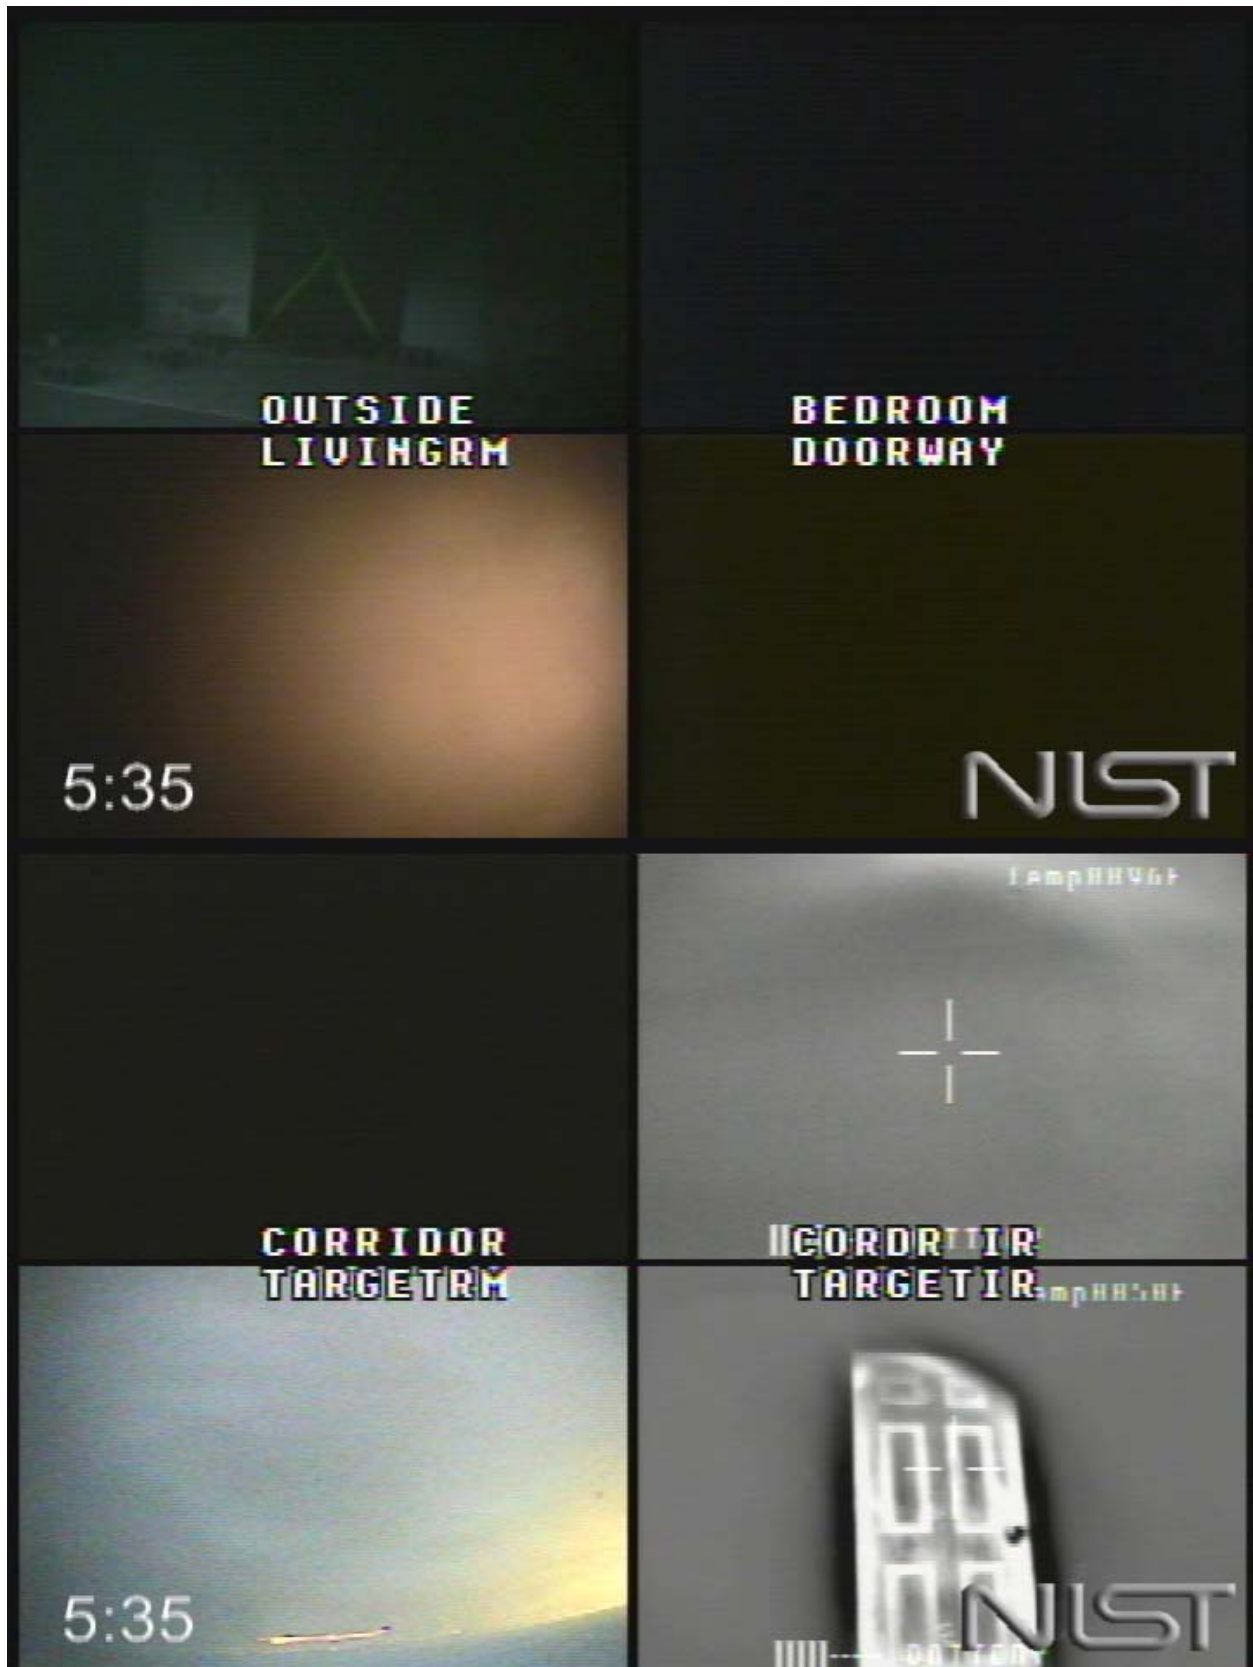
Figure 5.5.1-9. Experiment 5, WCD in place, 335 s after ignition.

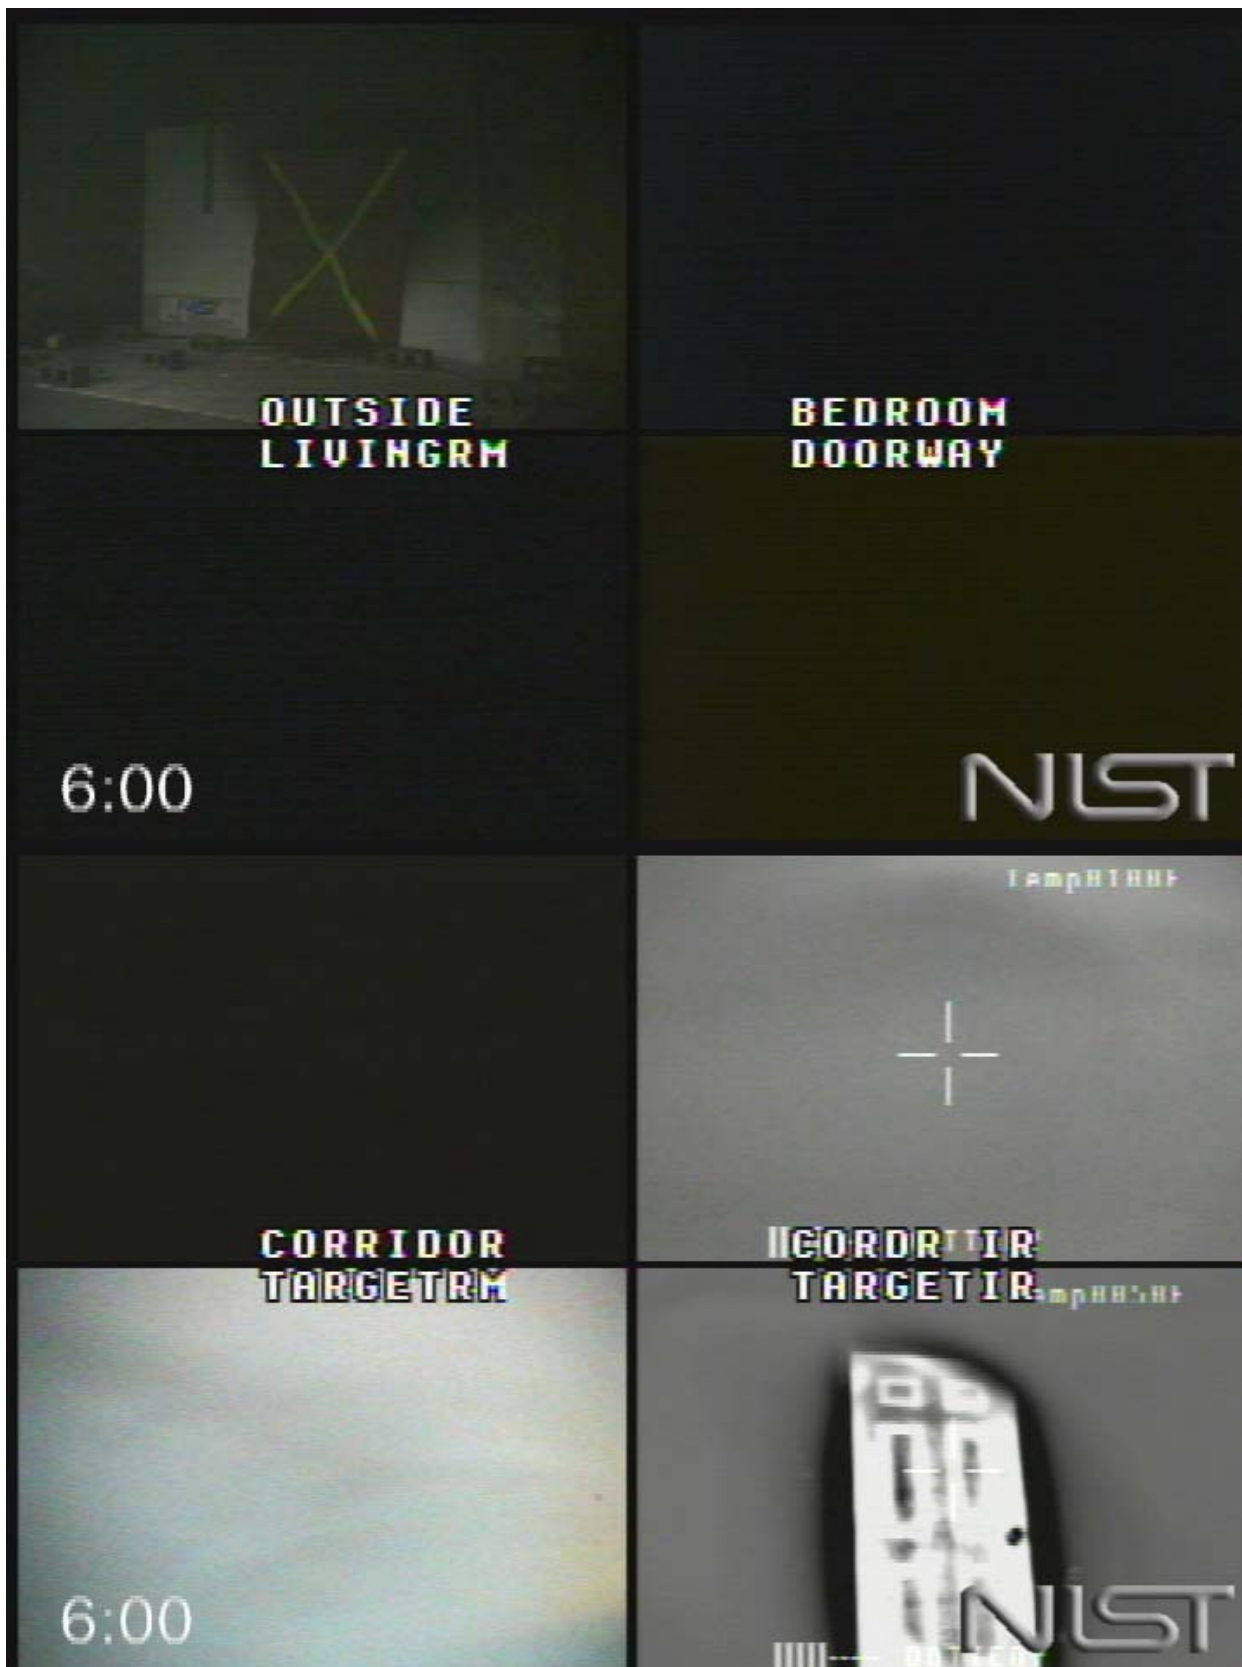
Figure 5.5.1-10. Experiment 5, 360 s after ignition.

Figure 5.5.1-10 shows the conditions at 360 s after ignition, or approximately 30 s since deployment of the wind control device. The interior video views were still obscured by soot. The thermal image from the corridor was still saturated with heat. In the target room the door continued to heat up but remained fully intact. White smoke obscured the view in the target room.

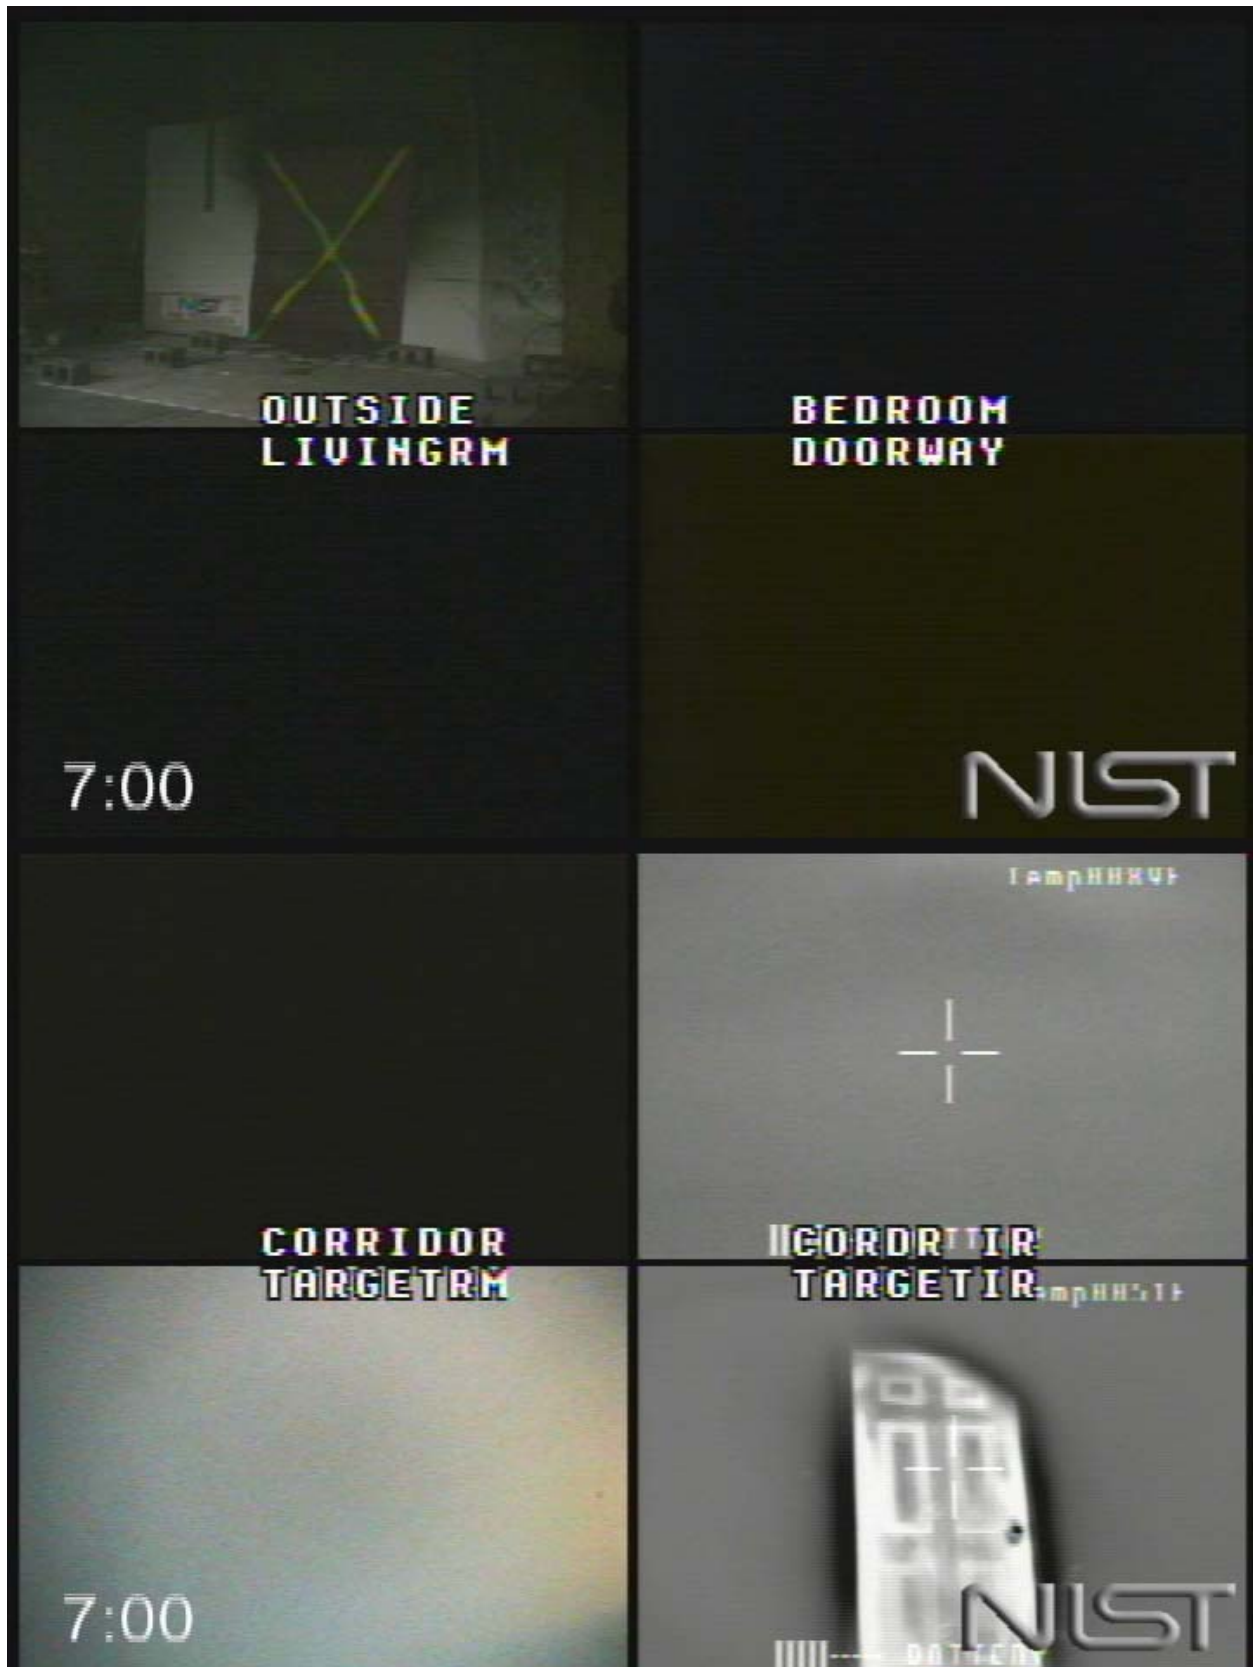
Figure 5.5.1-11. Experiment 5, 420 s after ignition.

Figure 5.5.1-11 shows the conditions at 420 s after ignition, which was about 30 s after the window sprinkler was activated. The interior video views were still obscured by soot. The target room thermal image shows the door is cooling down slightly.

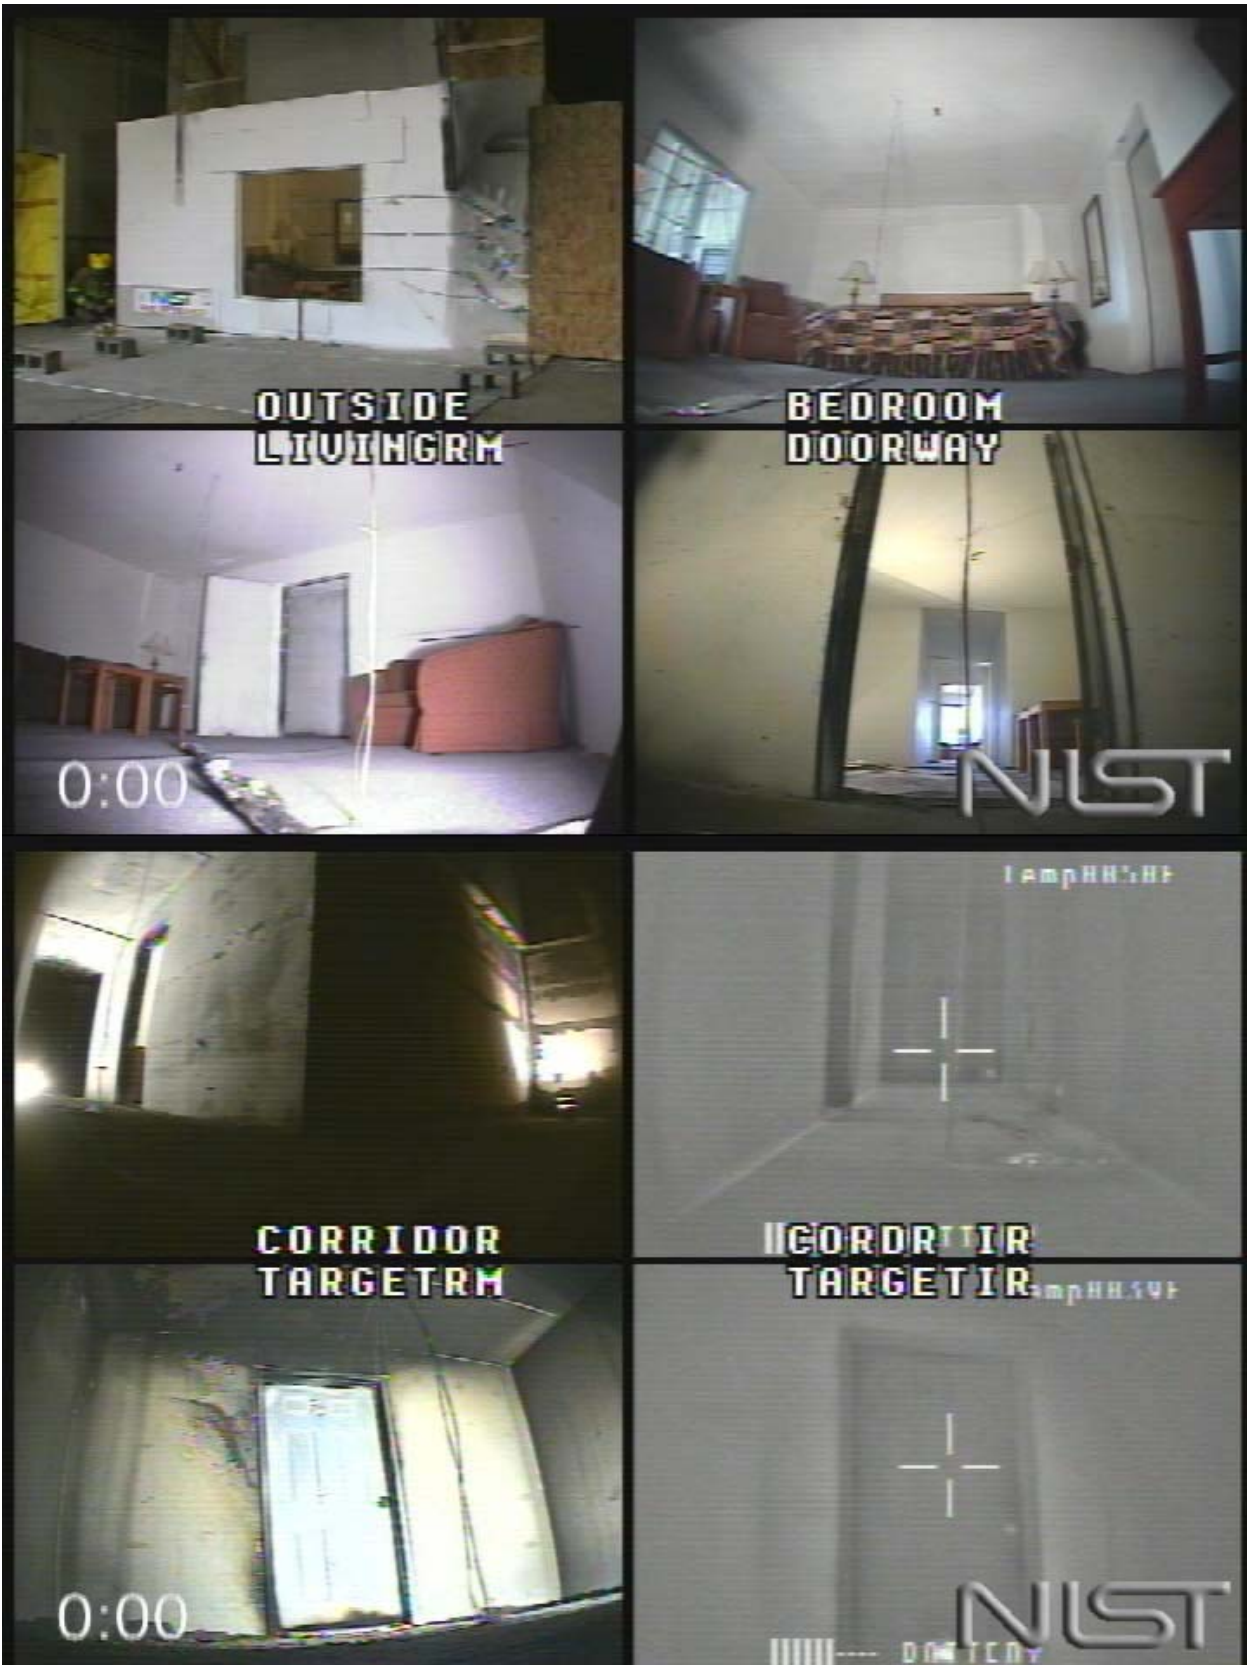
Figure 5.6.1-1. Experiment 6, ignition.

Figure 5.6.1-1 shows the conditions at the time of ignition. At this point, the six video views are clear and unobstructed. However, the thermal images provide limited thermal contrast, because the surfaces in the view were at nearly equal temperature.
