# NIST Technical Note 1618

## Fire Fighting Tactics Under Wind Driven Conditions: Laboratory Experiments

Daniel Madrzykowski  
Stephen Kerber

U.S. Department of Commerce  
Building and Fire Research Laboratory  
National Institute of Standards and Technology  
Gaithersburg, MD 20899

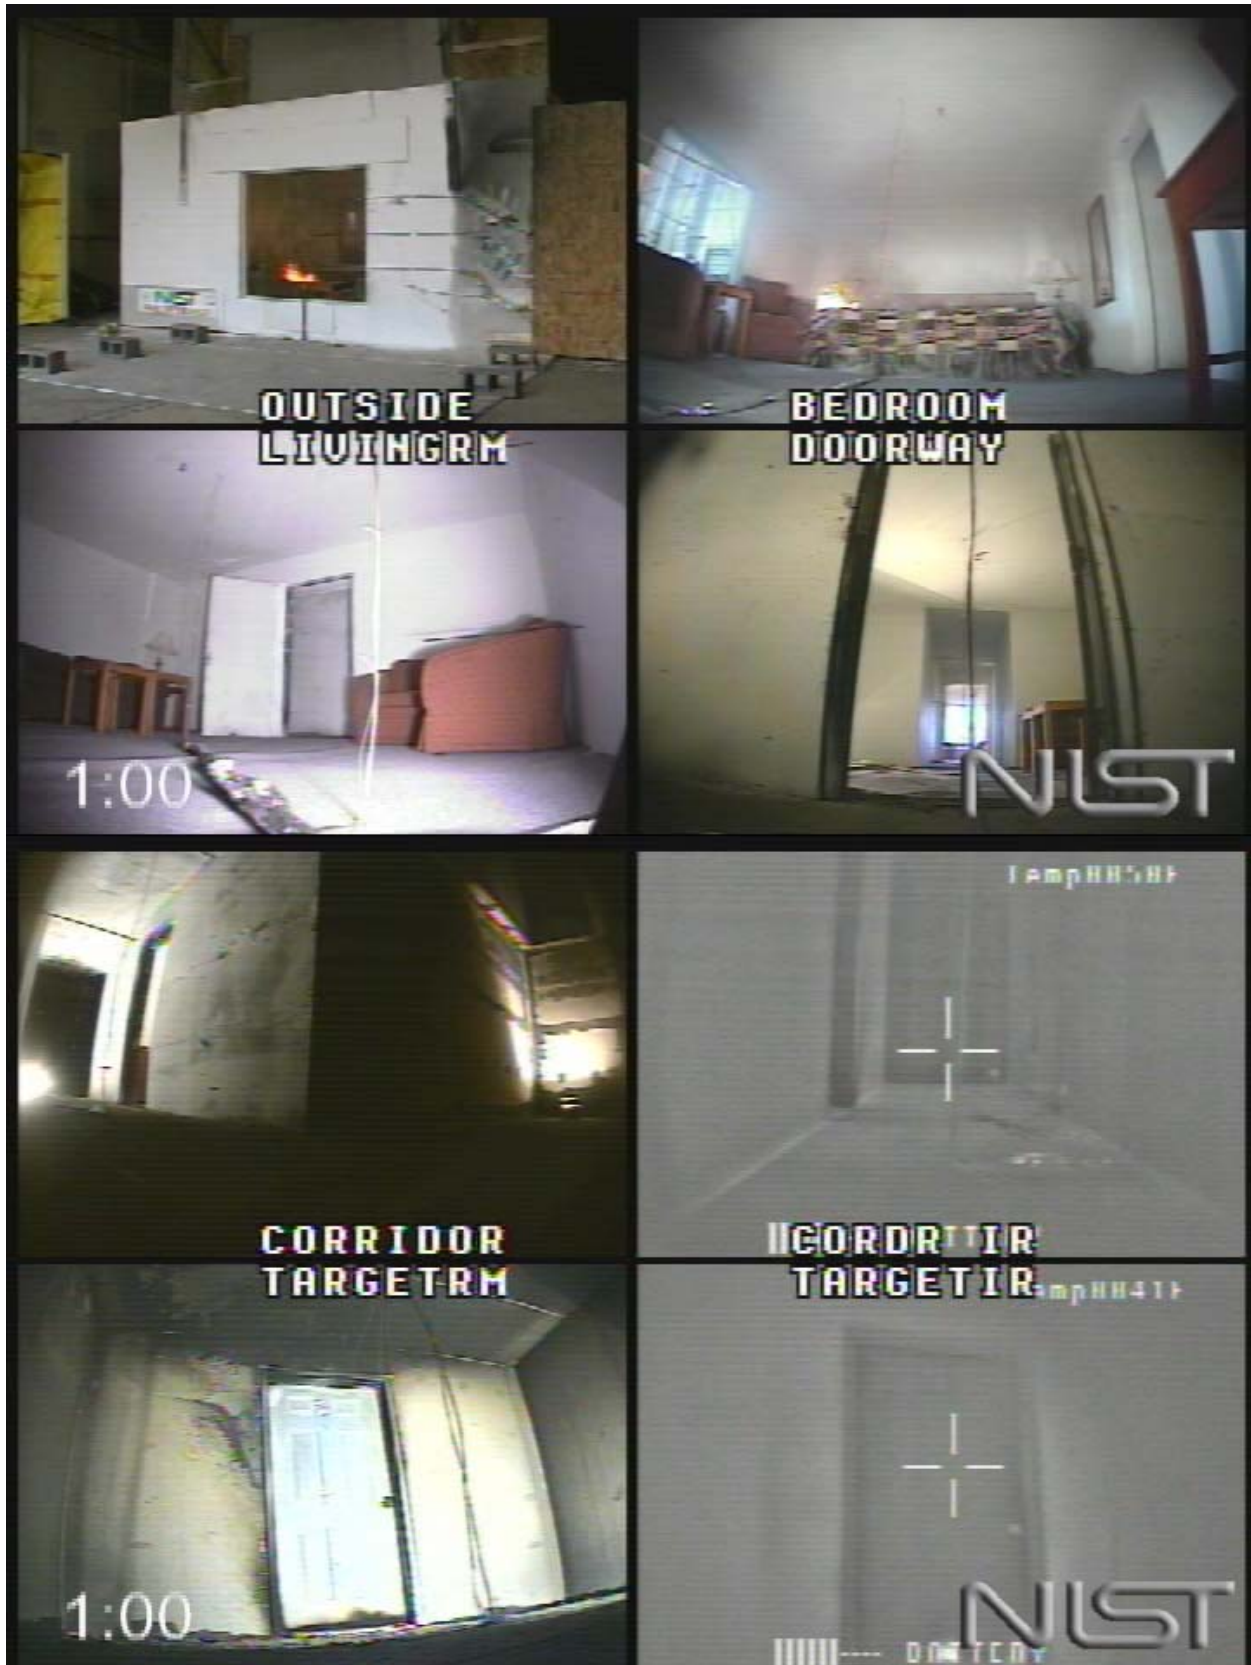
Figure 5.6.1-2. Experiment 6, 60 s after ignition.

The images in Figure 5.6.1-2 were captured 60 s after ignition. The fire from the trash container began to spread to the bed. Light colored smoke was produced and a thin smoke layer had developed across the ceiling of the bedroom. There was no smoke or change in thermal condition, in the living room, target room or corridor at this time.

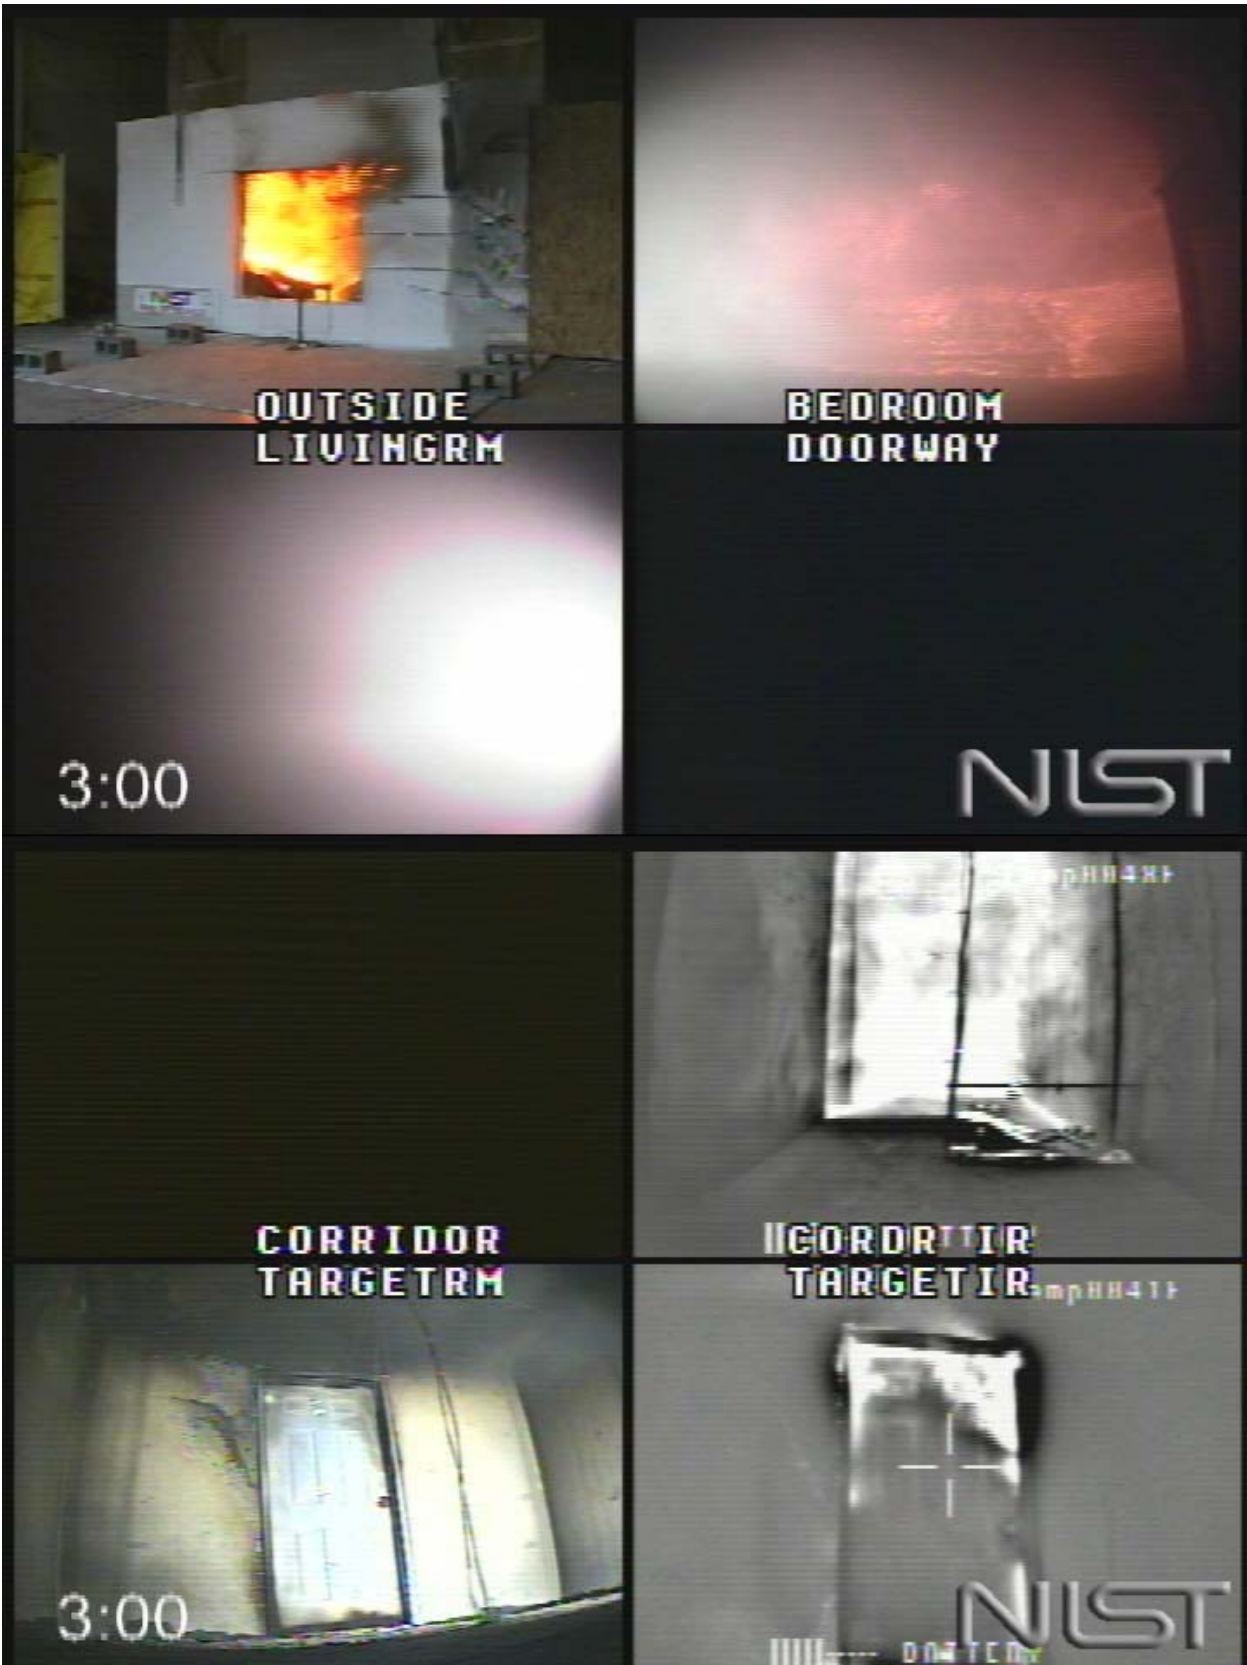
Figure 5.6.1-5. Experiment 6, 180 s after ignition.

Figure 5.6.1-5 shows the conditions at 180 s after ignition. Flames are seen filing the bedroom and moving across the floor level. The camera views in the living room, hallway and corridor are still obscured by smoke. Conditions in the image from the corridor IR camera and the target room views have not changed much since the previous figure.

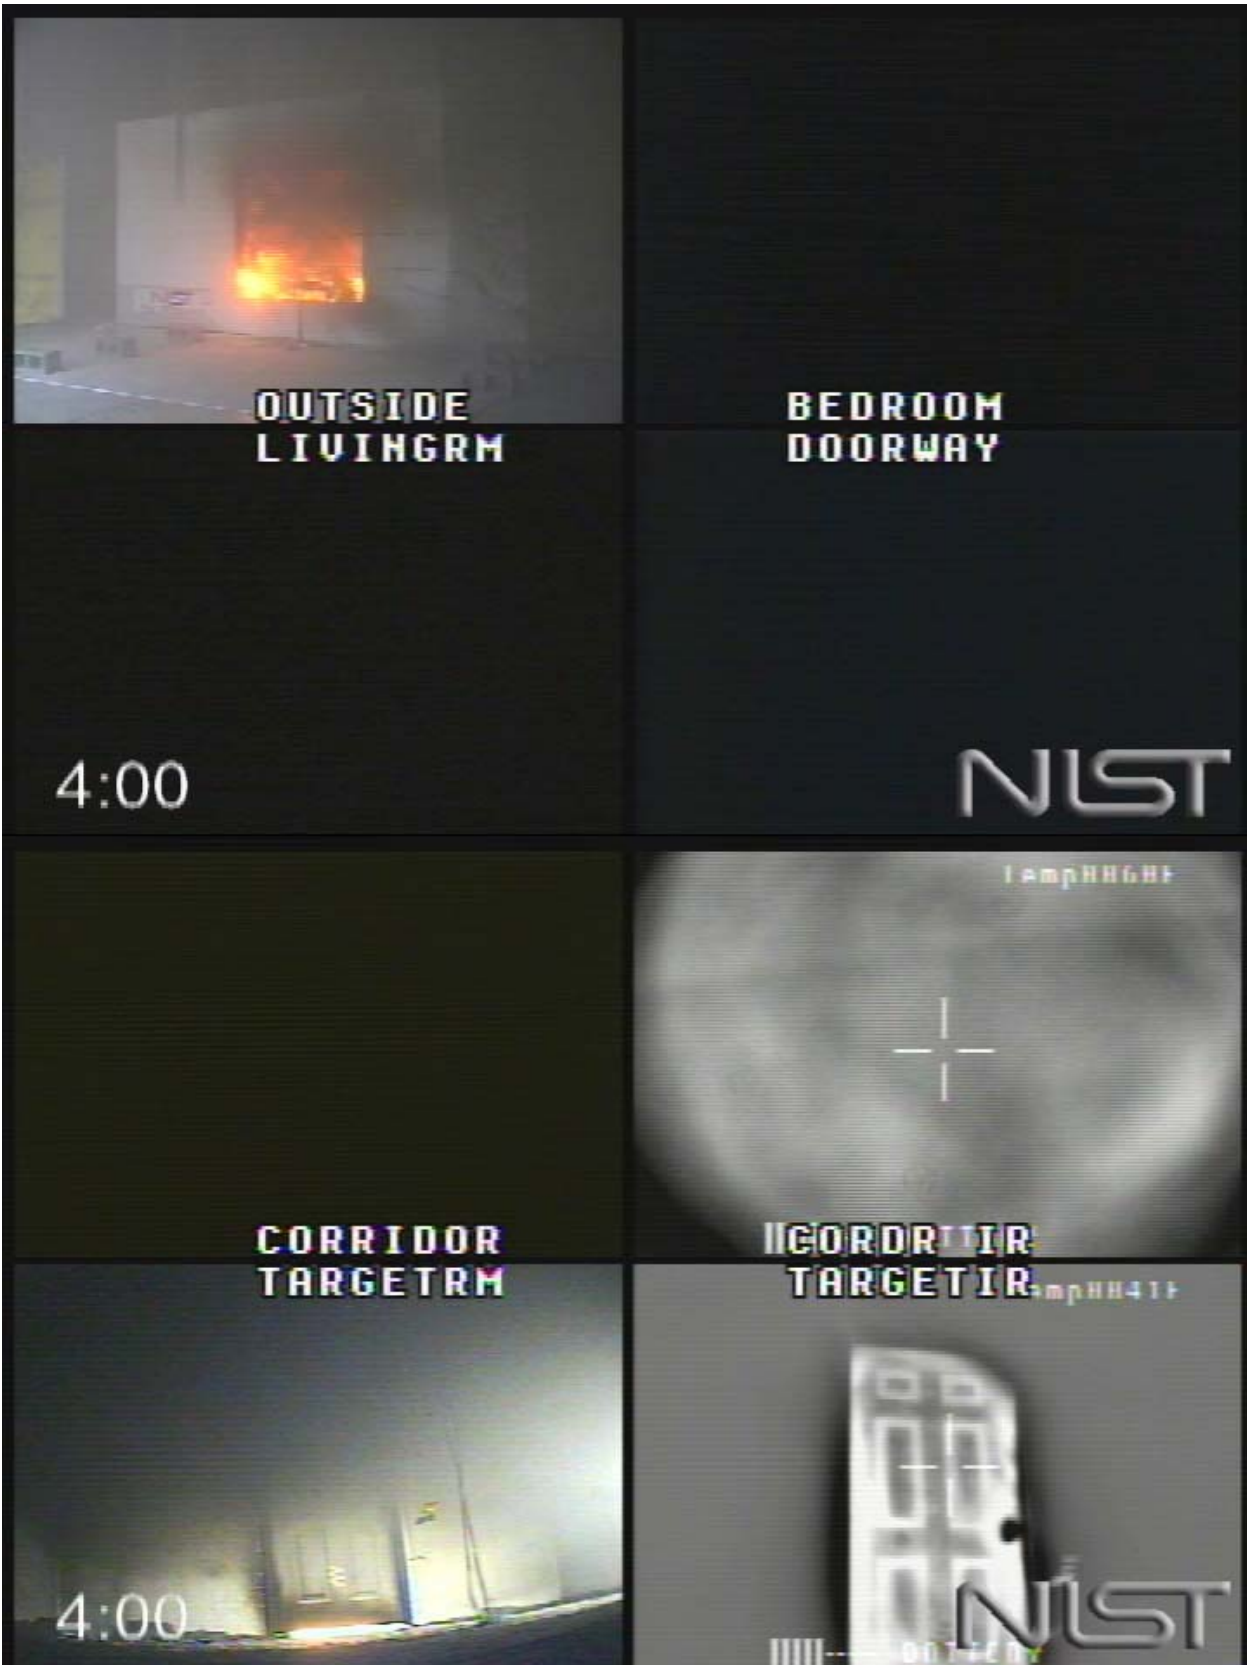
Figure 5.6.1-7. Experiment 6, 240 s after ignition.

Figure 5.6.1-7 shows the conditions at 240 s after ignition. Flames were pulsing out of the window opening. Smoke was obscuring the views in the bedroom, living room and corridor. The amount of heat entering the hallway has caused the image from the corridor IR camera to deteriorate substantially. The visual image in the target room showed flames continuing to burn under the door. The visibility at the lower layer in the target room remained good.

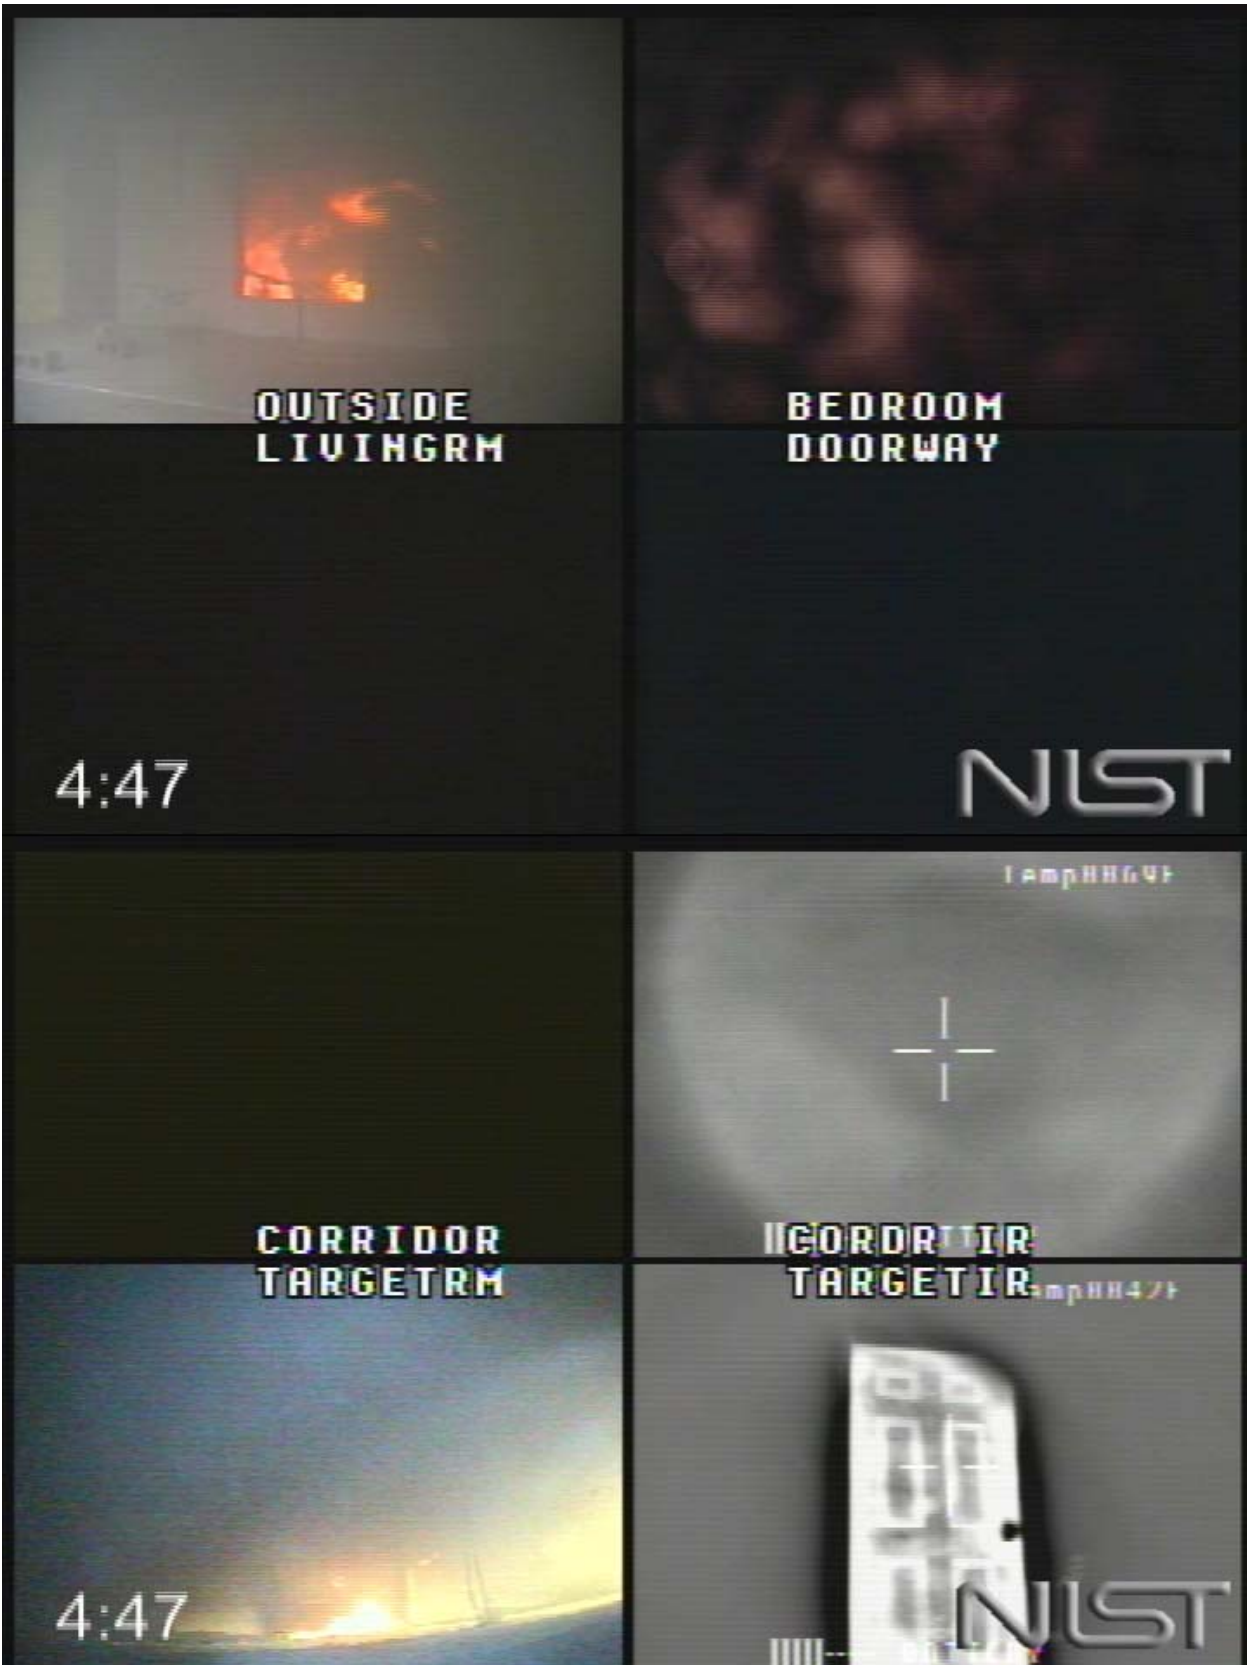
Figure 5.6.1-9. Experiment 6, 287 s after ignition, 20 s after window sprinkler activation.

At 287 s after ignition, the images in Figure 5.6.1-9 were recorded. The window sprinkler had been activated for 20 s. Flames stilled pulsed from the window opening. The flames near the window appeared to be partially blocked by soot. The interior video views were still obscured, only a glow was visible in the bedroom view. The thermal view of the corridor was obscured due to high thermal conditions. Conditions in the target room had decayed as the hot gas layer dropped within 0.30 m (1.0 ft) of the floor. Flames were still visible under the door to the hallway. In the thermal image of the target room door, the door had become whiter in color, indicating that had become hotter.

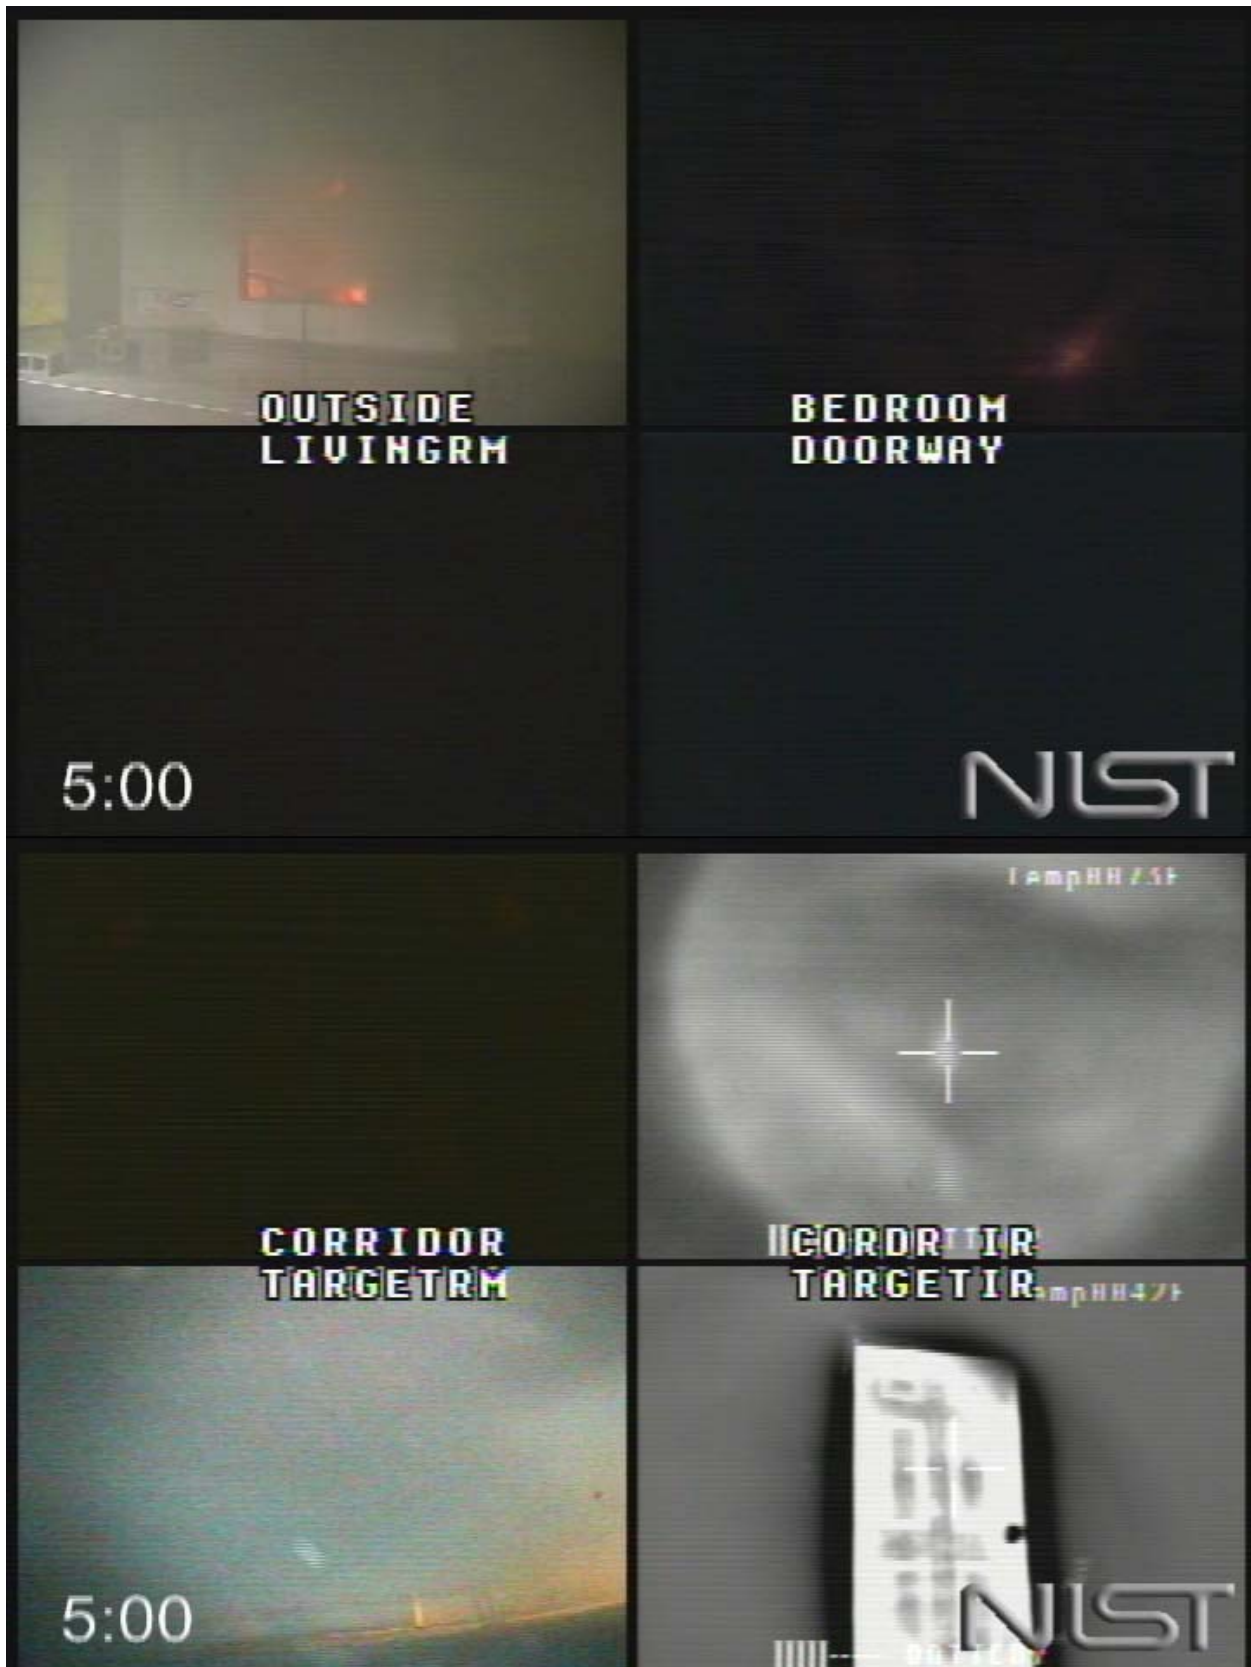
Figure 5.6.1-10. Experiment 6, 300 s after ignition.

Figure 5.6.1-10 shows the conditions at 300 s after ignition, or approximately 8 s after the water fog was started across the window opening. The interior video views were still obscured by smoke. The thermal image from the corridor was still saturated due to high heat conditions. In the target room, the smoke layer was near the floor, flames were no longer visible coming under the door. The door continued to heat up, as shown in the target room thermal view.

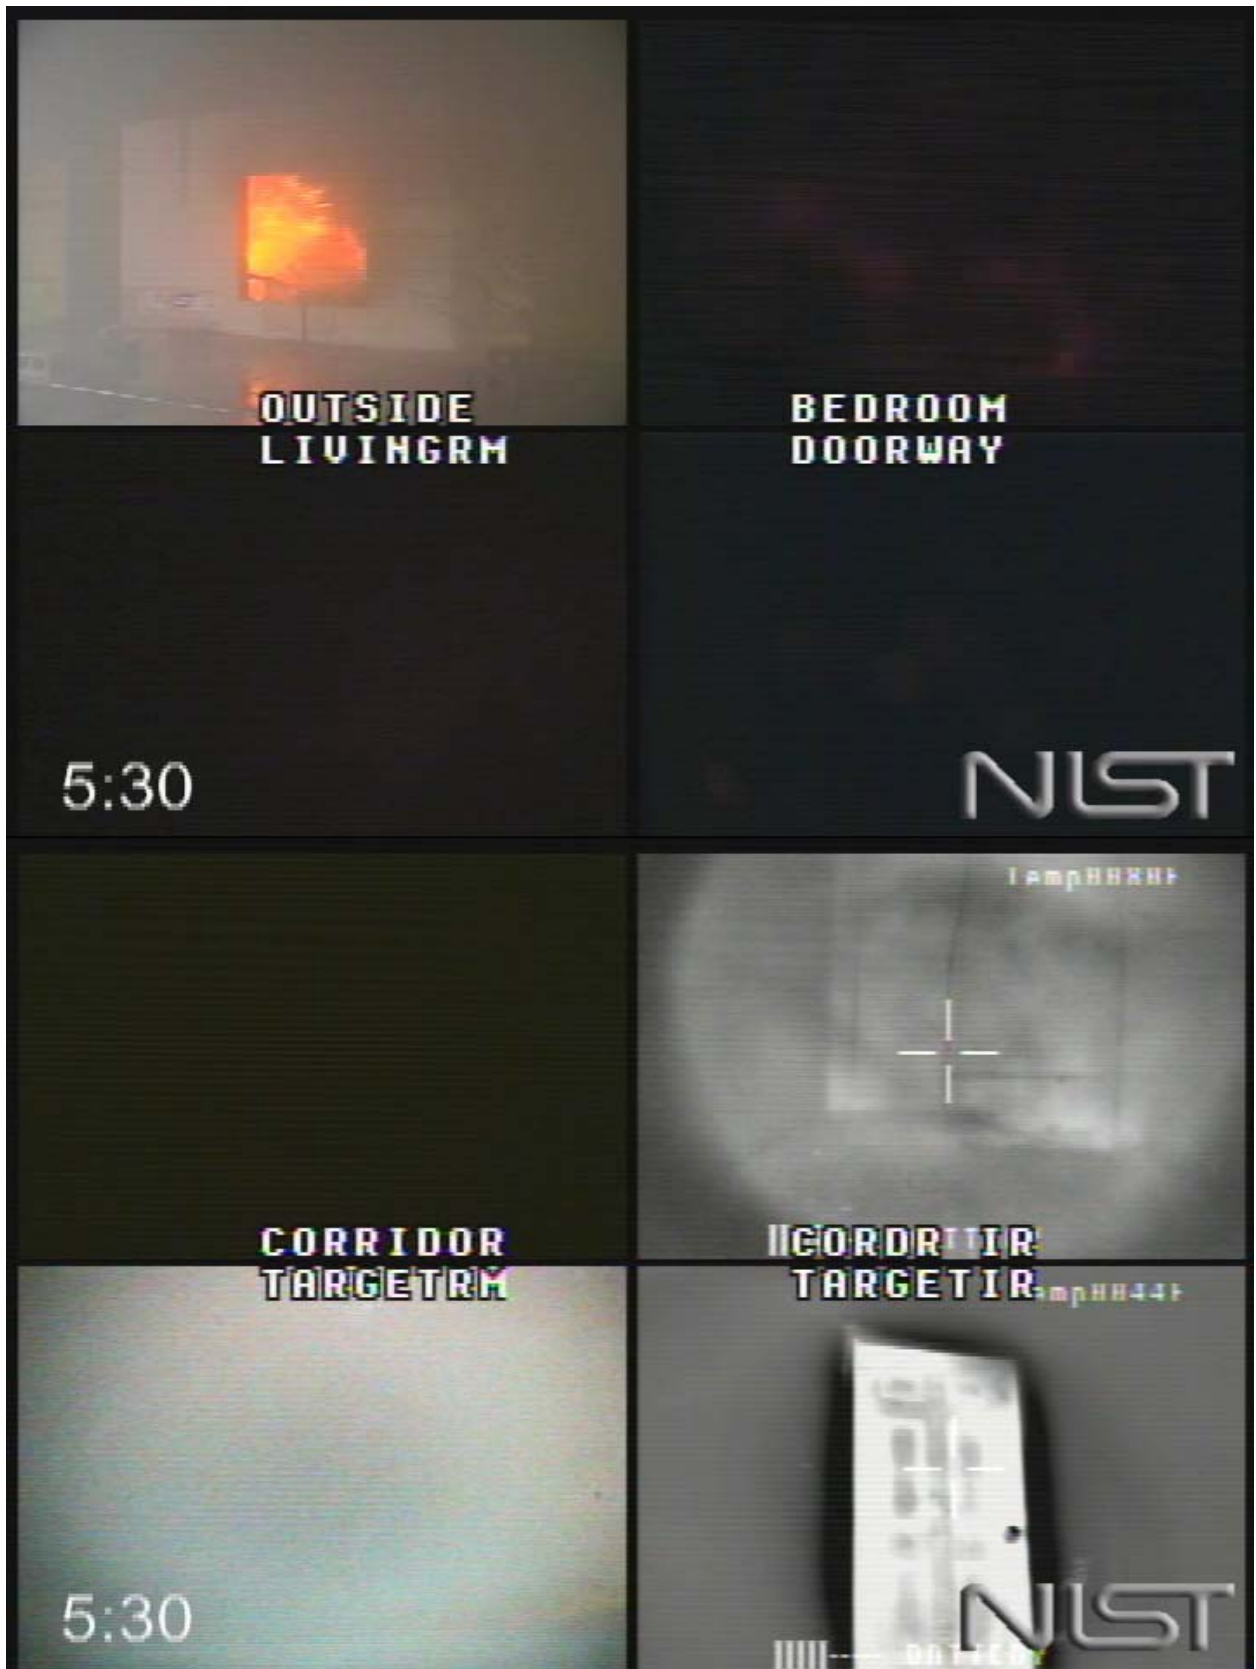
Figure 5.6.1-11. Experiment 6, fog stream across window off, 330 s after ignition.

Figure 5.6.1-11 shows the conditions at 330 s after ignition, just as the fog water was shut off. The window sprinkler was still activated. The area in the center of the window opening was free from fire.

All of the interior video views were still obscured by soot. The corridor thermal image shows more contrast indicating that the thermal conditions in that location had cooled. The target room thermal image shows that the door remained hot.

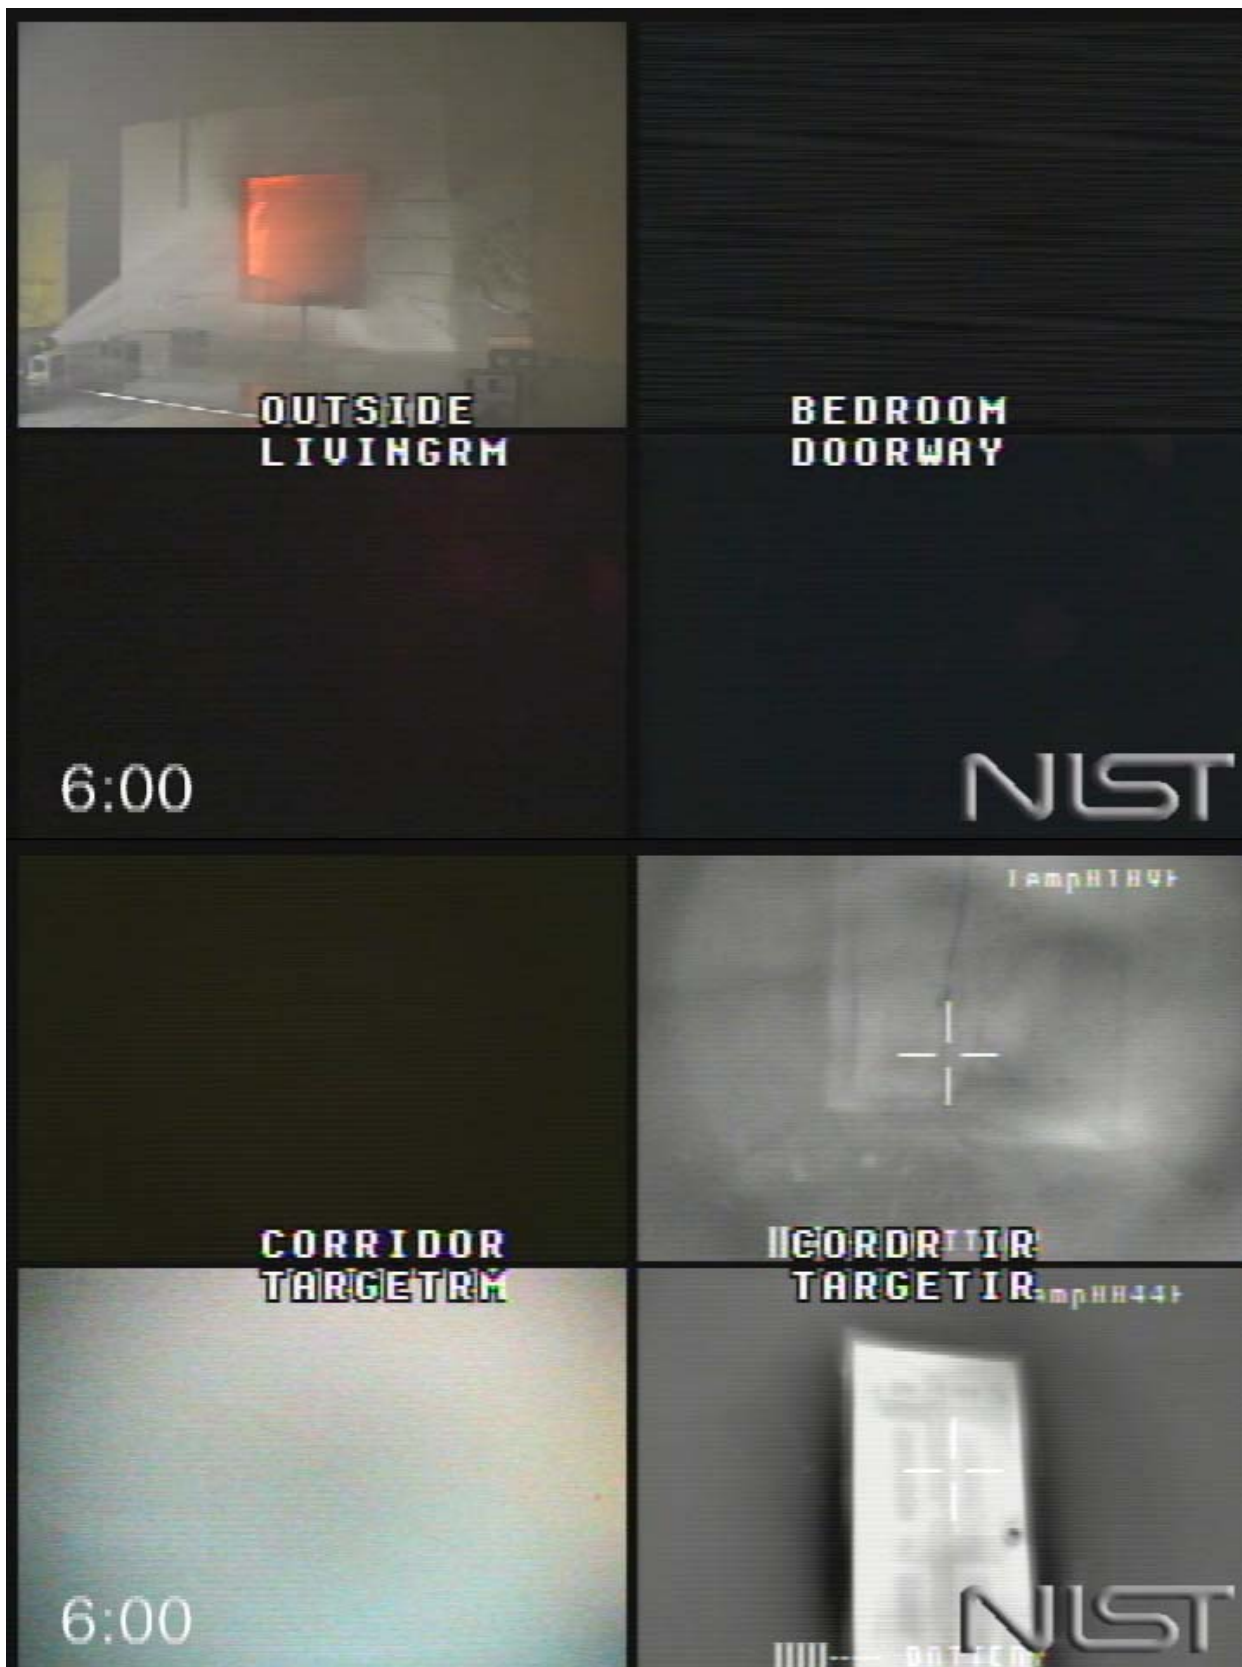
Figure 5.6.1-13. Experiment 6, 360 s after ignition.

Figure 5.6.1-13 shows the conditions 13 s after the fog spray directly into the window was started. The images seem similar to the images in Figure 5.6.1-12.

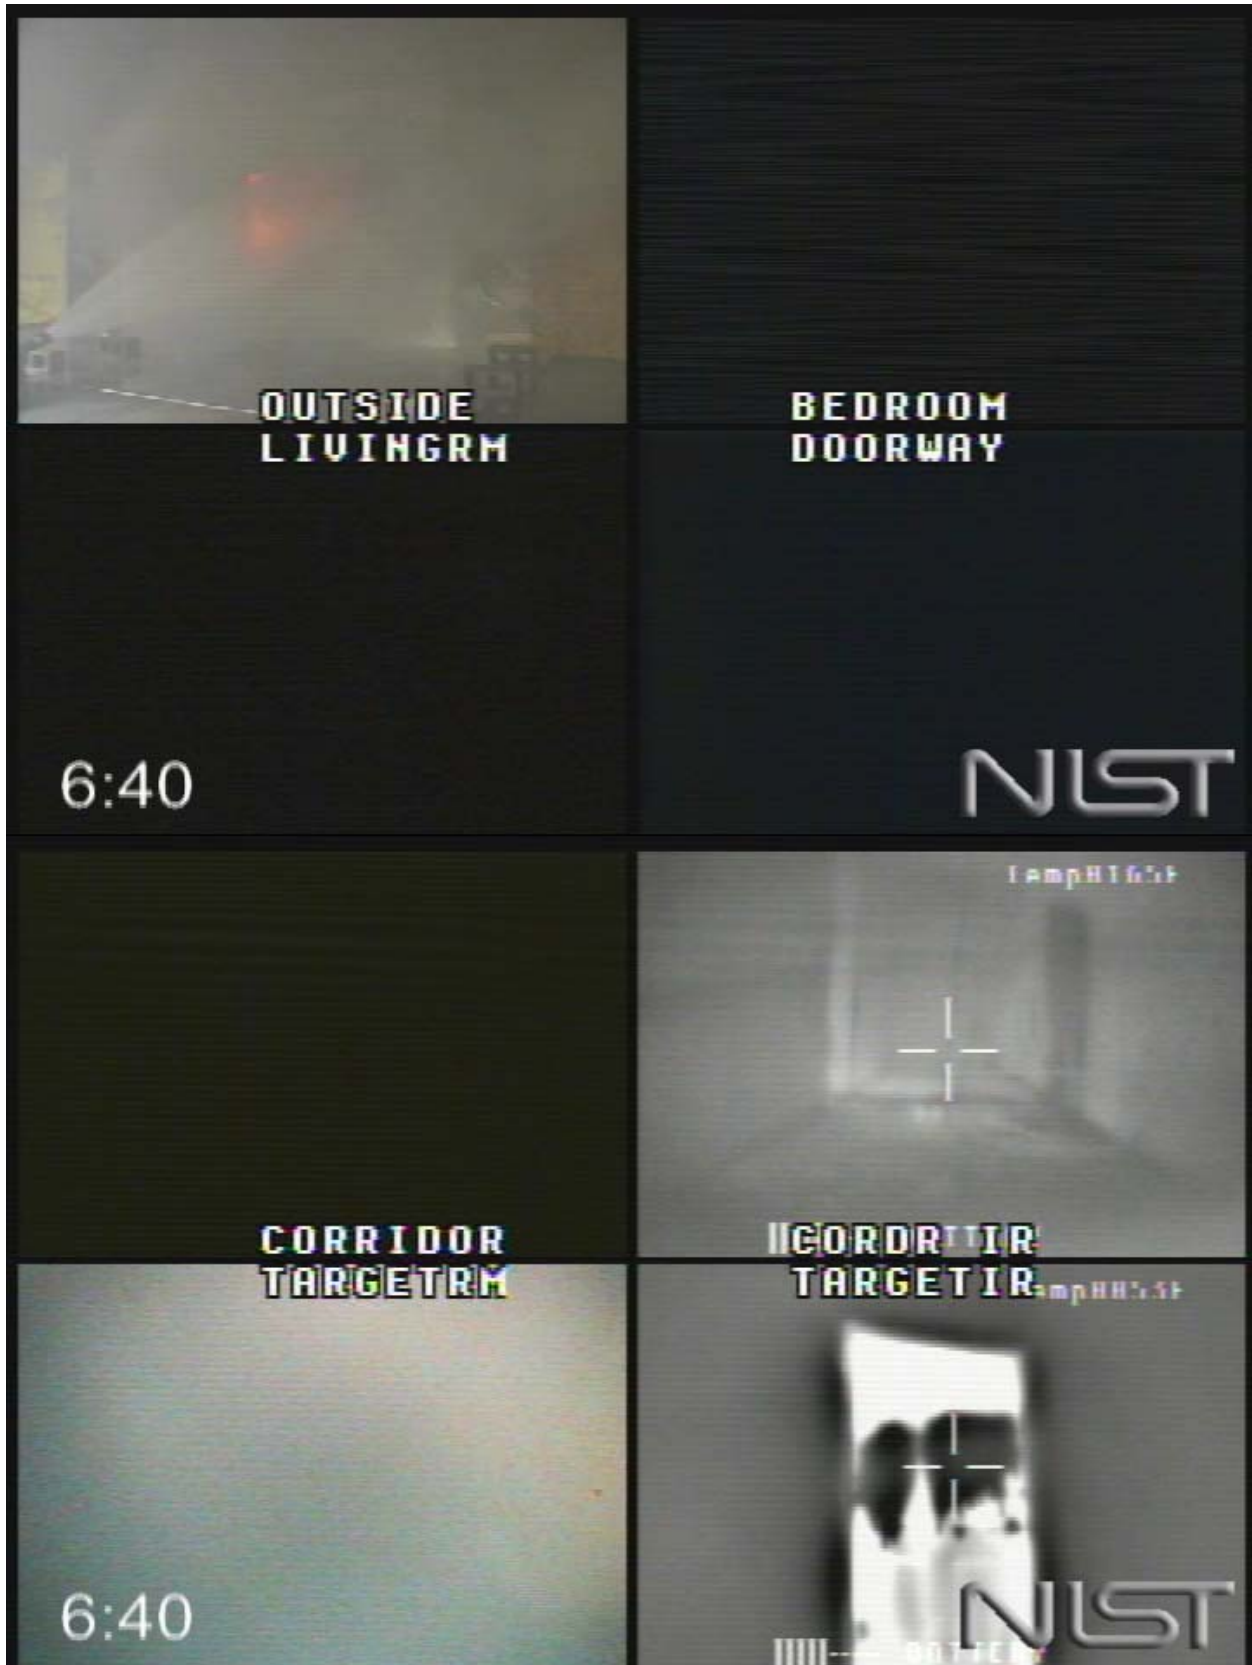
Figure 5.6.1-14. Experiment 6, 400 s after ignition.

The images in Figure 5.6.1-14 were recorded after 50 s of direct, fog stream application. The flames in the bedroom had decreased. The interior video views were still obscured. The corridor thermal view shows continued cooling. The black area on the east wall across from the door is indicative of the wall cooling due to the water. Portions of the target room door appear to have been impacted by the water in the areas that appear dark.

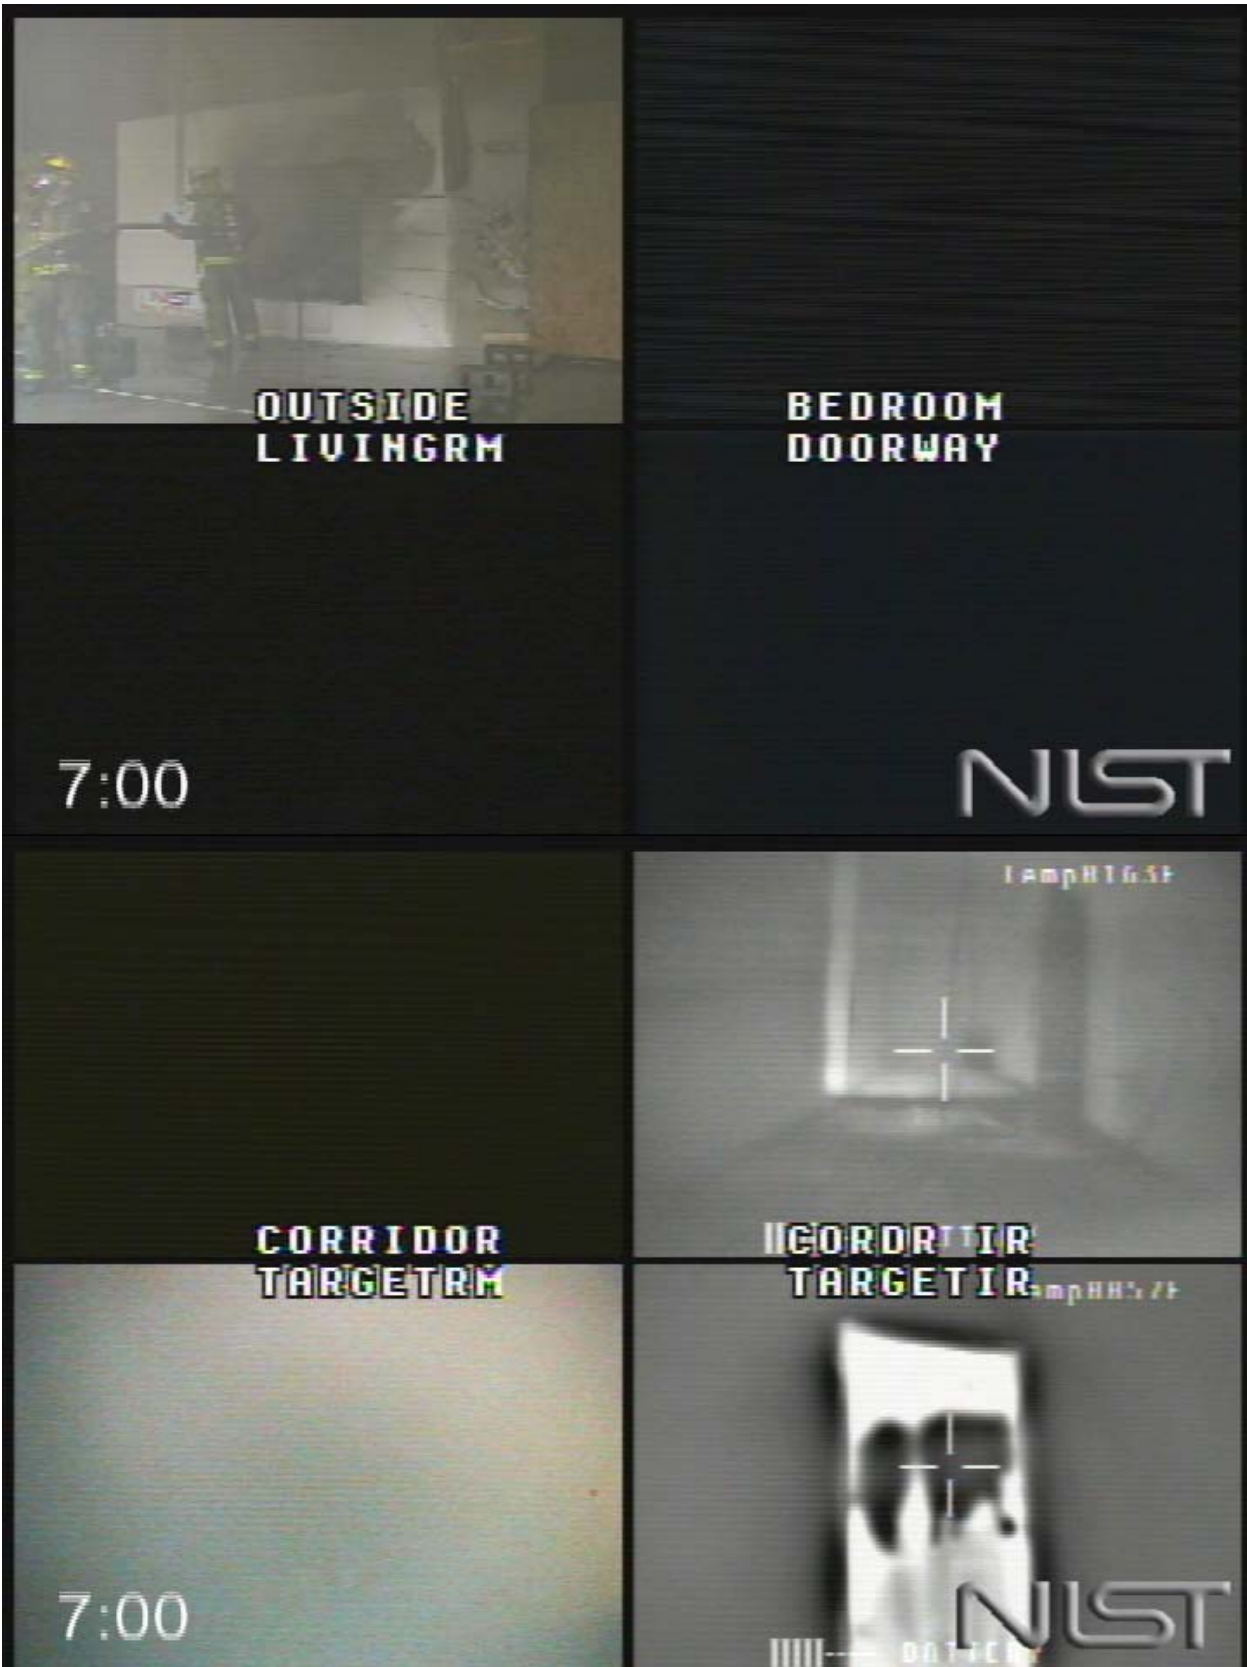
Figure 5.6.1-15. Experiment 6, 420 s after ignition.

The post-test images are shown in Figure 5.6.1-15. The fire in the bedroom had been suppressed. The conditions in the corridor continued to cool. All other views had not changed. Post test inspection indicated that the protective covers for the interior video cameras were coated with soot.

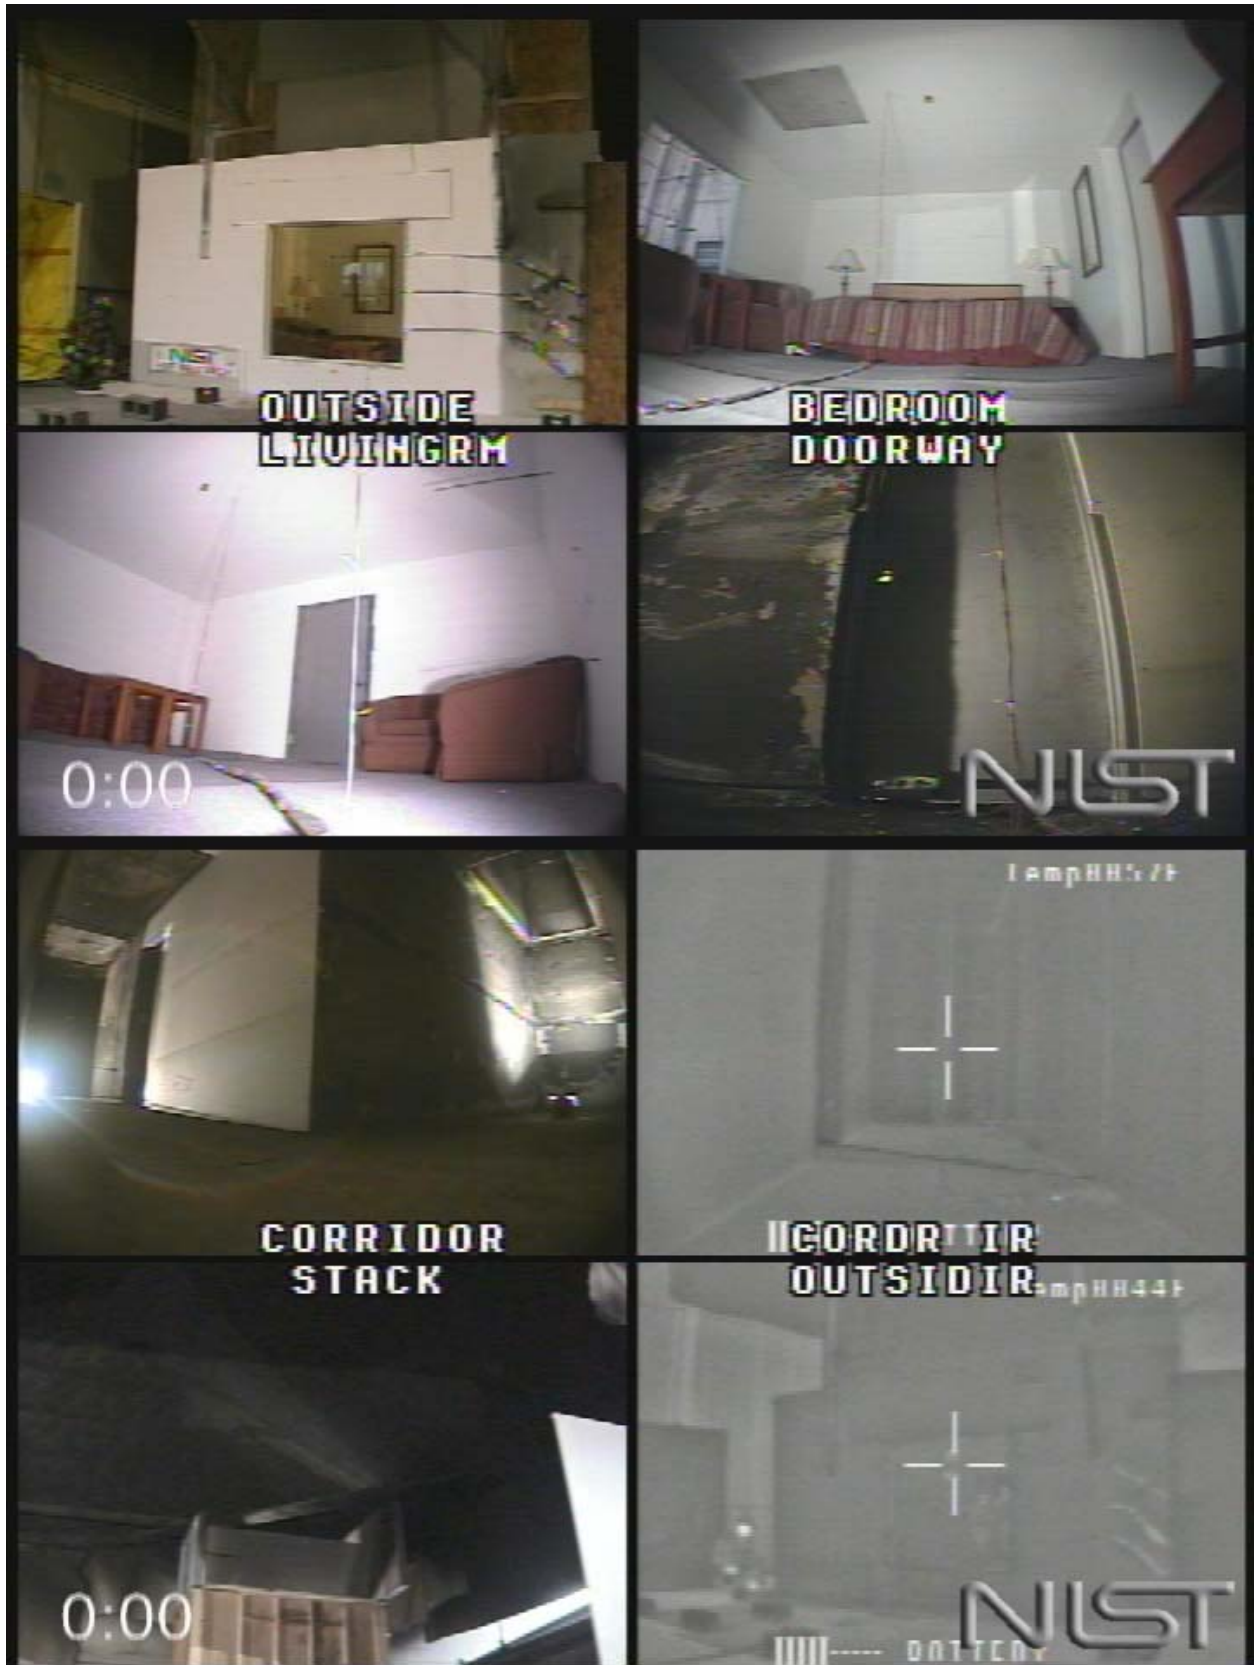
Figure 5.7.1-1. Experiment 7, ignition.

Figure 5.7.1-1 through Figure 5.7.1-13 present sets of eight images, one from each camera position, at a given time, from the time of ignition to 550 s after ignition. Each image view is labeled. Figure 5.7.1-1 shows the conditions at the time of ignition. At this point, the six video views are clear and unobstructed. However, the thermal images provide limited thermal contrast, because the surfaces in the view were at nearly equal temperature.
