# NIST Technical Note 1618

## Fire Fighting Tactics Under Wind Driven Conditions: Laboratory Experiments

Daniel Madrzykowski  
Stephen Kerber

U.S. Department of Commerce  
Building and Fire Research Laboratory  
National Institute of Standards and Technology  
Gaithersburg, MD 20899

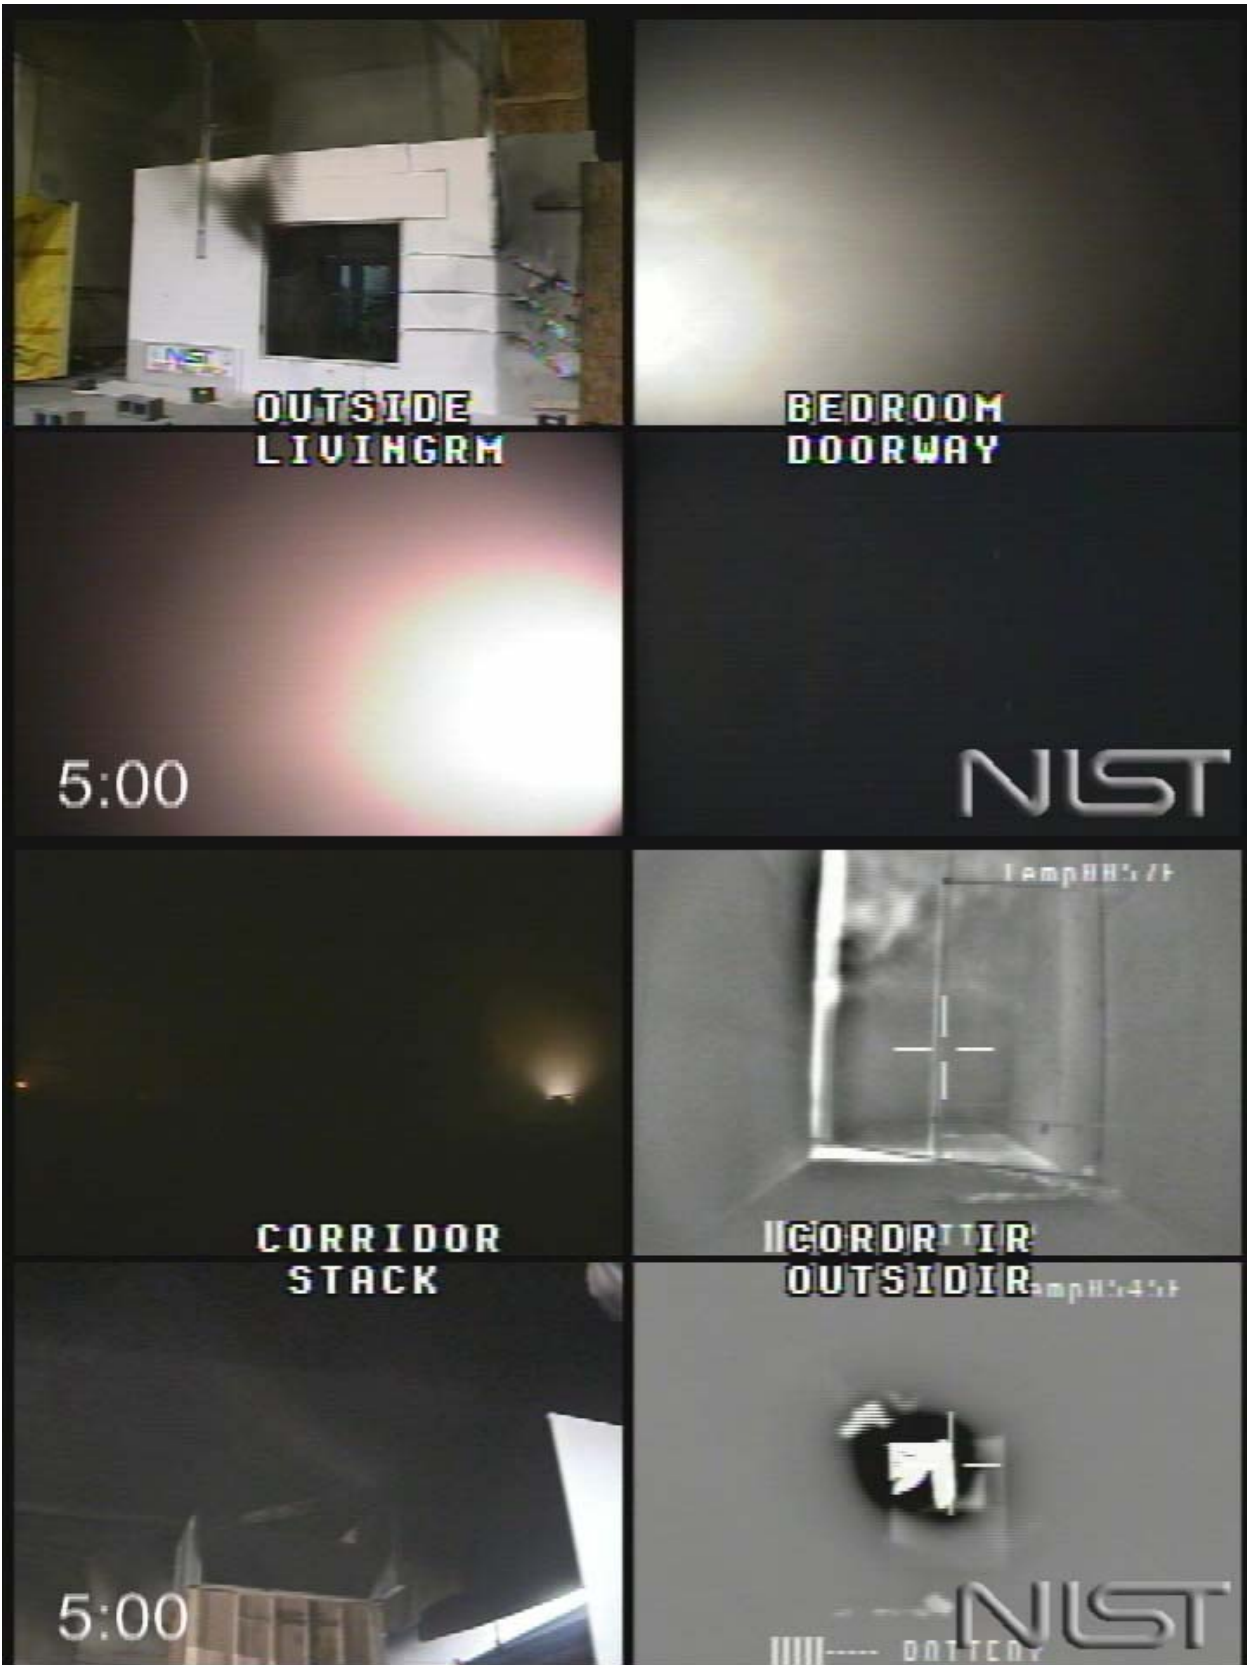
Figure 5.7.1-6. Experiment 7, 300 s after ignition.

Figure 5.7.1-6 shows the images at 300 s after ignition. The smoke layer descended to the floor in most of the structure. The corner of the window had cracked and fell out. There was an increase in the amount of heat entering the corridor through cracks around the door and the visibility in the corridor was diminishing. Light smoke was visible from the stack.

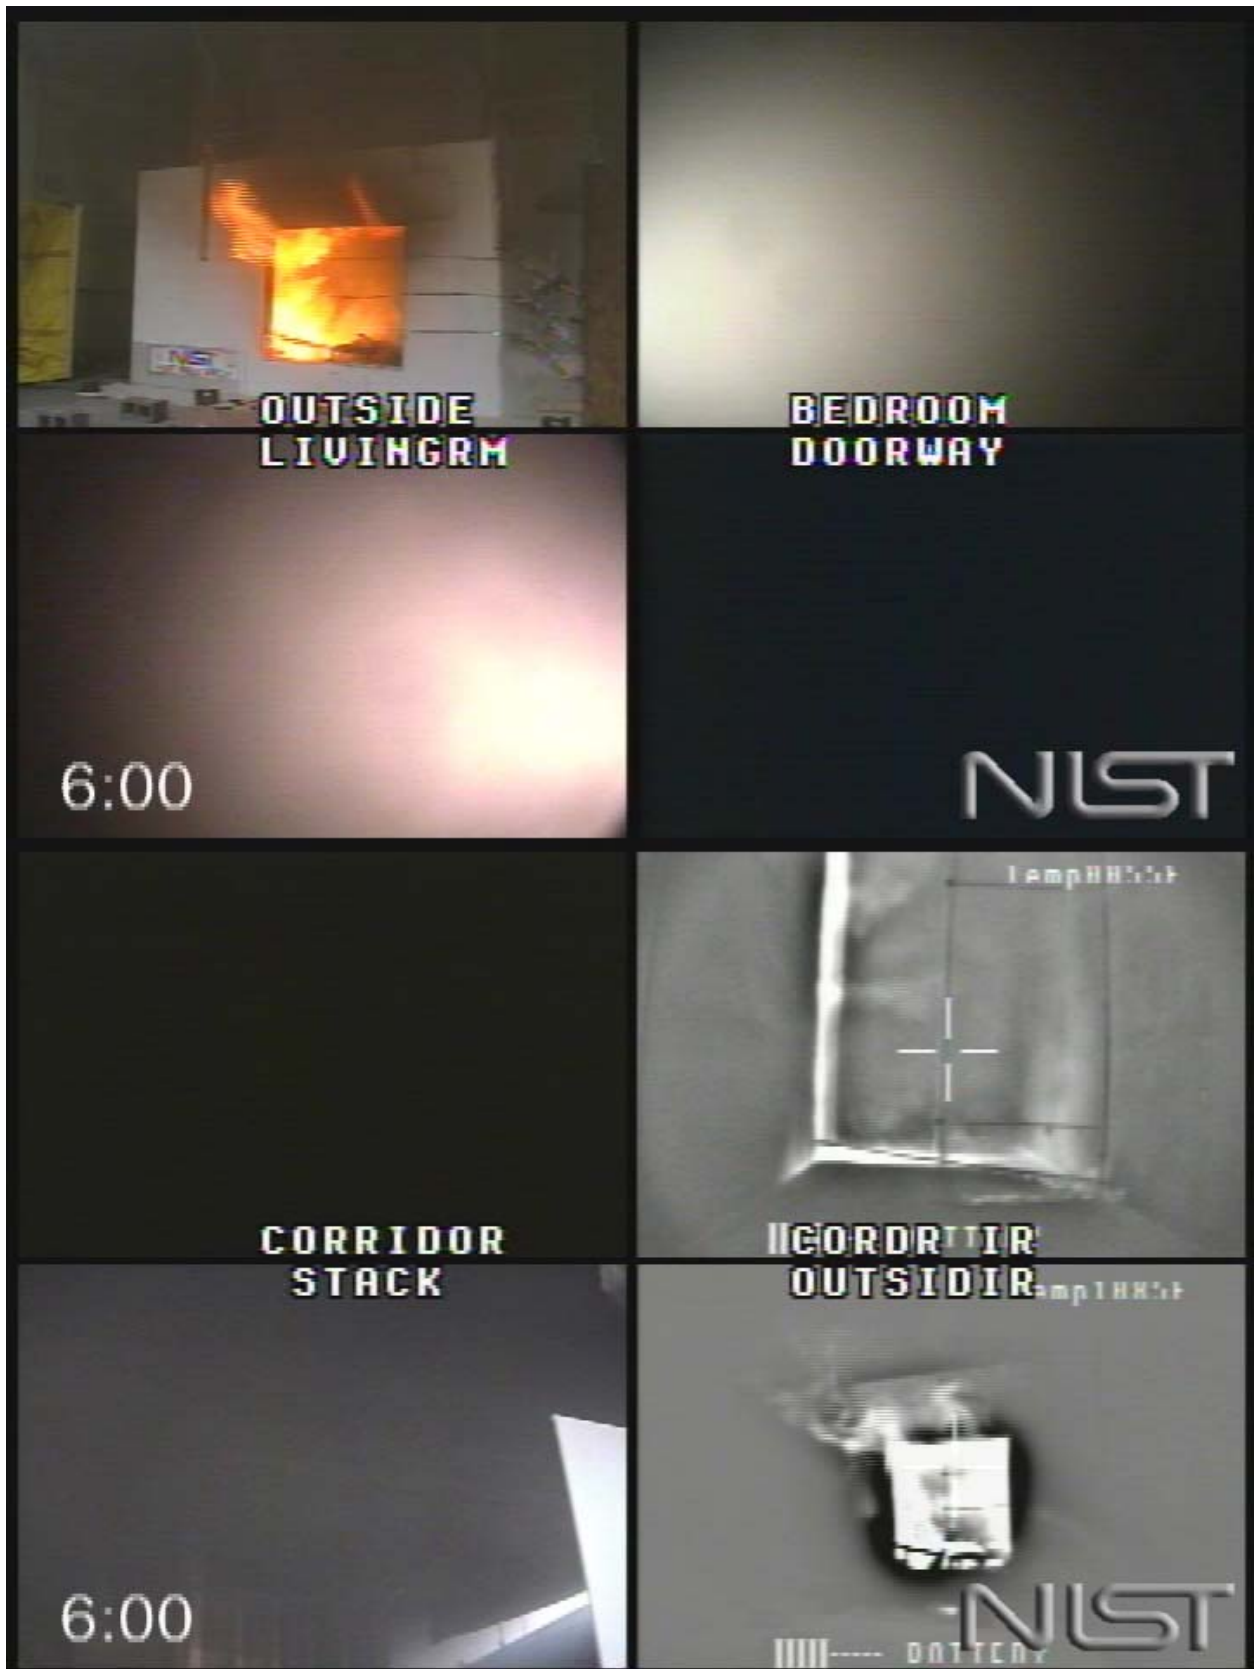
Figure 5.7.1-8. Experiment 7, 360 s after ignition.

Figure 5.7.1-8 shows the conditions at 360 s after ignition. Flames are still flowing out of the top of the window opening. There was very little visibility in the rest of the structure. The door to the corridor was still closed so the heat was being forced around the door and through the hole for the door knob. The stack was being obstructed by smoke as well.

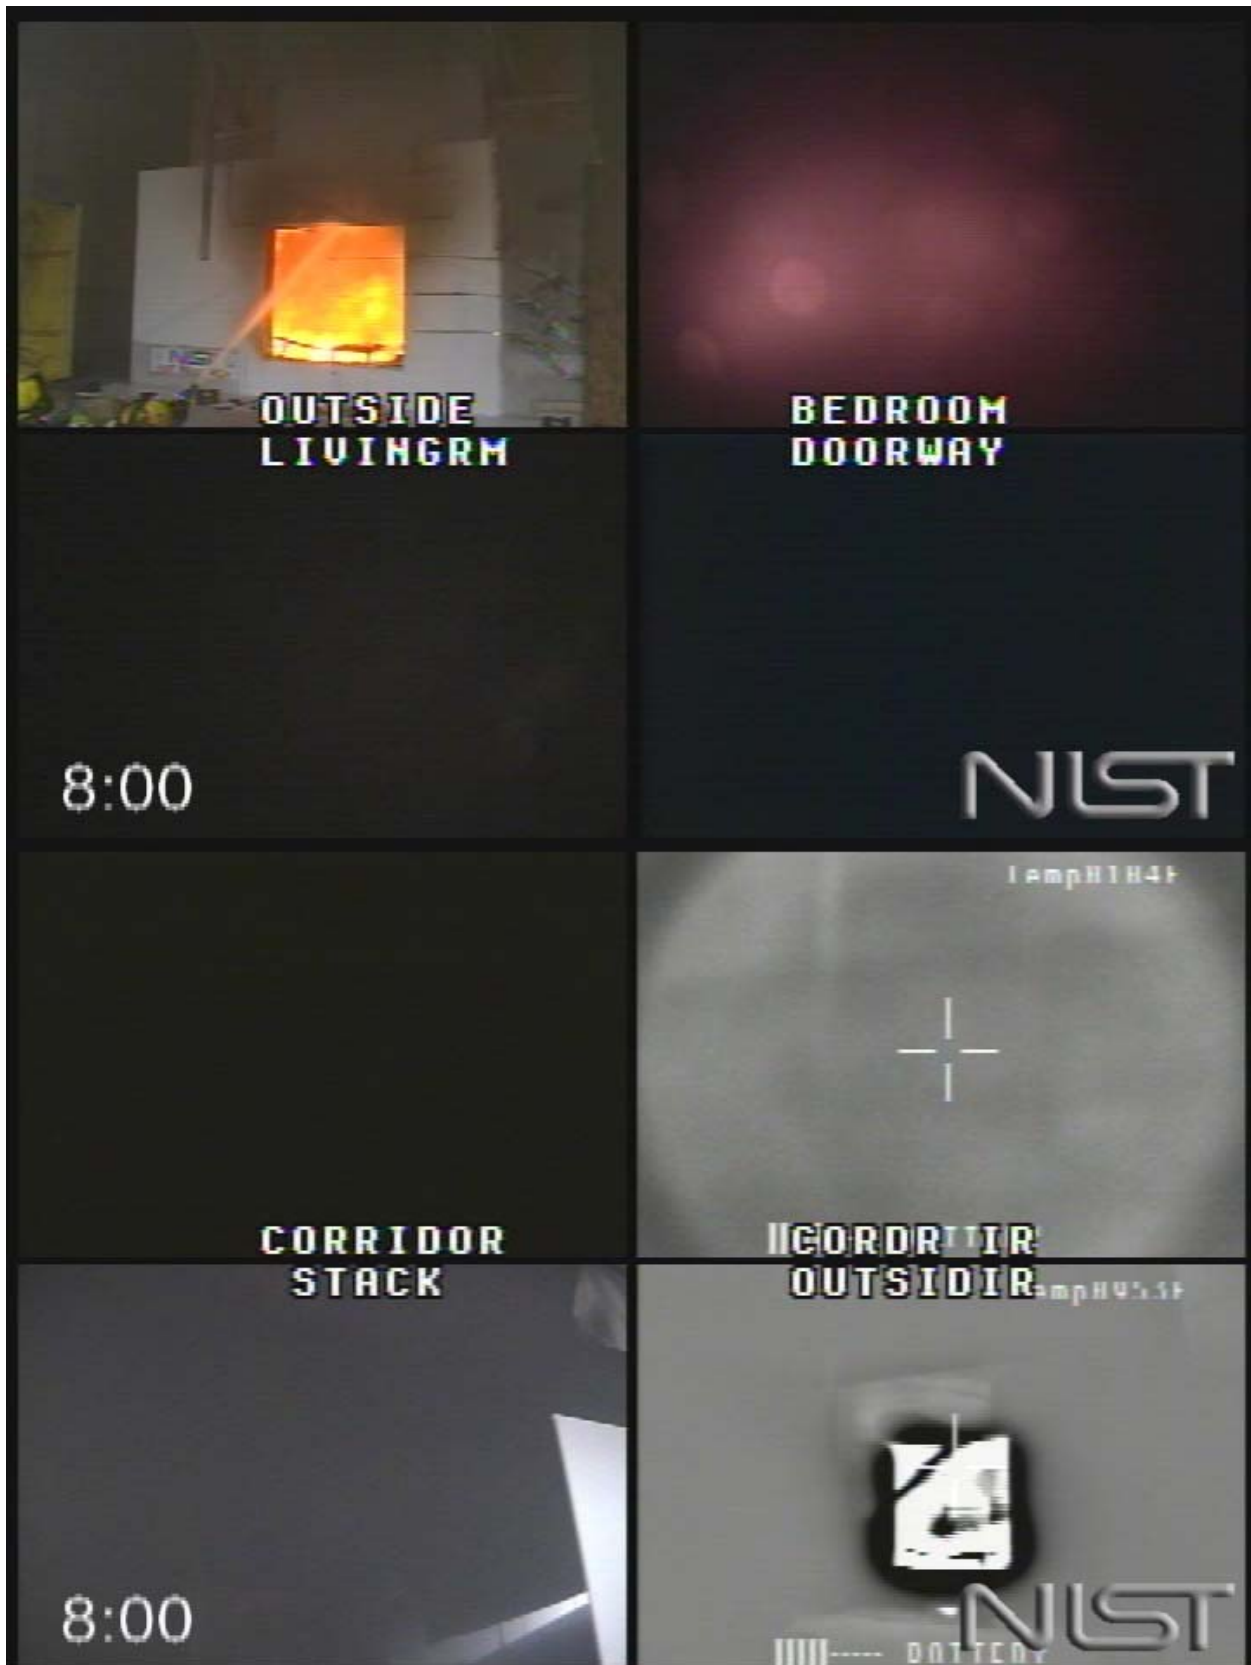
Figure 5.7.1-11. Experiment 7, 480 s after ignition.

Figure 5.7.1-11 shows the conditions at 480 s after ignition, or approximately 45 s since activation of the hose stream. The interior video views were still obscured by soot, but the bedroom view was returning to show flames. The thermal image from the corridor was still saturated with heat but started to improve in clarity. The outside thermal imaging view shows all of the heat going back into the structure.

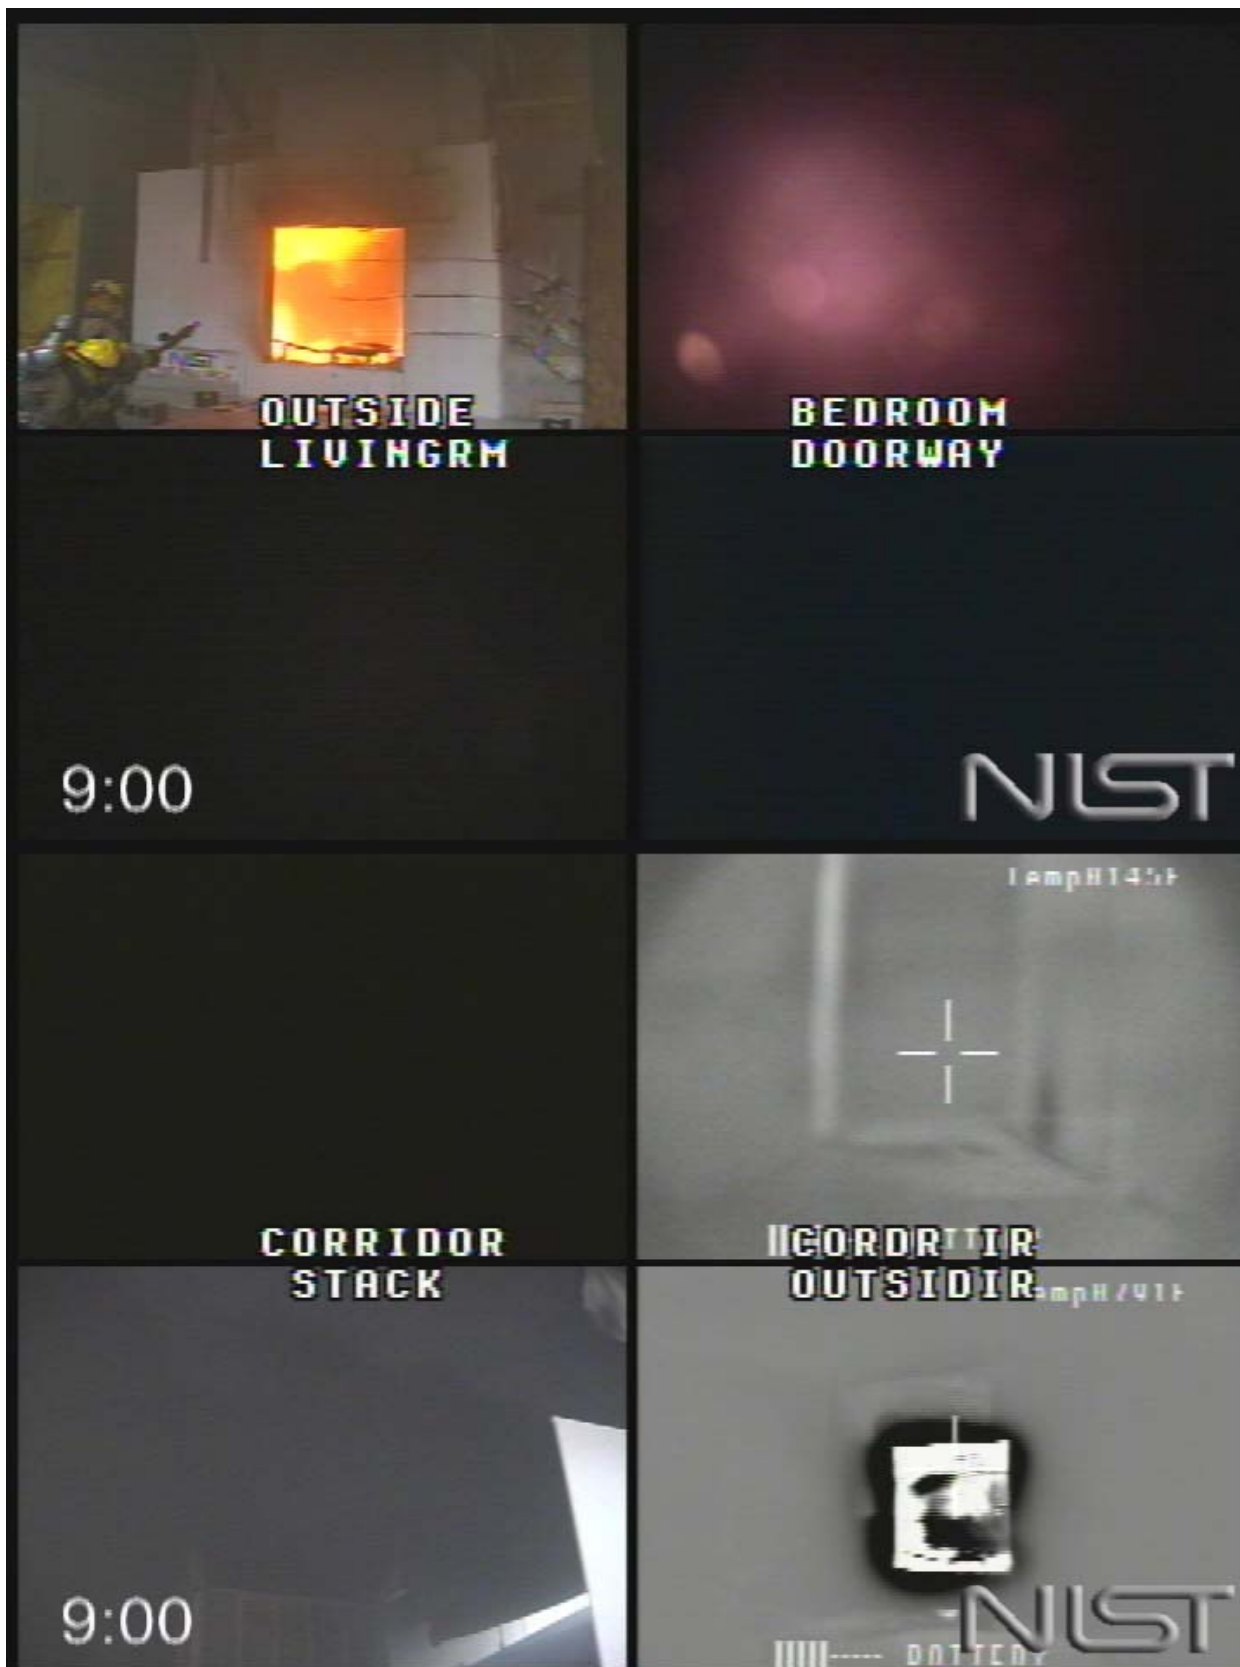
Figure 5.7.1-12. Experiment 7, 540 s after ignition.

Figure 5.7.1-12 shows the conditions at 540 s after ignition, which was about 2 s after the hose stream was turned off. Flames are still visible in the bedroom, but not coming out of the bedroom window. The internal views are still obscured but the thermal imaging view in the corridor has returned to a usable image showing little heat flow. The dark spots on the wall and floor also indicate that water made it to the corridor. The stack was once again visible showing a reduced smoke production rate.

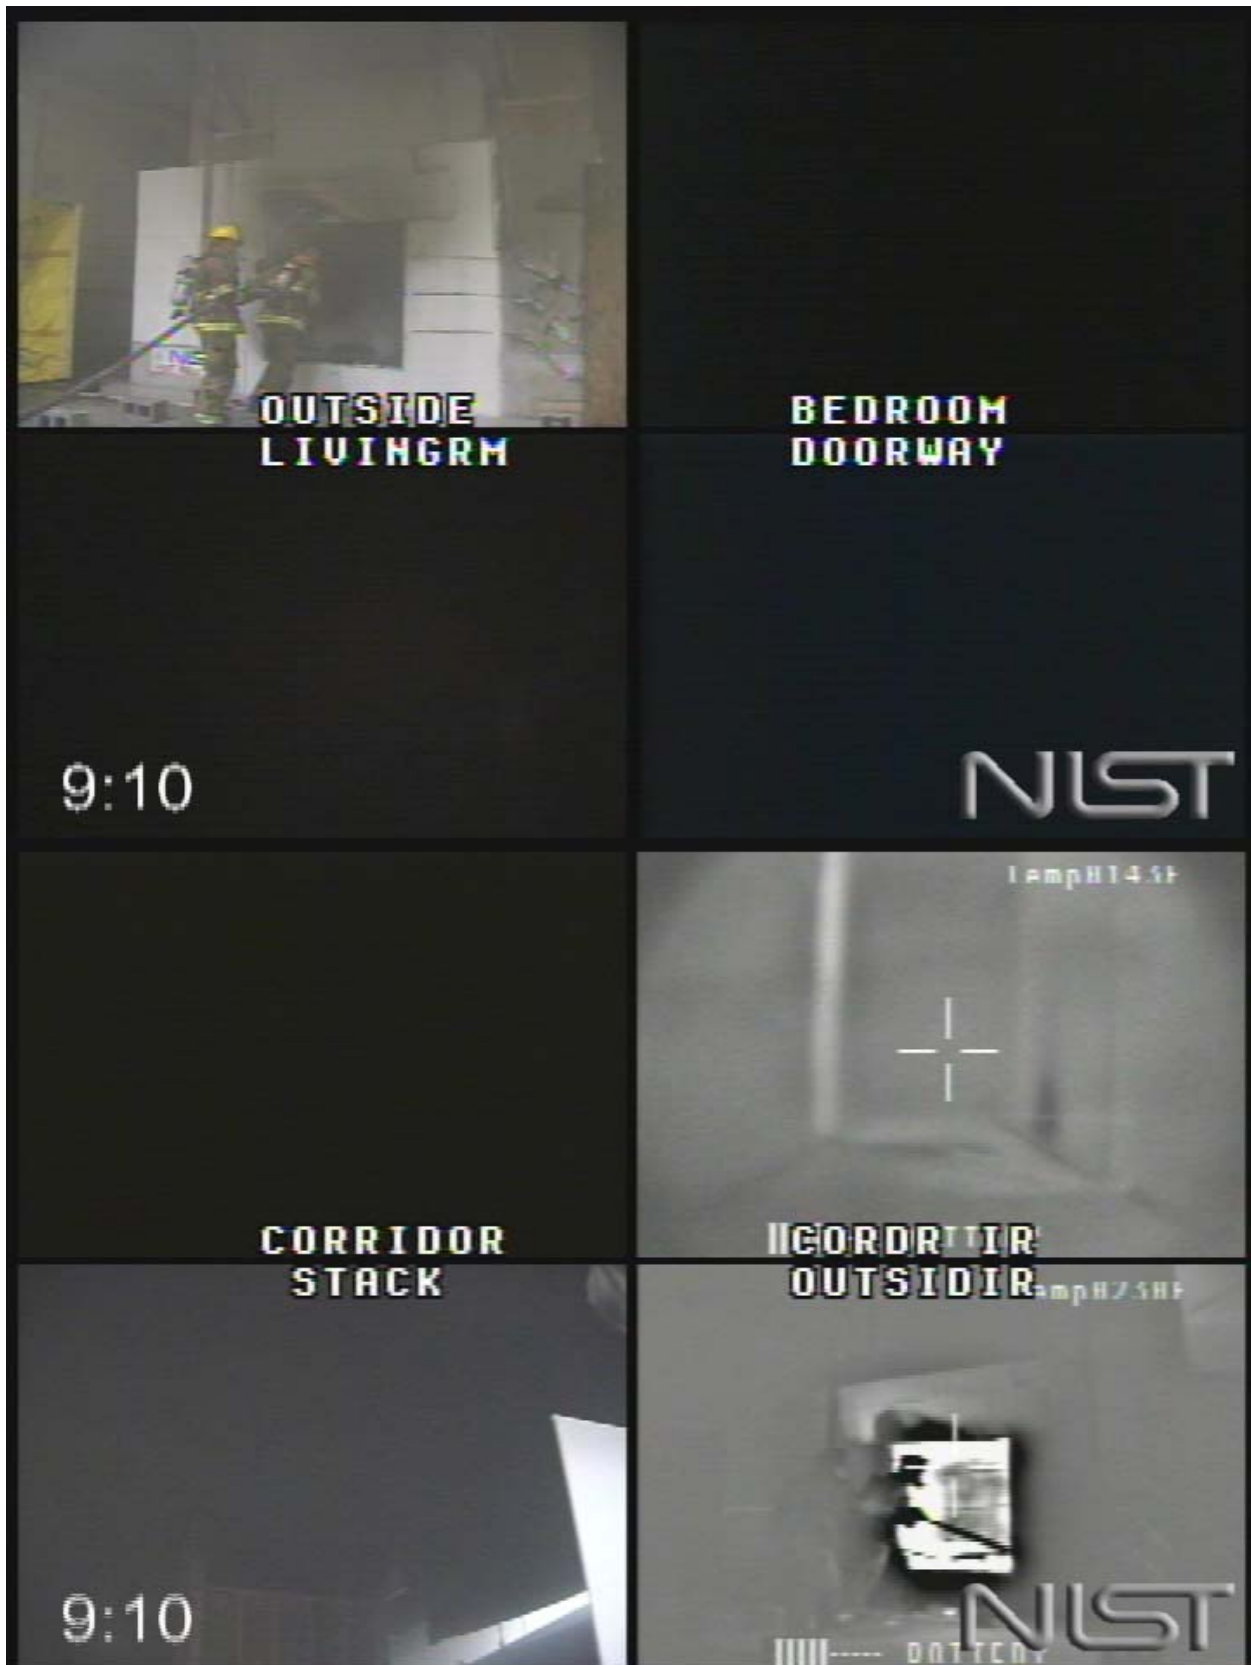
Figure 5.7.1-13. Experiment 7, direct suppression, 550 s after ignition.

The final images at 550 s after ignition show final suppression of the burning items remaining in the bedroom. The water did not reach the furnishings just inside the window so they needed to be extinguished from inside the window. All of the interior images were still obscured by soot deposition on the camera lenses.

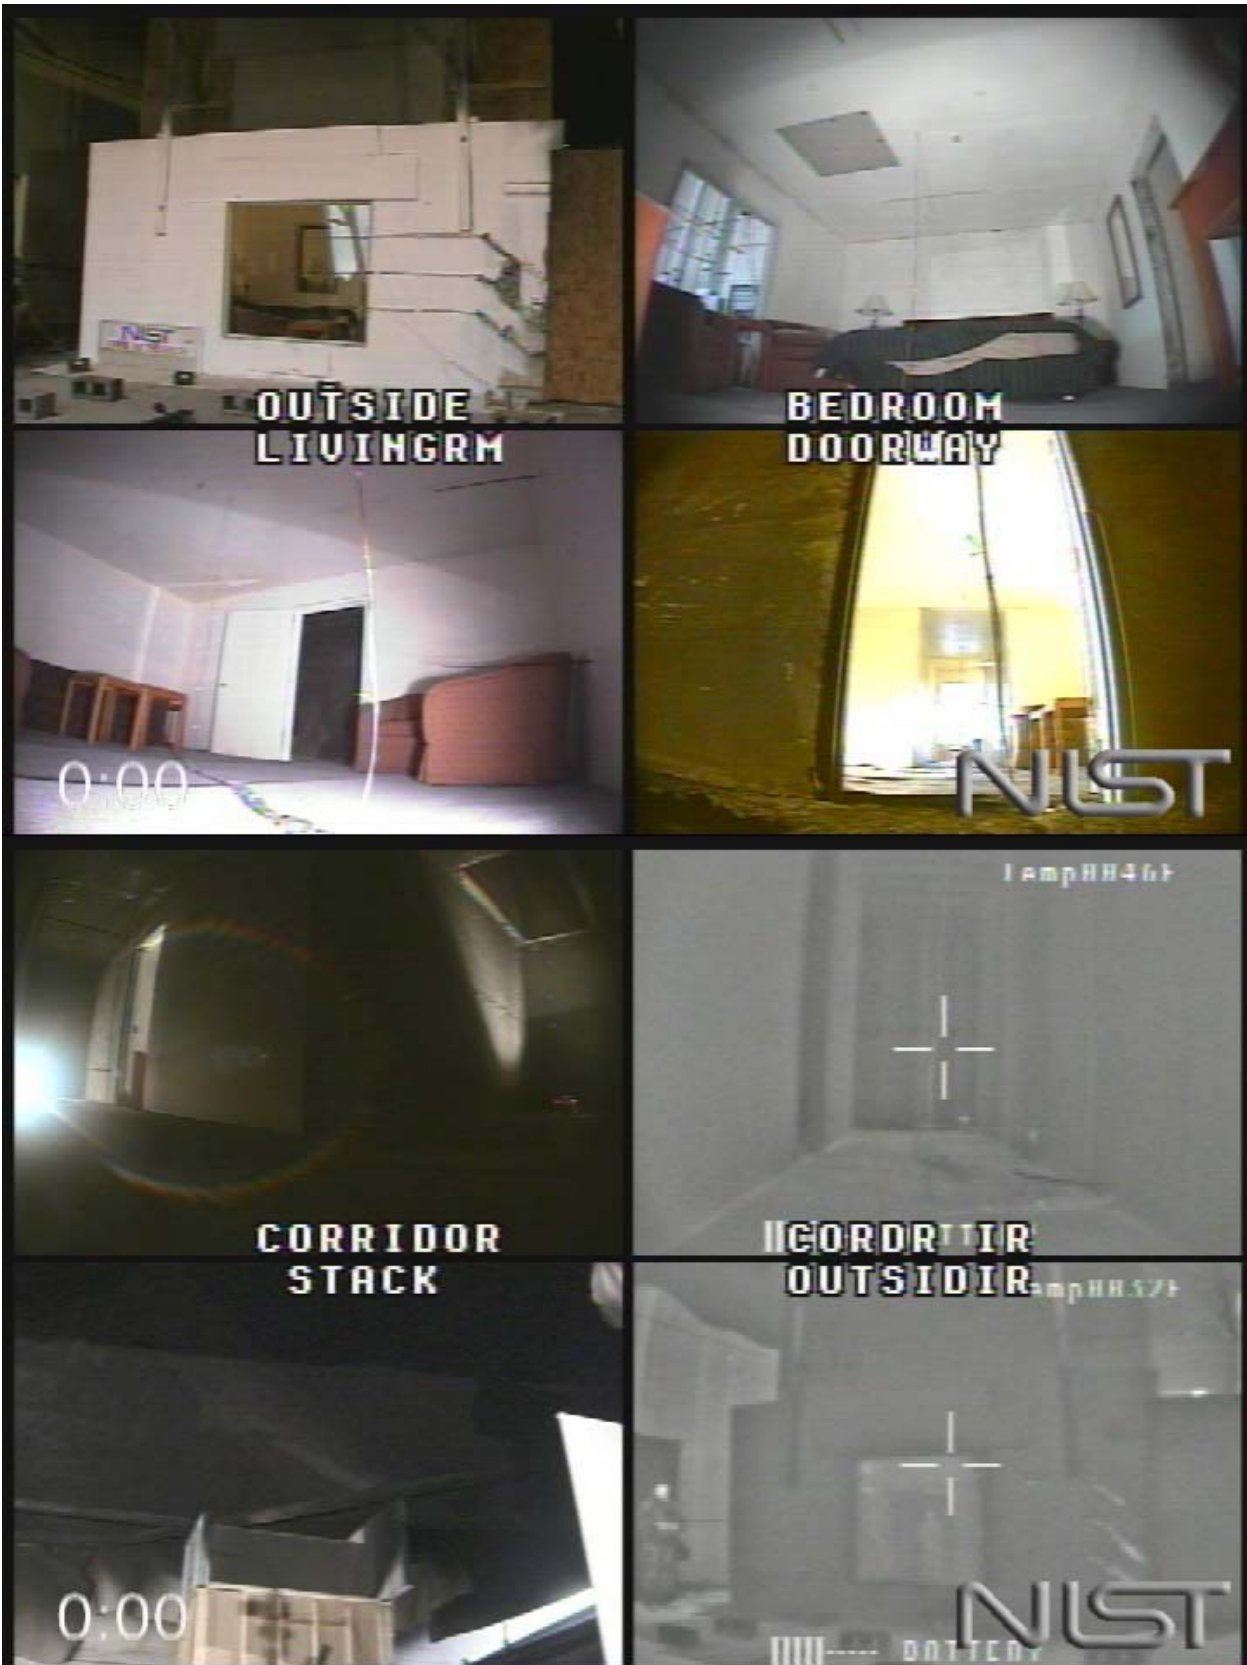
Figure 5.8.1-1. Experiment 8, ignition.

Figure 5.8.1-1 shows the conditions at the time of ignition. At this point, the eight video views were clear and unobstructed. However, the thermal images provided limited thermal contrast because the surfaces in the view were at nearly equal temperature.

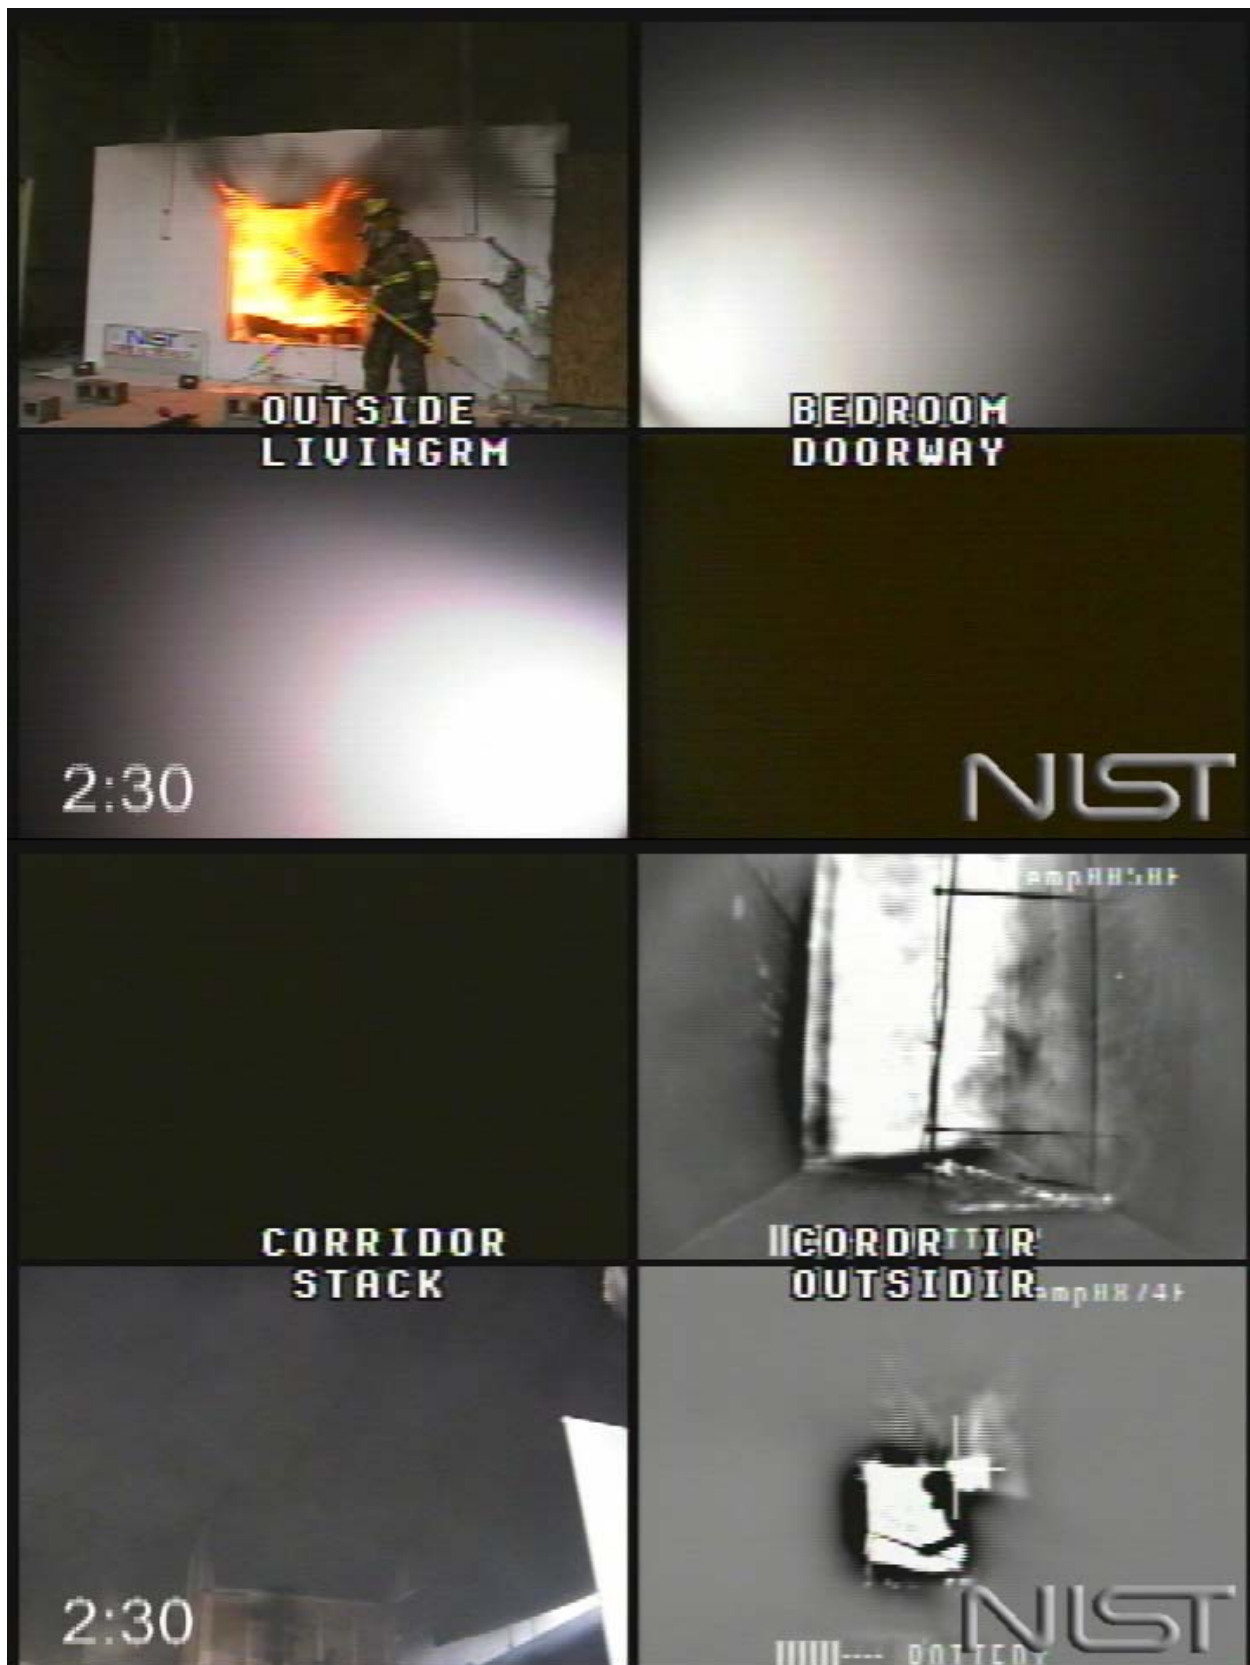
Figure 5.8.1-4. Experiment 8, window fully vented, 150 s after ignition.

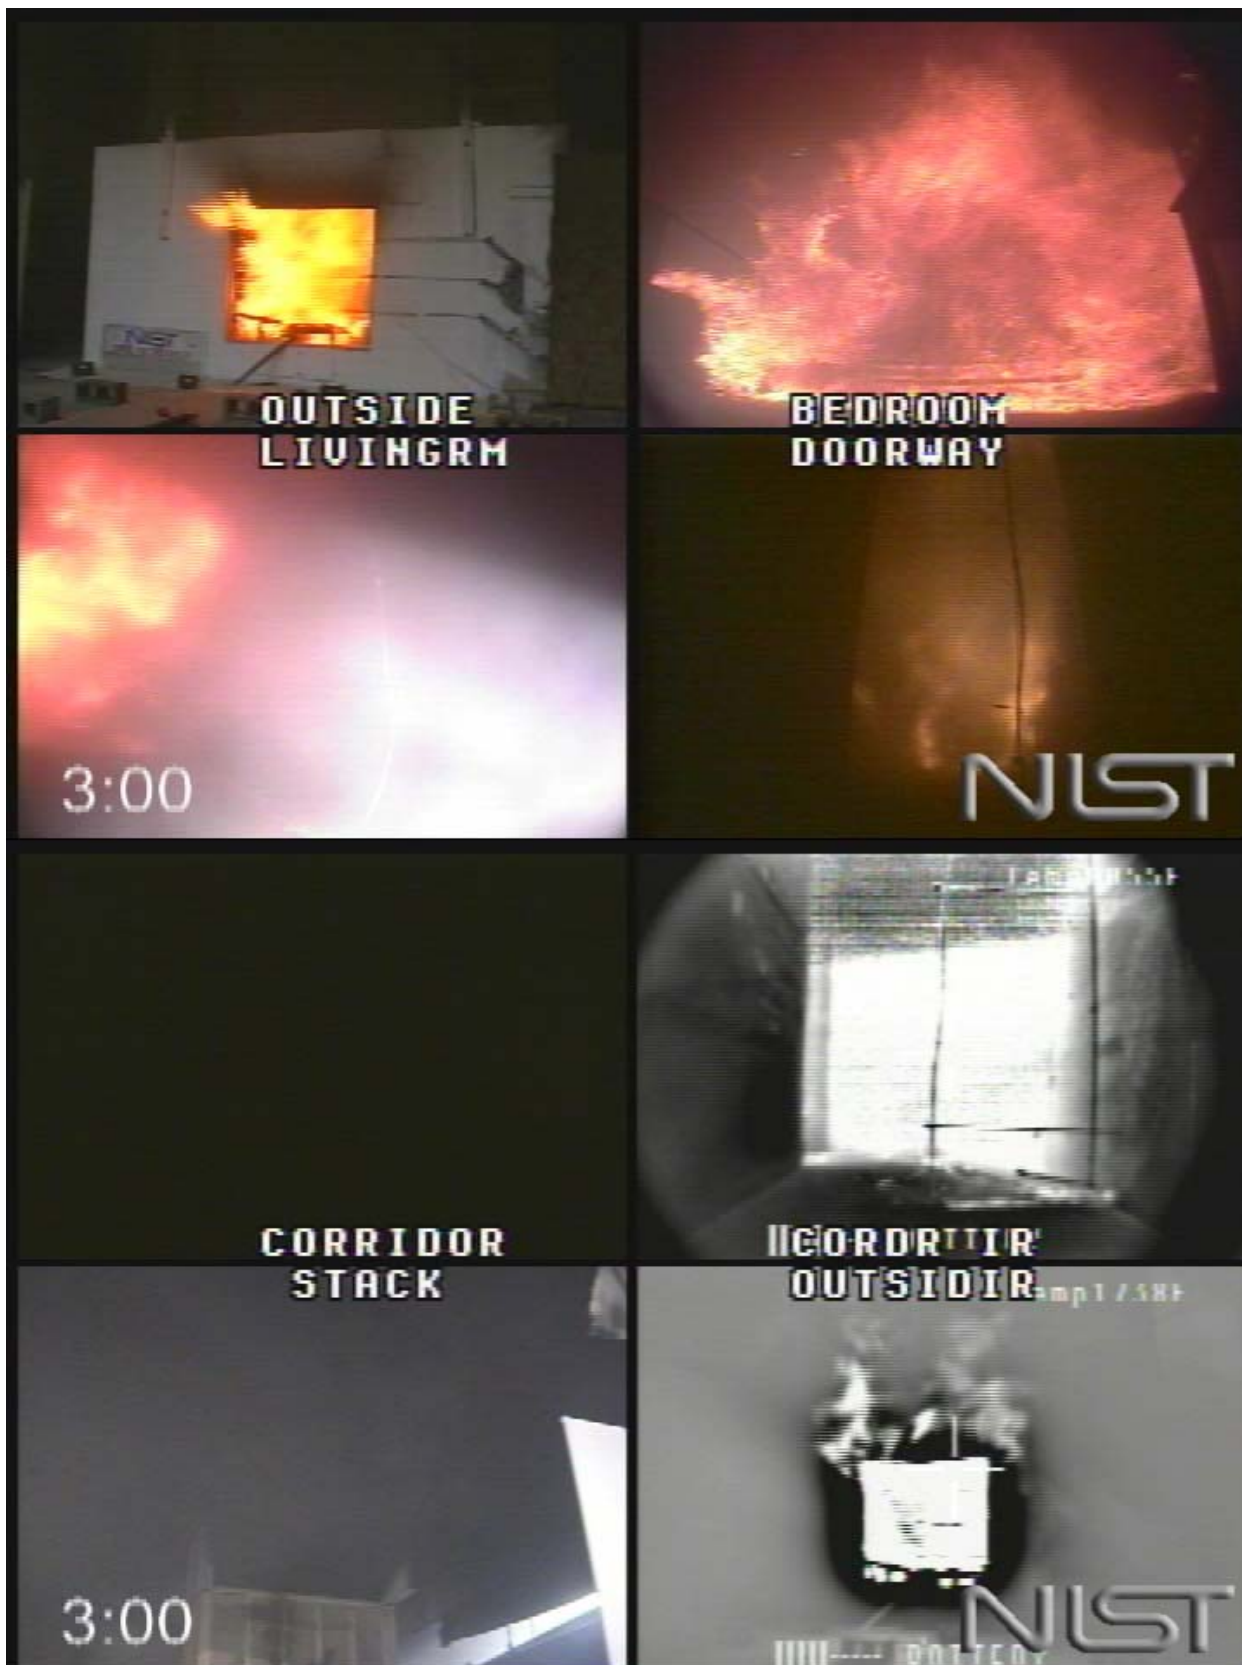
Figure 5.8.1-5. Experiment 8, 180 s after ignition.

Figure 5.8.1-5 shows the conditions at 180 s after ignition. Flames had encompassed the full height of the bedroom and extend into the living room. Some visibility has returned to the bedroom and living room.

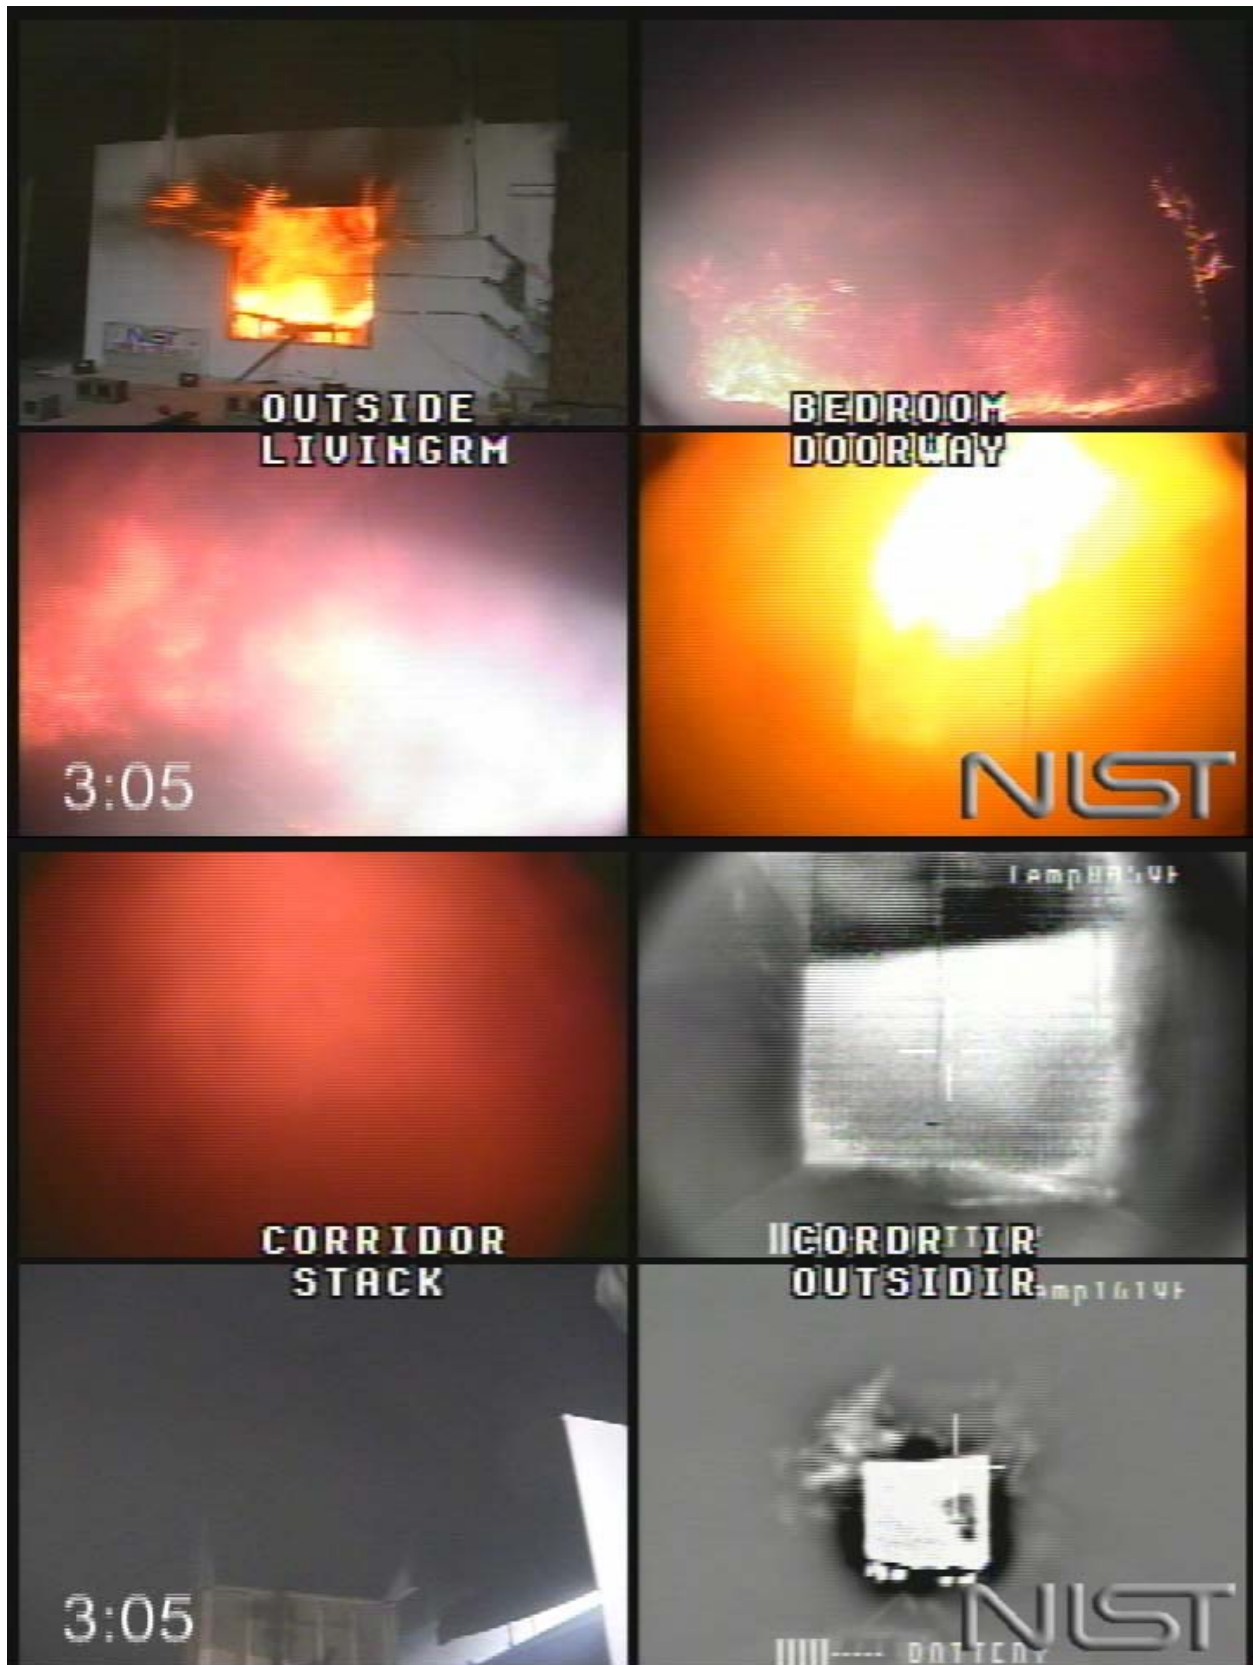
Figure 5.8.1-6. Experiment 8, corridor flames, 185 s after ignition.

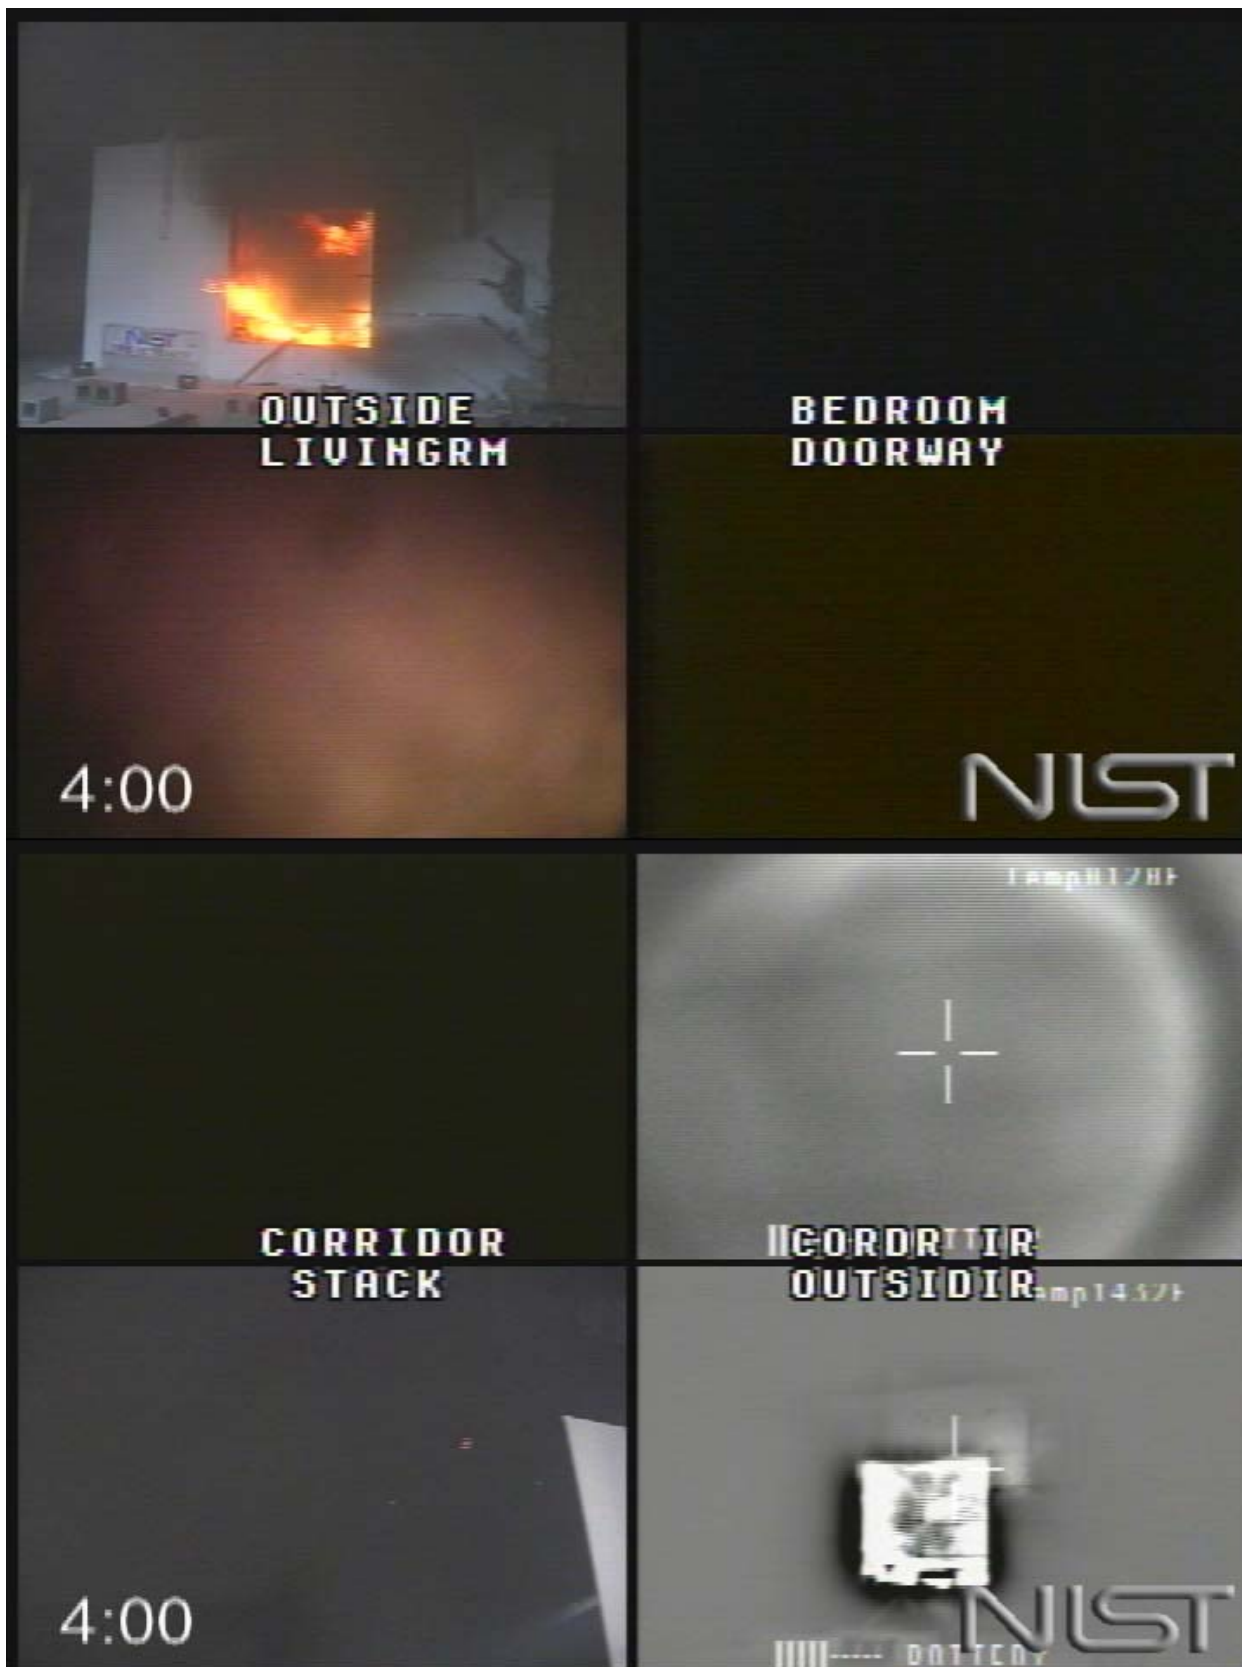
Figure 5.8.1-7. Experiment 8, 240 s after ignition.

Figure 5.8.1-7 shows the conditions at 240 s after ignition. At this point there was zero visibility in any of the internal views, including the corridor IR camera. Smoke had begun to fill the laboratory structure and has thus obscured the external stack view as well.
