# NIST Technical Note 1618

## Fire Fighting Tactics Under Wind Driven Conditions: Laboratory Experiments

Daniel Madrzykowski  
Stephen Kerber

U.S. Department of Commerce  
Building and Fire Research Laboratory  
National Institute of Standards and Technology  
Gaithersburg, MD 20899

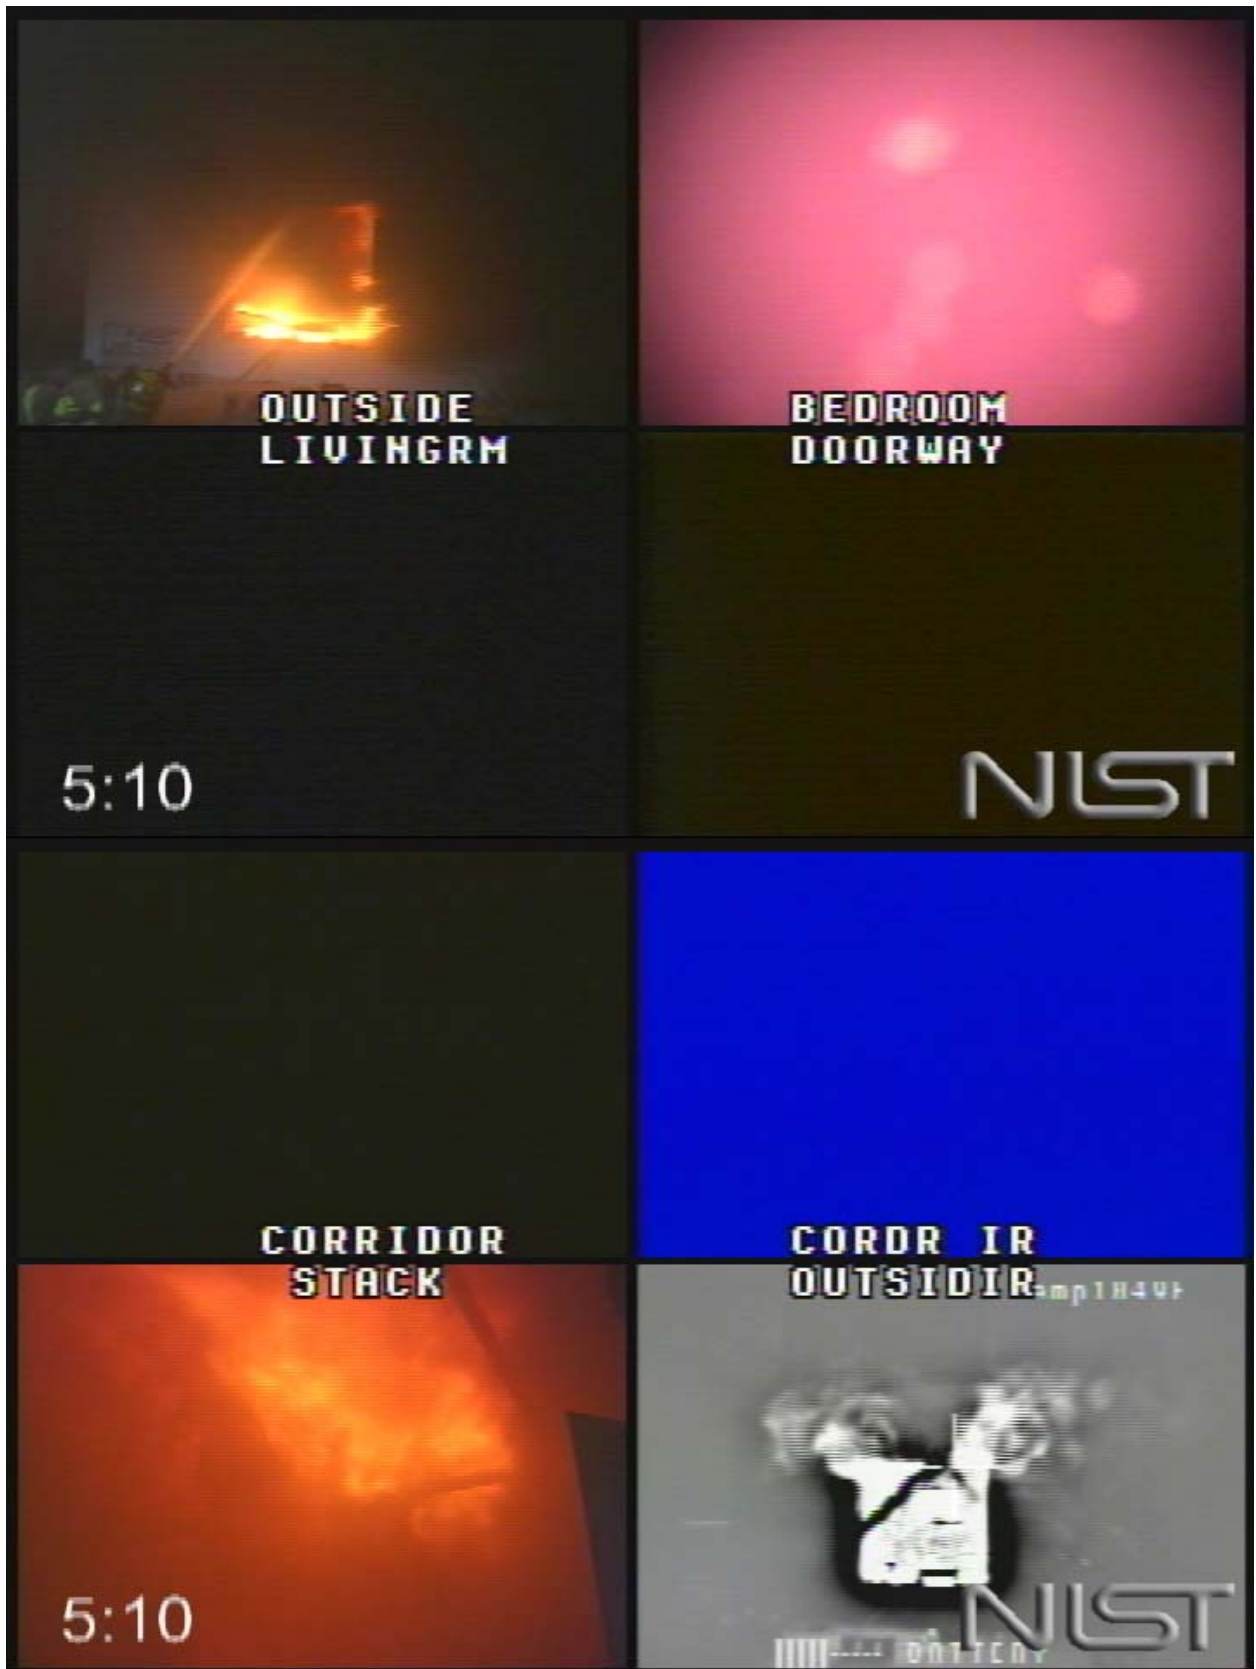
Figure 5.8.1-9. Experiment 8, indirect suppression started, 310 s after ignition.

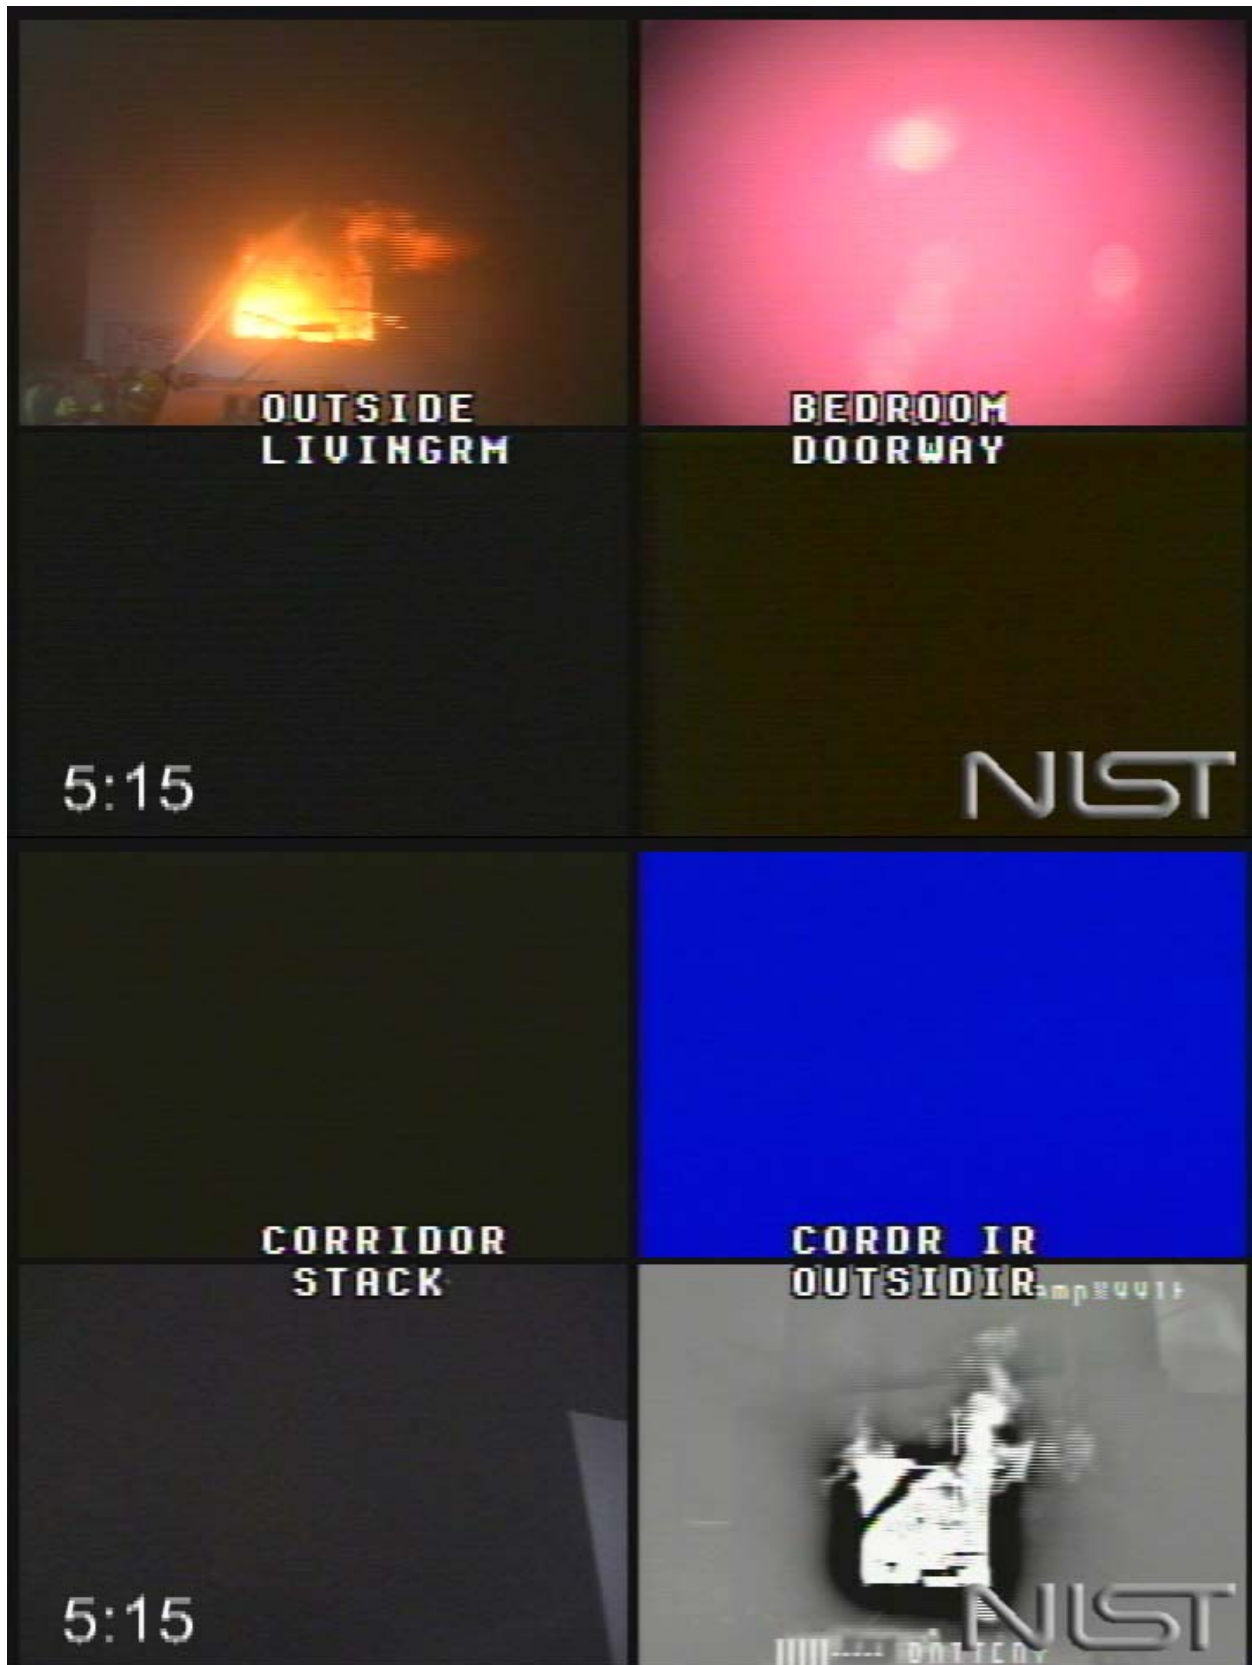
Figure 5.8.1-10. Experiment 8, flames withdraw from vent, 315 s after ignition.

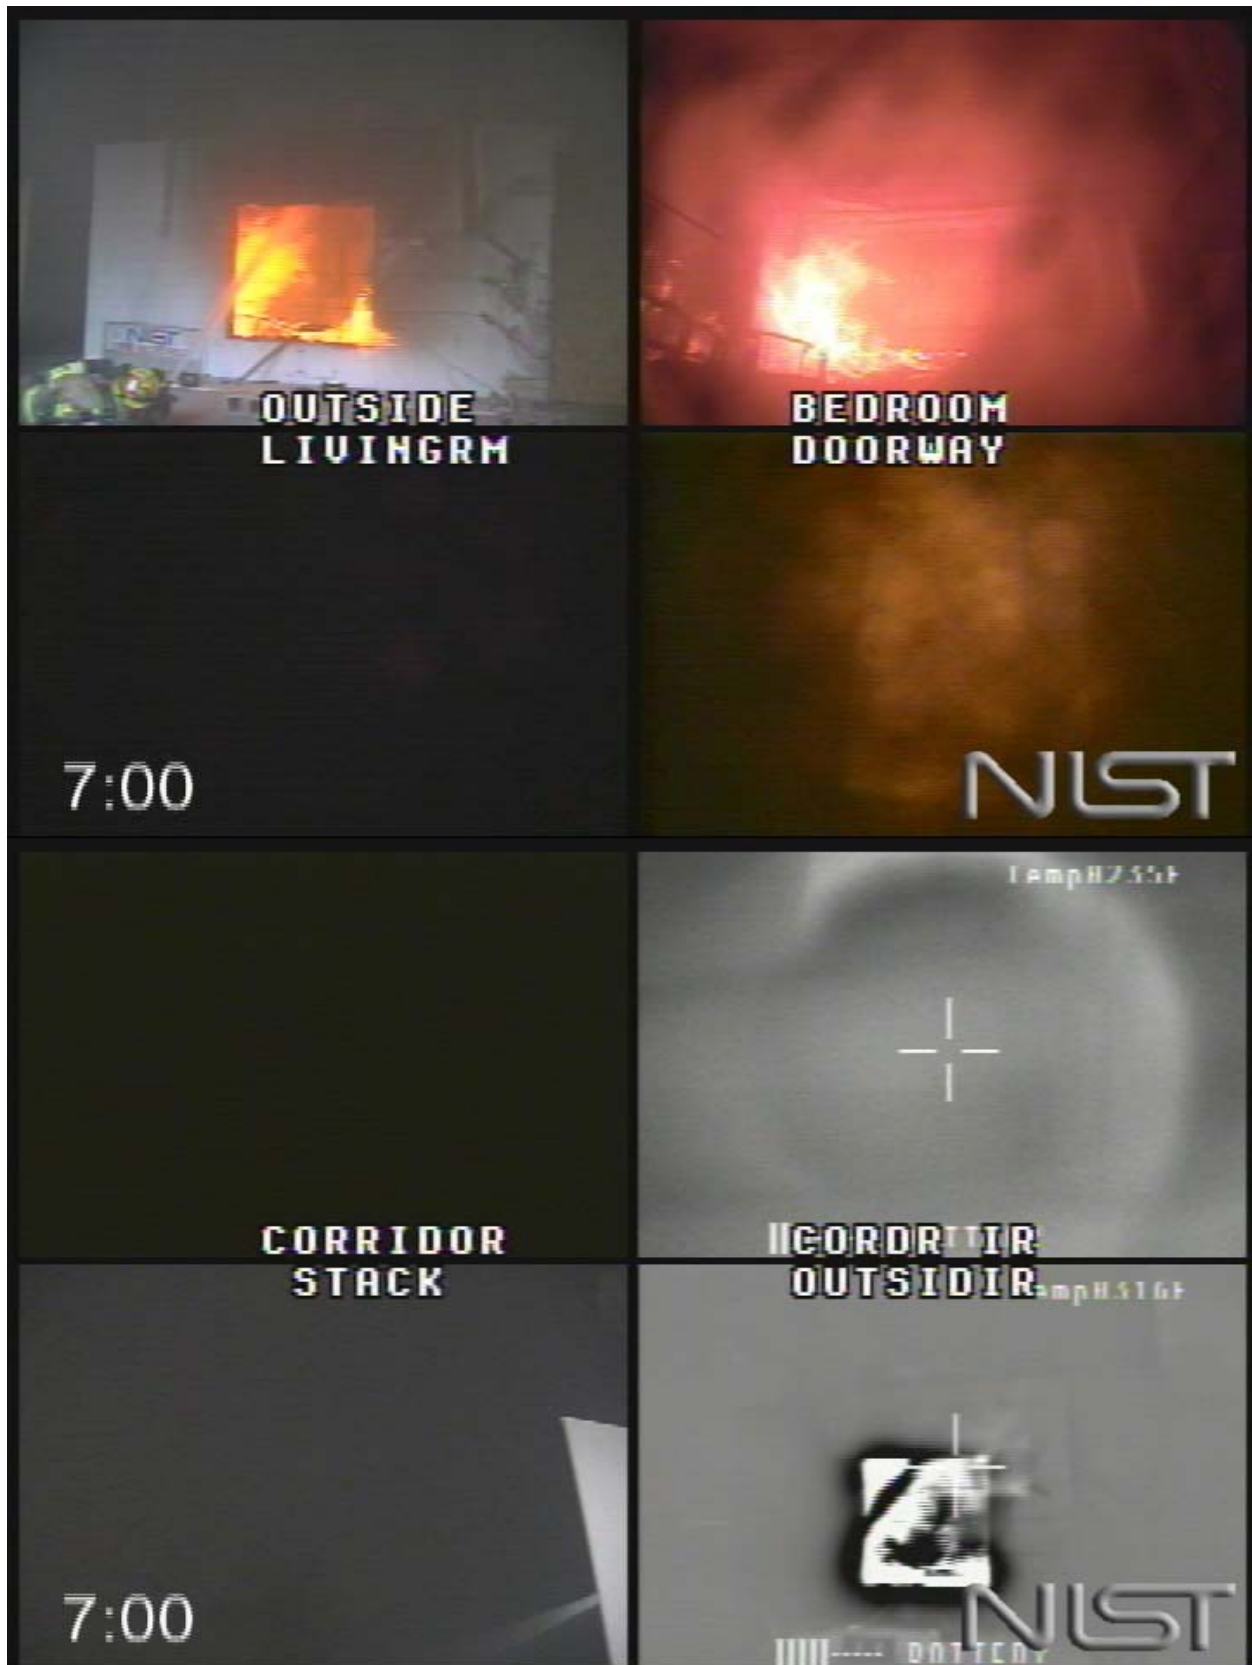
Figure 5.8.1-12. Experiment 8, 420 s after ignition.

The images in Figure 5.8.1-12 were recorded at 420 s after ignition. Visibility had returned to the bedroom and had begun to return to the living room. Indirect suppression was still ongoing.

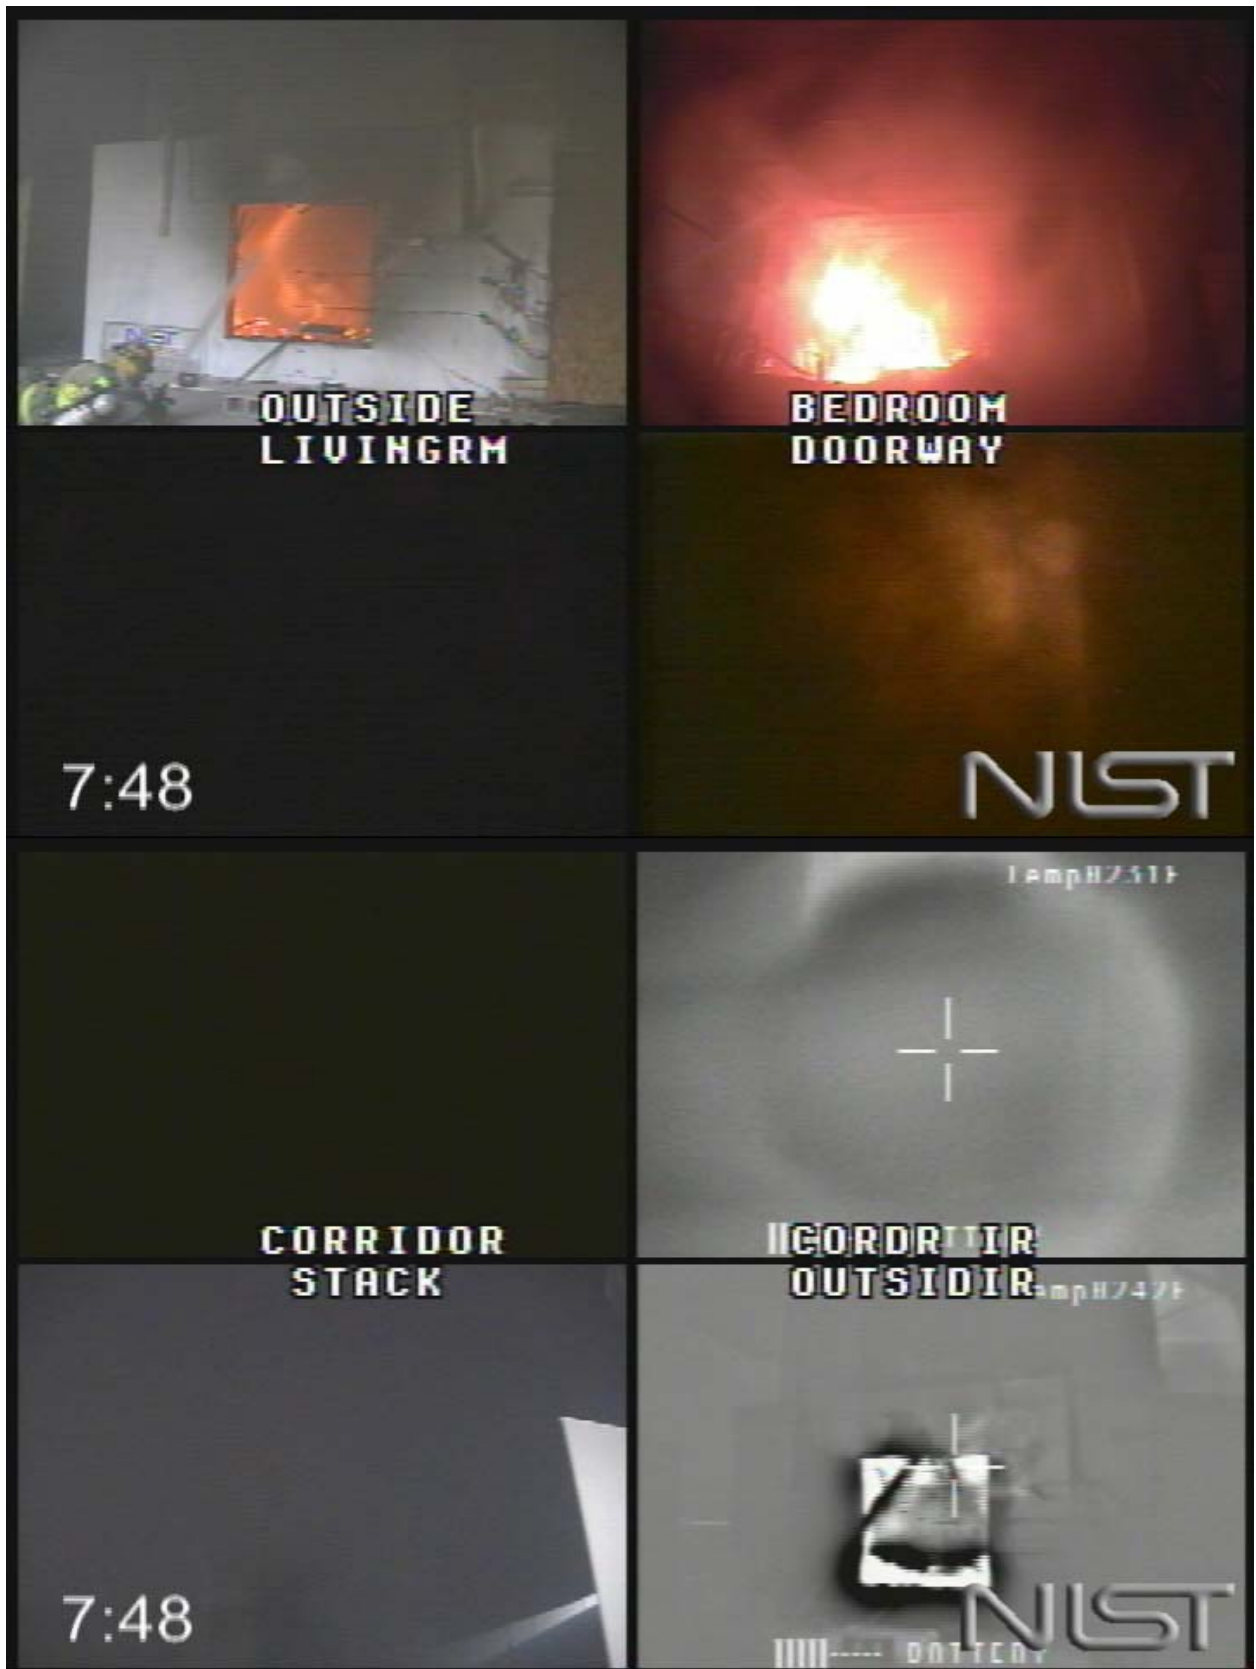
Figure 5.8.1-13. Experiment 8, indirect suppression stopped, 468 s after ignition.

The images in Figure 5.8.1-13 were recorded at 468 s after ignition. Within several seconds indirect suppression stopped and direct suppression began.
