LAKE PONTCHARTRAIN, LOUISIANA AND VICINITY

CHALMETTE AREA PLAN

BAYOU BIENVENUE  
CONTROL STRUCTURE

PERIODIC INSPECTION REPORT NO. 1

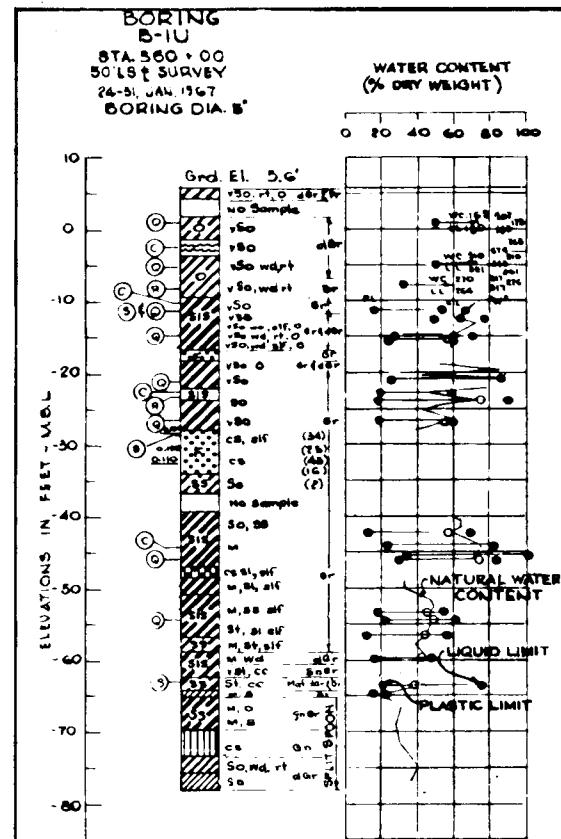
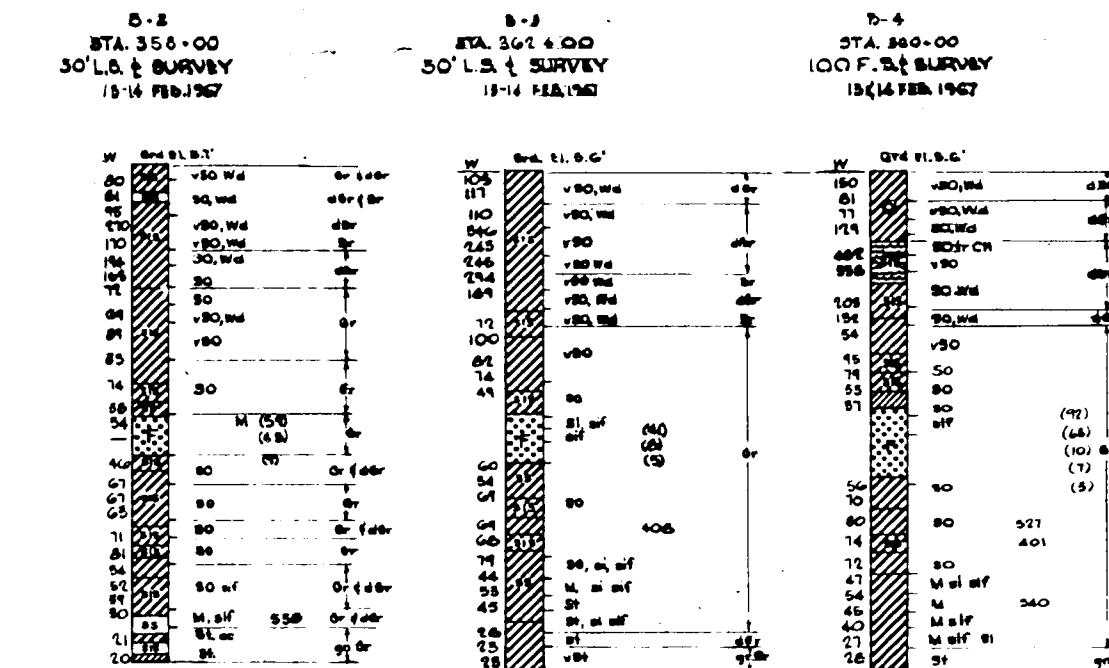
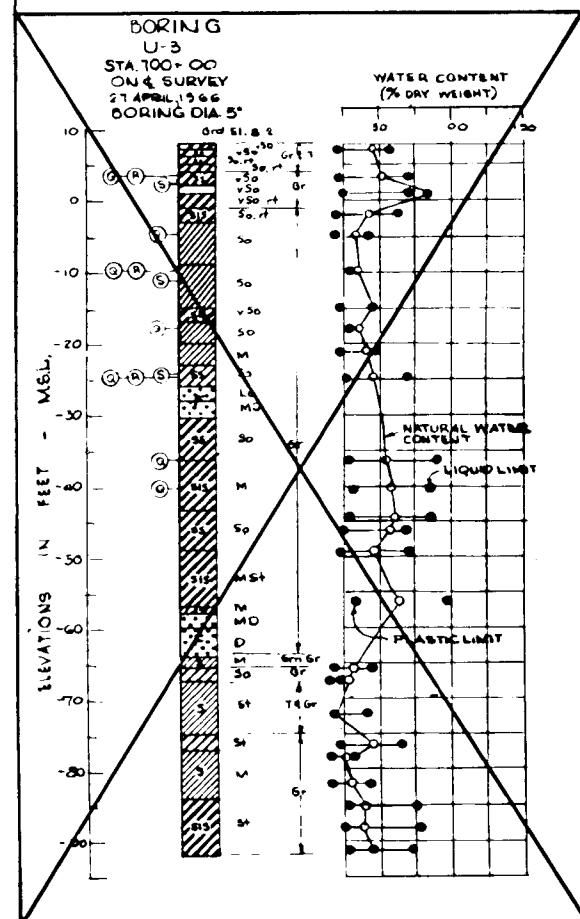
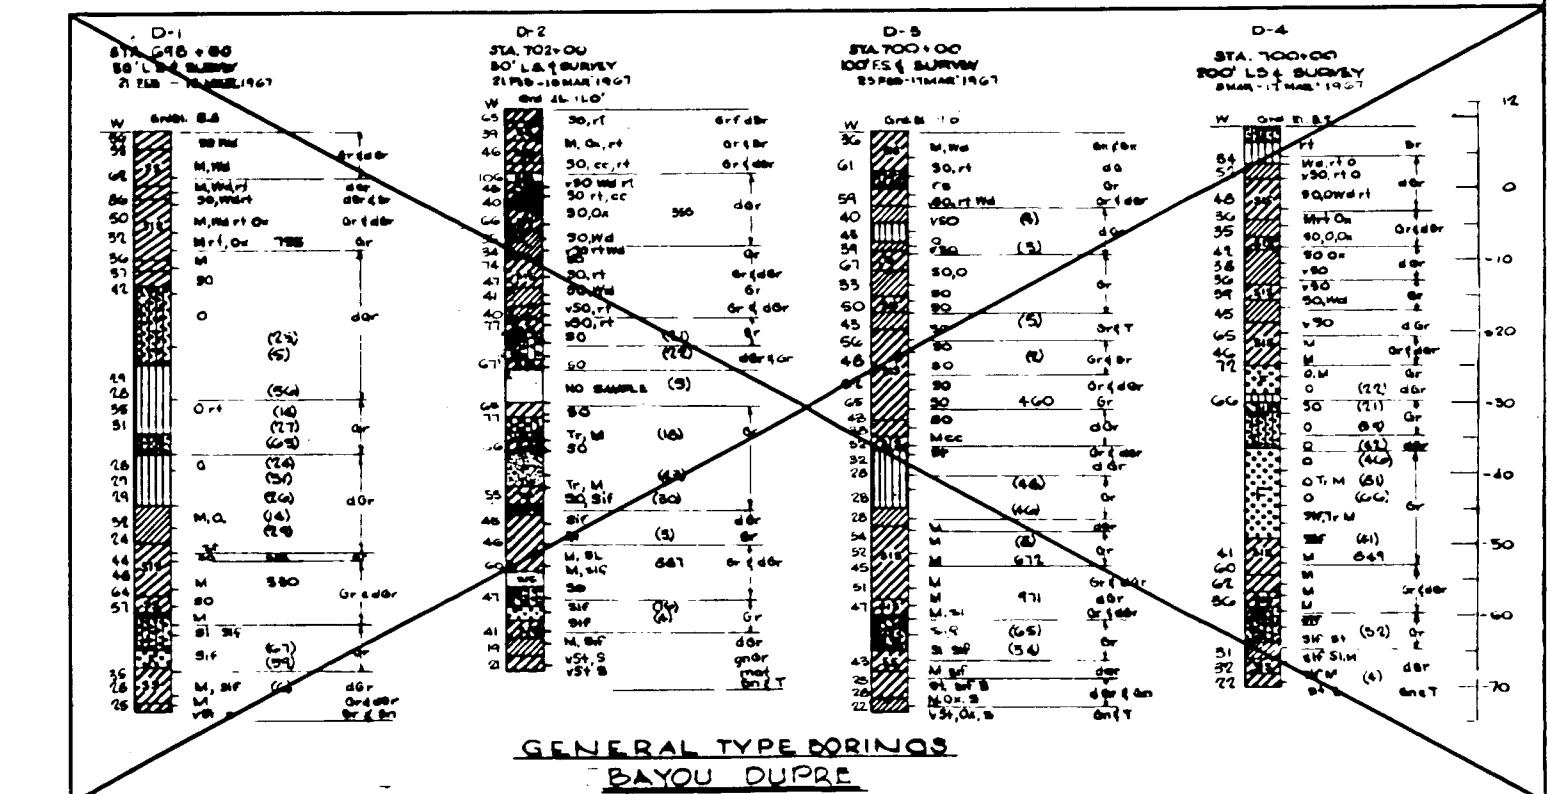
BAYOU BIENVENUE CONTROL STRUCTURE PLATE II-4

GENERAL TYPE BORINGS  
BAYOU BIENVENUE

GENERAL TYPE BORINGS  
BAYOU DUPRE

NOTES:  
1-FOR LOCATION OF BORINGS SEE DWGS. NO. 2 & NO. 3.  
2-FOR SOIL BORING LEGEND SEE DWG. FILE NO.  
H-2-21800.  
3-GENERAL TYPE SOIL SAMPLES WERE TAKEN WITH  
A 1½" ID. CORE BARREL SAMPLER. COHESIONLESS  
SAMPLES WERE TAKEN WITH 1½" ID., 2" O.D.  
SPLIT SPOON SAMPLER USING A 143 LB.  
HAMMER WITH A 30" DROP.  
4-UNDISTURBED SOIL SAMPLES WERE TAKEN  
WITH A 5" ID. STEEL TUBE PISTON-TYPE SAMPLER.  
5.ELEVATIONS REFER TO M.S.L. DATUM.

LOG OF BORINGS

2-07 Subsurface Conditions. The subsurface soils in the vicinity of the Bayou Bienvenue control structure are indicated in the log of boring B-1U and shown on plate no. II-4. From existing ground at elevation 5.5 to elevation about -8.0, the soil is a very soft, dark gray and dark brown clay with peat, wood and fine rootlets, and has a water content which ranges up to 310 percent. From elevation -8.0 to elevation -28.0 the stratum consists of soft to very soft gray clay with silt pockets, sandy silt pockets and shell fragments having a water content between 50 and 80 percent. From elevation -28.0 to elevation -35.0, there

is a stratum of gray sand ranging from loose to dense. From elevation -35.0 to elevation -63.0 there is a soft to stiff gray clay with silt pockets and occasional small shell fragments. From elevation -63.0 (top of the Pleistocene) to elevation -78.0 (limit of boring), the soil consists of soft to medium gray clays, green clays with silt and sand lenses. See plates II-2 and II-4.

3-02 Soils and Foundation. a. Investigations. Design Memorandum No. 3, General Design, Chalmette Area Plan, contains a discussion of the geology of the general area and the subsurface exploration and laboratory test data for the general area. In addition, four 1 7/8-inch I.D. general type borings were made by the Corps of Engineers at each structure \*location and the logs are shown on plate III-4. At Bayou Bienvenue one 5-inch\* I.D. undisturbed boring designated as B IU was made by the Corps of Engineers \*and the results of the (Q), (R), and (S) tests are shown on plate III-1.\* Location and the log of the boring are shown on plates II-2 and II-4.

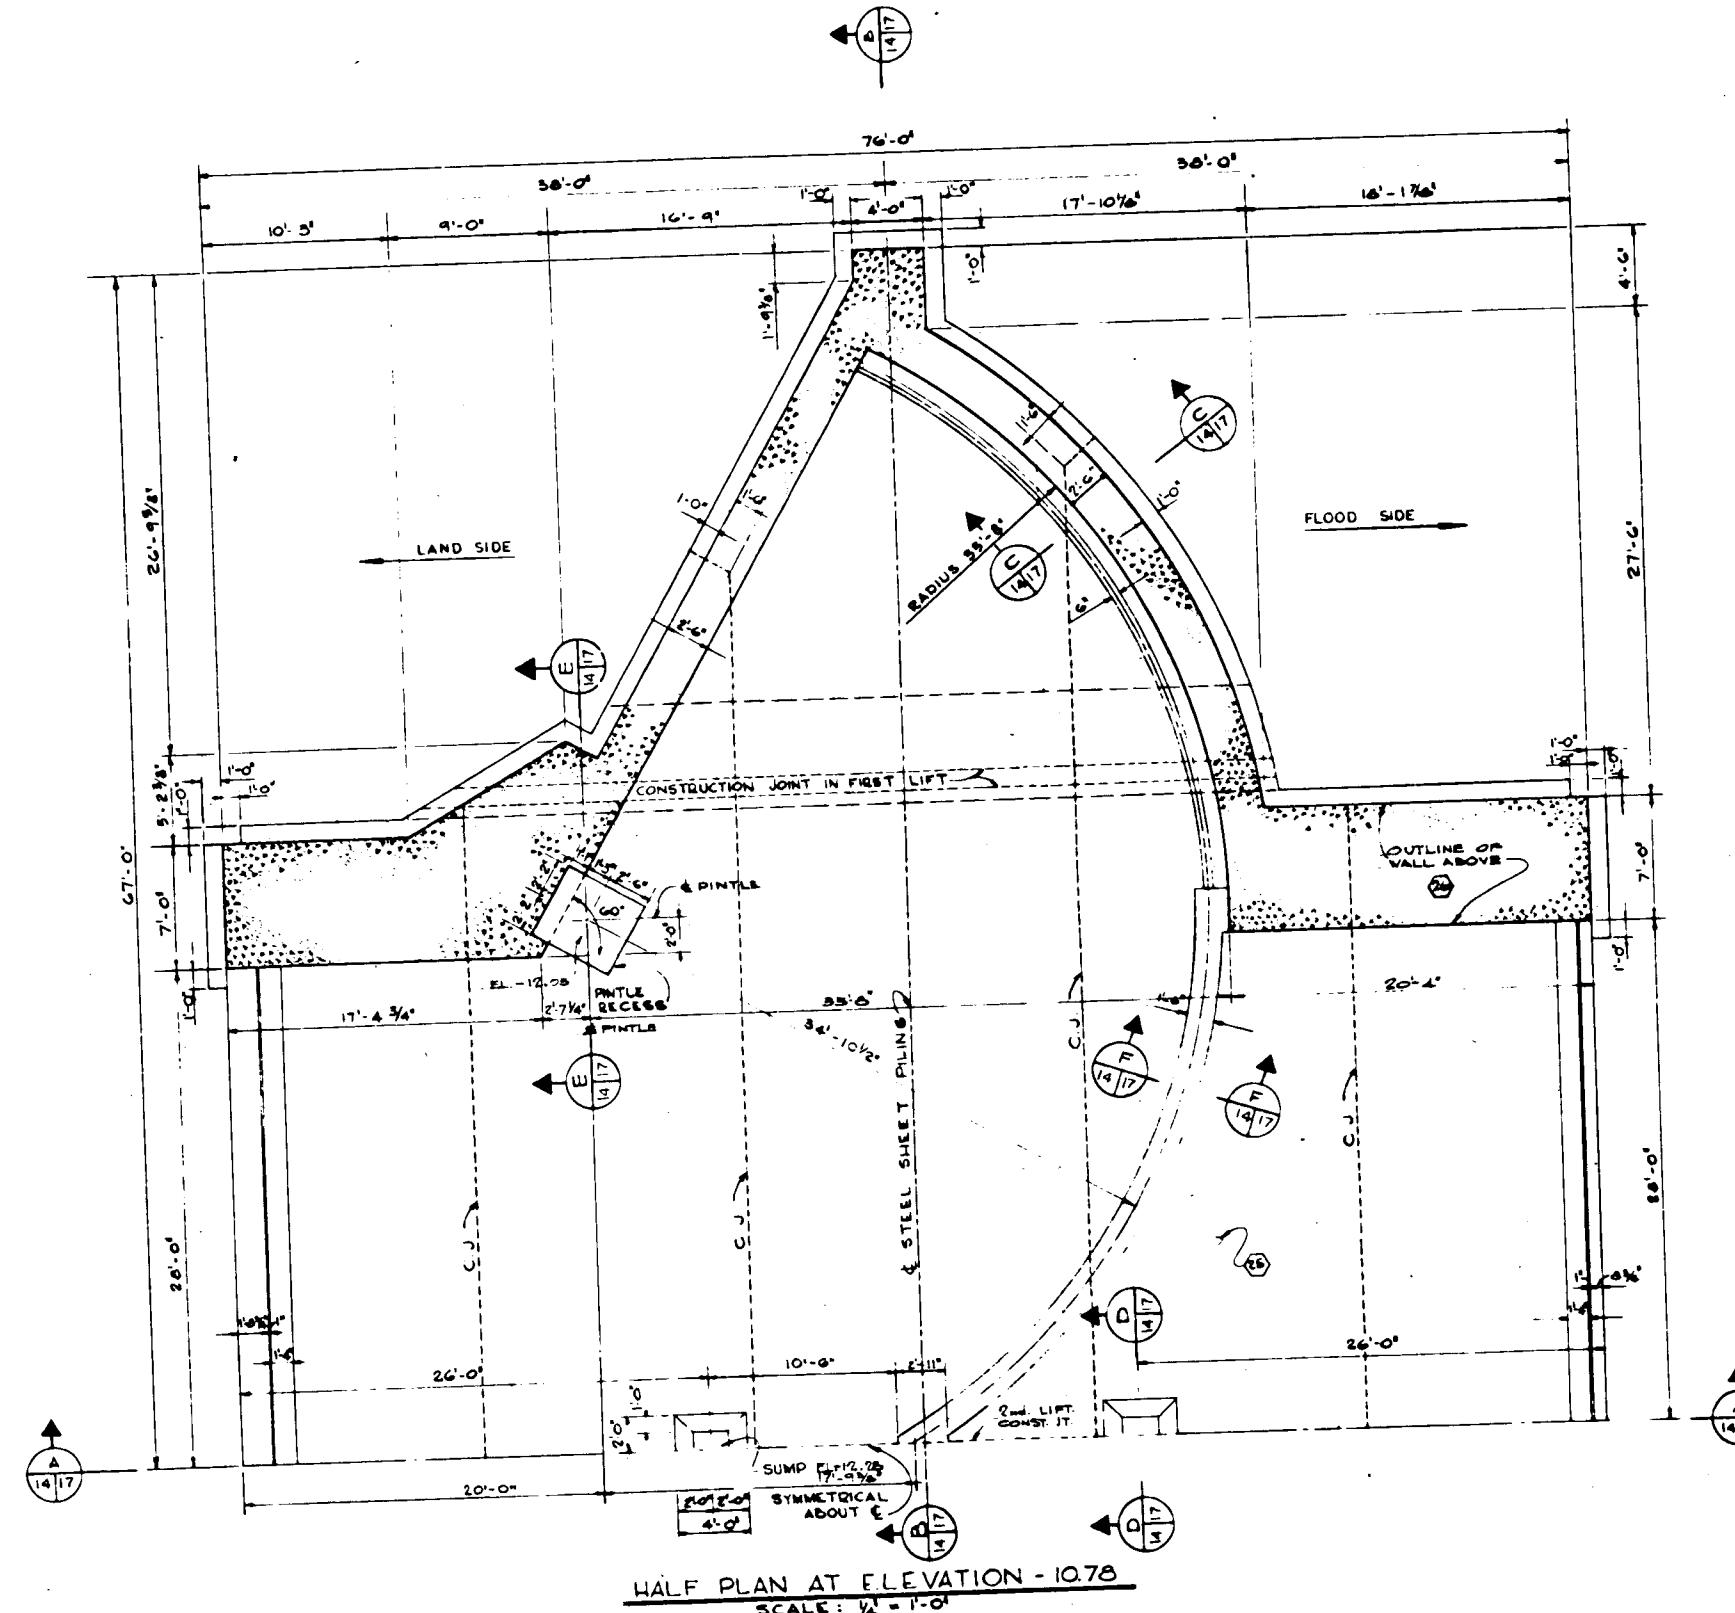
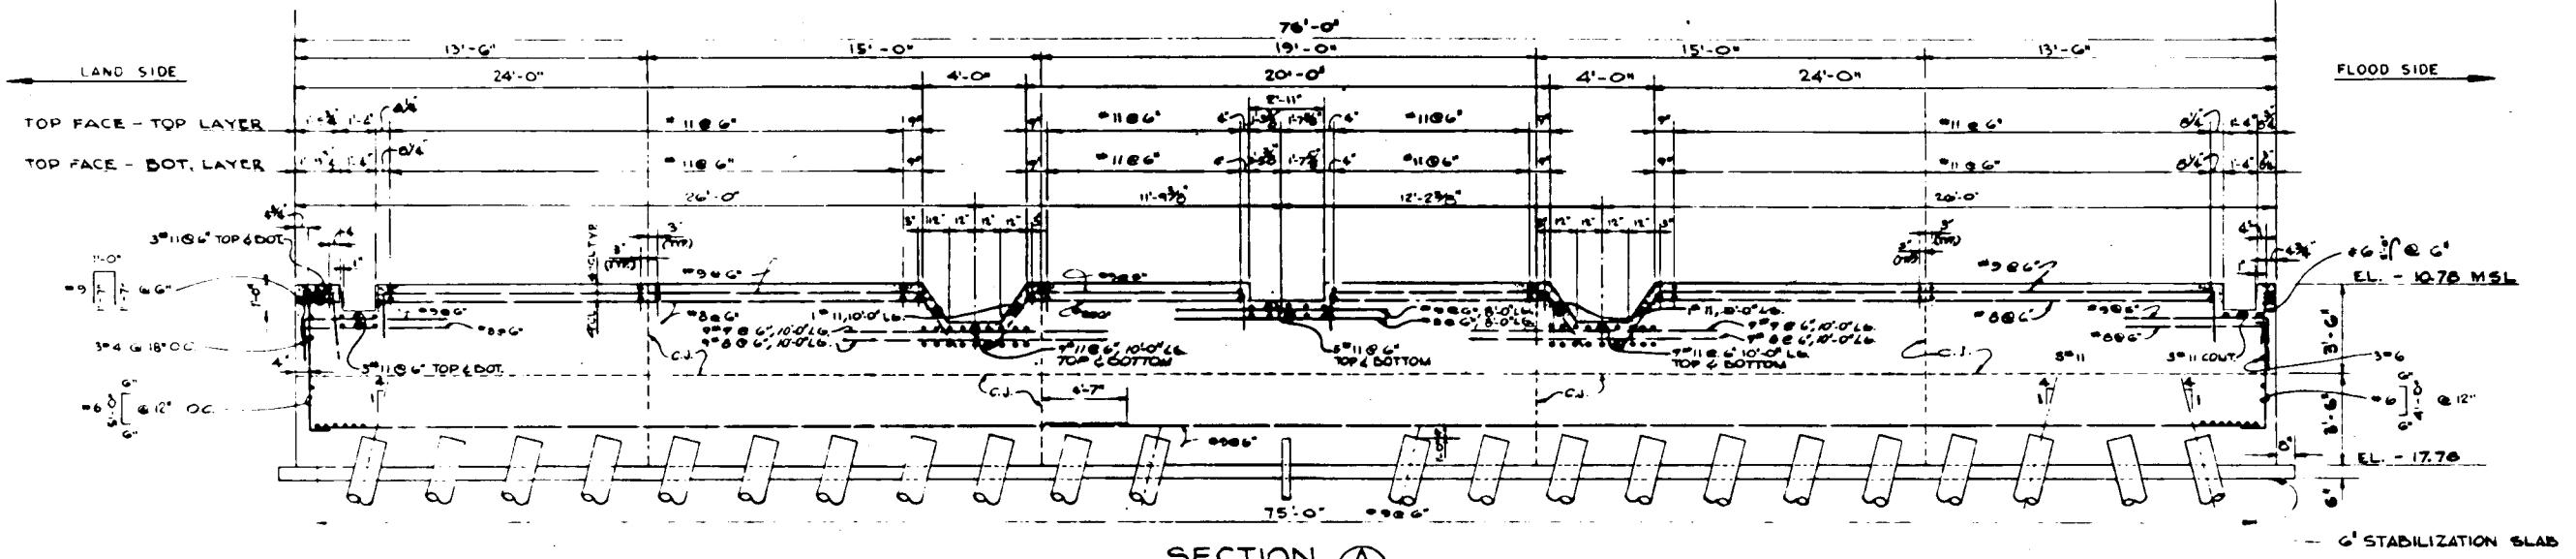
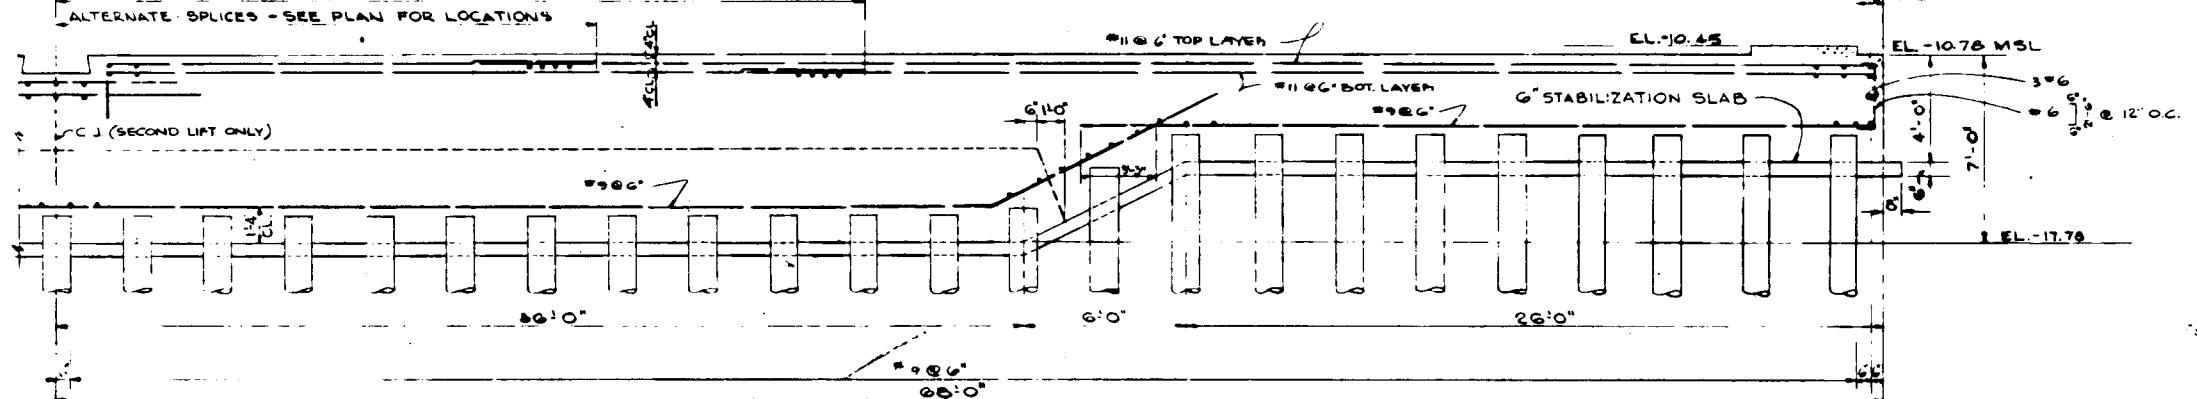
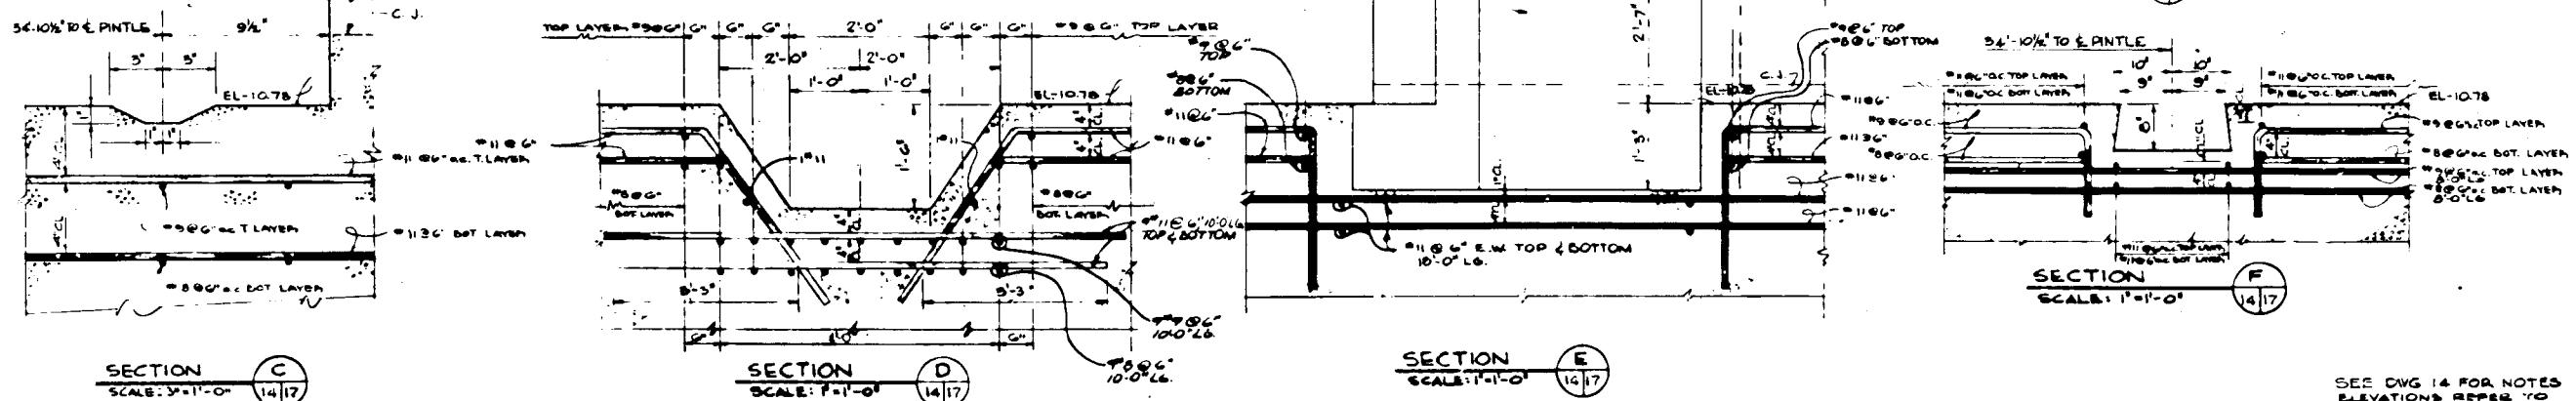
TOP FACE - TOP LAYER  
TOP FACE - BOT. LAYER

SYMMETRICAL ABOUT G

ALTERNATE SPLICES - SEE PLAN FOR LOCATIONS  
ALTERNATE SPLICES - SEE PLAN FOR LOCATIONS

SECTION B

SECTION C

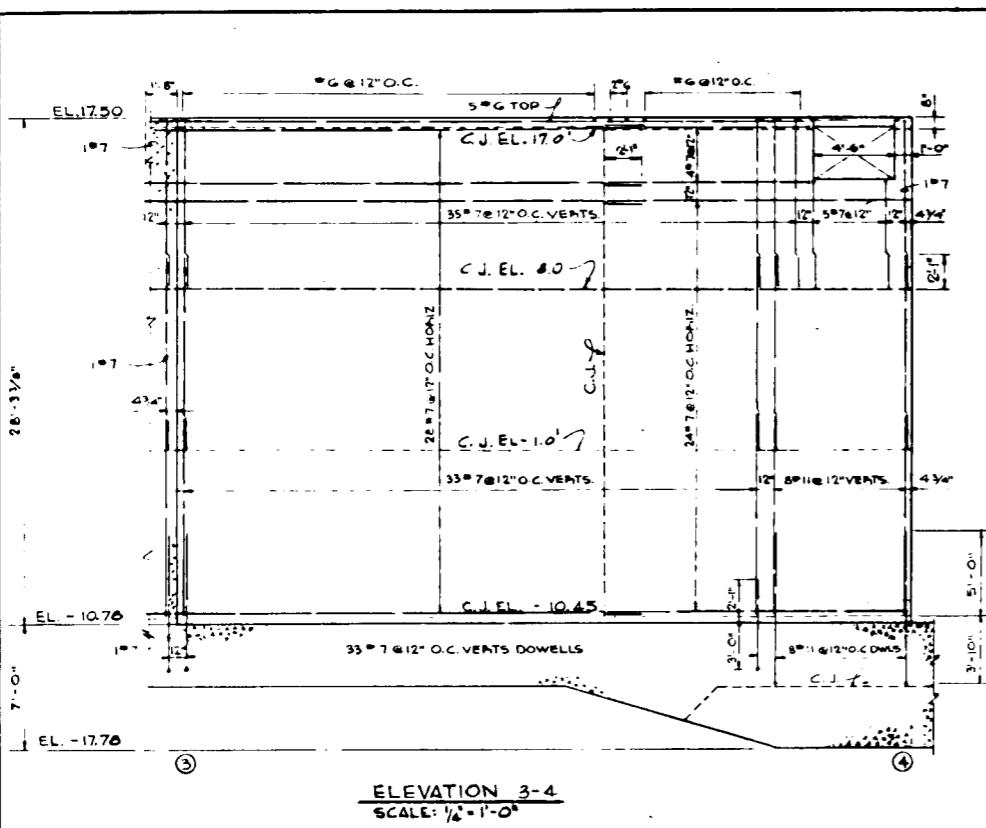
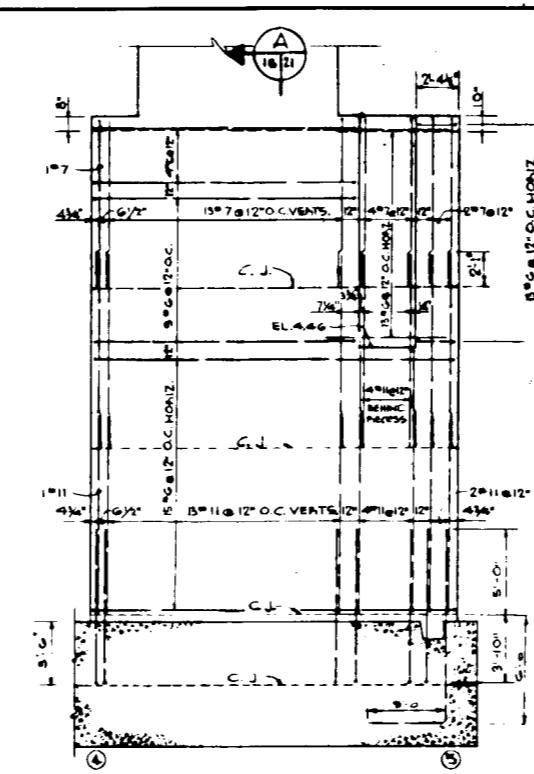
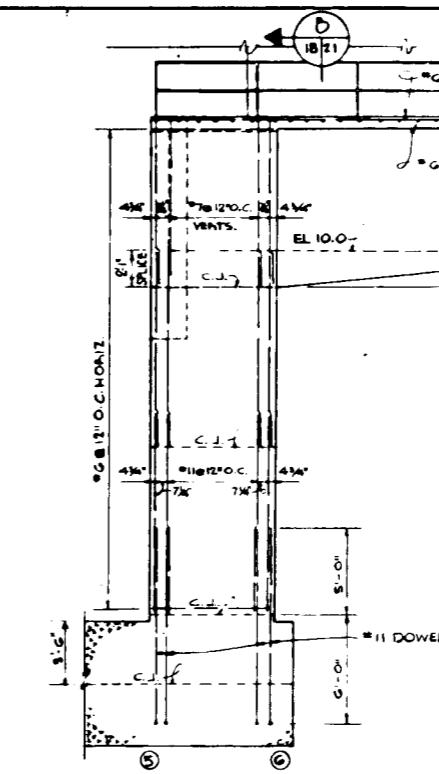
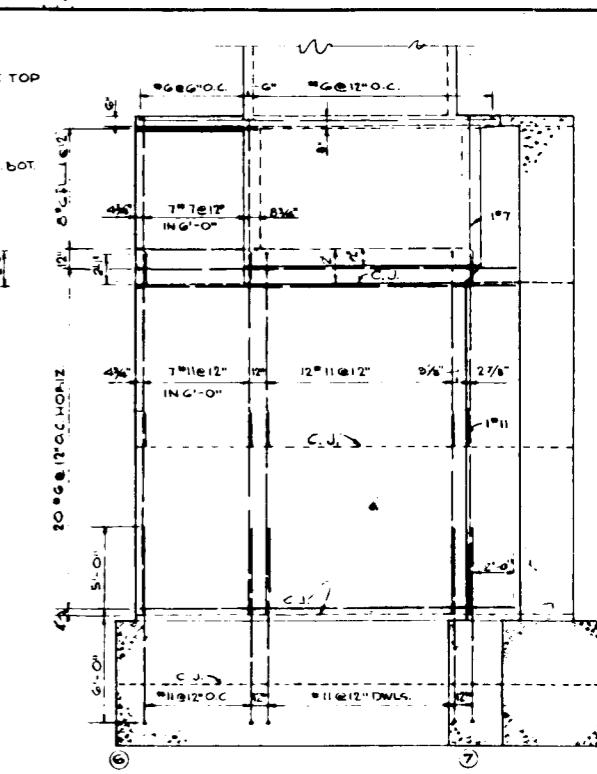
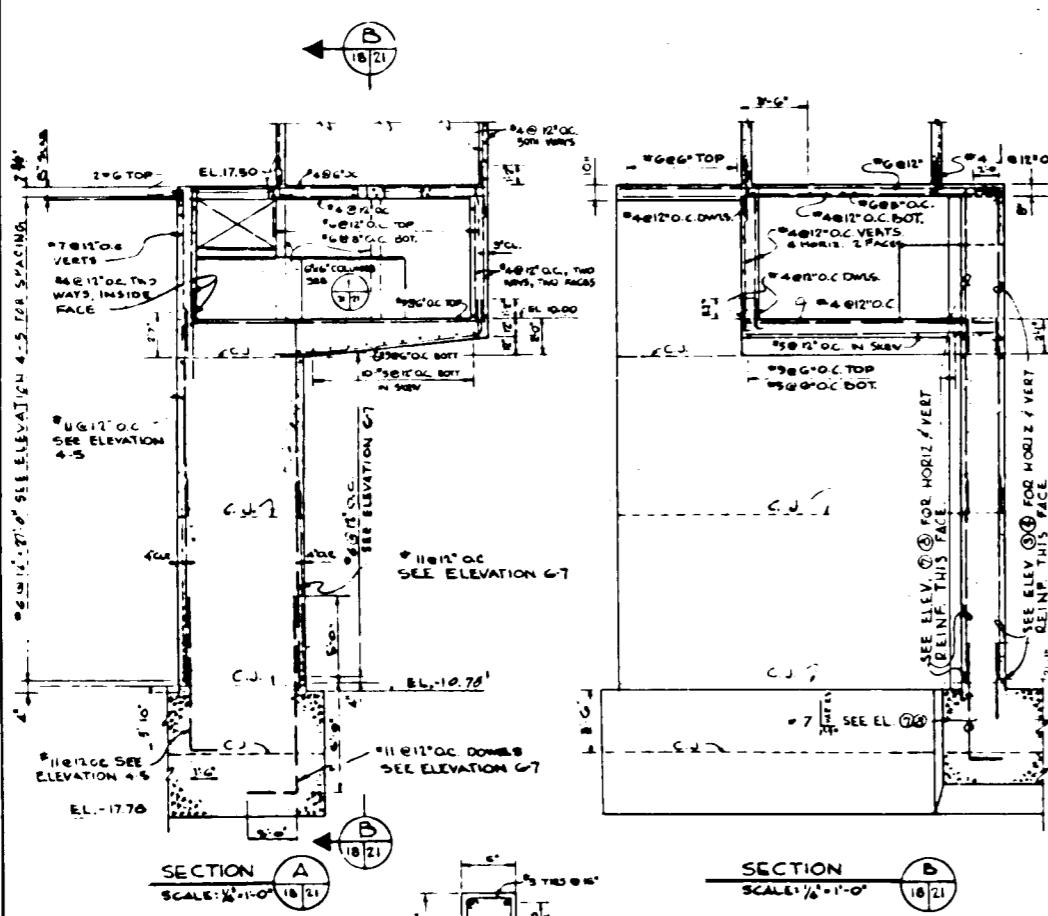
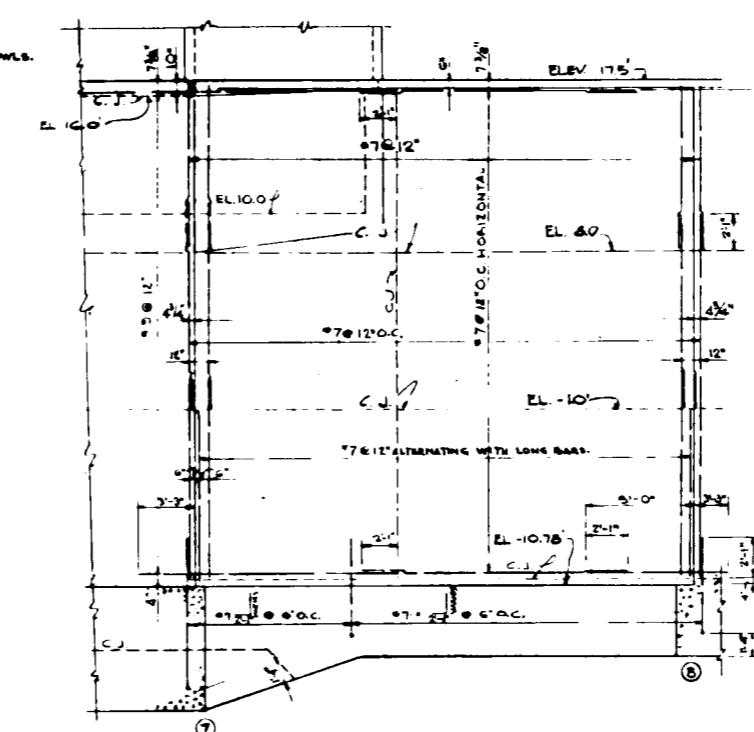
BAYOU BIENVENUE CONTROL STRUCTURE PLATE II-13

GATE BAY WALL - ELEVATIONS AND SECTIONS

c. Gate bay. The gate bay was designed as a reinforced concrete "U" frame, 76 feet in length with a channel clearance of 56 feet as shown in plates II-8 thru II-14. The top of the gates, the gate bay walls and the inverted "tee" floodwalls are at elevation 17.5 and the sill is at -10.78 feet. The "I" floodwalls will be driven after the final levee lift is placed and the levee settlement has stabilized. Slots for the needle girder and needles have been provided so that the gate bay can be dewatered for repair or painting of the gates. At the ends of the gate bay there are concrete sheet pile wingwalls installed with tie backs to retain the adjacent backfill. See plate II-21. Two small control houses constructed of reinforced concrete are located above the machinery space on each side of the gate bay. Control House No. 1 contains the engine driven generator and the electrical switch gear. Both control houses contain the machinery for manual operation and control panels to start the generator and to operate the gate electrically from either side. Each leaf may be manually operated from its respective control house. See plates II-15 and II-16.

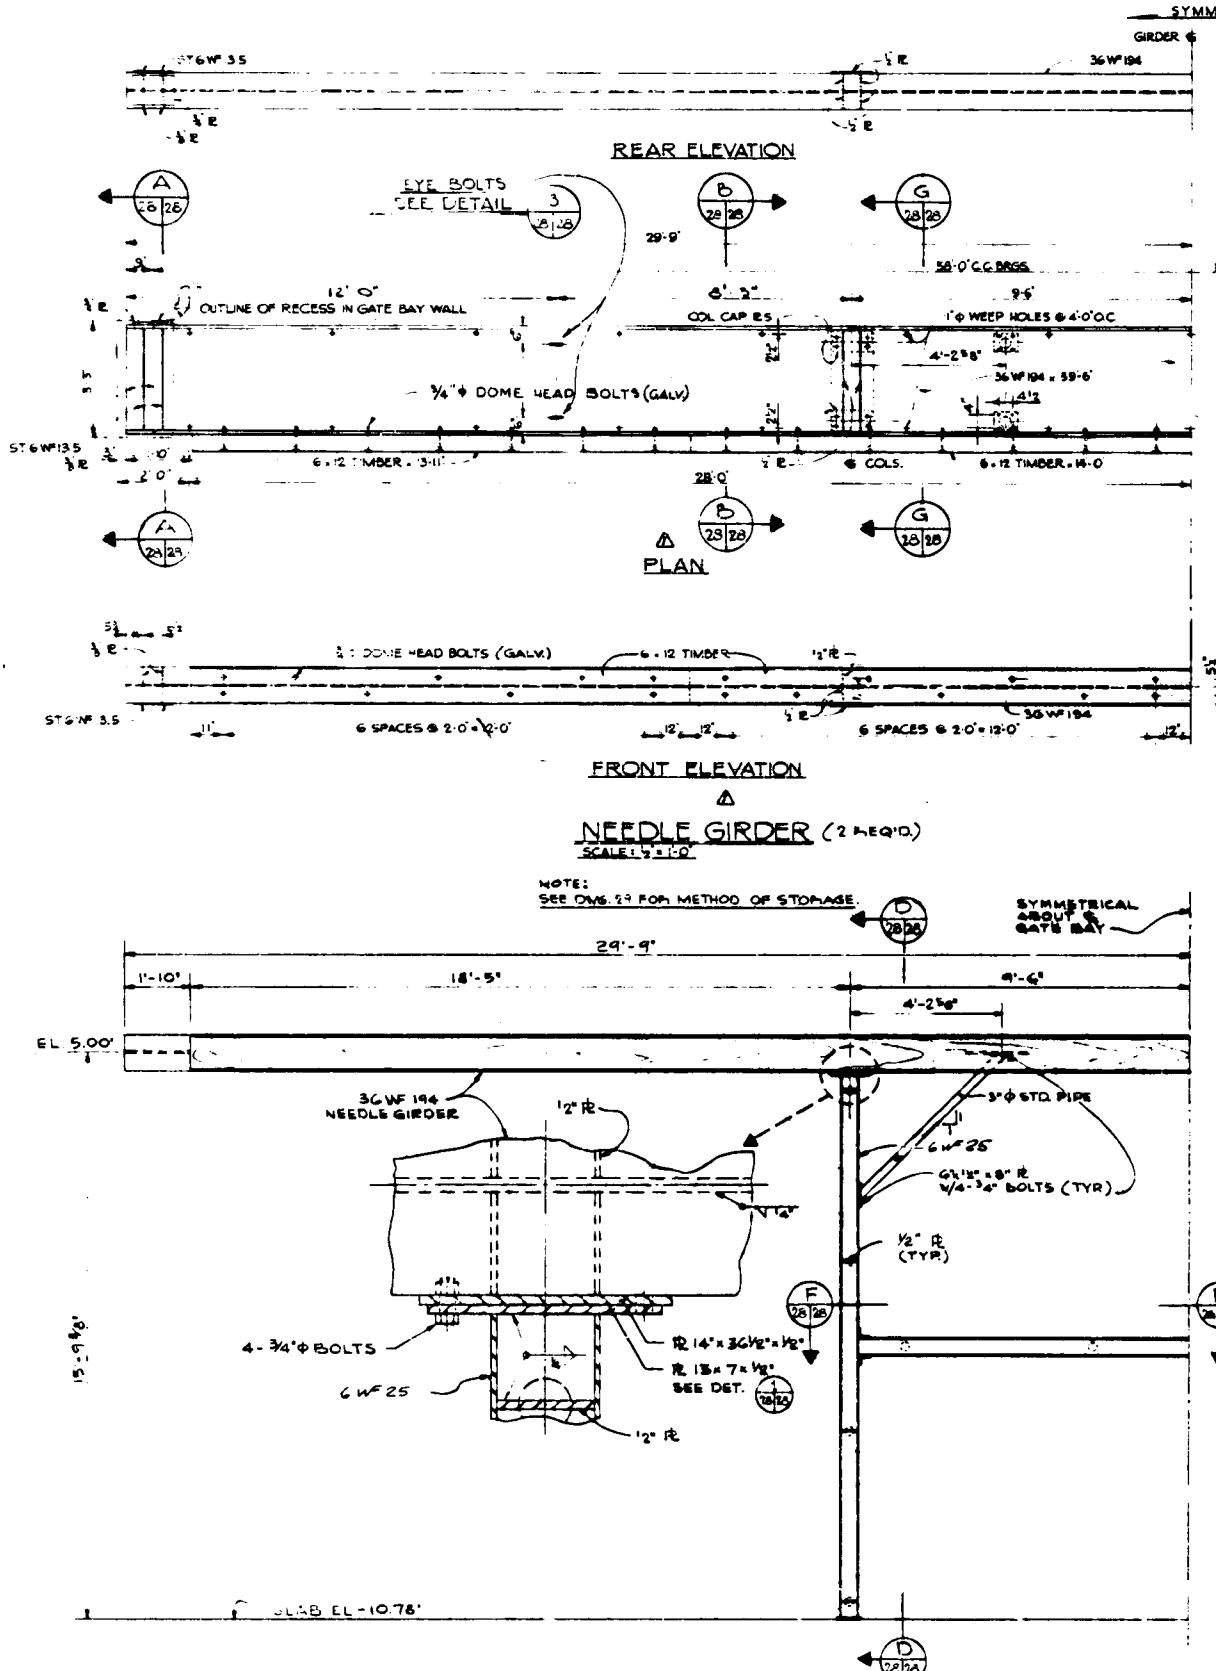
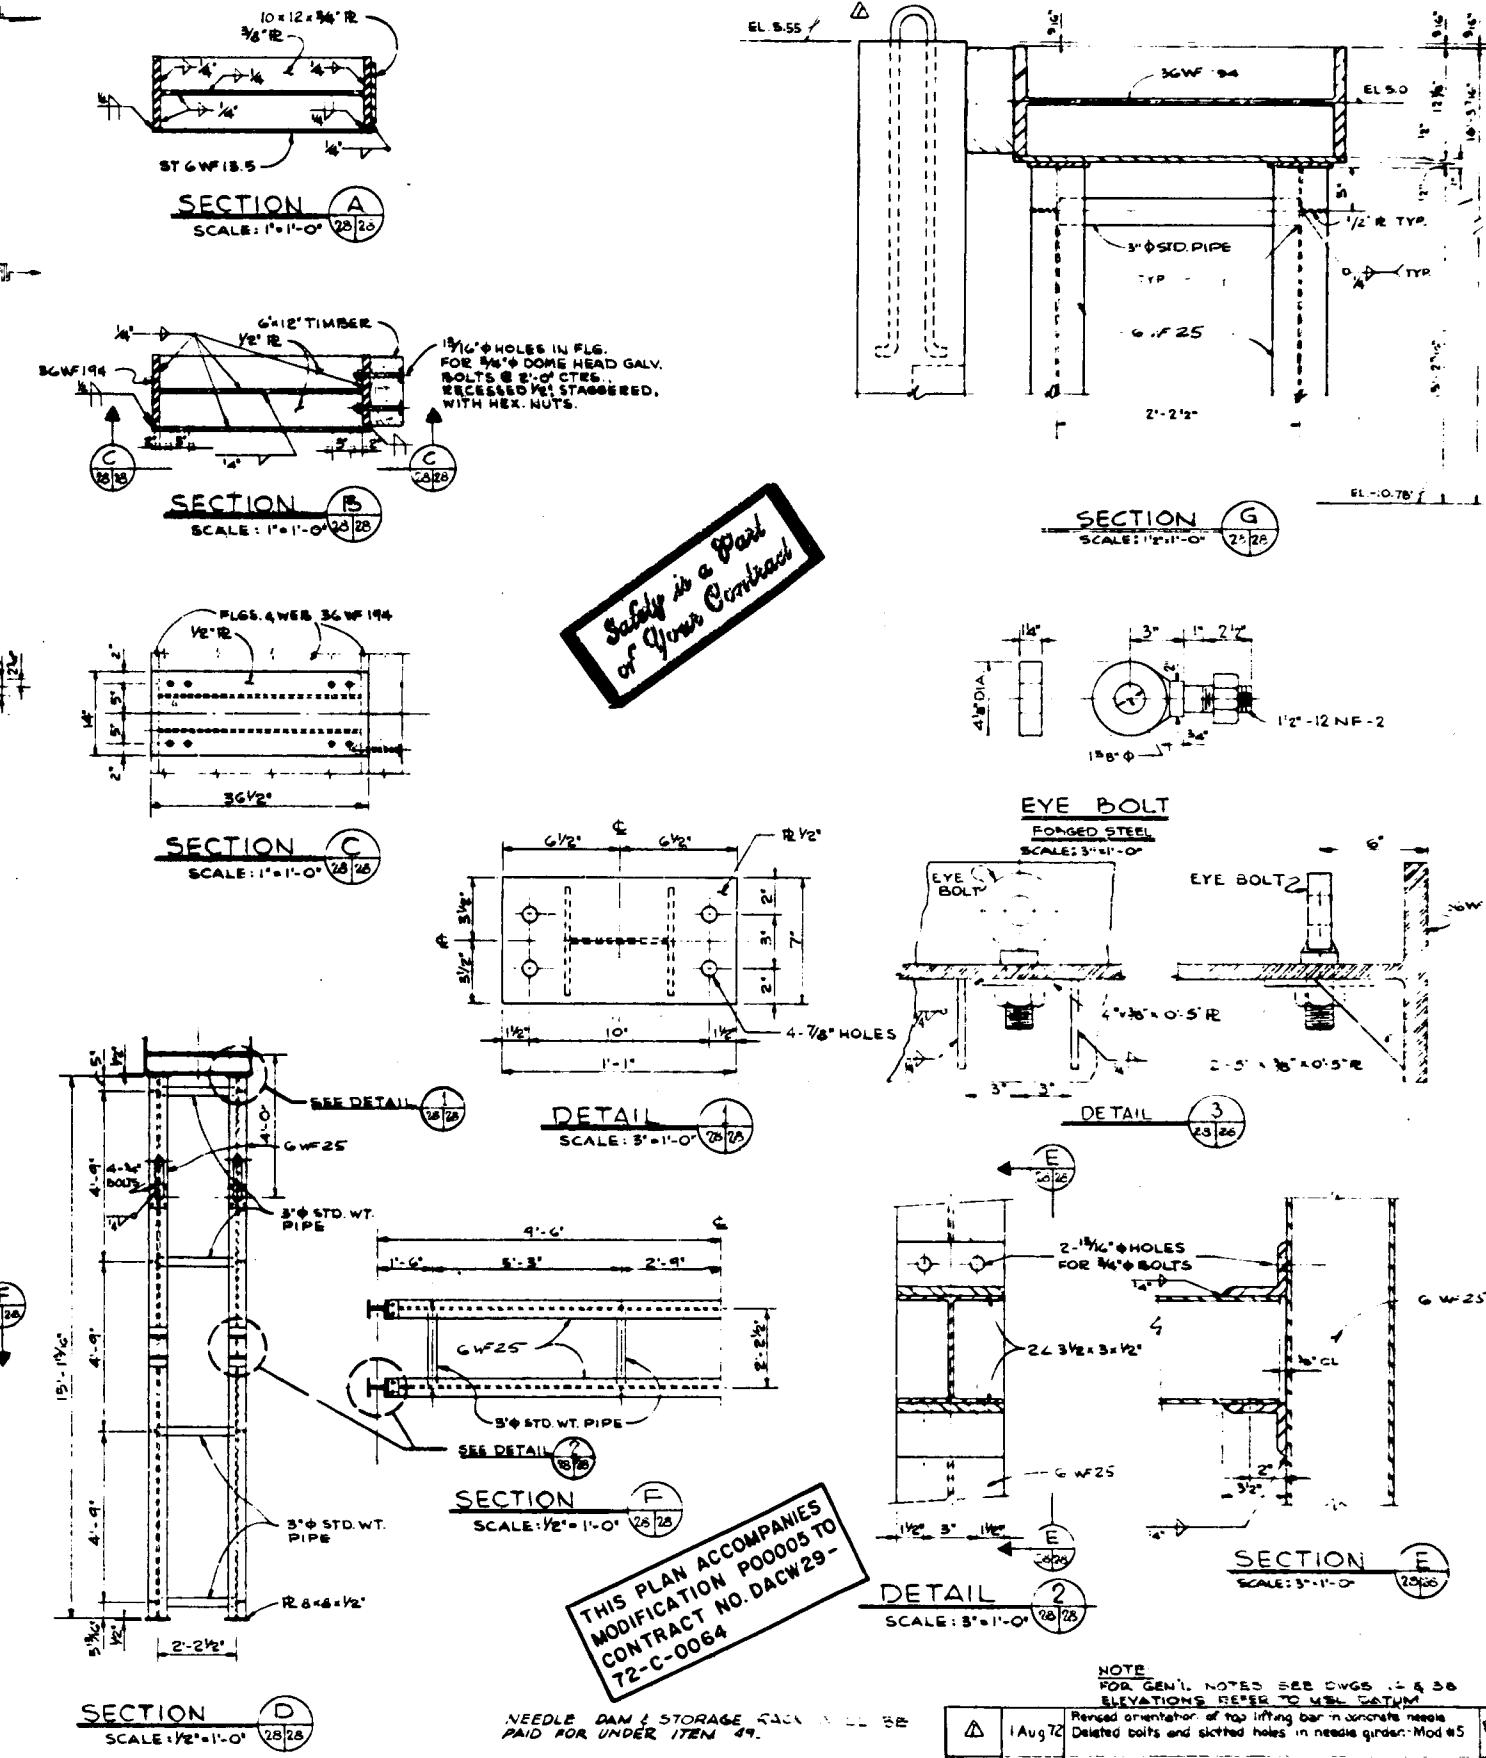
NEEDLE DAM & STORAGE RACK A-22-3B  
PAID FOR UNDER ITEM 49.

NEEDLE GIRDER - PLAN AND DETAILS

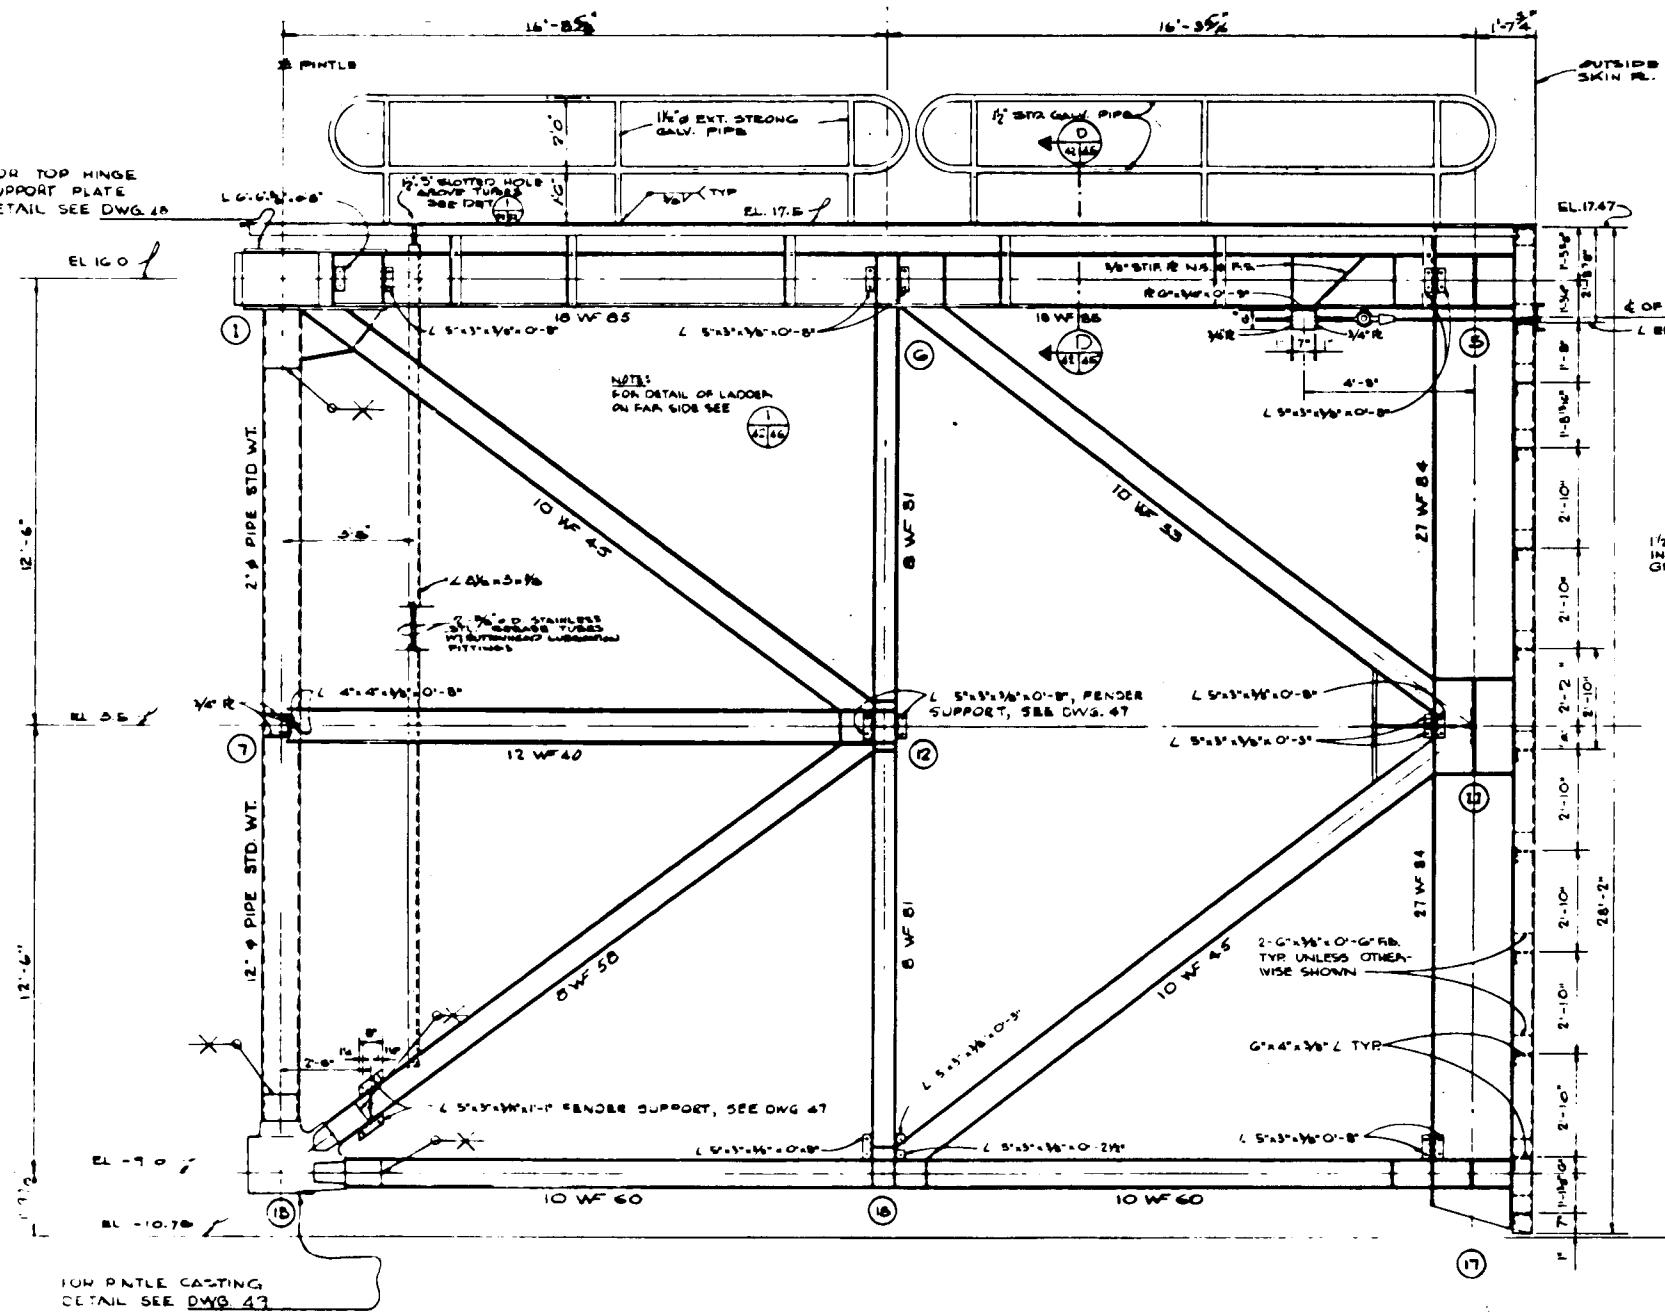
BAYOU BIENVENUE CONTROL STRUCTURE PLATE II-28

CHANNEL TRUSS ELEVATION

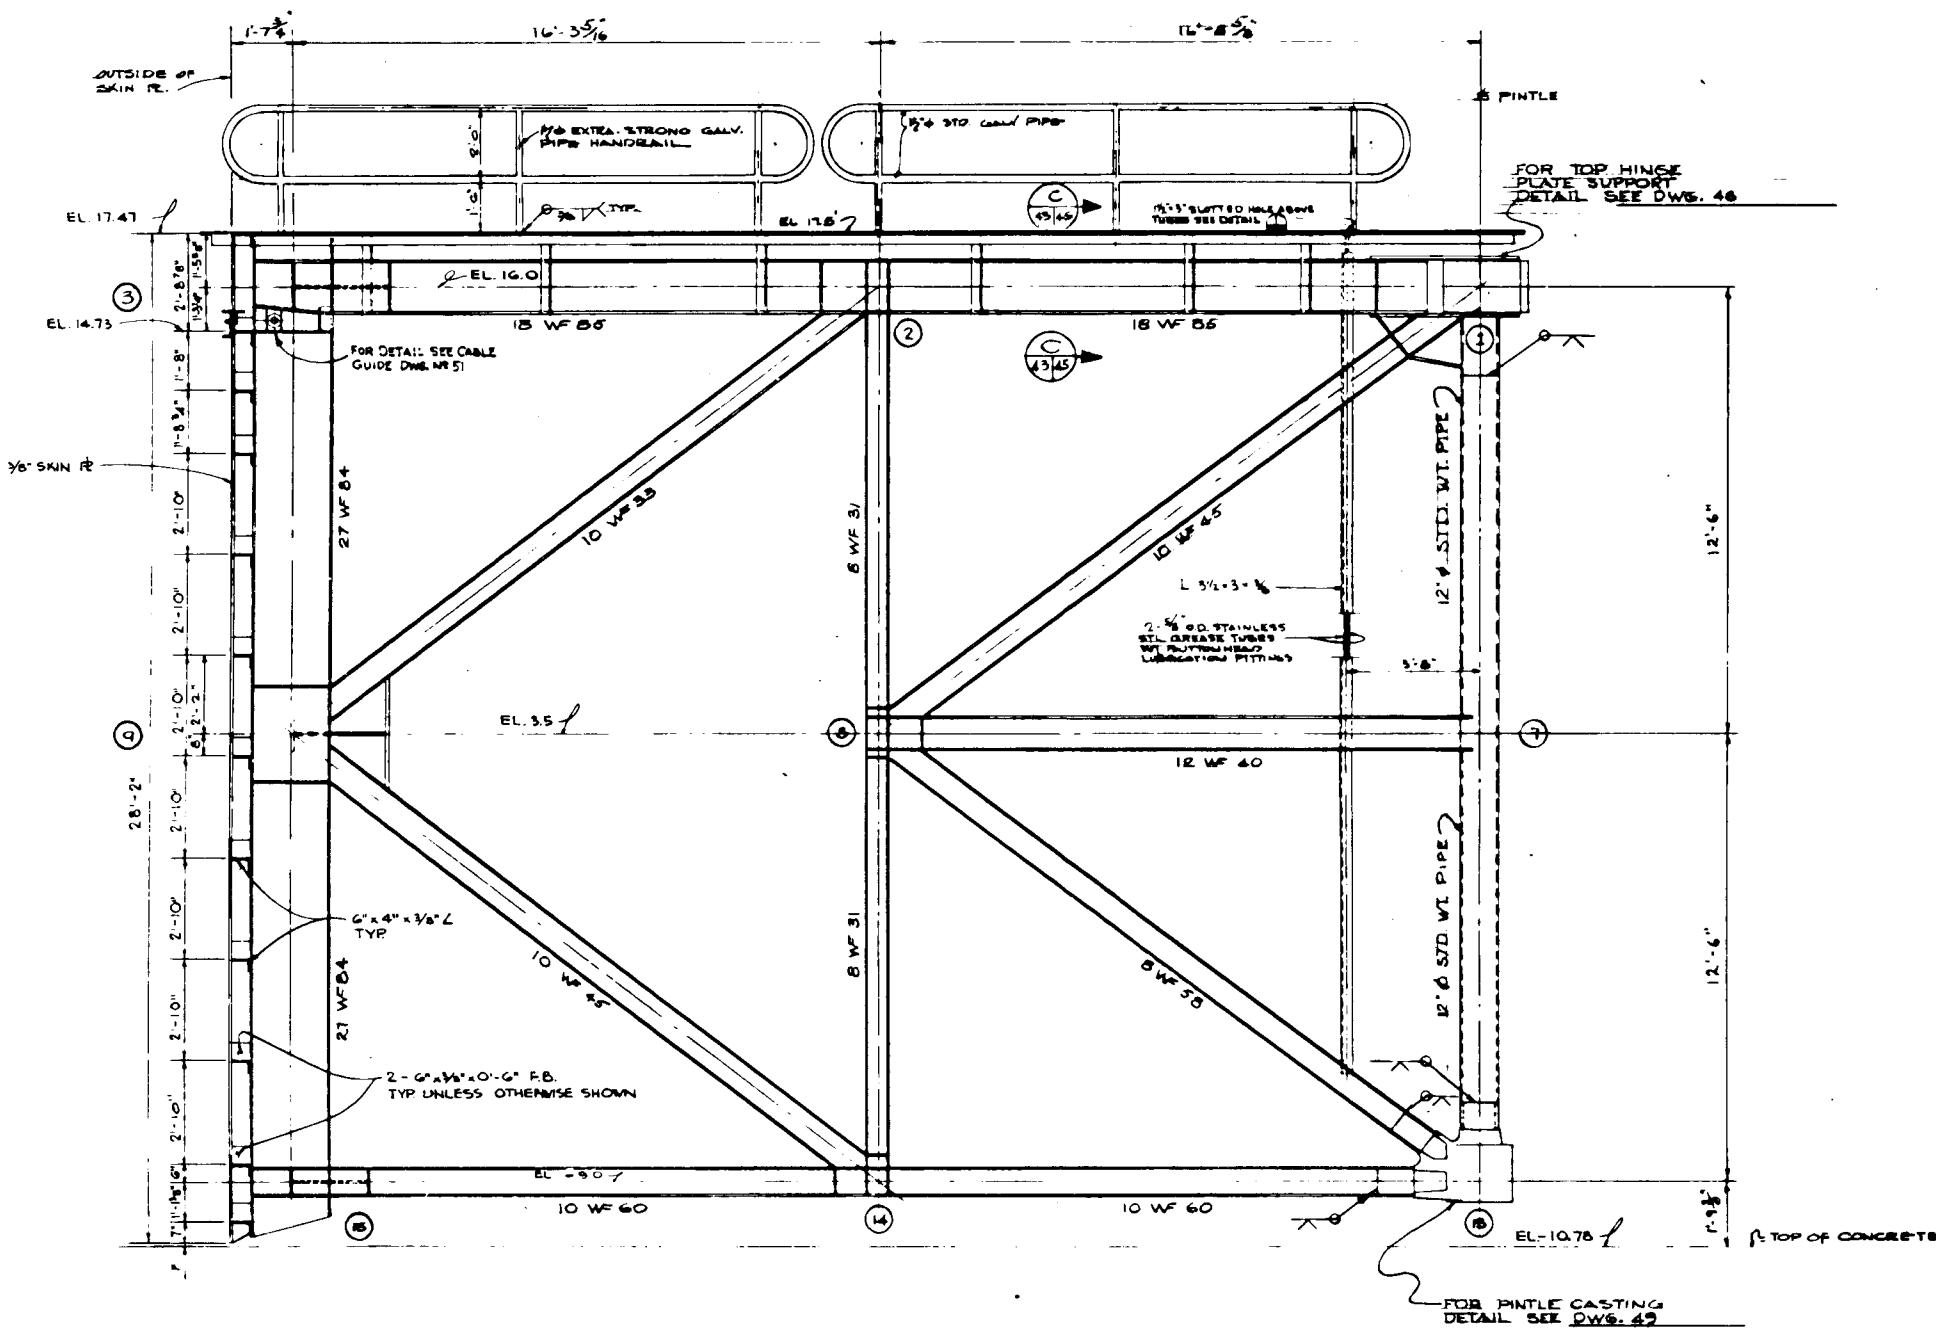
BAYOU BIENVENUE CONTROL STRUCTURE PLATE II-29  
ent. October, 1971 DWG. NO. DWG. N. 72-B-008

RECESS TRUSS ELEVATION

SECTOR GATES - RECESS TRUSS
