LAKE PONTCHARTRAIN, LOUISIANA AND VICINITY

CHALMETTE AREA PLAN

BAYOU BIENVENUE  
CONTROL STRUCTURE

PERIODIC INSPECTION REPORT NO. 1

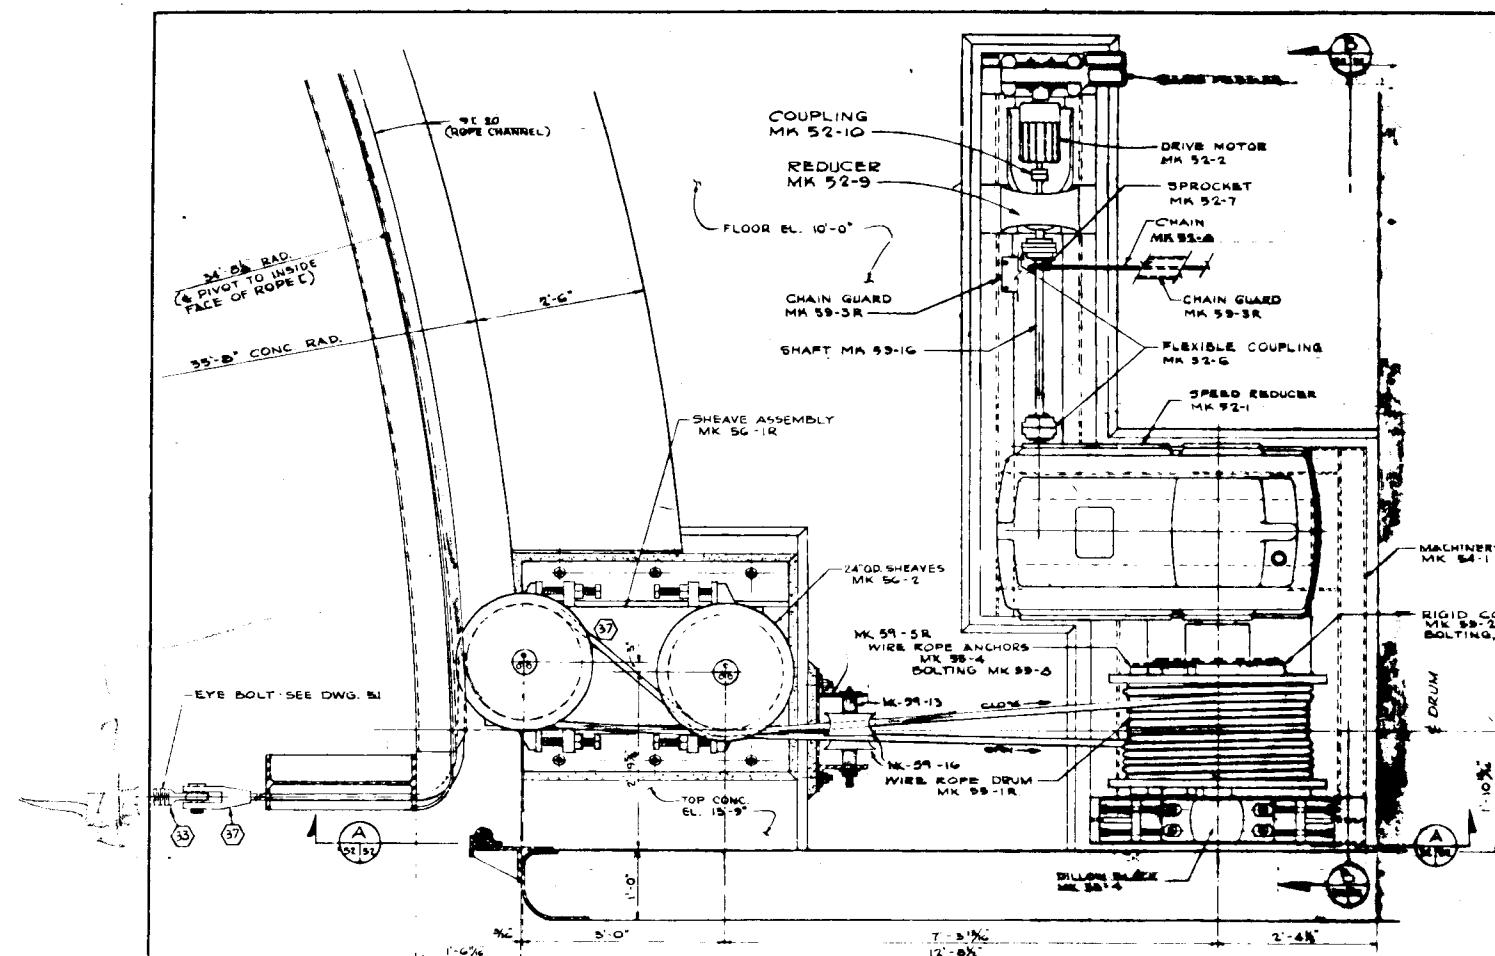
**PLAN**  
(GATE IN OPEN POSITION)  
SCALE 1'-0"

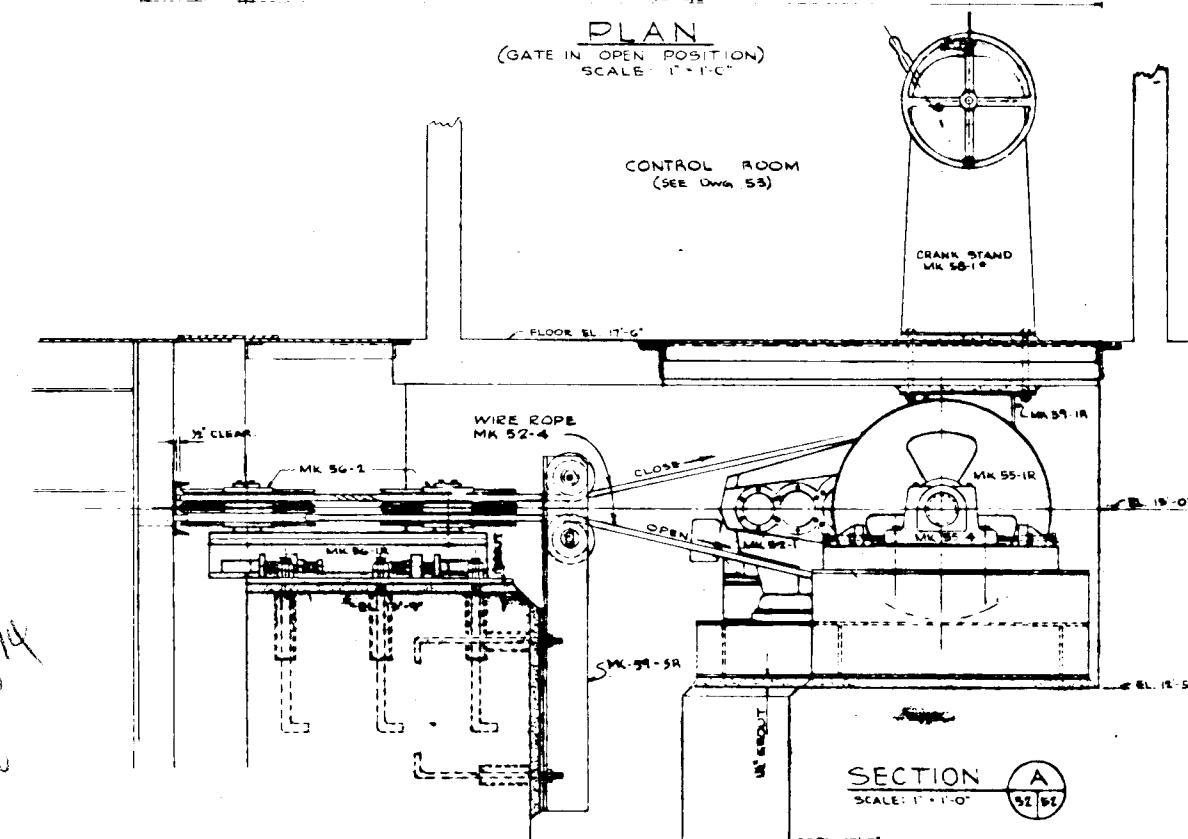
**SECTION A**  
SCALE 1'-0"

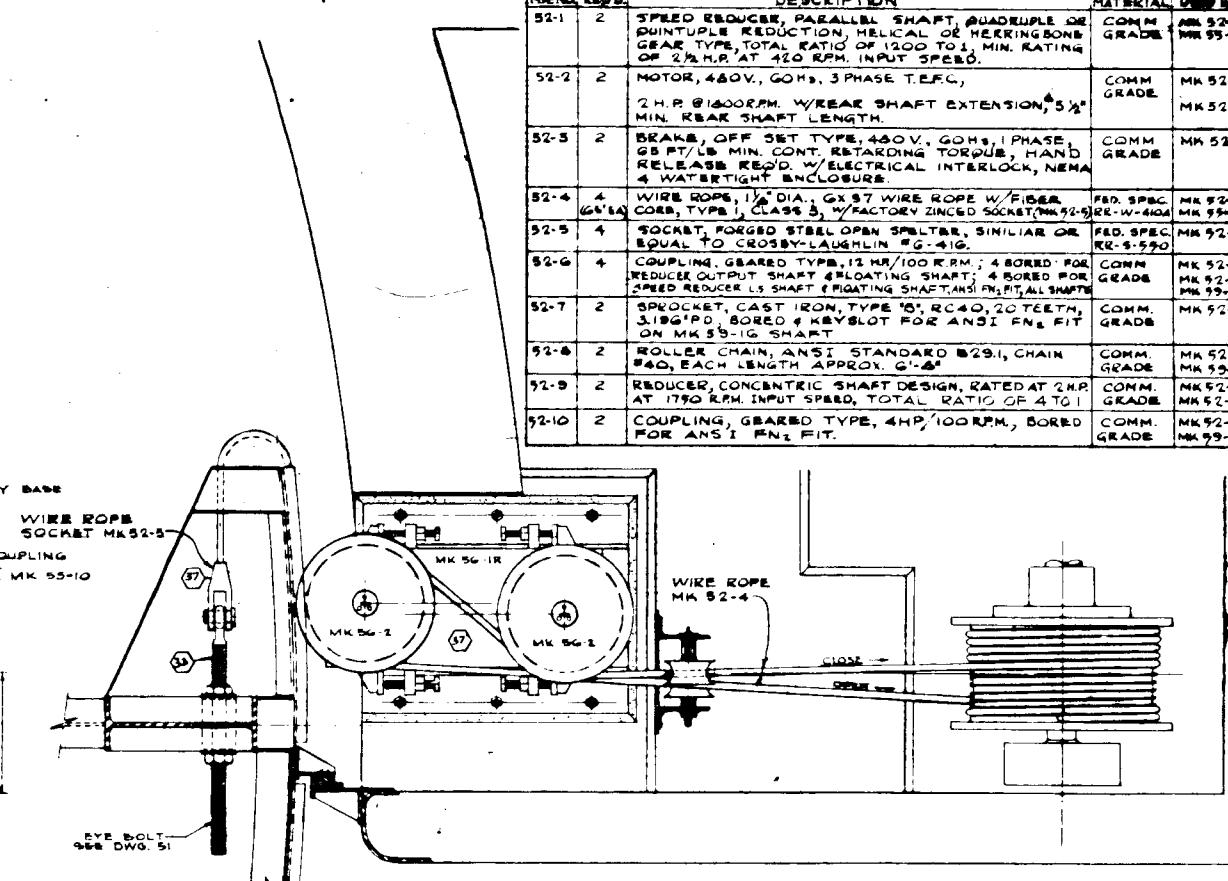
**PLAN**  
(GATE IN CLOSED POSITION)  
SCALE 1'-0"

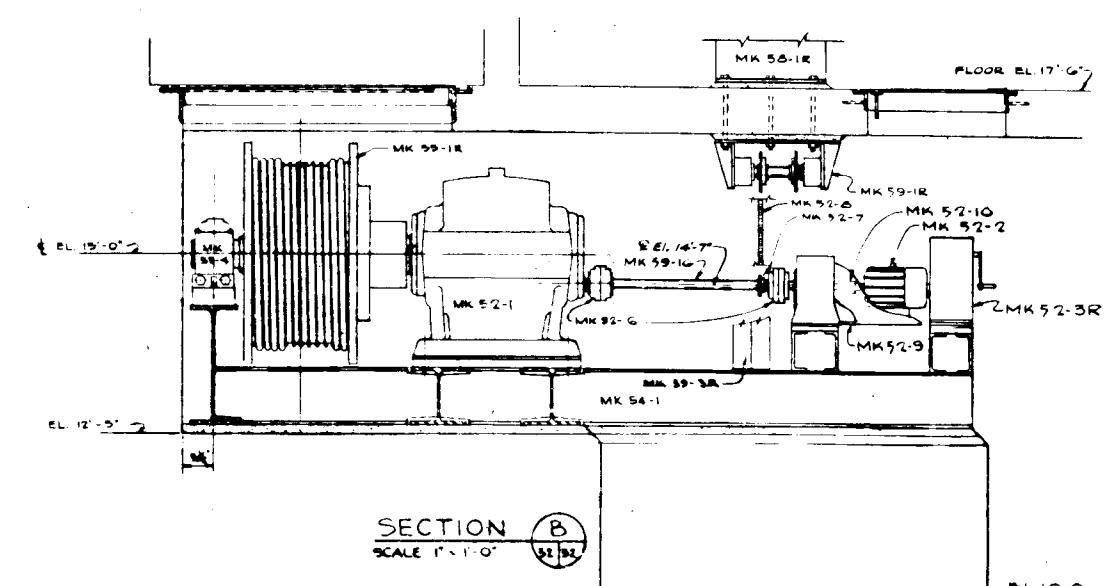
**SECTION B**  
SCALE 1'-0"

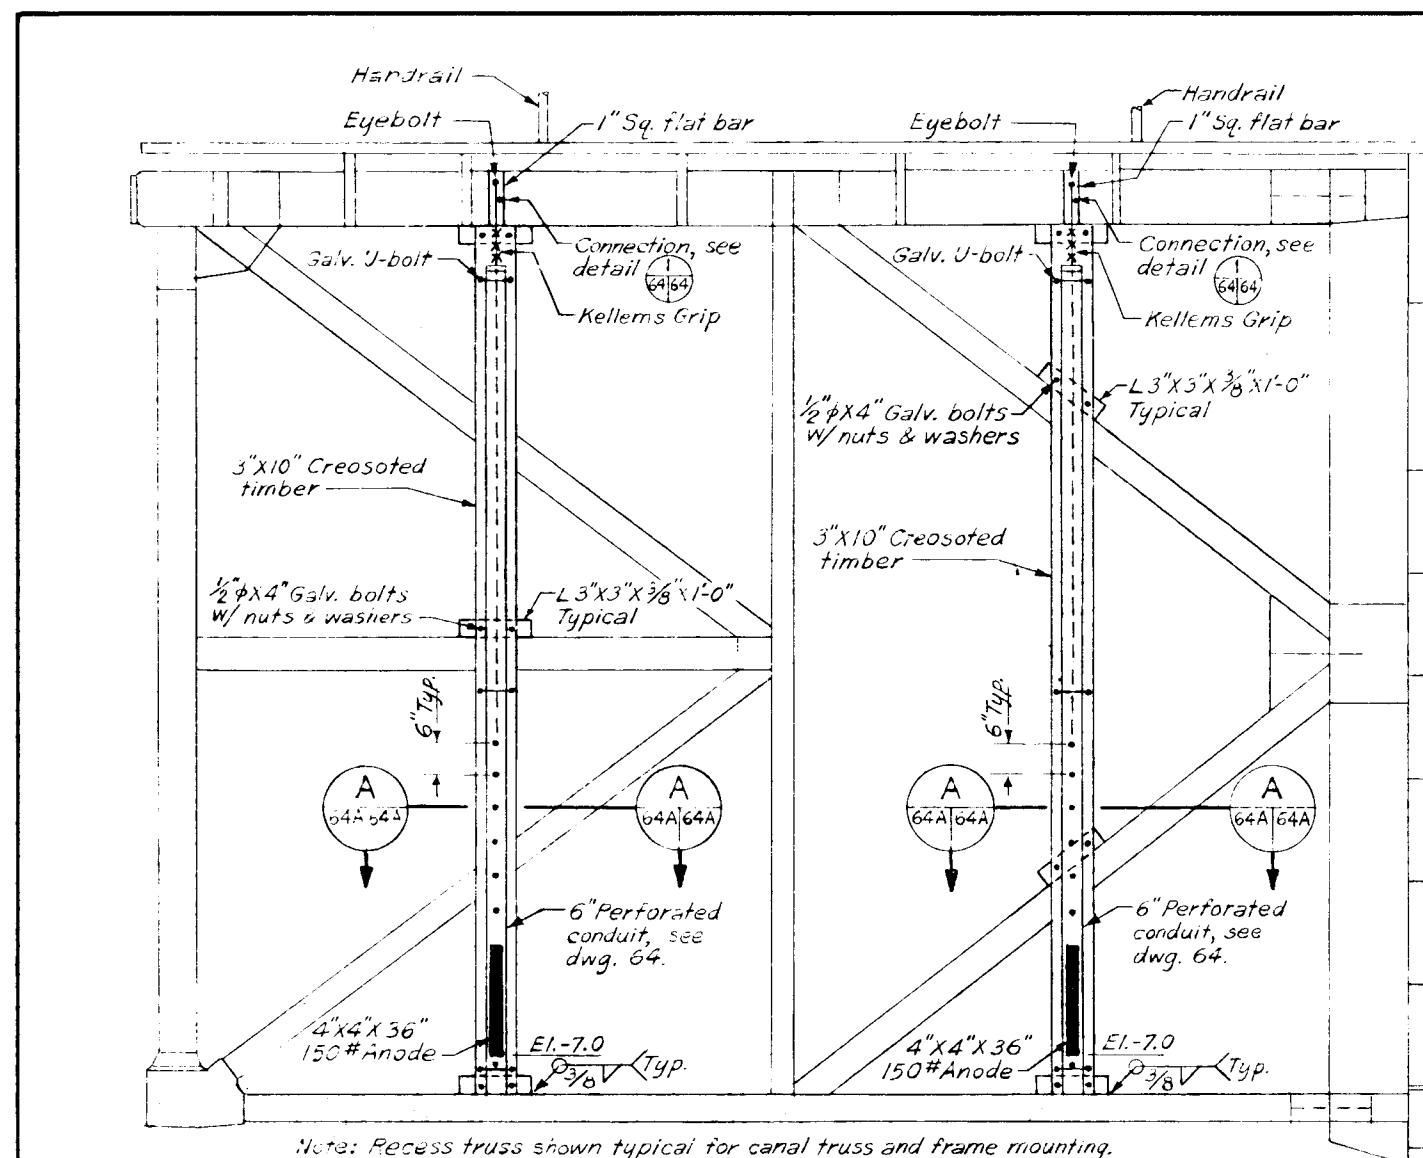
Note: Recess truss shown typical for canal truss and frame mounting.

#### ANODE MOUNTING - RECESS TRUSS

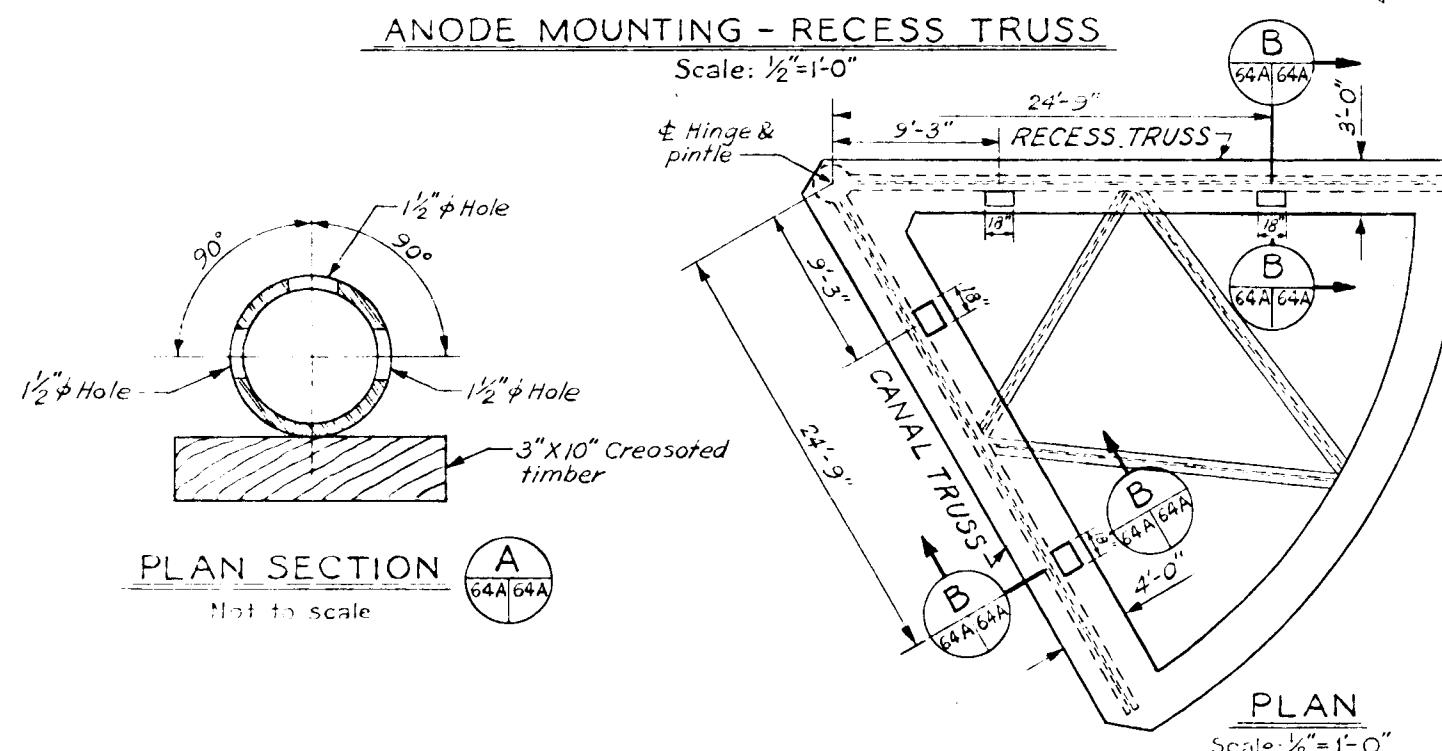
#### PLAN SECTION

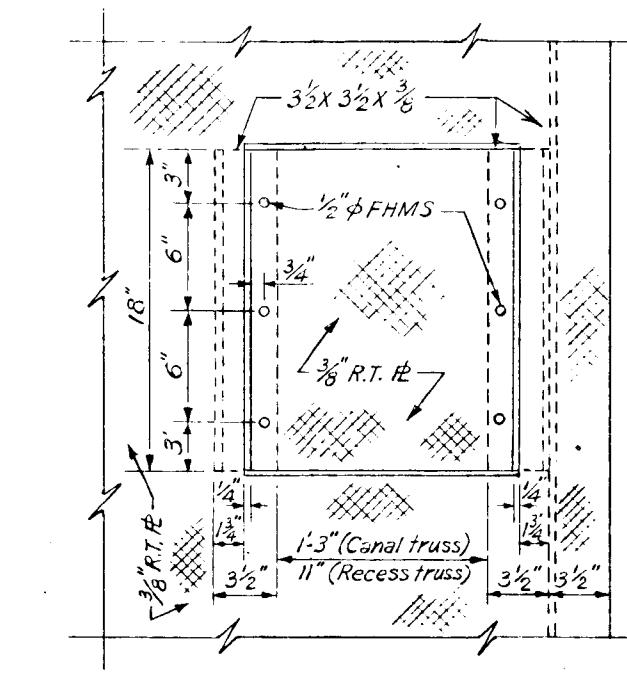
#### PLAN OF ACCESS HOLE

Scale:  $1\frac{1}{2}'' = 1'-0''$

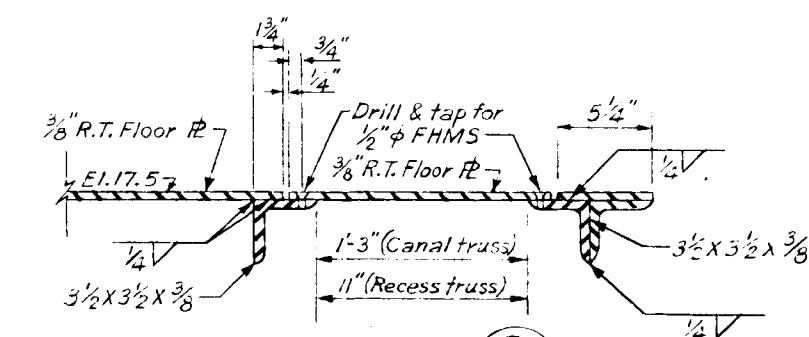
#### SECTION

Scale:  $1\frac{1}{2}'' = 1'-0''$

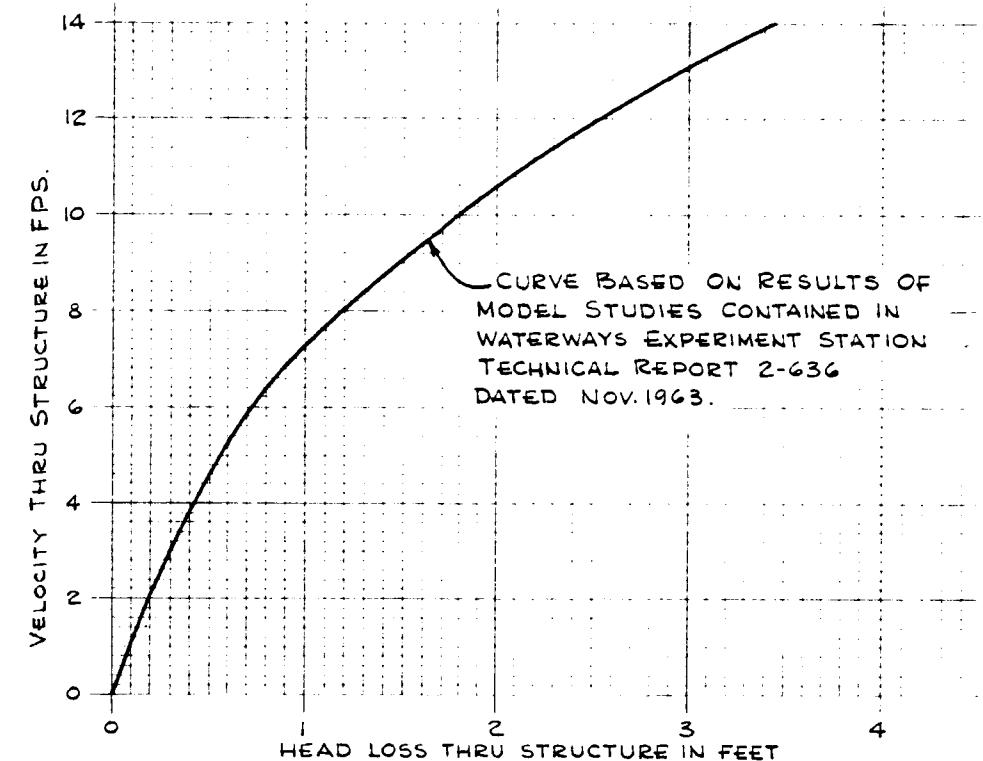
VELOCITY VS. HEAD LOSS THRU STRUCTURE

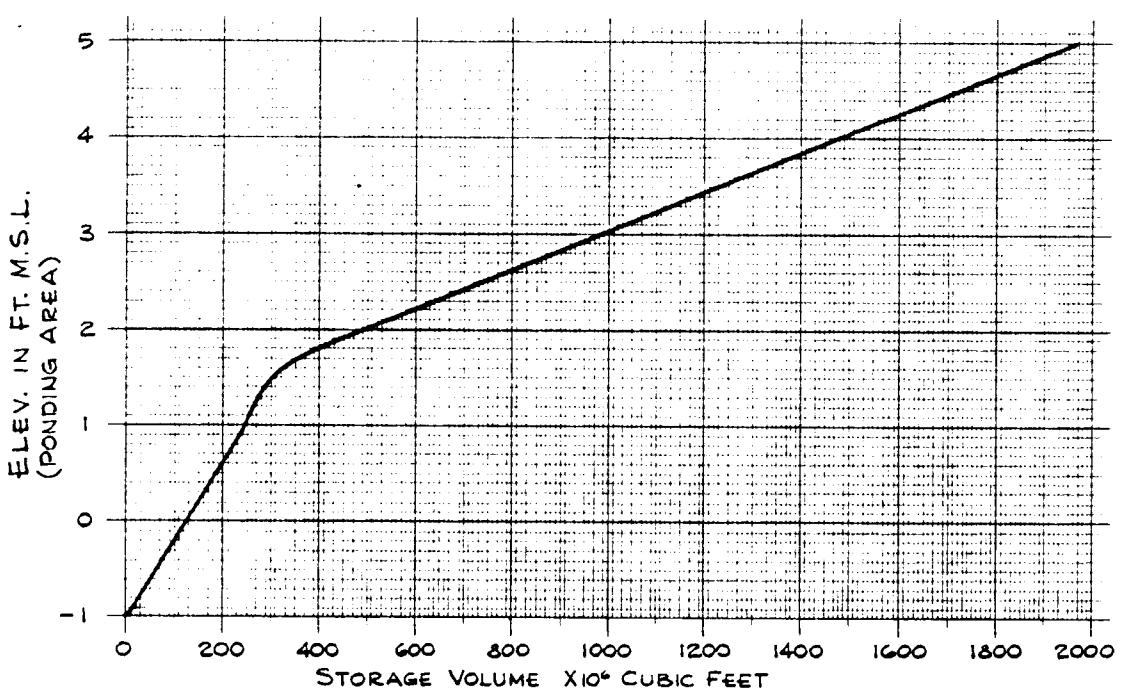
STORAGE VOLUME VS. PONDING AREA LEVEL  
(11,500 ACRES = 1/2 OF TOTAL PONDING AREA)

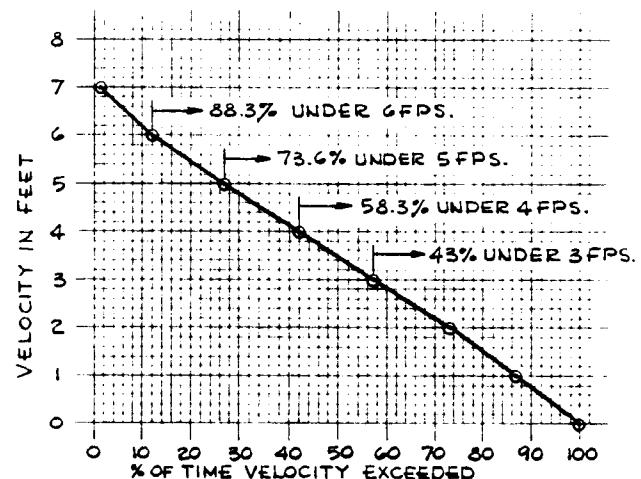
VELOCITY THRU STRUCTURE VS. PERCENT OF TIME

NOTE: CURVE BASED ON 2,063 HOURLY READINGS  
MAX. HIGH TIDE 2.64 MIN. LOW TIDE -0.95

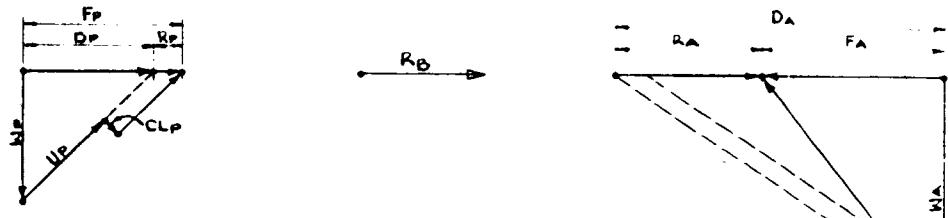
PASSIVE WEDGE    CENTRAL WEDGE    ACTIVE WEDGE

SURFACE B3 THIRD STAGE F.S. WITH RESPECT TO SHEAR STRENGTH  
 $= \frac{R_A + R_B + R_P}{D_A - D_P} = \frac{91,629}{59,927} = 1.53$

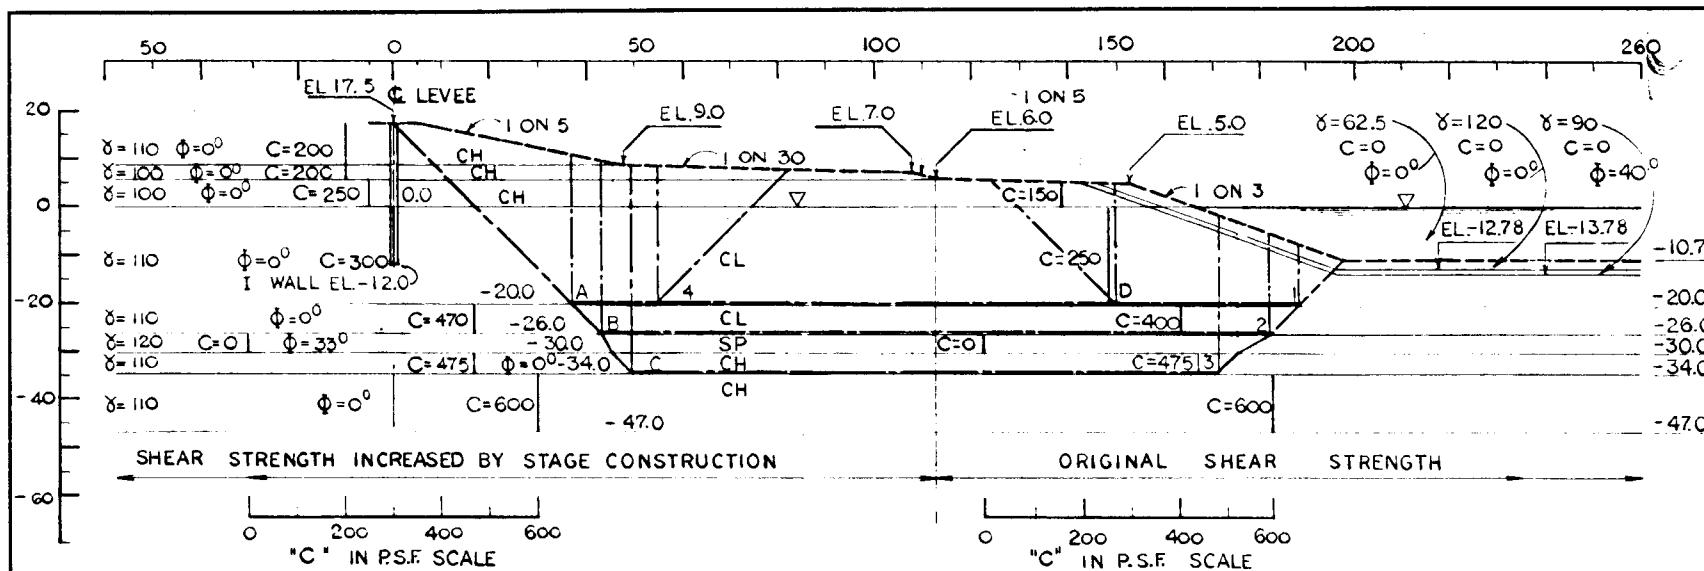
- BAYOU DUPRE - SECTION THRU LEVEE AND CHANNEL -  
"Q" STABILITY

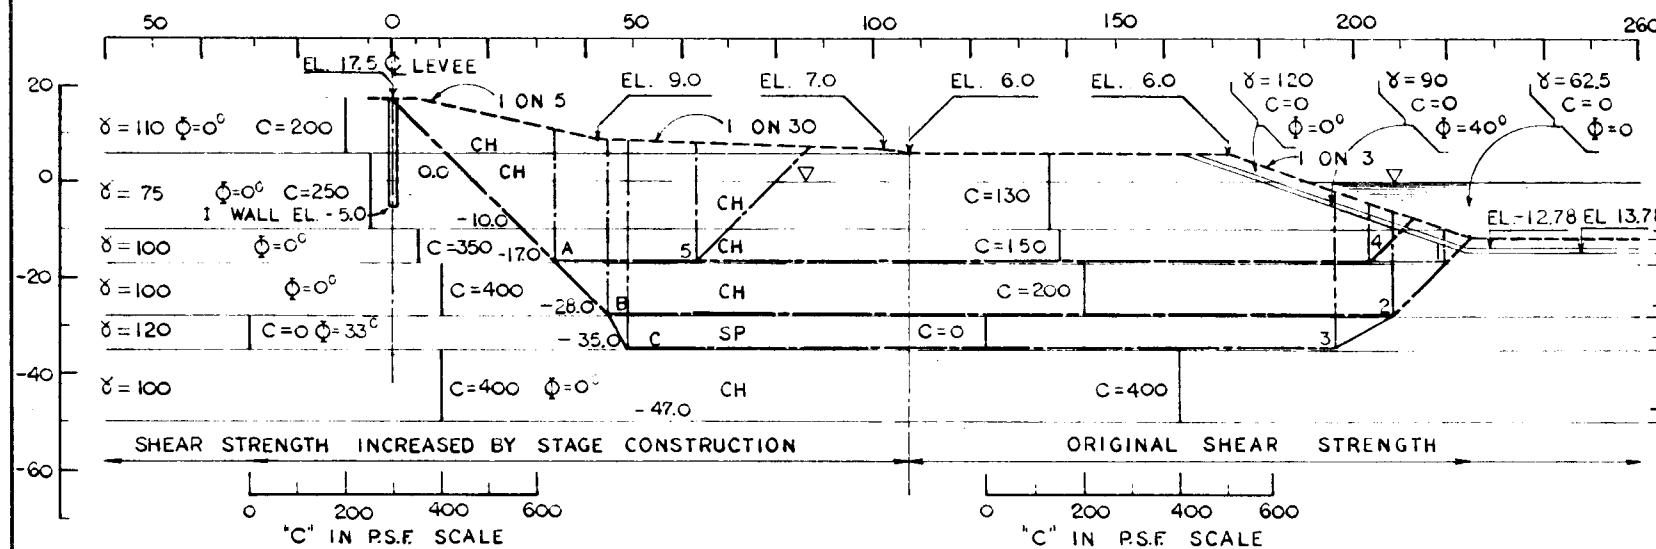
- BAYOU BIENVENUE - SECTION THRU LEVEE AND CHANNEL -  
"Q" STABILITY

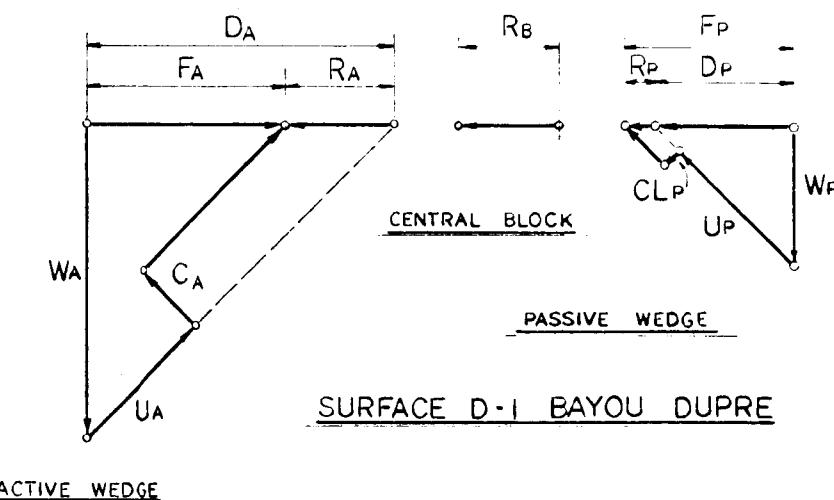
F.O.S. WITH RESPECT TO SHEAR STRENGTH  
 $= \frac{RA + RB + RP}{DA - DP} = \frac{25047}{18349} = 1.37$

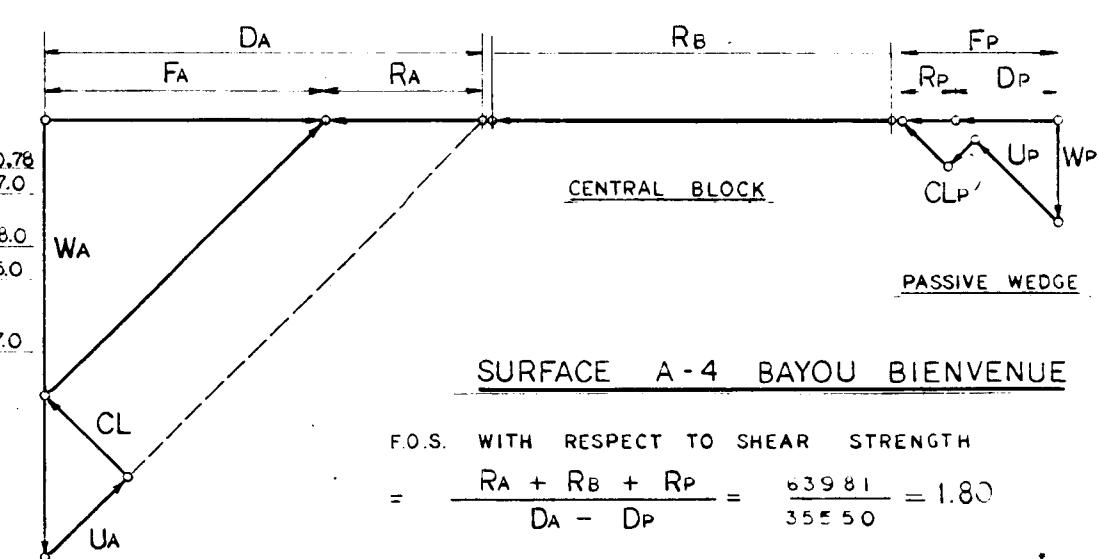
F.O.S. WITH RESPECT TO SHEAR STRENGTH  
 $= \frac{RA + RB + RP}{DA - DP} = \frac{63981}{35550} = 1.80$

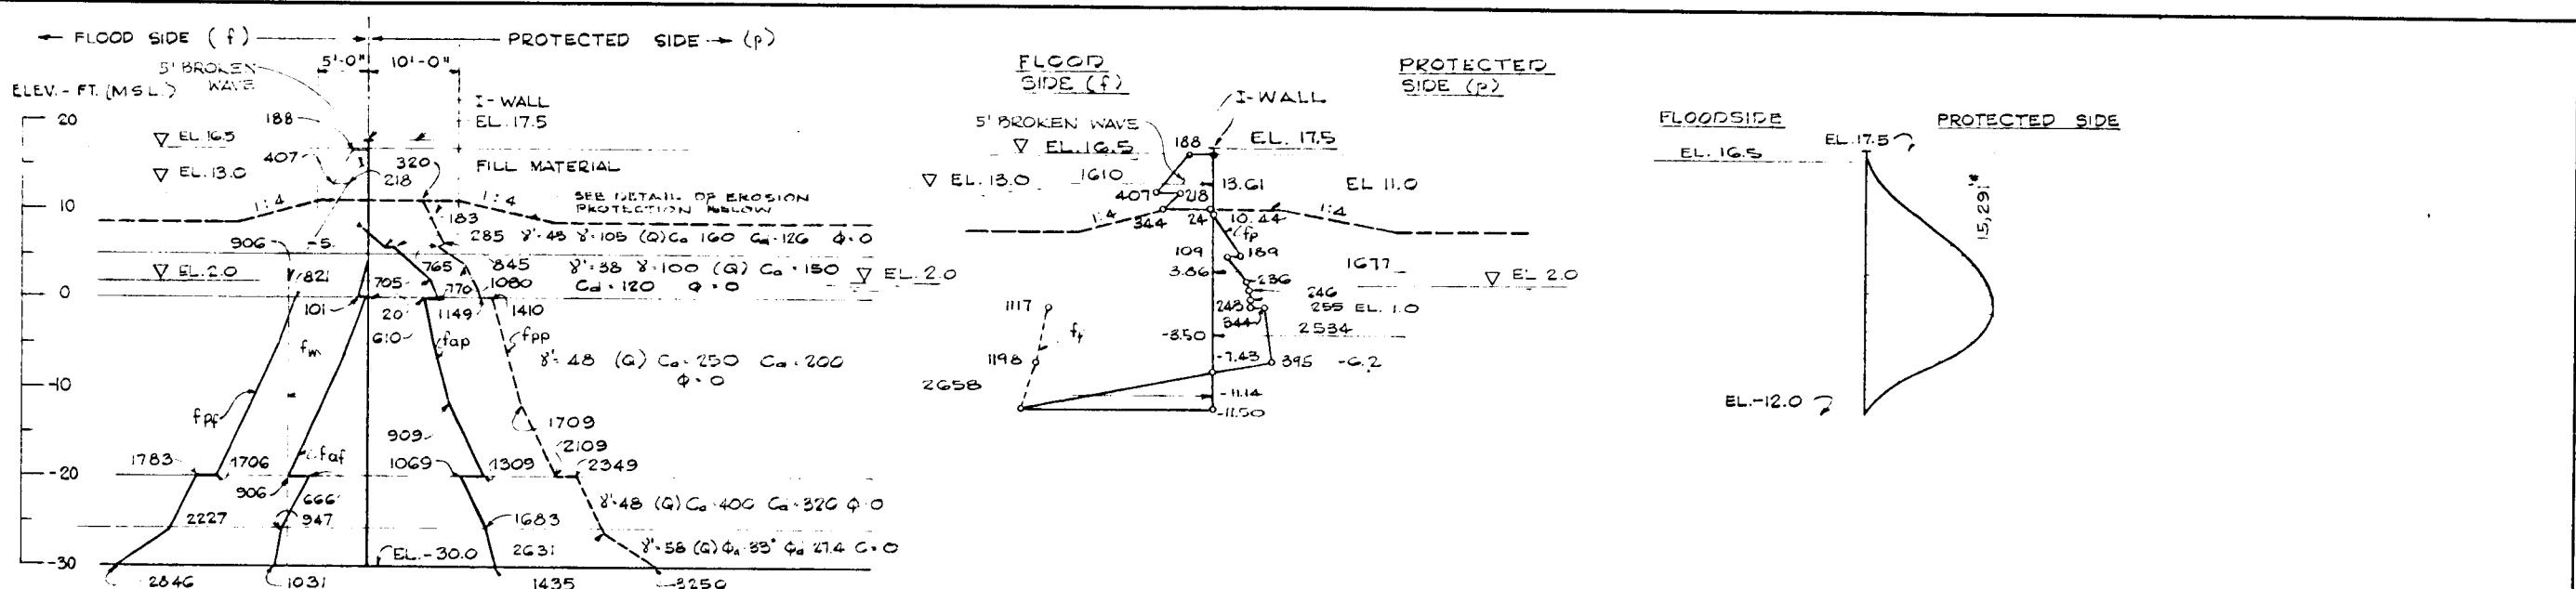
GROSS PRESSURE DIAGRAM

F.S. = 1.25  
SCALE 1" = 1000 PSF  
SCALE 1" = 10'-0"

\*See plate IV-38 for the stability studies and governing conditions. \*

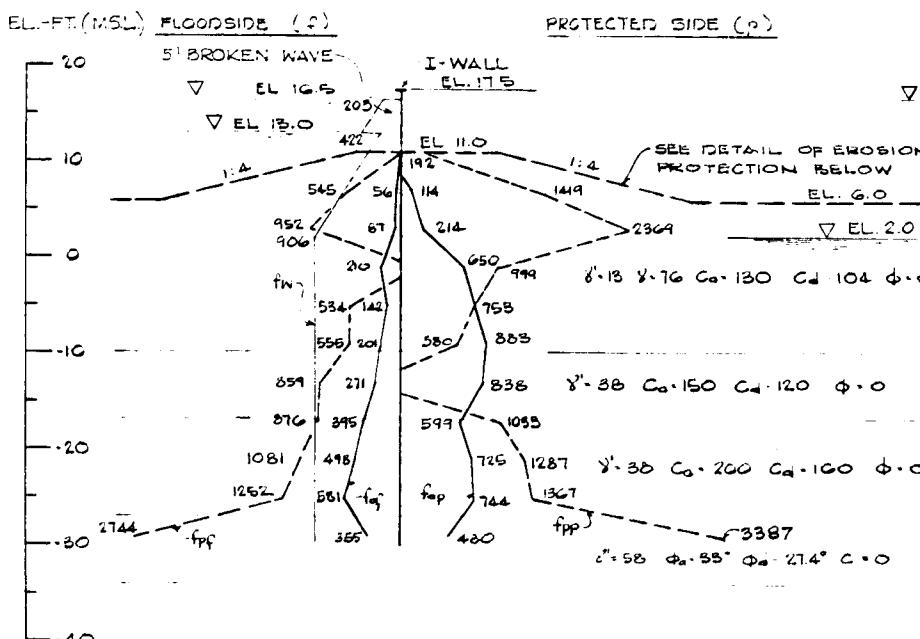
GROSS PRESSURE DIAGRAM

F.S. = 1.25  
SCALE 1" = 1000 PSF  
SCALE 1" = 10'-0"

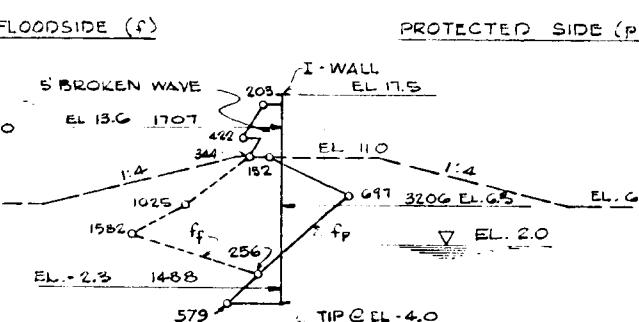
NET PRESSURE DIAGRAM

"Q" STABILITY  
SCALE 1" = 1000 PSF  
SCALE 1" = 10'-0"  
F.S. = 1.25

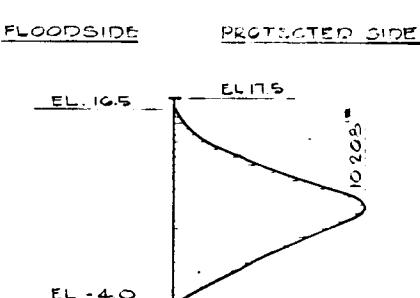
MOMENT DIAGRAM

F.S. = 1.25  
SCALE 1" = 2000 FT. LB.  
SCALE 1" = 10'-0"

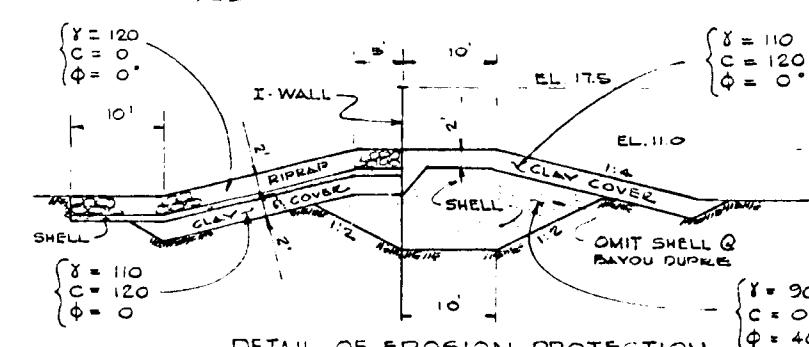
DETAIL OF EROSION PROTECTION

SCALE 1" = 10'-0"

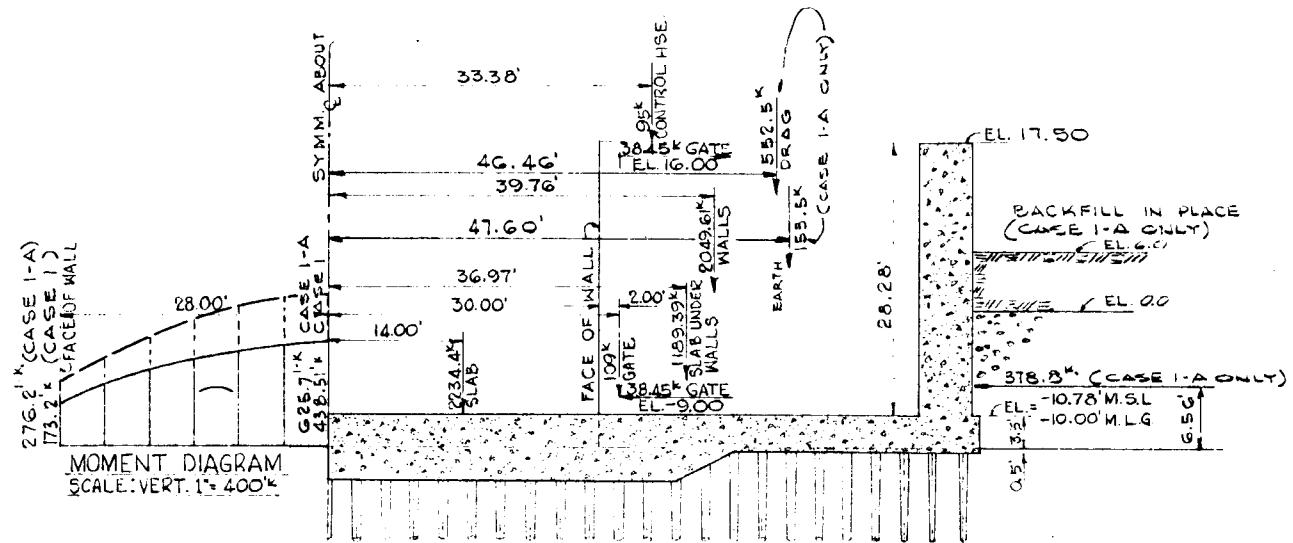
LOADING CONDITION CASE I  
GATE OPEN, BACKFILL NOT IN PLACE  
NO BUOYANCY  
PILE REACTIONS ASSUMED UNIFORMLY  
DISTRIBUTED IN TRANSVERSE DIRECTION  
LOADING CONDITION: CASE I-A  
SAME AS CASE I EXCEPT BACKFILL IN PLACE  
NOTES:  
LOADS SHOWN ARE FOR HALF OF  
STRUCTURE.  
MOMENTS SHOWN ARE FOR ONE FOOT  
STRIP.  
— INDICATES TENSION IN TOP OF SLABS.

CASE I		
	MAXIMUM	MINIMUM
PILES A	19.21' K	19.04' K
PILES B	17.81' K	17.63' K

CASE I-A		
	MAXIMUM	MINIMUM
PILES A	21.61' K	21.38' K
PILES B	20.07' K	19.82' K

Case 6 was found to be critical for design in the longitudinal direction and Case 1A was critical in the transverse direction. See \*plates IV-3 and IV-8.\*

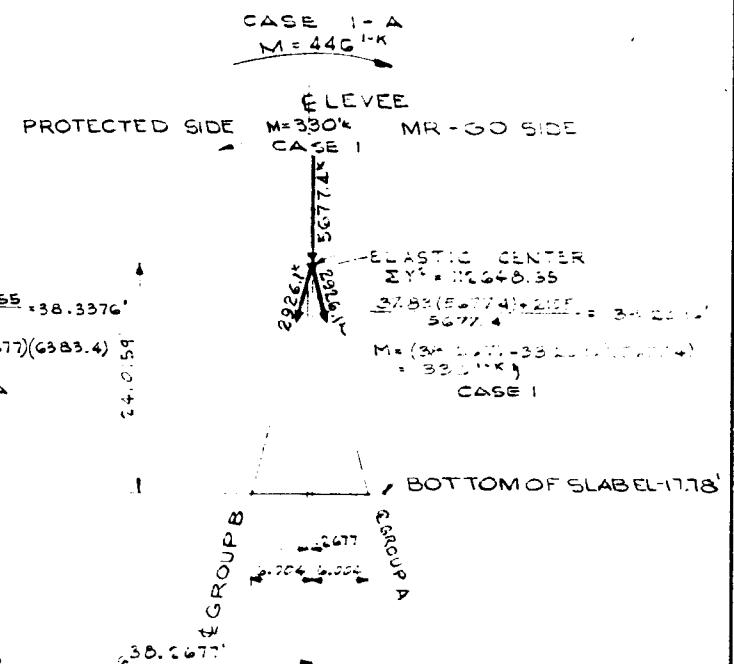
#### DRAG FORCE COMPUTATION:

EL. G.O TO EL. 0.0 CLAY C=120 P.S.F.  $\phi=0^\circ$   $\delta=110' / ft^3$   
EL. G.O TO EL.-17.78 SHELL C=0 P.S.F.  $\phi=40^\circ$   $\delta=92' / ft^3$   
DRAG FORCE FOR CLAY =  $(G_C X LENGTH OF WALL)$   
DRAG FORCE FOR SHELL = LATERAL FORCE  $\times \tan \phi \times L$   
LATERAL FORCE = OVERBURDEN WT.  $\times \tan^2(45 - \phi/2)$   
TOTAL DRAG FORCE = DRAG FORCE FROM CLAY + SHELL  
LENGTH OF WALL FROM EL. 17.5 TO EL-14.78 = 89 FT  
LENGTH OF WALL FROM EL 17.5 TO EL-17.78 = 29 FT

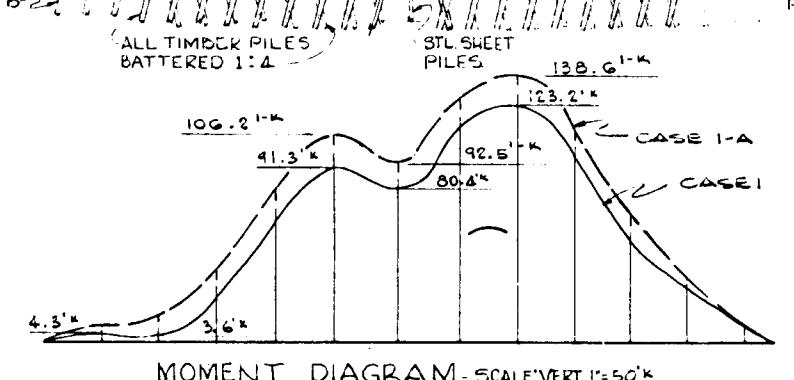
LONGITUDINAL SECTION - SCALE: 1" = 10'

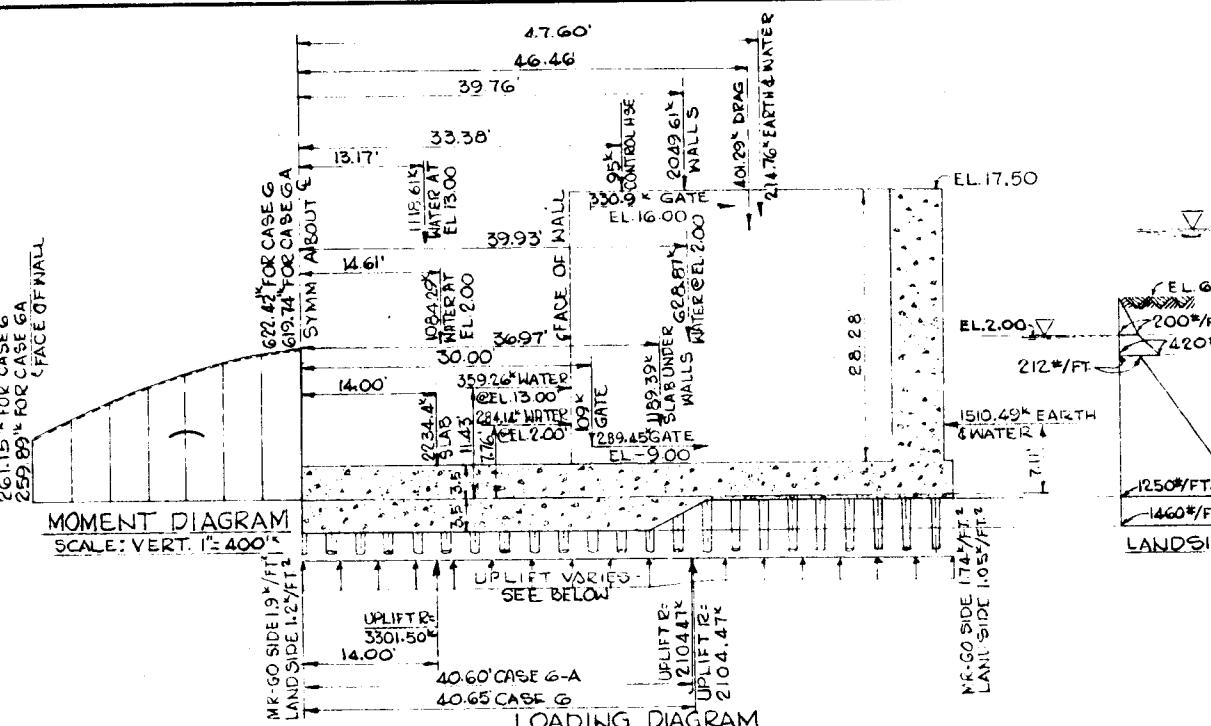
#### LOADING CONDITION: CASE 6

STRUCTURE COMPLETE, BACKFILL IN PLACE. HURRICANE CONDITION, GATE CLOSE & WATER MR-GO SIDE AT EL 13.00 M.S.L. WATER LANDSIDE AT EL 12.00 M.S.L., BUOYANCY ACTIVE, SHEET PILE CUT-OFF WALL IMPERVIOUS, WAVE LOAD MR-GO SIDE.

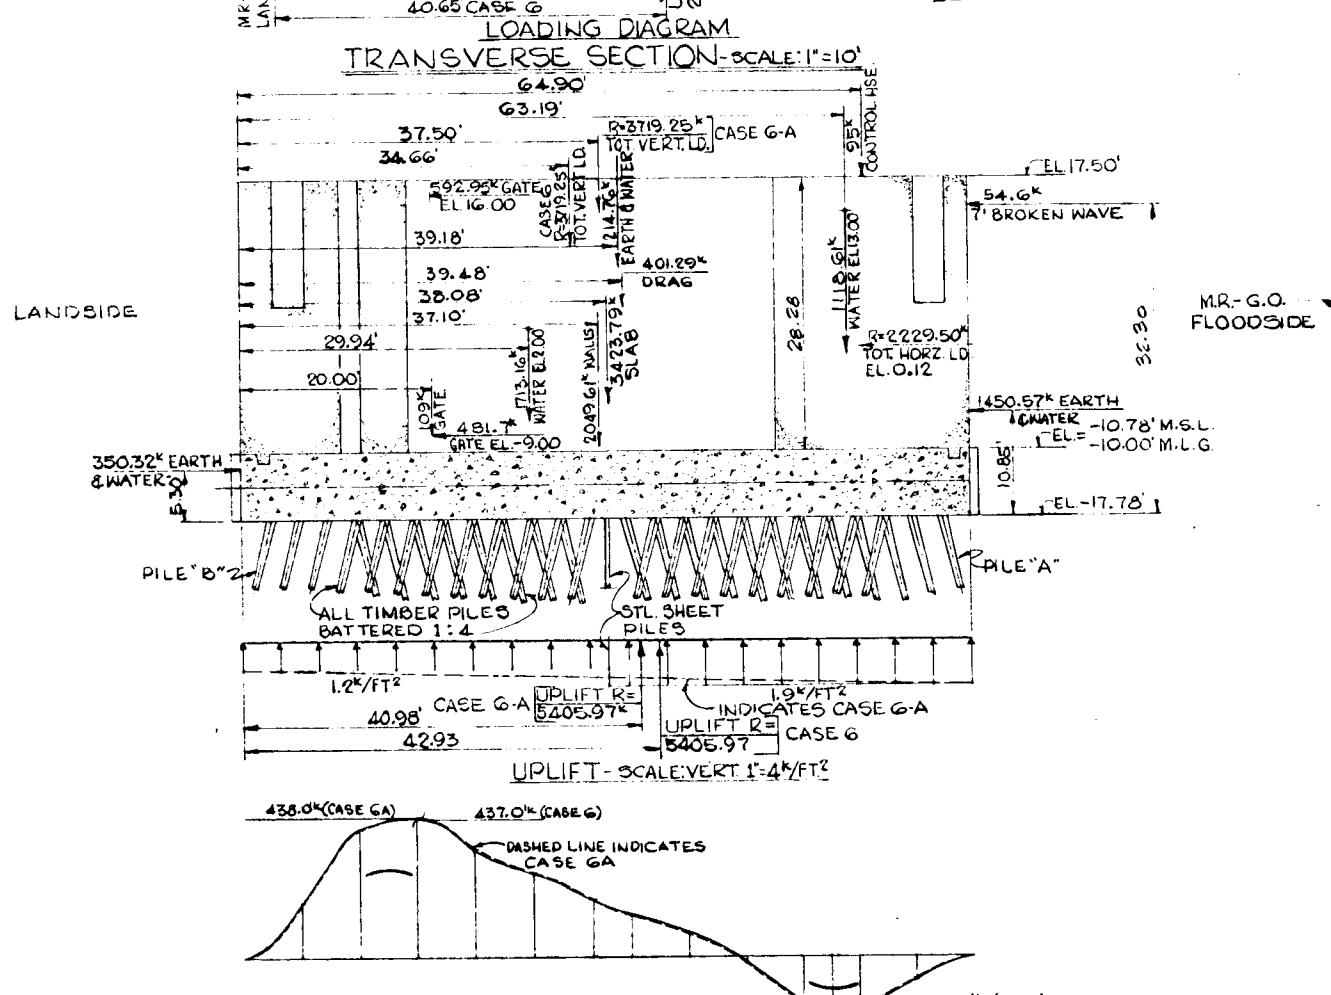
$$\begin{aligned} \text{CASE 6} \\ M &= (24.0159 - 17.9)(2229.5) - \\ &(38.2677 - 34.66)(3719.25) \\ &= 217.46^k \end{aligned}$$

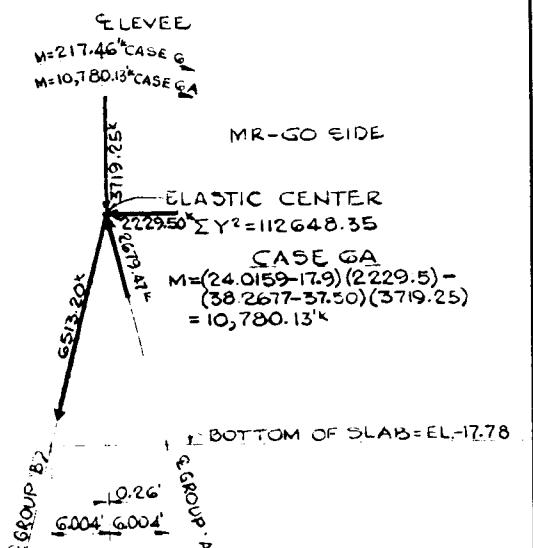
#### STABILITY DIAGRAM

SCALE: LINEAR 1"-10'  
LOADS 1"-3,000"

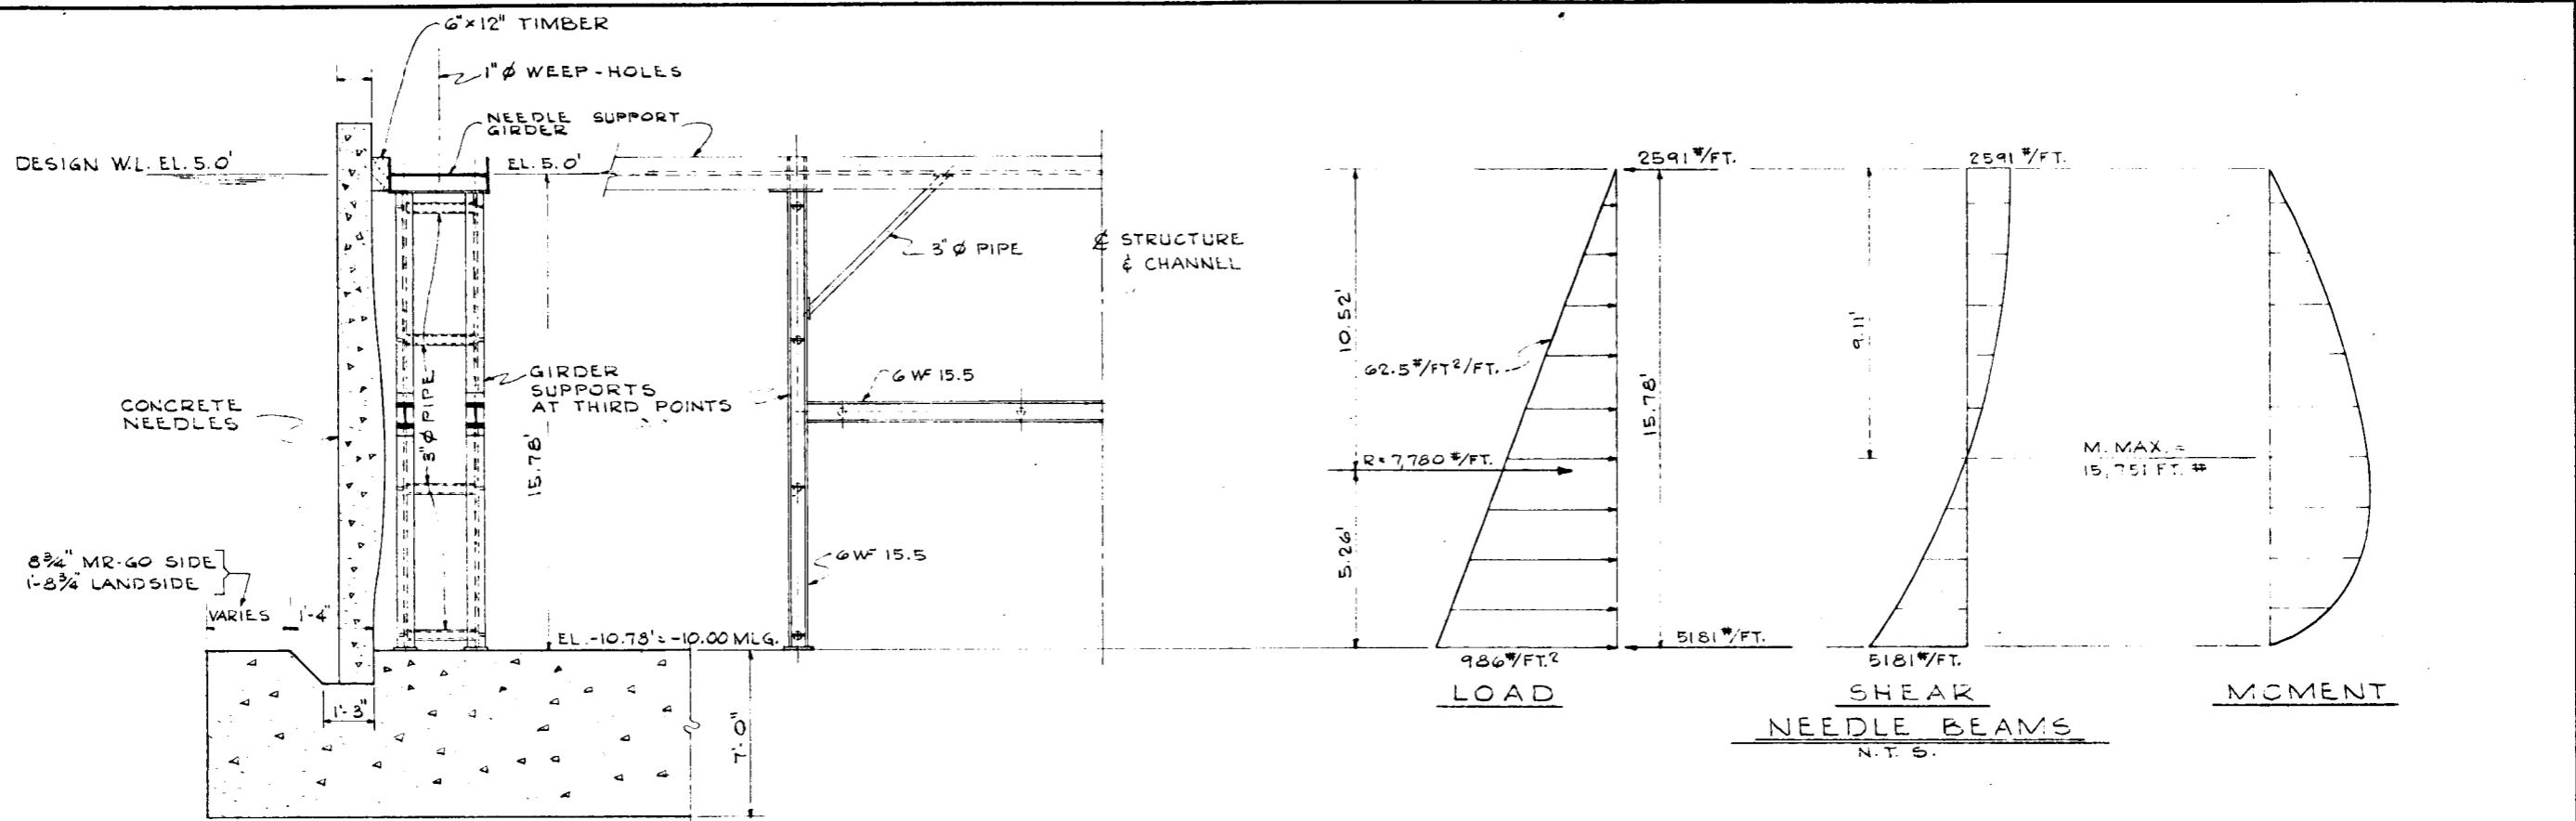
SECTION THRU NEEDLE DAM

22 NEEDLES REQUIRED  
TO BE STORED AT ONE STRUCTURE

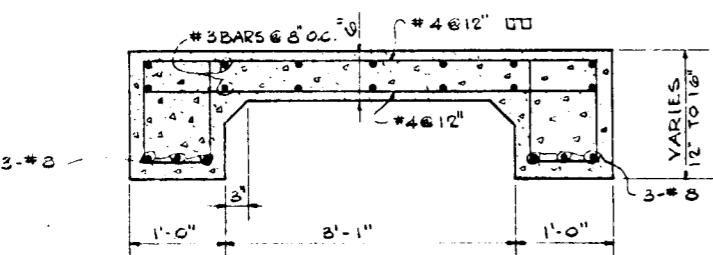
SECTION THRU NEEDLE

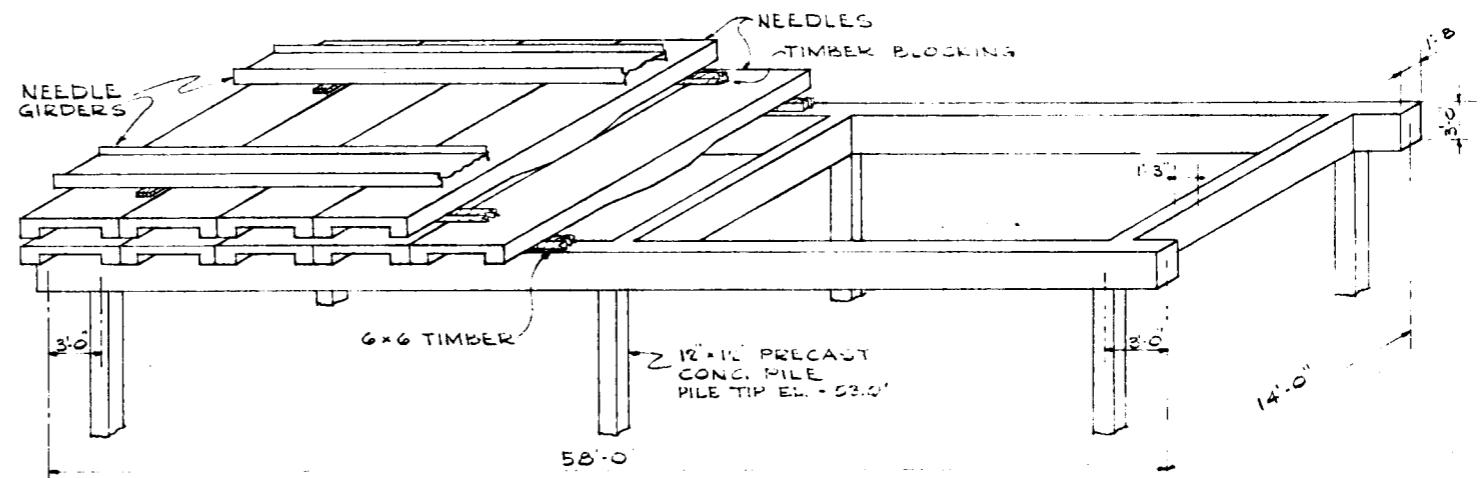
ISOMETRIC VIEW OF NEEDLE  
DAM STORAGE RACK  
(BAYOU BIENVENUE STRUCTURE ONLY)  
(SEE PLATE I-7 FOR LOCATION)
