RAILROAD COMMISSION OF TEXAS
PIPELINE SAFETY SECTION
Study Report on
COMPRESSION TYPE COUPLINGS

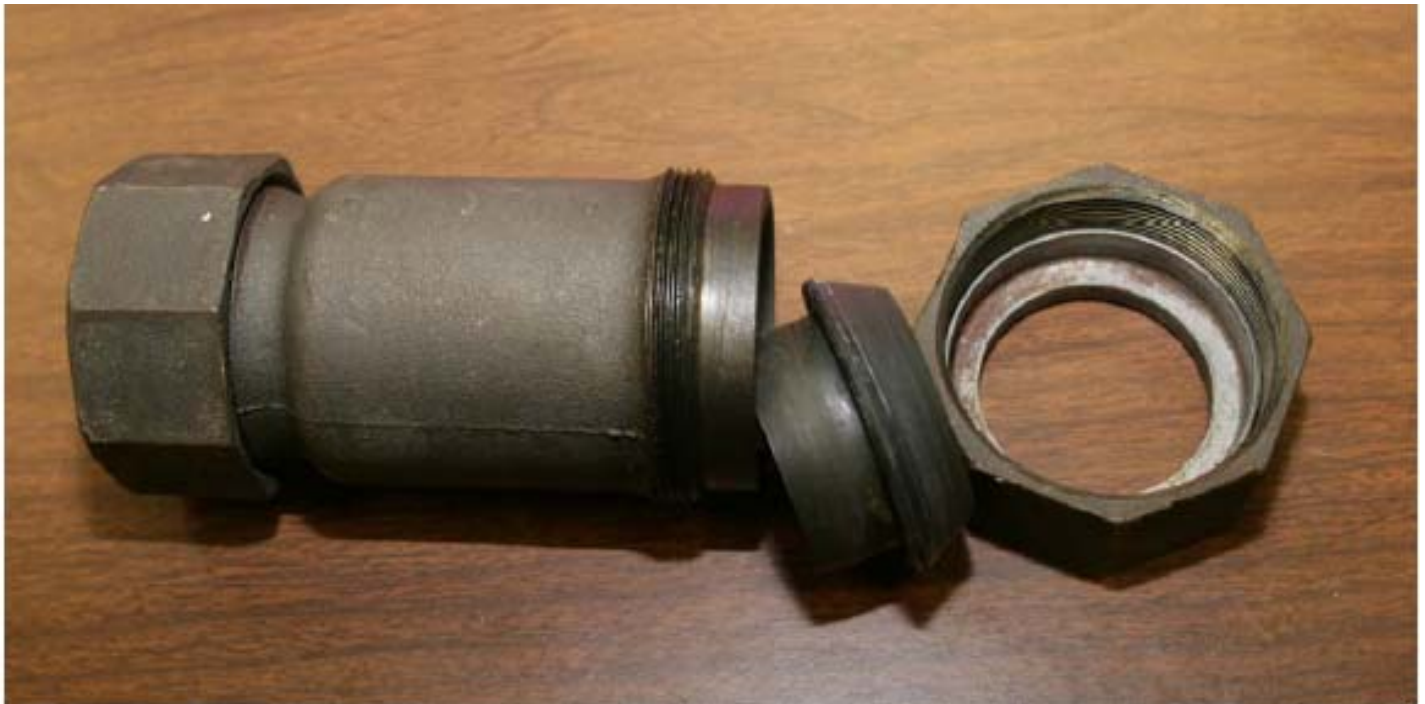
For the purpose of describing and explaining a typical coupling, the Dresser type coupling is pictured below. This information was extracted from a diagram created by PHMSA. Figures 1 and 2 provide examples of a typical Style 90 type Dresser coupling. A number of variations are available to join similar materials (such as steel to steel or PE to PE) or different materials (such as transitioning from steel to PE as in Figure 2). In addition to the straight coupling shown below, the Style 90 can also appear as an elbow (45 or 90 degree), tee, reducing coupling, or integrated with a riser. A variety of gaskets and sleeves exist depending on the specific application.

Figure 1 – Example of a Style 90 Type Dresser Coupling, Open Ended Barrel for View of Components
