Department of Energy
Richland Operations Office (RL)
Surveillance Report

Surveillance Number: S-11-SED-CHPRC-PFP-002

Facility: Plutonium Finishing Plant (PFP)

Title: Planning and Execution of Radiological Work

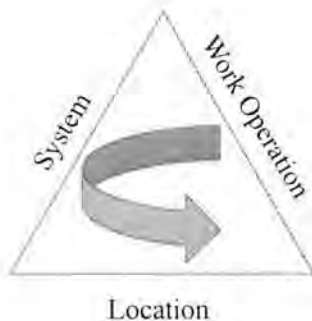
To adequately plan work, the hazards associated with the work must be fully understood. The radiological hazards are the sum of the hazards from the system that is being breached, the work operation being performed, and the hazards associated with the work location.

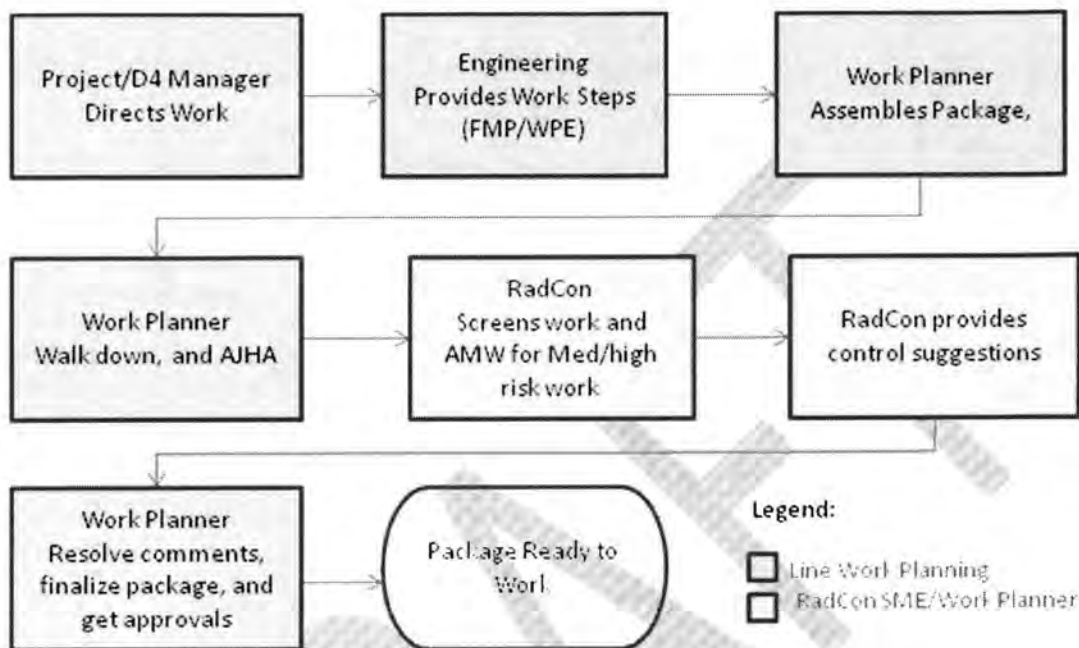
Figure 1 Simplified Work Planning Process Flow Chart

interviews of personnel, the basic simplified flow chart of the work planning process used at PFP is shown below:

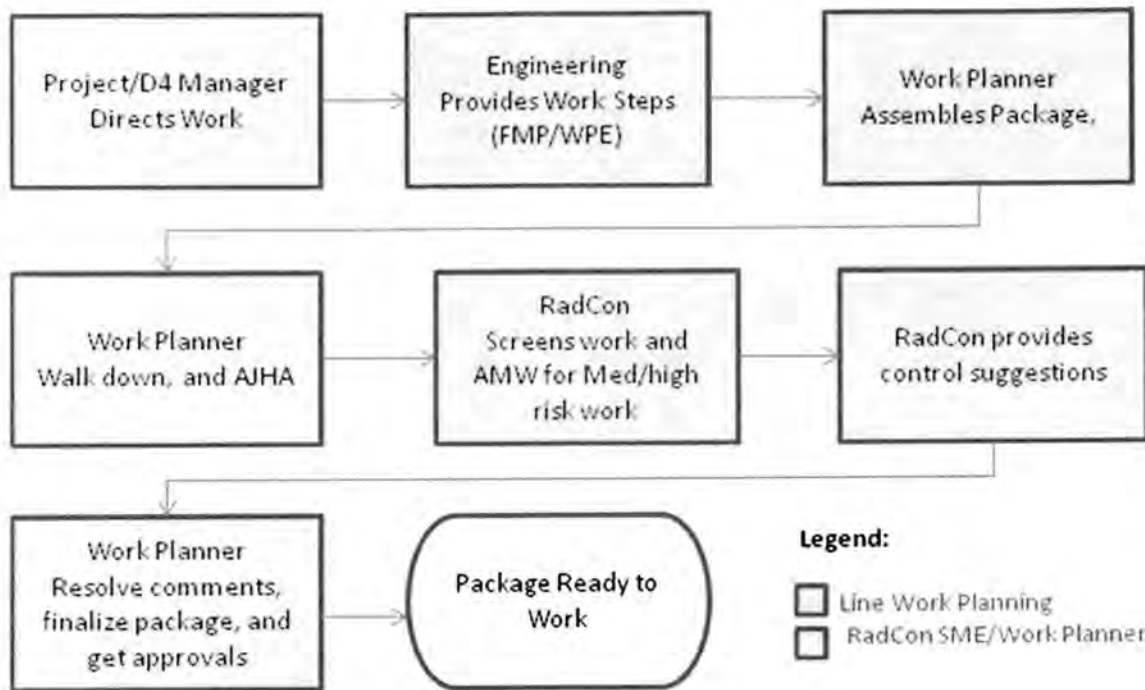
Figure 1 Simplified Work Planning Process Flow Chart

interviews of personnel, the basic simplified flow chart of the work planning process used at PFP is shown below:

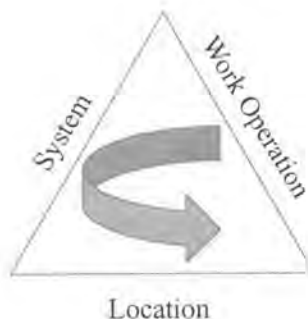
To adequately plan work, the hazards associated with the work must be fully understood. The radiological hazards are the sum of the hazards from the system that is being breached, the work operation being performed, and the hazards associated with the work location.

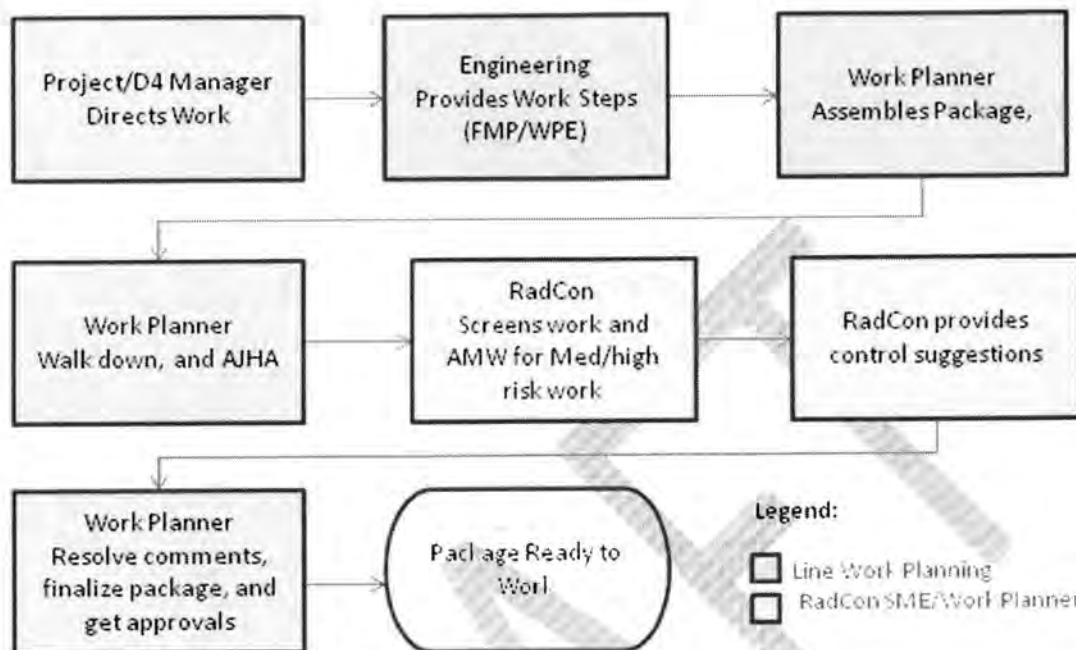
The surveillance team performed a process audit, looking at the PFP process for planning work. From a review of the contractor procedures, and interviews of personnel, the basic simplified flow chart of the work planning process used at PFP is shown below:

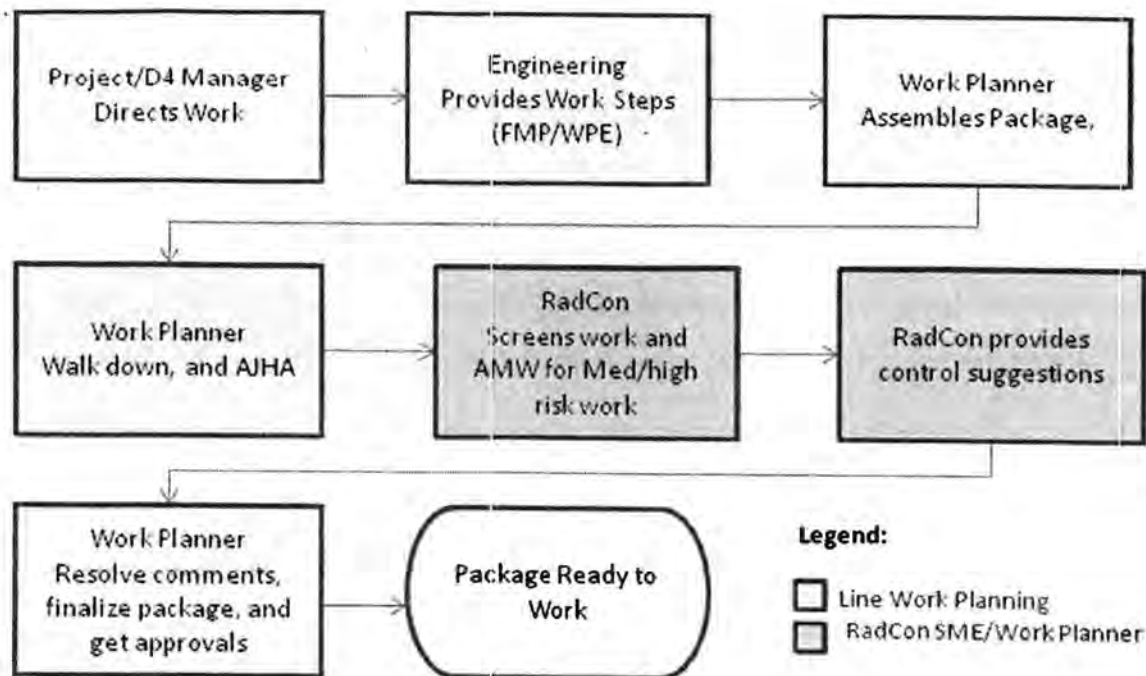
Figure 1 Simplified Work Planning Process Flow Chart

The surveillance team performed a surveillance of the work planning process, looking at the PFP process for planning radiological work. From a review of the contractor procedures, and interviews of personnel, the basic simplified flow chart of the work planning process used at PFP is shown below.
