Incidents Associated with Oil and Gas Operations

Outer Continental Shelf 1998

This report can also be obtained on MMS's homepage at <http://www.mms.gov>

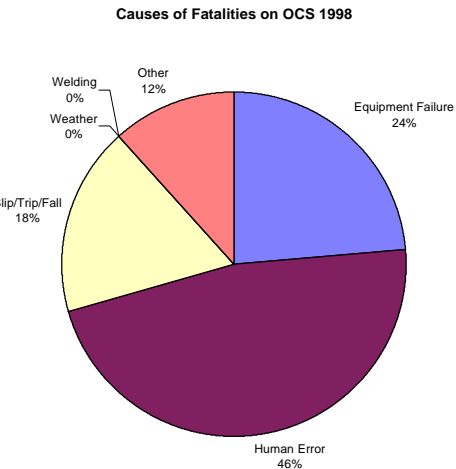
Overall, the main cause of incidents in 1998 was human error, followed by equipment failure. The majority of these incidents occurred during production operations. Fires were the most frequent type of incident reported to the MMS in 1998, followed by injuries. Both the number of fires and number of injuries recorded in TIMS tripled from 1995 to 1997 (Appendix A). Part of this increase may be a result of changes in Gulf of Mexico (GOM) record keeping requirements effective August 1996. The 1998 fires and injuries showed a return to the 1996 levels. The majority of the reported injuries were minor.

The primary cause of fatalities (14) was human error, followed by equipment failure. Most fatalities occurred during production operations, followed by drilling, then well completion, and finally welding operations.

Blowouts (7) were mainly a result of equipment failure and human error, resulting primarily from drilling operations, followed by well completion activities. Explosions mainly occurred during production activities and were caused by equipment failure and human error.

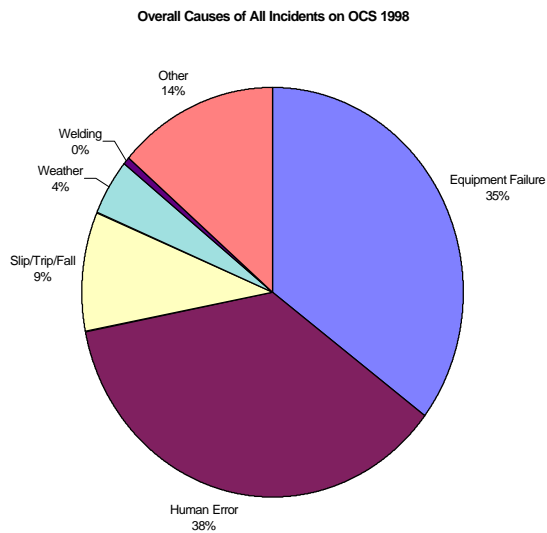
- The primary causes of fatalities (14) were human error (8) and equipment failure (4). The 14 deaths were the result of 11 individual incidents. Three of the 11 individual incidents resulted in multiple fatalities.
- Explosions (4) were a result of equipment failure (2) and human error (2), resulting primarily from production operations.
- Overall, the main cause of incidents in 1998 was human error (75), followed by equipment failure (72).
