# RECLAMATION

## **Dam Safety Public Protection Guidelines – Examples of Use**

**Examples of How to Use Risk to Support Dam Safety Decisions**

**U.S. Department of the Interior  
Bureau of Reclamation  
Dam Safety Office  
Denver, Colorado**

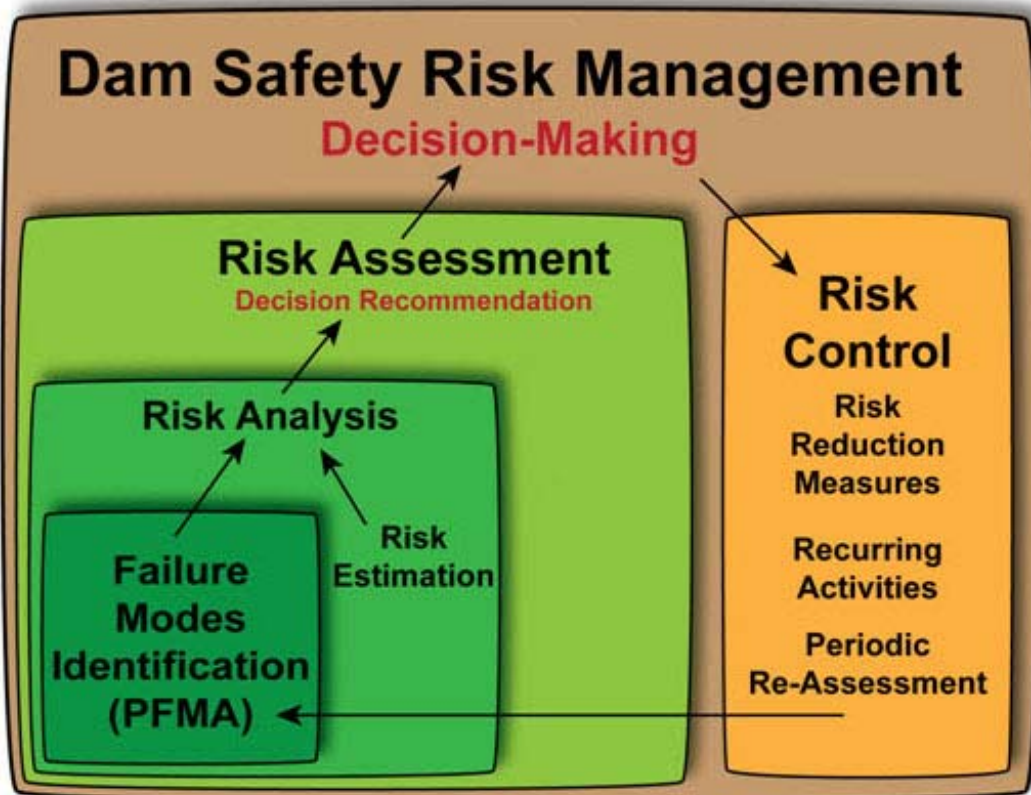
Figure 1. Dam Safety Risk Management Components

This document is intended to be used in conjunction with the Reclamation’s 2011 revision to the *Dam Safety Public Protection Guidelines*. The purpose of this document is to give some examples of how risk analysis results are used to support risk management decisions. Figure 1 shows the general input to risk management. The terms in Figure 1 are defined in the *Dam Safety Public Protection Guidelines* and are not repeated here. Table 1 is Reclamation’s Dam Safety Priority Rating (DSPR) chart, which is a key tool for risk management prioritization, and which will be discussed further in this document.

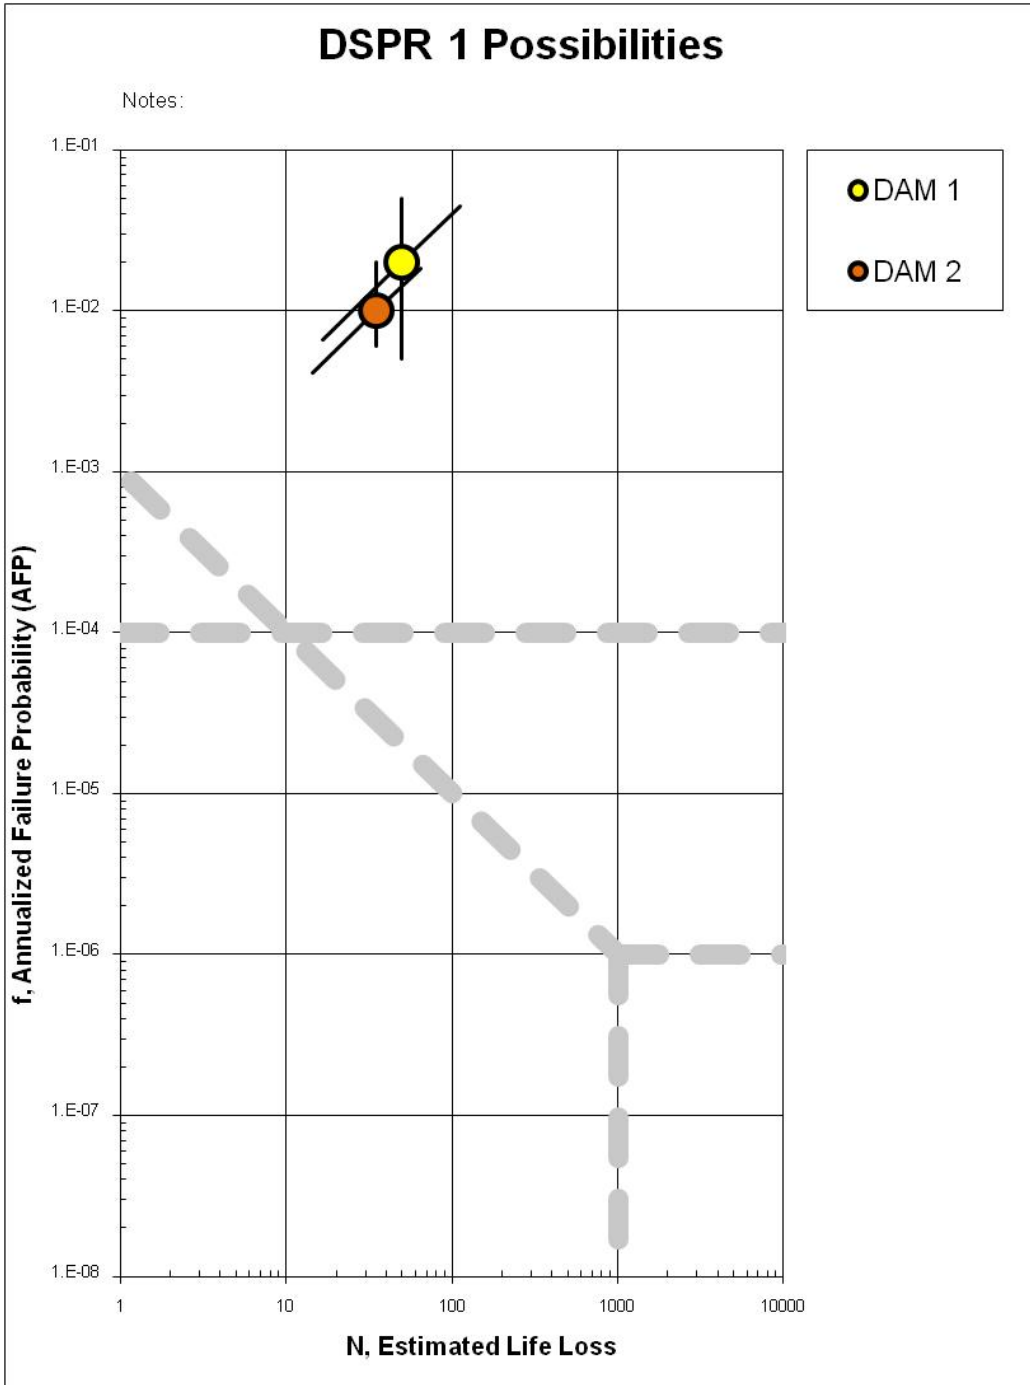
Figure 2. Potential DSPR 1 Dams

**DSPR 1 Possibilities (Figure 2)**

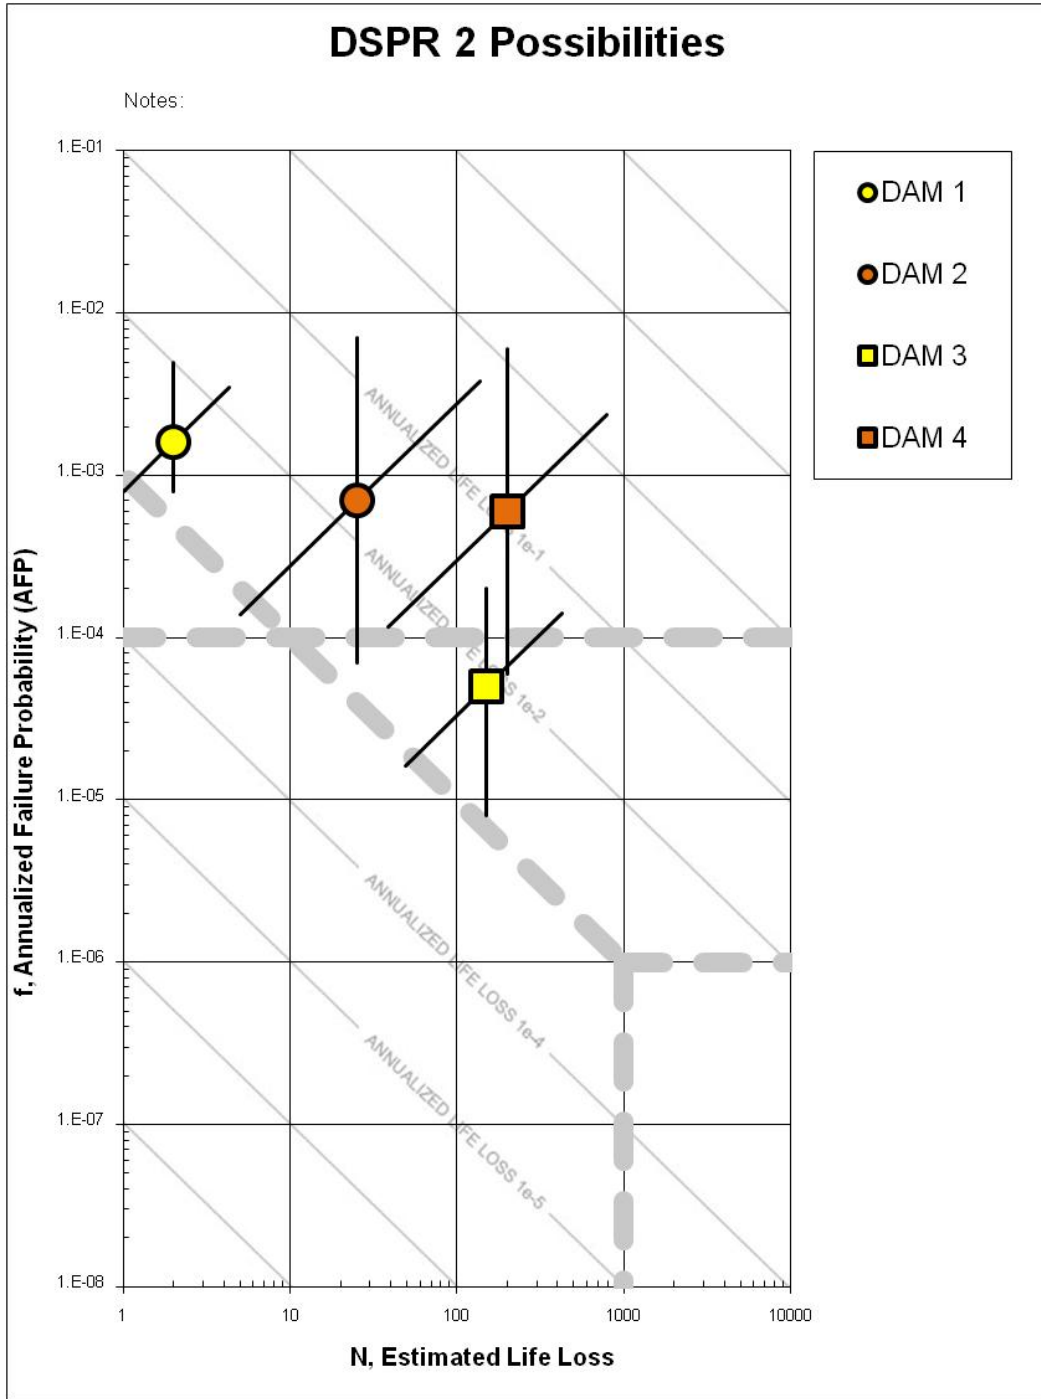
Figure 3. Potential DSPR 2 Dams

**DSPR 2 Possibilities (Figure 3)**

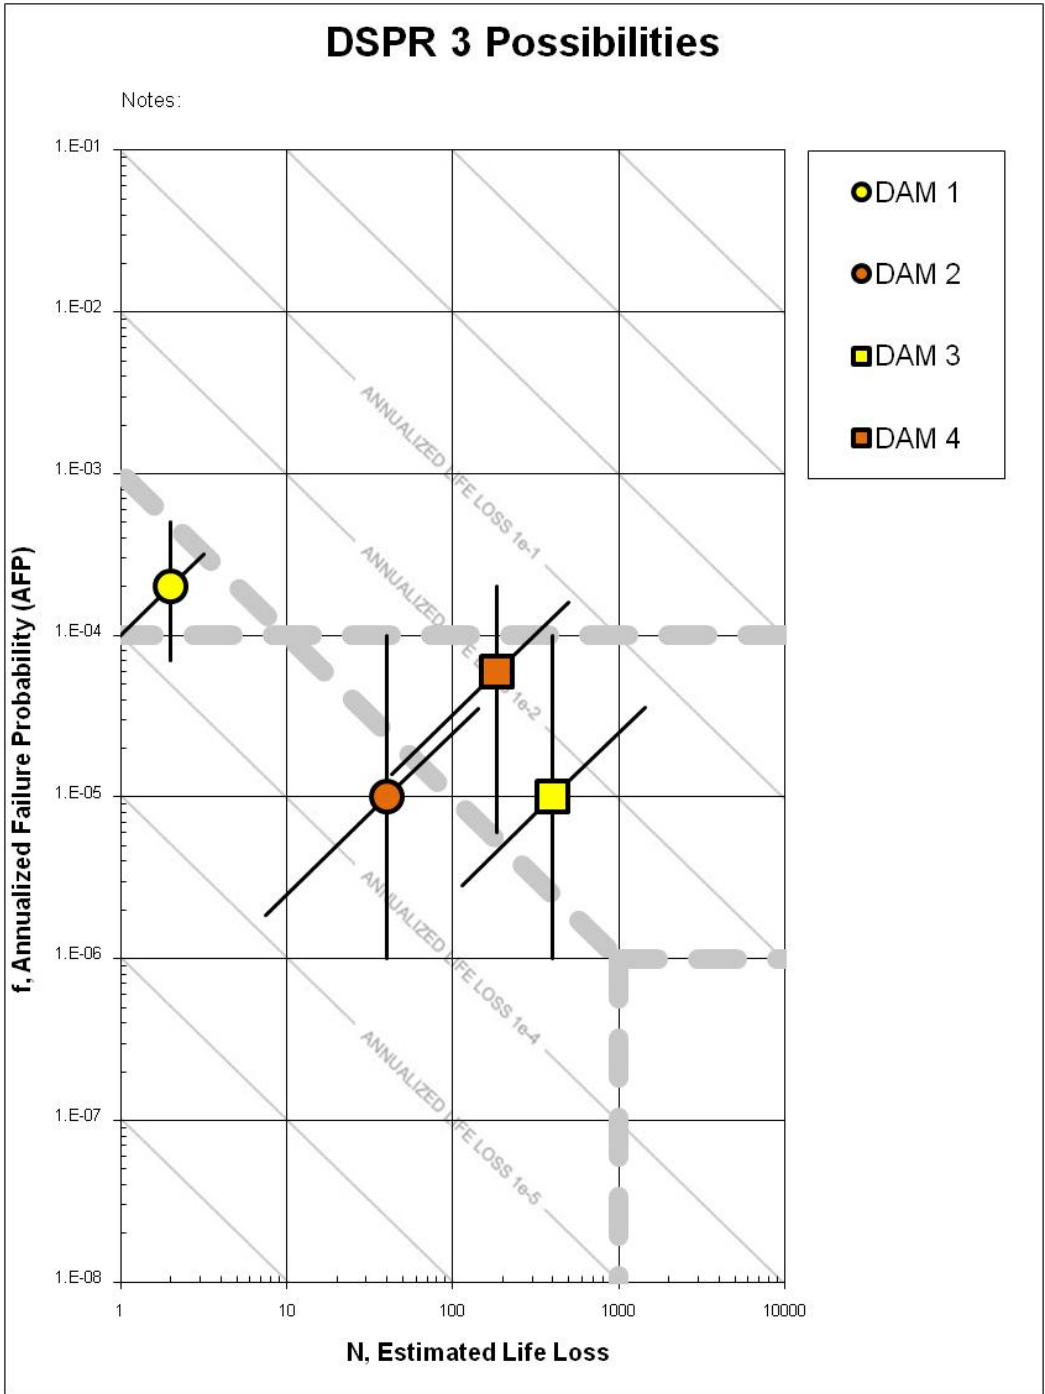
Figure 4. Potential DSPR 3 Dams

**DSPR 3 Possibilities (Figure 4)**

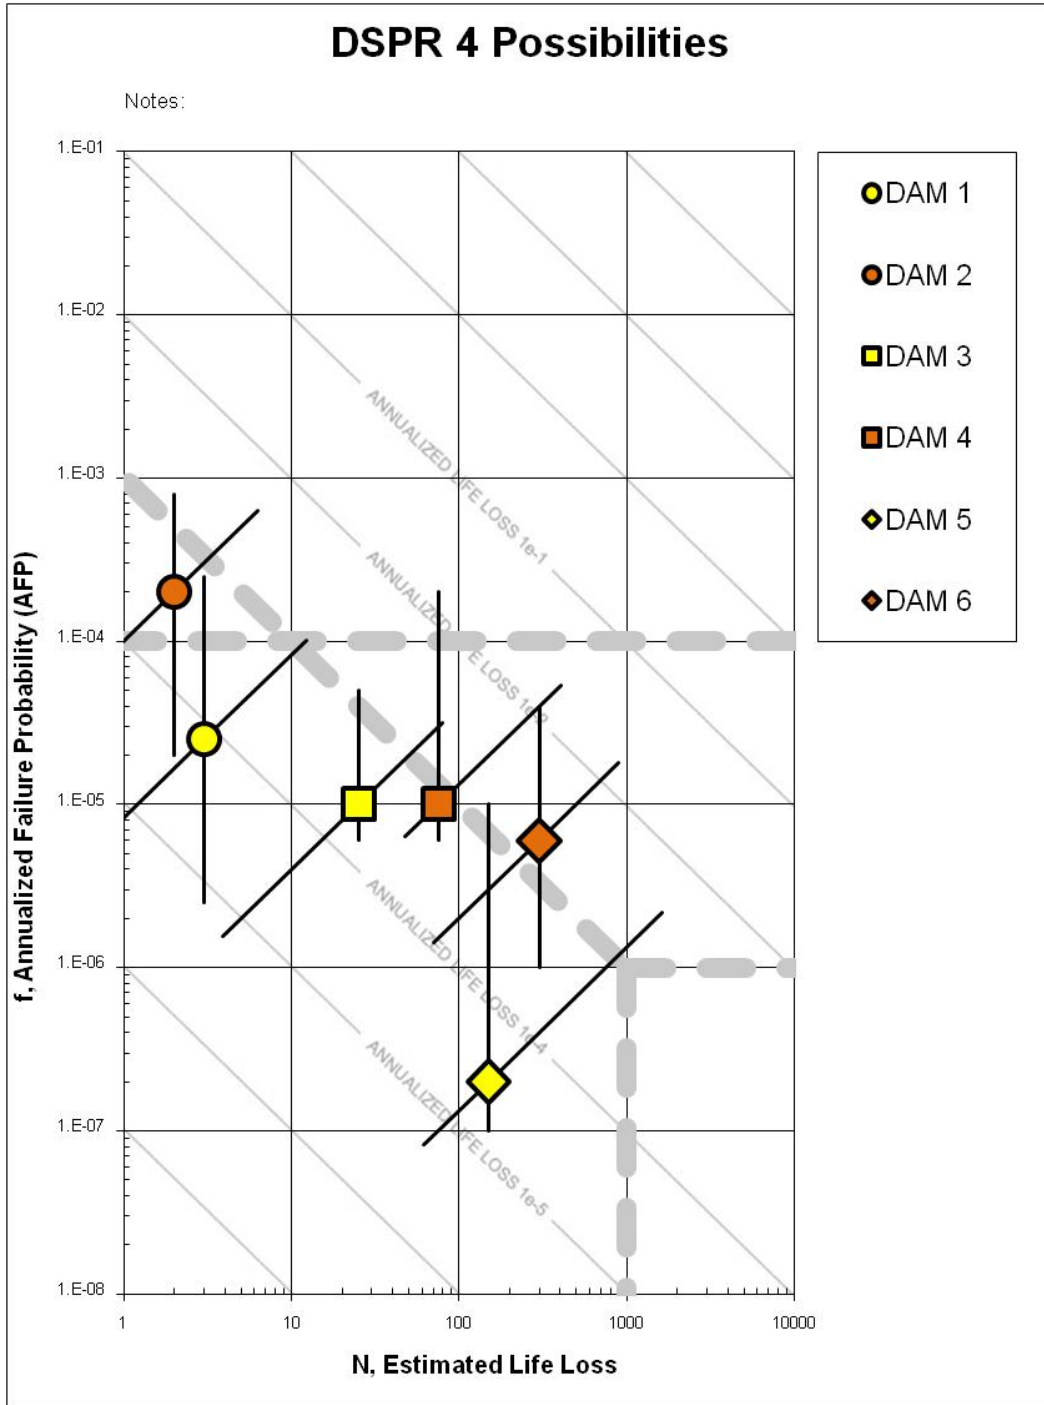
Figure 5. Potential DSPR 4 Dams

### **DSPR 4 Possibilities (Figure 5)**

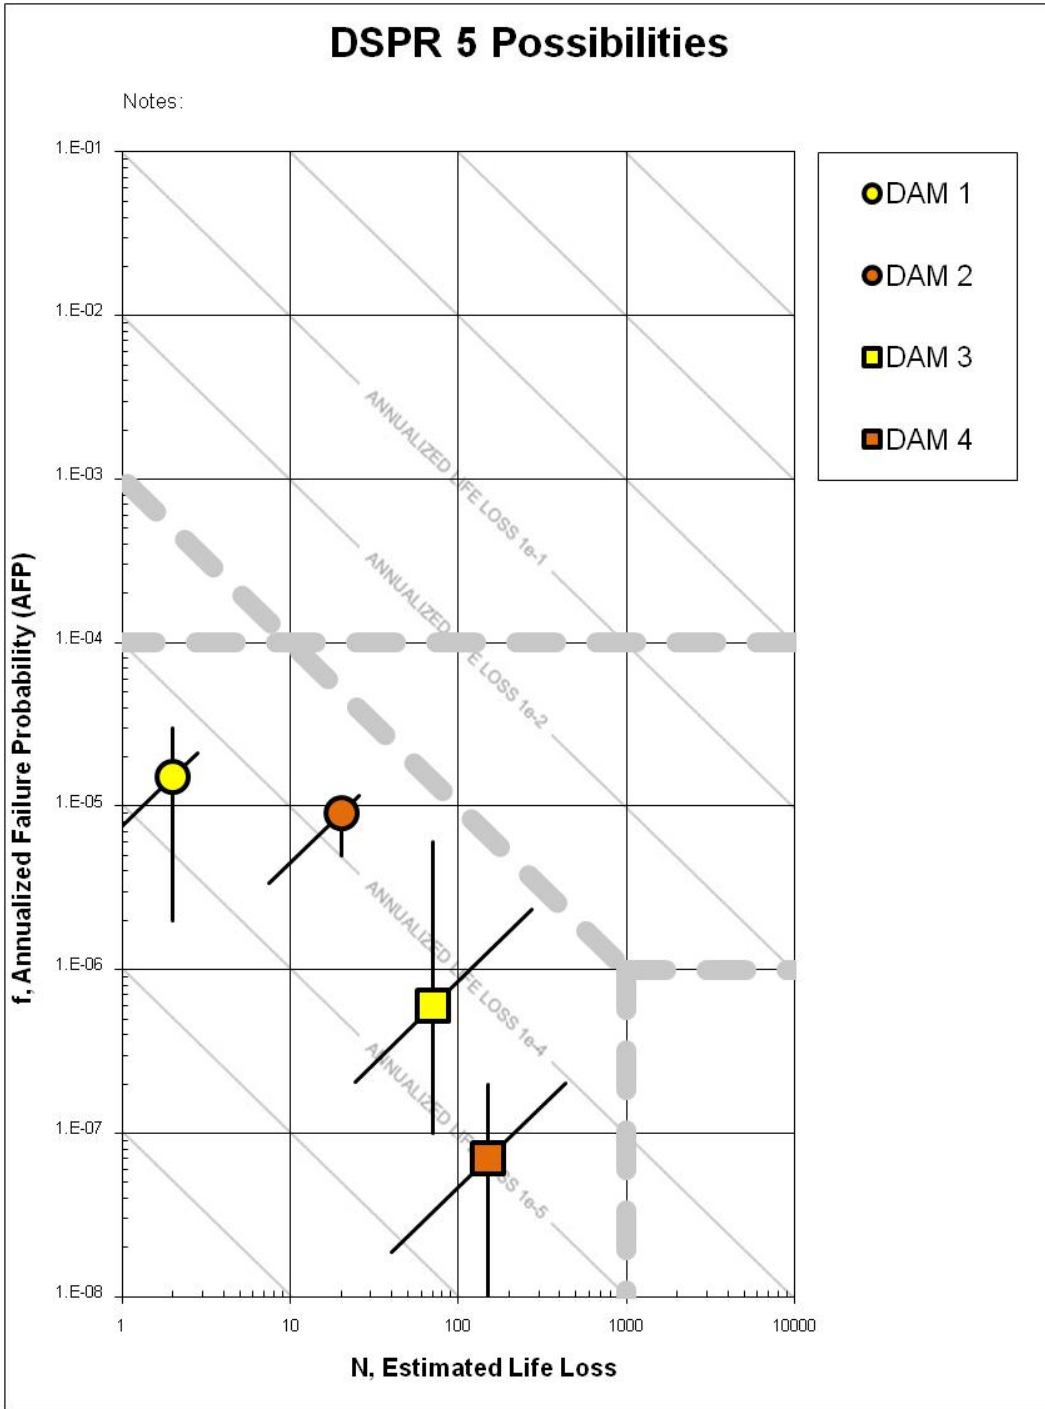
Figure 6. Potential DSPR 5 Dams

**DSPR 5 Possibilities (Figure 6)**

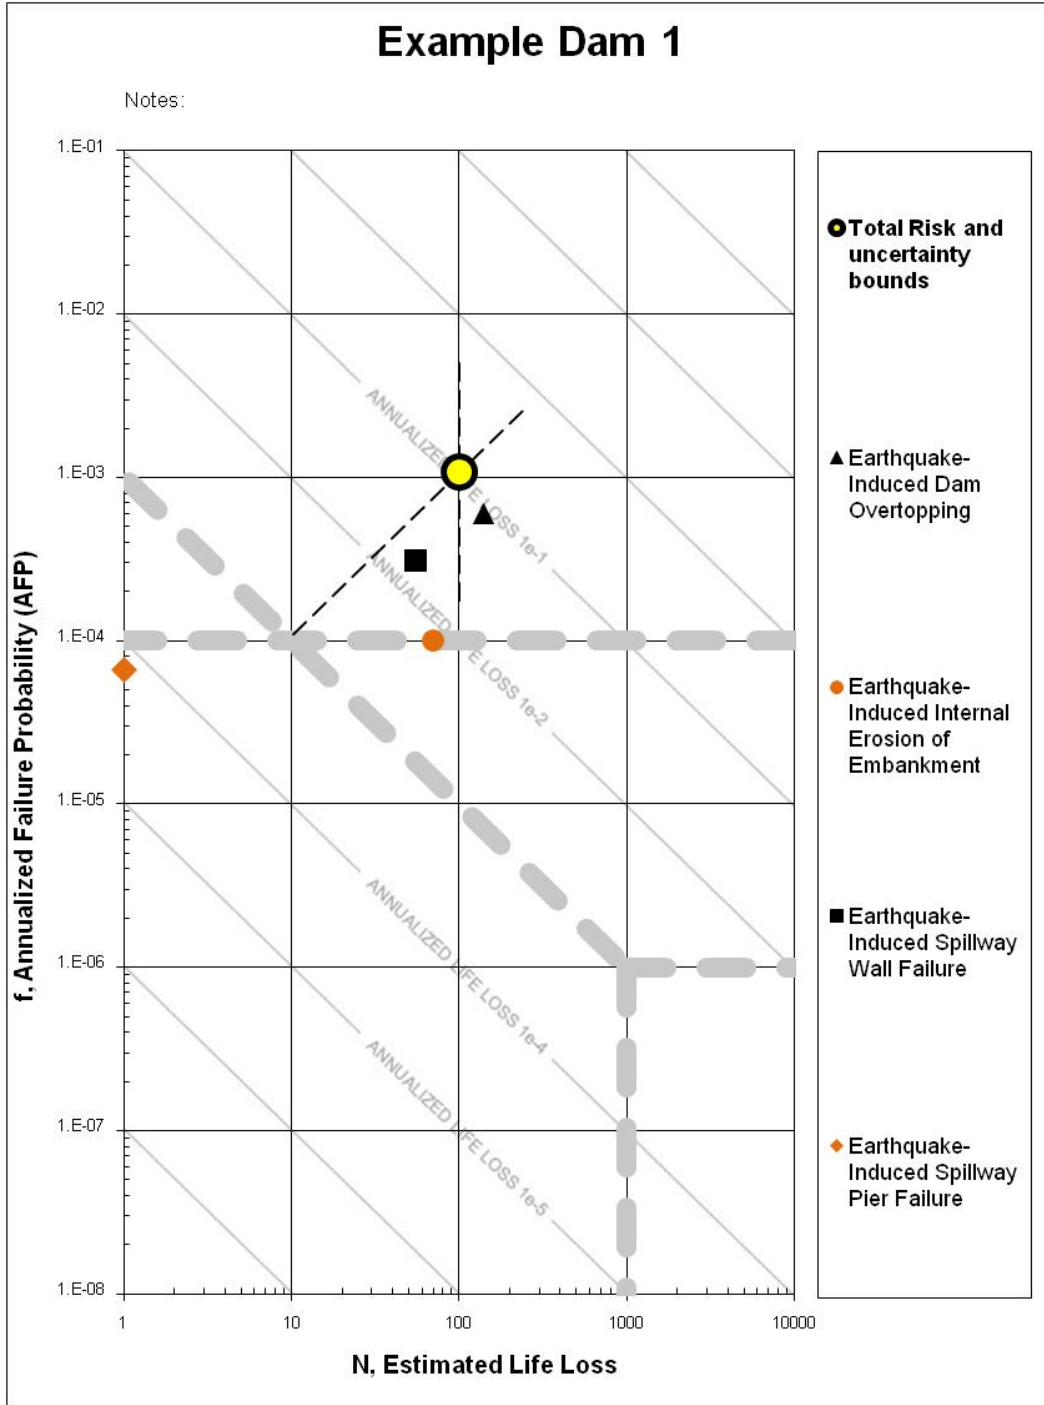
Figure 7. Risk Chart for Example 1

The estimated risks are tabulated in Table 3 and plotted on Figure 7.

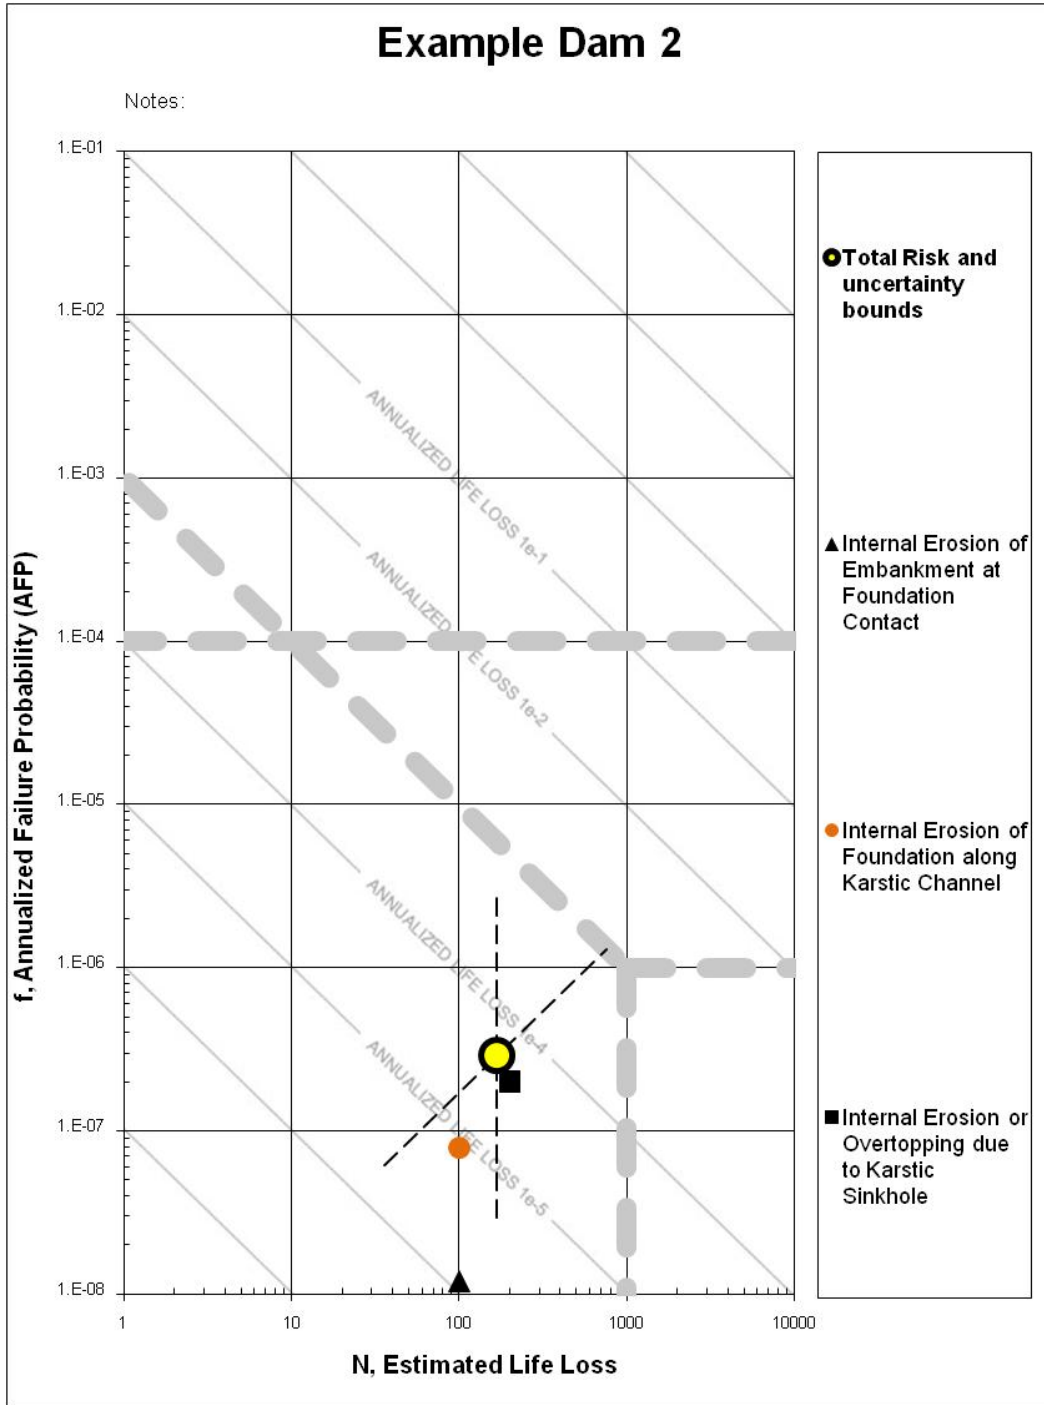
Figure 8. Risk Chart for Example 2

Risks were estimated in the CR using event trees and mean estimate probabilities for each node. As is typical for a CR, an order of magnitude range of uncertainty was assumed, and no Monte Carlo simulations were performed. The estimated risks are tabulated in Table 4 and plotted on Figure 8.

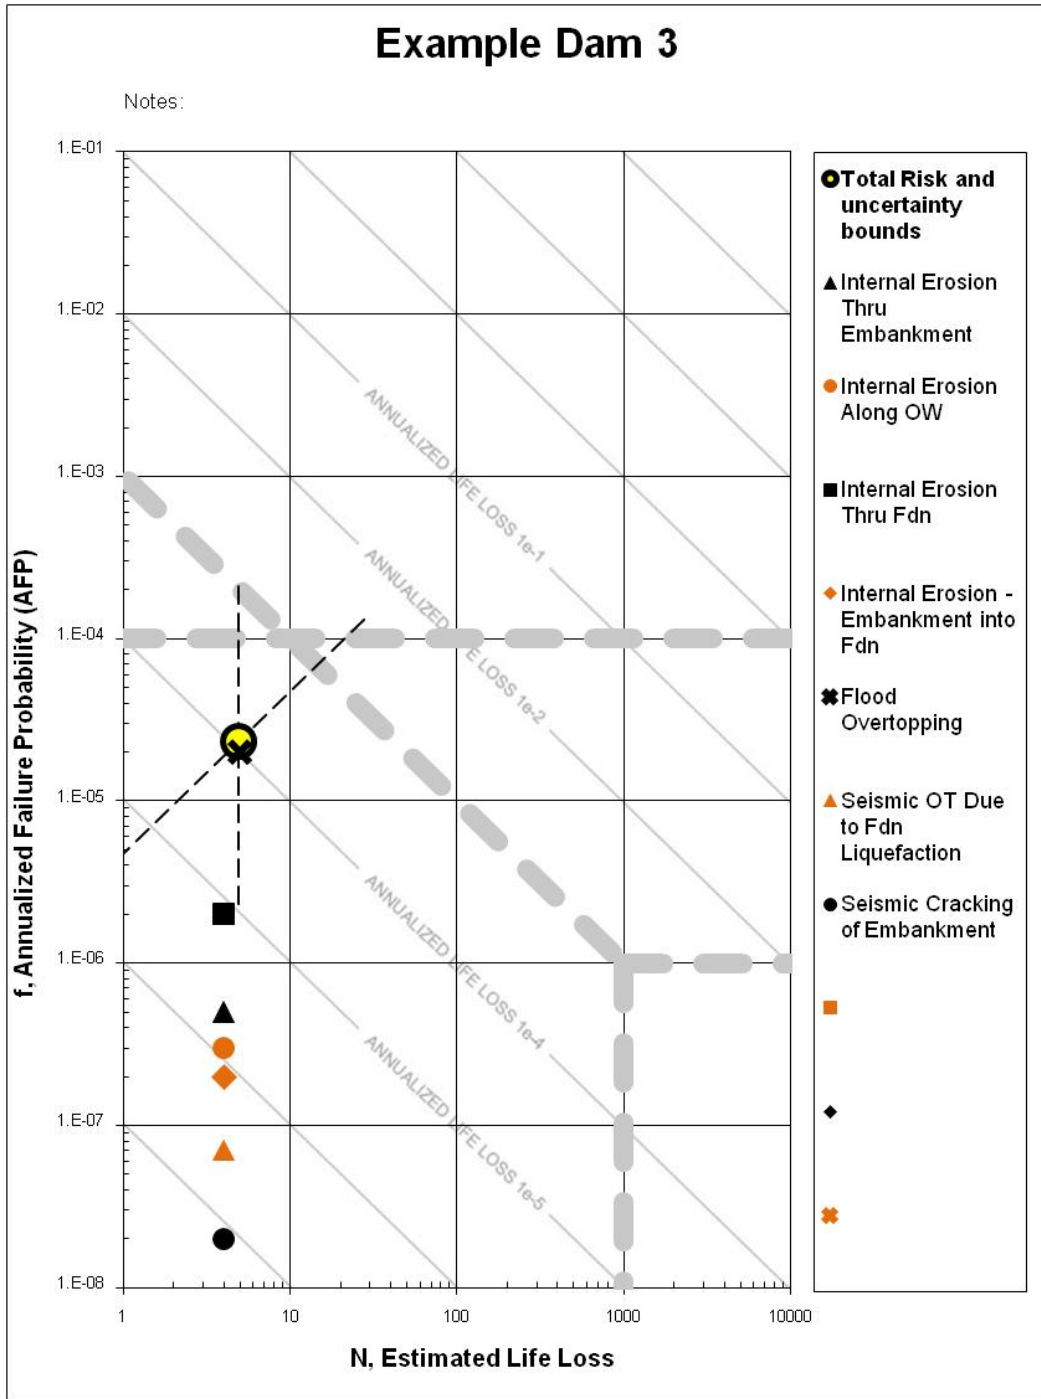
Figure 9. Risk Chart for Example 3

The risk estimates are summarized in Table 5 and Figure 9.

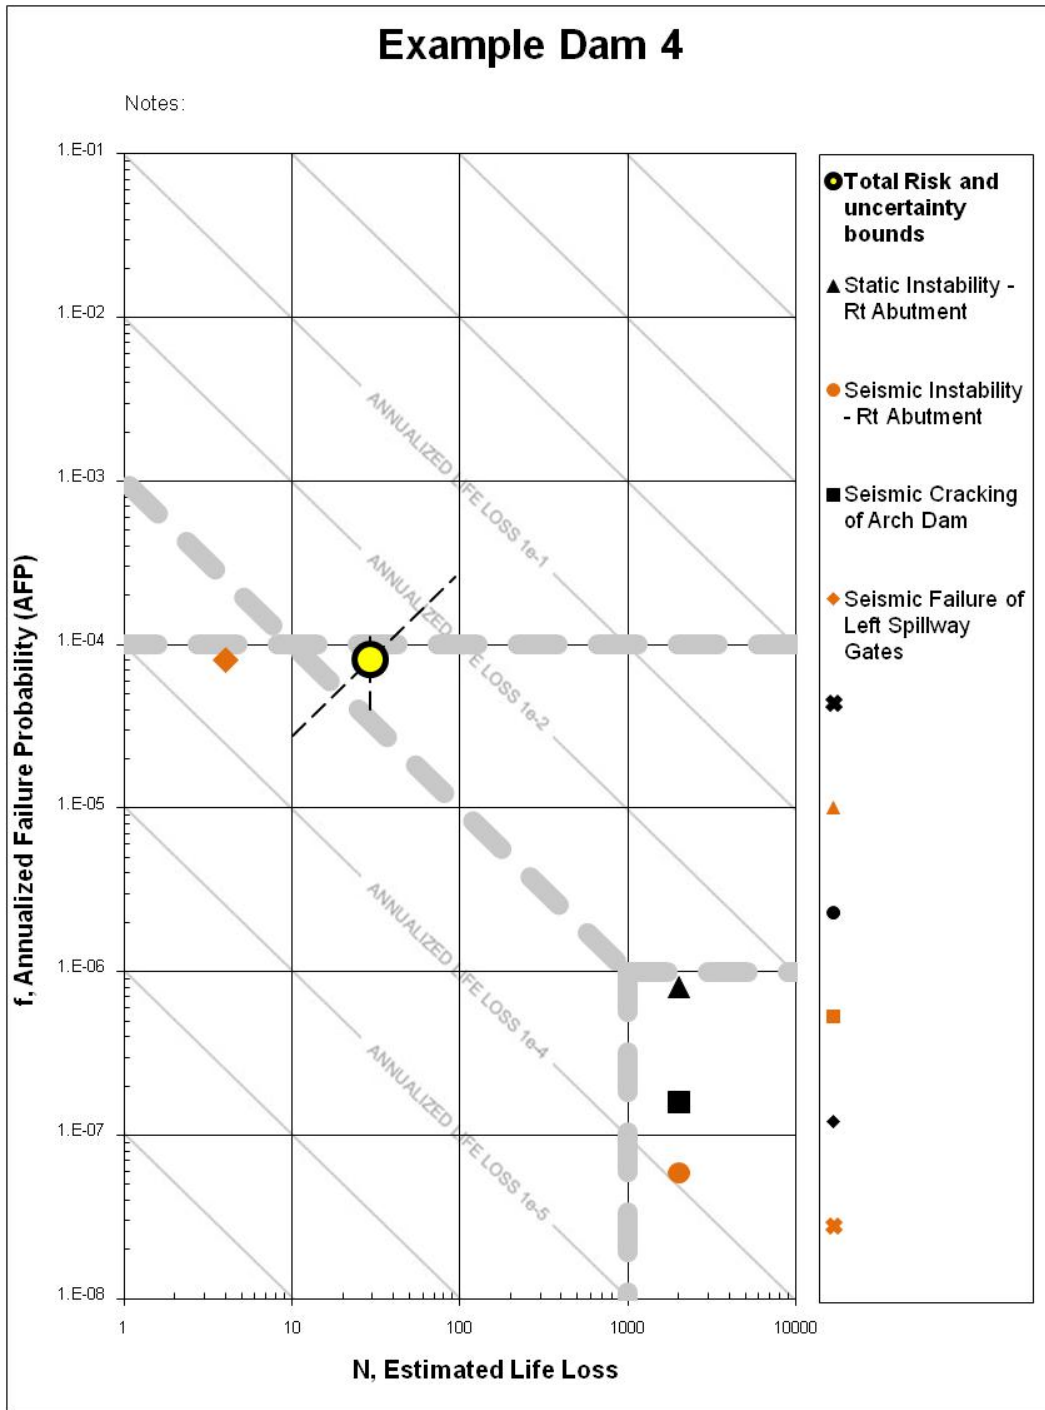
Figure 10. Risk Chart for Example 4

Risks were estimated by a team using typical Issue Evaluation event trees, group discussions and Monte Carlo simulations for PFM 1 and 2. Risk estimates for PFM 3 and 4 were adopted from the previous CR after a review by the Issue Evaluation risk analysis team. The risk estimates are summarized in Table 6 and Figure 10. This particular example is somewhat unique in that the total risk plotted on Figure 10 is a function of one failure mode (PFM 4) with a relatively high annualized failure probability and low life loss and a second failure mode (PFM 1) with a relatively low annualized failure probability but a high life loss. The resulting total risk plots between these two failure modes with a computed life loss not specifically related to either failure mode. In these cases, it becomes particularly important to look at the individual failure modes.

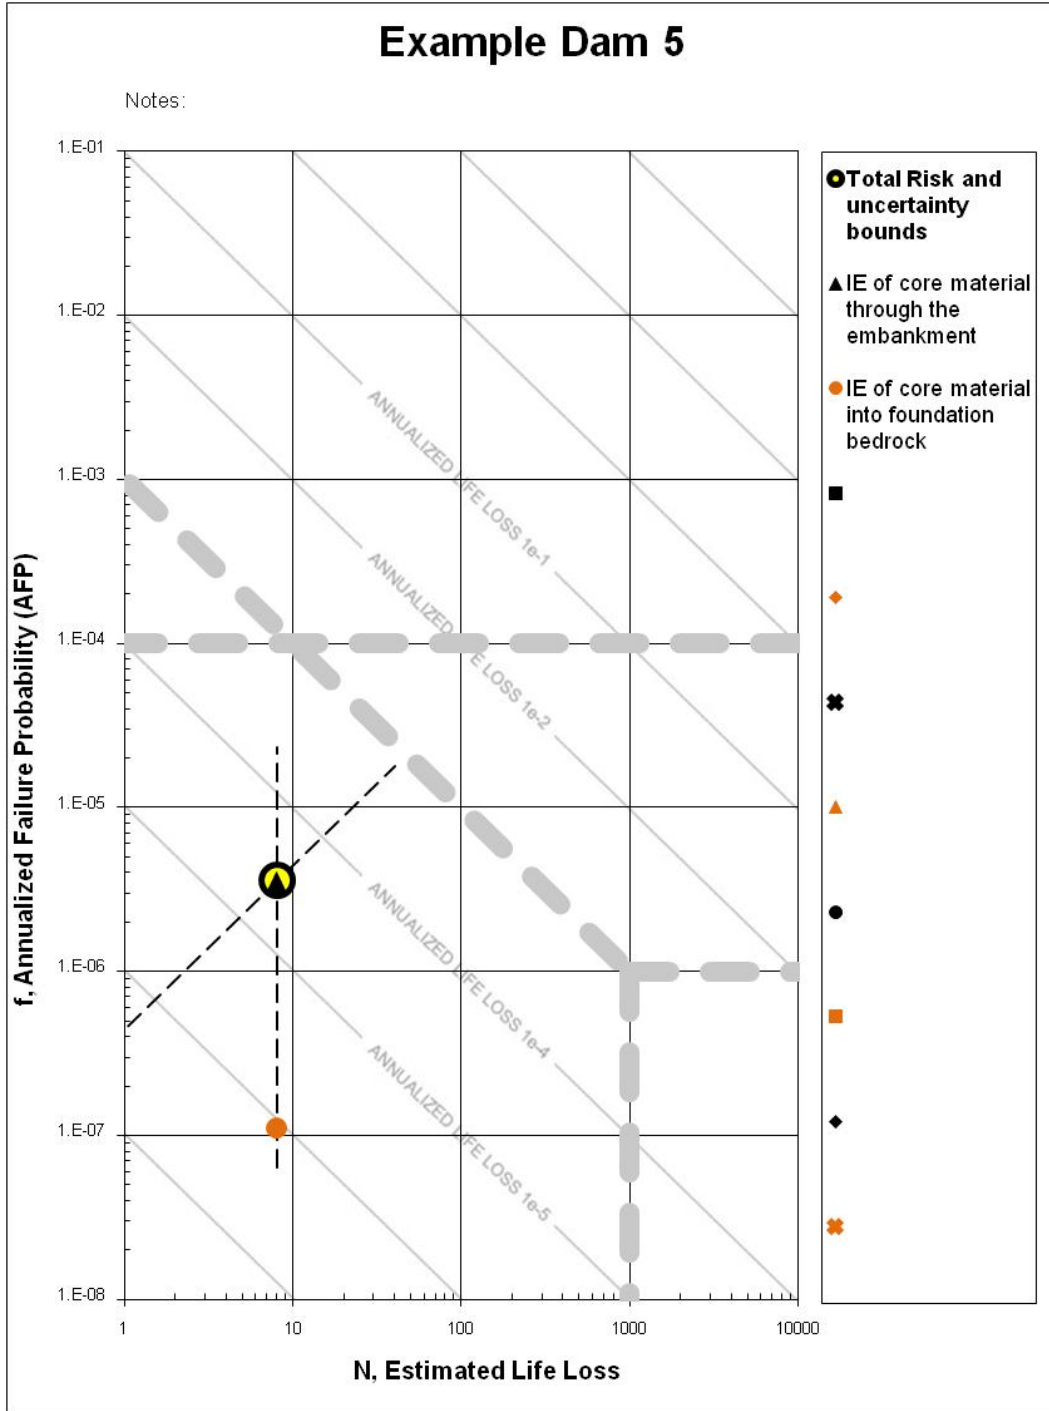
Figure 11. Risk Chart for Example 5

Risks were estimated by the Senior Engineer using a seven node event tree, slightly modified from the standard Best Practices [1] internal erosion event tree. Best estimate probabilities were assigned to each node; uncertainty was estimated but no Monte Carlo simulations were performed. The estimated risks are tabulated in Table 7 and plotted on Figure 11.

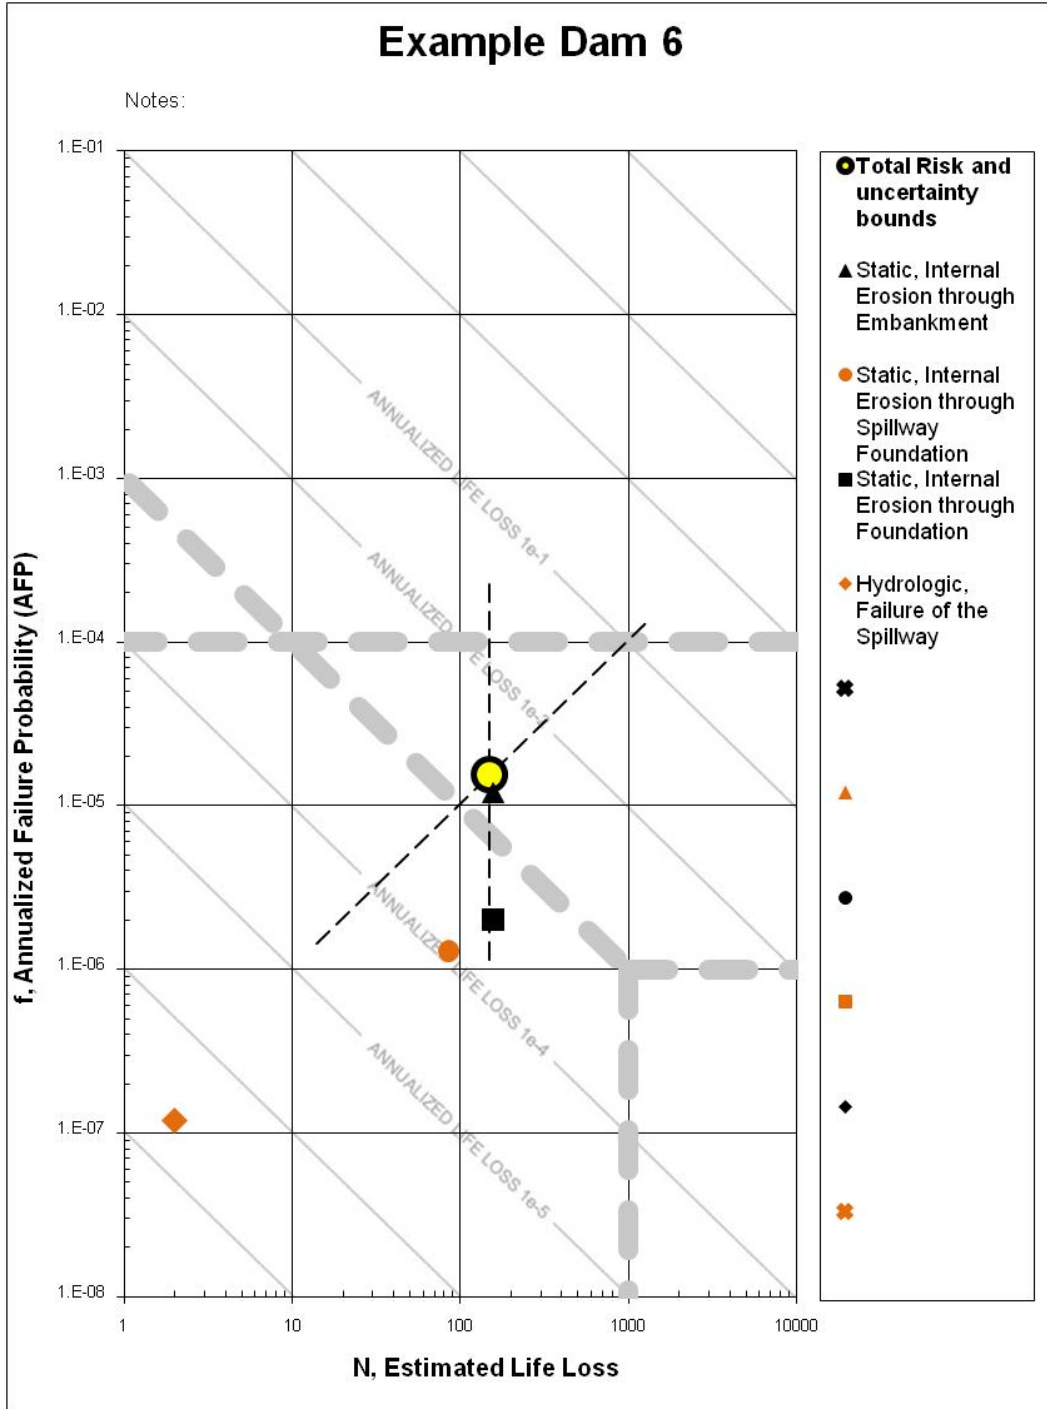
Figure 12. Risk Chart for Example 6

Internal erosion risks were estimated by the Senior Engineer using a seven node event tree, slightly modified from the standard Best Practices [1] internal erosion event tree. Water surface profiles were developed and hydraulic jacking calculations were performed to evaluate the factor of safety against slab jacking. Spillway failure risks were estimated using the flood frequency and slab jacking calculation results. Best estimate probabilities were assigned to each node; uncertainty was estimated but no Monte Carlo simulations were performed. The estimated risks are tabulated in Table 8 and plotted on Figure 12.

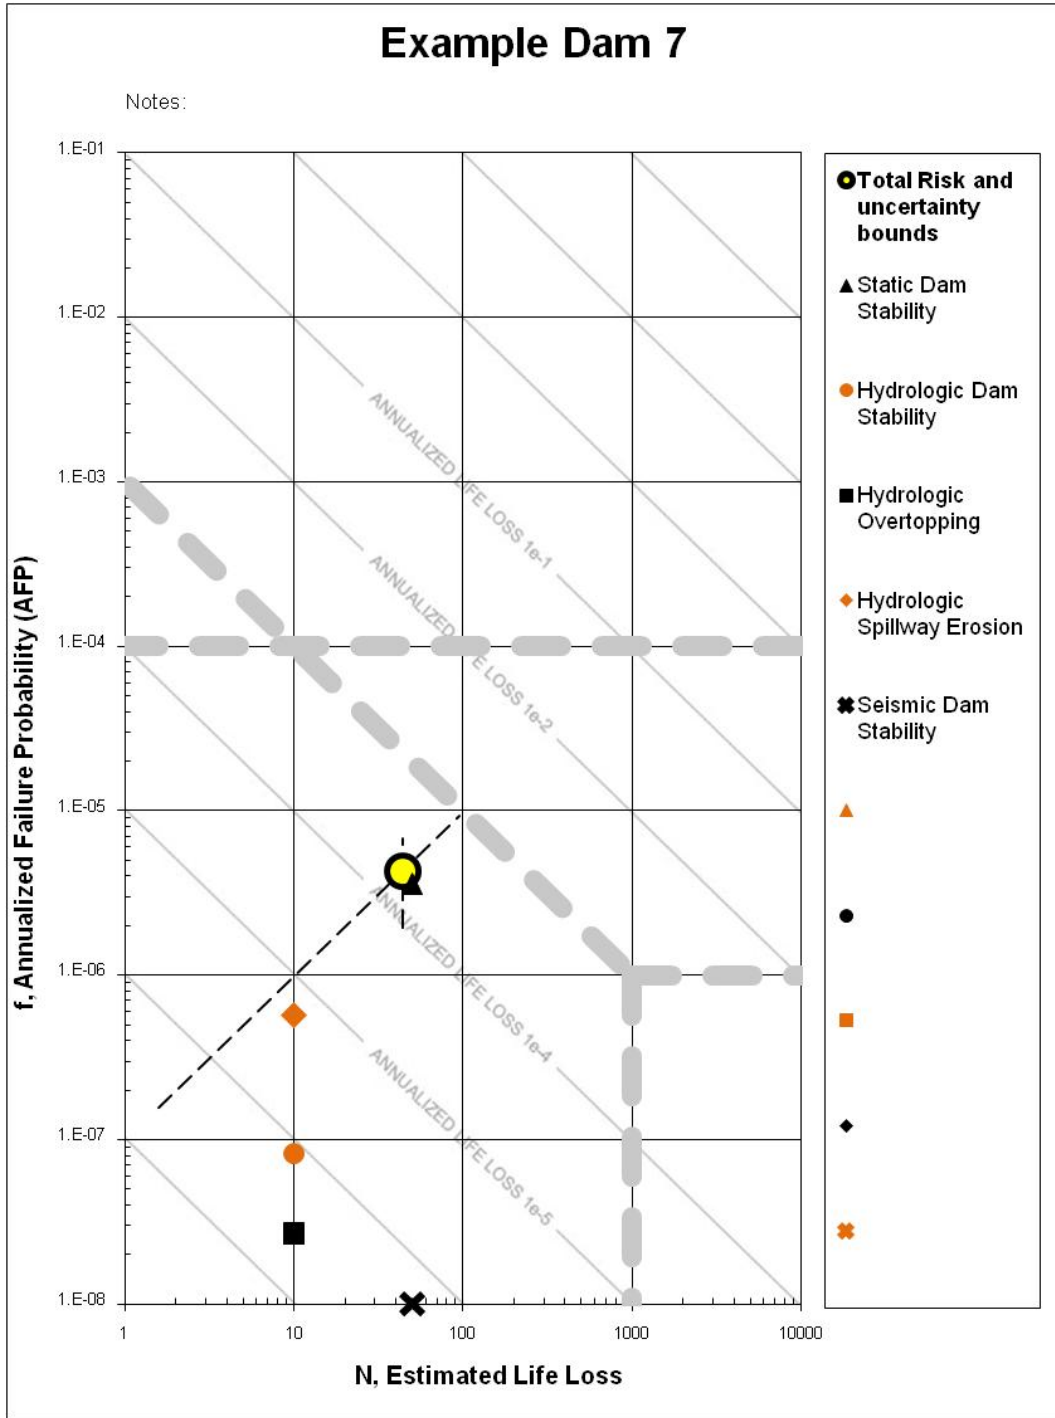
Figure 13. Risk Chart for Example 7

Risks were estimated in the CR using event trees and mean estimate probabilities for each node. As is typical for a CR, best estimate probabilities were assigned to each node; uncertainty was estimated but no Monte Carlo simulations were performed. The estimated risks are tabulated in Table 9 and plotted on Figure 13.

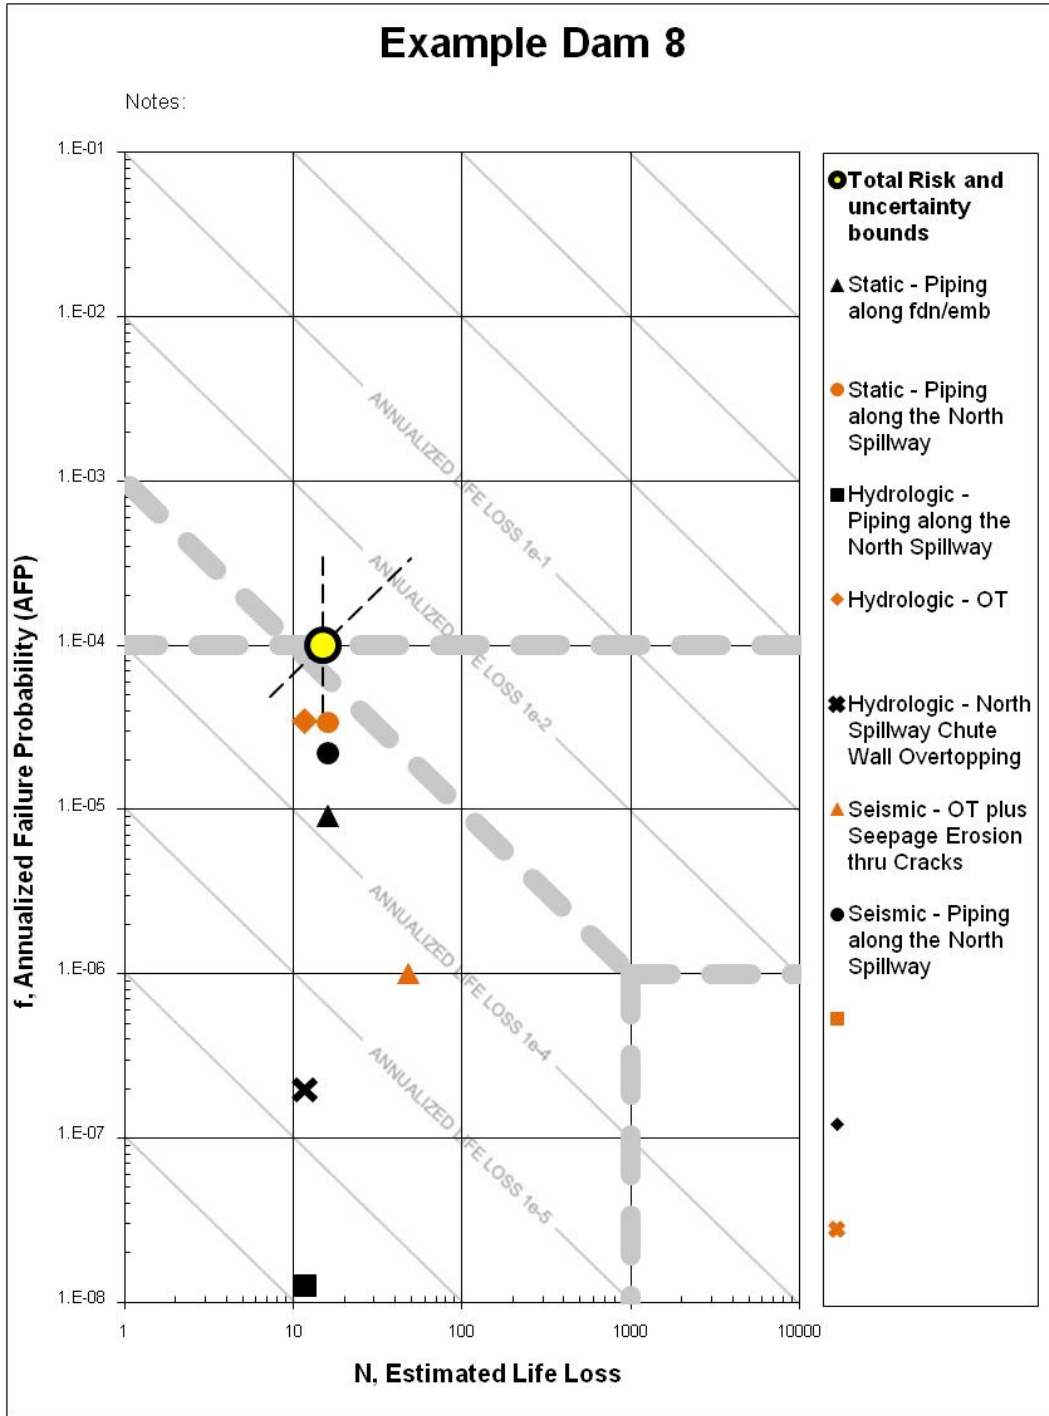
Figure 14. Risk Chart for Example 8

The risk estimates are summarized in Table 10 and Figure 14.

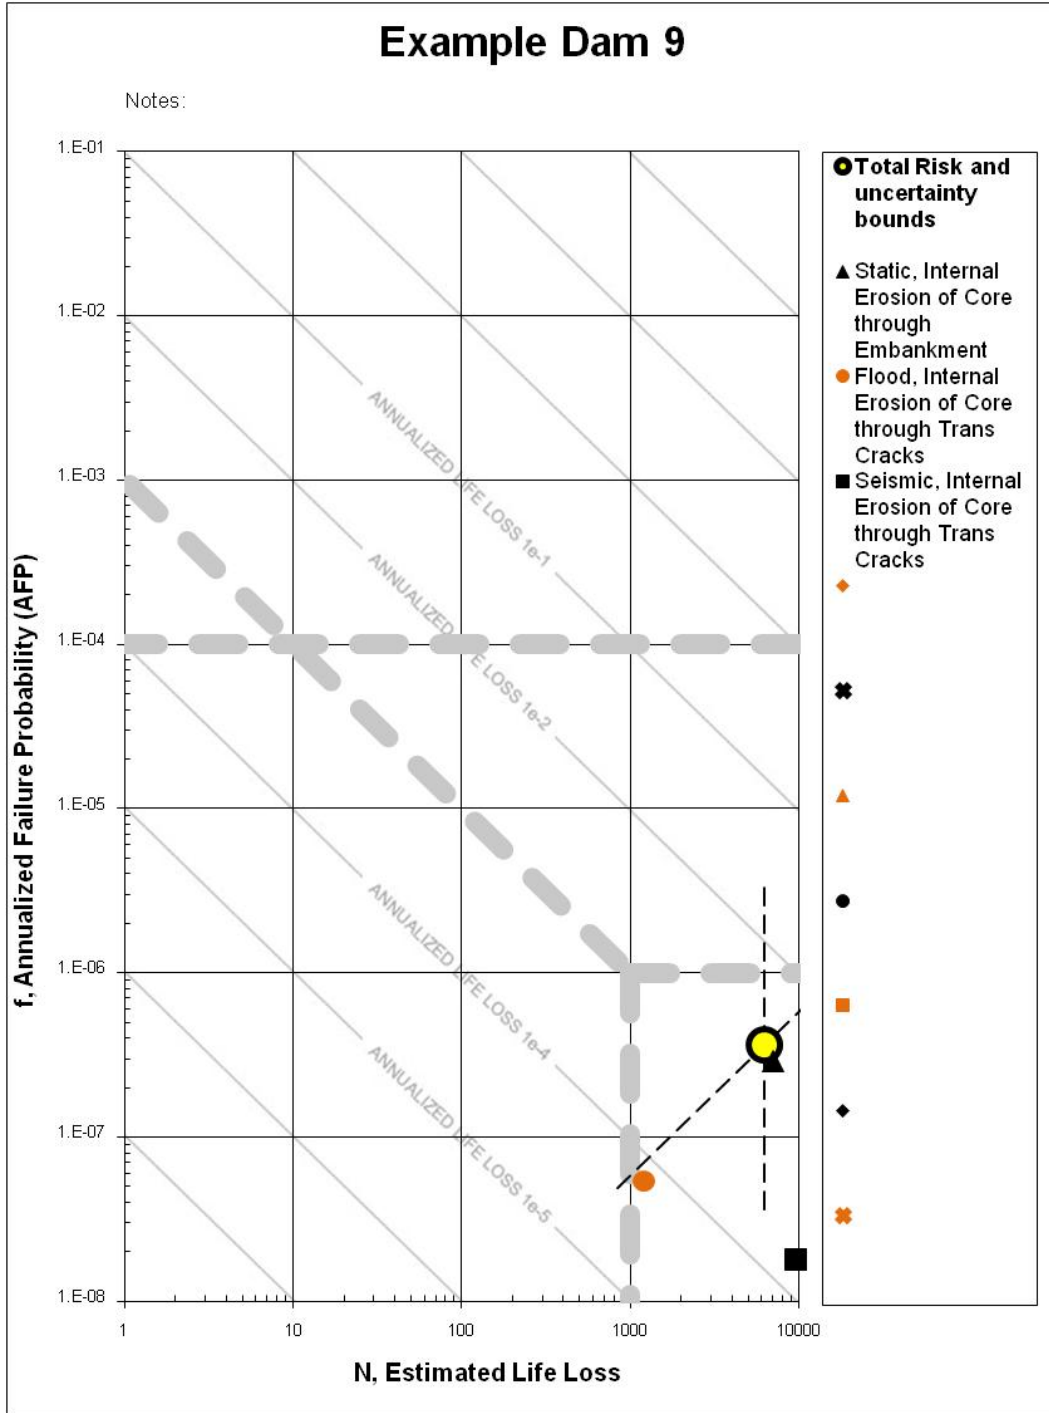
Figure 15. Risk Chart for Example 9

Internal erosion risks were estimated by the Senior Engineer using an eight node event tree, based on the standard Best Practices [1] internal erosion event tree. The risk analysis focused on two main issues; the probability that a defect exists where internal erosion could initiate, and the probability that zone 2 fails to filter either the zone 1 core or the zone 2A transition. For the static and flood conditions, the existing defect was judged to be related to transverse cracking through the core caused by settlement. For the seismic failure mode, shaking could cause settlement and cracking leading to internal erosion. Best estimate probabilities were assigned to each node; an order of magnitude uncertainty was assumed and no Monte Carlo simulations were performed. As indicated by the values in Table 11, the estimated probabilities of failure are very low – judged to be near the lower limit of what can be reasonably estimated. The large PAR results in a large potential loss of life. Overall, total risk and individual failure mode risks are in the area where ALARP considerations should be addressed, as shown on Figure 15.
