# Wood Pole Lines

## Sustain Program

### Asset Management Strategy

Rob Ochs, Program Manager  
March 2012

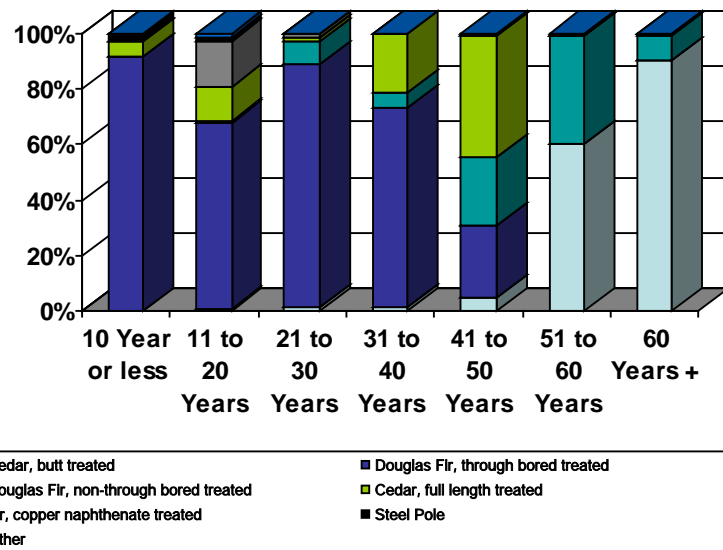
% Pole Type by Age Classification

Pole Mix as of 12/31/2011	Cedar, butt treated	Douglas Fir, through bored treated	Douglas Fir, non-through bored treated	Cedar, full length treated	Fir, copper naphthenate treated	Steel Pole	Other	12/31/2011 Total	9/30/2009 Total	Change
10 Year or less	47	17,658	36	1,001	20	466	34	19,262	16,248	3,014
11 to 20 Years	67	4,539	41	853	1,135	51	114	6,800	4,830	1,970
21 to 30 Years	180	11,238	1,037	202	149	1	7	12,814	13,592	(778)
31 to 40 Years	122	5,878	451	1,707	2	-	14	8,174	8,926	(752)
41 to 50 Years	482	2,472	2,444	4,205	5	-	82	9,690	10,246	(556)
51 to 60 Years	5,997	6	3,894	24	2	-	68	9,991	13,749	(3,758)
60 Years +	6,406	10	644	17	-	20	4	7,101	6,227	874
<b>Total</b>	<b>13,301</b>	<b>41,801</b>	<b>8,547</b>	<b>8,009</b>	<b>1,313</b>	<b>538</b>	<b>323</b>	<b>73,832</b>	<b>73,818</b>	<b>14</b>

Status on 9/30/2009	16,496	37,300	9,335	8,233	1,422	530	502	73,818		
Change	(3,195)	4,501	(788)	(224)	(109)	8	(179)	14

- Approximately 74,000 wood poles on 4,775 miles of wood pole transmission lines
- Expected service life of 60 years
- 10% of wood poles exceed 60 years of age (over 7,100 poles). This is an increase from 2 years ago. Older poles tend to be butt treated cedar
- Pole strength and capability declines with age
- Loss of 1/3 of original strength = need to replace-pole no longer meets standards
- Since September 2009, approximately 4500 wood poles have been replaced on the BPA system.

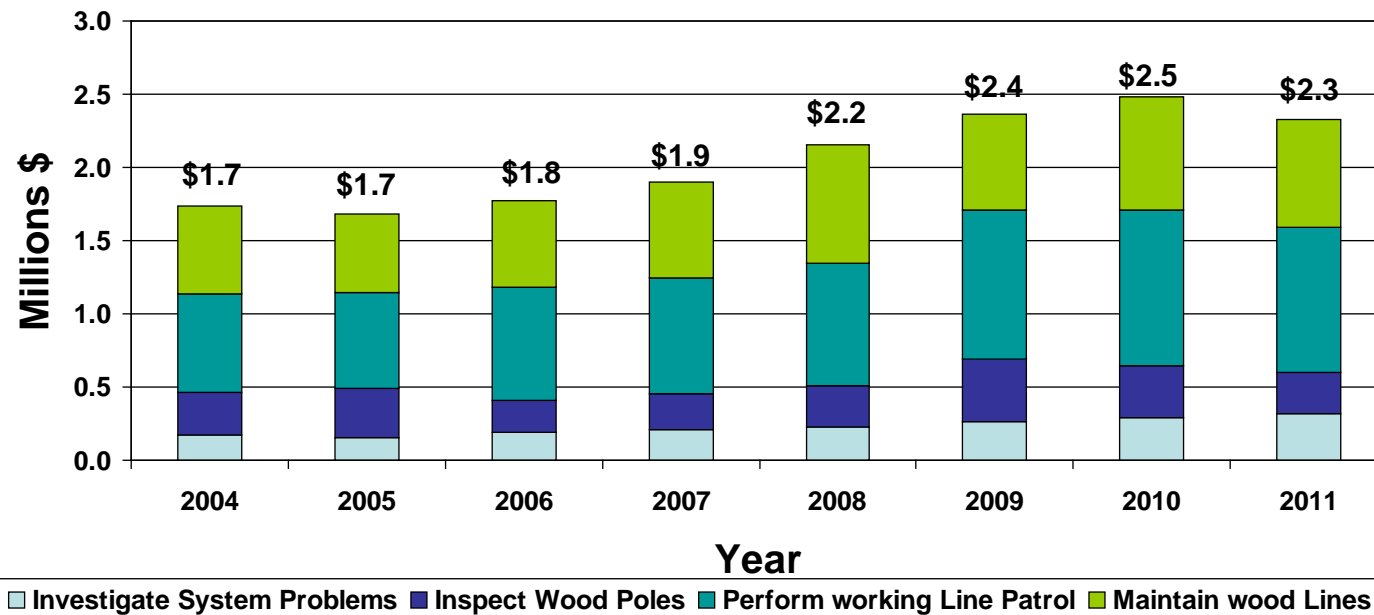
### Wood Lines Maintenance Expense FY 2004 - 2011, by type

- Annual maintenance costs for 4775 miles of wood transmission line – FY 2004 through FY 2011

- A major component of this cost is labor hours, to inspect and maintain these lines. Costs exclude right-of-way maintenance, access roads and vegetation management.
- The strategy for these lines, as well as steel, includes improvements in asset information – component condition, line performance and cost.

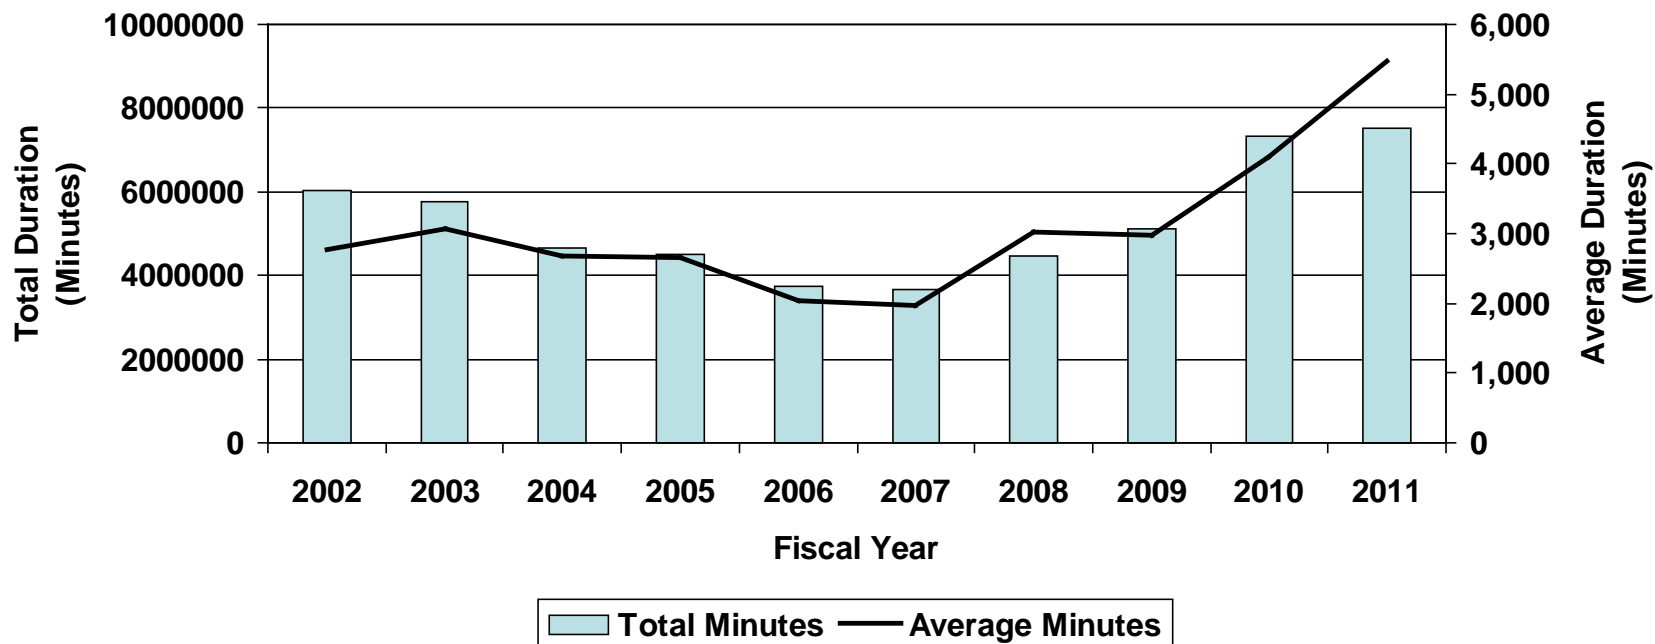
### Planned Maintenance & Construction Outage Trends\*

- To address the aging asset issue, planned line outages went up significantly in FY 2010 and 2011 for critical maintenance work and line rebuild/construction.
- Prior to FY 2010, the majority of the planned outages were for maintenance type activities. With the plan to rebuild approximately 150 miles of wood lines each year BPA expects this trend will level off and continue until line rebuild activity declines.

\* Note: Chart includes all lines 230 kV and less

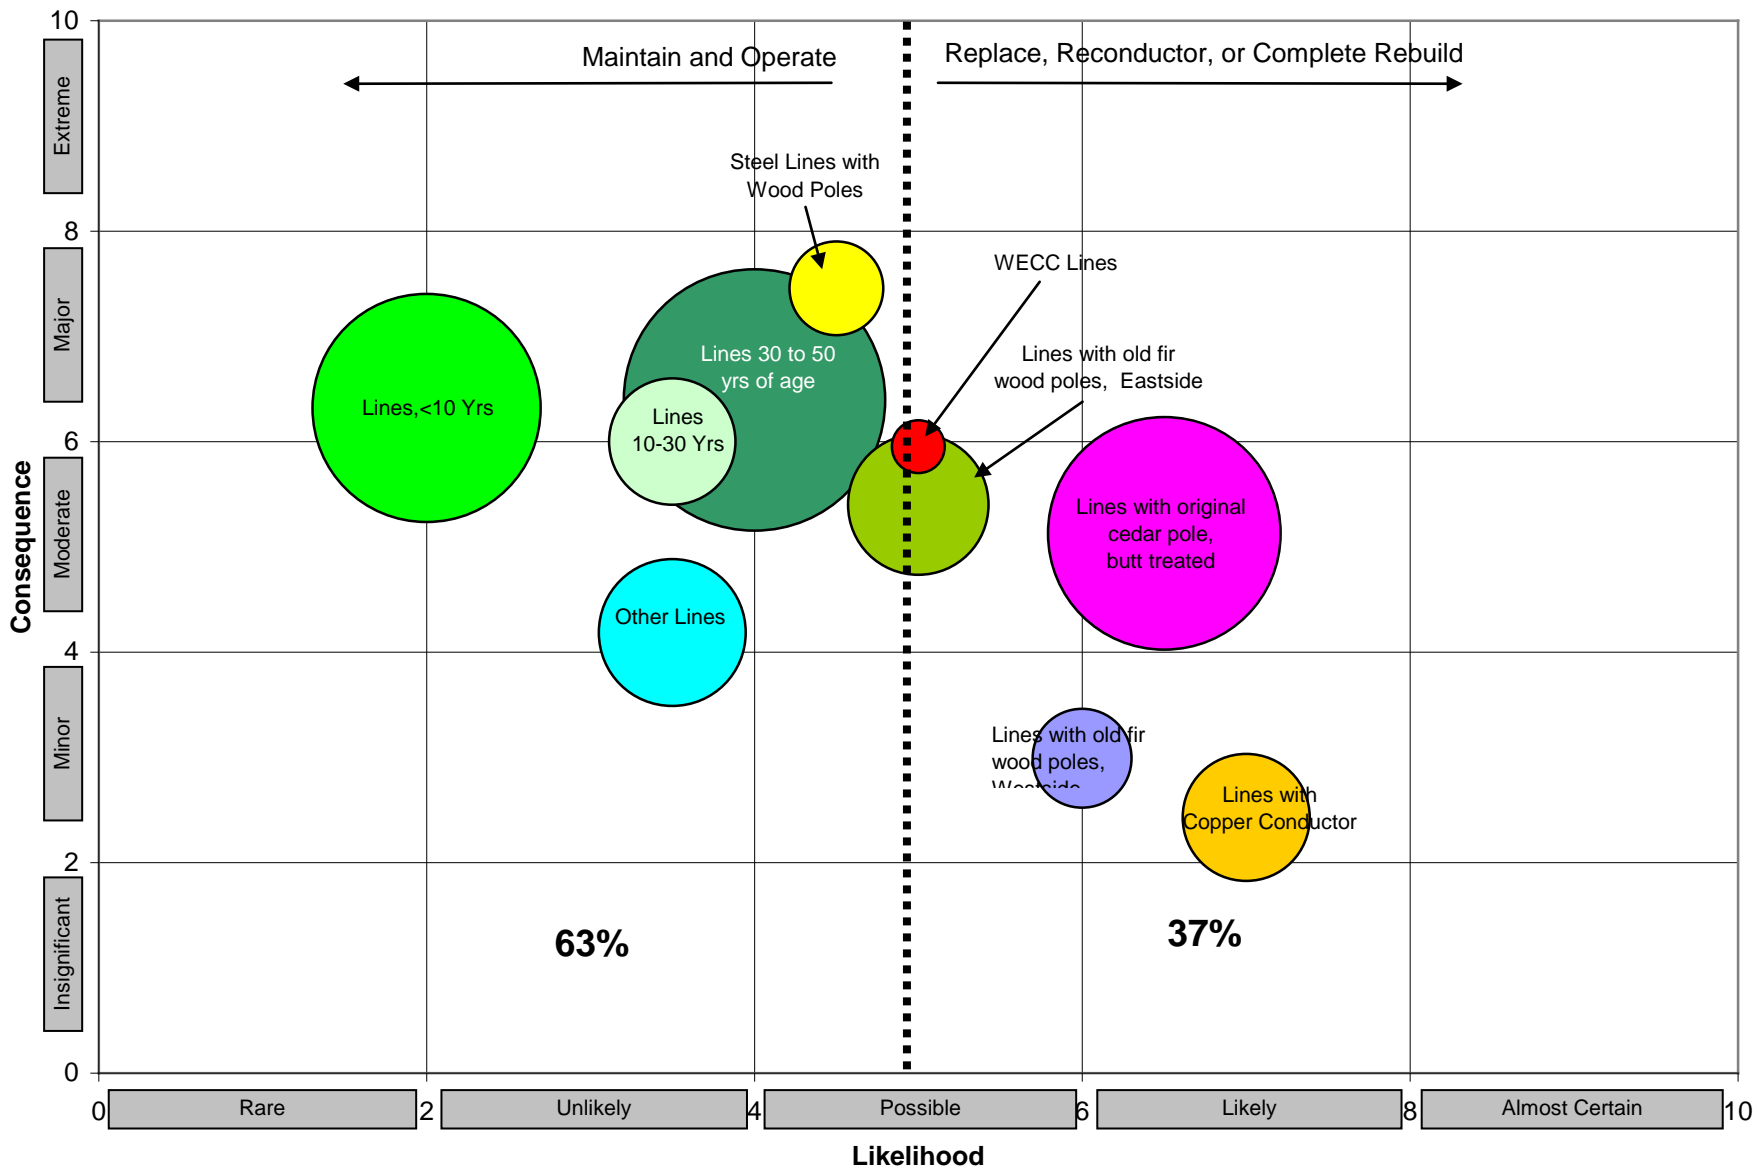
# Future State Risk Map (FY 2030)

(Bubble size represents volume of poles in each grouping)
