Status of NHTSA's Research on Occupant Protection in Rollovers

NHTSA / GM Research Meeting
March 29, 2006

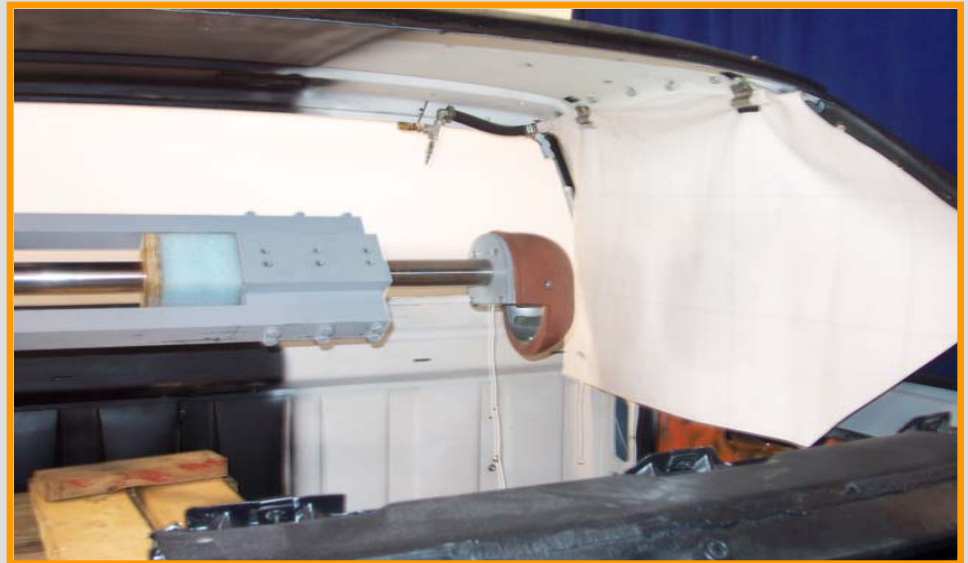
Ejection Mitigation Guided Impactor

- **18 kg Mass**
- **Featureless Headform**
 - Average of front & side of head geometries
 - More uniform shape
- **Measures Displacement**
- **Positioned Inside Vehicle**
- **Impact a Variety of Locations**

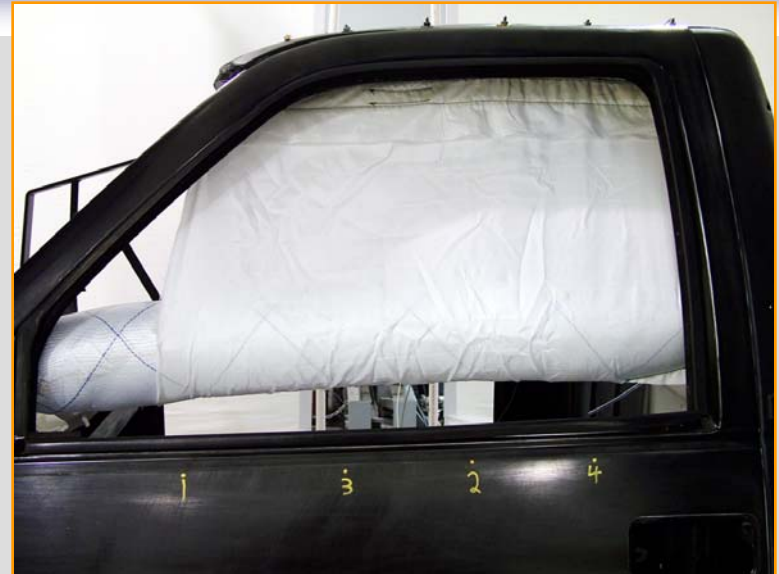
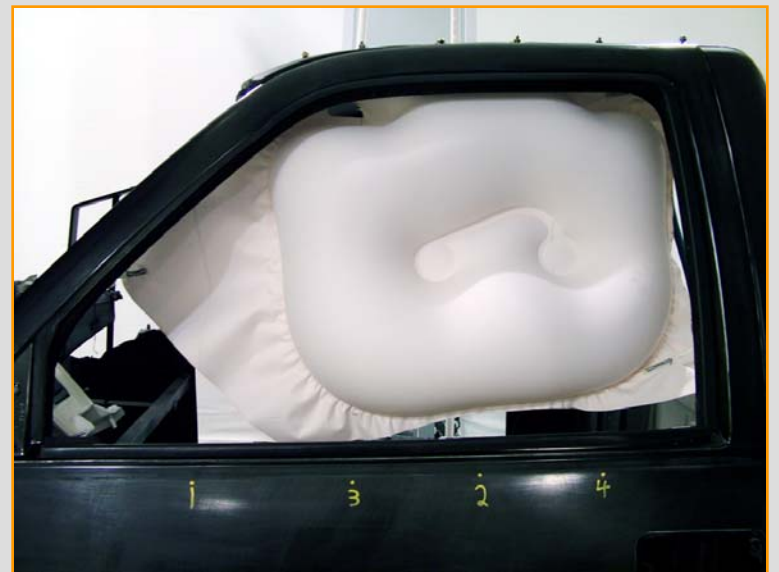
Ejection Mitigation Systems Evaluated on C/K Platform

- **Inflatable Systems**
 - Modified Advanced Head Protection System (AHPS)
 - Zodiac Automotive US
 - Prototype Window Curtain
 - TRW Automotive
- **Inflatable/Laminated Glazing Combination**
 - Less door frame modifications than glazing alone

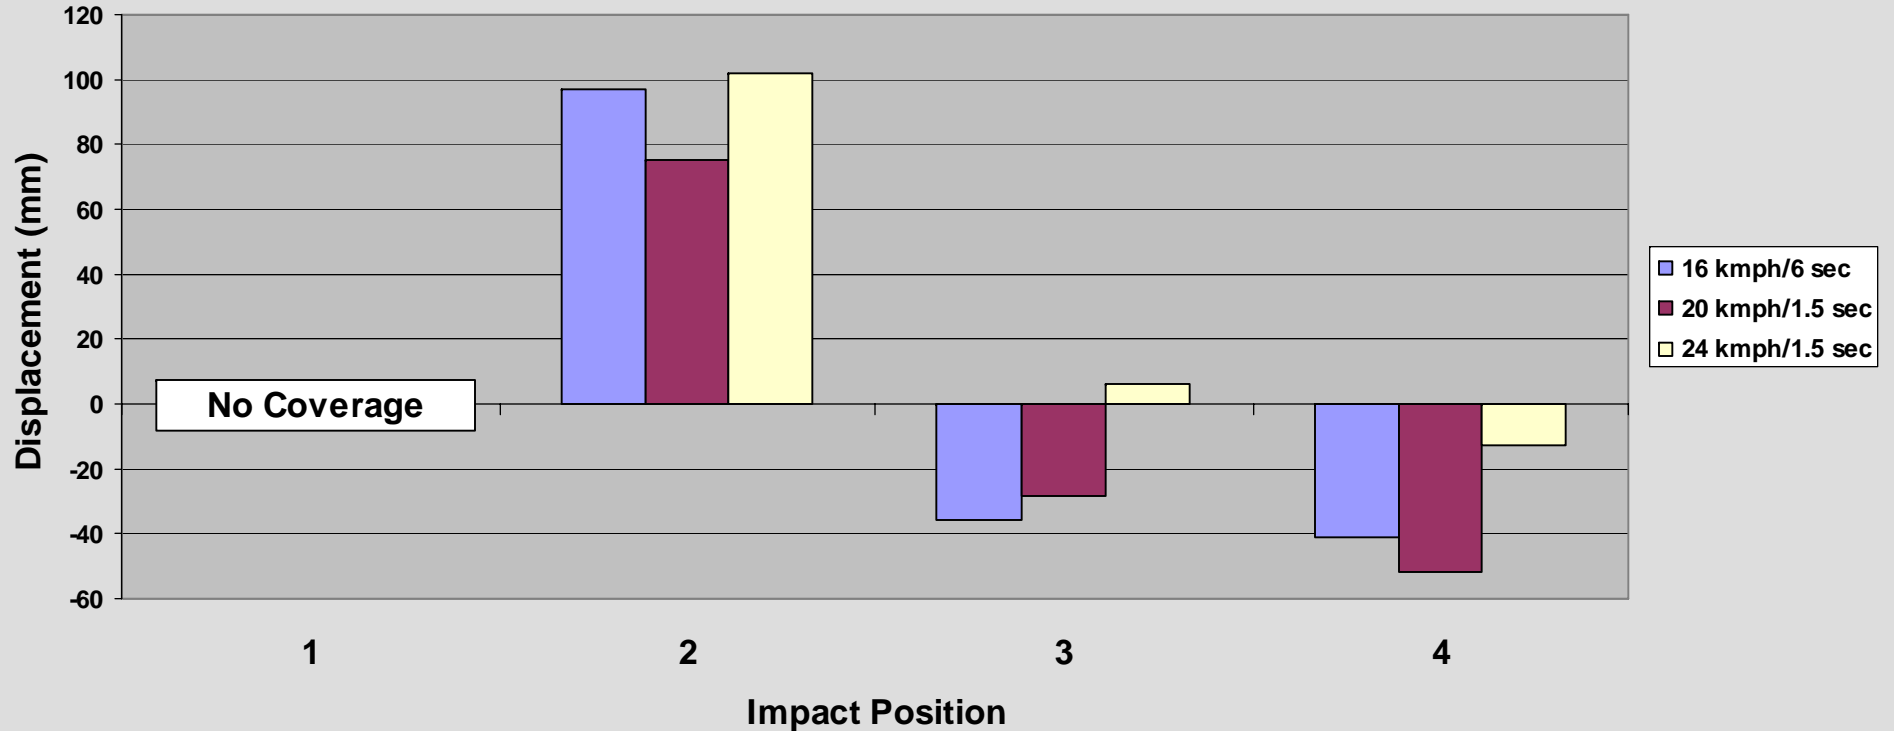
Maximum Excursion Beyond Window Plane
TRW - No Glazing

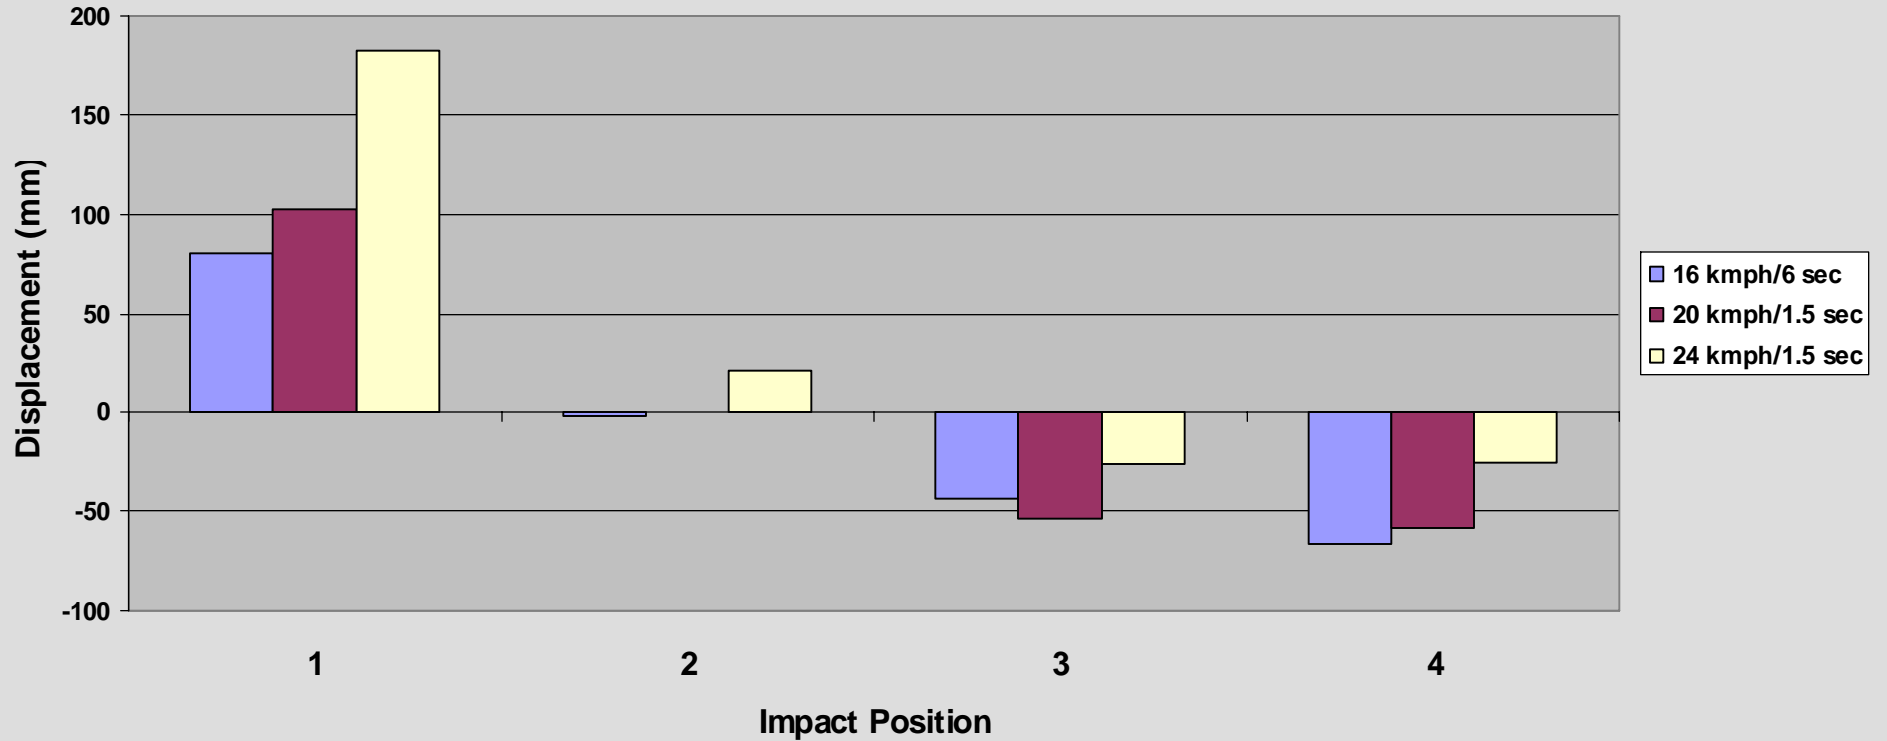
Maximum Excursion Beyond Window Plane
TRW - Pre-Broken HP Laminate

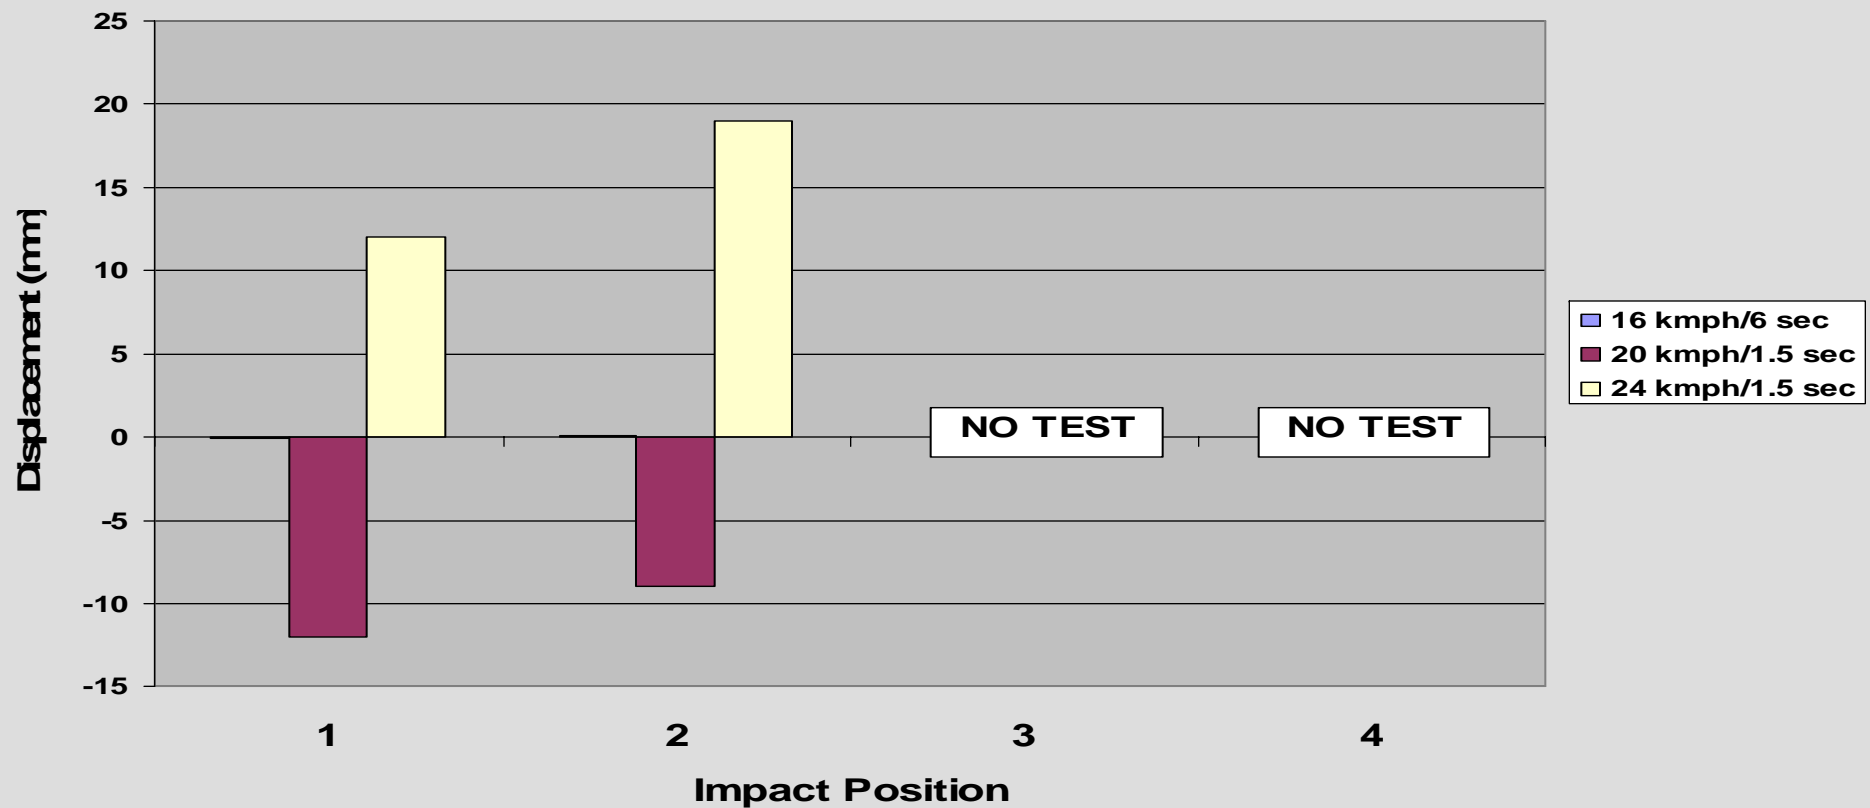
**Maximum Excursion Beyond Window Plane
Zodiac AHPS(beltline) - No Glazing**

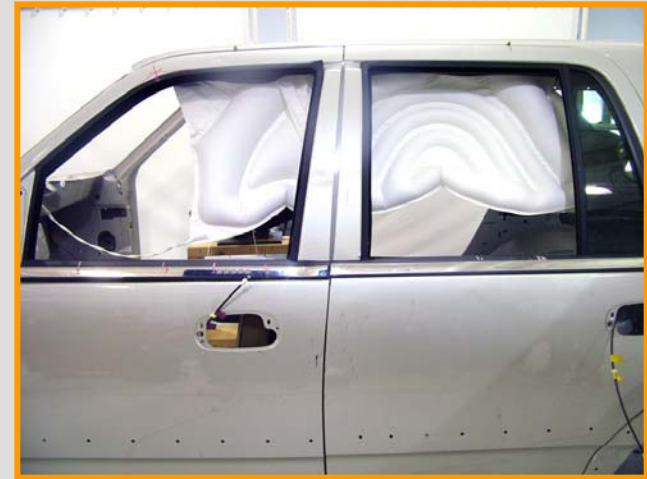
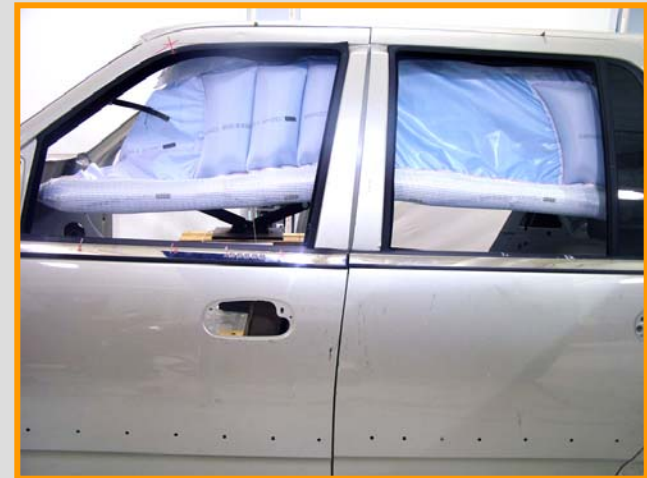
Additional Systems Evaluated

- **Inflatable Systems**
 - Production Window Curtains
 - 2003 Lincoln Navigator
 - 2004 Volvo XC90
 - Advanced Head Protection Curtain (AHPC)
 - Zodiac Automotive US
- **Inflatable/Laminated Glazing Combination**
 - 2003 Lincoln Navigator (front only)
 - 2004 Volvo XC90

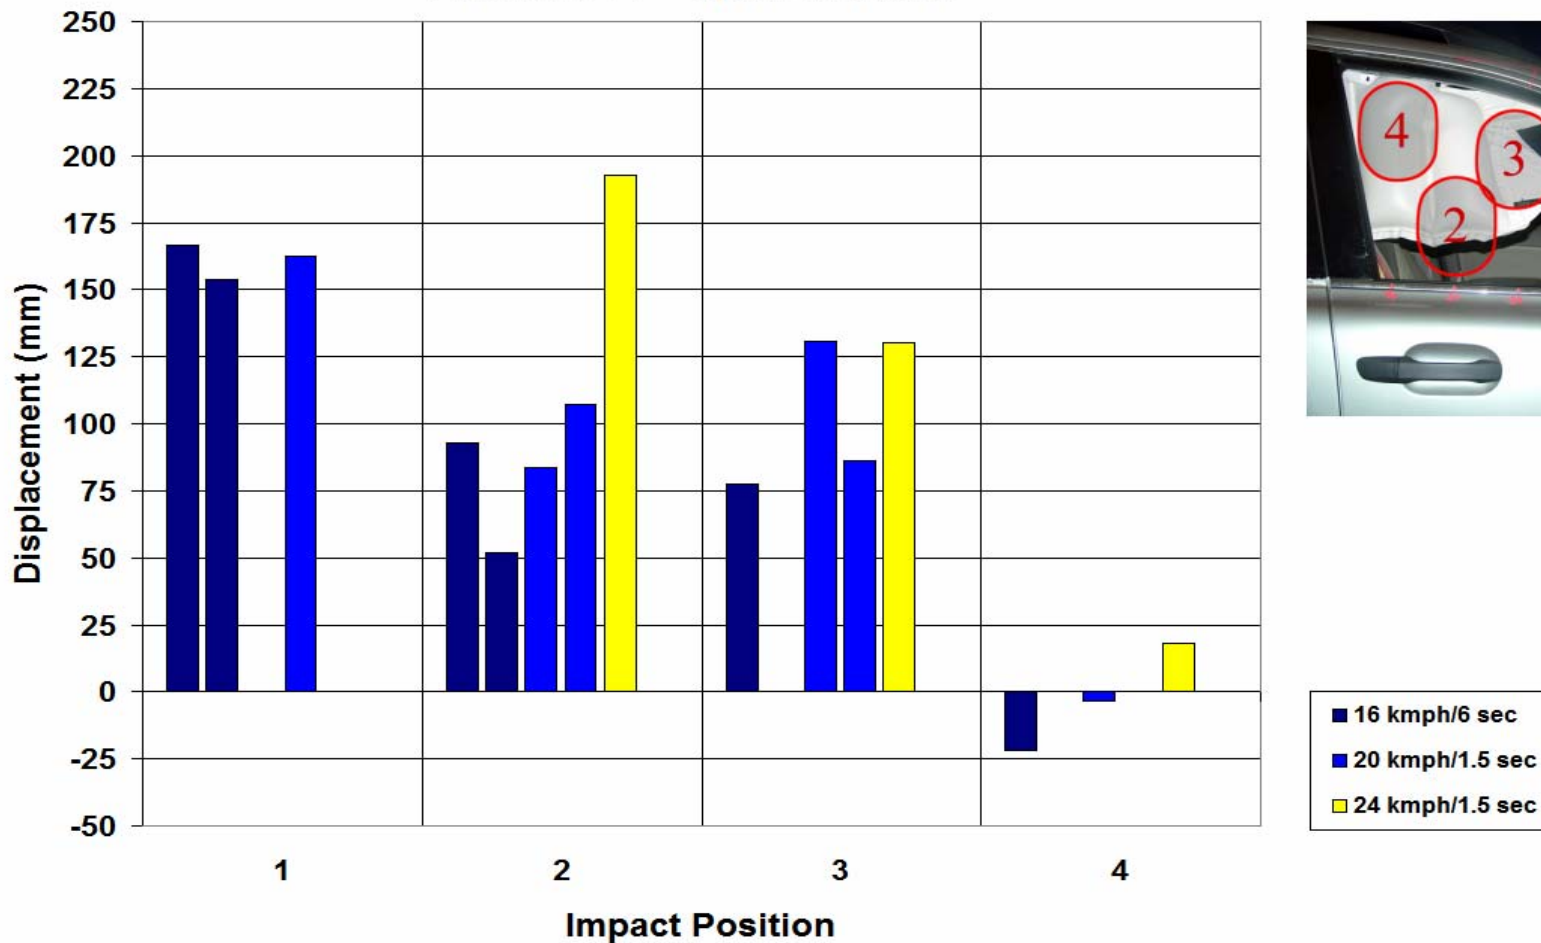
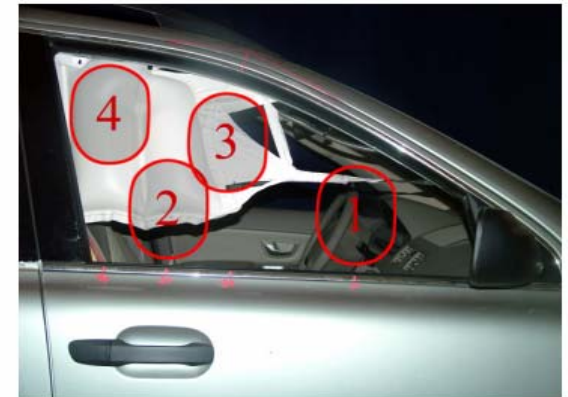
Ejection Mitigation Impactor Results – Front Window

Maximum Excursion Beyond Window Plane
Volvo XC90 - Open Window

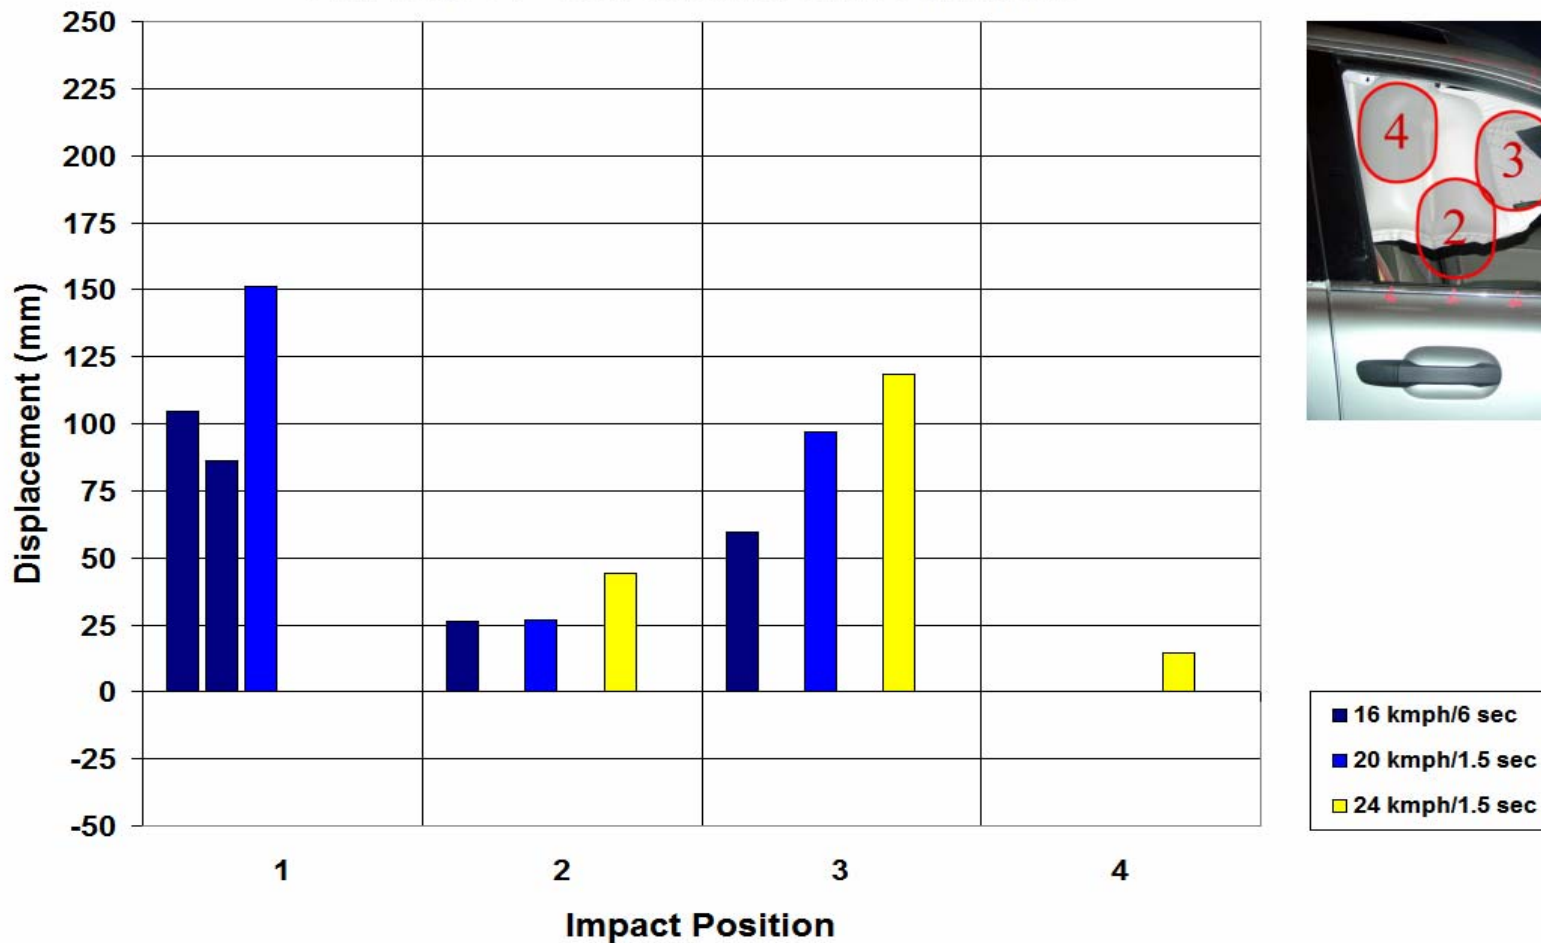
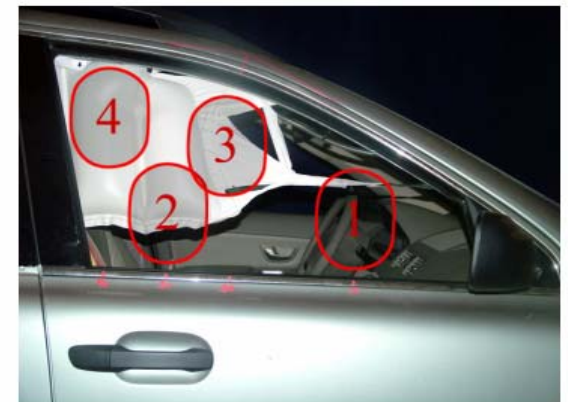
Ejection Mitigation Impactor Results – Front Window

Maximum Excursion Beyond Window Plane
Volvo XC90 - Pre-Broken Side Laminates

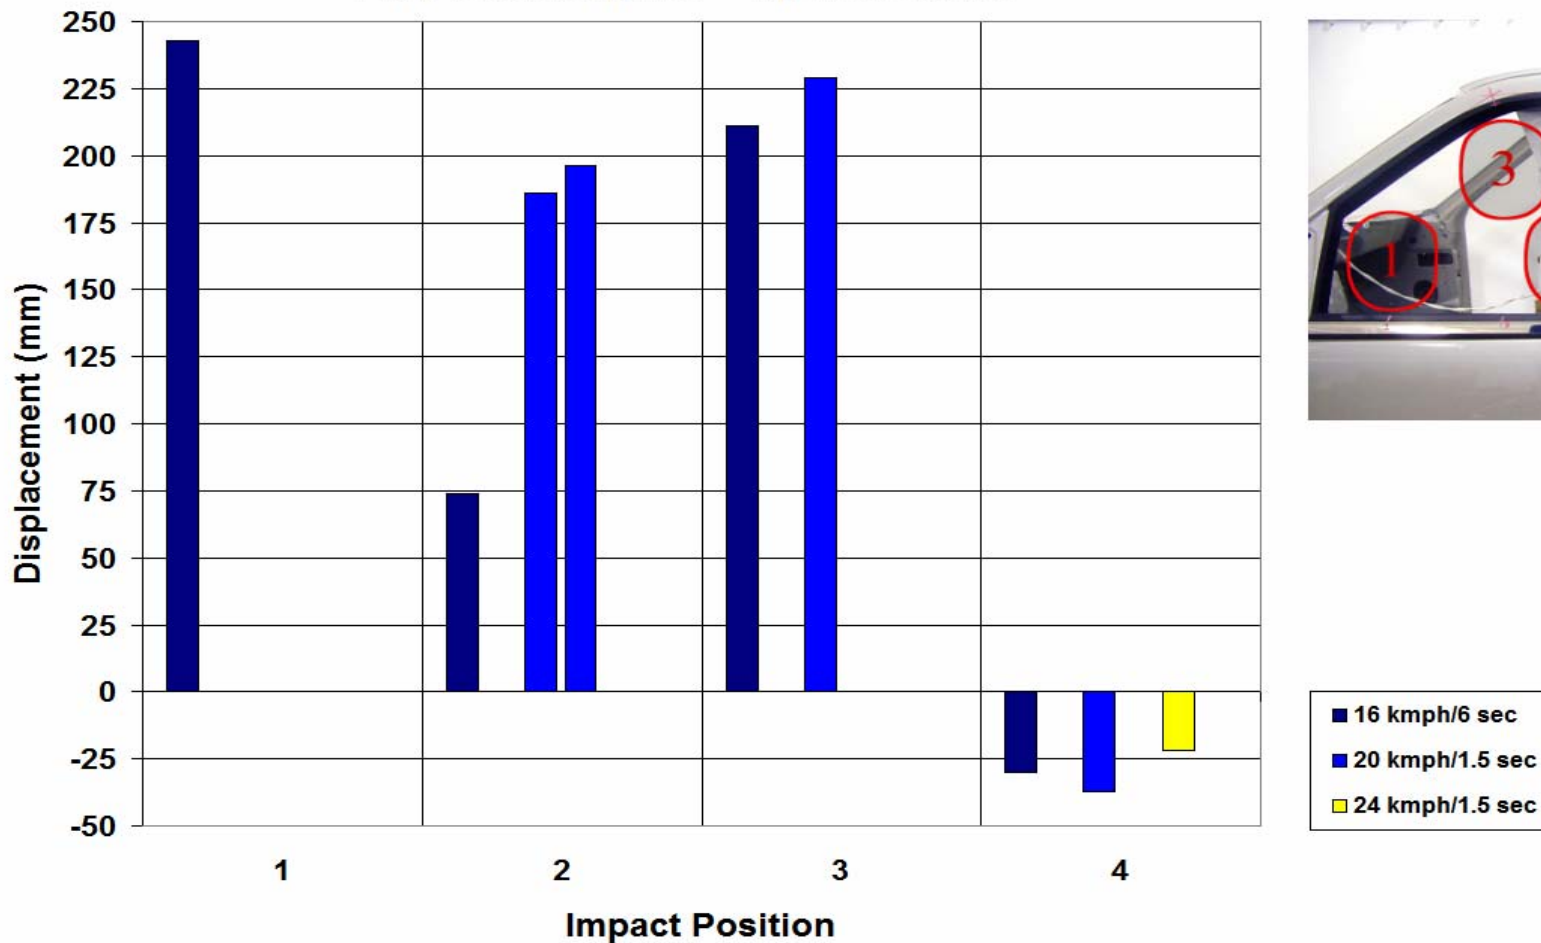
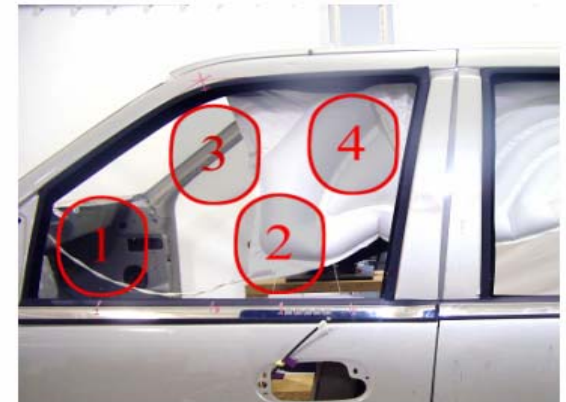
Ejection Mitigation Impactor Results – Front Window

Maximum Excursion Beyond Window Plane
Lincoln Navigator - Open Window

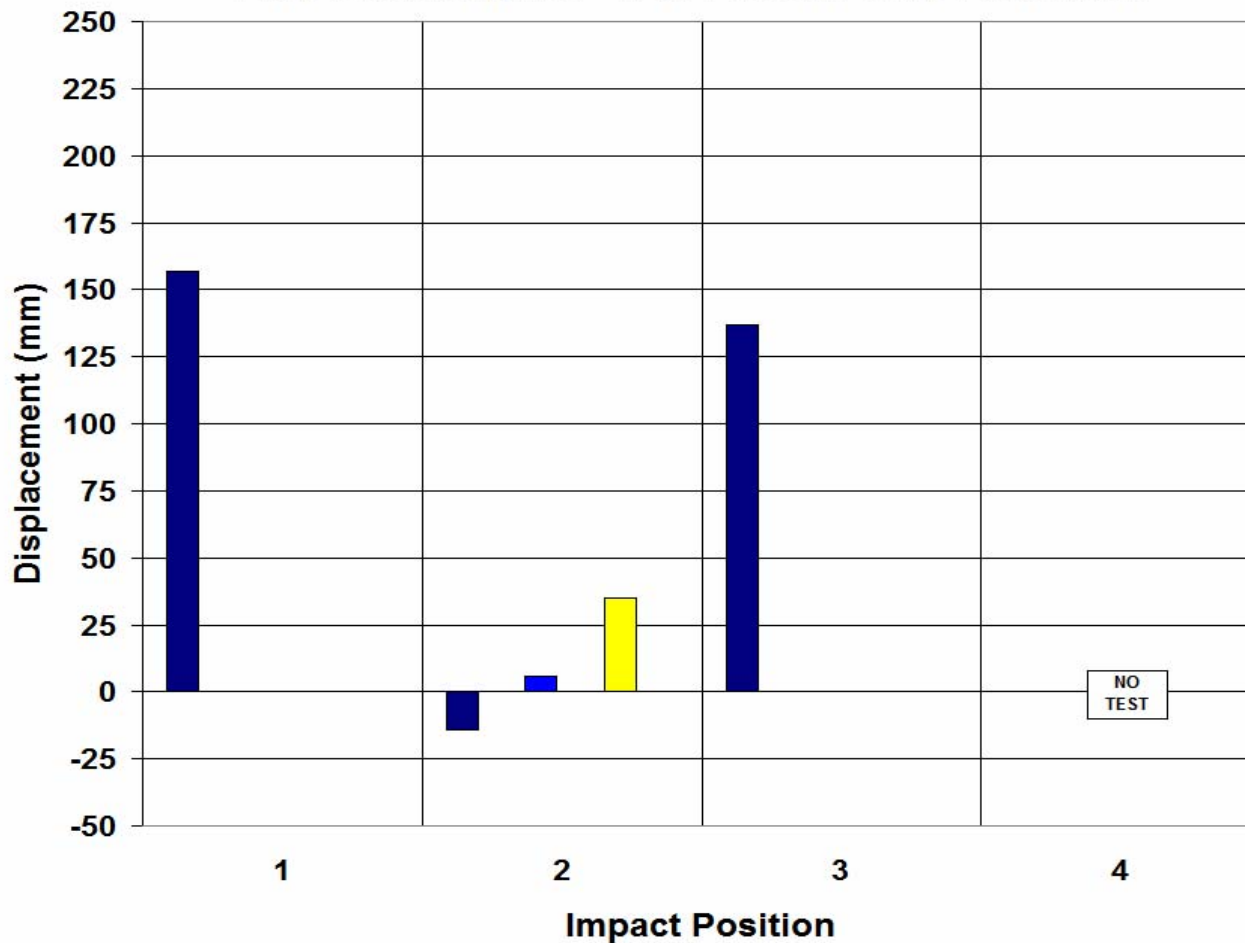
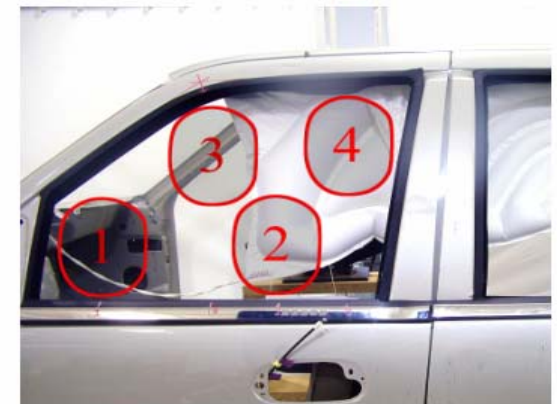
Ejection Mitigation Impactor Results – Front Window

Maximum Excursion Beyond Window Plane
Lincoln Navigator - Pre-Broken Side Laminates

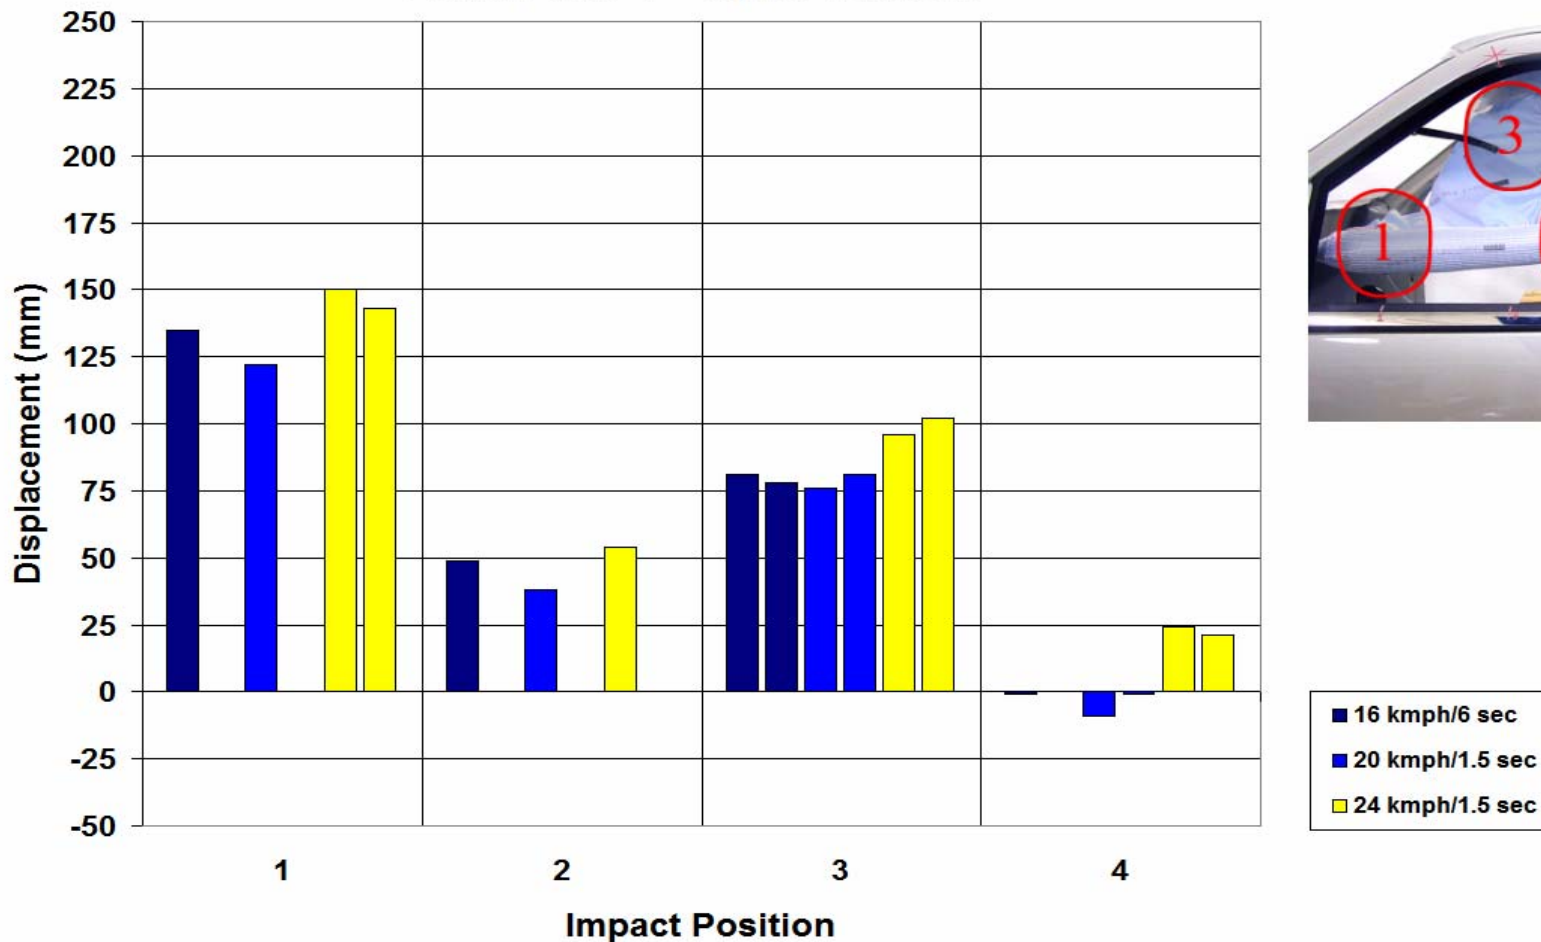
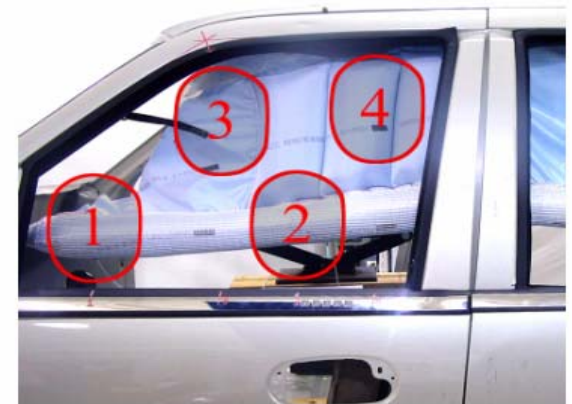
Ejection Mitigation Impactor Results – Front Window

Maximum Excursion Beyond Window Plane
Zodiac AHPC - Open Window

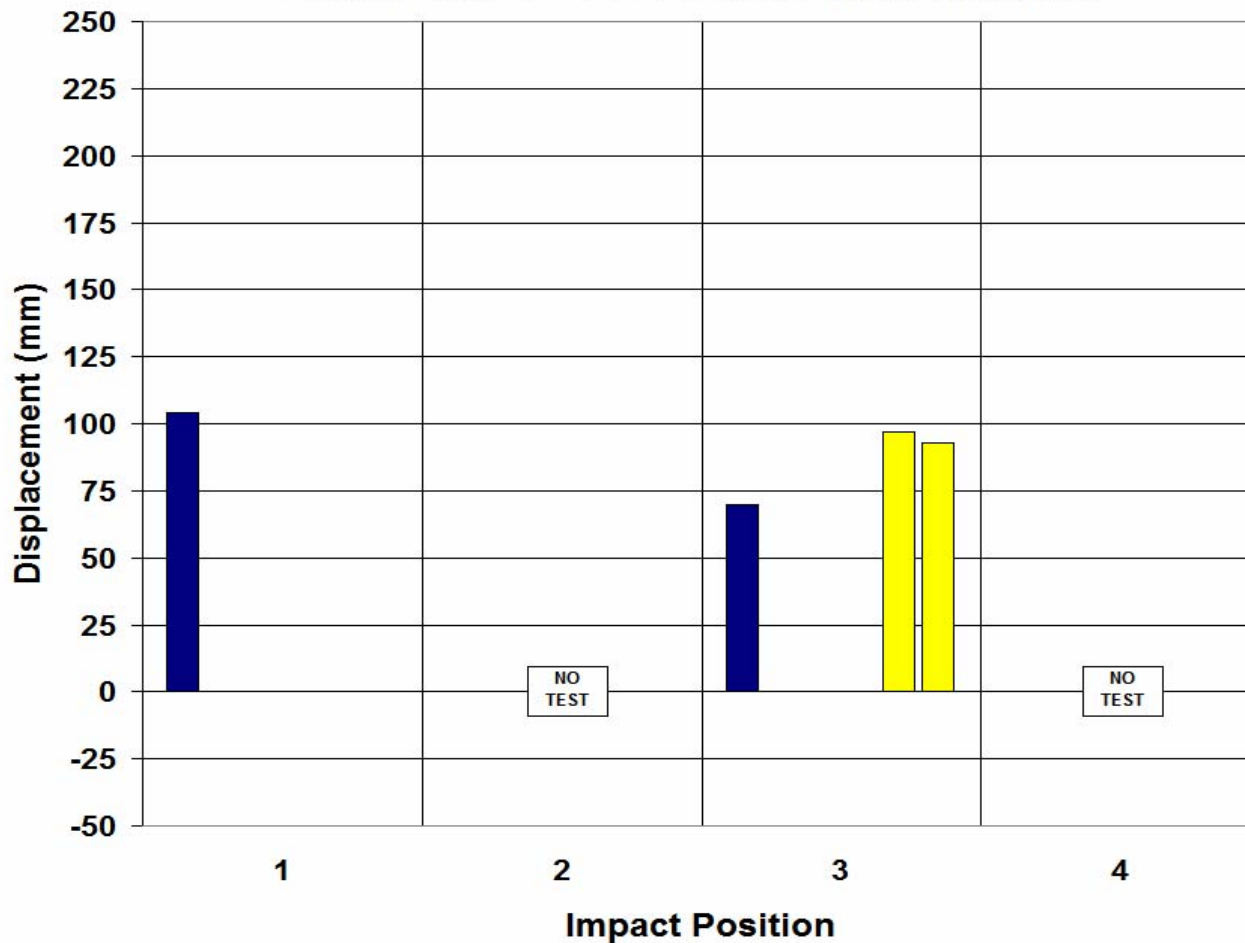
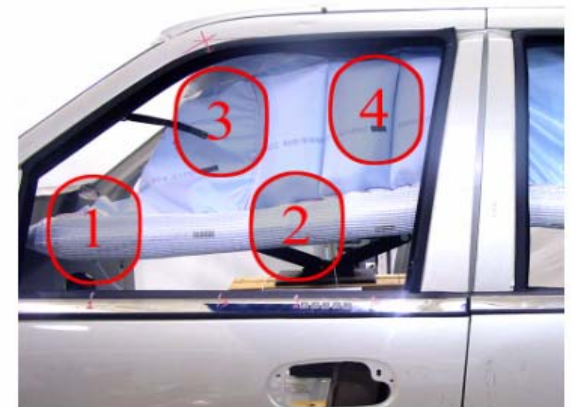
Ejection Mitigation Impactor Results – Front Window

Maximum Excursion Beyond Window Plane
Zodiac AHPC - Pre-Broken Side Laminate

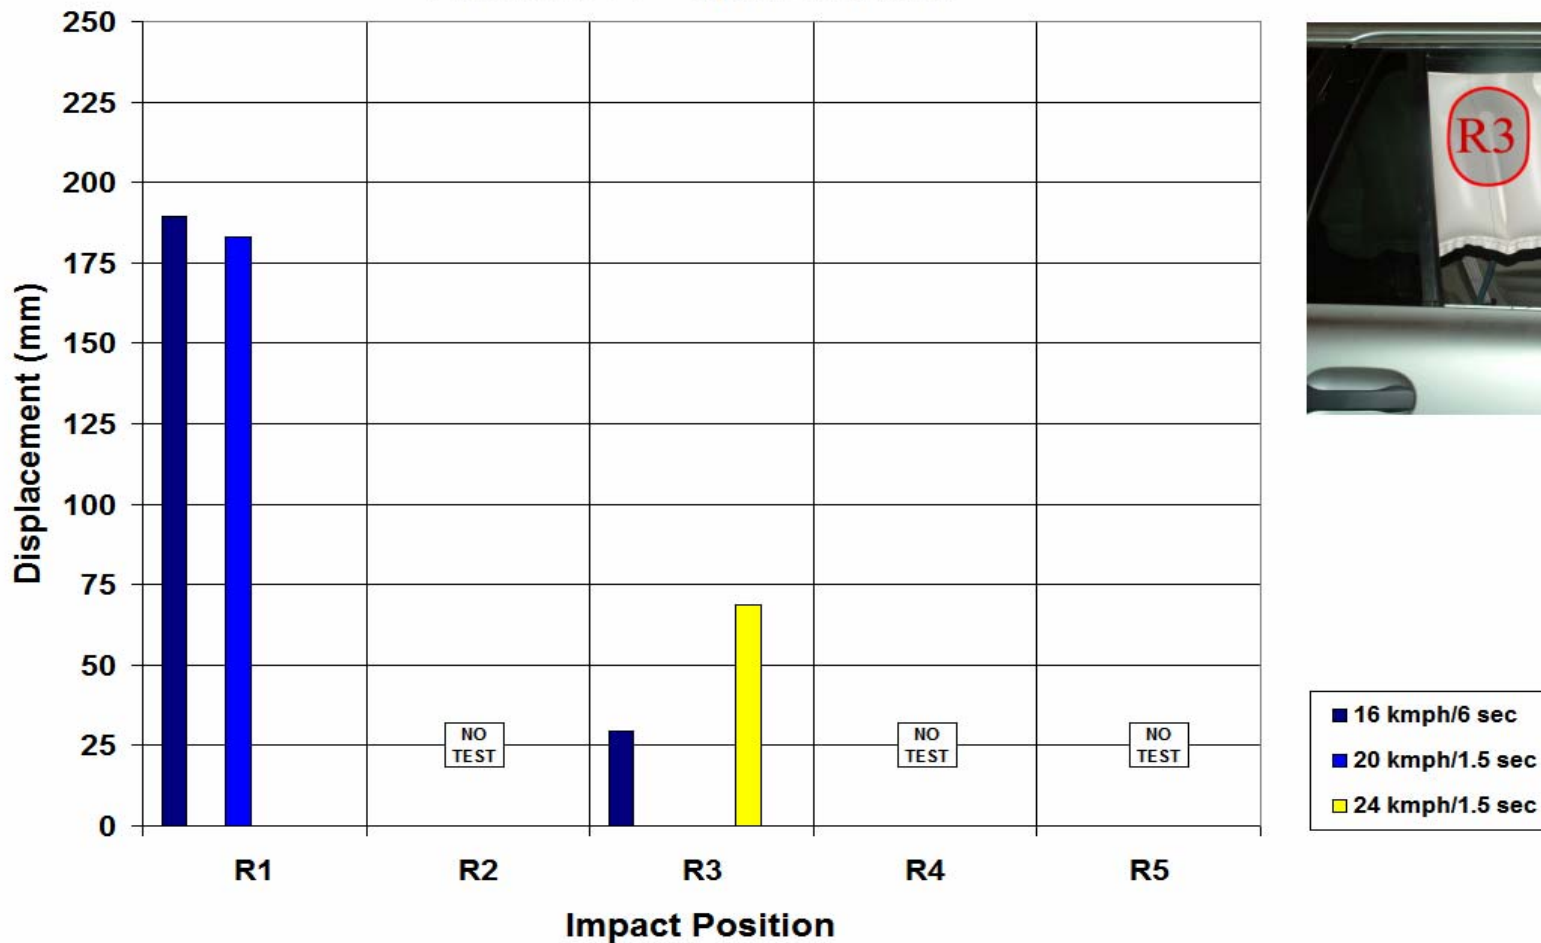
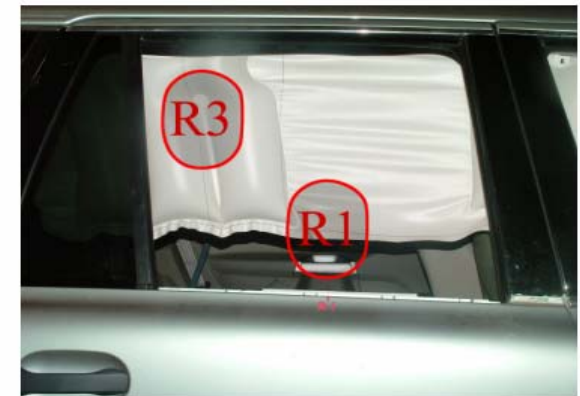
Ejection Mitigation Impactor Results – Rear Window

Maximum Excursion Beyond Window Plane
Volvo XC90 - Open Window

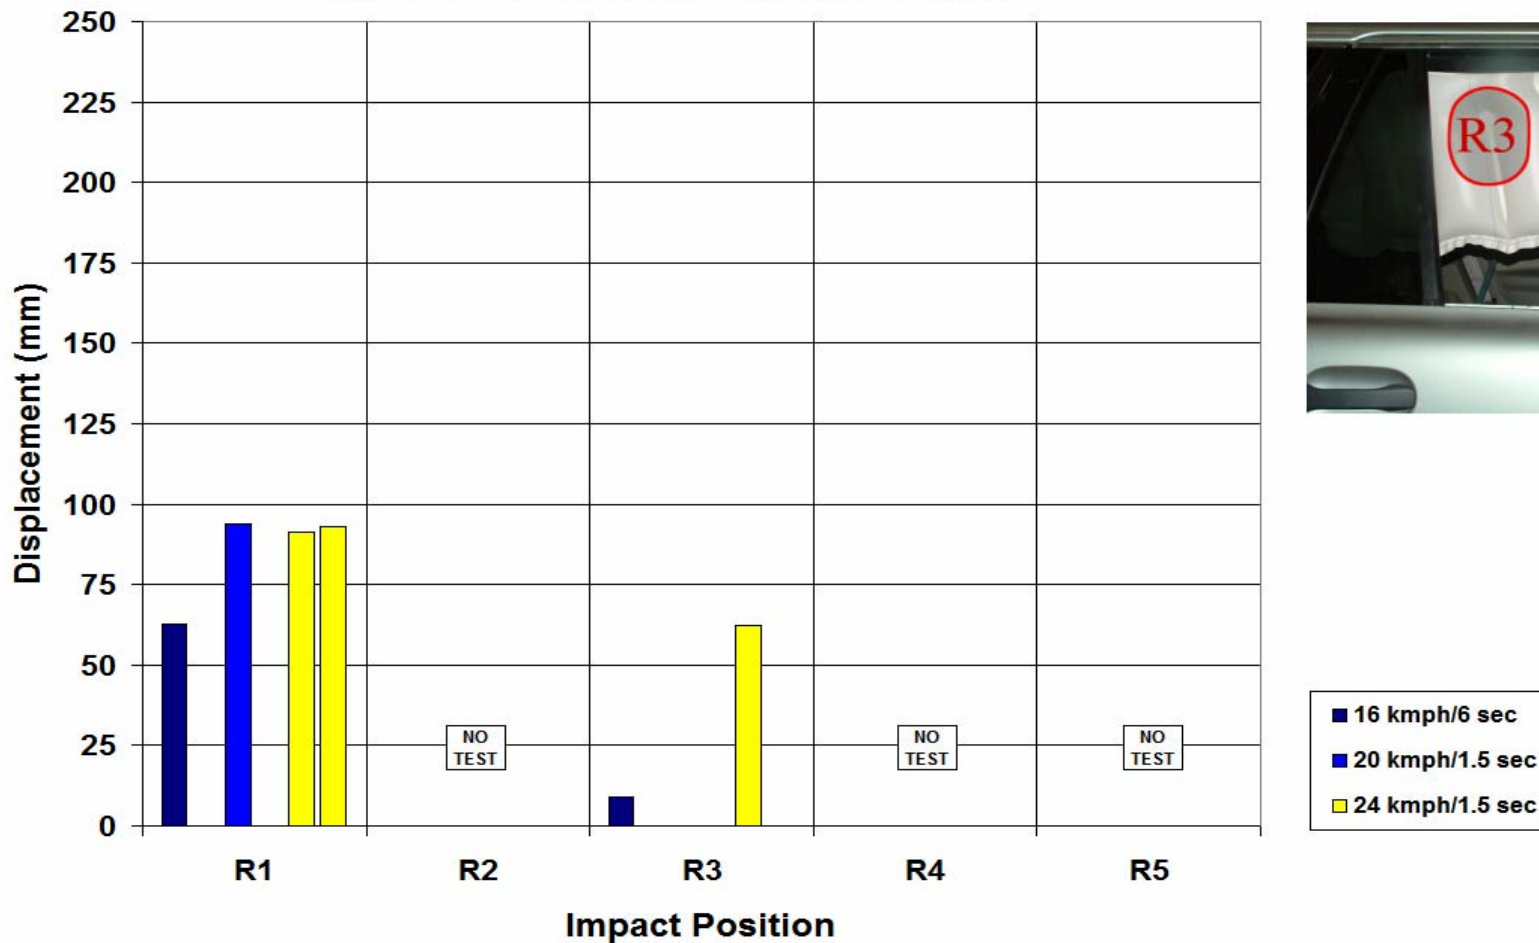
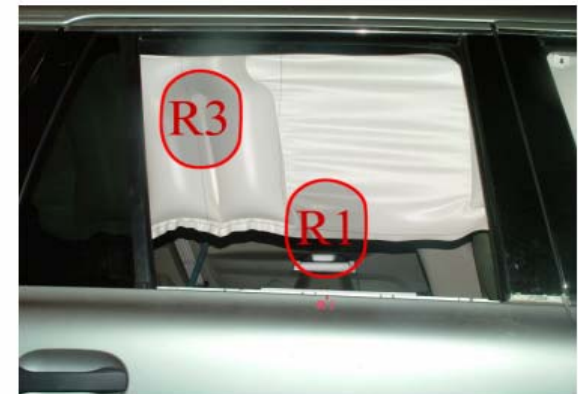
Ejection Mitigation Impactor Results – Rear Window

Maximum Excursion Beyond Window Plane
Volvo XC90 - Pre-Broken Side Laminate

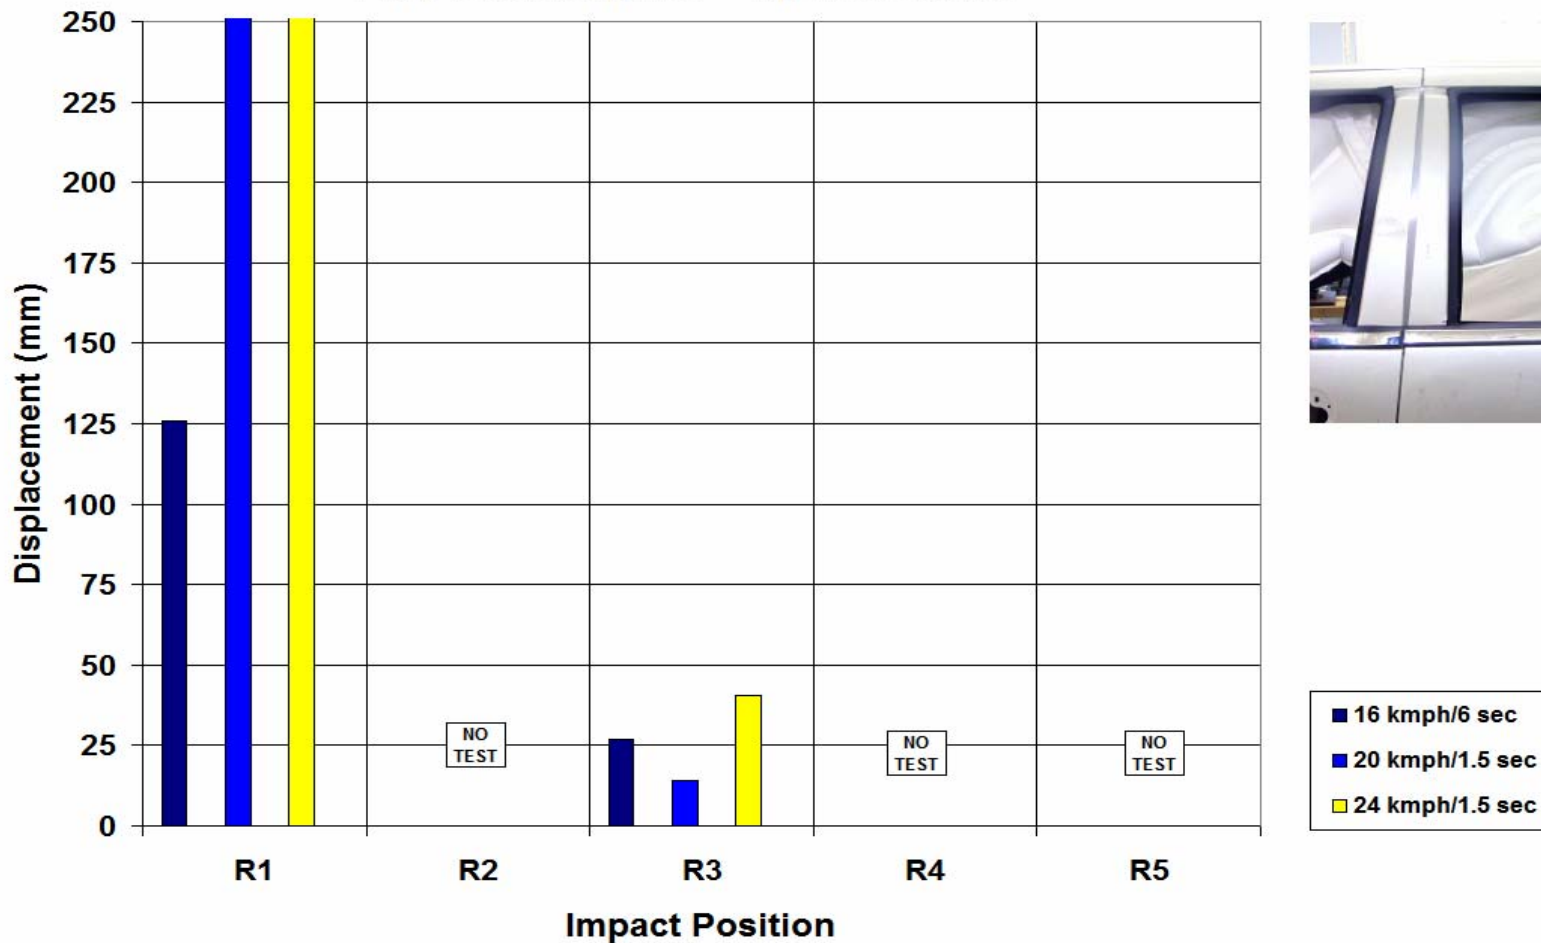
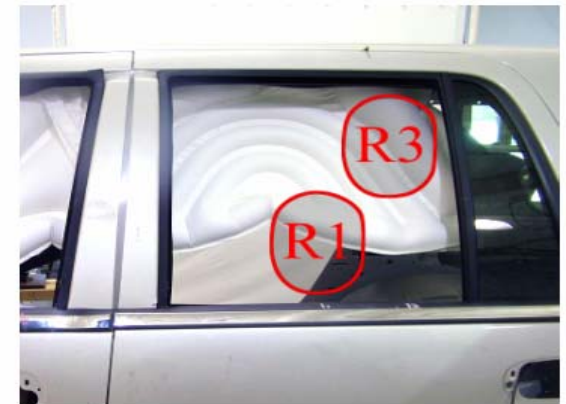
Ejection Mitigation Impactor Results – Rear Window

Maximum Excursion Beyond Window Plane
Lincoln Navigator - Open Window

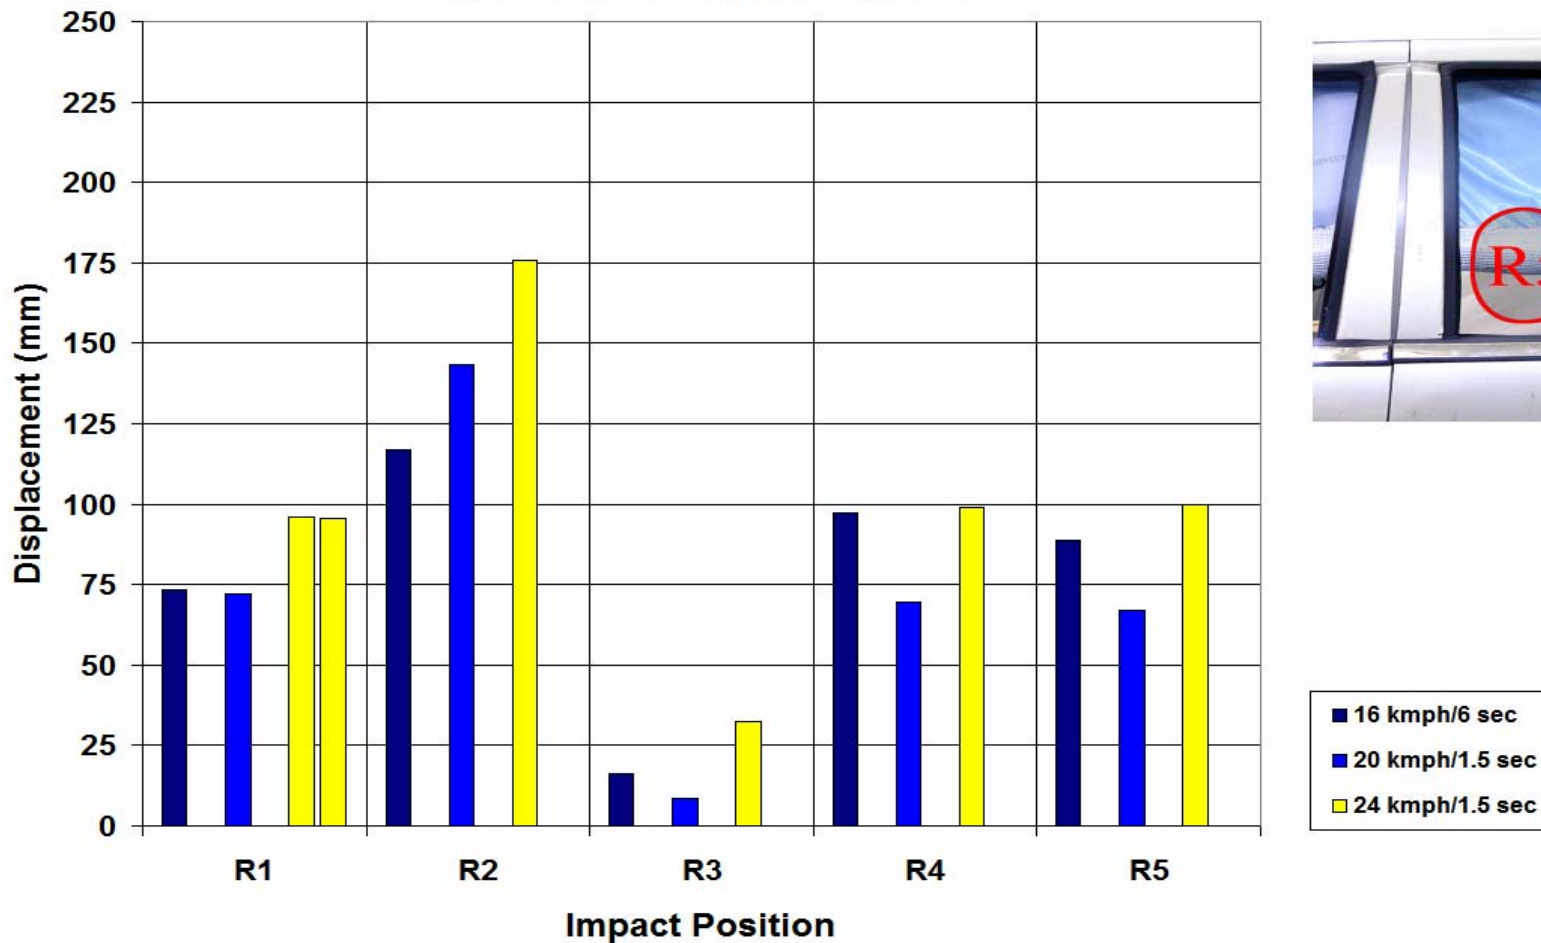
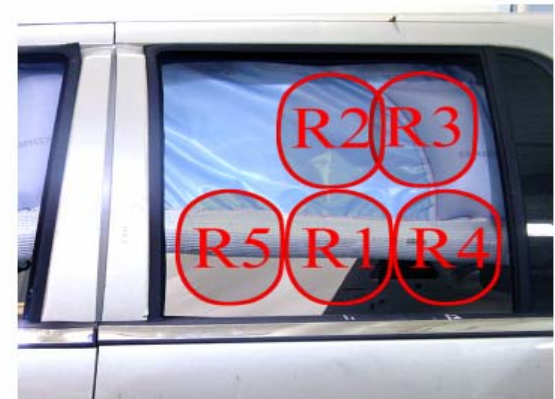
Ejection Mitigation Impactor Results – Rear Window

Maximum Excursion Beyond Window Plane
Zodiac AHPC - Open Window
