Status of NHTSA's Research on Occupant Protection in Rollovers

NHTSA / GM Research Meeting
March 29, 2006

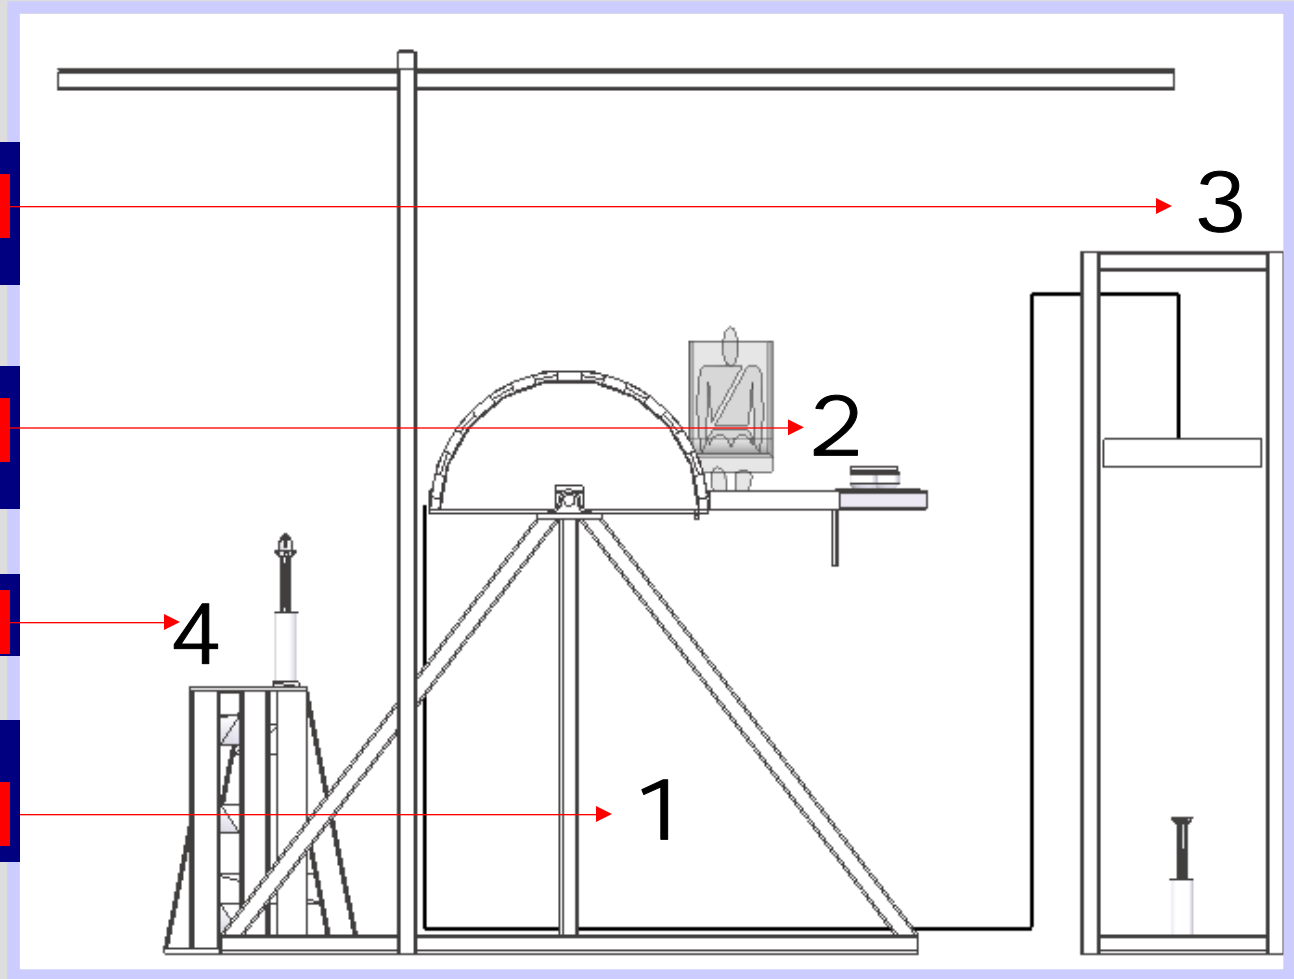
Rollover Restraint Tester

Free-Weight
Drop Tower

Rotating Test
Platform

Shock Tower

Support
Framework
