# Dive Team Implodes Building on Kwajalein Atoll

By Captain Charles T. Denike

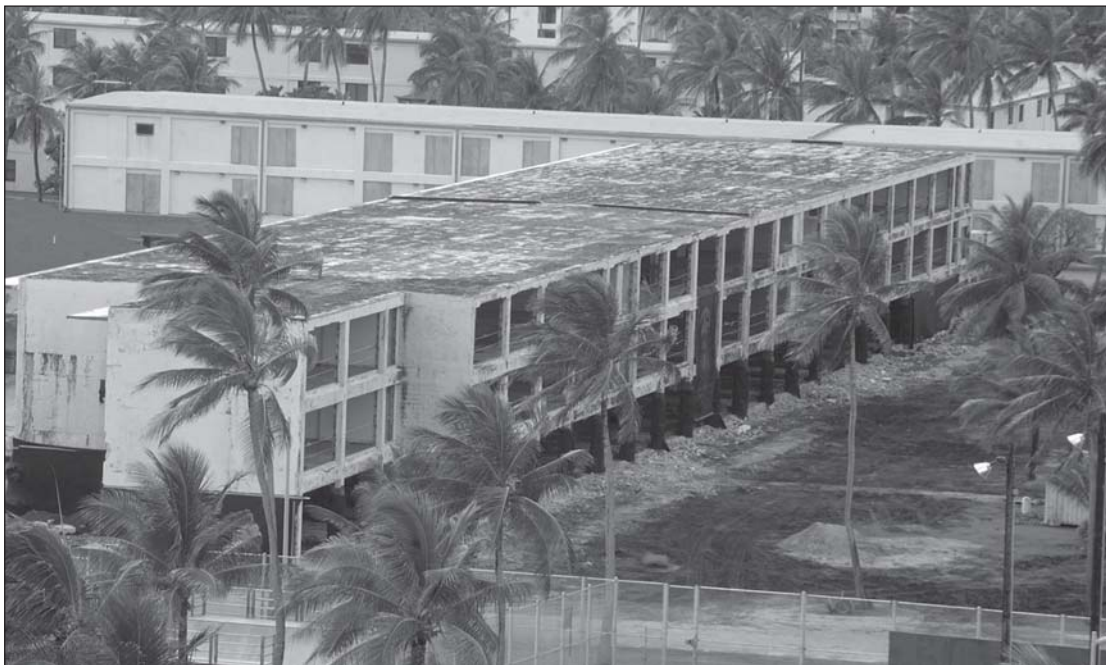
Glass and other interior components were removed from Building 708 in preparation for the implosion.

**F**rom March through June, Kwajalein Range Services (KRS) conducted soft demolition of the building, which included removing all glass, interior walls, paint, electrical wires, plumbing, fixtures, and furniture. KRS also installed window barricades on surrounding buildings to protect against glass breakage, but did not remove the building's four stairwells, each of which went to the third floor and was surrounded by secondary columns and concrete masonry unit (CMU) walls. While not designed to be load bearing beyond the limits of the stairwells, these columns and walls were strong enough to withstand a substantial load. With the time allowed, the 82d Engineer Company was able to remove three of the four stairwells on the first floor.

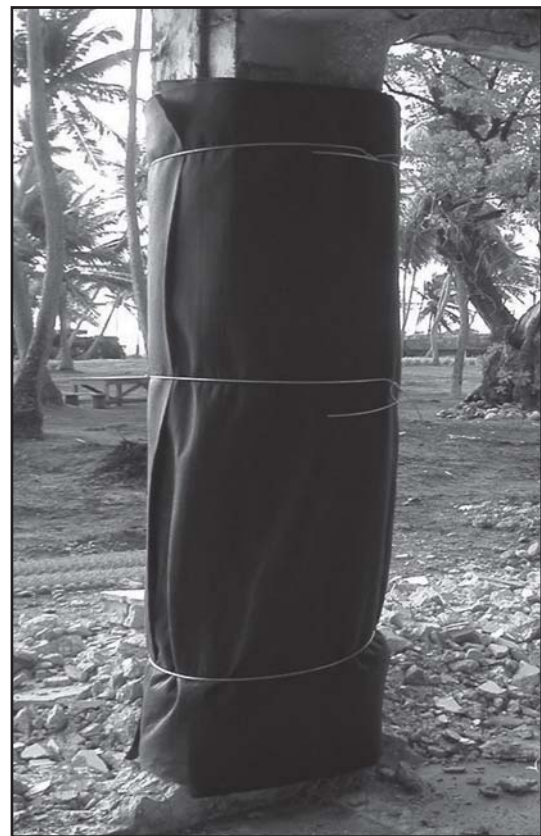
Each column was wrapped with two layers of chain-link fence and nonwoven geotextile fabric to contain fragmentation.

The team primed 168 charges, loaded them in the boreholes, and stemmed the boreholes with expanding foam. They wrapped all 84 columns with two layers of chain-link fence and nonwoven geotextile fabric to contain fragmentation. On each column, the chain-link fence was secured with four hog rings and the nonwoven geotextile fabric was secured with three wire ties. Four M15 high- and low-strength time delay blasting caps (two primary and two secondary systems) were used, and two M11 high-strength blasting caps were used to create the 225 milliseconds delay between each of the eleven sequences that detonated consecutively from the south to the north end of the building. The net explosive weight (NEW) of each sequence was 8.92 pounds and the total NEW for all sequences was 94.45 pounds. Since the sequences were delayed 225 milliseconds (more than the industry standard of 8 milliseconds), the entire blast was modeled with a NEW of 8.92 pounds. The blast was initiated with two M81 igniters (primary and secondary) and two M13 (1,000-foot) low-strength blasting caps.

- Using protective materials at the charge placement. Each column was wrapped with two layers of chain-link fence and two layers of nonwoven geotextile fabric that reduced the number of fragments projected from the column and their speed. The wrap contained 95 percent of the fragmentation on the test shot column. Additionally, the

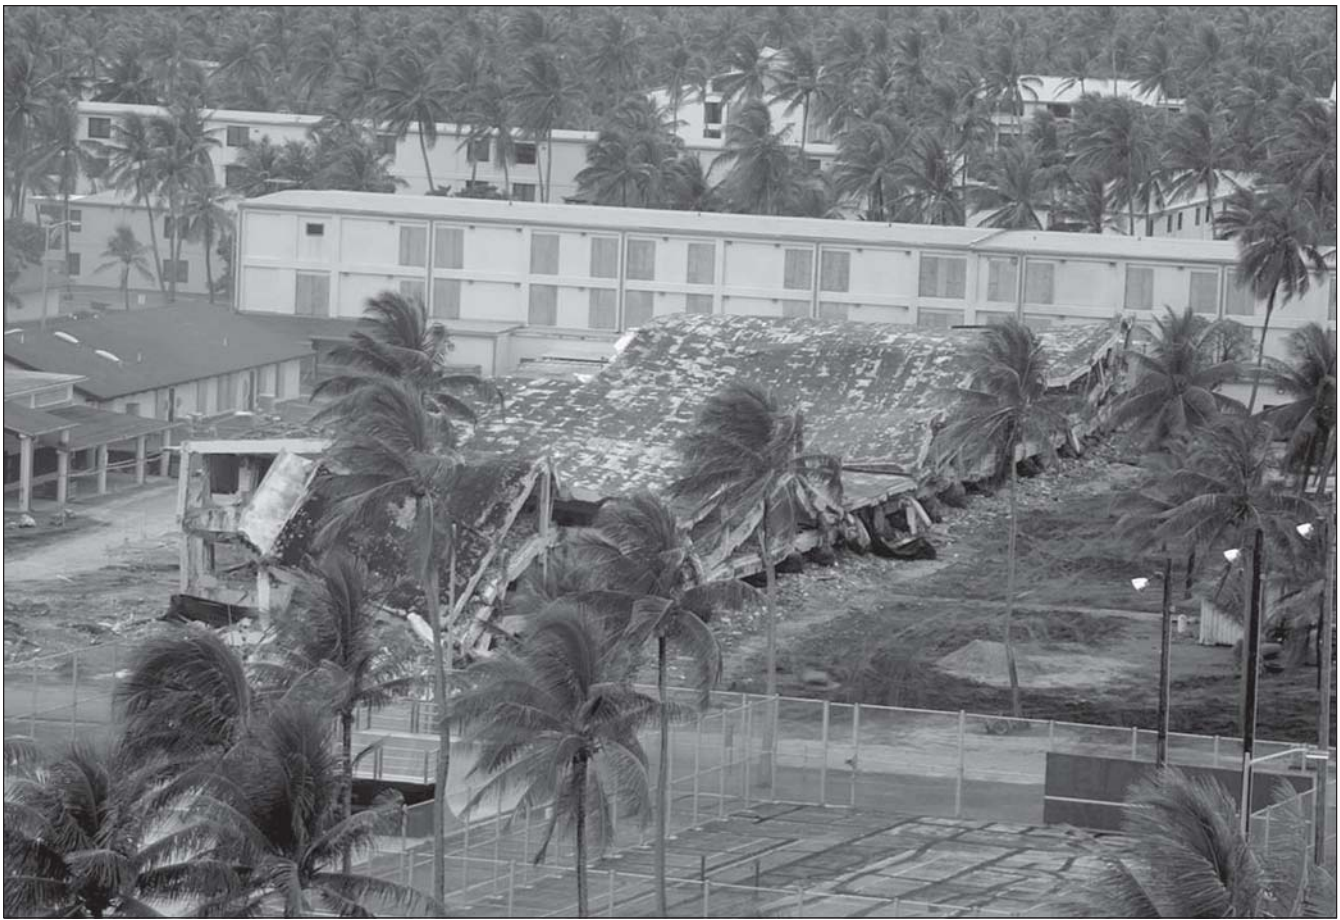
**The building was reduced by at least half by the blast.**

The blast collapsed the entire first floor, 75 percent of the second floor, and 50 percent of the third floor. The final stairwell that was unable to be removed on the first floor supported some of the structure during the collapse. Portions of the second and third floor remained supported since the stairwells had not been removed above the first floor.
